Conservation Management Plan

Salk Institute for Biological Studies

La Jolla, California

October 2016 [Redacted May 2017]

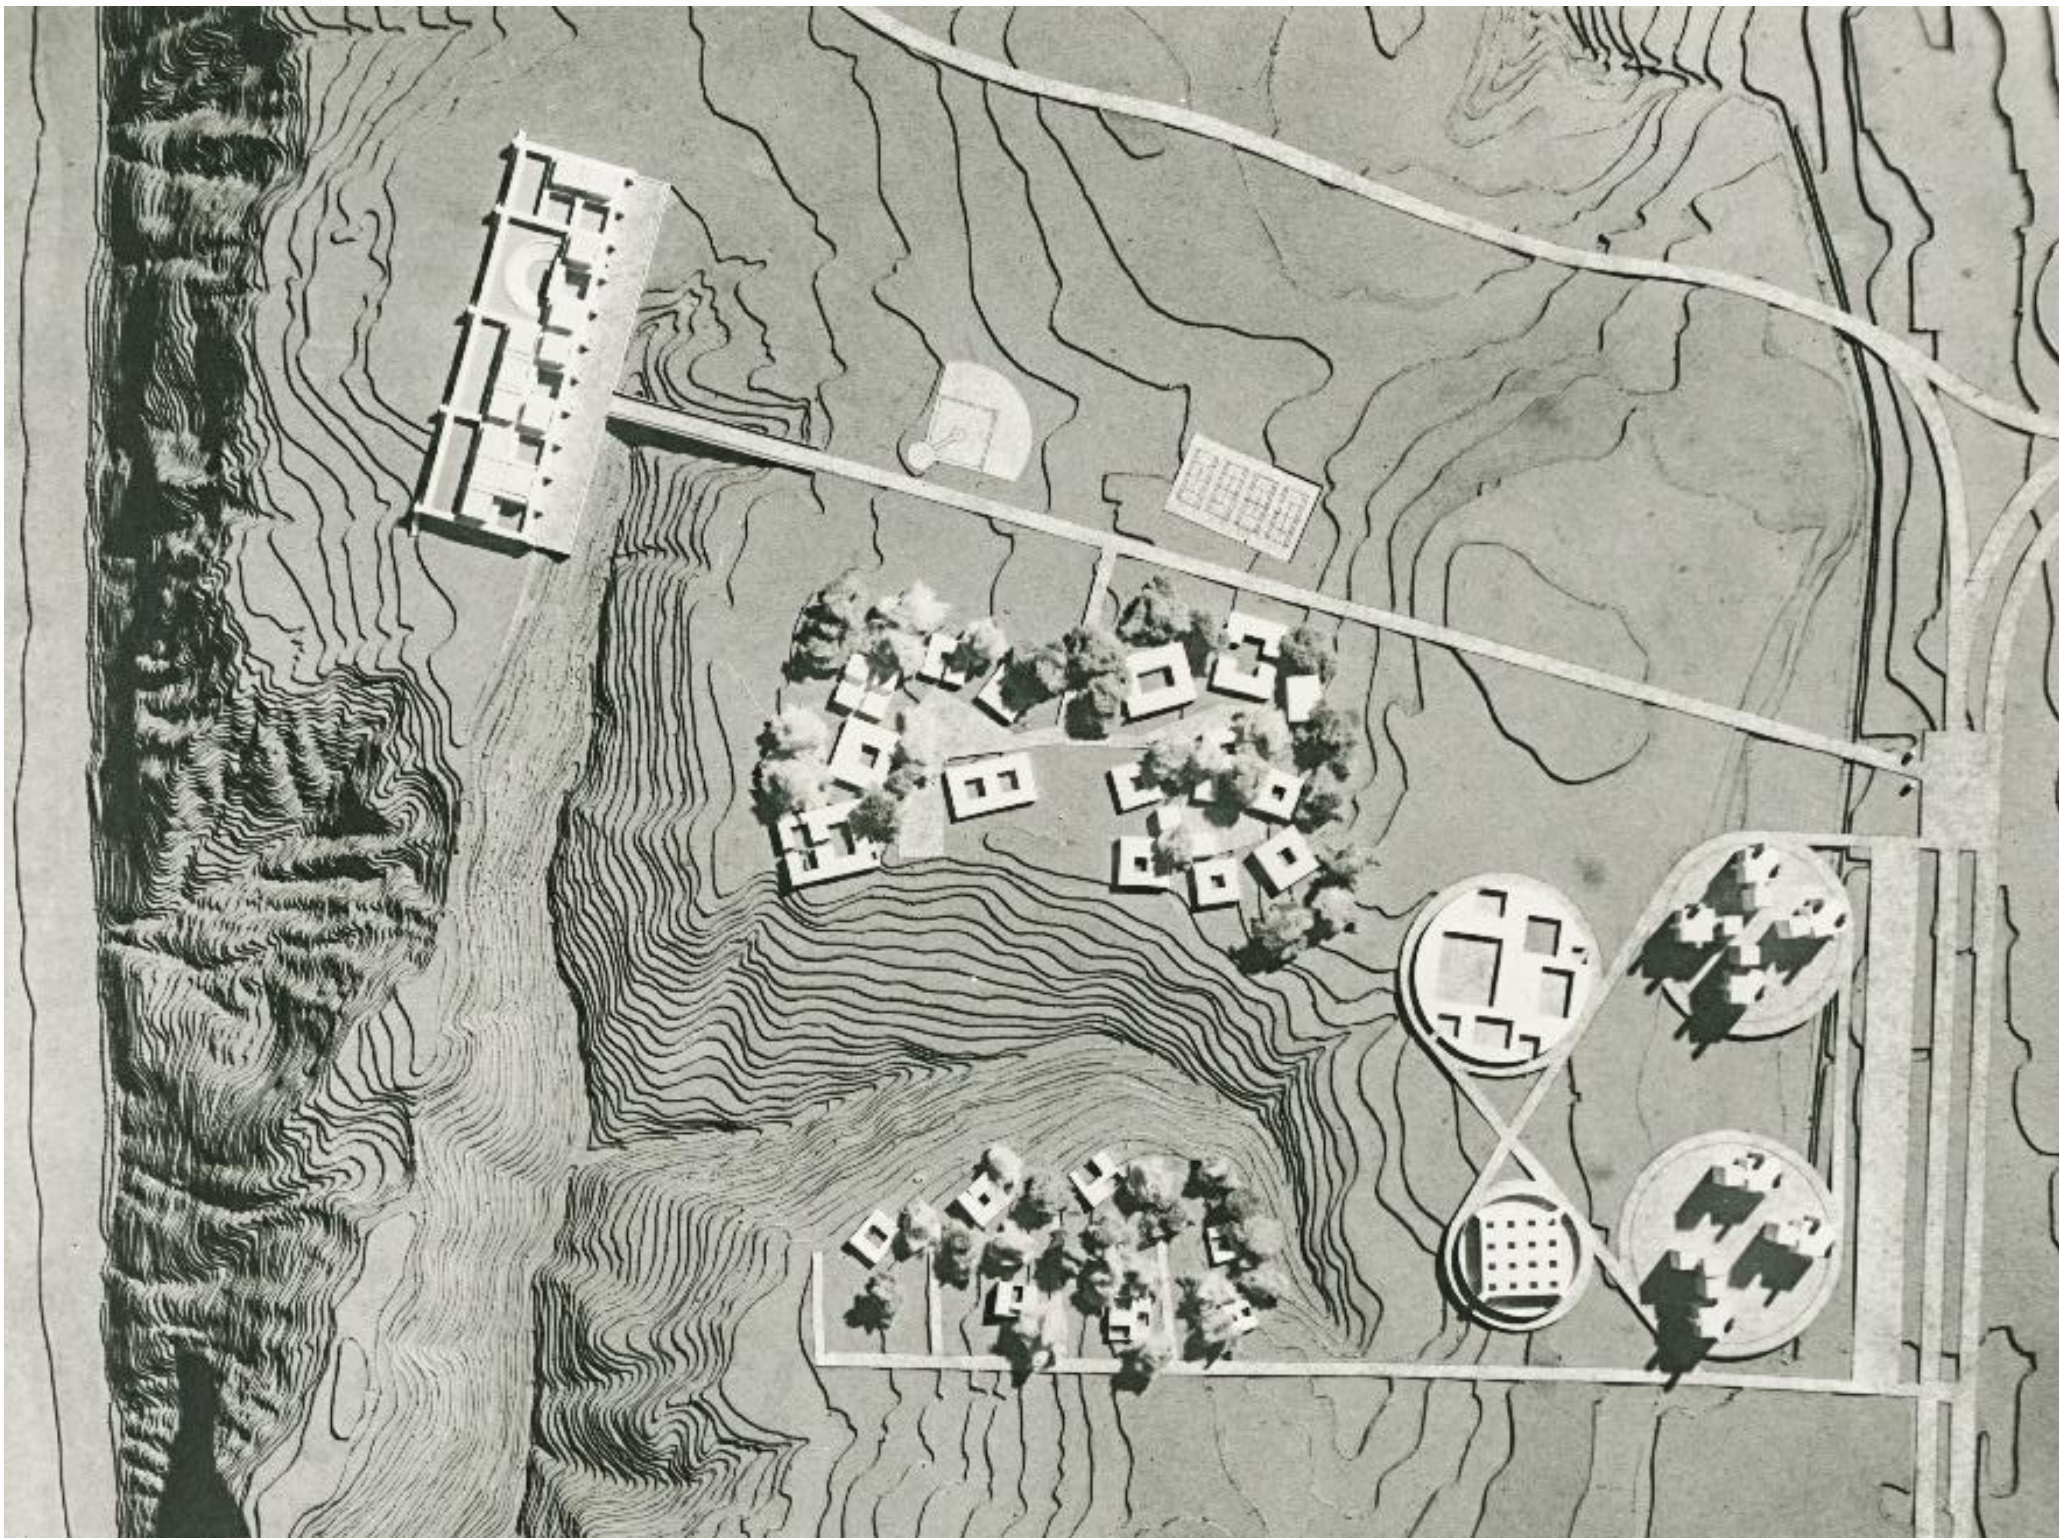
First Design, model of proposal presented to the city of San Diego, March 1960: scheme planned around a north drive; predominant Meeting House by ocean; recreation and housing placed either side of canyon; laboratory towers by highway.

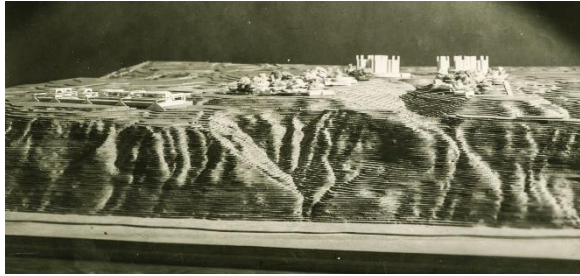
First Design, model view east from ocean; Meeting House on left and laboratory towers in distance, March 1960.

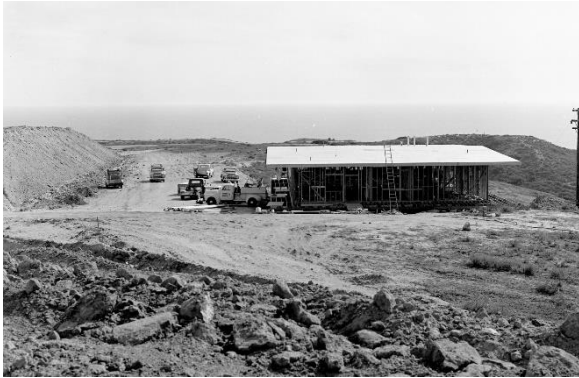
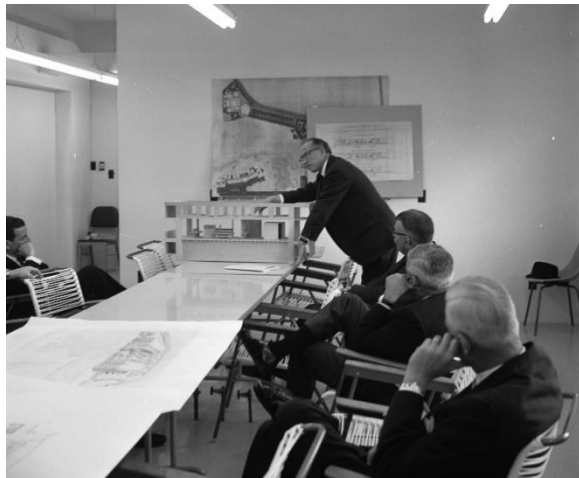
Top: Temporary Building No. 1 under construction, 1963.
Bottom: Dr. Salk explaining the Third Design to Trustees in the temporary buildings, 1964.

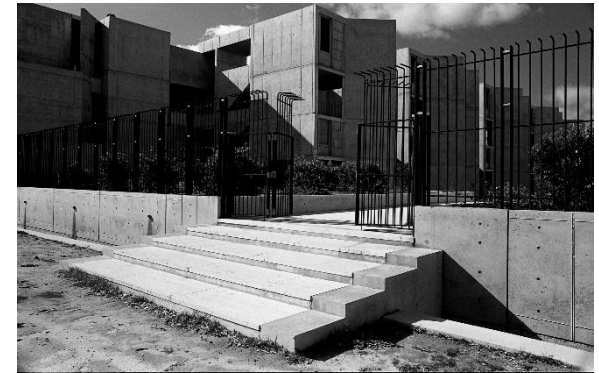
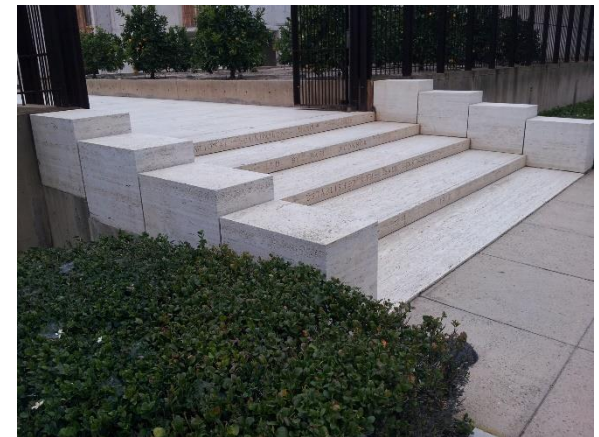
The ornamental Corten and stainless steel railings that extend between the concrete shafts and the East Gate were designed by Kahn's office in 1963 and erected in 1965. The steps from the grove were constructed in travertine set flush with concrete strings, but the travertine block parapets were introduced to meet code sometime after 1967.⁴⁷

Top: East Gate, 1967.
Bottom: East Gate steps, 2015.

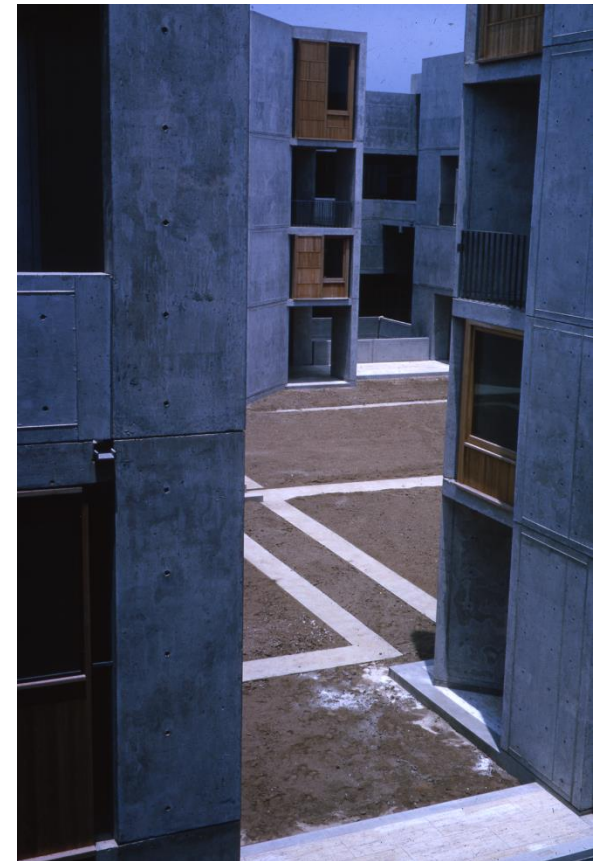
Plaza left with earth infill between channels, 1965.

The finishing of the court had been left incomplete when construction work stopped in July 1965. By that time, the principal construction access ramps from the west had been removed and the retaining walls and steps to the West Court had been constructed. So that the building could be used, travertine paving was installed along the sides of the Plaza below the study towers and returned across the east end; access at the west was through the West Court. However, the center of the Plaza was left unfinished except for a concrete grid of channels defining earth-filled bays either side of what would be the central rill; as Suzanne Bourgeois recalls it was a “muddy mess.”⁵³ Paving below the study towers and the retaining wall to the West Court were in place by July 1965.⁵⁴

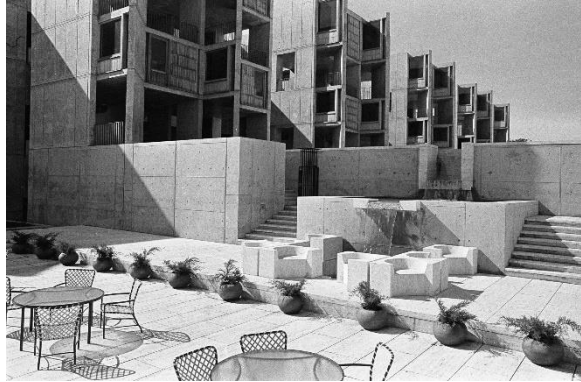
West Court, 1969. Kahn objected to the introduction of pot plants in the Plaza and the West Court.

Sometime before December 1969, plants in terra cotta pots were introduced into the court, much to Kahn's dismay. They were arranged along the rill and on the parapet at the west end of the Plaza, Kahn found them pitifully small and their presence an intrusion. He was much relieved when they were removed.⁶⁵ If plants were to be introduced, Kahn felt that they should be much larger and his sketch sections illustrate such plants in the study porticos and the lower garden courts, but not the Plaza.

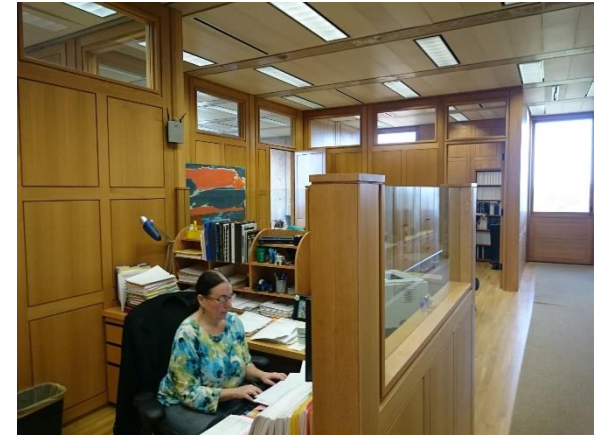
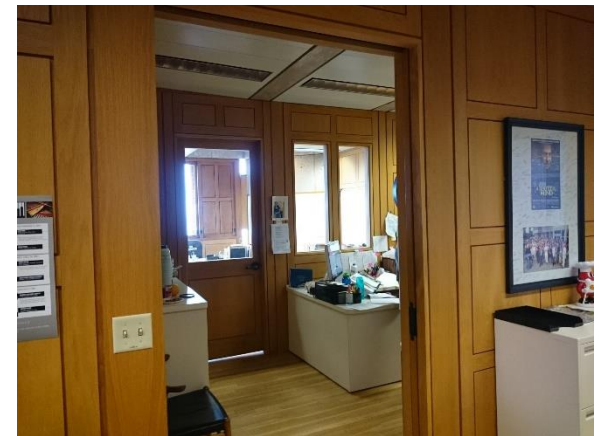
Executive offices, alteration of millwork partitioning, 2015.

As envisaged by the architect, over the years the partitions have been rearranged and supplemented to suit the changing requirements of the Institute with its ever growing staff levels. However, the planning has not been as skillful as that laid out in 1966 and the spatial generosity and richness have been lost. The subdivision of Dr. Salk’s offices has resulted in the creation of internal rooms dependent on borrowed light that would have been an anathema to Kahn, and on level 1, running a corridor adjacent to the window wall isolates the offices from the elevation. Even the travertine-paved “verandas” are devalued by the addition of built-in furniture and storage.

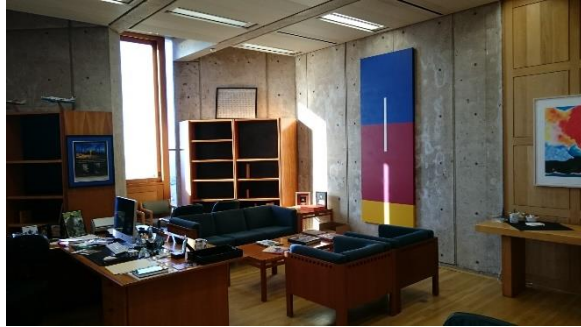
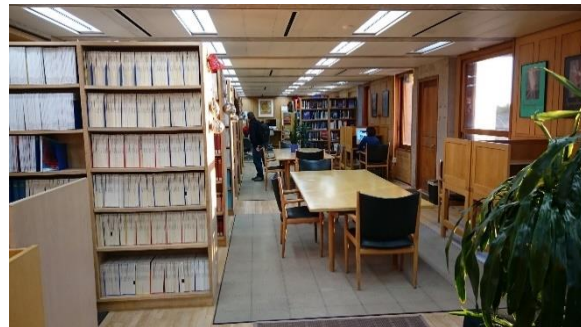
Top: North Office Wing, fifth floor office, 2015
 Bottom: North Office wing Library with later cases and replacement ceiling, 2015.

Growth has also affected the modest library. The bookcases were originally set only between the concrete piers on the east wall; those that project into the space were introduced in an ad hoc manner in the late 1960s onwards.

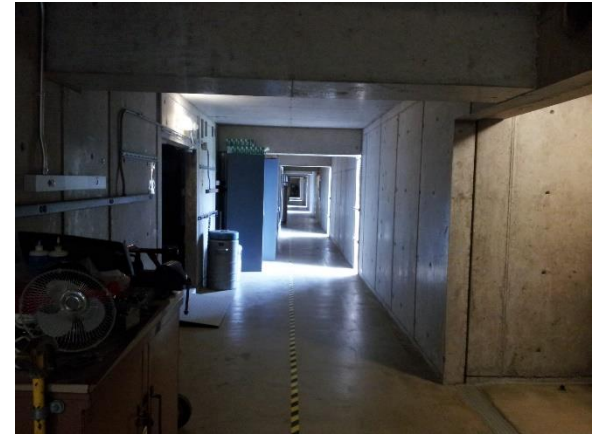
North Laboratory building, circulation adjacent to pipe floor, 2015.

The transparent laboratory elevations contrast with the concrete elevations of the interstitial pipe floors, which are blind except for occasional, narrow, blank openings that give some daylight to the enclosed walkway surrounding the pipe space. The openings were infilled with stainless steel mesh in 1995; the effect is intrusive.

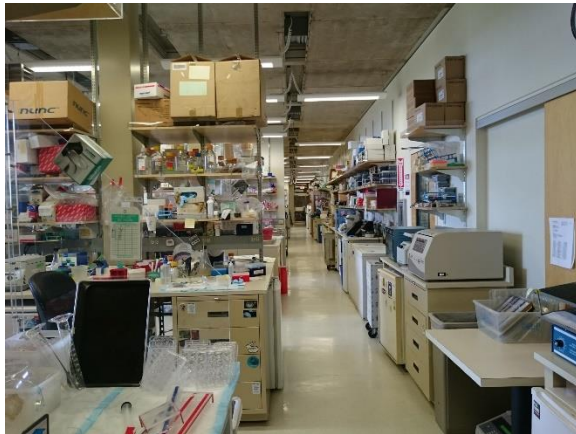
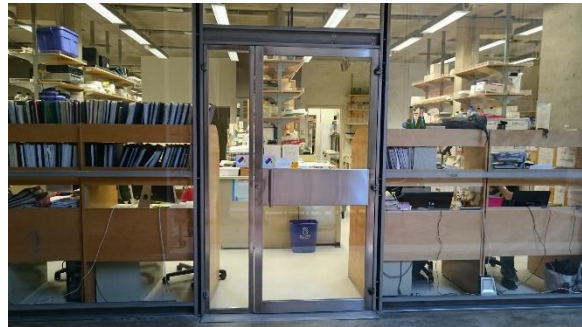
Top: Typical Laboratory, 2015.
Bottom: Intrusive introduction of shelving across the windows, 2015.

density of the laboratory outfitting is in line with the flexibility in layout and servicing for which the building was designed, but it has also caused storage and bench space to extend across the windows, eroding the connection with the outside environment that was so important to Kahn and his client. Similarly, re-siting doors within the storefronts to suit the requirements of a specific research program has affected the modulation of the elevation and is considered intrusive.

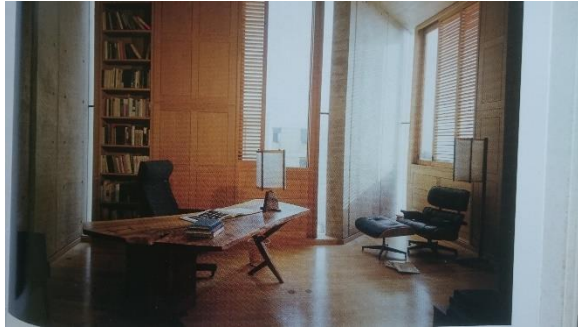
North Study Towers, furnished study with millwork.

The use of stone ashlar with a concrete structure, together with teak windows and millwork, reinforced the separation of the studies from the concrete and steel of the laboratories in both the Second Design and the earliest proposals for the Third. It also associated them with the administrative areas of the laboratory complex, and, more importantly, with the Meeting House where stone was to be used extensively. However, concrete replaced stone in the final scheme.

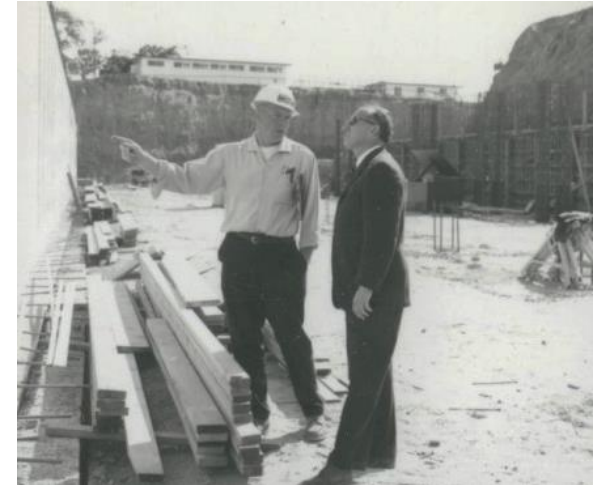
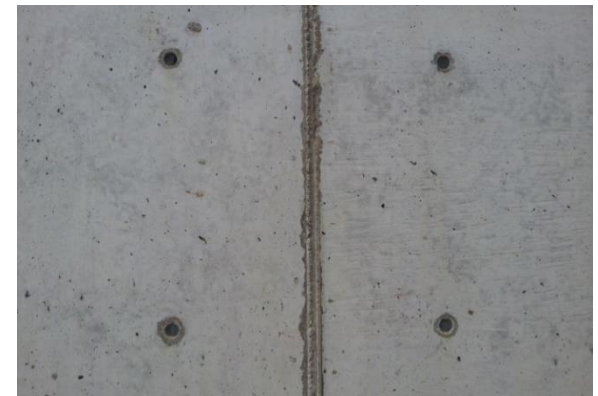
Top: Dr. Salk reviewing concrete samples in the excavation for the Mechanical Wing.
Bottom: Typical concrete fins and lead plugs.

In order to experiment with concrete and its detailing, they chose to use the east and west walls of the lower mechanical wing and retain them in the building as an historical record with their site markings. Large sample panels of concrete construction, 8 feet 6 inches high, showed finish and pattern.¹⁰¹ Seven wall types were developed in January 1963, and another three types for the pipe spaces were developed in February 1963.¹⁰² By the end of January 1963, Fuller had poured sixteen sample wall panels and four sample columns for Kahn and Salk's review. There were delays in pouring the samples due to the time required for approval of form details by the architects and for obtaining the "Special Blend" cement from Riverside Cement. Five sample wall panels were poured using Scofield integral color. By the end of February 1963, the color of the concrete was selected and Riverside Special Blend cement was ordered. To insure a uniform color for the entire project, the materials used for the concrete work were supplied from the same sources for the duration of the contract.¹⁰³ The existing pozzolan blended concrete was a lightweight concrete composed of sand and pumice aggregate. The pumice is typically 3/8 inch diameter and constitutes half of the volume of the concrete. The reinforcing bar is 1/2-inch-diameter embedded 3/4 inch into the concrete.

The general plywood panel size was 8 feet by 4 feet and the maximum was 12 feet by 4 feet. The use of non-standard 14-foot plywood was approved for the top lift of the upper studies at the meeting of 18 June 1964.¹⁰⁴ For exposed vertical surfaces, the forms were constructed from 3/4-inch-thick, exterior type concrete form plywood. The surface texture of concrete was achieved by using plastic-coated plywood. As liquid concrete tends to bleed at form work joints, the edges of the form panels were slightly beveled to provide the place for bleeding, so "fins" were formed, consisting of approximately 1/4-inch-wide projections. Formwork between floors was built so the adjacent plywood panels did not abut edge-to-edge but were separated by wood strips at the top of each form. The top of the panel has a rebate, 1-1/2 inches high and 5/8 inch deep, with a 1/8 inch chamfer to shed water. Beams and slabs are also expressed by this shadow gap. This recess was also then used to align a tacking strip on the bottom of the next set of forms. To reinforce the concept of lateral distribution of services, formwork panels are laid horizontally to the laboratory pipe spaces, mechanical wings, and balconies, whereas vertical panels are used on the other buildings.

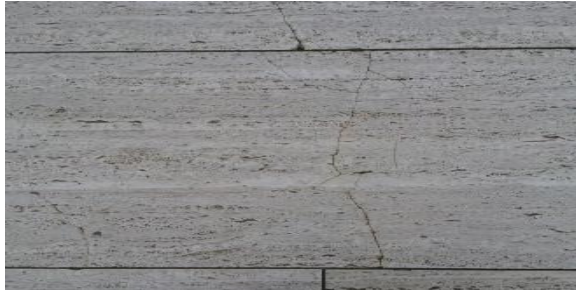
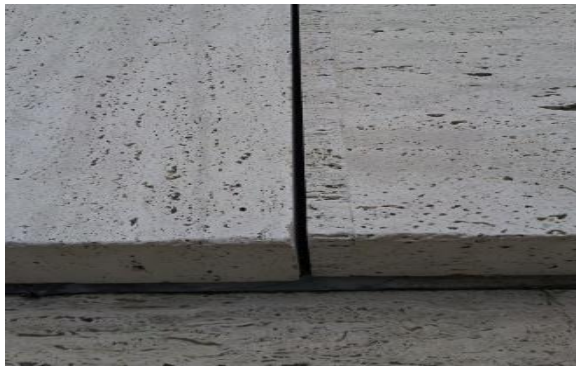
Top: Minor fractures in travertine do not warrant replacement.
Bottom: Careful attention to detail required when repairing travertine.

The backs of the pavers were moistened with water before setting, buttered with neat cement mortar, set on a mortar bed, and then tamped with rubber mallets to achieve a solid, even bearing at the proper level. Joints, a maximum 1/8 inch width, were to be grouted with a colored mortar using unfading, lime-proof, mineral pigments, if so directed by Kahn. (It is not known if this was carried out and it seems antithetical to Kahn's philosophy.) On the study stairs, the typical riser is 7-1/4 inch to 7-5/16 inch and the tread is 11-1/4 inch, all with 1/8 inch joints.

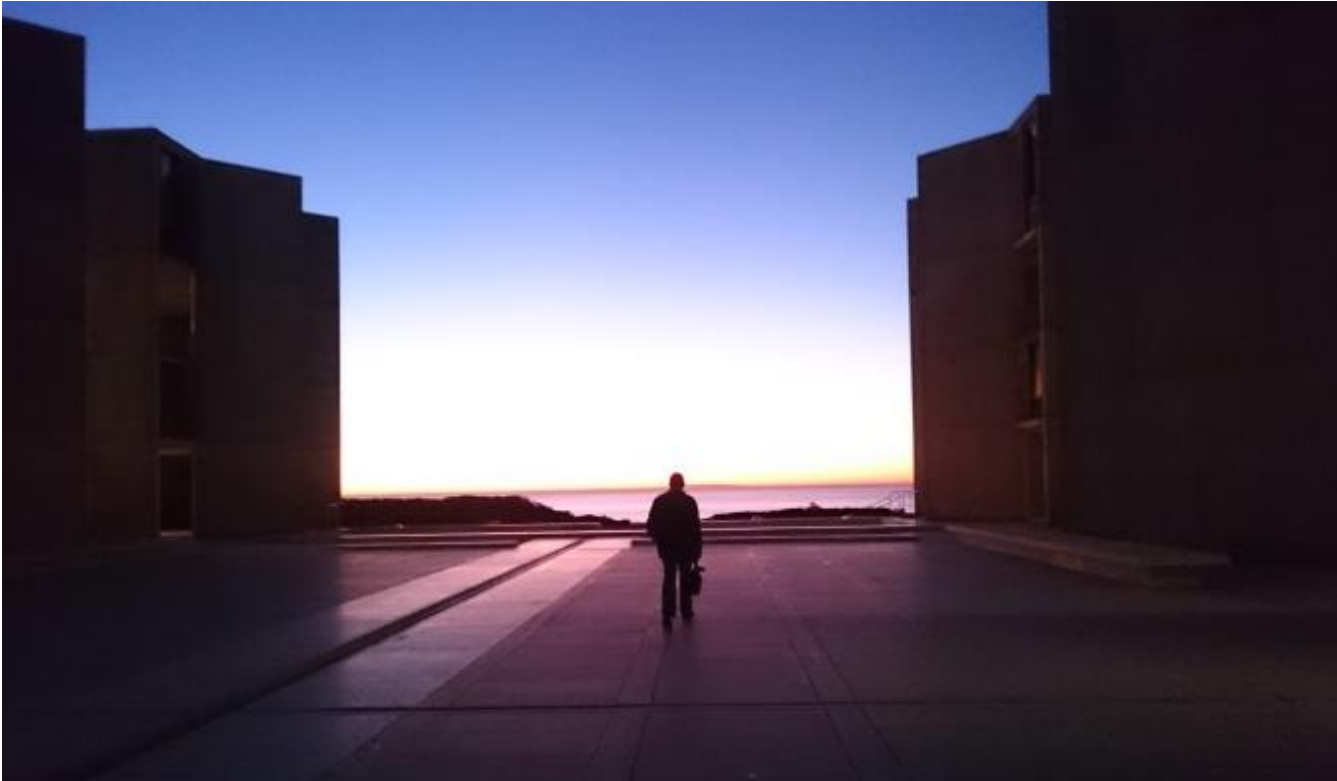
Top: Daytime effect of the replacement travertine to the canal.
Bottom: Nighttime effect of the same replacement travertine.

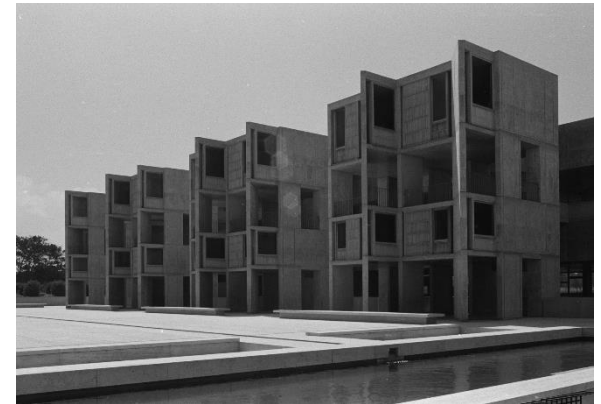
Top: Reflecting pool in 1968, looking towards South Study Towers.

Bottom: Reflecting pool with fiberglass lining in 2015 has detrimental visual impact.

The pools were re-lined in 2011–2012. The water is chemically treated regularly to prevent algal growth that results from the sunlight exposure.

To reconsider the approach to lining the water pools to meet Kahn's original architectural and aesthetic intentions, when budget and program permit. The use of modern materials would be acceptable. Any modification of the original detailing of the travertine should be avoided. The associated staining of travertine should be understood and addressed.

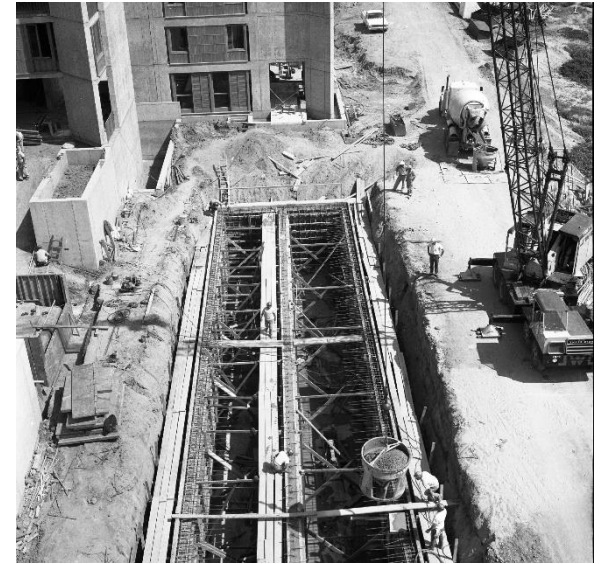
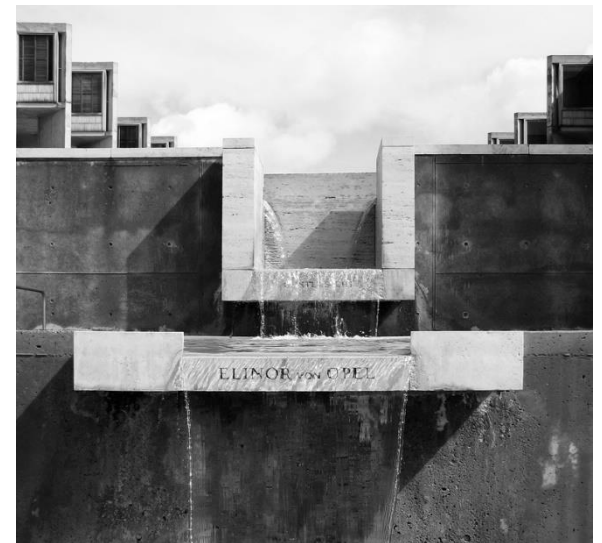
Top: Construction of cistern below West Court, 1965.
Bottom: Cascade from West Court.

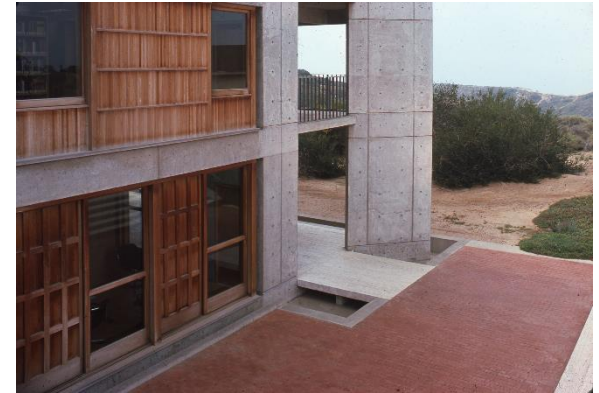
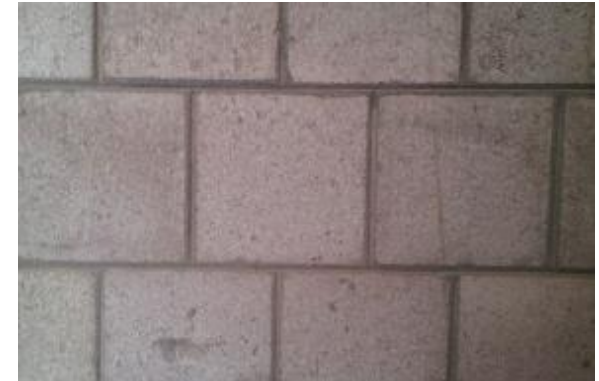
Top: Brick paving at northwest entrance
Bottom: Square concrete blocks and pointing.

The solid paving bricks are “Building Brick,” Class MW, made by Hazard Products.¹³⁸ Paving brick, 3-3/4 inches by 8-1/8 inches, were generally laid flat in stretcher bond in a 1 part cement to 1 part lime to 4 parts sand mortar on a 4-inch-thick concrete slab, set on a 4-inch bed of stone, and bedded and pointed in a grey portland cement mortar. According to the 1964 specification, the top surface of the bricks was ground down using a terrazzo grinding machine to even out the surface and to remove cement and other stains.

Kahn originally intended these walls to be brick, but this was altered on 16 November 1963 to concrete block to save money.¹⁴⁰ Brick was kept for the toilets. Concrete blocks, 8 inch by 8 inch facing size, Grade A, were laid in running or half-bond, similar to the travertine and brick. A sample of Hazard block was presented for approval by 18 March 1964.¹⁴¹ The mortar mix was either 1:1/2:2-1/2 or 1:1:3 (cement: hydrated lime/lime putty: sand), and the sand for the pointing mortar was Del Monte no.1 ground white 80 mesh sand. The joints were sack rubbed or floated flush on all exposed blockwork and the exposed joints width did not exceed 3/8 inch. The grout consisted of a 1 part cement to 3 parts sand mix, gauged with two parts pea gravel where spaces were greater than 2 inches in the horizontal. The grout was designed for a minimum compressive strength of 2,000 psi at 28 days. The grout mix was specified as 1:1/10:3 using hydrated or slaked lime, and the mix could be gauged with two parts pea gravel where spaces were greater than 2 inches in the horizontal. Lintels over doorways were reinforced to code requirements. The joint depth was increased to 1/2 inch at heads, jams, and sills at knock-out panels. The concrete block was unpainted.

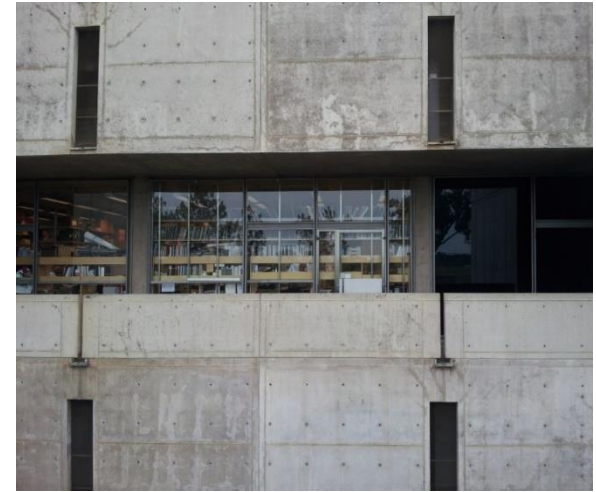
Typical tripartite stainless steel window wall altered to accommodate more than one entrance into a typical laboratory bay.

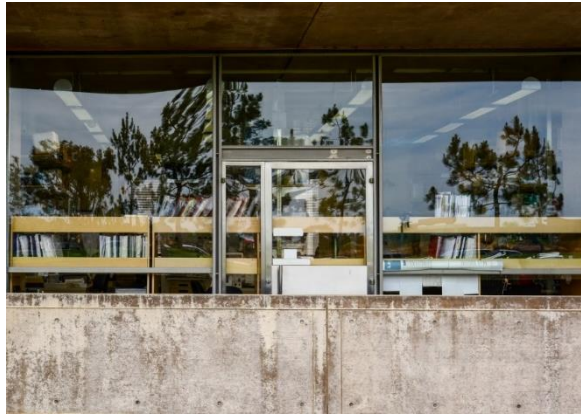
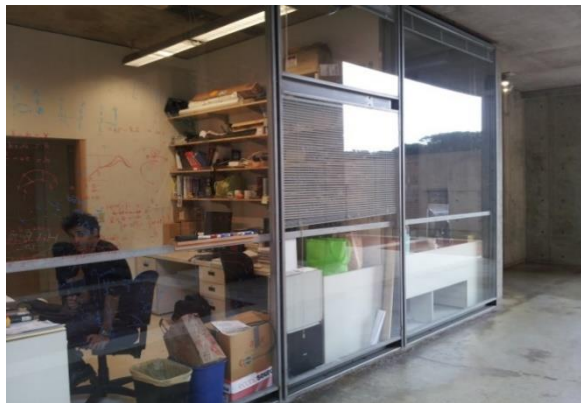
Top: Tempered glass produces different reflections to the original polished plate.
Bottom: Kahn likely never suspected glazed walls would become “chalkboards.”

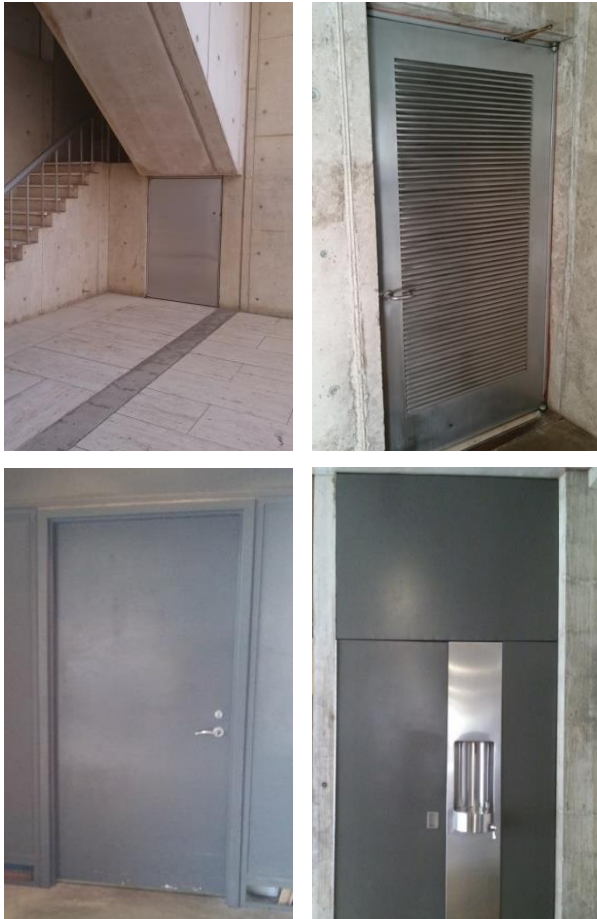
Top left: Kahn-designed flush stainless steel door.
 Top right: Kahn-designed louvered door.
 Bottom left: Post-Kahn introduction of painted hollow flush metal door.
 Bottom right: Kahn-designed painted steel paneling and polished steel drinking fountain.

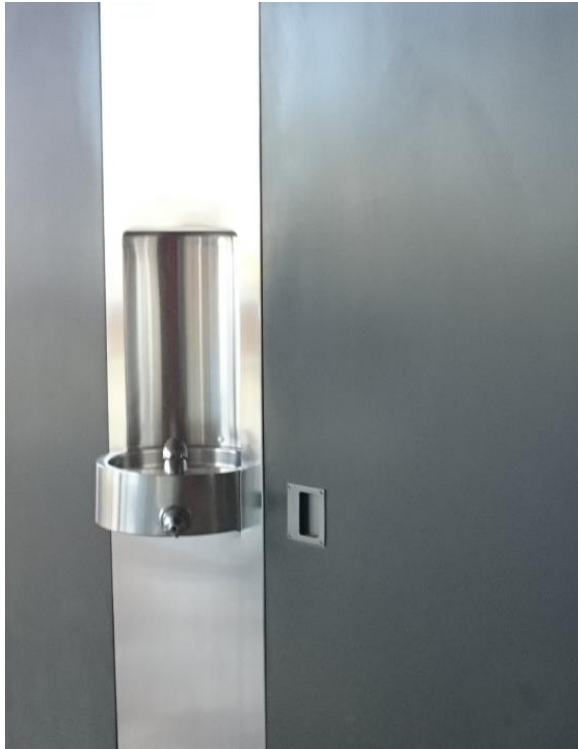
Detail of Kahn-designed painted steel paneling and polished steel fountain.

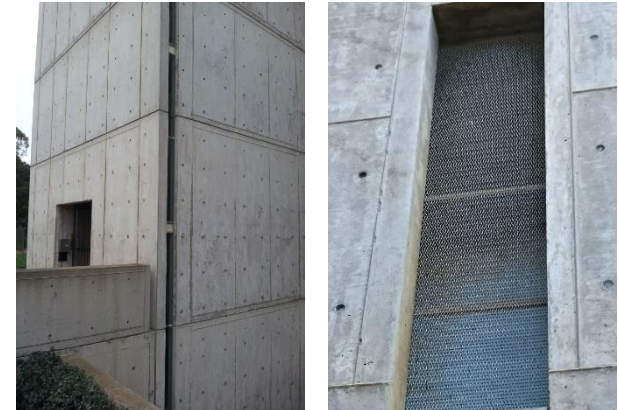
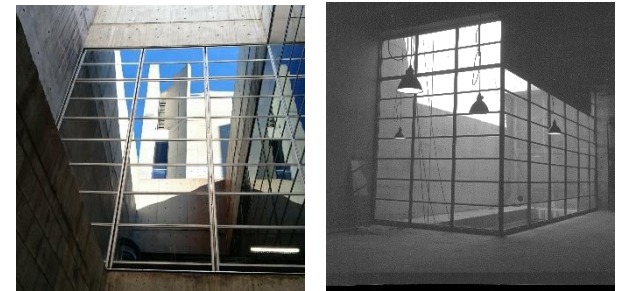
Top left: Slot windows to service towers.
 Top right: Later mesh to blank openings to pipe spaces.
 Bottom left: Demountable glass wall giving plant access to mechanical wing.
 Bottom right: Mechanical wing light well in 1965.

The Special High Laboratories in the canted ends of the North and South Mechanical Wings are lit by slot windows, 2 feet 7 inches wide and 14 feet 8 inches high, constructed from 16-gauge stainless steel frames and glazing stops. The 1/4-inch-thick polished plate glass is subdivided by a horizontal 1/2-inch-thick lead came. The lead came is omitted on the windows to Shipping and Receiving in the South Mechanical Wing and elevation 363 in the North Mechanical Wing, all of which are 8 feet 3-1/2 inches high. Insect screens are used in lieu of glazing at the Transformer Rooms in the North and South Mechanical Wings, and are of different heights: 14 feet 8 inches in the former and 11 feet 4-1/2 inches in the latter.

During January 1965, Bayer installed the steel window frames in the North and South Service Towers.¹⁵¹ The same detail is employed for the 9-inch-wide slot windows in the North and South Service Towers, although the glazing is 1/4-inch-thick wired glass. Snap-in stainless steel covers are used at the slab landings.

To provide natural daylight to the fan chambers in the North and South Mechanical Wings, Kahn designed demountable glass walls. This stainless steel-framed window wall is similar in concept and material to the laboratory window walls. Similar recessed sills, heads, and transoms are employed, except that the transoms are strengthened with vertical reinforcement plates. Above the door and fixed glazing is an Airo-lite stainless steel louver no. 666. On the lower mechanical level the fixed glazing has four equal window divisions, while there are seven equal window divisions on the upper mechanical level. The glazing is 1/4-inch-thick polished wire glass. Where set in metal frames, glass was installed in the multiple-compound glazing method: polybutene tape against rabbit silicone rubber for bedding, and a glazing compound for sealing stops.

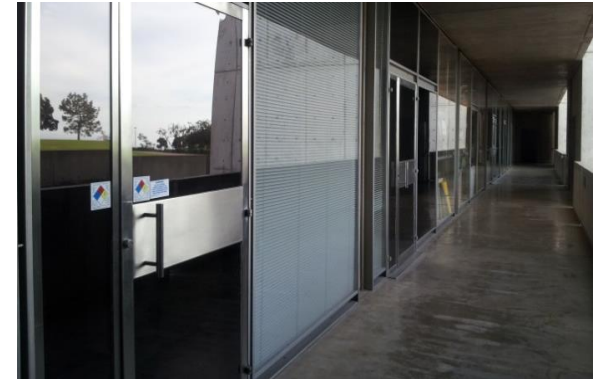
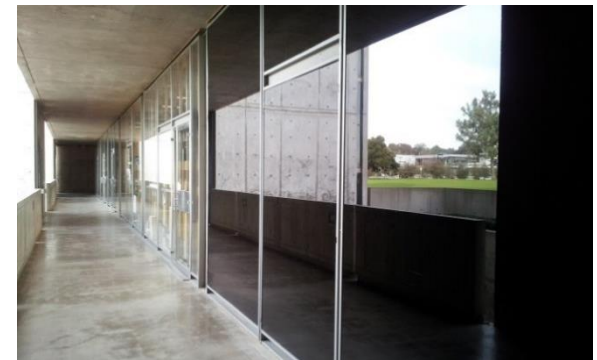
Top: Later introduction of blinds to control glare.
Middle: Later use of black films is visually intrusive.
Bottom: Use of the white films to glazing, also intrusive.

Changing the type of glass from polished plate to tempered glass for repairs affects the aesthetics and architectural intentions as well as being visually intrusive. The reflections that result from its use are different to those that result from polished plate due to the roller wave distortion.

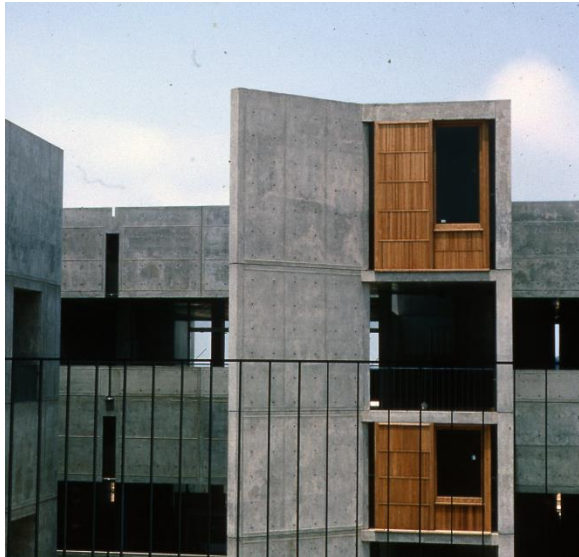
Stainless steel railings to porticos of the study Towers.

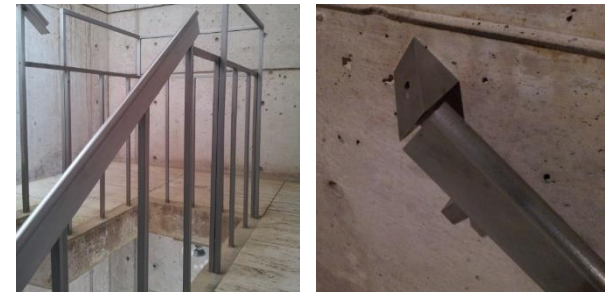
Left: Kahn’s original stainless steel railings and extruded stainless steel handrail and the 1972 additional safety railings. Right: Kahn’s end detail to wall rails.

By contrast, the rails at the Studies and porticos of the Office Wings were code compliant at 42 inches high, and composed of the same stainless steel, Type 316, and 2D finish. Typically, all framing members are 1-1/2 inch by 1/2 inch steel bars, with 1-1/2 inch by 1/4 inch balusters spaced 6 inches apart. The bottom rail is fixed into the concrete curb at 2-foot centers. The railings are separated from the walls, although the end bars are bolted into the concrete wall through stainless steel sleeves welded to a 4 inch by 4 inch by 1/4 inch square steel plate located 10 inches below the top rail. Single panels are generally used throughout, except at the porticos of the North and South Office Wings, where two panels abut and are fixed with a T-shaped stainless steel plate arrangement.

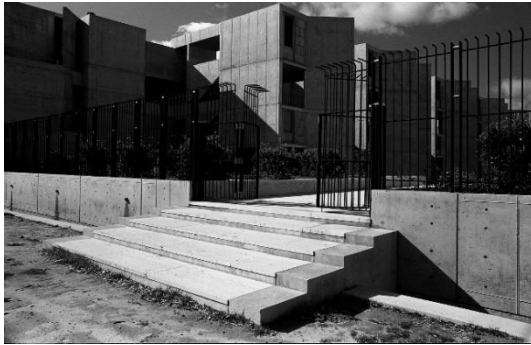
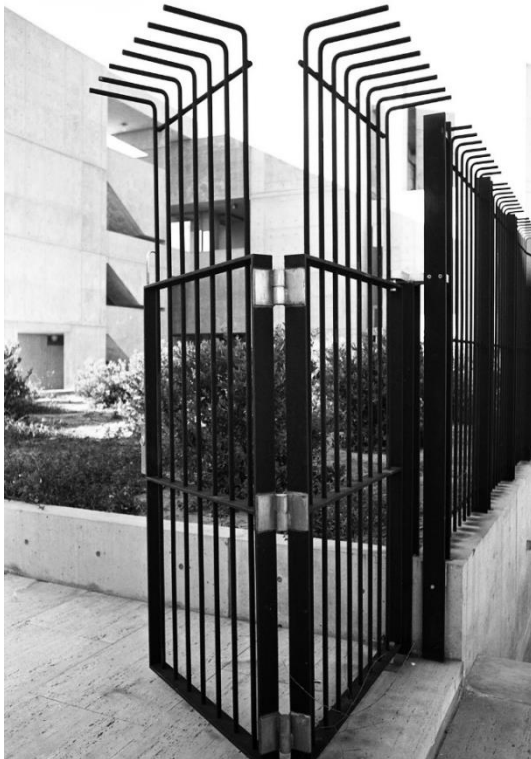
Top: East Gate Corten gates and railings in 1967. Travertine parapets not yet added to the steps.
Bottom: Corten folding gates and railings to the East Gate in 1967.

Kahn intended cadmium plated steel but changed to Corten in September 1963, presumably to reduce costs.¹⁶⁰ All of the hardware and functioning parts are Allegheny metal grade 18-8M, Type 316 stainless steel, with a satin finish. All other material in the exterior fences and gates was U.S. Steel Corten, in continuous welded construction, and mechanical joints were employed so as to eliminate grinding. The installation of posts employed the same details and materials as the rails.

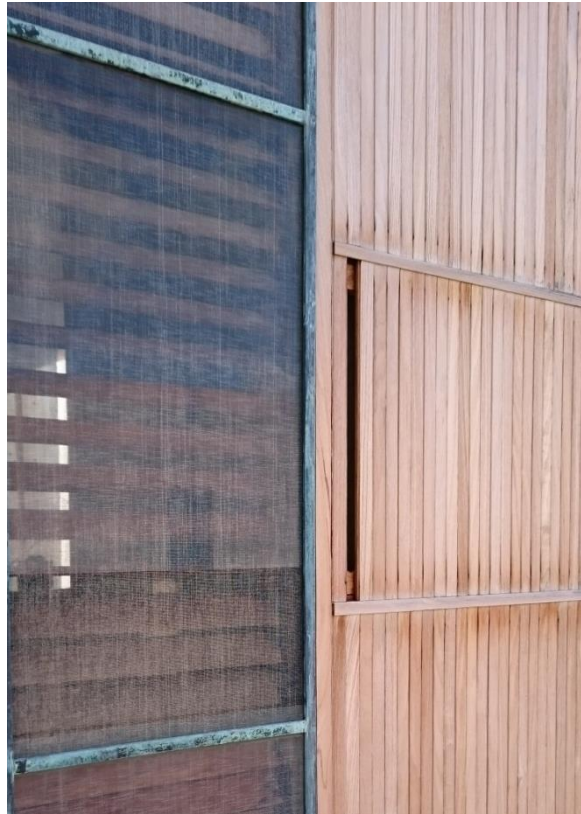
Failure of teak siding, as a result of weathering due to ultraviolet exposure over time, revealed concealed nailing and reduced the cross-sectional area of the wood.

The significant loss of cross-sectional areas of the siding and water tables, possibly as much as 1/4 inch, makes them unrepairable, and replacement is the only option. The iron staining as a result of nails into the tongue-and-groove panel sections probably cannot be removed without aggressive sanding, resulting in further loss of dimensional area. It was probably over-optimistic to believe that the 1/4 inch projection of the water tables as constructed would provide adequate protection to the end grain of teak siding in severe exposures, though it appears to have been somewhat effective in well-protected areas such as the north-facing elevations of the studies facing the laboratories and under the bridges. The reasons that led to this change in size are not yet explicitly known but given the extent and context of cost reductions throughout the construction history, it is reasonable to assume it was budgetary rather than aesthetic.

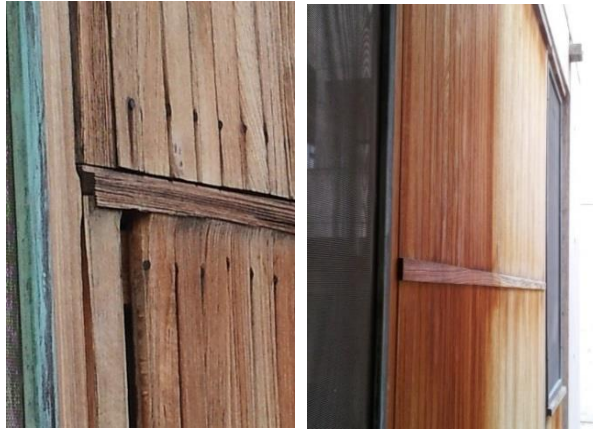
Left: erosion of water tables by erosion: exposure of secret nails and loss of siding.
 Right: Impact of differential weathering on teak siding. At left, the non-original red-colored varnish remains, while at right, the teak surface is exposed.

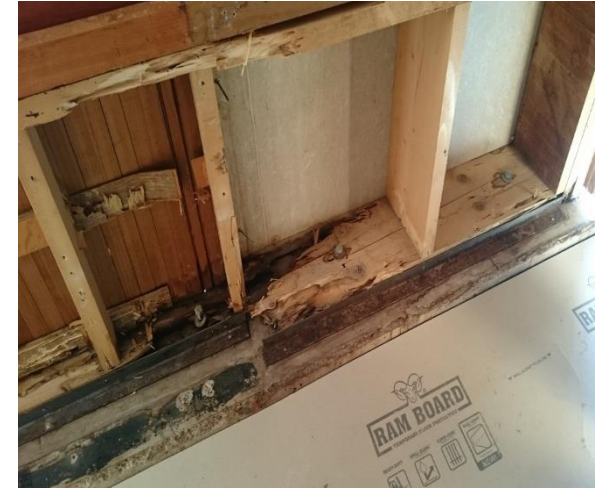
Top: Severe termite damage to North Study Tower, 2015
Bottom: Water damage to teak millwork.

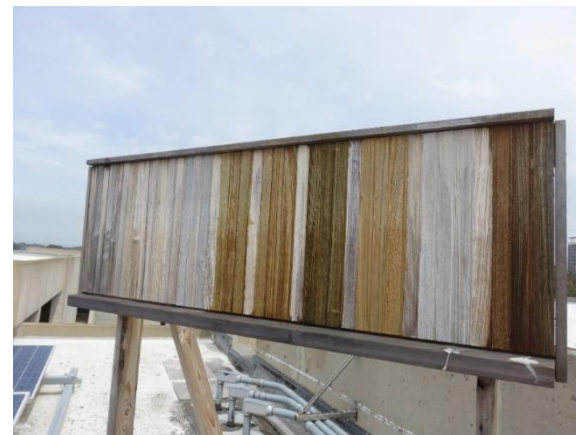
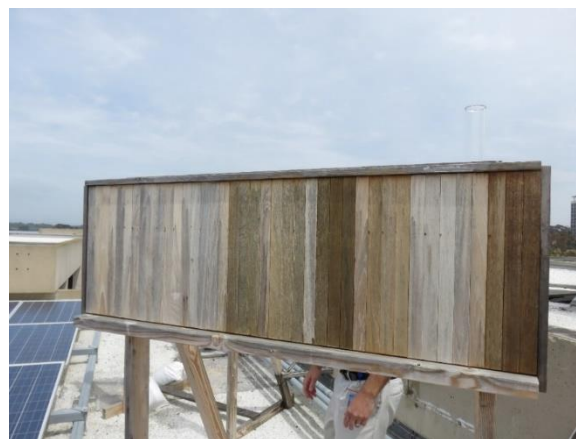
Top: View of original teak panel, as part of mock-up.
Bottom: View of new teak, as part of mock-up.

Based on the laboratory analysis and observation of the trial panels, the following conclusions were reached relative to the coating of the teak substrate:

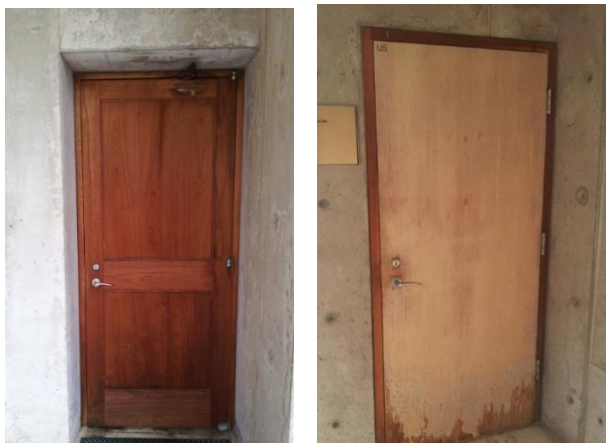
Left: Teak door and hardware by Kahn to North Study Towers.
Right: Plywood door were installed at the South Study Towers due to economic cut backs.

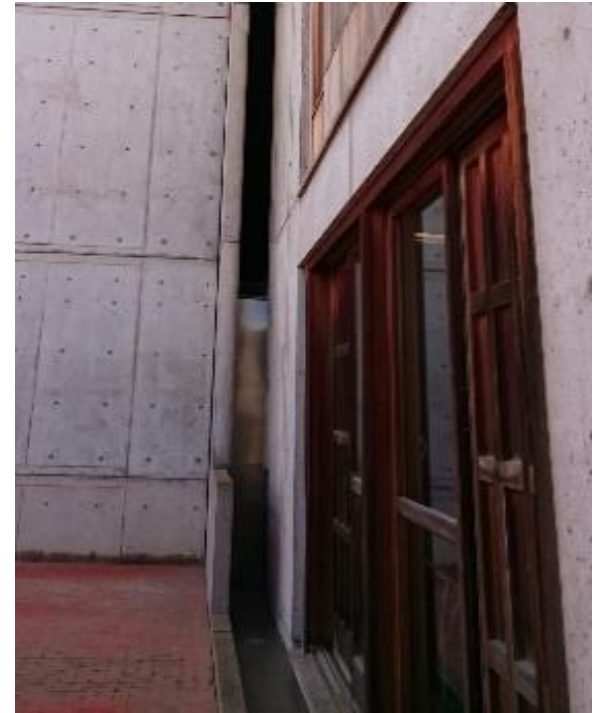
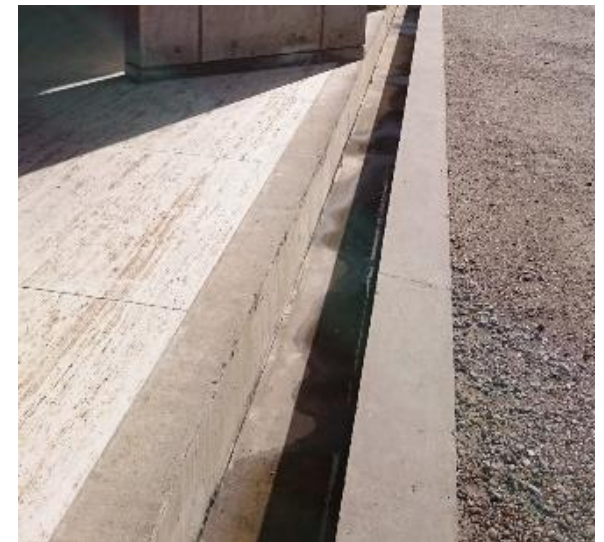
Top: Cascade and moat infilled by later metal duct is intrusive
Bottom: Moat to arcades of office wings.

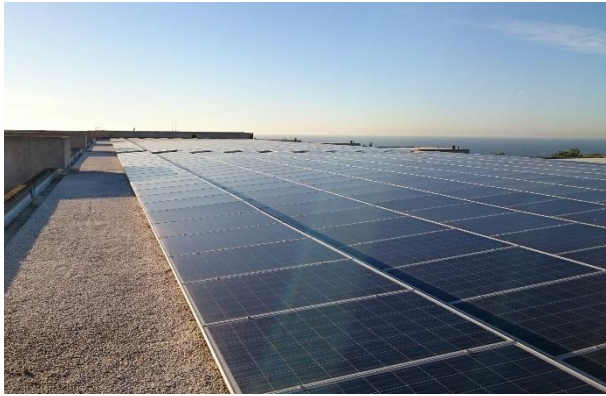
Roof solar panels.

with a stainless steel termination bar anchored to the concrete parapet wall. Much of the lead-coated copper flashing and trim present at the various roof areas was retained. Sealants at flashings, copings, and termination bars have deteriorated. At some locations the sealant has partially de-bonded, resulting in open joints. Termination bars at expansion joints have displaced. These conditions should be addressed for as part of the maintenance plan.

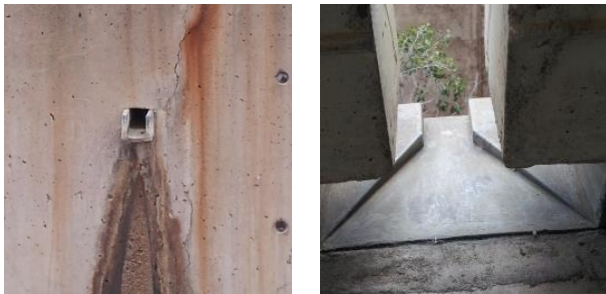
Left: Kahn's lead scupper to roof garden.
Right: Kahn's lead scupper to laboratories.

Terra cotta was deleted from the contract on 22 November 1963, although \$17,255 budget for this work was retained throughout George A. Fuller Company's cost reports until the end of 1965. The scuppers were then changed to cast lead and the contract was let by 29 February 1964 to New England Lead of Connecticut for the sum of \$5,091. The lead alloy was 98 percent chemically pure lead, with 2 percent antimony. The scuppers

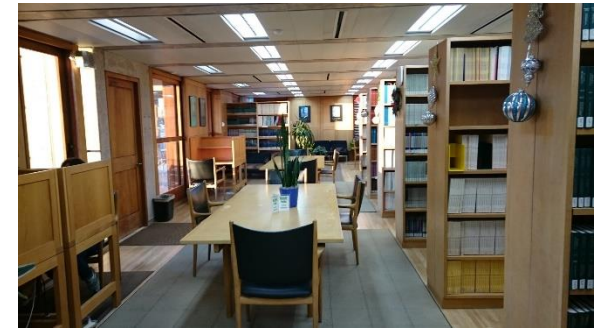
Library in 2015 showing replacement ceiling and light fixtures.

The ceiling in the technical library was replaced in 1995, while the majority of other ceilings have also been replaced at various dates for a number of reasons. It has been reported that the difficulty and high cost of re-manufacturing the perforated aluminum strips led to the change in design and selection of standard types and finishes that has been introduced throughout the office wings and cores, and the mechanical wings. The light fixtures within the various ceilings vary from square to rectangular. The ceiling of the cafeteria appears to be a standard suspended sheet ceiling with a grid of flush, square light fixtures contained between the downstand beams (beams expressed below the ceiling plane and connected to the slab), and probably dates from the 1990s fit-out. The dropped ceiling with downlights at the southeast corner above the servery appears to relate to a more recent fit-out. The suspended ceilings to the bathrooms in the South Service Towers are recent and relate to re-fitting for universally accessible lavatories and general upgrades.
