Conservation Management Plan

Salk Institute for Biological Studies

La Jolla, California

October 2016 [Redacted May 2017]

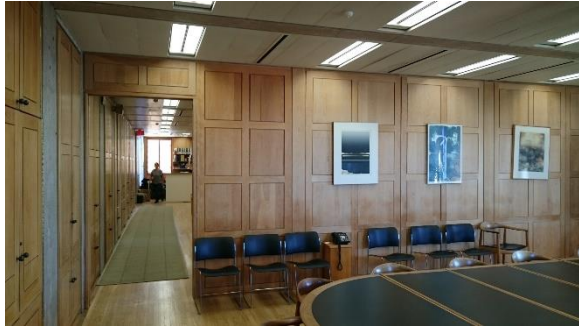
Top: Sliding pocket doors reduced in size by half, impacting oak-paneled walls and compromising Kahn's design intentions.

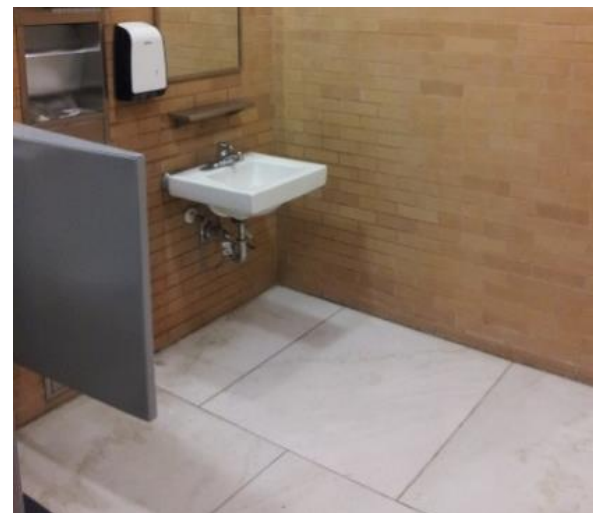
Top left: Facing bricks and mortar in service areas, North Office Core and North Service Towers.
 Top right: Marble flooring layout, carefully considered by Kahn.
 Bottom: Restroom designed by Kahn.

During May 1964 Wikholm constructed the prototype toilet (room 21) in the North Mechanical Wing using the approved brick substitution from Kraftile.²¹⁹ During August 1964 the facing brick had arrived on site and the toilets to elevations 343 and 354 of the North Service Towers were completed. October 1964 saw the completion of the brickwork and blockwork for all of the North Service Towers, Office Core toilets, and the janitors’ closets. Wikholm cleaned and pointed the brickwork and blockwork in the North Service Towers during December 1964.

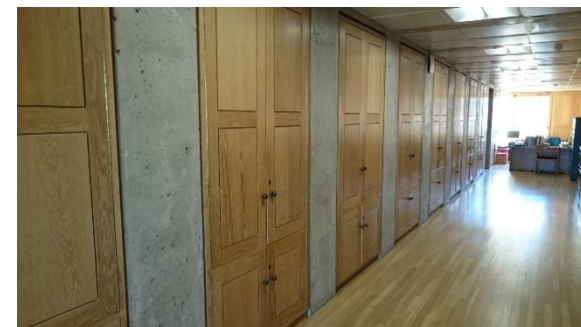
White oak strip flooring in North Office Wing, installed 1965.

ABC Flooring Company commenced work by 31 March 1965, setting out the subflooring to the levels 382 and 394 in the North Office Wing, and had started to finish the floor of level 394 by that date. At the same time, the sand, wax and polish sample was ready in the prototype study. By 30 April, ABC Flooring had completed the laying of all oak flooring and was installing the cork strips.²²³ By 1 June 1965, only the sanding and finishing remained to be completed in the office wings.²²⁴ Cork strips were replaced soon after completion in 1967, possibly due to continued water ingress.

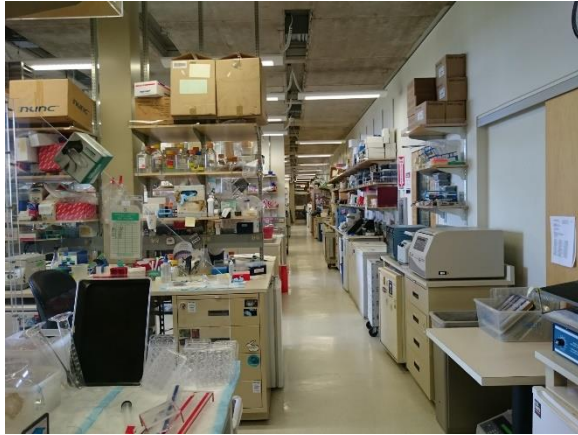
Top: Sheet-vinyl flooring in North Laboratory.
Bottom: Exposed concrete floor in corridors.

Kahn specified the sheet flooring to be Vinyl Corlon, Tessera series, manufactured by Armstrong Cork Co. It was a homogenous sheet vinyl flooring of uniform thickness, 0.090-inch-thick, not less than 54 inches in width, with hydrocord back, sufficiently dense to withstand loads of 100 psi, moisture proof, annealed, and pre-shrunk. After adhesives had set, floors were cleaned with a neutral cleaner and then two coats of wax were applied and buffed with a polishing machine.

This package was let for \$1,856 in August 1964 and Tri-Co Floors was engaged. Little work was done as only \$397 was expended. An order was subsequently placed with Armstrong Cork Co for their “Tessera Vinyl Corlon” no. 86549 on 1 December 1965 for \$3,850.²²⁵ Presumably the color was selected by Kahn.

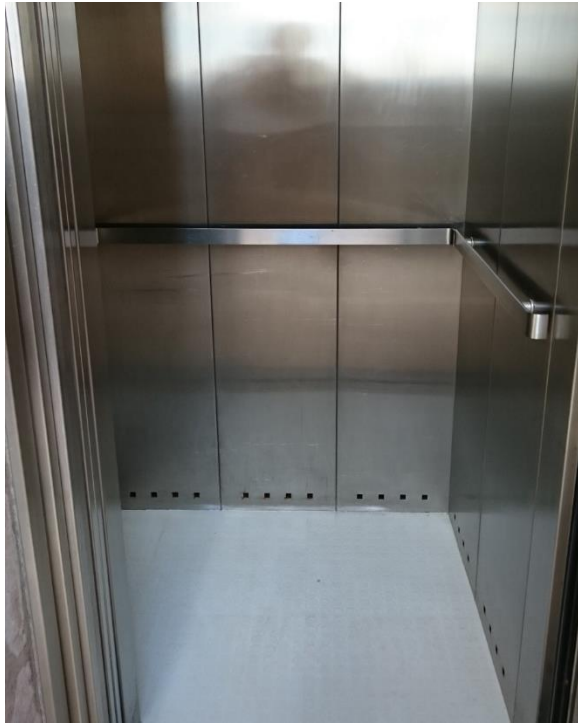
Kahn-designed elevator in the North Study Tower.

Kahn designed the elevator cabs, call stations, and operating panels.²²⁸ They are constructed in stainless steel, type 304, with no. 4 finish, with the furniture steel in a white baked enamel finish. Ceilings and soffits over the cove lighting have the baked enamel finish while all other panels are stainless steel. The perforated cab wall panels and doors are 14-gauge stainless steel, the ceiling panels are 16-gauge furniture steel, and the lighting coves are 16-gauge stainless steel. The handrails are 1/4-inch-thick stainless steel, with 2-inch-high rails at the study and office elevators, while 8-inch-high rails were used for the service tower elevators. The corridor call station faceplates, including those to the Mechanical Wing, are 3/32-inch-thick stainless steel in the same finish as the cabs, and project approximately 3/4 inch, with a 1/16 inch shadow gap. All the buttons, lights, etc., are in white plastic, except for the red “stop” buttons. The operating panels follow the same design but are surface mounted on the concrete with concealed fasteners.

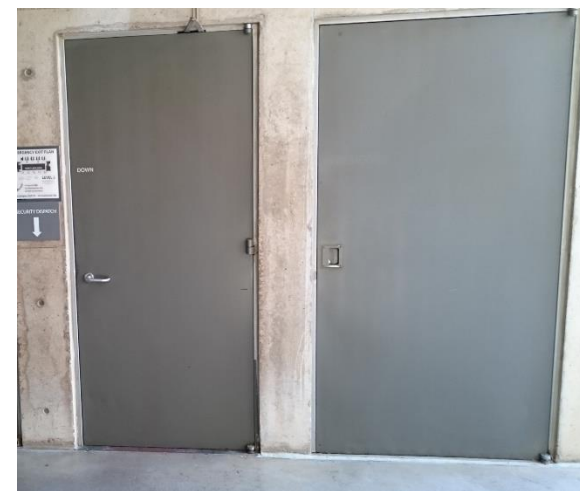
Top: Kahn's painted flush steel doors in unpainted stainless-steel frames.
Bottom: Failing paintwork on steel gate.

Policy 8 applies. Paint microscopy/analysis should be carried out on the external and internal decorations, including millwork, lockers, and mechanical plant etc.

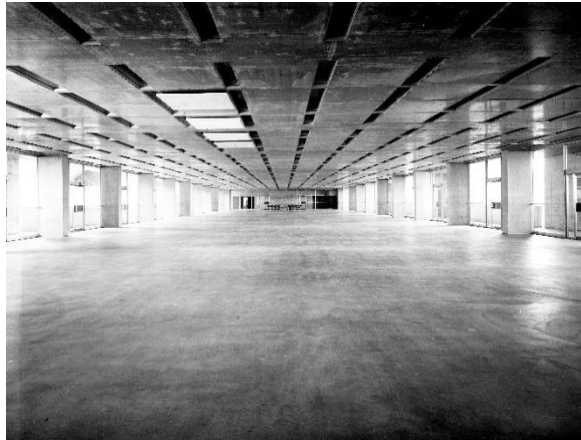
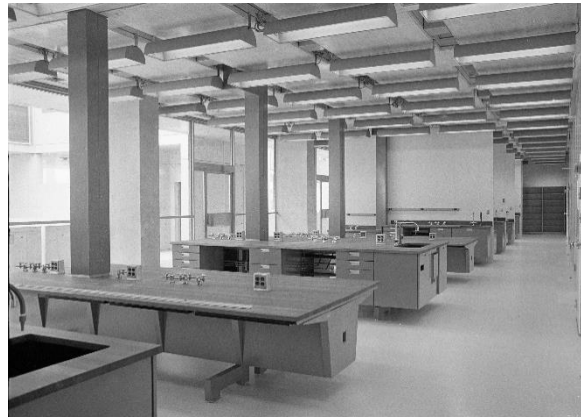
Top: Typical shell of North Laboratory in 1965.
Bottom: Fit-out of North Laboratory underway but not yet complete in 1966.

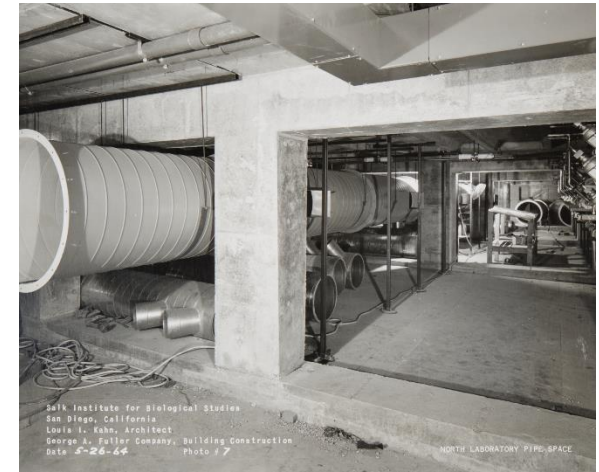
Top: Fitting principal air distribution duct through the center of the Vierendeel trusses during construction of the North Laboratory in 1964.
Bottom: 1965 completion of fit-out.

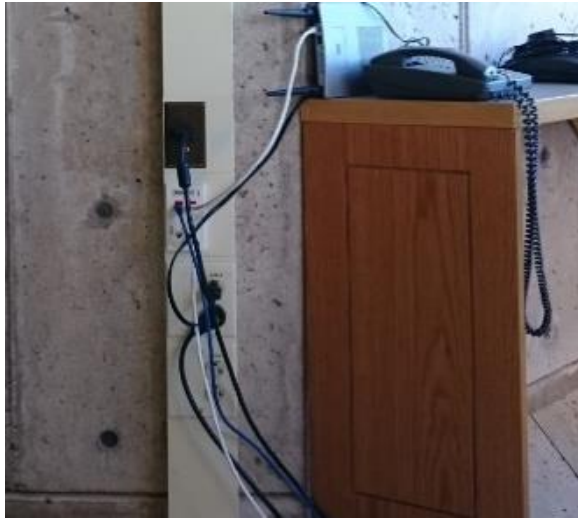
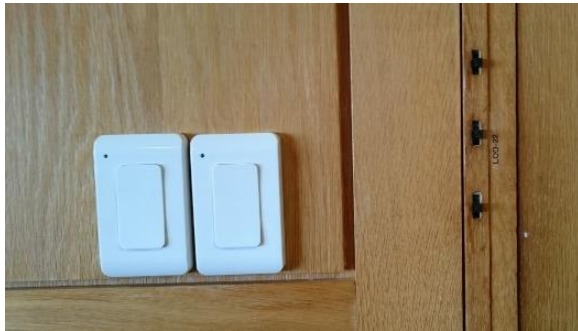
Top: Ad-hoc plethora of cabling in offices.
Bottom: Intrusive addition of new switches (left); original switches integrated with millwork (right).

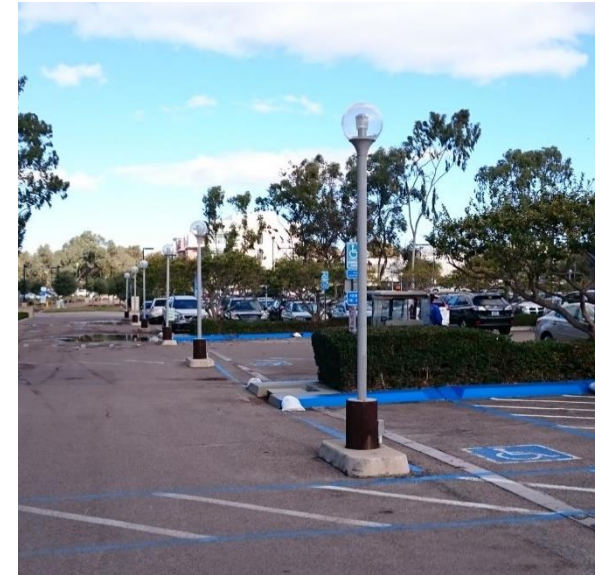
Original light fittings:
 Top: Pole lights in the east parking lot.
 Bottom left: Edison Price bollard light.
 Bottom right: Recessed wall light.

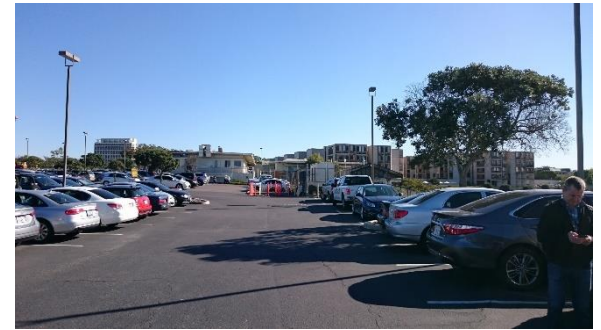
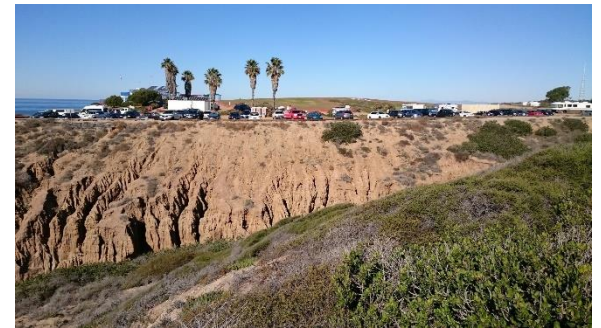
Top: Encroachment of the North Parking Lot across the canyon rim. The esplanade was to run along the left-hand side of the area shown in this image, 2015.

Bottom: Palm trees on the site proposed for the Meeting House in the First Design, seen from that of the Second and Third Designs, which avoided having to cross the ravine, 2015.

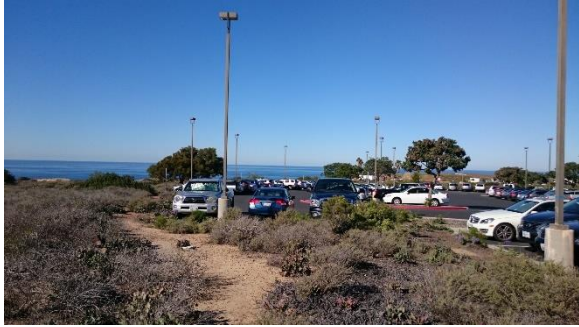
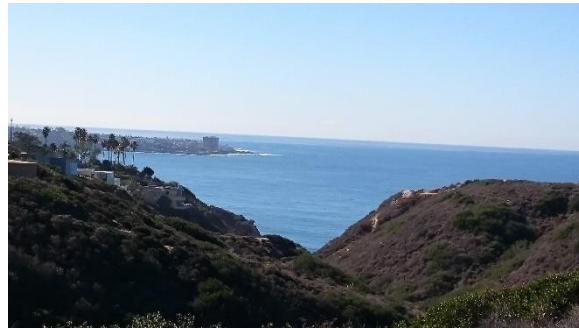
Top: The site of the Meeting House in the Second and Third Designs; occupied by the North Parking Lot, 2015.
Bottom: The view south from the proposed Meeting House site, 2015.

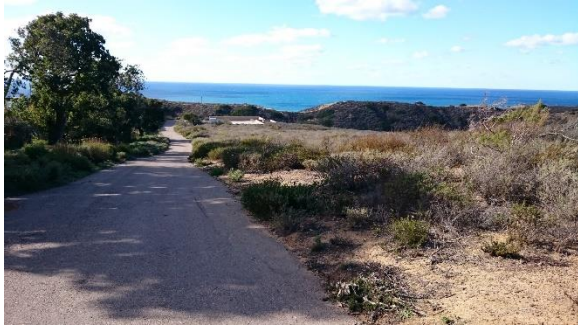
Salk Institute Road with the new pumping house on the site proposed for the Living Place, 2015.

The area remains with its natural landscape, but a replacement pumping station was constructed by the City at the west end of the housing site in the location of the community center.

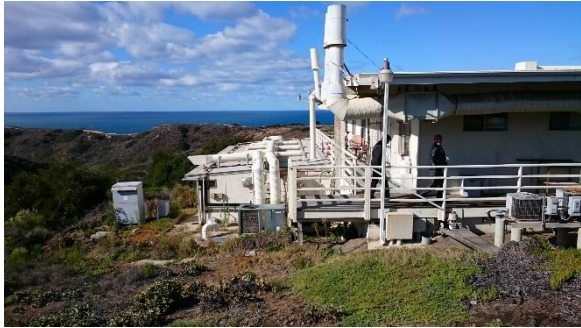
Temporary Building No.1 with later modifications, 2015.

The Barracks, as the temporary buildings were known, are two-story structures cut into the rising ground so that they appear as single story structures from the parking lot to the north. They were constructed with standard building systems based on a steel frame with wood-framed studwork infill below shallow gabled roofs. The two earlier buildings were finished with painted sheeting with cover strips over the joints. The later building were clad with vertical siding. The interiors were finished with gypsum wallboard. Their siting within the canyon area belonging to the City was selected in order to avoid any sites where permanent

Both of the surviving buildings have been altered extensively. They were intended to serve as temporary features that would be replaced by other aspects of Kahn's design. In their current location, they intrude on the character of the canyon landscape that formed an essential aspect of the setting of the Laboratory Complex, as well as the designed views to the west.

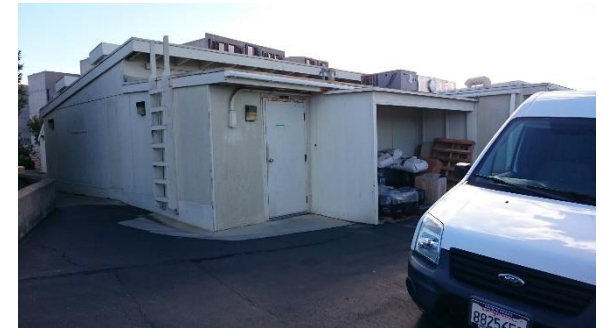
Temporary Buildings No. 4 and 5, 2015.

Like Buildings No. 1 through 3, Buildings No. 4 and 5 were intended as temporary features that would be replaced by other aspects of Kahn's design. In their current location, they intrude on the character of the canyon landscape that formed an essential aspect of the setting of the Laboratory Complex. Screen plantings of exotic oleander shrubs are also not consistent with the goal of promoting native habitats within the canyon. Similar to Buildings No. 1 through 3, these buildings are of historical interest because of their association with Dr. Salk and the early history of the Salk Institute, and should be documented to HABS standards to mitigate their future removal.

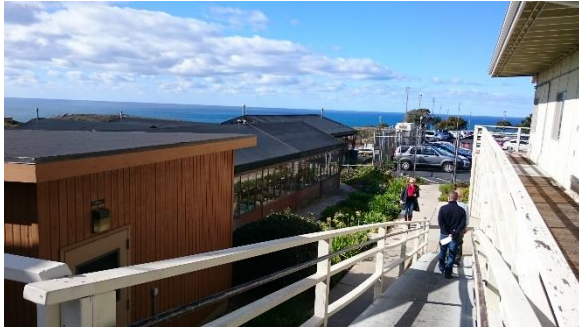
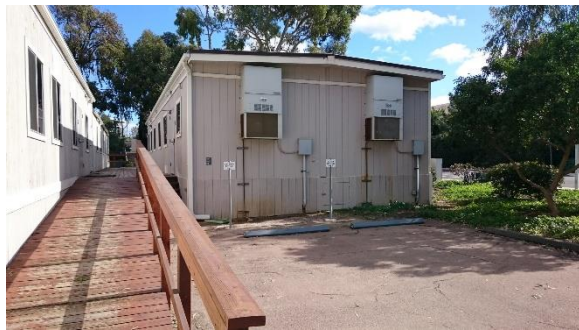
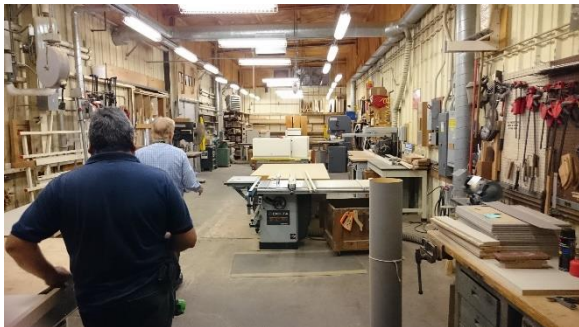
Top: Temporary buildings with greenhouses, 2015.
Middle: East Interim Facility, 2015.
Bottom: Accessory Building, 2015.

The first greenhouse was built about 1988, and a second, wood-framed structure was in place by 1990. Three more timber greenhouses followed giving a total of five by the early 1990s (GvG**).

The warehouse is a standard industrial building with a steel frame clad in ribbed sheet metal below a shallow, gable roof. It housed the animal quarters. The subsequent extension on the north side accommodated cage washing and associated facilities. The building was vacated when the animal quarters moved to the new extension below the South Lawn, which was completed in 1977; it is currently in use as a construction workshop as part of Facilities Department.

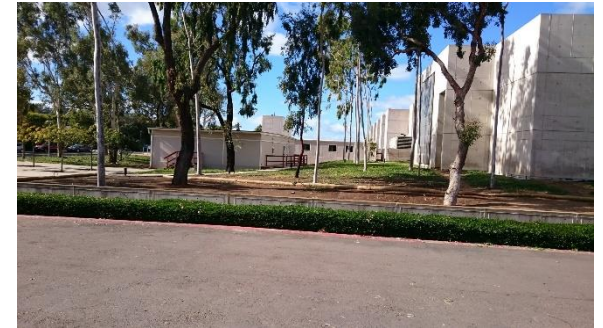
Temporary buildings south of the East Building, 2015.

To remove the Accessory Building, Temporary Offices, and temporary structures south of the East Building.

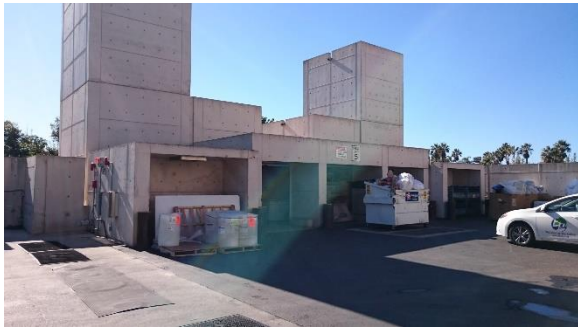
Service Yard: the service towers were introduced in 1975.

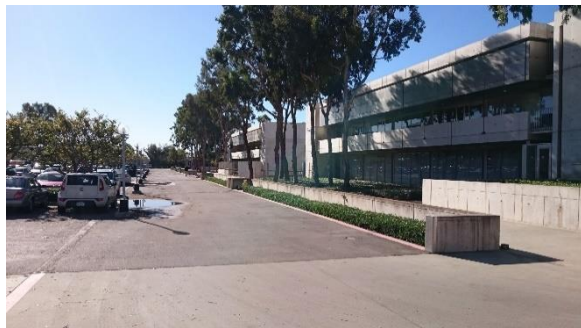
East Building.

The East Building has little cultural significance. It survives in good condition. However, it is intrusive on the Eucalyptus Grove and the setting of Kahn's Laboratory Complex, particularly in the way that the brick court between the wings has denuded the landscape and lost the quality of Kahn's building being revealed as it is approached.

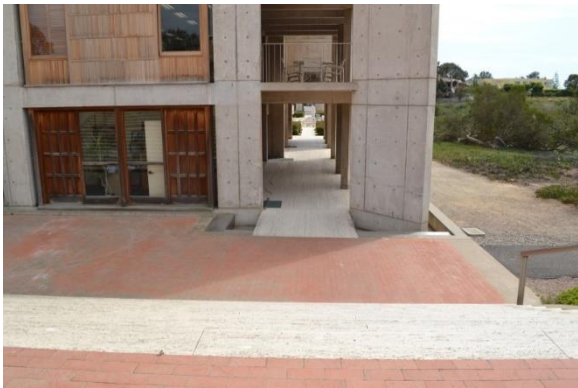
Bottom: Numerous paving materials are used throughout the campus. These include brick, concrete, asphalt, decomposed granite, and travertine, all of which appear in this image.

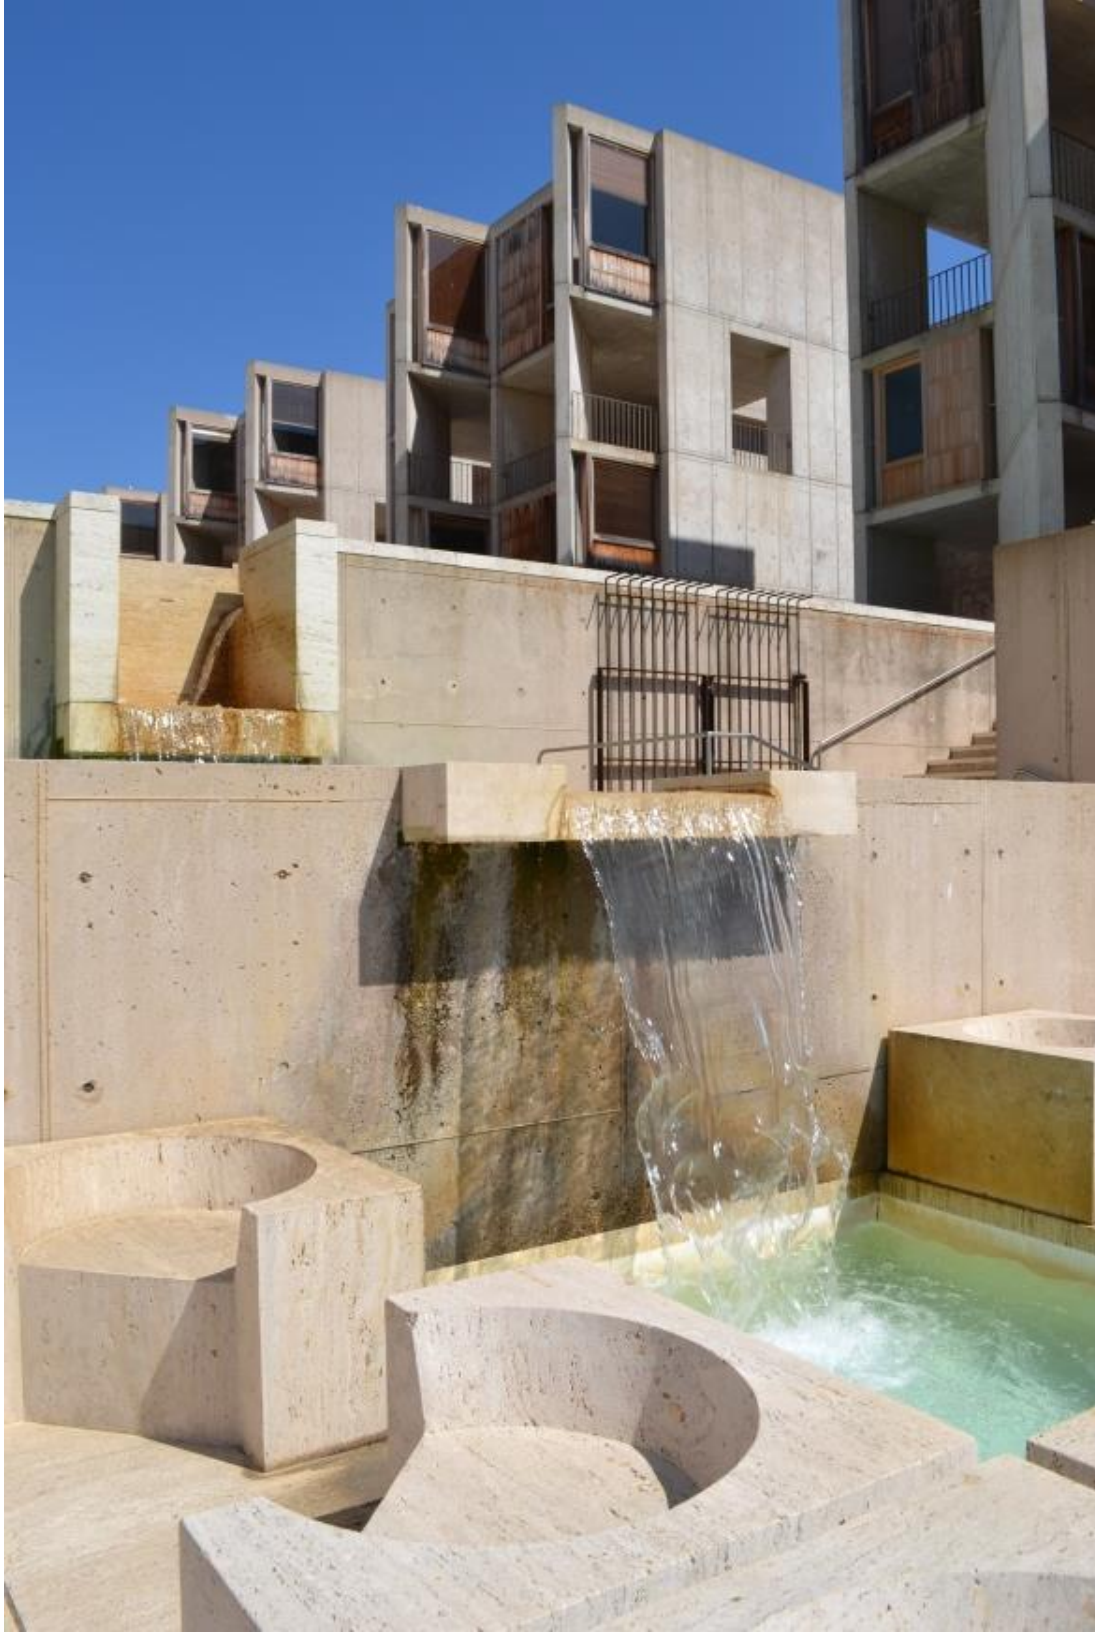
The pools, fountains, and seating shown were part of the original Kahn design for the West Court.

The west court edges the Plaza to the west. It is set a full story below the Plaza, accessed via flights of travertine stairs. Water from the reflecting pool cascades to a secondary pool set half way between the Plaza and west court. Water also cascades from the second pool into a lower pool set at the level of the west court. The water in these fountains is recycled and stored in cisterns. Water from the roof of the Laboratory Complex is also channeled into the pools and cistern. Carved square blocks of travertine, inset with rounded seats edge the lower pool. A level travertine terrace extends between the north and south office wings. The terrace is edged to the west by a low wall. Cut-out areas that feature planter boxes are set within the pavement at the north and south ends. Expansive views of the canyon, Pacific Ocean, and Gliderport are afforded from the terrace. All of these features are historic and composed as part of Louis Kahn's original design. They were assessed in the Assessment of Cultural Significance as possessing exceptional significance.

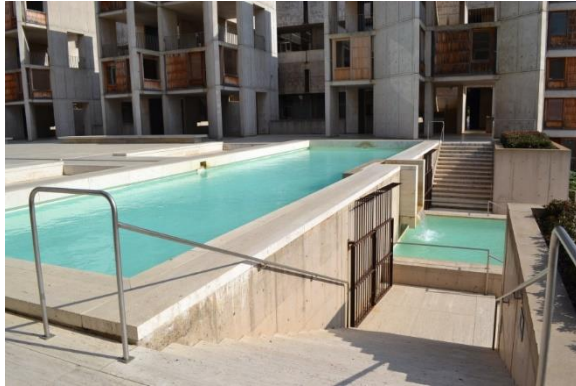
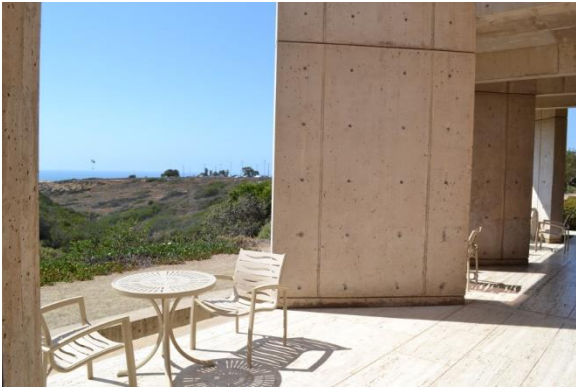
Top: The upper and middle pools.
Bottom: Tables and chairs associated with the makeshift cafeteria.

Changes that have occurred within this space include the addition of movable outdoor furniture, including tables, chairs, umbrellas, lighting, and trash receptacles, and the addition of shrubs in the planter boxes. The planter boxes were once planted with silver acacia trees based on the request of Dr. Salk. The trees repeatedly blew over in the wind before being removed. They have been replaced with Yeddo hawthorne shrub plantings. Given the difficulty associated with maintaining trees in this location, continued use of shrub plantings in the planter boxes is acceptable given the relatively unobtrusive nature of these planting. Alternatively, the replanting of acacia trees, supported by a modest guy wire system, could be evaluated and considered. Like the reflecting pool at the Plaza level, the two pools that edge the west court contain liners that are visually intrusive and should be returned to a more historically appropriate character.

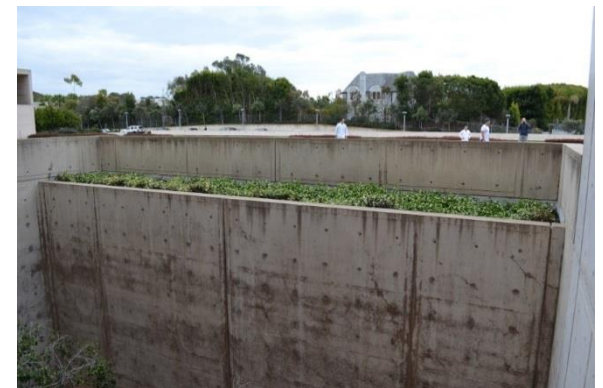
Bottom: Vines in the planter boxes associated with the concrete walls of the garden courts. Creeping jasmine, which has a fragrant flower, is one of the species planted in these boxes. The vines will eventually cascade into the courts.

There appear to be no changes currently planned within the lower garden courts. Every effort should be made to preserve and maintain the significance and integrity of the space and its associated views, patterns of spatial organization, and materials. Intrusive elements, such as the trees in tubs, should be removed. The vine plantings should be maintained such that they cascade into the lower garden courts to soften the space and provide the desired greenery.

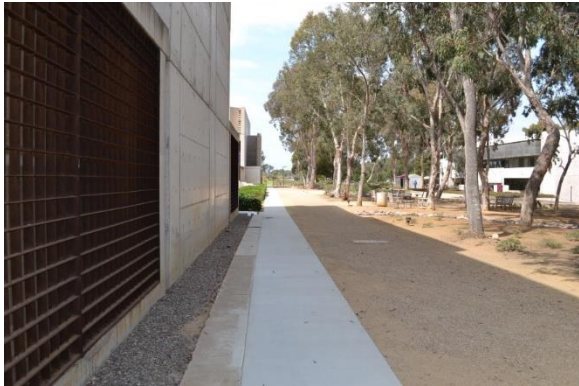
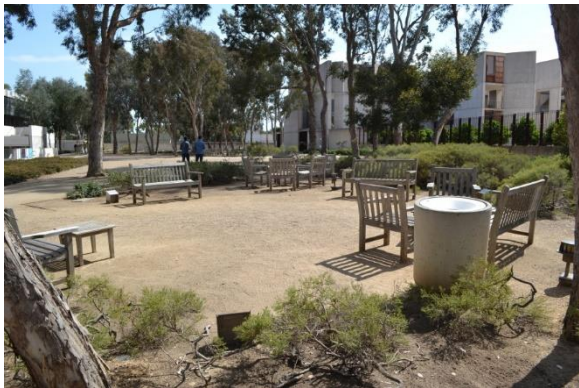
Top: View north along the concrete walk that parallels the east facade of the Laboratory Complex within the East Garden. The fire lane parallels the walk. It is edged by the grove of eucalyptus trees.
Bottom: The Eucalyptus Grove is an important gathering place at the Institute.

A concrete walk parallels the fire lane to the west, following the alignment of the Laboratory Complex. This walk is not historic and is visually intrusive. Consider options for diminishing the visual impact of the walk, such as applying a warm brown stain or coating so that it matches the decomposed granite walk in color.

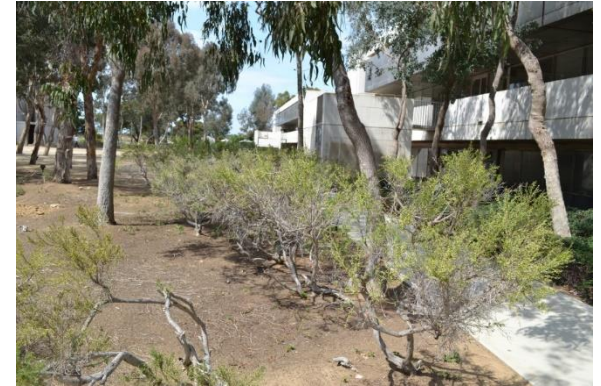
View of Eucalyptus Grove and declining shrub plantings.

Care should also be taken to maintain the existing grove. Each year, trees are lost to storms, disease, and drought. Eucalyptus trees are increasingly subject to damage during storms as they grow taller, particularly those sited on high ground, which tend to fall over. During the 2010s alone some thirty-five trees were lost in a single storm. Additionally, eucalyptus is an invasive species that is also allelopathic, with toxic resins contained in the leaves that can interfere with the growth of nearby plants. The existing shrub underplantings are not thriving and will require replacement as part of the rejuvenation of the eucalyptus grove. Consideration should be paid to designing the beds in the area to reestablish the original meandering paths. Because eucalyptus is an invasive non-native, it should not be grown in proximity to the canyon and MHPA.

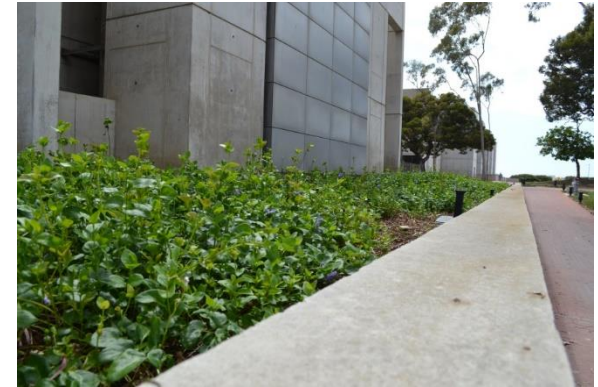
Top: Healthy large periwinkle ground cover planting
 Middle: View of the north gate and periwinkle beds in full sun that are in decline due to droughty conditions.
 Bottom: South gate.

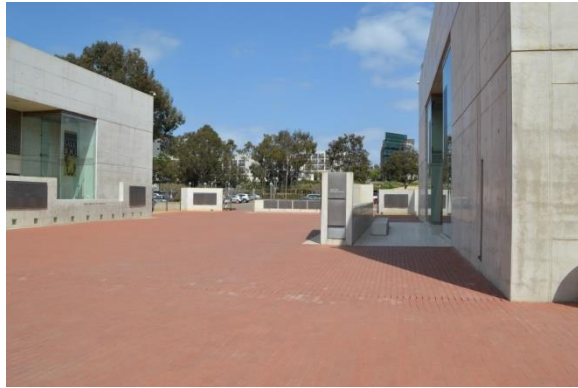
A brick entry terrace sits between the two structures that form the East Building complex. The terrace is not historic, and the expanse of red brick is visually intrusive. Every effort should be made to screen this area from view from the Laboratory Complex Plaza.

Top: Brick entry terrace.
Middle: Accessible walk associated with the East Building.
Bottom: Wall and hedge at the eastern edge of the character area.

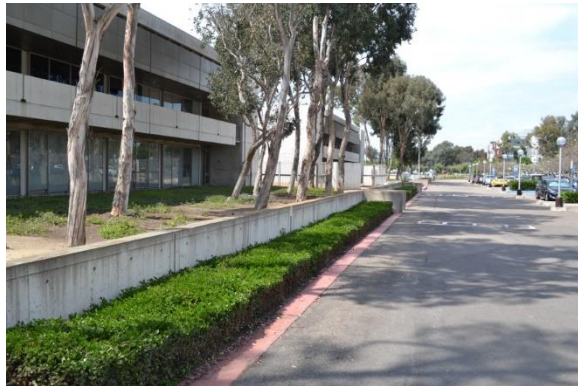
The East Building was designed to have two rows of trees along the facade. One of the retaining walls near the East Building was destroyed by tree roots and had to be rebuilt. Root barriers should be used in conjunction with future plantings of this type.

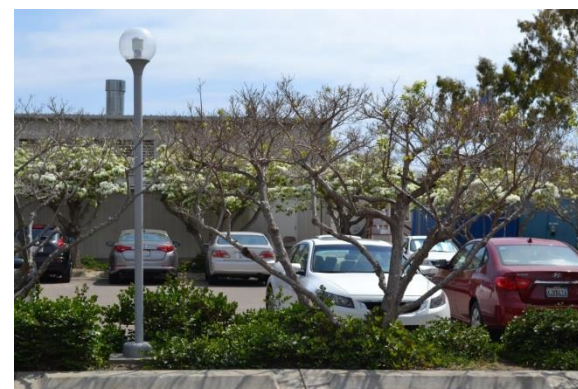
Top: View west toward the East Building across the east parking area.
Bottom: Chinese fringe trees in an east parking area median.

The Chinese fringe trees, while attractive when in leaf and fragrant in flower, the trees often present an unkempt appearance and have not been a popular component of the campus planting design. As noted, the trees have thick surface roots strong enough to break and warp the east parking area pavement. The roots also tend to invade water lines and storm drains.

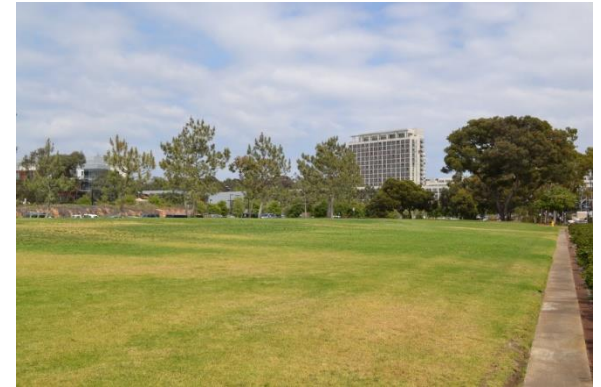
View of the north lawn, with drought-related stress of the turf evident.

The turf used as to create the north and south lawns requires irrigation to thrive. Water restrictions resulting from the current drought limit the degree that the lawn can be watered. The lawns are now in decline. Consideration should be paid to replacing the existing turf with a drought tolerant species once the underground structure is completed.

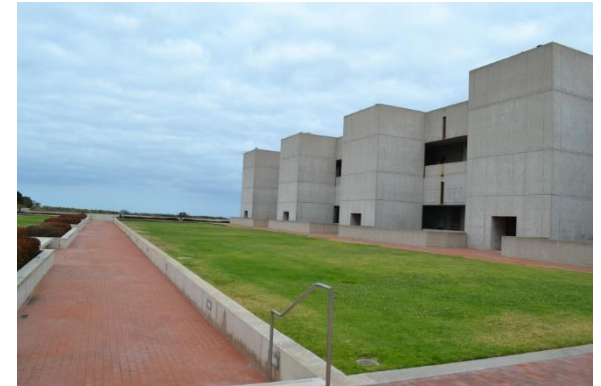
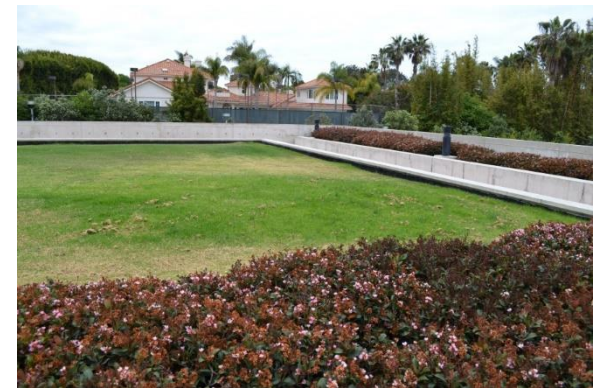
Top: View of the northern lawn panel.
Bottom: View of the undulating south lawn, the turf exhibiting poor growth, and the subsidence evident along the wall.

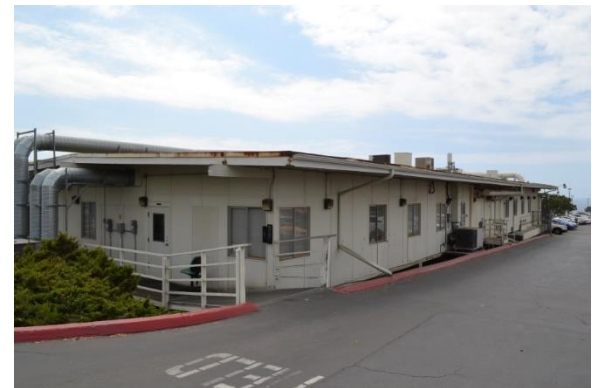
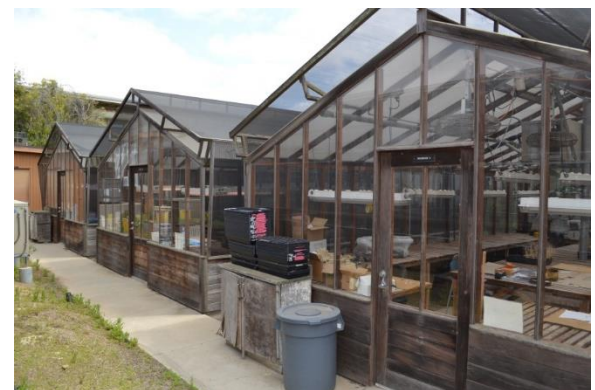
Top: Identity sign near the intersection of Salk Institute Road.
 Middle: One of the temporary lab buildings, which was used by Jonas Salk as a laboratory beginning in 1961.
 Bottom: View of several of the greenhouses located within the character area.

These temporary structures are indicated for removal in the 2008 master plan, as well as the Conservation Management Plan. The city of San Diego has indicated that the buildings should be removed as part of a broader effort to afford unobstructed views of the Pacific Ocean wherever possible within the campus. The 2008 master plan suggests that three greenhouses will be built within the service corridor landscape to replace the greenhouse use presently accommodated in this location.

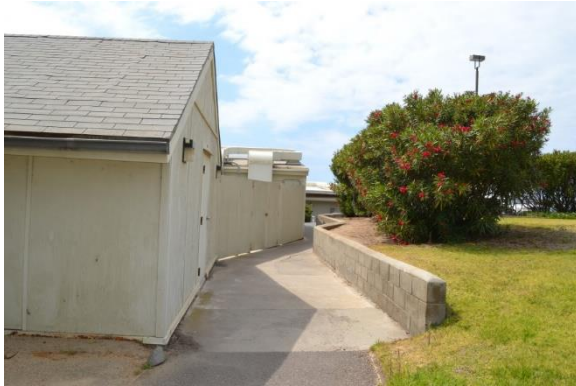
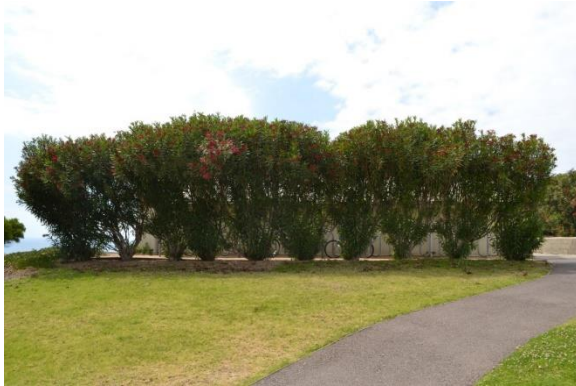
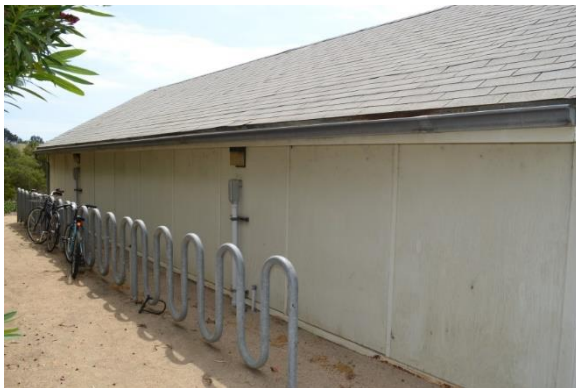
Top: Concrete block wall and concrete walk linking building cluster with the north lawn.
Middle: Oleander screen planting.
Bottom: Bicycle rack behind the oleander screen planting.

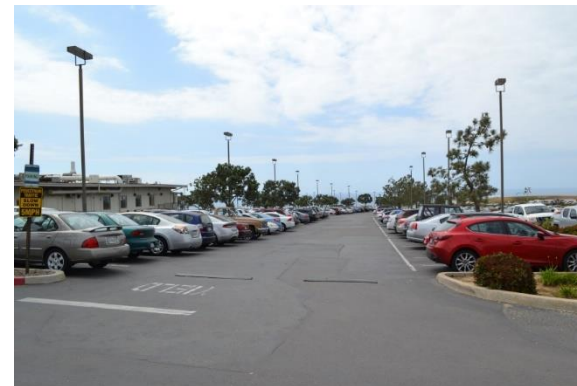
View west across the north parking area.

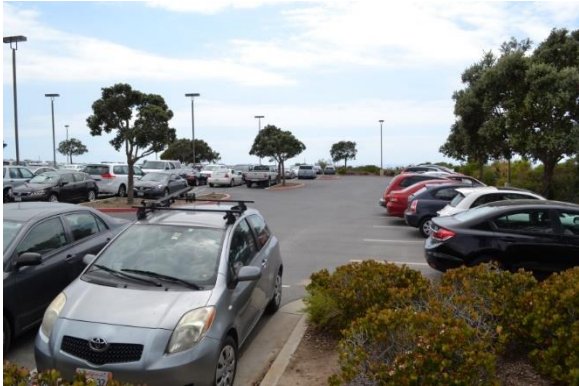
Ornamental plantings and lighting within the north parking area.

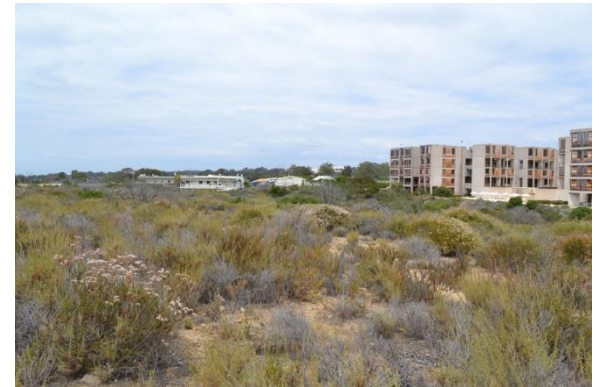
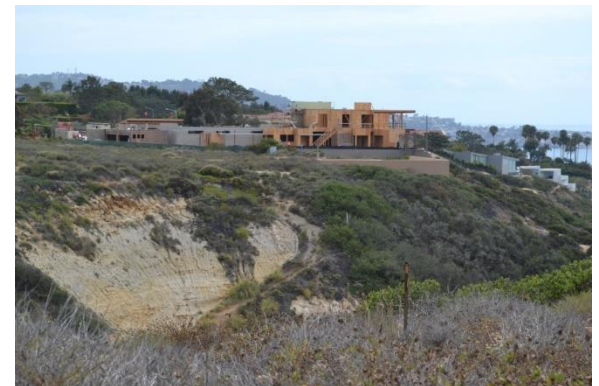
Views are afforded from the south mesa, as well as other parts of the campus, of large residences that abut the Salk Institute campus. These views are not historic and the residences intrusive.

Top: Native vegetation on the south mesa.
Bottom: Views of residences south of the property.
