LAS CRUCES, NEW MEXICO, U.S.A., OCTOBER 14-19, 1990

6th International
Conference on the
Conservation of
Earthen Architecture

Adobe 90 Preprints

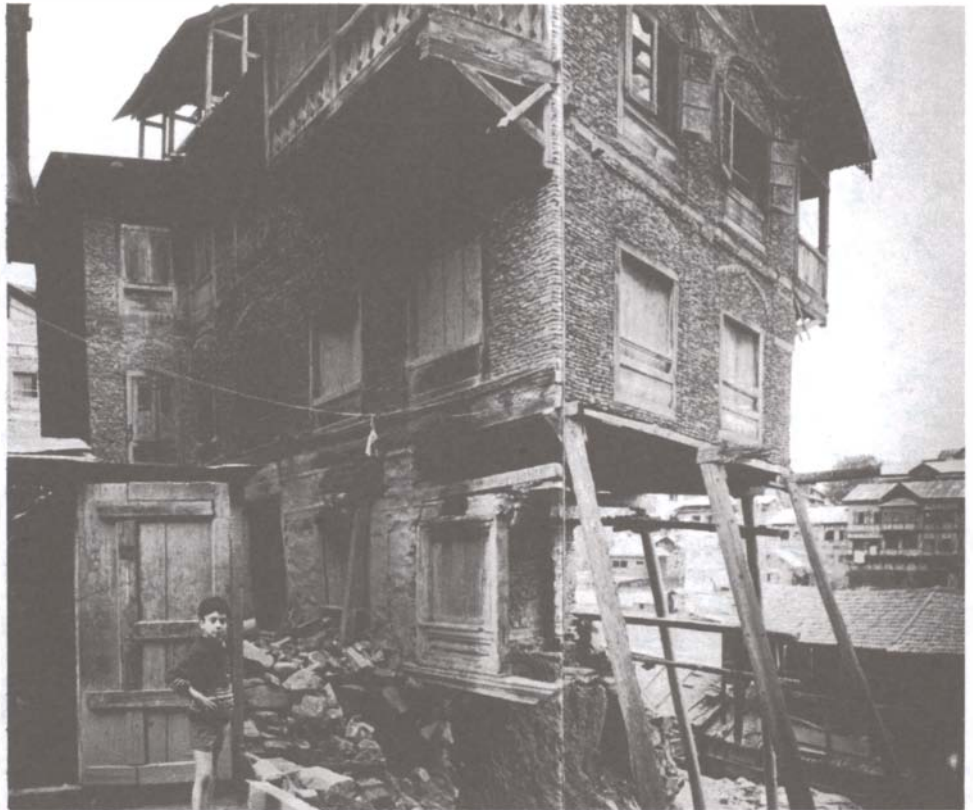
Above right: A Taq system house undermined by the river shows the remarkable flexibility and strength of this timber/masonry system (and the fearlessness of the workers.)

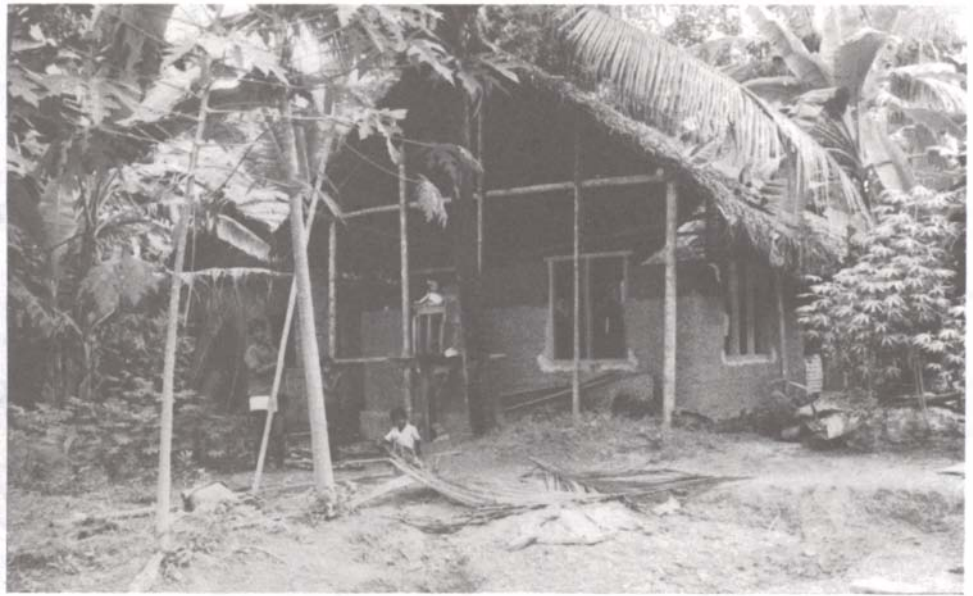
Figure 5. A house with rammed earth-walls, under construction; note the temporary roof standing on timber supports.

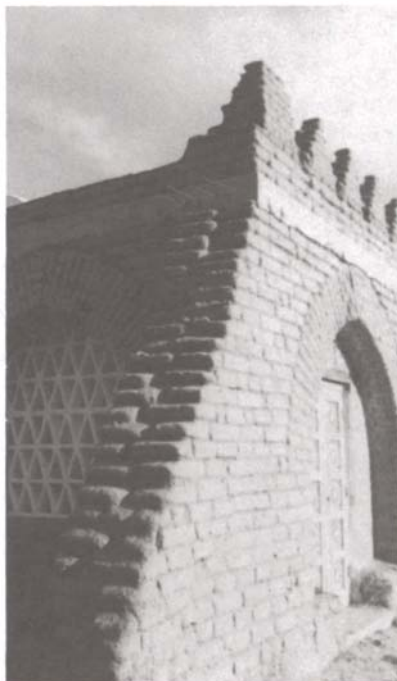
5. Buttress wall and concrete lintel beam.
Photo: James Steele.

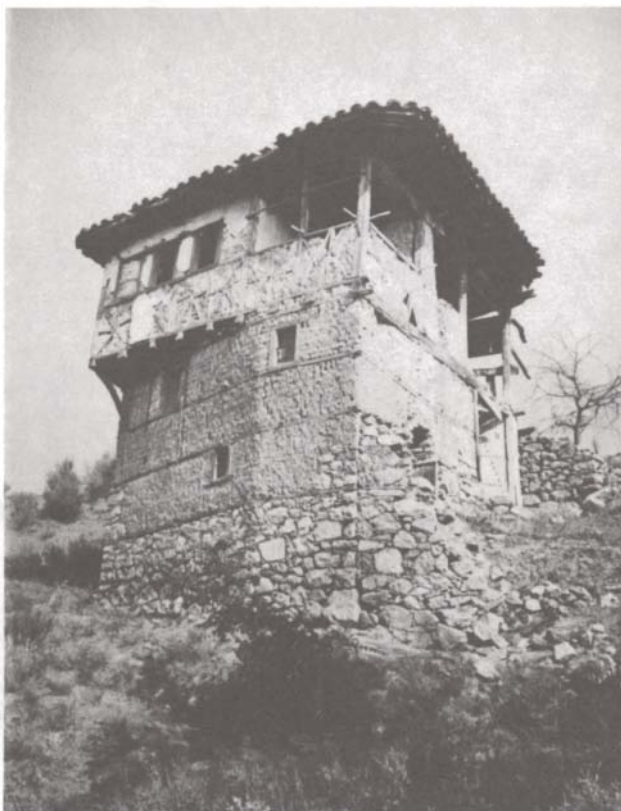
Fig. 2 - Typical traditional aseismic elements
v. Cucer (Skopje region)

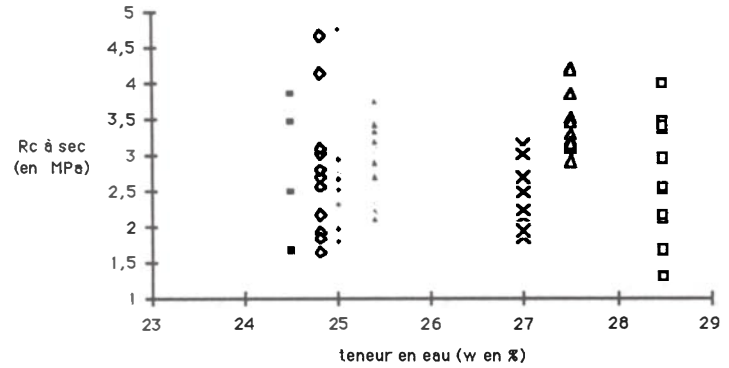
figure 8 : (Résistance à sec / teneur en eau) pour le matériau stabilisé à 6% de ciment

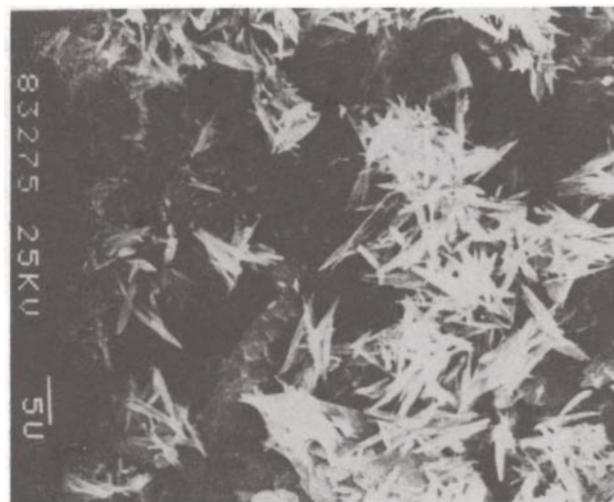
Fig 9 SEM photograph of PS-C, 9000 x.

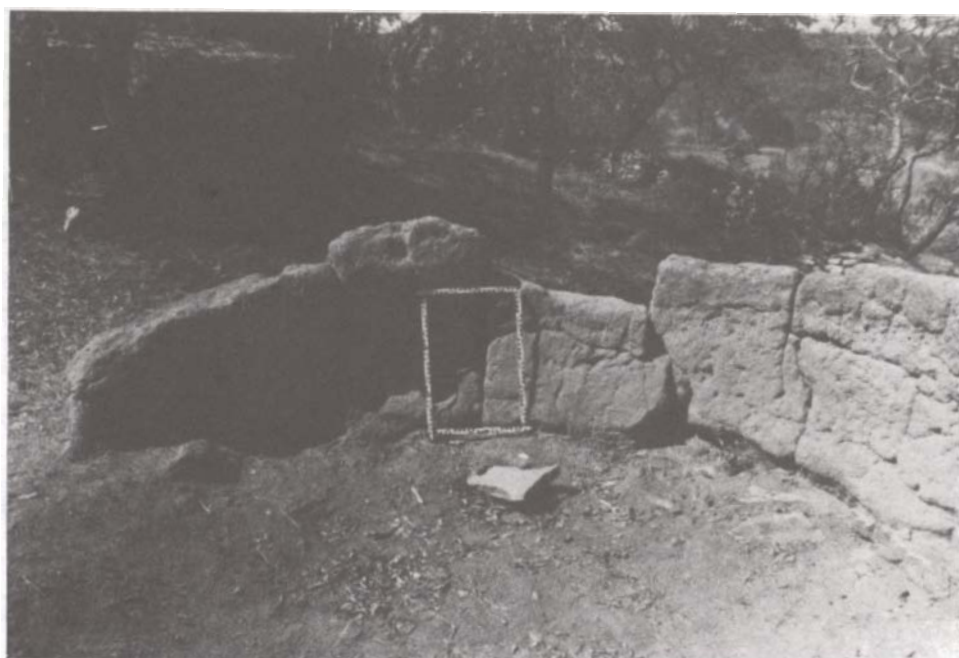
Fig. 2: Prehistoric structure-interior decay.

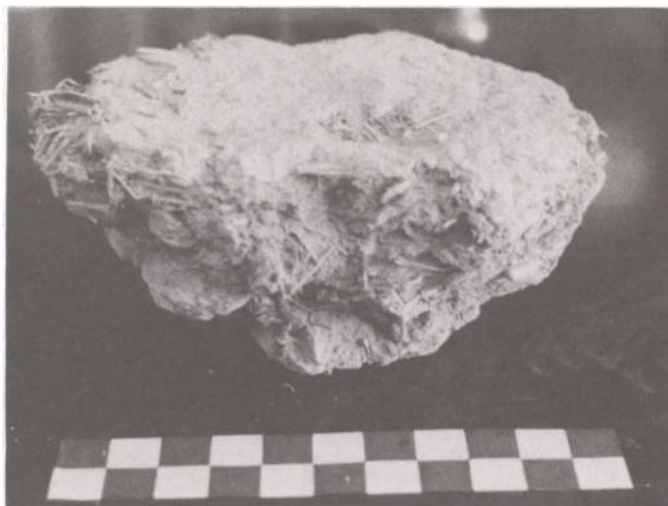
Figure 2: SC1A1 Partial Brick Exposing Straw Binder
