# Conservation and Seismic Strengthening of Byzantine Churches in Macedonia

Predrag Gavrilović

GCI Scientific Program Reports

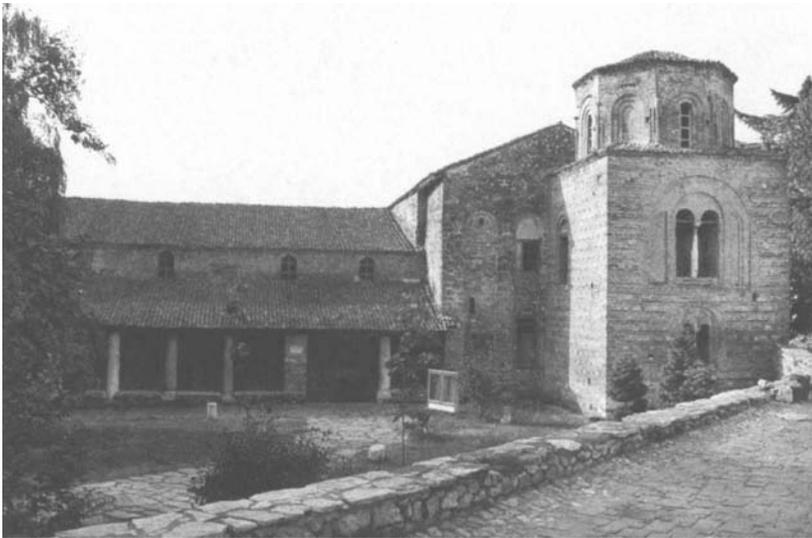
**Figure 2.1**  
Basilica-type church, St. Sofia, Ohrid:  
(a) north facade, (b) west facade.

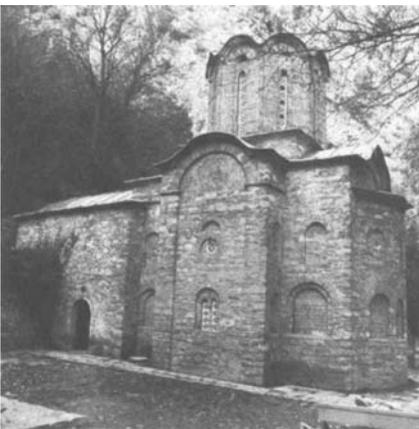
**Figure 2.2**  
Triconch church, St. Andreja, Matka: south  
and east facades.

tetraconch churches with a single dome (figs. 2.2 and 2.3, respectively) were characteristic of the middle of this period, from the tenth to twelfth century. Single-dome and quincunx churches with developed or narrowed inscribed crosses in a rectangular plan (fig. 2.4), single-nave churches (fig. 2.5), and smaller buildings with more simplified plans prevailed from the twelfth to fourteenth century. These basic types of structures, especially those with an inscribed cross, are found in many variations and modifications.

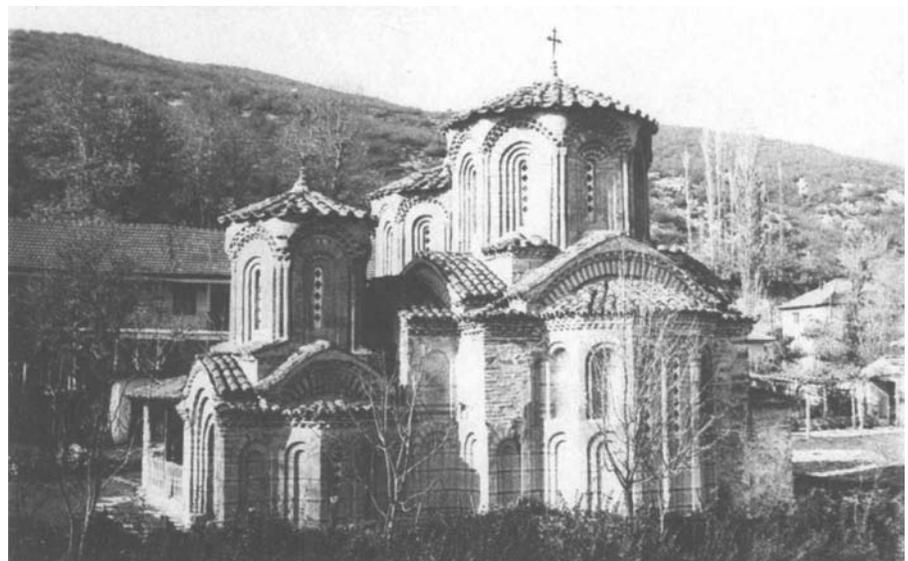
**Figure 2.3**  
Tetraconch church, St. Bogorodica Eleusa,  
Veljusa: south and east facades.

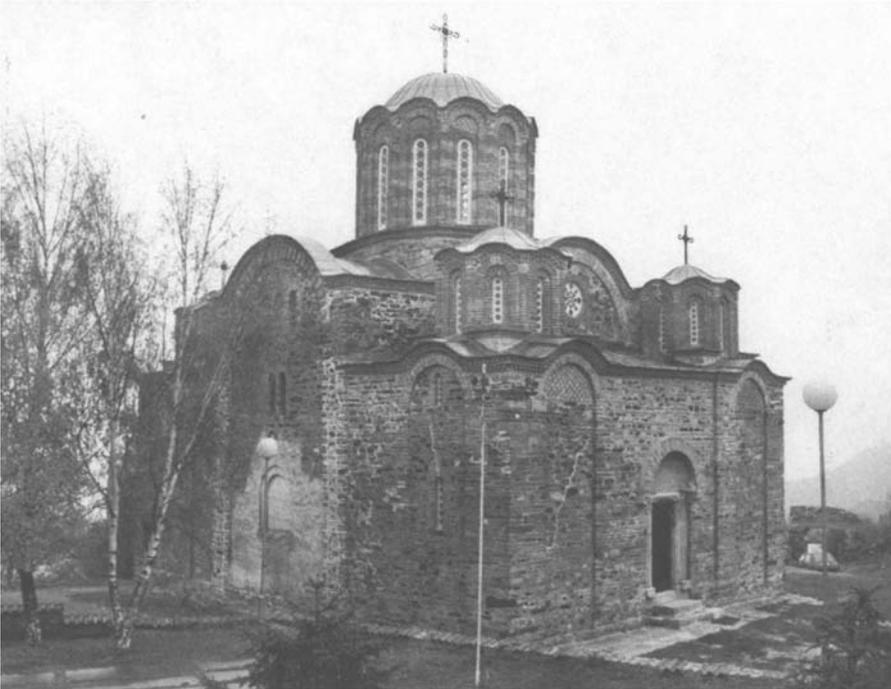
**Figure 2.4**  
Quincunx church, St. Bogorodica,  
Matejče: north and west facades.

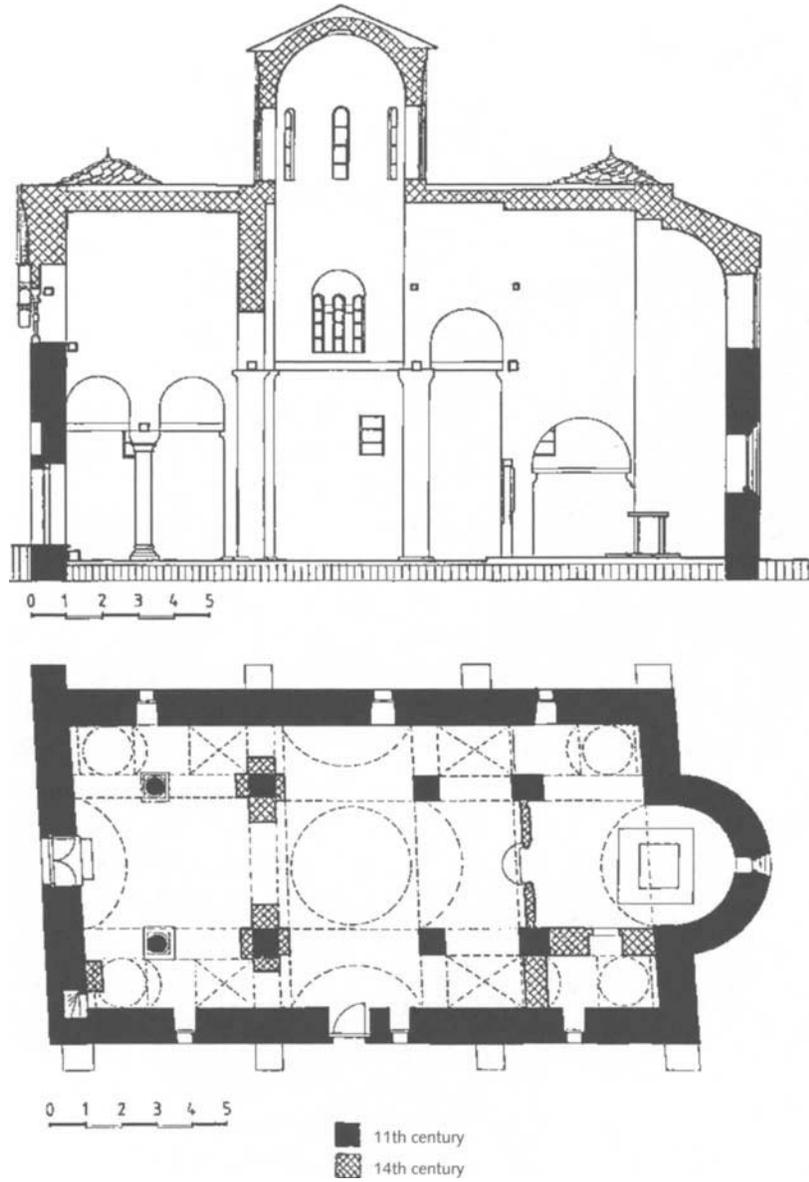
**Figure 2.6**  
 St. Gjorgji, Staro Nagoričane: basilica plan and elevation.

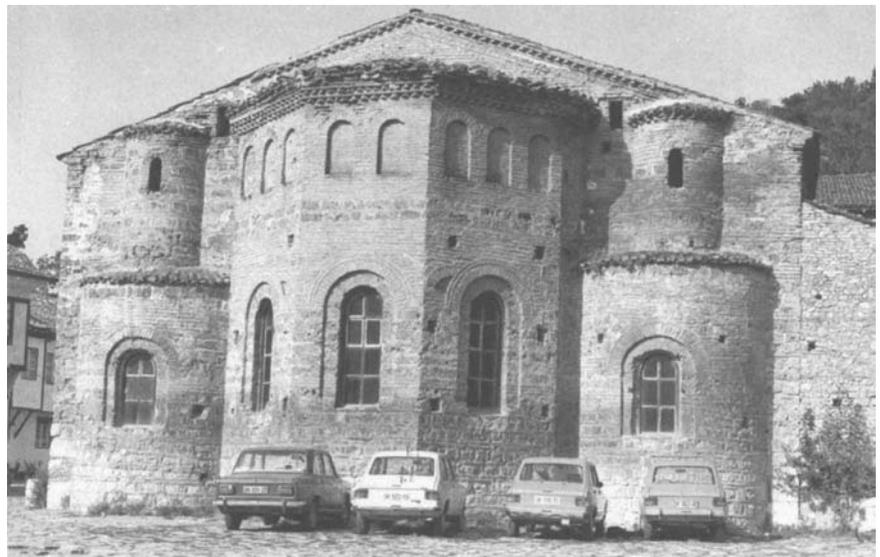
**Figure 2.7**  
 St. Sofia, Ohrid: east facade and apse.

Basilica-type structures continued to be constructed in Macedonia for many years, continuing the Roman basilica design. The structural system of the basilica is characterized by massive, meter-thick facade walls and two rows of symmetrically placed columns that separate the central nave from the two aisles. Usually, the plan was a three-nave structure with a flat timber roof. An example of this type is the older part of the church of St. Gjorgji, Staro Nagoričane (fig. 2.6). Exceptions exist, however, such as the churches of St. Sofia, Ohrid, and St. Bogorodica, Drenovo, whose naves are surmounted by vaults. In the original structures, the central naves apparently had domes, but these no longer exist. The exterior shapes of the single apses of basilicas are either semicircular or polygonal (fig. 2.7).

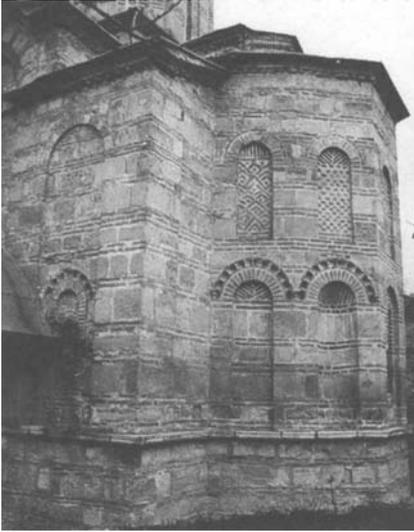
**Figure 2.8**  
St. Dimitrija, Markov Monastery, Sušica:  
east facade and apse.

In a variation of this design, the dome was supported by corner pilasters, which represent, in fact, wall areas. These churches were usually built without a narthex; that is, there was only an altar area and a naos. The prothesis and the diaconicon were constructed either as separate areas or as two semicircular niches in the east wall. In some cases, the niche was decorated on the outside with semicircular blind niches (fig. 2.8).

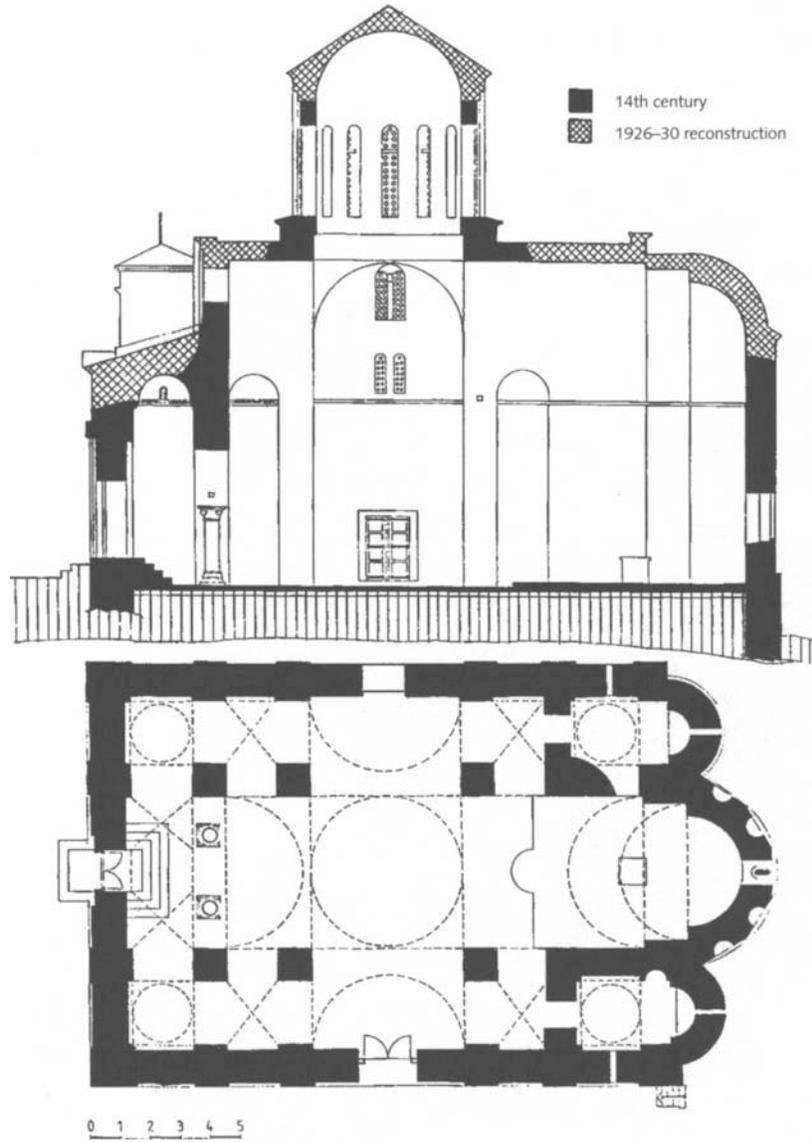
**Figure 2.9**  
St. Bogorodica, Matejče: Quincunx plan and elevation.

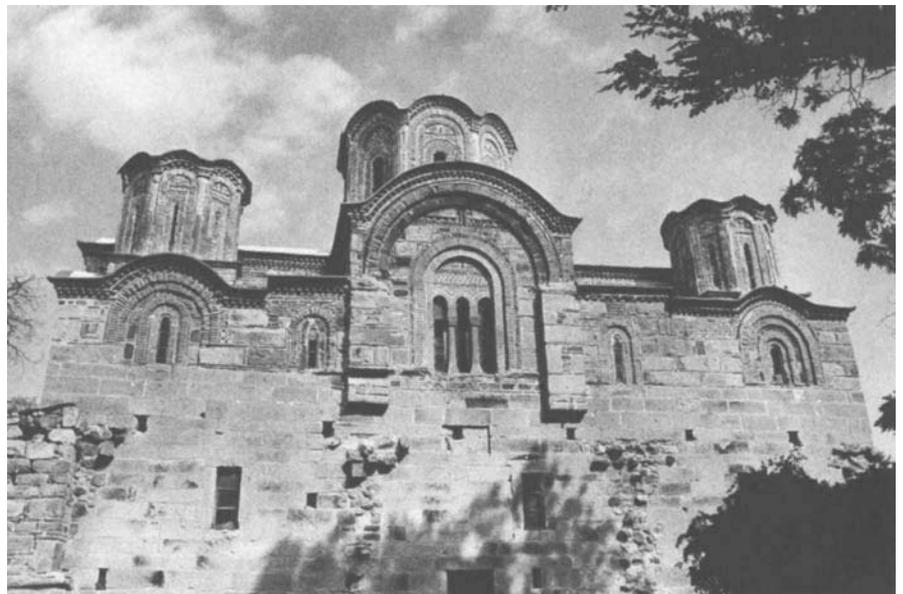
**Figure 2.10**  
St. Gjorgji, Staro Nagoričane: south facade.

The church of St. Gjorgji, Staro Nagoričane (fig. 2.10), was created by renovating a ruined Byzantine basilica. The five-dome plan was incorporated into the old basilica outline, resulting in a combination of a basilica and a quincunx (see fig. 2.10). The side naves of the basilica were incorporated and columns were constructed in the interior.

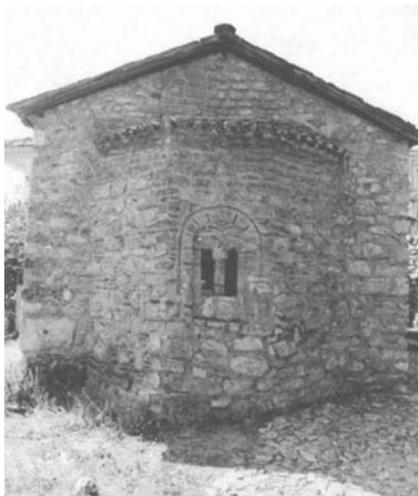
**Figure 2.14**

St. Vračı Mali, Ohrid: apse.

Many of the churches in Macedonia belong to this architectural group, which is characterized by simple, single-nave designs (figs. 2.11, 2.12). The much smaller, rectangular buildings have barrel vaults or timber-couple roofs and usually have an apse that is semicircular on the inside and polygonal on the outside (figs. 2.13, 2.14).

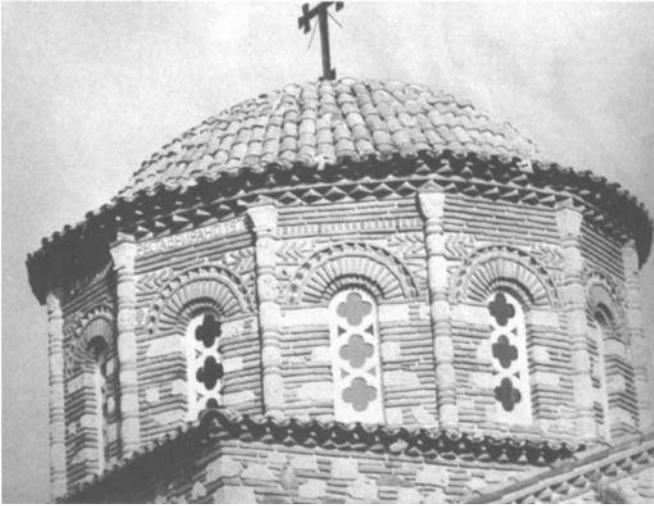
**Figure 2.15**  
St. Leontije, Vodoča: tambour and dome.

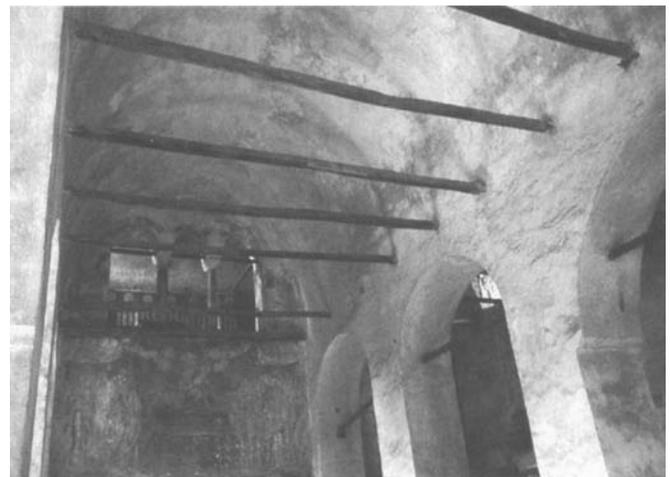
**Figure 2.18**  
St. Sophia, Ohrid: interior timber ties.

An important feature of almost all Byzantine churches was the incorporation of visible timber ties placed at several upper levels in the interior of the church (fig. 2.18). These ties sustained the tensile stresses in the structure resulting from differential settlement, wind loads, and seismic effects. To ensure the uniform settlement of buildings during the temporary interruption of construction required by the slow curing of

lime mortar, dual horizontal timber belts were embedded within the walls at vertical separations of 1.0–1.2 meters. They were connected in the transverse direction every 60–70 centimeters by smaller beams and at the corners of the walls. These wooden elements were the same height as the walls and were connected with wooden ties at the base level of vaults or arches, as well as at the bases of the tambours and domes. The belts served also to stiffen the structure and increase its stability under seismic or other dynamic loads. Over time many of the timber belts in Byzantine-period churches have deteriorated or have been destroyed by insects, so voids now exist at many former belt locations.

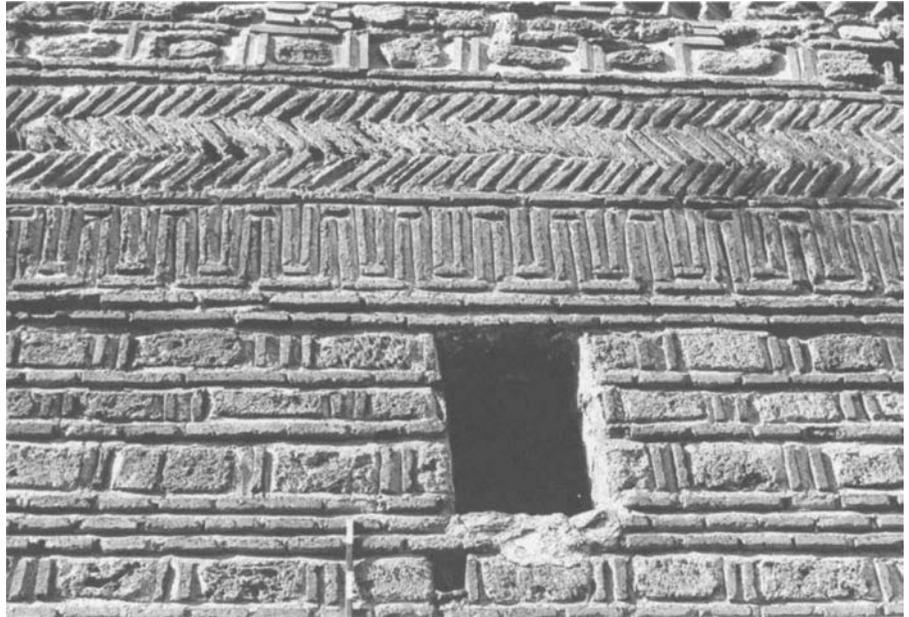
**Figure 2.23**  
St. Dimitrija, Varoš: facade polychromy.

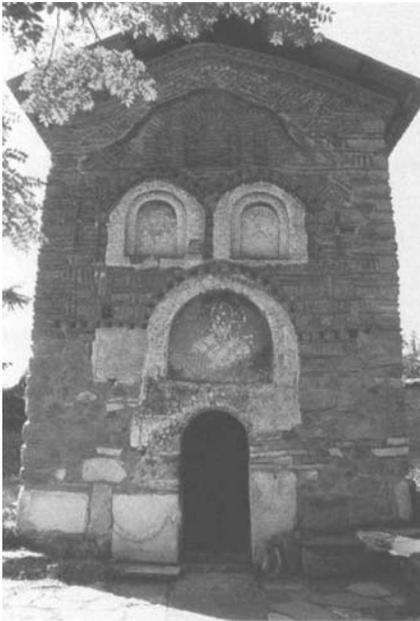
**Figure 2.25**  
St. Nikola, Varoš: exterior fresco and polychromy.

Multicolored stone was used occasionally, and mortar was available in colors ranging from white to light rose, depending on the composition and quantity of the ground brick or brick powder added to enhance the strength of the mortar. The polychromatic effect obtained in this way is one of the most striking characteristics of Byzantine architecture. Outstanding examples of such polychromy can be seen in the churches of St. Nikola, Varoš (fig. 2.25), and St. Bogorodica Zahumska, Trpejca (fig. 2.26).

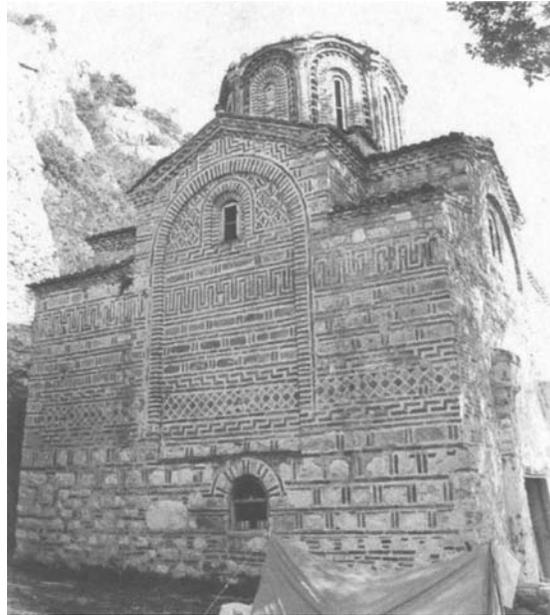
**Figure 2.26**  
St. Bogorodica Zahumska, Trpejca: west facade.

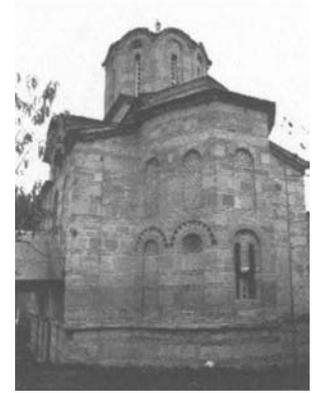
**Figure 2.27**  
St. Dimitrija, Markov Monastery, Sušica: apse.

Flat wall surfaces were visually enhanced by incorporating pilasters, arches, and niches. Deep semicircular niches in the facade, especially on the east-facing apse, created a particularly dramatic effect. This can be seen, for example, in the churches at St. Bogorodica Eleusa, Veljusa; St. Spas, Kučevište; and St. Dimitrija, Markov Monastery, Sušica (fig. 2.27).

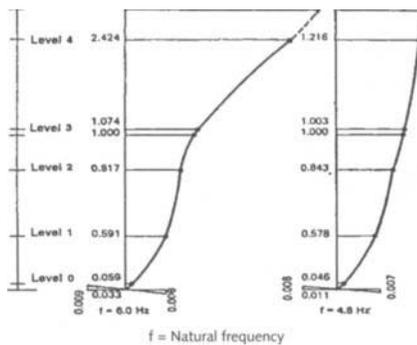
**Figure 3.2**  
Calculated mode shapes for St. Nikita, Banjani.

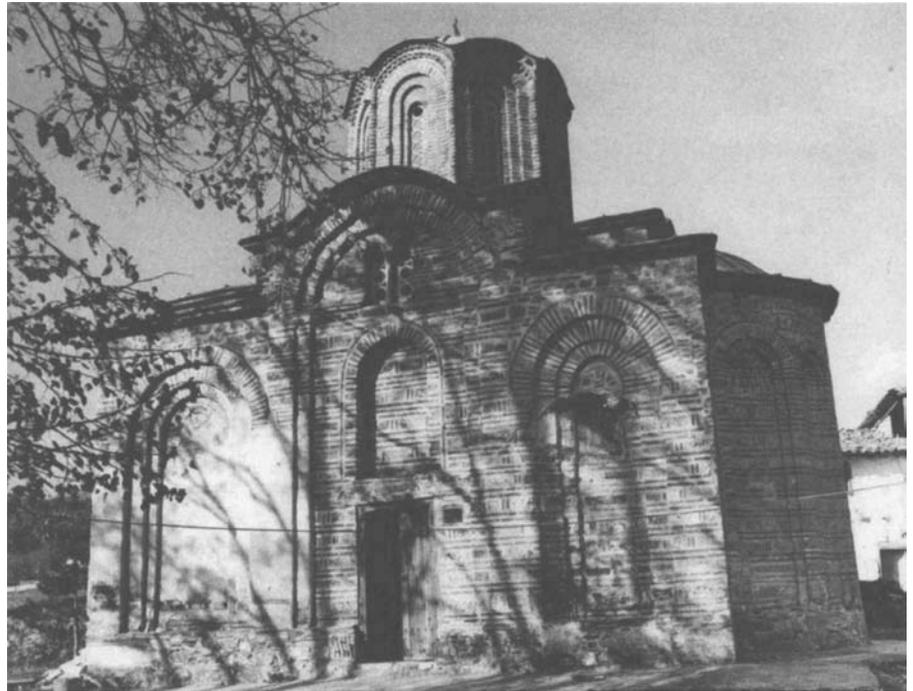
**Figure 3.3**  
 Prototype church, St. Nikita, Banjani:  
 south (with door) and east (with apse)  
 facades.

in the gable wall over the west entrance, while the south wall (see fig. 3.3) has a shallow, single niche with a blind arch. All niches on the north facade are triple, with three blind arches constructed of bricks (see fig. 3.5), and a double niche occupies the central part of the south facade (fig. 3.6).

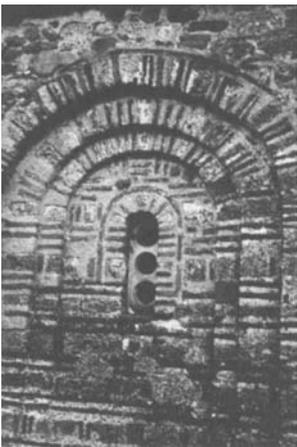
**Figure 3.5**  
St. Nikita: north facade window.

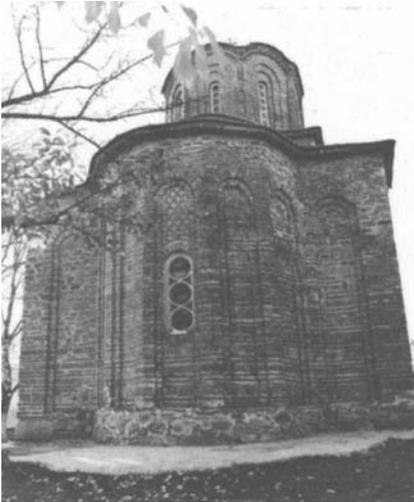
**Figure 3.7**  
St. Nikita: apse.

The pentagonal apse (fig. 3.7) is broken up visually by double niches with blind brick arches, the tympanums of which are characterized by polychromy achieved by varied arrangements of bricks (rhomboids, cubes, and alternating horizontal and vertical bricks). All the cornices, with the exception of those of the tambour, are constructed of wavy, double-dentiled brick courses. The tambour is fabricated entirely of brick, and the corners are constructed in the form of semicircular pilasters without capitals (fig. 3.8). The recent reconstruction of the upper part of the tambour and the need for replacement of deteriorated mortar in the lower section are evident.

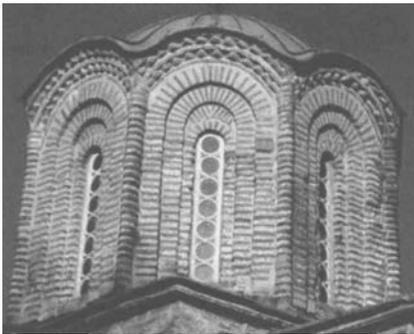
**Figure 3.8**  
St. Nikita: tambour.

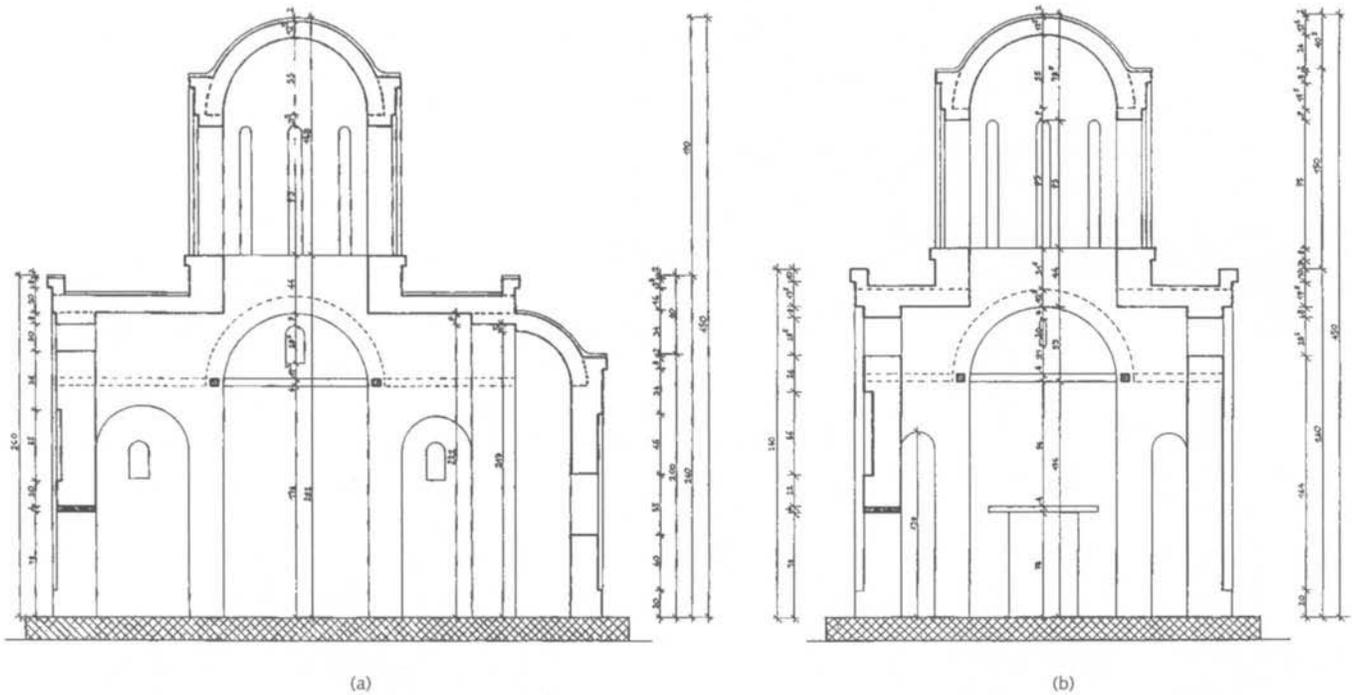
Figure 4.3  
Elevations of model: (a) north-south,  
(b) east-west.

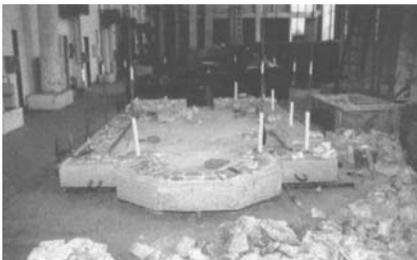
**Figure 4.4**  
Model foundation during construction.

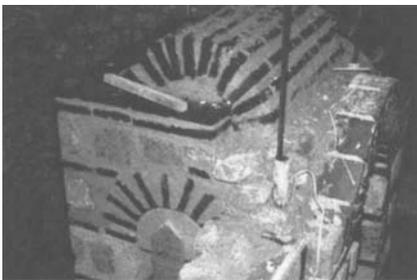
**Figure 4.5**  
Model vault construction.

The thickness of the arches, vaults, and dome was 12 cm, which was equal to the brick thickness (fig. 4.5). These elements, along with the blind niches, pilasters, and other interior and exterior architec-

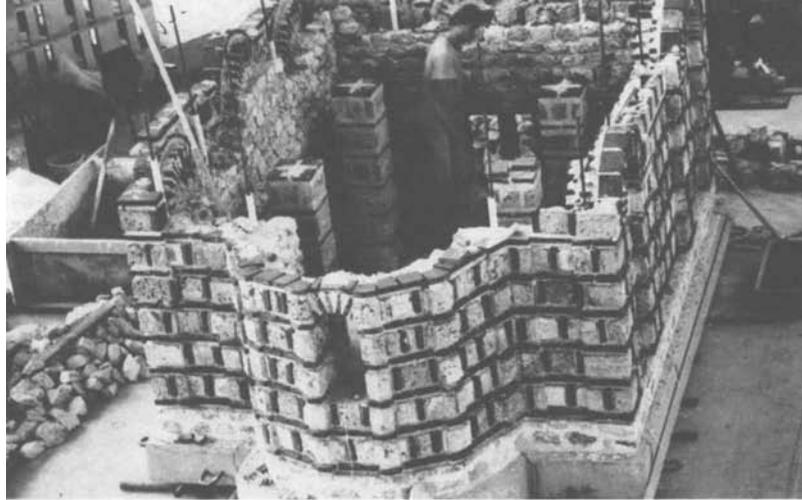
**Figure 4.6**  
Model under construction.

tural elements, were simulated with regard to both appearance and the order and the continuity of construction. Figures 4.6 and 4.7 show the model at different stages of construction. Figure 4.8, an interior view, shows the timber ties at the vault level and the spherical, triangular pendentives that connect the vaults to the tambour above. A close-up of the tambour and dome is shown in figure 4.9, and a photograph of the completed model appears in figure 4.10.

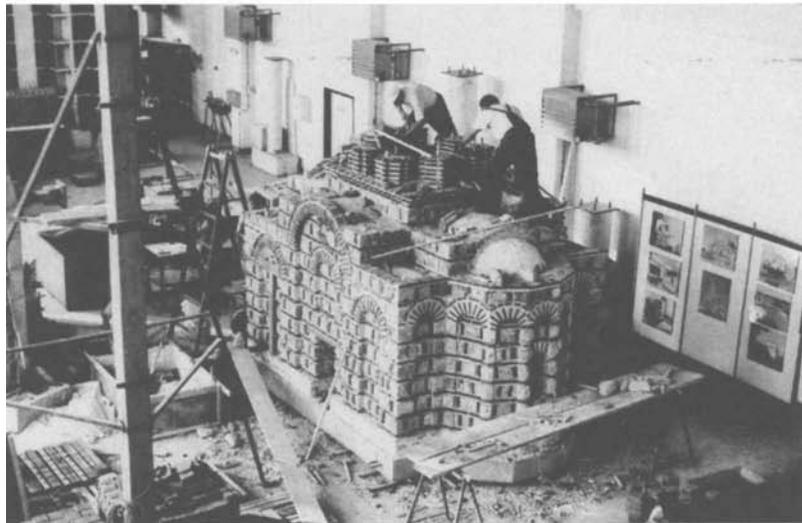
**Figure 4.7**  
Model under construction.

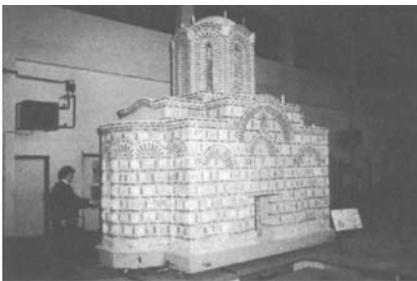
**Figure 4.10**  
Completed model.

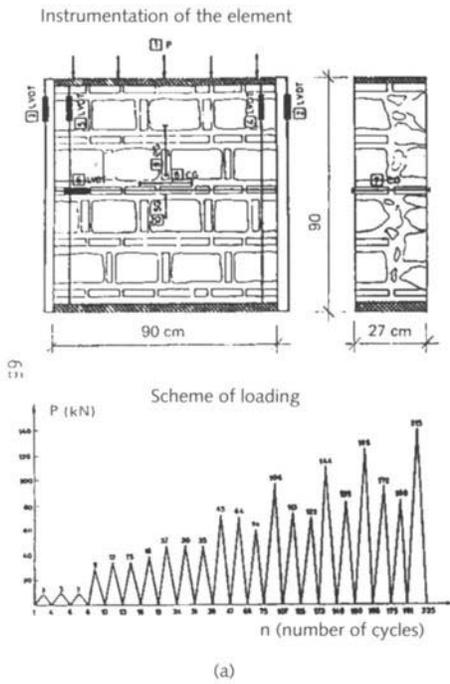
**Figure 4.11 (above)**  
Wall section, test WAC-1, axial compression by cyclic loading: (a) instrumentation of the element, (b) type of failure, (c) P-Δ diagrams for total axial shortening of the wall and the side deformation.

Both elements that were exposed to axial loads were characterized by occurrence of lateral cracks along the center of their width, which in both WAC-1 and WAC-2 resulted in loss of material and, in the case of WAC-2, total separation of the two faces of the wall. In the case of the third element, WSC-3, the force was applied monotonically at an angle of 45 degrees relative to the expansion joints of the wall up to total failure of the sample (fig. 4.13). Figure 4.13b shows the characteristic failure mechanism with the occurrence of diagonal cracks, and figure 4.13c shows the P-Δ diagrams for the deformations along the element diagonals, which yielded the sliding angle (distortion). In this test, the values of the tangential and normal stresses ( $\tau_u$  and  $\sigma_0$ ) are identical because of the angle of action of forces with respect to the planes of failure development.

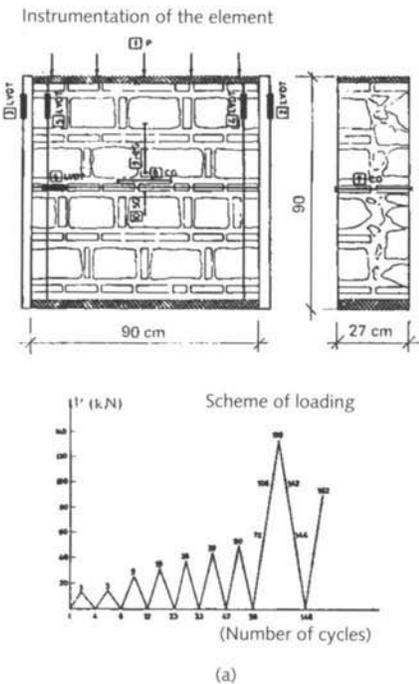
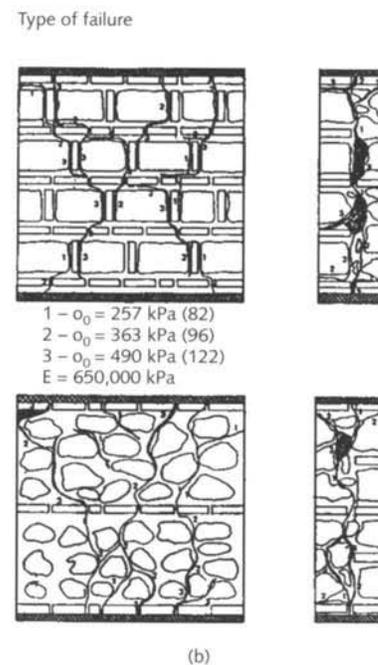
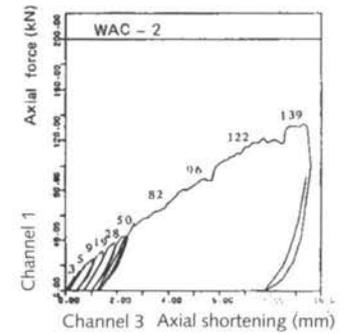
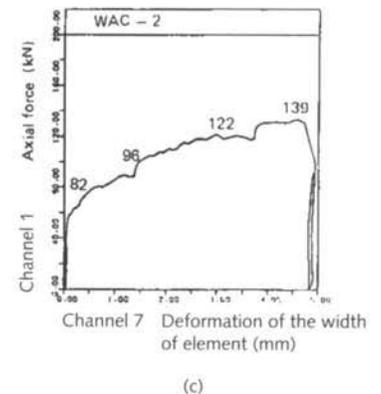
**Figure 4.12 (below)**  
Wall section, test WAC-2, axial compression by monotonic loading increases: (a) instrumentation of the element, (b) type of failure, (c) P-Δ diagrams for total axial shortening of the wall and the side deformation.

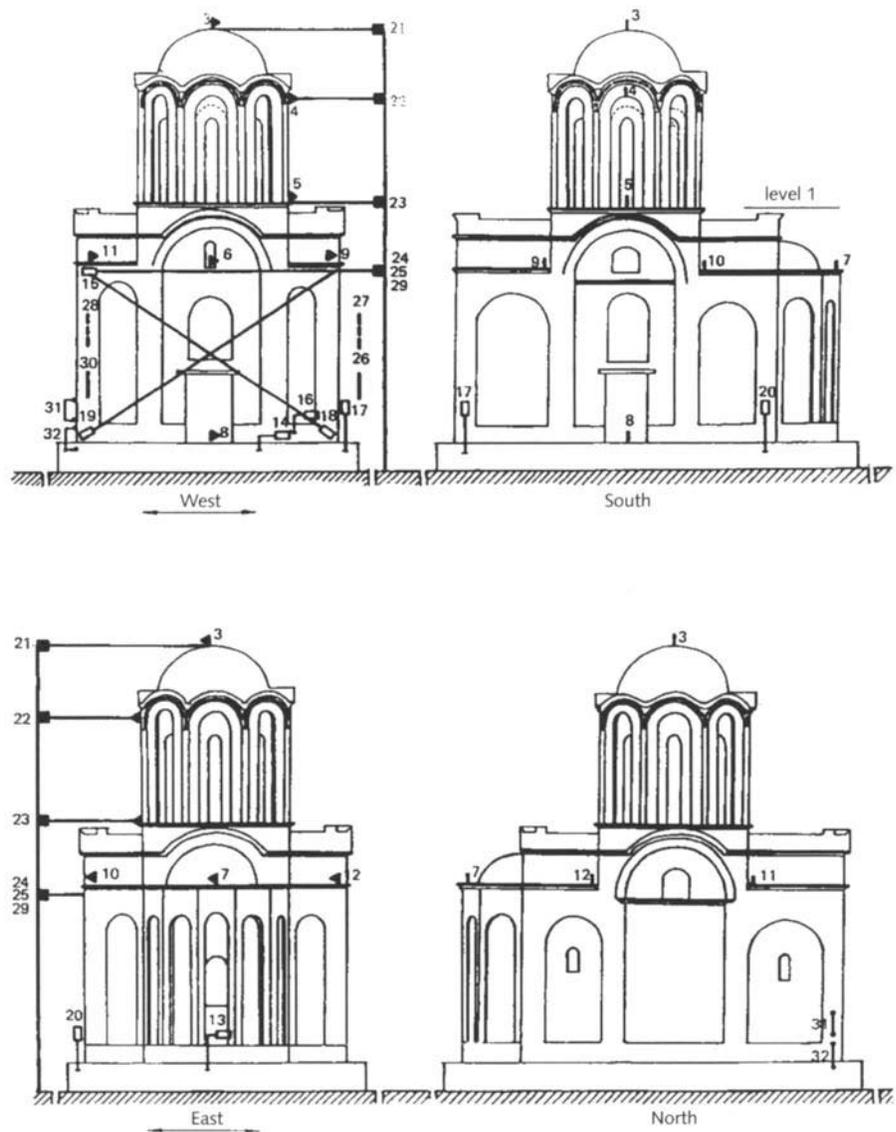
**Figure 5.1**  
Location of model instrumentation.

The shaking-table motion was controlled by an accelerometer and monitored by a displacement transducer, both of which were mounted on the table itself. Time histories of the displacement and acceleration of the table were considered to be the ground motion input. Response of the model at various levels and locations was obtained by measuring accelerations and displacements at the top of the dome and at a number of points along the height of the model, as well as at several points at level 1 (fig. 5.1).

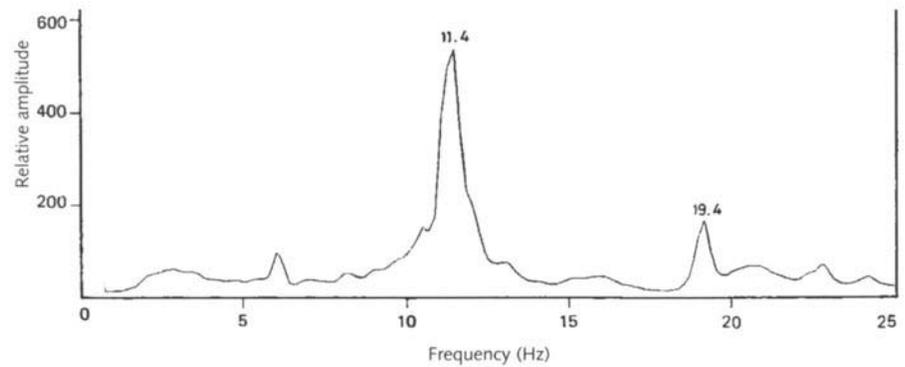
**Figure 5.2**  
Ambient vibration spectrum of model.

Ambient vibration measurements were carried out to check the dynamic properties of the original model before it was subjected to earthquake excitation and, later, on the strengthened model after repairs

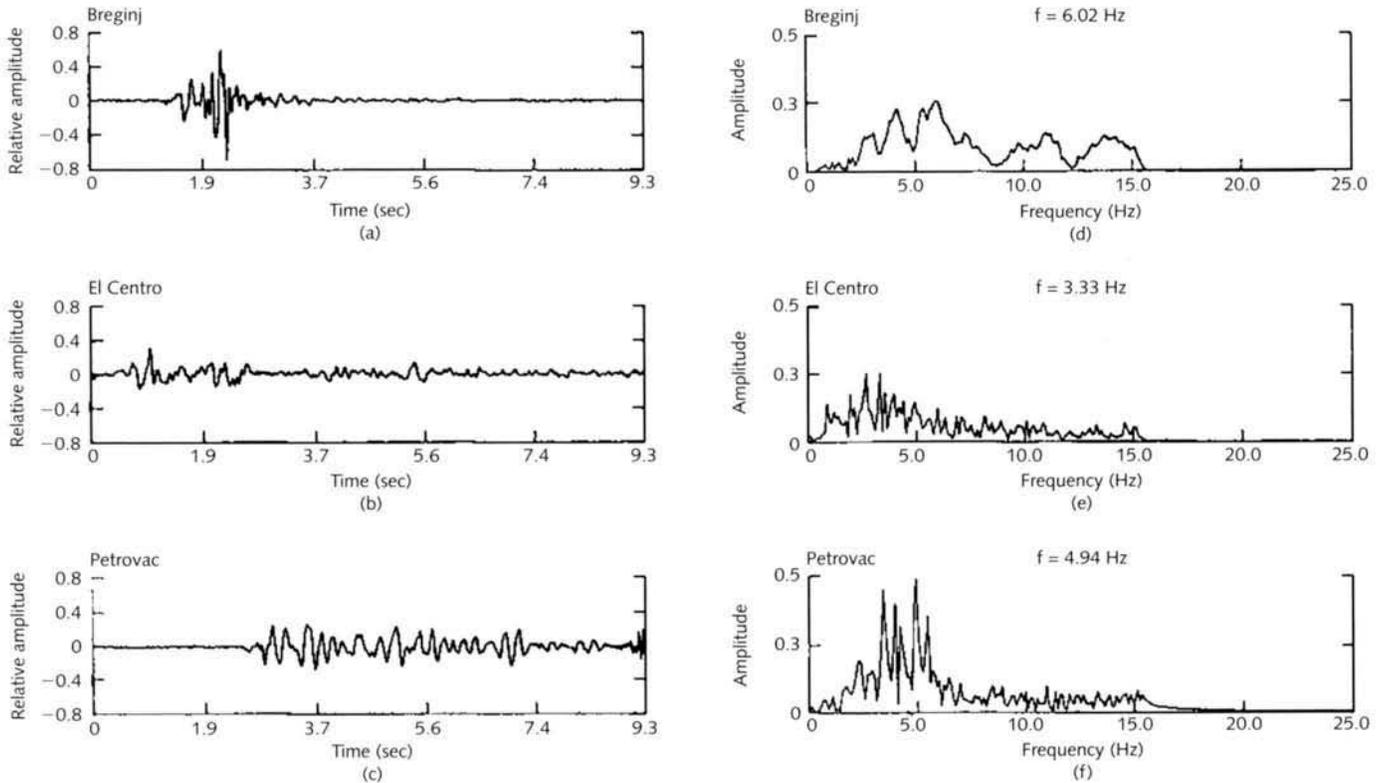
**Figure 5.3**  
Scaled time histories of the amplitude as functions of time and frequencies for the Breginj, El Centro, and Petrovac earthquakes.

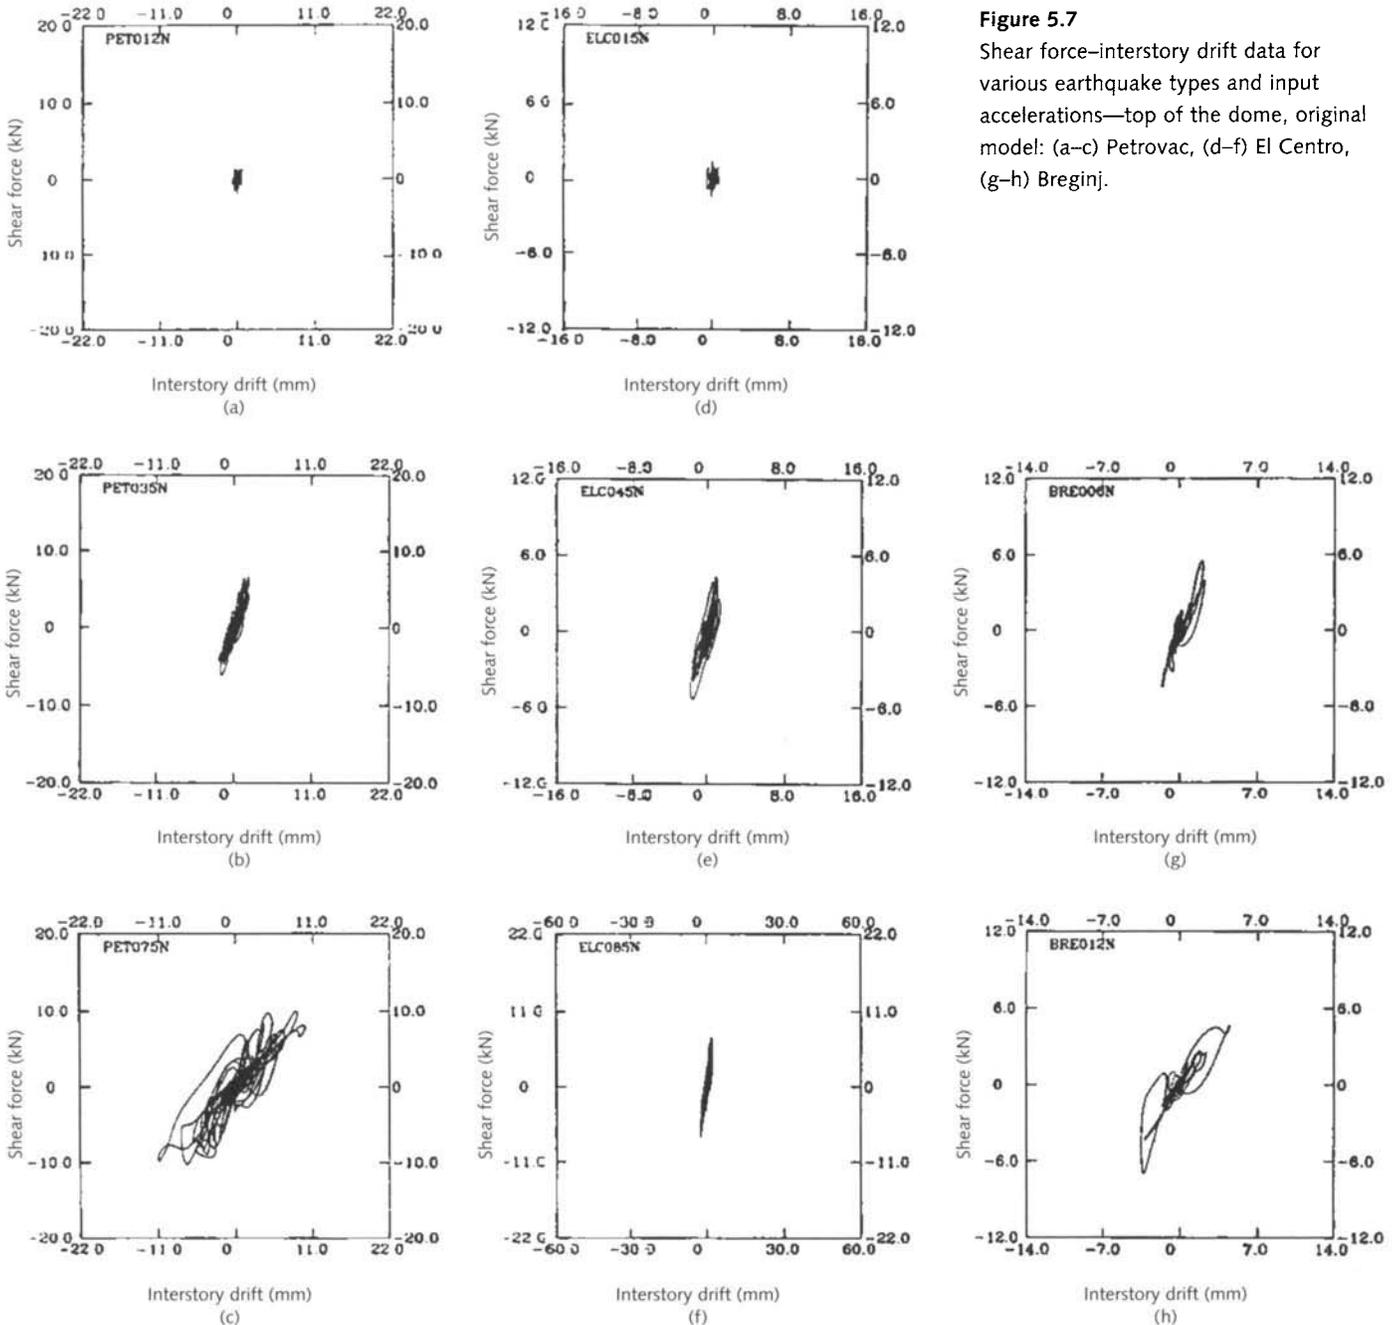
**Figure 5.7**

Shear force–interstory drift data for various earthquake types and input accelerations—top of the dome, original model: (a–c) Petrovac, (d–f) El Centro, (g–h) Breginj.

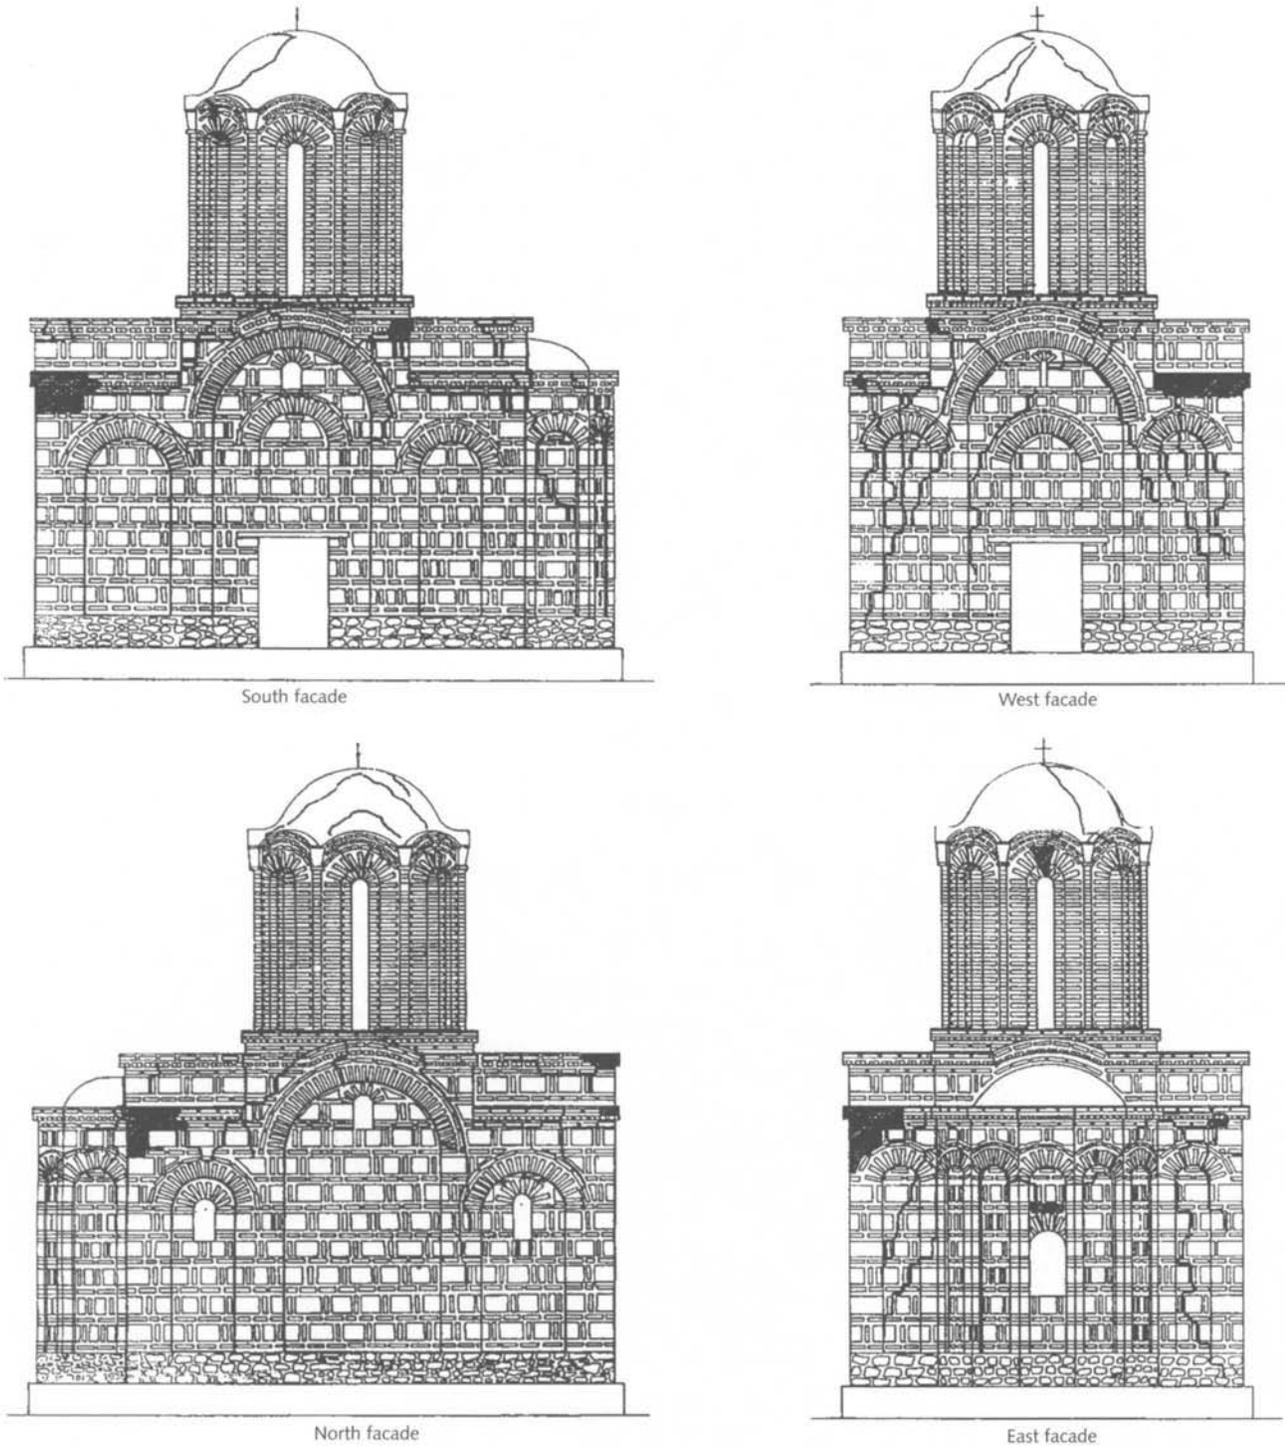
**Figure 5.9 (above left, top and bottom)**  
Damage to the original model: south and north facades.

The first cracks occurred during the next excitation, the application of the Petrovac earthquake with  $a_{\max}$  (PGA) = 0.20 g. Large

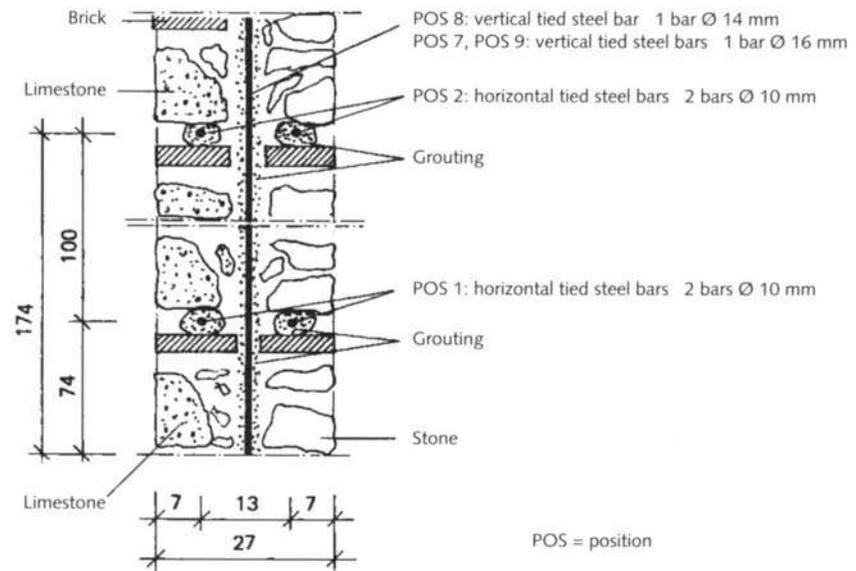
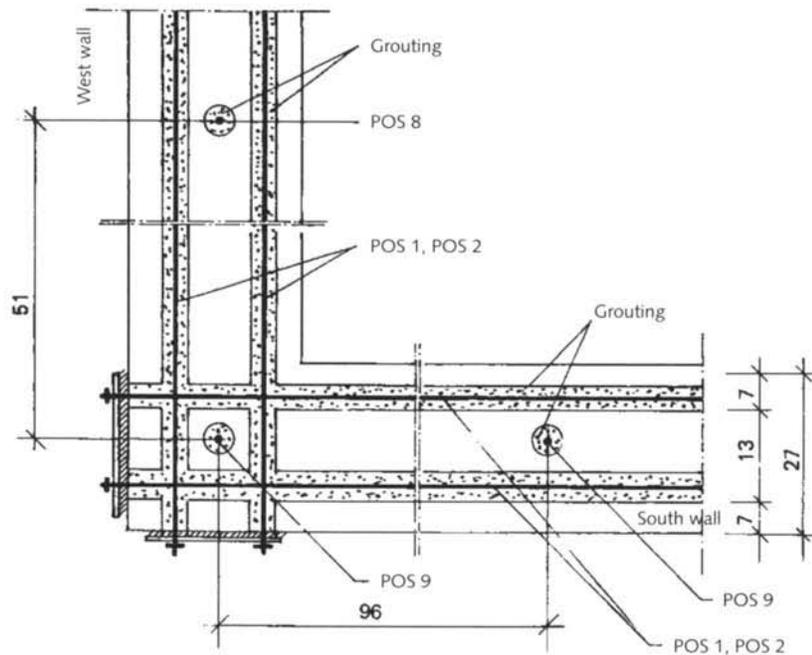
**Figure 5.11**  
Details of horizontal belt courses.

Horizontal steel belt courses were inserted into the void spaces purposely built into the perimeter walls during construction at the levels +0.74 m and +1.74 m, and at a height of 2.6 m in the square base of the tambour, as shown in figure 5.11. Each of the two steel reinforcement bars was 10 mm in diameter. The ends were bolted to vertical, steel, stress-distribution plates, 10 mm thick, and the bars were pre-stressed to about 1 ton. The steel plates were visible on the exterior of the facade, but for use on the prototype church, they would be recessed below the surface and would not be visible. Ringlike belt courses were incorporated below the apsidal cornice and at the base of the dome. These belts were each made of four sections of  $6 \times 0.4$  cm sheet steel. The horizontal belt at the tie level (fig. 5.12) was of special importance

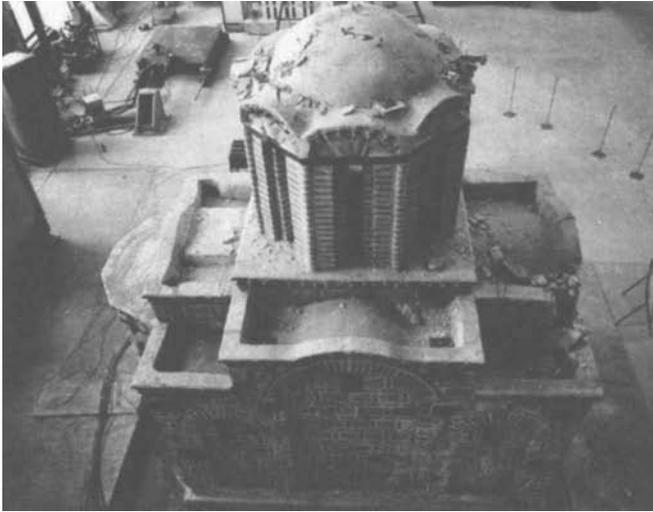
**Figure 5.14**  
Damage to the retrofitted model after exposure to earthquake acceleration  $a_{\max} = 0.54$  g, north view.

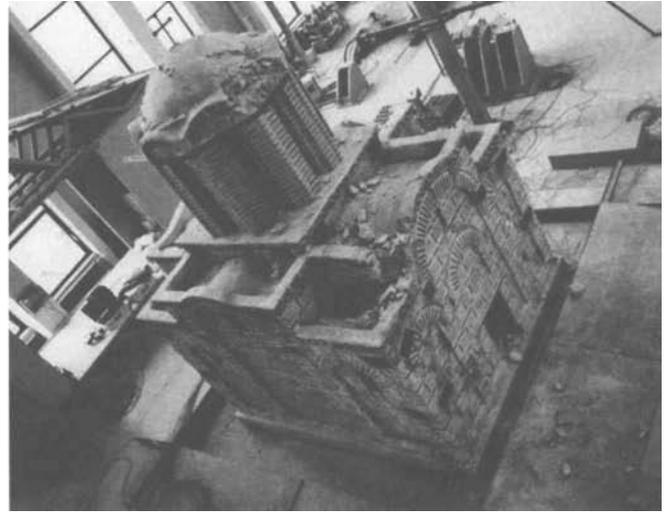
**Figure 5.15**  
Damage to the retrofitted model after exposure to earthquake acceleration  $a_{\max} = 0.54$  g, north-west view.
