# Conservation and Seismic Strengthening of Byzantine Churches in Macedonia

Predrag Gavrilović

GCI Scientific Program Reports

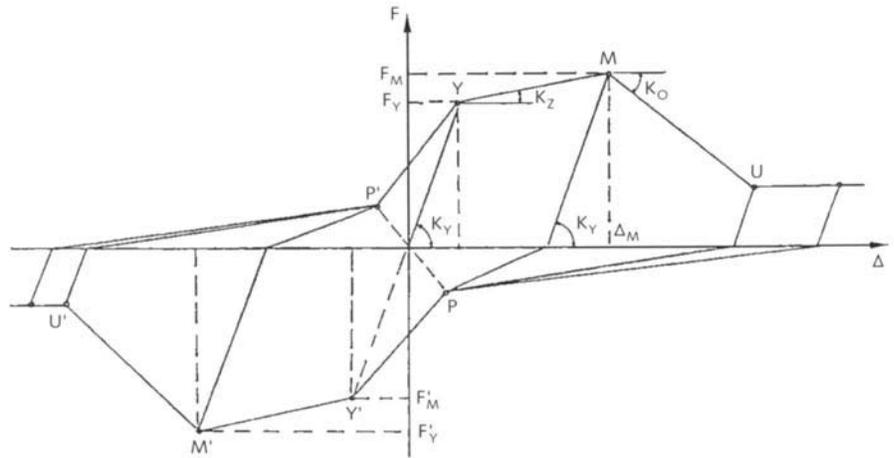
**Figure 6.5**  
General trilinear IZIIS computer model.

- A delineated range, M-U, is identified in the hysteretic diagram. The model defines the stiffness modification and the behavior of the structure; that is, it describes the structure after it has reached the maximum deformation ( $\Delta_M$ ), which in other models is characterized as the ultimate or failed state. This provides the possibility of describing structures that have not yet failed, although they have suffered considerable damage. From diagrams obtained dur-

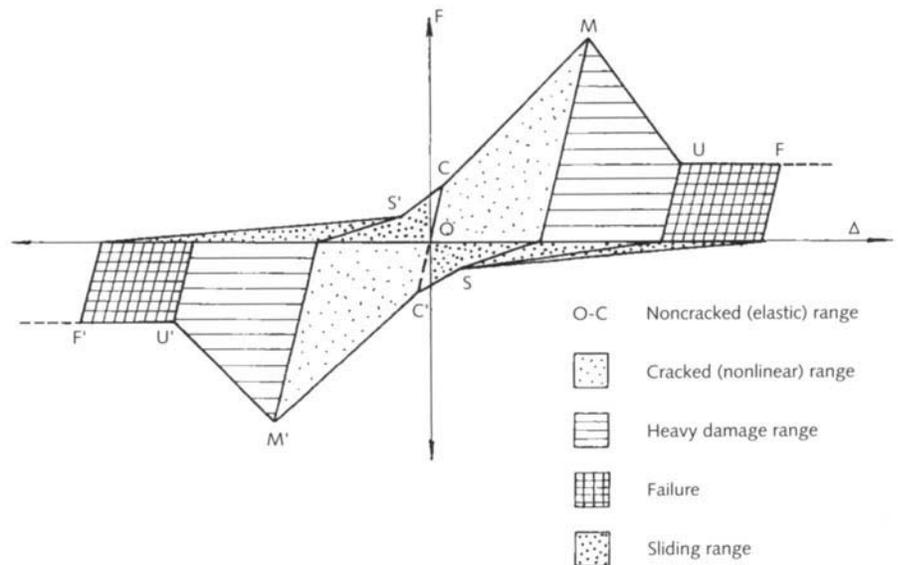
**Figure 6.6**  
Adapted trilinear IZIIS model for masonry structures.

- The model introduces the pinching of the hysteretic loop (point S in figure 6.6), which accounts for the stiffness variations under reversible loading that occur as a result of sliding and loss of adhesion between masonry materials. This feature allows the modeling of the shear effects.

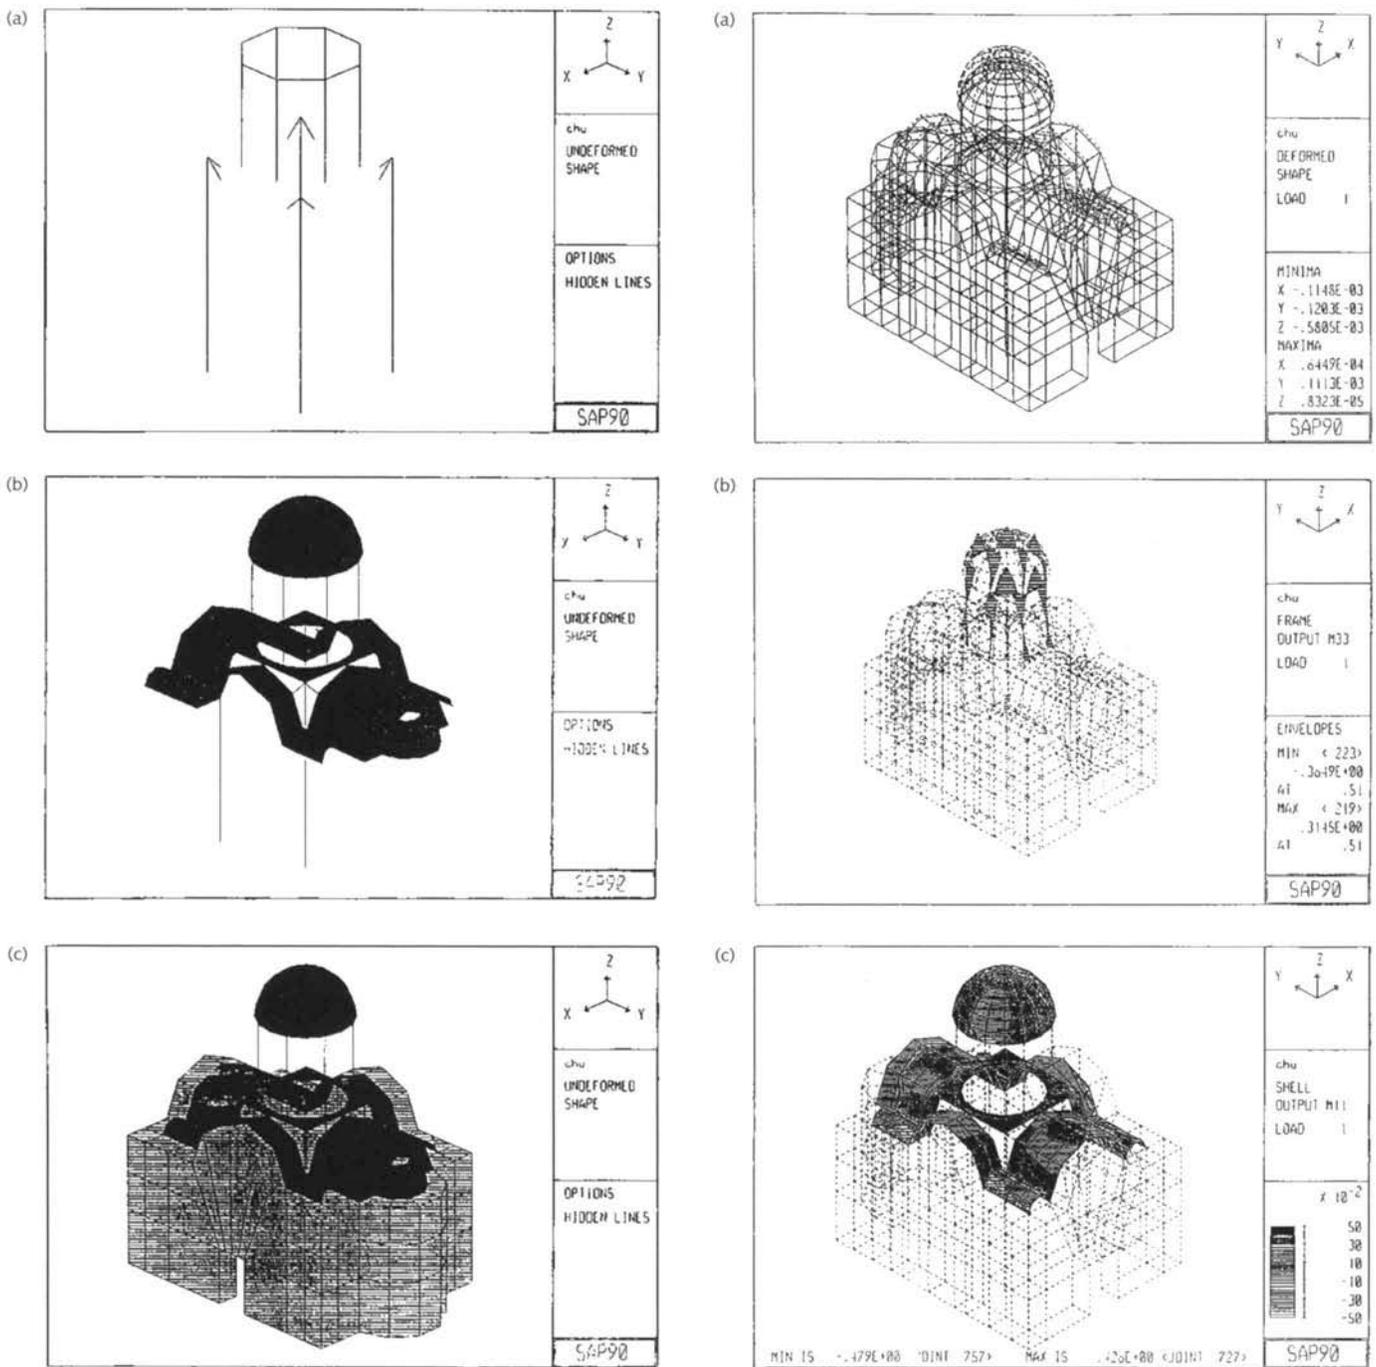
**Figure 7.2 (above left, top to bottom)**  
 Finite-element modeling of the original model using the SAP90 computer program: (a) columns and beams; (b) vaults, apse, and dome; (c) facade walls.

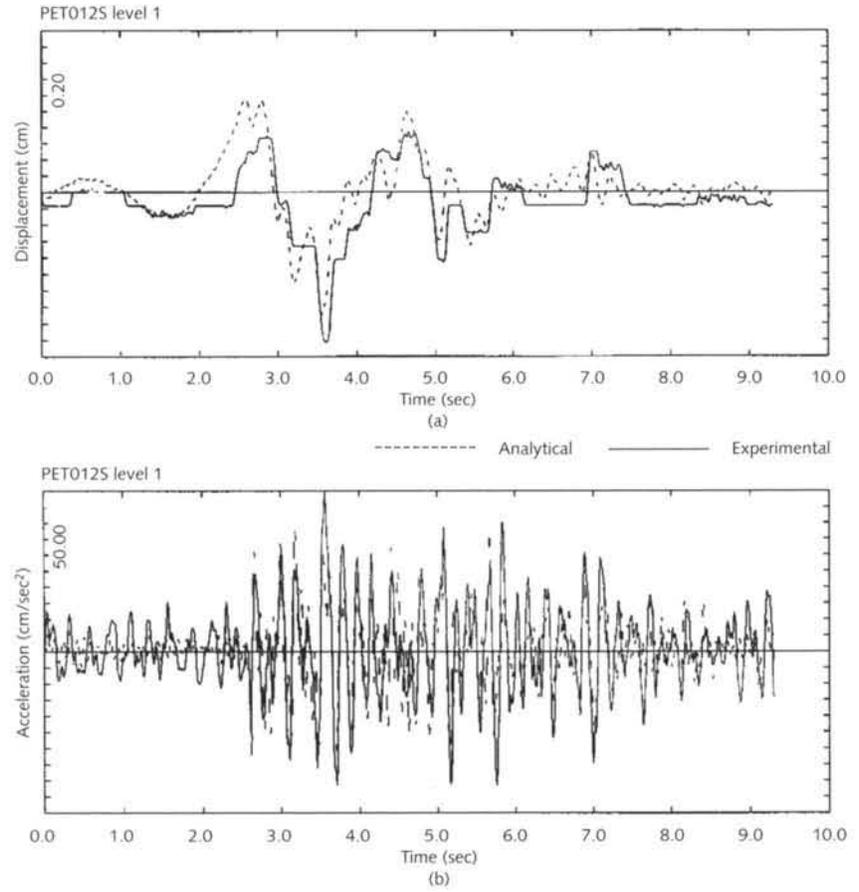
**Figure 7.10**  
Time histories for level 1 (PET012S):  
(a) displacement, (b) acceleration.

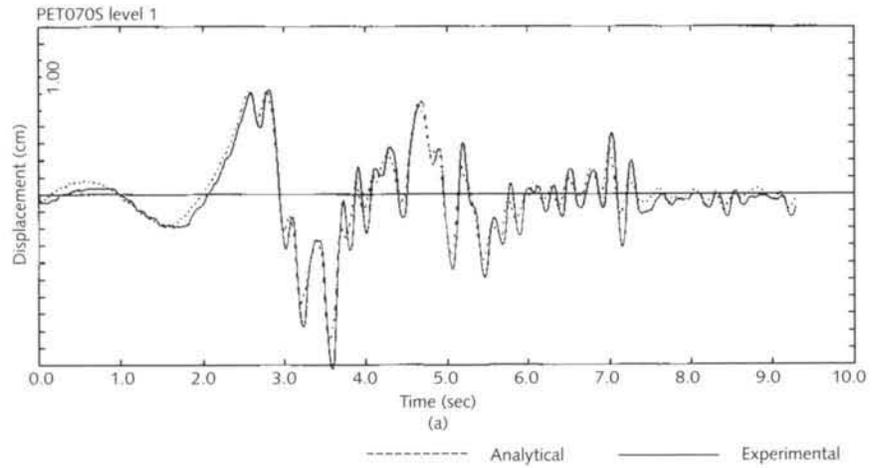
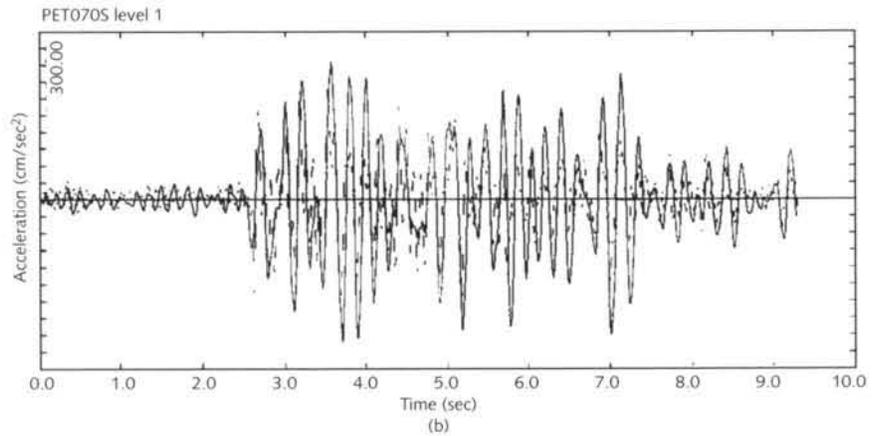
**Figure 7.13**  
Time histories for level 1 (PET070S):  
(a) displacement, (b) acceleration.

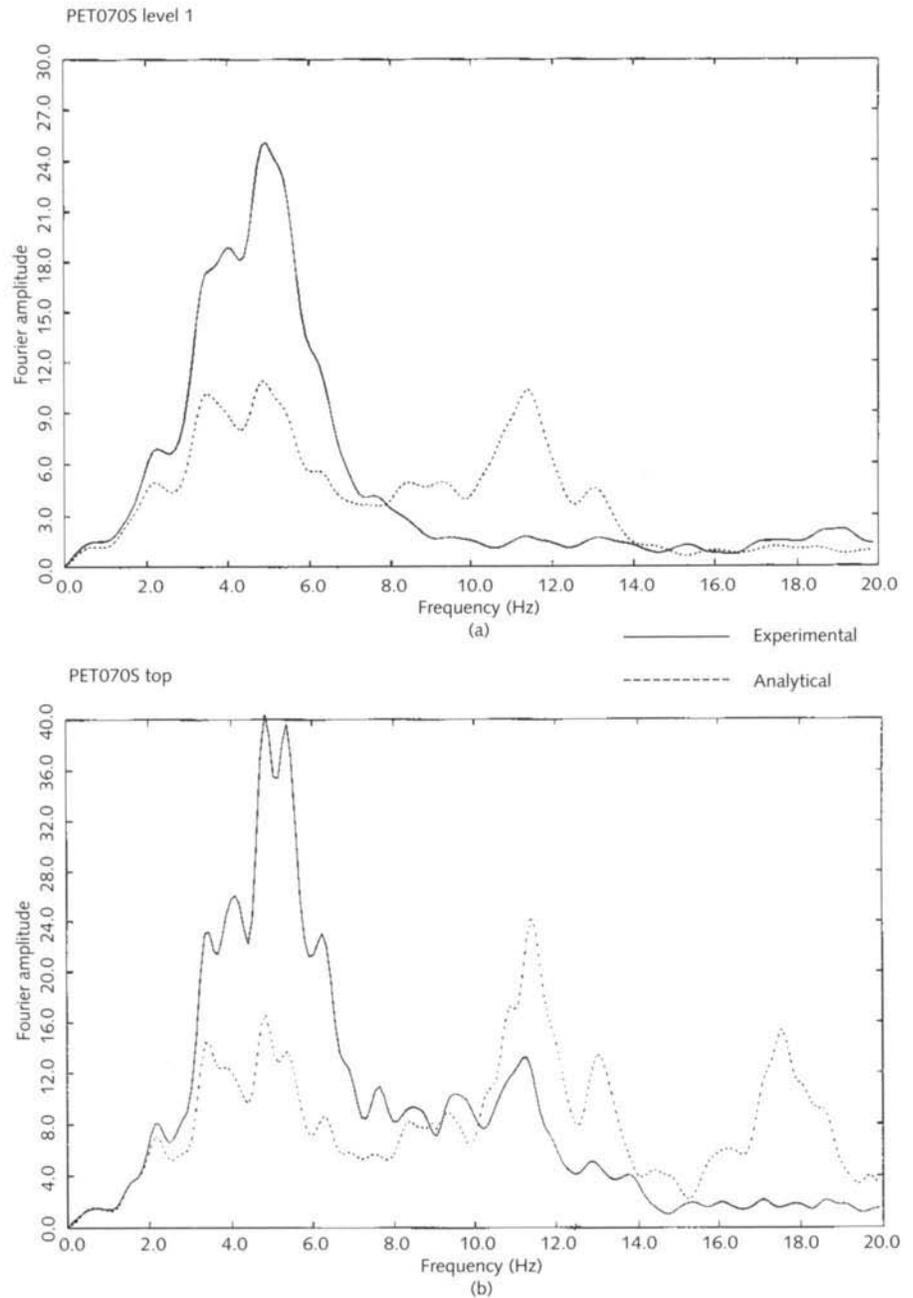
**Figure 7.15**  
Frequency content of experimentally and analytically obtained accelerations (PET070S): (a) level 1, (b) top of the dome.

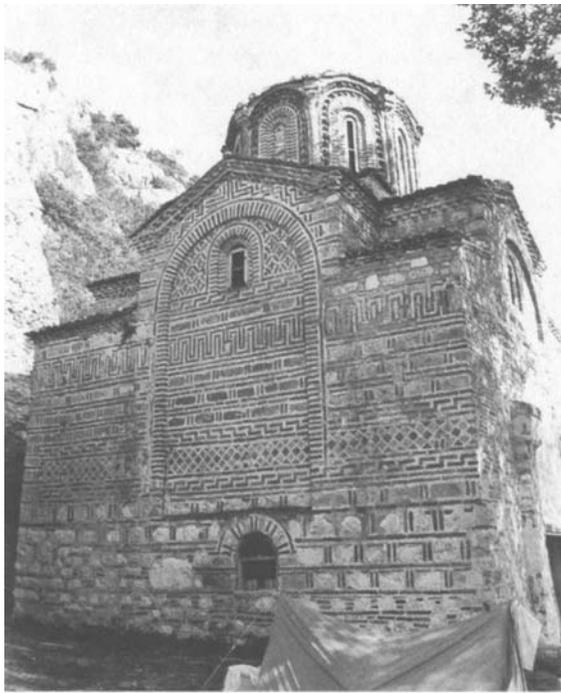
(a)

This church (fig. 9.1a) is situated on a small plateau south of the village of Trpejca on the coast of Lake Ohrid. Figure 9.1b shows a plan and elevation of St. Bogorodica Zahumska, and a detailed description of its architectural, structural, and material characteristics is given in Gavrilović, Šumanov, et al. (1991, vol. 12).

Structurally, two rows of timber ties were used in the walls, one at the height of the capitals of the columns (lower zone) and the other at the height where the vaults of the cross arms merge (the upper zone). The principal structural system of the church has suffered considerable damage in the past. The southeast column in the central part of the building—the naos—is considerably damaged and deformed, and the northeast column is also badly damaged. The southeast column is inclined from its original vertical position as a result of seismic effects. This has resulted in an eccentricity in the transfer of the axial forces,

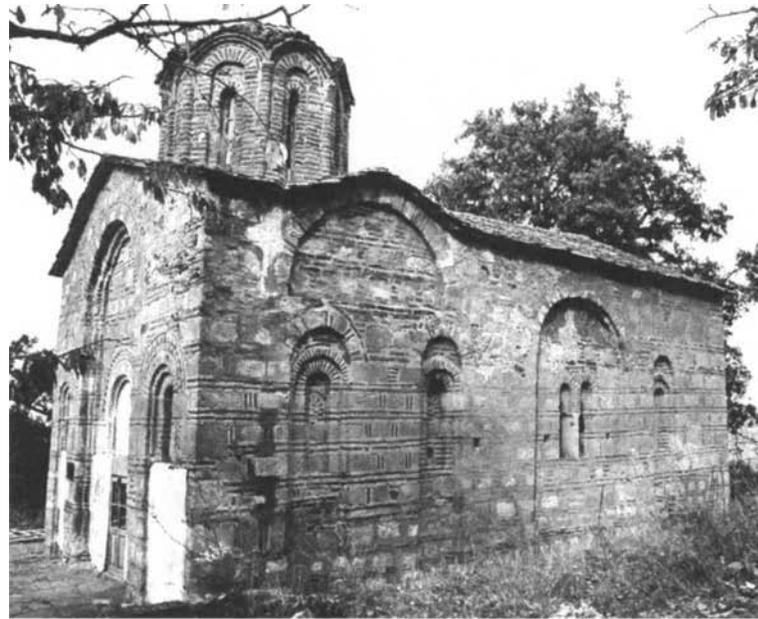
(a)

The church of St. Nikola in the village of Psača is a structure with an inscribed cross in a rectangular plan with a narthex in the western part, a three-sided apse, and a former dome in the naos and narthex (fig. 9.2). The structure of the church consists of massive facade walls constructed of roughly dressed stone and brick. The walls and two symmetrical rows of columns support the vaulted roof elements and the dome above the exonarthex.

In general, the present state of the building is not considered to be satisfactory. Paved areas adjacent to the church and drainage channels on the south, east, and north sides are in poor condition. This has resulted in capillary moisture rise and rain- and snow-water damage to both the interior and exterior walls up to a height of about 1 meter. Stone blocks in the upper zone sustained damage from roof leaks. Damage at the level of the supports and the vaulted structures was particularly noticeable and timber belts are missing at the first naos level. Further details of the structure are given in Gavrilović, Šumanov, et al. (1991, vol. 12).

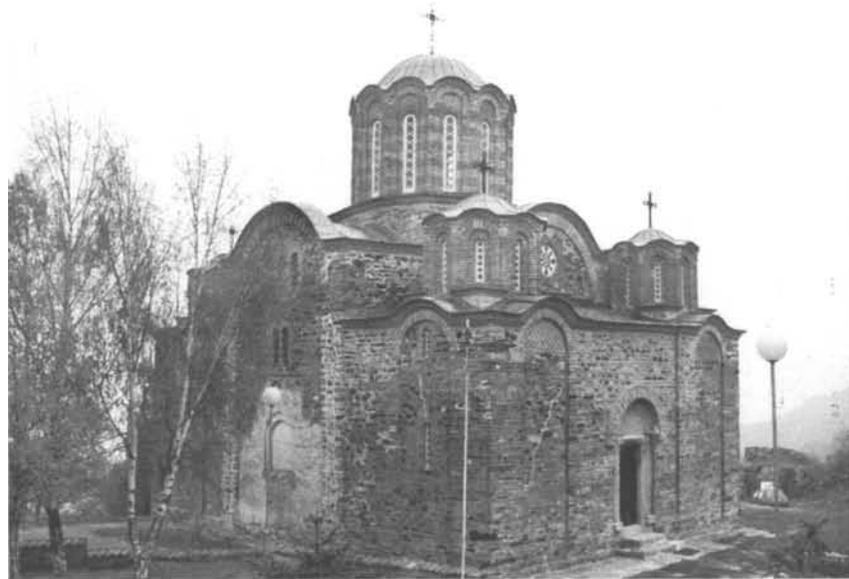
(a)

The church of St. Bogorodica (fig. 9.3a) is situated on a plateau on the slopes of Crna Gora, a mountain located north of the village of Matejče. One of the reasons for selecting this church as a representative subject for this project was the extensive reconstruction and conservation activities initiated around 1930 and continued in 1970. A plan and elevation of this church are shown in figure 9.3b.

Generally, the present state of the structure is relatively satisfactory from both the structural and conservation points of view, with the exception of the permanent penetration of capillary moisture through the perimeter walls and the church floor. Part of the reconstruction of the church included incorporating reinforced concrete elements, columns, and belt courses within the massive masonry structure, which was originally constructed of stone and brick set in lime mortar. Complete reconstruction of the vaults and domes was performed in

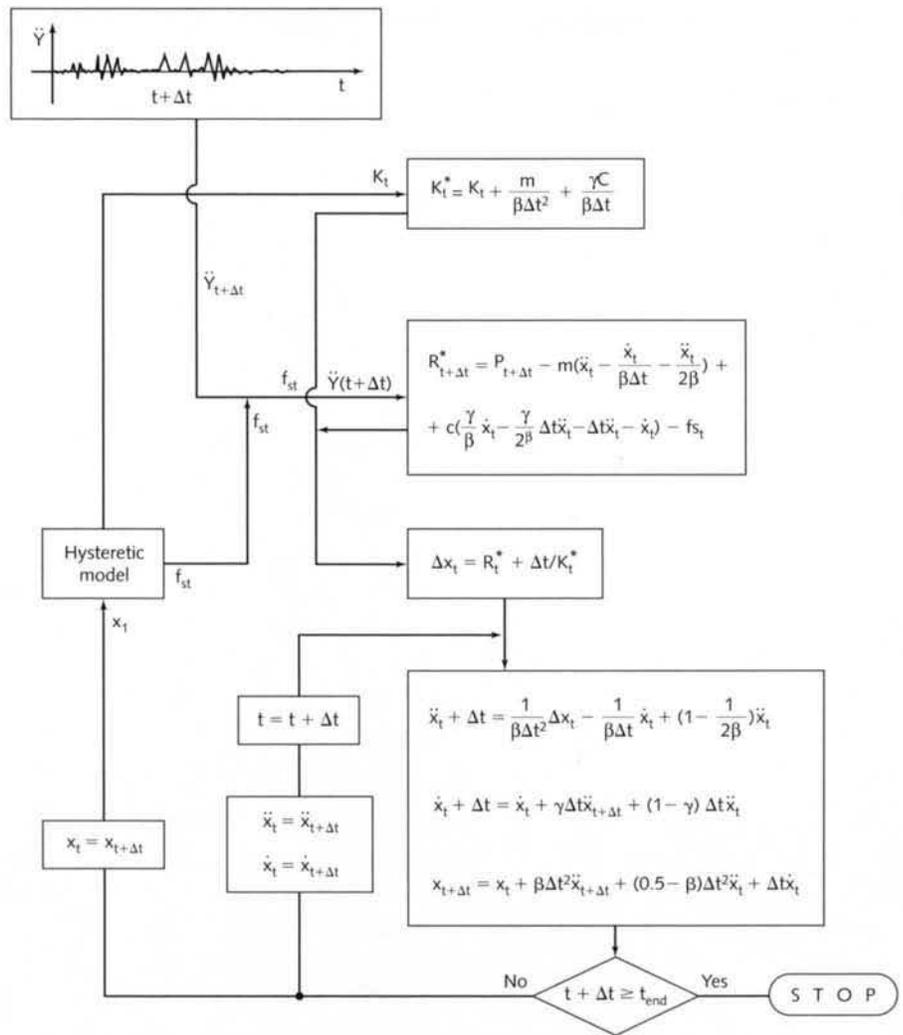
**Figure B.1**  
 Analysis of a single-degree-of-freedom system.

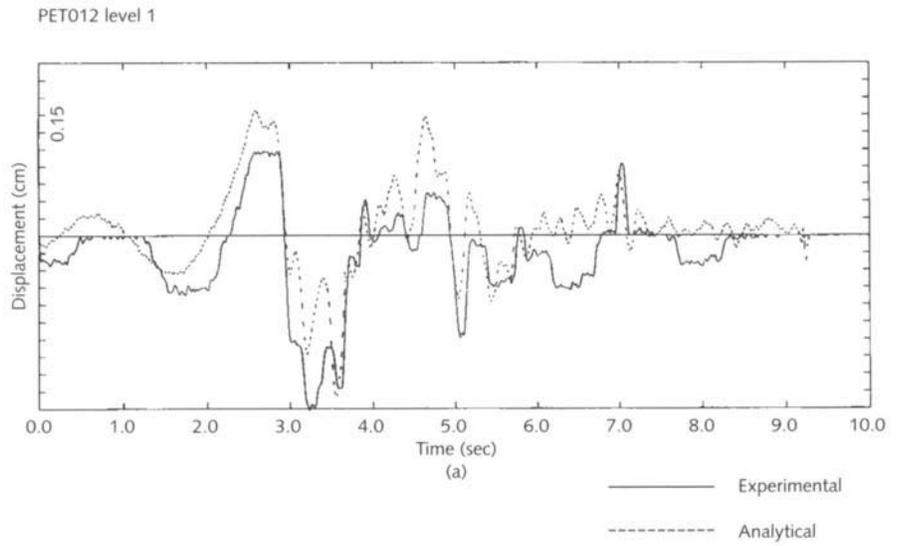
**Figure C.1a**  
Displacement time history for level 1 (PET012N).
