Conservation of Ancient Sites on the Silk Road

Proceedings of the Second International
Conference on the Conservation of Grotto Sites,
Mogao Grottoes, Dunhuang, People's Republic of
China, June 28–July 3, 2004

Edited by Neville Agnew

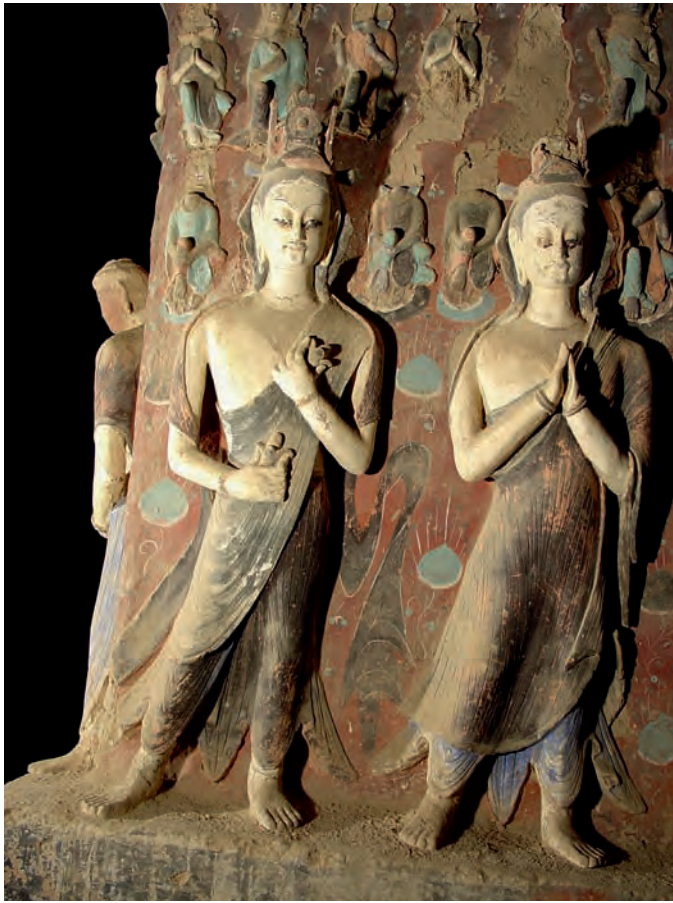
FIGURE 1 Mogao, cave 260. Bodhisattvas in the N. Wei scheme of ca. 520/30. Photo © J. Paul Getty Trust

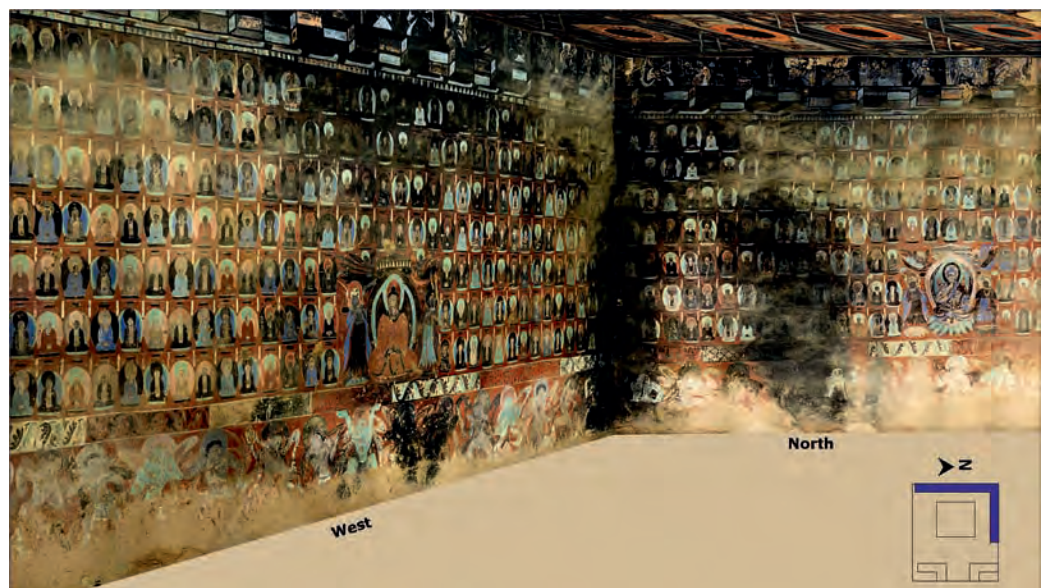
FIGURE 4 Effects of habitation fires from White Russian soldiers interned in cave 260 in 1922, shown on splayed mosaiced images of the north and west walls surrounding the central pillar. Basemap images © Dunhuang Academy. Mosaicing and graphics © Courtauld Institute

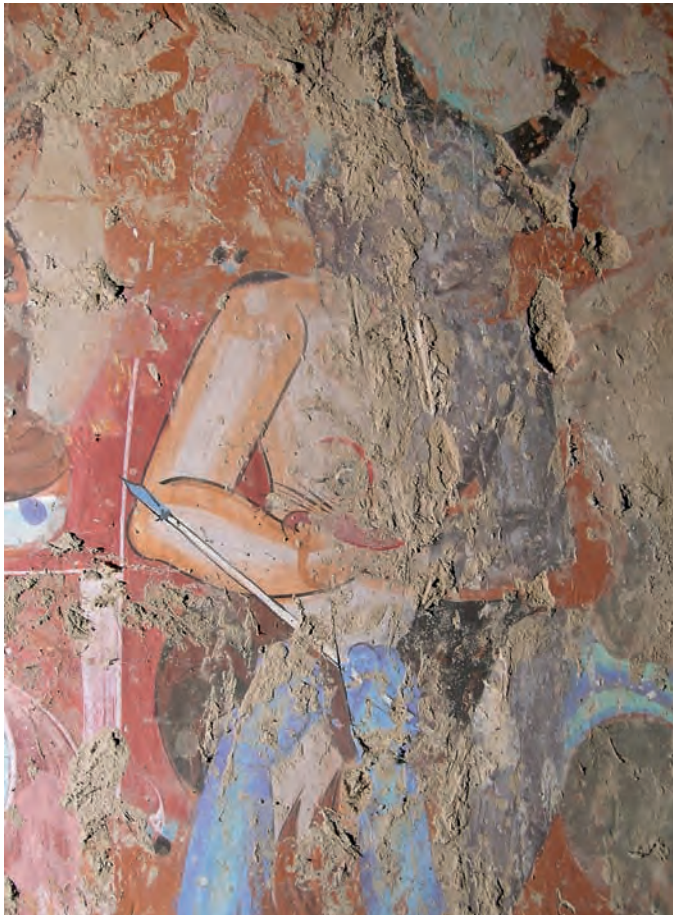
FIGURE 5 Mogao, cave 260. An area protected by a Song period architectural addition (removed in the 20th century) is relatively unaltered. Original flesh tones and the organic colorant glaze on the red background contrast markedly with the same features in the unprotected area of the figure. Photo © Courtauld Institute

FIGURE 6 Mogao, cave 260. Exceptional preservation of the painting in figure 5 facilitates analysis by means of false-color infrared imaging. © Courtauld Institute; imaging by G. Verri

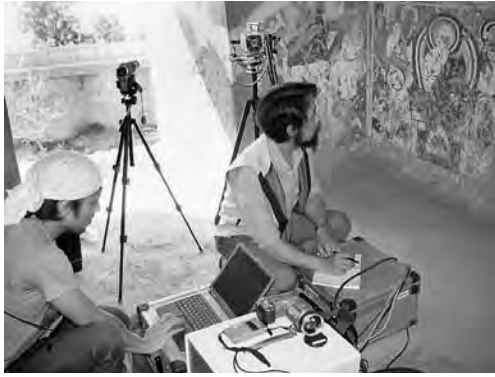
FIGURE 4 Project specialists assess damage to Kumtura mural paintings.

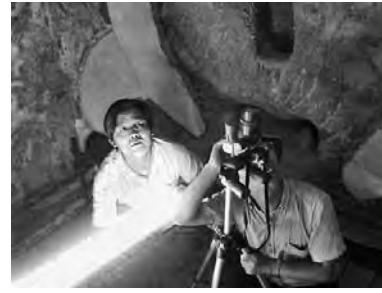
FIGURE 5 Project specialists assess rock damage inside a Kumtura cave.

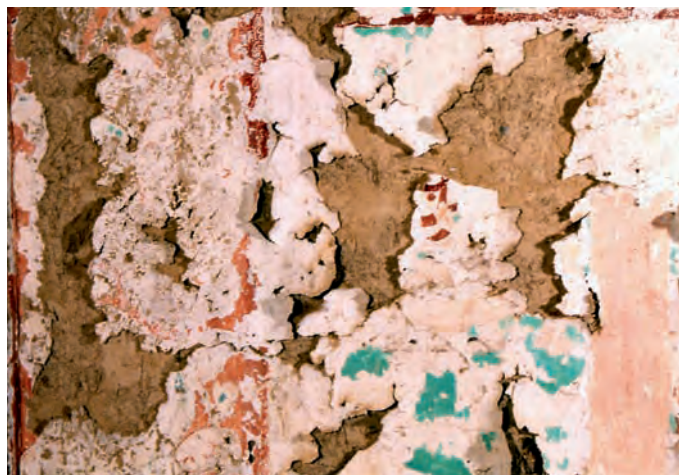
**FIGURE 1** Plaster disruption of wall painting in cave 26, Mogao Grottoes, Dunhuang.

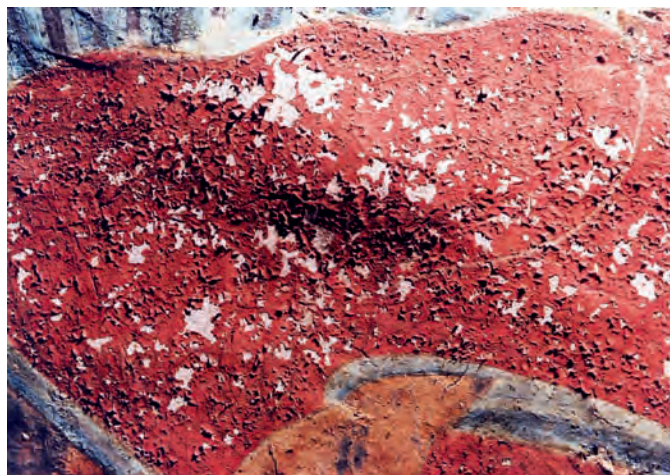
**FIGURE 2** Blistering and disruption of wall painting in cave 35, Mogao Grottoes, Dunhuang.

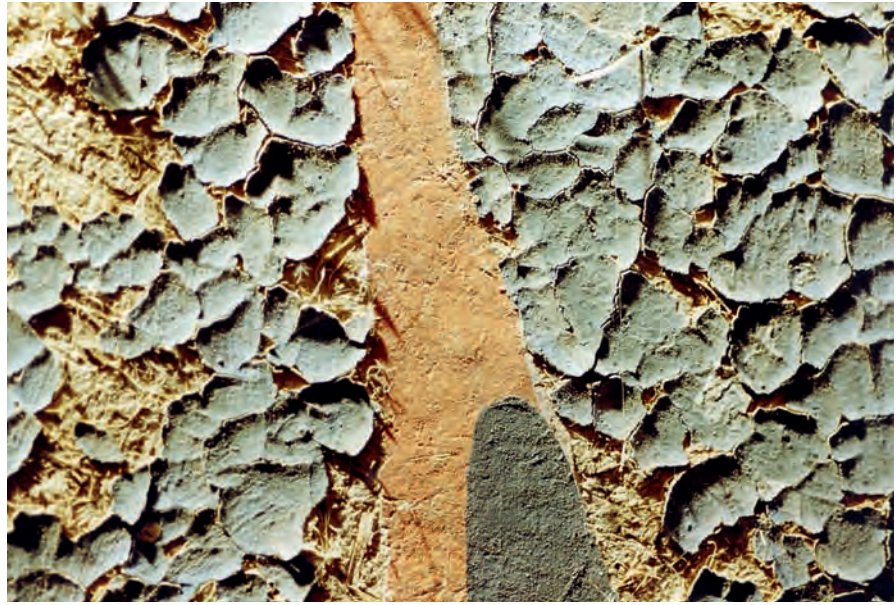
FIGURE 3 Flaking paint layer of wall painting in cave 428, Mogao Grottoes, Dunhuang.

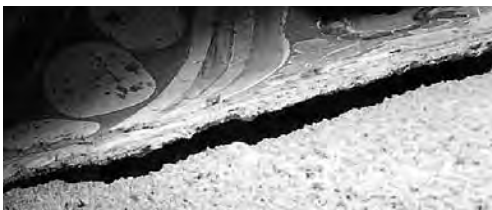
The lifting and peeling of the paint and ground layers from the fine clay layer of the plaster is caused primarily by soluble salts, which affect the cohesion of the clay (fig. 4).

FIGURE 4 Plaster detachment of wall painting in cave 6, Yulin Grottoes, Dunhuang.

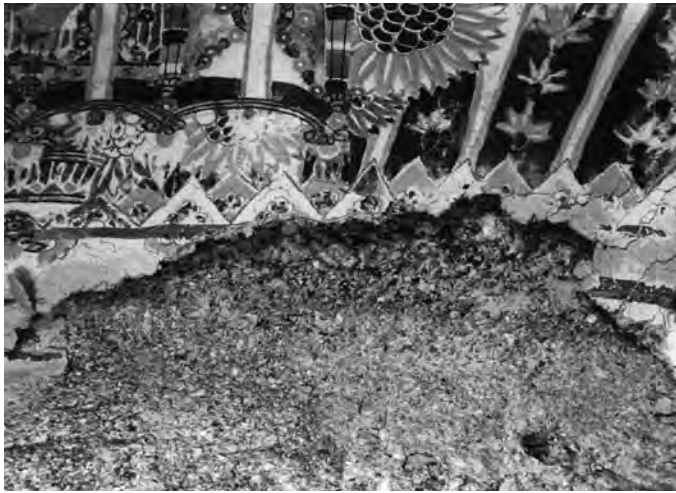
The primary reason for the detachment or separation of the plaster from the cave rock is that the rock surface was too weathered when it was originally plastered and painted. At the Mogao and Yulin Grottoes and the Western Thousand Buddha Caves, the cliffs are composed of weak, poorly cemented conglomerate. Because of this, the plaster layer easily detaches from the rock during earthquakes and may fall immediately or at a subsequent time. Also, water easily penetrates the conglomerate, wetting the plaster and causing large areas of detachment between the rock surface and the plaster (fig. 5). Many roof paintings in the upper-level caves have already fallen, due to rainwater penetration. This is seen especially at the Yulin Grottoes. In addition, sand and pebbles from the weathered cliff frequently have accumulated in the detached areas between the plaster and rock surface. This sand and pebble buildup pushes out on the plaster and contributes to loss.

FIGURE 5 Large area of plaster loss in wall painting in cave 368, Mogao Grottoes, Dunhuang.

at the base; hence the walls incline inward slightly. This puts additional gravitational strain on the plaster, which is often heavy, having been applied thickly to cover the uneven, coarse-grained rock surface of the side walls, or does not adhere well to the wall because of the coarse and loose rock surface. Thus the inclination of the side walls puts additional strain on the already at-risk plaster, and the plaster with wall paintings in these caves easily collapses when disturbed by earthquakes or other types of vibration.

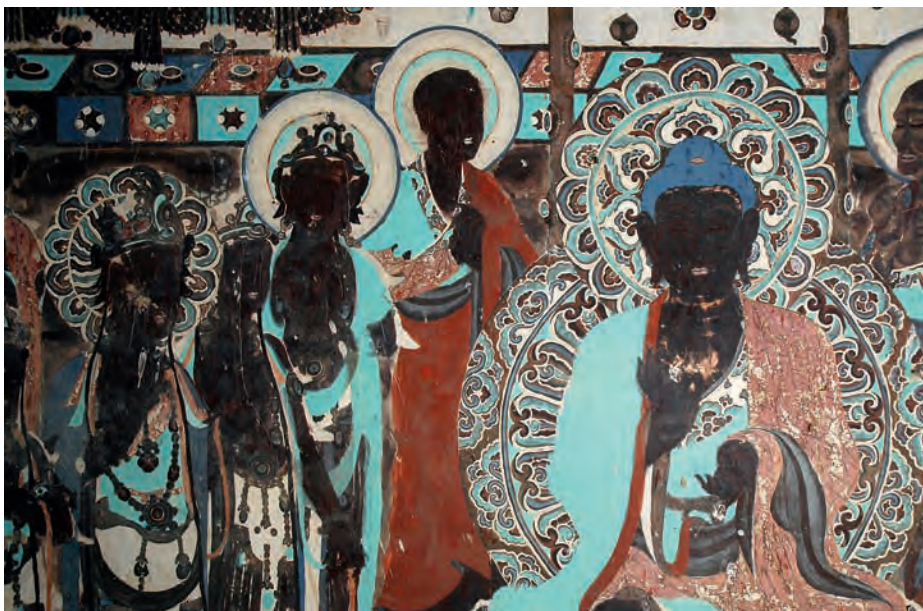
FIGURE 6 Pigment discoloration and fading in wall painting in cave 205, Mogao Grottoes, Dunhuang.

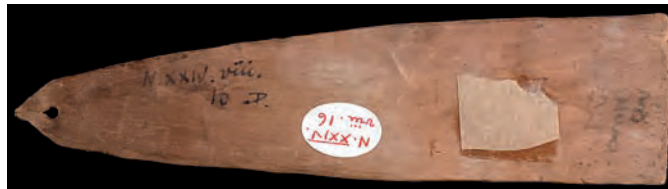
FIGURE 6 Wooden document found by Stein at Niya and bearing his inked site signature: N.XXIV.viii.19. Courtesy The British Library, Or.8211/1412(B)

The following is an example of Stein’s coding system used for another Silk Road site. The wooden document shown in figure 6 bears Stein’s ink signature “N.XXIV.viii.19.” “N.” stands for Niya, a third- through fourth-century site on the southern Silk Road consisting of a spread-out settlement now in the Takla Makan north of present-day Minfeng. Stein prepared plans of all the houses he excavated there and assigned each a Roman numeral. So, for example, N.XXIV is the twenty-fourth residence he excavated. It can be seen from his plan of this residence (fig. 7) that the house consisted of

several rooms, which Stein also numbered in Roman numerals, so “viii” is the eighth room of the house. The plan also shows the area where Stein found what he calls the “Hidden Archive”—a cache of wooden manuscripts from which the wooden document shown in figure 6 is the nineteenth he excavated from this cache.

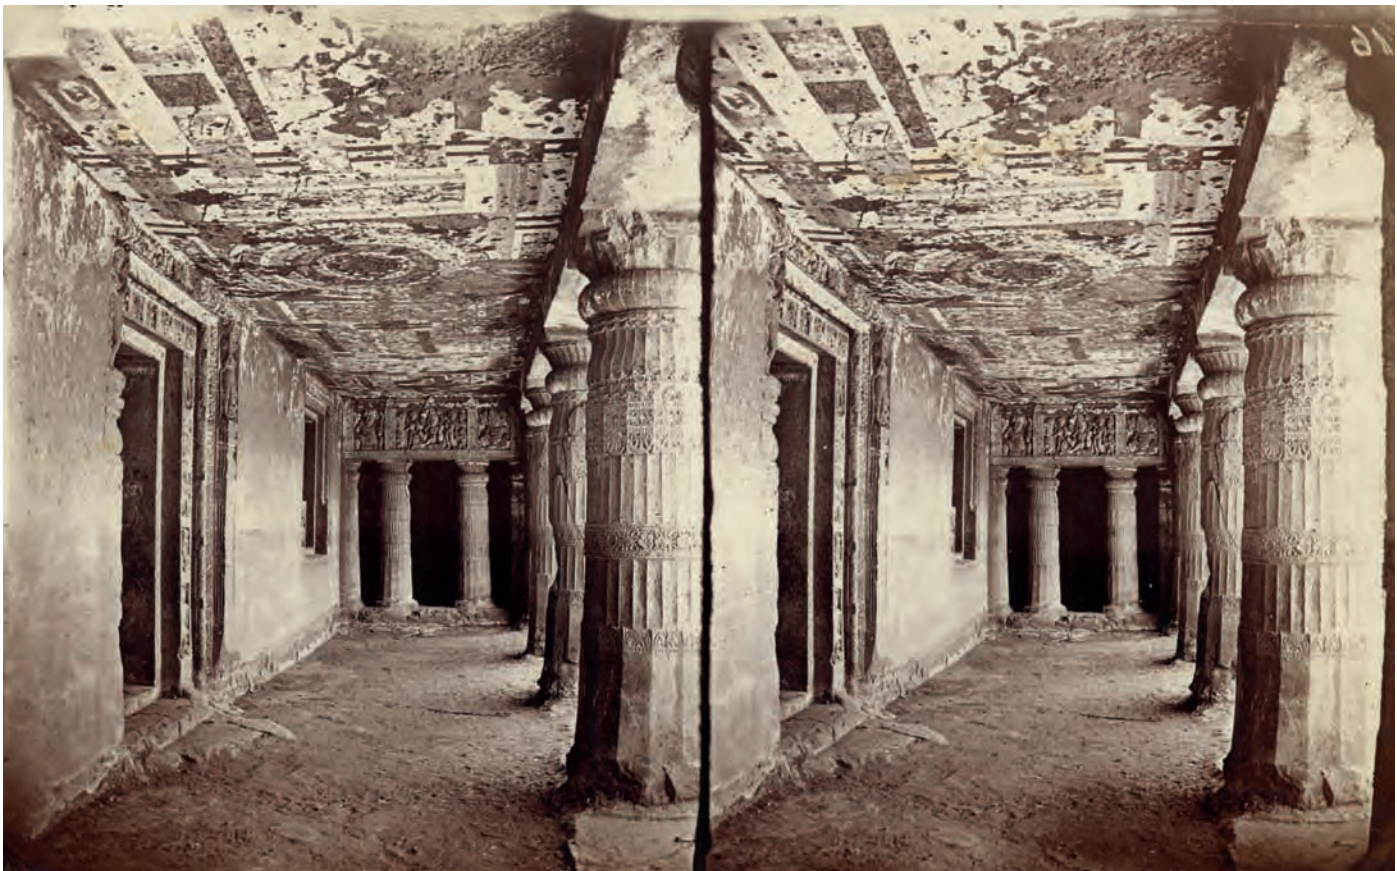
FIGURE 2 Stereoscopic interior view of the veranda from Cave II, Ajanta, India, taken by Robert Gill in 1868. British Library, APAC Photo 1000/20 (2062)

caves, building up a detailed photographic record of the caves comprising many hundreds of images. Despite an admirable attempt to work to a systematic pattern—all the cave porches, for example, are photographed three times: a head-on view, followed by views of the right and left sides (fig. 2)—the darkness of the interiors, compounded by the grimy state of many of the paintings, prevented the achievement of a comprehensive photographic record. While this remains a fragmentary documentation, of limited use to the modern scholar attempting to re-create the nineteenth-century condition of the paintings, the publication of some of the photographs, accompanied by Fergusson’s text, served to broaden knowledge of both the paintings themselves and their fragile condition (Fergusson and Gill 1864a, 1864b).

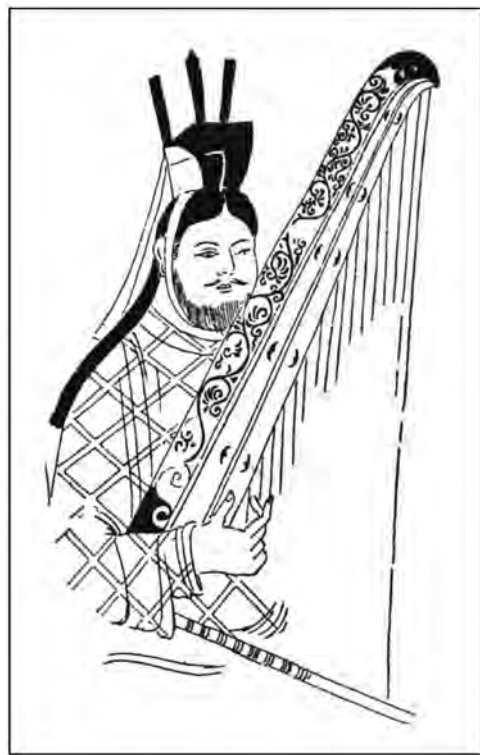
FIGURE 4 In this image from Khocho, 50 kilometers southeast of Turpan, the player's arm obscures the pin of his harp, making it difficult to determine if it is an angular harp or the cantilever variant.

no longer reached down to the level of the rod, and the two parts could no longer support each other. Instead, the rod was attached to a slender tail that descended from the box. To achieve balance, a pin was inserted between the box and the rod. In other words, the rod had become a cantilever projecting beyond a fulcrum (the pin) and supported by a balancing force from the tail. Figure 3 shows an extant harp in the Shosoin Treasure House in Nara, Japan, which clarifies this construction (Lawergren 1995: fig. 4f). It is dated ca. 800, but earlier examples are depicted in Iran and on the Silk Road. I shall call this variant of the angular harp pattern a “cantilever harp.” Elegance was gained by the new design, but strength was sacrificed. Unfortunately, it is sometimes difficult to identify such harps in paintings because the player's right arm may obscure the pin (e.g., fig. 4).

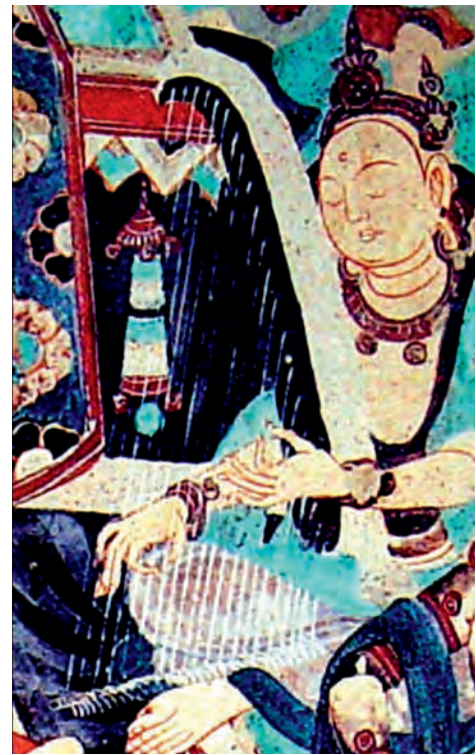
FIGURE 5 Depiction of a cantilever harp from the Mogao Grottoes (cave 156).

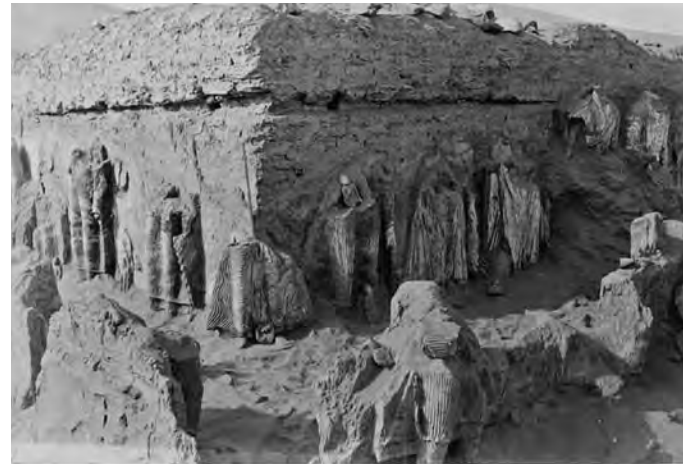
FIGURE 2 Ruins of colossal statues along the exterior south corner of the inner wall of the Rawak Vihara (remains of outer wall in foreground). Photograph from the Stein Library, Library of the Hungarian Academy of Sciences, Budapest

Figure 2 shows the best examples of what much of the sculpture looked like when Stein visited the Rawak Vihara (Stein 2001: fig. 66).¹ These statues are found along the exterior south corner of the inner wall and are numbered R66–74 on the Rawak map (see fig. 1). If this amount of sculpture was present on both interior and exterior sides of the inner wall surrounding the stupa and if there was an equally decorated outer wall all the way around, this must have been a most impressive monument. Based on the ninety-one sculptures Stein found and the additional thirty-nine that Trinkler found, we can estimate that five hundred or more statues at one time adorned the Rawak Vihara, probably in a definite Buddhist program or iconography.

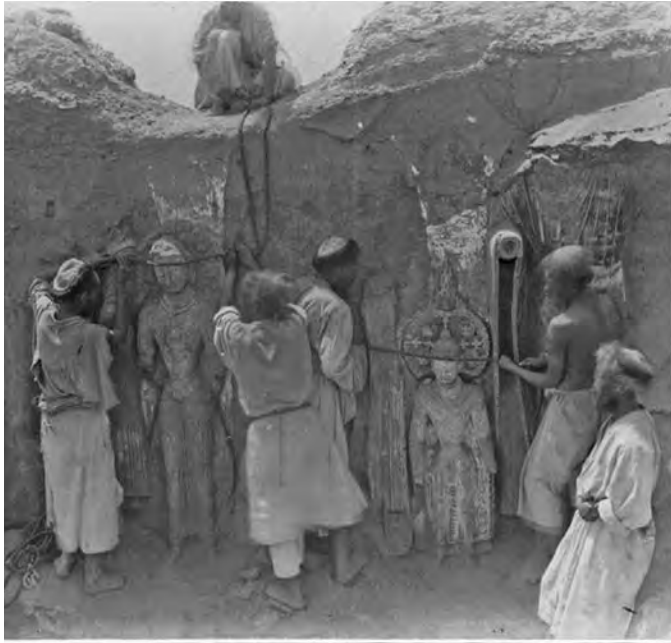
FIGURE 3 A headless buddha with Abhaya-mudra (right) and a life-size bodhisattva (left) at the Rawak Vihara. Photograph from the Stein Library, Library of the Hungarian Academy of Sciences, Budapest

Colossal Buddha with Abhaya-mudra (R1). This statue (fig. 3) gives the best general idea of the scale and type of sculpture that Stein encountered (see Stein 2001: fig. 69). The buddha with Abhaya-mudra, a hand gesture meaning no fear (although the arm is missing), is the tall, headless sculpture to the extreme right in the photograph, behind one of Stein’s workers (second person from the right). Since this sculpture measures 5 feet 3 inches (1.6 m) from its feet to just below the bent elbow (arm missing), it is clear that this buddha was

over 3 meters high. The abundant, congruent folds of clothing are in a Greco-Roman manner known as Gandharan style, as described earlier.

Bodhisattva (R4). To the extreme left in figure 3 is a life-size bodhisattva that Stein (2001: 419) describes as being about 6 feet (1.8 m) high. The figure is dressed differently than the previous statue; he wears the garments of a prince (and note the jewelry on his chest). A bodhisattva is a savior being, a potential buddha, just as was the historical Buddha (Siddhartha Gautama, ca. 563–483 B.C.E.) before his enlightenment. The head fell off the statue after this photograph was taken and can be seen on the ground in another of Stein's photographs (2001: fig. 61; not included here). Stein brought back the head of this statue for the British Museum and published a black-and-white photograph of it in his book *Ancient Khotan* (2001: pl. 81).

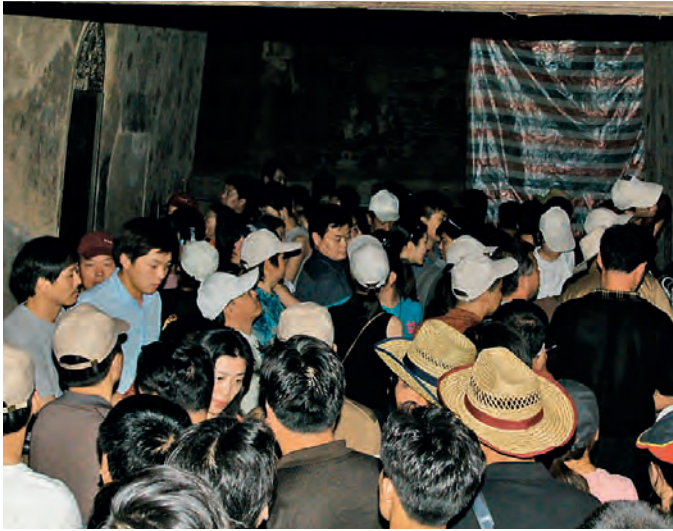
FIGURE 5 Overcrowding in the caves can damage the fragile wall paintings and diminish visitor experience.

the temperature and relative humidity inside the caves, causing damage to the wall paintings, and at times causing both guides and visitors to faint (fig. 5). Investigations are continuing to determine whether visitors have an impact on the physical fabric of the caves.

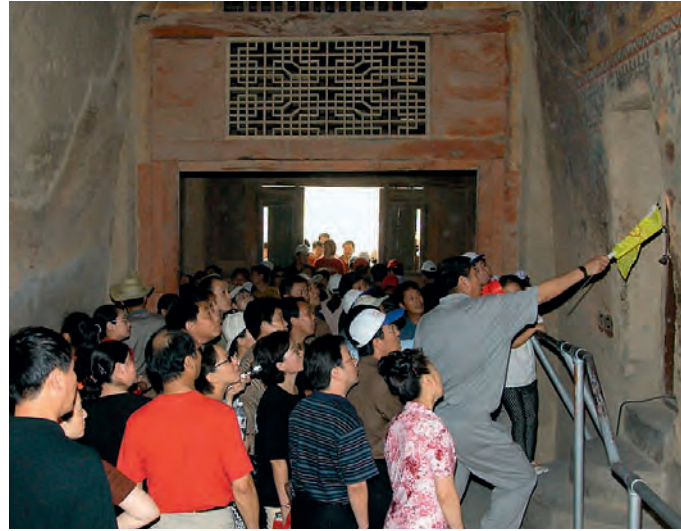
FIGURE 6 A tourist guide pointing to a feature on the wall painting. Damage caused by touching the wall paintings increases during holiday periods.

The wall paintings and sculpture are extremely fragile, and damage is irreversible (fig. 6). The caves are highly susceptible to damage, as well as vandalism, so that, in addition to providing the narration, the guides are required to be vigilant and maintain security. The glass protective screens are intrusive and, if broken, pose a potential threat to the safety of fragile wall paintings and statues (fig. 7). Poor lighting hinders visitors' appreciation and understanding of the wall paintings.

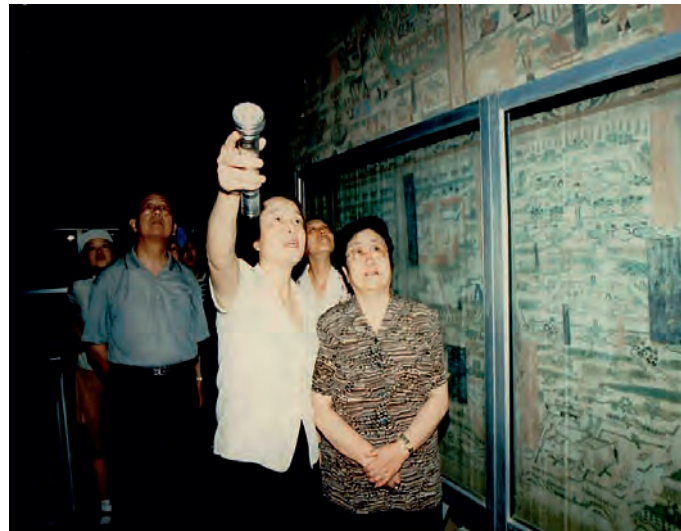
FIGURE 7 Inadequate lighting and intrusive glass screens diminish visitor appreciation and understanding of the wall paintings.

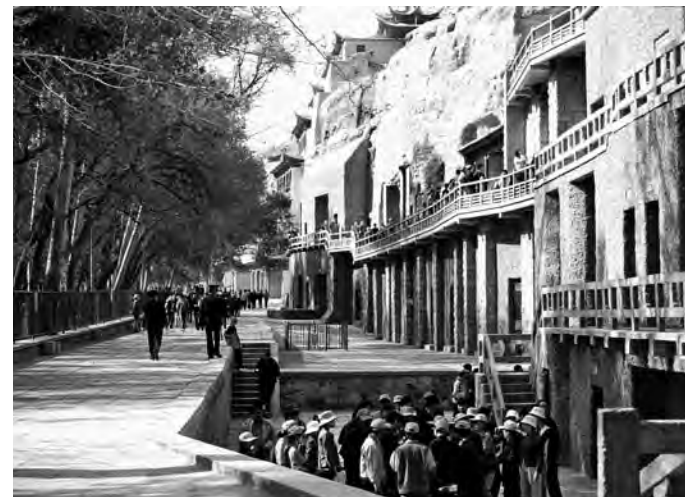
FIGURE 2 The Grotto Zone is the protected, narrow strip along the cliff face into which the caves were carved, many of which are open to public visitation. Photo: J. Paul Getty Trust

Current management policies and use zones. Existing management policies and practices relevant to carrying capacity are the number of guides, tour size and numbers, opening hours, and so on. Current use zones are the Grotto Zone (fig. 2), where the decorated caves are excavated into the cliff face, and the Visitor Use Zone, where visitor facilities and exhibition buildings are located. This study is aimed primarily at the Grotto Zone.

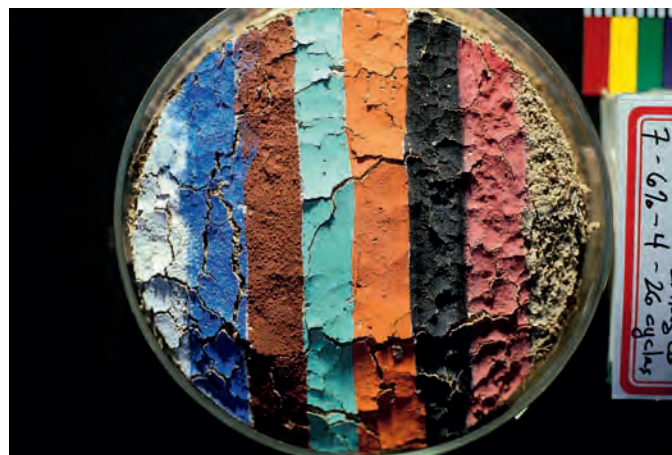
FIGURE 5 Clay coupon, simulating the structure, composition, and pigments of the wall paintings, showing typical salt-related deterioration after 26 cycles of high and low RH fluctuations in an environmental chamber. Photo: J. Paul Getty Trust

Salt-laden clay coupons identical to those cycled in the lab were installed in the caves to determine their feasibility for use as long-term deterioration monitoring tools. If and when the coupons show signs of deterioration, they will be compared to the reference deterioration index produced in the lab and assigned a rank of severity. The coupons are intended to supplement in situ inspection and provide standardized monitors for deterioration, over the long term, in susceptible caves.

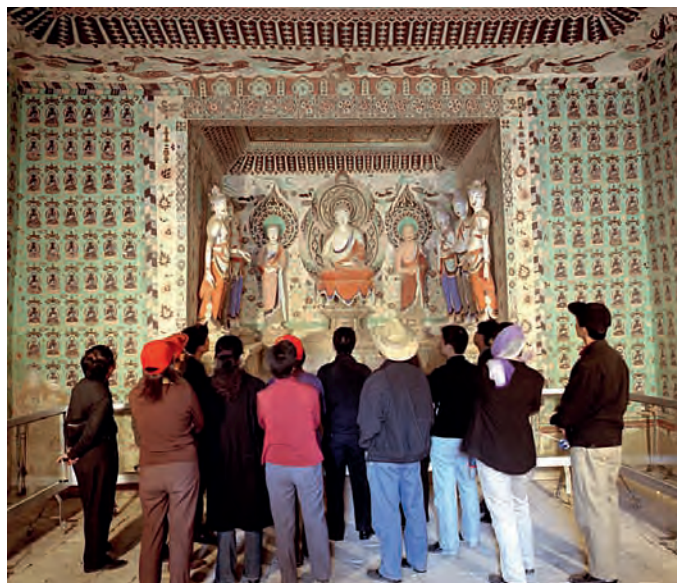
FIGURE 6 The physical capacity of a cave, based on usable area of the main chamber, varies markedly, with many caves being too small to handle a group of twenty-five persons. Inevitably, groups tend to cluster close to the guides and the main focal points. Photo: Richard Ross © J. Paul Getty Trust

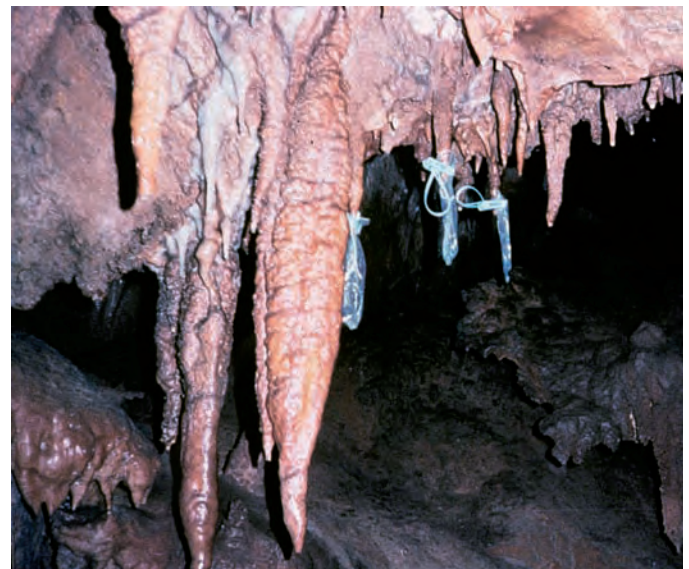
FIGURE 4 Rubber condoms are attached to some cave formations to measure the quantity of water entering the cave system. These data may be correlated with both external data (e.g., rainfall) and internal cave data (e.g., visitation numbers and frequency, desiccation). Courtesy of Jenolan Caves Reserve Trust

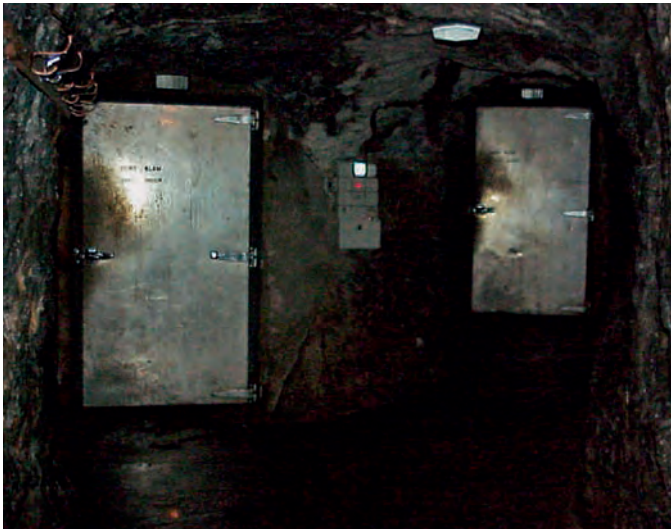
FIGURE 5 The opening and closing of airtight doors installed in the caves is used to stabilize humidity and manage desiccation. Courtesy of Jenolan Caves Reserve Trust

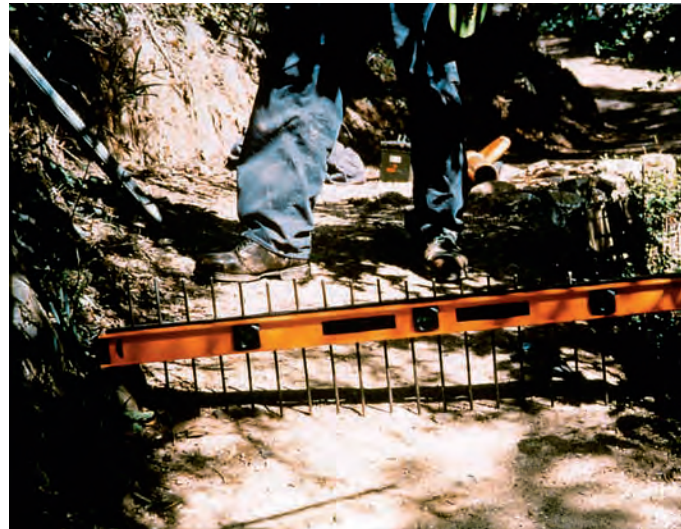
FIGURE 6 This specialized “track profile comb” was developed to measure and monitor trail degradation and erosion. Courtesy of Jenolan Caves Reserve Trust.

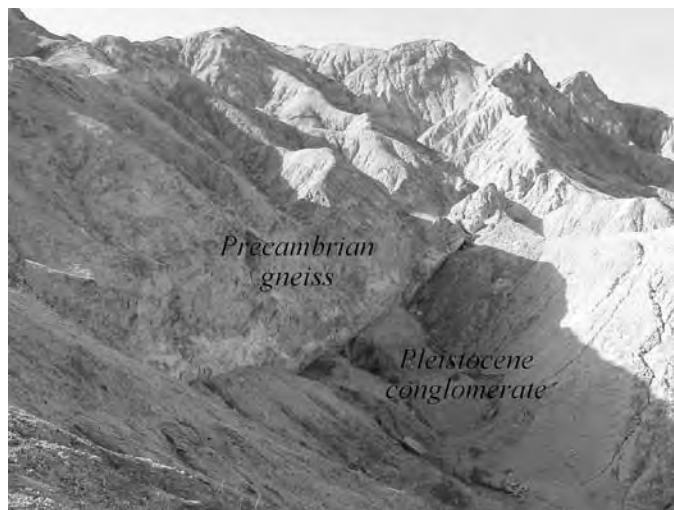
FIGURE 3 Reverse fault seen along the upper Daquan River where the Precambrian gneiss has been thrust over the Pleistocene conglomerate.

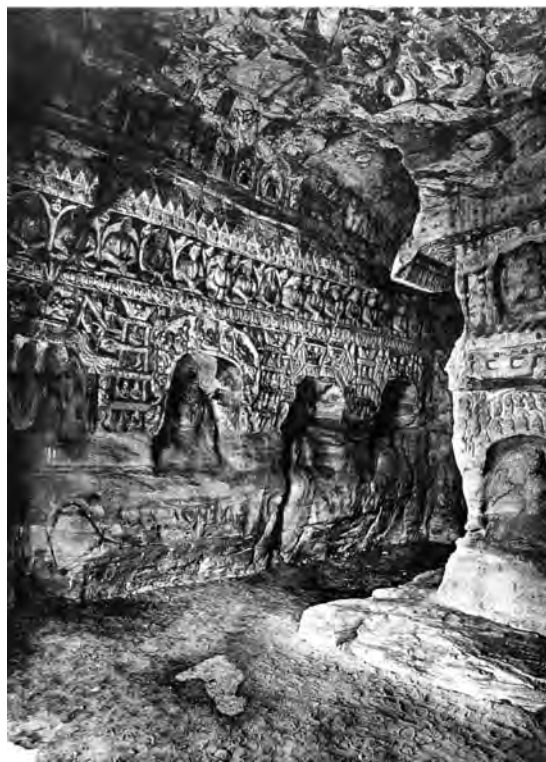
FIGURE 1 Weathering of the lower part of the west wall of cave 1 due to groundwater.

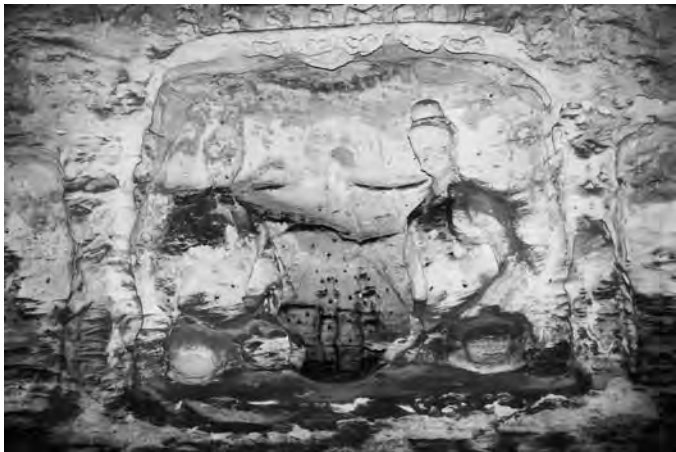
FIGURE 2 Tufa-shaped and stalactite-type weathering.

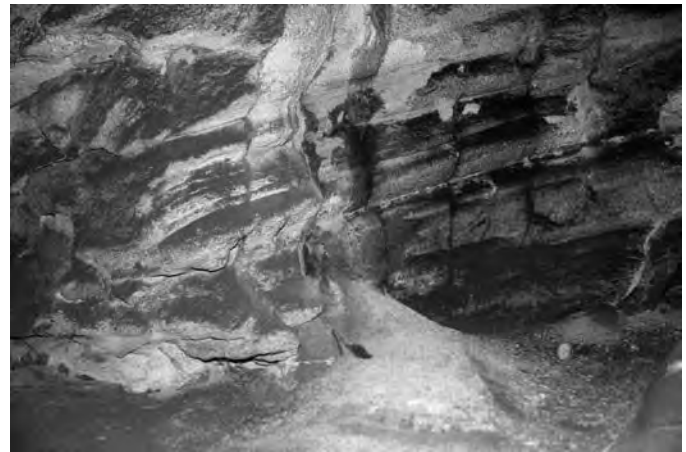
FIGURE 3 Powderlike weathering.

Flaking and scaling result in thin layers of stone lifting from the surface of statues and cave walls. The thickness of the detached layers is dependent on the size of the mineral grains. Flakes from coarse sandstone are about 3 to 4 millimeters thick; those from fine sandstone are about 0.5 to 1 millimeter thick. There is often multilayered exfoliation. Between the layers and between the detached layers and the base rock is white powder. In places with adequate sunlight and good ventilation, such damage is especially serious

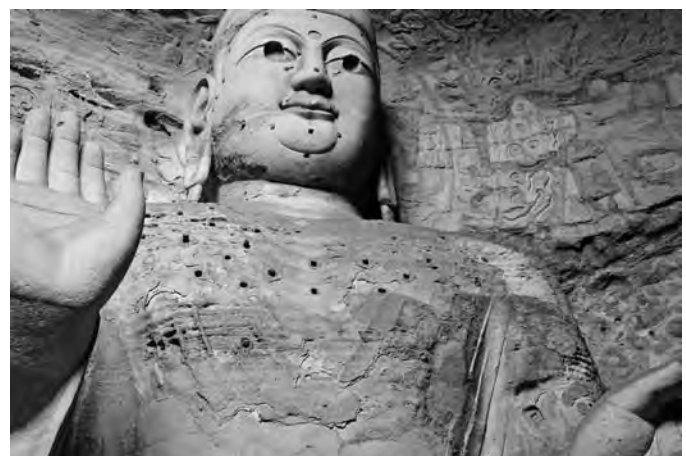
FIGURE 4 Scaling of the statues.

(fig. 4), and one can often find detached flakes and scaling parallel to the surfaces of the statues and rocks.

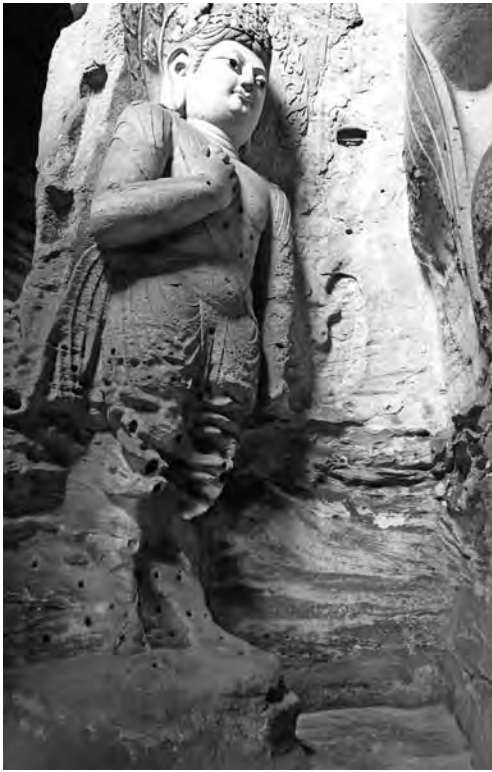
FIGURE 5 Stratigraphic weathering in cave 3.

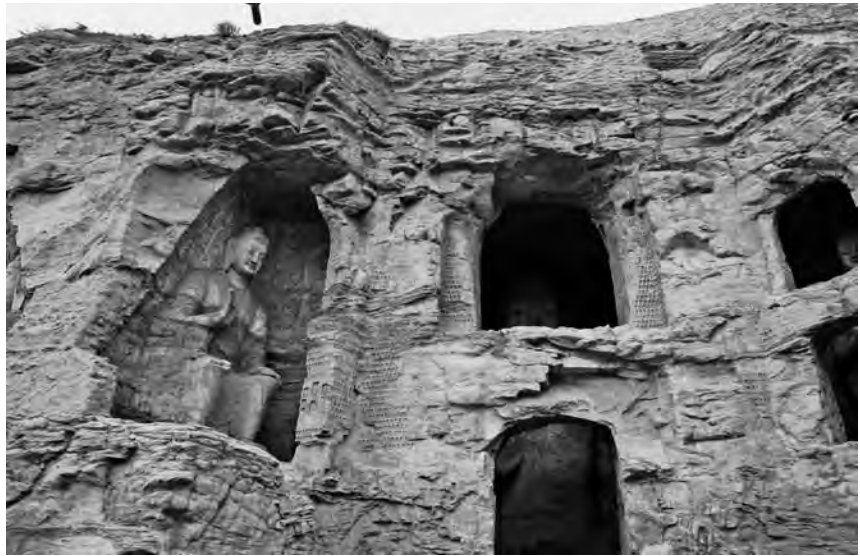
FIGURE 6 Slab-type weathering and loss at the top of cave 19's side chamber.

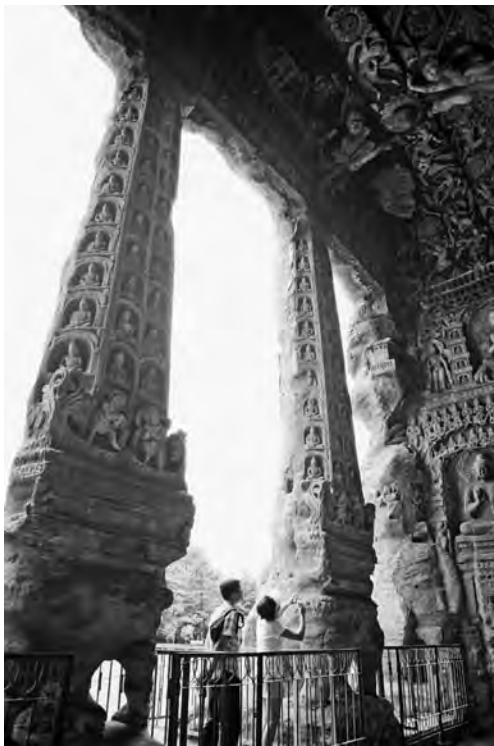
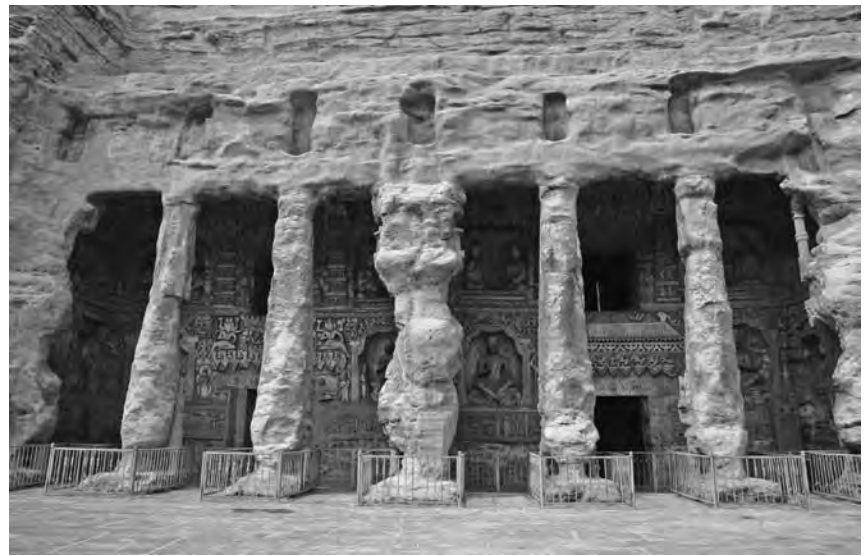
FIGURE 7 (a) Carvings on the inner sides of the pillars remain in comparatively good condition. (b) Carvings on the outer sides of the pillars are seriously eroded.

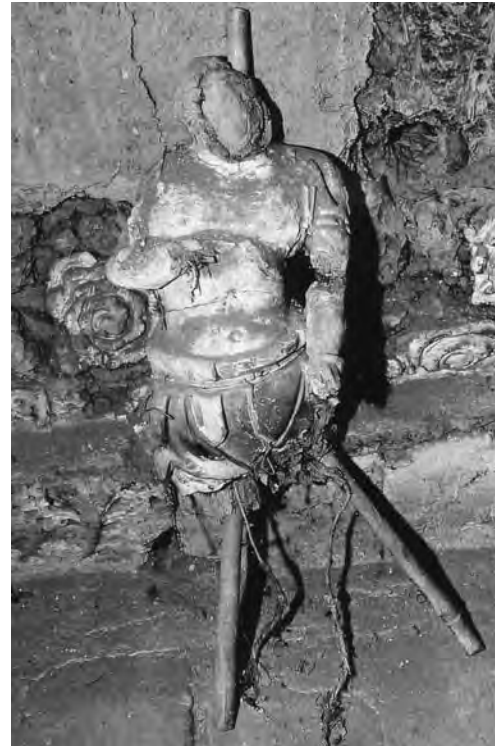
FIGURE 4 Severely damaged clay figure showing internal support structure. Credit: S. Wallner, Bayerisches Landesamt für Denkmalpflege München, 2001

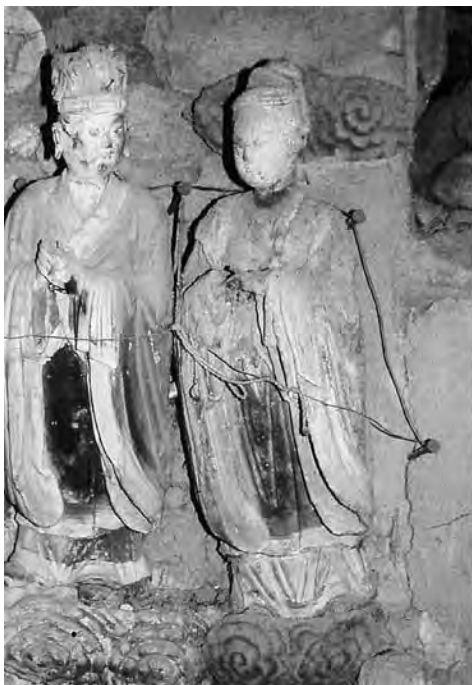
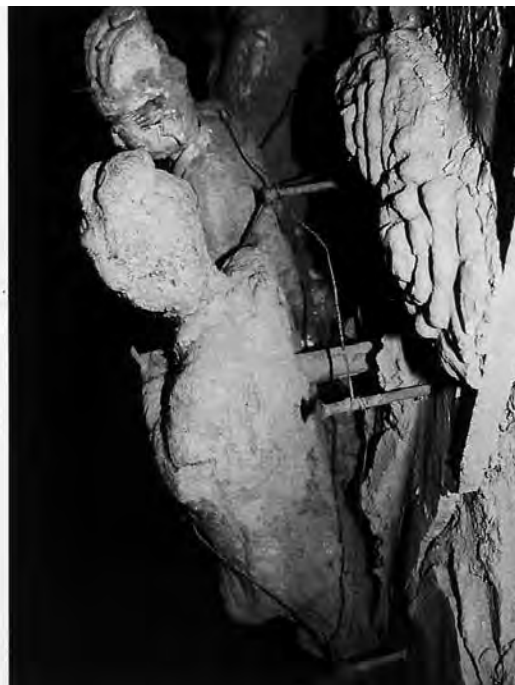
FIGURE 6 Test area 1 prior to conservation, showing two detached clay figures held in place by wire and nails. Credit: S. Scheder, Bayerisches Landesamt für Denkmalpflege München

Test area 1 consists of two figures detaching from the west wall; they were held in place by only a few nails and wires as the dowels had completely loosened from the wall. Figure 6 shows these figures before conservation; figure 7 shows them after conservation. One detached sculpture was used for tests to stabilize the clay layers.⁴

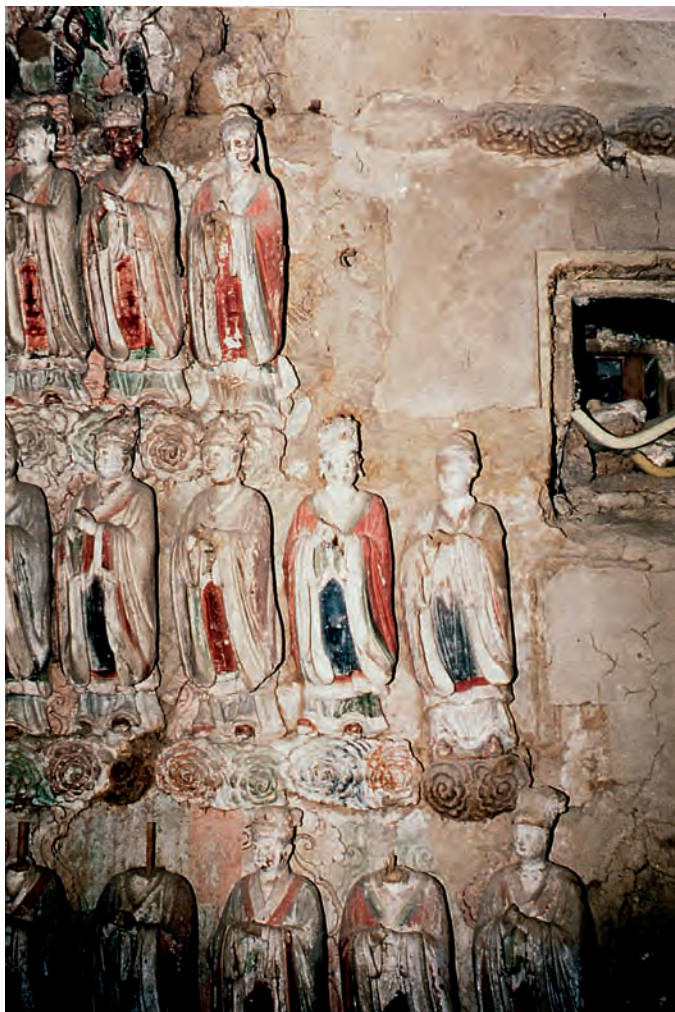
FIGURE 7 Test area 1 after conservation. Credit: C. Blaensdorf, Bayerisches Landesamt für Denkmalpflege München

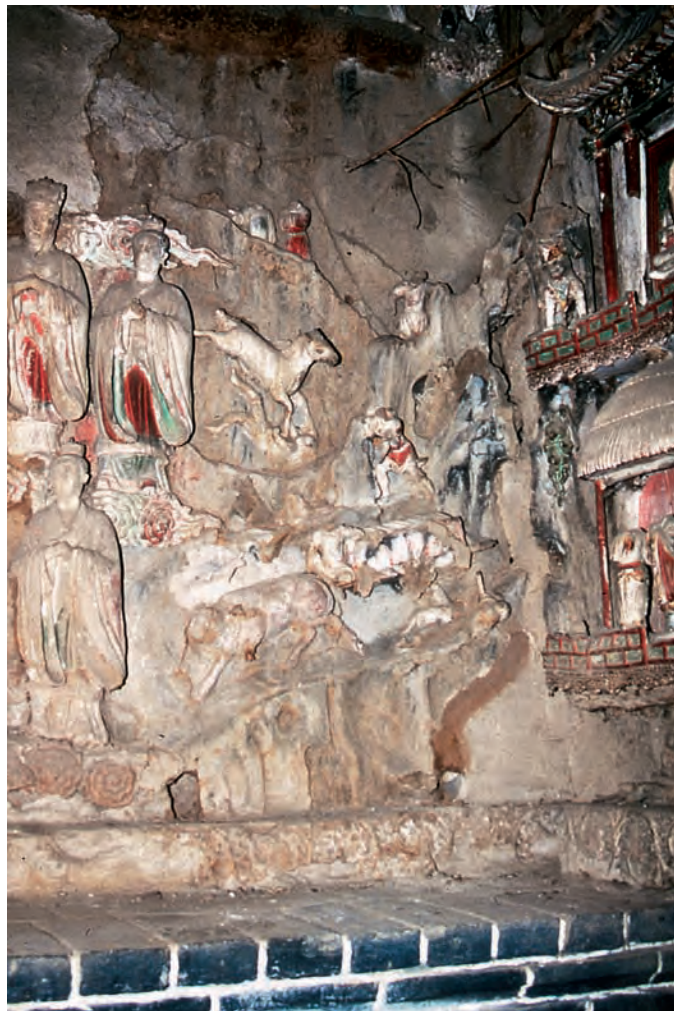
FIGURE 8 Test area 2: "Deadly accident" relief after conservation. Credit: Technical Center for Conservation, Xi'an, China

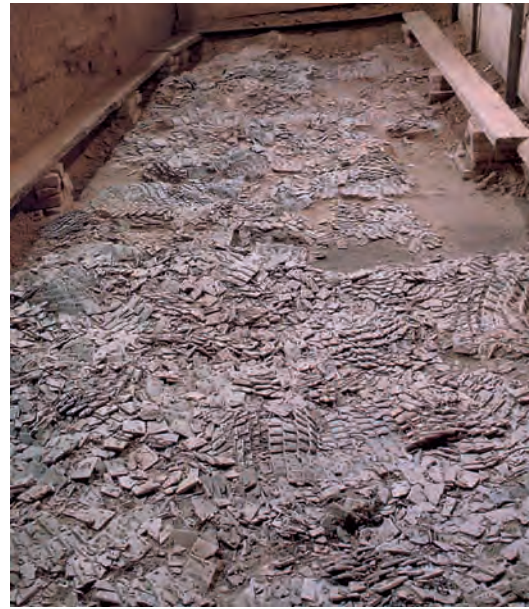
FIGURE 2 Current condition of stone armor in the excavation pit. Reproduced by permission of the Museum of the Terracotta Warriors and Horses of Qin Shihuang, Lintong, China

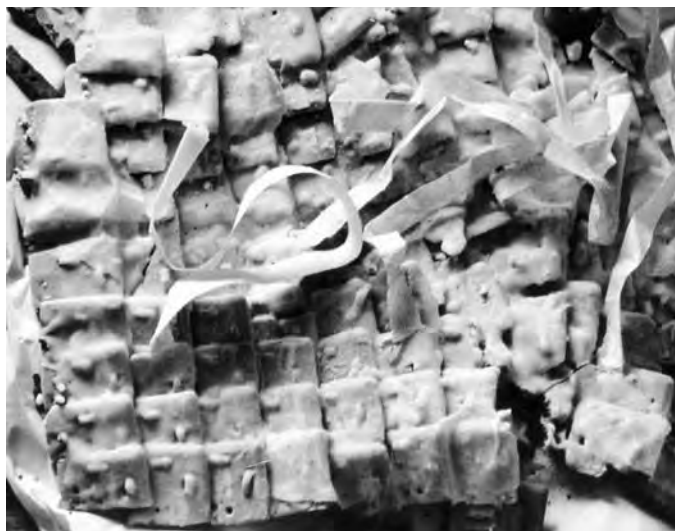
FIGURE 3 Close-up of cyclododecane-coated stone armor plates with lifting straps. Reproduced by permission of the Bavarian State Department of Historical Monuments, Munich, Germany

To avoid future losses, trials were conducted using cyclododecane (CDD) as a reversible consolidant. CDD is a nonpolar hydrocarbon compound that is solid at room temperature. It melts at 58–61°C, and it can be applied as a liquid to an object, after which it solidifies quickly into a waxlike coating. Its high vapor pressure causes it to sublime at ambient temperature (20–23°C) at a rate of 4.5 milligrams per day, leaving practically no trace behind, thus making it particularly gentle for use on fragile objects (Geller and Hiby 2002: 15).

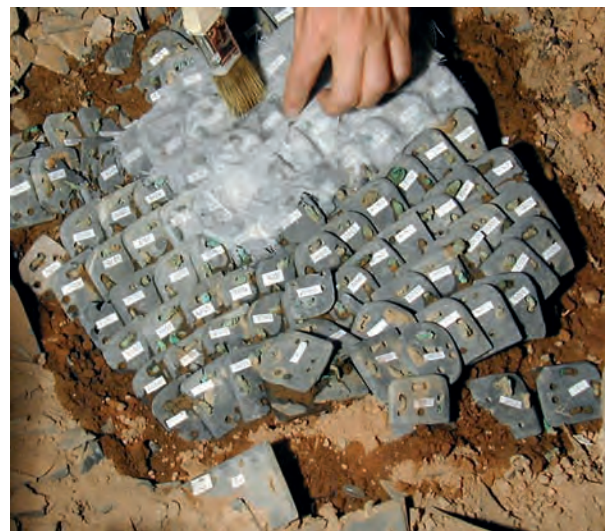
FIGURE 4 Brush application of cyclododecane over cotton gauze on test section of armor. Reproduced by permission of the Bavarian State Department of Historical Monuments, Munich, Germany

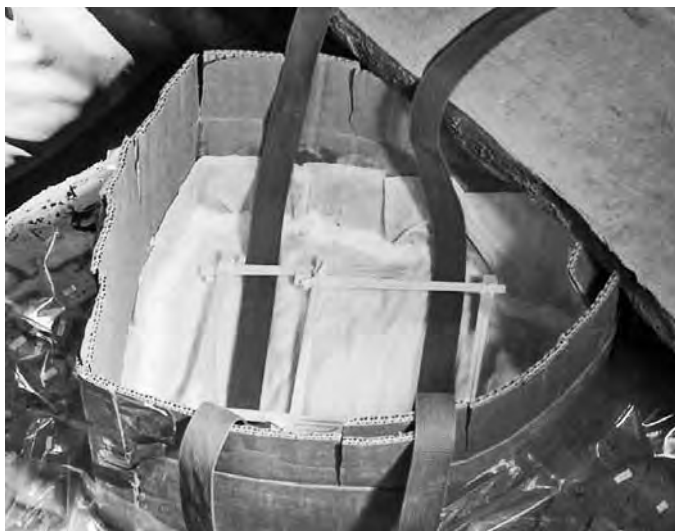
FIGURE 5 Removal unit with wooden reinforcement grid and lifting straps before addition of polyurethane foam. Reproduced by permission of the Bavarian State Department of Historical Monuments, Munich, Germany

- *Step 2:* After a wait of about twenty-four hours to be sure that the heptane had evaporated, the treated armor was encircled with a cardboard frame. This was filled with a layer of polyurethane foam, about 10 centimeters thick, and a wooden reinforcement grid and lifting straps were embedded in the foam (figs. 5, 6).

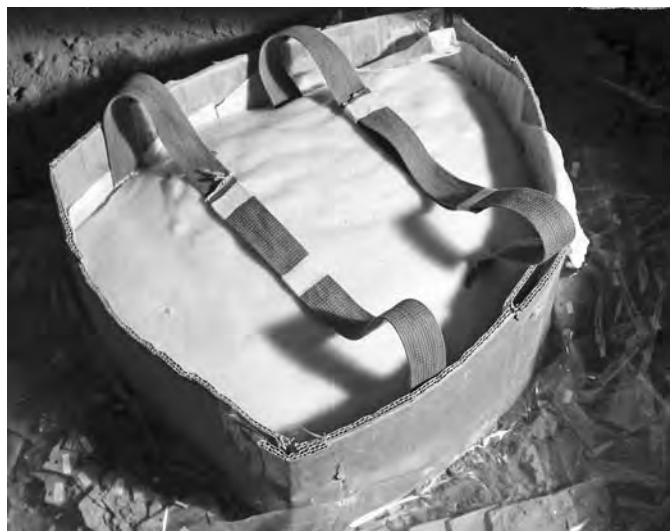
FIGURE 6 Removal unit with lifting straps embedded in polyurethane foam. Reproduced by permission of the Bavarian State Department of Historical Monuments, Munich, Germany
