Conservation of Ancient Sites on the Silk Road

Proceedings of the Second International
Conference on the Conservation of Grotto Sites,
Mogao Grottoes, Dunhuang, People's Republic of
China, June 28–July 3, 2004

Edited by Neville Agnew

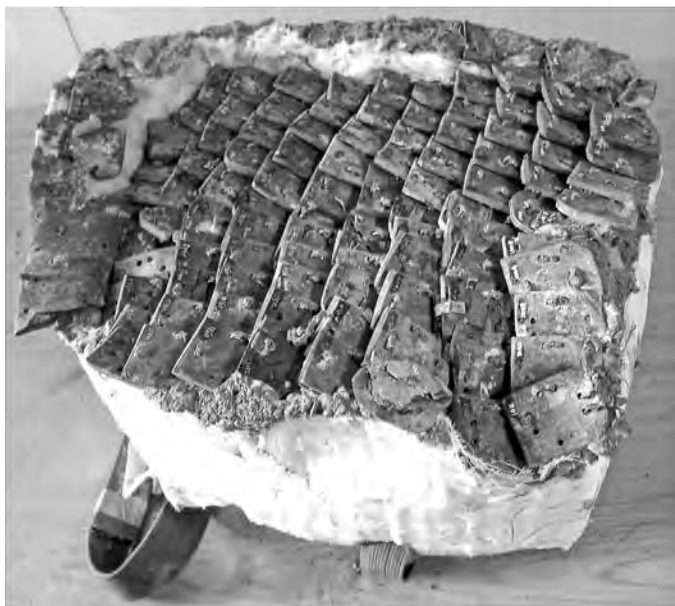
FIGURE 7 Underside of removal unit, revealing intact armor plates. Reproduced by permission of the Bavarian State Department of Historical Monuments, Munich, Germany

- *Step 3:* After the foam hardened completely, it was possible to raise the unit out of the ground with the lifting straps. The armor released cleanly from the ground without leaving behind any pieces. Turning the unit upside down revealed the side of the armor that originally had been faced down on the ground (fig. 7).

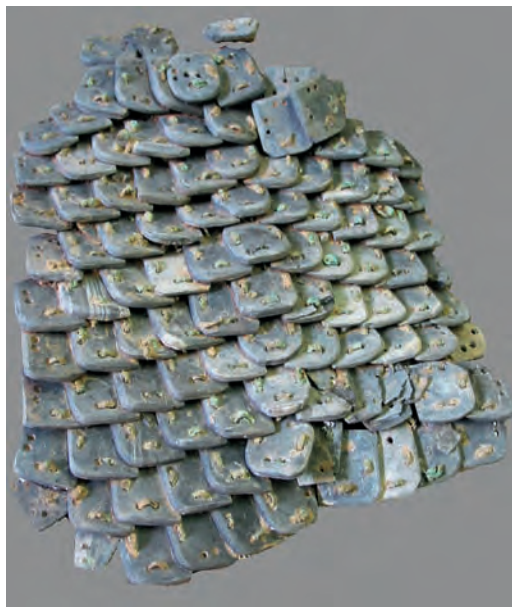
FIGURE 8 Restored test section of stone armor. Reproduced by permission of the Bavarian State Department of Historical Monuments, Munich, Germany

The exposed stone plates and wires were carefully cleaned, and any loose stone elements were glued in place with polybutyl-methylacrylate (Mowital B30 H15).¹ After cleaning, a plastic layer was applied over the exposed armor and a negative mold of the surface was made out of gypsum plaster, making it possible to turn over the armor. The plaster layer then became a support. Next, the polyurethane foam and layers of CDD-impregnated cotton gauze, now on top, were removed. This removal was done with a bath of heptane that penetrated the gauze and dissolved the CDD. The now-loosened fabric and foam were removed, revealing the side of the armor that had been faceup on the ground. Now this side could be cleaned. The restored test section of armor is shown in figure 8.

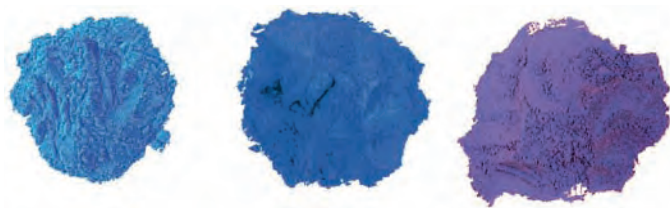
FIGURE 2 Left: Egyptian blue ($\text{CaCuSi}_4\text{O}_{10}$); middle: Chinese purple ($\text{BaCuSi}_2\text{O}_6$); right: Chinese blue ($\text{BaCuSi}_4\text{O}_{10}$).

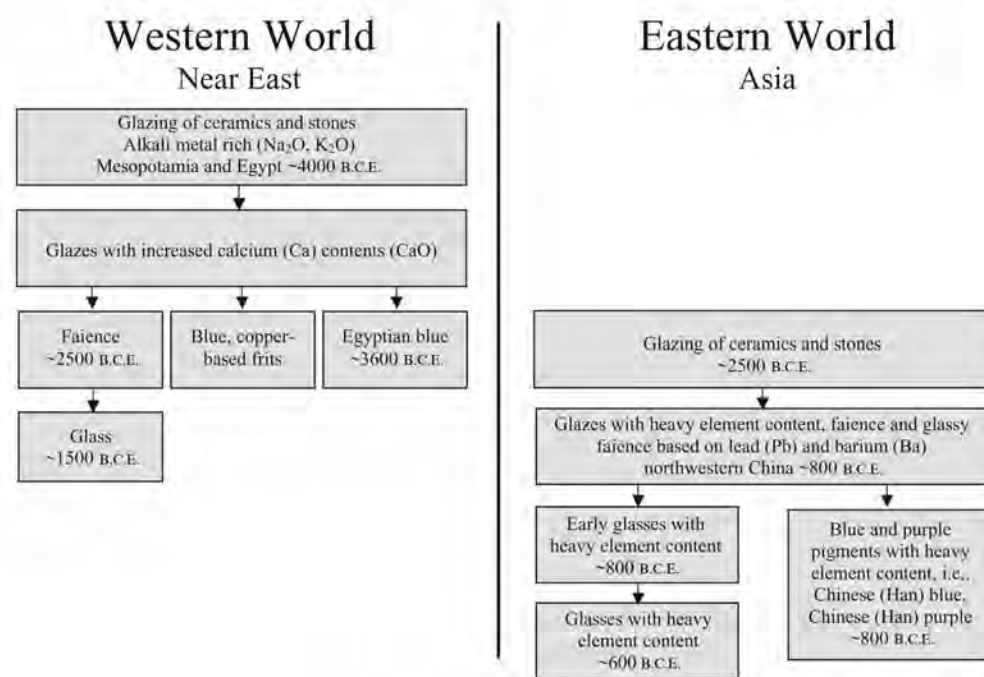
FIGURE 6 Flowchart showing possible pathways for the separate but parallel development of Egyptian blue and Chinese blue and purple in antiquity.

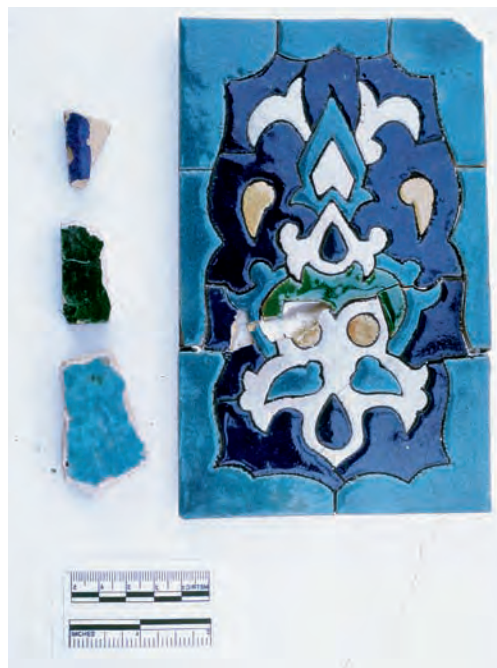
FIGURE 2 Modern tiles in a similar pattern and, to the left, the samples we analyzed in table 1.

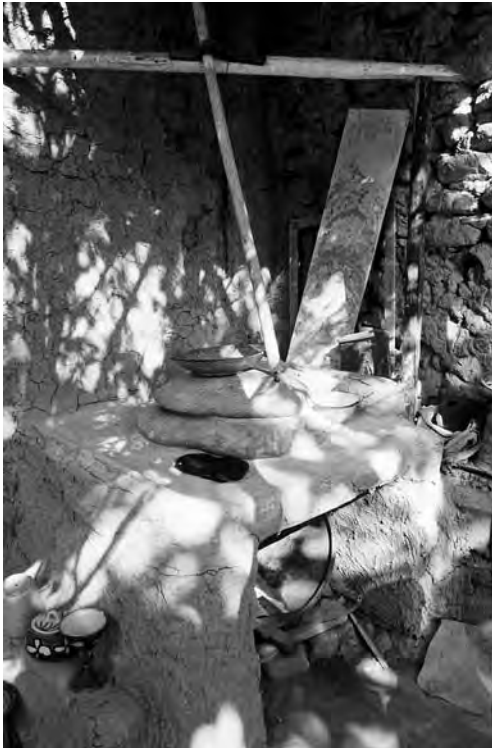
FIGURE 7 Hand-operated quern for milling *ishkor* ash, with a bowl of ash for one milling operation on the top in the courtyard of the Marajapov family.

was used to smother the fire within. If the flame threatened to burn through, more plants were added. Each type of plant was fired in a separate stack. The ash was milled dry in a hand quern over a period of one day and sieved to about 120 mesh (fig. 7). One workshop still retains a traditional donkey-driven mill, but it is used primarily for grinding clay, as the amount of *ishkor* glaze production is insufficient. Many workshops now compound an artificial ash composition made from commercial ceramic ingredients. The ash was then mixed at a ratio of 1.5 parts of ash with 1 part of quartz and, occasionally, small amounts of ground glass or lead compounds, then milled again. The final preparation of the glaze involves adding water to make a slurry with the consistency of cream.

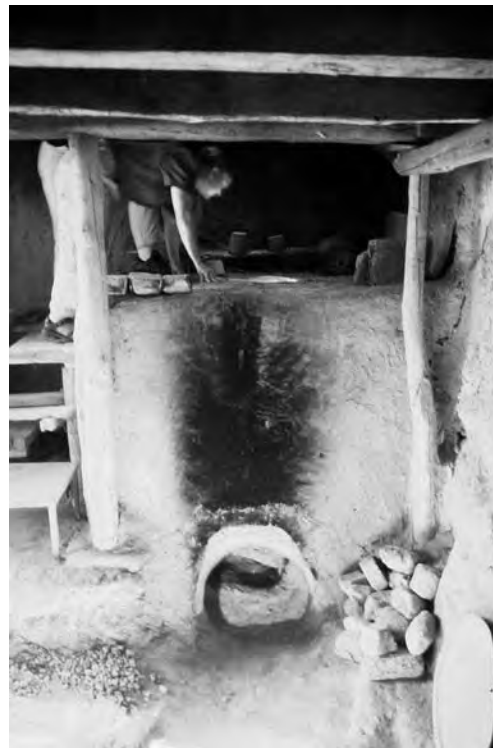
FIGURE 8 Gofferjahn Marajapov's circular, updraft kiln with a separate, lower firebox or chamber for fuel, being investigated by Amy Vandiver. Note the quartzite slab at the rear of the firebox.

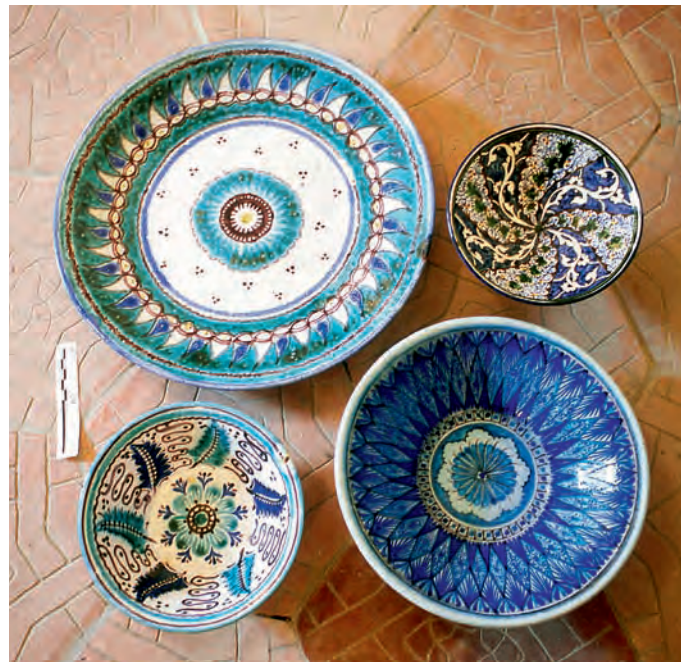
FIGURE 10 Four bowls by Ibrahim Kamillov, each showing a variation on the *ishkor* technique. Note the difference in gloss as shown in the specular reflectivity. The right side shows two bowls in traditional *ishkor* technique: the upper one with no lead oxide addition and the lower one with low lead. The left side shows two innovative bowls: the upper one with high barium oxide and the lower one with very high lead oxide content.

Table 3 provides evidence of innovation and special practices in the *ishkor* glazing process in some traditional workshops. For instance, Ibrahim Kamillov’s glazed wares (fig. 10) exhibit a wide range of gloss, reflectance, and translucency that he achieves by using materials, such as barium oxide and probably borax, that are fluxes, but their use is outside the lead and *ishkor* traditions. Rye and Evans (1976) documented the use of borax in glazes among pottery workshops in Pakistan, and the low compositional totals, for example, 94 percent, imply ingredients that we cannot detect by our methods of analysis. Kamillov’s glazes also have lower iron content, evidence that he used especially pure materials, such as quartz, to promote translucency.

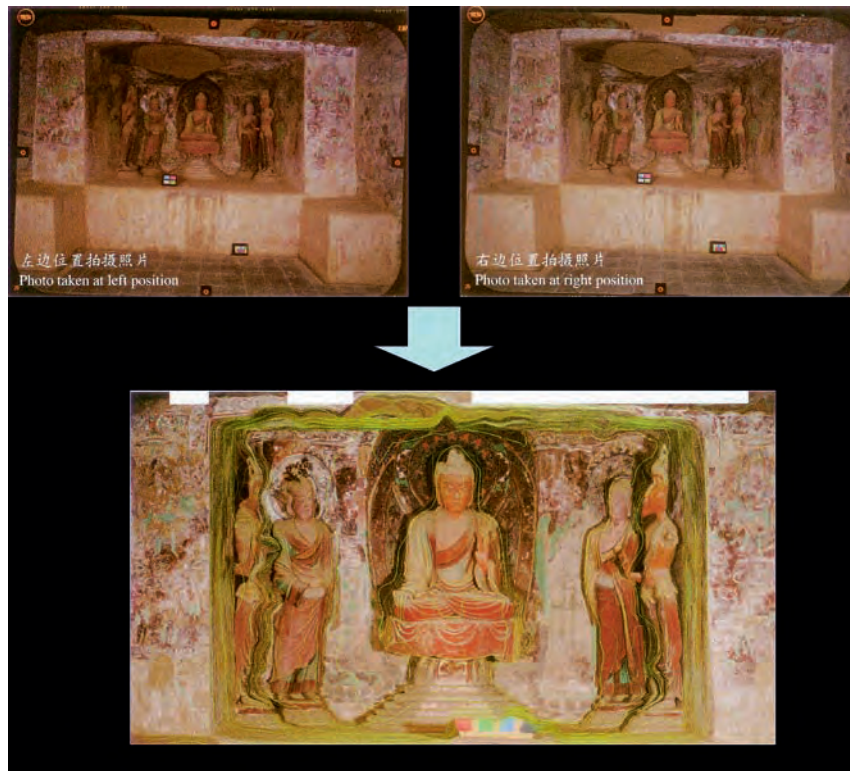
FIGURE 1 Reconstructed 3D wall painting with sculptural relief.

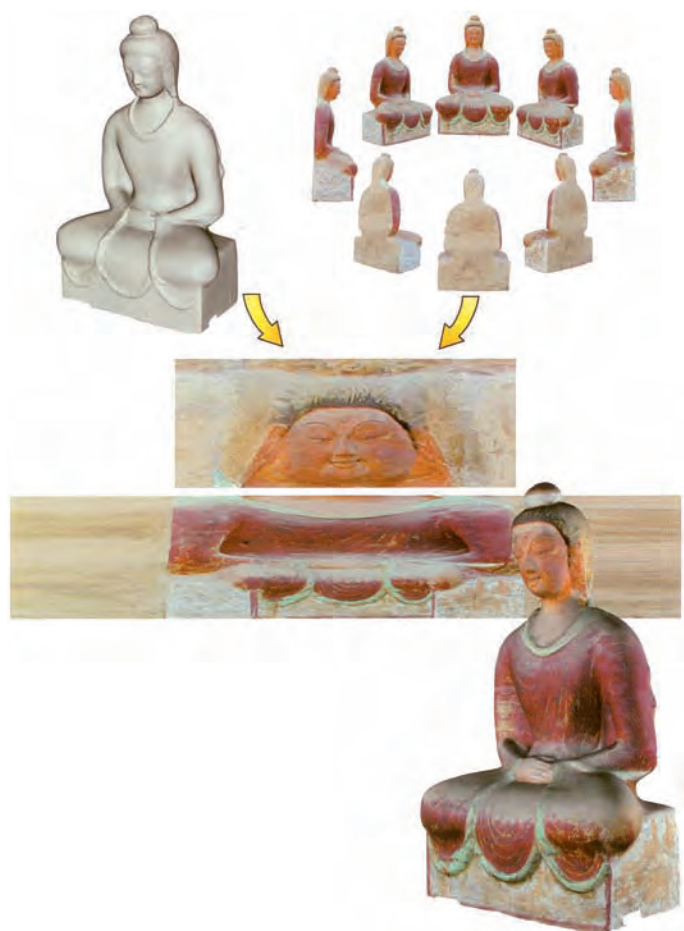
FIGURE 3 Process for generating texture on a statue's image.

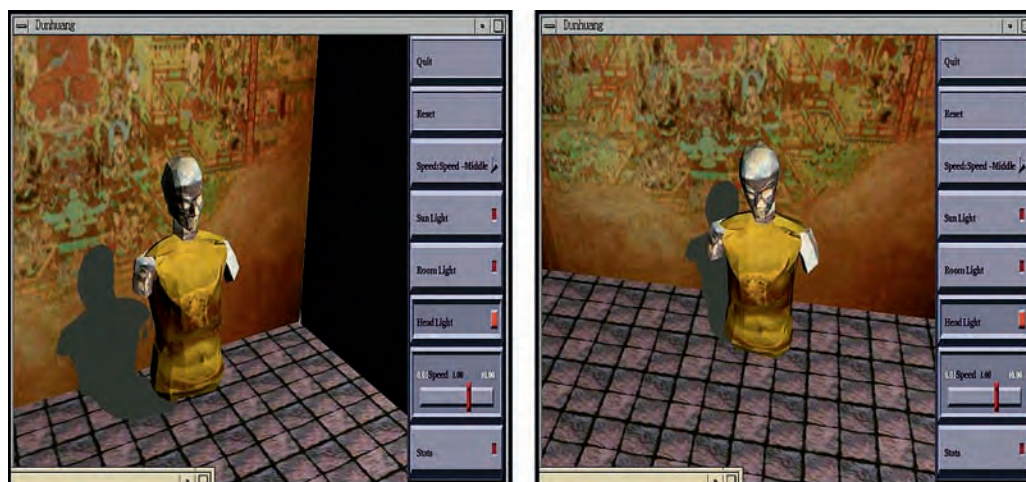
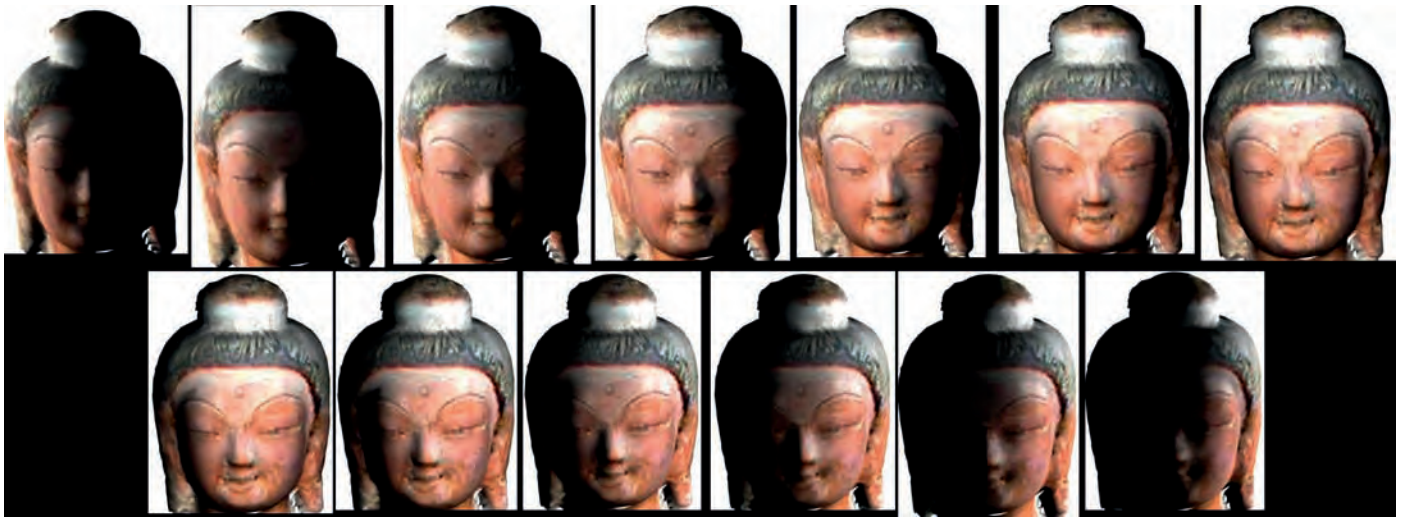
FIGURE 7 Analogy source images for shadowing.

In the algorithm, the analogy information source is approximate to the target under different light positions. We render images from any direction and under any light source for the acquired 3D model of a statue. We then put the rendered images into the source database and thus generate a set of analogy source images, as shown in figure 7.

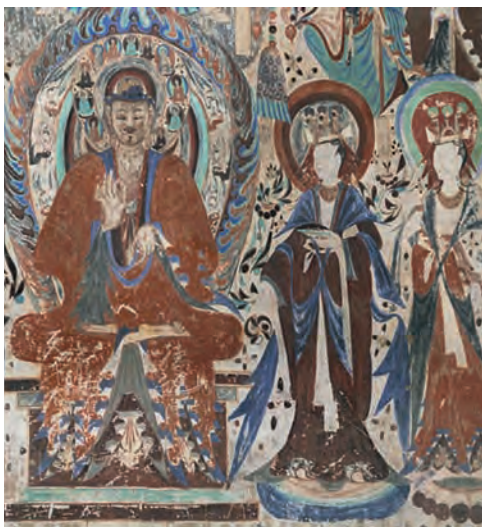
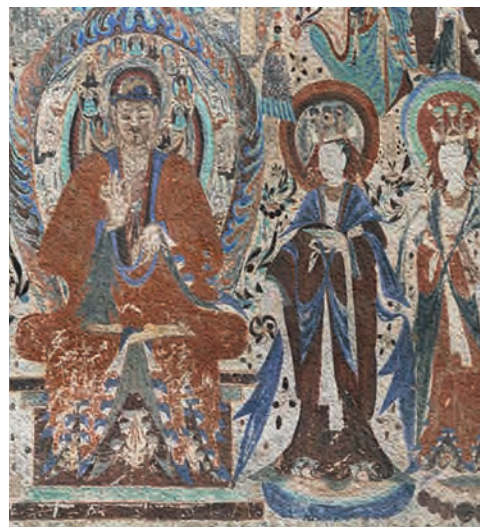
FIGURE 8 Mural section: (a) imaged without bump mapping; (b) imaged with bump mapping, showing generated surface roughness.

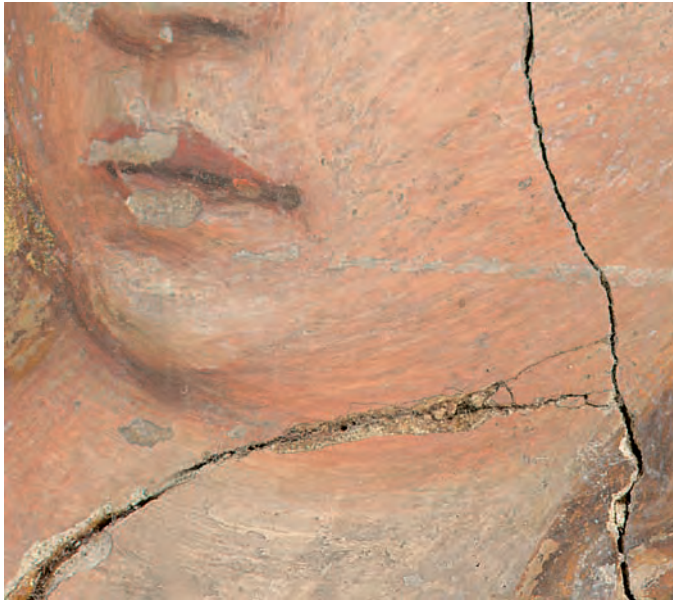
FIGURE 3 Detail from *Heads of Angels* (National Gallery, London, No. 1842) imaged with the NG CRISATEL system, showing the absence of color fringes at the edges of cracks.

light) is shown in figure 3. This demonstrates the accuracy of interchannel image registration, as no color fringes are seen at the edges of the cracks (a common problem with multiband images).

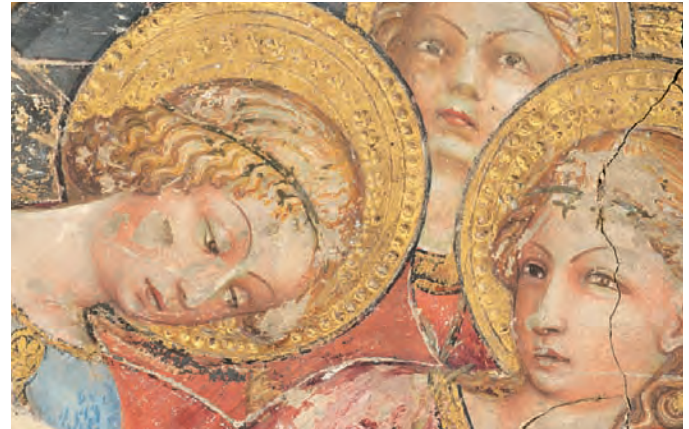
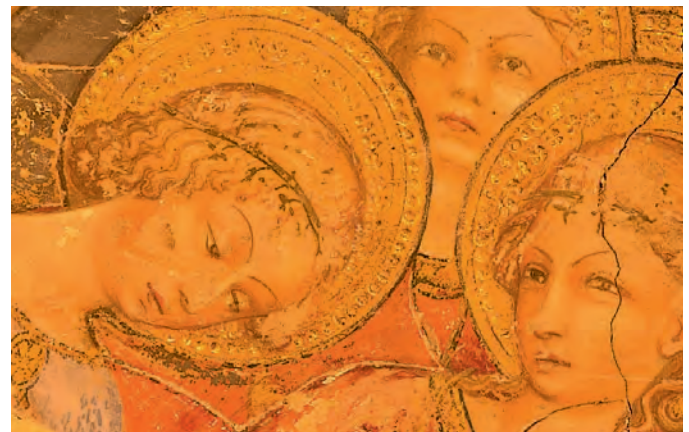
FIGURE 4 Color images of *Heads of Angels* rendered under (a) daylight and (b) candlelight.

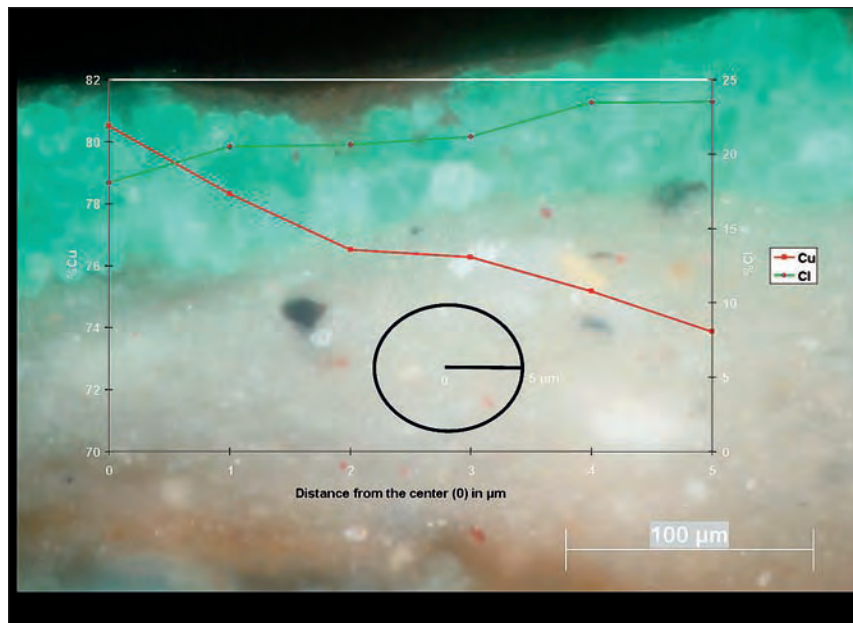
FIGURE 5 Cross-section photomicrograph (background) of rounded particles of green atacamite pigment in sample YW2. Superimposed is an EPMA-obtained profile of the copper and chlorine concentration distribution within a single particle.

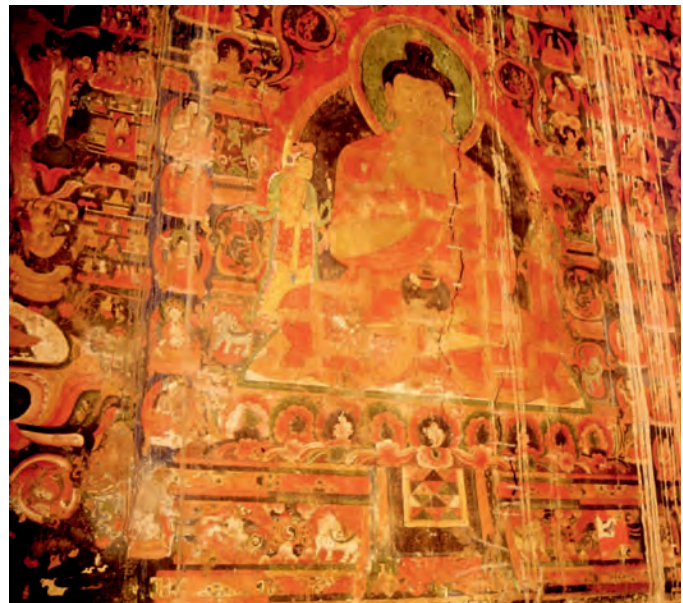
FIGURE 2 Section of the Chamba Lakhang's northeast wall, with a deep structural crack running down the center. The crack has been “stitched” with mesh strips (white patches) along its length.

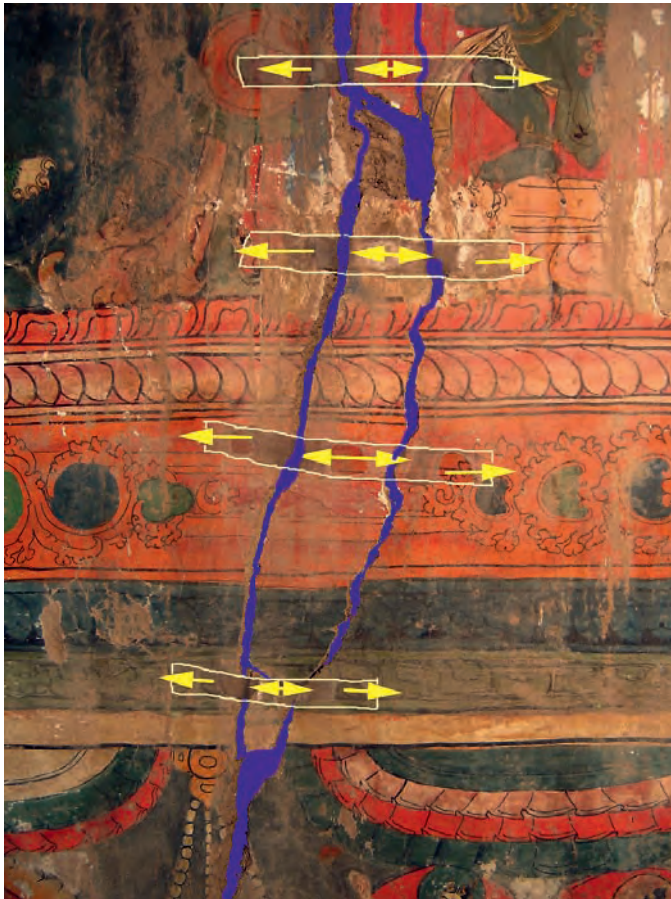
FIGURE 3 Portion of treated painting with schematic detail showing the location of mesh strips (yellow outline) used to secure plaster on either side of the cracks (blue). Arrows indicate adhesion points and the direction of forces that hold fragmented plaster in place.

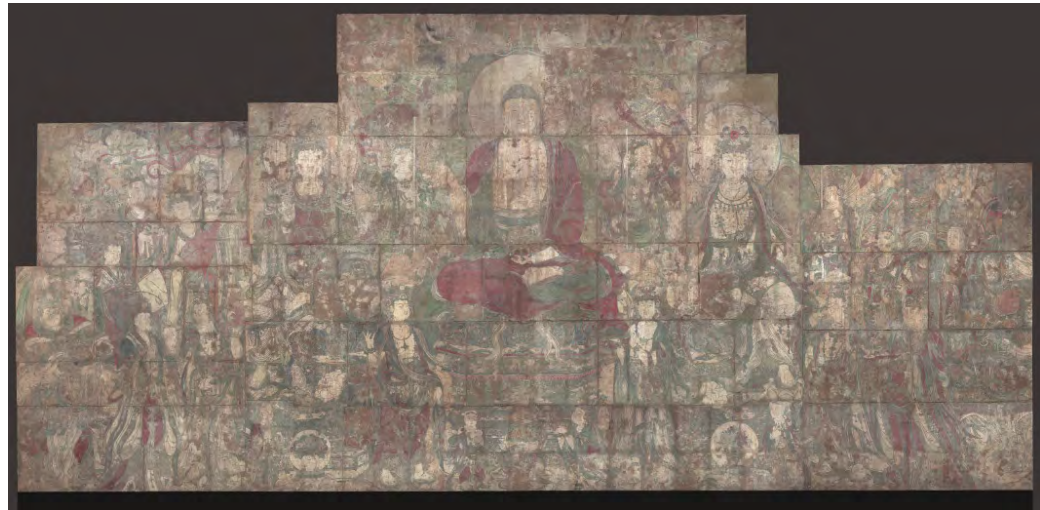
The wall painting, executed on clay and measuring 7.13 meters by 14.83 meters (w × h), depicts the Tejaprabha Buddha, whose name means “blazing light,” surrounded by figures representing celestial bodies, including the sun, moon, and five planets of traditional Chinese astronomy. This painting was located on the wall of one of the gable ends of the hall; a similar painting on the opposite wall is now located at the Metropolitan Museum of Art in New York

FIGURE 1 Digital mosaic of the *Paradise of the Tejaprabha Buddha* wall painting.

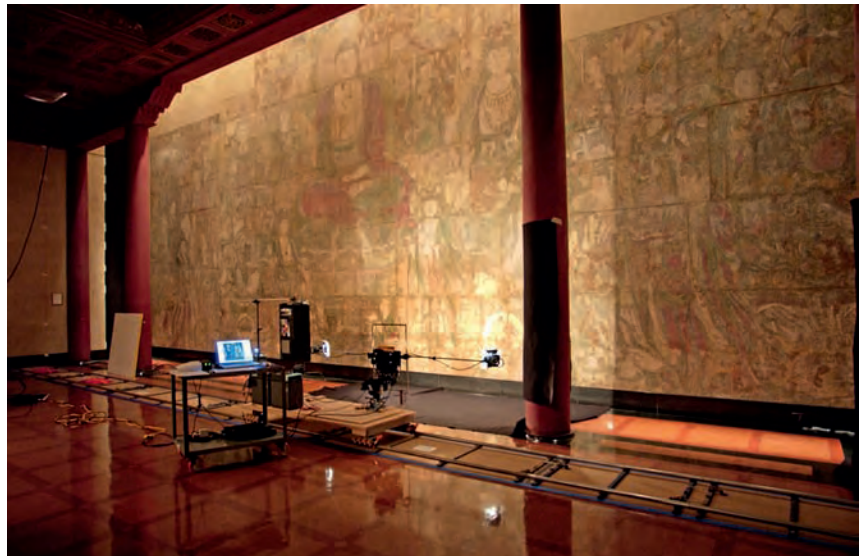
FIGURE 3 Physical setup for digital imaging of the wall painting.

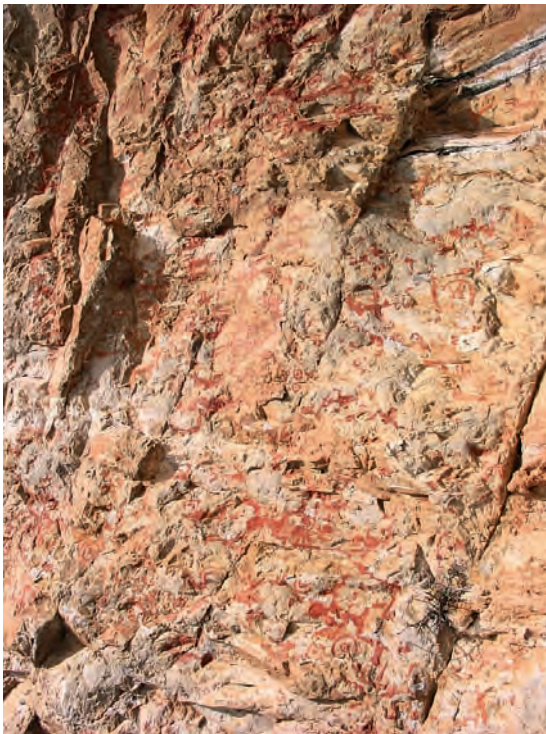
FIGURE 2 Weathering of the rock paintings on the Huashan cliff.

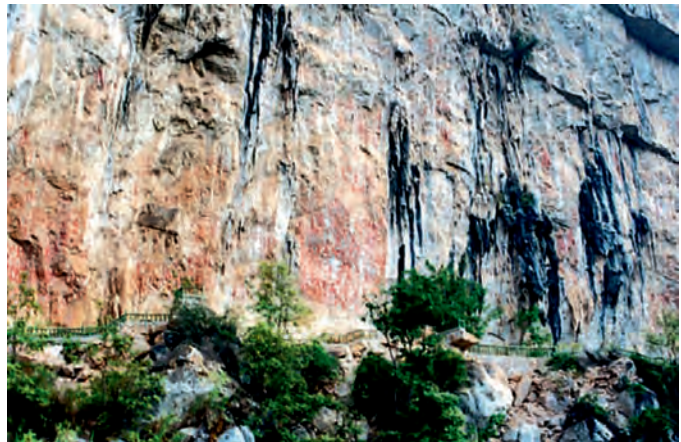
FIGURE 3 Stalactites and curtains on the Huashan cliff.

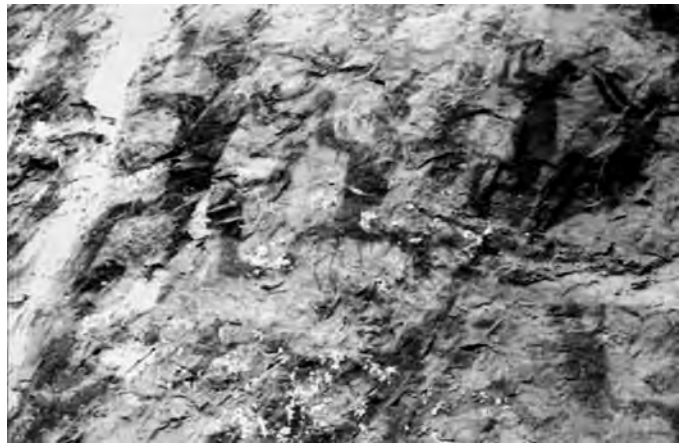
FIGURE 4 Granular substance on the Huashan cliff.

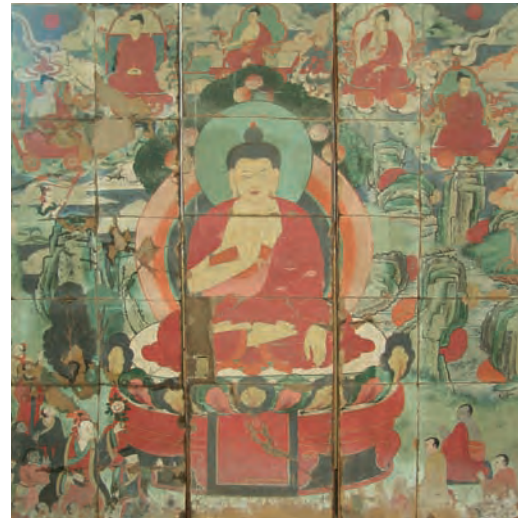
Excessive Incisions. The 34.96-square-meter panel was sliced into 186 irregular pieces and reconstructed into 76 individual sections after treatment (fig. 3). There are twenty-eight areas of 0.67 square meter marred by cuts and twenty areas unmarred by cuts but with relatively large cracks. The remaining sections of the mural are divided into small individual pieces. For example; sections 11–13 titled “Main Buddha” (Huabian Zhuti Fo) (dimensions 2.30 by 1.99, approx. 4.6 m²) were removed in 24 sections and reconstructed as three individual paintings after being treated. These three paintings can be put together to form a completed Buddha figure. The wall painting (fig. 4) was removed in a crude fashion concurrent with the repair of the walls. The section removed primarily depicts images of the Buddha and human figures. Only the Buddha and human figures were retained; the background, primarily depicting nature and living creatures, was abandoned.

FIGURE 3 Part of the wall painting during reconstruction.

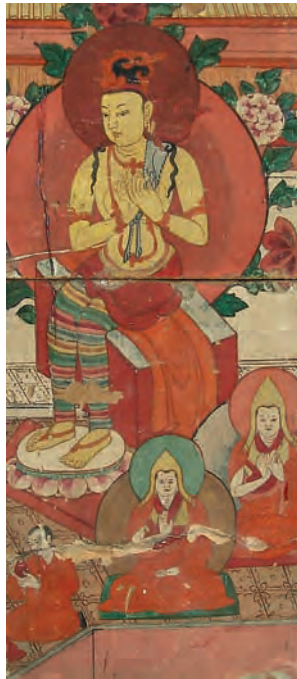
Minimal Consideration for the Integrity and Aesthetic of the Painting. In removing and saving parts of the wall painting, consideration was given only to the size of the segment and its appearance as a whole; the integrity of the painting itself was ignored. A transverse cut, in sections 11–55, “Avalokitesvara” (Guanyin Pusa) (dimensions 0.64 by 1.04 m²), cut the legs of the sitting Bodhisattva (Pusa) in two, severing the painting as a whole and diminishing its artistic beauty.

FIGURE 4 Inappropriate cutting of the wall painting.

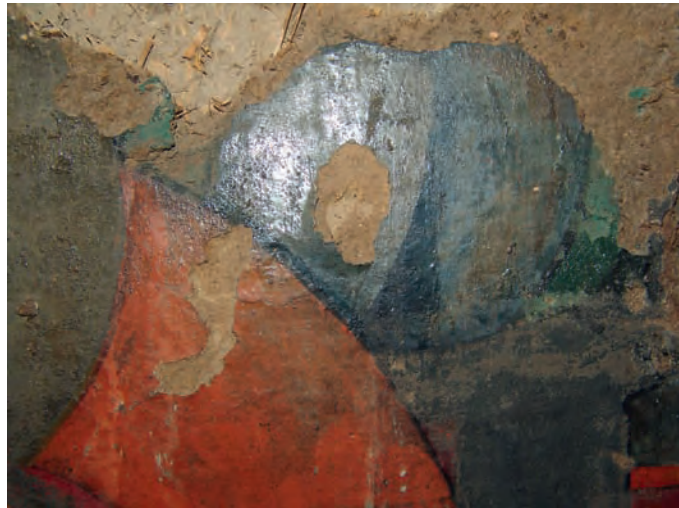
Epoxy resin was widely used in cultural heritage conservation during the 1980s. At that time the materials and the approach adopted to remove and conserve the Dazhao Temple wall painting were considered relatively advanced. However, epoxy resin becomes extremely hard once it sets, which is incompatible with the strength, cohesiveness, and elasticity of the much weaker “canvas” underside. More than a decade later, the adverse side effects of epoxy resin gradually appeared, creating cracks, displacement, disfiguration,

FIGURE 5 Adverse effects due to use of epoxy resin.

partial fragmentation, and other serious damage caused by the strength, age, and contamination of the substance (fig. 5).

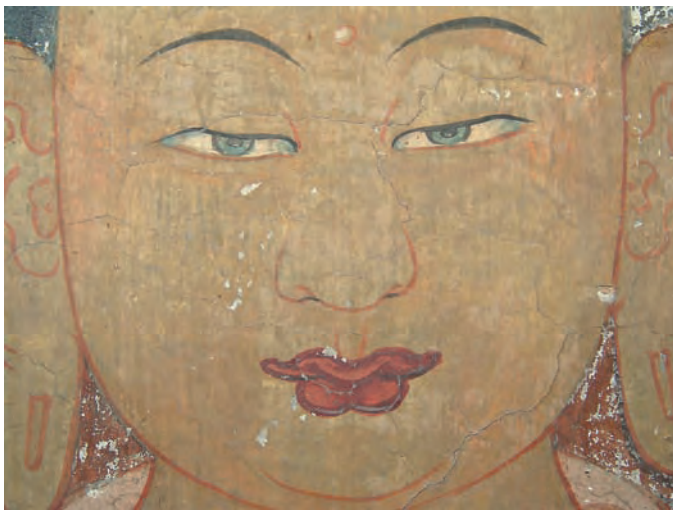
FIGURE 6 Powdering and loss in the wall painting.

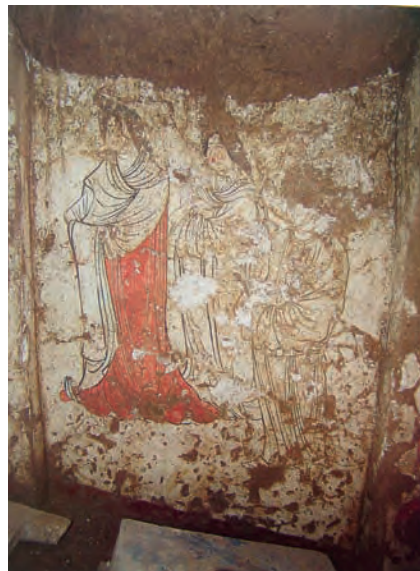
The wall paintings in the vertical shafts depict mainly human figures. Most have been relatively well preserved, with only a few areas of flaking, disruption, and detachment. However, paintings on the lower part of the shaft walls were damaged. When the tomb was sealed, backfill materials such as earth and fragments of bricks were dumped from the top of shafts, and this may have caused the damage. Figure 3 shows the painting on the west wall in the first vertical shaft.

FIGURE 3 Murals on the west wall of the first vertical shaft in the Huiling Mausoleum.

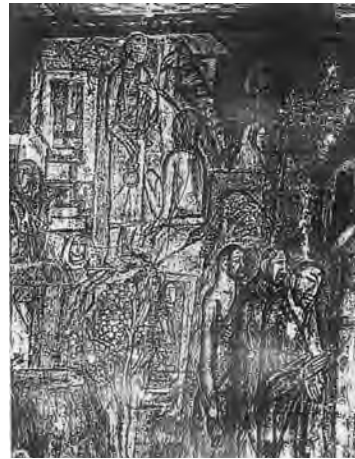
FIGURE 7 Medieval saints, depicted in a 1947 building mural in Santiniketan, West Bengal.

Jaipur, named Narsingh Lal, and Nandalal's students (fig. 6). Table 6 summarizes the characteristics of a Santiniketan mural depicting medieval saints painted by Benodebehari (fig. 7). Bose used the Rajasthan *buon fresco* technique, and Benodebehari used Italian *buon fresco*.¹

Technique	Italian <i>fresco buono</i>
Carrier	Brick wall superstructure done in a mortar of lime brick dust
Rough Plaster	Lime and plaster
Fine Ground	Fine lime plaster covered with a thin coat of slaked lime
Pigments	Earth color of various shades, like yellow ocher, red ocher, lime for white, lamp black, etc.
Medium	None

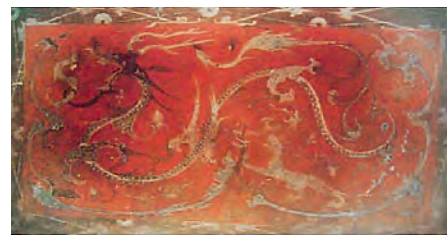
FIGURE 1 The Four Deities wall painting.

acetate (PVAc) emulsion was used to reinforce the flaking fragments. The painting was cut into five pieces (3.27 by 1.13 meters), and the surface was reinforced with 5 percent polyvinyl butyral (PVB) solution, gauze, and glue. The cut segments were secured onto an epoxy backing strengthened with cotton gauze and the backing fixed onto a wooden frame (Chen Jinliang 2001: 317–25).

The painting was deformed and cracked and the paint layer warped. Fissures occurred in the upper left and bottom right corners. The painting surface also bent following the distortion of the wooden frame. The wooden frame and epoxy backing were severely deformed. In addition, the securing fixtures had started to loosen.

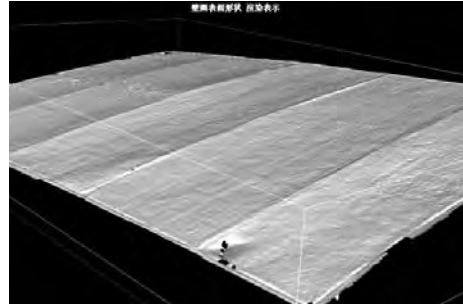
FIGURE 5 Net imaging of hole 1.

Figures 4 through 6 present the scanning results. This qualitative and quantitative mapping, recording, and analysis documents the condition of the painting and thus provides a database for future restoration work.

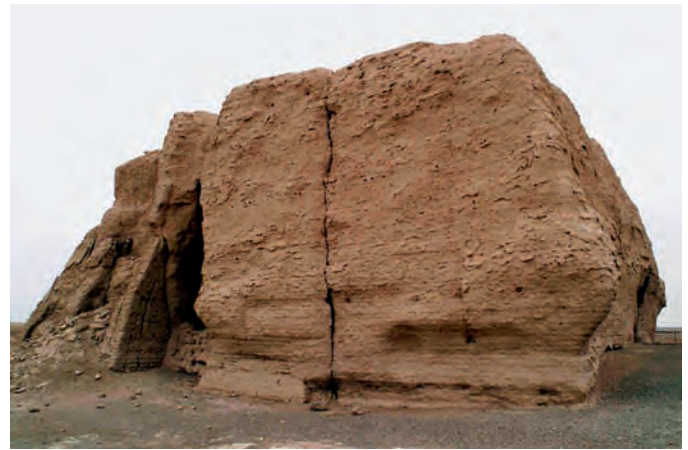
FIGURE 1 Condition of the Yumen Pass before consolidation.

The ruin of Yumen Pass, also called Xiaofangpan Fortress, is located on the Shule River in the Gobi Desert approximately 90 kilometers northwest of Dunhuang (fig. 1). Built during the Western Han dynasty, it served as a strategic point on the northern Silk Road and played an important role in the development of the Western Regions (Compiling Committee 1996). The extant structure is a square fortress with an area of approximately 702 square meters (26.4 m by 26.6 m). The

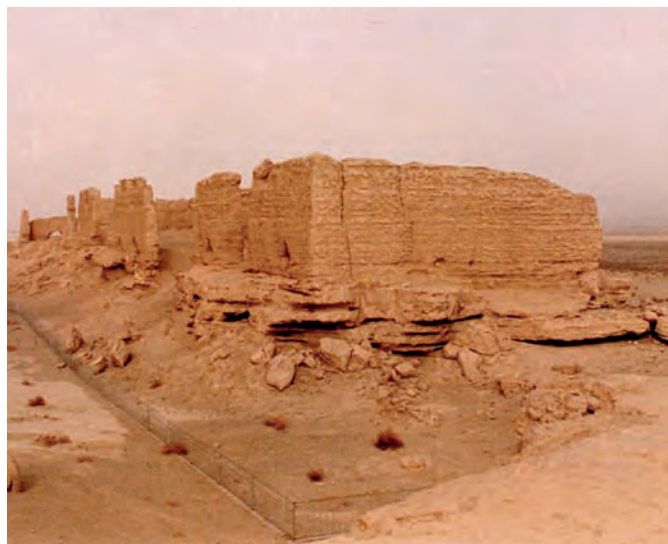
FIGURE 3 Condition of the Hecang Fortress before consolidation.

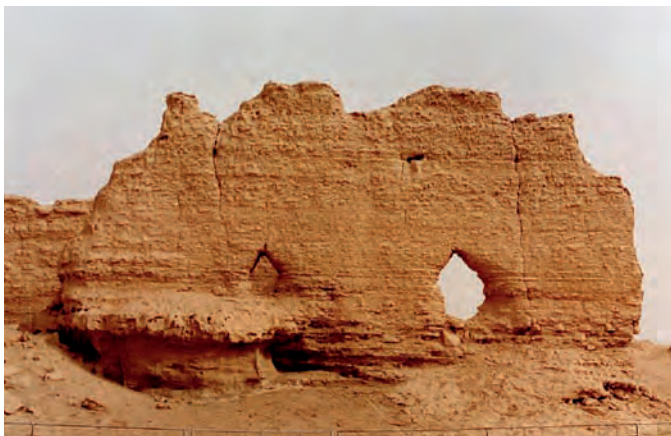
FIGURE 6 Hecang Fortress before consolidation.

Potassium silicate was the primary material for reinforcing the walls and foundations of the Hecang Fortress. After the softened areas were cleaned, three PS solutions of varying concentrations were sprayed on them at intervals of a week to ensure complete infiltration: 2 to 3 percent solution the first time, 5 percent solution the second time, and 7 percent solution the third time. Ten percent PS solution with added earth was applied to the softer and more porous

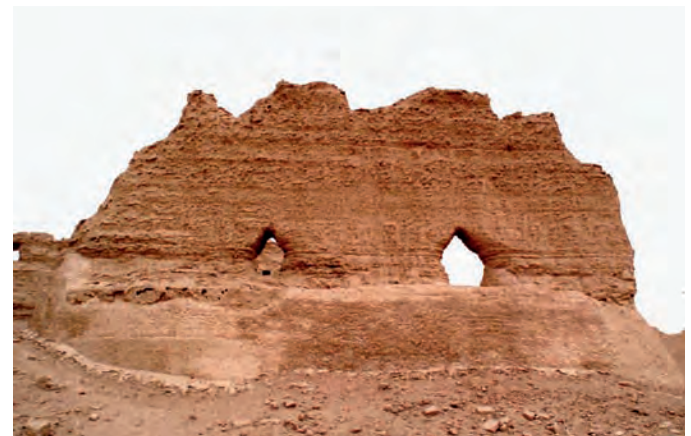
FIGURE 7 Hecang Fortress after consolidation.

areas to cement large grains of clay. Finally, mud from local earth was used to restore the original look.

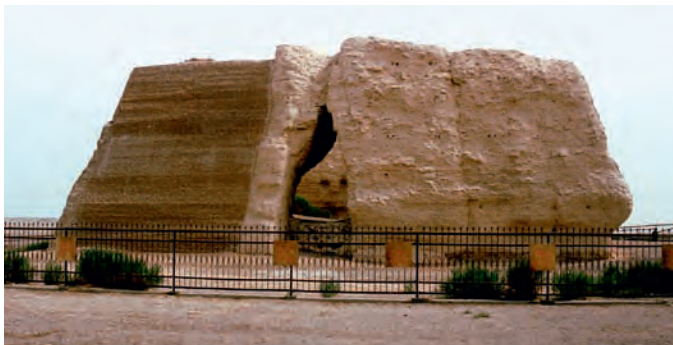
FIGURE 10 Reinforced outer section of the northern wall.

East Wall of the Yumen Pass. A brick wall foundation (25 m long, 0.5 m wide, and 40 cm deep) was laid along the footing of the reinforcing wall built in the 1980s to prevent the wall from sliding. The original wall was consolidated with PS solution. Along the original wall, a

40~500-centimeter-wide reinforcing wall was built to buttress the original wall.

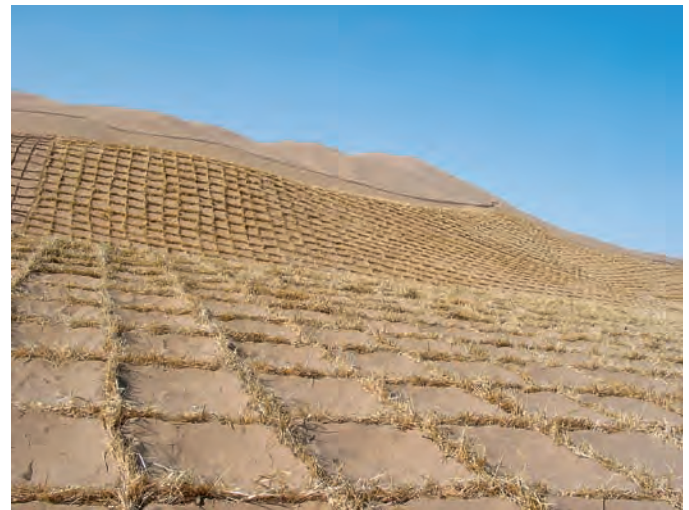
FIGURE 2 Half-buried straw checkerboard barriers.

The shifting sand is located in an area of small dunes and flat sand sheets at the front edge of the Mingsha megadune. A windbreak fence of open-knit nylon and half-buried straw checkerboard barriers (fig. 2) are the control measures here. The main function of the straw barriers planted in the sand in a square checkerboard grid is to stabilize the shift-

ing sand by changing the roughness of the surface. This decreases the impact threshold velocity, hence the rate of sand transport, and transport from the sand dune field is reduced. This also creates suitable conditions for growth of vegetation. The friction as a result of the straw checkerboard barriers in the areas of shifting sand and small dunes increases thirty to forty times, and the roughness of the surface also greatly increases.

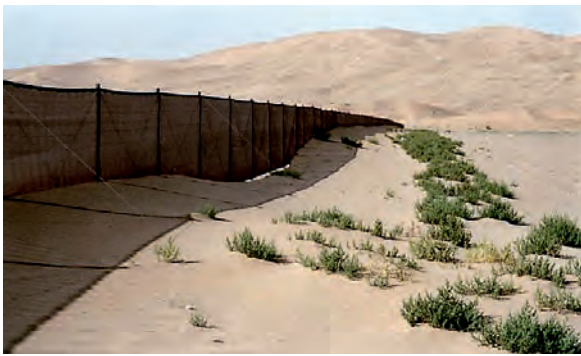
FIGURE 4 Sand accumulation around the wind fence.

total volume of 23,000 cubic meters of sand accumulated around the fences. Sand accumulation on the AC segment accounted for 13,000 cubic meters, which shows that the northwest direction is the main source under the control of the westerly winds. Sand accumulation on the AB segment to the southwest accounted for 5,400 cubic meters, which shows that the southwest is another sand source. Sand accumulations on the DE and FG segments were 3,600 and 1,700 cubic meters, respectively, showing sand mainly originating in situ.

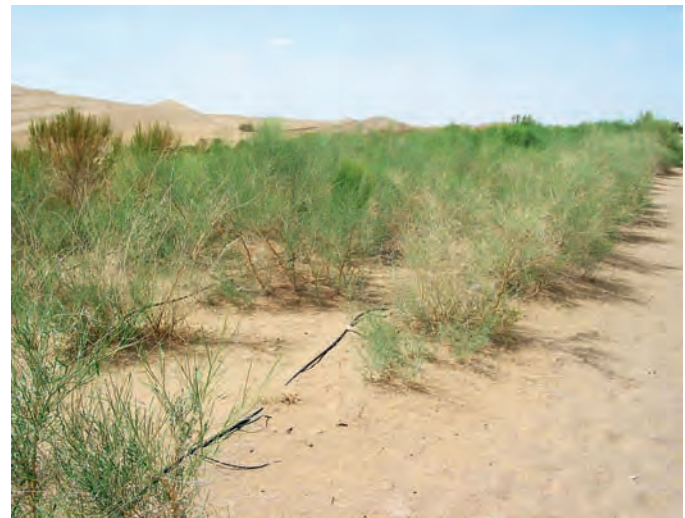
FIGURE 6 Vegetation wind fence and drip irrigation.

Figure 6 shows the vegetation windbreak on the plateau, in front of the Mingsha megadune. The airflow pattern near the shrub zone, which is 1.5 meters in average height and 50 percent permeation through the shrubs, is similar to that at the nylon wind fence, which has similar height and weave density. Based on the energy distribution, the flow pattern can be described as decelerating wind velocity that occurs before the shrub zone, decreasing speed in the shrub zone, recovering speed coming out of the shrub zone, and accelerating velocity that occurs far beyond the shrub zone. The shrub zone can obviously reduce wind speed, and a double line of shrub zones can reduce wind speed significantly. Wind speed downwind, at a distance of about twenty to thirty times the

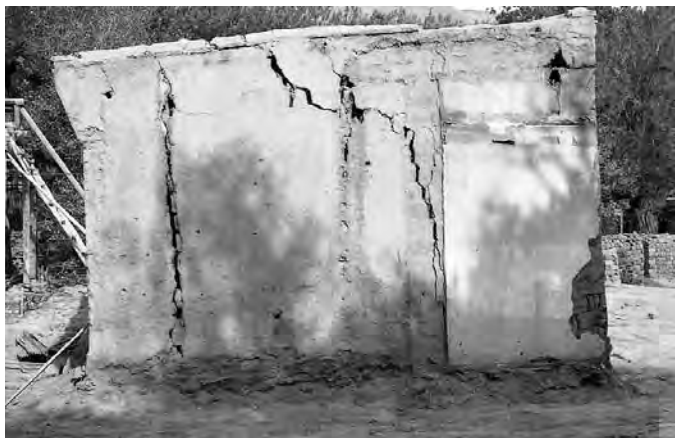
FIGURE 1 Deteriorated north wall of a building in the Upper Temple before restoration.

abandoned temples were seriously damaged by weathering, and parts of the temples collapsed. Branches of the old elms also endangered the roofs. Leaking water rotted the wooden supports under the roofs. Piles of rubbish that had accumulated at the foot of the buildings over the years led to rotting of the column bases. The mud plaster fell from the walls, exposing the mud bricks and subjecting the walls to salt efflorescence and cracking.

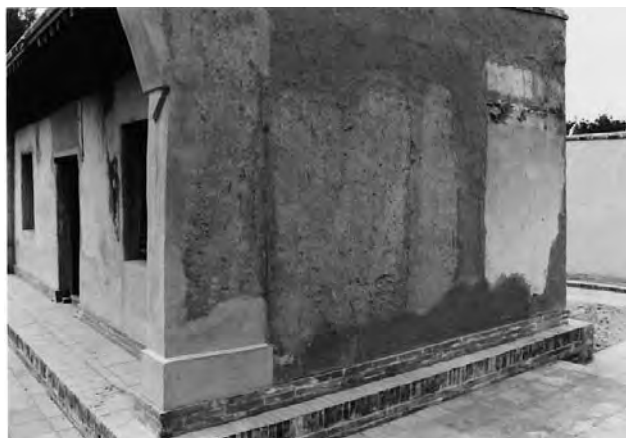
FIGURE 2 The north wall shown in figure 1 after restoration.

The deteriorated temples were eyesores, and their significance and conservation needs attracted the interest of colleagues from the Getty Conservation Institute and the Australia Heritage Commission. Experts from both institutions visited the temples in 2000 and proposed a treatment plan based on the China Principles (Agnew and Demas 2004) to stabilize the buildings and restore them to their original appearance (fig. 2).

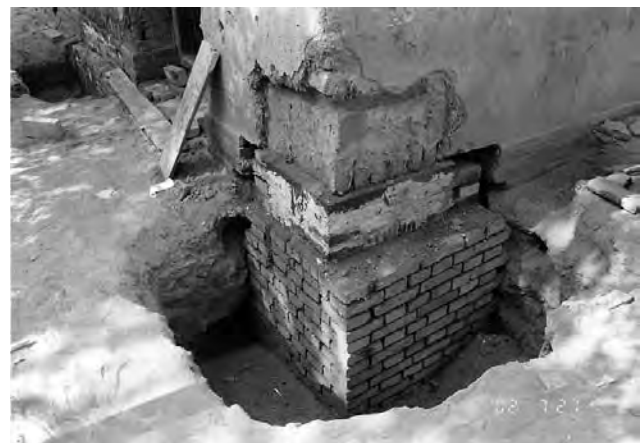
FIGURE 3 Wall stabilization with a brick footing.

Replacement of a Wall Foundation. Wooden boards and frames were used to support damaged walls before the deteriorated lower parts were undercut. The extent of cutting was based on the degree of deterioration. Wooden boards were used at the upper part of the cutting to support and stabilize the upper walls. During this procedure a trench about 1.5 meters long, 1.5 meters deep, and 1 meter wide was dug along the wall base. After the old footing was removed, the base of the trench was compacted. Then concrete was poured to form a foundation, after which a new footing of red brick was built. When the new footing reached ground level, a wall base was made of lime mortar and gray bricks (on the inner side of the wall there was one course and on the outer side three courses). Above the new base, mud plaster mixed with straw and adobe bricks that had been soaked in potassium silicate solution for added strength and durability were used to build up the base until it almost reached the bottom of the original wall, leaving a gap of about 1 centimeter. Then a 1:1 ratio of cement and clay mixture was used to fill the gap tightly. After the replacement was complete, the wall was plastered with a mixture of mud and straw, according to the original materials and technique used (fig. 3).

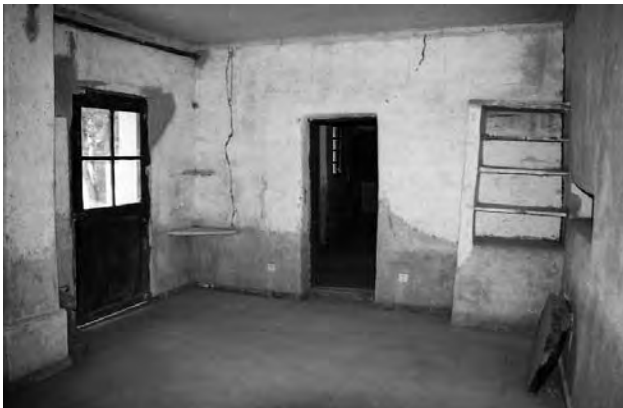
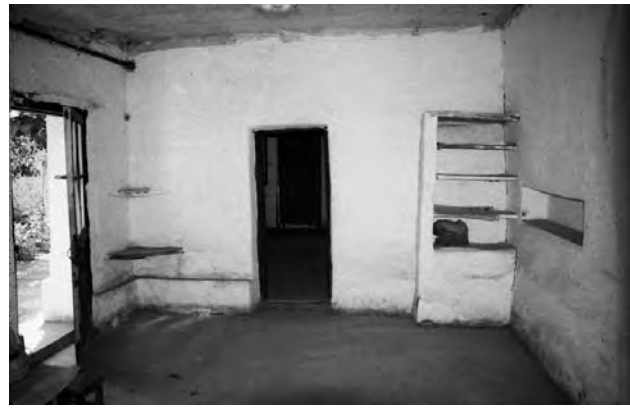
FIGURE 4 Chang Shuhong's residence before restoration.

FIGURE 5 Chang Shuhong's residence in the 1940s, after the removal of nonoriginal interventions.

Restoring building No. 20, a wing house in the north of the backyard of the Middle Temple, was a key task since it had been the residence of Chang Shuhong, first director of the institute. This restoration was left to a later stage of the project. Other than repairing the earthen *kang* (heated bed), bookcase, and bookshelf (both also earthen), little else was done so that the hardships experienced during those early

times could be preserved as witness to the early history of the Dunhuang Academy. Thus we achieved the aim of “restoring the relics to their original appearance” (figs. 4, 5).

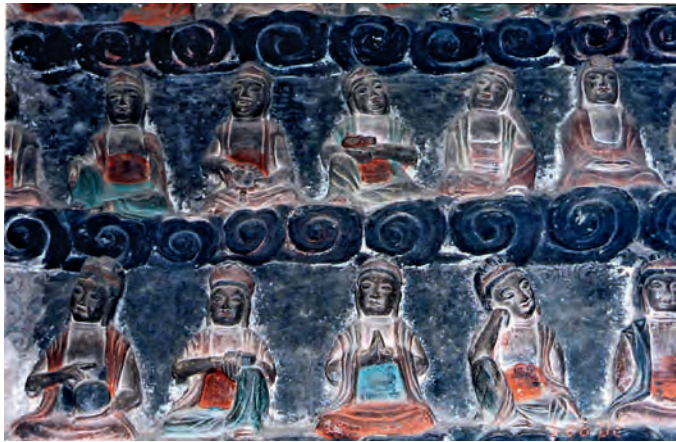
FIGURE 2 Painted figures blackened by deterioration.

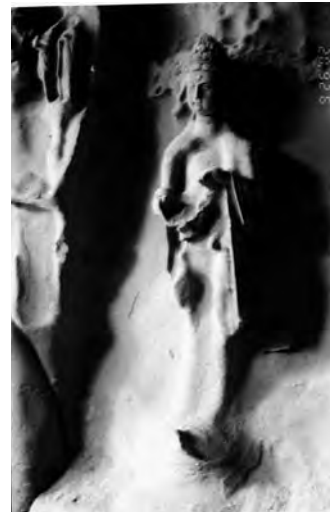
FIGURE 3 Figure eroded by soluble salt and water.

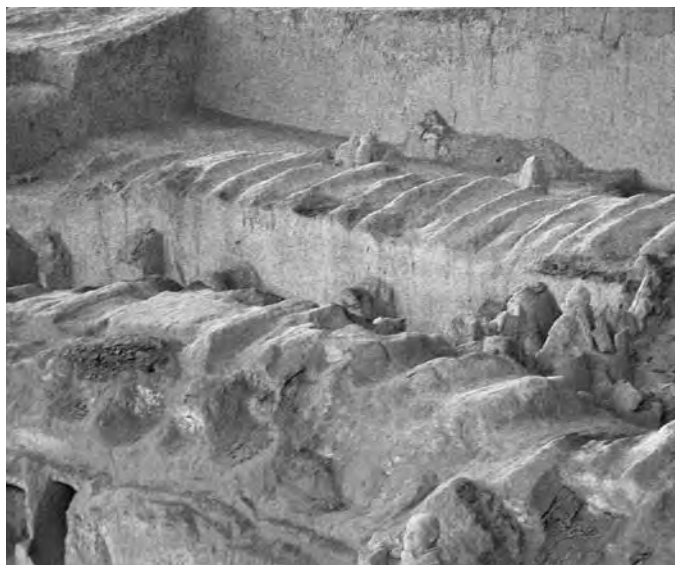
FIGURE 1 Consolidation of the dividing wall in pit 1 of the Terracotta Warriors. The front wall is untreated; the rear wall is treated.

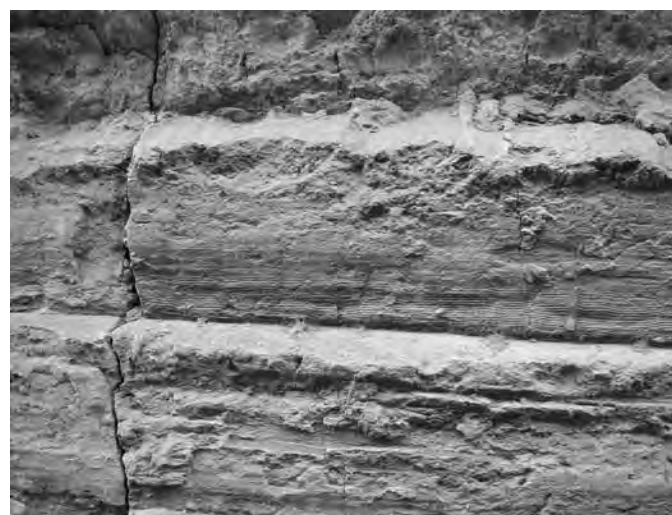
FIGURE 2 Consolidation of the wall of the Yang Mausoleum. The left side is untreated; the right side is treated.
