Conservation of Ancient Sites on the Silk Road

Proceedings of the Second International
Conference on the Conservation of Grotto Sites,
Mogao Grottoes, Dunhuang, People's Republic of
China, June 28–July 3, 2004

Edited by Neville Agnew

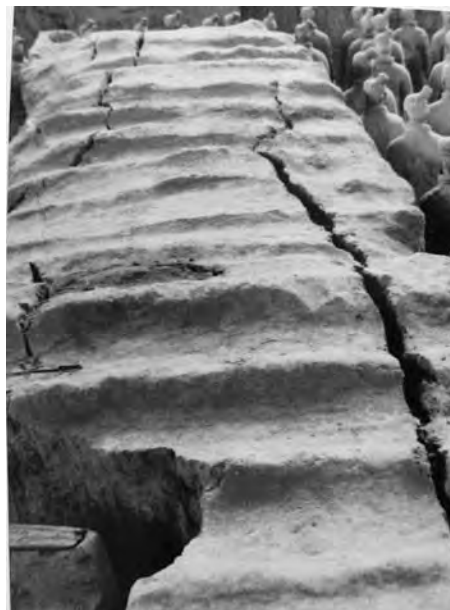
FIGURE 1 Ten-centimeter-wide cracks on the earthen partition wall in pit 1.

In 1988 some parts of a dividing wall were about to collapse. U- and H-shaped steel was used to stabilize ten areas of fissuring (figs. 2, 3). The steel was treated with anticorrosion material, and after installation the supports were further treated to blend visually with the earth.

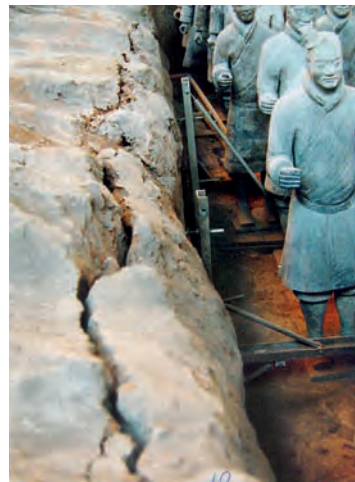
FIGURE 2 U-shaped bracket for reinforcing the earthen partition wall.

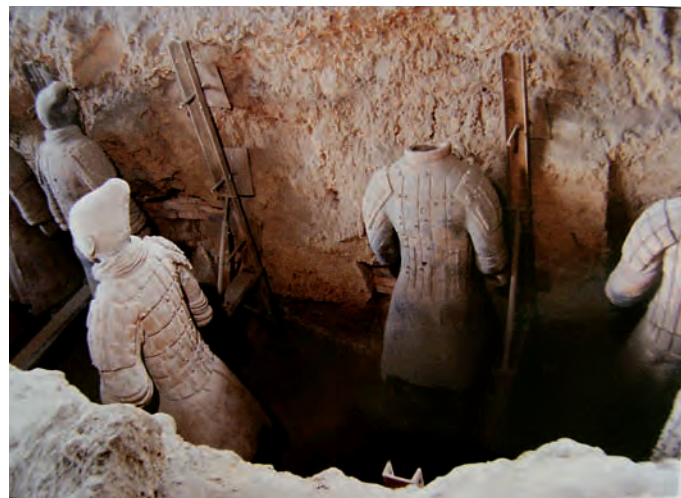
FIGURE 3 H-shaped bracket for reinforcing the earthen partition wall.

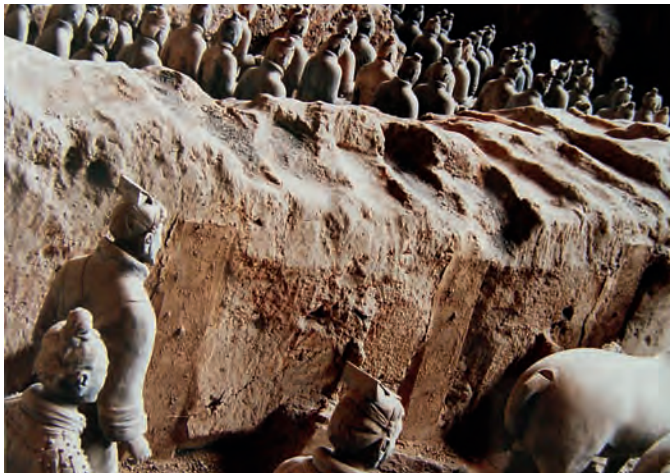
FIGURE 4 Steel plates for reinforcing the earthen partition wall.

FIGURE 5 Condition of the earthen partition wall after use of steel plates for reinforcing. The imprint of steel plates can be seen on the wall.

In 1991 an additional measure was taken to stabilize the walls. Steel plates on both sides of a wall were secured with a steel bar through the wall and anchored into the ground with cement (fig. 4). Cracks were filled with earth to improve the visual effect (fig. 5). The method was used in parts of pits 1 and 3 instead of the U- and H-shaped steel supports.

method for consolidating the dividing walls, especially when cracks occur on both sides of a wall. But it has drawbacks. Boring through the wall often damages its other side because of the pressure exerted. It is also difficult to drill holes from both sides that will meet each other, since the walls are thick. In addition, securing the system to the ground with cement bricks requires the removal of the original floor bricks.

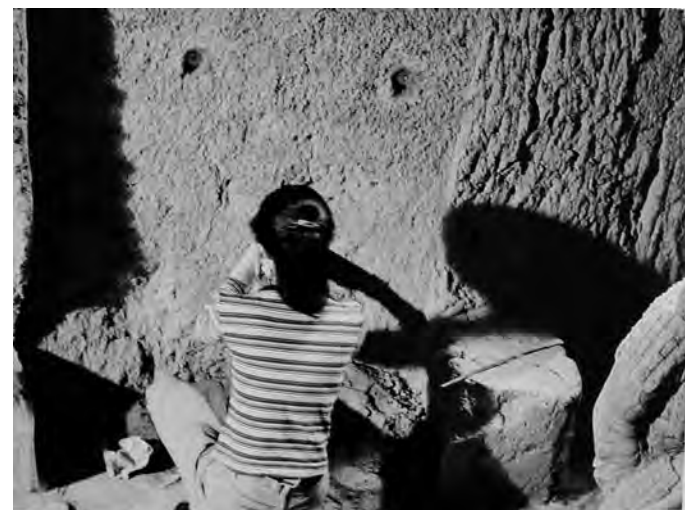
FIGURE 6 Reinforcing with the anchor bolts and grouting method.

Anchor bolts with sand and lime proved most satisfactory. The technique has the advantages of high efficiency, excellent appearance, low cost, and reliability, and it can be used in dry and wet situations. **Compared to the other stabilization methods, in general, it is the best way to conserve the Terracotta Army pits.**

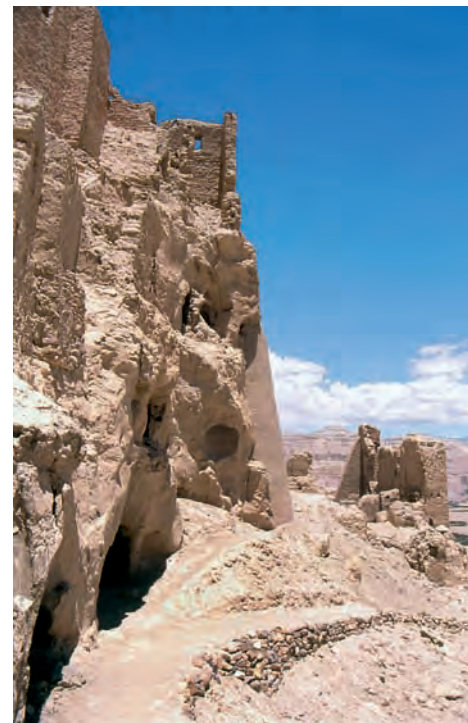
FIGURE 3 Cracking and threatened collapse of earthen architecture.

The main problems at the site relate to water: erosion, cracked and leaning walls, collapsed roofs, and deterioration of walls and indeed of the entire topography required emergency consideration (fig. 3). This paper does not deal with the grottoes and their paintings. It can be noted, however, that extensive damage arising from the loading of buildings above the grottoes with deformation of the cave walls occurred. In many cases, stagnant water accumulated in the decorated caves. In some cases accumulation of soil due to collapsed entrances tended to direct water into the cave interior.

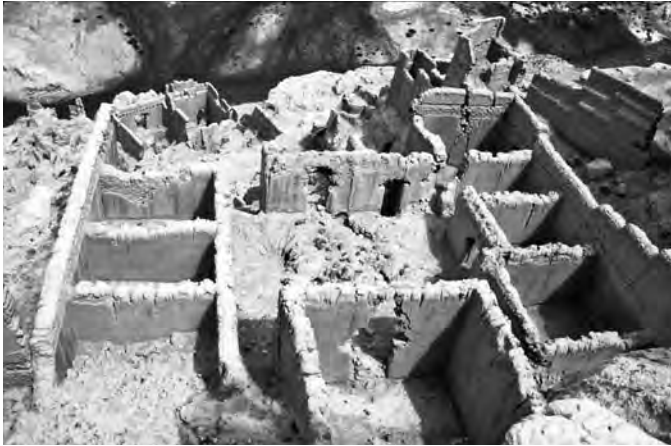
FIGURE 4 Building foundations and the mountainside eroded by rainwater.

The walls that remain standing on the site of the Guge castle are uniquely picturesque and embody the history and evolution of the castle complex (fig. 4). Therefore, maintaining the ruins in their present condition was important. Eliminating all causes of damage was unrealistic. We worked out a practical conservation plan that emphasized reinforcing at-risk sections and improving stability of especially important parts of the ruins. Repair and reinstatement of the drainage system to reduce the effects of water were key interventions. The final goal of the conservation project was to minimize deterioration and preserve the ruins as a whole.

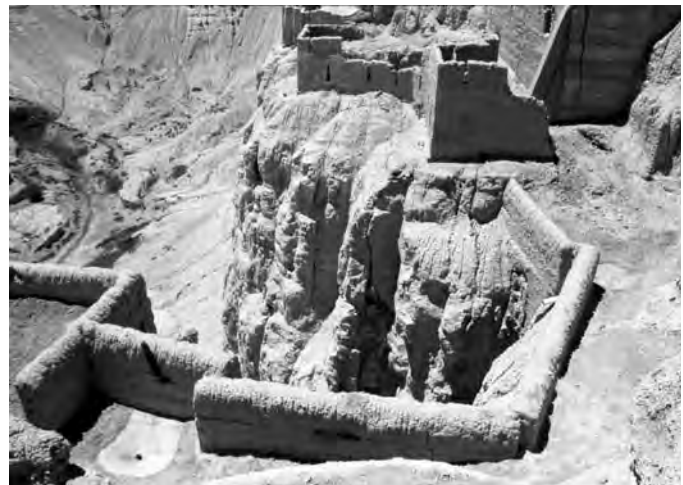
FIGURE 5 Drainage system.

- Large flat areas were paved and drained.
 - Pipes were added to the site to remove water.
3. Roofs: New roofs in the Tibetan style were added to extant buildings to prevent rainfall from affecting wall paintings and entering lower caves. The appearance of these roofs is consistent with the site's setting. Damaged roofs were restored in accordance with evidence discovered from investigation or archaeological work (fig. 6).

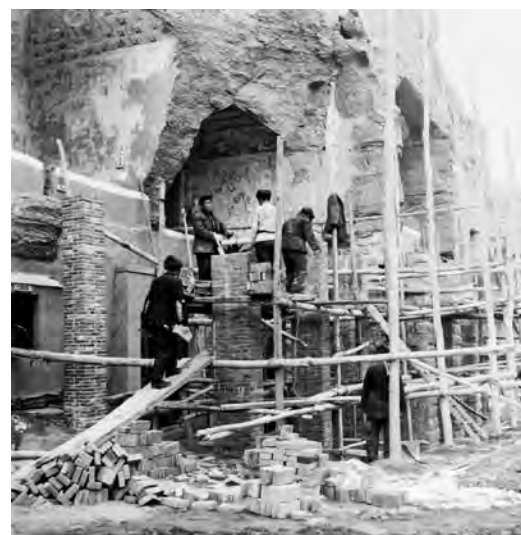
FIGURE 3 Cave 85 during construction of facade and walkways (1957–58). Pillars were built in front of the cave to support a wooden walkway and provide support to the fronts of caves 242 and 243.

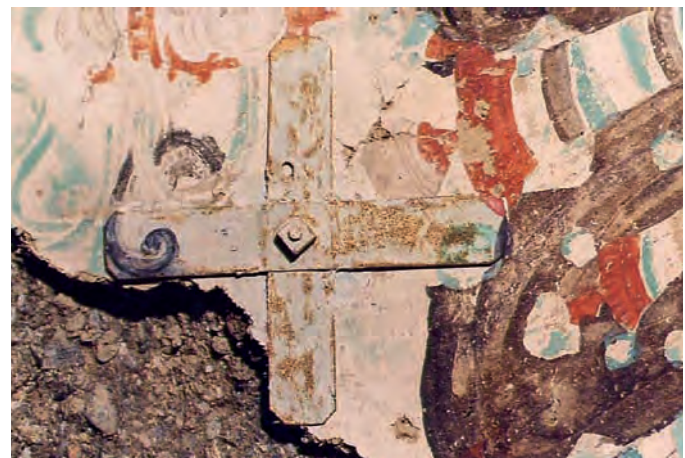
FIGURE 5 Example of the steel anchors used to secure areas of detached painted plaster in cave 85. The anchor was painted to match the decoration of the original painting.

ment as they sometimes caused cracking in the earthen plaster when inserted and they created stress in the painting around the anchor.

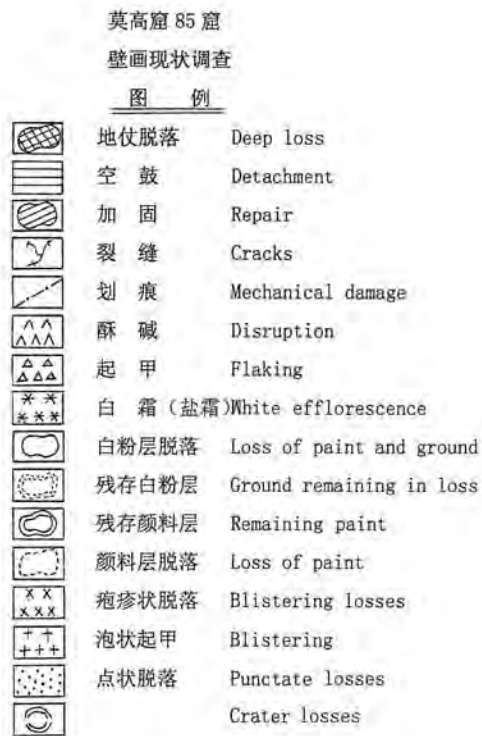
FIGURE 7 The graphic documentation key.

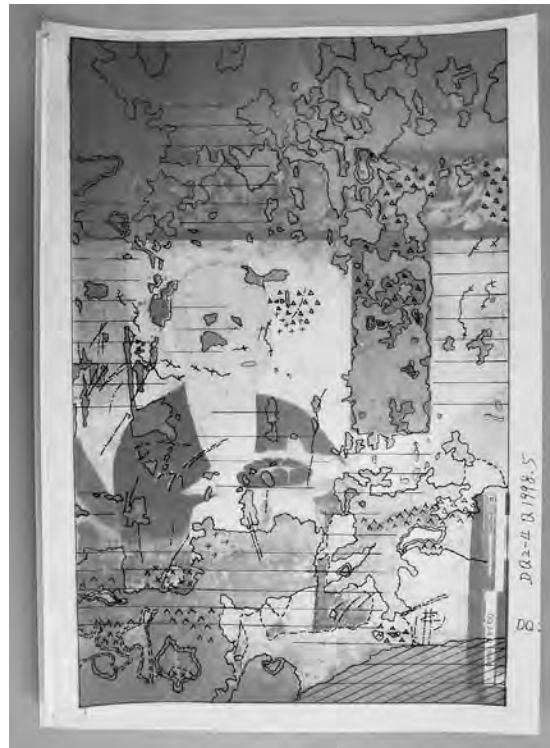
FIGURE 8 Example of the manual graphic documentation carried out using overlays on photographs.

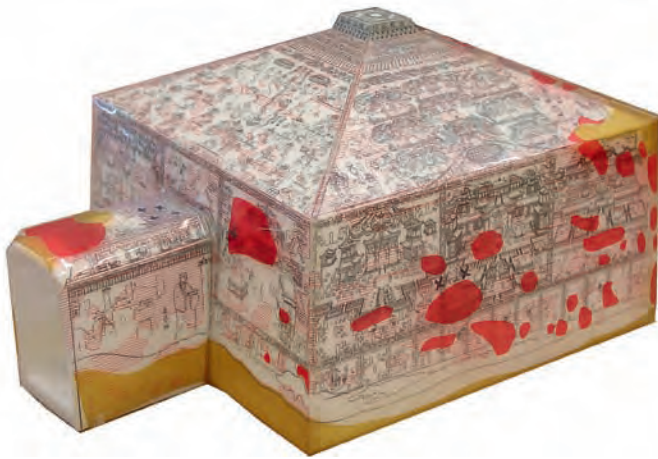
FIGURE 9 Scale model (1:35) of cave 85 with condition overlaid to show the distribution of deterioration.

Both in-depth and surface conditions showed a similar distribution pattern throughout the cave on a southeast to northwest axis (on both walls and ceiling slopes), increasing in severity toward the northwest end of the cave and most severe at the upper northwest corner of the cave. In contrast, the east end had noticeably less plaster detachment (with the exception of a large area on the north side of the east wall)

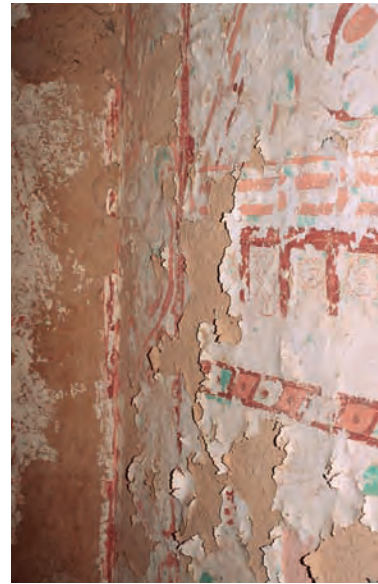
FIGURE 10 Area of severe exfoliation of the wall paintings in the northwest corner of cave 85.

- Surface or subsurface deterioration (i.e., of paint, ground, and upper plaster layers), which includes blistering and flaking of the paint and/or ground layers, combined lifting of the paint, ground, and upper plaster layers (exfoliation; fig. 10), and surface salt-related deterioration such as disruption, punctate losses, and crater eruptions.

Among these conditions, plaster detachment from the rock and a combination of surface conditions, which include primarily flaking and exfoliation and powdering of the paint layer, were the most serious, resulting in ongoing and visible loss of the painting.

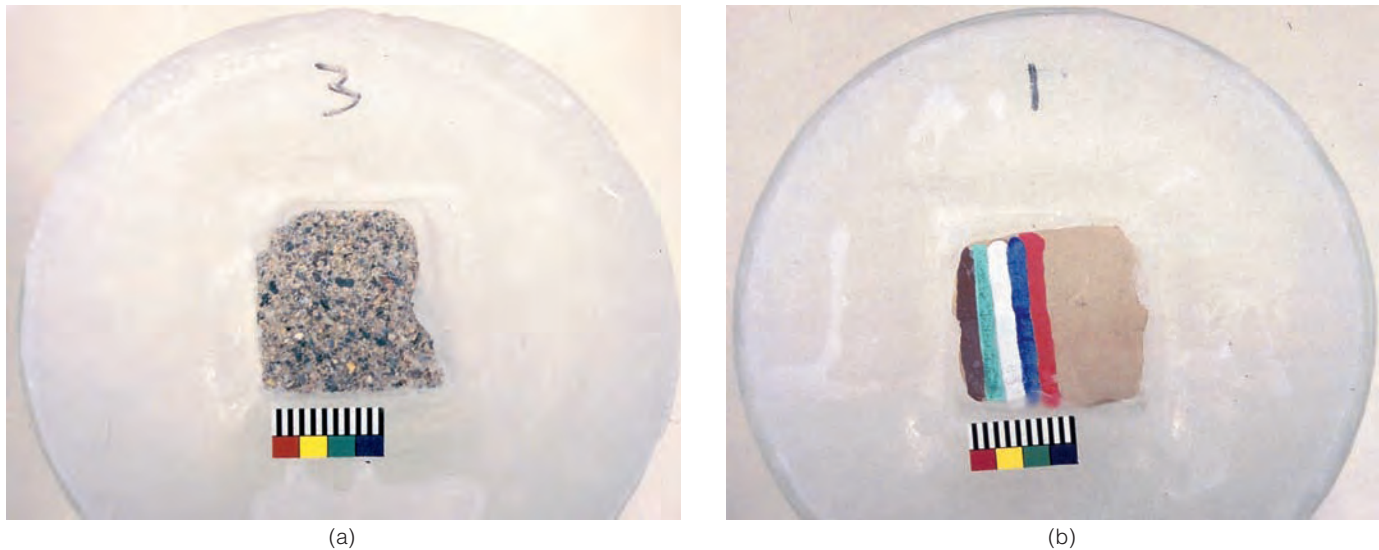
FIGURE 6 Sodium chloride migration experiments. (a) Conglomerate; (b) conglomerate with a layer of clay plaster, half of upper surface painted with pigments found at Mogao.

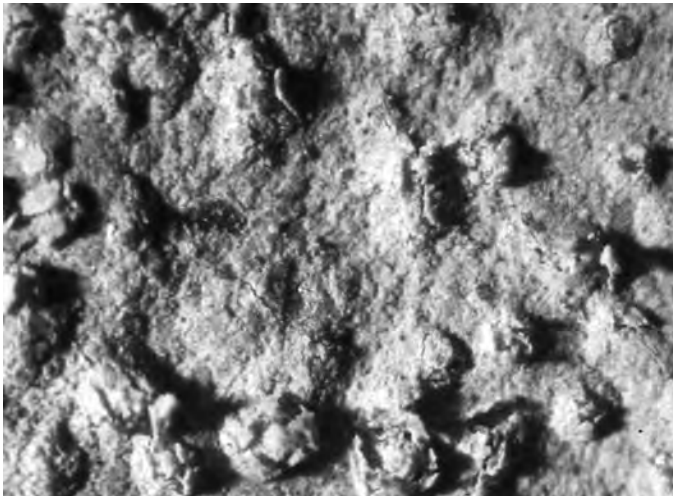
FIGURE 8 Salt eruption on the unpainted clay plaster.

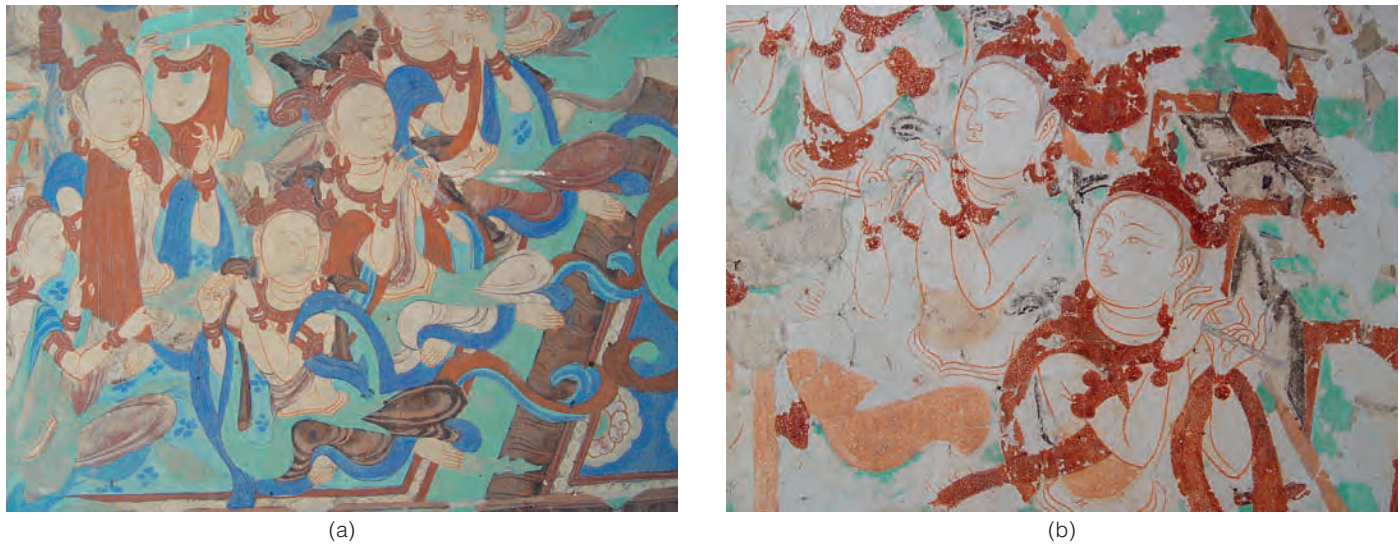
FIGURE 3 Details of similar scenes taken from the east and west ends of the south wall illustrating the difference in condition: (a) the paintings at the east, toward the front of the cave, are in near-pristine condition; (b) at the west, toward the back of the cave, they are in poor condition (loss of paint layer and color change).

Paint exfoliation and plaster detachment cause loss of painting on a large scale and therefore are the most severe problems that require intervention. Areas of detachment and exfoliation increase in severity toward the rear, northwest end of the cave, where large losses and anchors indicate a history of problems. Areas of detached plaster are prone to fall under gravity alone, or they are precipitated by seismic shock (Dunhuang is a seismic area) or extended periods of high humidity when hygroscopic salts have absorbed water, causing a weight increase of the plaster.

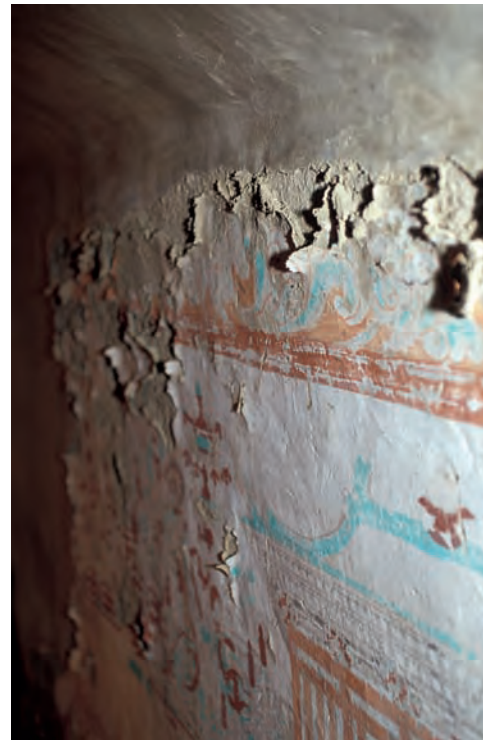
- *Exfoliation:* lifting of paint, ground, and upper plaster layers (fig. 4). This seems to be associated with previous treatments (in the 1970s) for flaking in which polyvinyl acetate and polyvinyl alcohol fixatives were used. Over time, these treatments failed and the conditions returned in most areas.

FIGURE 4 Exfoliation, the lifting of paint, ground, and upper plaster layers, apparently exacerbated by treatments for flaking (in the 1970s) using polyvinyl acetate and polyvinyl alcohol fixatives. The continued loss of painting indicates that this problem is ongoing, most notably at the northwest end of the cave.

The loss of paint, apparent by comparison of current condition and historic photographs, shows that this problem is ongoing, most notably at the northwest end of the cave.

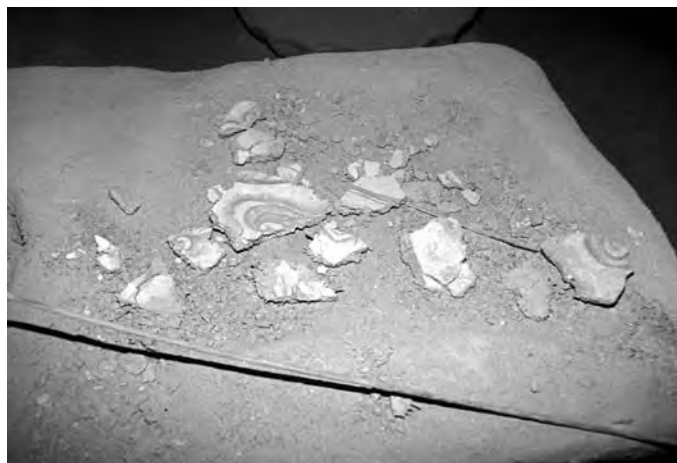
FIGURE 5 Detachment, followed eventually by collapse, is a widespread problem. Here, fragments of painted plaster lost from the west slope in 1996 near an anchor installed in the 1970s. Credit: J. Paul Getty Trust

- *Detachment*: loss of adhesion between earthen plaster and conglomerate rock body. This condition has been a long-term problem and is pervasive at the site. In the 1970s pinning with cross-bracing was used to hold the plaster in place in cave 85. However, this did not address the problem, and it was only a temporary solution. In 1996 a large piece of painted plaster fell from the west slope of the cave during a period of heavy rain (fig. 5). The loss occurred near a metal anchor used to treat the detachment problem thirty years ago.

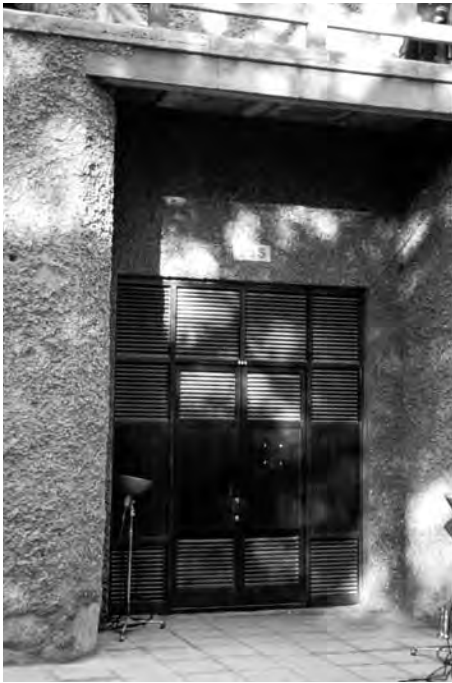
FIGURE 7 Exterior of cave 85 with door closed. A management decision was made to control relative humidity by keeping the cave closed during periods of rain when ambient relative humidity can rise to 75 to 80 percent.

cave doors closed and better sealed during periods of high humidity and rain (fig. 7). This form of passive conservation climate control has been successfully applied to historic buildings (Bläuer Böhm et al. 2001).

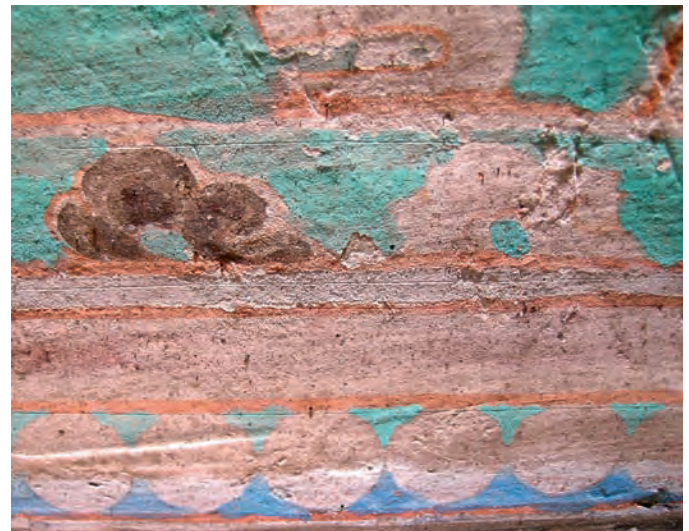
FIGURE 1 Fine straight-edge incisions in the ground layer provide guides for the painted design on the ceiling caisson. Photo: Rickerby/Shekede 2004

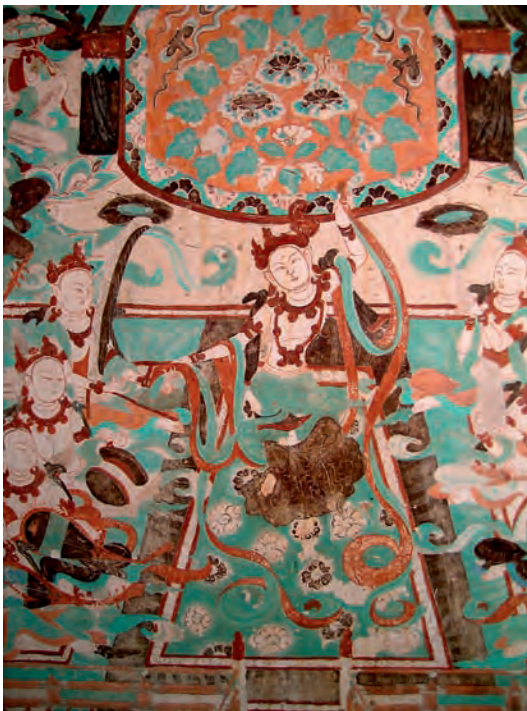
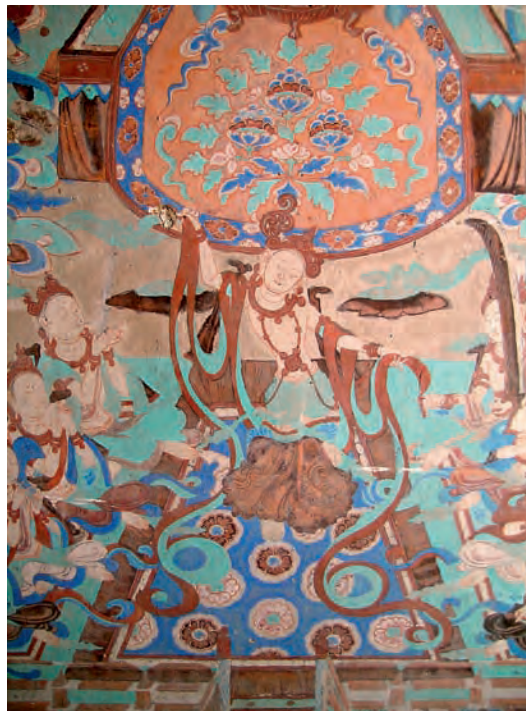
FIGURES 2 AND 3 Pigment alteration and degradation of organic components is far more severe to the west and north of the cave, clearly demonstrated by comparing a scene on the north wall (left) with a similar scene on the less affected south wall (right). Photos: Rickerby/Shekede 2004

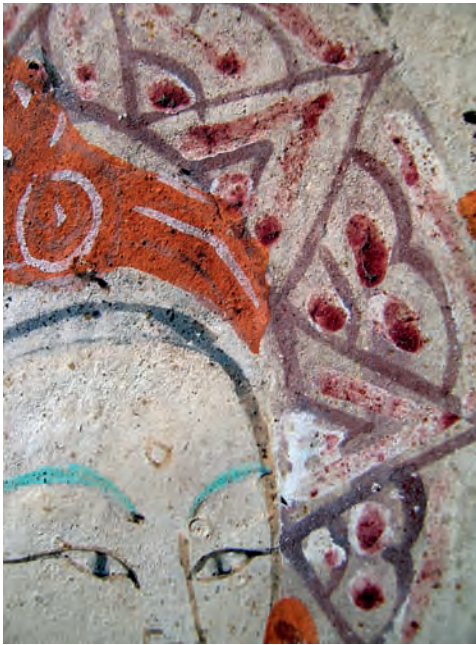
FIGURE 5 The rich purple-red organic glaze on a decorated halo survives at the east end of the south wall, but few traces have survived toward the west end of the cave due to light exposure and other environmental factors. Photo: Rickerby/Shekede 2004

Traces of colored organic glazes are virtually absent at the western end of the cave, whereas at the eastern end—which has suffered less from salts-related deterioration and light exposure—the original scheme is much better preserved. The most evident organic colorant is a rich, dark purplish red (fig. 5). A variety of effects were achieved by glazing over different opaque layers: over white, it produces a vivid light plum color; over black, a deep, rich, wine red results; mixed with yellow and applied over black, it gives an orange-red; applied over vermilion, it produces a deep, rich pink. The intent behind other applications is much less readily interpreted. For example, an organic red applied to modulate flesh tones is visible only as saturated, darkened patches on cheeks, necks, fingers, and abdomens, in some places so deteriorated that it can be seen only

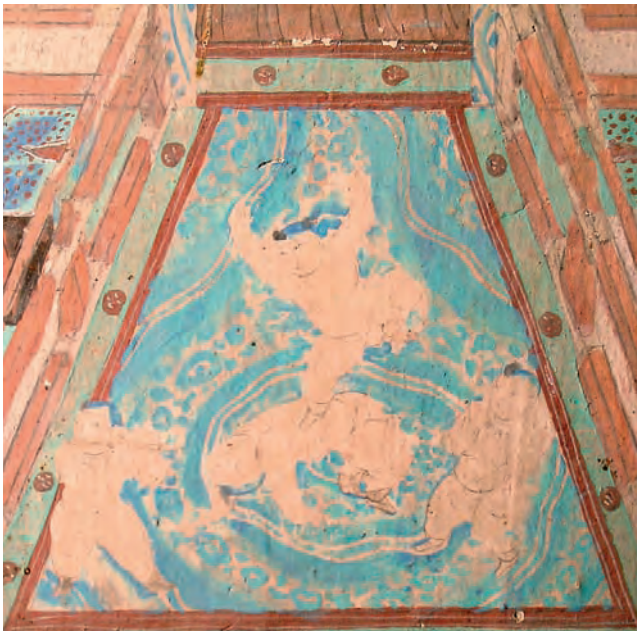
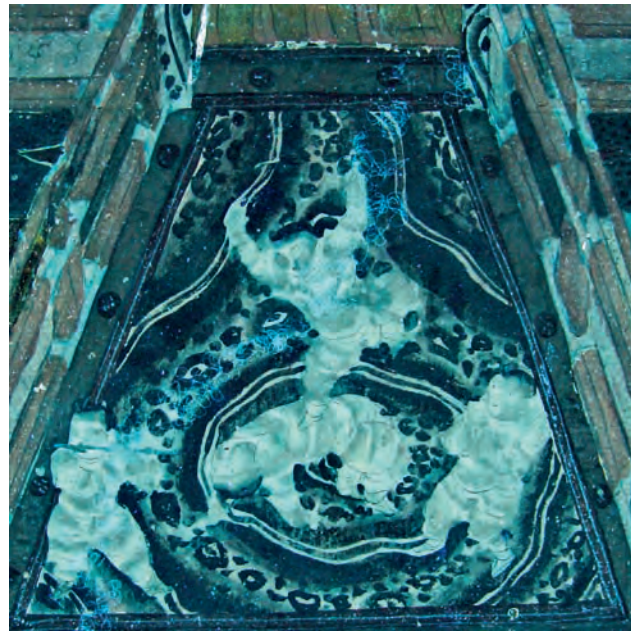
FIGURES 6 AND 7 The rosy flesh tones of these chubby boy acrobats, no longer visible in normal light (left), seem to have been achieved using organic glazes, but these can now be seen only in UV-induced fluorescence (right). Photos: GCI 2004

in UV-induced fluorescence (figs. 6, 7).⁸ Problems in the detection and analysis of many of these fragile materials ensure that their nature and purpose will continue to remain elusive.

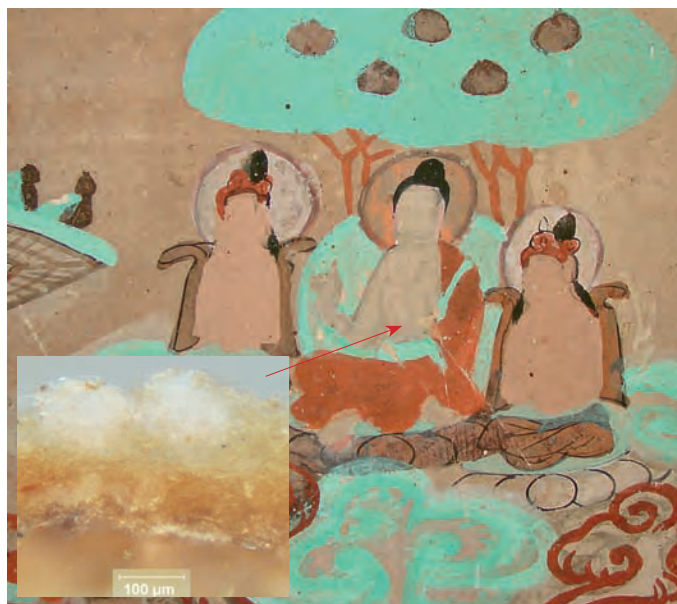
FIGURE 4 Figure on the east wall with a blached flesh tone (sample F03S20); and darkfield photomicrograph of a paint cross section (inset).

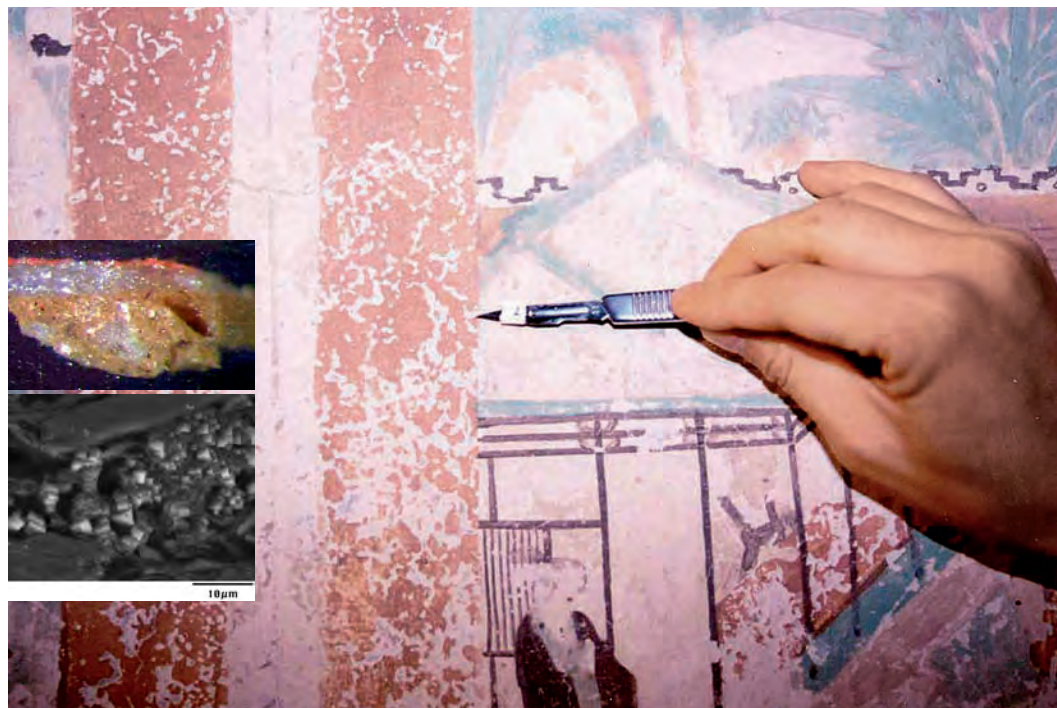
FIGURE 7 Punctate eruption of sodium chloride crystals between the red paint and ground layers in sample 85NQ98PE2. (a) Darkfield photomicrograph of paint cross section; (b) ESEM enlargement showing cubic crystals of sodium chloride.

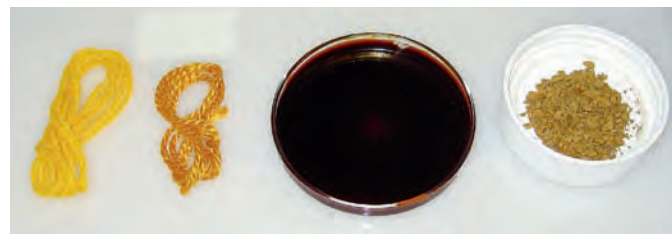
FIGURE 2 Series of AOC reference samples prepared from *Gardenia augusta* L. From left to right: dyed wool, dyed silk, cake and pigment.

Bulk reference samples were prepared from each biological source, using historical recipes when available (fig. 2). When

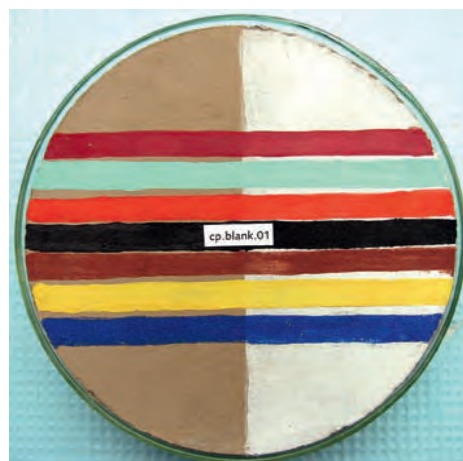
FIGURE 3 (a) Blank painted plaster coupon as received from the Dunhuang Academy. (b) Coupon with *Gardenia augusta* pigment paints in gum and animal glue applied.

One hundred forty painted plaster coupons, 15 centimeters in diameter, replicating the stratigraphy of the Mogao wall paintings were prepared by the Dunhuang Academy using clay and other materials available at Mogao. Each coupon has a traditional ground layer applied to half of its surface, overlaid with seven stripes of common inorganic paints used in the grottoes (fig. 3a). Organic paints prepared with the reference pigments were applied on the painted plaster cou-

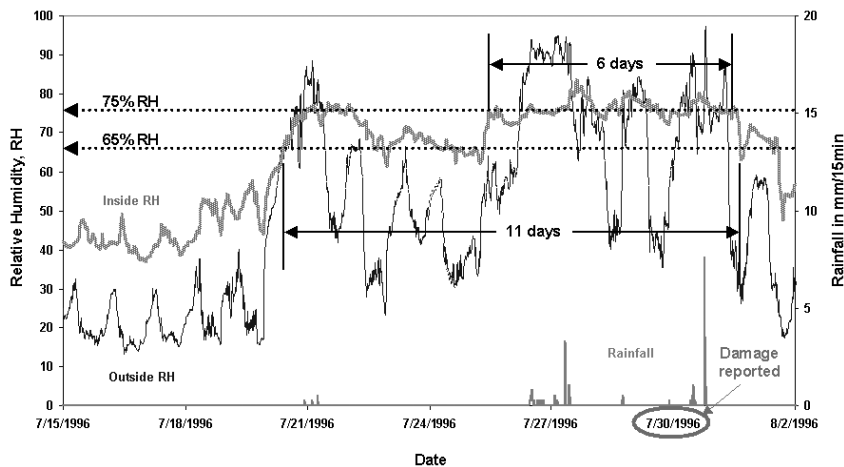
FIGURE 8 Combined plot of the rainfall, relative humidity of outside air, and relative humidity in cave 85 between July 15 and August 2, 1996. Bars extending from the baseline indicate the measured amount of rainfall for fifteen-minute periods. The Dunhuang Academy reported damage to the wall paintings in the cave on July 30.

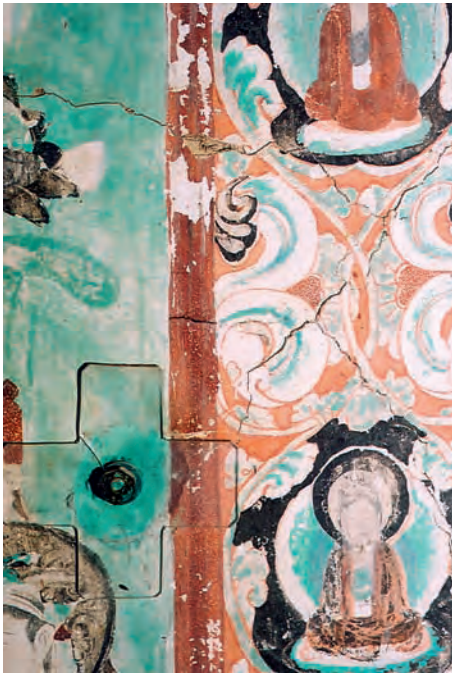
FIGURE 1 Previous attempts to address the problem of plaster separation in cave 85 have included pinning with rods and anchors. These have tended to concentrate stresses on already weakened plaster layers, leading to further damage and loss. Photo: Stephen Rickerby

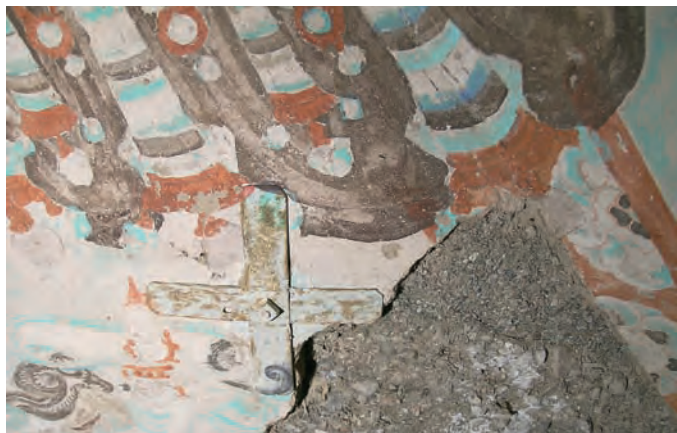
FIGURE 1 Detail of cave 85 showing where painted earthen plaster has separated and fallen away from the underlying conglomerate rock. A metal cross-brace was bolted into the rock by Dunhuang Academy conservators before the collapse but failed to prevent it. Photo: S. Rickerby

bulging, as was the case in cave 85. On the west wall, the part of the cave most affected, approximately 70 percent of the 57 square meters of plaster was separated from the rock. Huge risks were posed by the typically large size of individual areas of plaster separation, some extending over 1 to 2 square meters, with a gap between the plaster and the rock of up to 4 centimeters (fig. 1). The diverse painting materials of cave 85—the preparatory ground, pigments, organic colorants, and glazes—are also all extremely water-sensitive and in some cases water-soluble.

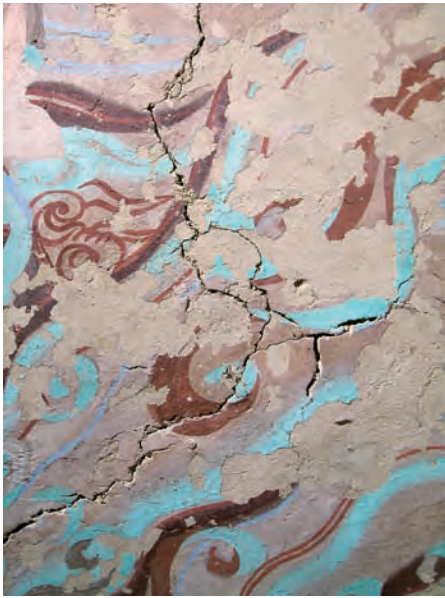
FIGURE 2 Cracks in the painted earthen plaster in cave 85. Photo: S. Rickerby

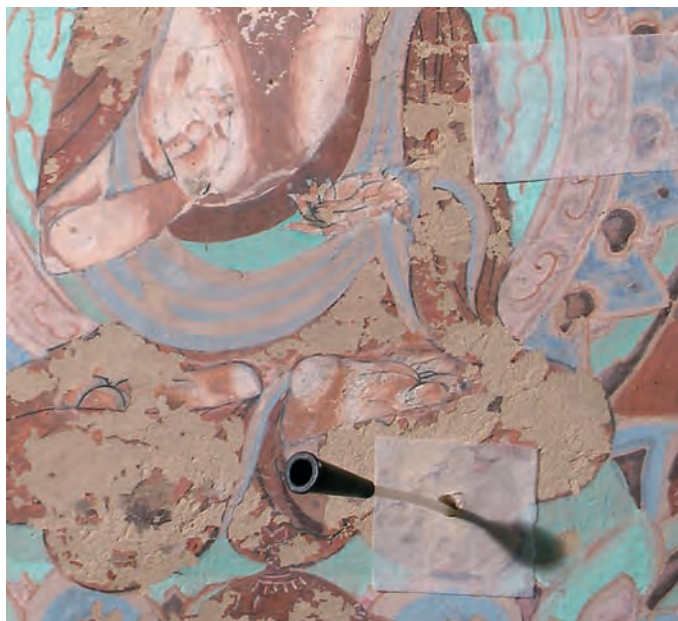
FIGURE 3 A grout catheter placed in an insertion point that has been stabilized with a temporary facing. Photo: S. Rickerby

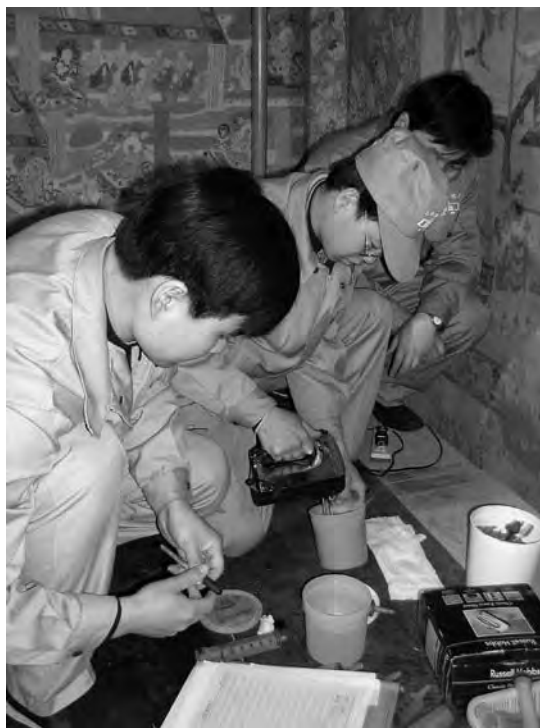
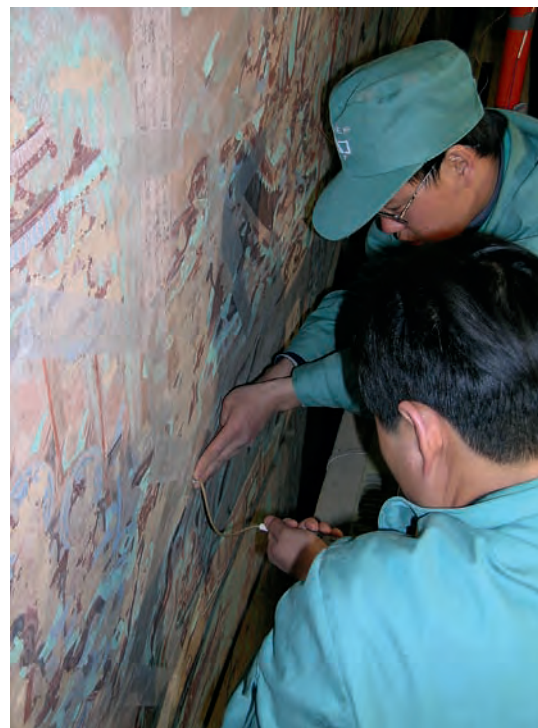
FIGURE 4 Grouting was a team exercise. Dunhuang Academy conservators (a) prepare grout and syringes and (b) deliver grout while supporting the treated area. Photos: S. Rickerby

Because of the risks, caution and restraint were essential. Usually four conservators were involved in the grouting of a single area: two preparing the grout and syringes, one delivering the grout, and the other manually checking and supporting the plaster (fig. 4). Since grouting is a team exercise, effective communication was key. Oversight was maintained by compiling treatment logs detailing the amount of injected grout and the quantities of added water required to fluidize the basic grout mixture in response to differing grouting situations.

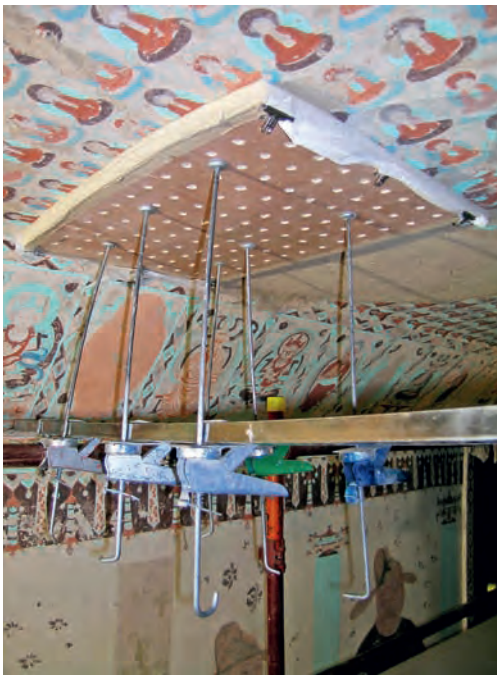
FIGURE 5 A customized press placed against treated plaster for support and to absorb moisture released from the grout. Photo: S. Rickerby

To absorb and contain moisture released from the grout, carrying with it dissolved salts from the original plaster and rock, absorbent tissue layers were incorporated into the presses that were placed against the treated plaster (fig. 5).⁶ This absorbent system was selected after extensive testing. Its efficacy in practice was dependent on monitoring and timing and involved teamwork between the project conservators and the conservation scientists.

thereafter as the grouted area slowly dried completely, typically over three to four weeks; in the final stages of drying, little salt was detected. Based on these findings, the absorbent layers were changed up to three times a day in the first few days after grouting, decreasing to twice a day for much of the remainder of the drying period. Only in the final stages of drying was it safe to leave the absorbent presses in place for longer periods.

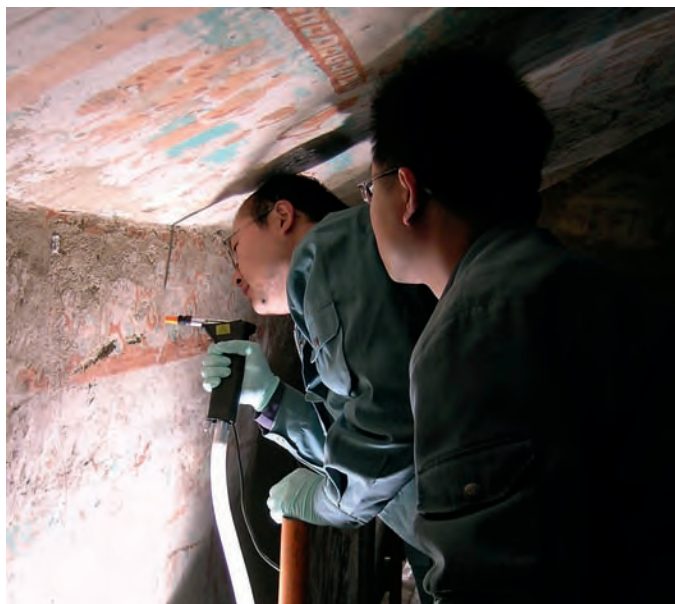
FIGURE 6 An ultrasonic humidifier being used to dissolve surface salts on the treated area of a wall painting. Photo: S. Rickerby

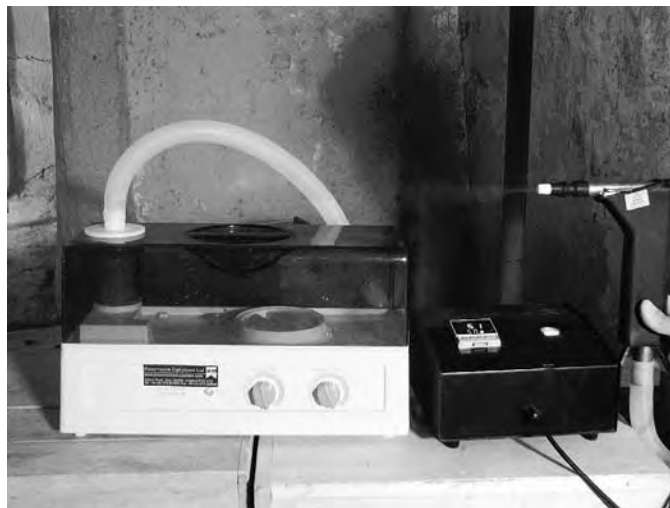
FIGURE 1 The Preservation Pencil.

plaster layers (Li Zuixiong 2005; Rickerby et al., “Testing and Development,” this volume). After poulticing, the salt content in the wall paintings was further reduced through the use of a Preservation Pencil (fig. 1), an ultrasonic humidifier manufactured by Preservation Equipment Ltd., England. By misting the wall paintings with water vapor directed from the nozzle of the device and blotting the paintings immediately with cotton paper, a portion of the salts could be removed safely from the painted surfaces (fig. 2).

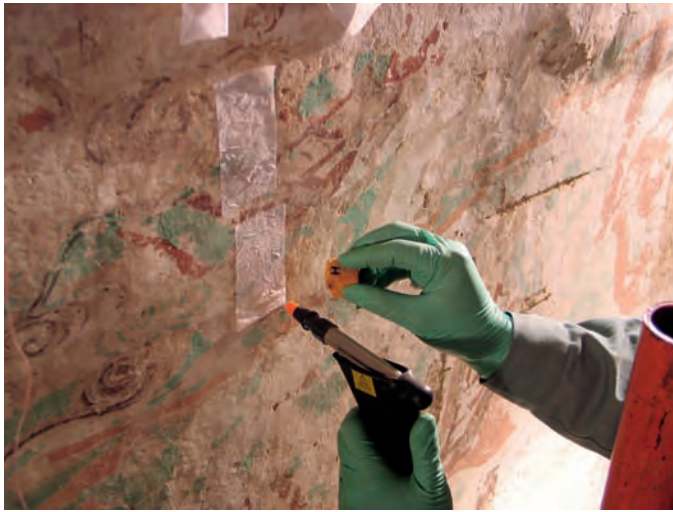
FIGURE 2 Salts being removed with the Preservation Pencil.

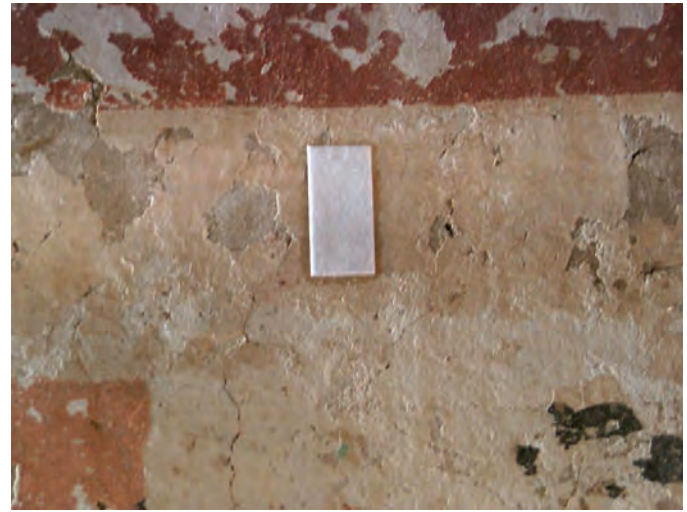
FIGURE 3 Prewettted paper strip applied to a wall painting in cave 85.

spot test method, a **prewettted and standardized size of absorbent chromatography paper** was applied to the surface of the wall painting for a specified amount of time, then removed and immersed in deionized water. The concentration of chloride ion in the water was then measured by a chloride-specific ion electrode.

A single layer of chromatography paper (Grade 81-24) was cut into strips 1 centimeter by 2 centimeters (approximately 40 mg in weight and 1 mm in thickness). The paper strip was placed into distilled water using a fine-point tweezers and removed after five seconds. Excess water was removed by touching the paper strip to the container wall. The average weight of water in the saturated paper was 160 milligrams \pm 2 percent relative standard deviation (based on twenty-seven replicate measurements). The wetted strip was applied to the surface of a prefabricated clay coupon that contained 6 percent by weight of salt (Chen Gangquan et al. 2005), carefully avoiding pockets of air. It was determined that the paper should be removed after forty seconds, by which time a maximum of 60 milligrams of water will have entered the plaster coupon and penetrated to a depth of 2 millimeters. The paper strips were then put into plastic tubes that contained exactly 2 milliliters of deionized water, and after six hours the chloride ion concentration was measured using a chloride-specific ion electrode (Thermo Orion Model 290 meter and

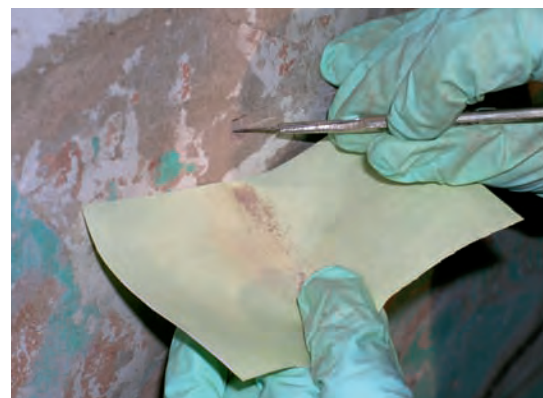
FIGURE 6 Plaster microcores being sampled as part of a comprehensive salt survey. Each core was taken at four or five incremental depths into the upper 10 millimeters of the wall where paint has been lost. The samples were analyzed to identify ions of soluble salts present and their topographic and stratigraphic distribution throughout the cave.

Preliminary investigations identified soluble salts as the primary cause of both surface and subsurface deterioration. A salt survey undertaken to confirm this hypothesis included the sampling of forty-seven microcores, each taken at four or five incremental depths into the upper 10 millimeters of the plaster, resulting in nearly two hundred samples (fig. 6). The incremental depths of the samples correspond

to the painting technique and stratigraphy. The microcores were then analyzed to identify ions of soluble salts present and their topographic and stratigraphic distribution.
