Damage Assessment of Historic Earthen Buildings After the August 15, 2007 Pisco, Peru Earthquake

Research Report

Claudia Cancino

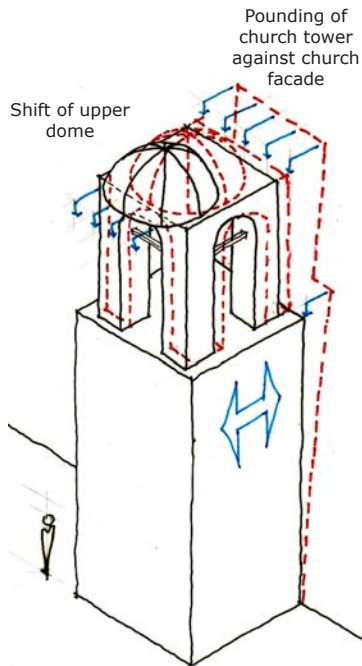
FIGURE 4.6
Scheme of mode of failure of typical church tower. In red, original position of tower. In blue, rocking of tower.

In these four structures, the structural difference between the quincha pillars and the adobe towers during pounding precipitated the dome's failure, shift, and in some cases eventual collapse (Figure 4.6). In most of the sites visited, severe termite damage was observed under detached plaster in all the wooden structures of the quincha pillars, vaults, and domes. The damage was not limited to the wooden elements, but was also present in the cane mesh that ties all elements of the wooden frame and the entire panel together. The damaged pillars of the towers did not resist the stresses of the earthquake. They failed and transmitted stress to the vaults, which, weakened by the poor condition of their wooden elements, moved horizontally and in some cases collapsed (Figures 4.7 and 4.8).

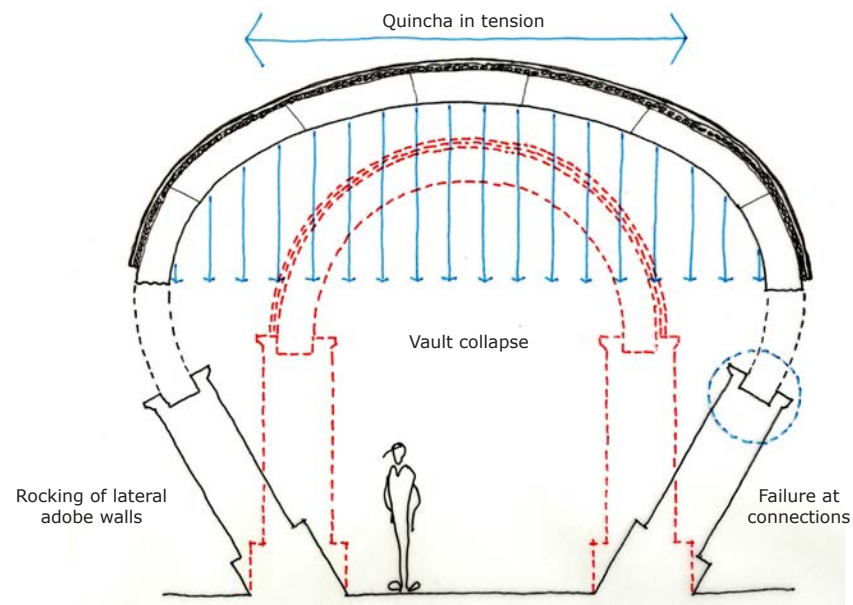
FIGURE 4.10

The rocking of the walls, compounded by a possible lack of proper connection to the roofing system, and a lack of connection between the roofing system and the facade, created stress in the flexible quincha roof. At the moment of the earthquake, the vault tried to restrain the rocking of the walls, adding stress to the deteriorated trusses and their connections until failure. The final result was the total collapse of the entire vault (Figure 4.10). At the churches of Coayllo, Guadalupe, Humay, and the Cathedral of Pisco, the presence of reinforced concrete arches at the end of

Scheme of vault under tension, In red: original position of the vault. In black: exaggerated displacement during earthquake.

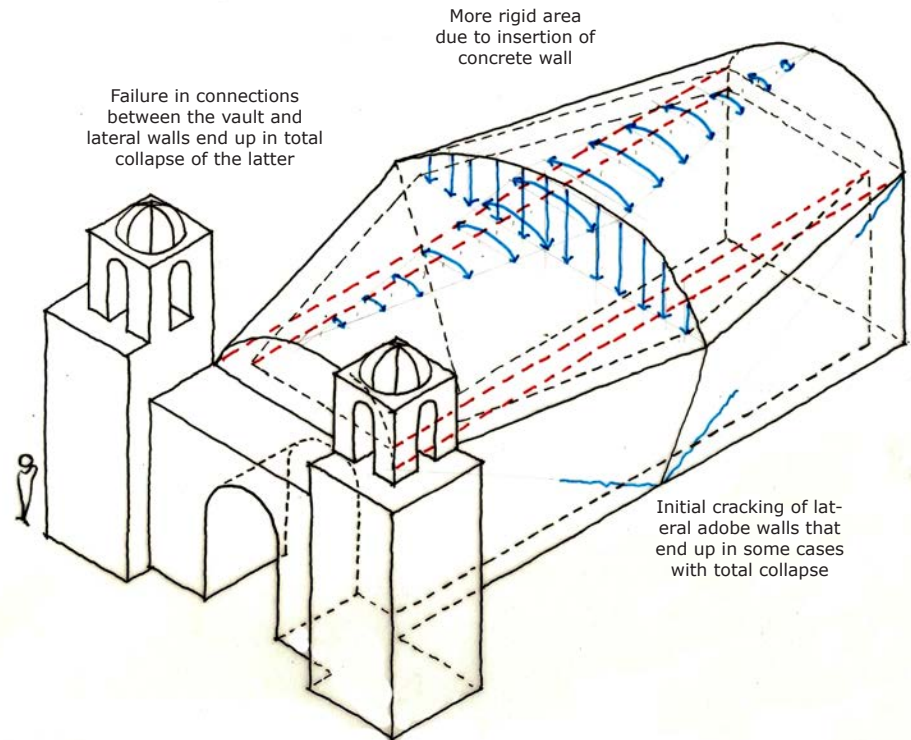
FIGURE 4.11

Scheme of vault total collapse and out-of-plane behavior of adobe lateral walls, as seen at the Church of Coayllo, Cañete.

the vaults stiffened the structure at both ends, which, in conjunction with the deteriorated arches, created transversal tension and induced the quincha vault to fail (Figures 4.11 and 4.12).

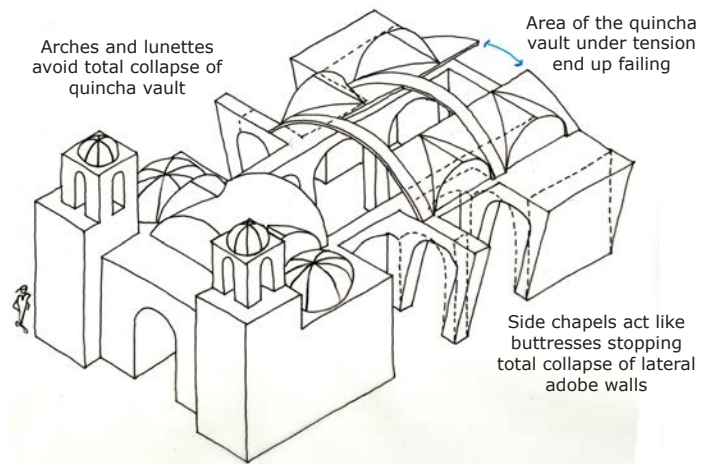
FIGURE 4.15
Scheme of the Cathedral of Ica detailing the position of quincha arches, lunettes, and pilasters.

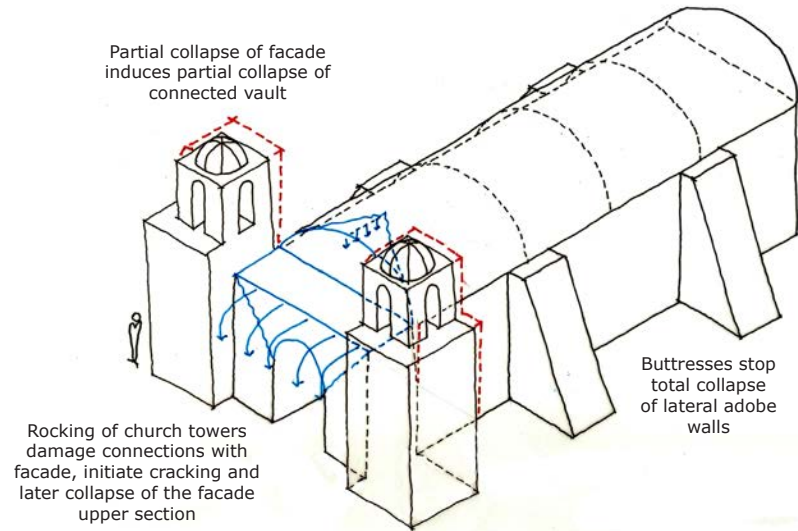
FIGURE 4.17

When entire vaults or domes collapsed, it was clear that walls (front facades or lateral walls) rocked until connections failed, resulting in partial vault collapse (Figures 4.9 and 4.17–19). In the case of the Church of Guadalupe, the concrete tower pounded the earthen façade until collapse of its upper section induced partial collapse of the vault (Figures 4.9 and 4.17). In the case of the Church of Coayllo, partial out-of-plane collapse of more recently constructed adobe walls caused the total failure of its vault (Figure 4.18).

Scheme of facade failure as seen at the Church of Guadalupe, Ica.

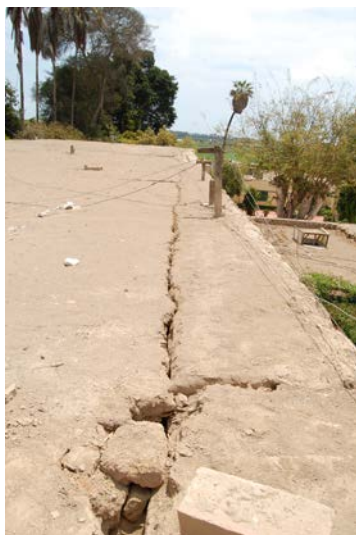
**FIGURE 4.23**

In the case of the Arona y Montalván Estate main house, it seems that the roof of the veranda moved in two directions: parallel and perpendicular to the long facade of the building. A resulting gap was observed at the roof of the building between the veranda and the main house, as well as a crack between the veranda and the main tower (Figure 4.23). The plaster detachment at the upper section of the columns could be the result of the rotation of the columns. The balustrade and the bases seem to have prevented the whole structure from collapsing. (Figures 4.24–4.27)

Displacement gap in the roof of the Arona y Montalván Estate main house, Cañete, as seen in October 2007.

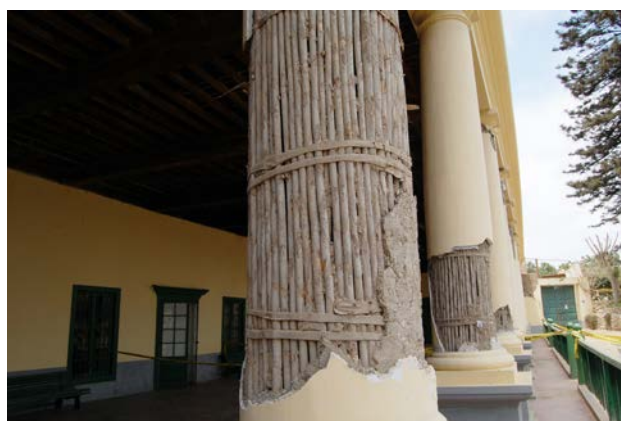
**FIGURE 4.24**

Plaster detachment on the colonnade of the Arona y Montalván Estate main house, Cañete, as seen in October 2007.

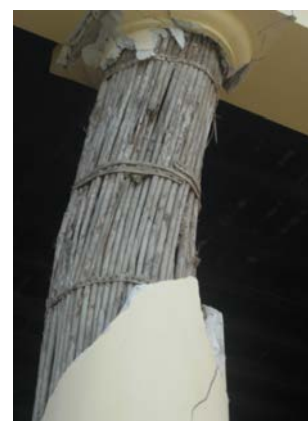
**FIGURE 4.25**

Detail of plaster detachment and rotation of column at the Arona y Montalván Estate main house, Cañete, October 2007.

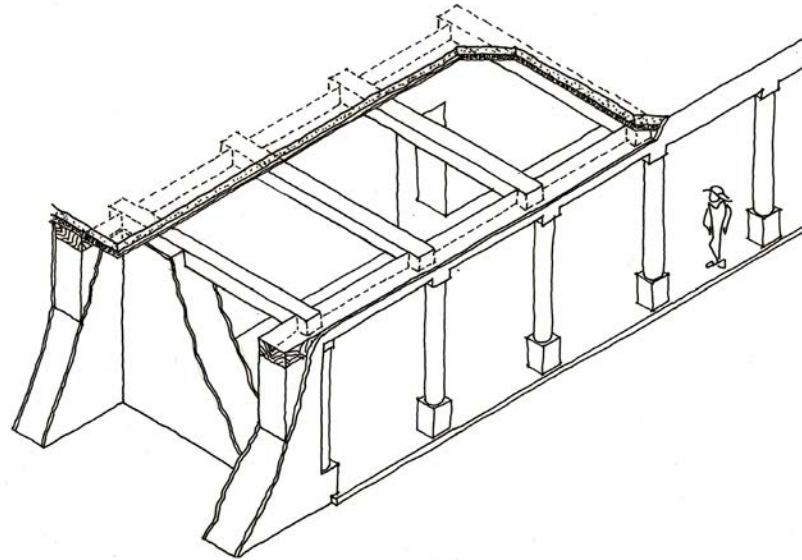
FIGURE 4.26

Scheme of the roofing system of the Arona y Montalván Estate main house.

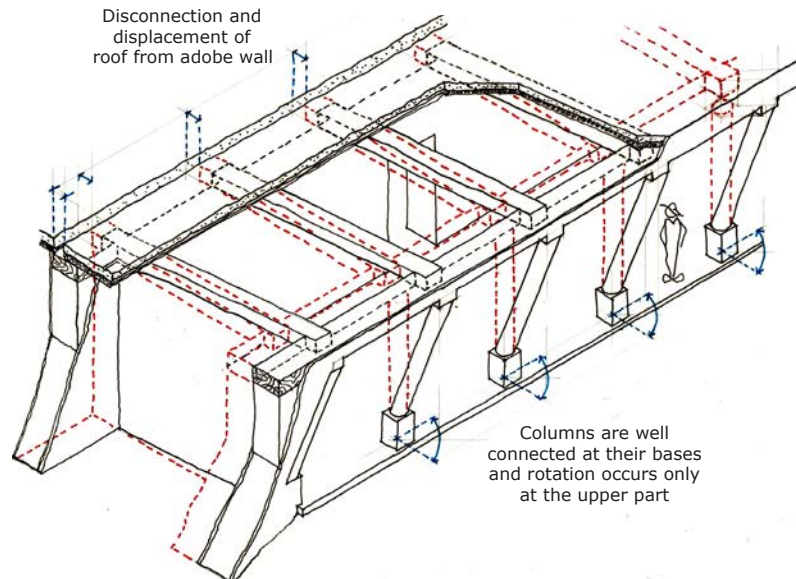
**FIGURE 4.27**

Scheme of roofing failure at the Arona y Montalván Estate main house. In red: the original position of the roofing system. In black: exaggerated displacement under seismic activity. In blue: direction of rotation of columns and crack displacement.

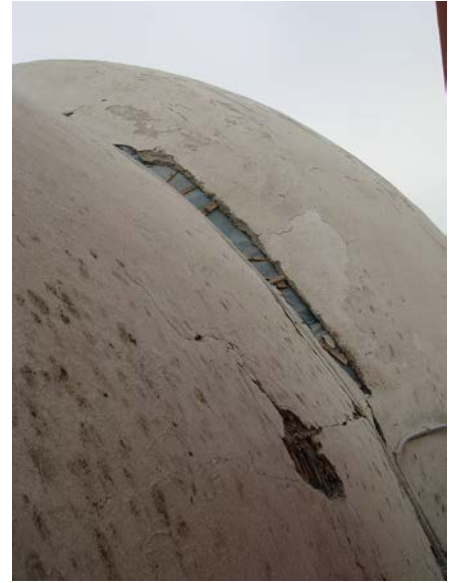
Many plaster detachments were observed on vaults, domes, walls, columns, and pillars of the visited sites (Figures 4.28 and 4.29). Furthermore, and most importantly, previous unrepaired plaster detachments left the wooden elements of the quincha roofing systems, as well as columns and pillars, exposed to the environment which generated termite damage, as observed at the Churches of San José and San Javier de Ingenio in Nazca.

FIGURE 4.29
Detail of plaster detachment on dome at the Church of Chilca, in Cañete, as seen in October 2007.

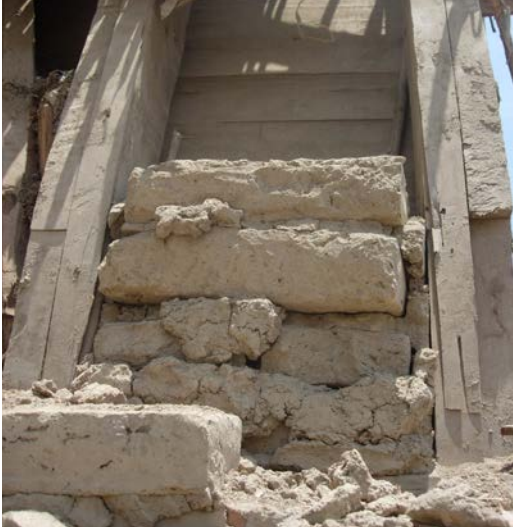
**FIGURE 4.33**

Detail showing weak mortar adhesion strength at the Church of Coayllo, Cañete, as seen in October 2007.

- Loss of structural integrity and lack of connections between damaged wooden elements of quincha vaults, pillars, and walls, which isolated parapets, partitions, and facades affecting their stability (Figures 4.30–4.32)
- Pre-existing and unrepaired structural cracking and weak mortar to block adhesion strength, which induced further cracking (Figure 4.33)
- Moisture damage to the quincha and adobe walls, to such an extent that the walls suddenly collapsed
- Beetle damage in the adobe blocks that reduced the strength of the wall (Figure 4.34)

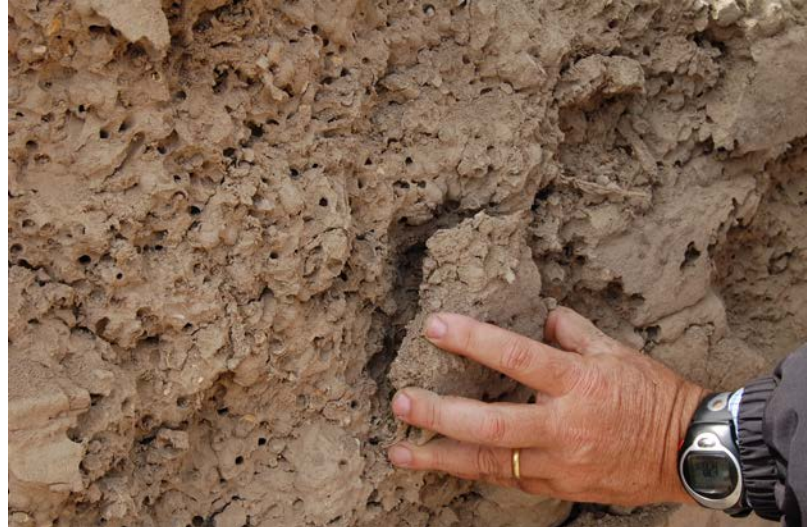
**FIGURE 4.34**

Detail showing beetle damage to the adobe walls at the worker residences of the Hacienda Arona y Montalván, Cañete, in October 2007.

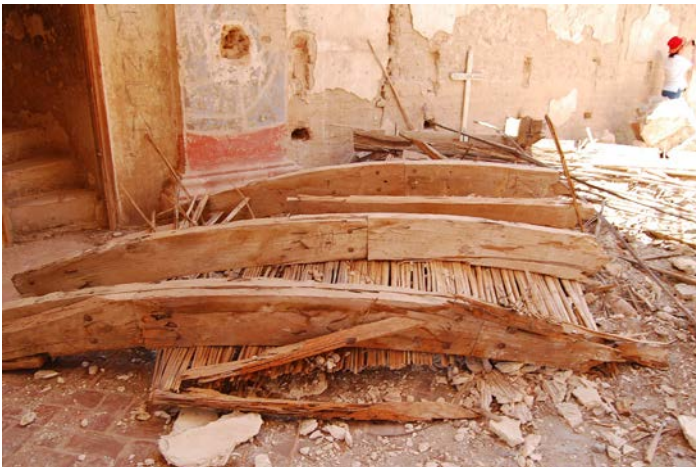
**FIGURE 4.35**

Detail showing termite damage to wooden framework at the Church of Hacienda San José de Nazca, in October 2007.

- Termite damage to the wooden framework of the quincha walls, which contributed to partial or total collapse of entire structures (Figures 4.35 and 4.36).
- Addition of different building materials and systems into the structure. Areas of fired brick or stone, and in a number of cases reinforced concrete frames with infill of adobe or fired brick, had an effect in the building performance of the visited sites (Figures 4.37–4.39).

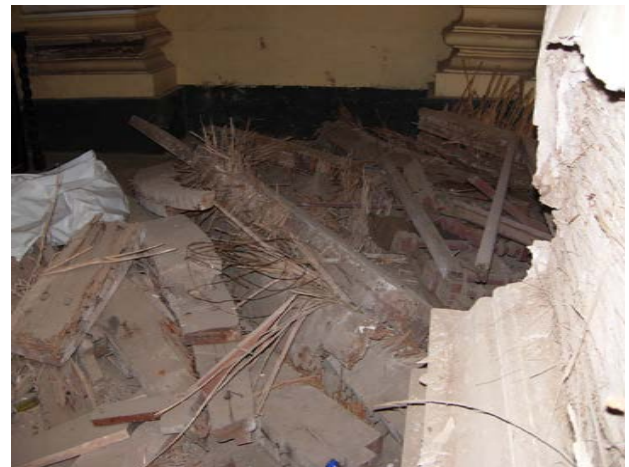
**FIGURE 4.36**

Detail showing termite damage to wooden framework at the Church of Hacienda San José de Nazca, October 2007.

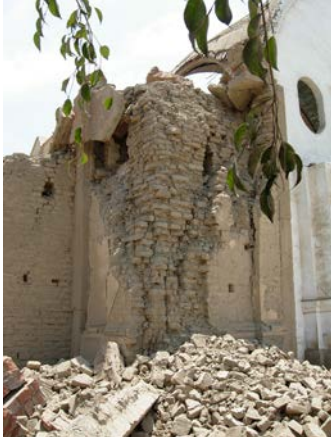
FIGURE 4.37
Detail showing the mixture of building materials used at the Church of Coayllo, as photographed in October 2007.

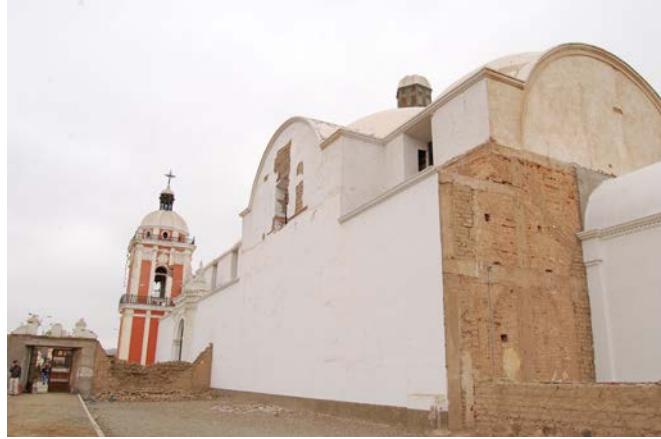
FIGURE 4.38
Detail showing the mixture of building materials used at the Church of Chilca, as photographed in October 2007.

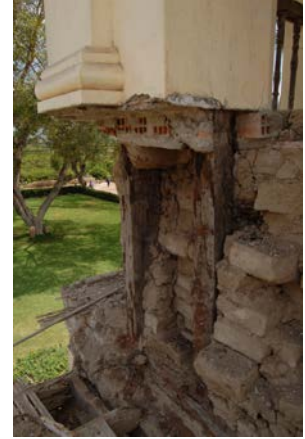
FIGURE 4.39
Detail showing the mixture of building materials used at the Hacienda Arona and Montalván in Cañete, as photographed in October 2007.
