总体状况概述 Overall Condition Summary

会乘殿，室内 - 塑像：

Huicheng Hall, Interior - Sculpture:

Avalokitesvara (*Guanyin*) on a *chaotianhou*

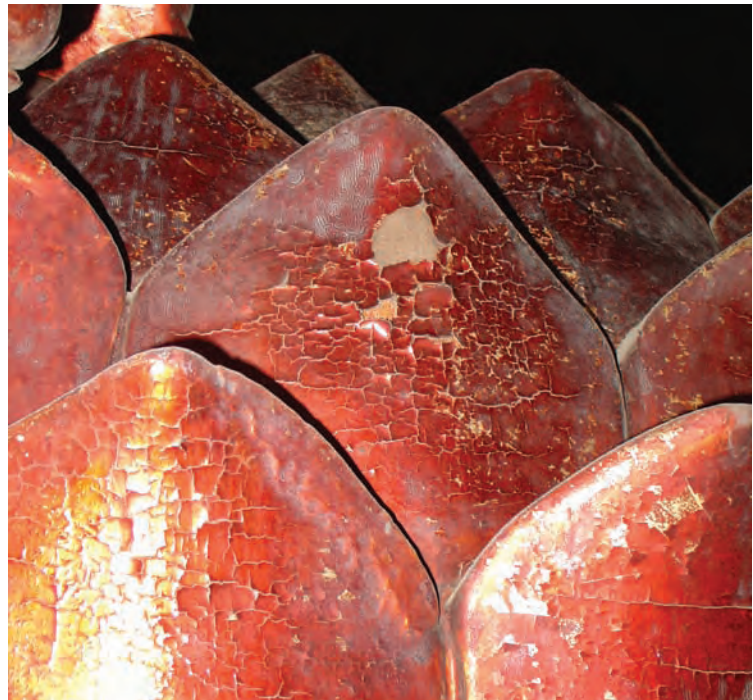
莲花瓣表面和地仗层起甲和脱落。

Flaking and loss of painted plaster on lotus petals.

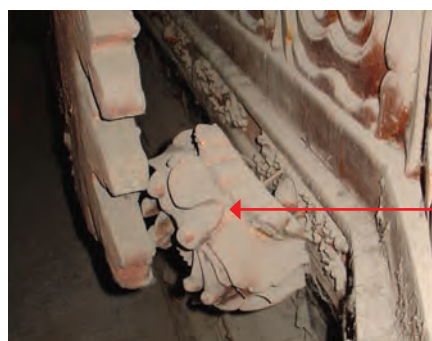
已松脱并被夹在塑像背后的背光装饰构件。

Decorative sculpture piece from the mandorla which has dislodged and is now caught behind the sculpture

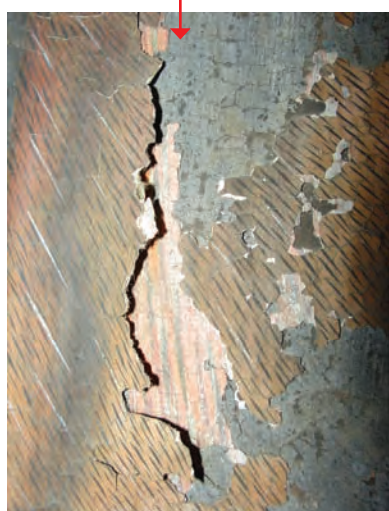
象鞍饰上油漆层脱落及起甲详图。
Detail of area of loss and flaking of the paint layer on the elephant's decorative saddle.

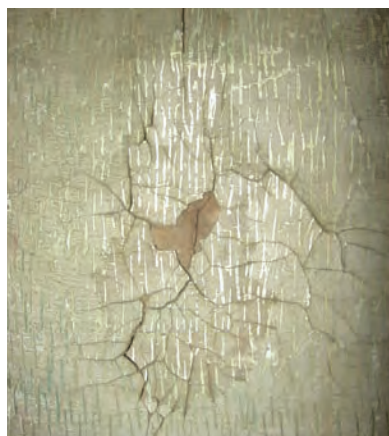
象身上起甲部分似乎已经用某种胶处理过，但是谁在什么时候执行这项工作却不清楚。
Area of flaking on the elephant that appears to have been treated with some kind of adhesive. It is unknown who carried out this work and when this treatment occurred.

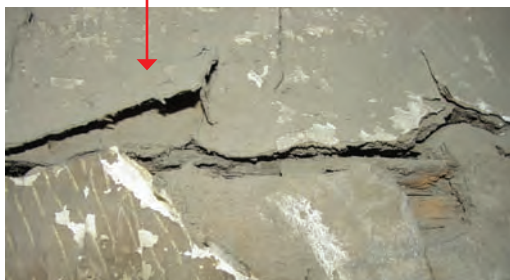
大裂缝的详图。
Detail of large crack.

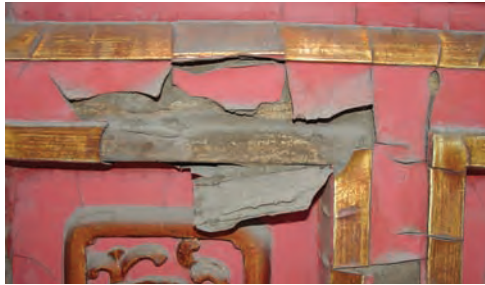
彩绘地仗的裂缝、空鼓脱落非常普遍。

Cracking, detachment and loss of the painted plaster is widespread.

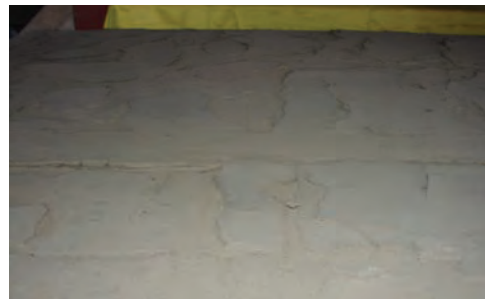
供桌桌面上的厚层尘土和地仗裂缝。

Tops of the offering tables have heavy dust deposition and cracking in the plaster.

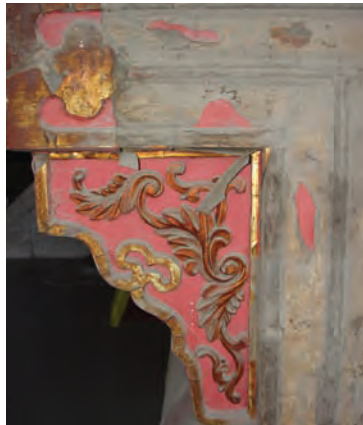
保留下来的叶状装饰，但大部分的红色底色和金饰已缺失。

The foliate relief decoration survives on the offering tables but much of the background red and gold decoration has been lost.

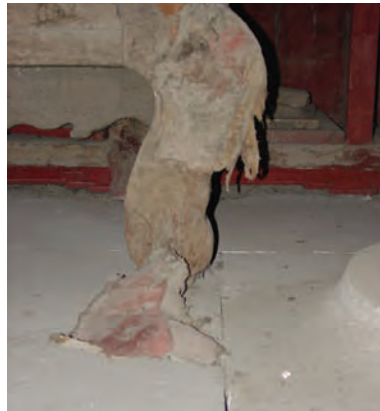
供桌后腿上大片彩绘地仗脱落。

Loss of large piece of painted plaster from back leg of table.

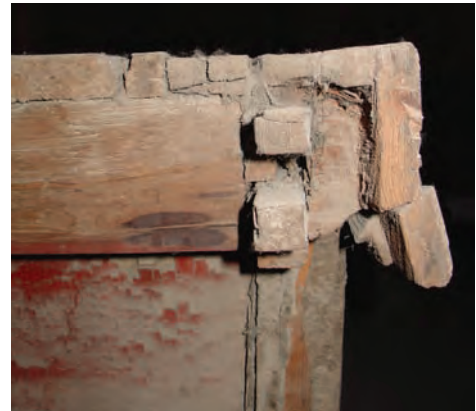
供桌前面部分缺失，曝露出木榫头。

Area of loss on the front of the offering table showing an exposed wood joint.

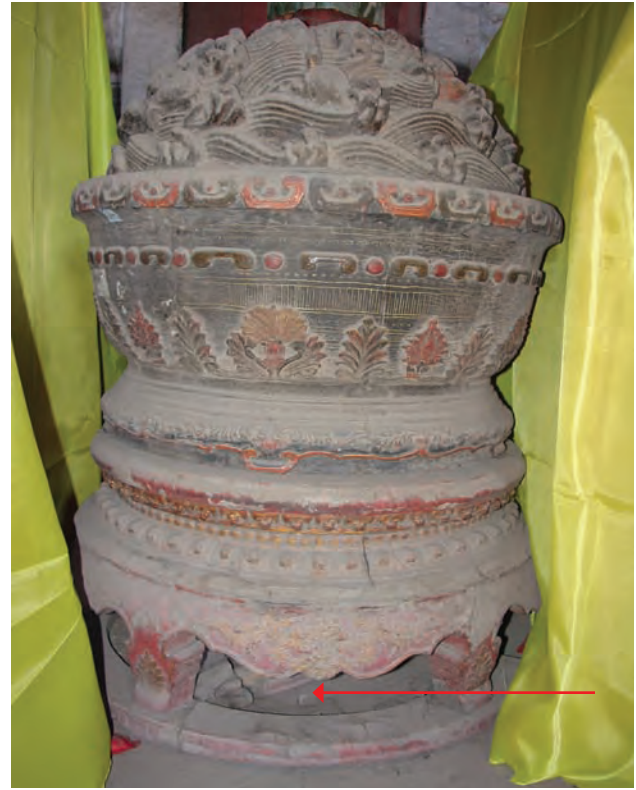
西侧珊瑚树底座。下面藏有已脱落的木构件。
Base of west coral tree. Note detached wooden pieces hidden below the base for storage.

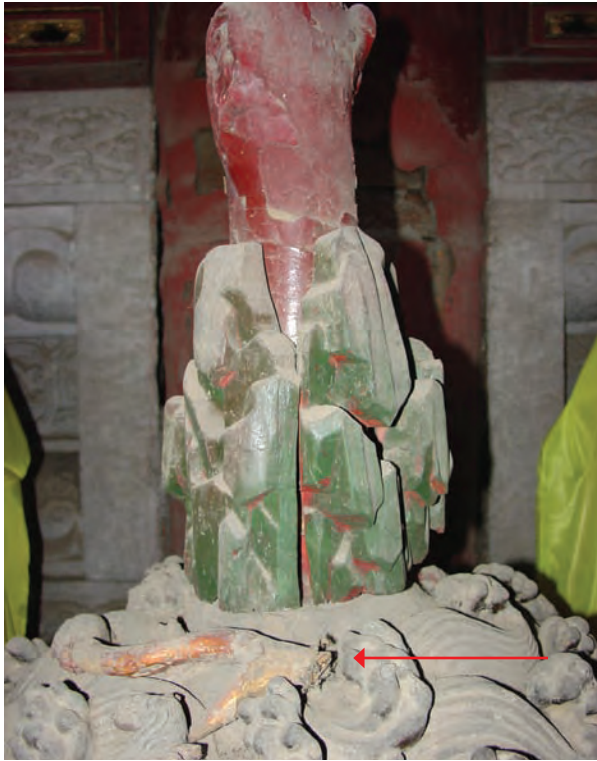
珊瑚树底部。注意已脱落的树枝。
Base of coral tree. Note detached branch.

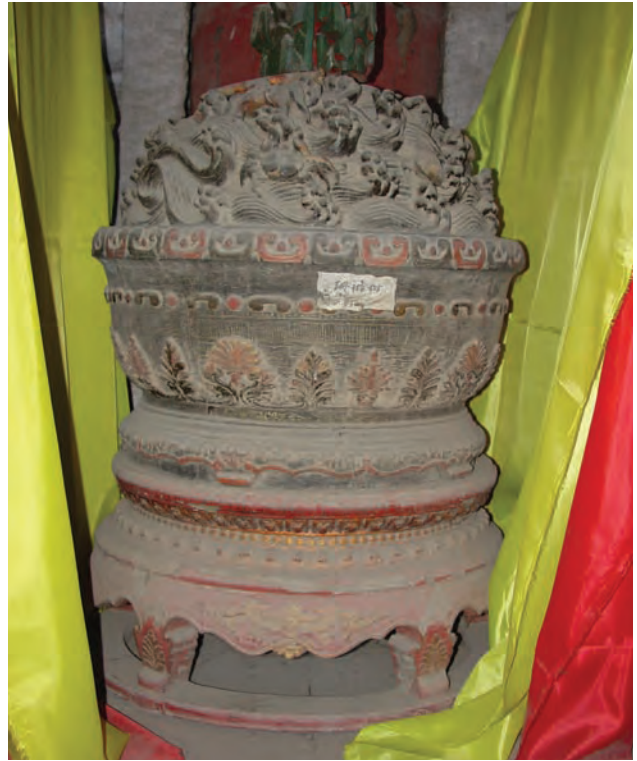
东侧珊瑚树底座。油饰地仗上有少量的脱落。
East coral tree stand. There are minor losses in the painted plaster decoration.

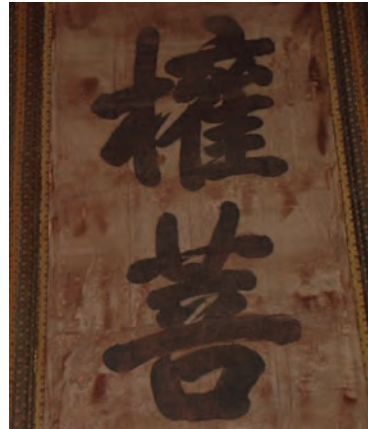
楹联表面的褐色污斑明显可见。
Brown/plum colored staining is visible on the surface.

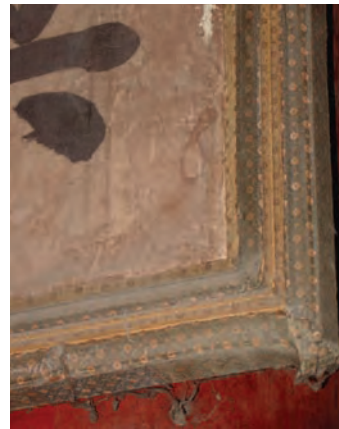
框架上的布条多处松脱。楹联表面的褐色污斑明显可见。
The fabric from the frame is coming up in places. Brown/plum colored staining is visible on the surface.
