CHAPTER 5

Church of Kuño Tambo

5.1 Summary

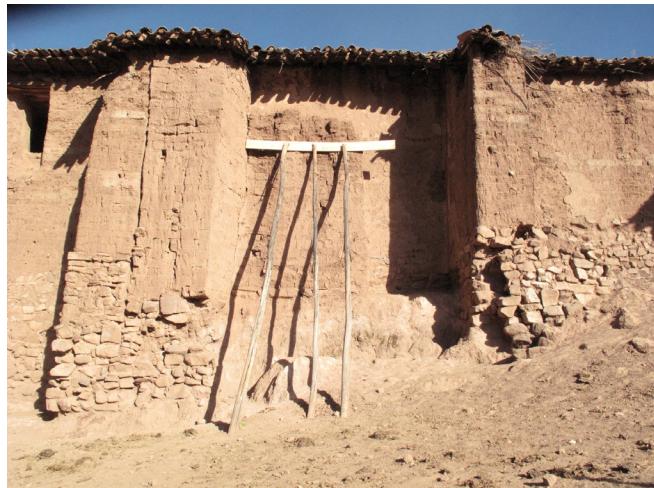
**FIGURE 5.20**

View of east lateral wall of main church, showing buttresses.

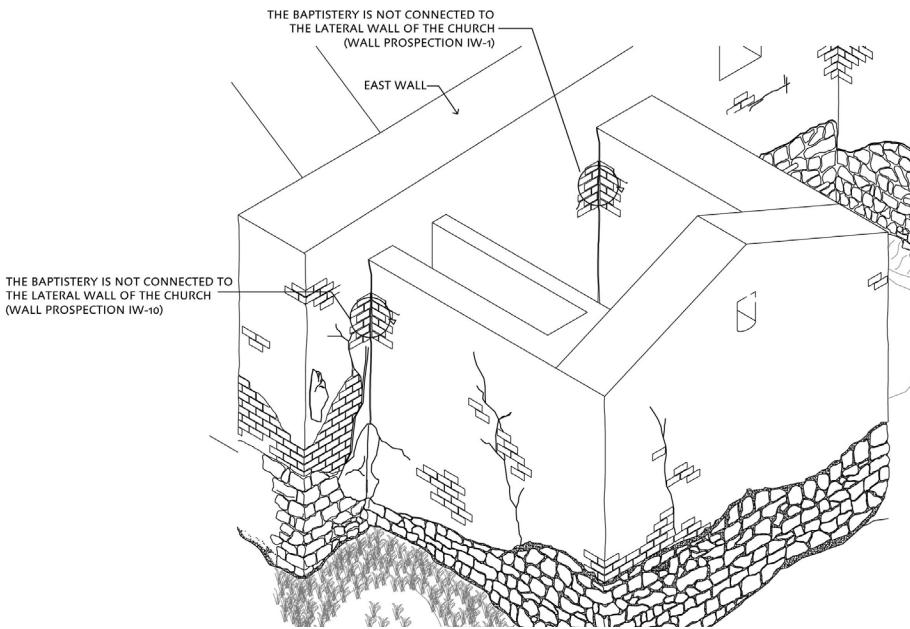
View of the east lateral wall of the church and baptistery wing, illustrating the wall connections.

The corners of the mud brick walls are woven together with overlapping bricks. The sacristy walls (sector E) are connected to the lateral wall of the nave through a similar connection; however, there is no connection between the baptistery walls (sector B) and the lateral wall of the nave (Figs. 5.22, 5.23). With the exception of the additional buttress at the east and west façades, all buttresses are connected to the nave walls with overlapping bricks.

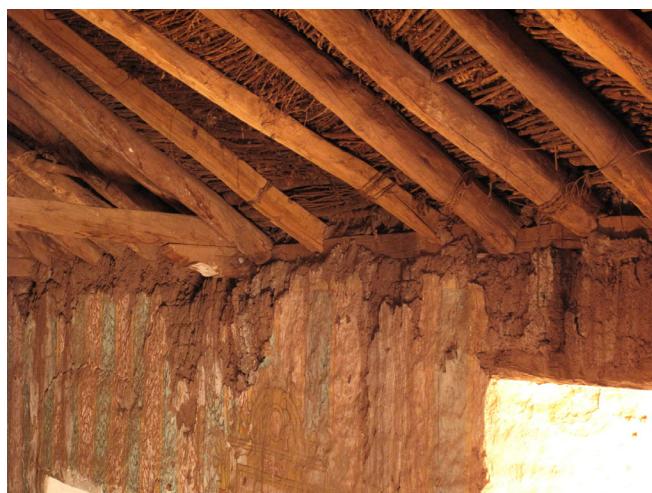
**FIGURE 5.31**

View of rafters and wall plate at the lateral wall of nave.
Image: Claudia Cancino.

- The pares y nudillos roof trusses do not work, due to the failure or lack of connections between the rafters and collar ties. Furthermore, the connection between the rafters and the mud brick wall has failed in some locations, due to erosion of the wall and lack of continuity in the wall plate.

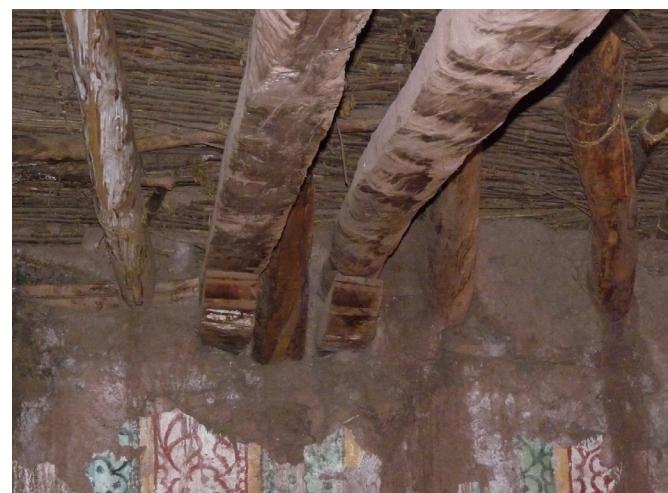
**FIGURE 5.32**

View of the pair of tie beams over the nave.
Image: Mirna Soto, for the GCI.

- Roof leaks have eroded the tops of the lateral mud brick walls, reducing the embedment and effectiveness of the tie beams.
- The thick mud brick walls are considered stable, according to the GSAP slenderness ratio criteria; however, several large openings (presently altered or infilled) in the lateral walls of the main church weaken those walls. The loss of some of the mud brick buttresses at the exterior face of those lateral walls further weakens them.

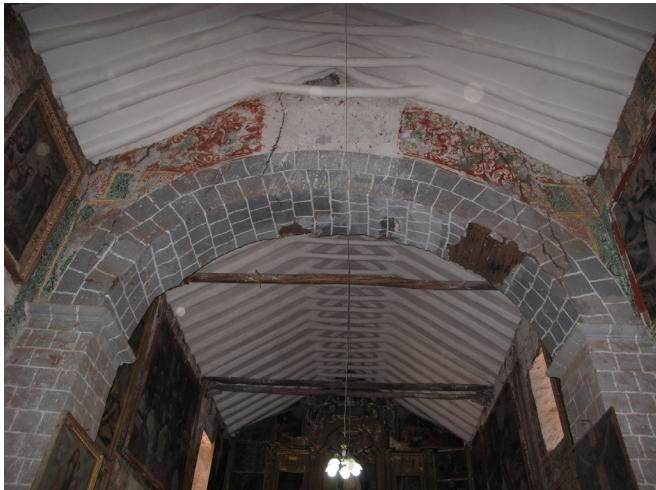
FIGURE 5.37

It is assumed that the church originally had a quincha arch separating the nave from the presbytery, based upon the extant damage at the top of the remaining earthen piers and the existence of an arch in the nearby Church of Rondocán, which is of a similar overall design to the church of Kuño Tambo (Figs. 5.37, 5.38). The arch has since collapsed or been dismantled, and the remaining west pier exhibits cracking (Figs. 5.39, 5.40).

View of intact quincha arch over mud brick piers, separating the nave from the presbytery at the Church of Rondocán.
