Seismic Retrofitting Project: Assessment of Prototype Buildings

Volume 1

Research Report

Seismic Retrofitting Project: Assessment of Prototype Buildings Volume 1

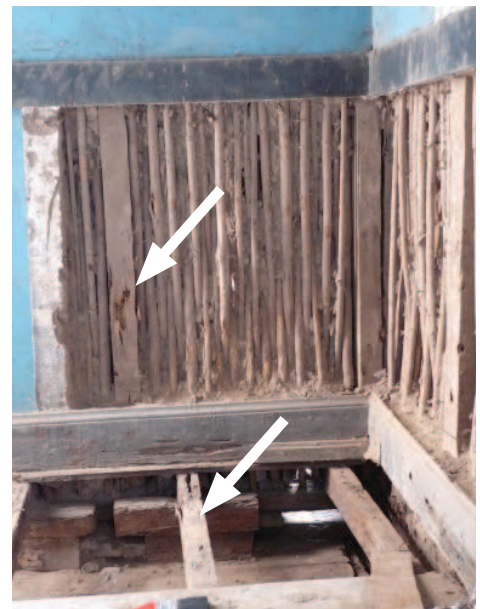
At the second floor, the typical quincha wall is 4.63 m high and is constructed with a wood frame made of 0.12 × 0.12 m posts (*pies derechos*); a 0.12 × 0.10 m top plate (*carrera*); and a 0.12 × 0.10 m sill plate (*viga solera*), which rests on the adobe wall below. The posts are connected to the top and sill plates by means of 0.06 m diameter by 0.10 m long dowels that go all the way through the plates. A 0.15 × 0.05 m wood cap plate (*viga de amarre*) spans across the top of the frame. The bottom 0.90 m of the frame is filled with mud bricks over two courses of fired bricks, as well as 0.11 × 0.11 m diagonal wood braces (*tornapuntas*). Over this filled base, four horizontal canes span across the posts, providing reinforcing, and vertical cane reeds are interwoven with the horizontal canes. In some panels *caña chancada*, or flattened cane reeds, are nailed over the wood posts. The panels are then covered with a 35 mm thick mud and straw layer, followed by a 25 mm thick mud layer, a 4 mm thick gypsum finish coat, and a final paint layer. The quincha posts do not align with the floor joists below (Figs. 3.25–3.29).

FIGURE 3.28 (FAR RIGHT)
 Prospection IIIS-1, showing the quinchá posts and floor joists do not align.
 Drawing: Mirna Soto for the GCI.

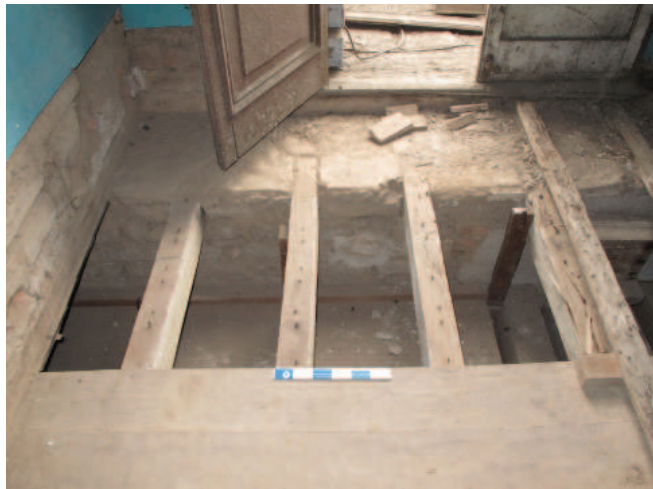
FIGURE 3.38 (BOTTOM)

Prospection IIS-1, showing the joist ends pocketed into the top of the first floor mud brick wall at the northeast façade.
Image: Sara Lardinois.

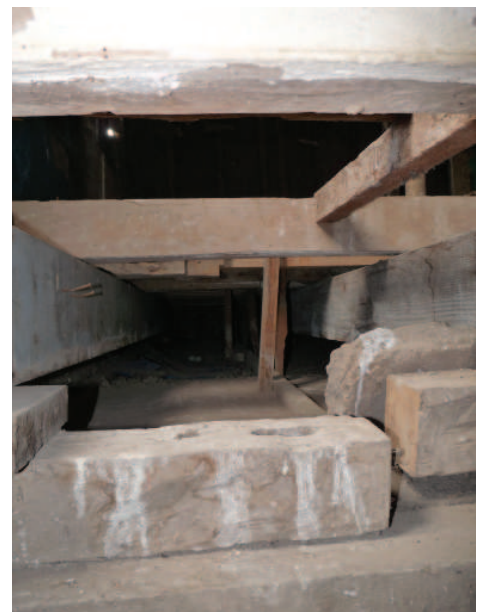
Prospection IIS-1, showing the overlapping beam ends, which presumably relate to the removal of a wall in the bar below.
Image: Mirna Soto, for the GCI.

- The structure of sector A is in most danger, as it appears that an original internal mud brick wall that originally supported the quincha walls above has been replaced with a column. Furthermore, the placement and overlapping of the wood floor beams above does not work and only adds load to the structure above. At that same sector, the conditions of the quincha partition walls at the second floor are poor and may lead to the collapse of the third floor area above the bar. Finally, the fact that this sector is located at the corner makes the building even more vulnerable to collapse during an earthquake.

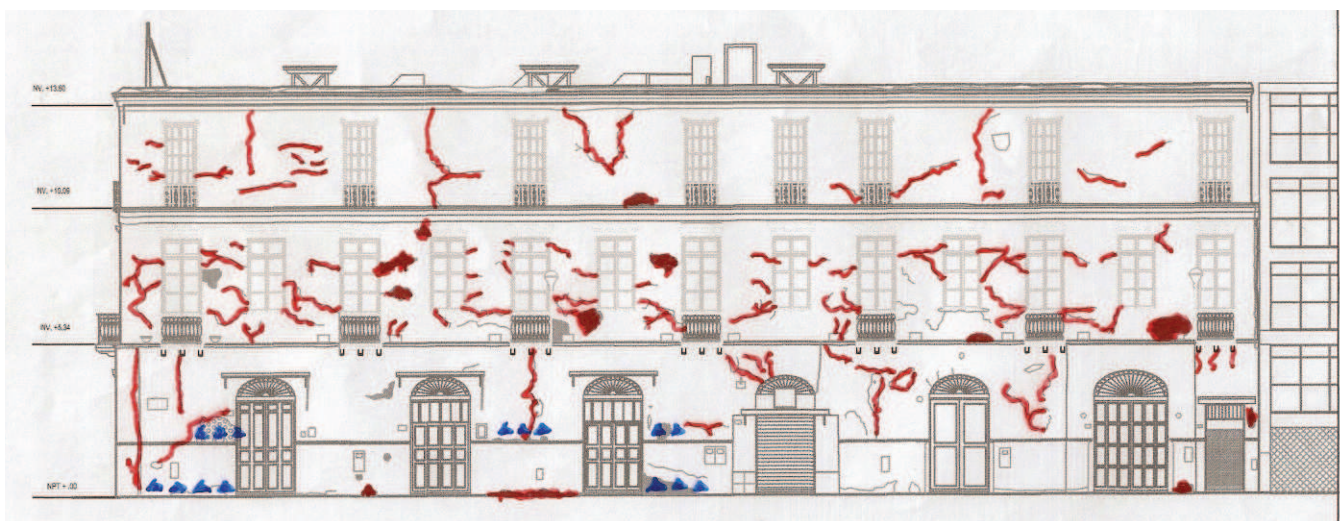
FIGURE 3.44

Both of the street façades show some signs of cracking, particularly at the second floor spandrels. There is diagonal and vertical structural cracking at the corner of the first floor at the northeast end of the long northwest façade (Jirón Carabaya). The northeast façade along Jirón Ancash also shows significant cracking in the second floor at the southeast end near the adjacent casona and at the third floor span-

drels (Figs. 3.44, 3.45). The patio façades are in fair condition but also show signs of cracking at the third level spandrels and also at the corners of the openings (Figs. 3.46, 3.47).

Northwest façade, graphic condition survey indicating observed cracks and areas of plaster loss in red and humidity in blue.

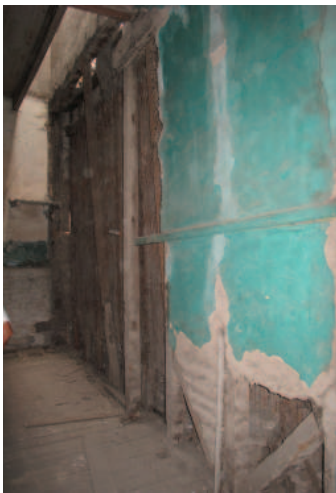
FIGURE 3.52
Northwest wall of room 243.
Image: Claudia Cancino.

- **Sector A:** It is likely that the wall separating sectors B and C at the first floor probably originally to the northeast façade. It has since been removed to create a larger dining room for El Cordano bar and a metal column has been installed to support the floor structure above. The overlapping wood beams at the second floor, above the El Cordano main dining room, appear to be alterations made to accommodate this transformation. Of particular concern is the northwest wall of room 243 over the bar dining room. With the removal of the mud brick wall, the second floor quincha wall frame was left hanging from the third floor quincha frame and is not bearing on the floor, thus creating a total disconnection between two floors (Fig. 3.52).
