Assessment of Current Conditions

Condition Survey

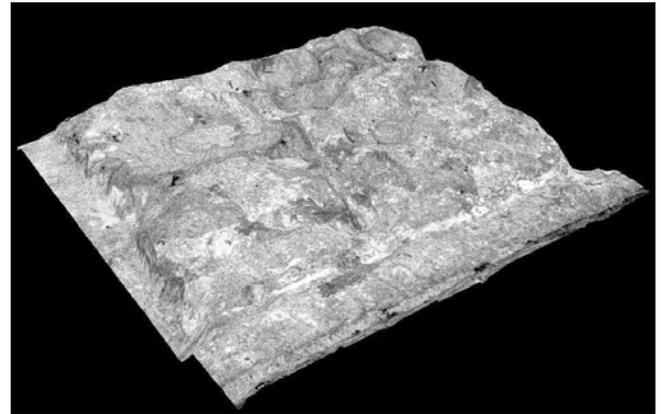
Figure 52 A digital surface model of glyph B, block 20, step 6, with the imagery draped over the surface.

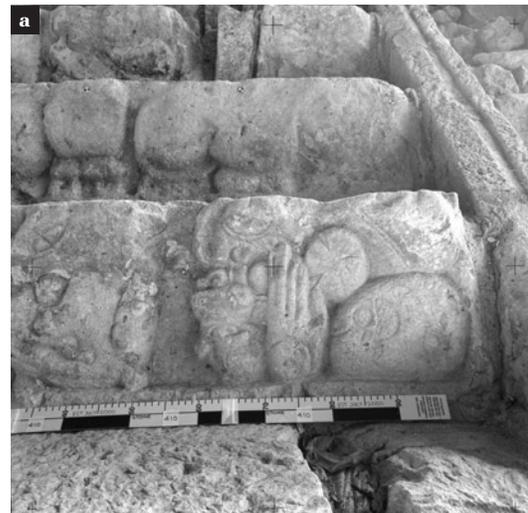
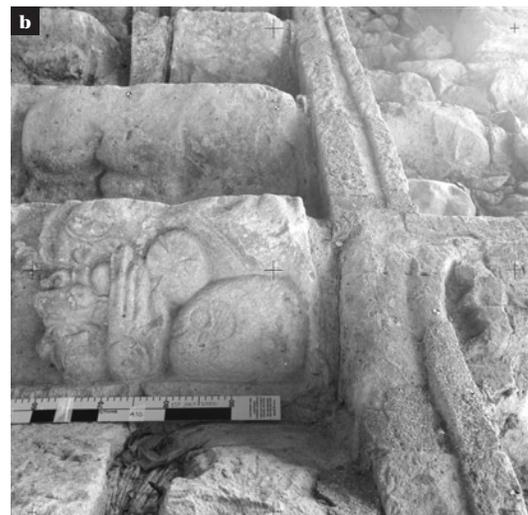
Figures 53a and b Stereophotographs of block 410, step 45, 2000.

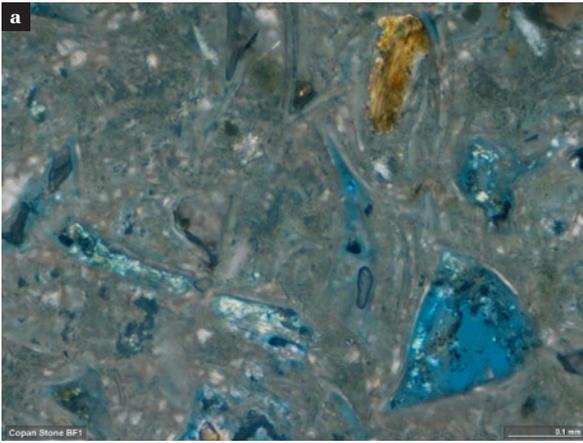
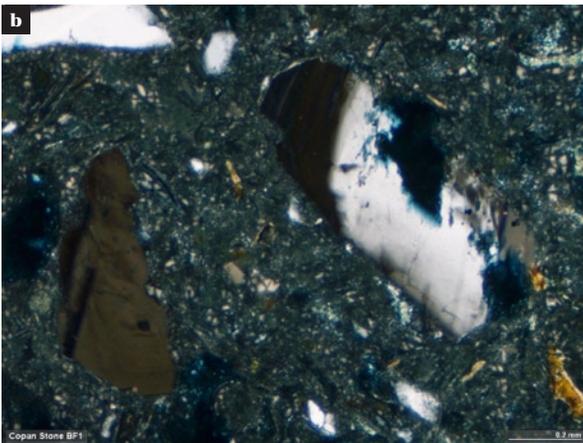
Figures 58a and b Thin section images by polarized light microscopy of bulk Copán stone. Sample BF1 under normal light (a) shows pores in blue, where volcanic glass has dissolved; the sample under cross-polarized light (b) shows a partially dissolved feldspar grain in a zeolite matrix.

and sanidine largely replacing the original glass matrix; mineral fragments are dissolved or altered to a lesser degree (**Figs. 58a, b**).

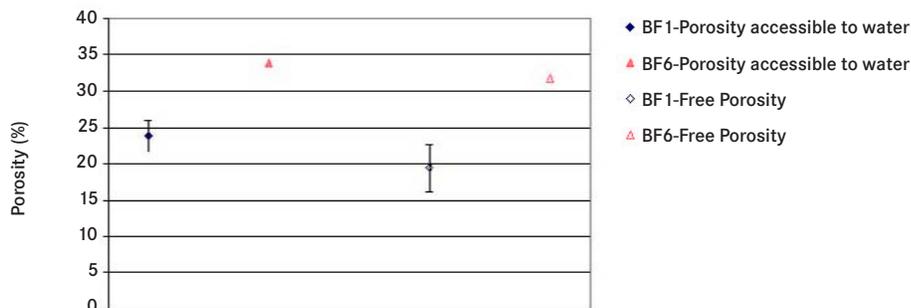
Copán stone has a relatively high porosity. Sample BF6 has a higher total porosity (N_t , measured under vacuum) than BF1, as well as a much higher free porosity (N_{48} , porosity open to water by capillarity). This result shows that BF6 has more connected pores that allow water to penetrate easily by capillarity (**Fig. 60**). These properties lead to a greater saturation coefficient (S_{48}) for both stones. The saturation coefficient is related to the susceptibility of the stone to frost, if temperature goes below zero, and to salt damage, if salts are present. When the saturation coefficient is greater than 0.85, the stone is considered susceptible to damage; when it is between 0.75 and 0.8, the stone is moderately resistant, and when it is less than 0.75, the stone is considered frost and salt resistant.

**Figure 60** Porosity data for samples BF1 and BF6.

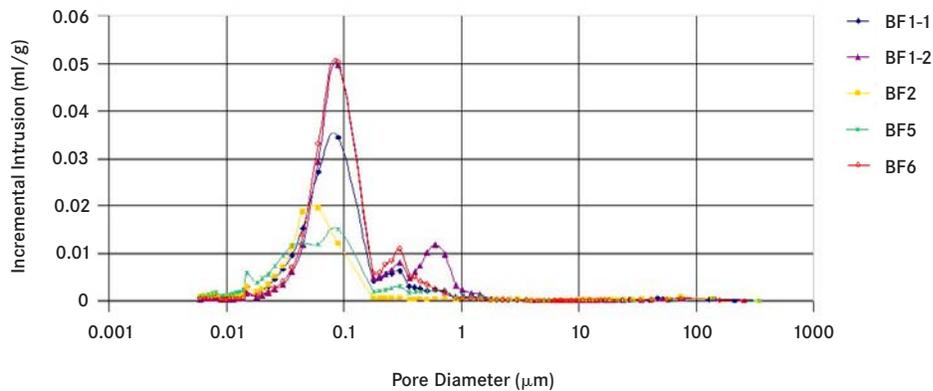
The pore-size distribution obtained by mercury intrusion porosimetry (**Fig. 61**) shows that all samples have more than half of their total pore volume made up of pores smaller than 0.1 μm. These pores are generally considered micropores where capillarity condensation can occur. In contrast to this high microporosity, all samples have a small percentage (1.2%–7.2%) of pores larger than 5 μm, a dimension at which liquid water circulates freely within the pores.

**Figure 61** Pore-size distribution by mercury intrusion porosimetry.**Table 5** Properties related to moisture transport characteristics of the four bulk samples of Copán stone (BF1, BF2, BF5, and BF6).

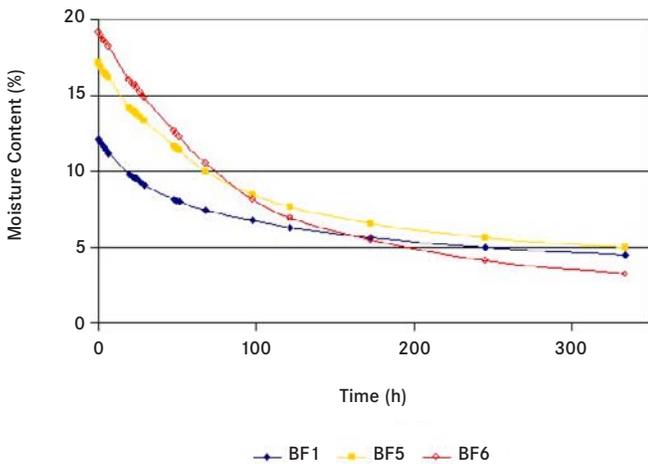
The results indicate that relative vapor transport rates are low and similar for all samples, varying from 22.2 to 29.1. As a matter of comparison, a μ -value of 40 is average for a limestone, 200 average for a marble. These low μ -values explain in part the slow drying rate of all stone samples (Fig. 62).

After almost two weeks, all of the samples still had significant moisture content, and none seemed to have reached equilibrium time (T_{eq}). However, a difference in the drying rate can be seen between the samples. For example, BF1, the sample with the lowest initial maximum moisture content, is the slowest-drying one. The horizon of evaporation withdraws beneath the surface, marking the end of the drying period entirely due to liquid water transport, a point called critical time (T_c), approximately 10–15 hours after the last maximum capillary wetting. BF5 and BF6 reach critical time (T_c) later, at around 20 hours.

Figure 62 Drying rate of three Copán stone samples.

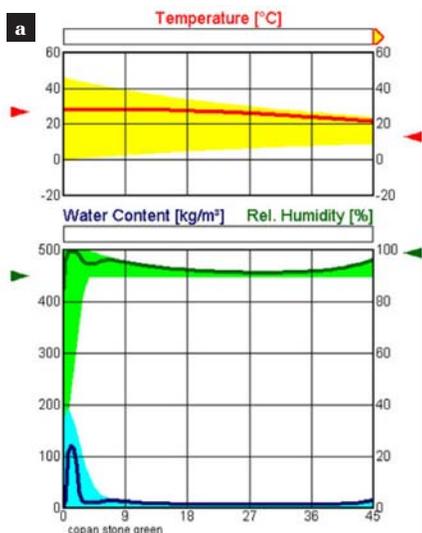
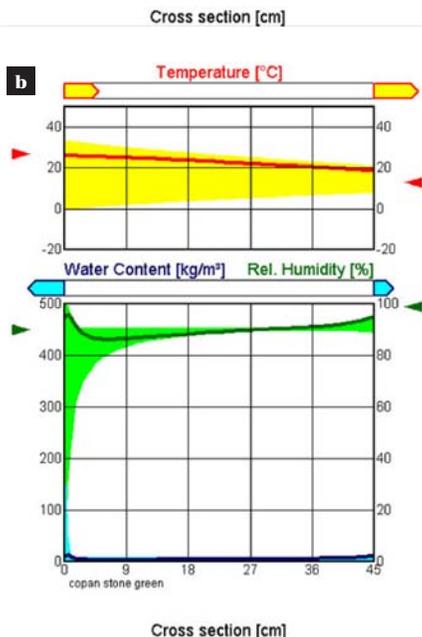
Figures 66a and b WUFI calculation for depth profiles of temperature, water content, and relative humidity. The lines do not represent the average but represent the final state at the end of the annual cycle. The colored areas illustrate the range of values covered in a typical year for unsheltered stone (a) and sheltered stone (b).

The physicomaterial properties measured for the stone and weather data from New Orleans, Louisiana, were used to generate graphic representations of the stone moisture and temperature depth profiles over a year, with the WUFI program (Künzel 1995). **Figures 66a and 66b** give the results of simulations run with sample BF1 parameters under two different situations. The upper figure (Fig. 66a) simulates an unsheltered situation, the lower figure (Fig. 66b), a sheltered situation, such as at the Stairway.

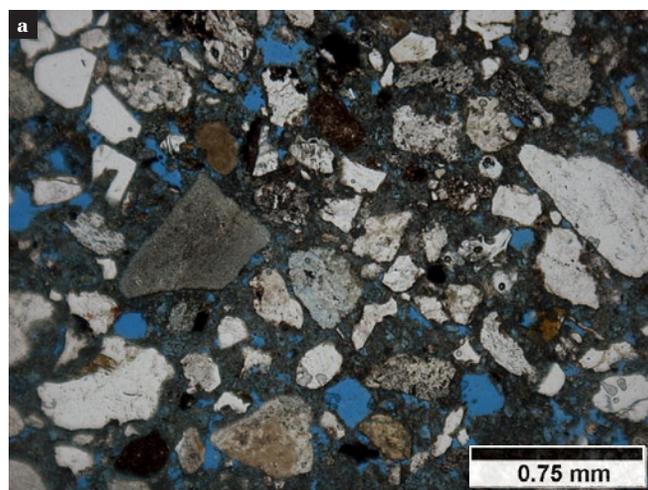
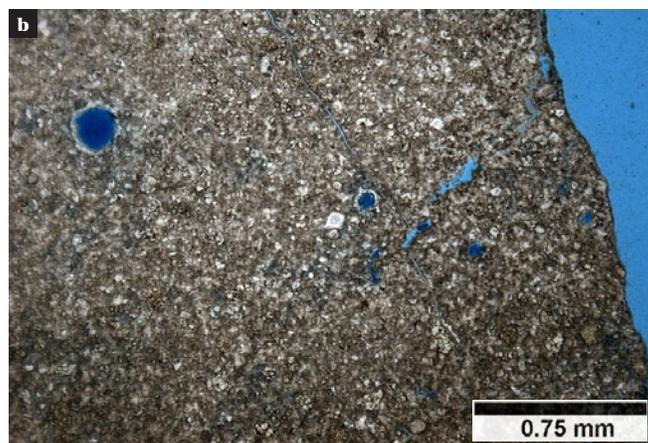
Texture analysis of thin sections of six additional samples of repointing mortar from the Stairway confirmed the previous results. These later samples show a large range of texture and aggregate grading, as **Figures 67a and 67b** illustrate.

Figures 67a and b Thin sections of two different samples of Stairway repointing mortars. In sample M2 (a), cement mortar has angular to sub-rounded particles, moderately sorted. There are mostly floating grains, with a few long contacts, high content of binder, and no orientation of the grains. Pore volume is mostly interstitial, with a few air voids. A few cracks are evident. In sample M4 (b), the dense cement mortar has fine, sub-angular to sub-rounded grains, well sorted. There are mostly floating grains, with high binder content, and some interstitial pores, with few rounded pores and fine cracks.

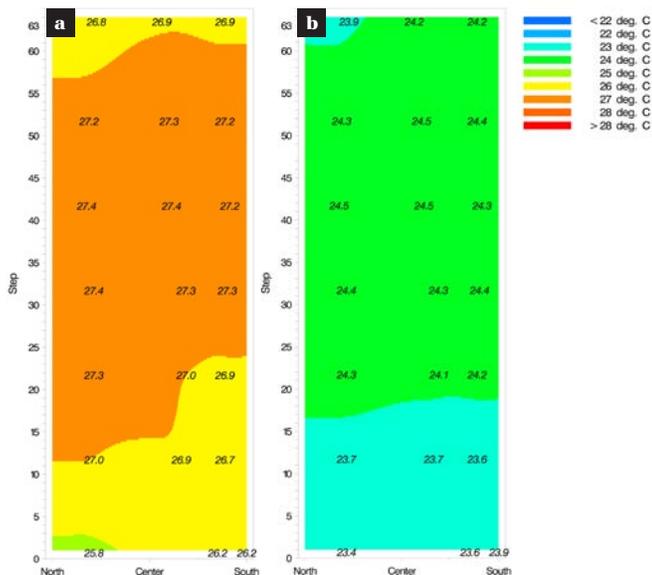
Reflecting trends in air temperature, surface temperatures on the Hieroglyphic Stairway exhibited seasonal differences. Mean wet season surface temperatures on the Stairway ranged from 25.8°C to 27.4°C, exceeding the range of dry season values (25.4°C to 24.5°C) (Figs. 71a, b). Surface temperatures were also elevated above ambient air temperatures during both the day and the night hours, preventing condensation from forming at the surface-air interface and limiting surface microbial activity.

Excluding days on which the shelter was removed for maintenance or replacement, maximum Stairway surface temperatures ranged from 38.9°C to 45.6°C during the wet season, and 34.5°C to 47.5°C during the dry season. However, surface temperature values above 40°C accounted for less than 0.2% of the sheltered Stairway data collected during the study period, and they may be the result of short-term exposure to direct sunlight from its penetration through eyelets and loose seams in the tarp. The mean daily variation of surface temperature ranged from approximately 8°C to 12°C throughout the year (Figs. 72a, b), but daily variation values during the dry season displayed a wider range than those of the wet season. The maximum daily variation recorded for a sheltered surface temperature sensor during the study period was 25.5°C (south side of step 12).

Figures 71a and b Contour maps displaying the mean surface temperature (°C) on the Hieroglyphic Stairway during the wet season, May to October (a), and the dry season, November to April (b). Values indicate the mean seasonal level for specific sensors on the Stairway. The data were collected from March 2001 to August 2004 (known dates of shelter removal are excluded).

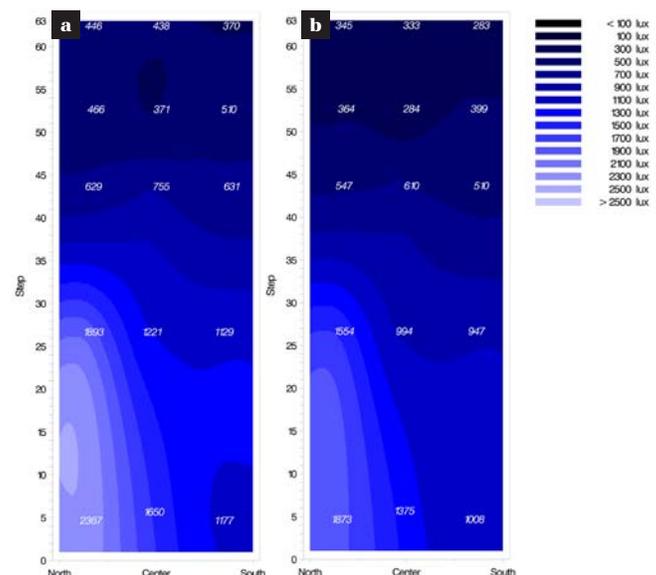
Figures 75a and b Contour maps displaying mean illumination (lux) at noon on the Hieroglyphic Stairway during the wet season, May to October (a), and the dry season, November to April (b). Values indicate the mean seasonal level for specific sensors on the Stairway. The data were collected from March 2001 to August 2004 (known dates of shelter removal are excluded).

Stairway displayed midday illumination values below 750 lux (both seasons), and mean values at the top step were as low as 280 lux (south side of step 65, dry season) (Figs. 75a, b). In contrast, midday illumination for the lower two-thirds of the Stairway, where the stone-tarpaulin distance was much greater, exceeded 1,120 lux and 940 lux during the wet and dry seasons, respectively. Furthermore, due to the wide contrast between the dimly lit upper Stairway and the bright sky (approximately 3,000 lux), which is brought into view through the opening at the top of the shelter, the upper reaches of the Stairway become very difficult to see when viewed from its base. Minimizing this contrast in illumination should improve the visual presentation.

Although it constitutes a lesser factor regarding viewing of the Stairway, a consistent year-round spatial pattern of Stairway illumination was observed because of the orientation of Structure 26, adjacent structures, and the tarpaulin shelter. Due to the relatively unobstructed north side of the Stairway—the south side is blocked by an adjacent structure—and the wider tarp-stone distances near its base, maximum mean illumination values (1,500 to 2,550 lux) were typically observed on the north sides of steps 5, 6, and 27 (Figs. 75a, b).

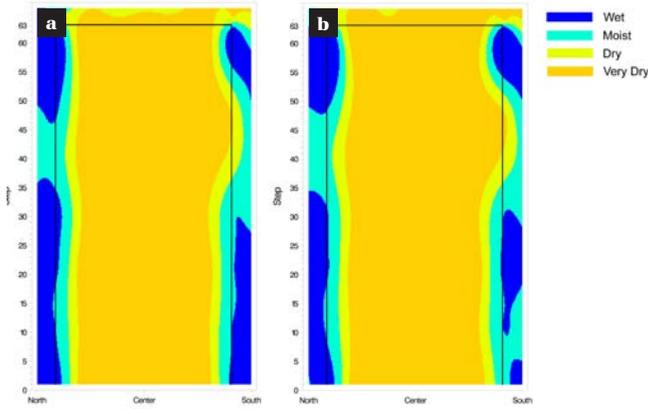
Figures 74a and b Contour maps displaying the discrete wet season perimeter time of wetness events at noon on September 24, 2001 (a), and September 10, 2002 (b). The resistance output of the sensors was categorized as follows: wet (0–10 k Ω), moist (10–100 k Ω), dry (100–1000 k Ω), and very dry (1000+ k Ω). Because of the protective shelter, the Hieroglyphic Stairway was assumed to be dry. The black borders within the figures delineate the top step of the Hieroglyphic Stairway and the north and south edges of the Stairway balustrade.

During the rainy season, the lower two-thirds of the Stairway perimeter remained wet (**Figs. 74a, b**). One factor may be the variability in distance between the Stairway and the tarpaulin from top to bottom. The larger distances between the tarp and stone in the lower sections of the Stairway can allow for wind-driven rain to reach the base of the balustrade and the Stairway itself. The presence of water on the Stairway has occasionally been observed—likely the result of wind-blown rain passing under the shelter.

A more important factor in perimeter wetness is the surface drainage surrounding the Stairway. The wetness displayed on the north side of the Stairway in Figures 74a and 74b is the result of a consolidated rubble slope between the Plaza floor and the Stairway’s midpoint that channels water toward the balustrade rather than away from it. A similar, but less drastic, scenario involves the terraces on the south side of the Stairway, extending from the Stairway base to roughly step 45 (above is consolidated rubble). This geometry provides for less-than-ideal drainage conditions, and accumulations of water have been observed on the terraces during periods of heavy rainfall. Although wetness sensors were not installed at its base, flooding at the bottom of the Stairway has also been observed during periods of heavy rain. These drainage problems should be corrected to allow for the swift drainage of rainwater away from the balustrade and the Stairway base, minimizing the potential for erosion, microbial growth, and salt migration.

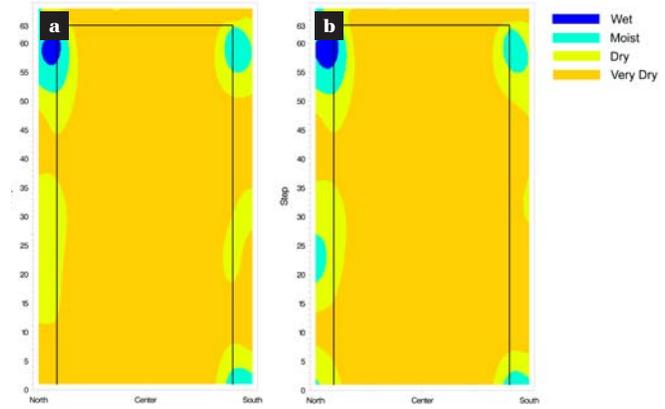
Although the Stairway perimeter remained dry in the absence of rainfall, the area between steps 54 and 62 on the north side of the balustrade, and to a lesser extent on the south side, exhibited apparent wetness (low electrical resistance) throughout the year (**Figs. 75a, b**). Since rainfall is largely

Figures 75a and b Contour maps displaying the discrete dry season perimeter time of wetness events at noon on March 17, 2001 (a), and April 1, 2002 (b). The resistance output of the sensors was categorized as follows: wet (0–10 k Ω), moist (10–100 k Ω), dry (100–1000 k Ω), and very dry (1000+ k Ω). Because of the protective shelter, the Hieroglyphic Stairway was assumed to be dry. The black borders within the figures delineate the top step of the Hieroglyphic Stairway and the north and south edges of the Stairway balustrade.

excluded from these areas by the shelter and because it can be disregarded as a factor during the dry season, these patches of low resistance may hint at the localized presence of salt.

Past restoration efforts utilized portland cement in the upper sections of the Stairway (Larios V. 1985c, 3), and the presence of sulfate and nitrate salts has been confirmed by material analyses of mortar samples (see “Analyses of Materials”). Moreover, the location of mortar samples harboring elevated concentrations of nitrate salts correlates well with the areas of low resistance shown near the top of the Stairway in Figures 75a and 75b. It is possible that salt-related damage can occur if intrusions of water in this area are allowed to deliquesce and transport salts. Future shelters should be able to provide at least the same level of protection as does the current shelter for this vulnerable location.

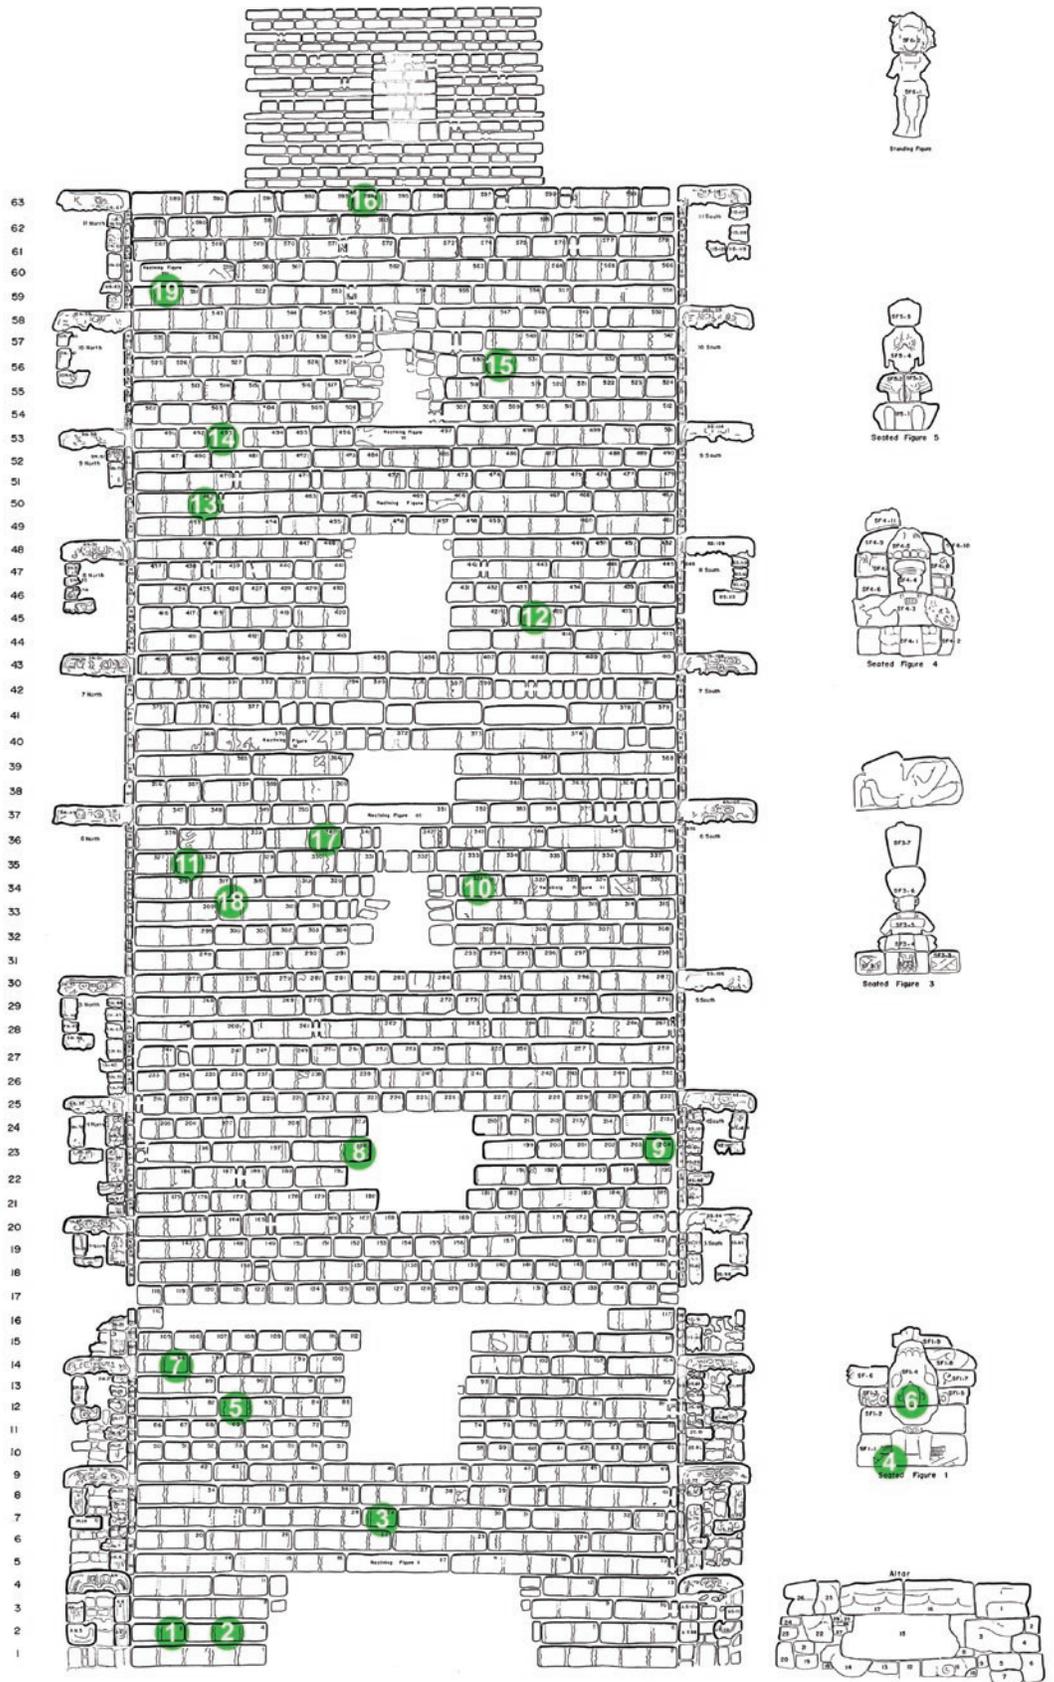
Forty samples were taken from the site and from the surrounding areas for the purpose of analyzing biodeterioration (**Fig. 77**). Sampling was usually carried out where macroscopic biodeterioration phenomena were appreciable; in some cases patinas

Figure 77 Locations of the biological samples taken from the Hieroglyphic Stairway, given as step number/glyph letter: 1 = 2/B; 2 = 2/D; 3 = 7/J; 4 = Seated Figure 1 (bottom); 5 = 12/D; 6 = Seated Figure 1 (mouth); 7 = 14/B; 8 = 23/I; 9 = 23/Q; 10 = 54/H; 11 = 35/B; 12 = 45/M; 13 = 50/D; 14 = 53/C; 15 = 56/J; 16 = 63/H; 17 = 36/F; 18 = 33/D (tread); 19 = 59/B (tread).

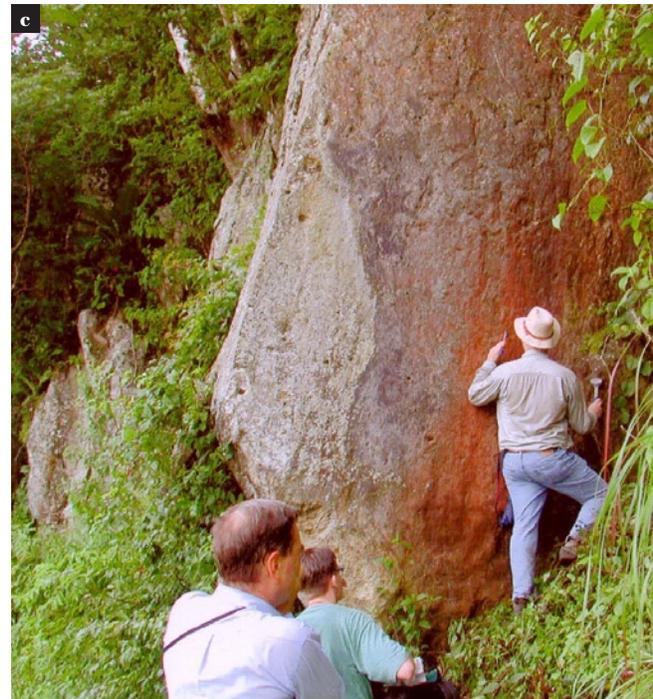
Figures 78a–c The present condition of sampled Stela H (a), of a sampled stela near the entrance (b), and of a sampled area of the quarry (c).

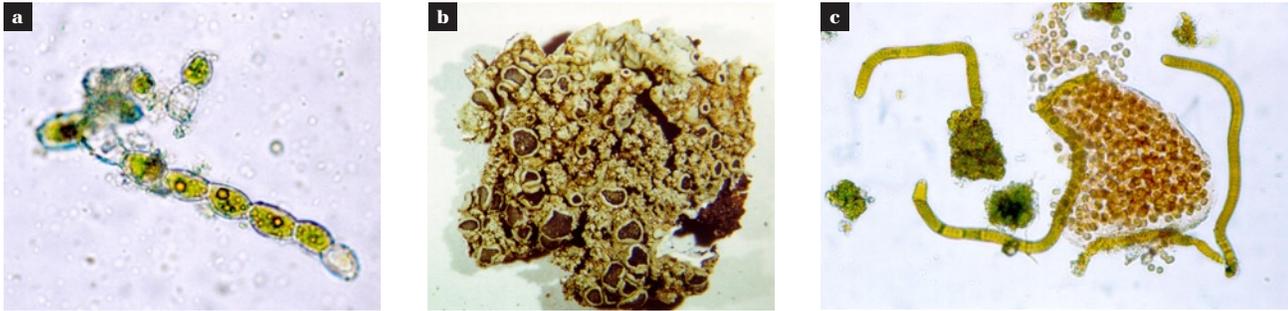
Figures 79a–c Microscopic view of (a) algal sample *Trentepohlia monilia* (x500), (b) lichen sample *Dirinaria picta*, and (c) cyanobacteria sample *Gloeocapsa rupestris* and *Scytonema javanicum* (x280) from Copán.

On the various monuments of the site, different patinas of cyanobacteria (e.g. *Gloeocapsa rupestris*, *G. kuetzingiana*, and especially *Stigonema hormoides* and *Scytonema javanicum*), green algae (*Trentepohlia aurea*), foliose and crustose lichens (e.g., *Parmelia incurva*, *Parmotrema crinitum*, *Candelaria concolor*, *Dirinaria picta*, *Buellia* sp.) (**Figs. 79a–c**), and cushions of mosses were widely distributed, especially in areas not protected from rainfall.

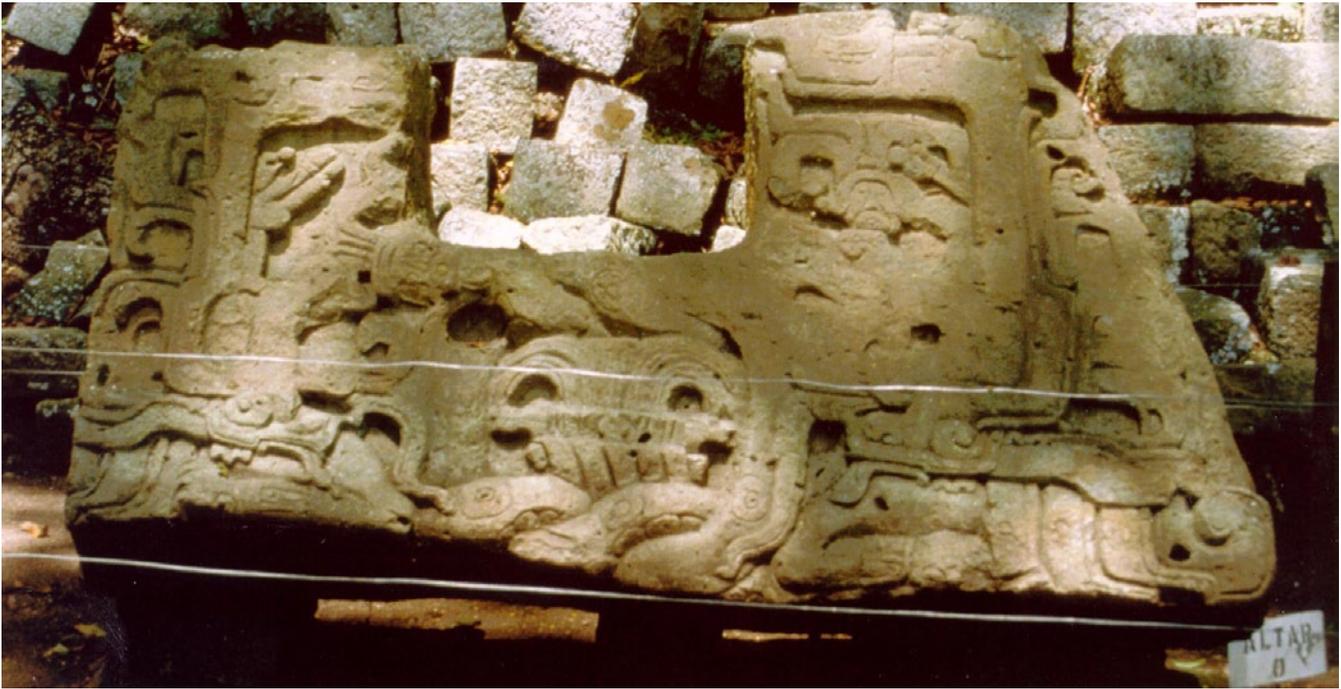
Figure 82 Altar 41 in 1985, after the biocide treatment for lichen removal.

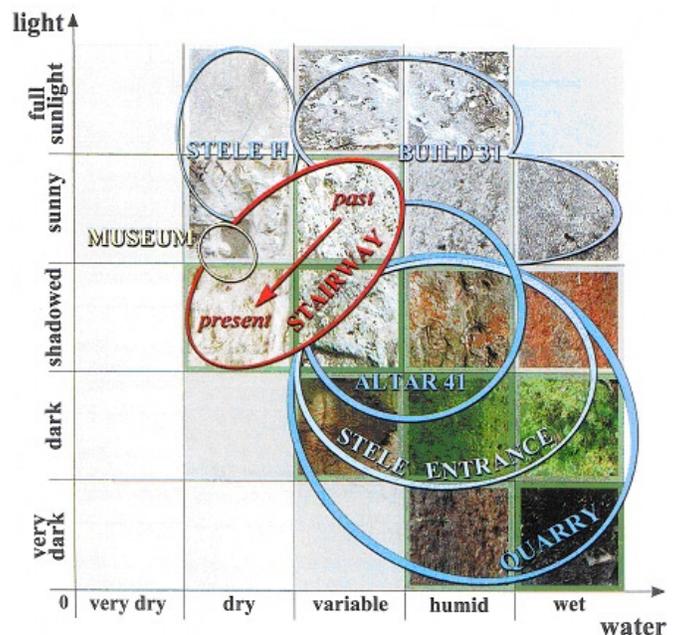
Figure 84 Ecological locations of the analyzed monuments in the Copán archaeological site, as well as the main biological weathering patterns (note also the changes of biodeterioration phenomena in the Hieroglyphic Stairway).

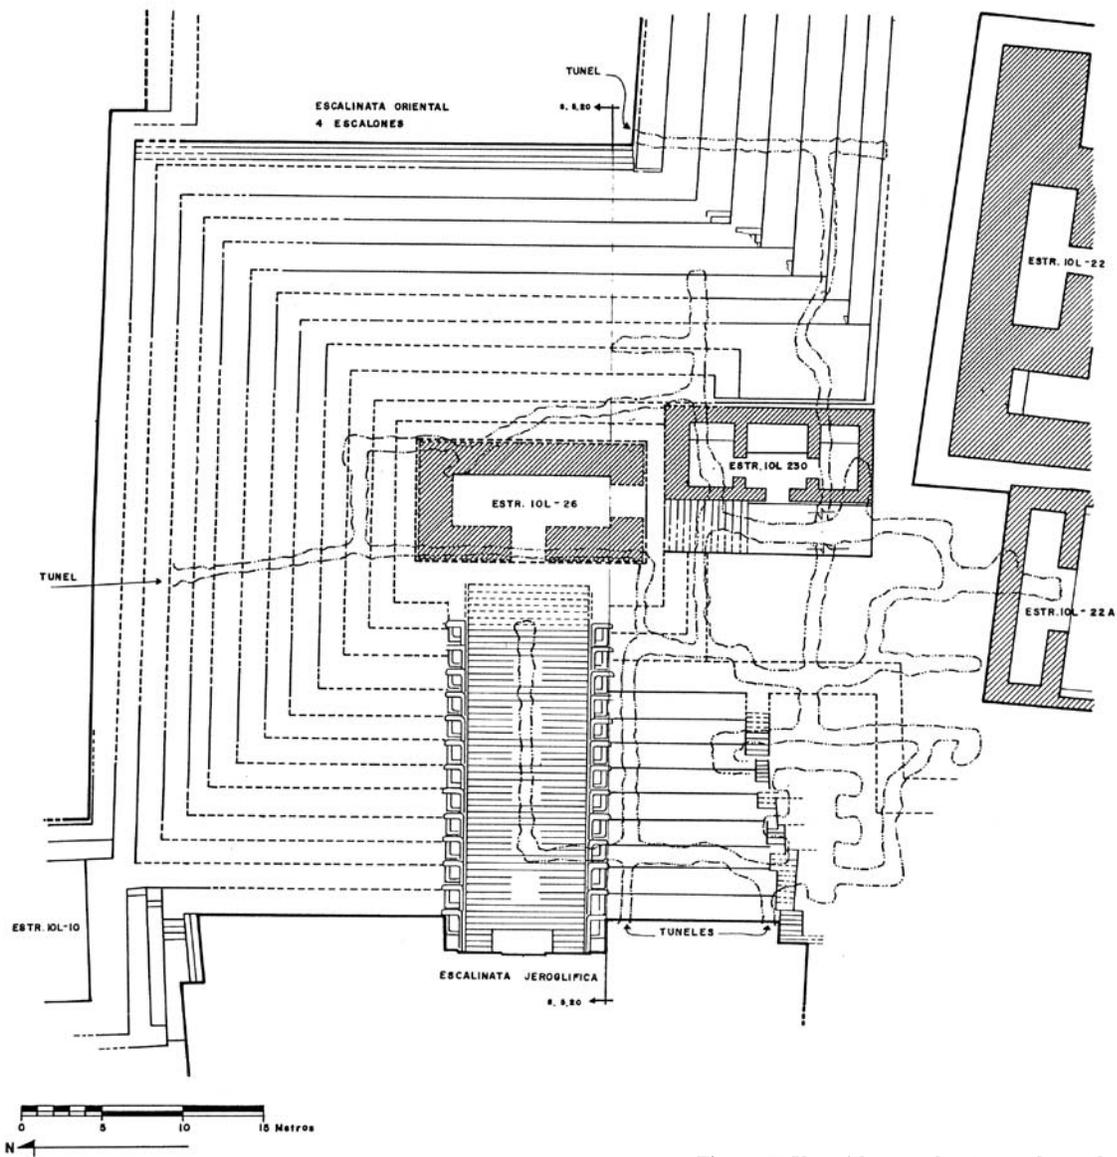
Numerous tunnels under the Copán Acropolis have been created throughout the years for the purpose of archaeological investigation. Some tunnels have been later backfilled, but most of them have been left open to maintain access to buried structures (**Fig. 89**).

Figure 89 Plan of the tunnel system underneath Structure 26.

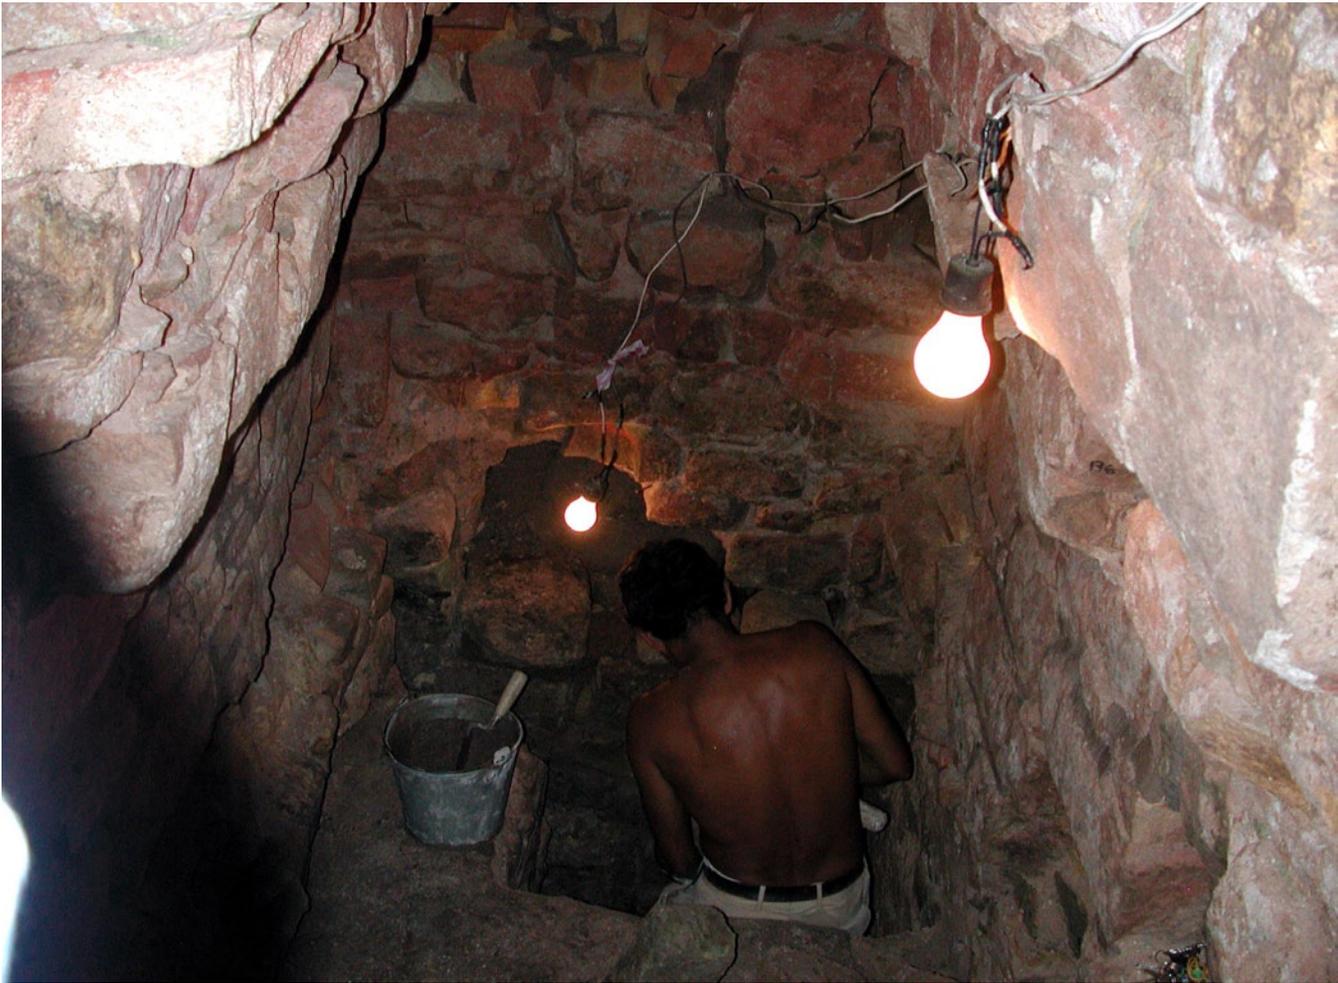
Underlying the final phase of Structure 26, which includes the Hieroglyphic Stairway, there is a successive series of monumental constructions that archaeologists have accessed through a network of tunnels (**Fig. 90**). No specific problems—in particular, tensile stress fractures indicating concentrations of load forces—were identified in the tunnels located in the area close to the Stairway. One shallow tunnel section, which had been excavated directly beneath the Stairway about halfway up the Structure has subsequently been filled with cobbles, sand, clayey earth and some cement. Another tunnel located farther from the Stairway was left unfilled, but it is at such a distance that it does not represent an immediate threat to stability. However, water infiltration and seismic activity represent threats to the stability of any tunnel, and a collapse could lead to major disruption to Structure 26, as well as to damage of the Stairway.

Figure 90 View of a tunnel in the Margarita Tomb, showing work in progress.

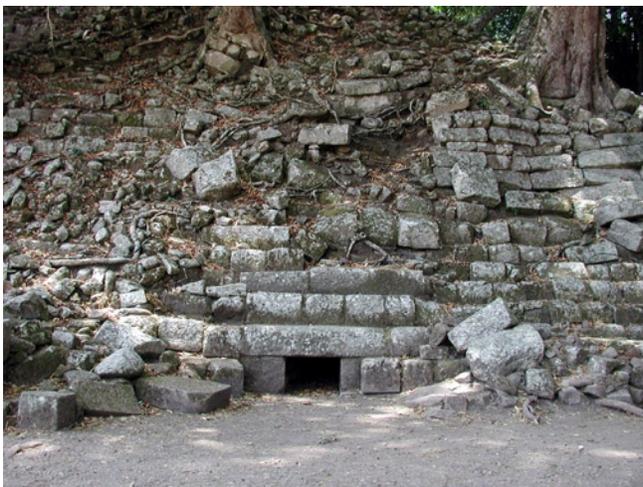
Ballcourt. There is no modern drainage system in the 250 by 100 meter area, but the ground is slightly sloping to the southwest corner of the Stairway Court, where an ancient rectangular drainage opening has been located (**Fig. 93**). Rough estimates suggest that this opening may be adequate to drain the Hieroglyphic Stairway Court during a normal heavy storm event but inadequate to remove rainwater from the entire area. The drainage of the main plazas is critical to the stability of tunnels within structures, at and below Plaza level (**Fig. 94**).

Figure 93 An ancient drain outlet in the southwest corner of the Court of the Hieroglyphic Stairway.

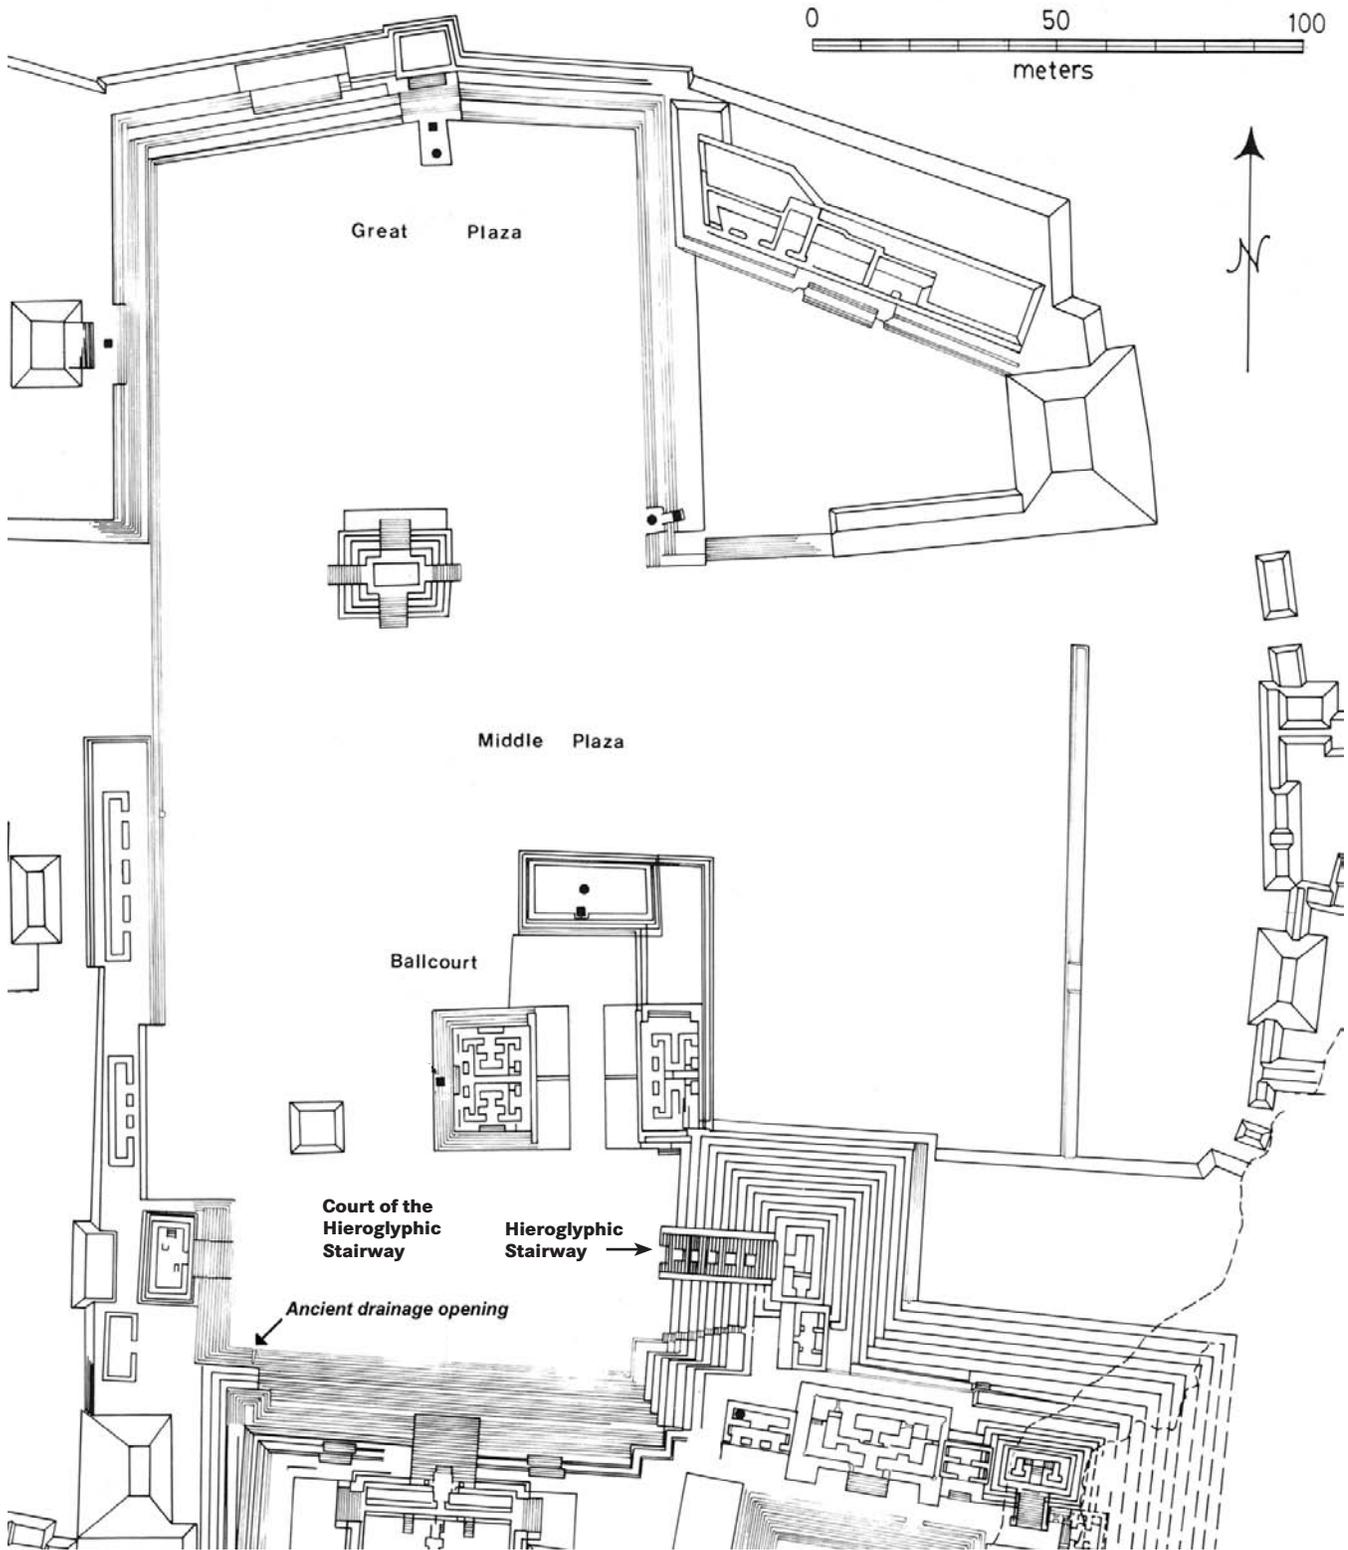
Figure 94 Map of the Great Plaza and the Court of the Hieroglyphic Stairway, showing the location of the ancient drain (see Fig. 95).
