LAETOLI

HOMINID TRACKWAY, SITE G

CONDITION RECORDS

G1 AND G2/3 FOOTPRINTS

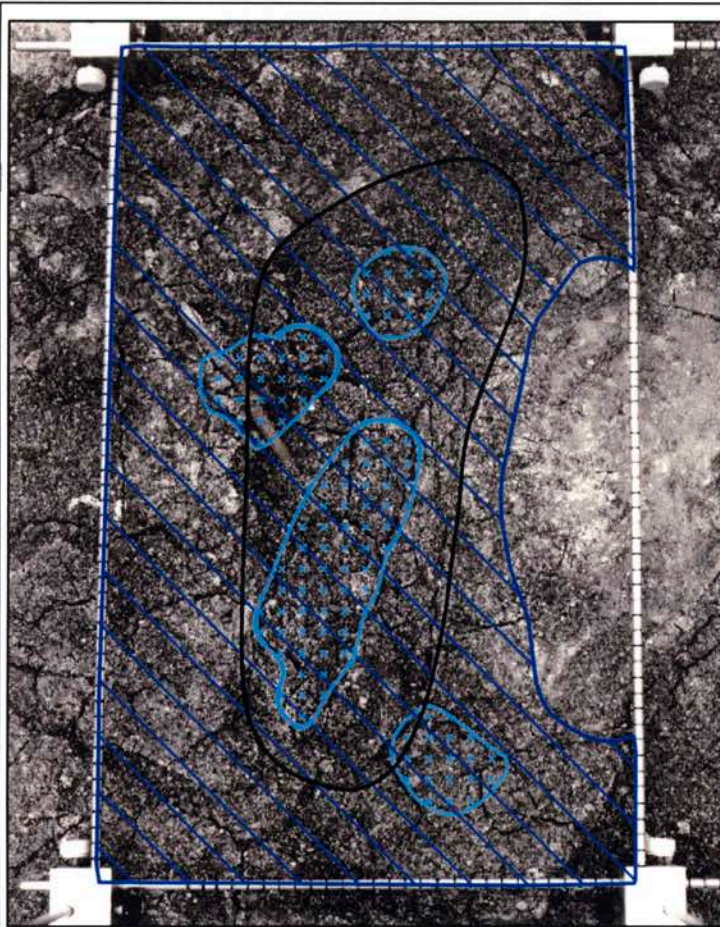
G1-19
TUFF CONDITIONS

General condition: Significant alteration: Poor

Weathering: Extensive and severe weathering throughout the print and surrounding tuff (with cracking to 0.5cm depth in 1-2 cm polygons).

Cracking: Two cracks in toe and heel area seen in 1978 photos were still evident in 1996 (not shown on graphic) but had merged with network of polygonal cracking of weathered tuff.

Detached/loose tuff: Areas of tuff along axis of print and outside margin of heel were loose. Tuff was also disrupted along the length of the root that traversed print.

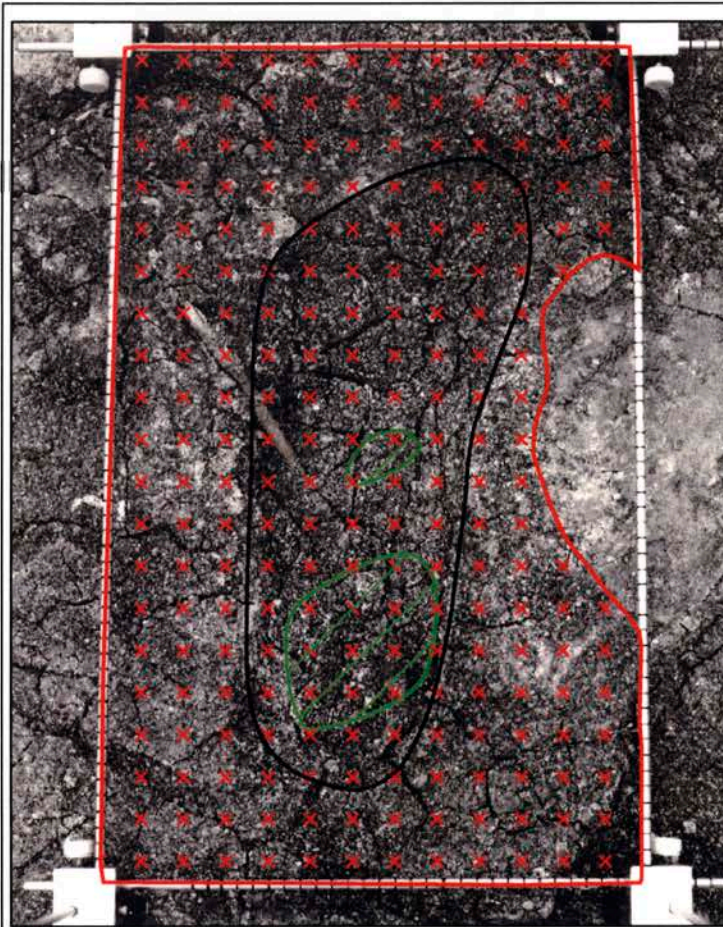
G1-19
CONDITIONS RELATED TO 1978-79 INTERVENTIONS

Bedacryl: Traces of Bedacryl stringers between cracks were found in the heel and arch portions.

Embedding: Embedding of fine particles in weathered areas and within cracks of weathered tuff.

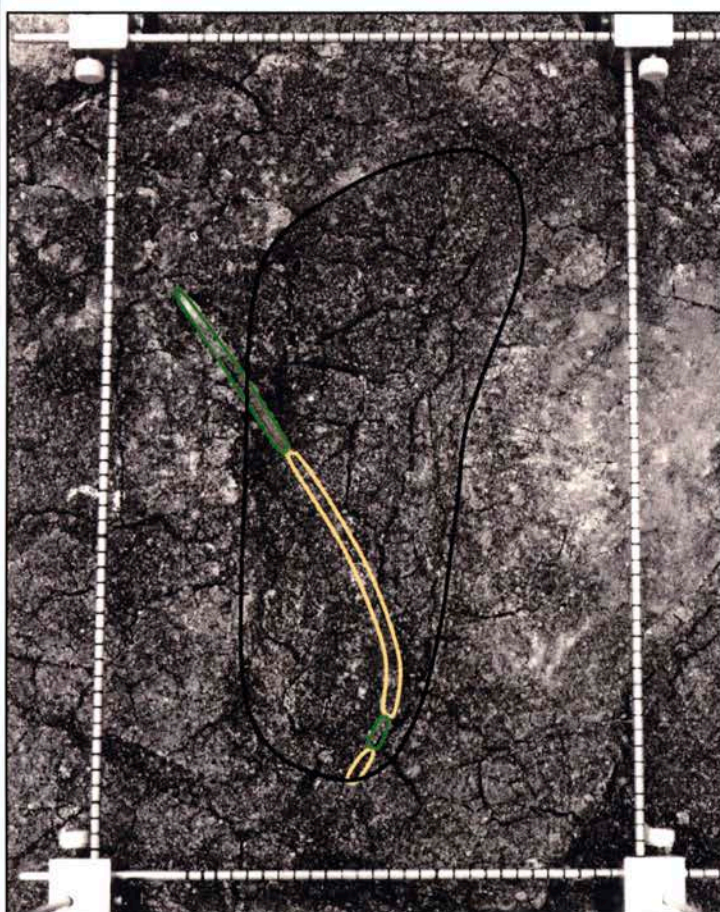
G1-19
ROOT DAMAGE AND INSECT ACTIVITY

Root damage: Large 5mm root penetrated tuff on interior lateral side near the arch, and progressed through the tuff, exiting and re-entering the tuff at the heel. Tuff was adhered to the root, and was disrupted along its length.

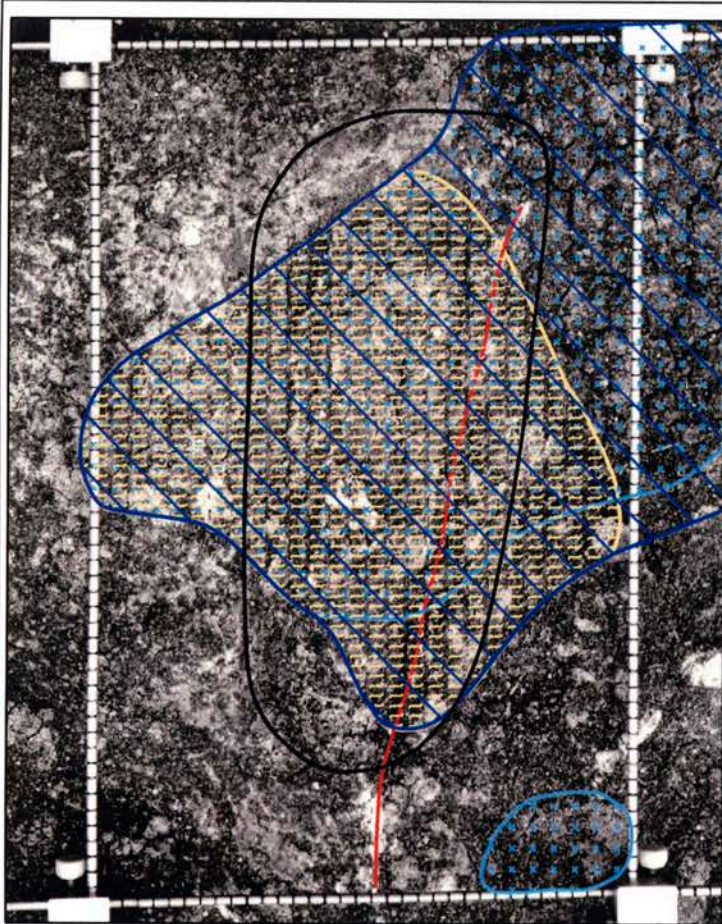
G1-21
TUFF CONDITIONS

General condition: Moderate alteration: Fair (unexcavated matrix)

Cracking: Crack with traces of calcite runs through infill matrix parallel to the medial margin.

Detached/loose: Infill matrix was loose from cracking, as were weathered areas of tuff outside print margin.

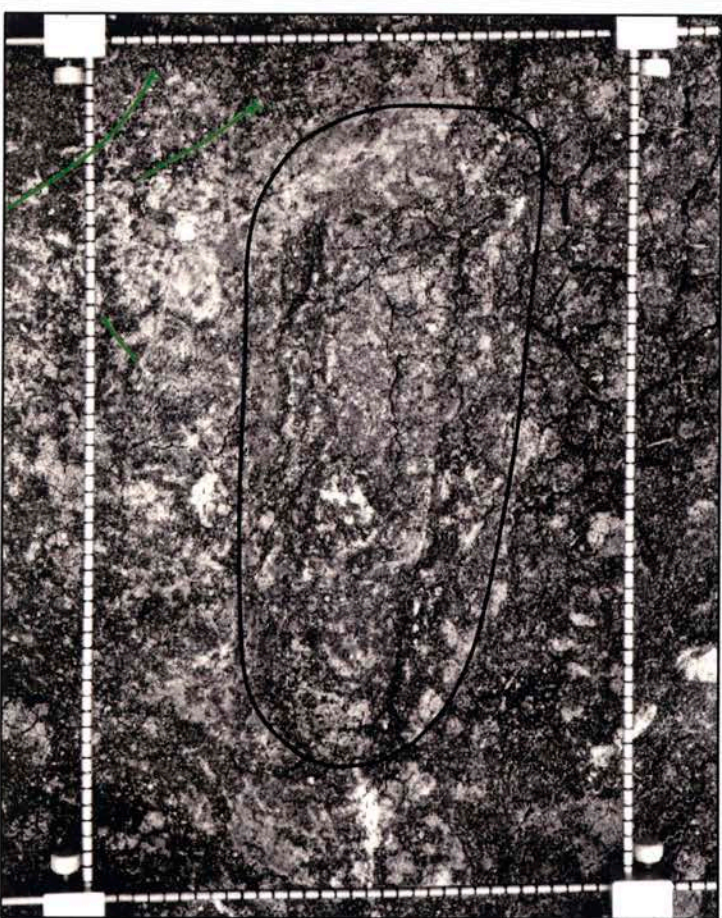
G1-21
ROOT DAMAGE AND INSECT ACTIVITY

Root damage: Rootlets on surface outside of lateral portion of print.

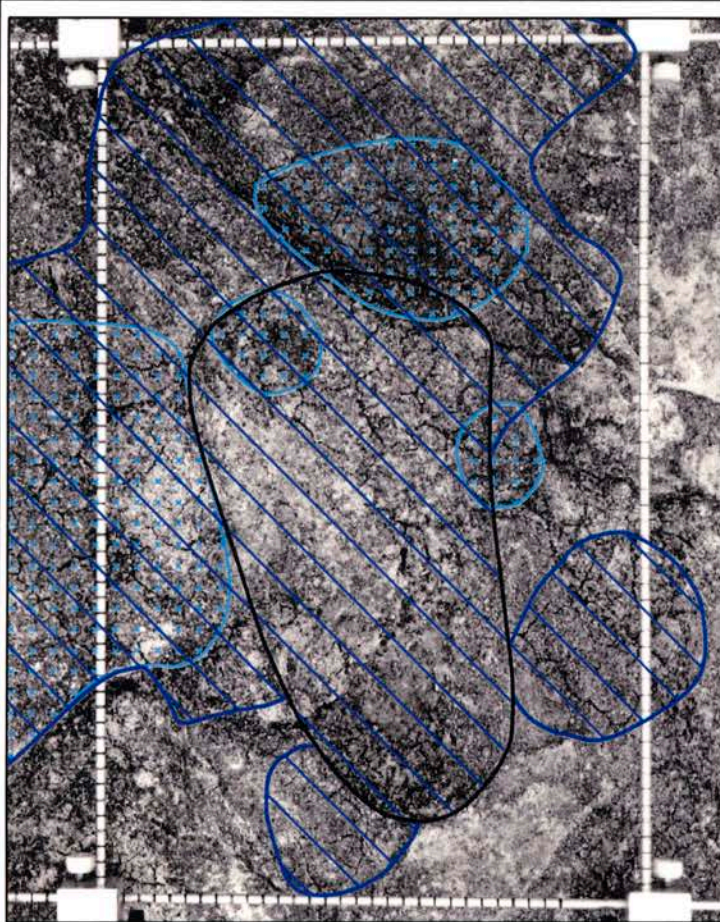
G1-22
TUFF CONDITIONS

<p><u>Location</u> Northern sector of trackway (in the graben), trench 6.</p>
<p><u>Excavation and Reburial History</u> Excavated and reburied in 1978; re-excavated and reburied in 1996.</p>
<p><u>1978-1979 Description</u> Complete right footprint.</p>
<p><u>1996 Condition</u> General condition: Moderate alteration: Fair</p> <p><u>Tuff conditions:</u> <u>Weathering:</u> Widespread, moderate weathering of tuff in and beyond print margins, with patches of well calcified tuff showing incipient weathering in the form of pattern cracking. <u>Cracking:</u> none <u>Losses:</u> none <u>Detached/loose tuff:</u> Loose tuff in area of great toe and on lateral margin; and outside medial and anterior margins. <u>Powdering:</u> none <u>Other:</u> none</p> <p><u>Conditions related to 1978-79 interventions:</u> <u>Bedacryl:</u> Slight traces of Bedacryl stringers in the anterolateral region. <u>Embedding:</u> Embedding of fine particles in the heel, lateral margin, and the great toe area. <u>Silicone:</u> Numerous traces of silicone outside the lateral margin of the print. <u>Excavation tool marks:</u> none <u>Inventory number on tuff:</u> none <u>Other:</u> none</p> <p><u>Root damage:</u> Small rootlet (<1mm diam.) penetrated heel margin of print. Root <5mm diam. and numerous small rootlets penetrated tuff outside of print and left impressions on tuff surface when removed.</p> <p><u>Insect activity:</u> none</p>

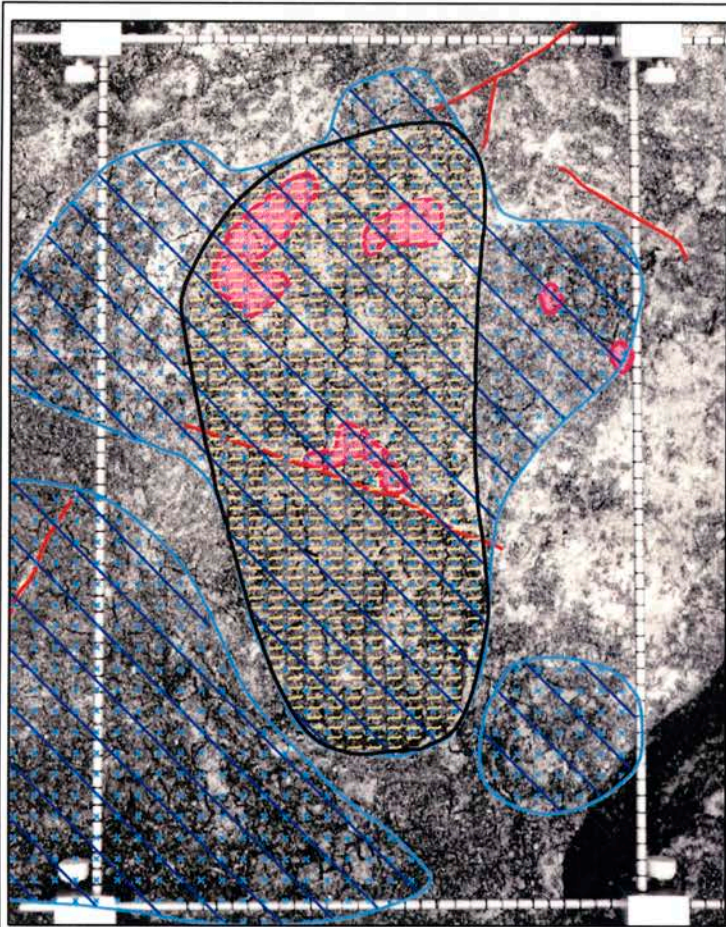
G1-23
TUFF CONDITIONS

<p><u>Location</u> Northern sector of trackway (in the graben), trench 6</p>
<p><u>Excavation and Reburial History</u> Outline of print was excavated and reburied in 1978 (infill of print not excavated in 1978); re-excavated and reburied in 1996.</p>
<p><u>1978-1979 Description</u> Complete left footprint. Again, it was impracticable to remove the filling but the form of the print is clear.</p>
<p><u>1996 Condition</u> <u>General condition:</u> Significant alteration: Poor (unexcavated matrix)</p> <p><u>Tuff conditions:</u> <u>Weathering:</u> Moderate to significant weathering of unexcavated matrix of print and surrounding tuff, especially on lateral side. <u>Cracking:</u> Cracks with calcite veins traversed the center of the print and were evident outside the margin of the print. <u>Losses:</u> Slight loss of surface of unexcavated tuff matrix from abrasion during removal of embedded fines in anterior and center of print. <u>Detached/loose tuff:</u> Loose tuff in weathered areas, including unexcavated matrix. <u>Powdering:</u> Unexcavated tuff matrix of print exhibited powdering on surface. <u>Other:</u> none</p> <p><u>Conditions related to 1978-79 interventions:</u> <u>Bedacryl:</u> none <u>Embedding:</u> Embedding of fine particles in weathered tuff, especially in heel area. <u>Silicone:</u> none <u>Excavation tool marks:</u> Marks of scoring on unexcavated matrix were visible along external rim of print (not shown on graphic; see comparison with photographs). <u>Inventory number on tuff:</u> none <u>Other:</u> none</p> <p><u>Root damage:</u> Numerous small rootlets penetrated tuff outside of print in heel area (not shown on graphic). Root impression in tuff outside anterior margin of print.</p> <p><u>Insect activity:</u> none</p>

Excavated 1978 reburial fill was very wet throughout the graben in 1996. Unexcavated tuff matrix in print was cracked and loose, and appeared as though it would release easily from the substrate of the print. Heel area excavated in 1978 to a slightly greater depth than surrounding matrix; the calcite lining of the print along the heel margin was clearly visible and intact.

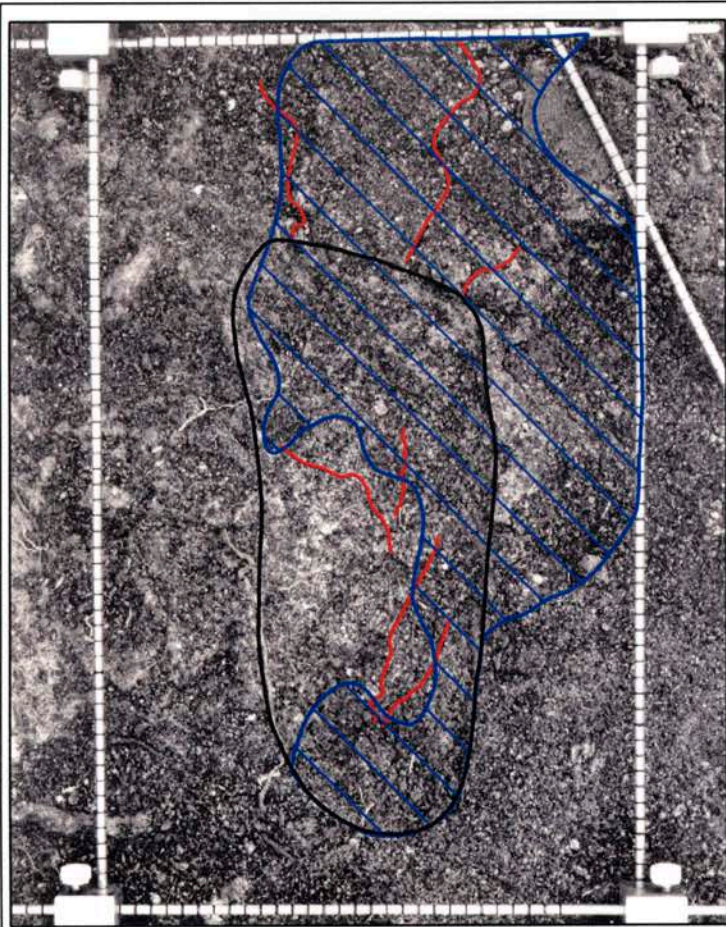
G1-24
TUFF CONDITIONS

<p><u>Location</u> Middle sector of trackway, trench 4.</p>
<p><u>Excavation and Reburial History</u> Excavated and reburied in 1978; re-excavated and reburied in 1996.</p>
<p><u>1978-1979 Description</u> Complete right footprint.</p>
<p><u>1995 Condition</u> <u>General Condition:</u> Minor alteration: Good</p> <p><u>Tuff conditions:</u> <u>Weathering:</u> Slight weathering of tuff on floor and margins of the print; and outside lateral and anterior margins. Elsewhere embedding obscures the well-consolidated tuff that characterizes this area. <u>Cracking:</u> Hairline cracks in central portion of print; and outside anterior margin. <u>Losses:</u> none <u>Detached/loose tuff:</u> none <u>Powdering:</u> none <u>Other:</u> none</p> <p><u>Condition related to 1978-79 interventions:</u> <u>Bedacryl:</u> Bedacryl was not visible <i>in situ</i>, but can be seen on 1978 photos as a distinct halo around the print. <u>Embedding:</u> Moderate embedding of fine particles on the interior portion of the print; and outside anterior margin, particularly within weathered areas. <u>Silicone:</u> Traces of silicone on the interior of the print; and outside of anterior margin of print. <u>Excavation tool marks:</u> none <u>Inventory number on tuff:</u> none <u>Other:</u> none</p> <p><u>Root damage:</u> Numerous small roots and rootlets (<1mm diam.) on surface and penetrating tuff or the layer of embedded particles. Roots identified as asparagus and acacia.</p> <p><u>Insect activity:</u> none</p>

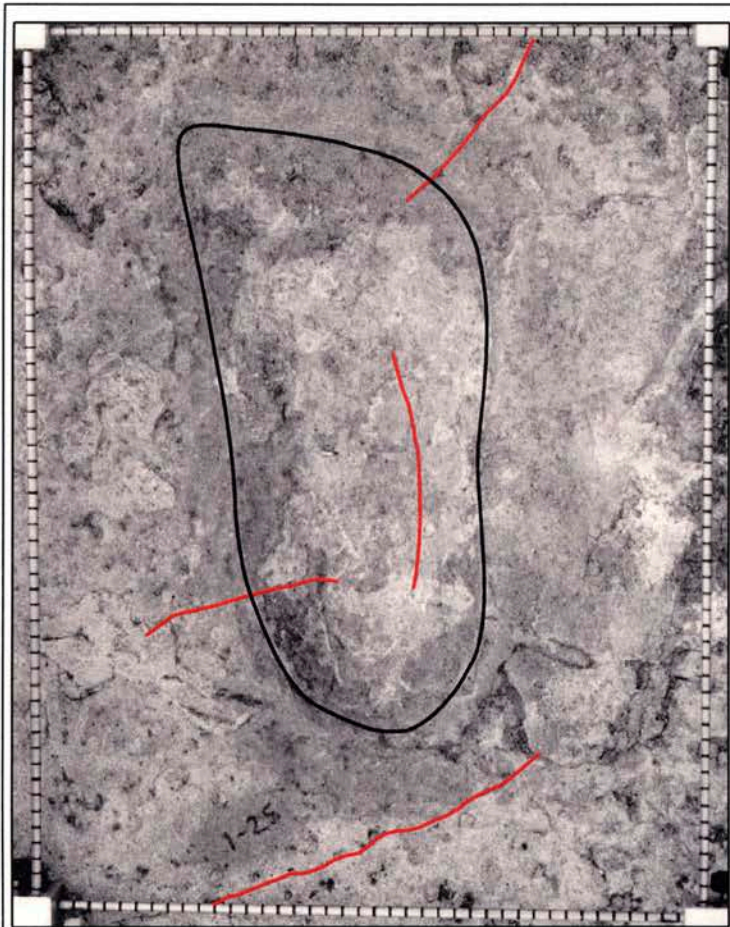
GI-25
TUFF CONDITIONS

General condition: Minor alteration: Good

Cracking: Hairline cracks on interior of print, and extending outside anterior and medial margins

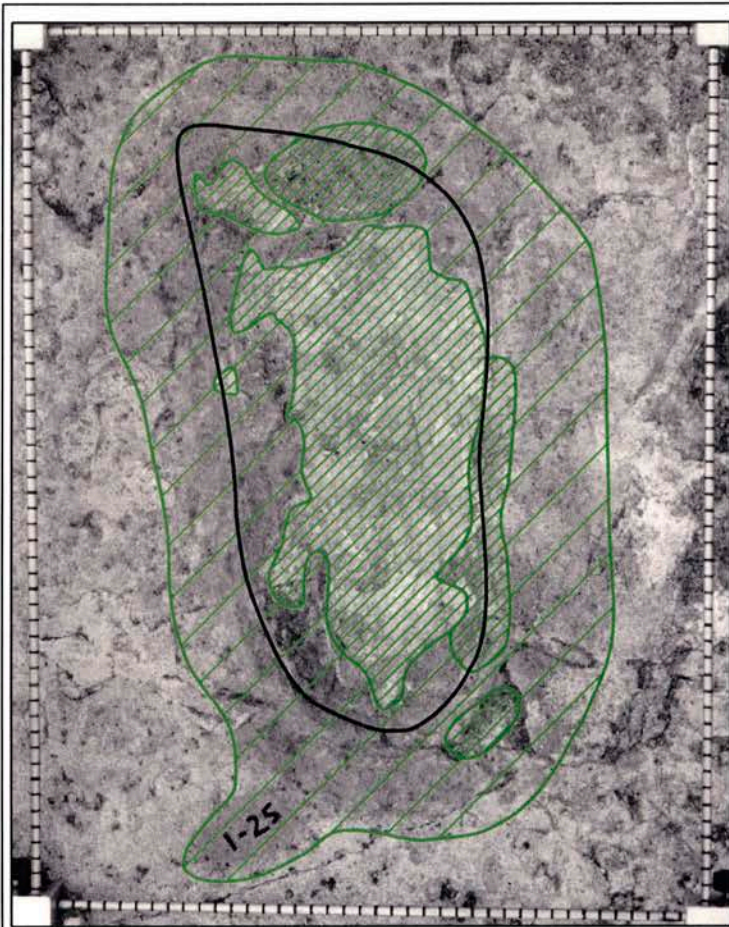
GI-25
CONDITIONS RELATED TO 1978-79 INTERVENTIONS

Bedacryl: Bedacryl found throughout most of the print, except in the central portion where it was missing, and outside margins of print. Patches of Bedacryl deteriorated along anterior and lateral margins. Area of missing Bedacryl creates a marked color difference with the Bedacryl coated parts (see Notes).

The condition of the print appeared unchanged from the 1993 assessment. It is surmised that the Bedacryl layer at the bottom of the print was removed during the molding process in 1979.

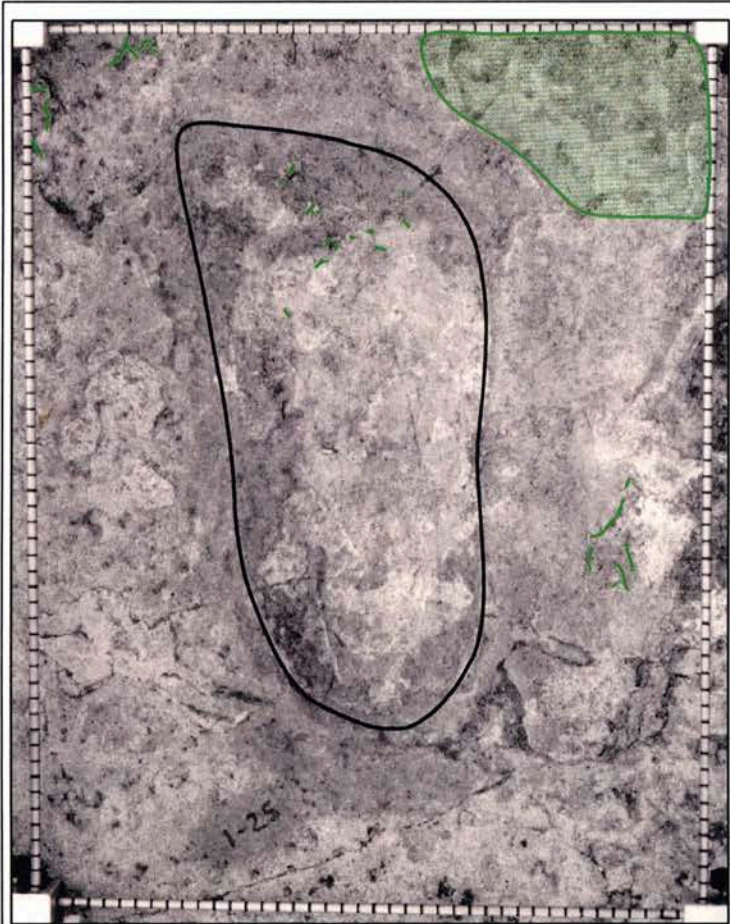
GI-25
ROOT DAMAGE AND INSECT ACTIVITY

Root damage: A few rootlets on the surface of tuff in anterior portion and a root mat outside margins of print.

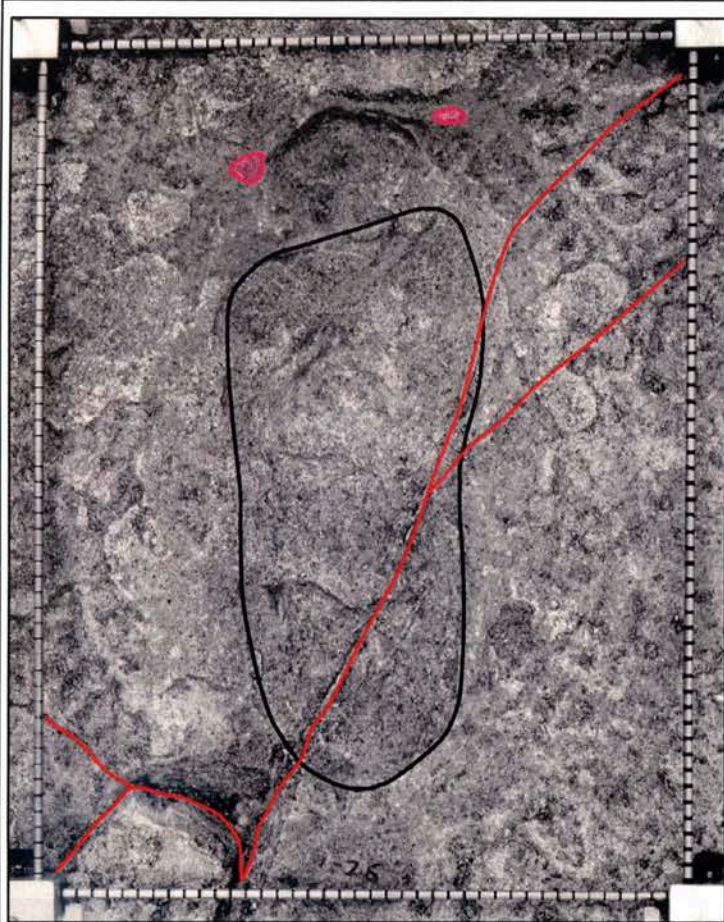
G1-26
TUFF CONDITIONS

<p><u>Location</u> Southern sector of trackway, trench 2.</p>
<p><u>Excavation and Reburial History</u> Partially excavated and reburied in 1978; excavated and reburied in 1979; re-excavated and reburied in 1995.</p>
<p><u>1978-1979 Description</u> Well preserved left footprint, the toes have been partially destroyed by a superimposed ?carnivore print.</p>
<p><u>1995 Condition</u> General condition: Minor alteration: Good</p> <p><u>Tuff conditions:</u> <u>Weathering:</u> none <u>Cracking:</u> Prominent crack with calcite vein traverses print along medial margin and extends beyond margins of print. <u>Losses:</u> Two minor areas of tuff loss noted outside margin of carnivore print (anterior to the hominid print), but these are also evident on the 1979 cast (see also <u>Bedacryl</u>). <u>Detached/loose tuff:</u> none <u>Powdering:</u> none <u>Other:</u> none</p> <p><u>Conditions related to 1978-79 interventions:</u> <u>Bedacryl:</u> Bedacryl throughout most of the print and surrounding it, though the layer had severely deteriorated in posterior half of print. Bedacryl appears to have been applied in a thin coat to this print. Two small patches of missing Bedacryl on the margins of the carnivore print correspond with tuff loss, indicating detachment during molding in 1979. <u>Embedding:</u> none <u>Silicone:</u> none <u>Excavation tool marks:</u> Tool marks on the floor of the print not recorded in condition survey, but were recorded in geological survey. <u>Inventory number on tuff:</u> 1979 label ("1-26") visible on tuff surface. <u>Other:</u> none</p> <p><u>Root damage:</u> Numerous tiny rootlets (graphically shown as root mat) weaved in and out of the deteriorated Bedacryl layer but did not appear to penetrate the footprint tuff.</p> <p><u>Insect activity:</u> none</p>

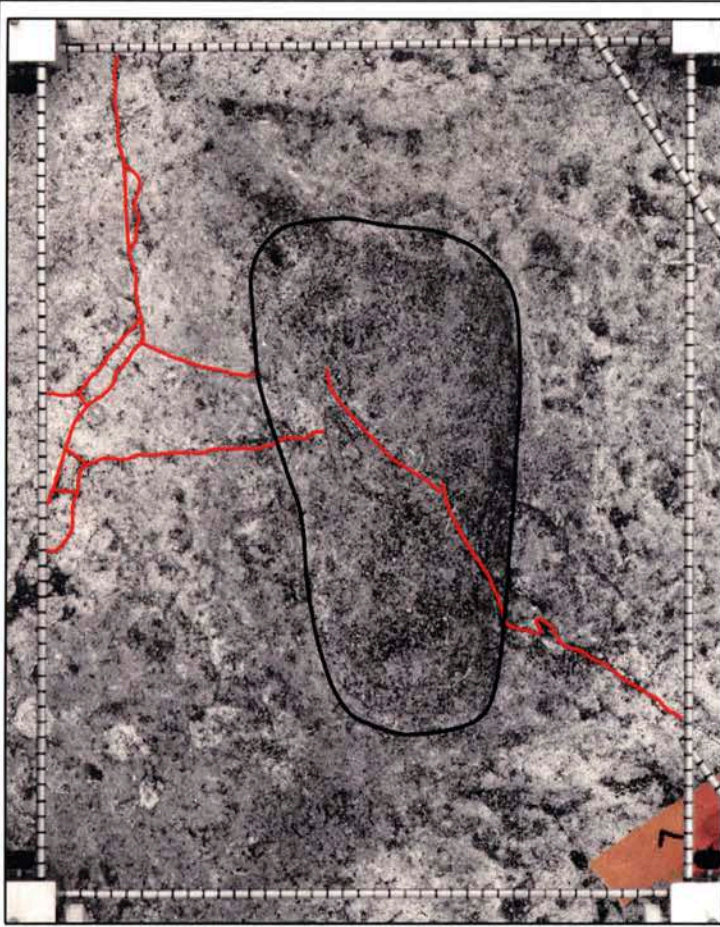
G1-27
TUFF CONDITIONS

General condition: Minor alteration: Good

Cracking: Crack traverses print; network of cracks with calcite vein outside medial margin.

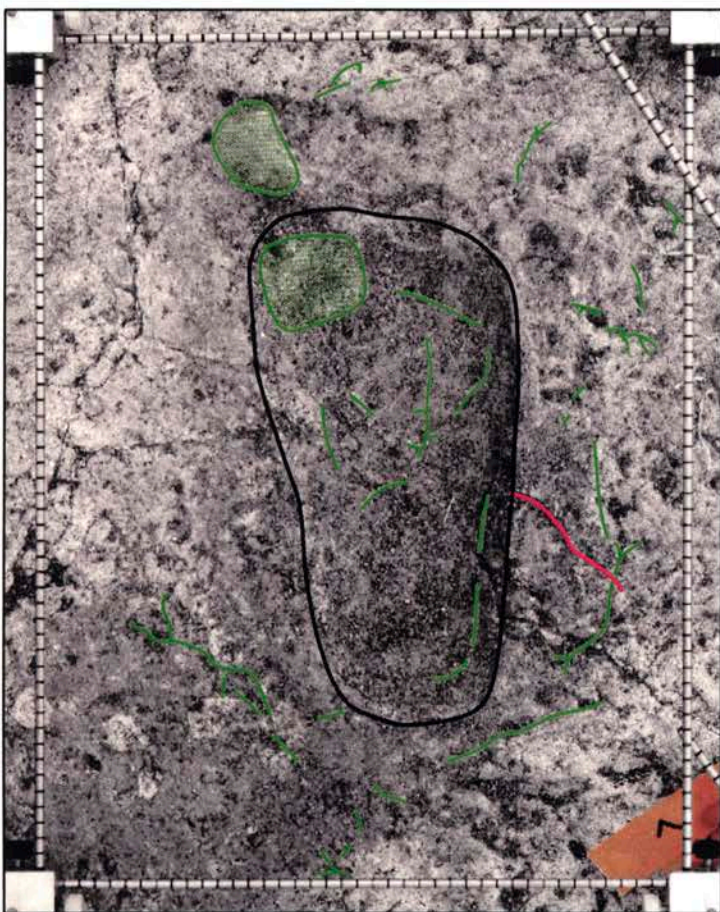
G1-27
ROOT DAMAGE AND INSECT ACTIVITY

Root damage: Numerous tiny rootlets on surface and matted in ball of foot and scuff-out area, but did not penetrate the footprint tuff. One rootlet left impression in tuff on lateral posterior margin.

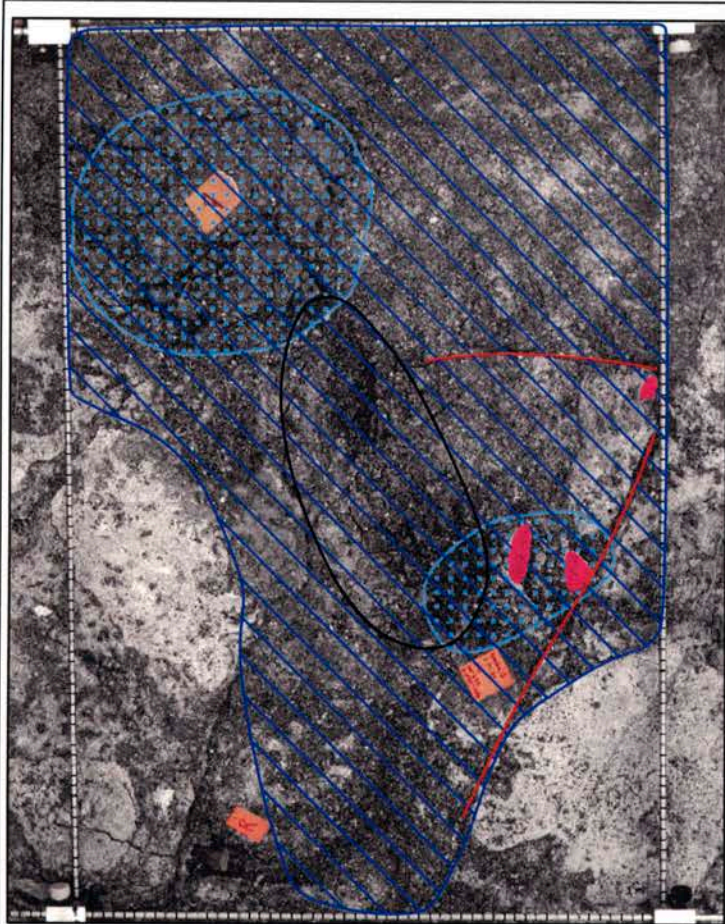
G1-28
TUFF CONDITIONS

General condition: Significant alteration: Poor condition

Weathering: Extensive weathering of tuff in floor of print and extending beyond margins of the print. G1-28 is located in the weathered strip of tuff in the southern trackway sector, characterized by patterned cracking with patches of well-consolidated tuff.

Cracking: Large crack with partially preserved calcite outside anteromedial margin; a second crack runs perpendicular to the axis of the print, outside medial margin.

Detached/loose tuff: Loose tuff anterior to print (associated with root disruption), and at heel margin.

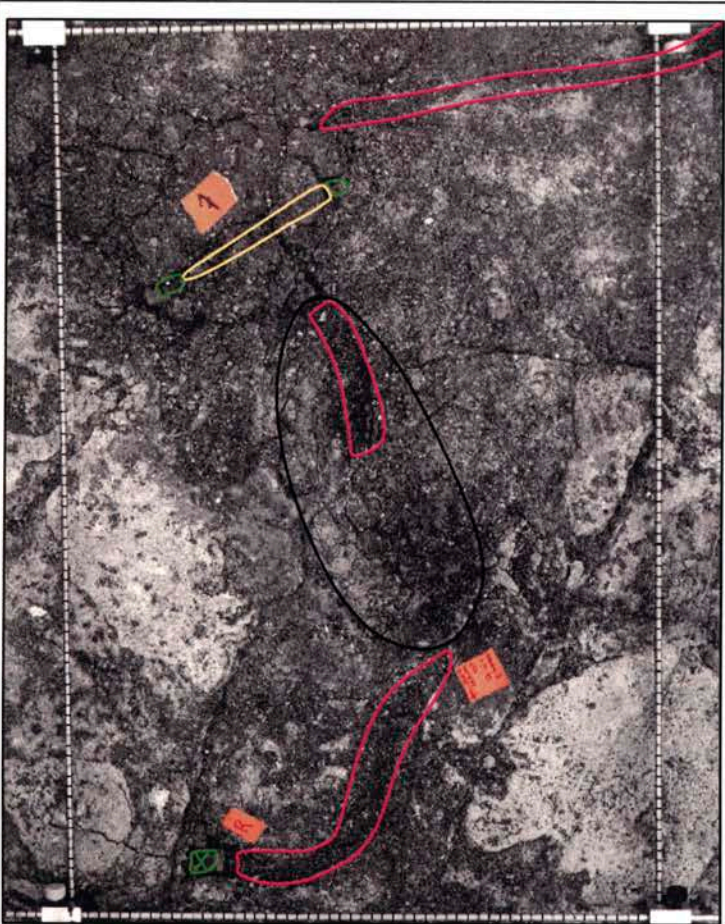
Root damage: Tuff was disrupted and loose from a large penetrating root outside anterior margin; the root was from stump no. 84. A second root penetrated the tuff well outside the posterior margin. Surface roots left three impressions in the tuff (one inside and two outside the print margins). Numerous small roots weaved through the cracked, weathered tuff.

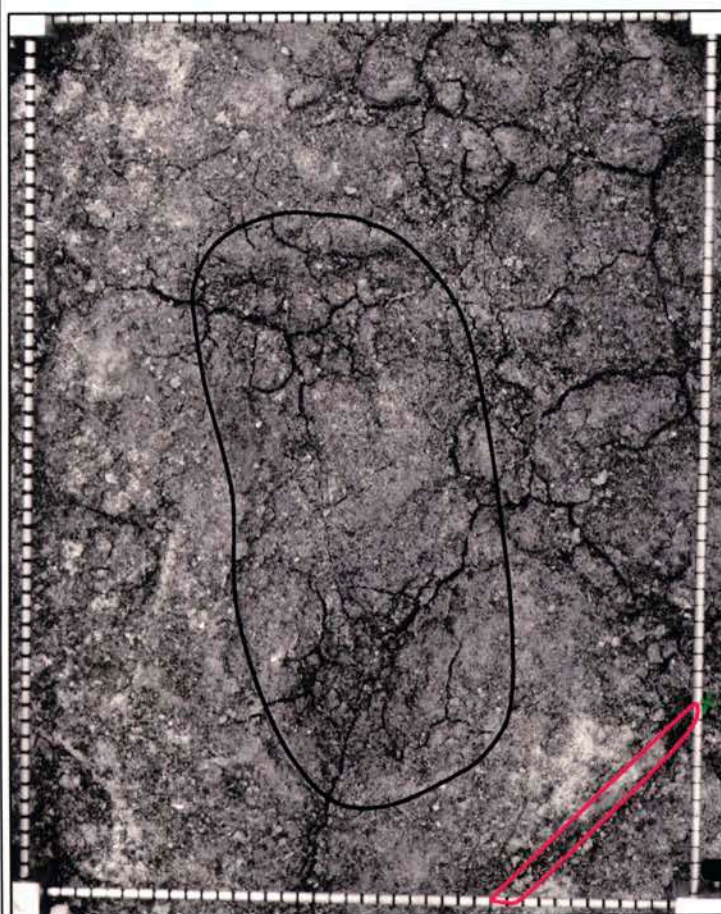
G1-29
ROOT DAMAGE AND INSECT ACTIVITY

<p><u>Location</u> Southern sector of trackway, trench 2.</p>
<p><u>Excavation and Reburial History</u> Excavated and reburied in 1979; partially exposed and reburied in 1992 and 1993; re-excavated and reburied in 1995.</p>
<p><u>1978-1979 Description</u> Left footprint also cracked and damaged by roots, especially by a young <i>Acacia</i> tree growing through the centre of the print.</p>
<p><u>1995 Condition</u> General condition: Moderate alteration: Fair</p> <p><u>Tuff conditions:</u> <u>Weathering:</u> Moderate weathering of tuff inside print margins; extensive weathering outside lateral and posterior margins. Patches of well-consolidated but fragmented tuff within print margins and outside anterior and medial margins. This print is located within the weathered strip of tuff in the southern sector of the trackway, characterized by patterned cracking with deep fissures that are filled with overburden. <u>Cracking:</u> Principally as a result of weathering of tuff (not shown as cracking on graphic). <u>Losses:</u> Minor surface loss of tuff just outside posteromedial margin. <u>Detached/loose tuff:</u> none <u>Powdering:</u> none <u>Other:</u> Disruption of tuff in an area inside and outside anterior margin of print, probably caused by root from stump no. 83, which penetrated the tuff just to the north.</p> <p><u>Conditions related to 1978-79 interventions:</u> <u>Bedacryl:</u> Bedacryl throughout print and outside medial and posterior margins. <u>Embedding:</u> Embedding of particles in weathered areas. <u>Silicone:</u> Traces of silicone inside print, particularly noticeable around decayed tree stump near the center of print; also numerous traces outside print. <u>Excavation tool marks:</u> none <u>Inventory number on tuff:</u> 1979 label ("1-30") visible on tuff surface. <u>Other:</u> none</p> <p><u>Root damage:</u> Stump of an acacia tree (inv. no. 157), cut and killed in 1979, had decayed and left a bark-lined void in the bottom of the print.</p> <p><u>Insect activity:</u> none</p>

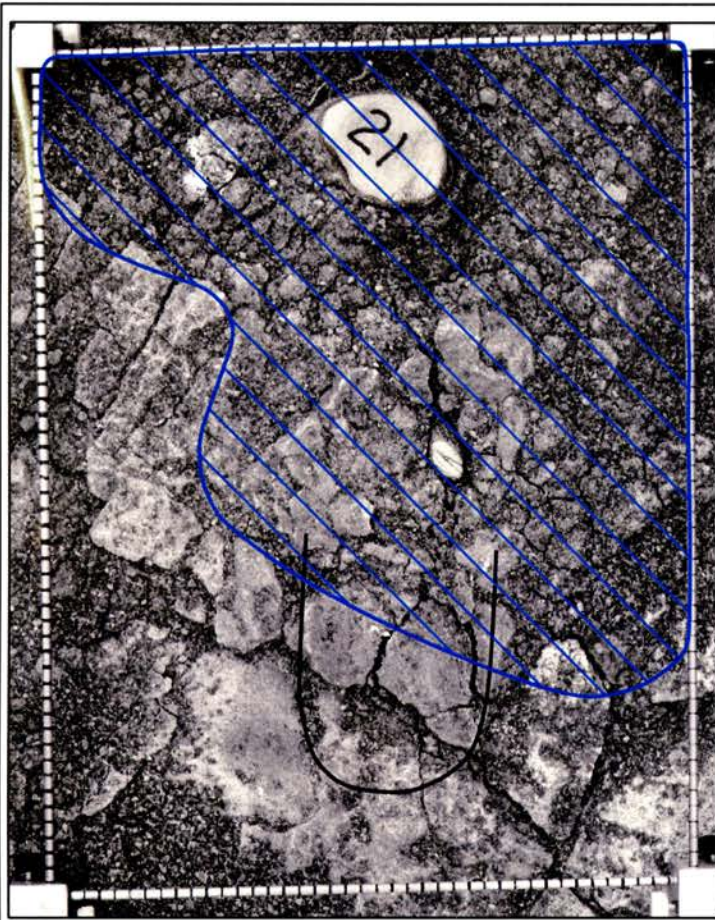
G1-32
TUFF CONDITIONS

<u>Location</u> Southern sector of trackway, trench 2.
<u>Excavation and Reburial History</u> Excavated and reburied in 1979; re-excavated and reburied in 1995.
<u>1978-1979 Description</u> Heel print only on uplifted fault block, probably of a left foot.
<u>1995 Condition</u> <u>General condition:</u> Moderate alteration: Fair <u>Tuff conditions:</u> <u>Weathering:</u> Advanced weathering in an area of fractured, calcite-cemented tuff; weathering was particularly severe around stump no. 21. This print is located in the weathered zone of the southern sector, characterized by patterned cracking and deep fissures filled with overburden. <u>Cracking:</u> Extensive cracking associated with weathering (not shown on graphic). <u>Losses:</u> none <u>Detached/loose:</u> none <u>Powdering:</u> none <u>Other:</u> none <u>Conditions related to 1978-79 interventions:</u> <u>Bedacryl:</u> none <u>Embedding:</u> Severe embedding of particles throughout weathered tuff. <u>Silicone:</u> Traces of silicone on tuff. <u>Excavation tool marks:</u> none <u>Inventory number on tuff:</u> 1979 label ("1-32") visible on tuff surface. <u>Other:</u> none <u>Root damage:</u> Stump of acacia tree no. 21 penetrated tuff outside anterior portion of print; an adventitious root of stump no. 21 penetrated tuff anterior to heel portion. <u>Insect activity:</u> none

<u>1995 Interventions</u> <u>Consolidation/stabilization:</u> Tuff surrounding stump no. 21 and its associated root was consolidated with WS-24 at 4% (shown on flyover Polaroid graphic 1995: VIII-2) <u>Fills:</u> none <u>Reattachment:</u> none <u>Root treatment:</u> Stump and root cut flush with tuff and treated with PCP (pentachlorophenol) wood preservative to prevent rapid decay of the wood and subsequent collapse of tuff. <u>Other:</u> none
<u>Comparison with 1978-79 Cast/Photograph</u> No cast. 1978 photograph (only one photo available) may show footprint before completion of excavation. Fractured and weathered tuff in the area defined as the print is evident in 1978 photo and showed little change in 1995, other than disruption of tuff caused by root of stump no. 21. 1978 photo shows extensive network of small roots from shallow overburden.

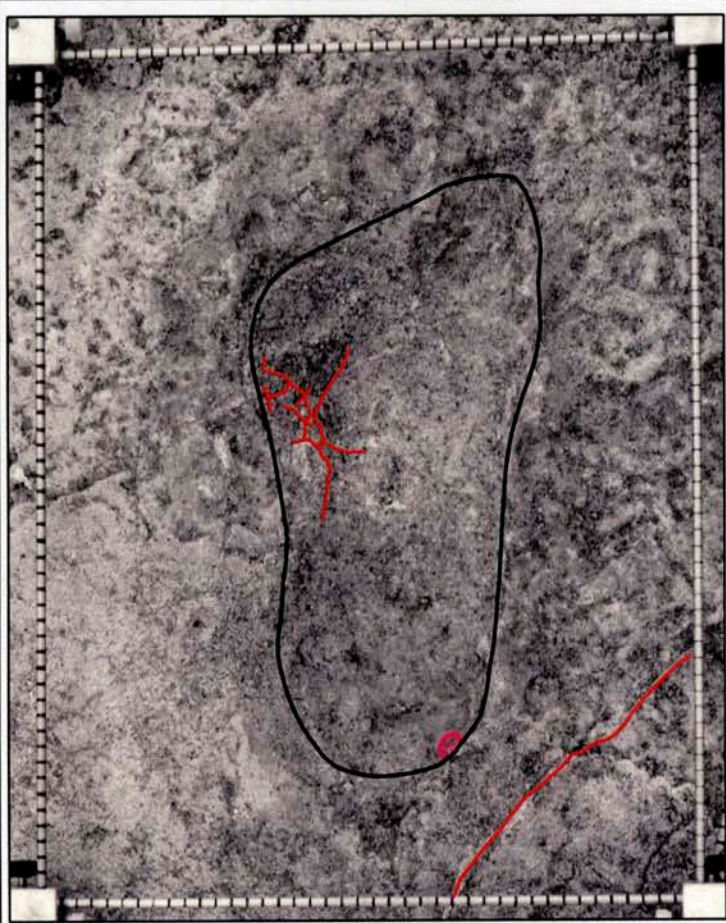
G1-33
TUFF CONDITIONS

1995 Condition**General condition:** Minor alteration: Good**Tuff conditions:**Weathering: noneCracking: Hairline sized cracks on the lateral margin; large crack with calcite vein outside of posteromedial margin.Losses: Minor surface loss of tuff on medial heel margin.Detached/loose: nonePowdering: noneOther: none**Conditions related to 1978-79 interventions:**Bedacryl: Bedacryl found throughout the print and surrounding tuff surface; slightly deteriorated with small patches of loss in the anterior portion of the print, and along medial side of heel impression.Embedding: Slight embedding of fine particles in Bedacryl layer.Silicone: Traces of silicone lateral to the print margin.Excavation tool marks: Excavation tool marks, very faint, concentrated in heel area; tool identified as dental pick.Inventory number on tuff: 1979 label ("1-33") visible on tuff surface.Other: none**Root damage:** Small rootlets penetrated the Bedacryl layer, but not the tuff.**Insect activity:** none**1995 Interventions****Consolidation/stabilization:** none**Fills:** none**Reattachment:** none**Root treatment:** Surface roots removed.**Other:** none**Comparison with 1978-79 Cast/Photograph**Comparison with the 1979 cast and photos showed loss of resolution of the fine details at the bottom of the print. Tool marks clearly visible in the cast and photos were only faintly visible in the heel portion of the footprint *in situ* due to Bedacryl and embedding.

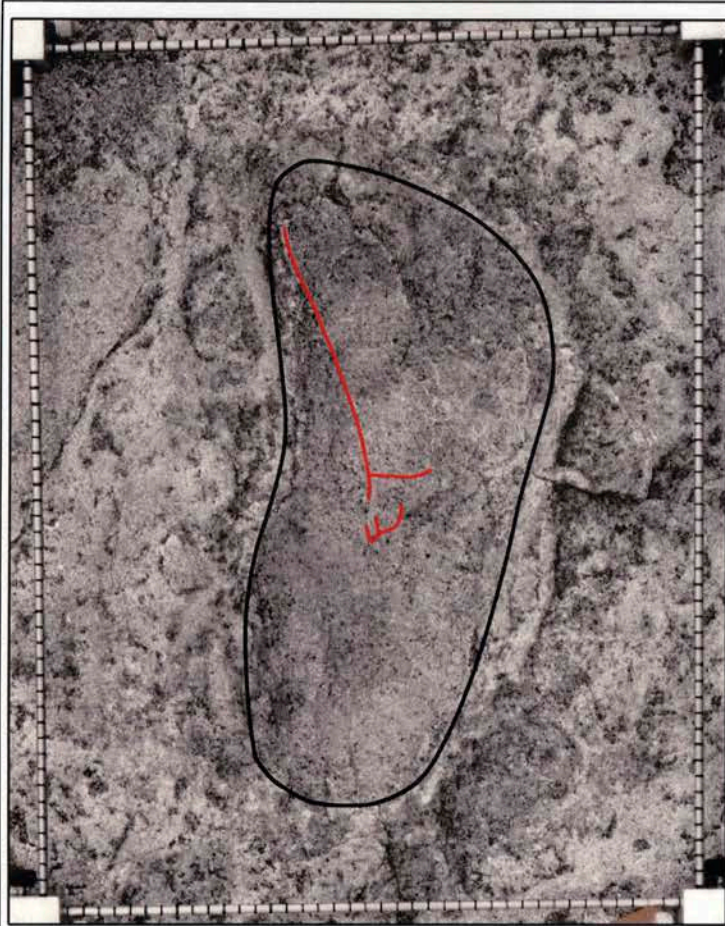
G1-34
TUFF CONDITIONS

1995 Condition**General condition:** Minor alteration: Good**Tuff conditions:**Weathering: noneCracking: A few hairline sized cracks on the surface near the center of the printLosses: noneDetached/loose: nonePowdering: noneOther: none**Condition related to 1978-79 interventions:**Bedacryl: Bedacryl found throughout the print and surrounding tuff surface. Deteriorated with minor loss in posterior portion and in small patches in anterior portion.Embedding: Slight embedding of fine particles in Bedacryl layer (not recorded on graphic).Silicone: Traces of silicone outside margins of print.Excavation tool marks: Tools marks visible on floor of the print (not recorded on graphic).Inventory number on tuff: 1979 label ("1-34") visible on tuff surface.Other: none**Root damage:** Only a few tiny rootlets on surface of tuff.**Insect activity:** none**1995 Interventions****Consolidation/stabilization:** none**Fills:** none**Reattachment:** none**Root treatment:** Surface roots removed.**Other:** none**Comparison with 1978-79 Cast/Photograph**Comparison with 1979 cast and photos showed slight loss of resolution of features due to the Bedacryl layer. A crack at the center of the footprint and excavation tool marks were more distinct in the cast and photos than *in situ*.

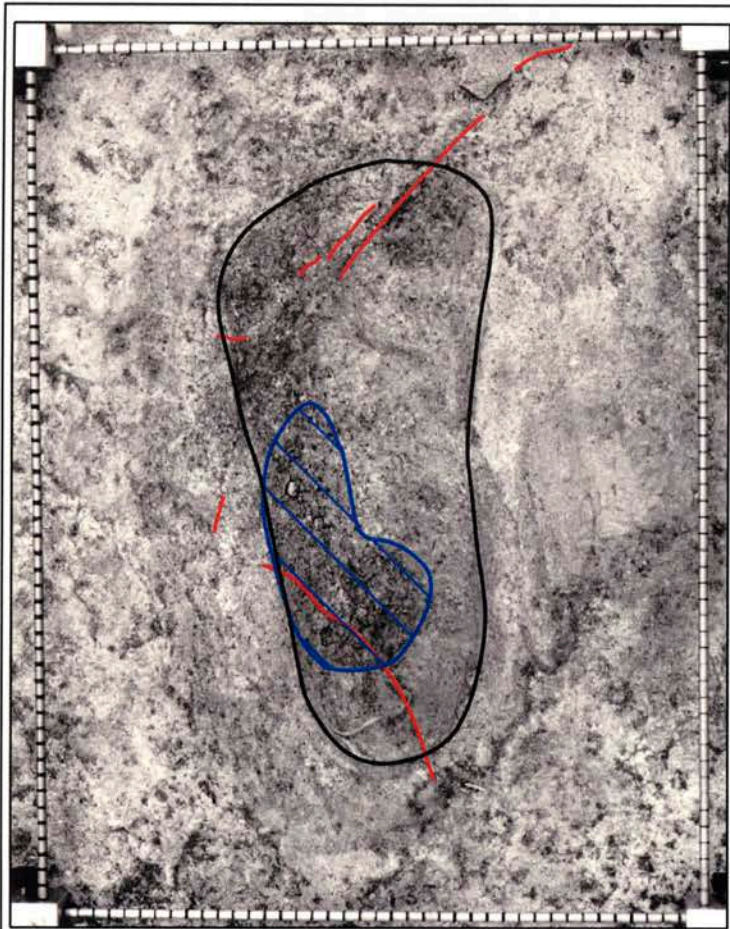
G1-35
TUFF CONDITIONS

Cracking: Cracks traverse heel and toe areas.

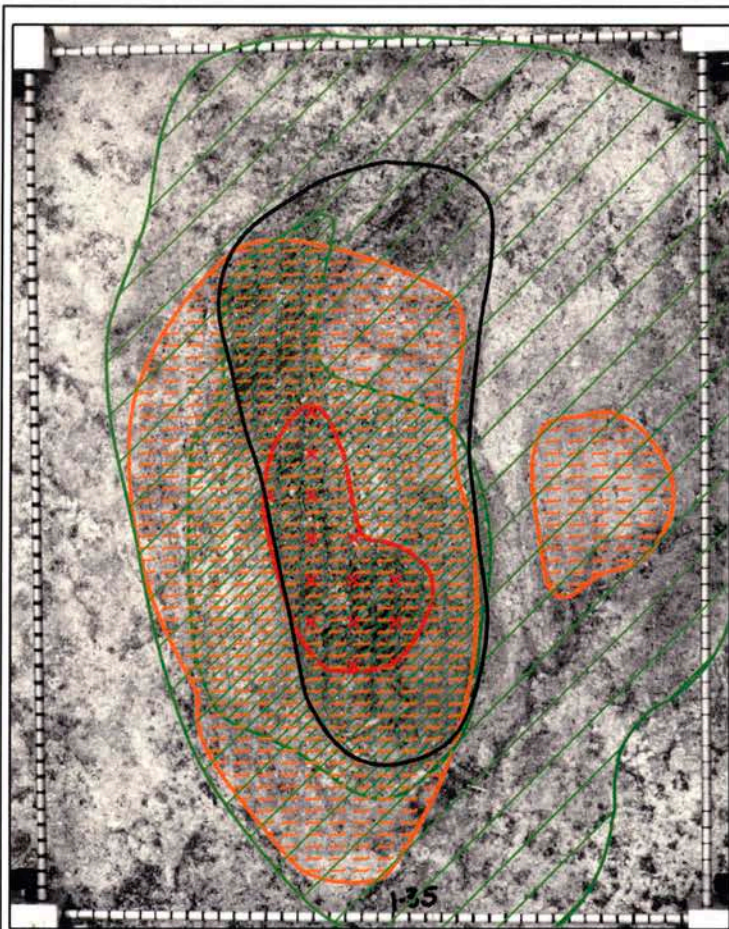
G1-35
CONDITIONS RELATED TO 1978-79 INTERVENTIONS

Bedacryl: Bedacryl covered the print surface and the surrounding tuff. The Bedacryl had deteriorated, with minor areas of loss, over most of the print surface, except the area of the great toe and ball, and was cracked near the lateral margin.

Embedding: Minor embedding of fine particles in areas of weathering and deteriorated Bedacryl.

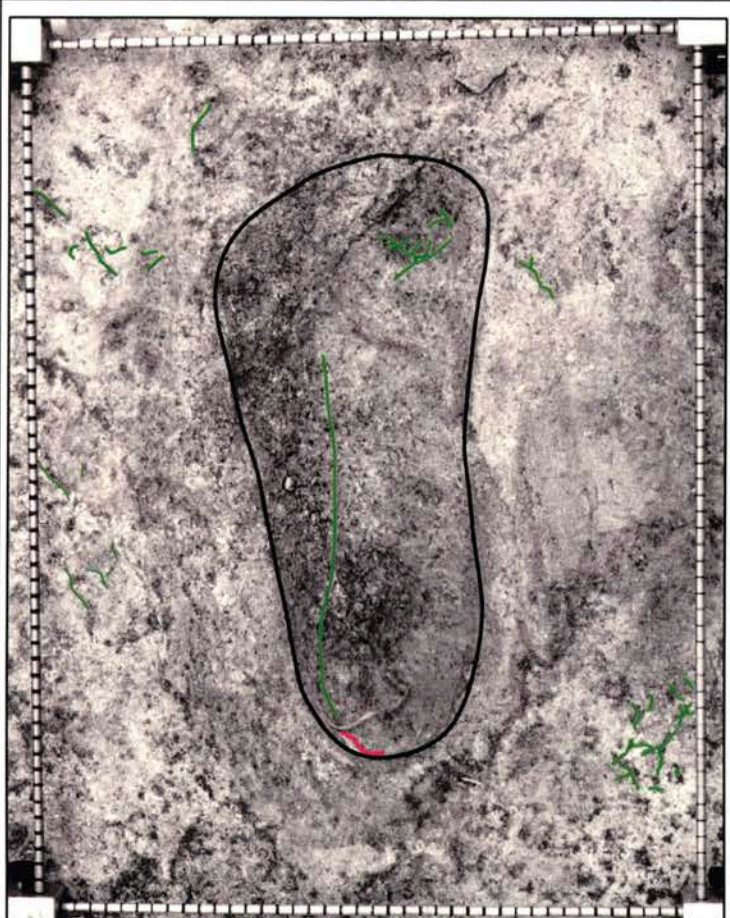
G1-35
ROOT DAMAGE AND INSECT ACTIVITY

Root damage: Rootlets were embedded in the Bedacryl layer in the area of the great toe and along the lateral margin, but did not penetrate the tuff.

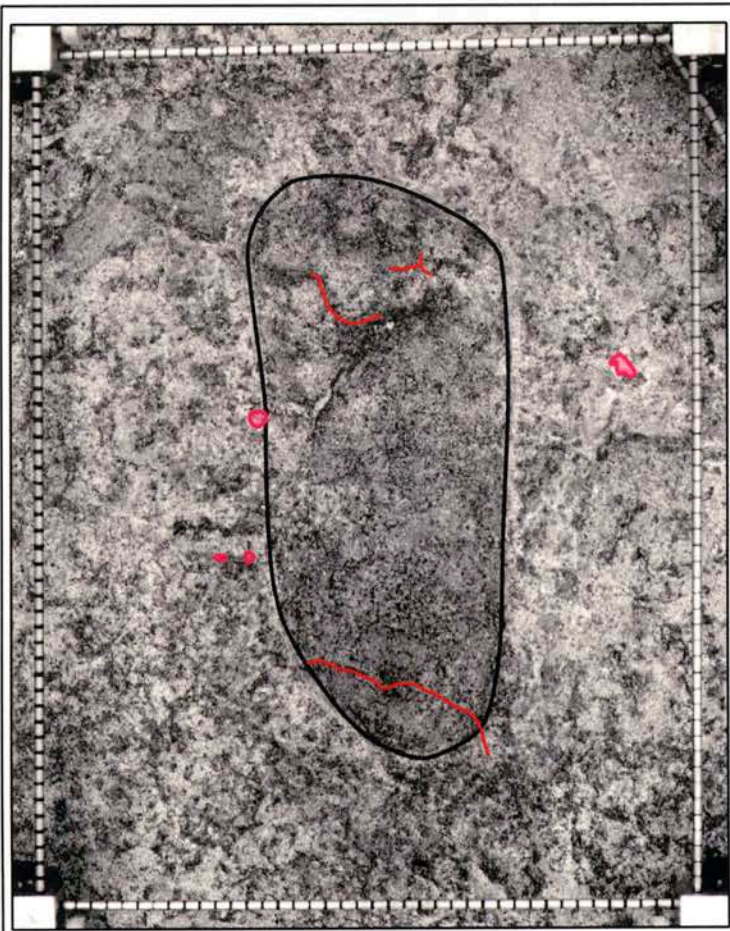
G1-36
TUFF CONDITIONS

Cracking: Hairline cracks transect heel and are evident on the fossilized termite burrows in anterior portion.

Losses: Minor loss of tuff surface noted outside medial and lateral margins of print.

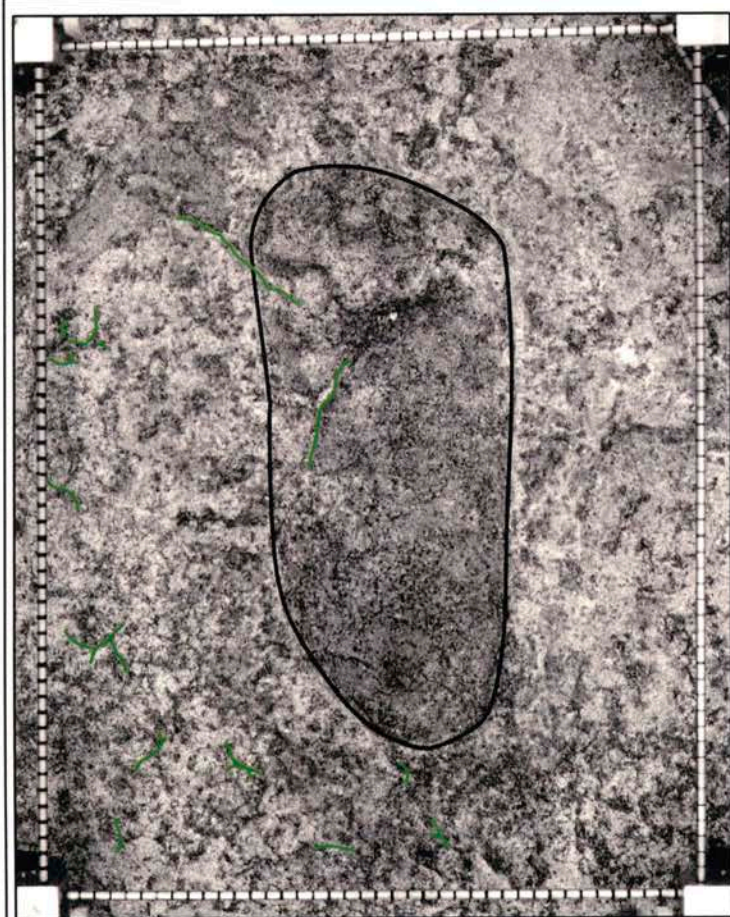
G1-36
ROOT DAMAGE AND INSECT ACTIVITY

Root damage: A few rootlets on the surface, which did not penetrate the Bedacryl layer.
