LAETOLI

HOMINID TRACKWAY, SITE G

CONDITION RECORDS

G1 AND G2/3 FOOTPRINTS

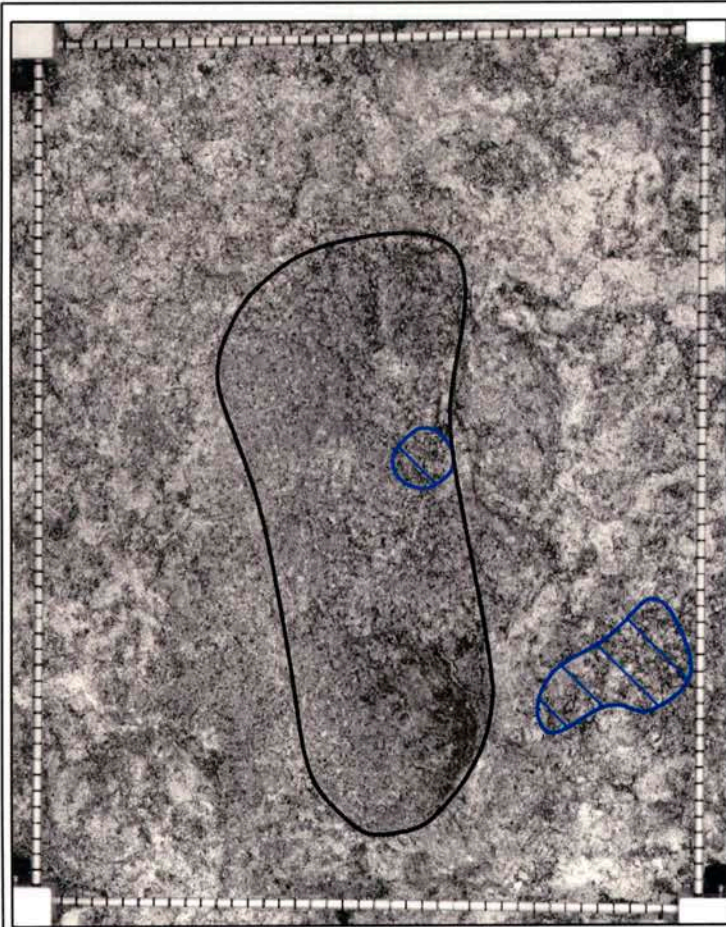
GI-37
TUFF CONDITIONS

1995 Condition**General condition:** Minor alteration: Good**Tuff conditions:****Weathering:** Slight weathering of tuff on medial margin near arch; and outside of the print margins.**Cracking:** none**Losses:** none**Detached/loose:** none**Powdering:** none**Other:** none**Conditions related to 1978-79 interventions:****Bedacryl:** Bedacryl covered surface of print and extended outside medial margin in area of the arch. Bedacryl deteriorated slightly in the heel, with minor losses, and toe and ball areas. The layer appears to have been thickly applied.**Embedding:** Slight embedding of particles in Bedacryl layer (not shown on graphic).**Silicone:** Very minor traces of silicone outside print.**Excavation tool marks:** Excavation tool marks were evident over much of the floor of the print.**Inventory number on tuff:** 1979 label ("1-37") barely visible on tuff surface.**Other:** none**Root damage:** Rootlets primarily on the surface; a few penetrated into the Bedacryl layer; one root penetrated tuff near center of print.**Insect activity:** none**1995 Interventions****Consolidation/stabilization:** none**Fills:** none**Reattachment:** none**Root treatment:** Surface roots removed.**Other:** none**Comparison with 1978-79 Cast/Photograph**Comparison with the 1979 cast and photos showed slight loss of resolution of fine details on the surface due to Bedacryl and particles embedded in the Bedacryl layer. Excavation tool marks were less visible *in situ*.

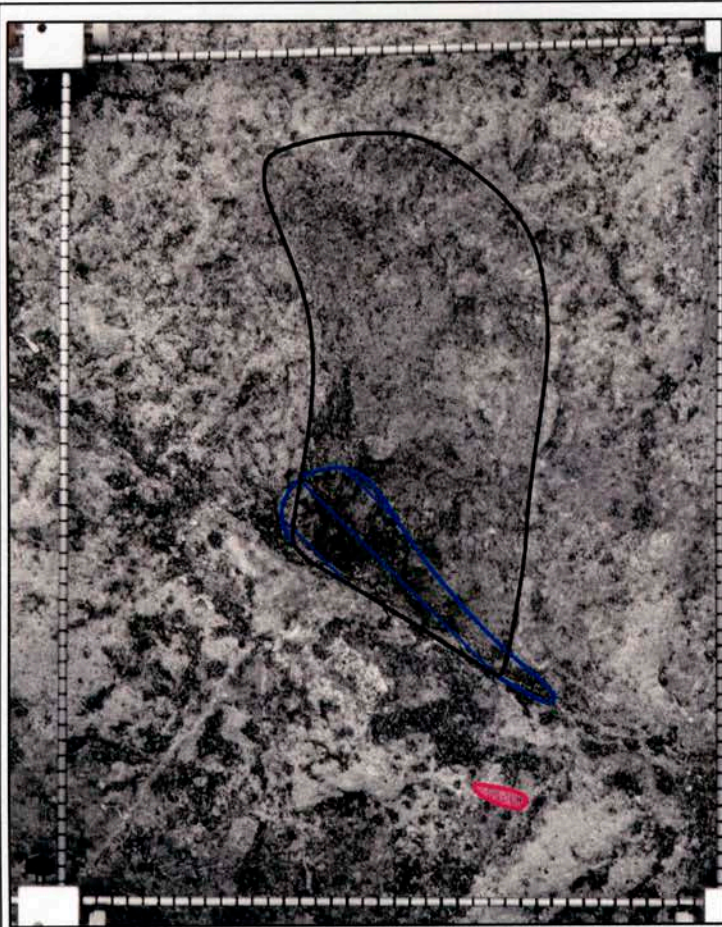
G1-38
TUFF CONDITIONS

Cracking: Fine surficial cracks at the fault intersection (not visible on graphic).

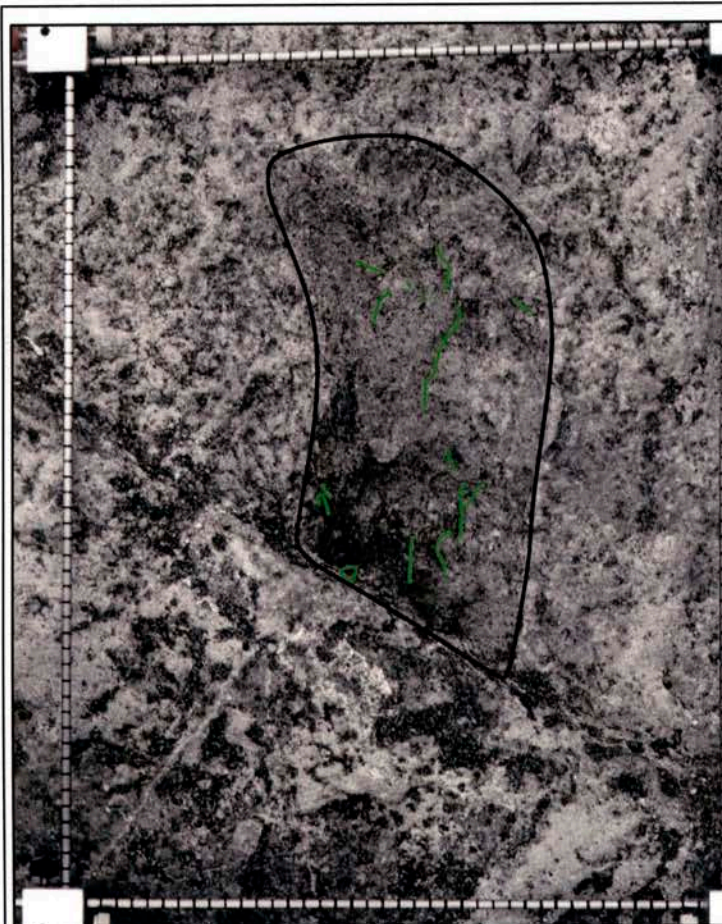
G1-38
ROOT DAMAGE AND INSECT ACTIVITY

Root damage: Root penetrated the wall of the fault where it intersected the print, but did not go directly into the floor of print. Rootlets on surface of print.

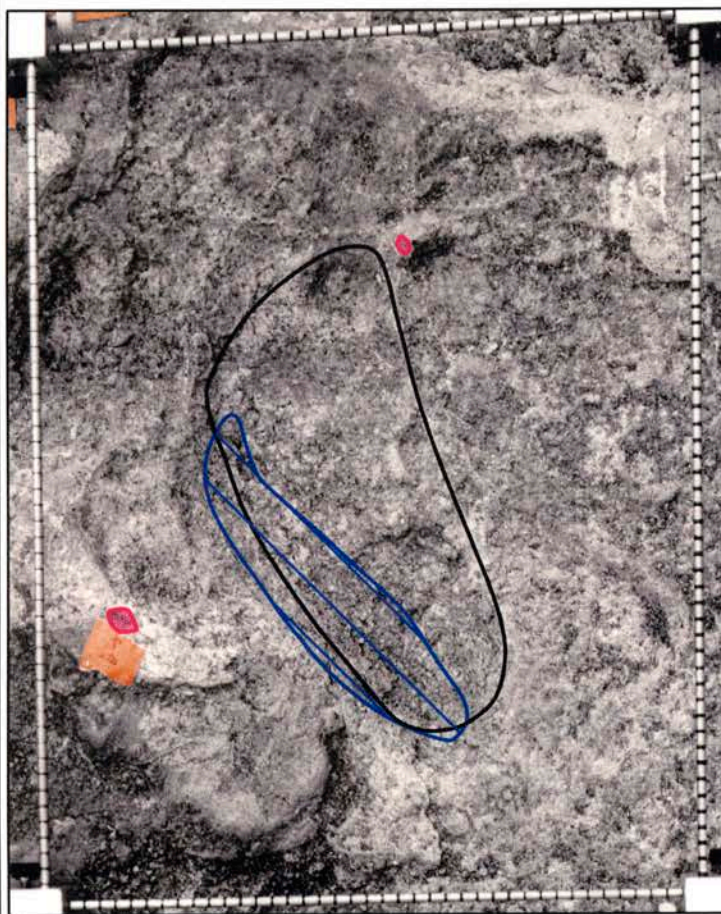
G1-39
TUFF CONDITIONS

<p><u>Location</u> Southern sector of trackway, trench 1.</p>
<p><u>Excavation and Reburial History</u> Excavated and reburied in 1979; re-excavated and reburied in 1995.</p>
<p><u>1978-1979 Description</u> Complete left footprint. The big toe has left a small unusually circular depression 29 mm long and 25 mm wide instead of the rather broad, oblong impressions usually made by the big toe in the G-1 trail. There is also a small ridge behind toes 2-5 where the ash has been pushed up against the ball of the foot. A print of the hipparion foal has impinged marginally on the anterior impressions of toes 2-5.</p>
<p><u>1995 Condition</u> <u>General condition:</u> Minor alteration: Good</p> <p><u>Tuff conditions:</u> <u>Weathering:</u> Slight weathering of the tuff along the lateral margin of print. <u>Cracking:</u> none <u>Losses:</u> Minor loss of tuff outside margin of great toe and lateral margin of print. <u>Detached/loose:</u> none <u>Powdering:</u> none <u>Other:</u> none</p> <p><u>Condition related to 1978-79 interventions:</u> <u>Bedacryl:</u> Bedacryl covered the surface of the print and surrounding tuff. It was slightly deteriorated along the lateral print margin with numerous hairline cracks in the Bedacryl layer, and outside the anterior margin. <u>Embedding:</u> Slight embedding noted in Bedacryl layer (not shown on graphic) <u>Silicone:</u> Minor traces of silicone outside print margins. <u>Excavation tool marks:</u> none <u>Inventory number on tuff:</u> 1979 label ("1-39") visible on tuff surface. <u>Other:</u> none</p> <p><u>Root damage:</u> Rootlets, less than 1mm diameter, weaved in and out of the Bedacryl layer and a few penetrated the tuff along the lateral side, forming a root mat in the lateral heel portion.</p> <p><u>Insect activity:</u> none</p>

<p><u>1995 Interventions</u> <u>Consolidation/stabilization:</u> none <u>Fills:</u> none <u>Reattachment:</u> none <u>Root treatment:</u> Surface roots removed. <u>Other:</u> none</p>
<p><u>Comparison with 1978-79 Cast/Photograph</u> Comparison with the 1979 cast and photos showed slight loss of resolution of surface features. Slight weathering on lateral margin was already visible in 1979 photos.</p>

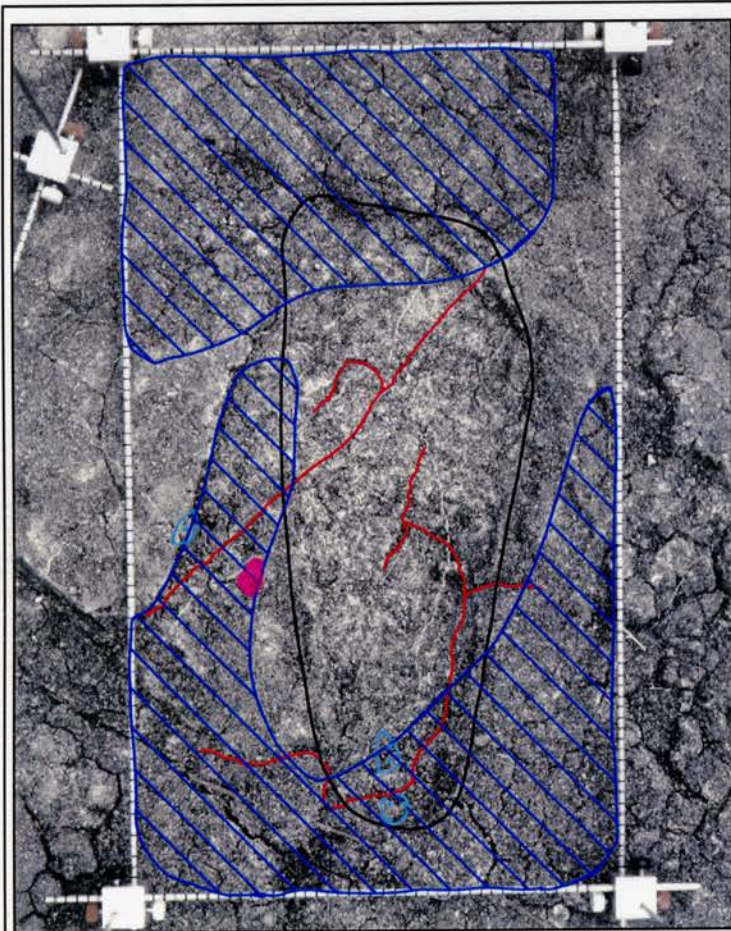
G2/3-2
TUFF CONDITIONS

Cracking: Minor cracks: one along the lateral side of the prints appeared to be new (does not appear in cast); another small crack ran from the medial side of the center of prints to the anterior portion, with a partially missing calcite vein.

Detached/loose tuff: Two small patches (< 1cm²) in heel and one beyond the medial margin.

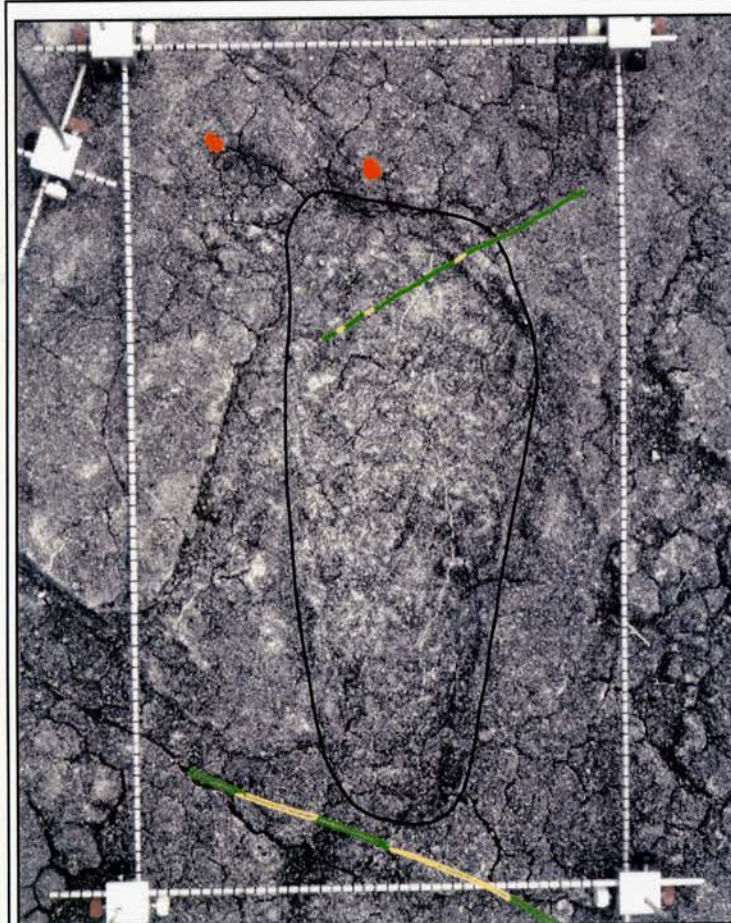
G2/3-2
ROOT DAMAGE AND INSECT ACTIVITY

Root damage: Network of fine rootlets on surface and penetrating weathered tuff (not shown on graphic). One root approximately 2mm in diameter penetrated the tuff in the anterior portion. A 3mm diameter root penetrated tuff numerous times just beyond the posterior margin.

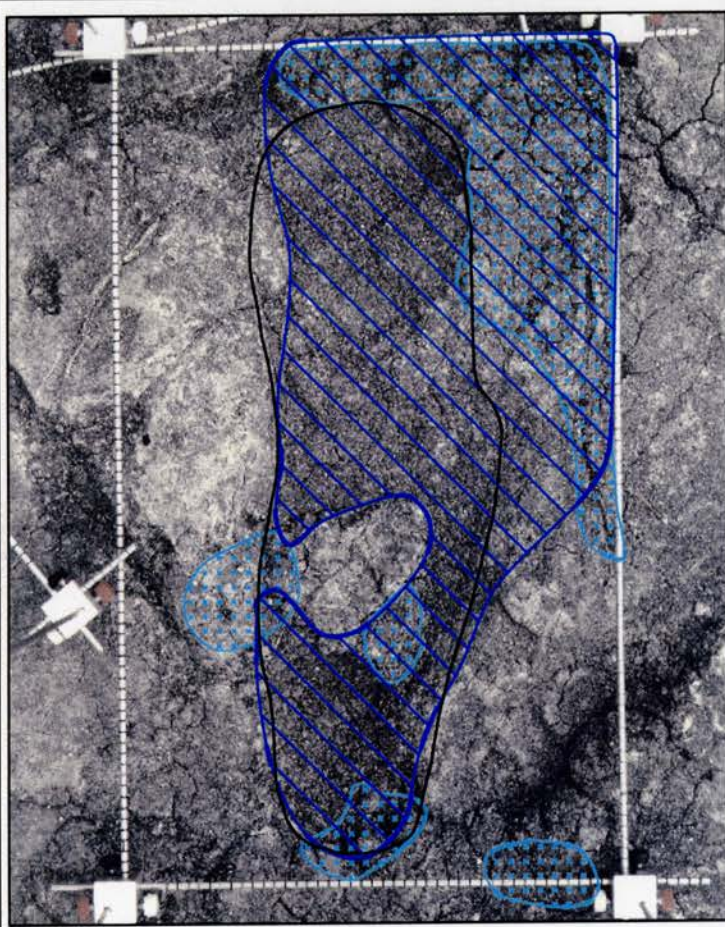
G2/3-6
TUFF CONDITIONS

<p><u>Location</u> Northern sector of trackway, trench 6.</p>
<p><u>Excavation and Reburial History</u> Excavated and reburied in 1978; re-excavated and reburied in 1996.</p>
<p><u>1978-1979 Description</u> A depression in the lower part of the tuff. All the upper surface has been lost through erosion, but the position in the trail indicates that it is of a right foot.</p>
<p><u>1995 Condition</u> <u>General Condition:</u> Moderate alteration: Fair</p> <p><u>Tuff conditions:</u> <u>Weathering:</u> Severely weathered on interior of the prints, except on an island of tuff (with remnants of L14) in the center, and outside anterior and lateral margins. <u>Cracking:</u> none <u>Losses:</u> none <u>Detached/loose tuff:</u> Discrete patches of loose tuff associated with weathering in posterior portion, and outside anterolateral margin. Two small fragments in posterior half, each averaging 0.50cm², were detached. <u>Powdering:</u> none <u>Other:</u> none</p> <p><u>Conditions related to 1978-79 interventions:</u> <u>Bedacryl:</u> Bedacryl stringers observed in raised central portion (anterior to island of L14 tuff). <u>Embedding:</u> Deeply embedded particles at bottom of the prints and in weathered areas. <u>Silicone:</u> none <u>Excavation tool marks:</u> none <u>Inventory number on tuff:</u> none <u>Other:</u> Yellow resinous material (identified as cellulose nitrate; see <u>Interventions: Other</u>) in raised central portion (island of L14 tuff).</p> <p><u>Root damage:</u> Numerous surface rootlets but no significant root penetration on interior of prints. Single root, 3-4mm diameter, penetrated the tuff beyond the lateral margin. Root had nearly disintegrated, leaving a distinct impression in the surface.</p> <p><u>Insect activity:</u> <u>Cut-worm pupal cases:</u> Six small cut-worm casings, all located outside medial and posterolateral margins.</p>

<p><u>1996 Interventions</u> <u>Consolidation/stabilization:</u> Loose fragments of weathered tuff stabilized with Acrysol WS-24 at 25%. <u>Fills:</u> none <u>Reattachment:</u> Two detached fragments in posterior half were reattached with Paraloid B-72. <u>Root treatment:</u> Surface rootlets removed. <u>Other:</u> Sample of yellow resinous material taken for analysis (identified as cellulose nitrate; location not shown on graphic); see <i>1996-1998 Report on the Laetoli Project</i>, p. 39 for discussion of analysis.</p>
<p><u>Comparison with 1978-79 Cast/Photograph</u> No cast. Comparison with the 1978 photos showed a slight loss of resolution of features on the prints' surface, particularly in the anterior portion; increased weathering of the tuff; and embedding of fine particles.</p>

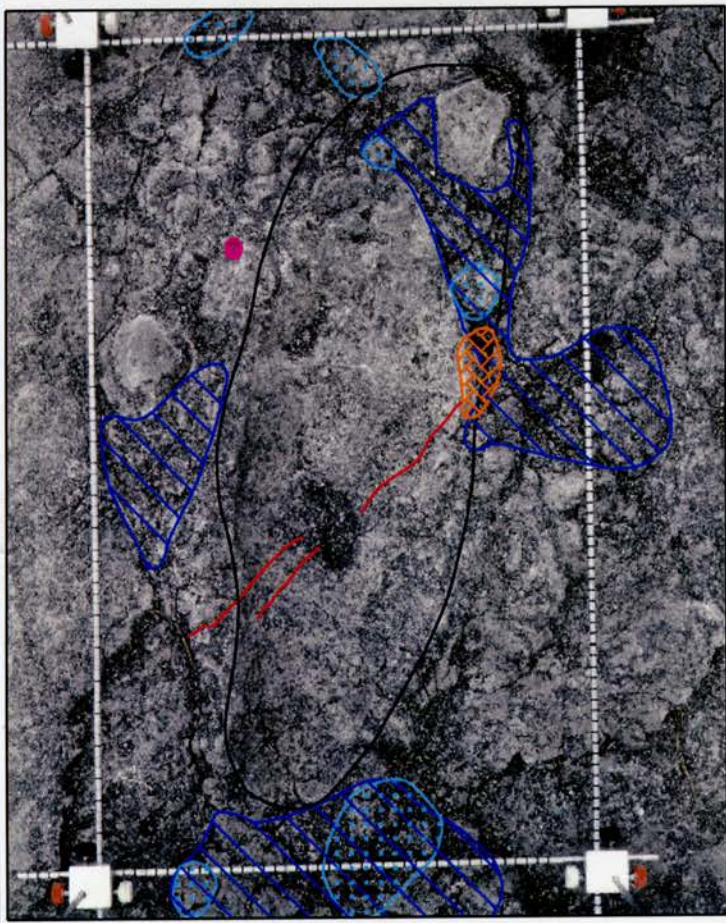
G2/3-7
TUFF CONDITIONS

Cracking: Two cracks associated with missing calcite vein in central portion.

Detached/loose tuff: Patches of loose tuff associated with weathering found primarily outside the posterior and anterior margins; two loose patches (~1cm² each) in the anterior portion.

Other: A void, possibly caused by insect activity, undercut the tuff on the medial margin near the center.

Consolidation/stabilization: Loose tuff was stabilized with Acrysol WS-24 at 25%.

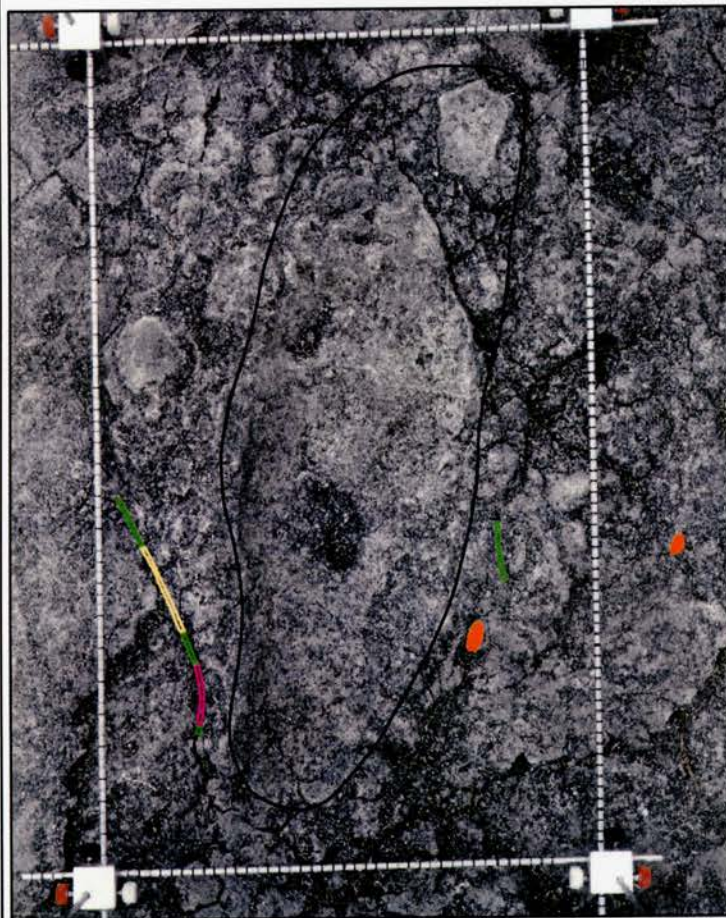
G2/3-7
ROOT DAMAGE AND INSECT ACTIVITY

Root damage: Rootlets located just outside the prints' margin. One root outside lateral margin penetrated tuff and left an impression.

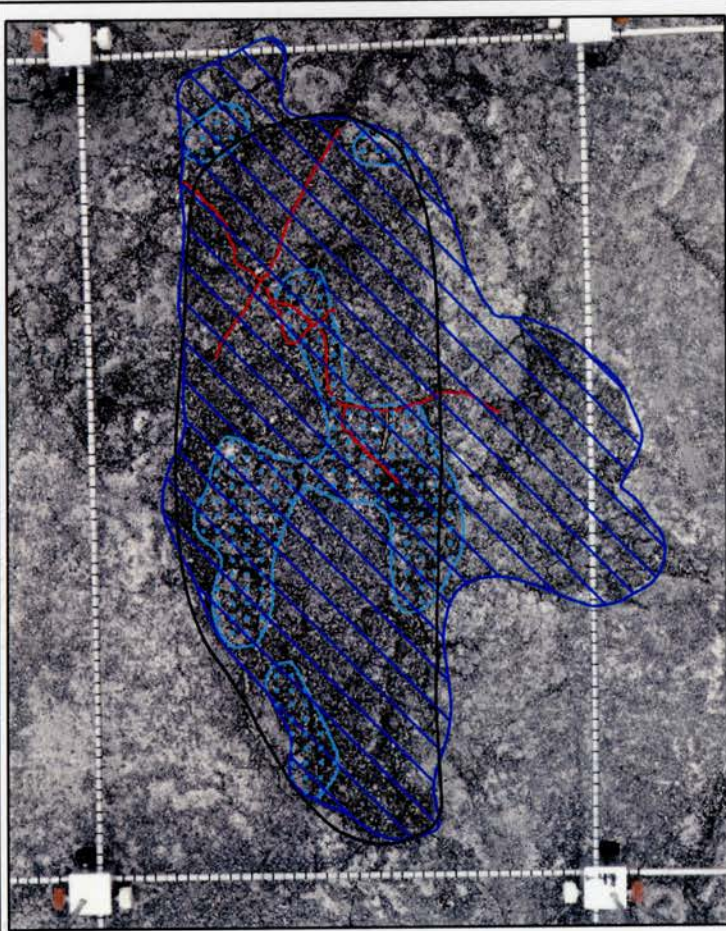
G2/3-8
TUFF CONDITIONS

1995 Condition**General Condition:** Moderate alteration: Fair**Tuff conditions:****Weathering:** Patchy weathering throughout the interior of the prints and outside lateral margin.**Cracking:** Two cracks traversed the prints in the anterior portion; one was associated with missing calcite vein.**Losses:** none**Detached/loose tuff:** Areas of loose tuff associated with weathered tuff.**Powdering:** none**Other:** none**Conditions related to 1978-79 interventions:****Bedacryl:** none (see Other)**Embedding:** Embedded fine particles throughout weathered areas, concentrated in low areas on the uneven surface of the prints.**Silicone:** none**Excavation tool marks:** none**Inventory number on tuff:** none**Other:** Remnant of plastic found just outside medial margin. Faint yellow staining in posterior portion and in one patch on the anterior margin; may be from cellulose nitrate, though it did not appear as resinous as other examples found on the northern sector of the trackway.**Root damage:** Rootlets on the anterior of the prints penetrated the tuff, but did not significantly disrupt the surface. One 6mm root penetrated the heel.**Insect activity:** none**1996 Interventions****Consolidation/stabilization:** Loose tuff in weathered areas was stabilized with Acrysol WS-24 at 25%.**Fills:** none**Reattachment:** Fragment of tuff (~4cm²) outside the lateral margin was reattached with Paraloid B-72.**Root treatment:** Surface rootlets were removed. 6mm diameter root in heel was cut and reduced to a level just below the tuff surface.**Other:** none**Comparison with 1978-79 Cast/Photograph**

No cast. Comparison with the 1978 photos showed a distinct increase in cracking of weathered tuff; cracks enlarged by 1-2mm after excavation. Slight loss of resolution of features on the prints' surface, but print margins retained similar level of definition.

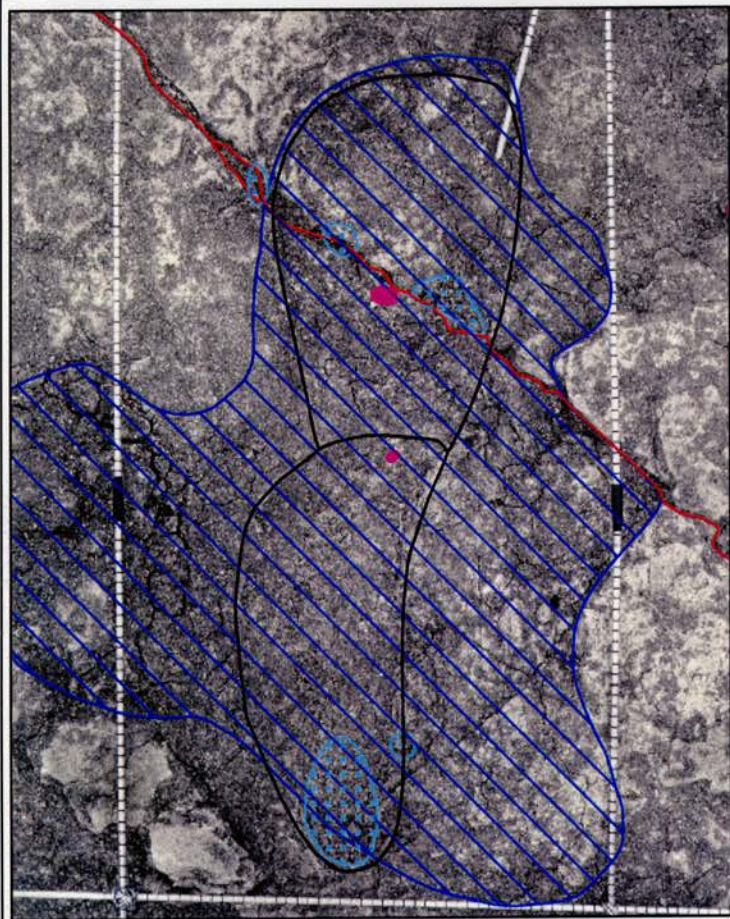
G2/3-9
TUFF CONDITIONS

Cracking: Large crack traversed G2 and was partially filled with overburden.

Detached/loose tuff: Loose tuff associated with weathering in the posterior portion of G3 and along crack in G2.

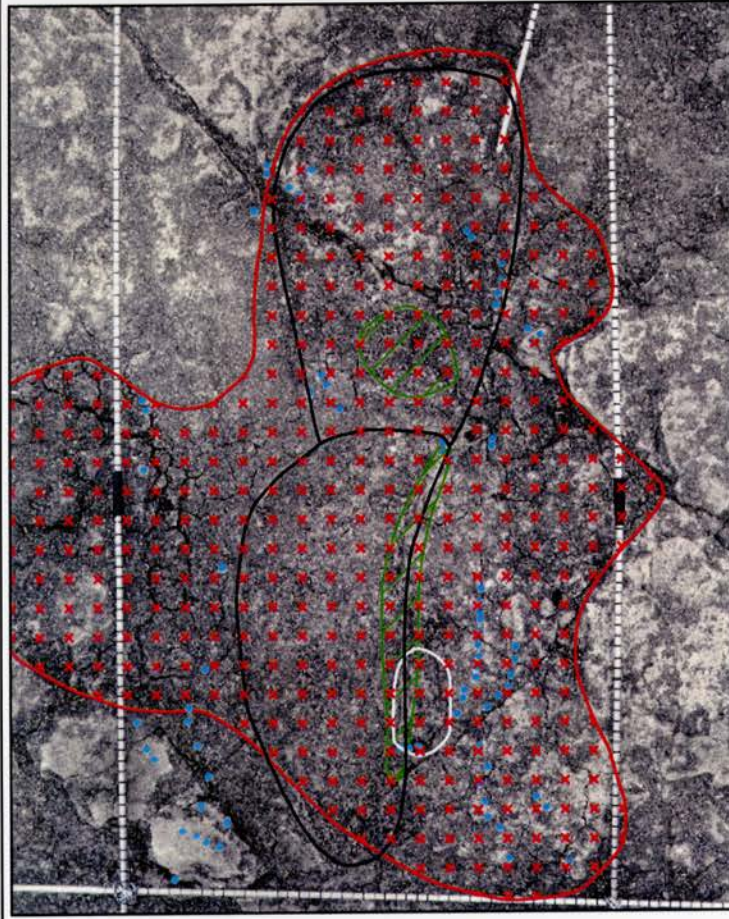
G2/3-9
CONDITIONS RELATED TO 1978-79 INTERVENTIONS

Conditions related to 1978-79 interventions:

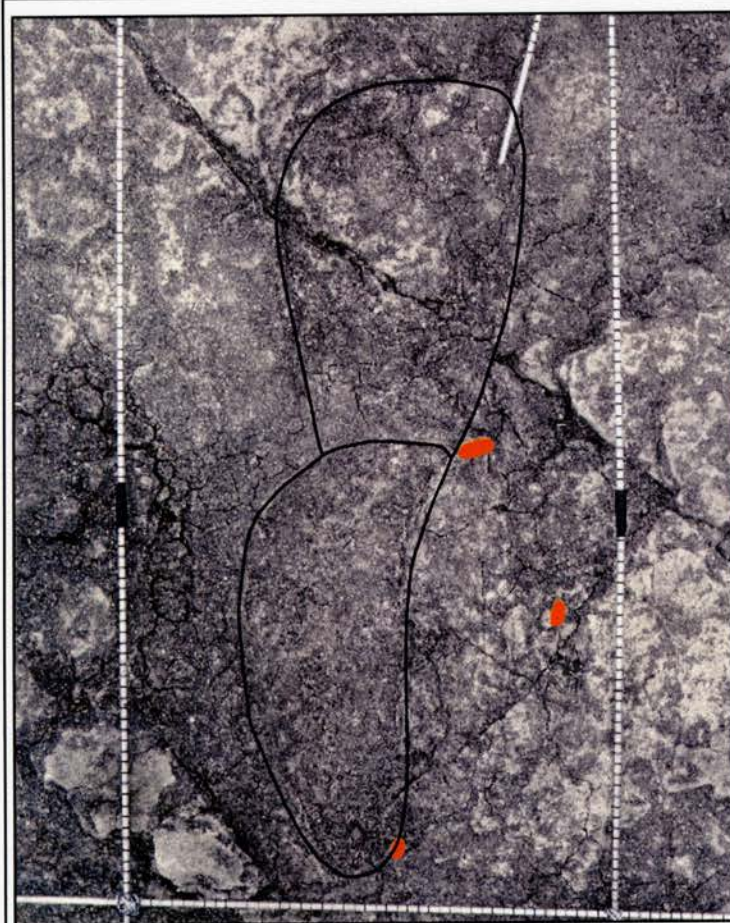
G2/3-9
ROOT DAMAGE AND INSECT ACTIVITY

Root damage: Rootlets were visible in some of the weathered cracks, but caused no disruption (not shown on graphic).

Root treatment: Surface rootlets were removed. Rootlets deep within the cracks were not removed.

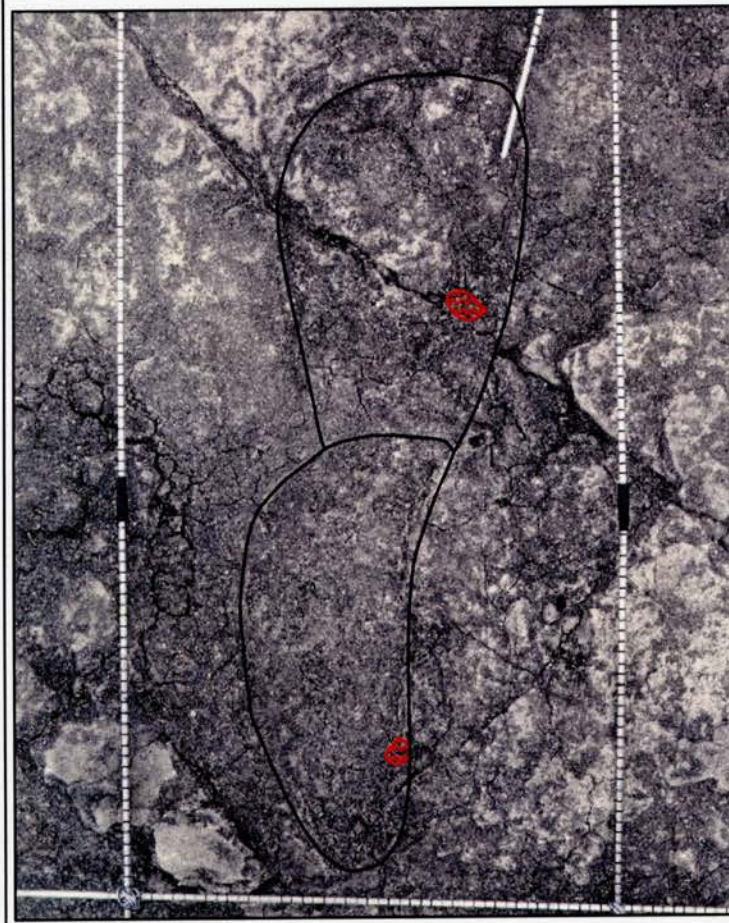
G2/3-9
1995-96 INTERVENTIONS

A remnant of the G2 print, which retains no morphology, was defined in 1996 and is shown in outline on the graphic.

Consolidation/stabilization: Loose tuff on medial margin of G3 was stabilized with Acrysol WS-24 at 25%. Fragment along crack in G2 was stabilized with a 33% solution.

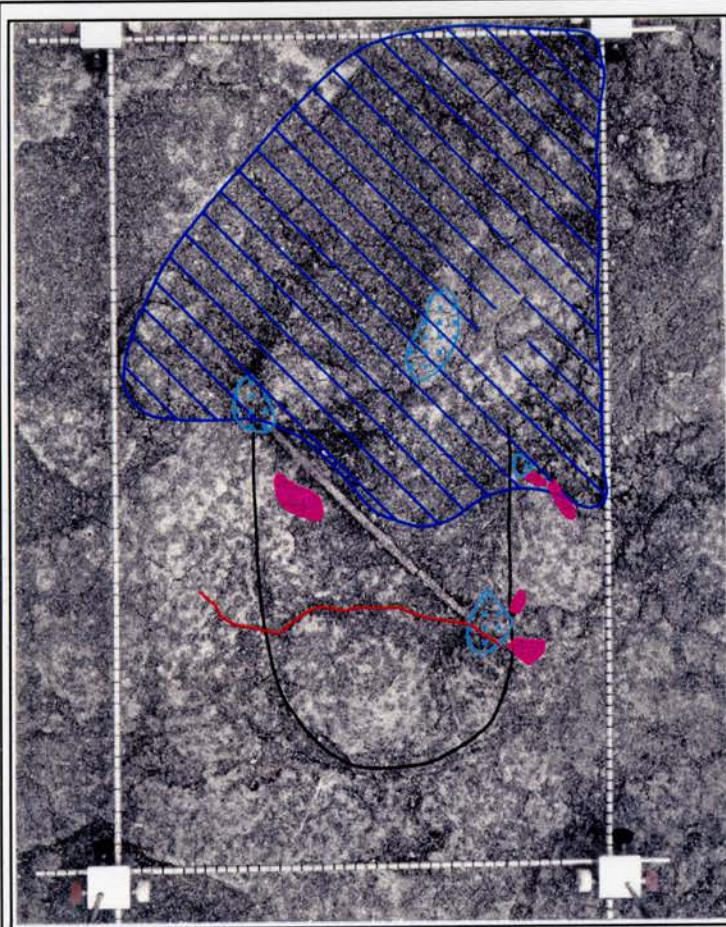
G2/3-10
TUFF CONDITIONS

Cracking: 2mm wide crack traversed the posterior portion of print.

Detached/loose tuff: Loose tuff associated with root penetration of tuff, and in weathered anterior portion.

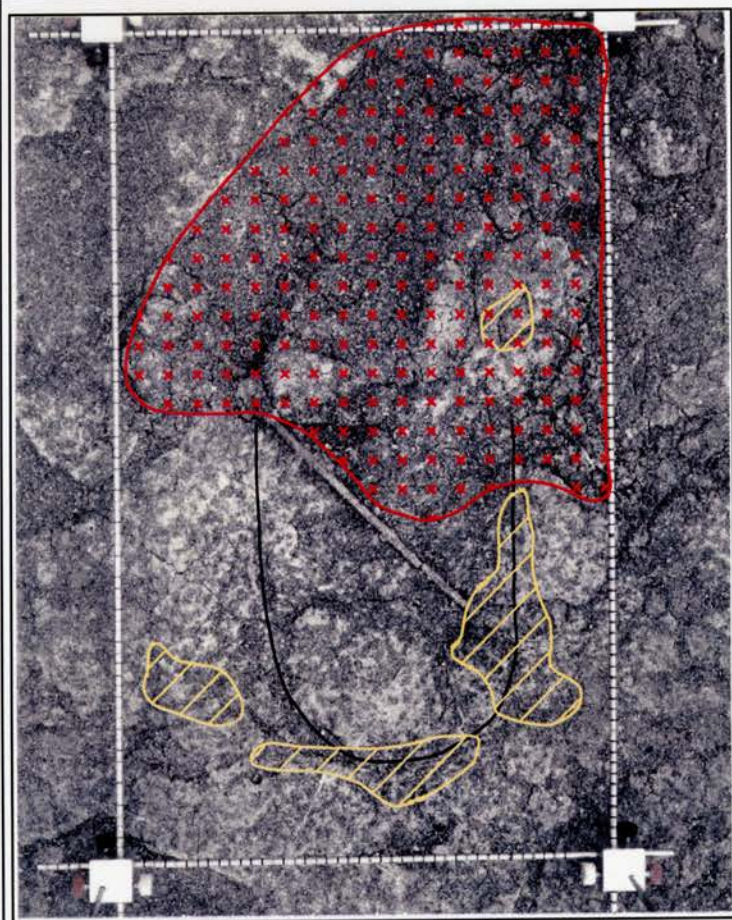
G2/3-10
CONDITIONS RELATED TO 1978-79 INTERVENTIONS

Other: Slight yellow staining mainly along posterior margins of print (possibly cellulose nitrate).

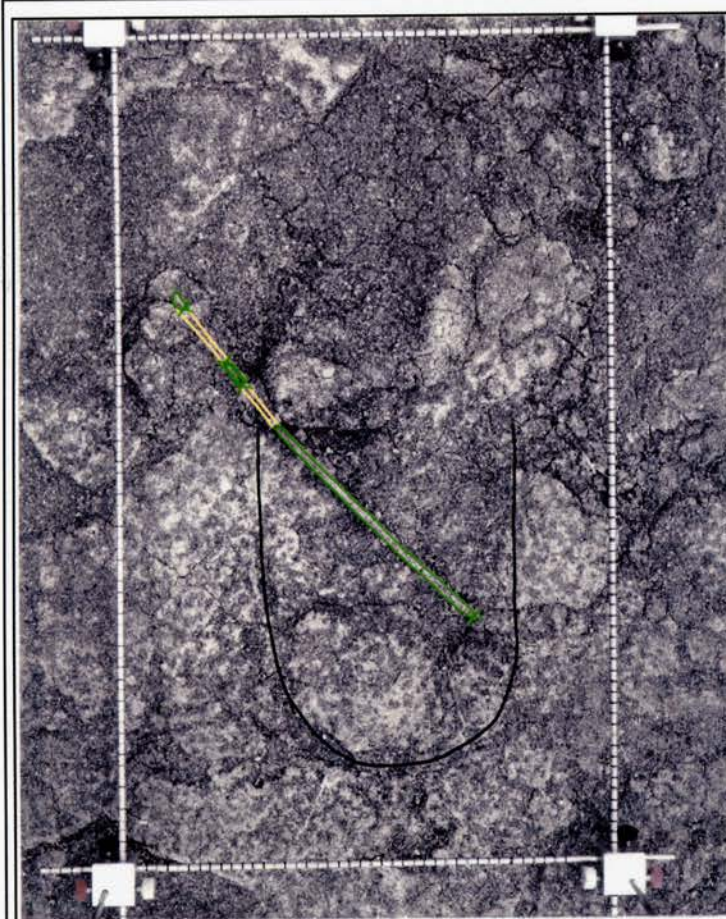
G2/3-10
ROOT DAMAGE AND INSECT ACTIVITY

Root damage: Large 4mm diameter root traversed the print from the central portion to the heel, penetrating the tuff in four places and slightly disrupting the tuff at two penetration points on margins.

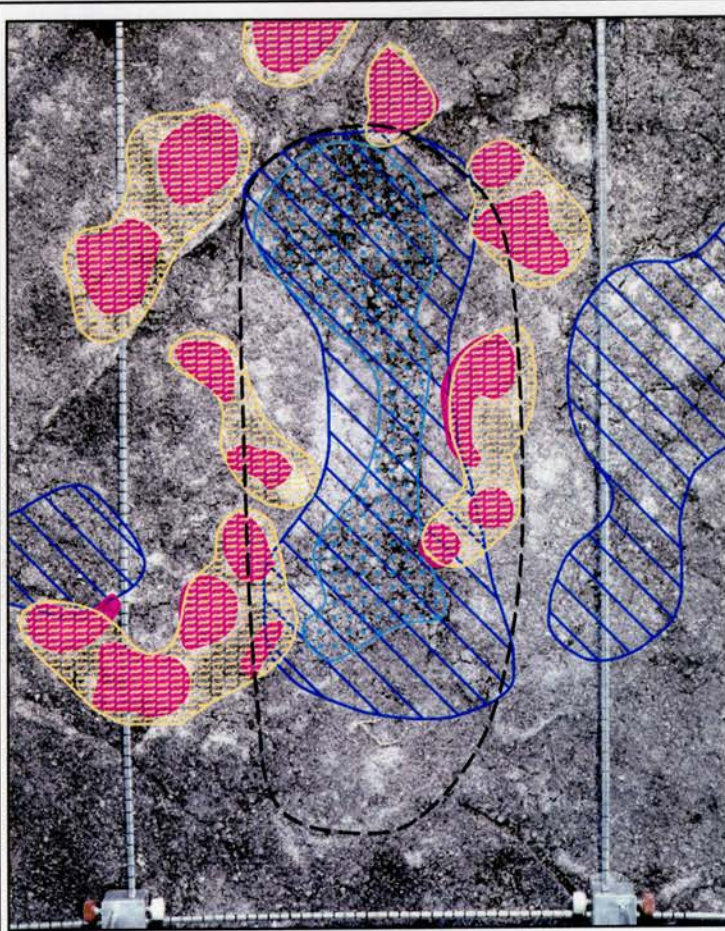
G2/3-15
TUFF CONDITIONS

1995 Condition**General Condition:** Significant alteration: Poor**Tuff conditions:****Weathering:** Severe weathering of tuff along the axis of the prints and in patches outside margins.**Cracking:** none**Losses:** Surface of powdering tuff slightly abraded as a result of brushing this weakly consolidated tuff.**Detached/loose tuff:** Tuff was loose within weathered area inside margins of prints.**Powdering:** Areas of tuff along and outside margins of prints were powdery.**Other:** none.**Conditions related to 1978-79 interventions:****Bedacryl:** none**Embedding:** Deeply embedded particles up to 3mm in diameter in the weathered areas, especially in the center of the prints.**Silicone:** none**Excavation tool marks:** none**Inventory number on tuff:** none**Other:** none**Root damage:** Root penetrated tuff outside the posterior margins, and left a distinct root impression when surface root removed. Small rootlets on the surface and within cracks.**Insect activity:** none**1996 Interventions****Consolidation/stabilization:** Weathered and loose tuff was stabilized with Acrysol WS-24 at 25%.**Fills:** none**Reattachment:** none**Root treatment:** Surface rootlets were removed.**Other:** none**Comparison with 1978-79 Cast/Photograph**

No cast. Comparison with the 1978 photos showed increased weathering of tuff, especially along axis of prints, and particle embedding. It is clear from the 1978 photos and notes that the tuff was in poor condition (weathered, fractured and powdering) in 1978. Print margins are not visible in 1978 photographs; identification of location based on tuff features.

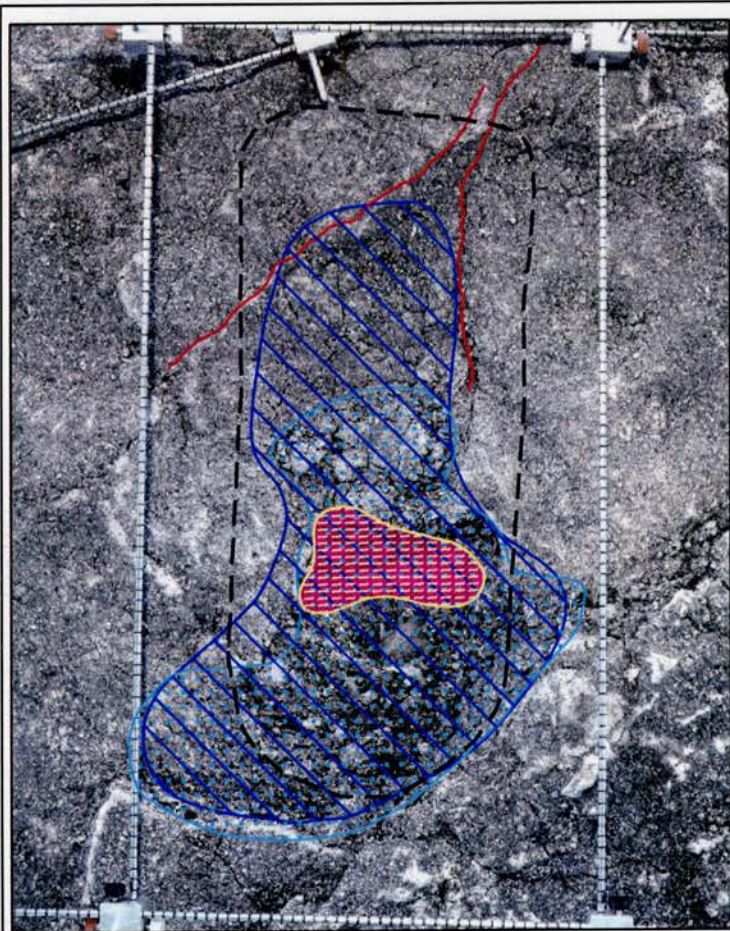
G2/3-16
TUFF CONDITIONS

1995 Condition**General Condition:** Moderate alteration: Fair**Tuff conditions:****Weathering:** Moderate to severe weathering of tuff in central and posterior portions of the prints.**Cracking:** Two 1-2mm wide cracks in anterior portion.**Losses:** Slight loss of surface grains in powdering areas of tuff.**Detached/loose tuff:** Tuff fragments were loose and easily dislodged throughout the weathered area and in the heel as a result of root penetration.**Powdering:** Tuff was powdering in the central portion of the prints.**Other:** none**Conditions related to 1978-79 interventions:****Bedacryl:** none**Embedding:** Deeply embedded particles within the weathered area and in the anterior region in a possible lagomorph print.**Silicone:** none**Excavation tool marks:** none**Inventory number on tuff:** none**Other:** Small fragment of plastic found on the heel surface.**Root damage:** 5mm root penetrated heel margin and caused disruption and dislodging of small tuff fragments. Rootlets present throughout the cracks and weathered tuff.**Insect activity:** none**1996 Interventions****Consolidation/stabilization:** Weathered and loose tuff in central and posterior regions was stabilized with Acrysol WS-24 at 25%.**Fills:** none**Reattachment:** none**Root treatment:** Surface rootlets and exposed portion of 5mm root were removed; subterranean root left *in situ*.**Other:** none**Comparison with 1978-79 Cast/Photograph**

No cast. Comparison with the 1978 photos showed increased weathering of the tuff and particle embedding, especially in the central and posterior regions of the prints. "Rainprints" visible in 1978 photo to the west of the print could not be seen *in situ* due to embedding of overburden in tuff. It was clear from the 1978 photo that G2/3-16 was in poor condition when first excavated. Print margins are not visible in 1978 photographs; identification of location based on tuff features.

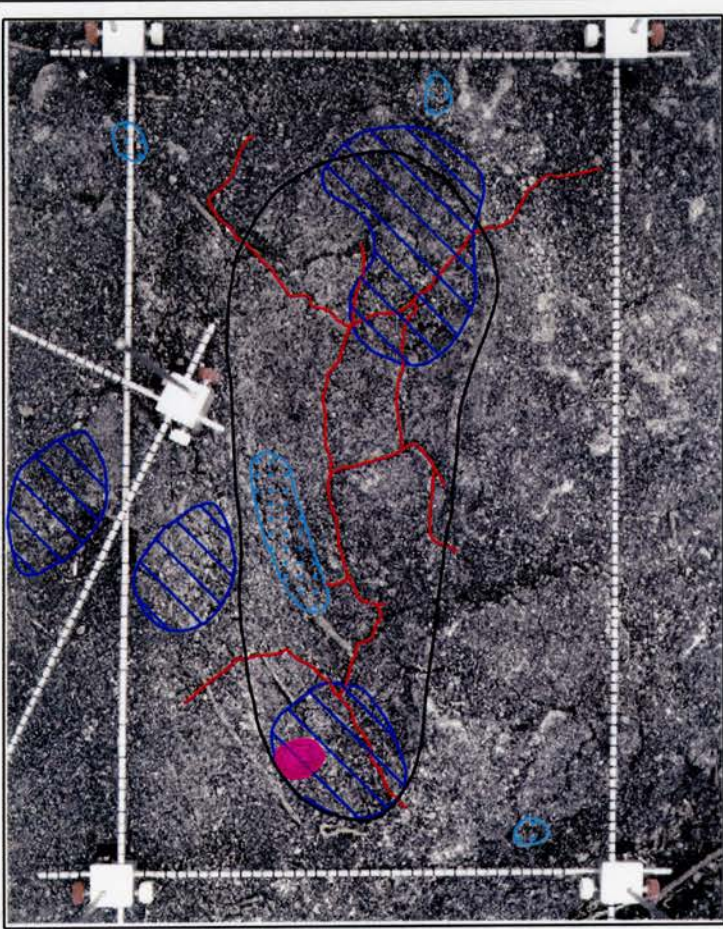
G2/3-17
TUFF CONDITIONS

1995 Condition**General Condition:** Moderate alteration: Fair**Tuff conditions:****Weathering:** Moderate weathering in the anterior and posterior regions and outside the lateral margins.**Cracking:** Series of 1-2mm wide cracks along the axis of the prints.**Losses:** 2cm² surface loss in lateral portion of the heel.**Detached/loose tuff:** Slight detachment of tuff fragments along subterranean root near lateral print margin, and in small, discrete patches outside of the prints.**Powdering:** none**Other:** none**Conditions related to 1978-79 interventions:****Bedacryl:** none**Embedding:** Entire area displays shallow particle embedding, but it is concentrated in the low part of heel and in a small patch in the anterior portion of the prints.**Silicone:** none**Excavation tool marks:** none**Inventory number on tuff:** none**Other:** none**Root damage:** One 5mm root and two smaller roots penetrated tuff in the area of the posterolateral margin; the 5mm root caused slight disruption of small tuff fragments. Rootlets present throughout the surface and within cracks.**Insect activity:** none**1996 Interventions****Consolidation/stabilization:** Loose tuff near lateral margin and outside the prints was stabilized with Acrysol WS-24 at 25%.**Fills:** none**Reattachment:** none**Root treatment:** Surface rootlets and exposed portion of 5mm root were removed.**Other:** none**Comparison with 1978-79 Cast/Photograph**

No cast. Comparison with the 1978 photos showed a slight loss of resolution of features on the print's surface; an increase in weathering of tuff and widening of cracks during exposure; as well as particle embedding from overburden.

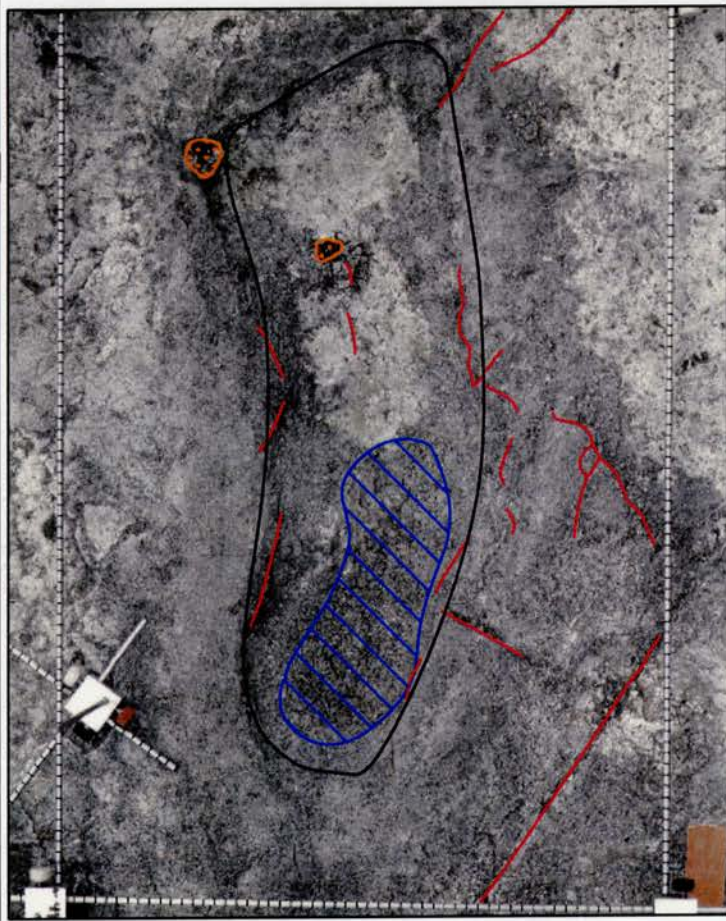
G2/3-18
TUFF CONDITIONS

Cracking: Hairline cracks (~1mm wide) along medial and lateral margins; large crack, located just outside of heel on lateral side, with partially missing calcite vein.

Detached/loose tuff: Tuff detached around spear penetration points (see Other).

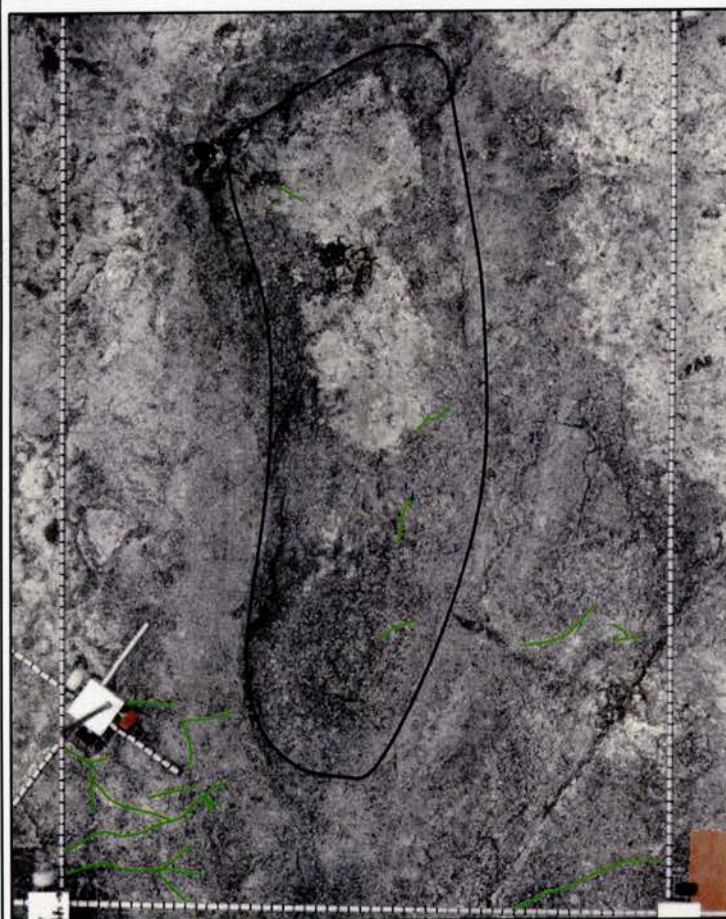
G2/3-18
ROOT DAMAGE AND INSECT ACTIVITY

Root damage: Surface roots only.

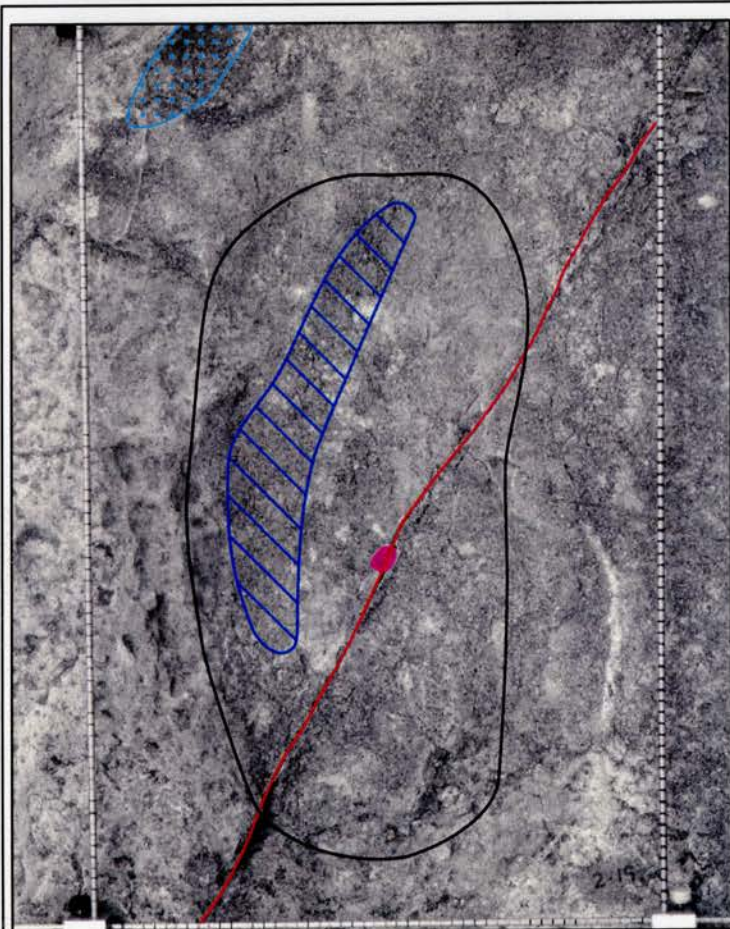
G2/3-19
TUFF CONDITIONS

1995 Condition**General Condition:** Minor alteration: Good**Tuff conditions:****Weathering:** Slight weathering near lateral margin.**Cracking:** Large crack with a maximum width of 2mm traversed the prints; associated with calcite vein.**Losses:** 1cm² loss along crack.**Detached/loose tuff:** Localized area of tuff was loose outside the anterior margin of the prints.**Powdering:** none**Other:** none**Conditions related to 1978-79 interventions:****Bedacryl:** Bedacryl found throughout the prints and just beyond the margins. It had deteriorated slightly and was impacted by rootlet penetration on the floor of the prints and extending beyond the anterior margin, and was lost in small discrete areas within the prints. The Bedacryl layer was more thickly applied in the deteriorated areas.**Embedding:** Minor embedding of very fine particles in the Bedacryl (not shown on graphic).**Silicone:** none**Excavation tool marks:** none visible (see Comparison below)**Inventory number on tuff:** 1979 label ("2-19") located just beyond the medial heel margin.**Other:** none**Root damage:** Extensive network of rootlets (indicated as root mat on graphic) penetrated the Bedacryl layer, but did not appear to penetrate the footprint tuff; most are not visible in photo.**Insect activity:** none**1996 Interventions****Consolidation/stabilization:** Loose tuff beyond the anterior print margin was stabilized with Acrysol WS-24.**Fills:** none**Reattachment:** none**Root treatment:** Surface rootlets were removed. Since removal of the rootlets penetrating Bedacryl layer would have caused disruption to the layer, most were not removed.**Other:** none**Comparison with 1978-79 Cast/Photograph**Comparison with the 1979 cast and photos showed slight loss of resolution of some of the finer details on the prints' surface, particularly at the bottom, and darkening of the surface, both due to the coating of Bedacryl. Tool marks were visible in the cast that were obscured by the Bedacryl coating *in situ* and calcite ridge in crack was more prominent in cast than *in situ*.

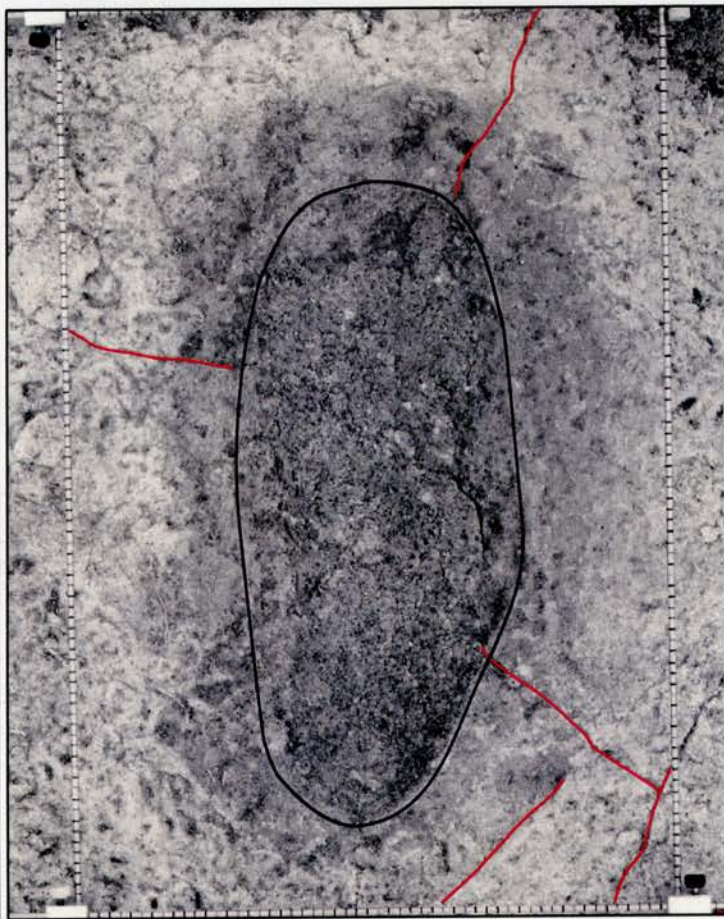
G2/3-20
TUFF CONDITIONS

1995 Condition**General Condition:** Minor alteration: Good**Tuff conditions:**Weathering: noneCracking: Three 1-2mm wide cracks extended outward from print margins.Losses: noneDetached/loose tuff: nonePowdering: noneOther: none**Conditions related to 1978-79 interventions:**Bedacryl: Bedacryl found throughout the prints and just beyond the margins. It had slightly deteriorated on the floor of the prints and was penetrated by rootlets, and was lost in small discrete areas.Embedding: Minor embedding of very fine particles of overburden in the Bedacryl layer (not shown on graphic).Silicone: noneExcavation tool marks: noneInventory number on tuff: 1979 label ("2-20") located just beyond the lateral heel margin.Other: noneRoot damage: Network of rootlets penetrated the Bedacryl layer, especially in the posterior portion (shown as root mat on graphic), but did not appear to penetrate the tuff.Insect activity: none**1996 Interventions**Consolidation/stabilization: noneFills: noneReattachment: noneRoot treatment: Surface rootlets were removed.Other: none**Comparison with 1978-79 Cast/Photograph**

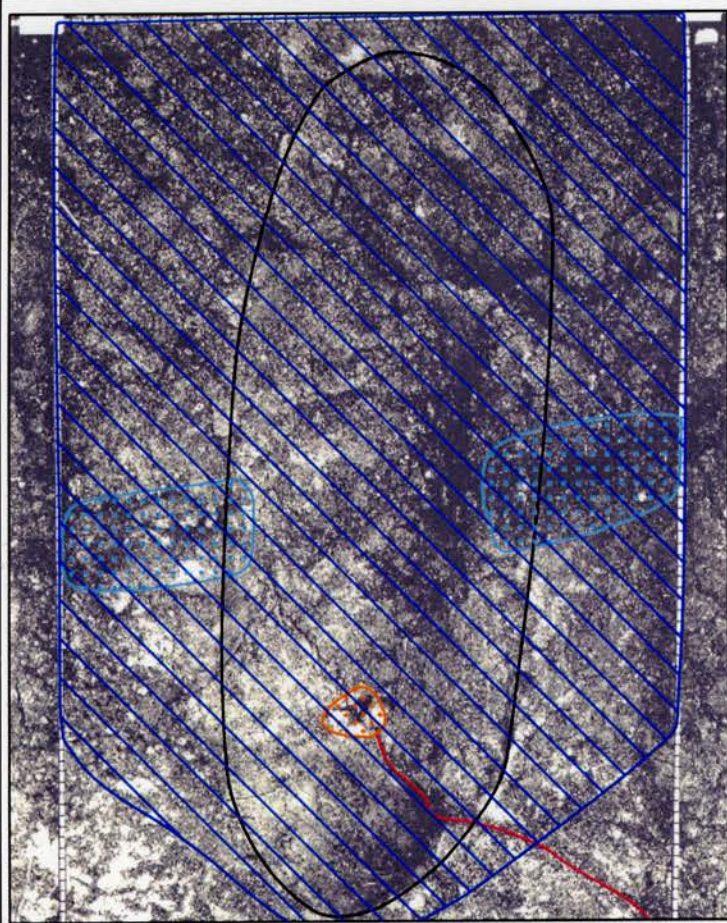
G2/3-21
TUFF CONDITIONS

G2/3-21 is located in the weathered strip of tuff in the southern sector of the trackway, characterized by patterned cracking with deep fissures that are filled with overburden.

Cracking: Significant cracking throughout the prints associated with weathering of tuff; a single crack in consolidated tuff enters print from outside posteromedial margin (see Comparison).

Detached/loose tuff: Loose tuff associated with root penetration.
