LAETOLI

HOMINID TRACKWAY, SITE G

CONDITION RECORDS

G1 AND G2/3 FOOTPRINTS

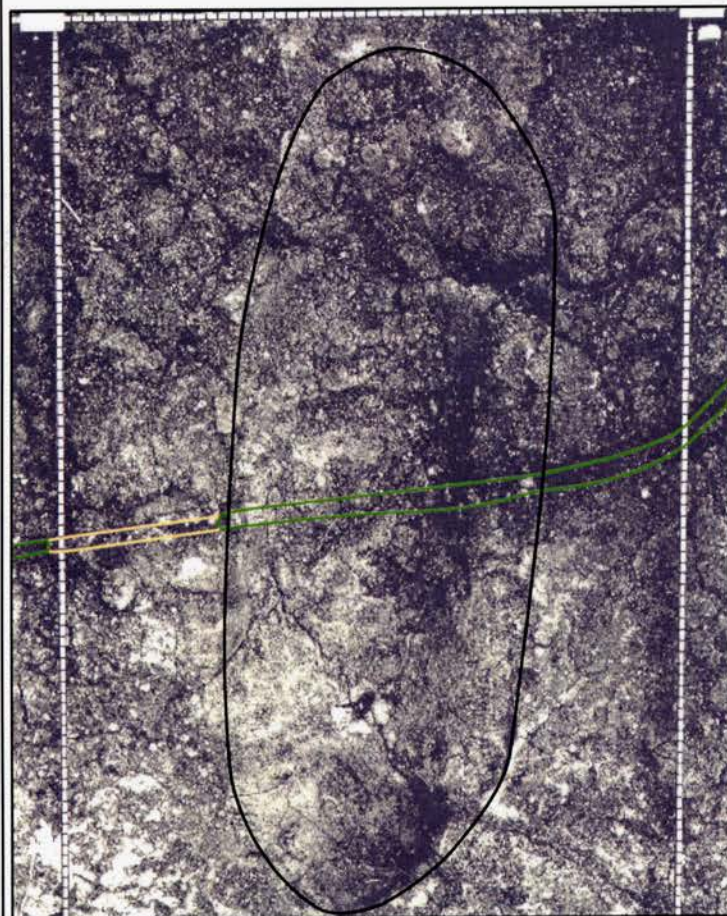
G2/3-21
ROOT DAMAGE AND INSECT ACTIVITY

Root damage: Large 10mm diameter root from stump no. 83 passed through the lateral and medial margins of the prints, causing considerable disruption of the overlying and surrounding tuff and leaving a root impression on the surface where portions were removed. Some subterranean root fragments were left *in situ* because they could not be removed without damaging the tuff. Rootlets penetrated throughout the weathered tuff.

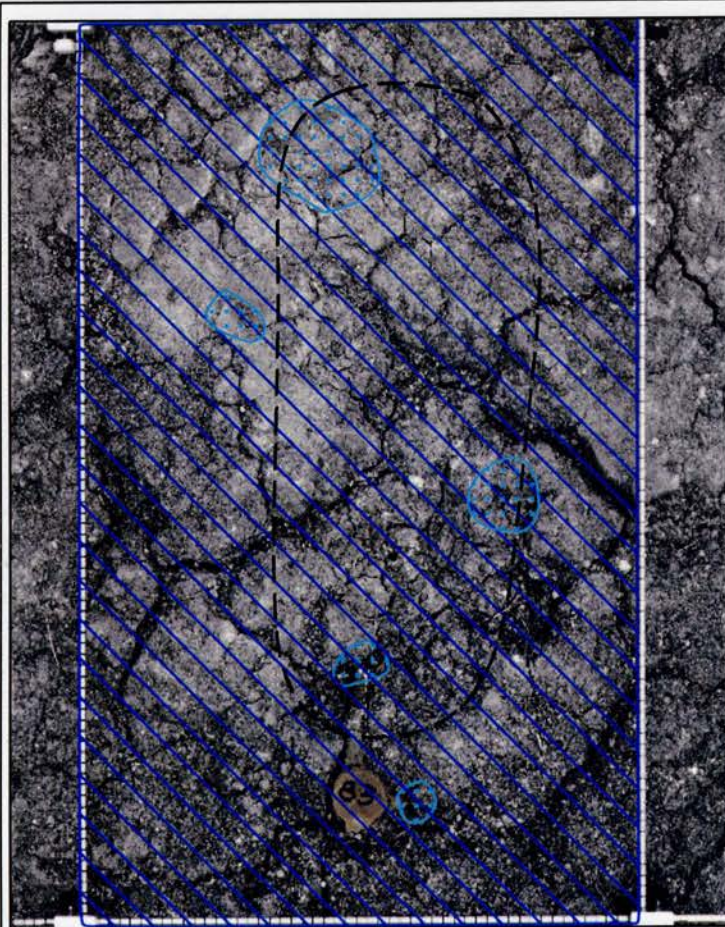
G2/3-22
TUFF CONDITIONS

Weathering: Severe weathering throughout the prints and the surrounding tuff. G2/3-22 is located in the weathered strip of tuff in the southern trackway, characterized by patterned cracking with deep fissures.

Cracking: Significant cracking throughout the prints, averaging 2-3mm wide, associated with weathering of the tuff.

Detached/loose tuff: Loose patches of tuff in the anterior portion, near the lateral margin, and associated with stump no. 83 in the posterior portion.

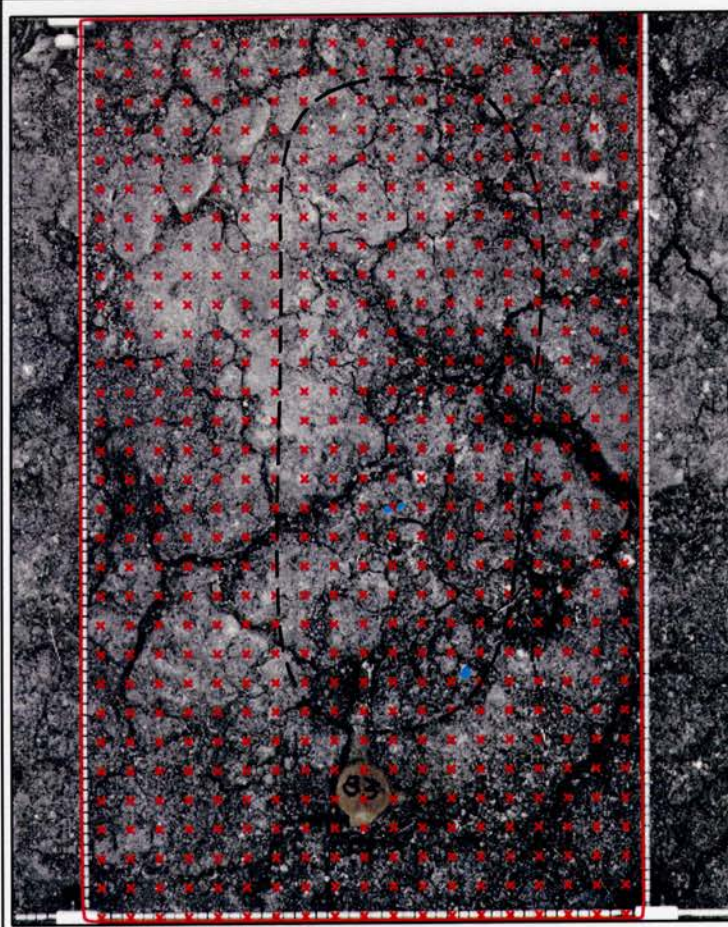
G2/3-22
CONDITIONS RELATED TO 1978-79 INTERVENTIONS

Bedacryl: Bedacryl was not detected, though 1978 photographs showed dark staining which may be Bedacryl.

Embedding: Fine particles were embedded in the weathered tuff, especially in the cracks.

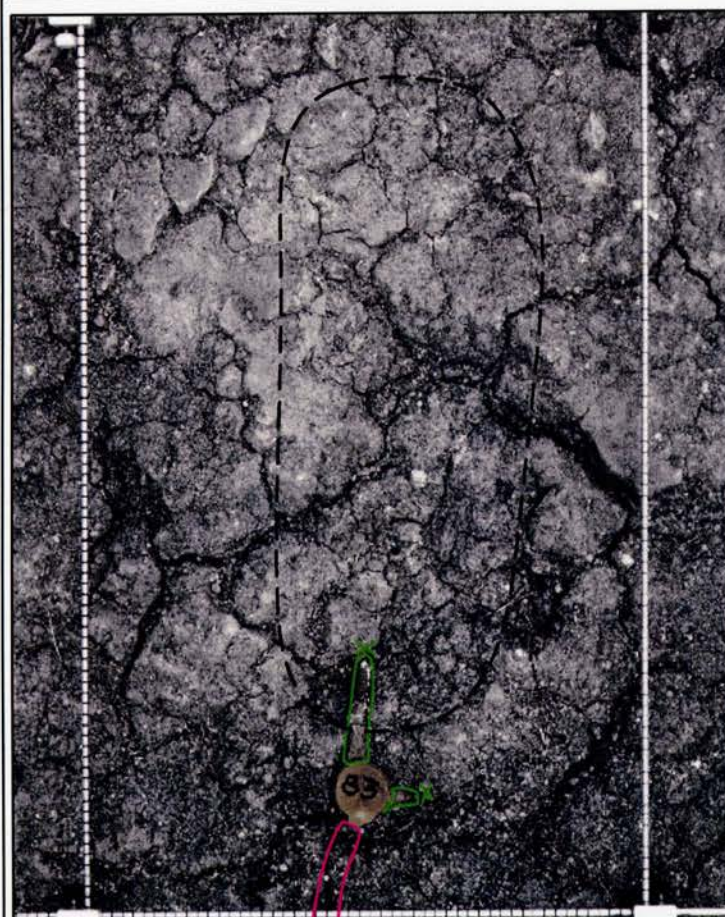
G2/3-22
ROOT DAMAGE AND INSECT ACTIVITY

Root damage: Large acacia stump no. 83 (the source for the root that also damaged G2/3-21) penetrated the heel. There was no significant disruption of the tuff surrounding the root, though the penetration area is large (~15cm²). A deep root impression was left in and beyond the posterior margin where surface portions were removed. Rootlets penetrated throughout the weathered tuff.

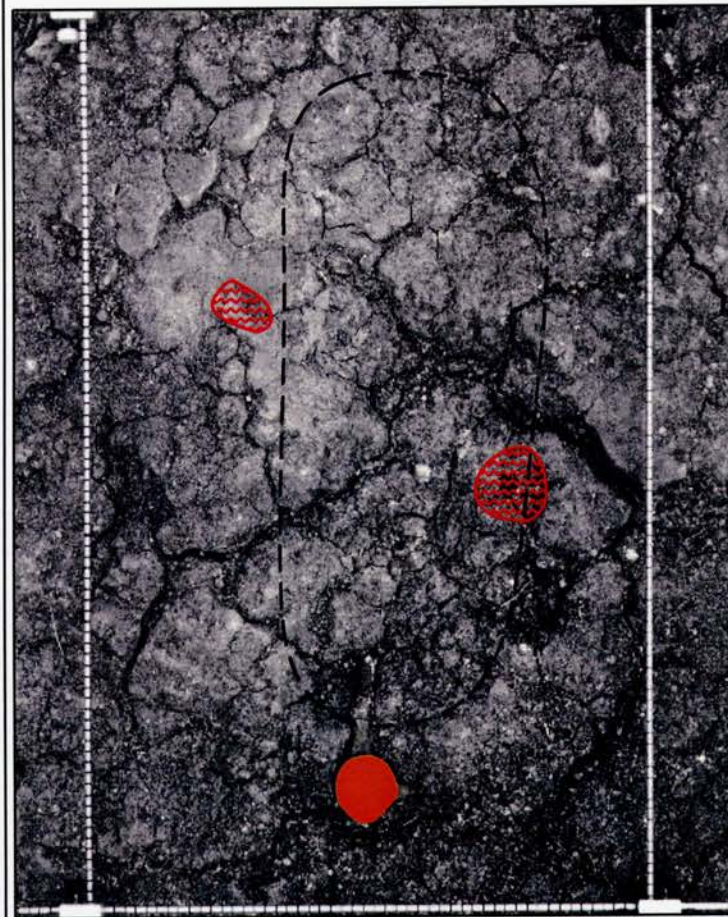
Comparison with the 1979 photos showed increased weathering of the tuff and disruption and deformation of the tuff where stump and root penetrated. Loss of resolution on the prints' surface and margins were also noted. The 1979 cast was made prior to complete excavation and was not relied upon for comparison.

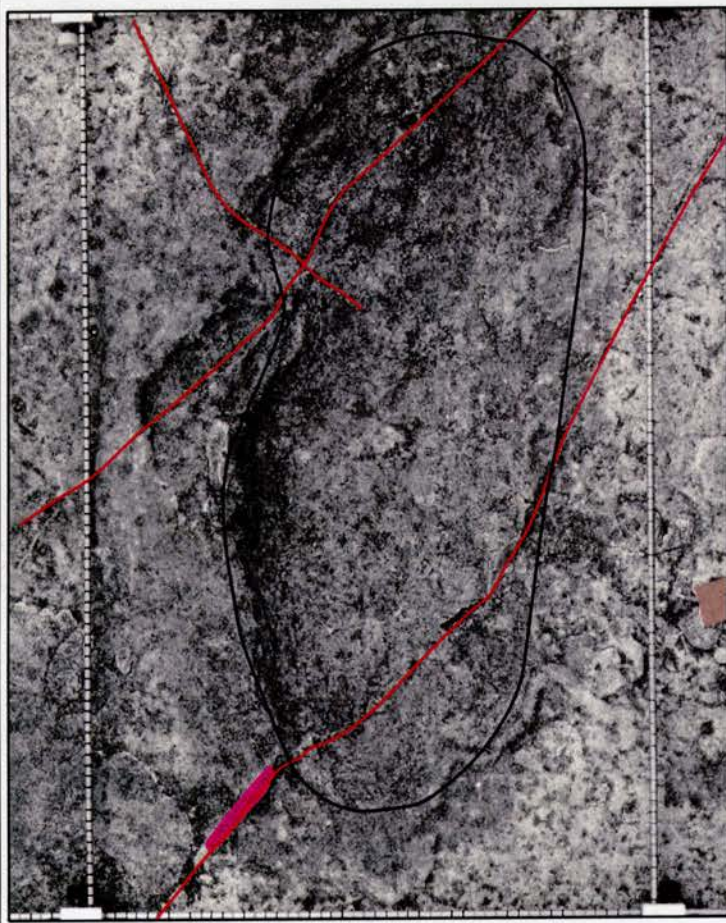
G2/3-24
TUFF CONDITIONS

Cracking: Three distinct cracks, 2 filled with calcite, traversed the print's anterolateral and posteromedial margins.

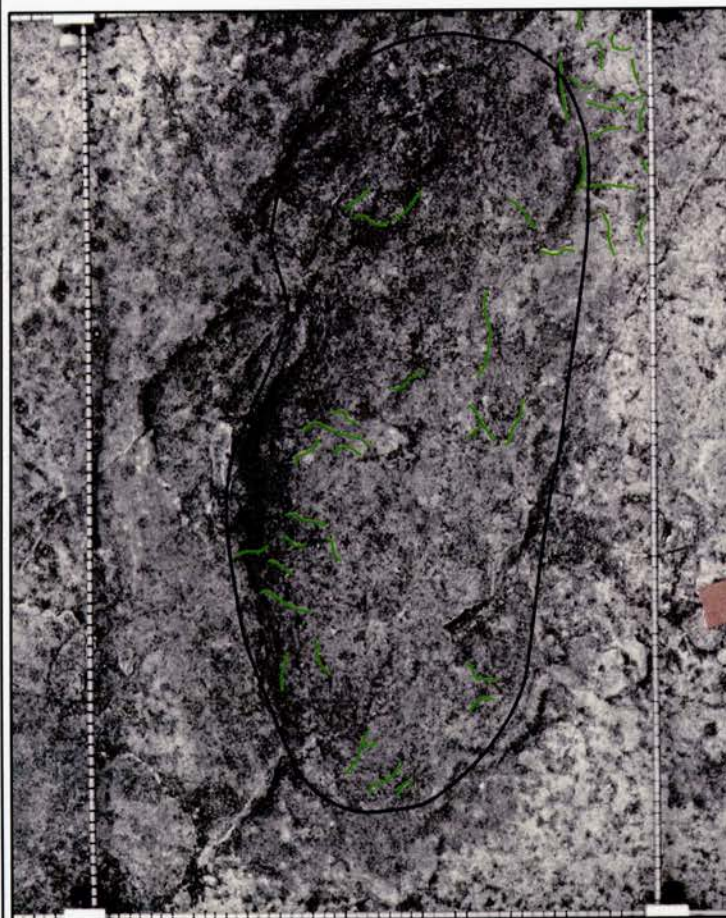
G2/3-24
ROOT DAMAGE AND INSECT ACTIVITY

Root damage: Abundant rootlets penetrated the Bedacryl layer but did not appear to penetrate the footprint tuff.

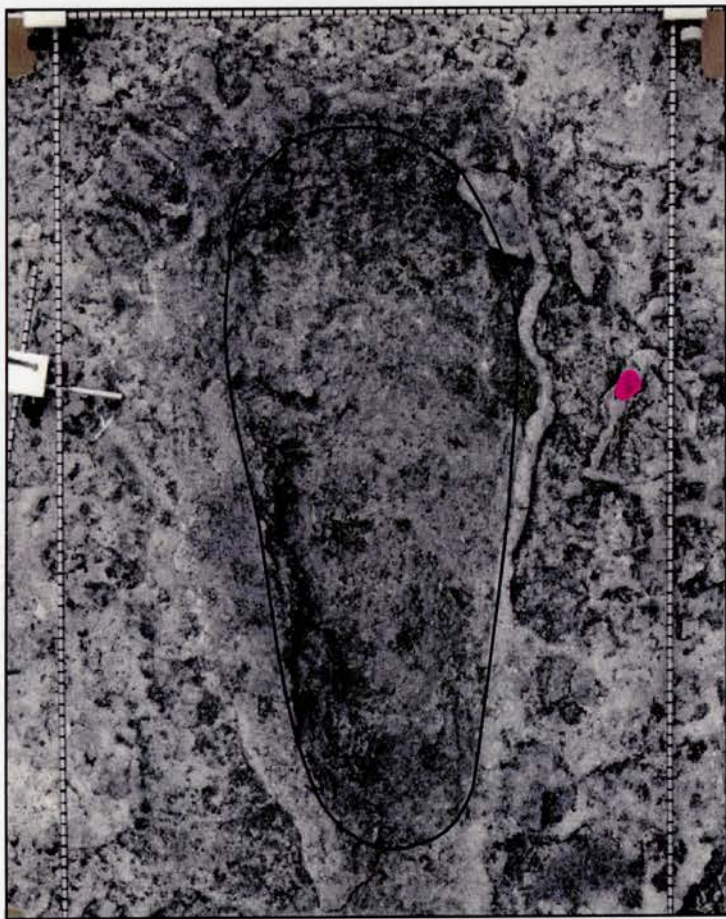
G2/3-25
TUFF CONDITIONS

Cracking: none

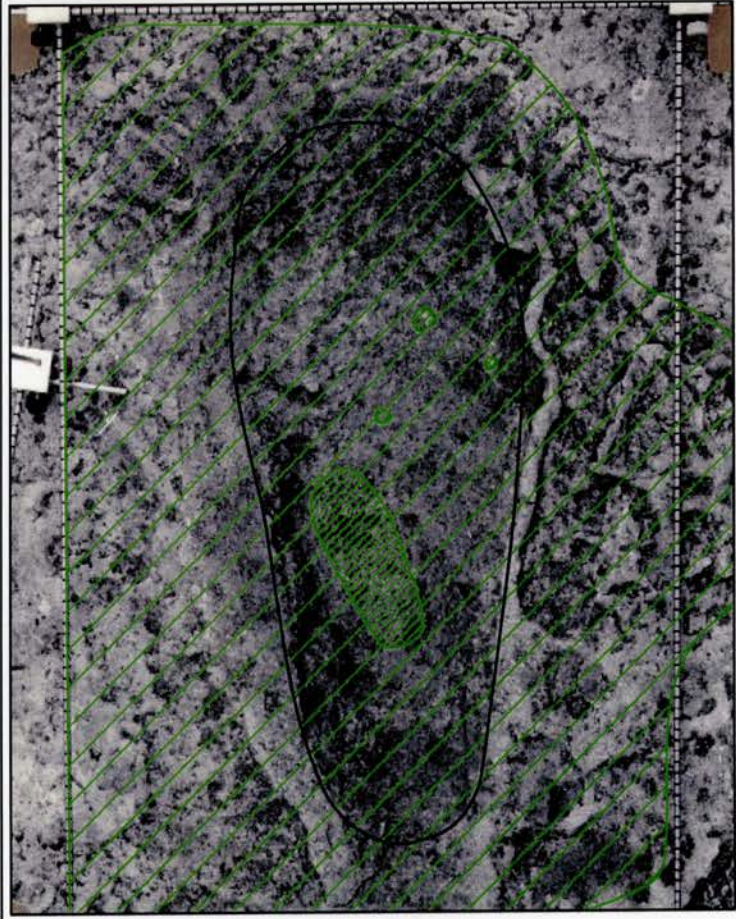
G2/3-25
CONDITIONS RELATED TO 1978-79 INTERVENTIONS

Bedacryl: Bedacryl found throughout the prints and surrounding tuff. Bedacryl had deteriorated or was lost in small patches on the floor of the prints.

Prior to cleaning, comparison with the 1979 cast and photos showed a slight loss of resolution on the prints' surface due to the Bedacryl coating and to the fine particles embedded in it. After cleaning, comparison showed a higher level of detail, though tools marks clearly seen in the heel of the casts were not as prominent *in situ*.

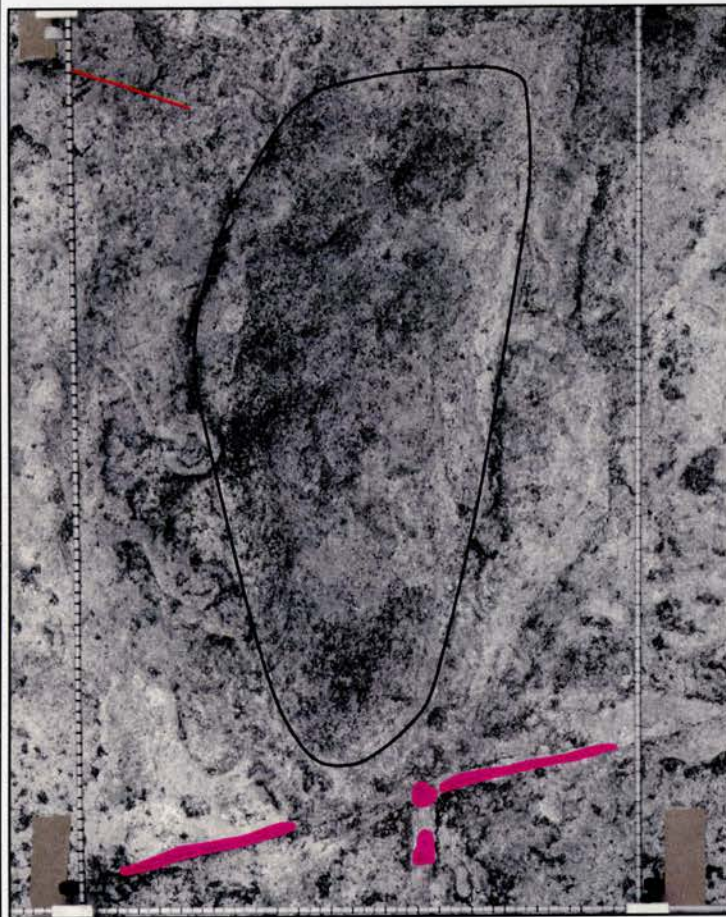
G2/3-26
TUFF CONDITIONS

1995 Condition**General Condition:** Minor alteration: Good**Tuff conditions:**Weathering: noneCracking: A hairline crack was visible outside of lateral margin of the anterior portion of prints (comparison with the cast showed the crack continued through the toe area, but this was not apparent *in situ*).Losses: Abrasion on the prominent ridges of tuff posterior to the heel margin (see Comparison).Detached/loose tuff: nonePowdering: noneOther: none**Conditions related to 1978-79 interventions:**Bedacryl: Thin layer of Bedacryl throughout the prints and surrounding tuff surface; deteriorated patches near center and posterior portion; small patches of Bedacryl loss within each of the deteriorated areas.Embedding: Slight embedding of fine particles in Bedacryl layer (not shown on graphic).Silicone: Traces of silicone outside posterior margin.Excavation tool marks: Tool marks visible just inside and outside the lateral margin (see Comparison).Inventory number on tuff: Two 1979 inventory numbers ("2-26" and "2-25") visible on tuff surface beyond the medial heel margin.Other: none**Root damage:** Surficial rootlets penetrated the Bedacryl layer, but not the tuff.**Insect activity:** none**1996 Interventions****Consolidation/stabilization:** none**Fills:** none**Reattachment:** none**Root treatment:** Surface rootlets were removed.**Other:** none**Comparison with 1978-79 Cast/Photograph**Comparison with 1979 cast and photos showed only slight loss of resolution of details due to the Bedacryl layer and particle embedding within the Bedacryl. Tool marks visible on the cast in the ball of the G-2 print, and a hairline crack visible in the photos and cast running across the anterior portion of the prints, were obscured *in situ*. Abrasion of the tuff surface noted on the T-shaped ridge outside the print was evident on the cast, except for the abrasion of the right side of the "T", which appeared to be fresh.

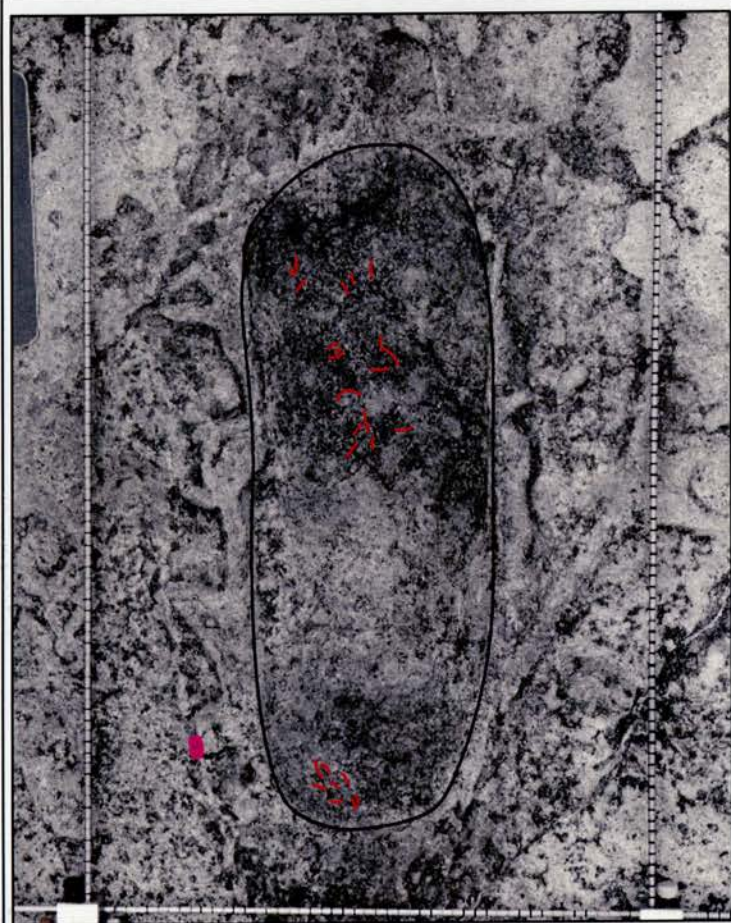
G2/3-27
TUFF CONDITIONS

Cracking: Network of fine cracks, <1mm wide, in tuff underneath deteriorated Bedacryl in anterior and posterior portions.

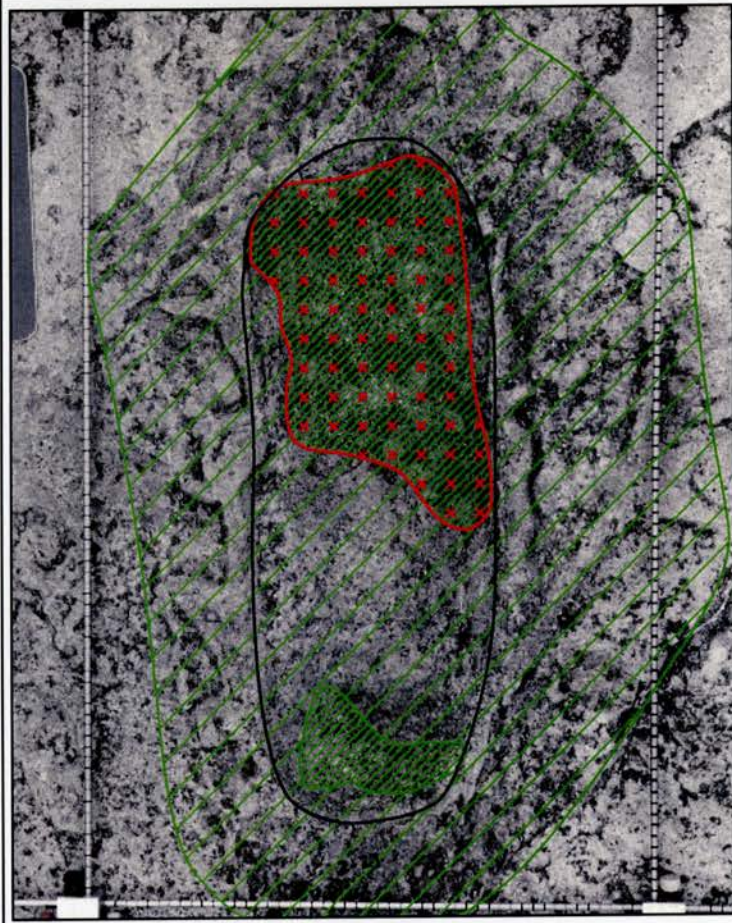
G2/3-27
CONDITIONS RELATED TO 1978-79 INTERVENTIONS

Bedacryl: Bedacryl covered the print and the tuff surrounding it. The Bedacryl was deteriorated at the bottom of the anterior half and deteriorated and partially lost near the posterior margin. The Bedacryl layer was relatively thick.

Embedding: Slight embedding of fine particles in the Bedacryl layer, especially in the deteriorated areas.

Comparison with 1979 cast and photos showed loss of resolution of features due to the thick layer of Bedacryl, especially the deteriorated areas. Excavation tool marks, which can be seen to cover the floor of the print in cast and photos, are obscured *in situ*. A crack in the anterior portion is less distinct *in situ*.

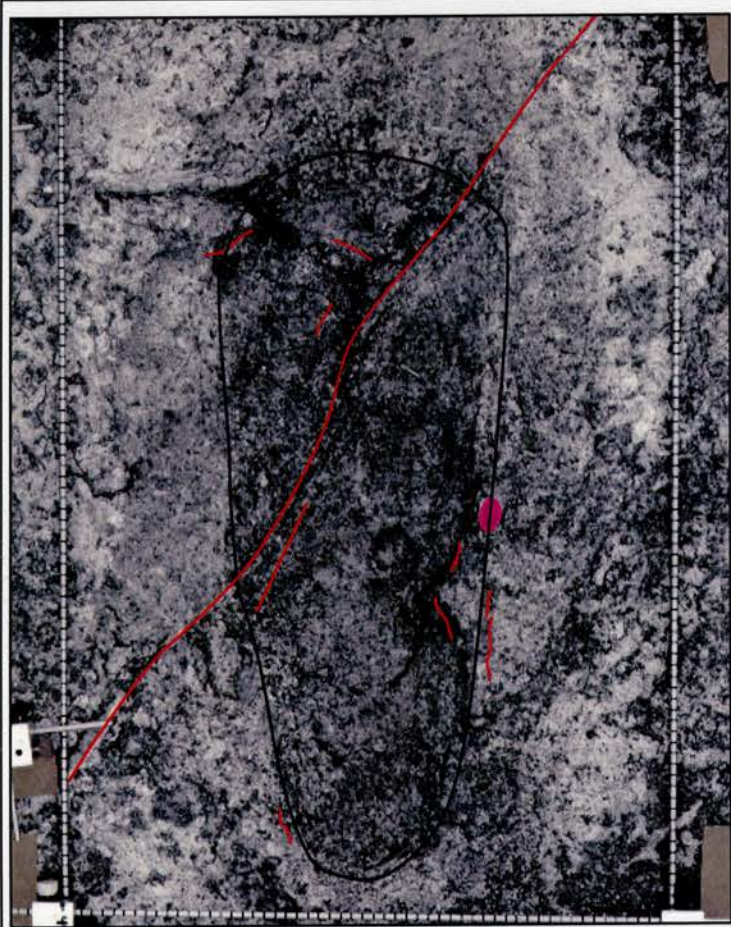
G2/3-28
TUFF CONDITIONS

1995 Condition**General Condition:** Minor alteration: Good**Tuff conditions:**Weathering: noneCracking: A crack with a calcite vein traversed the anterior and central portion of the prints.

Minor cracks in the tuff along prints' margin.

Losses: Minor loss of the tuff surface where Bedacryl had deteriorated near center of medial margin.Detached/loose tuff: nonePowdering: noneOther: none**Conditions related to 1978-79 interventions:**Bedacryl: Bedacryl throughout the prints and surrounding tuff; patches of Bedacryl on the floor and medial margin of the prints had begun to deteriorate and crack with minor areas of loss, exposing a lighter colored tuff underneath.Embedding: Fine particles from the overburden adhered to Bedacryl layer, especially on the floor of the print.Silicone: Traces of silicone on anterior margin.Excavation tool marks: noneInventory number on tuff: 1979 label ("2-28") visible on tuff surface beyond the heel margin.Other: none**Root damage:** Tiny rootlets weaved in and out of the Bedacryl layer, and two roots, approximately 1-2mm in diameter, penetrated the tuff on the anterior portion, without causing damage or disruption of the tuff.**Insect activity:** none**1996 Interventions****Consolidation/stabilization:** none**Fills:** none**Reattachment:** none**Root treatment:** Surface rootlets removed.**Other:** none**Comparison with 1978-79 Cast/Photograph**

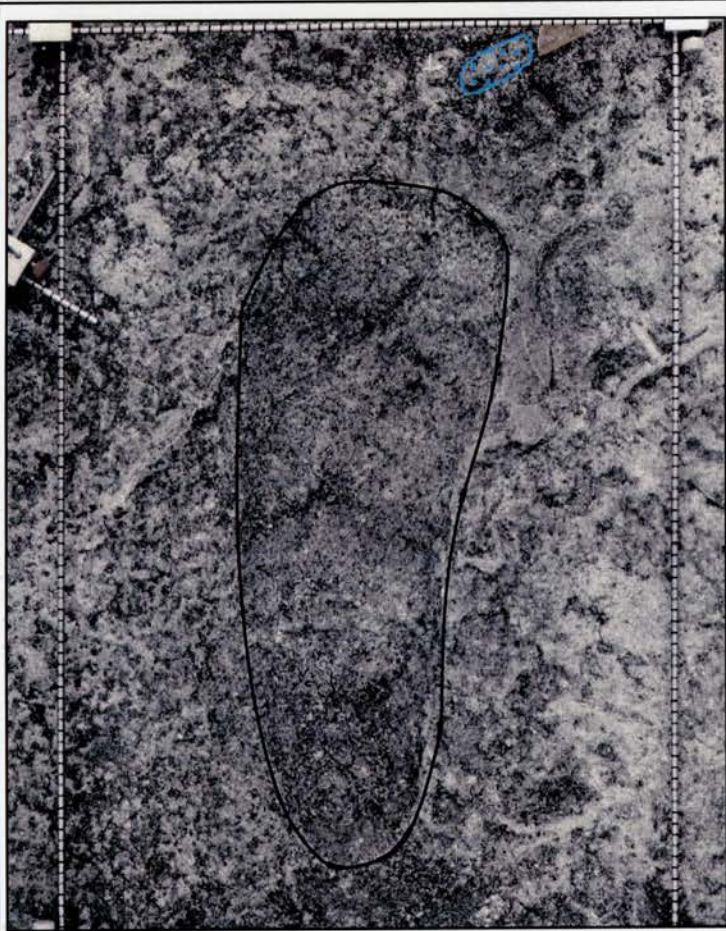
G2/3-29
TUFF CONDITIONS

Detached/loose tuff: Small fragment of detached tuff outside anterior print margin.

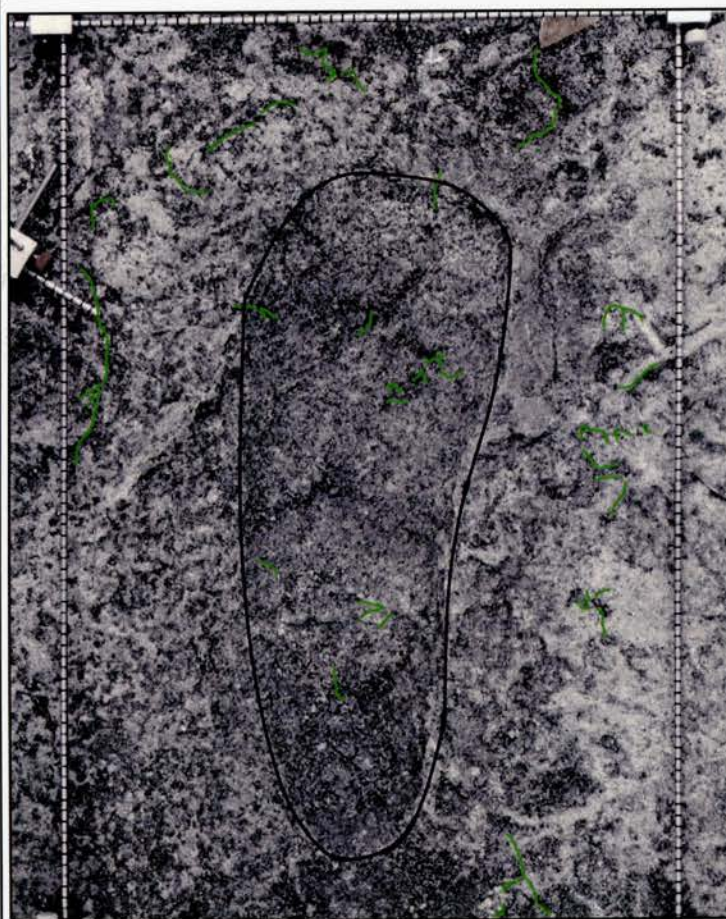
G2/3-29
ROOT DAMAGE AND INSECT ACTIVITY

Root damage: Numerous rootlets on surface only.

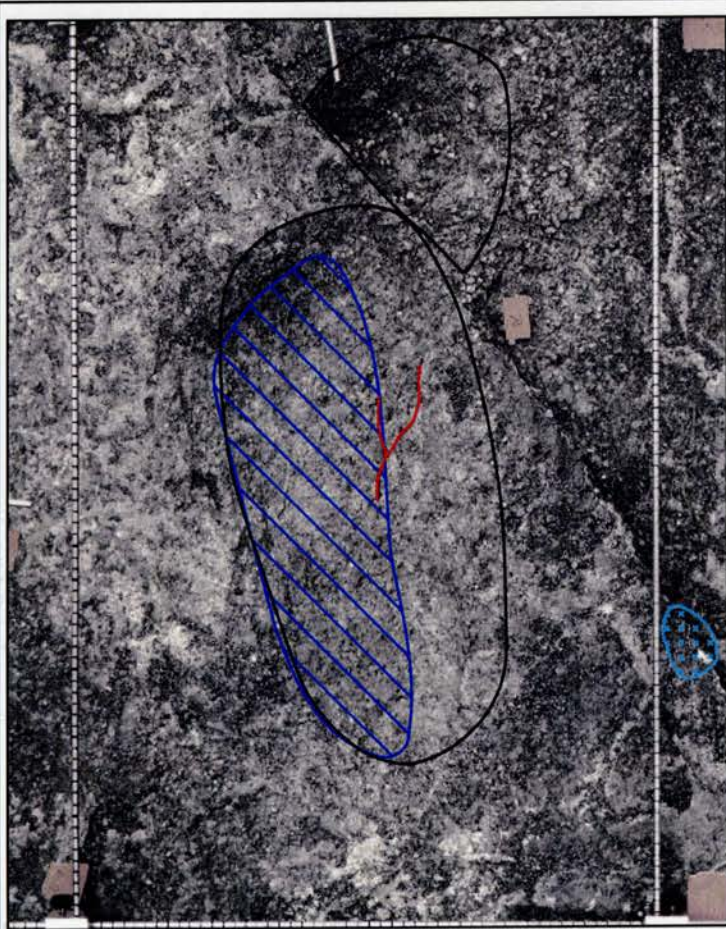
G2/3-30
TUFF CONDITIONS

1995 Condition**General Condition:** Minor alteration: Good**Tuff conditions:****Weathering:** Slight weathering along the lateral margin and bottom of the prints.**Cracking:** Hairline cracks near center of prints.**Losses:** none**Detached/loose tuff:** Area of tuff along fault line beyond posteromedial margin was fragile and loose.**Powdering:** none**Other:** none**Conditions related to 1978-79 interventions:****Bedacryl:** Bedacryl throughout prints and surrounding tuff south of the fault. Bedacryl was not identified north of the fault. The Bedacryl layer was missing outside the lateral margin and was deteriorated or missing in patches inside the prints near the center; missing Bedacryl probably removed during the molding operation in 1979.**Embedding:** Moderate embedding throughout the prints and the surrounding tuff, especially in anterior part north of fault.**Silicone:** Traces of silicone outside medial margin.**Excavation tool marks:** none**Inventory number on tuff:** none (see Comparison)**Other:** none**Root damage:** Rootlets on surface; one rootlet penetrated Bedacryl layer in anterior portion.**Insect activity:** none**1996 Interventions****Consolidation/stabilization:** Loose tuff along edge of fault outside the prints' margin was stabilized with Acrysol WS-24 at 4%.**Fills:** none**Reattachment:** none**Root treatment:** Surface rootlets were removed.**Other:** none**Comparison with 1978-79 Cast/Photograph**Comparison with 1979 cast and photos showed loss of resolution of details on floor of print due to Bedacryl and fine particles embedded in the coating. Inventory number, which is visible on photos, was not seen *in situ* due to embedding.**Notes**

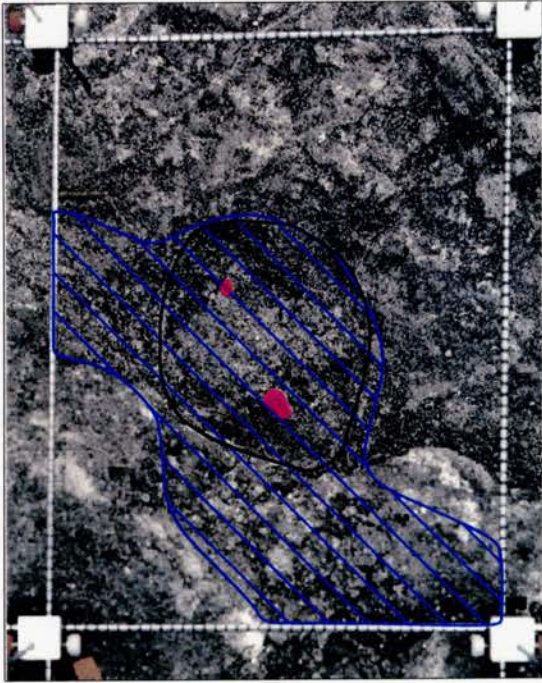
G2/3-31
TUFF CONDITIONS

General Condition: Moderate alteration: Fair

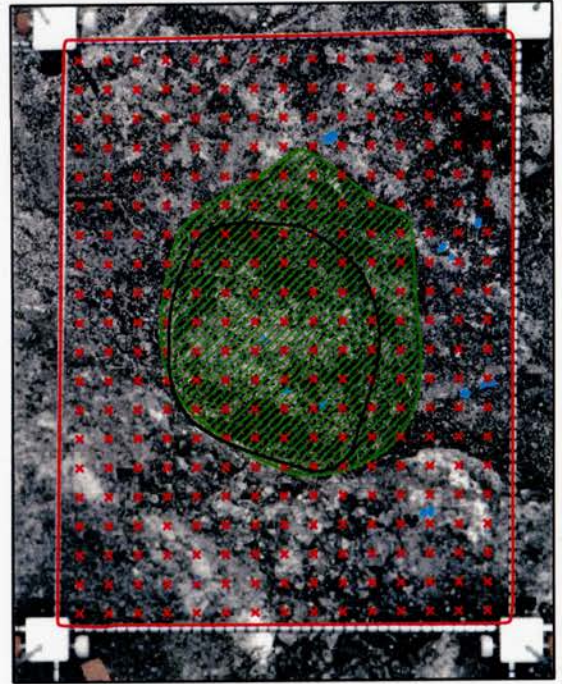
G2/3-31
CONDITIONS RELATED TO 1978-79 INTERVENTIONS

Bedacryl: Bedacryl detected throughout print. It was deteriorated in all but a small patch in the center.

Comparison with 1979 cast and photos showed loss of resolution of details on floor of print due to Bedacryl and fine particles embedded in the coating; and an increase in weathering.

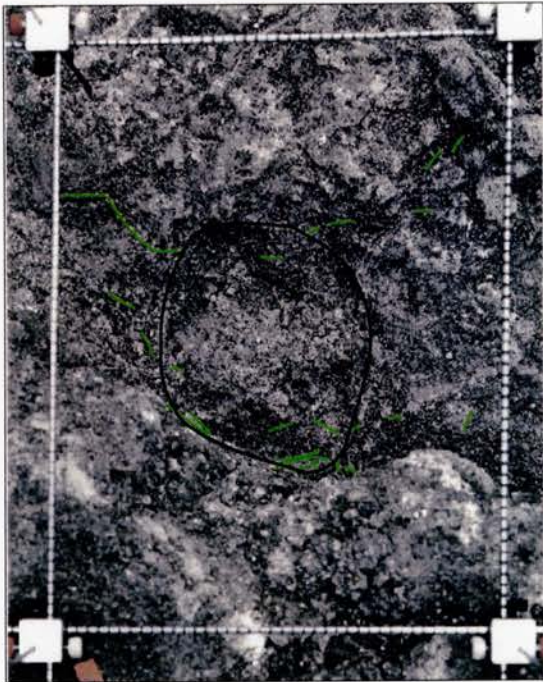
G2/3-31
ROOT DAMAGE AND INSECT ACTIVITY

Root damage: Rootlets concentrated on the posterior end where the print meets the higher augite-biotite tuff.
