LAETOLI

HOMINID TRACKWAY, SITE G

CONDITION RECORDS

G1 AND G2/3 FOOTPRINTS

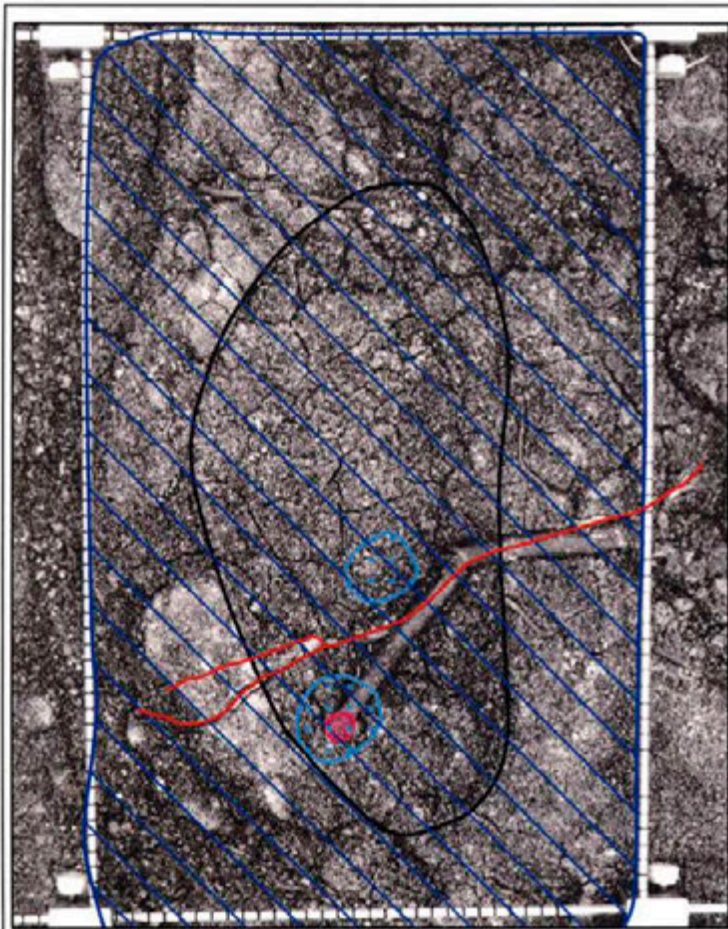
G1-3
TUFF CONDITIONS

On excavation in 1996, the 1978 reburial fill was very hard and compact.
Video footage (by Pedro Celedon) of root removal from G1-3.

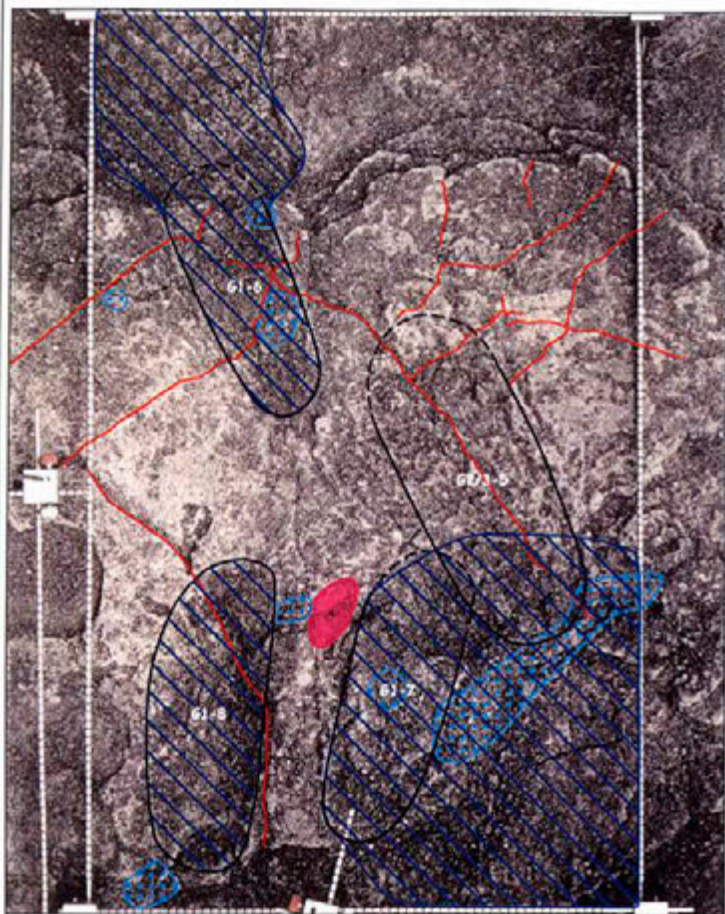
G1-6,7,8+G2/3-5
TUFF CONDITIONS

Graphic condition record includes prints G1-6, 7, 8 & G2/3-5 and is printed at a different scale than the other Polaroids with single prints. See other written condition records for description of conditions in and around those prints.

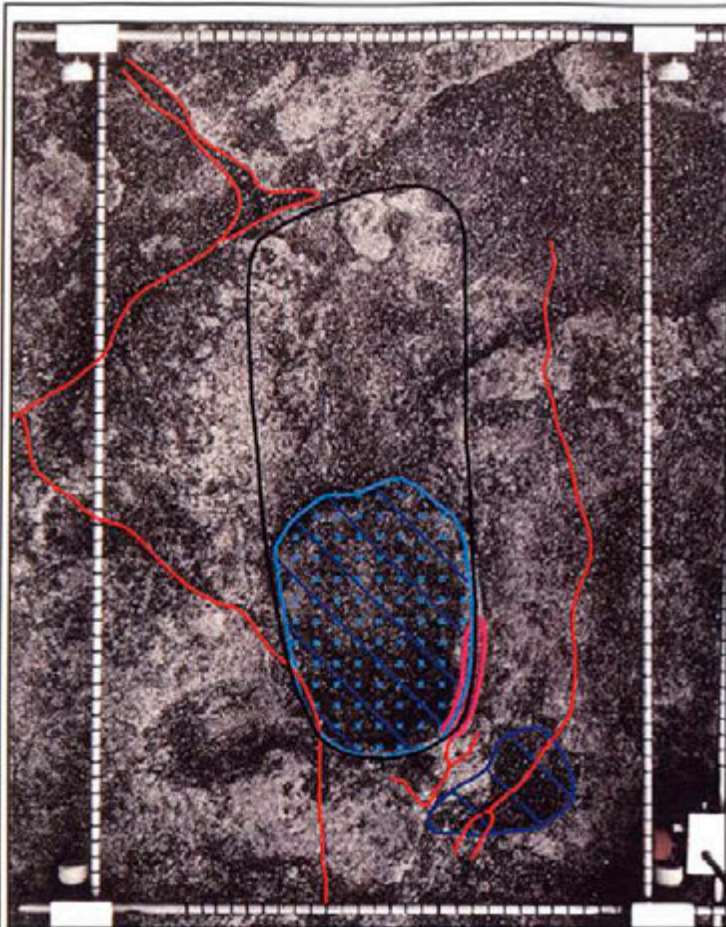
G1-9
TUFF CONDITIONS

| <p><u>Comparison with 1978-79 Cast/Photograph</u> No cast. Comparison with 1978 photos showed slight loss of resolution of details, an increase in weathering in heel portion, and embedding of particles in tuff.</p> |
| <p><u>Notes</u> Three lagomorph prints outside posterior and lateral margins.</p> |

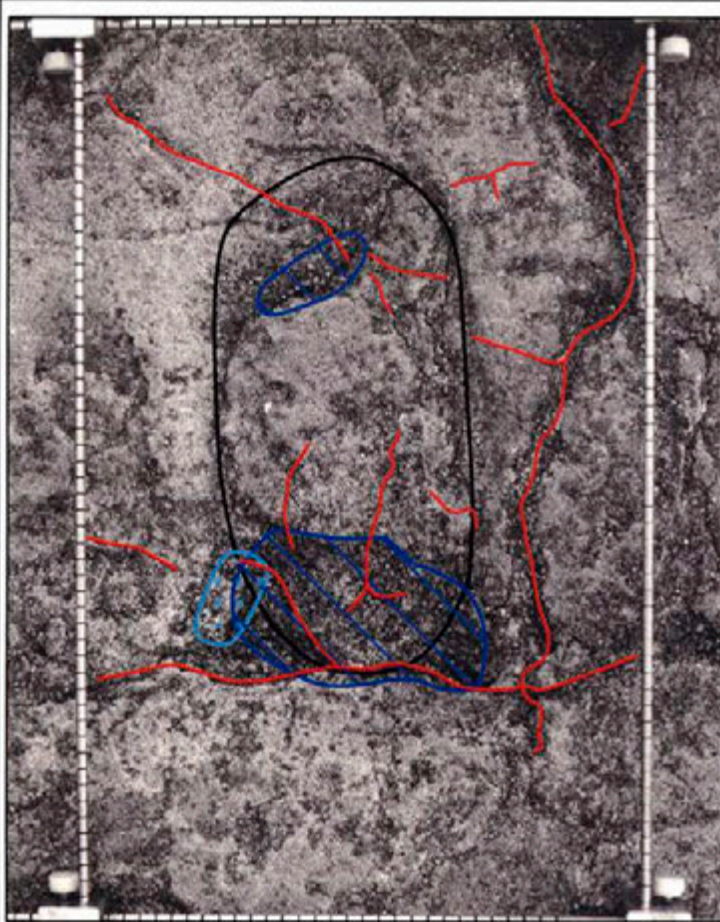
G1-10
TUFF CONDITIONS

On excavation, the 1978 fill was compacted and adhered to tuff.

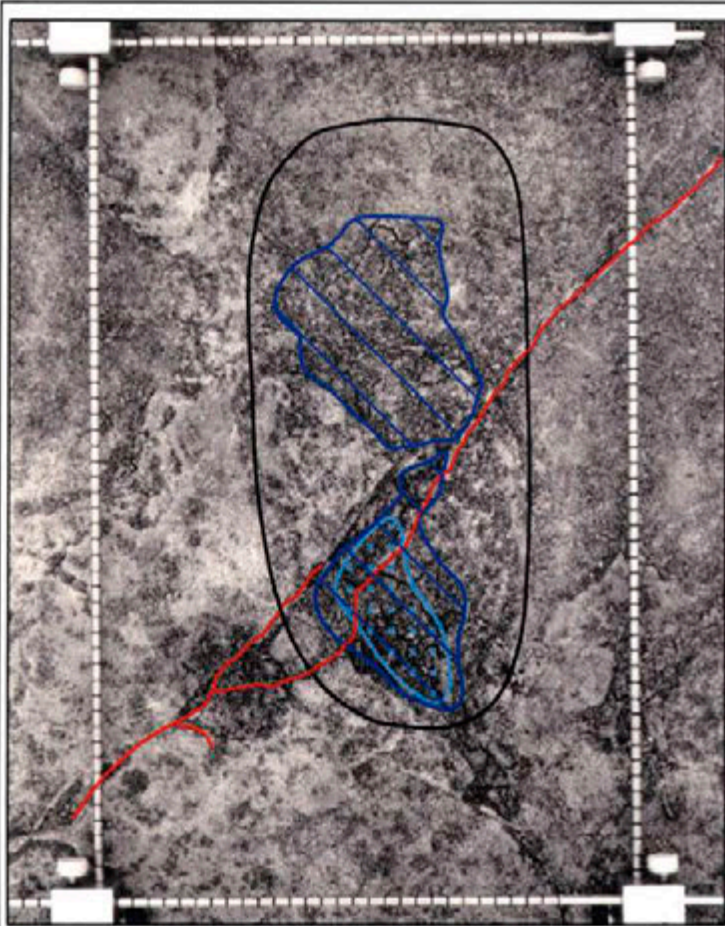
GI-II
TUFF CONDITIONS

On excavation in 1996, the 1978 reburial fill was compacted and contained pebbles 0.2-0.4 cm in diam.

Lagomorph print lateral to heel.

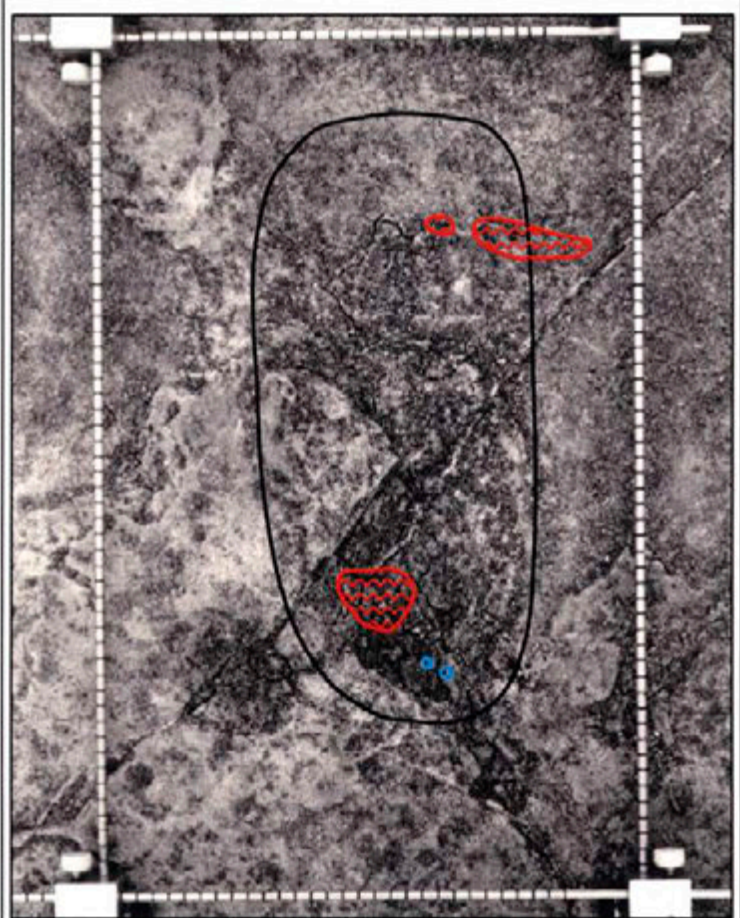
GI-II
ROOT DAMAGE AND INSECT ACTIVITY

| <p><u>1996 Condition</u> General condition: Minor alteration: Good</p> <p><u>Tuff conditions:</u> <u>Weathering:</u> Moderate weathering of tuff in heel portion; and in lagomorph print outside medial margin. <u>Cracking:</u> Crack with calcite vein (fragments of calcite missing) runs parallel to axis of print outside lateral margin; a second large crack runs perpendicular to the first outside posterior margin. <u>Losses:</u> none <u>Detached/loose tuff:</u> none <u>Powdering:</u> none <u>Other:</u> none</p> <p><u>Conditions related to 1978-79 interventions:</u> <u>Bedacryl:</u> none <u>Embedding:</u> Severe embedding of fine particles in weathered areas. <u>Silicone:</u> none <u>Excavation tool marks:</u> none <u>Inventory number on tuff:</u> none <u>Other:</u> none</p> <p><u>Root damage:</u> A few surface rootlets in heel portion and beyond print margin (not shown in graphic).</p> <p><u>Insect activity:</u> none</p> |

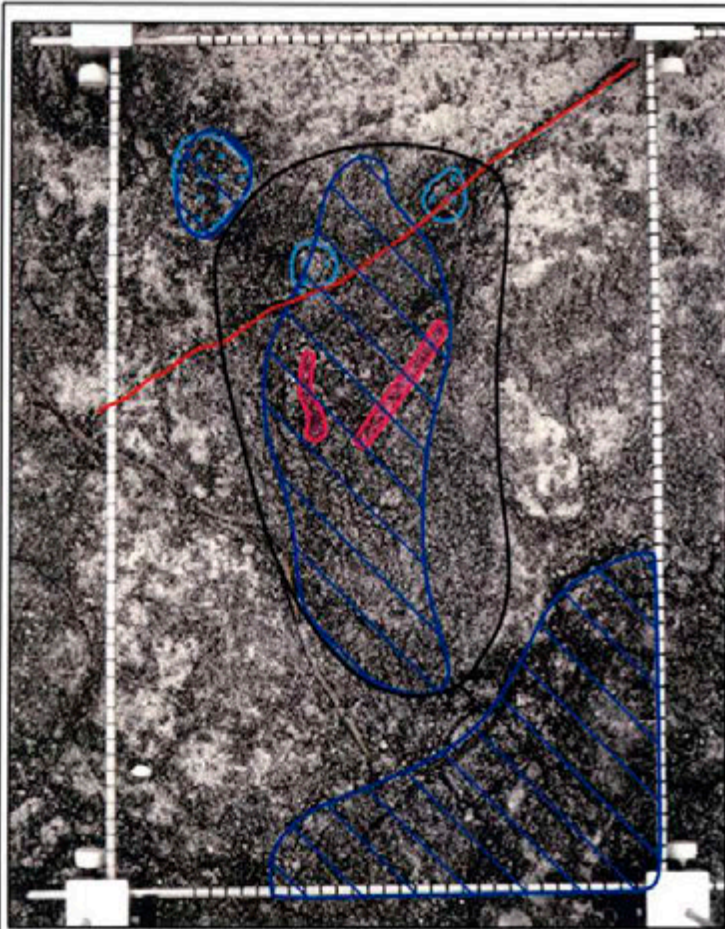
G1-13
TUFF CONDITIONS

Cracking: Crack with partially preserved calcite vein traverses the anterior portion of the print.

Detached/loose tuff: Two small areas of loose tuff in anterior portion, and one outside anterior margin.

No cast. Comparison with 1978 photos showed loss of resolution of features; slight deformation and loss of surface of tuff due to insect activity; significant increase in weathering of tuff, particularly the patch of higher tuff in interior arch portion; embedding of particles in weathered areas; and slight loss of calcite in crack near lateral margin.

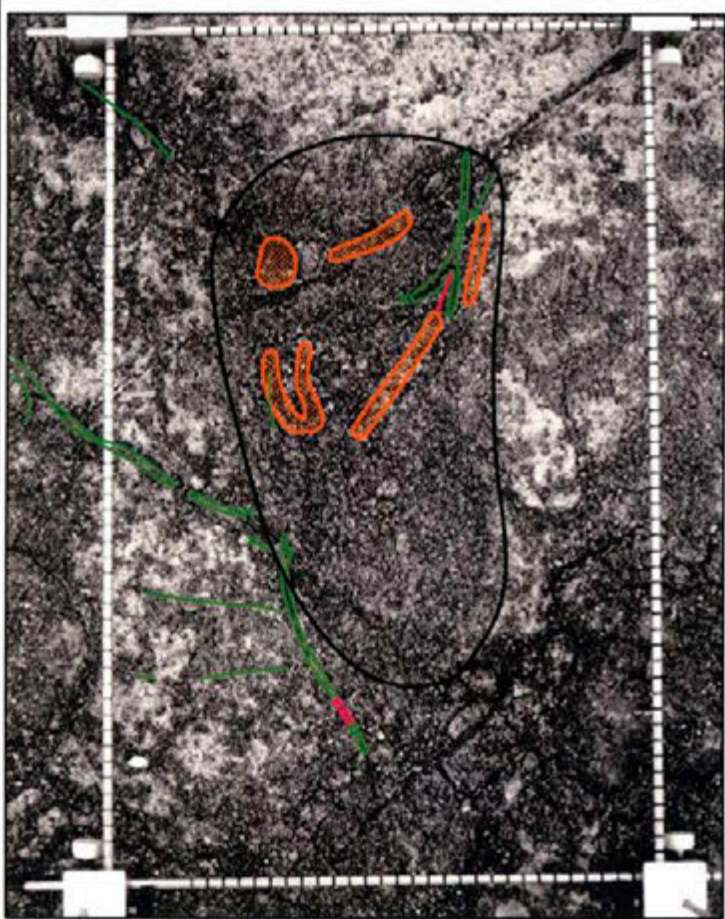
G1-13
ROOT DAMAGE AND INSECT ACTIVITY

Root damage: Rootlets (~2mm diam.) penetrated tuff on lateral side of print and in area of great toe. Roots left slight impressions on surface after removal.

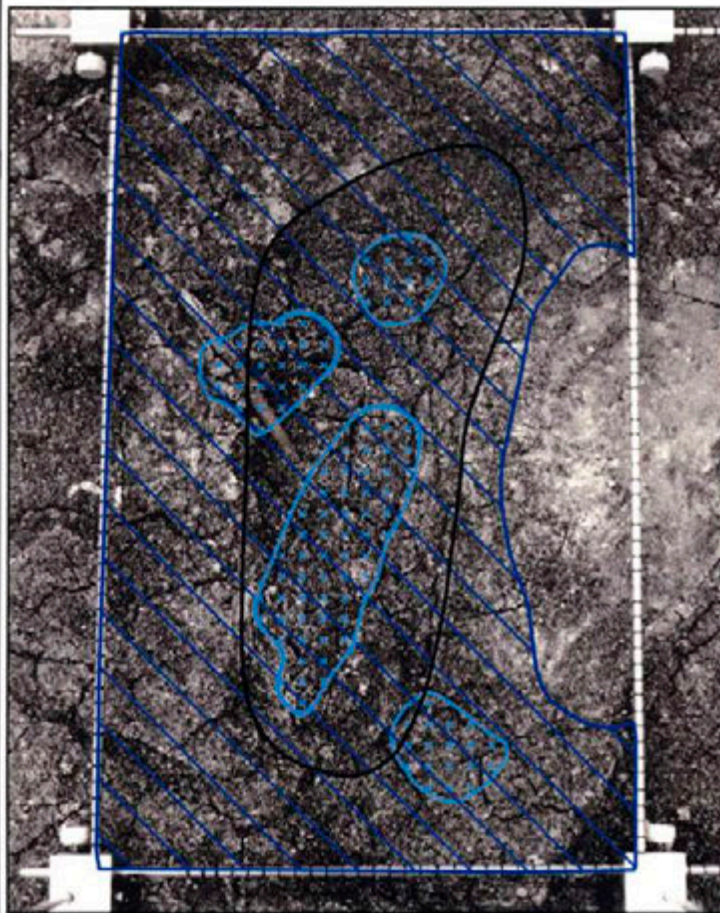
G1-19
TUFF CONDITIONS

1996 Condition**General condition:** Significant alteration: Poor**Tuff conditions:****Weathering:** Extensive and severe weathering throughout the print and surrounding tuff (with cracking to 0.5cm depth in 1-2 cm polygons).**Cracking:** Two cracks in toe and heel area seen in 1978 photos were still evident in 1996 (not shown on graphic) but had merged with network of polygonal cracking of weathered tuff.**Losses:** none**Detached/loose tuff:** Areas of tuff along axis of print and outside margin of heel were loose. Tuff was also disrupted along the length of the root that traversed print.**Powdering:** none**Other:** none**Conditions related to 1978-79 interventions:****Bedacryl:** Traces of Bedacryl stringers between cracks were found in the heel and arch portions.**Embedding:** Embedding of fine particles in weathered areas and within cracks of weathered tuff.**Silicone:** none**Excavation tool marks:** none**Inventory number on tuff:** none**Other:** none**Root damage:** Large 5mm root penetrated tuff on interior lateral side near the arch, and progressed through the tuff, exiting and re-entering the tuff at the heel. Tuff was adhered to the root, and was disrupted along its length.**Insect activity:** none**1996 Interventions****Consolidation/stabilization:** The weathered tuff was stabilized with injections of acrylic dispersion where it was loose and where disrupted by root penetration, @ 25 and 33% WS-24, respectively.**Fills:** none**Reattachment:** none**Root treatment:** Only the exposed portion of the root was removed. The subterranean root could not be removed without disrupting tuff.**Other:** none**Comparison with 1978-79 Cast/Photograph**

Comparison with 1978 cast and photos showed a marked difference in the appearance of the print. The print shape was still clearly defined, but had lost surface details due to severe weathering of the tuff surface and particle embedding; and was damaged by penetration of root in lateral arch area.

Monitoring of G1-19 (with a 10x scale loop) showed widening of cracks up to 0.8mm over the 6 and a half weeks it was exposed; see *1996-1998 Report on the Laetoli Project, Appendix III-C* for results of crack monitoring.

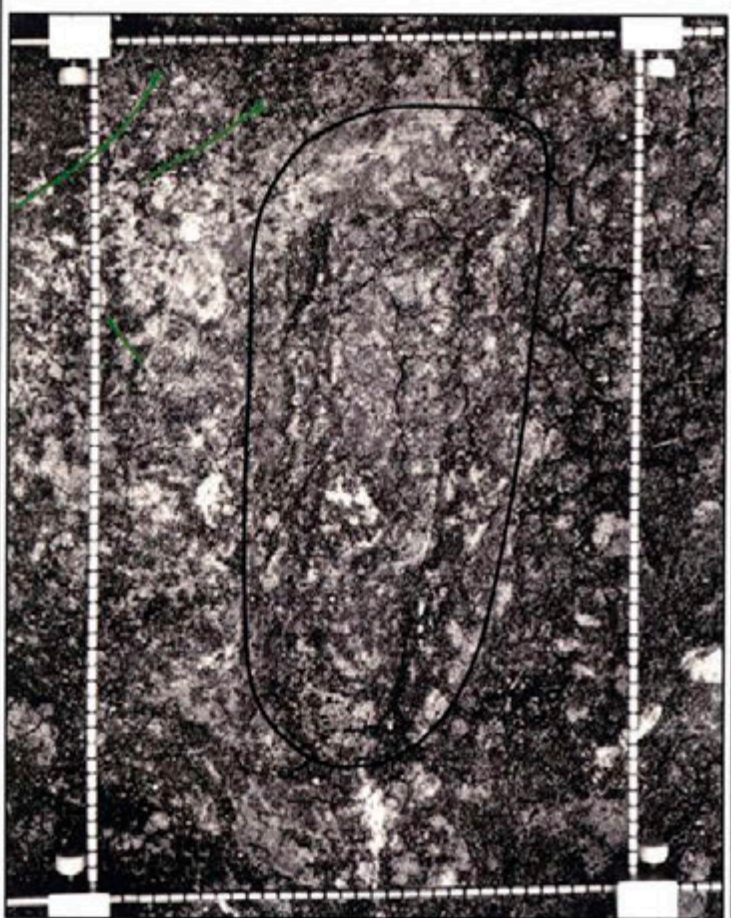
G1-21
ROOT DAMAGE AND INSECT ACTIVITY

Root damage: Rootlets on surface outside of lateral portion of print.

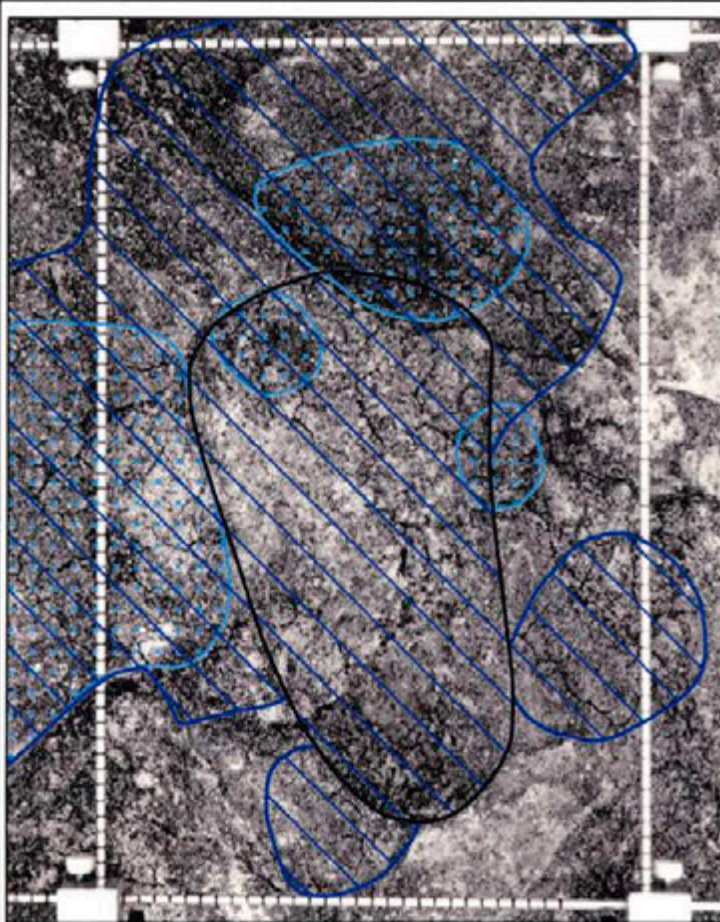
G1-22
TUFF CONDITIONS

| <p>1996 Condition General condition: Moderate alteration: Fair</p> <p>Tuff conditions: <u>Weathering:</u> Widespread, moderate weathering of tuff in and beyond print margins, with patches of well calcified tuff showing incipient weathering in the form of pattern cracking. <u>Cracking:</u> none <u>Losses:</u> none <u>Detached/loose tuff:</u> Loose tuff in area of great toe and on lateral margin; and outside medial and anterior margins. <u>Powdering:</u> none <u>Other:</u> none</p> <p>Conditions related to 1978-79 interventions: <u>Bedacryl:</u> Slight traces of Bedacryl stringers in the anterolateral region. <u>Embedding:</u> Embedding of fine particles in the heel, lateral margin, and the great toe area. <u>Silicone:</u> Numerous traces of silicone outside the lateral margin of the print. <u>Excavation tool marks:</u> none <u>Inventory number on tuff:</u> none <u>Other:</u> none</p> <p>Root damage: Small rootlet (< 1mm diam.) penetrated heel margin of print. Root < 5mm diam. and numerous small rootlets penetrated tuff outside of print and left impressions on tuff surface when removed.</p> <p>Insect activity: none</p> |
| <p>Comparison with 1978-79 Cast/Photograph Comparison with 1978 cast and photos showed very slight loss of resolution of features in the lateral portion of the print; and new weathering of tuff.</p> |

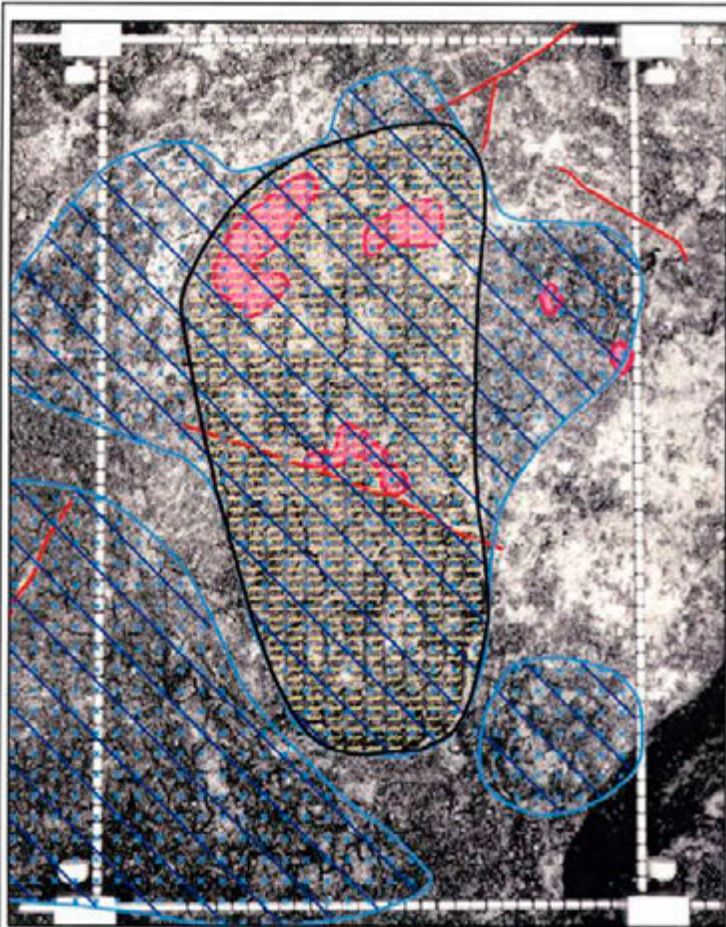
LAETOLI PROJECT SEPTEMBER 1996 0mm 25mm G1-23 TUFF CONDITIONS

Cracking: Cracks with calcite veins traversed the center of the print and were evident outside the margin of the print.

Detached/loose tuff: Loose tuff in weathered areas, including unexcavated matrix.

No cast. Comparison with 1978 photos showed loss of resolution of fine details, such as excavation scoring along rim and a fossilized insect burrow outside anterior margin, as a result of weathering and particle embedding in tuff. Shape and features of the print in 1978 were still very clear *in situ*, including print margin and the calcite vein that transects the matrix in the print at the arch portion, but the unexcavated matrix and surrounding tuff had weathered significantly; tuff was embedded with particles; and matrix was loose and powdering.

Excavated 1978 reburial fill was very wet throughout the graben in 1996. Unexcavated tuff matrix in print was cracked and loose, and appeared as though it would release easily from the substrate of the print. Heel area excavated in 1978 to a slightly greater depth than surrounding matrix; the calcite lining of the print along the heel margin was clearly visible and intact.

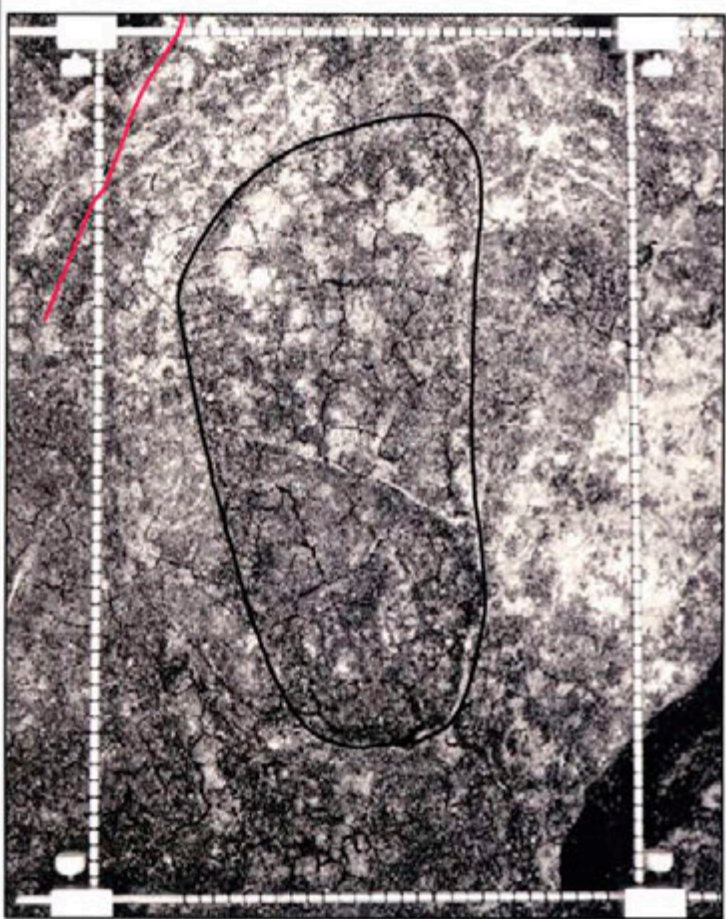
LAETOLI PROJECT SEPTEMBER 1996 0mm 25mm G1-23 ROOT DAMAGE AND INSECT ACTIVITY

Root damage: Numerous small rootlets penetrated tuff outside of print in heel area (not shown on graphic). Root impression in tuff outside anterior margin of print.

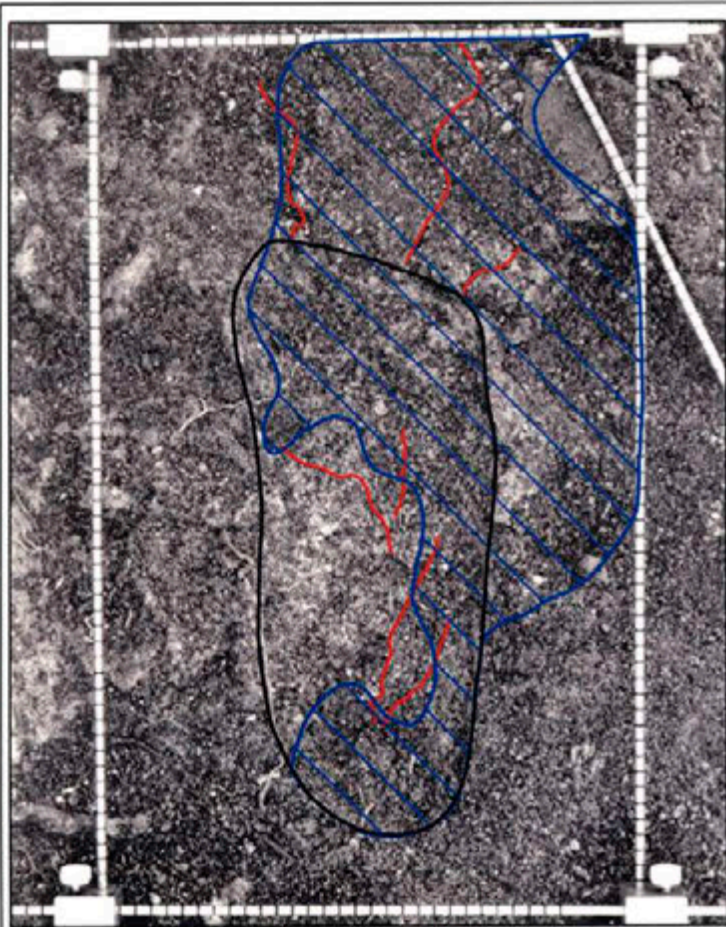
LAETOLI PROJECT AUGUST 1996 0mm 25mm G1-24
TUFF CONDITIONS

Cracking: Hairline cracks in central portion of print; and outside anterior margin.

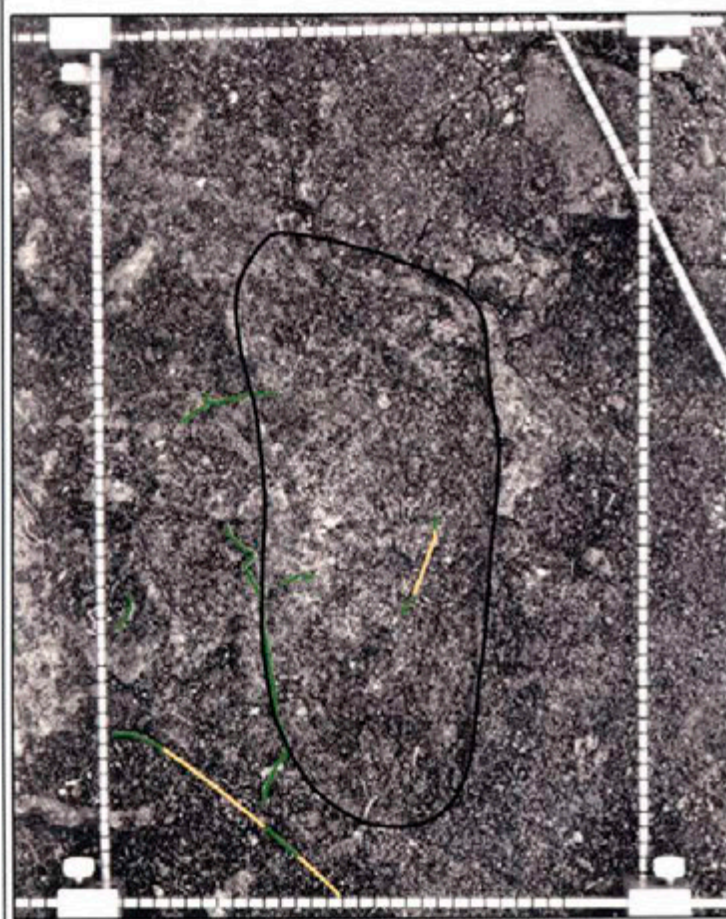
LAETOLI PROJECT AUGUST 1996 0mm 25mm G1-24
ROOT DAMAGE AND INSECT ACTIVITY

Root damage: Numerous small roots and rootlets (<1mm diam.) on surface and penetrating tuff or the layer of embedded particles. Roots identified as asparagus and acacia.

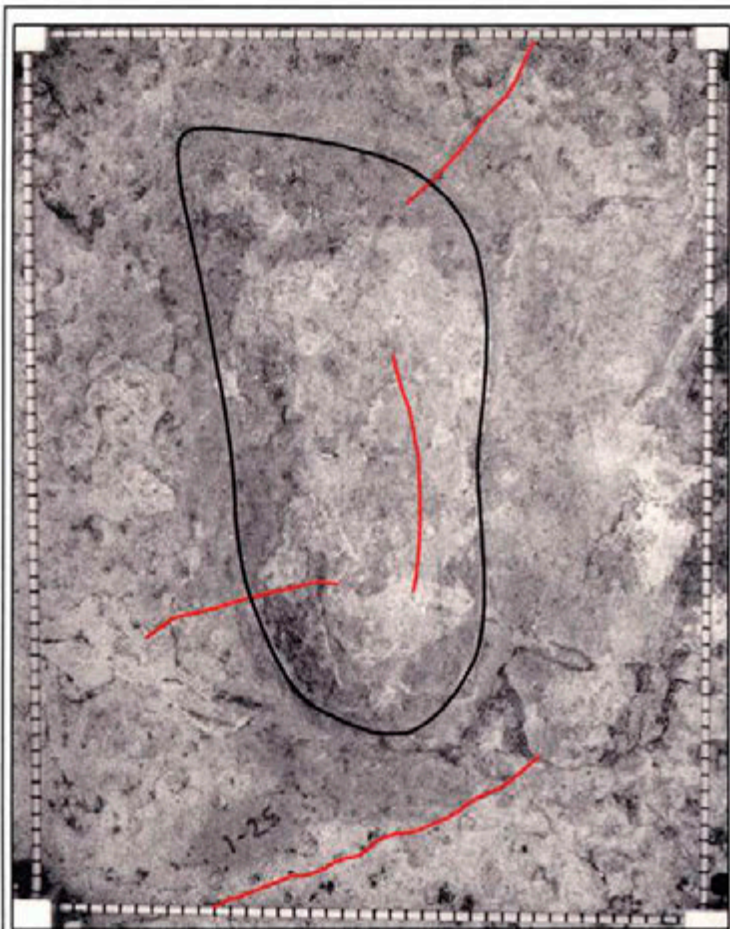
GI-25
TUFF CONDITIONS

Cracking: Hairline cracks on interior of print, and extending outside anterior and medial margins

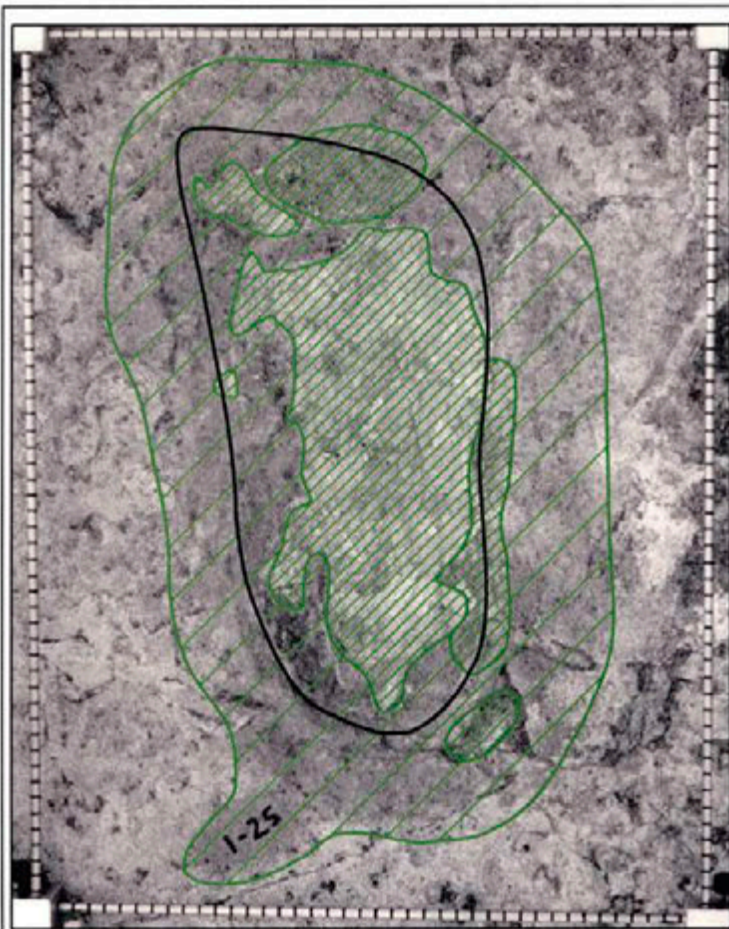
GI-25
CONDITIONS RELATED TO 1978-79 INTERVENTIONS

Bedacryl: Bedacryl found throughout most of the print, except in the central portion where it was missing, and outside margins of print. Patches of Bedacryl deteriorated along anterior and lateral margins. Area of missing Bedacryl creates a marked color difference with the Bedacryl coated parts (see Notes).

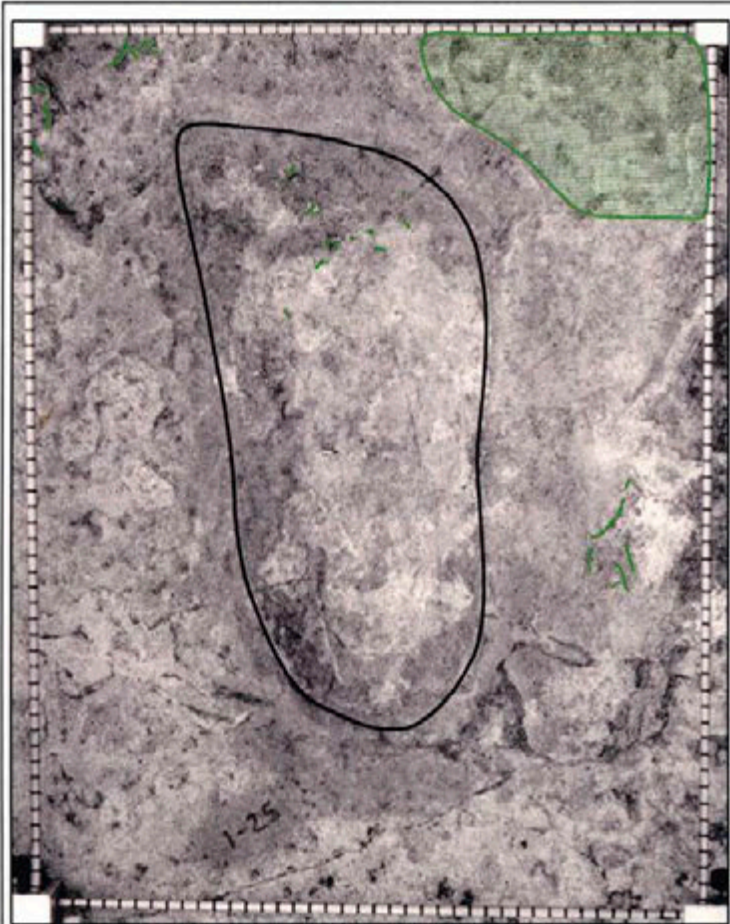
GI-25
ROOT DAMAGE AND INSECT ACTIVITY

Root damage: Numerous tiny rootlets (graphically shown as root mat) weaved in and out of the deteriorated Bedacryl layer but did not appear to penetrate the footprint tuff.

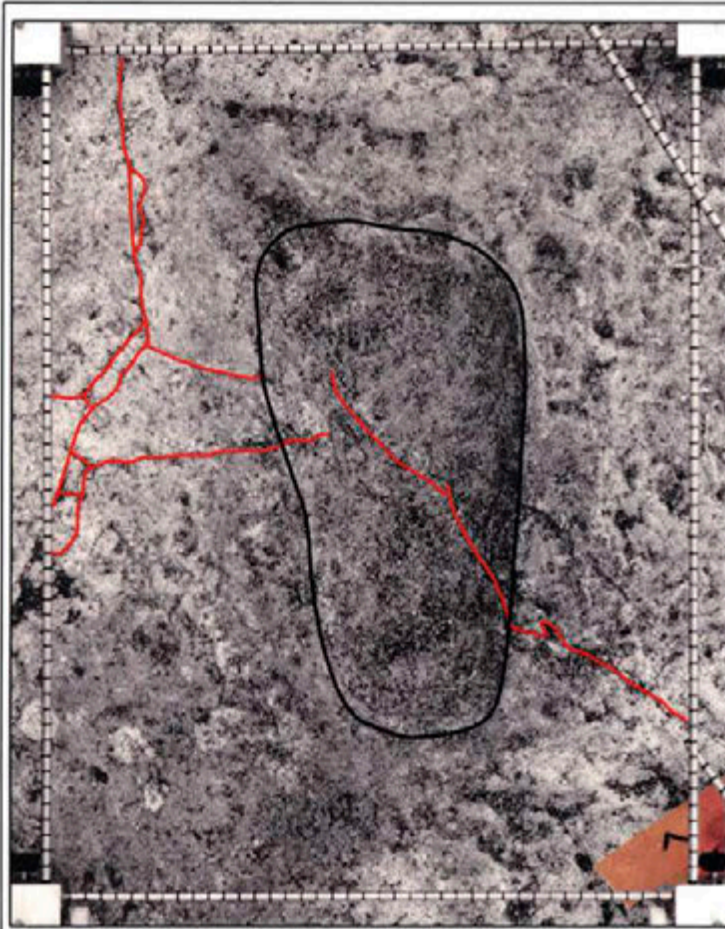
G1-27
TUFF CONDITIONS

| <p><u>1995 Condition</u> General condition: Minor alteration: Good</p> <p><u>Tuff conditions:</u> <u>Weathering:</u> none <u>Cracking:</u> Crack traverses print; network of cracks with calcite vein outside medial margin. <u>Losses:</u> none <u>Detached/loose:</u> none <u>Powdering:</u> none <u>Other:</u> none</p> <p><u>Conditions related to 1978-79 interventions:</u> <u>Bedacryl:</u> Bedacryl throughout the print and surrounding it. Deteriorated near the great toe and scuff-out area, along the margins of the heel, and just outside lateral margin. <u>Embedding:</u> Slight embedding of fine particles in Bedacryl layer. <u>Silicone:</u> Extensive traces of silicone outside medial margin of print; minor traces outside lateral margin of heel area. <u>Excavation tool marks:</u> Tool marks faintly visible on floor of print (not recorded on graphic; see comparison with cast). <u>Inventory number on tuff:</u> 1979 label ("1-27") visible on tuff surface. <u>Other:</u> none</p> <p><u>Root damage:</u> Numerous tiny rootlets on surface and matted in ball of foot and scuff-out area, but did not penetrate the footprint tuff. One rootlet left impression in tuff on lateral posterior margin.</p> <p><u>Insect activity:</u> none</p> |

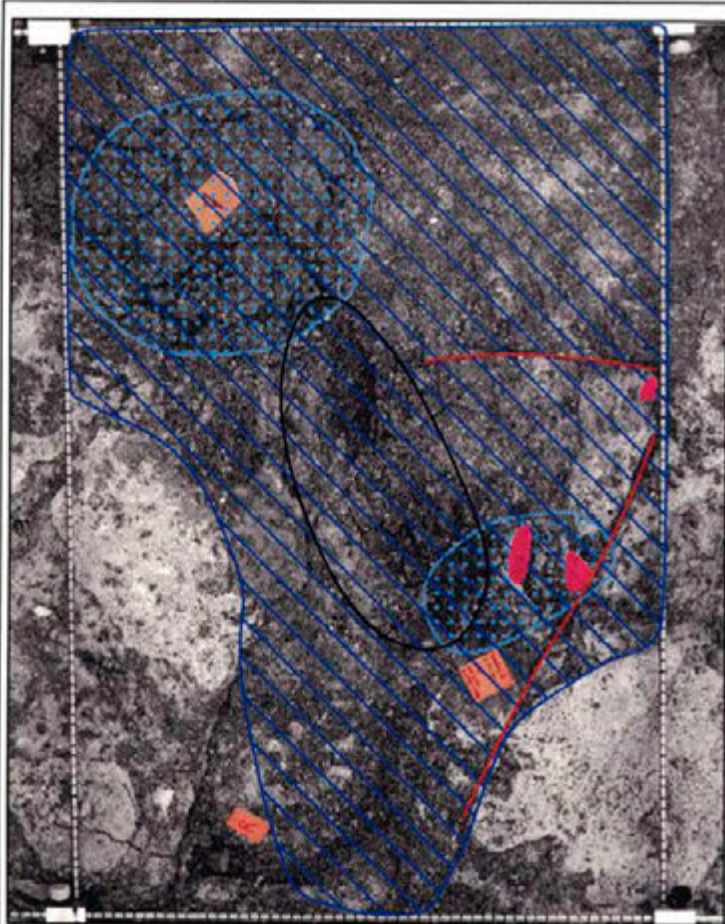
LAETOLI PROJECT
AUGUST 1995
0mm 25mm
GI-28
TUFF CONDITIONS

Weathering: Extensive weathering of tuff in floor of print and extending beyond margins of the print. G1-28 is located in the weathered strip of tuff in the southern trackway sector, characterized by patterned cracking with patches of well-consolidated tuff.

Cracking: Large crack with partially preserved calcite outside anteromedial margin; a second crack runs perpendicular to the axis of the print, outside medial margin.

Detached/loose tuff: Loose tuff anterior to print (associated with root disruption), and at heel margin.

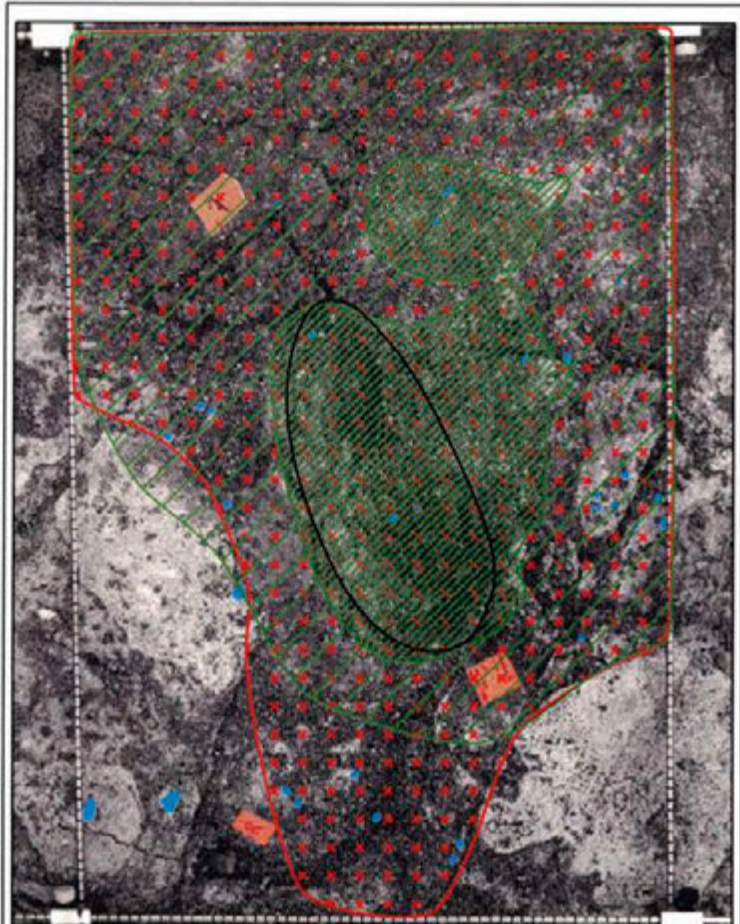
LAETOLI PROJECT
AUGUST 1995
0mm 25mm
GI-28
CONDITIONS RELATED TO 1978-79 INTERVENTIONS

Bedacryl: Bedacryl throughout the print and surrounding it. Deteriorated with minor patches of loss in the weathered area.

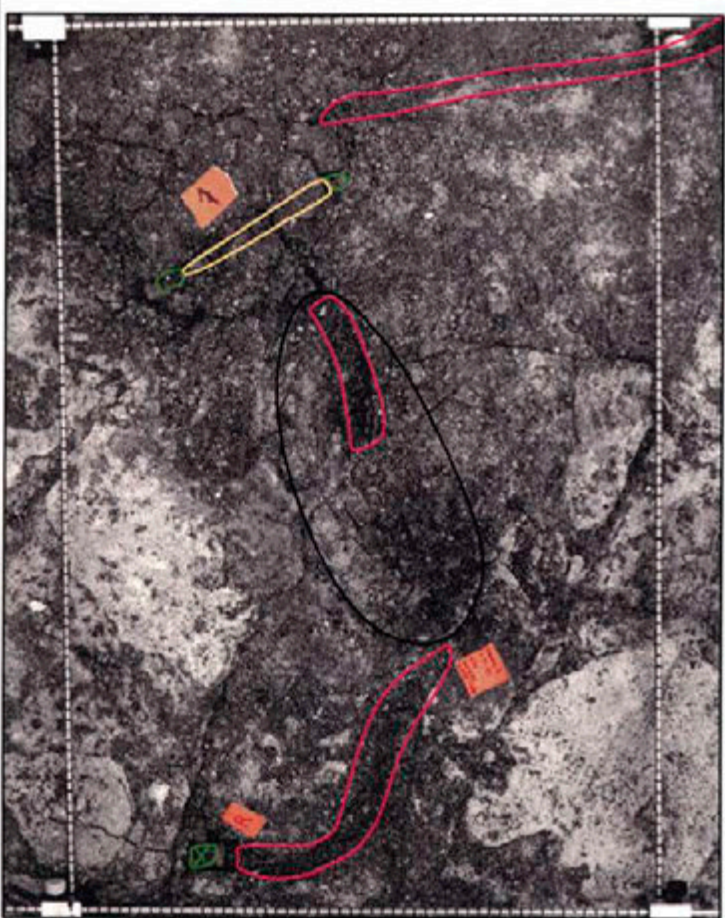
LAETOLI PROJECT
AUGUST 1995
0mm 25mm
GI-28
ROOT DAMAGE AND INSECT ACTIVITY

Root damage: Tuff was disrupted and loose from a large penetrating root outside anterior margin; the root was from stump no. 84. A second root penetrated the tuff well outside the posterior margin. Surface roots left three impressions in the tuff (one inside and two outside the print margins). Numerous small roots weaved through the cracked, weathered tuff.

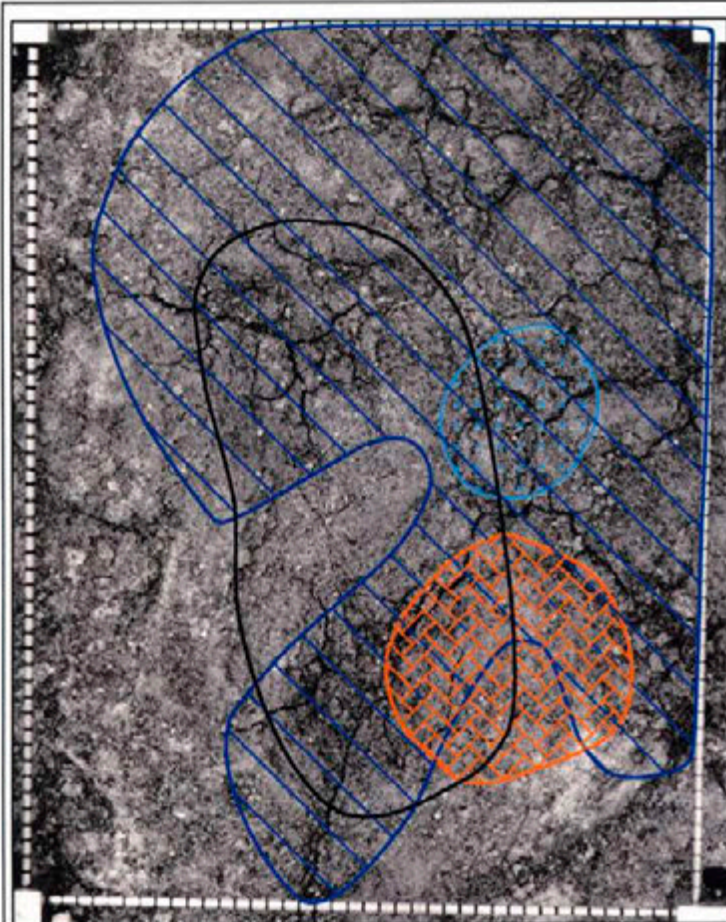
G1-29
TUFF CONDITIONS

Weathering: Extensive weathering of tuff inside print in anterior and heel areas; and outside anterior and lateral margins. G1-29 is located in the weathered strip of tuff in the southern sector of the trackway, characterized by patterned cracking with deep fissures that are filled with overburden.

Cracking: Cracks are associated with weathering of tuff in this area (not shown on graphic).

Detached/loose tuff: Patch of loose tuff on lateral margin.

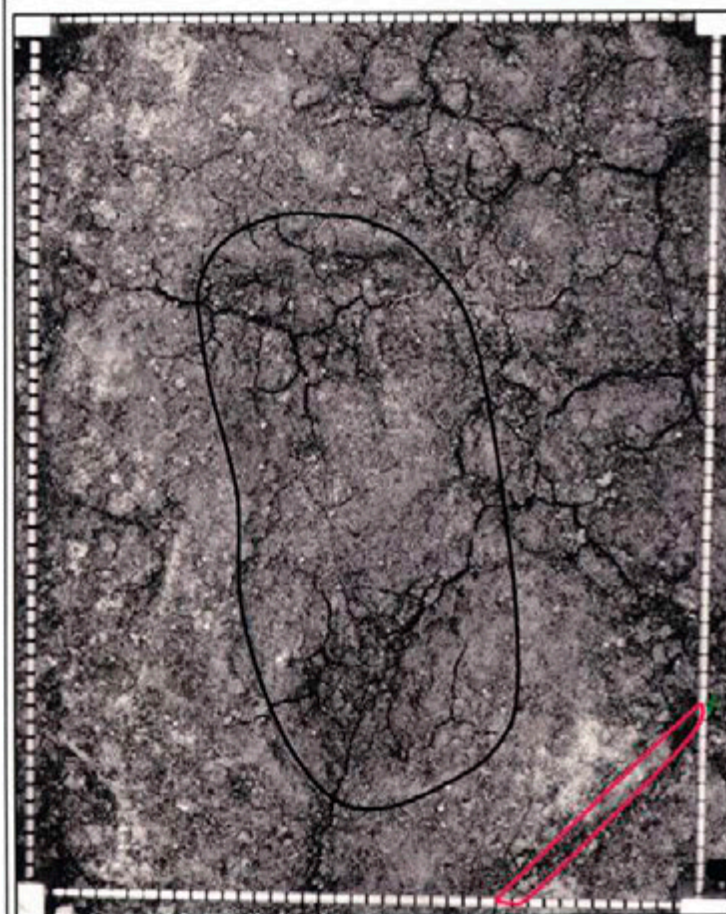
G1-29
ROOT DAMAGE AND INSECT ACTIVITY

Root damage: Root impression from large surface root outside posterior margin; root penetrated tuff at eastern end of impression.

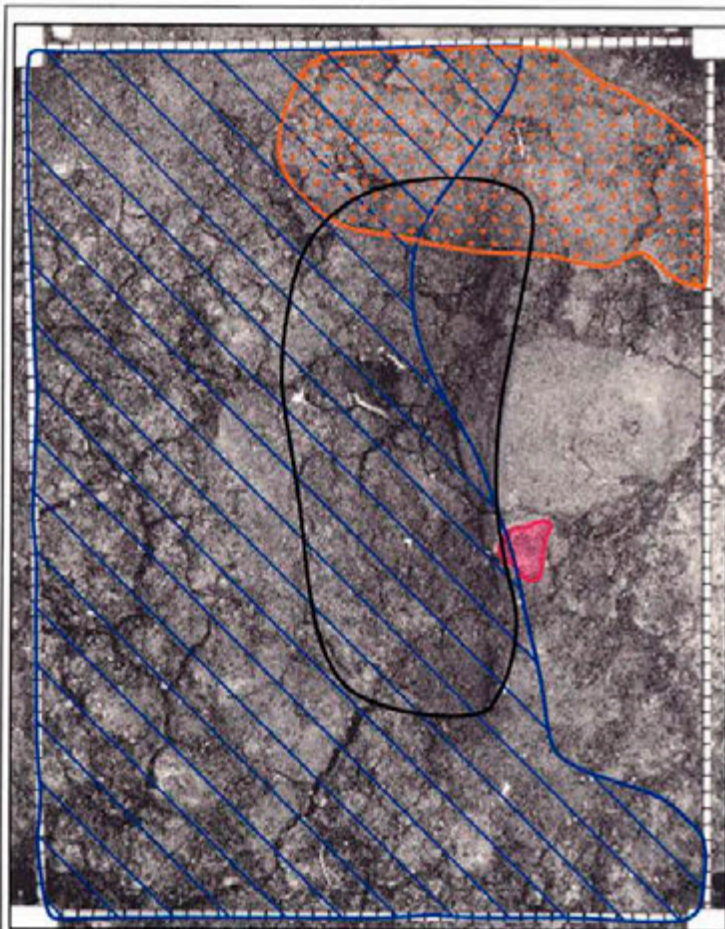
G1-30
TUFF CONDITIONS

Weathering: Moderate weathering of tuff inside print margins; extensive weathering outside lateral and posterior margins. Patches of well-consolidated but fragmented tuff within print margins and outside anterior and medial margins. This print is located within the weathered strip of tuff in the southern sector of the trackway, characterized by patterned cracking with deep fissures that are filled with overburden.

Cracking: Principally as a result of weathering of tuff (not shown as cracking on graphic).

Other: Disruption of tuff in an area inside and outside anterior margin of print, probably caused by root from stump no. 83, which penetrated the tuff just to the north.

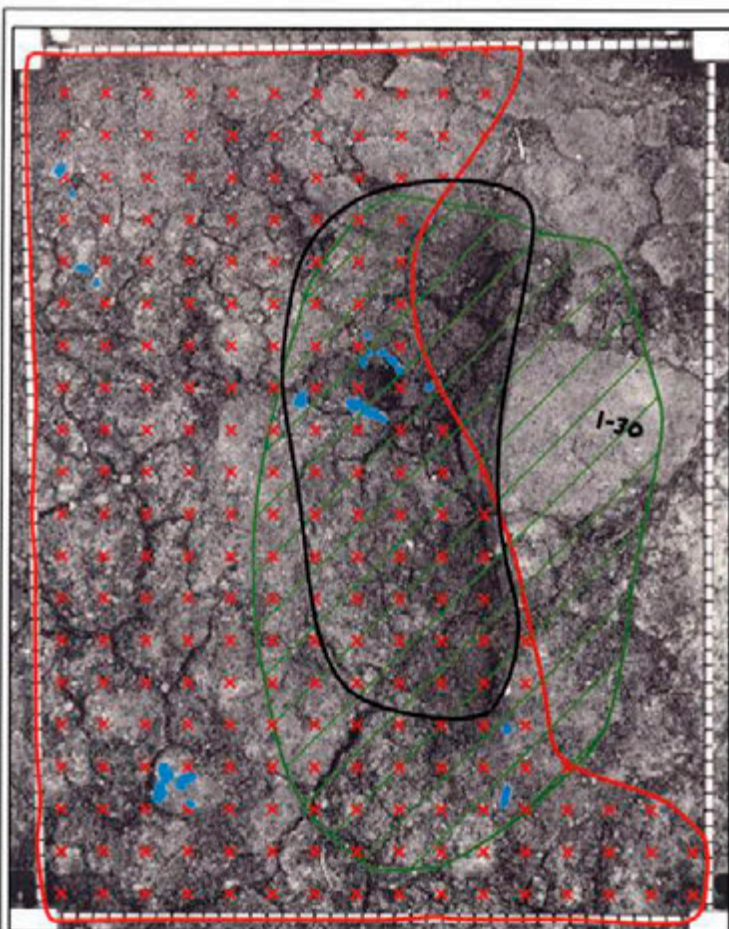
G1-30
CONDITIONS RELATED TO 1978-79 INTERVENTIONS

Silicone: Traces of silicone inside print, particularly noticeable around decayed tree stump near the center of print; also numerous traces outside print.

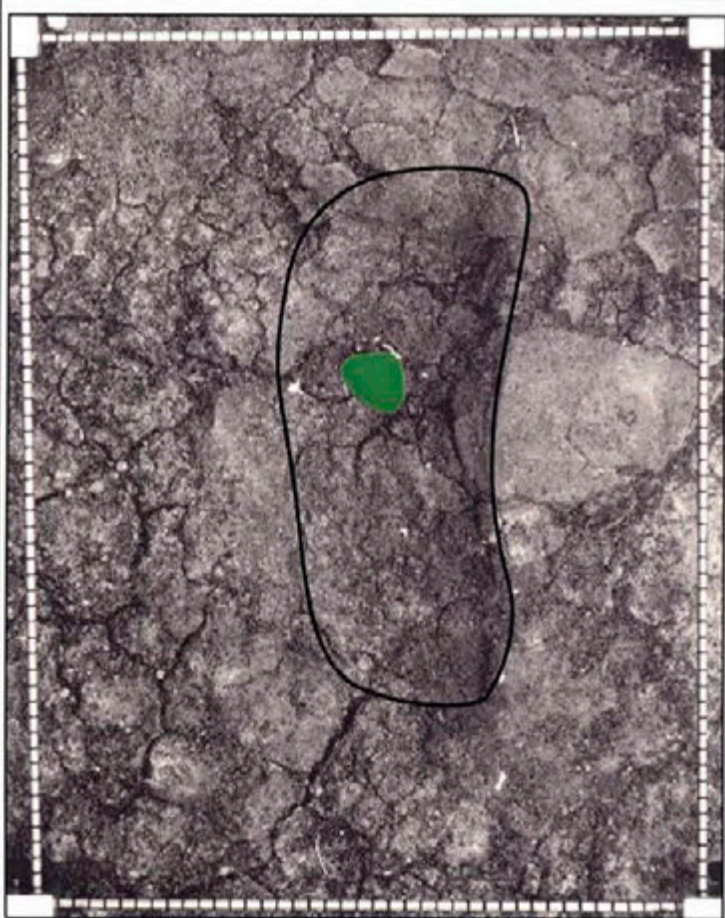
G1-30
ROOT DAMAGE AND INSECT ACTIVITY

Root damage: Stump of an acacia tree (inv. no. 157), cut and killed in 1979, had decayed and left a bark-lined void in the bottom of the print.

Root treatment: Bark of decayed stump removed.

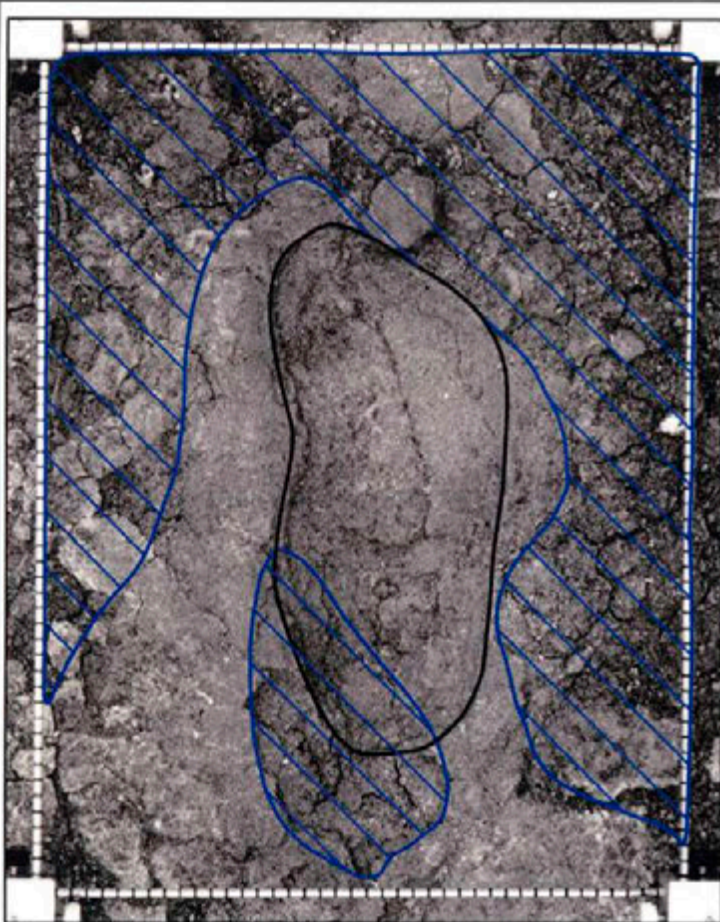
G1-31
TUFF CONDITIONS

Weathering: Moderate weathering in the posteromedial portion of print and extending outside margin. The rest of the tuff inside print margins and immediately surrounding print was calcite cemented, but fractured, tuff. Beyond the fractured tuff was severely weathered tuff. This print is located in the weathered strip of tuff in the southern trackway sector, characterized by patterned cracking with deep fissures that are filled with overburden.

Cracking: Cracking associated principally with weathering of tuff (not shown on graphic).
