LAETOLI

HOMINID TRACKWAY, SITE G

CONDITION RECORDS

G1 AND G2/3 FOOTPRINTS

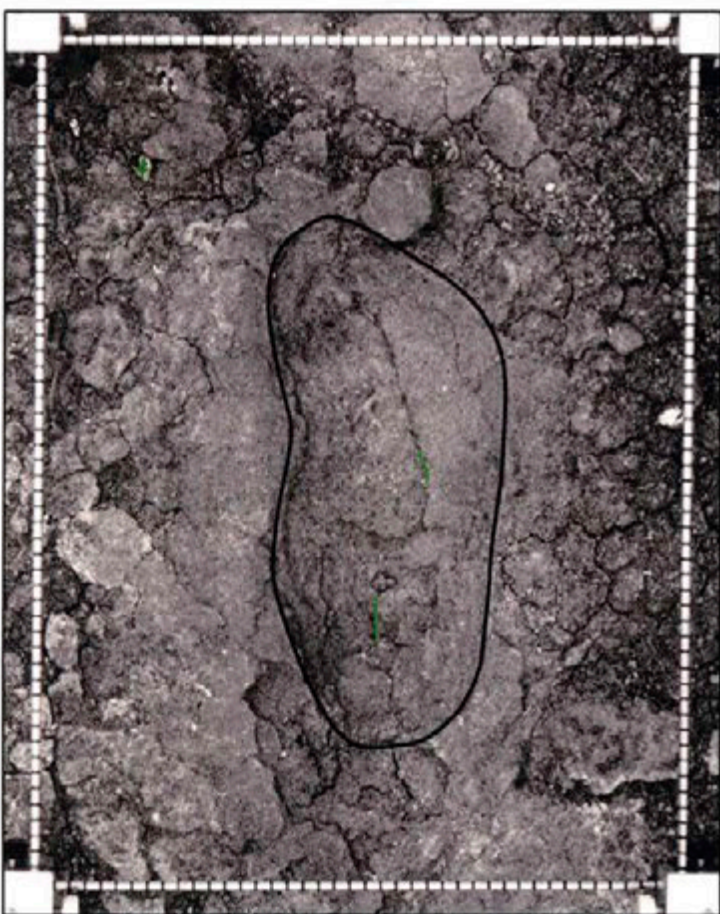
G1-31
ROOT DAMAGE AND INSECT ACTIVITY

Root damage: Numerous fine rootlets and one small root from the shallow overburden penetrated the weathered tuff surrounding print and cracks within print.

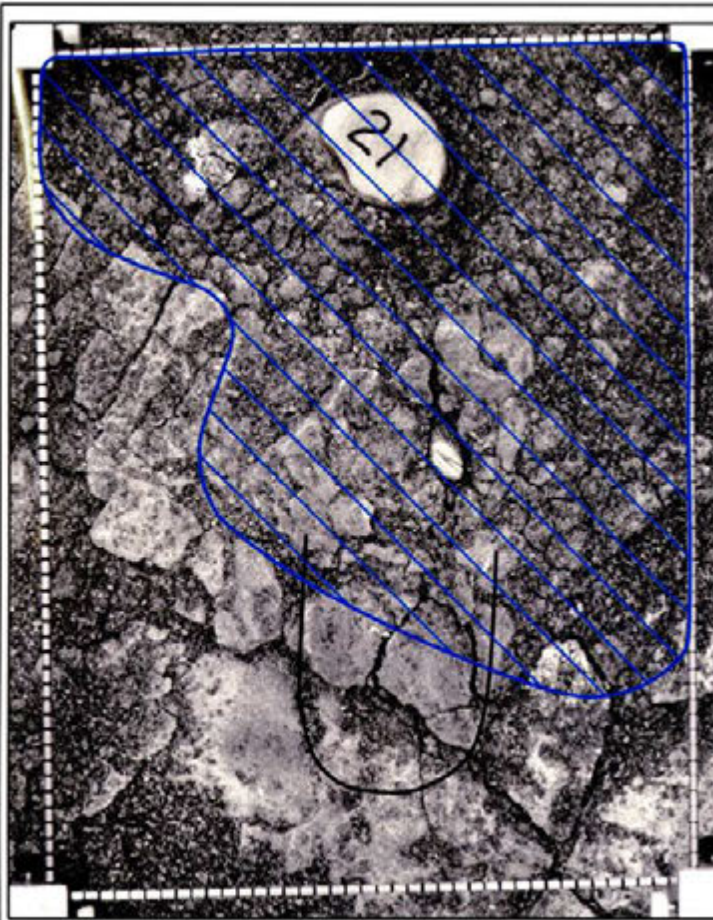
G1-32
TUFF CONDITIONS

Weathering: Advanced weathering in an area of fractured, calcite-cemented tuff; weathering was particularly severe around stump no. 21. This print is located in the weathered zone of the southern sector, characterized by patterned cracking and deep fissures filled with overburden.

Cracking: Extensive cracking associated with weathering (not shown on graphic).

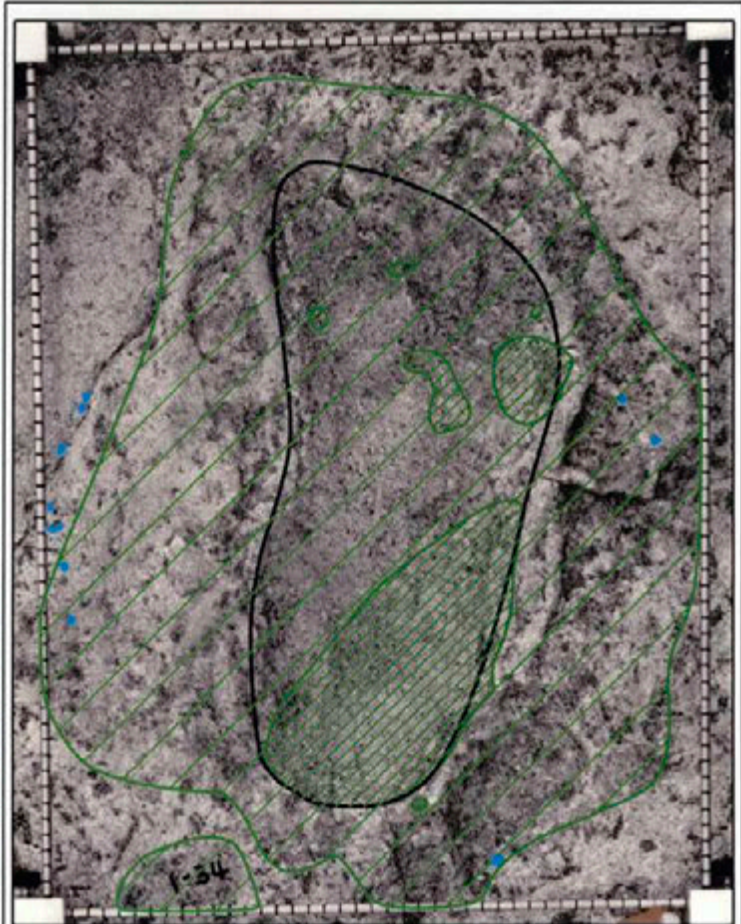
G1-34
TUFF CONDITIONS

Cracking: Cracks traverse heel and toe areas.

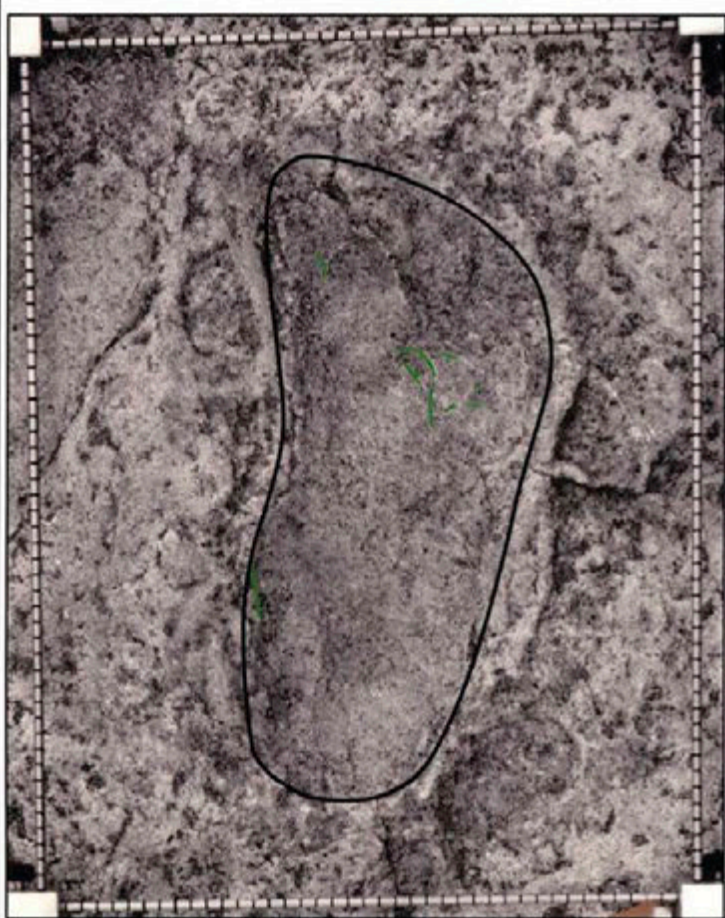
G1-34
CONDITIONS RELATED TO 1978-79 INTERVENTIONS

Bedacryl: Bedacryl covered the print surface and the surrounding tuff. The Bedacryl had deteriorated, with minor areas of loss, over most of the print surface, except the area of the great toe and ball, and was cracked near the lateral margin.

Embedding: Minor embedding of fine particles in areas of weathering and deteriorated Bedacryl.

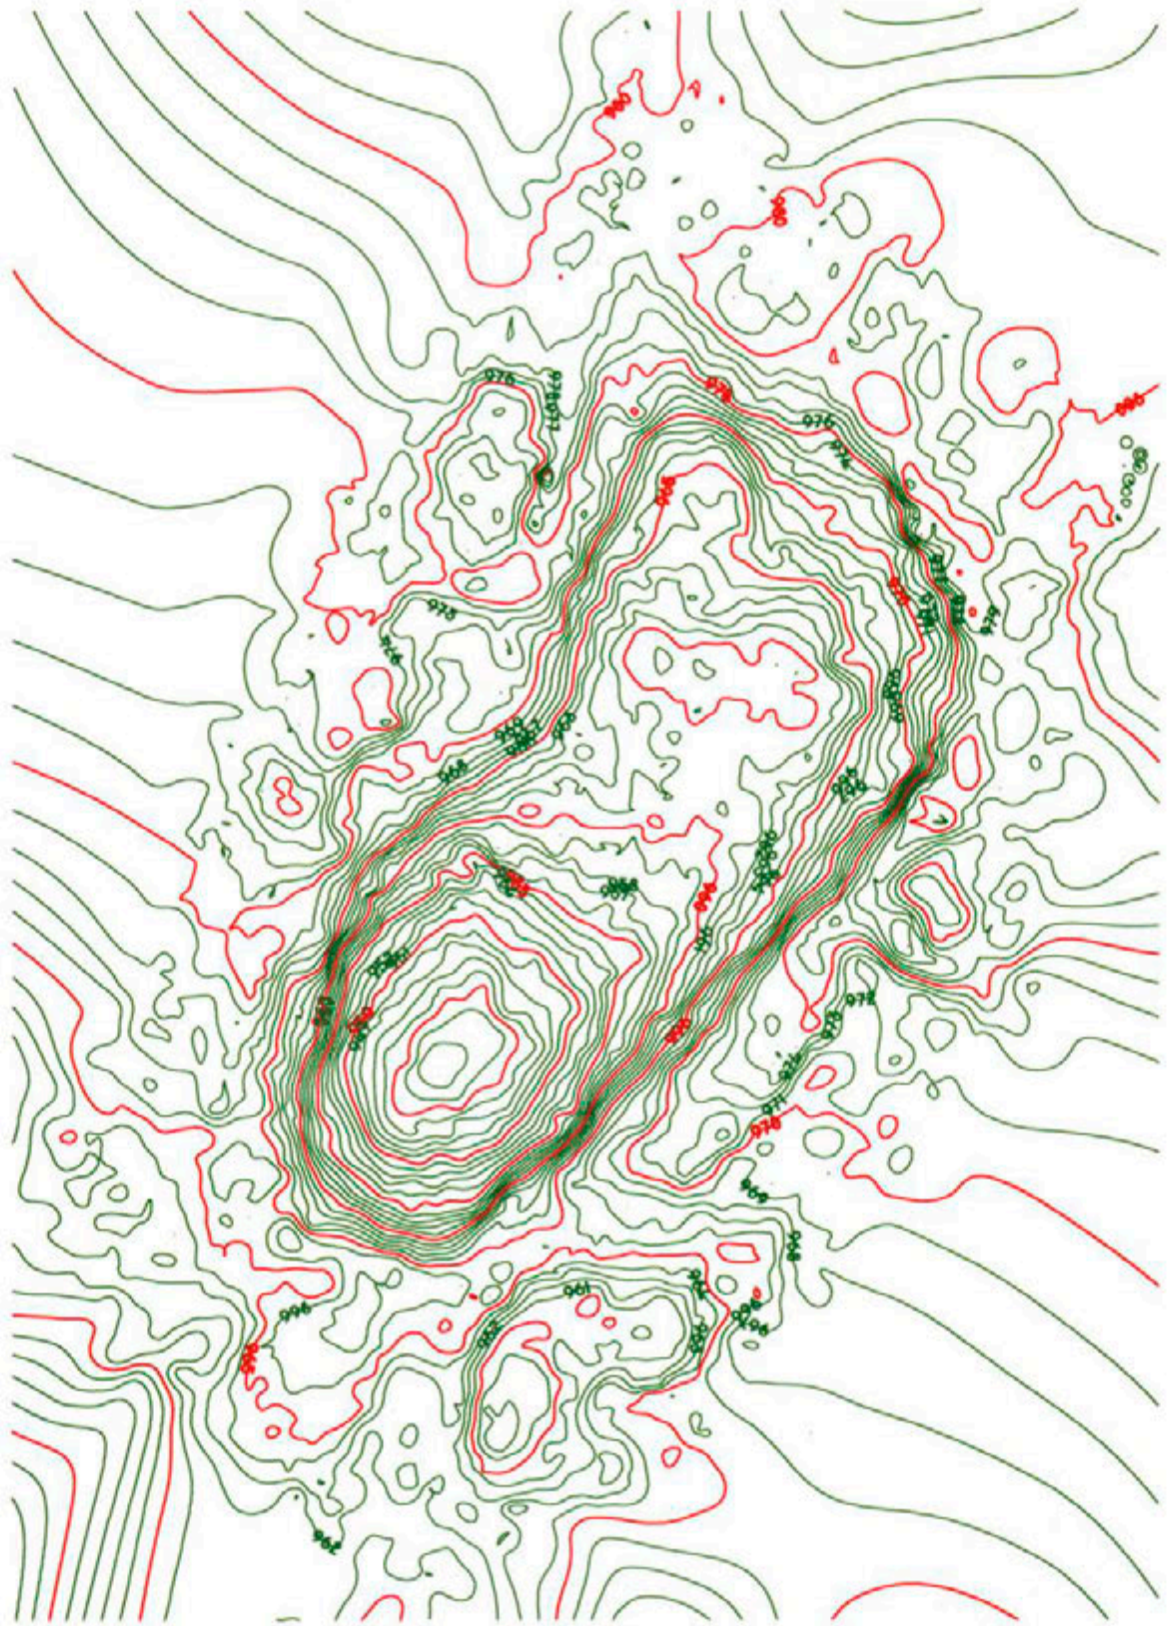
G1-34
ROOT DAMAGE AND INSECT ACTIVITY

Root damage: Rootlets were embedded in the Bedacryl layer in the area of the great toe and along the lateral margin, but did not penetrate the tuff.

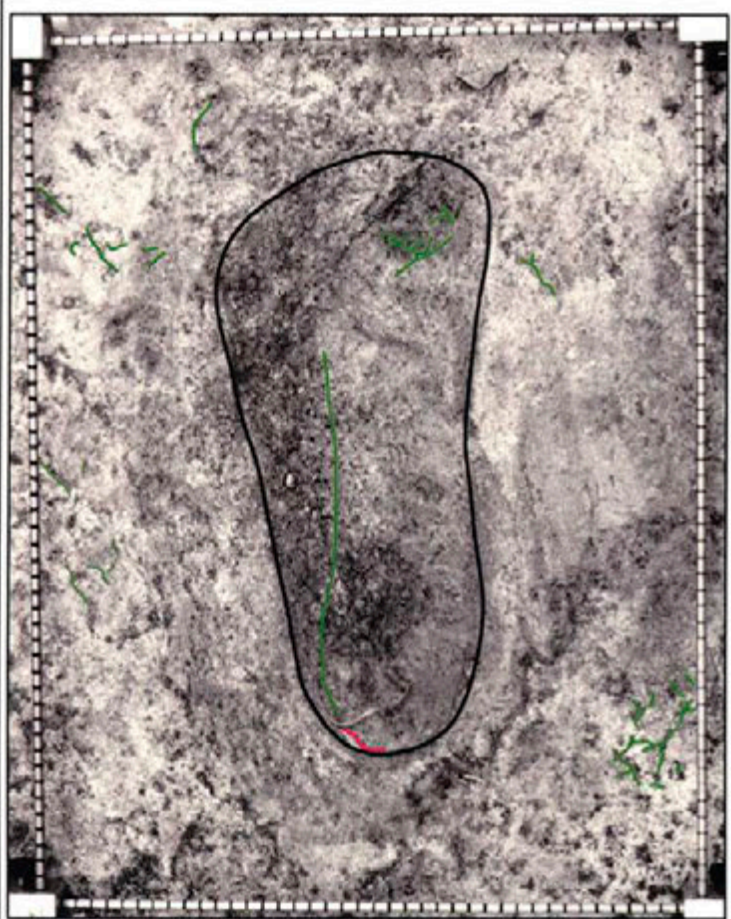
LAETOLI PROJECT AUGUST 1995 G1-35
ROOT DAMAGE AND INSECT ACTIVITY

Bedacryl: Bedacryl found throughout the print and surrounding it; deterioration of Bedacryl in heel area and anterior to arch.

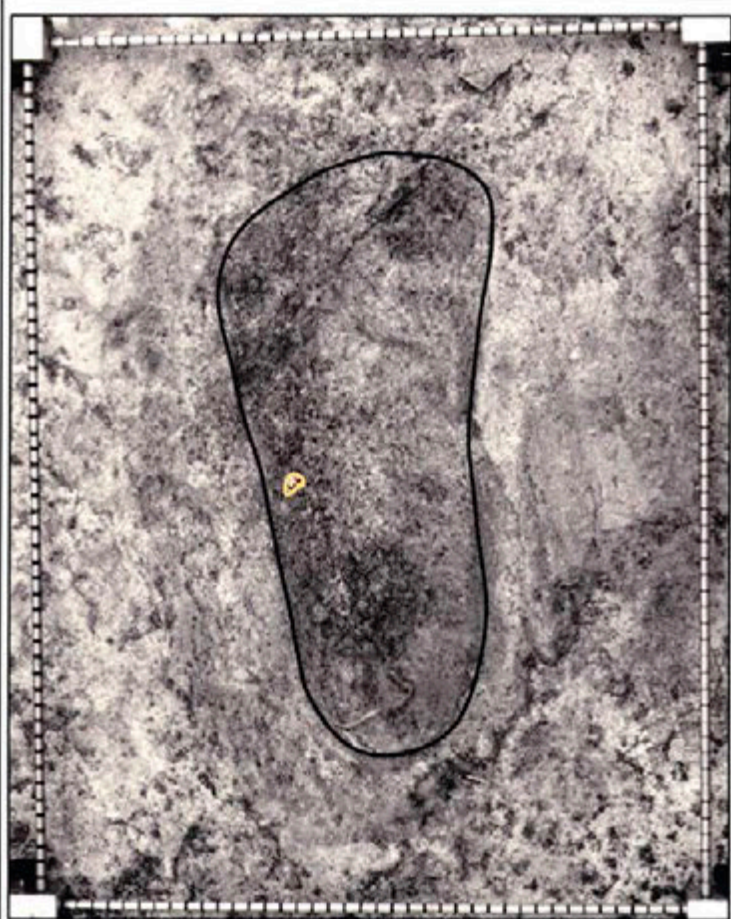
LAETOLI PROJECT AUGUST 1995 G1-35
1995-96 INTERVENTIONS

Root damage: A few rootlets on the surface, which did not penetrate the Bedacryl layer.

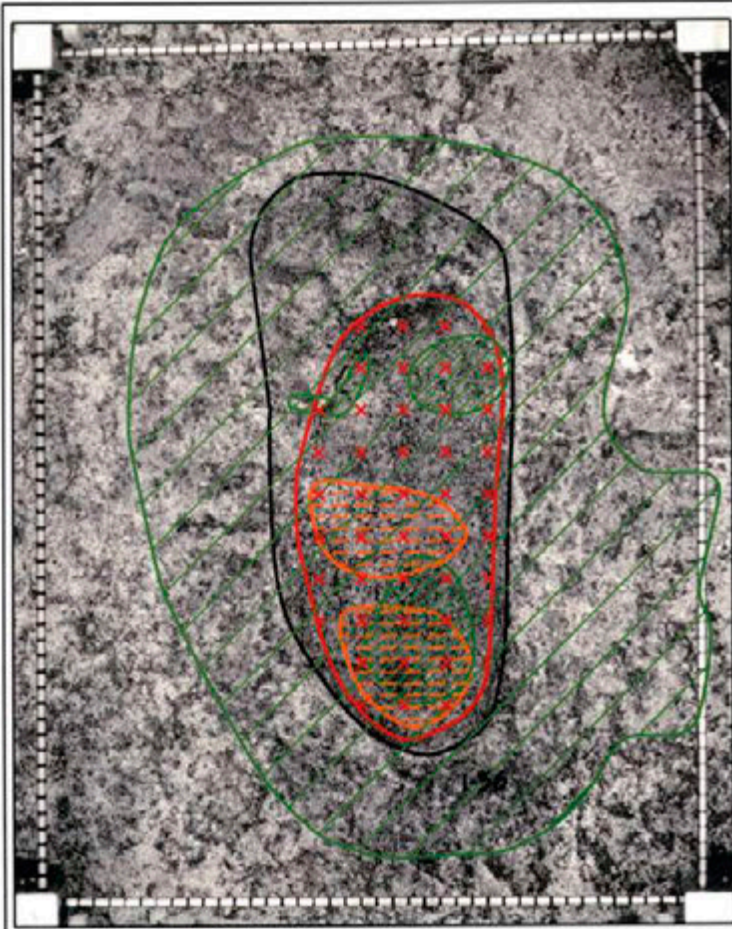
G1-36
TUFF CONDITIONS

Cracking: none

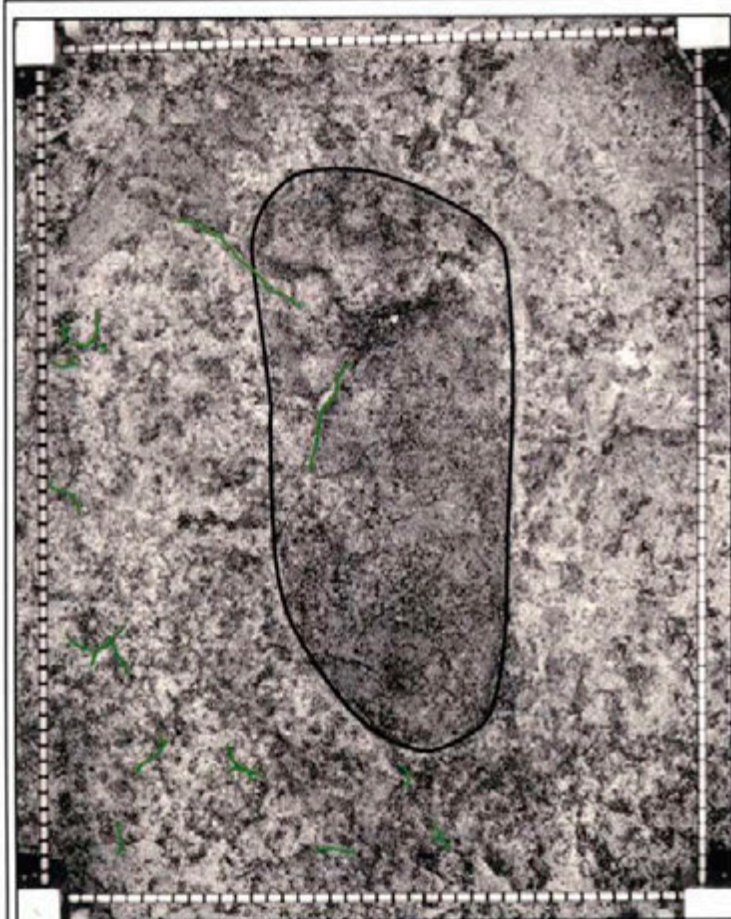
G1-36
CONDITIONS RELATED TO 1978-79 INTERVENTIONS

Bedacryl: Bedacryl covered surface of print and extended outside medial margin in area of the arch. Bedacryl deteriorated slightly in the heel, with minor losses, and toe and ball areas. The layer appears to have been thickly applied.

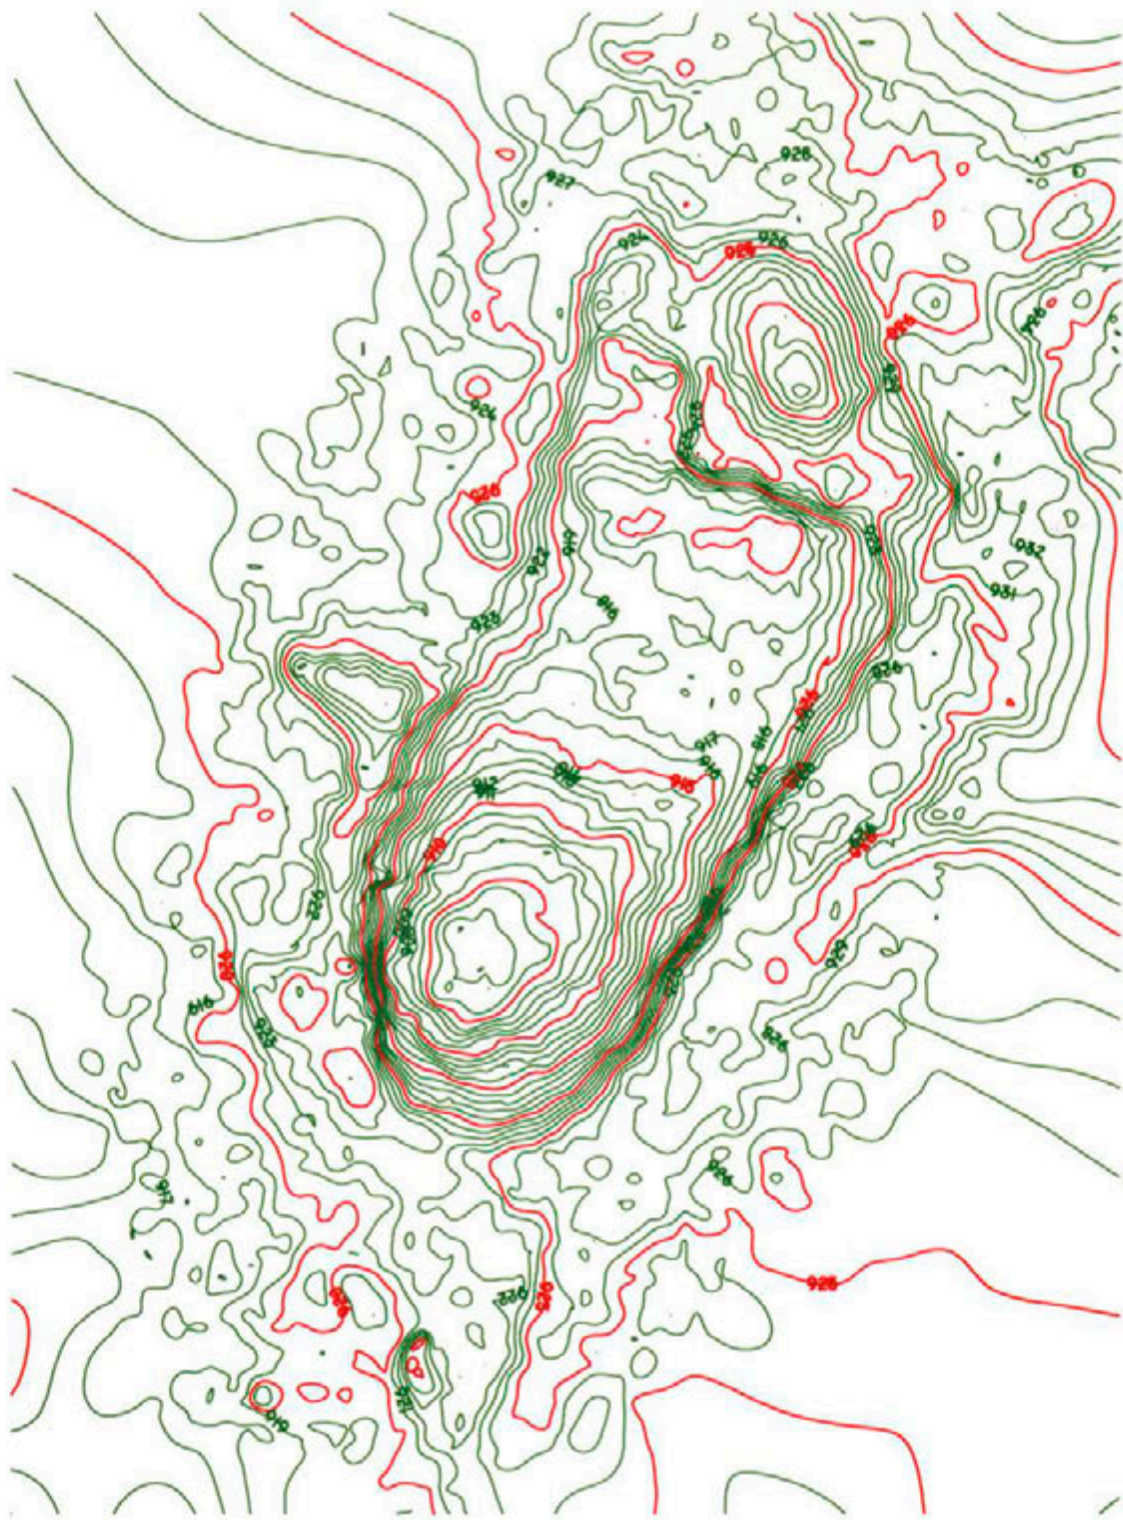
G1-36
ROOT DAMAGE AND INSECT ACTIVITY

Root damage: Rootlets primarily on the surface; a few penetrated into the Bedacryl layer; one root penetrated tuff near center of print.

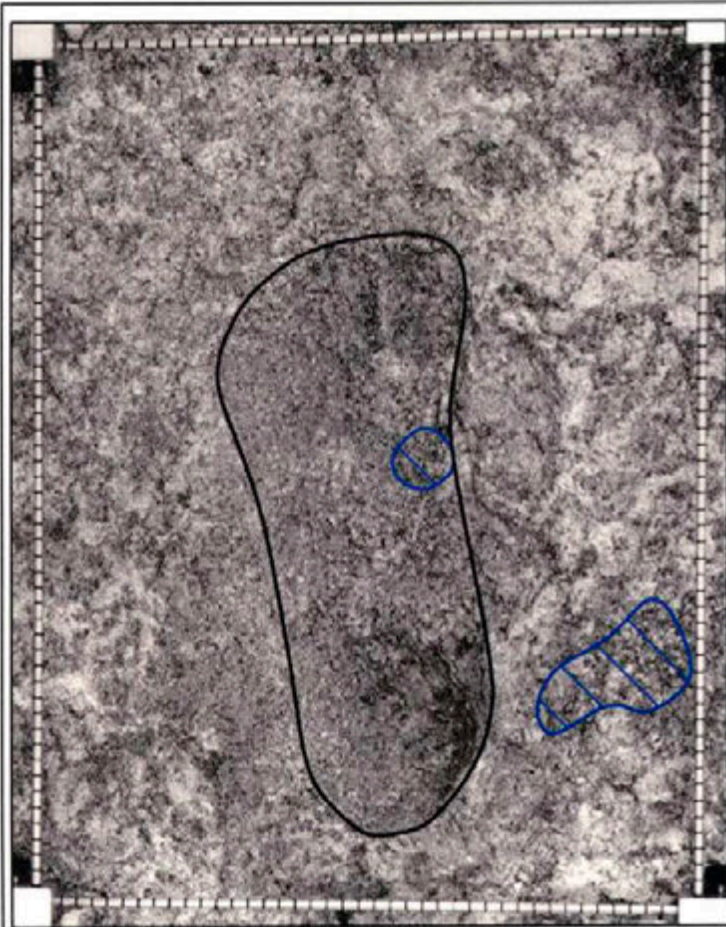
GI-37
TUFF CONDITIONS

Cracking: Fine surficial cracks at the fault intersection (not visible on graphic).

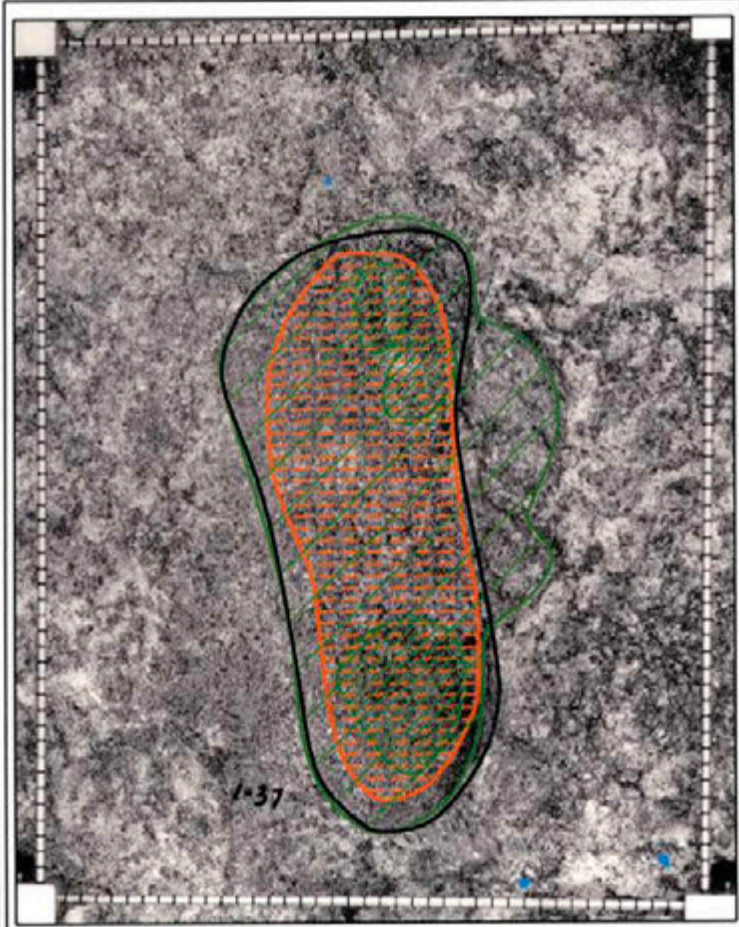
GI-37
CONDITIONS RELATED TO 1978-79 INTERVENTIONS

Bedacryl: Bedacryl covered the print and surrounding tuff surface. Patches of deteriorated Bedacryl on floor of print.

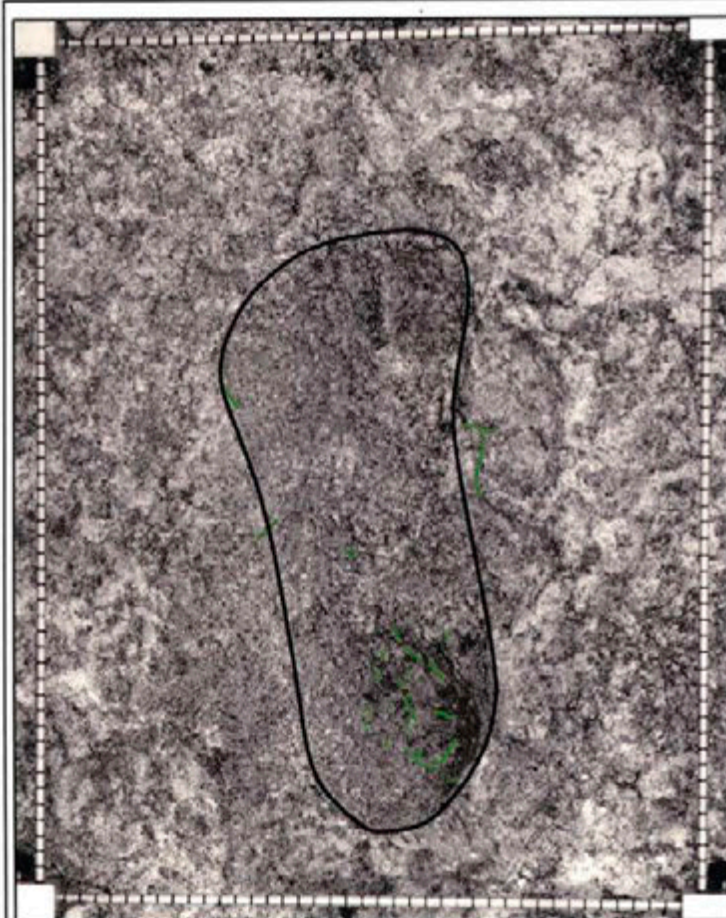
GI-37
ROOT DAMAGE AND INSECT ACTIVITY

Root damage: Root penetrated the wall of the fault where it intersected the print, but did not go directly into the floor of print. Rootlets on surface of print.

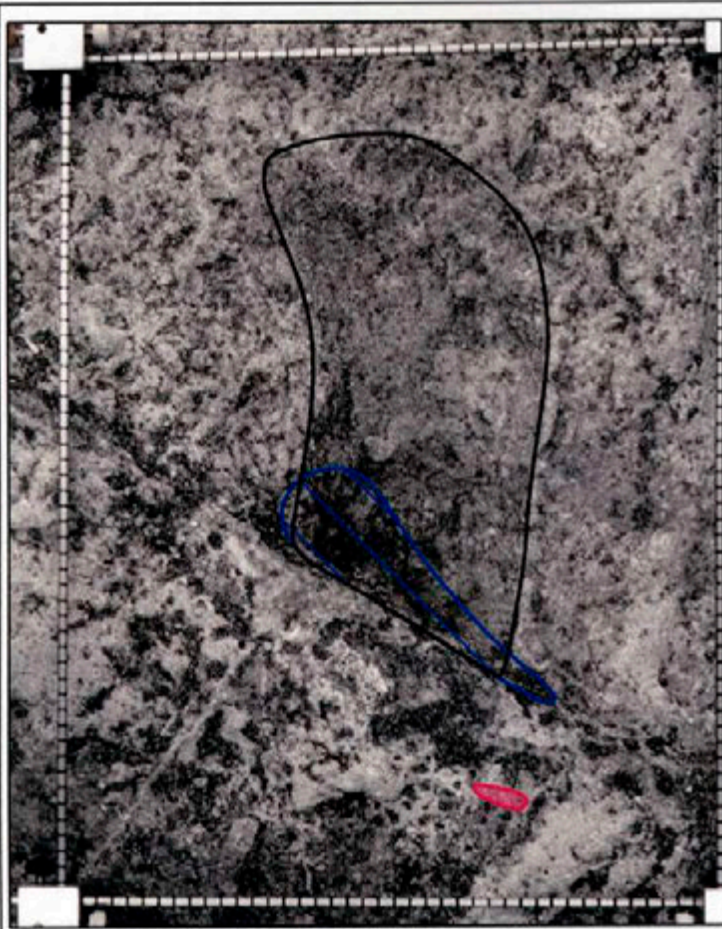
G1-38
TUFF CONDITIONS

| <p>1995 Condition General condition: Minor alteration: Good</p> <p>Tuff conditions: <u>Weathering:</u> Slight weathering of the tuff along the lateral margin of print. <u>Cracking:</u> none <u>Losses:</u> Minor loss of tuff outside margin of great toe and lateral margin of print. <u>Detached/loose:</u> none <u>Powdering:</u> none <u>Other:</u> none</p> <p>Condition related to 1978-79 interventions: <u>Bedacryl:</u> Bedacryl covered the surface of the print and surrounding tuff. It was slightly deteriorated along the lateral print margin with numerous hairline cracks in the Bedacryl layer, and outside the anterior margin. <u>Embedding:</u> Slight embedding noted in Bedacryl layer (not shown on graphic) <u>Silicone:</u> Minor traces of silicone outside print margins. <u>Excavation tool marks:</u> none <u>Inventory number on tuff:</u> 1979 label ("1-39") visible on tuff surface. <u>Other:</u> none</p> <p>Root damage: Rootlets, less than 1mm diameter, weaved in and out of the Bedacryl layer and a few penetrated the tuff along the lateral side, forming a root mat in the lateral heel portion.</p> <p>Insect activity: none</p> |

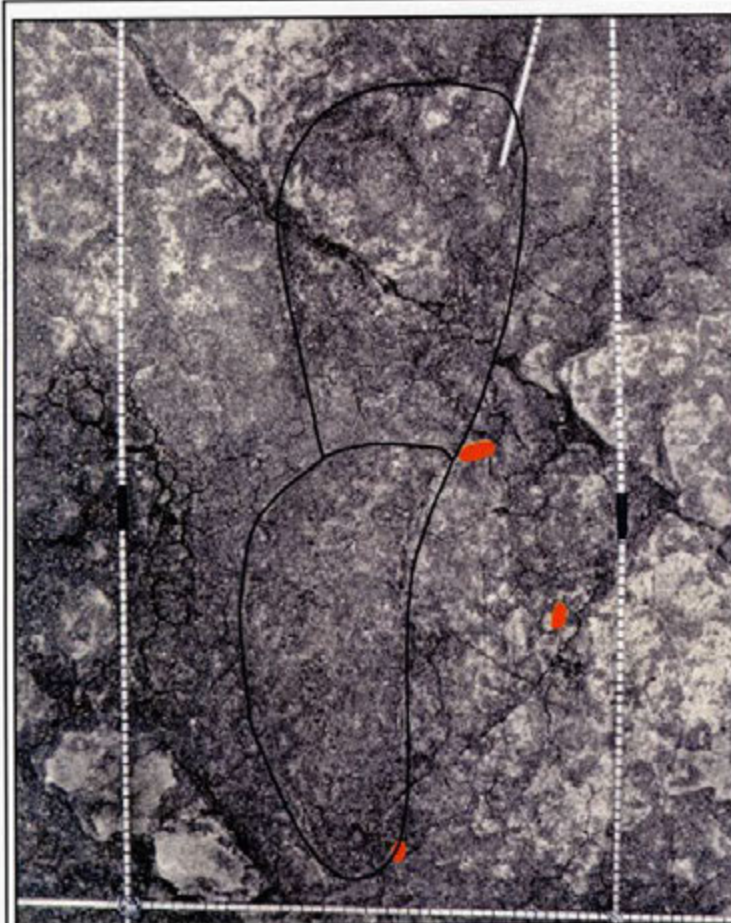
G2/3-9
ROOT DAMAGE AND INSECT ACTIVITY

Root damage: Large 4mm diameter root traversed the print from the central portion to the heel, penetrating the tuff in four places and slightly disrupting the tuff at two penetration points on margins.

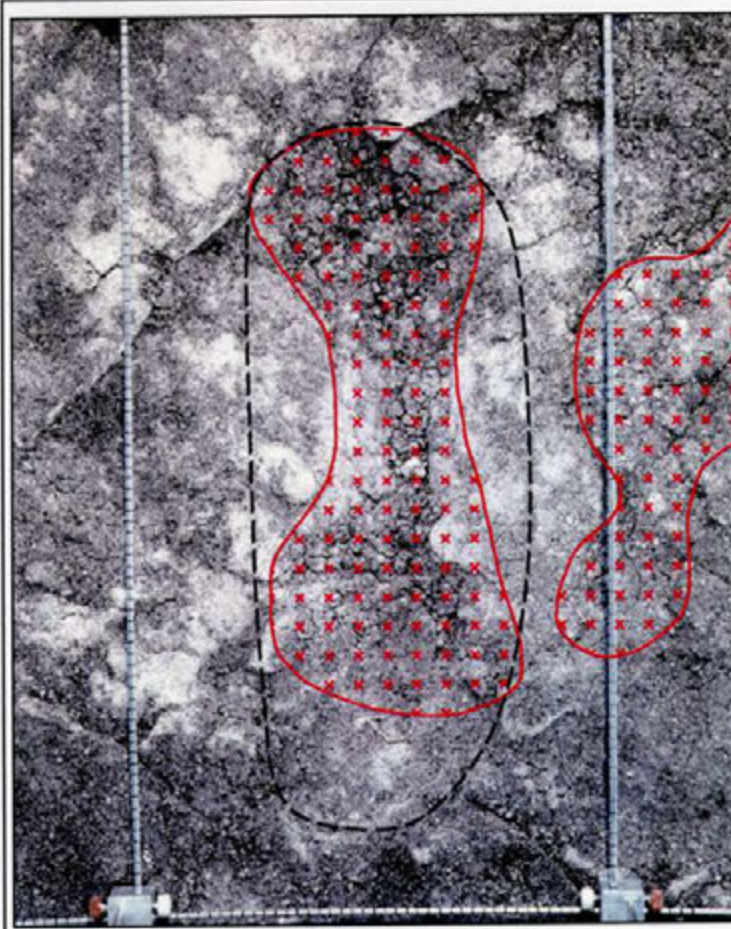
G2/3-15
CONDITIONS RELATED TO 1978-79 INTERVENTIONS

1995 Condition**General Condition:** Significant alteration: Poor**Tuff conditions:****Weathering:** Severe weathering of tuff along the axis of the prints and in patches outside margins.**Cracking:** none**Losses:** Surface of powdering tuff slightly abraded as a result of brushing this weakly consolidated tuff.**Detached/loose tuff:** Tuff was loose within weathered area inside margins of prints.**Powdering:** Areas of tuff along and outside margins of prints were powdery.**Other:** none.**Conditions related to 1978-79 interventions:****Bedacryl:** none**Embedding:** Deeply embedded particles up to 3mm in diameter in the weathered areas, especially in the center of the prints.**Silicone:** none**Excavation tool marks:** none**Inventory number on tuff:** none**Other:** none**Root damage:** Root penetrated tuff outside the posterior margins, and left a distinct root impression when surface root removed. Small rootlets on the surface and within cracks.**Insect activity:** none**1996 Interventions****Consolidation/stabilization:** Weathered and loose tuff was stabilized with Acrysol WS-24 at 25%.**Fills:** none**Reattachment:** none**Root treatment:** Surface rootlets were removed.**Other:** none**Comparison with 1978-79 Cast/Photograph**

No cast. Comparison with the 1978 photos showed increased weathering of tuff, especially along axis of prints, and particle embedding. It is clear from the 1978 photos and notes that the tuff was in poor condition (weathered, fractured and powdering) in 1978. Print margins are not visible in 1978 photographs; identification of location based on tuff features.

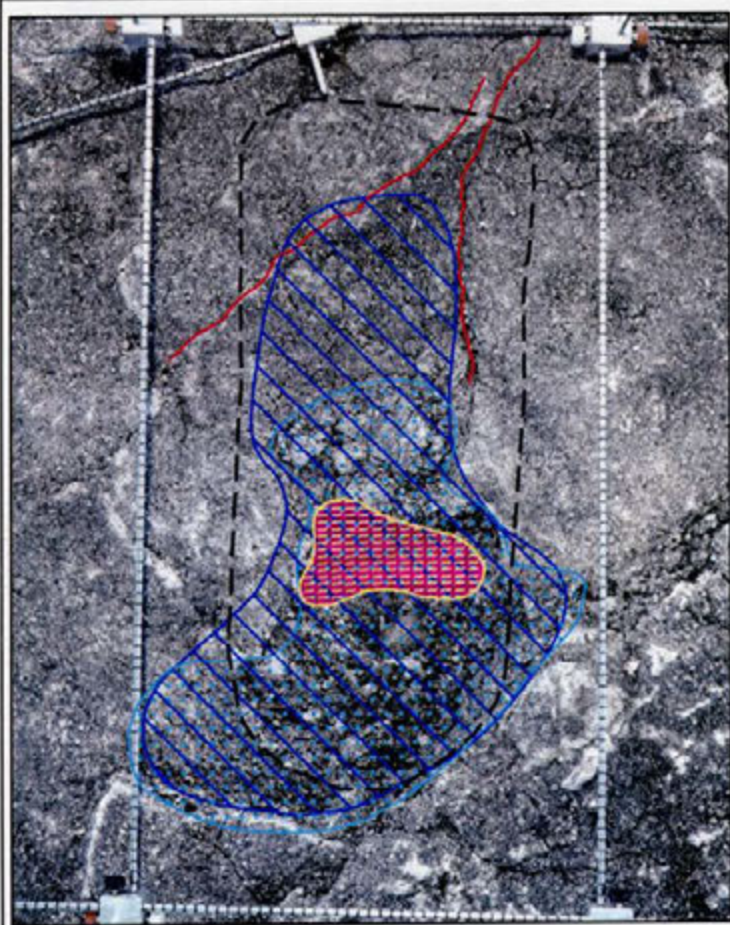
G2/3-16
TUFT CONDITIONS

1995 Condition**General Condition:** Moderate alteration: Fair**Tuff conditions:****Weathering:** Moderate to severe weathering of tuff in central and posterior portions of the prints.**Cracking:** Two 1-2mm wide cracks in anterior portion.**Losses:** Slight loss of surface grains in powdering areas of tuff.**Detached/loose tuff:** Tuff fragments were loose and easily dislodged throughout the weathered area and in the heel as a result of root penetration.**Powdering:** Tuff was powdering in the central portion of the prints.**Other:** none**Conditions related to 1978-79 interventions:****Bedacryl:** none**Embedding:** Deeply embedded particles within the weathered area and in the anterior region in a possible lagomorph print.**Silicone:** none**Excavation tool marks:** none**Inventory number on tuff:** none**Other:** Small fragment of plastic found on the heel surface.**Root damage:** 5mm root penetrated heel margin and caused disruption and dislodging of small tuff fragments. Rootlets present throughout the cracks and weathered tuff.**Insect activity:** none**1996 Interventions****Consolidation/stabilization:** Weathered and loose tuff in central and posterior regions was stabilized with Acrysol WS-24 at 25%.**Fills:** none**Reattachment:** none**Root treatment:** Surface rootlets and exposed portion of 5mm root were removed; subterranean root left *in situ*.**Other:** none**Comparison with 1978-79 Cast/Photograph**

No cast. Comparison with the 1978 photos showed increased weathering of the tuff and particle embedding, especially in the central and posterior regions of the prints. "Rainprints" visible in 1978 photo to the west of the print could not be seen *in situ* due to embedding of overburden in tuff. It was clear from the 1978 photo that G2/3-16 was in poor condition when first excavated. Print margins are not visible in 1978 photographs; identification of location based on tuff features.

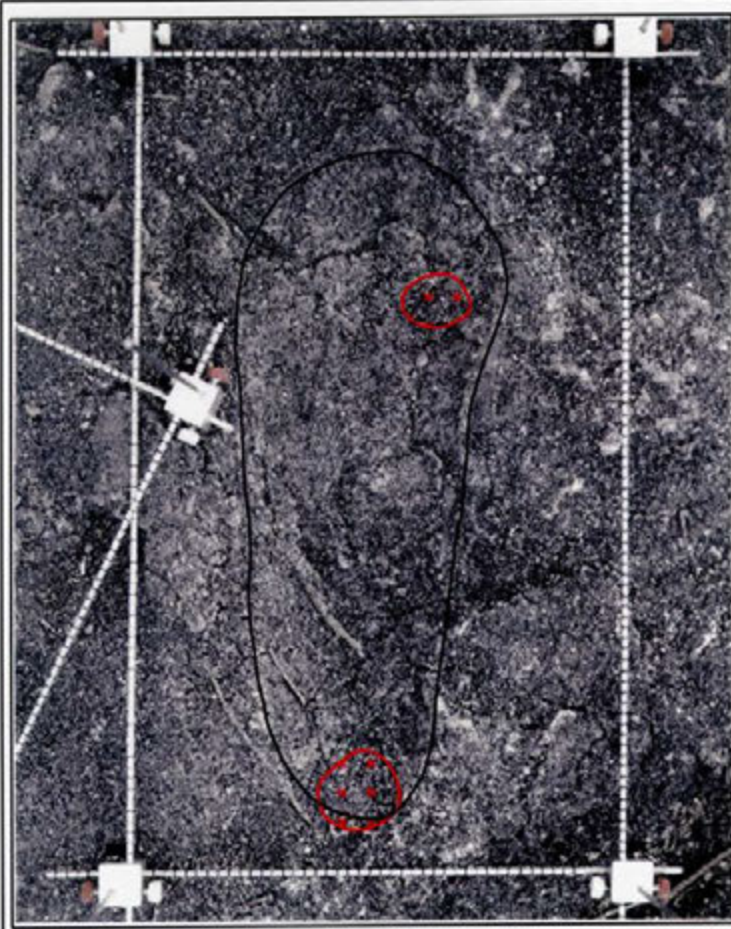
G2/3-17
CONDITIONS RELATED TO 1978-79 INTERVENTIONS

The 1978 reburial fill excavated in 1996 was moderately consolidated and was removed relatively easily from the prints' surface. Tuff surface inside margins noted as being dark in comparison with surrounding tuff, suggesting application of Bedacryl, although its presence could not be confirmed.

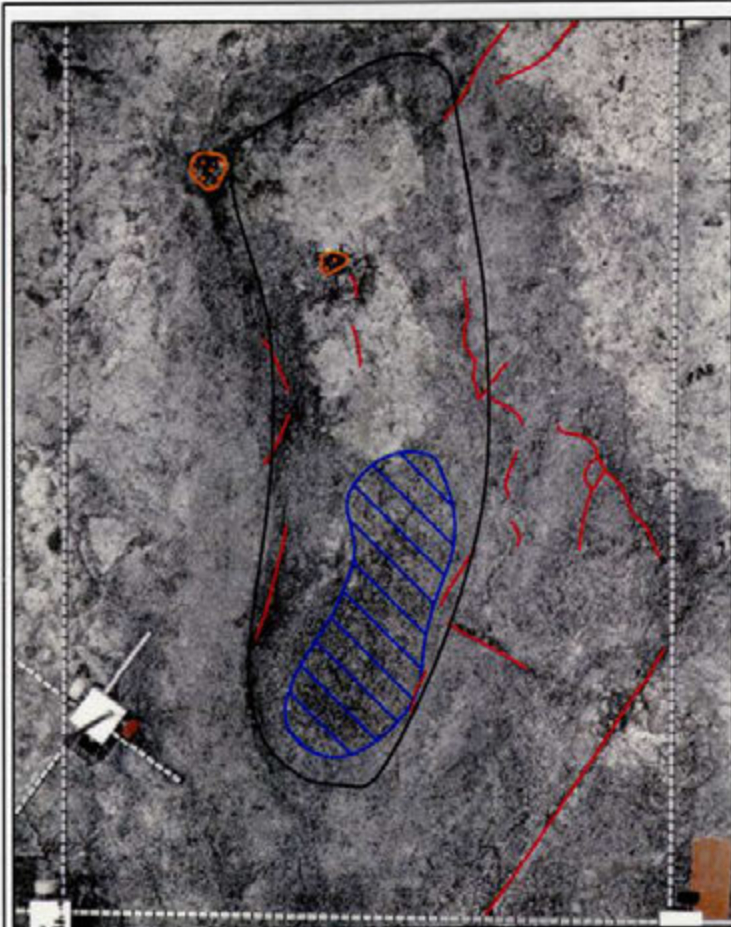
G2/3-18
TUFF CONDITIONS

1995 Condition**General Condition:** Moderate alteration: Fair**Tuff conditions:****Weathering:** Slight weathering in the posterior half of prints.**Cracking:** Hairline cracks (~1mm wide) along medial and lateral margins; large crack, located just outside of heel on lateral side, with partially missing calcite vein.**Losses:** none**Detached/loose tuff:** Tuff detached around spear penetration points (see Other).**Powdering:** none**Other:** Disruption: two areas of disruption (approximately 0.75cm diam.) in anterior portion of the prints, likely from the penetration of a spear point in 1993 or 1994.**Conditions related to 1978-79 interventions:****Bedacryl:** Bedacryl found throughout most of the prints and surrounding tuff; it had deteriorated slightly on the bottom of the prints and a small patch was missing in the anterior portion. Area of missing Bedacryl created a marked color difference with the Bedacryl coated parts.**Embedding:** Very fine particles of overburden were embedded in the Bedacryl layer (not shown on graphic).**Silicone:** none**Excavation tool marks:** Tool marks visible on the floor of the prints and along lateral margin, especially in the posterior half; they were less visible *in situ* than on the cast due to the Bedacryl coating.**Inventory number on tuff:** 1979 label ("2-18") visible on tuff surface.**Other:** none**Root damage:** Surface roots only.**Insect activity:** none**1996 Interventions****Consolidation/stabilization:** Loose tuff around spear-penetration points was stabilized with Acrysol WS-24.**Fills:** none**Reattachment:** Disrupted fragments of tuff around spear penetration points were reattached with Paraloid B-72.**Root treatment:** Surface rootlets were removed.**Other:** none

Comparison with the 1979 cast and photos showed loss of resolution of some of the finer details on the prints' surface (such as excavation tool marks) and darkening of surface, both due to the coating of Bedacryl; and slight loss of calcite in crack outside heel margin. Spear penetration points were made in 1993 or 1994 and therefore are not seen in the photos or cast. The missing Bedacryl layer, which creates a noticeable color contrast at the bottom of the prints, was not visible in 1979 photos and may have been removed during the molding process in 1979.

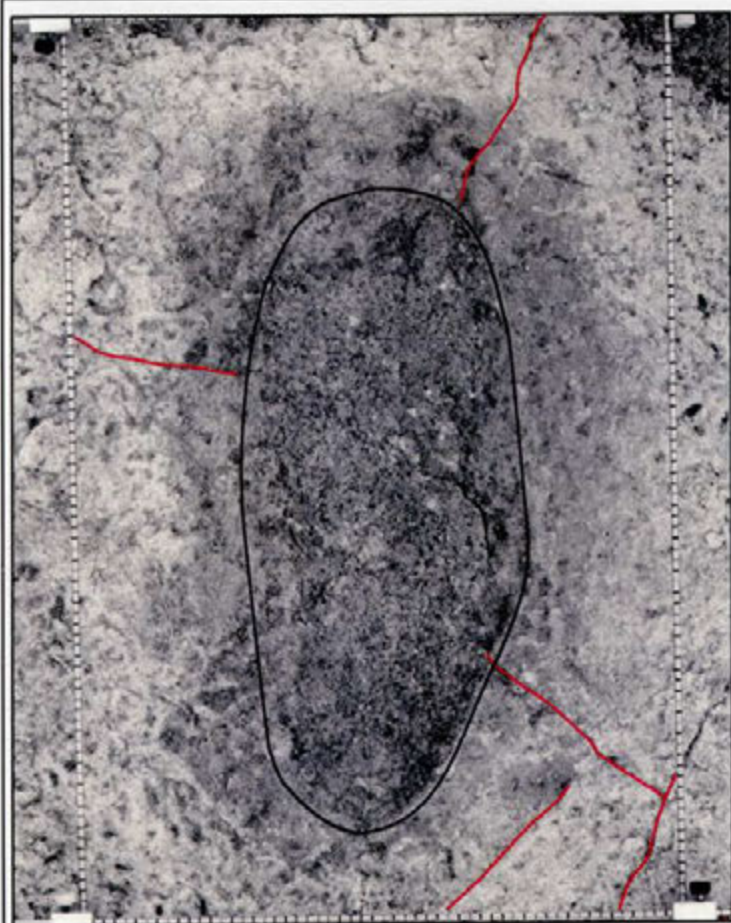
G2/3-20
TUFF CONDITIONS

General Condition: Minor alteration: Good

Cracking: Three 1-2mm wide cracks extended outward from print margins.

Comparison with the 1979 cast and photos showed slight loss of resolution of some of the finer details on the prints' surface, particularly on the floor of the prints, and darkening of the surface; both due to the coating of Bedacryl.

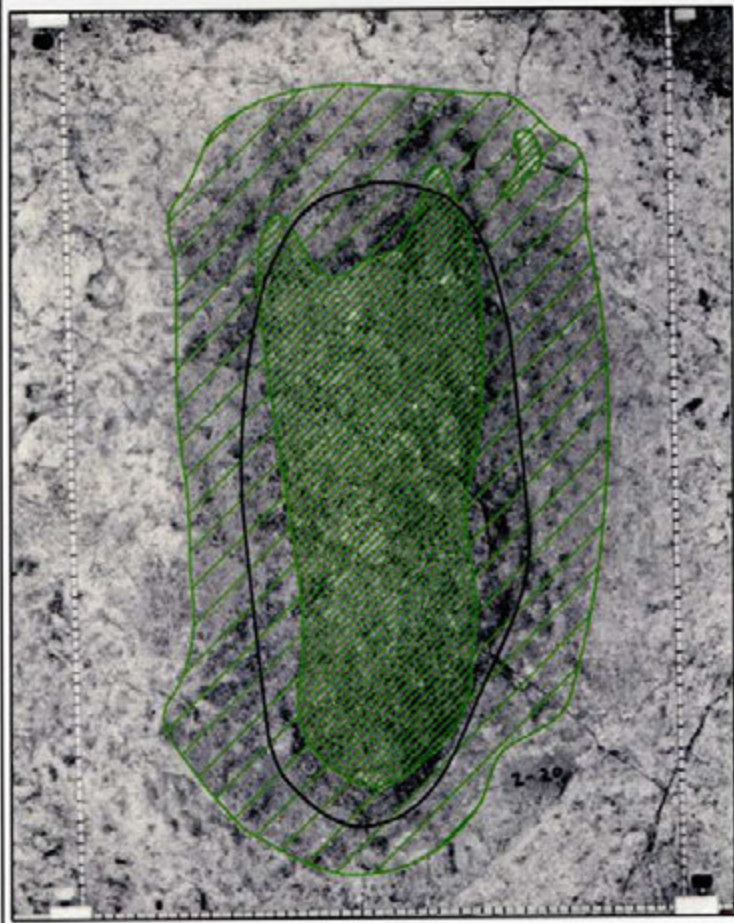
G2/3-20
CONDITIONS RELATED TO 1978-79 INTERVENTIONS

Bedacryl: Bedacryl found throughout the prints and just beyond the margins. It had slightly deteriorated on the floor of the prints and was penetrated by rootlets, and was lost in small discrete areas.

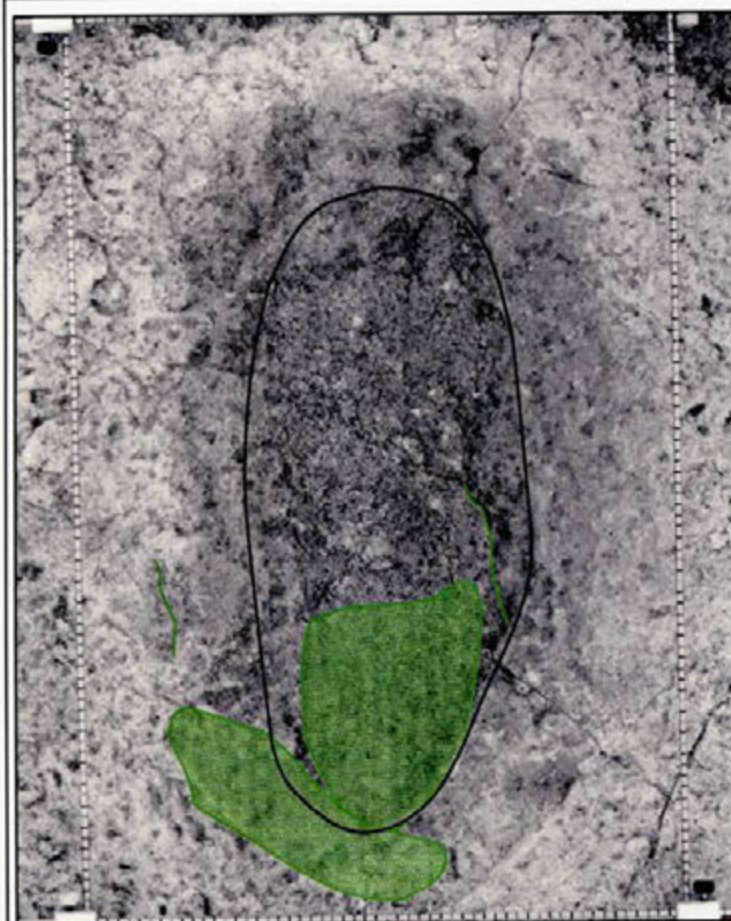
G2/3-20
ROOT DAMAGE AND INSECT ACTIVITY

Root damage: Network of rootlets penetrated the Bedacryl layer, especially in the posterior portion (shown as root mat on graphic), but did not appear to penetrate the tuff.

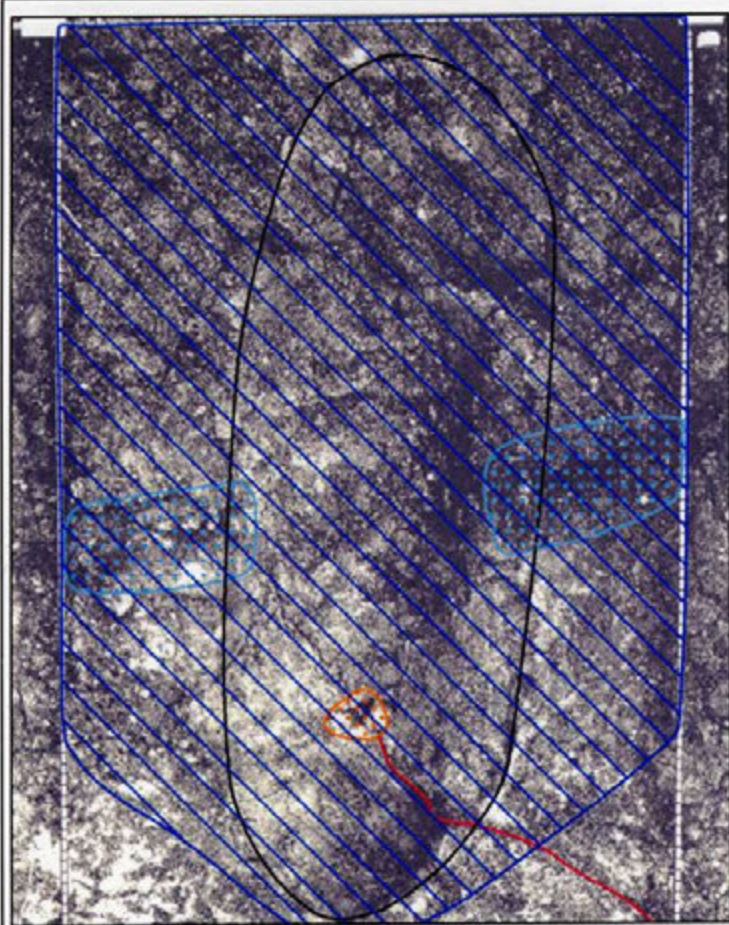
G2/3-21
TUFT CONDITIONS

1995 Condition**General Condition:** Significant alteration: Poor**Tuff conditions:****Weathering:** Moderate to severe weathering throughout the prints and the surrounding tuff.

G2/3-21 is located in the weathered strip of tuff in the southern sector of the trackway, characterized by patterned cracking with deep fissures that are filled with overburden.

Cracking: Significant cracking throughout the prints associated with weathering of tuff; a single crack in consolidated tuff enters print from outside posteromedial margin (see Comparison).**Losses:** none**Detached/loose tuff:** Loose tuff associated with root penetration.**Powdering:** none**Other:** Disruption: one 2-3mm² area of tuff disrupted in heel portion, likely from the penetration of a spear point.**Conditions related to 1978-79 interventions:****Bedacryl:** Bedacryl found throughout the prints and surrounding tuff. It had slightly deteriorated near the center of the prints, and was lost in discrete areas.**Embedding:** Fine particles were embedded in the weathered tuff (not shown on graphic).**Silicone:** Remnants of silicone located within and exterior to the prints.**Excavation tool marks:** none**Inventory number on tuff:** none**Other:** none**Root damage:** Large 10mm diameter root from stump no. 83 passed through the lateral and medial margins of the prints, causing considerable disruption of the overlying and surrounding tuff and leaving a root impression on the surface where portions were removed. Some subterranean root fragments were left *in situ* because they could not be removed without damaging the tuff. Rootlets penetrated throughout the weathered tuff.**Insect activity:** none**1996 Interventions****Consolidation/stabilization:** Loose tuff along root penetration areas, adjacent to lateral and medial margins, was consolidated with 4% dispersion of Acrysol WS-24 followed by full bottle strength.**Fills:** Acrysol and fumed silica mixture was used to fill a void left from a removed root, on the medial margin.**Reattachment:** none**Root treatment:** Penetrating root was cut; surface portions were removed, leaving a root impression; a portion of the subterranean root, ~3.3cm long, was also removed and the void filled. Surface rootlets were removed.**Other:** none

Comparison with the 1979 photos showed a loss of resolution of details on the prints' surface due to increased weathering and to the coating of Bedacryl. Root and spear point penetration marks were new, but the crack on the posteromedial margin was evident in 1978 photos. The 1979 cast was made prior to complete excavation and was not relied upon for comparison.

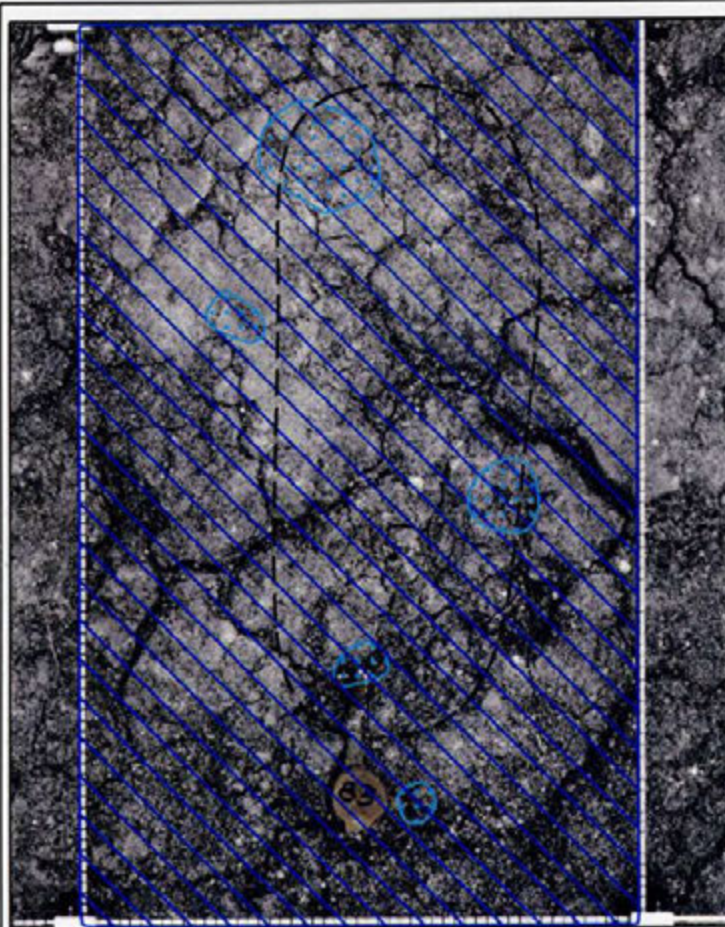
G2/3-22
TUFF CONDITIONS

1995 Condition**General Condition:** Significant alteration: Poor**Tuff conditions:**

Weathering: Severe weathering throughout the prints and the surrounding tuff. G2/3-22 is located in the weathered strip of tuff in the southern trackway, characterized by patterned cracking with deep fissures.

Cracking: Significant cracking throughout the prints, averaging 2-3mm wide, associated with weathering of the tuff.
