LAETOLI

HOMINID TRACKWAY, SITE G

CONDITION RECORDS

G1 AND G2/3 FOOTPRINTS

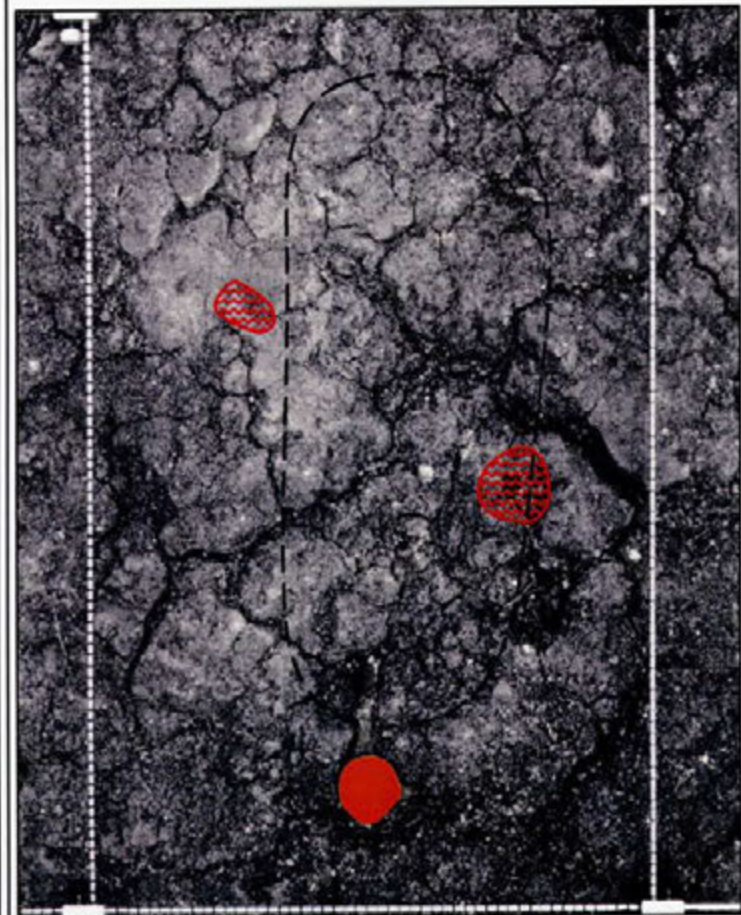
G2/3-22
ROOT DAMAGE AND INSECT ACTIVITY

Root damage: Large acacia stump no. 83 (the source for the root that also damaged G2/3-21) penetrated the heel. There was no significant disruption of the tuff surrounding the root, though the penetration area is large (~15cm²). A deep root impression was left in and beyond the posterior margin where surface portions were removed. Rootlets penetrated throughout the weathered tuff.

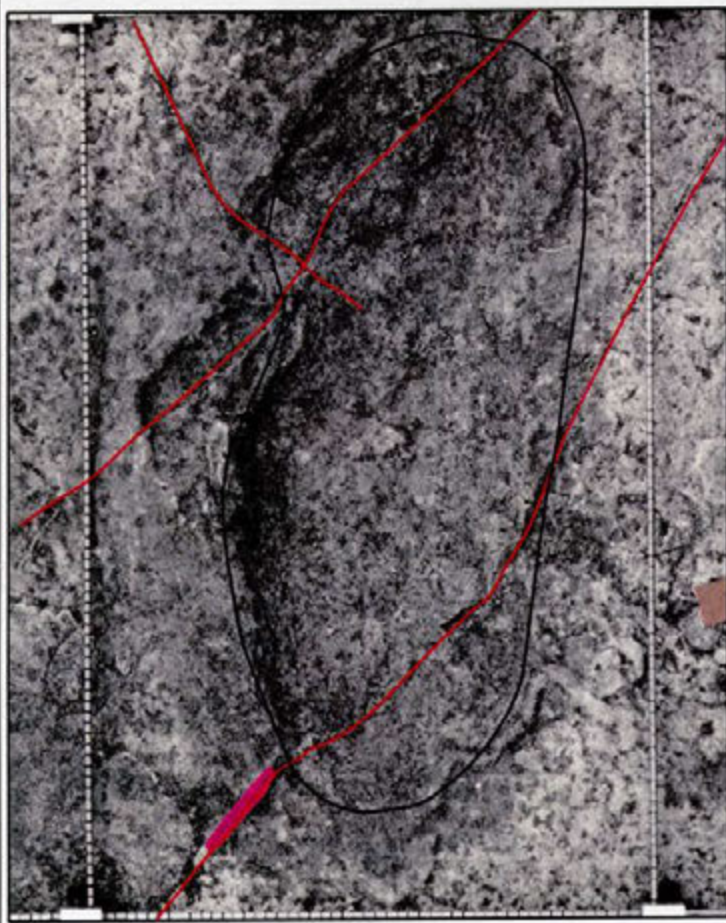
G2/3-24
TUFF CONDITIONS

1995 Condition**General Condition:** Minor alteration: Good**Tuff conditions:****Weathering:** none**Cracking:** Three distinct cracks, 2 filled with calcite, traversed the print's anterolateral and posteromedial margins.**Losses:** Portion of prominent calcite vein and a bit of surface tuff was lost just beyond anterior posterior margin.**Detached/loose tuff:** none**Powdering:** none**Other:** none**Conditions related to 1978-79 interventions:****Bedacryl:** Bedacryl found throughout most of the prints and surrounding tuff. Bedacryl had deteriorated in patches around the margin of the prints.**Embedding:** Embedding of fine particles in the Bedacryl layer.**Silicone:** Minor traces of silicone outside posterior margin of the prints.**Excavation tool marks:** Faintly visible in the toe and on the lateral margin.**Inventory number on tuff:** 1979 label ("2-24") located just beyond the medial heel margin.**Other:** none**Root damage:** Abundant rootlets penetrated the Bedacryl layer but did not appear to penetrate the footprint tuff.**Insect activity:** none**1996 Interventions****Consolidation/stabilization:** none**Fills:** none**Reattachment:** none**Root treatment:** Surface rootlets were removed.**Other:** none**Comparison with 1978-79 Cast/Photograph**Comparison with the 1979 cast and photos showed loss of resolution of details on the prints' surface such as tool marks, which were clearly visible in cast and photos, but only faintly visible *in situ* due to the Bedacryl coating and to the fine particles embedded in it. The prints were darker in color for the same reason. Calcite veins seen in the cast were still clearly visible in the print.

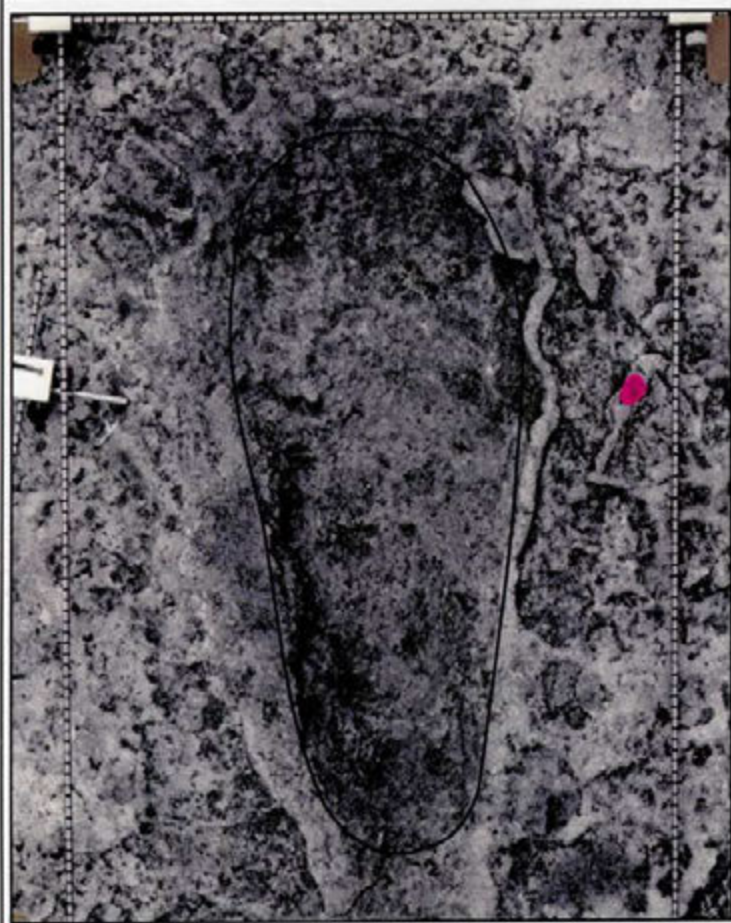
G2/3-25
TUFF CONDITIONS

1995 Condition**General Condition:** Minor alteration: Good**Tuff conditions:**Weathering: noneCracking: noneLosses: 0.25cm² loss of surface tuff outside of the anteriomedial margin.Detached/loose tuff: nonePowdering: noneOther: none**Conditions related to 1978-79 interventions:**Bedacryl: Bedacryl found throughout the prints and surrounding tuff. Bedacryl had deteriorated or was lost in small patches on the floor of the prints.Embedding: Fine particles of overburden were embedded in the Bedacryl (not shown on graphic).Silicone: noneExcavation tool marks: see Comparison.Inventory number on tuff: noneOther: none**Root damage:** none**Insect activity:** none**1996 Interventions****Consolidation/stabilization:** none**Fills:** none**Reattachment:** none**Root treatment:** none**Other:** Bedacryl was cleaned from the prints with acetone in a cotton poultice (Polaroid shows print before cleaning).**Comparison with 1978-79 Cast/Photograph**Prior to cleaning, comparison with the 1979 cast and photos showed a slight loss of resolution on the prints' surface due to the Bedacryl coating and to the fine particles embedded in it. After cleaning, comparison showed a higher level of detail, though tools marks clearly seen in the heel of the casts were not as prominent *in situ*.

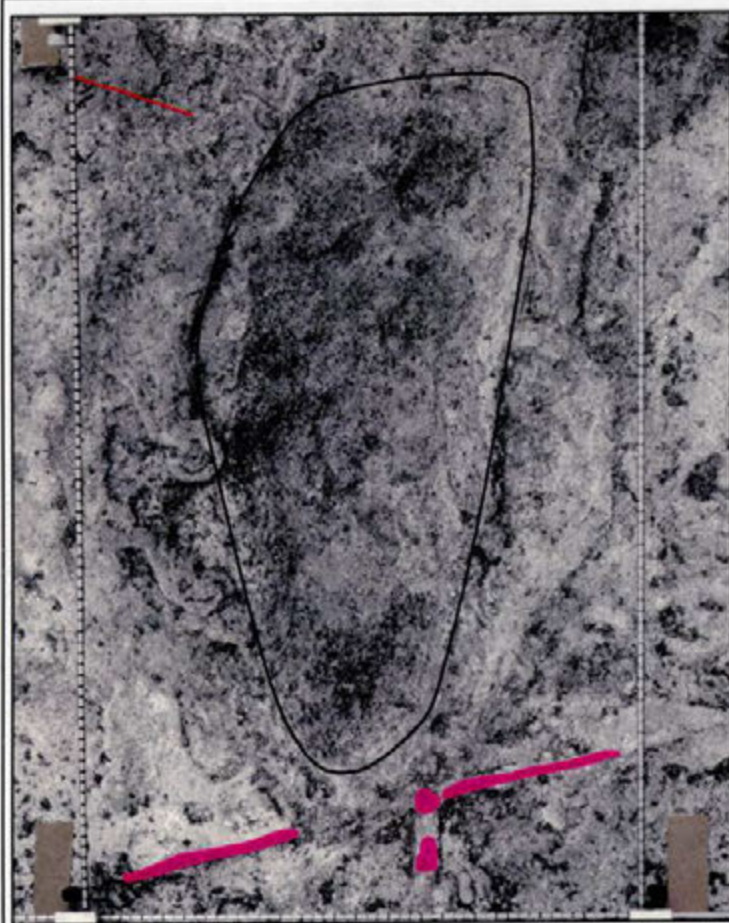
G2/3-26
TUFF CONDITIONS

1995 Condition**General Condition:** Minor alteration: Good**Tuff conditions:**Weathering: noneCracking: A hairline crack was visible outside of lateral margin of the anterior portion of prints (comparison with the cast showed the crack continued through the toe area, but this was not apparent *in situ*).Losses: Abrasion on the prominent ridges of tuff posterior to the heel margin (see Comparison).Detached/loose tuff: nonePowdering: noneOther: none**Conditions related to 1978-79 interventions:**Bedacryl: Thin layer of Bedacryl throughout the prints and surrounding tuff surface; deteriorated patches near center and posterior portion; small patches of Bedacryl loss within each of the deteriorated areas.Embedding: Slight embedding of fine particles in Bedacryl layer (not shown on graphic).Silicone: Traces of silicone outside posterior margin.Excavation tool marks: Tool marks visible just inside and outside the lateral margin (see Comparison).Inventory number on tuff: Two 1979 inventory numbers ("2-26" and "2-25") visible on tuff surface beyond the medial heel margin.Other: none**Root damage:** Surficial rootlets penetrated the Bedacryl layer, but not the tuff.**Insect activity:** none**1996 Interventions****Consolidation/stabilization:** none**Fills:** none**Reattachment:** none**Root treatment:** Surface rootlets were removed.**Other:** none**Comparison with 1978-79 Cast/Photograph**Comparison with 1979 cast and photos showed only slight loss of resolution of details due to the Bedacryl layer and particle embedding within the Bedacryl. Tool marks visible on the cast in the ball of the G-2 print, and a hairline crack visible in the photos and cast running across the anterior portion of the prints, were obscured *in situ*. Abrasion of the tuff surface noted on the T-shaped ridge outside the print was evident on the cast, except for the abrasion of the right side of the "T", which appeared to be fresh.

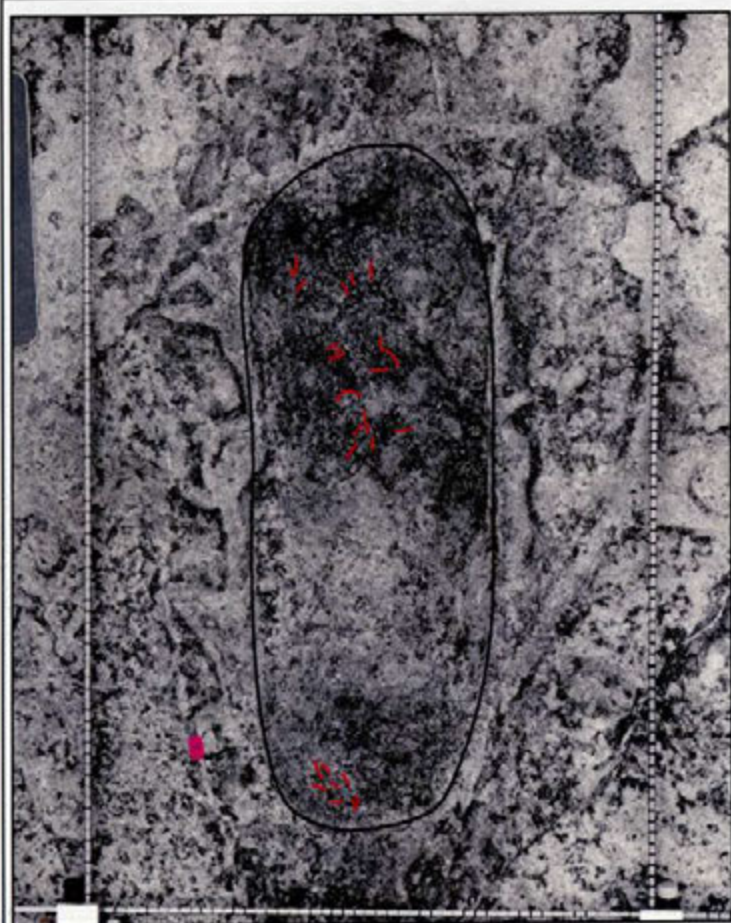
G2/3-27
TUFF CONDITIONS

1995 Condition**General Condition:** Minor alteration: Good**Tuff conditions:**Weathering: noneCracking: Network of fine cracks, <1mm wide, in tuff underneath deteriorated Bedacryl in anterior and posterior portions.Losses: Minor surface abrasion on rim of termite tunnel outside posterior medial print margin.Detached/loose tuff: nonePowdering: noneOther: none**Conditions related to 1978-79 interventions:**Bedacryl: Bedacryl covered the print and the tuff surrounding it. The Bedacryl was deteriorated at the bottom of the anterior half and deteriorated and partially lost near the posterior margin. The Bedacryl layer was relatively thick.Embedding: Slight embedding of fine particles in the Bedacryl layer, especially in the deteriorated areas.Silicone: noneExcavation tool marks: Not visible due to Bedacryl layer (see Comparison below)Inventory number on tuff: 1979 label ("2-27") visible on tuff surface beyond the heel margin.Other: noneRoot damage: Extensive network of rootlets (shown on graphic as root mat) weaved in and out of the Bedacryl layer especially in the areas where the Bedacryl was deteriorating (anterior half and posterior margin), but did not appear to penetrate the tuff.Insect activity: none**1996 Interventions**Consolidation/stabilization: noneFills: noneReattachment: noneRoot treatment: Surface rootlets were removed. Where fine rootlets had worked their way into the Bedacryl layer and were well adhered, they could not be removed without risking loss of Bedacryl and were, therefore, left.Other: none**Comparison with 1978-79 Cast/Photograph**Comparison with 1979 cast and photos showed loss of resolution of features due to the thick layer of Bedacryl, especially the deteriorated areas. Excavation tool marks, which can be seen to cover the floor of the print in cast and photos, are obscured *in situ*. A crack in the anterior portion is less distinct *in situ*.

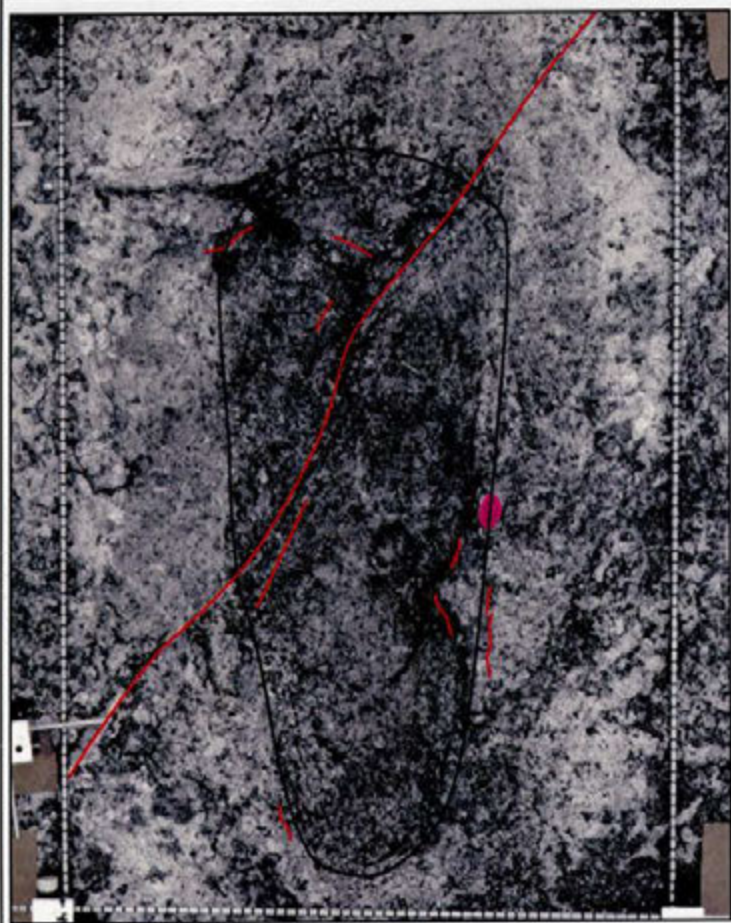
G2/3-28
TUFF CONDITIONS

Cracking: A crack with a calcite vein traversed the anterior and central portion of the prints.

Minor cracks in the tuff along prints' margin.

Losses: Minor loss of the tuff surface where Bedacryl had deteriorated near center of medial margin.

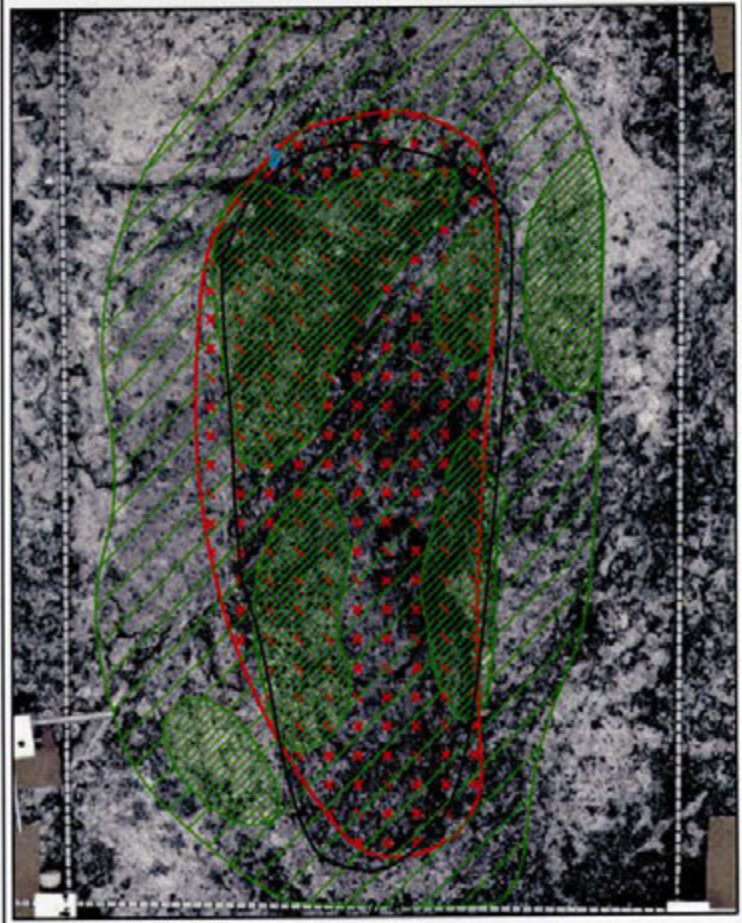
G2/3-28

Bedacryl: Bedacryl throughout the prints and surrounding tuff; patches of Bedacryl on the floor and medial margin of the prints had begun to deteriorate and crack with minor areas of loss, exposing a lighter colored tuff underneath.

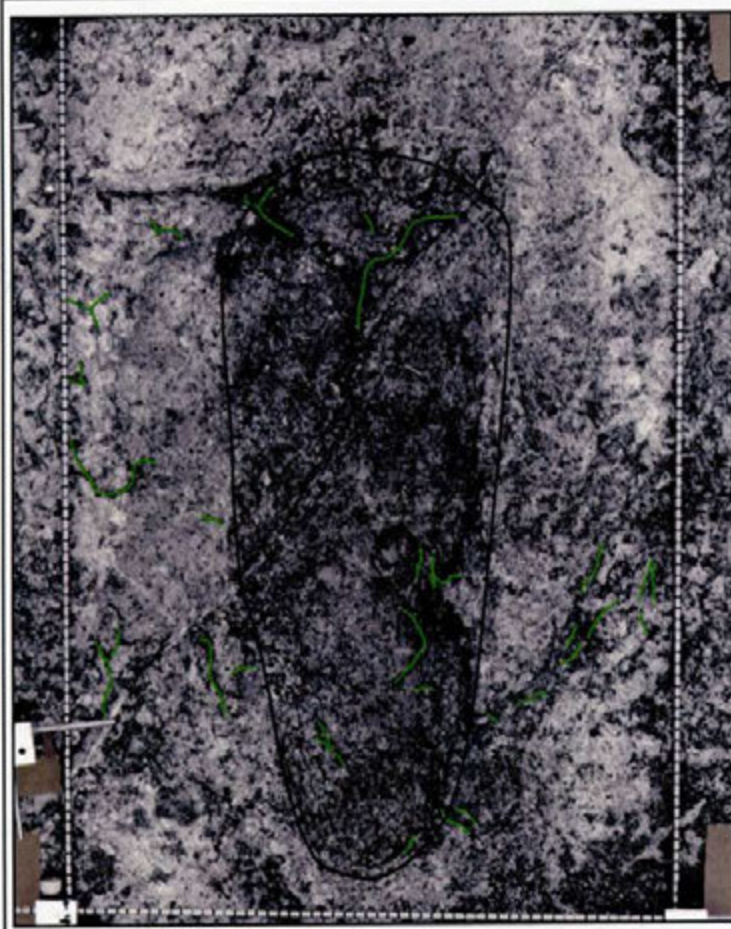
G2/3-28
ROOT DAMAGE AND INSECT ACTIVITY

Root damage: Tiny rootlets weaved in and out of the Bedacryl layer, and two roots, approximately 1-2mm in diameter, penetrated the tuff on the anterior portion, without causing damage or disruption of the tuff.

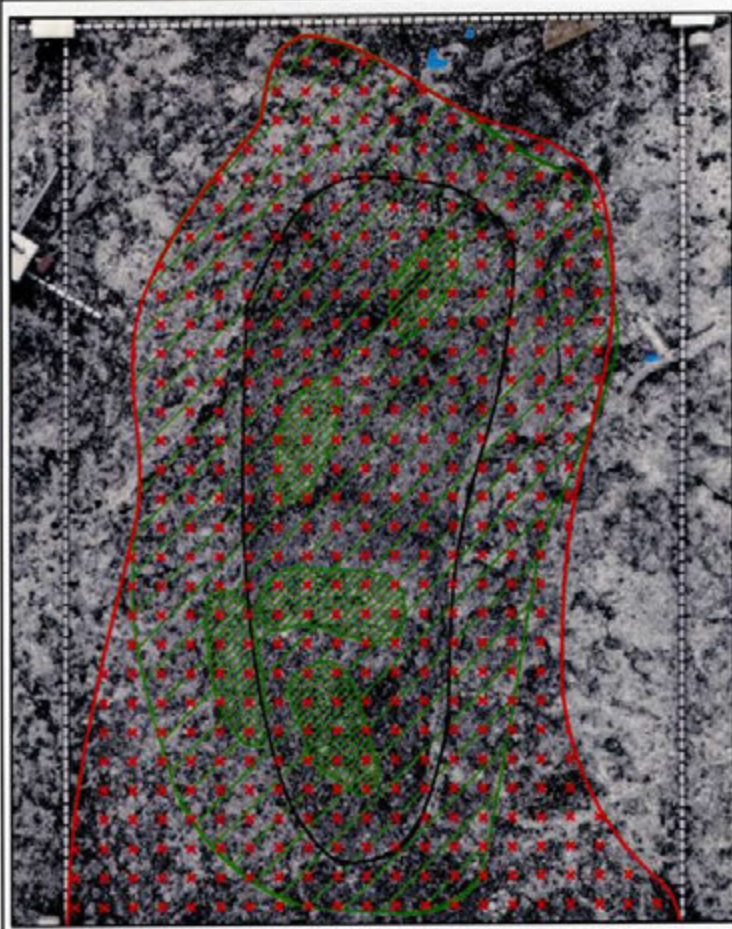
G2/3-29
CONDITIONS RELATED TO 1978-79 INTERVENTIONS

Bedacryl: Bedacryl detected throughout the prints and surrounding tuff. Deteriorated patches on floor of prints. Bedacryl had been applied thickly and was cracked.

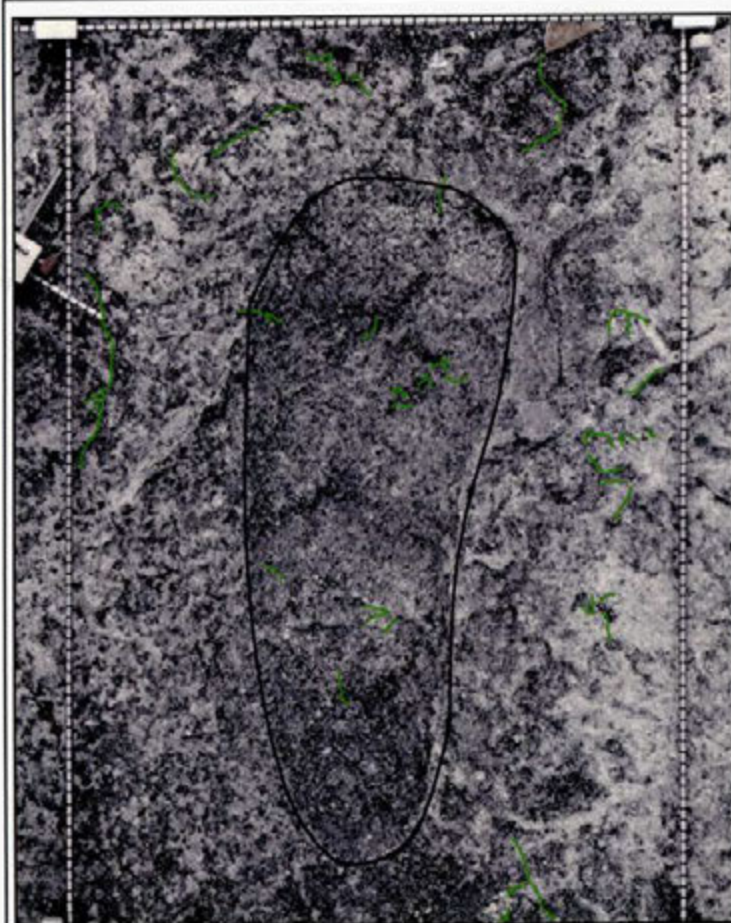
G2/3-29
ROOT DAMAGE AND INSECT ACTIVITY

Root damage: Numerous rootlets on surface only.

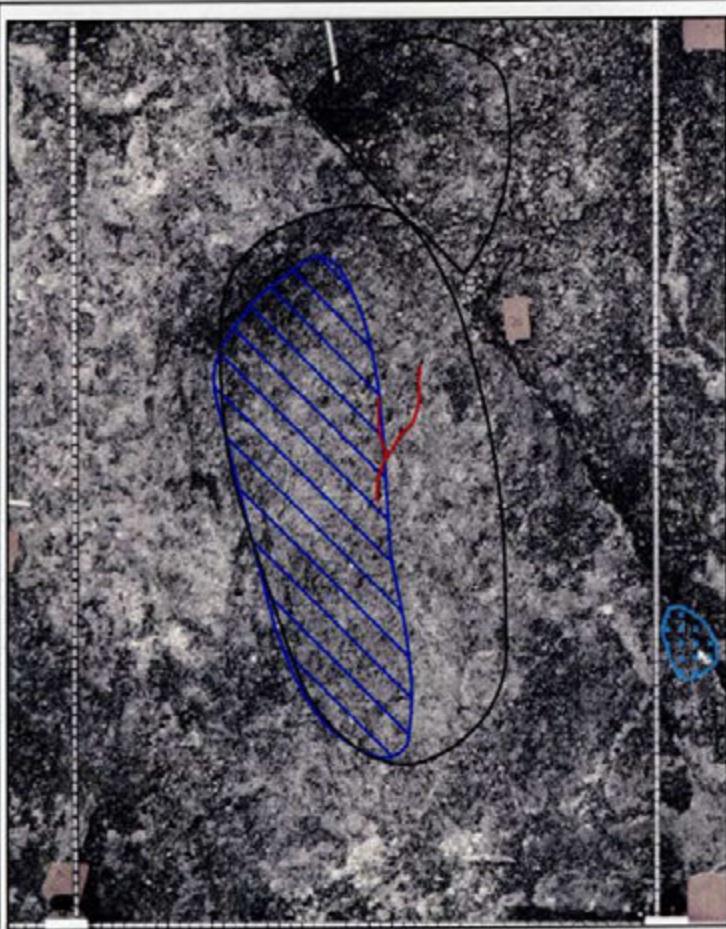
G2/3-30
TUFF CONDITIONS

1995 Condition**General Condition:** Minor alteration: Good**Tuff conditions:****Weathering:** Slight weathering along the lateral margin and bottom of the prints.**Cracking:** Hairline cracks near center of prints.**Losses:** none**Detached/loose tuff:** Area of tuff along fault line beyond posteromedial margin was fragile and loose.**Powdering:** none**Other:** none**Conditions related to 1978-79 interventions:****Bedacryl:** Bedacryl throughout prints and surrounding tuff south of the fault. Bedacryl was not identified north of the fault. The Bedacryl layer was missing outside the lateral margin and was deteriorated or missing in patches inside the prints near the center; missing Bedacryl probably removed during the molding operation in 1979.**Embedding:** Moderate embedding throughout the prints and the surrounding tuff, especially in anterior part north of fault.**Silicone:** Traces of silicone outside medial margin.**Excavation tool marks:** none**Inventory number on tuff:** none (see Comparison)**Other:** none**Root damage:** Rootlets on surface; one rootlet penetrated Bedacryl layer in anterior portion.**Insect activity:** none**1996 Interventions****Consolidation/stabilization:** Loose tuff along edge of fault outside the prints' margin was stabilized with Acrysol WS-24 at 4%.**Fills:** none**Reattachment:** none**Root treatment:** Surface rootlets were removed.**Other:** none**Comparison with 1978-79 Cast/Photograph**Comparison with 1979 cast and photos showed loss of resolution of details on floor of print due to Bedacryl and fine particles embedded in the coating. Inventory number, which is visible on photos, was not seen *in situ* due to embedding.**Notes**

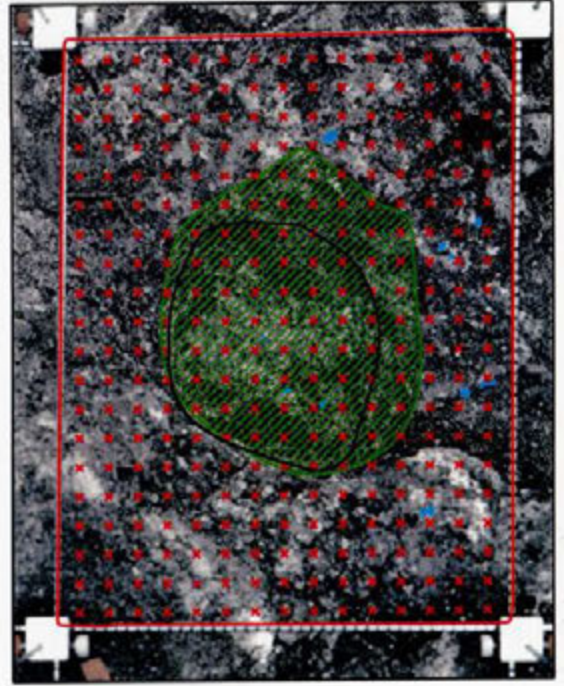
G2/3-31
CONDITIONS RELATED TO 1978-79 INTERVENTIONS

Bedacryl: Bedacryl detected throughout print. It was deteriorated in all but a small patch in the center.

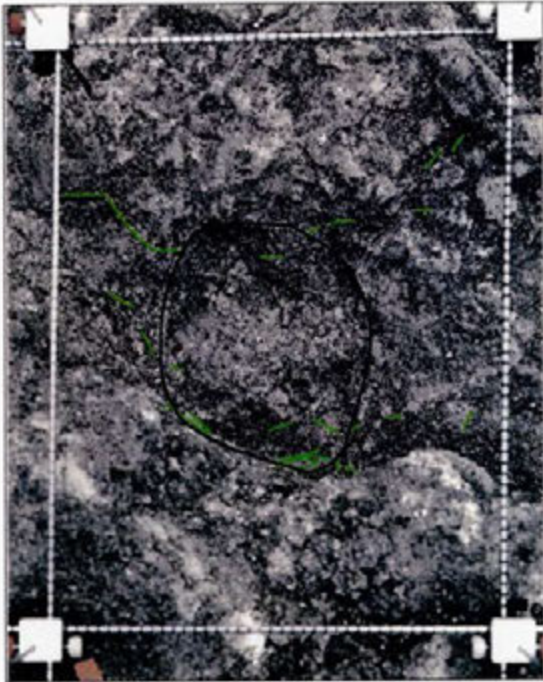
G2/3-31
ROOT DAMAGE AND INSECT ACTIVITY

Root damage: Rootlets concentrated on the posterior end where the print meets the higher augite-biotite tuff.
