*Report on the partial re-excavation
of the Laetoli hominid trackway, Site G*

The Getty Conservation Institute

Partial re-excavation of the Laetoli hominid trackway, February 2011

Condition record of Laetoli hominid prints re-excavated in February 2011

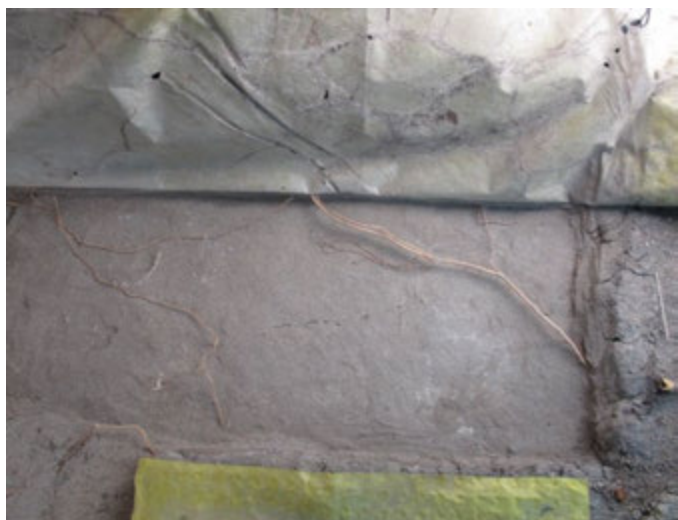
Geotextile pulled back to reveal Layer 1. Roots growing between geotextile and surface of Layer 1 emanate from east and south 1979 baulk.

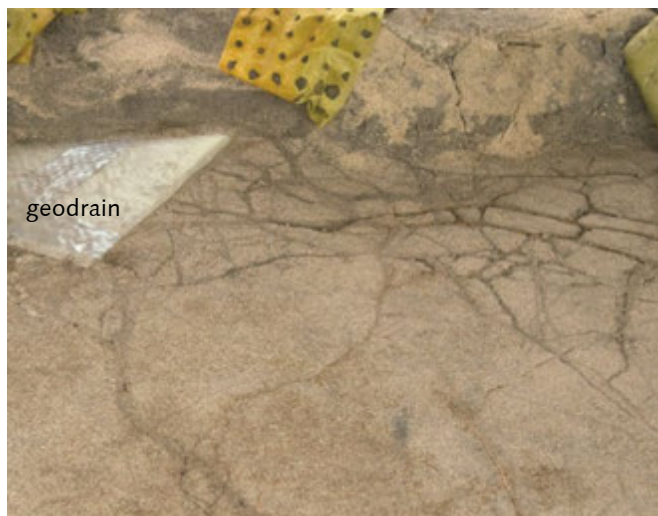
Impressions of dead roots in Layer 1 with evidence of termite activity in damp fill near the geodrain drain in the 1979 west trench.

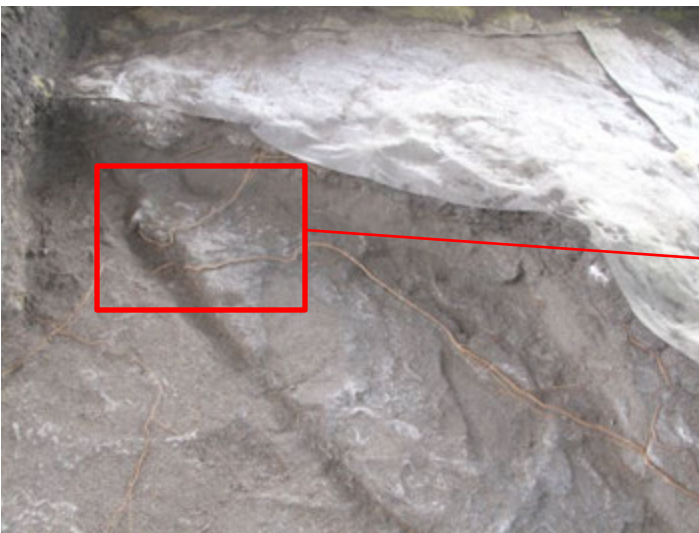
Roots penetrating tuff at edge of Fault 1. Root penetration in conjunction with excavation dislodged a piece of the tuff.

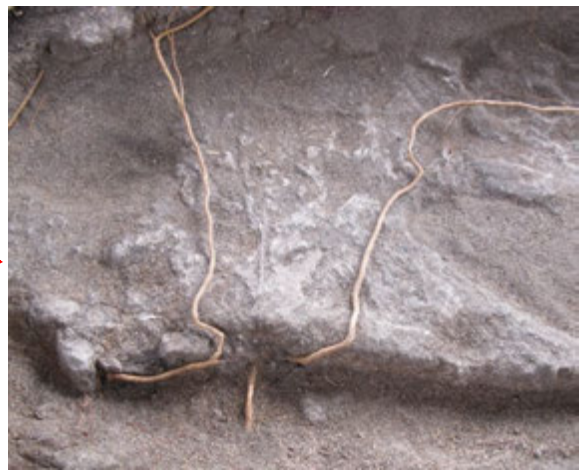
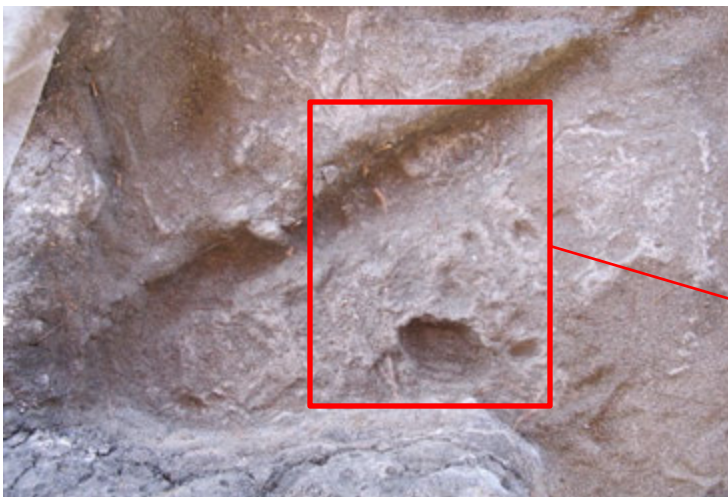
Roots at edge of Fault 1 after cutting; one can follow the root eastward (dashed line) into the unexcavated 1979 trench wall.

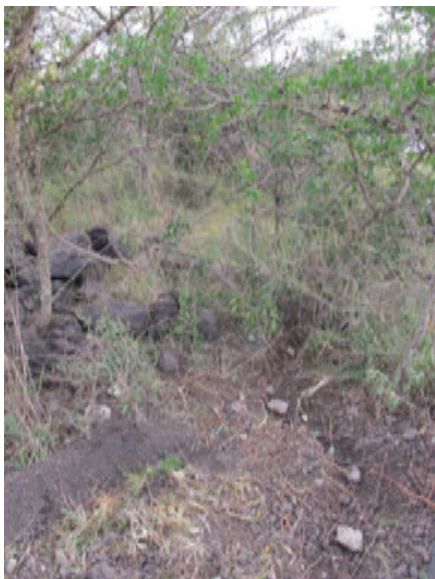
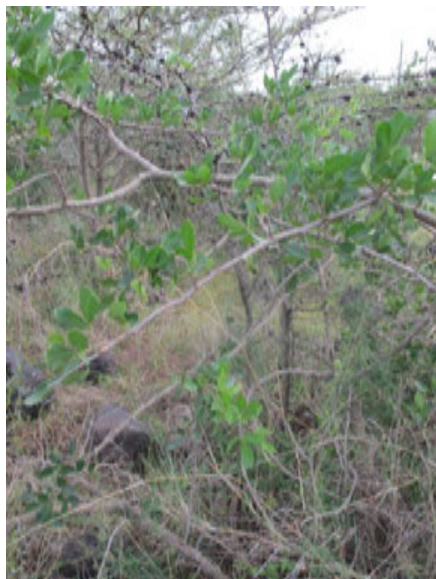
Unidentified tree (likely *Balanites sp.*), growing amidst *Acacia drepanolobium*, was responsible for the lateral roots that entered the mound from the east.

The 2011 assessment revealed weaknesses in the Laetoli reburial. The problem of root intrusion can be overcome with additional killing of trees in an extended buffer zone and this step is being implemented by the Antiquities Division. The cracking or weathering of tuff requires further research and an in-depth mineralogical investigation to determine definitively whether cracking is due to mineralogical change (weathering) or drying on exposure or both. Subsurface moisture should be investigated and controlled since indisputedly conversion of tuff minerals into clays is mediated by water. Site drainage and stabilization is essential for preservation of the trackway under conditions of either reburial or sheltering.

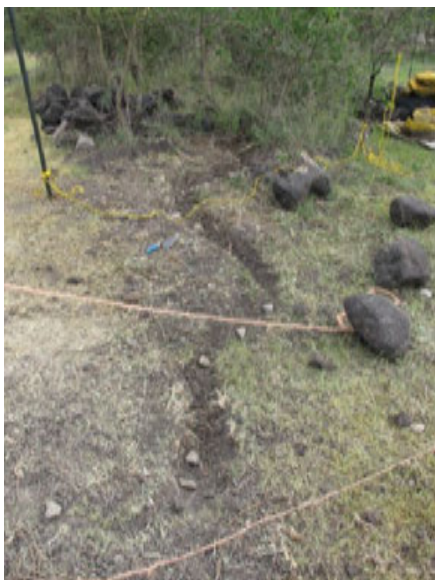
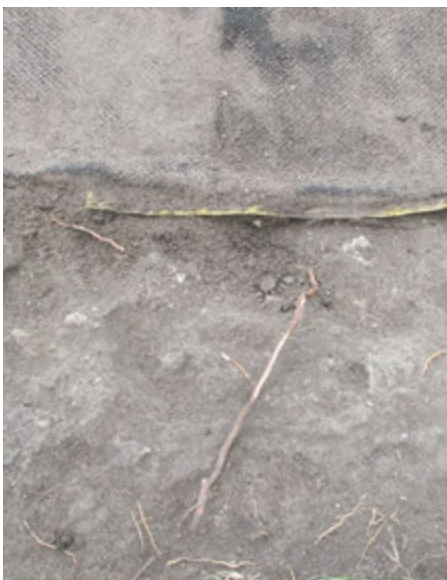
The main root from this tree was traced (far left) traveling 8.3 m to the edge of the trench where it can be seen penetrating unexcavated 1979 ground surface, near Biobarrier 2 (left), to emerge from the 1979 trench wall.

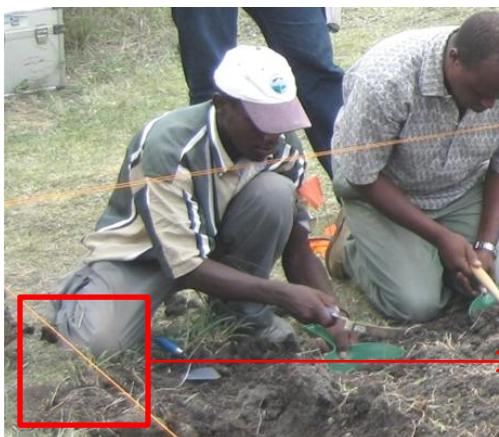
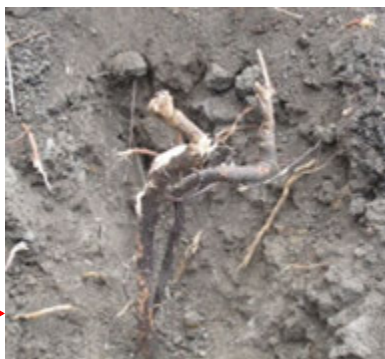
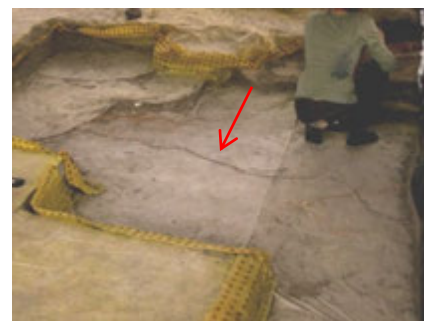
Live, unidentified tree stump (probably *Acacia drepanolobium*) in the SE corner of reburial mound (visible far left during removal of Layer 5). A root running N-S above the geotextile from the SE part of the trench (far right photo) may emanate from this cut tree stump.

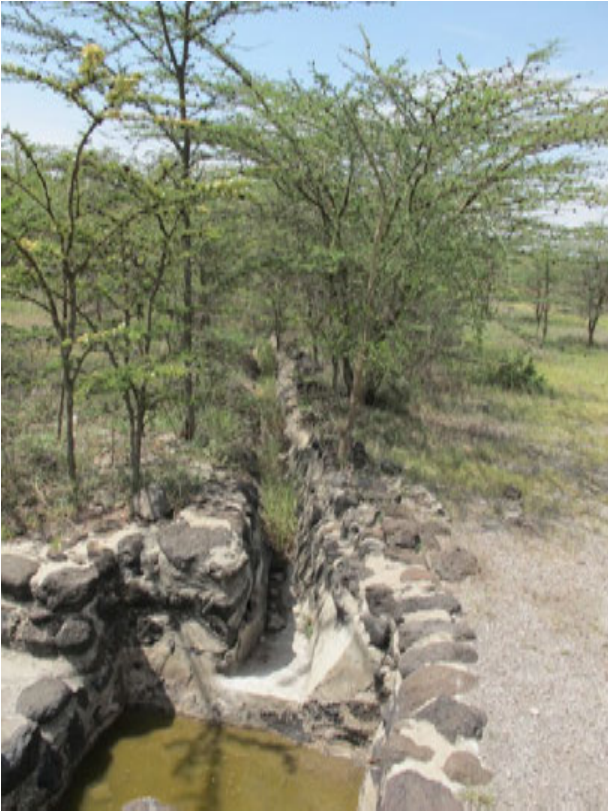
Extensive growth of acacia trees adjacent to drainage channel, which is clogged with vegetation. Catchment sump in foreground.

The three options reviewed above - which need not be mutually exclusive (that is, a combination of approaches could be envisioned) - need to be considered in the light of these findings. But immediate action is required to rectify the problems noted in this report in relation to the current reburial (that is, killing of additional trees and repair and clearance of the drainage system).

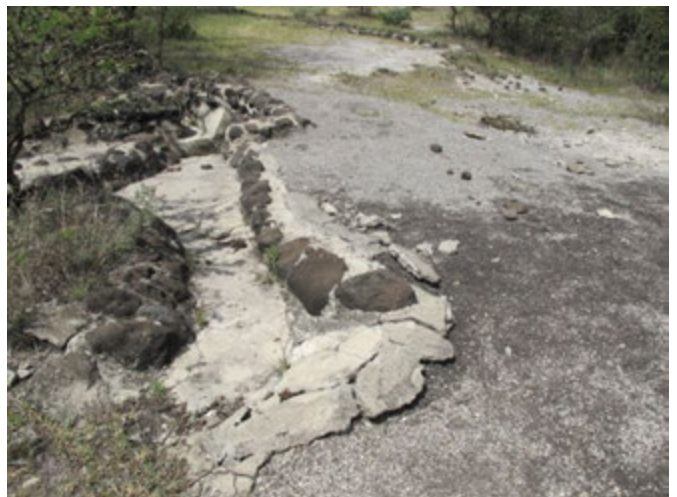
Cement inlet apron on east drainage channel is breaking up.

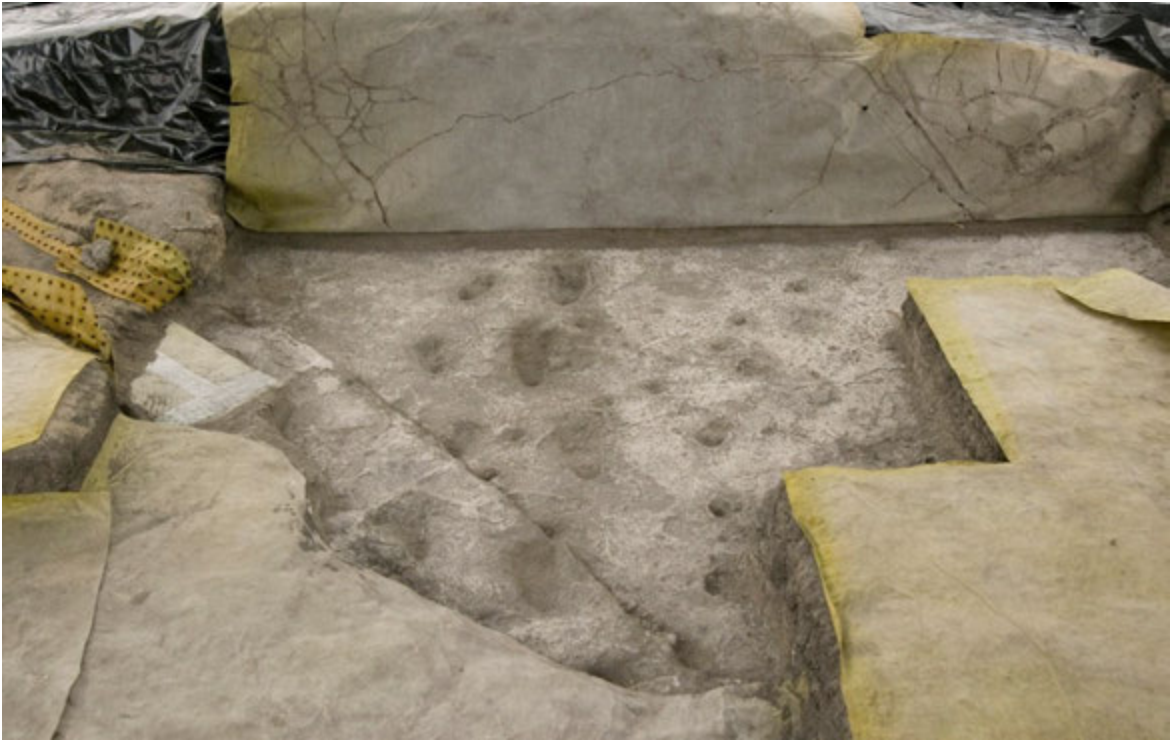
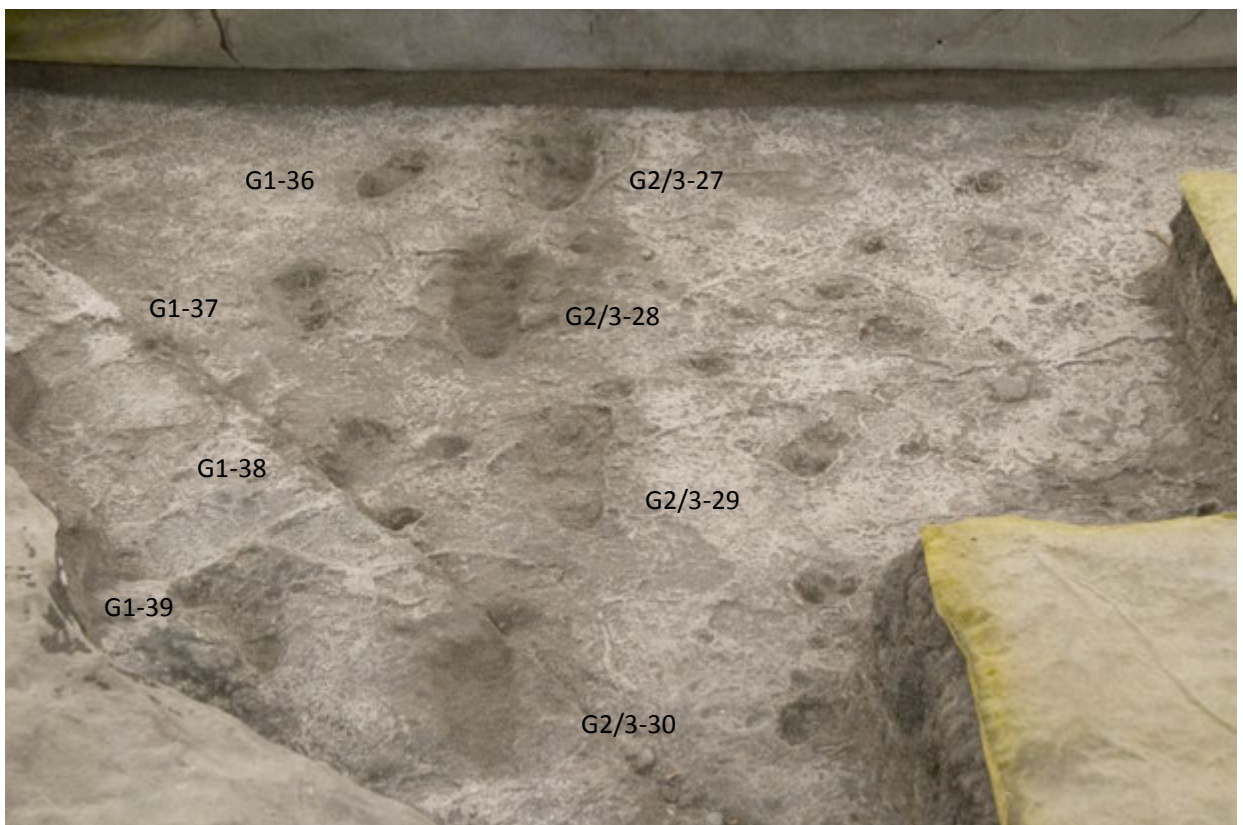
Embedding of sand particles and growth of hair roots in the Bedacryl layer (consolidant used on the prints in 1979) and the tuff obscured details on the floor of the prints. Bedacryl, noted as a problem in 1995, continues to be problematic. It darkens the prints and their immediate surround and has likely trapped moisture in the prints.

3.50 meter section of southern trackway after re-excitation in February 2011. Eight footprints and numerous hipparion prints were exposed. The prints were not cleaned to the same level as in 1995 due to lack of time required to remove adherent and embedded fine particles from the floor of the prints. Dark color in the prints and the 'halos' around them is due to Bedacryl applied in 1979. Geotextiles remain in situ on the unexcavated surfaces in photo.

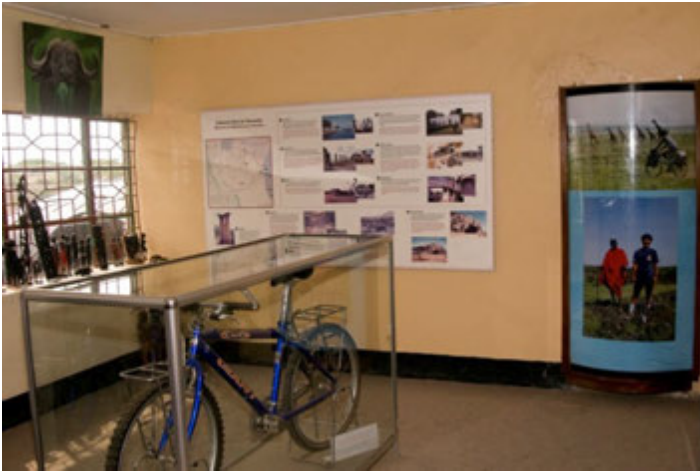
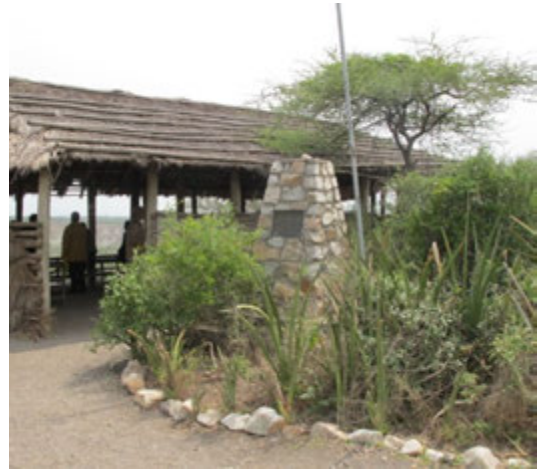
Irrelevant additions in the Orientation room at Olduvai (bicycle and 2 large panels) and 2m high stone memorials erected at the Olduvai Museum (right) and at the site of Laetoli by a Japanese cyclist undermine the integrity of the exhibit.

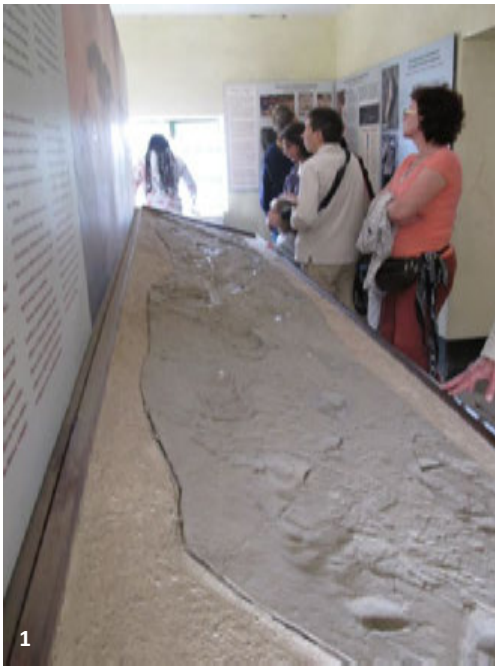
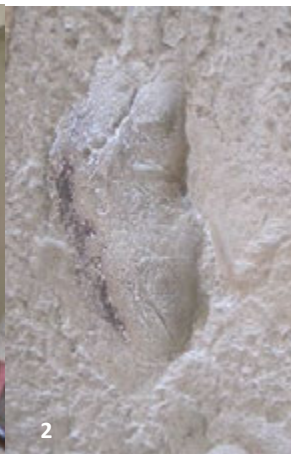
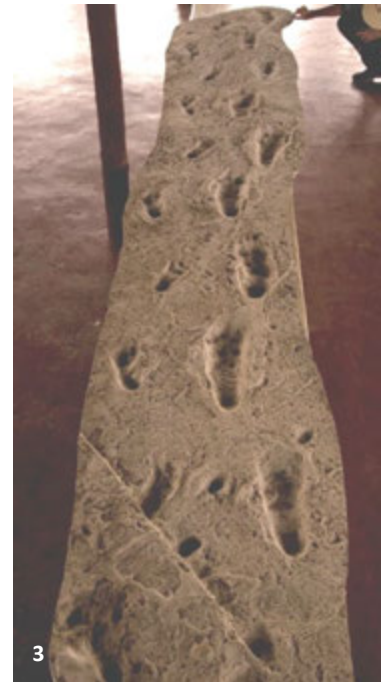
Laetoli casts

Replica cast of southern trackway in Olduvai exhibit (1). Touching of prints by visitors has deposited oils from hands and removed some of the patination (2). The impact of touching is mainly superficial; the cast could be cleaned and repatinated. The master epoxy cast made in 1995 (3), which is now the only replicable cast of the trackway as excavated in 1979, was transported from its permanent storage in Dar es Salaam to the temporary exhibit hall at the Laetoli site in 2009.

The original 1979 cast has a scientific value that surpasses that of the trackway itself since it constitutes the most precise record of the southern trackway as excavated in 1979. The mother mold from which it was made is deteriorated beyond use and the cast cannot be further replicated due to risk of damage. The cast was wrapped for its protection and placed in purpose-built shelving by the GCI in a storeroom at Olduvai in 1996. In 2011 it was found to be in an exposed and vulnerable state (4) resulting in some mechanical damage on its exposed edge (5).

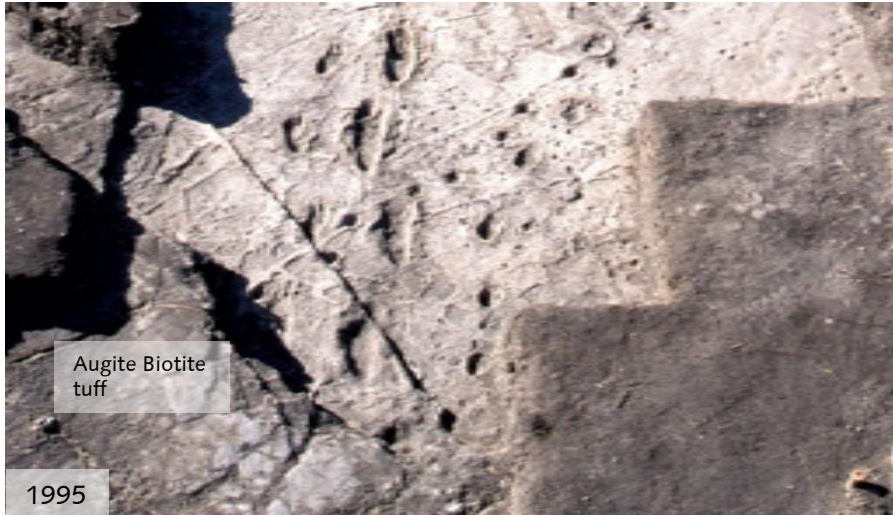
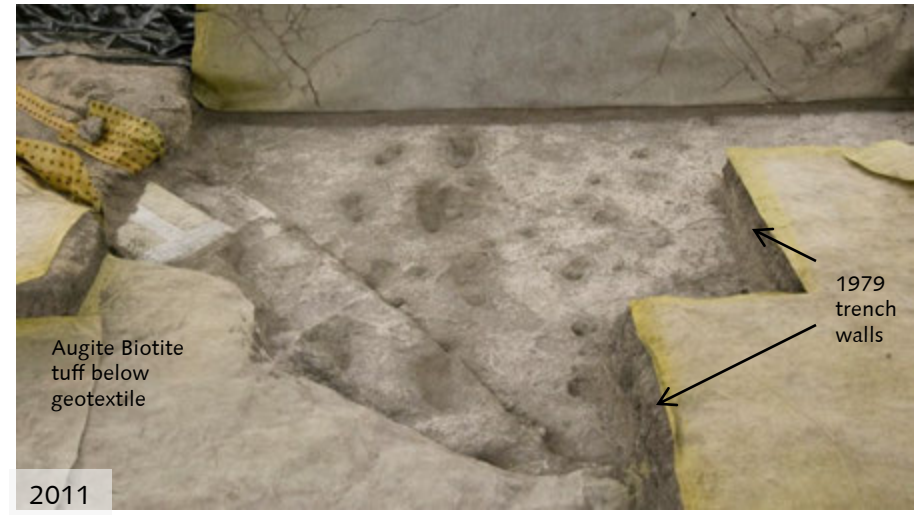
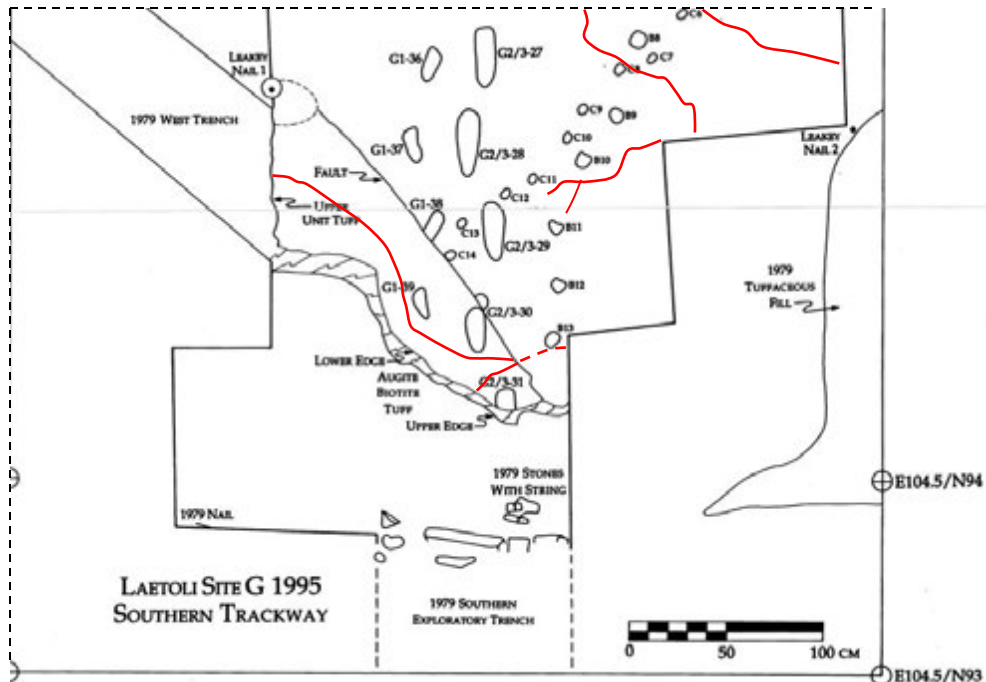
Area re-excavated in 2011 (above right) and as seen in 1995 photo and in the plan of the southern part of the trackway (left). The geotextile that covered unexcavated surfaces in the 1995 reburial were not removed in 2011 and can be seen in situ above. The 1979 West trench was re-excavated only in its upper layers and the geodrain placed in the trench in 1995 at the bottom of the 1979 trench can be seen protruding into the 2011 excavated area.

The unexcavated Augite Biotite tuff and the 1979 trench walls, referred to in the report, are indicated above. The main root system that entered the trench from the east is approximately indicated on the plan in red.

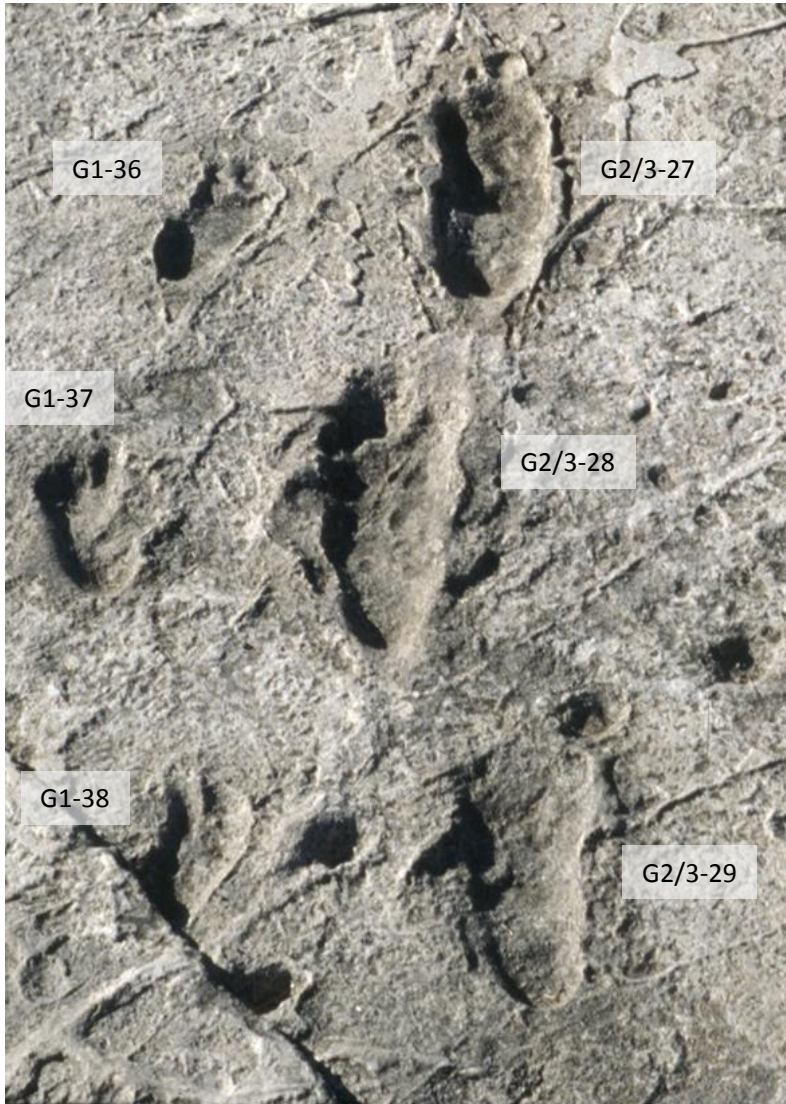
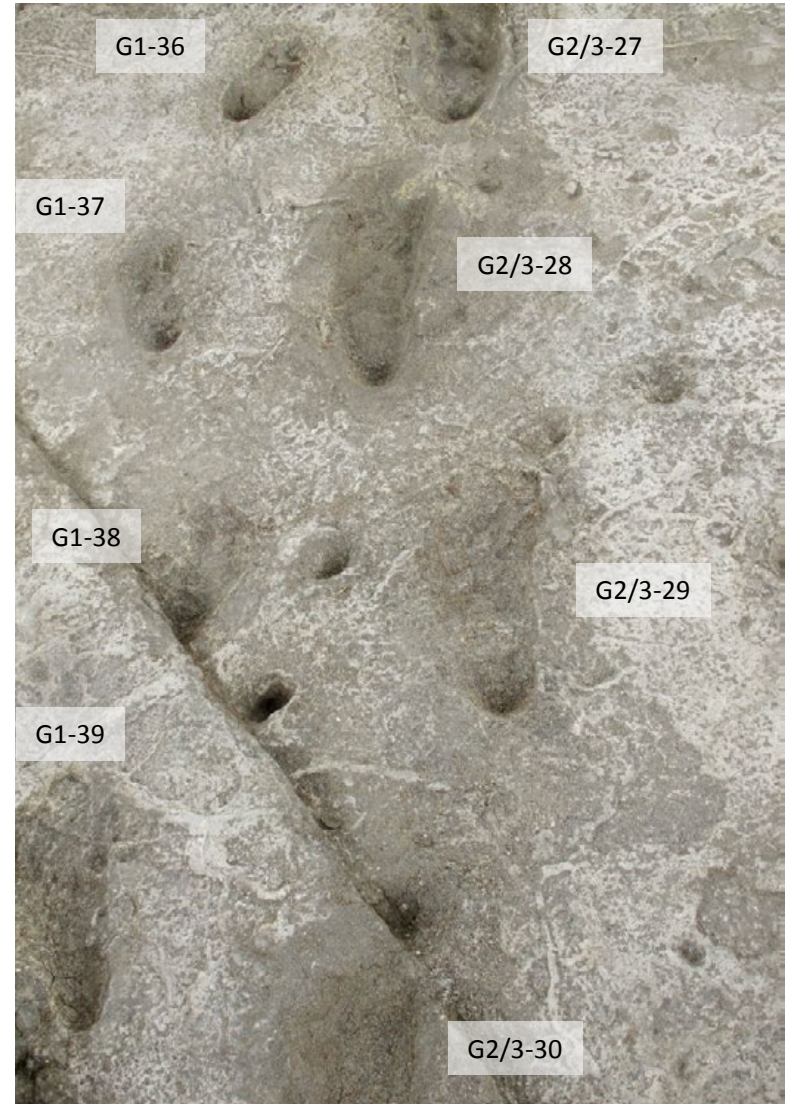
Footprints: Eight hominid footprints were re-excavated. Four prints (G1-37, G1-38, G2/3-28 and G2/3-29) were judged to exhibit minor alteration and thus to be in good condition compared to their condition in 1995. The principal condition was embedding. Four prints (G1-36, G1-39, G2/3-27 and G2/3-30) showed moderate alteration and thus to be in fair condition compared to their condition in 1995. Conditions were principally related to increased cracking of the tuff and penetration of hair roots.

Hominid prints as re-excavated in 1995 (left) and February 2011 (right)

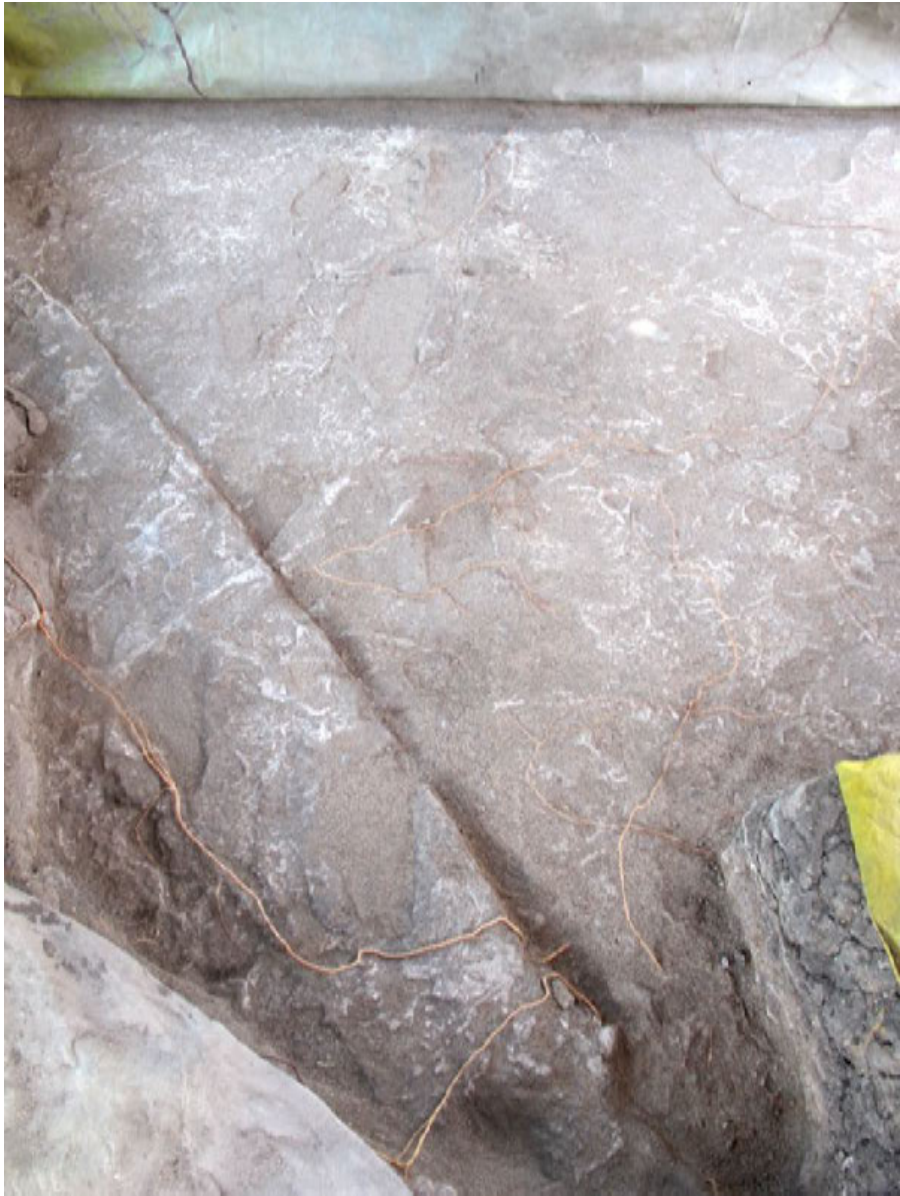
Detached/loose tuff: A small piece of tuff on the edge of Fault 1 was detached from root penetration.

Trackway before final cleaning of tuff surface and with fill still in prints. Roots growing in Layer 1 are visible on the surface and penetrating tuff at the edge of Fault 1.

Roots intruding in the burial were cut; the tree stump at the SE corner of the reburial mound was treated with Baphosate 480SL (chemically glyphosate isopropyl ammonium salt) provided by Dr Joel Bujulu. Our information is that this is the equivalent of 'Round-Up' (sodium glyphosate) used to kill trees previously. Antiquities staff will return to the site to treat all trees within a 35m buffer zone around the reburial mound and then 4 months later for re-treatment as necessary and followed by annual inspections and treatment as needed. Antiquities staff was also requested to undertake all necessary repairs to the site stabilization and drainage interventions.

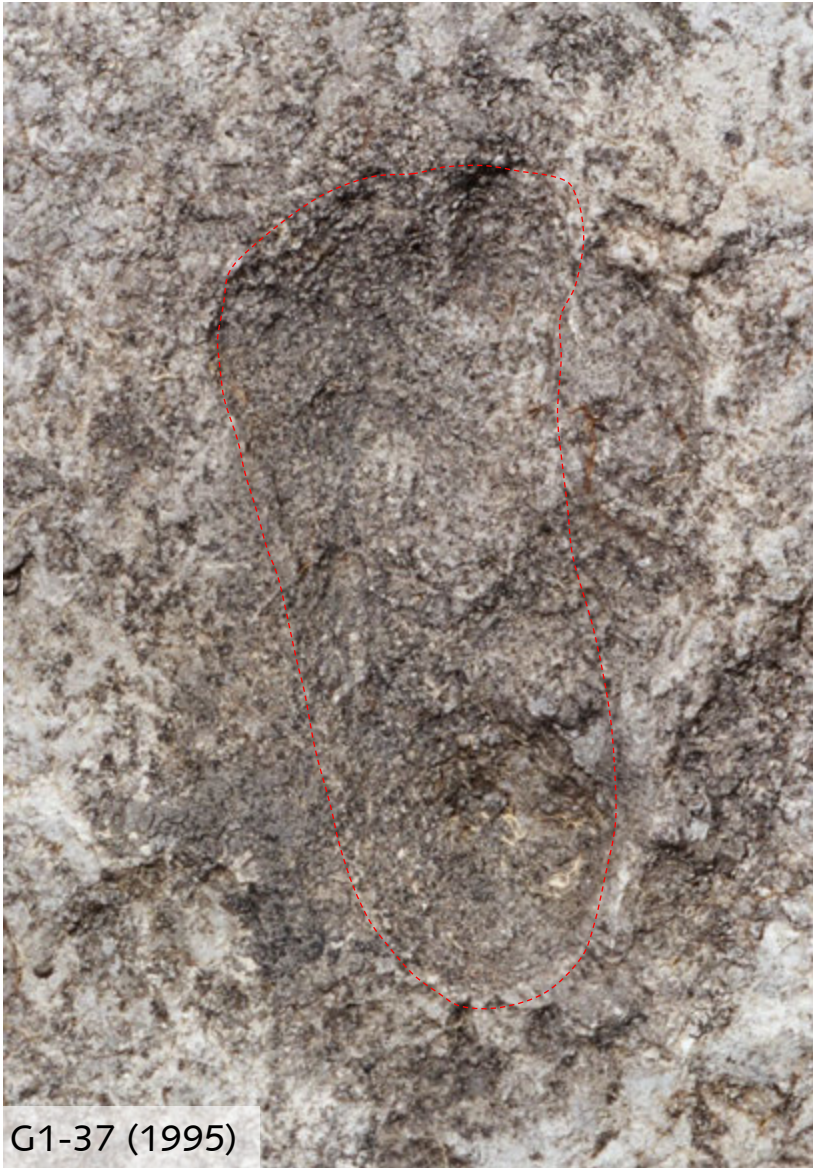
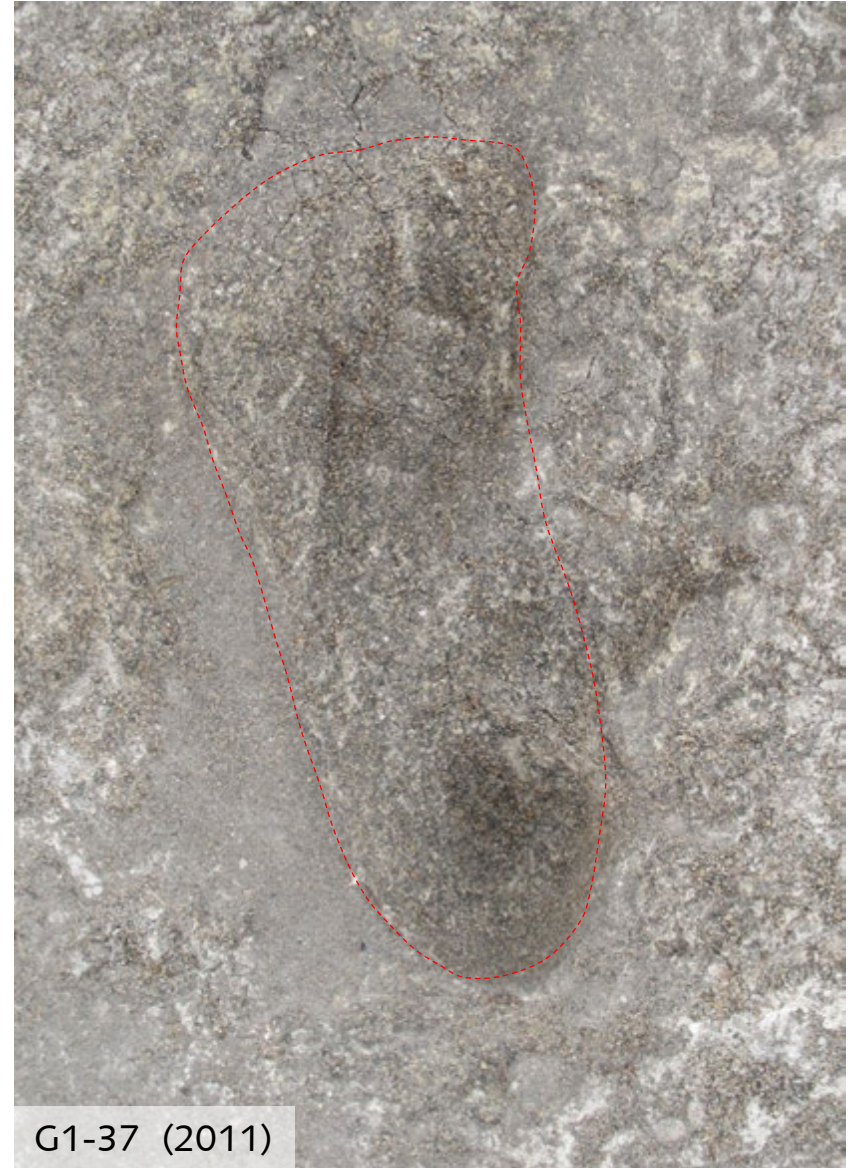
[Print was not cleaned to the same level as in 1995]

Comparative photos of G1-37 in 1995 and 2011. Morphology of print is difficult to discern in photos; dashed outline is drawn for clarification, but is only an approximation.

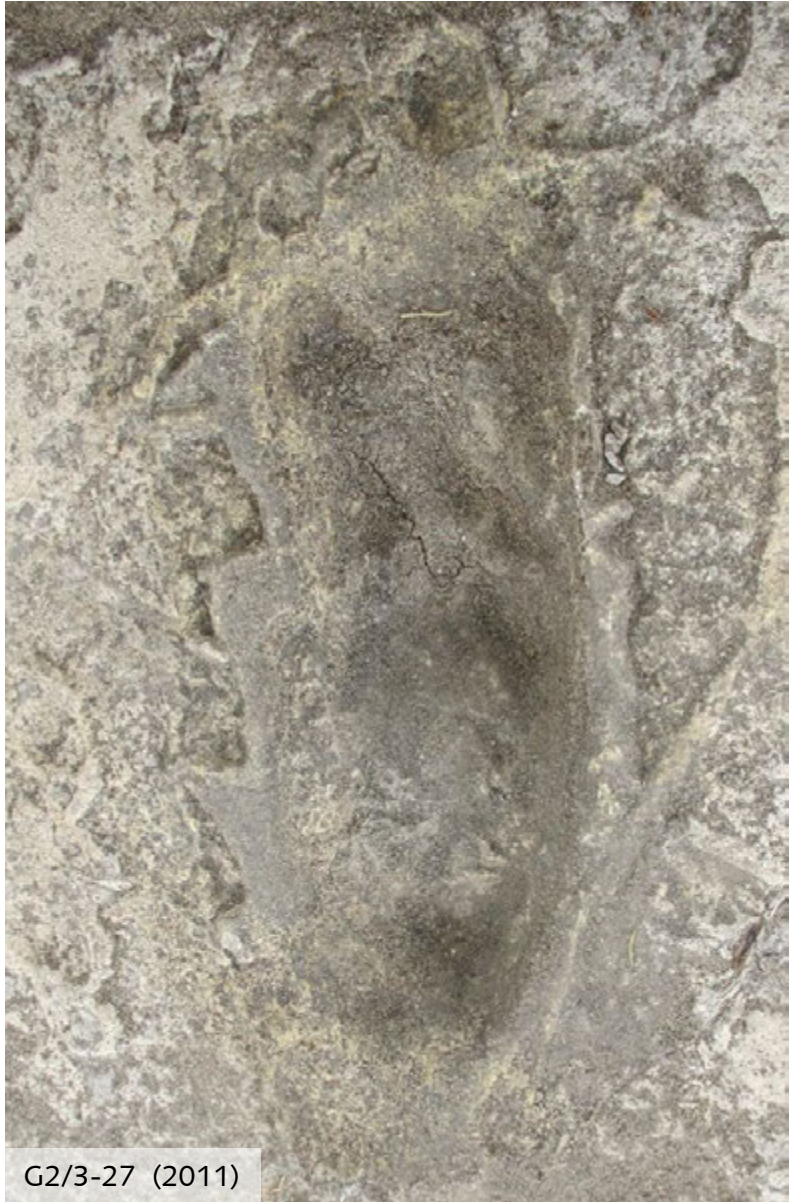
G2/3-27 (2011)

Mechanical damage: The 2011 re-excavation resulted in mechanical damage from excavation to the fossil termite burrow on print G2/3-27.

Comparative photos of G2/3-27 in 1995 and 2011

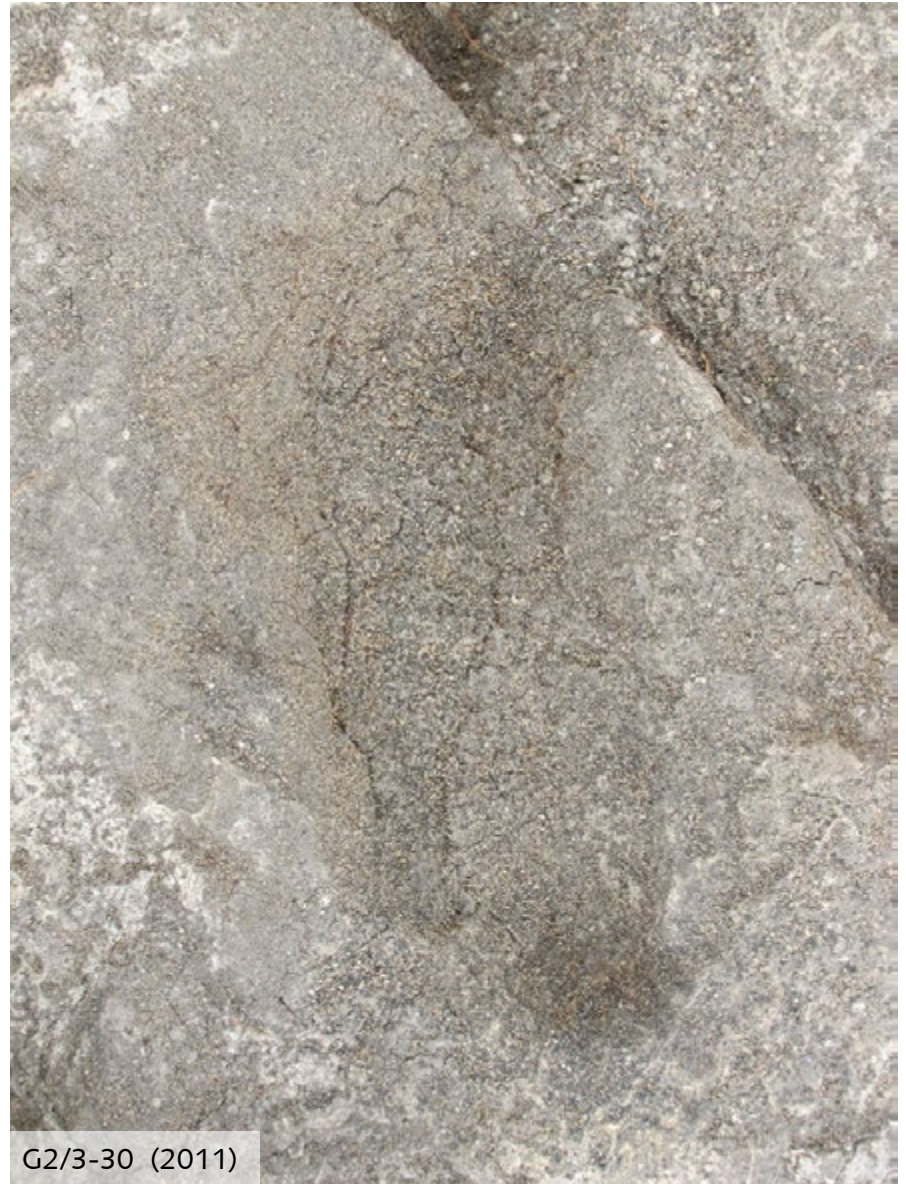
The 1979 overburden and tuff in this area was very damp when excavated in 1995. [\[Print was not cleaned to the same level as in 1995\]](#)

Comparative photos of G2/3-30 in 1995 and 2011

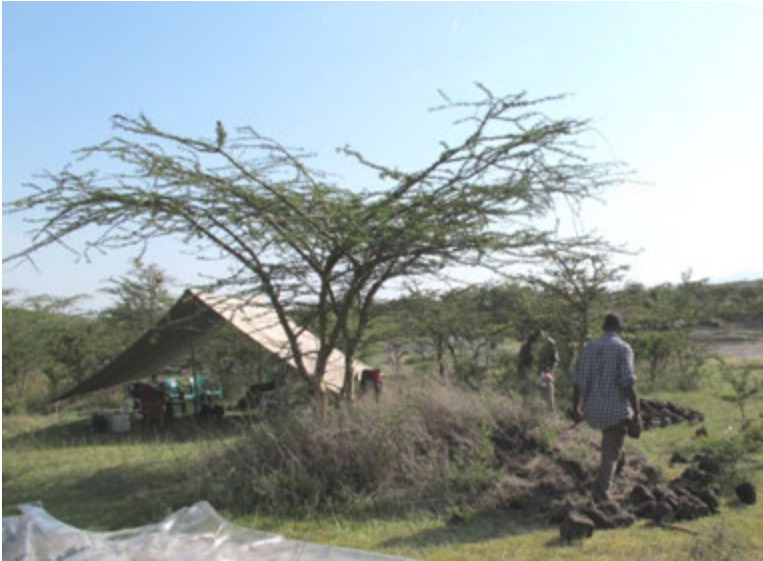
The buried monitoring trench as it appeared before re-excitation in 2011. The *Acacia seyal* had grown far larger than the other *Acacia drepanolobium* around the trench.

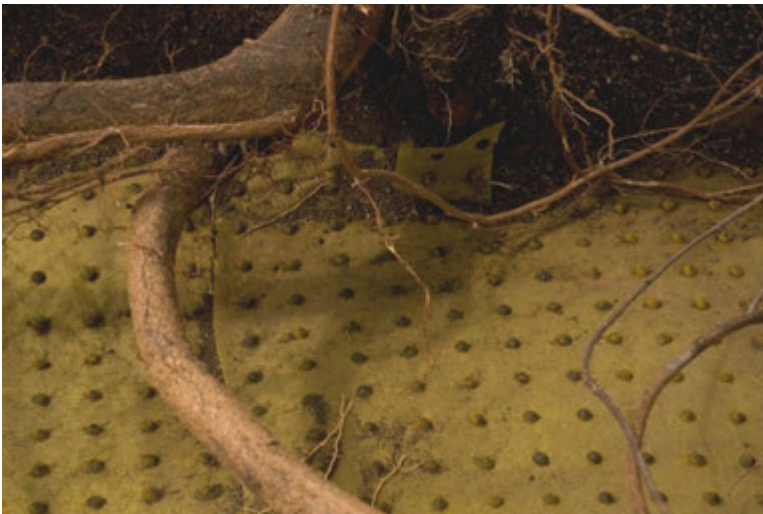
Roots of the *Acacia seyal* are seen growing and spreading just above the Biobarrier, avoiding contact with it.

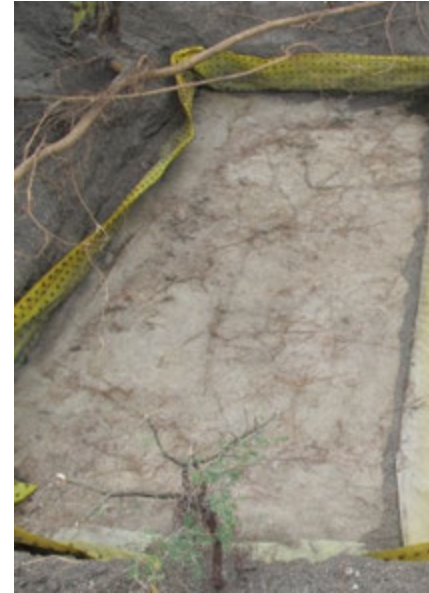
As in the trackway reburial, roots are entering the trench laterally through gaps and tend to follow the surface of the geotextile, as seen here.

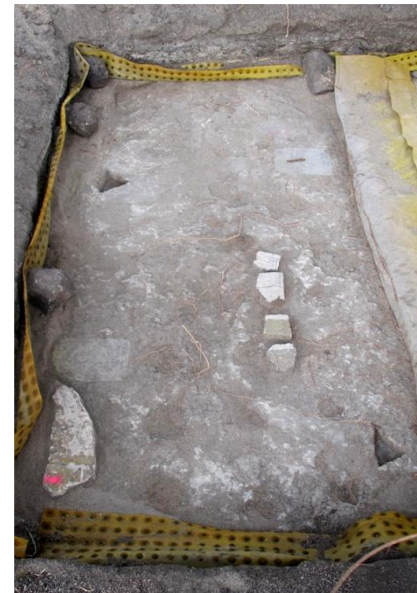
Quadrants 1 and 2 of the trench after removal of geotextile and Layer 1.
