Valley of the Queens Assessment Report

Volume 2

Assessment of 18th, 19th, and 20th Dynasty Tombs

A collaborative project of the Getty Conservation Institute
and the Supreme Council of Antiquities, Egypt

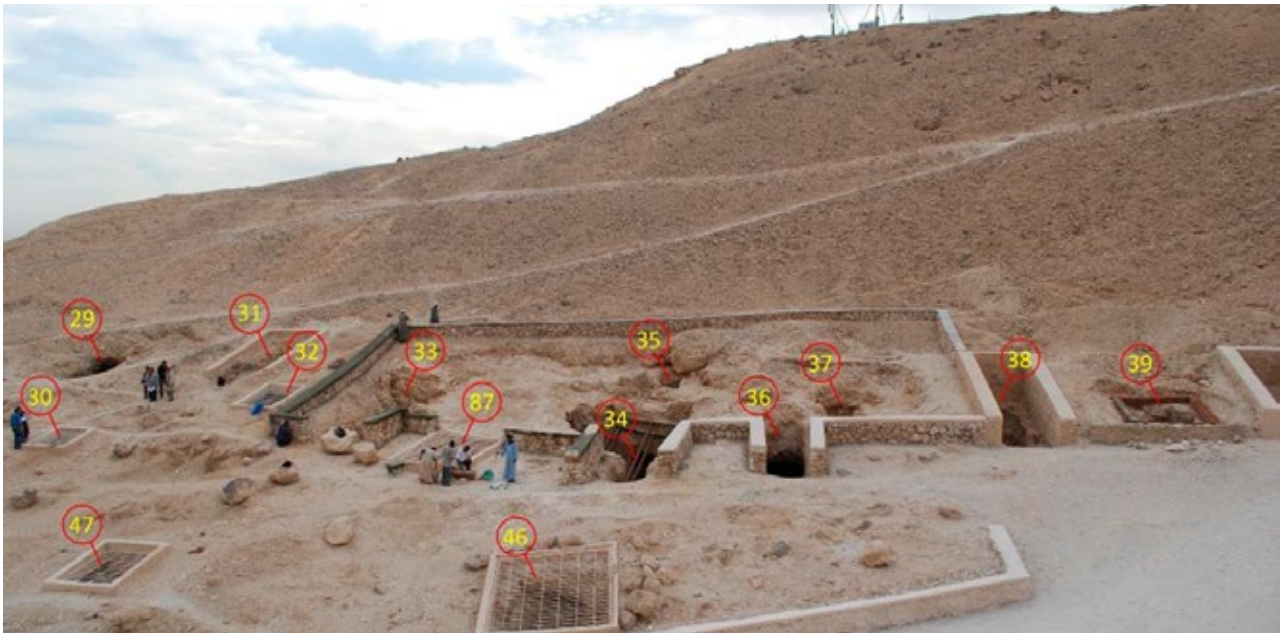
View of 18th - 19th-20th Dynasty tombs on the south side of the side wadi in area of weak rock and collapse.

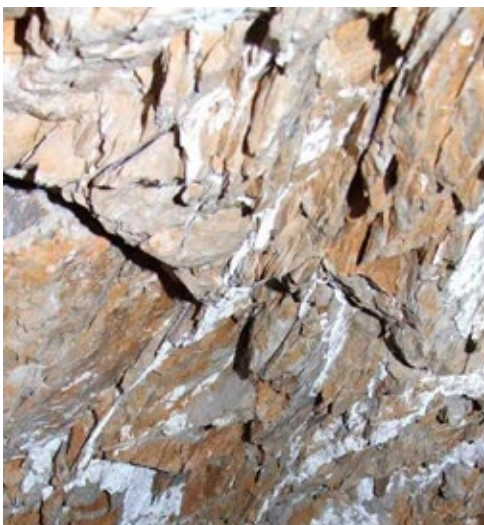
Fissile, rust-brown shale with salt infill, detail from QV 47.

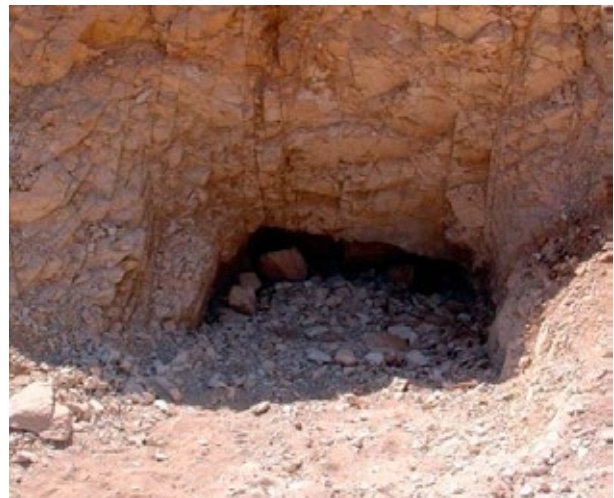
View of entrance in 2007, prior to SCA reburial.

As QV 2 is already largely filled, it is recommended to rebury the tomb, so as to better protect it from water infiltration and debris fill. In 2009, the SCA filled remainder of the tomb with scree.

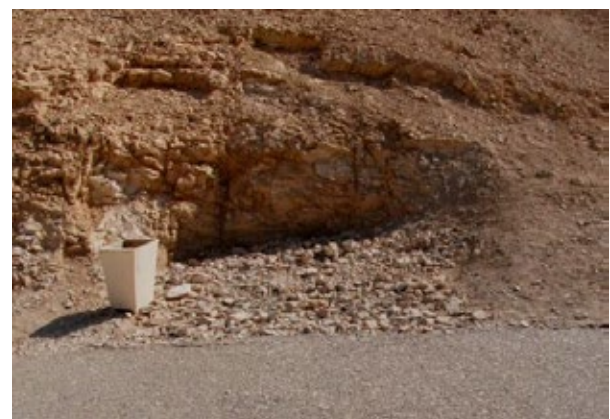
The tomb following reburial with scree by SCA in 2009.

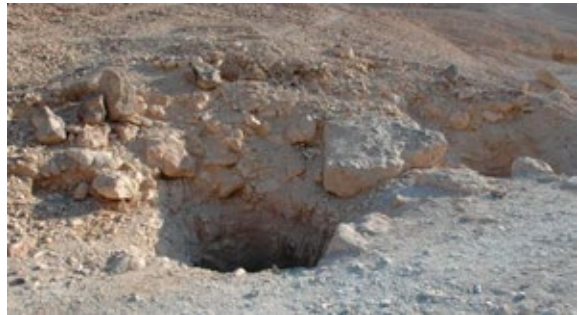
Entrance to QV 3 prior to installation of masonry surround by SCA.

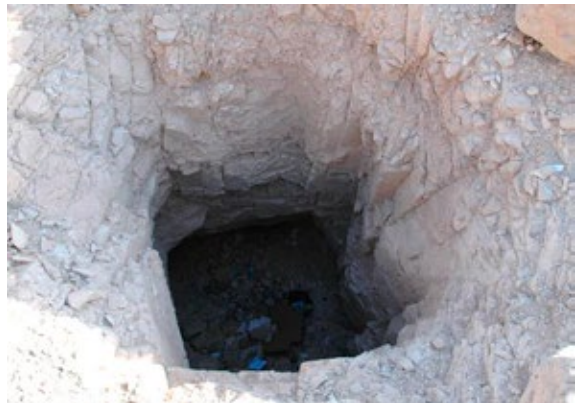
QV 3 shaft with trash accumulation at bottom.

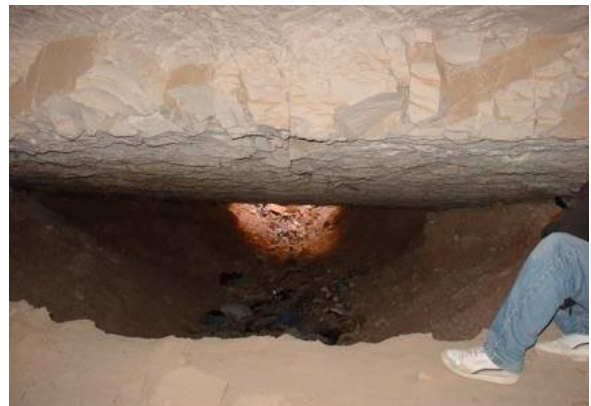
View of the marl slab above shale in first chamber, seen from connection with QV 81.

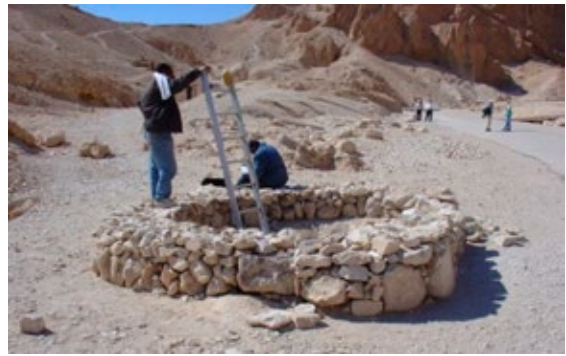
Low rubble wall surrounds shaft entrance during initial assessment (2007).

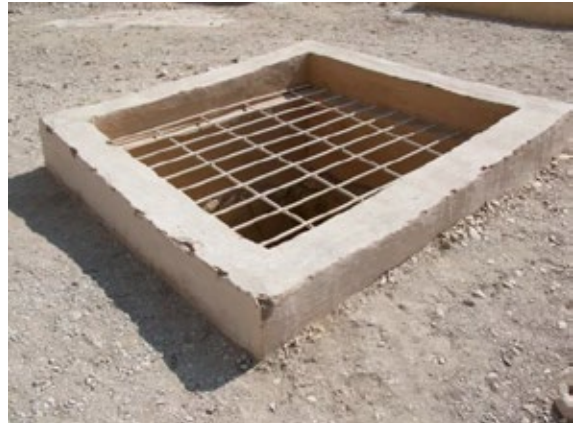
As of Dec. 2009, the SCA had installed a masonry surround with a metal grate.

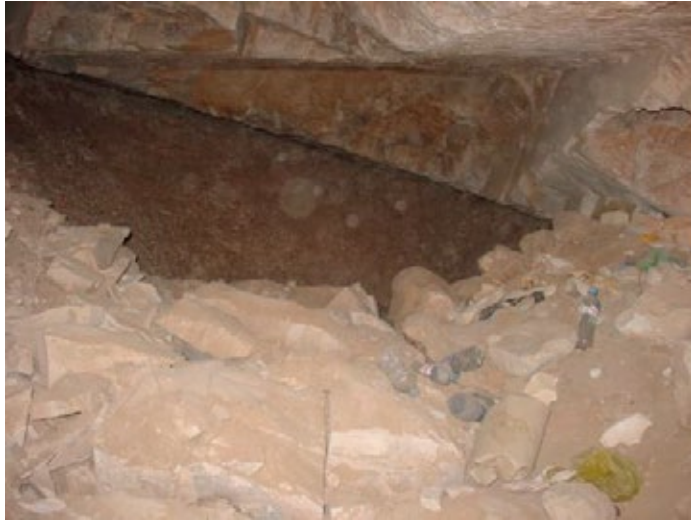
Adjacent beds of shale (bottom) and marl (top) clearly distinguished by their color and characteristics.

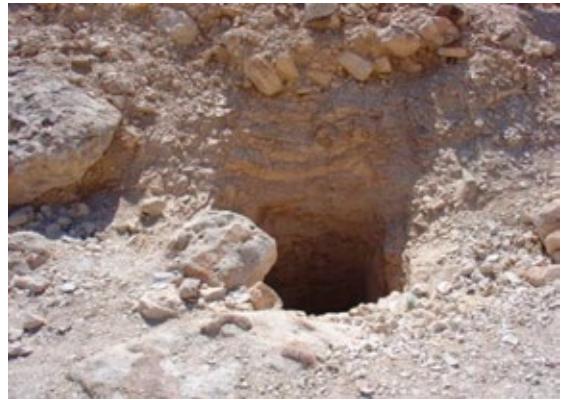
The marl rock of both tomb shafts is friable, with loose rock perched precariously near the entrances. Because both tombs are largely filled with debris, their chambers were inaccessible for assessment.

QV 5 entrance before installation of surround.

It is recommended that both tombs be reburied to protect them from flooding and to ensure visitor safety.

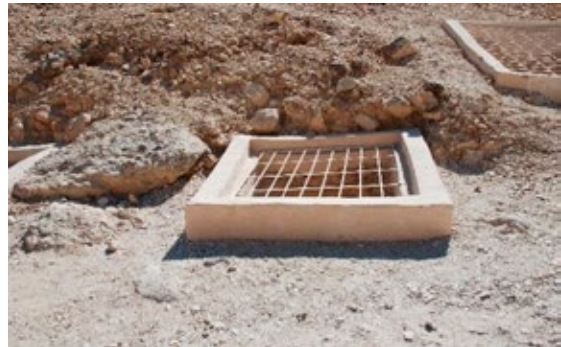
QV 5 shaft entrance with surround in 2009.

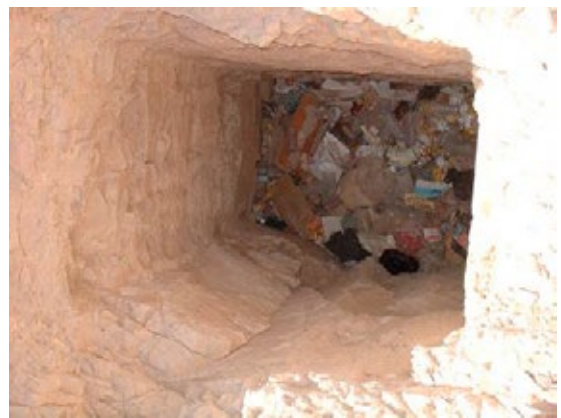
QV 5 shaft partially filled by debris and trash, seen from above.

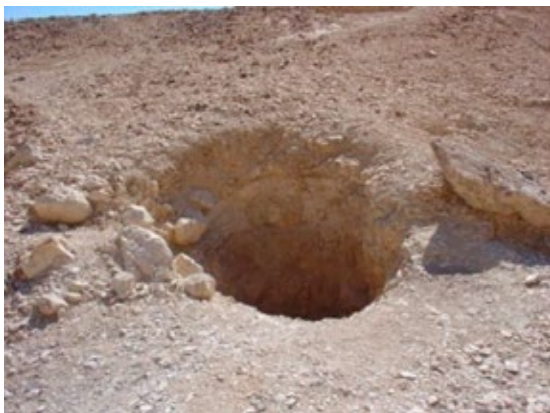
QV 6 shaft entrance before installation of surround.

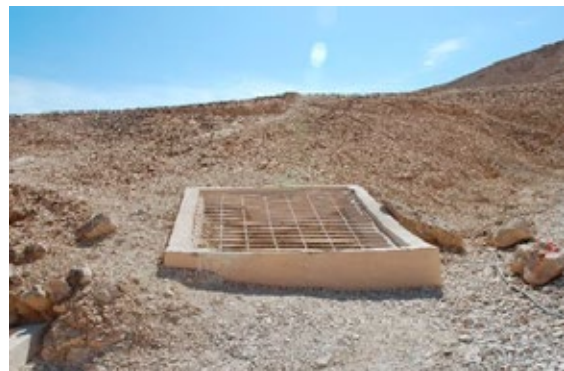
QV 6 shaft entrance with surround installed in 2009.

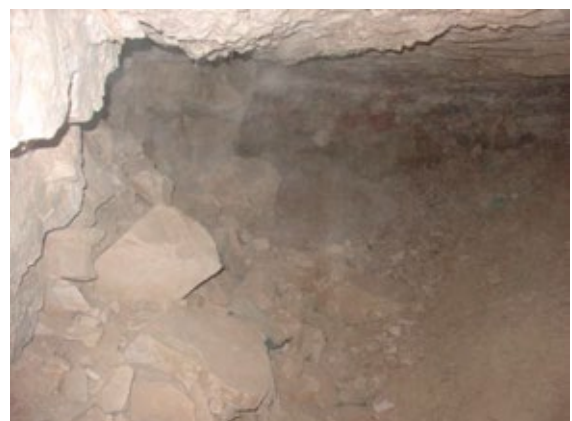
Chamber (B) consists of a marl slab ceiling with walls generally comprised of shale. The tomb shaft appears stable. The marl ceiling of chamber (B) is extensively fractured, though following assessment, it has been judged to be stable. Silt was observed on the walls of shaft (A) and thick cracked, dried mud on the floor and ceiling of chamber (B), indicating past water infiltration, presumably during the 1994 flood. Trash had accumulated at base of shaft, removed in 2007 and 2008.

View of main chamber (B) with rock collapse on left.

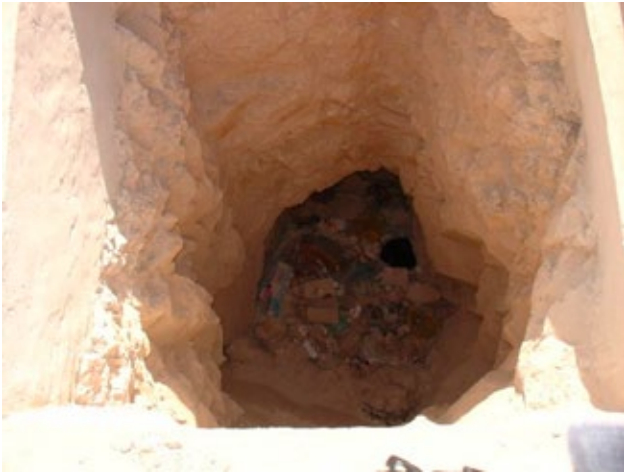
Water infiltration has likely impacted the stability of the tomb, particularly affecting the fragile shale into which the tomb is principally excavated. Flooding continues to be a serious threat due to the location of the tomb's unprotected shaft next to the main drainage channel.

View of shaft from above.

It is recommended that a shaft cover be installed to prevent entry of water, debris, and animals, as well as to ensure visitor safety.

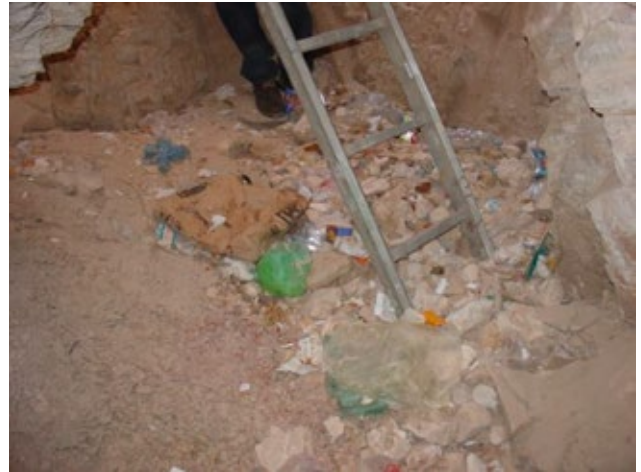
Trash and debris accumulated at base of shaft (removed in 2007).

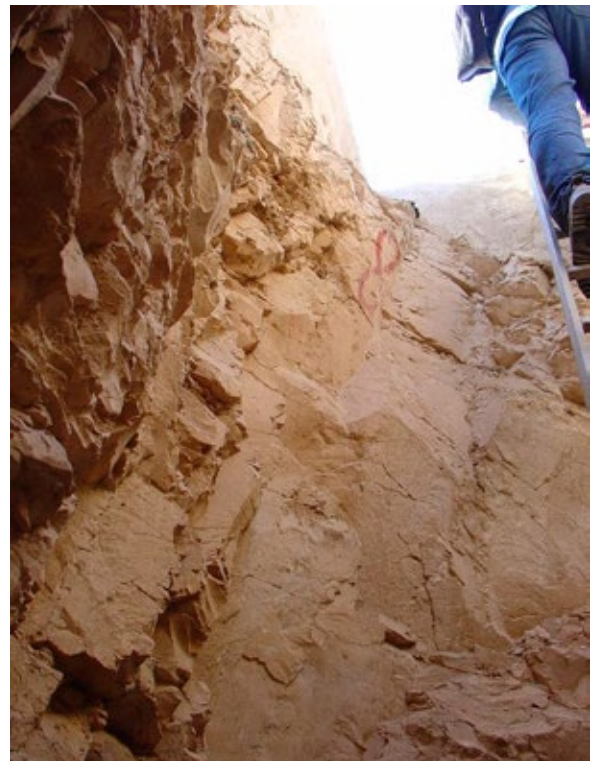
Roughly cut shaft of good quality marl.

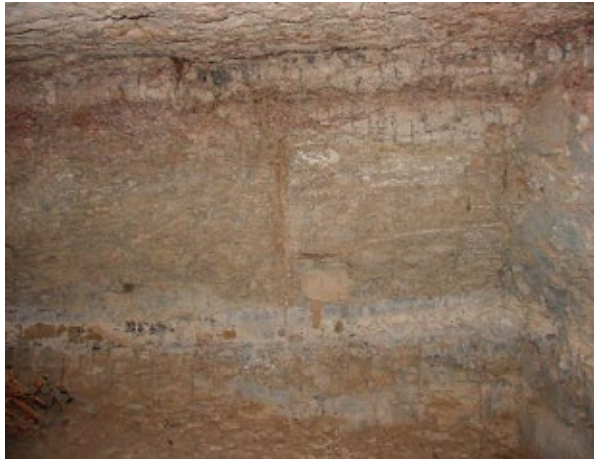
Detail of banded marl and shale in rear wall of tomb chamber, also seen in QV 9.

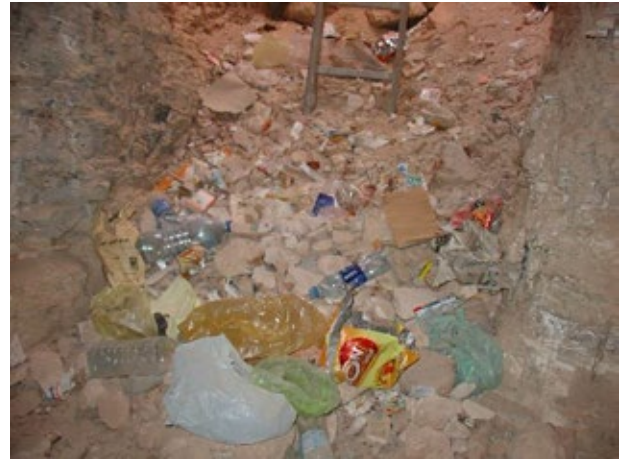
Accumulation of trash at bottom of shaft.

It is recommended that a shaft cover be installed to prevent entry of water, debris, and animals, as well as to ensure visitor safety.

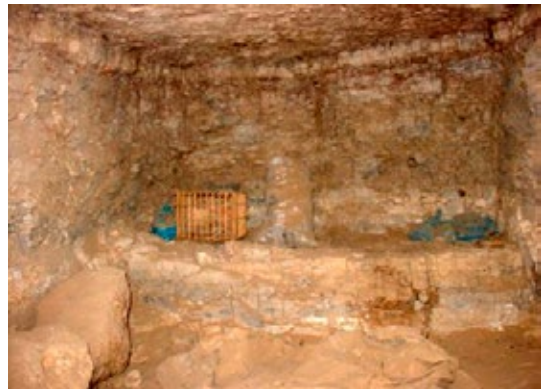
Rear of QV 9 with rock-cut bench and inter-bedded marl and shale; study material in situ prior to removal by SCA and CNRS.

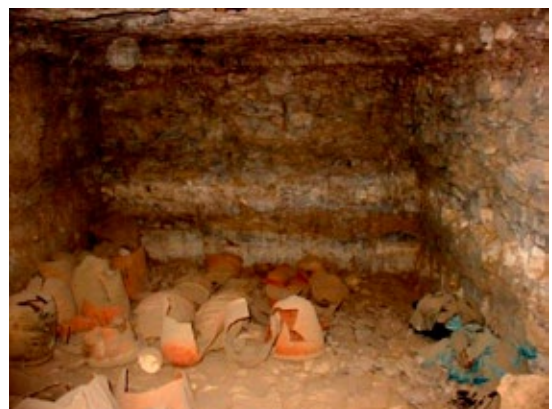
QV 10 chamber with inter-bedded marl and shale; study material in situ prior to removal by SCA and CNRS.

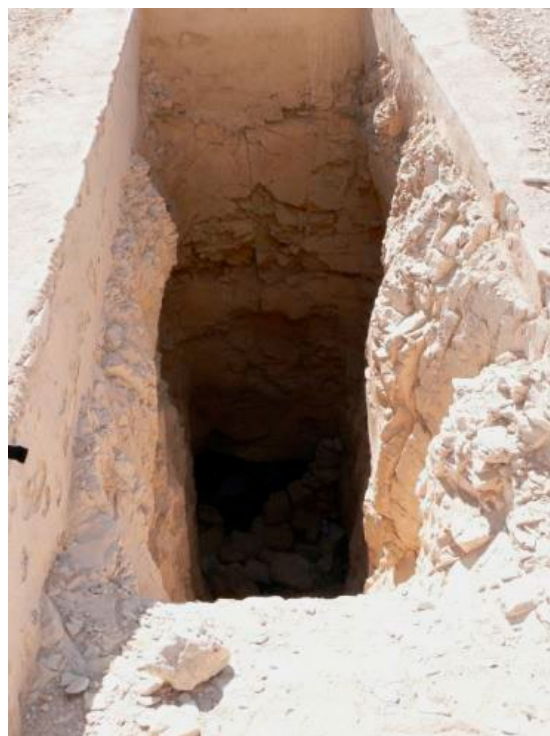
Tomb entrance with ramp and partial surround.

It is recommended that a secure surround be built and door installed at the entrance to the chamber to prevent entry of floodwater, debris, and animals. A sill wall at the top of the ramp and increasing the height of the surround would serve to further protect the tomb.

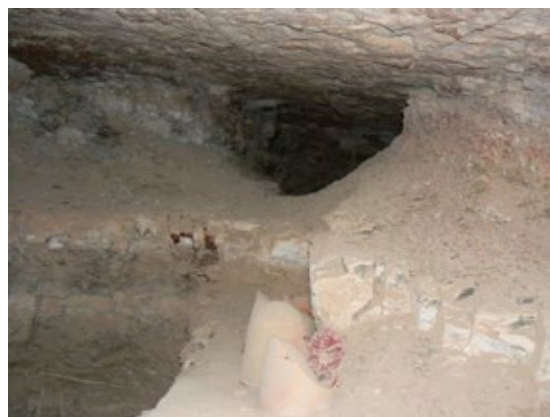
Passage into QV 12 as seen from Chamber B with west pit in foreground; a wall of friable shale to the right.

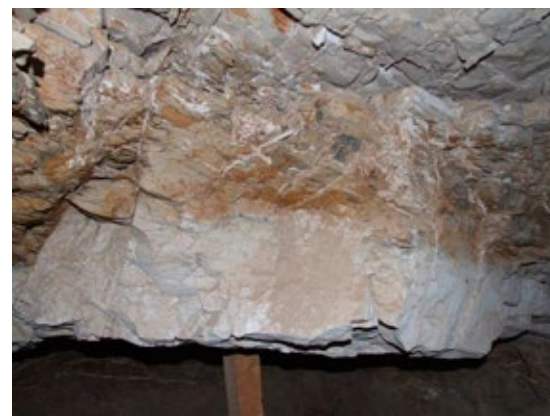
Rock overhang in south with shoring below.

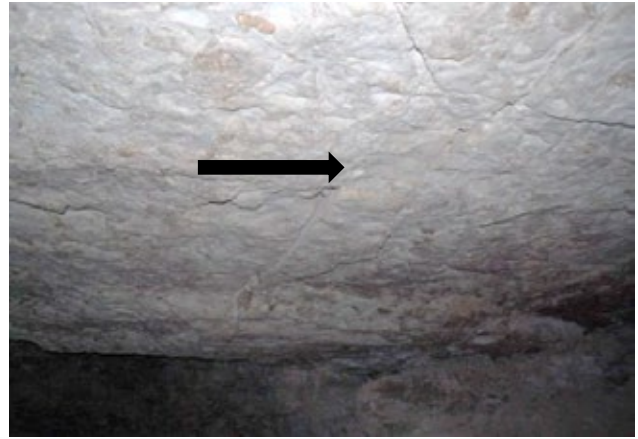
Excavated into the clay-rich shale of the south side of the wadi, QV 11 has large transecting ceiling fractures running the length and width of the tomb. Upon geotechnical assessment by Hamza Associates, it was recommended that the most prominent of these ceiling fractures should be monitored for future movement. The two pits are cut into poor quality, rust-colored shale with prominent salt veins. An overhang of rock has been shored with a wooden member in the south pit. Both pits have areas of fallen rock. Some wasp nests are present on the rock surface.

Ceiling fracture in chamber (B) near arrow.

The ceiling fractures in chamber (B) should be monitored at regular intervals, at least once a year. Interventions must be coordinated with those of QV 12 since the two tombs are connected.

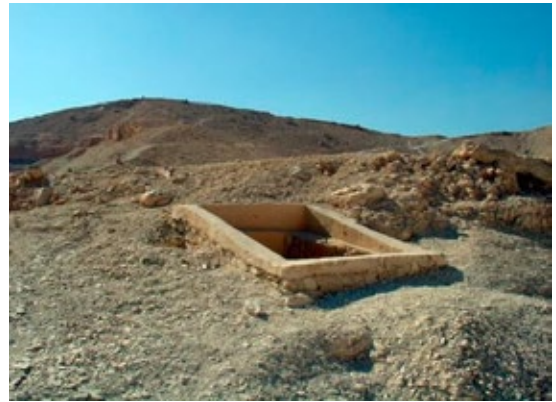
Shaft entrance with masonry surround.

It is recommended that a shaft cover be installed to prevent entry of rain, floodwater, debris and animals.

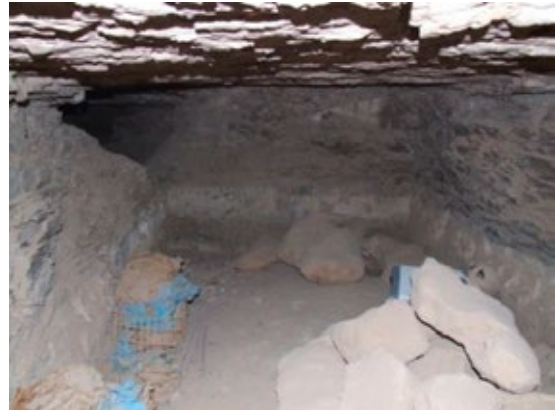
Like its adjoining neighbor, QV 12 is cut into intercalated beds of differing quality rock: orange-brown shale, grey clay-rich marl, and white marl. Much of the rock is loose or detaches easily. Some areas of rock show signs of blackening. Nevertheless, following the assessment of this tomb, it appears to be in generally stable condition. A layer of fine silt over the floor of the tomb suggests flooding from the 1994 rains. Some wasp nests are also present on the rock surface.

Overview of chamber (B) with bands of different rock types.

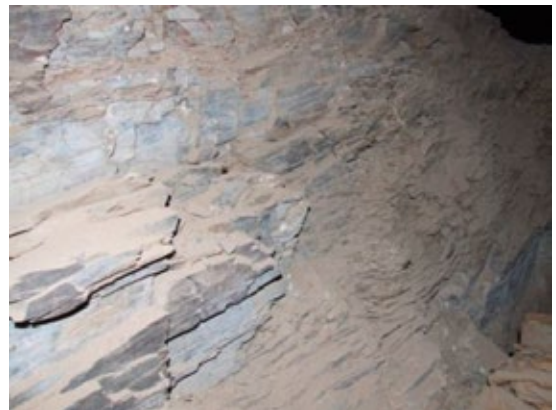
Detail of rock on west wall of tomb, with some surface blackening.

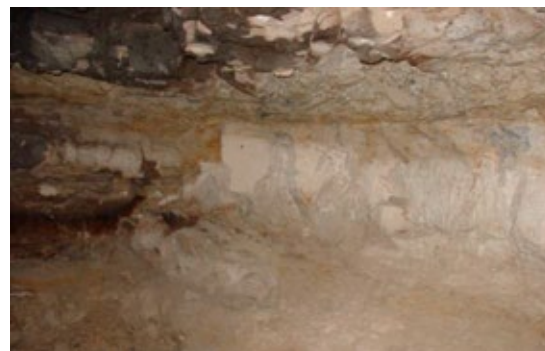
Chambers (C) and (E) consist of inter-bedded shale and marl, with marl ceilings. The rock of the entire tomb is highly fractured. The tomb generally appears stable, with no signs of fallen rock, although the upper area of the passage between chambers (C) and (E) appears in particularly poor condition. Following a geotechnical assessment by Hamza Assoc. in December 2009, the tomb was deemed to be in stable condition. The ceilings of chambers (C) and (E) are blackened. Bird and wasp nests were observed in the tomb.

Overview of chamber (E) showing fractured and blackened rock.

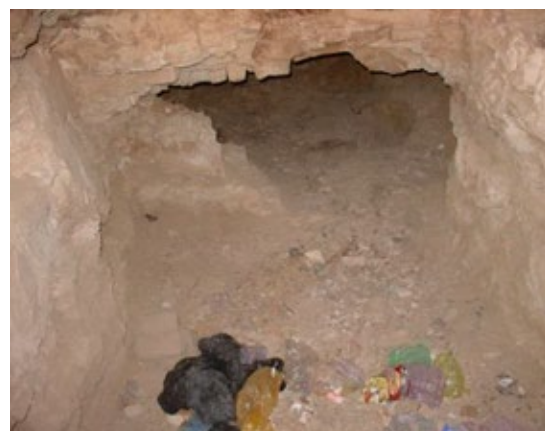
Chamber (C) looking toward chamber (E) with fractured doorway (D) between.

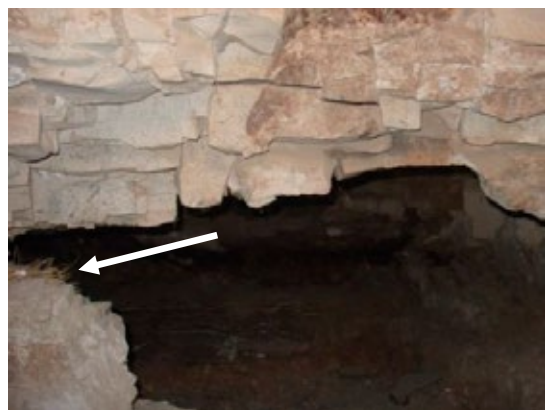
Detail of passage (D) and active bird nest with eggs (arrow).

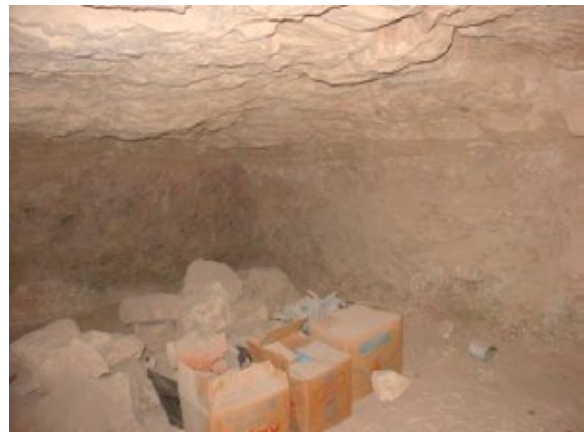
The tomb is excavated from extensively fractured rock, although it generally appears stable. The shaft and ceiling of the main chamber are composed of marl, and all the rock of the main chamber below the ceiling is shale, slightly orange in color.

View of main chamber with boxes of study materials. Note marl rock of ceiling and shale below.

Installation of a shaft cover is recommended to prevent entry of floodwater, debris, and animals.

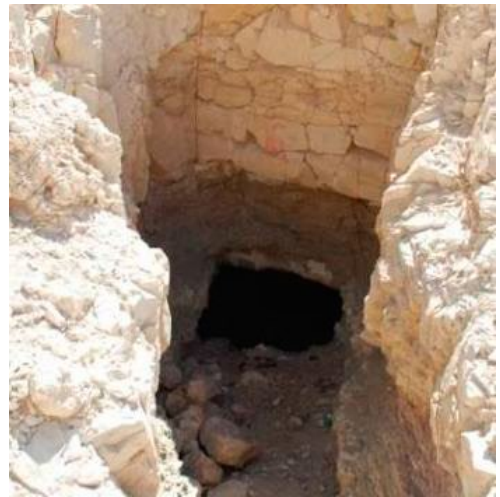
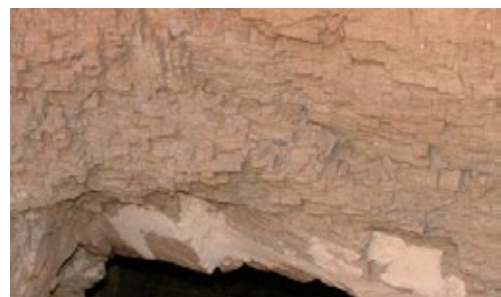
The inherent weakness of the rock and its susceptibility to moisture have led to rock fracturing and localized loss. Blackening of the rock surface was presumably caused by fire.

QV 16 entry shaft showing cream-colored fractured marl above grey shale (above); detail of shale (below).

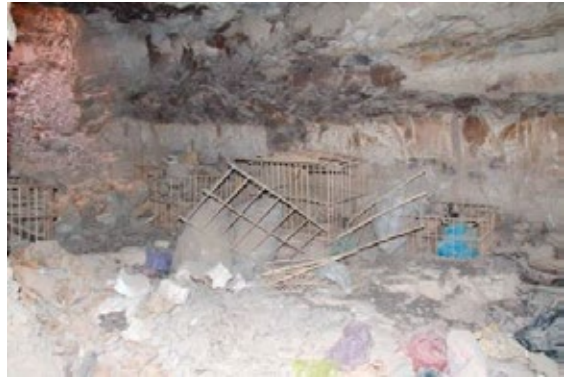
View of QV 15; rock staining visible with localized loss, trash in foreground.

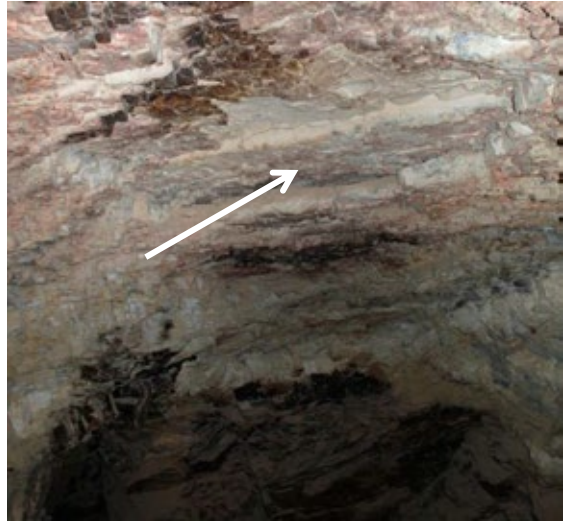
Both tombs were geotechnically assessed in December 2009 by Hamza Associates. QV 16 was found to be stable. Likewise, QV 15 is generally stable, though there is a delaminated shelf in the ceiling of chamber (C) that should be regularly monitored. Since the tombs have long been home to colonies of bats and it is a goal of the project to leave some already inhabited tombs open to bats, which are important for the local ecology, it is recommended that QV 15 have a shaft cover that allows bat access, while the entrance to QV 16 be plugged. If the bats are to remain only in QV 15, a barricade wall must also be built to separate the two tombs.

Delaminated shelf (arrow) in the ceiling of QV 15 chamber (C).

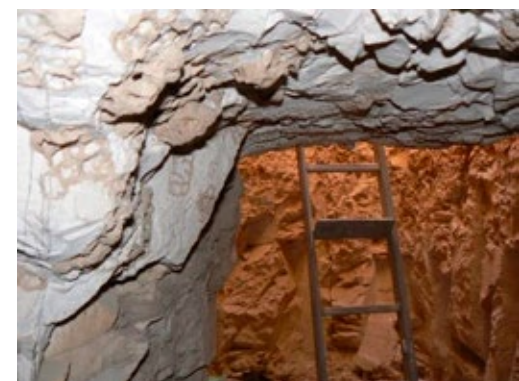
Shaft with ladder and remnants of wasps nests in foreground.

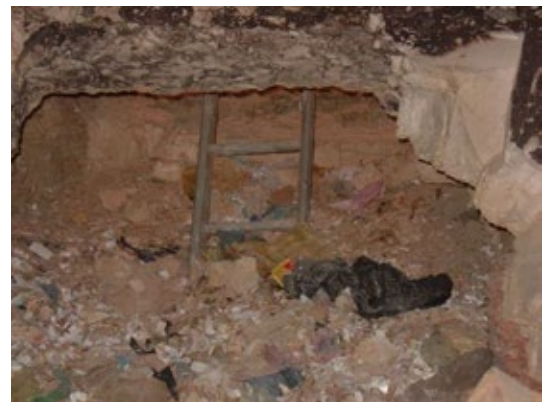
Debris and trash have accumulated at bottom of shaft.

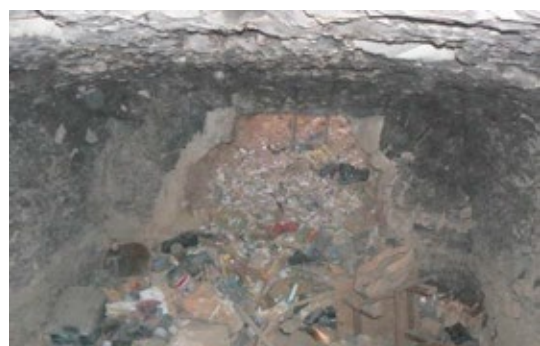
The tomb is generally stable, though the rock surface in the chamber is extensively blackened, which hindered identification of the rock type and condition. It appears that most of the tomb is composed of marl, although there is shale at the bottom of the east and south parts of the chamber. The ceiling of the chamber is extensively fractured.

Chamber interior with blackened surface and trash on floor.

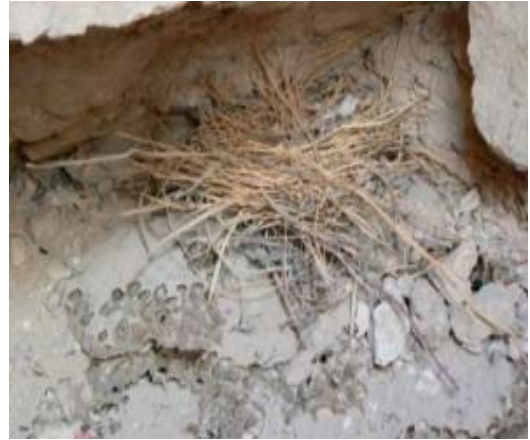
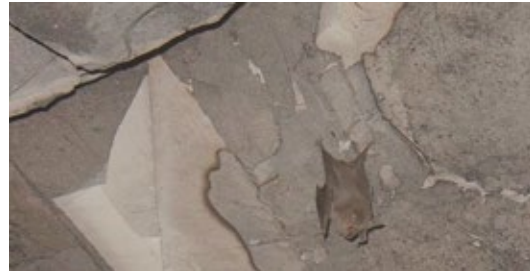
At least one bat was recorded by the assessment team and accumulated droppings on the floor are evidence of long-term habitation. A bird's nest was also noted in the shaft and an old wasp nest in the main chamber. Trash littered the floor of the shaft and entry to the main chamber, removed in 2007.

Bird nest in shaft (above) and bat roosting (below).

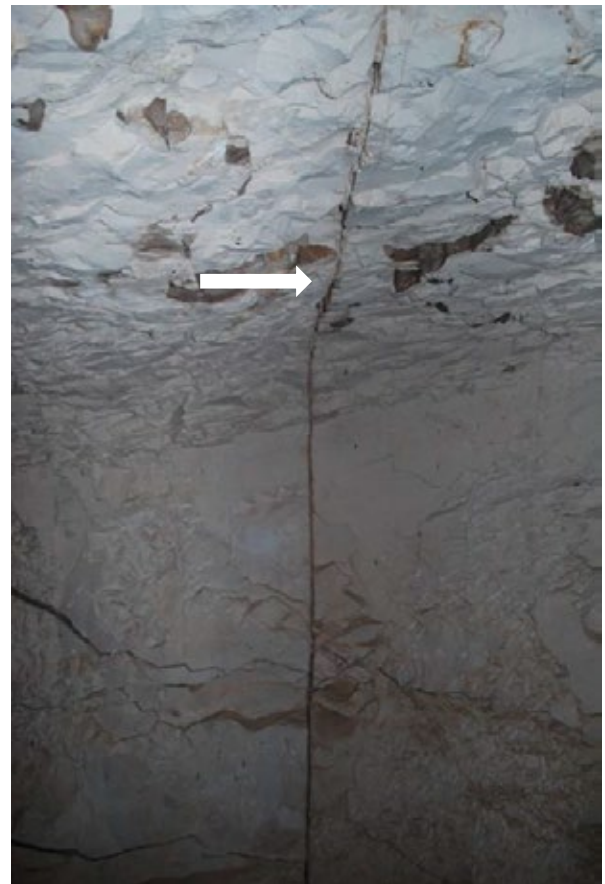
The entire tomb is cut into relatively good quality marl, and appears generally stable. However, there is significant fissuring through the chamber both along its length and width, with substantial separation of rock at the upper rear wall of the chamber and within the shaft. One prominent fissure occurs midway between the entrance and the rear wall, extending continuously through the floor, ceiling, and both walls. This fissure was also noted by the Franco-Egyptian team at the time of their clearing campaign. Since the rear half of QV 19 is immediately above the chamber of QV 20, the tomb was evaluated for signs of slumping and delamination by Hamza Associates. Joint planes throughout the tomb, including this fissure, appear to be a local manifestation of a more extensive movement in the bedrock, and no signs of ceiling slumping in QV 20 are evident.

Fissure (indicated by arrow) extends continuously through the floor, ceiling, and both walls.

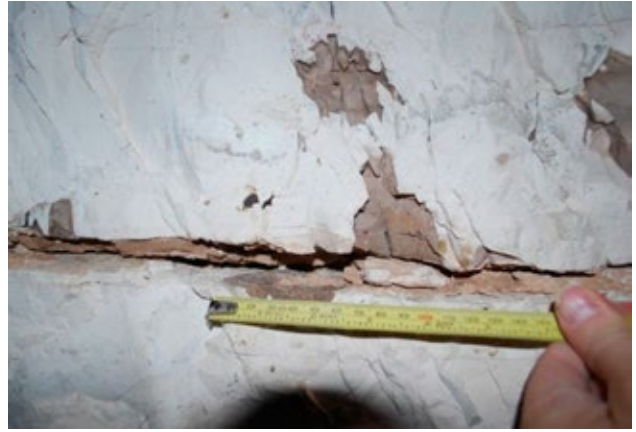
Lateral displacement of chert nodule divided by fissure indicates movement along the fault plane mentioned above.

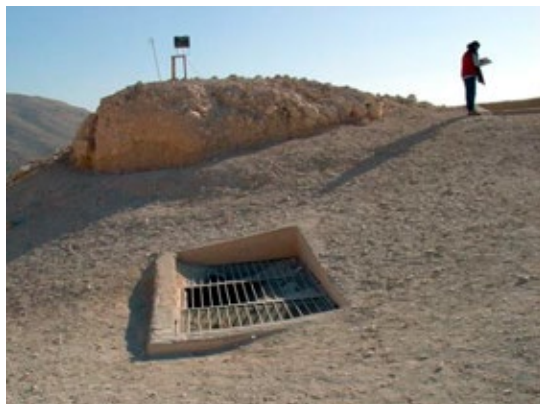
Tomb entrance with masonry surround and metal grill.

Because of the quality of the shaft, the clear hand or foot holds, and its proximity to the visitor path, it is recommended that the shaft surround be left open with a metal grill for visitor viewing from above. The surround will need to be raised to prevent entry of floodwater and debris and bi-annual monitoring will be undertaken to ensure that there is no settlement in the ceiling in the rear portion of the tomb.

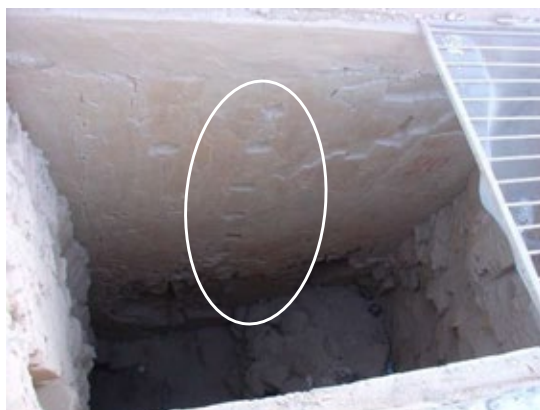
Tomb shaft with cut hand or foot holds, visible within the oval.

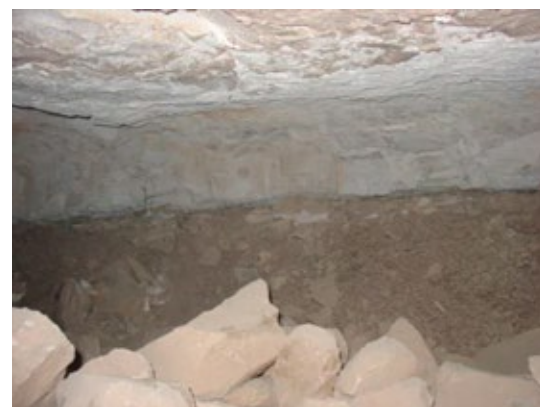
The tomb is cut into rock of varying quality, comprising orange-brown shale and cream-colored marl. The shale is highly fractured and collapsing into large piles. Large blocks of marl have also fallen from the ceiling and interior wall. Localized, but substantial salt efflorescence is present on rock surfaces. Although no direct evidence of flood entry has been found, anecdotal evidence indicates severe flooding and resulting rock collapse, heard from above after water was pumped out following the 1994 flood.

Adjacent beds of marl (top) and shale (bottom).

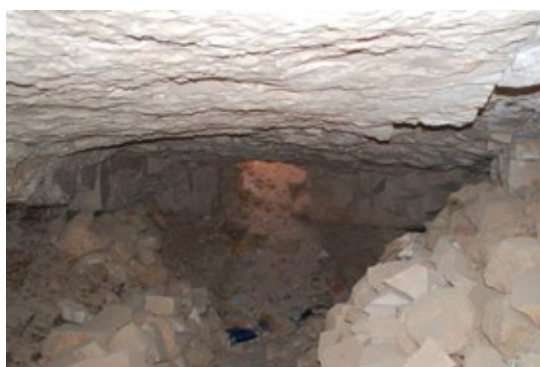
Rock piles associated with collapse of interior walls.

The inherently poor quality of the rock in the tomb and the impact of flood waters are the principal causes for deterioration.

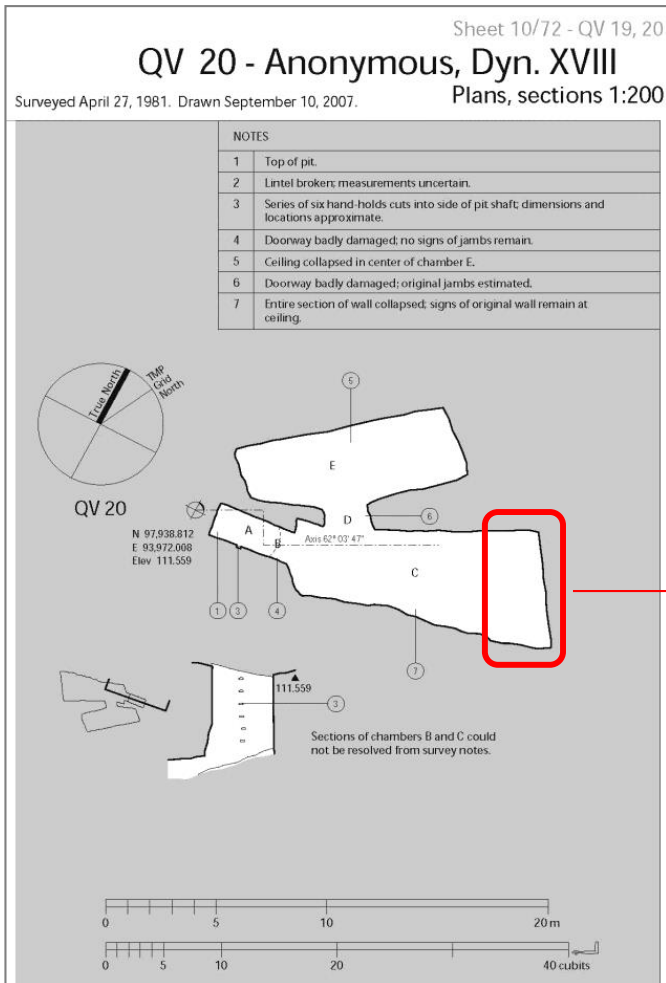
Despite the dramatic deterioration of the rock in the tomb, QV 20 is considered stable according to a geotechnical assessment conducted by Hamza Associates in December 2009, provided that floodwaters no longer enter the tomb. Nevertheless, since QV 19 is located directly above the rear portion of QV 20, a bi-annual inspection to monitor for signs of settlement in the ceiling of QV 20 is recommended.

Approximate area where QV 19 overlaps QV 20

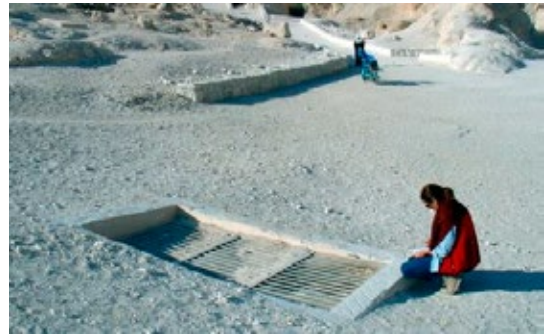
Shaft entrance with masonry surround, metal grill and mesh.

A shaft cover should be installed over the built surround to prevent entry of floodwater, debris and animals.

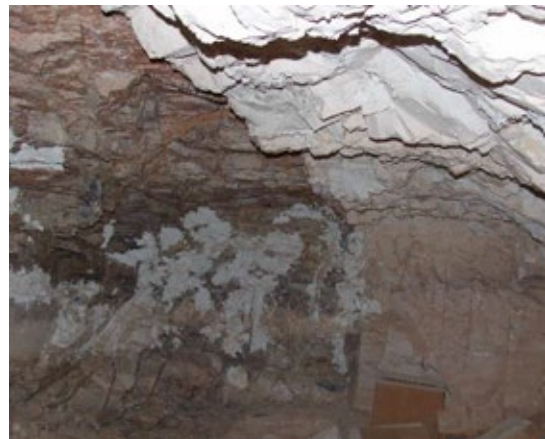
The tomb is cut into an area of intersection of two different types of rock: shale and marl. The horizon between the two rock types runs throughout the tomb, and is relatively vertical in chamber (E). Fracturing and loss of both types of rock are widespread throughout the tomb. A geotechnical assessment was conducted by Hamza Associates in December 2009, and the tomb was deemed to be structurally sound.

Chamber (E) showing relatively vertical interface between two rock types: dark shale on the left (with mortar interventions) and lighter marl on the right.

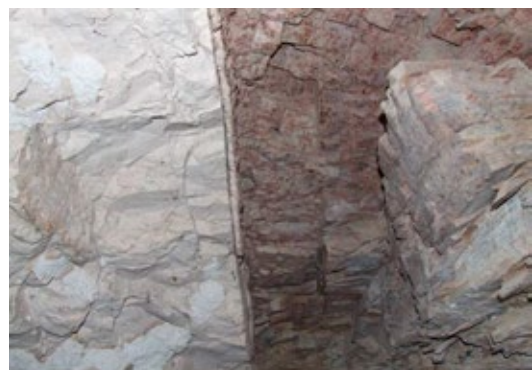
Detail of interface between marl and shale.

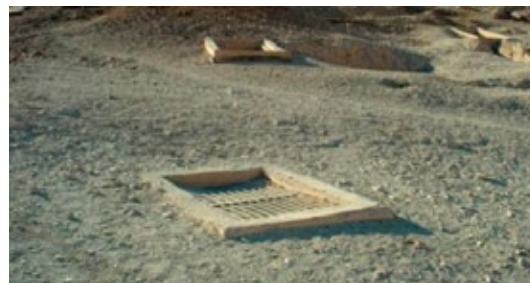
Shaft entrance with surround.

It is recommended to install a shaft cover over the built surround to prevent entry of floodwater, debris, and animals.

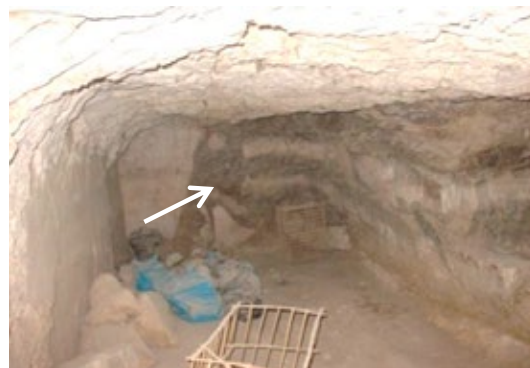
Like its neighbors, QV 22 is cut into an area of intersection between two different qualities of rock. The marl and shale are separated by a clear horizon which runs in a nearly vertical fashion along the length of the main chamber. More specifically, the southern portion of the eastern end of the main chamber as well as the entirety of the side chamber are cut into weak, highly fractured, brown shale. The remainder of the tomb is composed of marl. In some areas where shale is present, there are signs of rock fall and deterioration.

Main chamber with interface (indicated by arrow) between two rock types: dark shale on the right and lighter marl on the left.

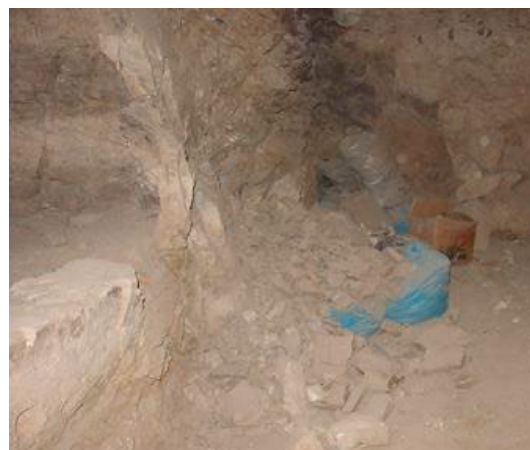
More vulnerable to damage from water infiltration, the shale has deteriorated more rapidly than the marl in this tomb.

Shale deteriorating in main chamber, adjacent to entrance of side chamber.

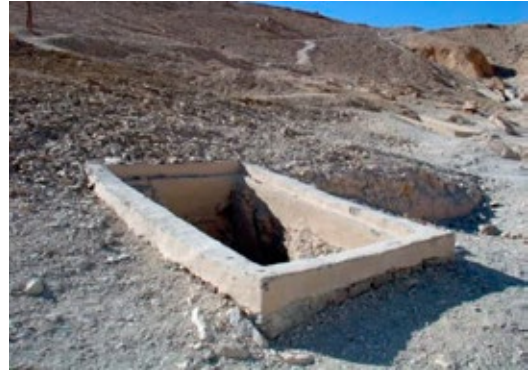
Shaft entrance with masonry surround.

Installation of a shaft cover over the built surround is recommended to prevent entry of floodwater, debris, and animals.

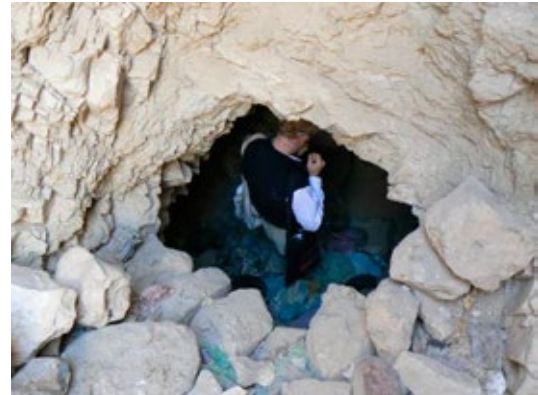
Pile of rubble partially occluding main entrance.

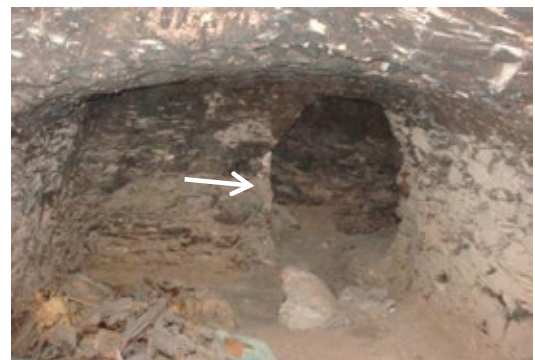
The tomb generally appears stable. It is cut into both marl and shale. The wall and ceiling surfaces in both upper chambers are blackened. Although this blackening made it difficult to assess the nature of the rock, it appears that the lower part of the main chamber is cut into shale, with the upper part appearing to be marl. Most of rock in the main chamber is fractured.

Main chamber, with entrance to smaller side chamber at its rear (arrow); black patina on chamber walls and ceiling.

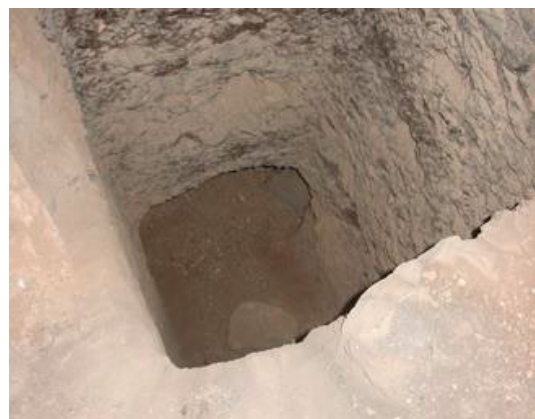
Interior shaft in side chamber, leading to lower chamber where bats were heard roosting.

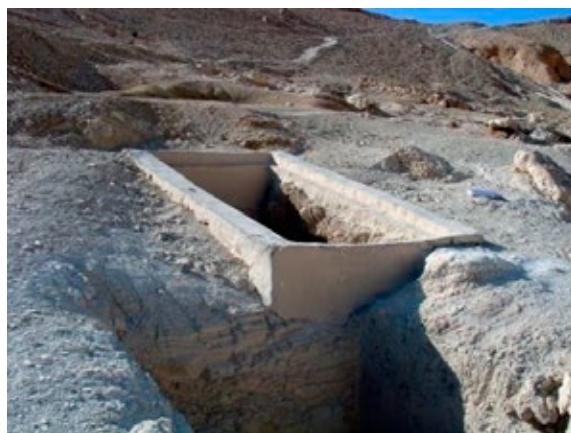
Shaft entrance of QV 25 with masonry surround and unfinished QV 24 in the foreground.

Installation of a shaft cover over the built surround is recommended to prevent entry of floodwater, debris, and animals. The opening to the unfinished QV 24 should be filled.

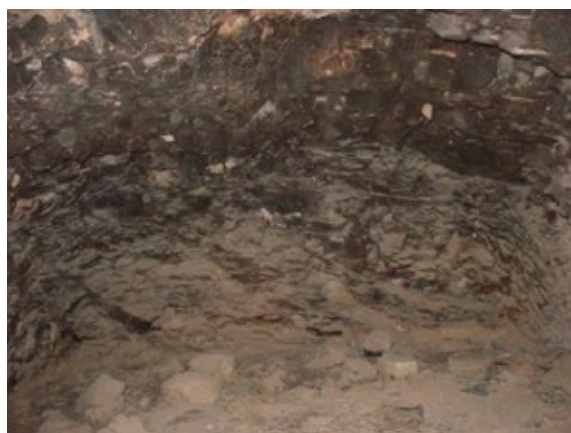
While the blackened rock is extensively fractured and some loss of friable rock is evident, the tomb appears to be stable overall. The floor was littered with trash at the time of assessment and removed in 2007.

Blackened rock with area of friable shale.

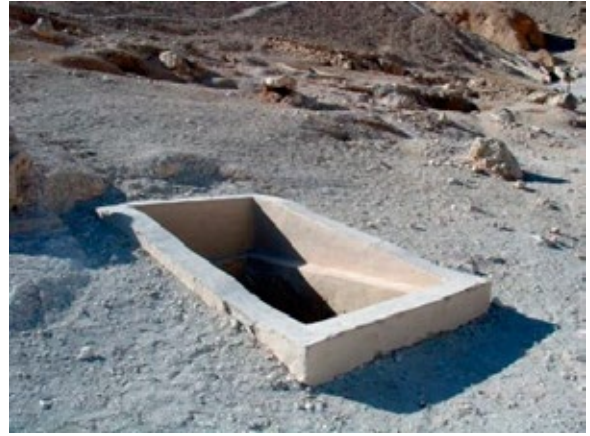
Shaft entrance with constructed surround.

Installation of a shaft cover over the built surround is recommended to prevent entry of floodwater, debris, and animals.

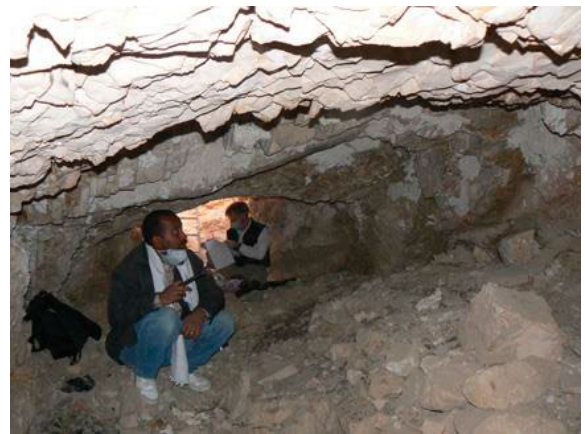
The tomb is primarily cut into fractured, weak shale. Ceiling rock has collapsed in some areas. The ceiling of chamber (C) has been extensively plastered in modern times to stabilize falling rock. Nevertheless, following assessment, the tomb was judged to be structurally sound.

View of Chamber (C) facing tomb opening (at rear), collapsed rock on the right.

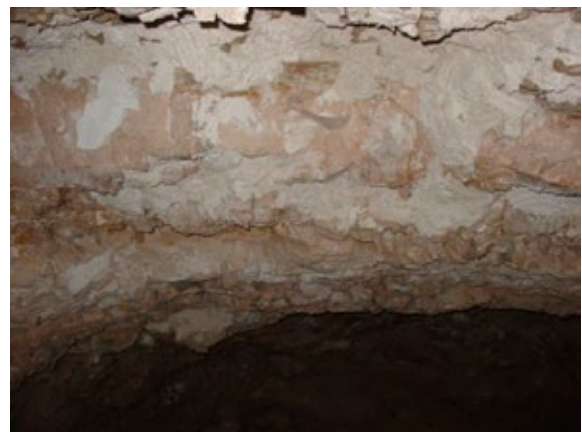
Cement mortar applied to ceiling.

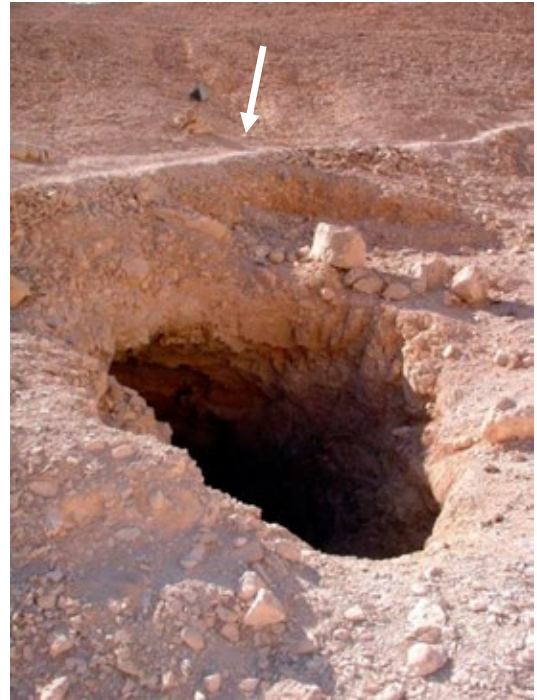
The tomb is cut into friable shale and has a shallow overburden, which includes the footpath. The shaft opening shows signs of erosion and has the appearance of an irregular hole. Fractured rock is present throughout the chamber and small amounts of fallen rock are visible on the ground.

The poor quality of the rock into which the tomb is cut is a principal factor in its deterioration. Susceptibility to upslope runoff and erosion from the footpath has also contributed to shaft erosion and exacerbated rock fracture.

Shaft entrance, adjacent to footpath (arrow).

Given the poor condition of the tomb overall and, in particular, the shaft and its opening, it is recommended that the tomb be reburied to protect it against flooding and also contribute to the general surface stability of the area.

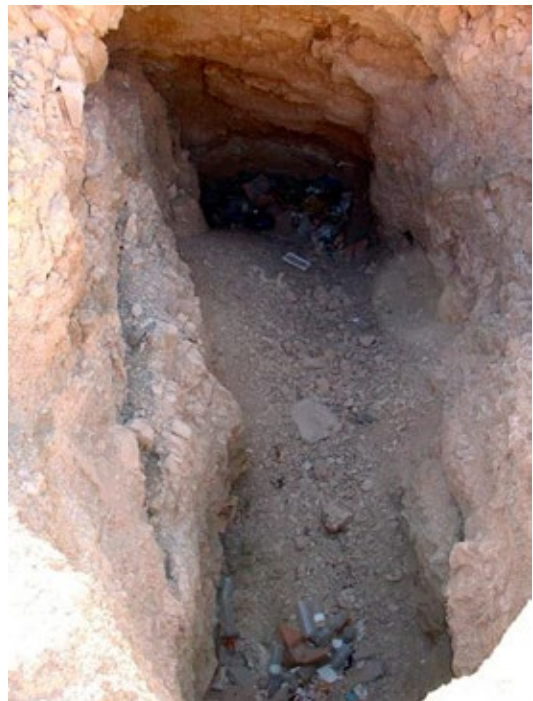
Tomb interior, showing signs of extensive collapse.

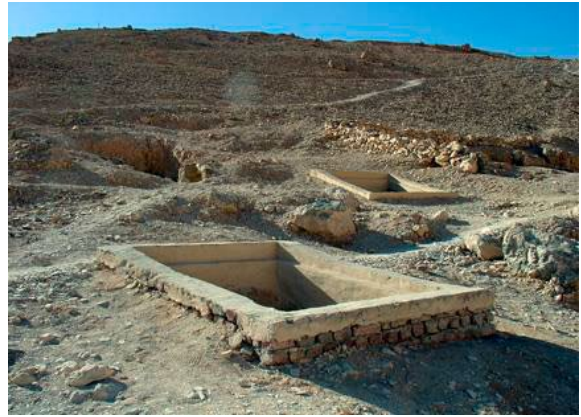
The poor quality of rock is the principal cause of deterioration. The tomb opening is in a location susceptible to upslope runoff.

Shaft entrance with masonry surround.

Installation of a shaft cover over the built surround is recommended to prevent entry of floodwater, debris, and animals.

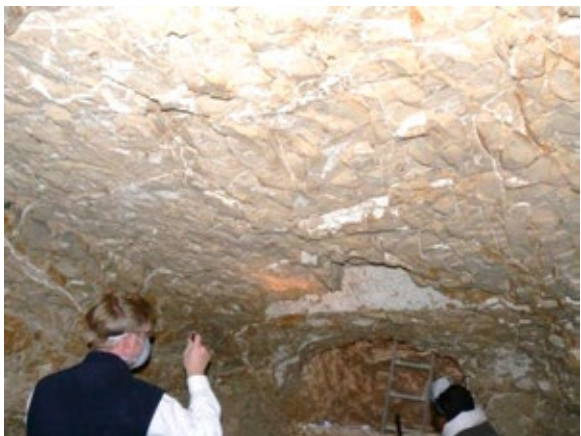
The tomb is cut into extensively fractured shale, with the rock below the ceiling in chamber (C) ochre and yellowish brown in color with many veins of white salts running through it. A thick layer of cracked, dried mud is on the floor in the front part of chamber (C), indicating that water has infiltrated into the tomb in the past. Following assessment in December 2009, the tomb was judged to be structurally sound.

View of the fractured ceiling of chamber (C) facing the tomb opening (background).

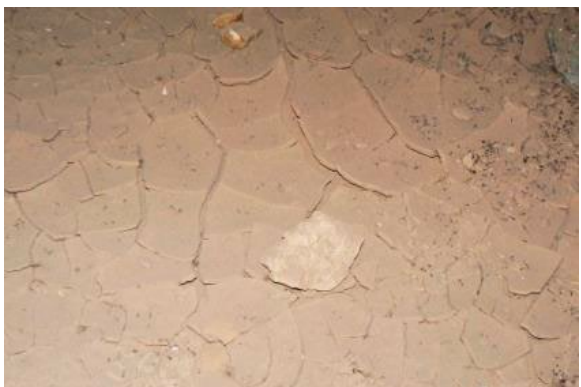
Dried mud layer on floor in chamber (C).
