Valley of the Queens Assessment Report

Volume 2

Assessment of 18th, 19th, and 20th Dynasty Tombs

A collaborative project of the Getty Conservation Institute
and the Supreme Council of Antiquities, Egypt

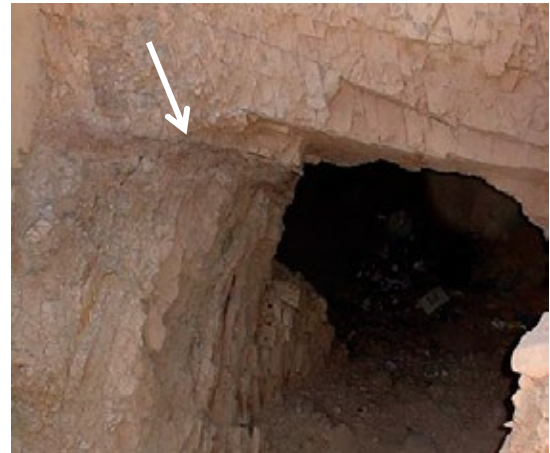
Dried, cracked silt and the relatively large volume of debris within the tomb and mud caked on the ceiling show unquestionable signs of previous flooding. The expansion of the shale when exposed to water has led to further collapse.

View down shaft with evident marl and shale interface (indicated by arrow).

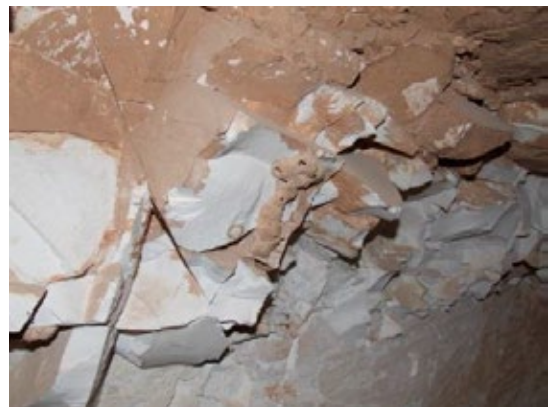
The tomb is in stable condition. Fractured marl occurs above the entrance and vertical fractures run down the rear wall of marl. A large amount of debris currently lies in the tomb and the drawings from 1981 show the tomb almost completely full (prior to excavation by CNRS). Mud and wasp nests are present on the rock of the ceiling.

Mud adhered to the ceiling rock indicates the tomb was once filled with floodwater.

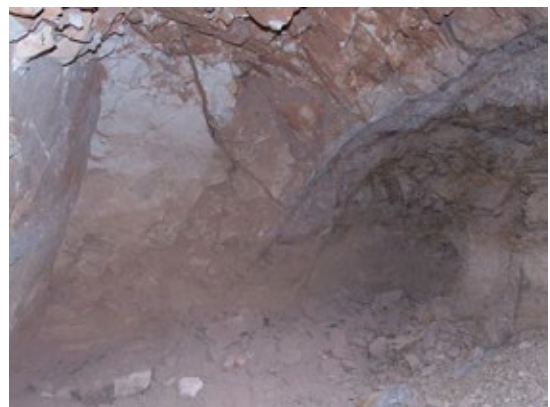
General view of chamber with piles of debris on ground.

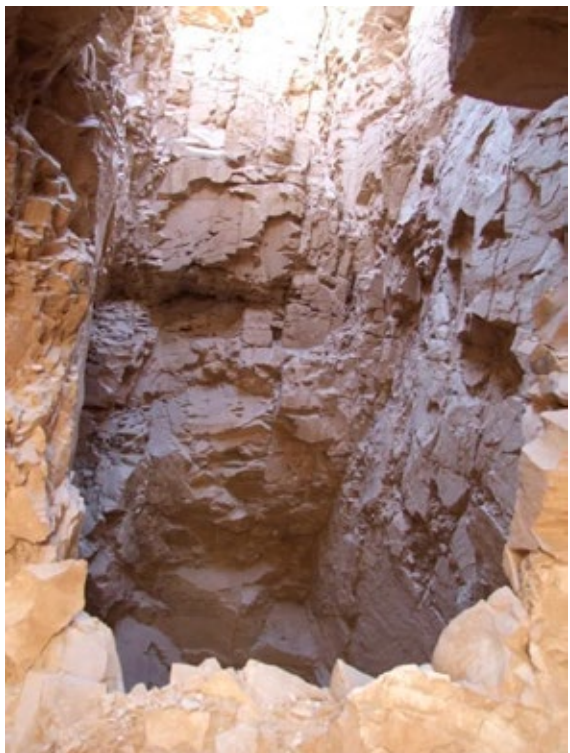
The shaft appears to be in good condition, despite the opening in the north wall to adjacent QV 34 and the large area of ceiling collapse in that tomb.

Signs of flooding through the tomb shaft and into neighboring QV 34 are present. Periodic episodes of flooding have contributed to the fractured nature of the rock and the collapses evident throughout QV 34.

View of shaft from adjoining QV 34.

It is recommended that the shaft be plugged to prevent entry of water, debris, and animals. The implementation of the plugging needs to be closely coordinated with the extensive engineering work proposed for adjacent QV 34.

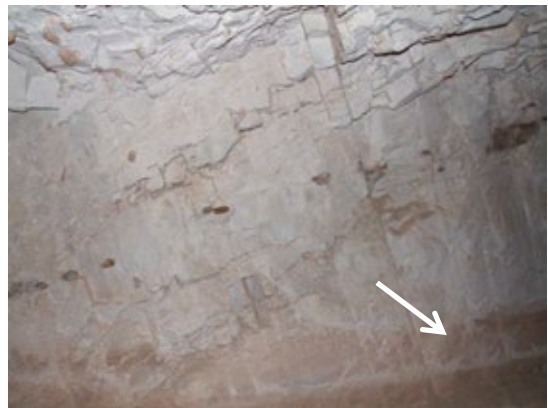
Dried, cracked mud on the floor of the tomb and adhered dirt and staining at the base of the walls indicate past flooding.

Water staining at base of wall (arrow); a line of chert nodules indicates the orientation of the bedding planes.

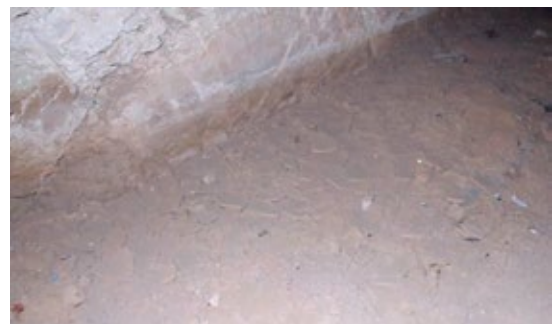
Cracked mud layer on floor with basal staining of wall.

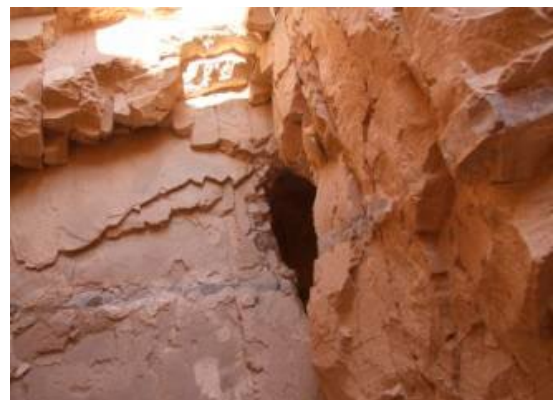
Detail of break in shaft wall leading into QV 36.

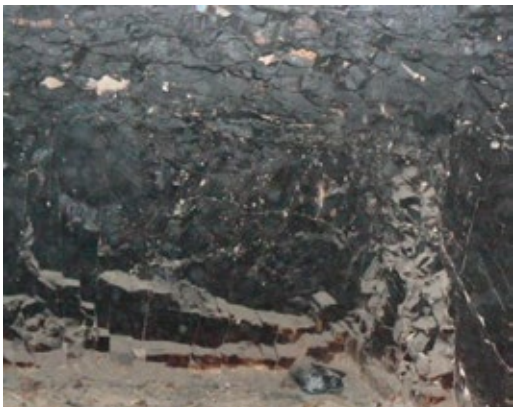
Rear chamber with severe blackening.

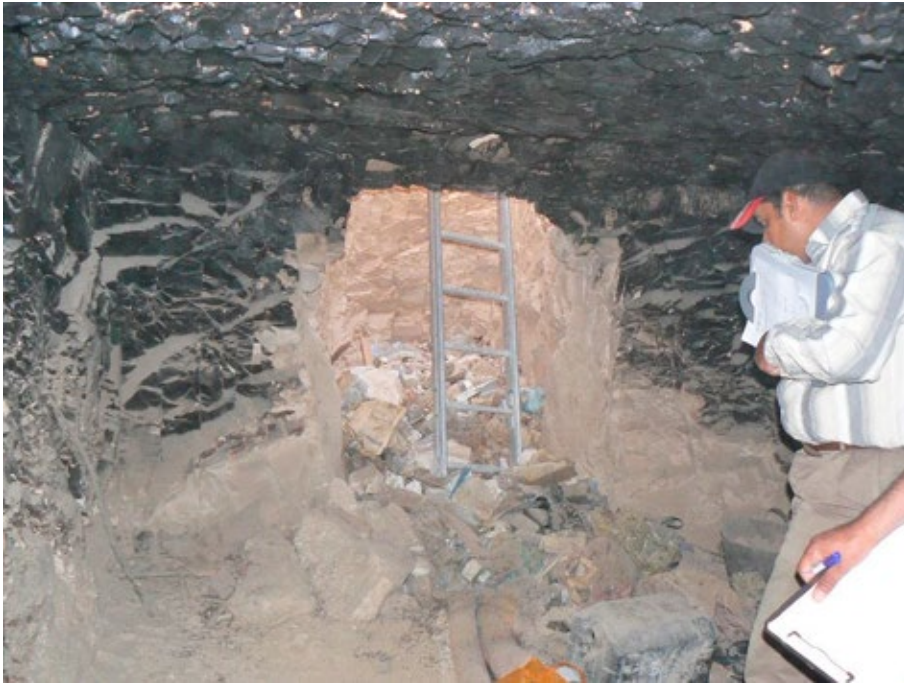
Tomb shaft with accumulated trash, removed in 2007

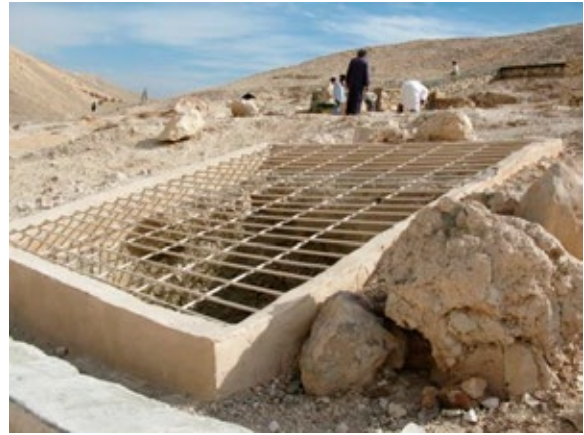
Shaft entrance and masonry surround, constructed by SCA in December 2009.

In 2009 the SCA installed a new masonry surround. Re-grading of surroundings may be necessary to improve drainage away from shaft and minimize erosion.

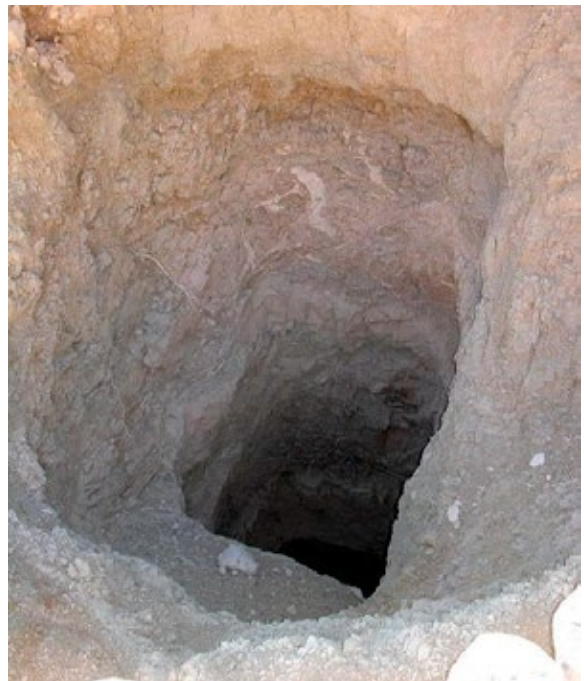
The shaft from above. Note friable shale throughout length of shaft.

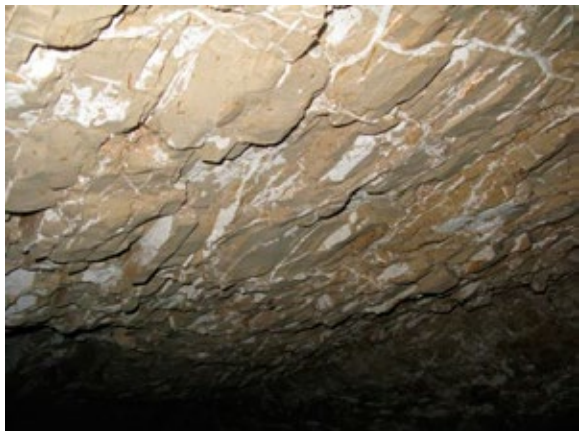
Extensive salt or gypsum deposition (white) in joints of the ceiling.

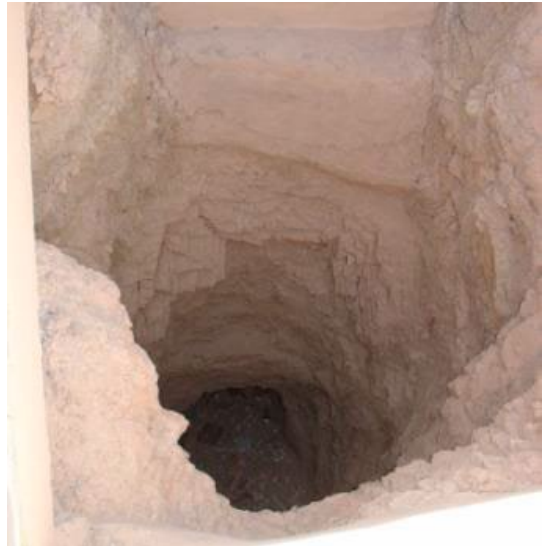
The clay content of the shale is the principal cause of its friability following exposure to water. Accumulations of silt and debris provide evidence for previous flooding events.

Shaft from above with shale along its length.

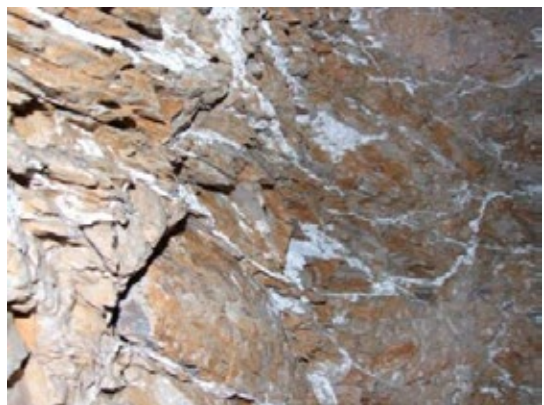
Detail of shale within chamber. Note salt or gypsum veins in rock.

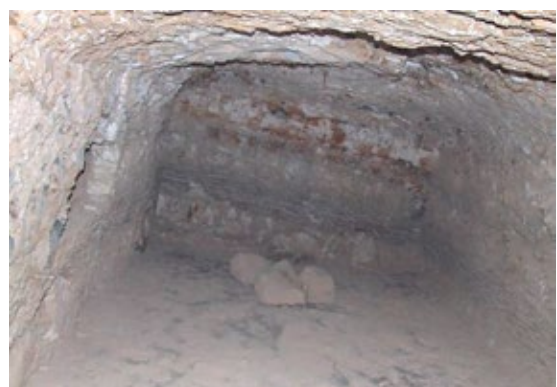
General view of chamber (C).

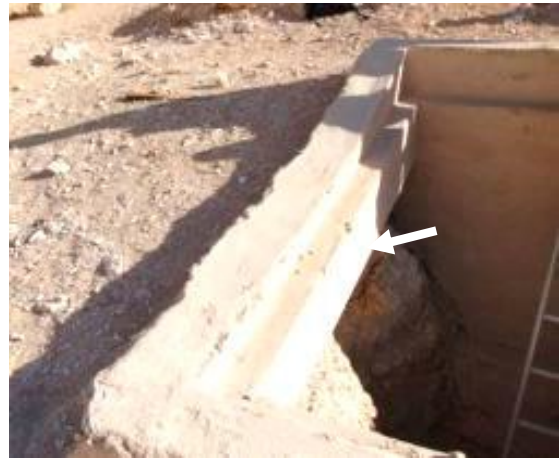
Detail of tomb surround. Arrow points to absence of rock beneath edge of surround.

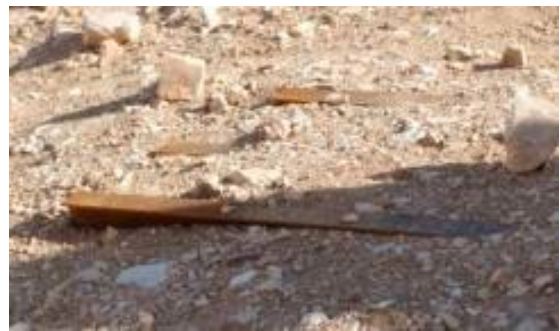
Detail of exposed, steel cross-braces supporting masonry surround and requiring attention.

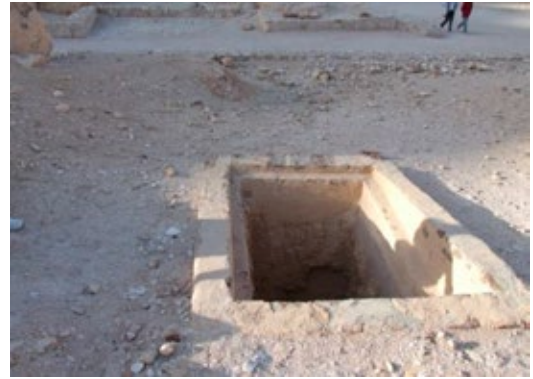
Shaft entrance with surround (grill has been removed).

As the tomb is a favorite for bats, and not well preserved or of particular significance, it is recommended that it be left open for bat habitation. The current surround should be raised and a bat-accessible metal grill installed. Due to the shallow overburden, surface drainage and measures to keep visitors from walking on the area above the tomb should be installed.

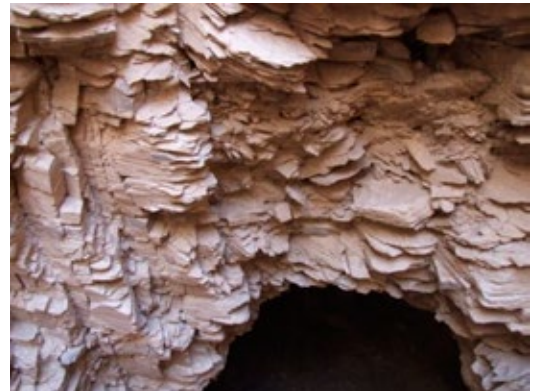
The amount of debris in the tomb and its location on the slope suggest it has undergone a number of flooding events, resulting in the weakening of the rock and fracturing of the intercalated bands of shale and marl. Flooding was recorded in 1994. Furthermore, the tomb has relatively shallow overburden, increasing the risk of ceiling collapse.

Fractured, friable rock above entrance to tomb at bottom of shaft.

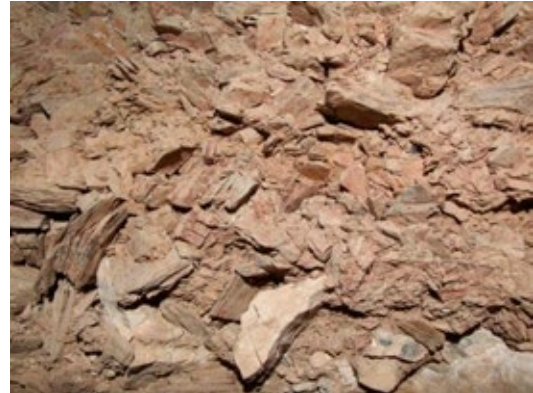
Detail of cemented breccia.

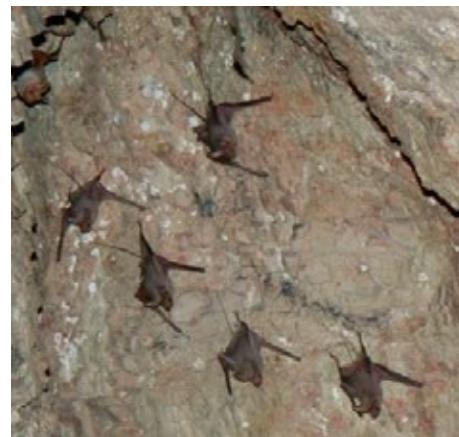
Bats roosting in tomb.

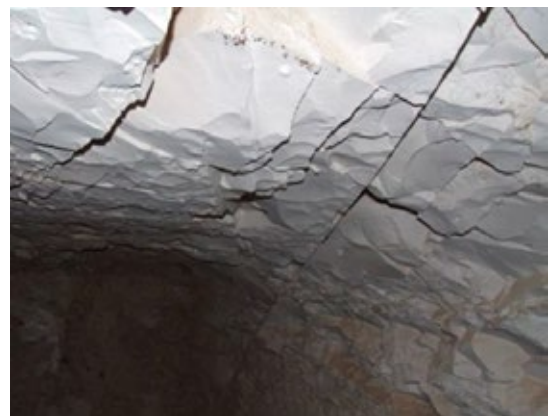
In general, the tomb seems to be in stable condition. Nonetheless, a number of fractures run through both chambers and the shaft, many of these filled with salts. Substantial salt growth is present, both as encrustations on the rock and fibrous/columnar halite crystals protruding from the rock.

Fracture running through ceiling and wall of chamber (E).

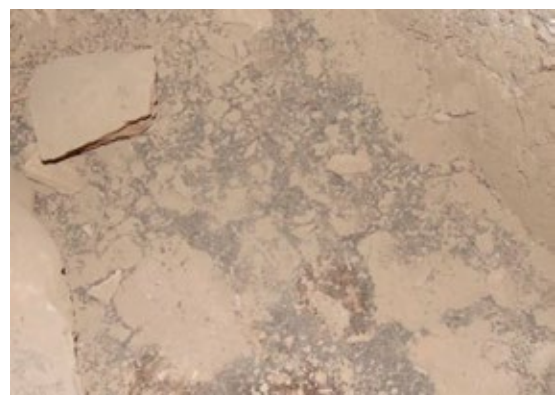
Bat droppings in chamber (C).

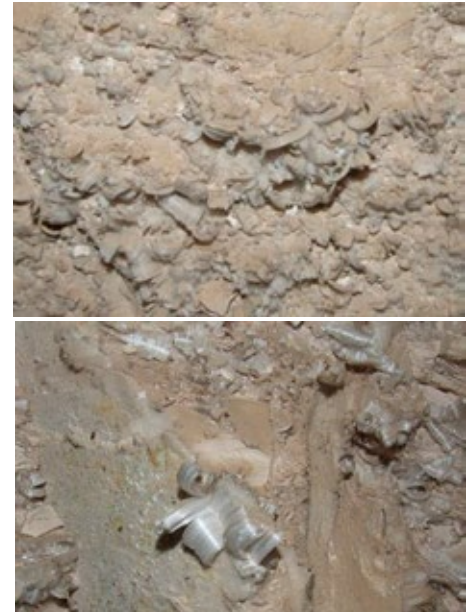
Water infiltration and resulting mobilization of salts is the largest concern in this tomb.

Above: Salt crystallizing on surface of rock in chamber (C). Below: fibrous salts.

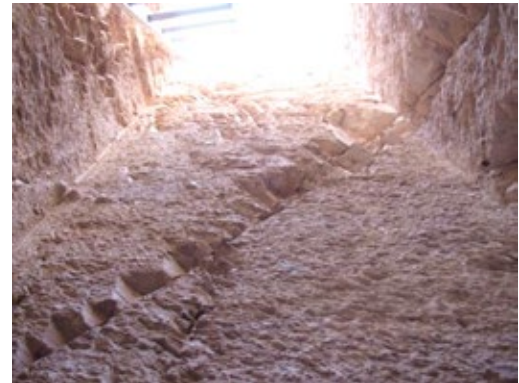
Shaft from below, with visible open fracture.

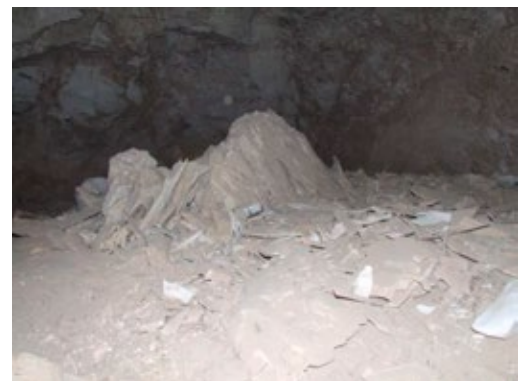
The assessment in January 2008 revealed a tomb in very different condition from that described by E. Thomas in her 1966 work. Substantial losses were evident in the ceiling and walls of the single chamber (entirely comprised of marl). Open fractures, including one that runs through the shaft, were observed with adjacent areas of rock loss and a large pile of rock fallen from the ceiling in the middle of the chamber.

The entry of flood waters and seepage into the rock may be the single most important factor of damage in this tomb. The description of E. Thomas suggests that rock fragility and damage have occurred within the past 40 years, further pointing to the 1994 flood as a major cause of the deterioration of the tomb rock. There is additional rock loss evident on top of the cracked mud. However, some of the fallen rock lies embedded in the dried mud, making it unclear if rock fall occurred long before flooding or while the mud was still wet.

Evidence of ceiling collapse in center of chamber (C).

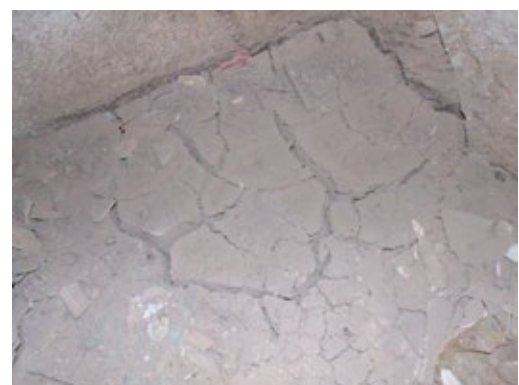
A thick layer of cracked mud lies on the floor from the 1994 flood, as confirmed by Christian Leblanc. Silt or mud adheres to some ceiling surfaces.

Thick layer of cracked mud on floor of tomb.

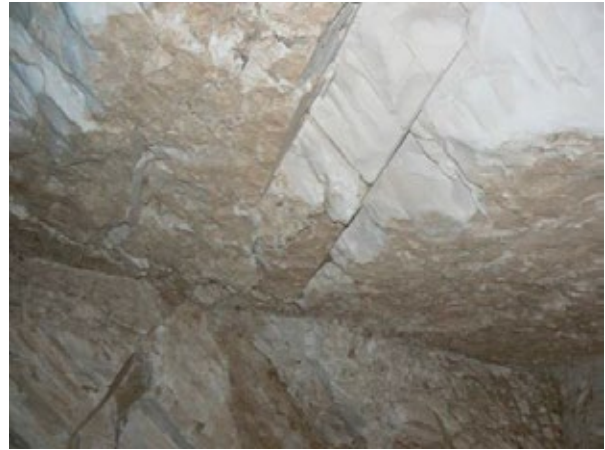
Silt/mud adhered to the ceiling suggests the tomb had filled with flood water.

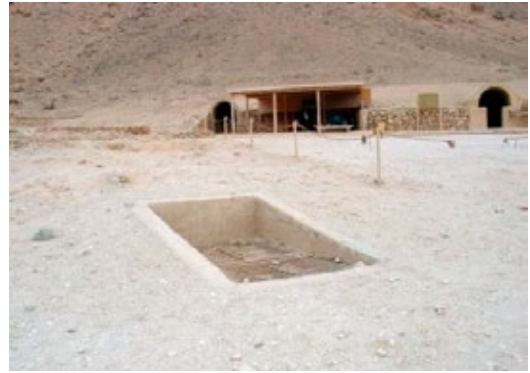
Shaft entrance and masonry surround.

A shaft cover should be installed to prevent entry of animals, flood waters, and debris. Further flood mitigation efforts, such as raising the height of the masonry surround should be considered.

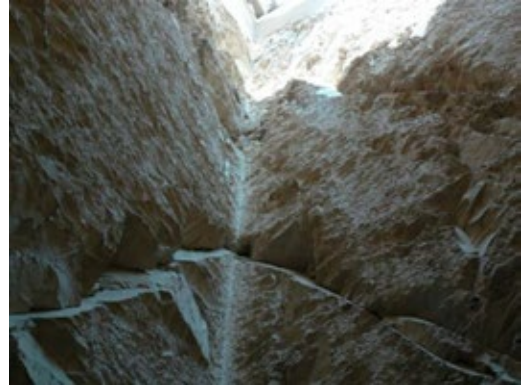
The deep shaft has large open diagonal fractures and partial debris fill. The large chamber (C) is roughly 8m in length and half filled with debris and large stones (not collapsed rock from the tomb), presumably from the original sealing of the chamber entrance and shaft. At the northwest end of the chamber, a large pile of fallen rock is evident on top of the dried mud. Salts are present in abundance, infilling cracks and efflorescing on surfaces.

Shaft walls with open diagonal fractures.

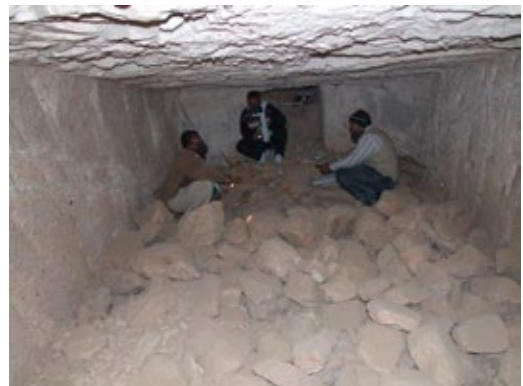
Chamber (C), looking towards the entrance. Debris and large stones fill the chamber.

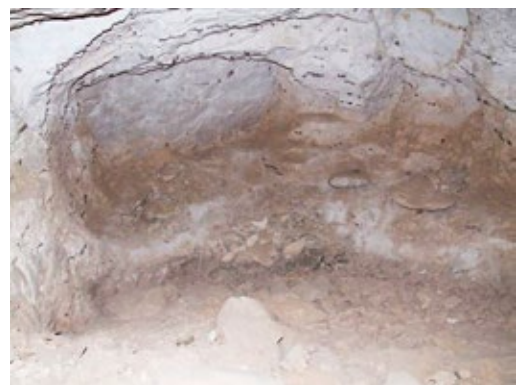
Evidence of the 1994 flood is particularly clear in chamber (E), where dried mud carpets the floor, and horizontal "high-tide" stains are visible on the walls. Dirt covering the boulders in chamber (C) and debris in the shaft also indicate flooding. Salt efflorescence is further evidence of moisture infiltration into the rock.

Rear of chamber (E), with horizontal staining of wall.

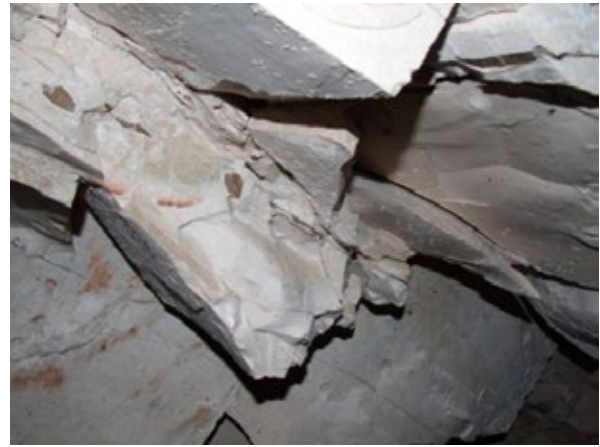
Detail of fractured ceiling rock with areas of salt efflorescence.

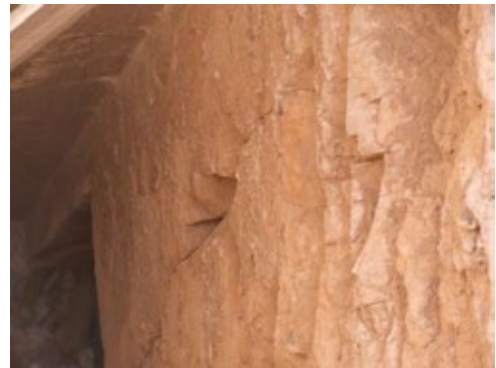
Vertical fracture running down south side of shaft as seen from above.

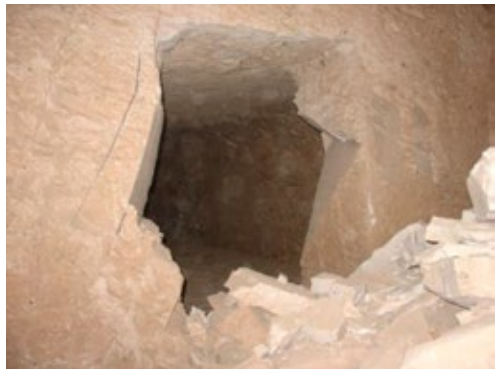
Partial collapse of door jamb between chambers (C) and (E).

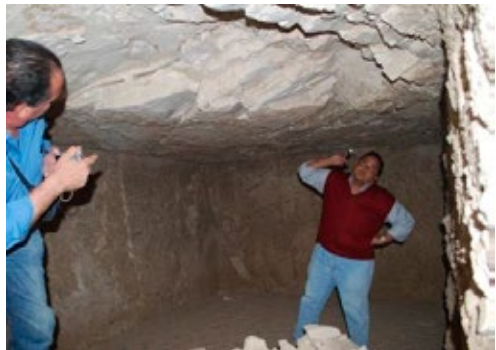
Thick, cracked mud is present throughout the tomb, providing evidence of past flooding, including the 1994 flood. The recent substantial loss appears to be related to the flooding, which may have completely filled some of the chambers.

Area of substantial ceiling collapse in chamber (C).

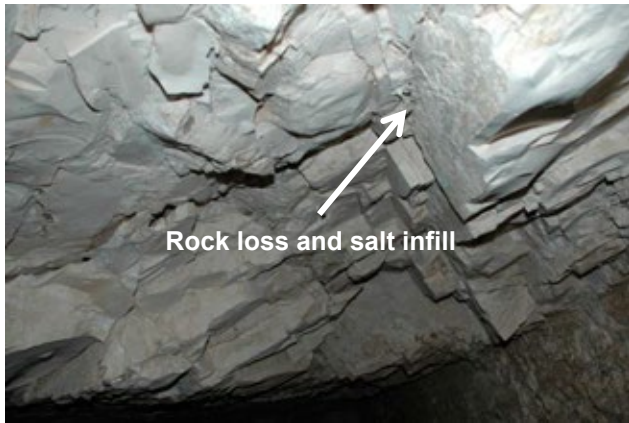
Detail of ceiling rock in chamber (C).

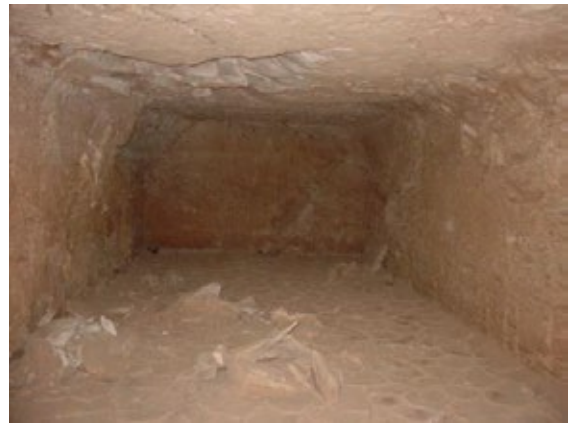
Third chamber (on CNRS sketch below) with localized ceiling rock collapse.

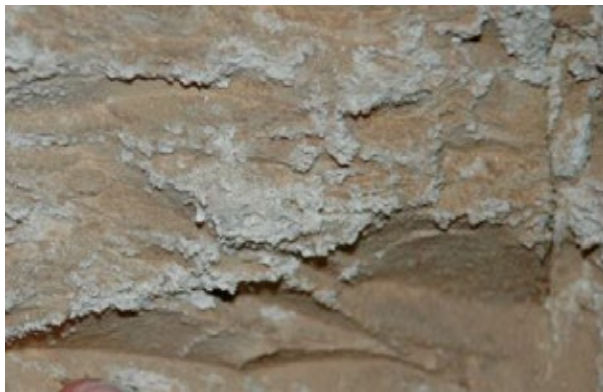
Detail of surface salt efflorescence.

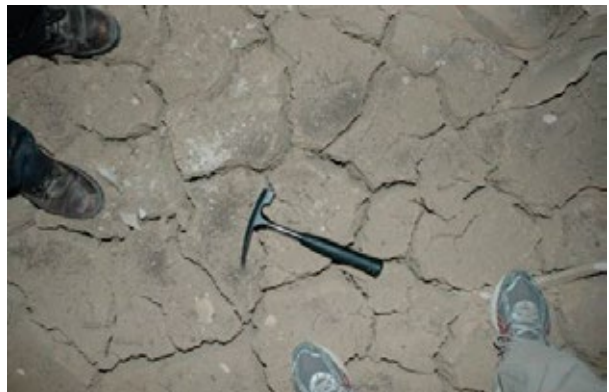
Thick cracked mud on tomb floor.

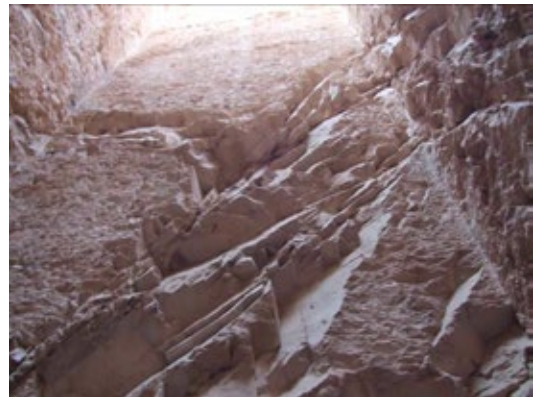
The rock of QV 64 is fractured and shows localized loss, although not as severe as that of QV 61. Rock loss seems to be occurring along joint planes, leaving clean smooth surfaces after rock fall. Some fallen rock is dispersed about the tomb and lies atop cracked mud. A large area of brown staining is present on the wall in the rear of the tomb and a horizontal brown line is present at the base of the walls, most likely "high tide" marks from previous floods. Cracked mud carpets the floor of the tomb.

View of shaft from below, with visible fractures.

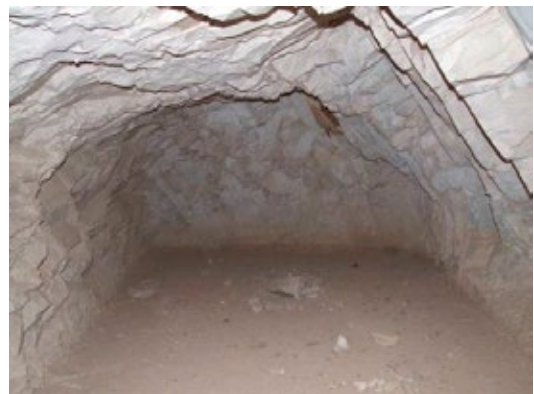
Cracked mud and the basal horizontal stain are signs of flooding which Christian Leblanc witnessed in this tomb in 1994. This flooding led to substantial rock loss, such that the tomb is no longer in the pristine condition observed by Thomas in 1966.

General view of chamber, with localized fallen rock, and basal flood line.

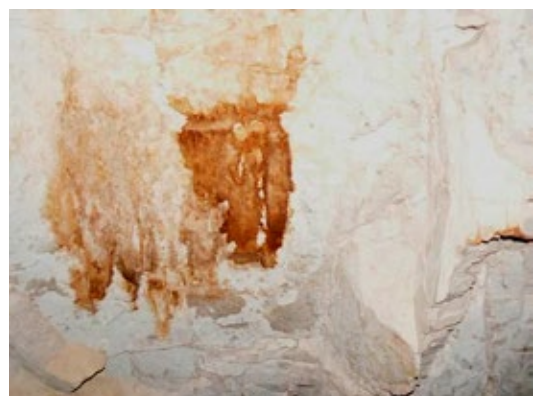
Evidence of biological activity includes silverfish, mud wasps' nests, and staining (possibly from bats).

Brown staining on rear wall, perhaps due to bats.

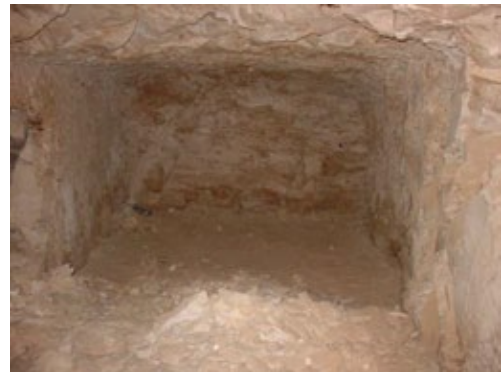
Ancient and recent (1994) flooding has contributed to the substantial collapse found in this tomb. The roof is relatively shallow and may be prone to collapse.

View of main chamber with fallen rock and dried mud covering floor.

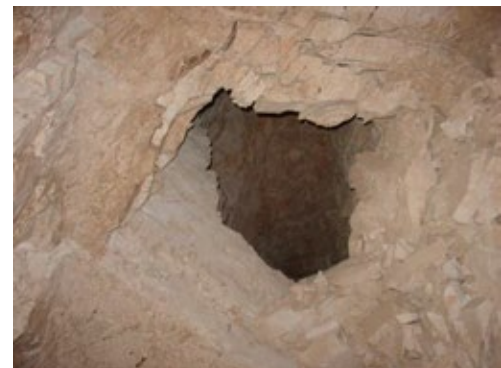
While the marl of the tomb appears to be in stable condition, much of the ceiling in both chambers has collapsed in the past. Following this collapse, the rock layer separating the ceiling of the tomb and the surface is now very shallow. Prominent fissures are also visible in both chambers. Dried mud now coats the floor, evidence of the 1994 flood. At that time, the tomb was completely filled with water that the Franco-Egyptian team removed by pump. Three bats were observed roosting in the tomb in November 2007. More than ten bats were observed in the side chamber in December 2009.

Entrance to side chamber housing an active bat colony.

A door should be installed at the entrance of the tomb to prevent people or animals from entering the chambers. A sill wall should be constructed at the top of the ramp to protect the tomb in the event of a flood. The bats currently inhabiting the tomb must be removed.

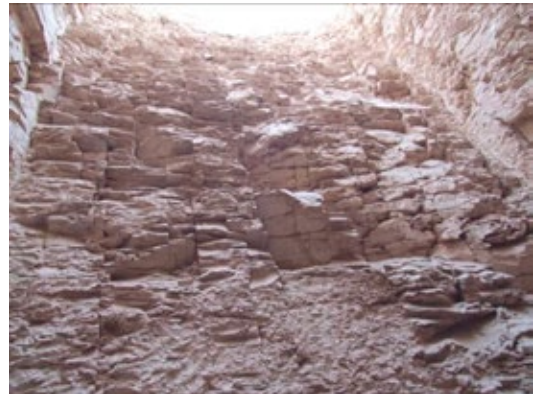
View of shaft from below. Note areas of friable rock.

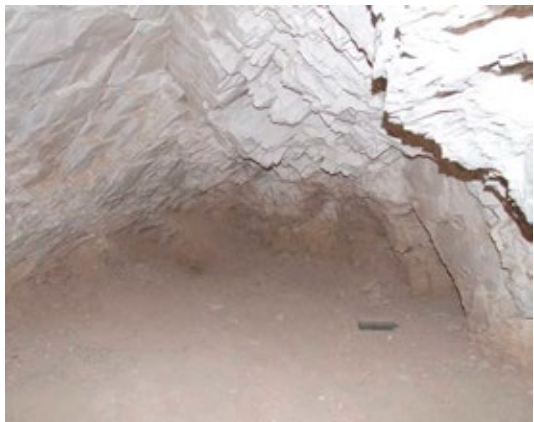
The presence of mud on walls and part of the ceiling, cracked mud on the floor, and a band of brown stain at the base of the walls are evidence that the tomb has flooded.

End of chamber with notable staining/discoloration along base of wall.

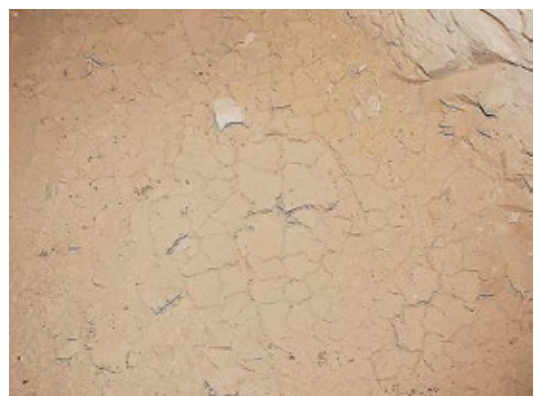
Water infiltration is the primary cause of rock deterioration and loss. However, there seems to be minimal loss since the 1987-88 clearing of the tomb, since no fresh losses were noted.

Cracked mud on the floor of tomb.

A shaft cover is necessary to prevent animal and flood water entry. Further flood mitigation may be necessary, in the form of surface diversion and drainage channels.

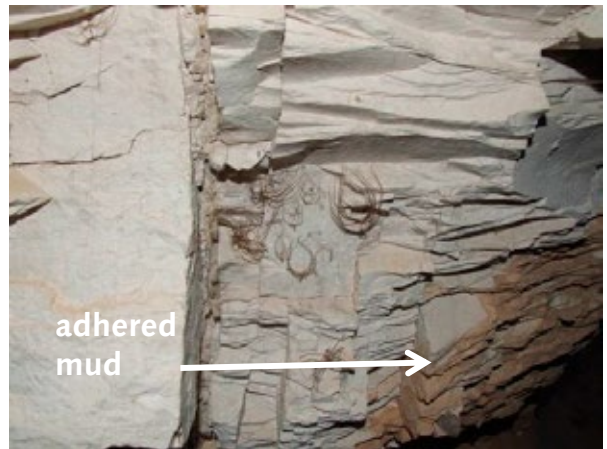
Detail of wall with an area of adhered mud on the lower right, evidence of past flooding.

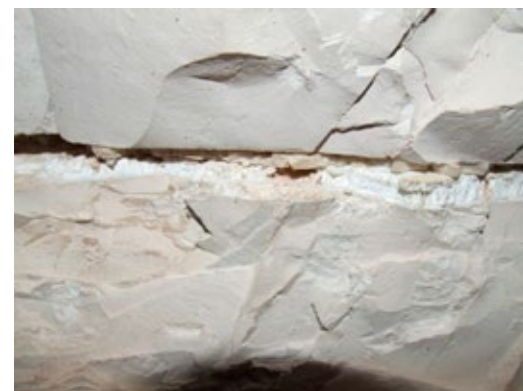
The tomb is in good condition, with stable rock, despite a fault and fractures running through the tomb. Salt infill is present in open fractures and analysis identified individual layers of calcite and anhydrite within one fracture.

Flooding has resulted in salt infill in rock fractures.

Detail of salt infill in fracture. Analysis identified the upper, darker layer as calcite and the lower, white material as anhydrite.

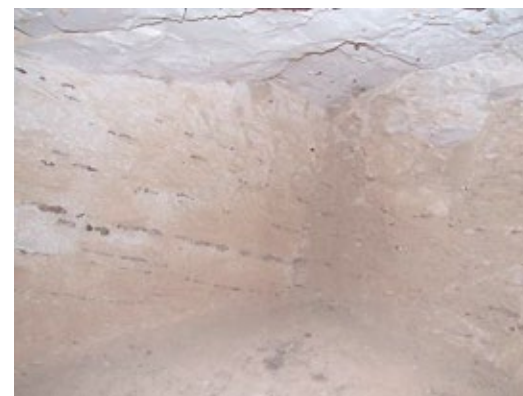
Fault visible in corner of tomb, with salt infill.

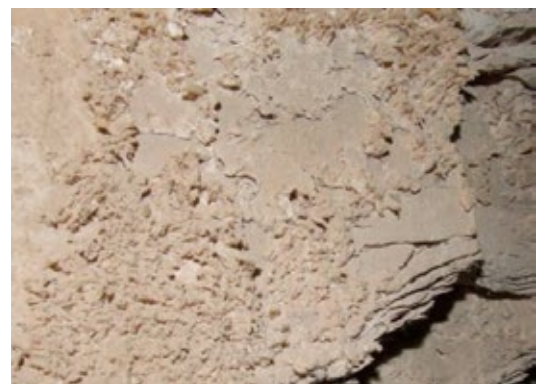
The presumed ingress of moisture, perhaps as seepage through the rock from the surface or adjacent tombs has resulted in salt crystal growth and related rock deterioration on the rear wall of the chamber.

Fibrous halite crystal growth on rear wall of chamber.

It is proposed that this tomb, adjacent to the visitor path and with a well-formed shaft, be left open for viewing from above. To prevent entry of floodwaters and debris the current masonry surround would need to be raised to a height of approximately 1 meter and a metal grill placed for safety. Lighting could be installed inside the tomb to provide illumination of the shaft.

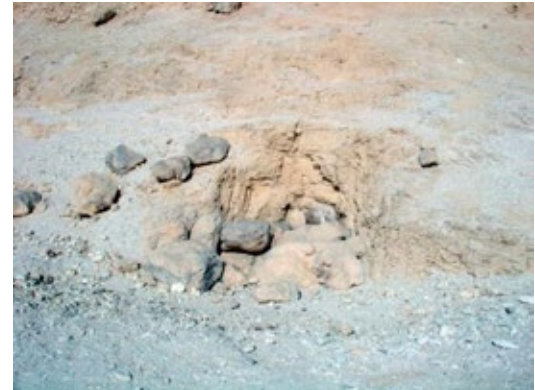
View of shaft entrance, filled with boulders.

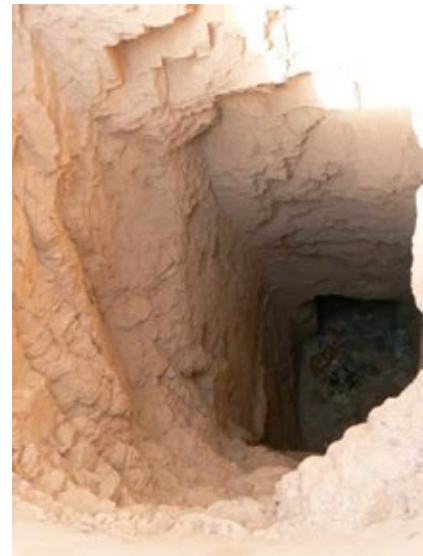
View of shaft opening with surround.

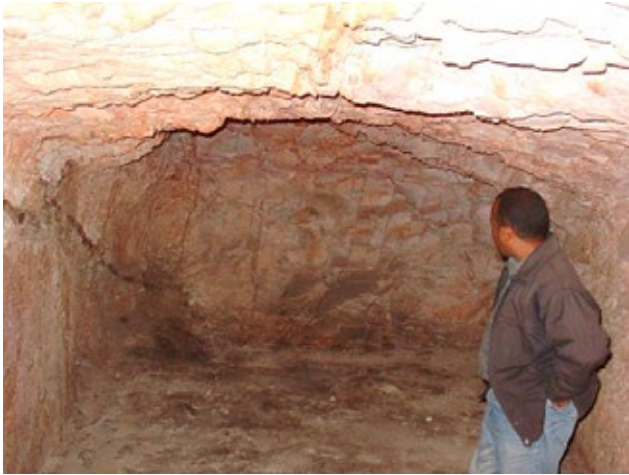
Reddish coloration of heavily jointed ceiling.

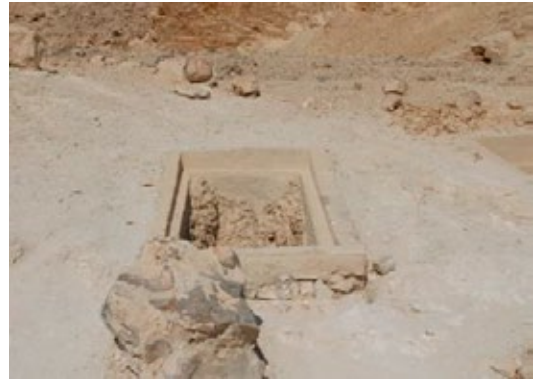
Shaft entrance and masonry surround.

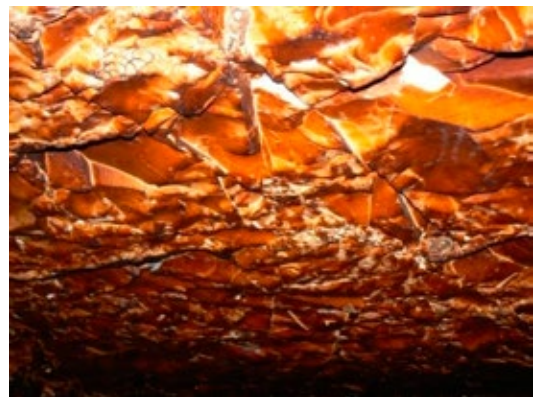
The tomb is in stable condition. Chamber (C) is roughly hewn and the rock of the ceiling and much of the walls shows an orange-brown lustrous appearance similar to the side chamber (G) of QV 42 and chamber K of QV 43, presumably caused by intense fire or heat damage of some sort.

The rock discoloration is thought to be the product of fire. The floor and lower portions of the walls that are not discolored were presumably protected by debris fill at the time of the fire.

Detail of discolored rock ceiling in chamber (C).

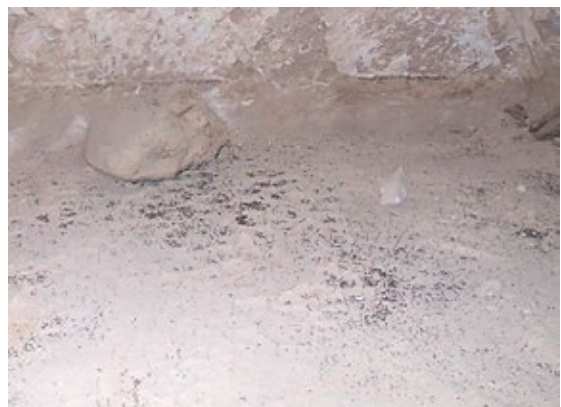
Bat droppings and localized rock staining are present throughout the tomb and five bats were observed by the GCI assessment team in January 2008. Wasps' nests were also adhered to the walls.

Cracked mud layer on floor of side chamber, with bat droppings.

The entrance of the tomb should be closed with a shaft cover to prevent entry of animals, flood waters, and debris.

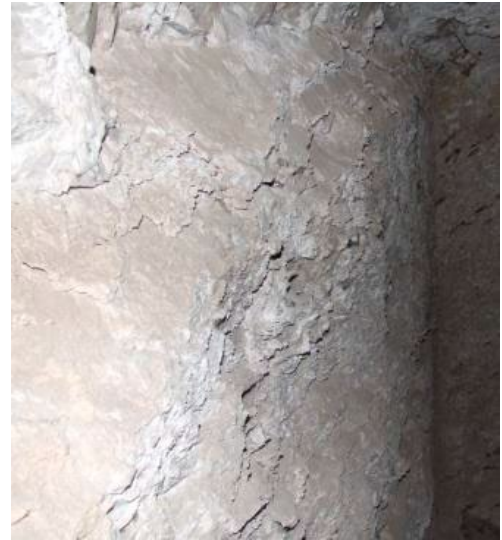
The tomb is considered stable. The 5m deep shaft exhibits some fractures and is partially filled with debris. The rock of the chambers has minor fracturing with an area of substantial loss from the ceiling at the entrance. There is a thin layer of cracked mud on the floor of the side chamber, providing evidence of previous flooding. Substantial quantities of salt have effloresced on the north wall of the main chamber.

Entry of floodwaters and debris have contributed to salt efflorescence and deterioration on the rear wall of the tomb and have gradually filled the shaft with debris. Hydrological analysis suggests runoff from upslope will flow directly into the tomb.

Salt efflorescence and related deterioration in main chamber.

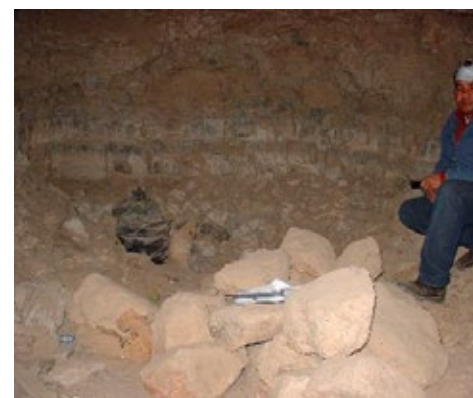
The rock throughout the tomb, particularly the shale, is highly fractured. The upper marl ceiling of the three chambers has areas of loss and rock collapse; the weak shale below has largely crumbled. There is evidence of flooding with cracked, dried mud on the floor of the middle and eastern chambers, and to a lesser extent on the floor of the western chamber, which is at a higher level than the others. Given that the QV81 shaft opening is at a relatively high elevation near the top of a hill, past flood waters apparently passed from QV3 to QV 81. Following a geotechnical assessment conducted by Hamza Associates in February 2010, this tomb was deemed to be stable despite the fractured rock.

The inherently poor quality of the shale and its subjection to flooding have resulted in widespread fracturing and localized rock collapse. The tomb continues to be at high risk of flooding through QV 3.

Central chamber facing rear end, with fractured shale.

It is recommended that a shaft cover be installed to prevent entry of water, debris, and animals. Interventions require coordination with those for QV 3, as the tombs adjoin.

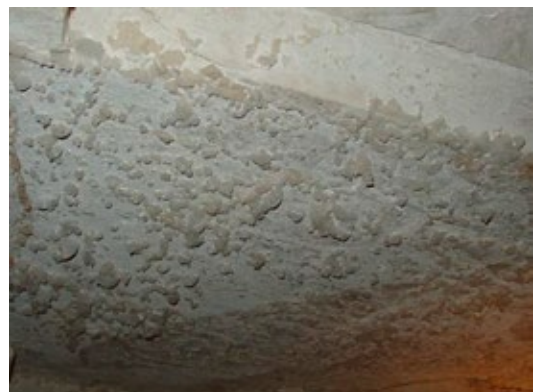
The tomb is in good condition despite past flood events, indicated by a thin layer of dried, cracked mud that covers the chamber floor and is adhered to some wall surfaces. Also, fibrous salt crystals have formed on many surfaces throughout the tomb.

Fibrous salt crystal growth on rock.

It is recommended that a shaft cover be installed to prevent the entry of animals, flood water and debris.

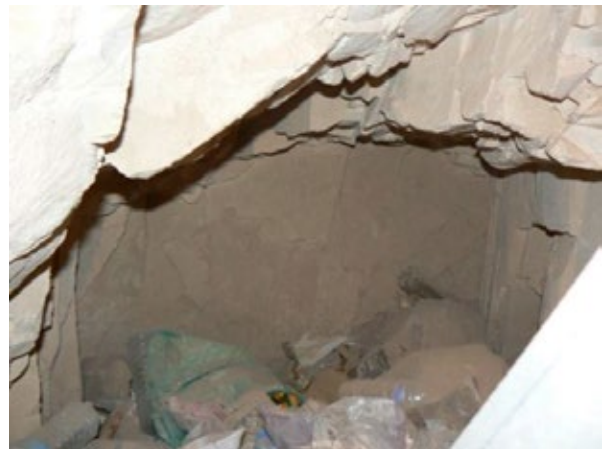
The small chamber and shaft were partially filled with trash at the time of assessment and were difficult to access. Nonetheless, the rock of the small tomb seems stable with no apparent surface deterioration or large fractures.

View of small chamber, partially filled with trash.

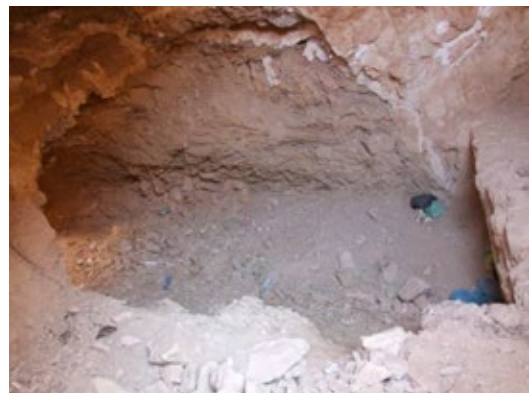
The tomb is structurally compromised with severely fractured and friable rock throughout the chamber. Previous interventions have tried to stabilize the tomb through the application of cement in the rear of the chamber along cracks and at the interface between shale and marl layers.

Tomb interior seen from shaft. White cement interventions are visible in the upper part of the rock wall.

It is recommended that a shaft plug be installed to prevent entry of water, debris, and animals. The implementation of plugging requires close coordination with the engineering works to stabilize adjoining QV 34.

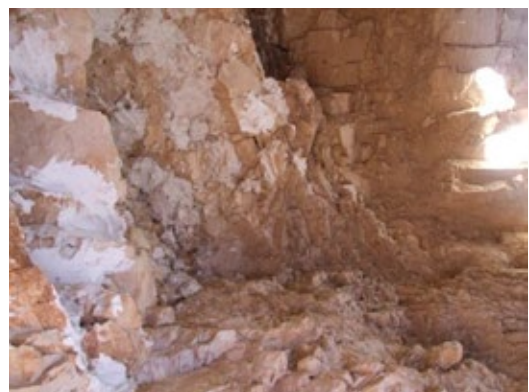
The poor quality of the rock is the principal factor in the deterioration of the tomb. The collapse of the adjacent rock overburden in the main chamber of QV 34 likely contributed to deterioration as well.

Detail of shale and white cement patches on walls.

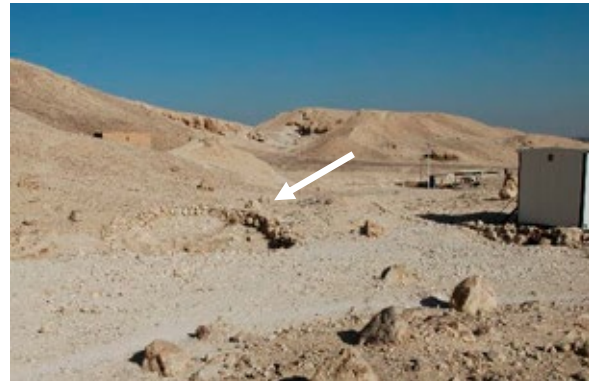
Location of tomb (arrow) behind WC and adjacent to side drainage.

It is recommended that the tomb be filled and reburied to prevent further erosion and damage associated with flooding. SCA staff should determine if it is necessary to remove the accumulated waste before filling the tomb.

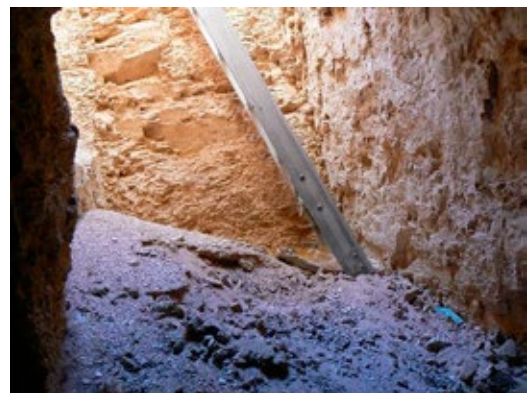
Accumulation of debris at bottom of shaft.

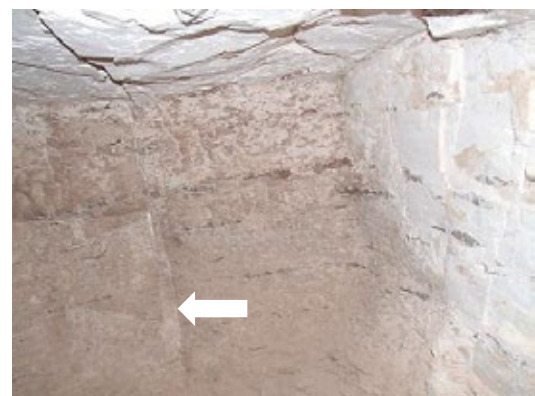
Corner of tomb with fracture running through ceiling and wall.

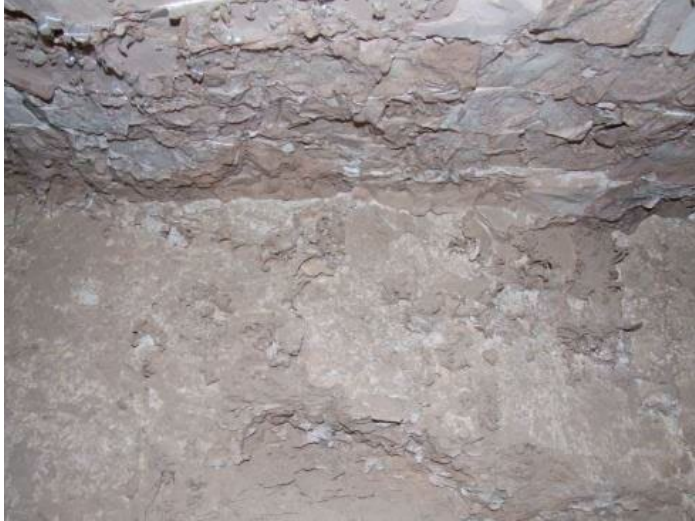
The presence of silt and debris on the tomb floor as well as the relative abundant salt growth suggest that flood waters have contributed to the deterioration of the tomb in the past. Salt crystal growth may also be due to surface water seeping through the rock from above.

Fibrous halite salt growth in area of ceiling and wall.

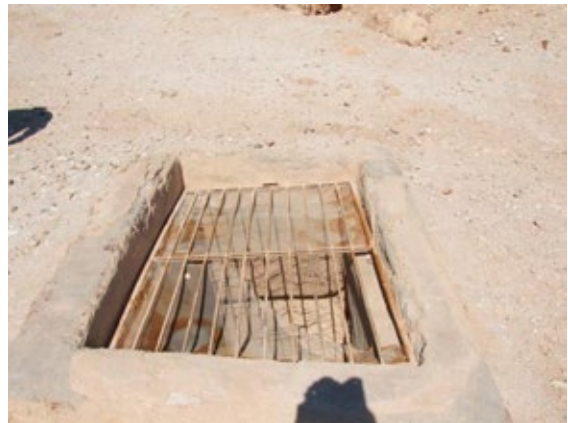
Shaft entrance prior to the installation of the prototype shaft cover in 2008.

A shaft cover should be installed so as to prevent entry of floodwater, debris and animals. The current prototype, installed in 2008, will require replacement with a final model of the shaft cover.

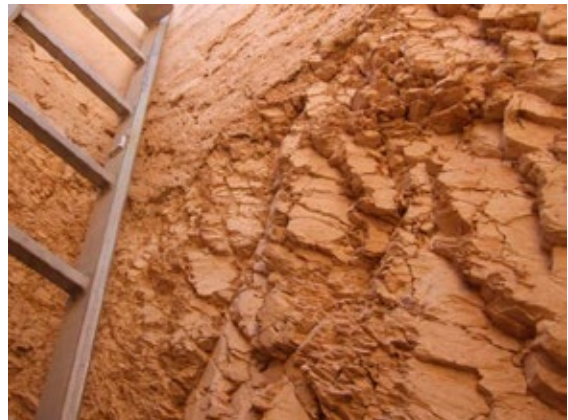
The tomb is considered stable, although there are signs of rock deterioration. Marl in the shaft exhibits areas of surface fracturing and detachment. Inside the chamber, rows of chert nodules and perpendicular joints reveal drastically upturned bedding planes.

Heavily fractured rock in shaft.

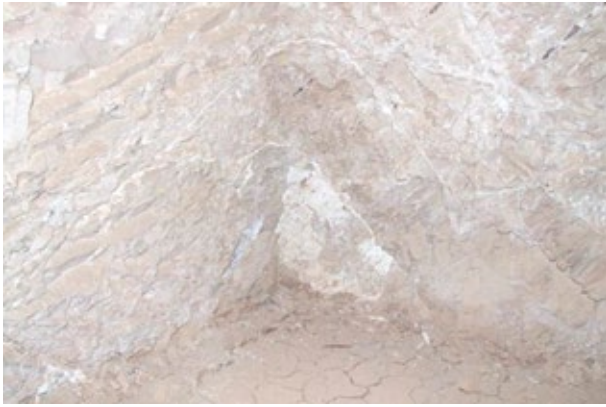
Tilted bedding planes visible on the chamber wall.

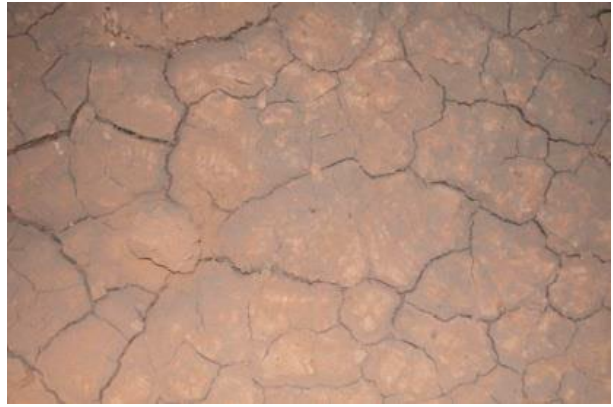
Thick, cracked mud covers the floor and is occasionally caked on the walls, indicating that a relatively large amount of flood water and debris has entered the tomb. This was corroborated by Christian Leblanc, who recalls having to pump water out of the tomb after the 1994 flood. Localized signs of bats are present, as are mud wasp nests.

Detail of cracked mud on the chamber floor.

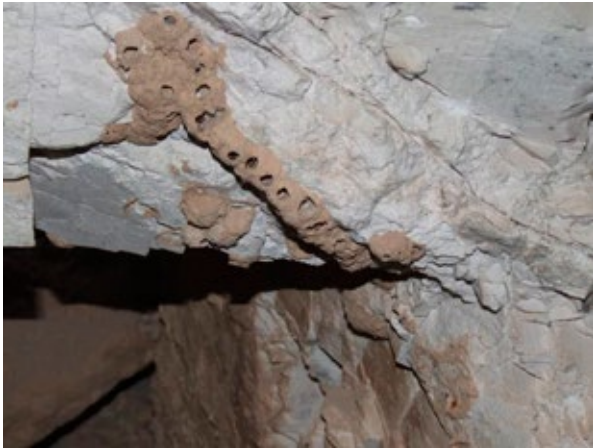
Wasp nest adhered to wall near entrance.

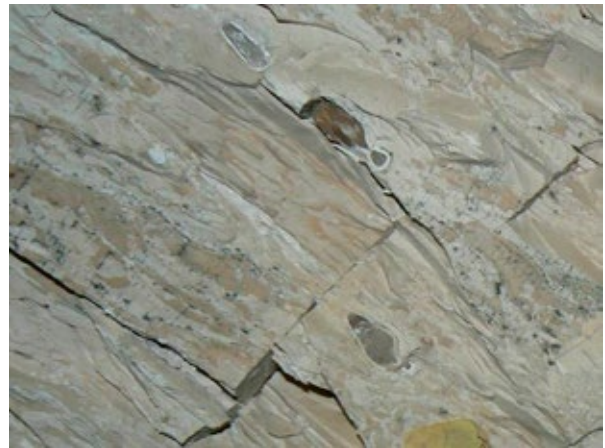
Chert nodules in marl of chamber wall.

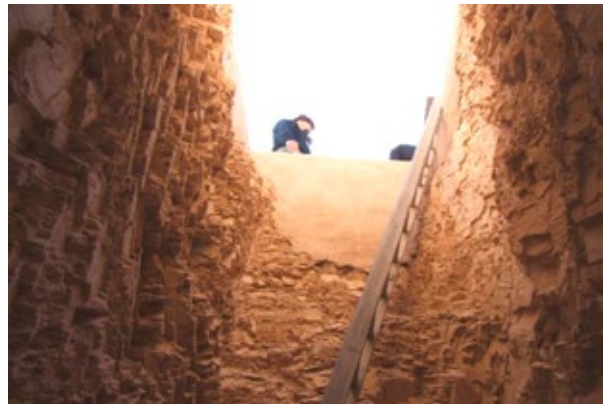
The tomb is considered stable, although the shaft walls, composed of relatively high-quality marl, are heavily fractured. Rows of chert nodules and perpendicular joints reveal upturned bedding planes, and many of the fractures have been filled with a thick accretion of salt. Arabic graffiti is present on the east and north walls.

Fractured rock in shaft.
