Valley of the Queens Assessment Report

Volume 2

Assessment of 18th, 19th, and 20th Dynasty Tombs

A collaborative project of the Getty Conservation Institute
and the Supreme Council of Antiquities, Egypt

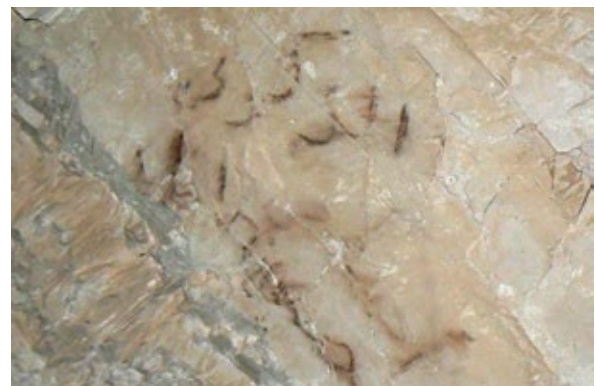
Arabic graffiti on east wall.

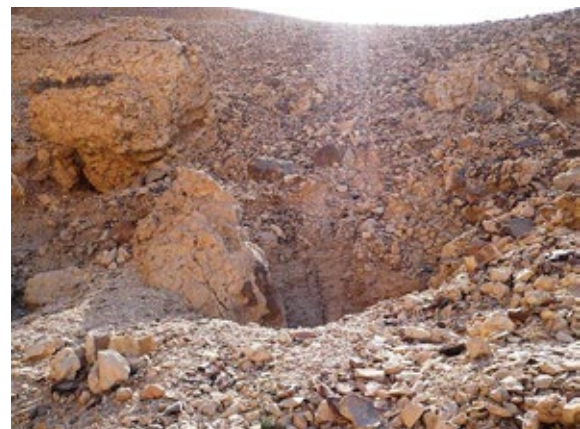
Debris eroding from the slope above both of these tombs will gradually fill their shafts. Water also continues to infiltrate these tombs, particularly QV 92, which is located adjacent to a small, natural drainage path.

Entrance to tomb 92 showing surface erosion into shaft.

Localized U or V-shaped diversion walls should be installed immediately upslope of the tomb entrances to significantly decrease the rate of erosion and amount of water infiltration into the tombs.

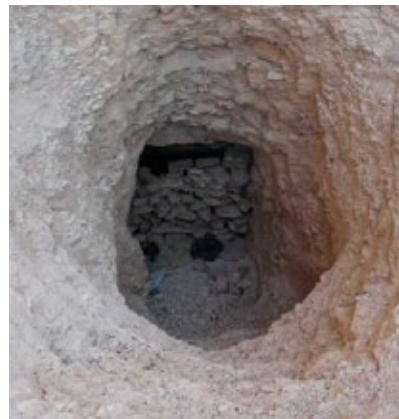
The key to the steel door blocking access to the tomb was not available at the SCA Inspectorate, therefore this tomb was not assessed from the interior. The shale surrounding the entrance is friable and continues to erode. The door remains in good condition, and a rubble wall has been constructed in front of the door.

Roughly hewn ramp leading to modern rubble wall blocking entrance of QV 97.

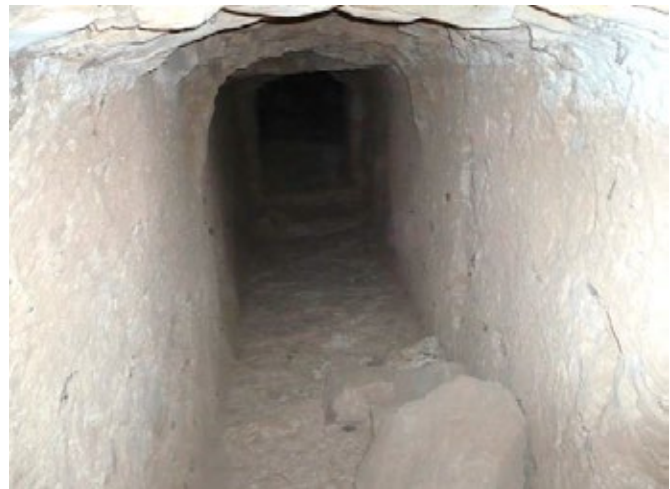
Given what is visible from the doorway, it appears that the corridor is also in good condition, having been cut into relatively high quality marl. The chamber itself, however, is likely to be as unstable as it was when it was first discovered.

View of QV 97 corridor from the steel door.

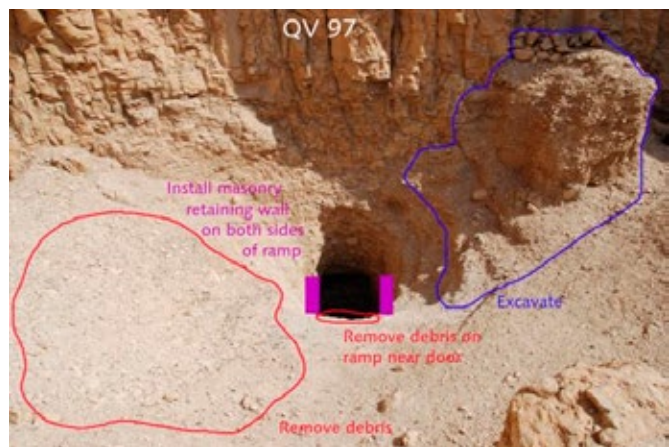
Erosion of the friable shale surrounding the entrance ramp threatens to obscure or rebury the entrance once again. Both the Italian and the Franco-Egyptian expedition were concerned about the stability of the ceiling of the tomb's chamber, though the rate of deterioration remains uncertain.

Diagram of recommended interventions to stabilize the entrance.

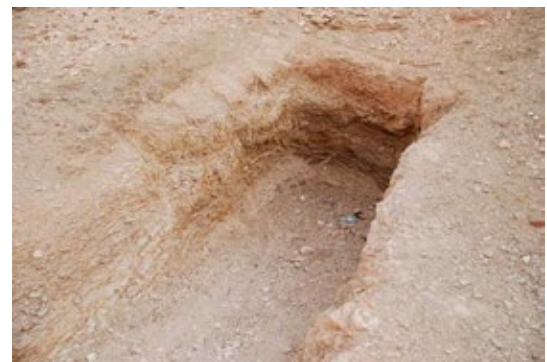
Detail of entrance to QV 88, almost entirely filled with debris.

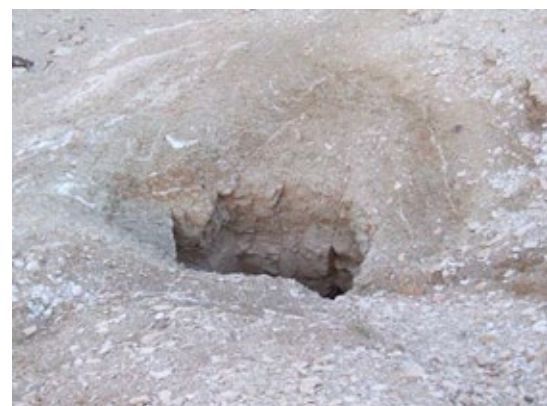
These tombs are susceptible to continuing erosion from surface water draining through the Valley of Prince Ahmose. While the volume of such water is relatively small compared to that of the main wadi, the susceptibility of the surrounding shale to water accelerates the rate of decay, as does the lack of a protective surround at the shaft entrances.

Entrance to QV 98, with eroded surface surrounding shaft.

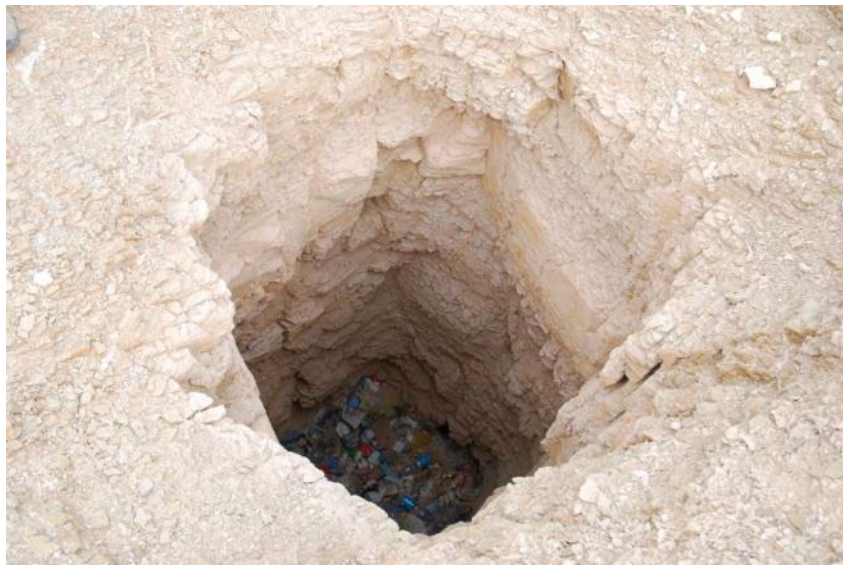
Detail of entrance of QV 98. Note trash at bottom of shaft.

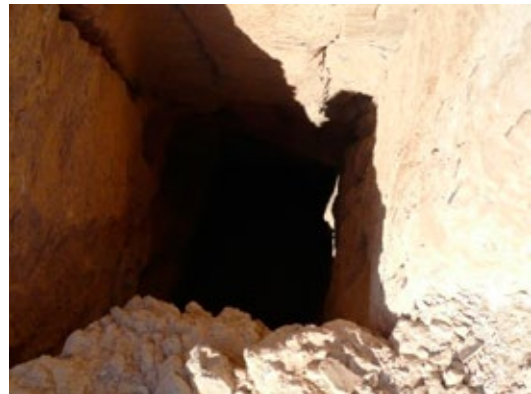
Due to the remote location of these tombs and the depth of their shafts, the team did not assess these three tombs from the interior. The shafts appear to be in good condition and are carved into marl, though substantial amounts of debris have accumulated at their base due to erosion.

Eroded shaft of QV 90.

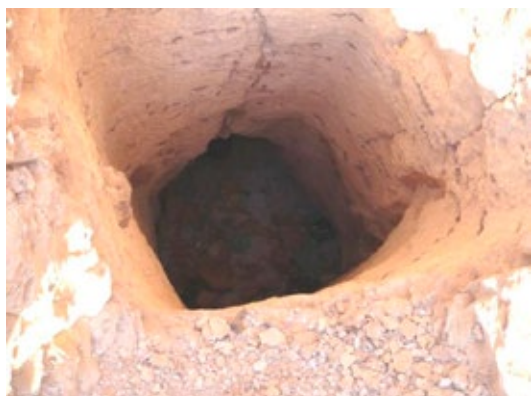
Shaft of QV 90.

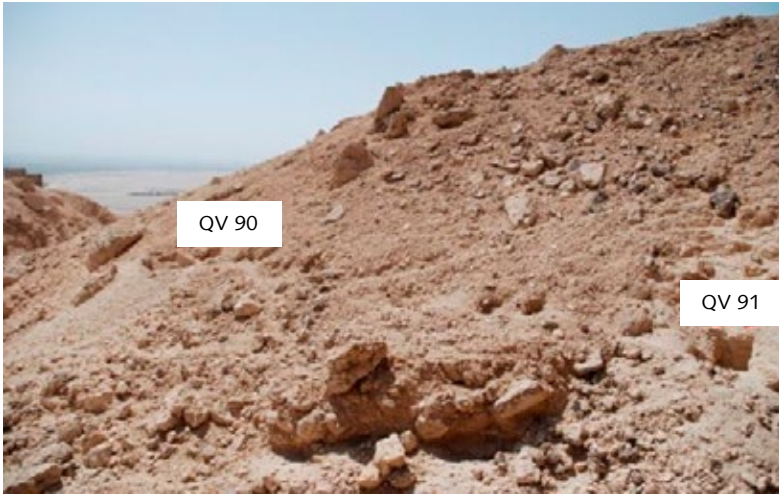
Shaft of QV 91 with trash at bottom.

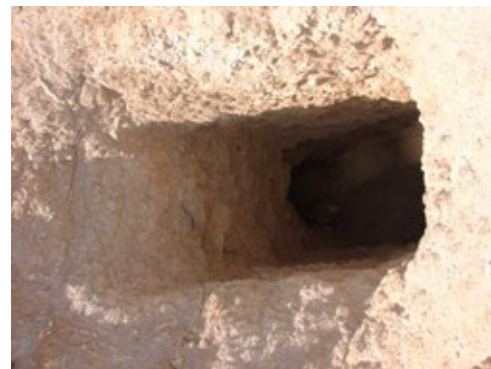
Eroded shaft of QV "B."

It is recommended that these tombs be treated as a group, with one or several diversion walls constructed upslope to divert rain and flood waters and prevent erosion of the shaft entrances. It may be most appropriate to rebury several of the tombs such as QV "D" and QV "H," which have already been largely filled with debris.

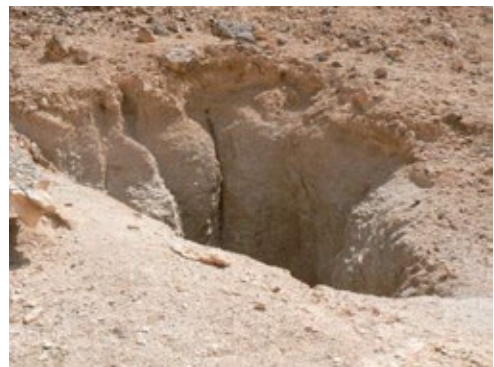
Entrance of QV "D."

Concerns about structural stability prevented the assessment of the interior of these tombs. The area immediately adjacent to their entrances is often severely eroded, and most of the shafts have been partially filled with debris. In some cases, particularly Tombs D, F, and H, erosion has created deep runnels that have isolated large blocks of shale, making them more prone to collapse. In Tombs J, K, and L, a red powder was cemented to the tomb floor at the time of the Franco-Egyptian investigations, attesting to previous water infiltration. The ceiling of Tomb J had also collapsed. At the time of the assessment conducted by the GCI, the entrance to Tomb L could not be located and it appears to have been naturally reburied since the time of the Franco-Egyptian excavations.

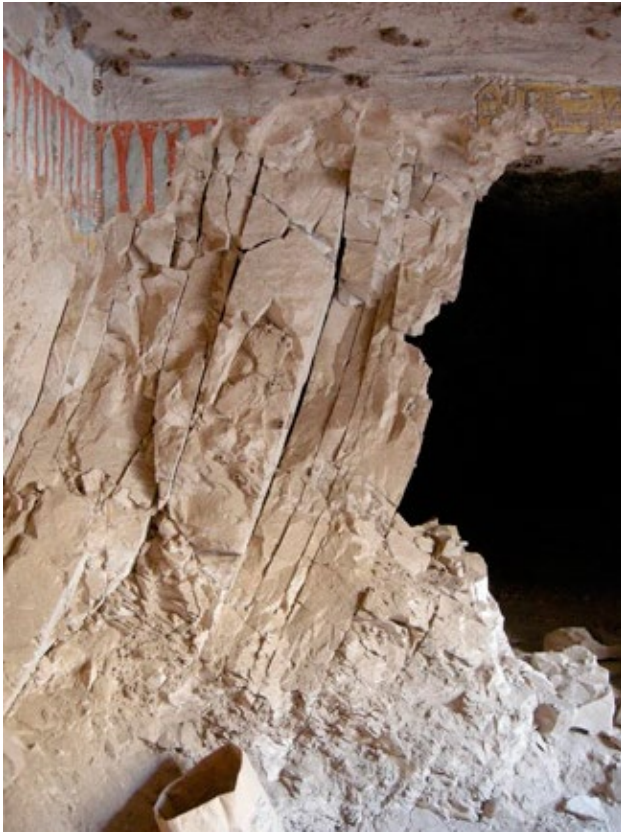
The rock into which the tombs were cut and then decorated was highly fractured as can be seen in this example from chamber (C) of QV 31. The diagonal fissures and fractured nature of the rock required substantial plaster to stabilize the underlying rock and prepare the surface for painting.

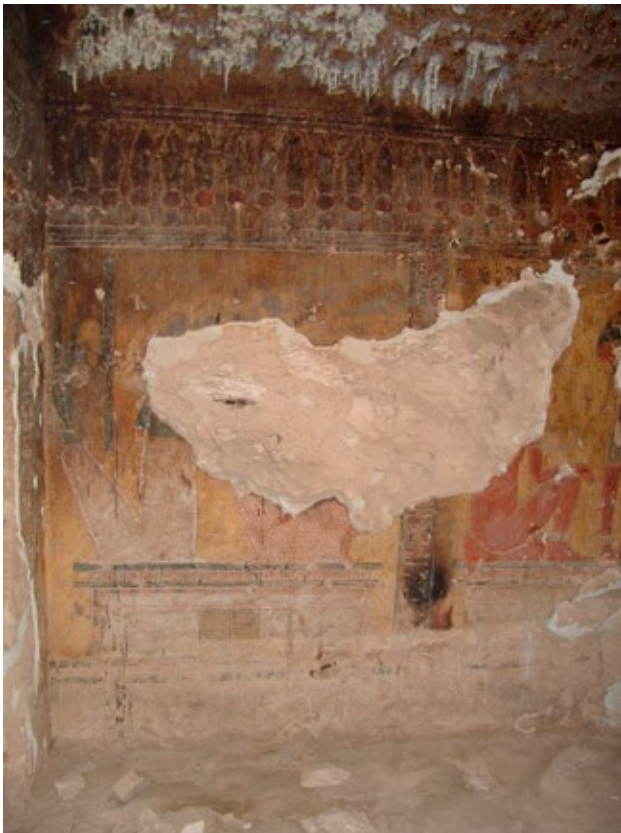
Large repairs, required to fill voids in the rock, have had a tendency to fall out or have lost their upper areas of painting, as in this example from chamber (E) of tomb QV 42.

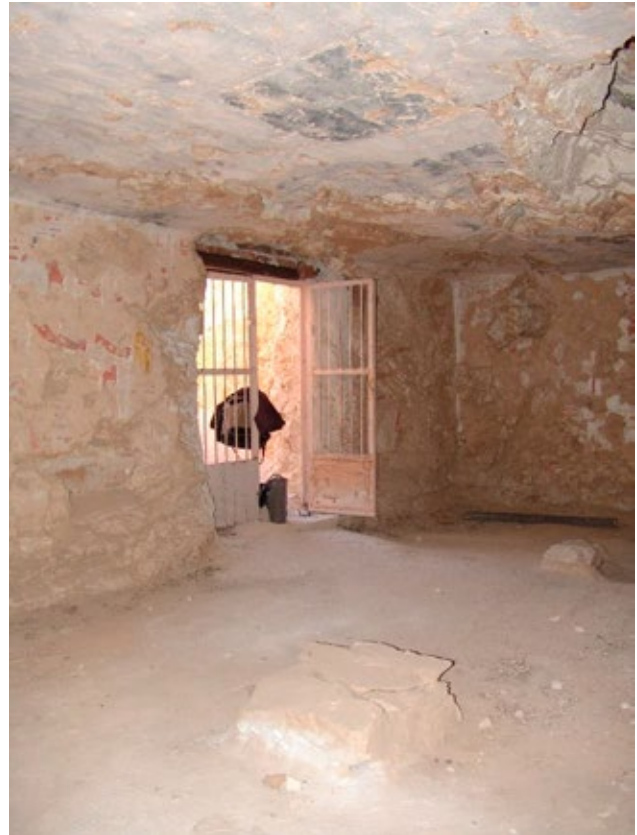
The pillar in chamber (C) of tomb QV 73 has been lost. The painting on the ceiling indicates that the pillar was constructed after the ceiling was initially painted and therefore most likely did not play a structural role.

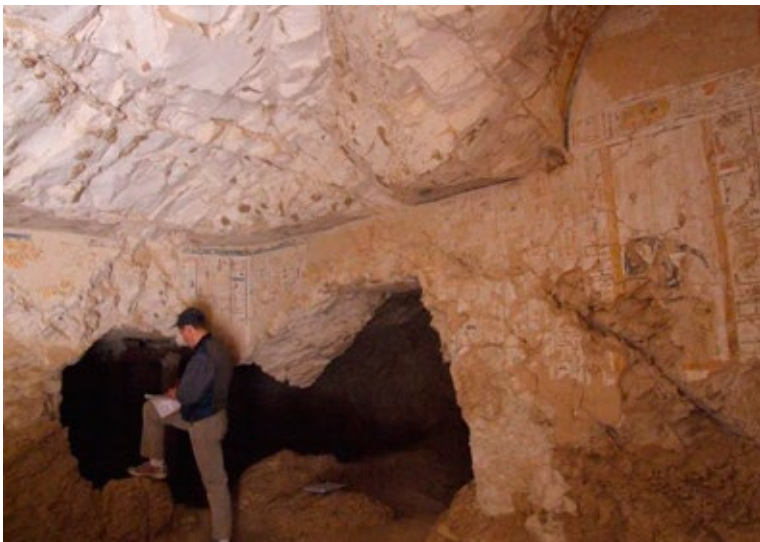
QV 60, shown here, exemplifies some of the severe rock related problems of tombs affecting their structural stability and wall paintings.

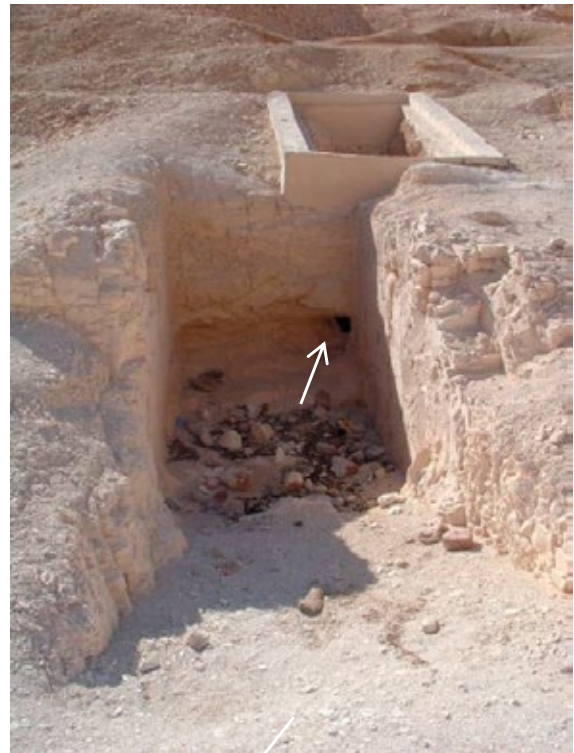
QV 24 with an arrow indicating the small opening to the shaft of QV 25. Prior to cleaning in 2007-2008, trash and human waste had accumulated in a shallow pit at the end of ramp.

It is recommended to partially rebury tomb to prevent continued use. Alternative toilet and trash receptacles for site personnel are needed on site.

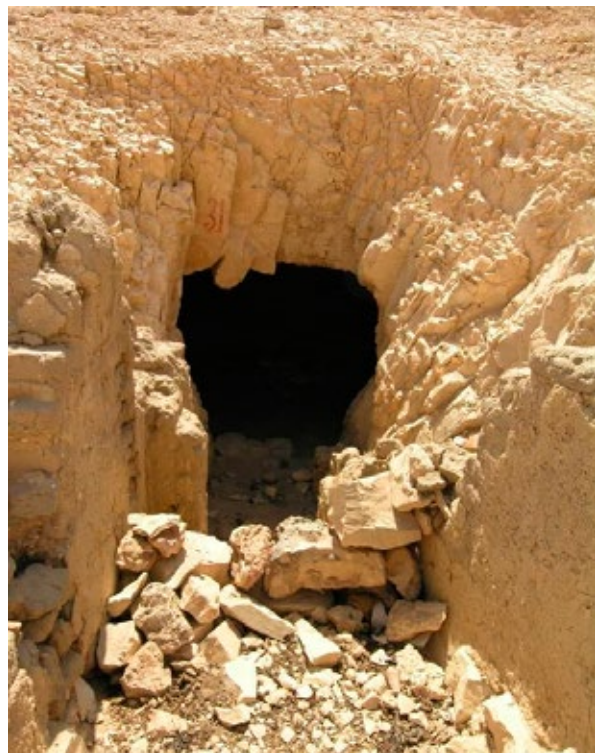
Ramp and Entryway in 2007. Fractured and falling rock along ramp and outside entryway; mudbrick walls lining the ramp; dry rubble wall in foreground placed in recent times as a barrier.

Stabilization of falling and heavily jointed rock is necessary to prevent loss of rock and associated plaster decoration. The mudbrick walls lining the entrance ramp also require stabilization. Thorough assessment of earlier interventions is required and any removal or replacement may be determined necessary.

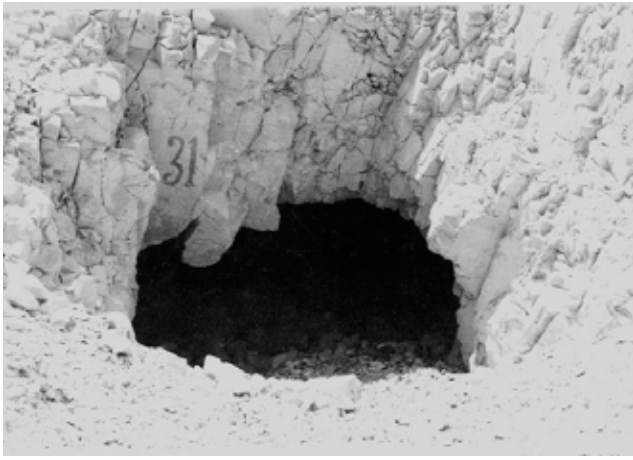
Entrance (B) showing fractured rock, before clearing of ramp in 1986-87 (Image: CNRS).

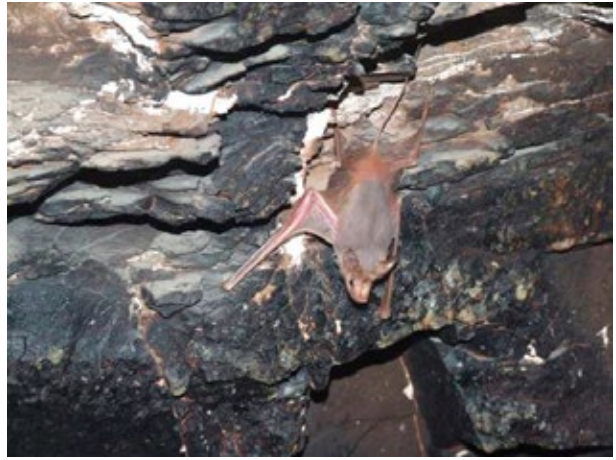
Chamber (I). A bat hangs from the wall of the chamber in an area of surface blackening.

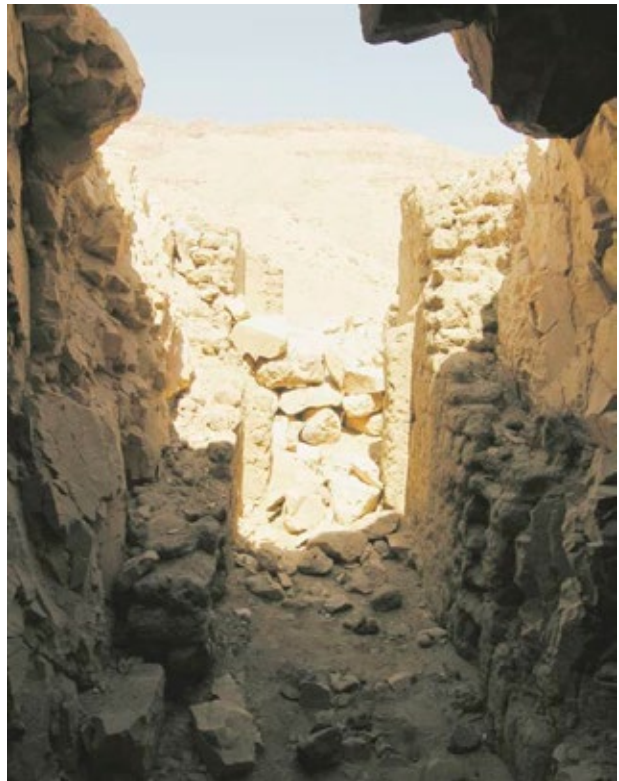
Localized loss of stone and mudbrick on each side of entry ramp (A), noted since 1990 photo.

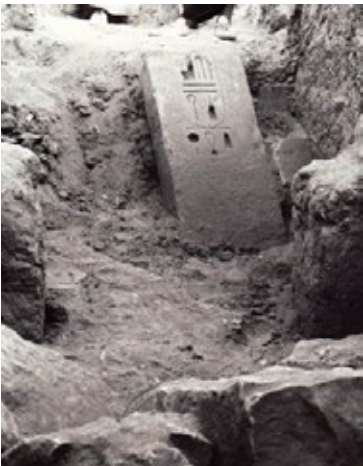
Left: Door jamb, re-used in tomb, as found during excavations in 1987 (Image: CNRS);

Right, door jamb as found in 2007 lying upside-down amid trash and fallen debris; removed in 2008

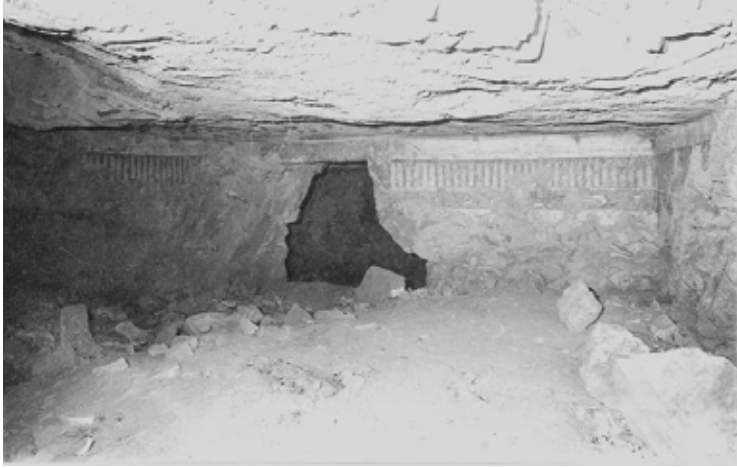
Chamber (C) before clearing by CNRS in 1986-1987. Debris was accumulated in the chamber about one-third of wall height. (Image: CNRS)

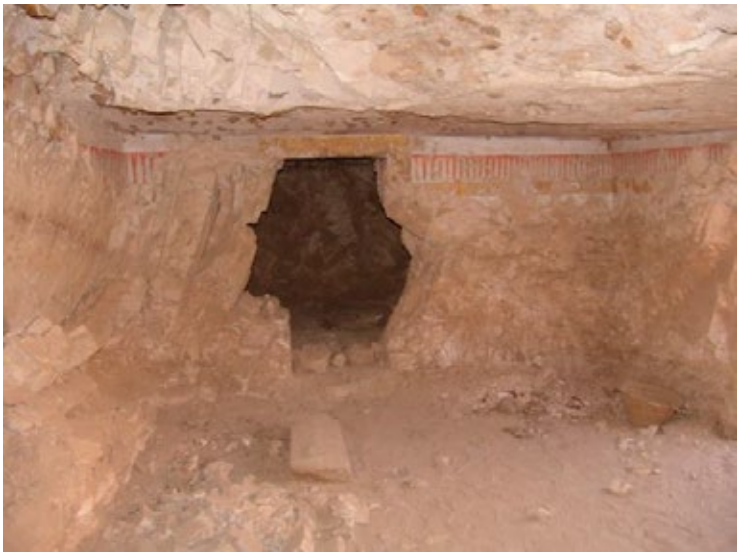
Severe and widespread loss of rock is found throughout the tomb, especially above the entrance and in the lower two-thirds of chamber walls in main chamber (C). Comparison with CEDAE photographs from 1990 confirms that most of the loss occurred prior to that date and that more recent losses are localized. There is evidence of recent collapse along the rear wall of the main chamber where parallel fractures (joints) run perpendicular to the bedding planes; a dark horizontal stain runs along the walls of this chamber. Further evidence of rock loss is present in the entrance ramp and in the ceiling of the main chamber. Fractures also run along the west wall on either side of the doorway in the main chamber. There are recent localized losses of mudbrick and rock, primarily in the main chamber and ramp as evidenced by the photographic documentation. Previous documentation in side chambers was not available for comparison but recent loss of ceiling rock is evident from small piles of fallen rock in west side chamber (E).

Main chamber (C), view towards doorway (D). Fractures with resulting loss along rear wall of tomb; painting only survives in this chamber along upper portion of wall; a large area of ceiling plaster is also extant (photo 2007).

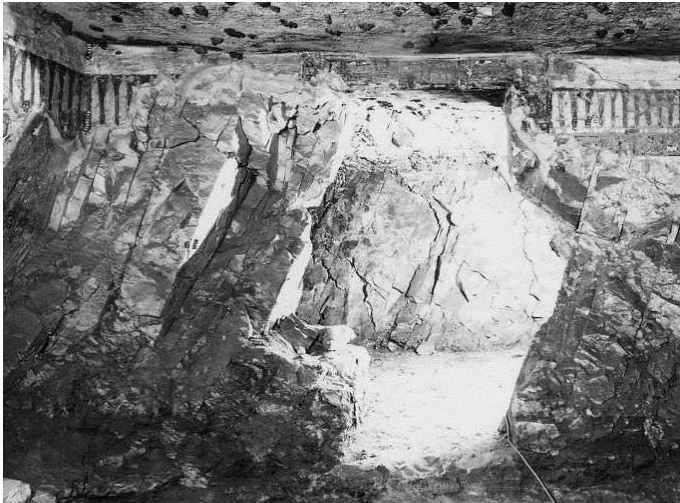
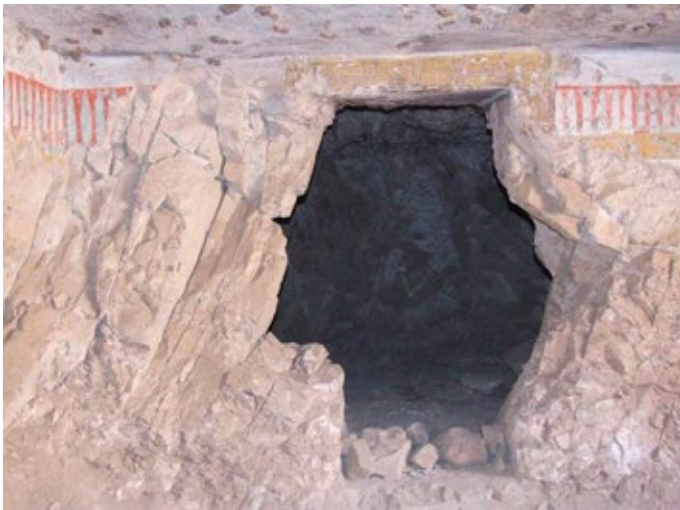
The doorway (D) from the main chamber into the western chamber (E) has suffered severe rock loss in both jambs, resulting in a trapezoidal shape. Rock fracturing and deformation are particularly notable within the south jamb (on the left). The south jamb of doorway (D) has parallel fractures running through the rock that have weakened it and resulted in deformation and cracking. Localized progressive cracking was observed here in comparison with photos from 1990.

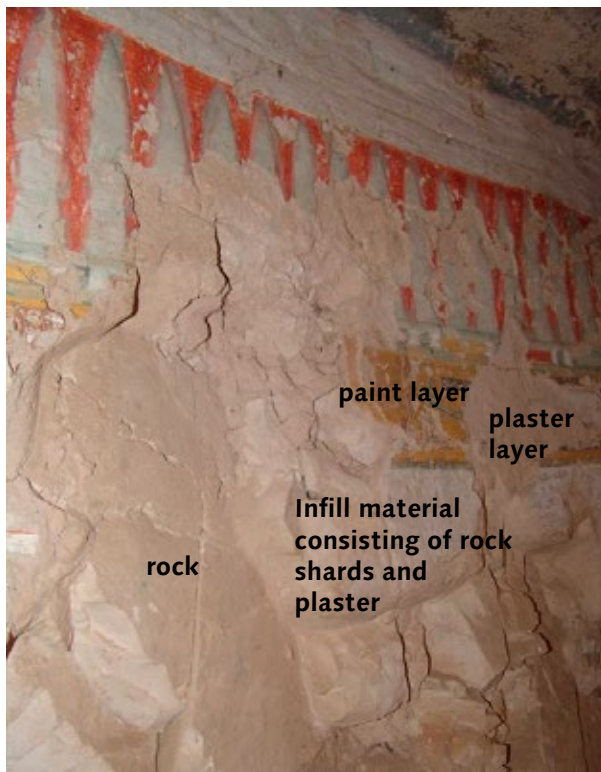
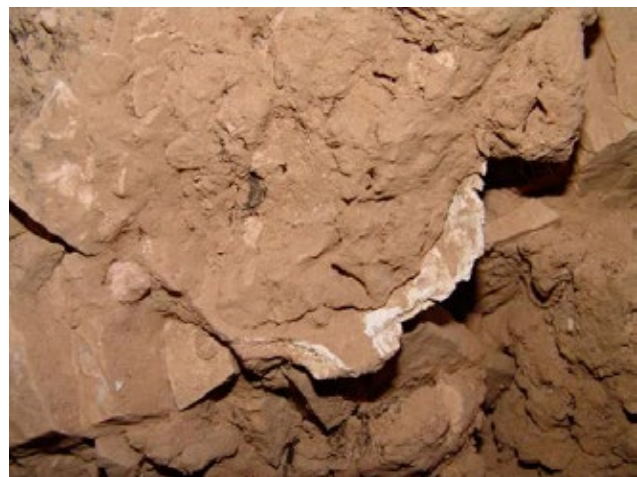
A skull fragment used as fill material was found on the east wall of the main chamber (C).

Area of loss on west wall of main chamber (C) provides a good opportunity to see the stratigraphy of the painted plaster.

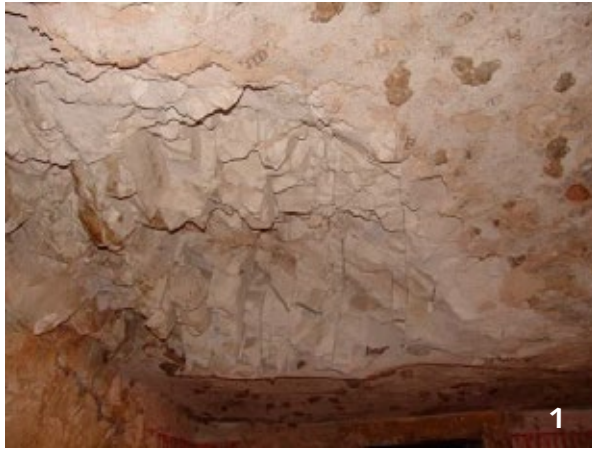
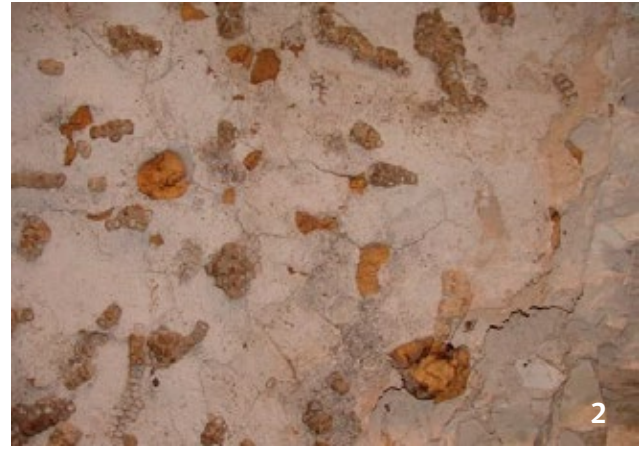
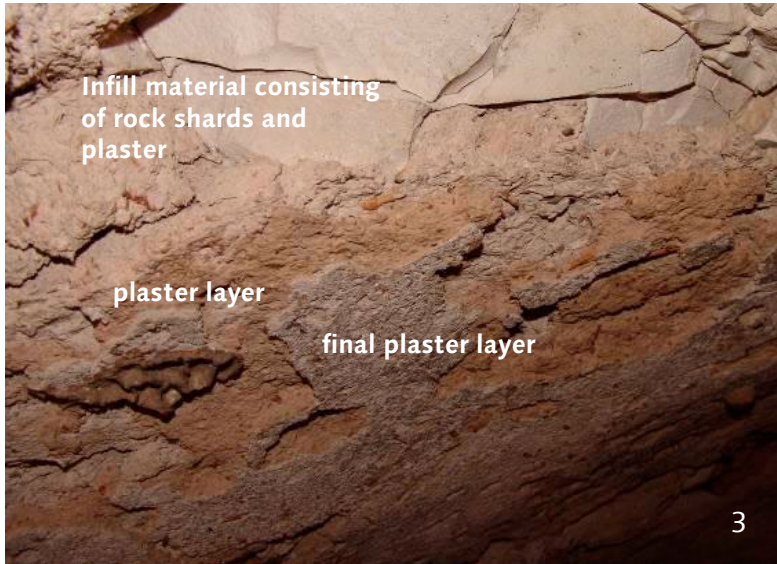
Ceiling of main chamber (C):

1. Most of the undecorated ceiling plaster in chamber (C) is intact, but there is a large area of loss above the rear south wall.
2. Animal dung inclusions and remains of wasp nests are present on plaster.
3. Area of loss on ceiling of main chamber (C) provides a good opportunity to see the stratigraphy of the painted plaster.

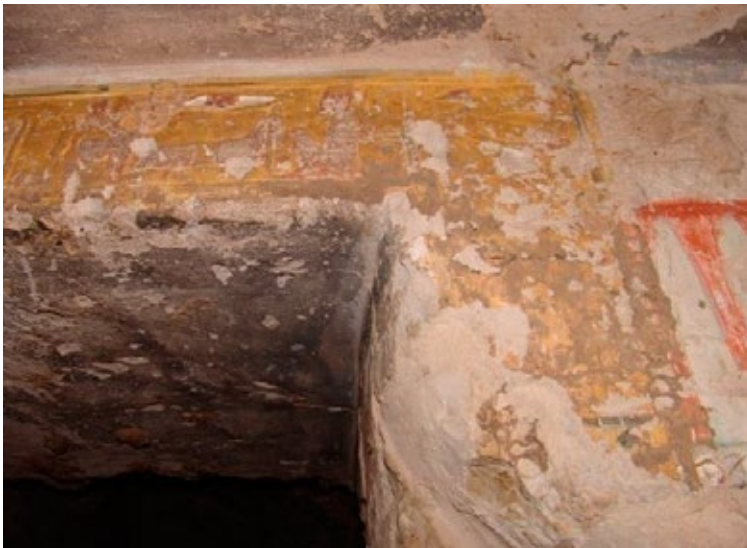
The repair plasters used around areas of painting, which are stronger than the original plaster, may have contributed to cracking and eventual detachment and loss of adjacent areas of painted plaster.

Evidence of later overplastering on original painted plaster on door jamb (F) of main chamber (C) . Traces of wasp nests are also visible here.

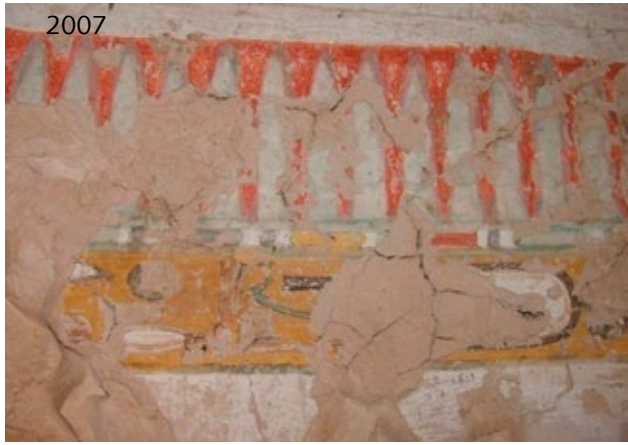
2007
Detail of an area of painting on the west wall of main chamber (C) taken in 2007. Note the cracking in the plaster layer.

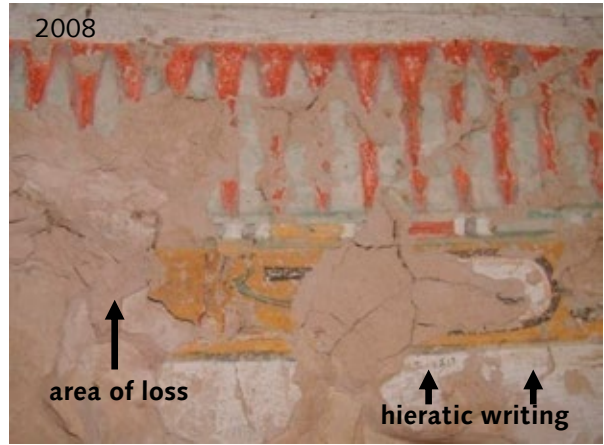
2008
Photograph of the same area taken one year later in 2008. Note the loss of painting. Hieratic writing is visible in this area (lower right).

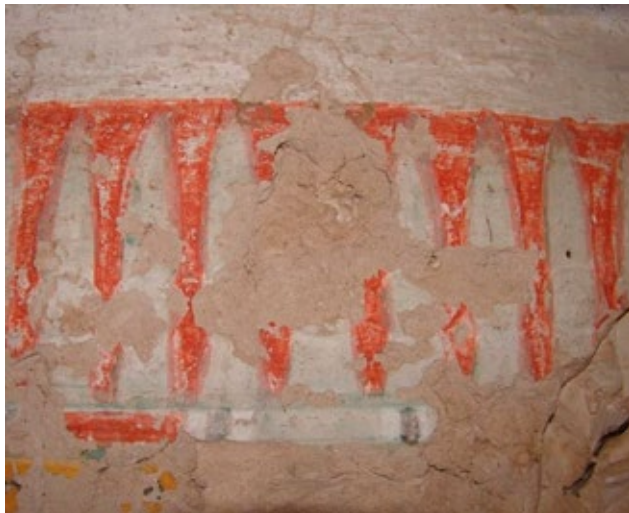
The surviving decoration is fragmentary and is found only at the tops of walls (*kheger* frieze) and on the ceiling. Of the few remaining areas of painting the plaster is fragile with cracking and detachment. Losses of painted plaster can be seen in comparison with the 1990 CEDAE photographs. Recent losses were also noted on the west wall of main chamber (C) between an inspection in February 2007 and a year later in 2008. Two hieratic inscriptions exist in areas close to these losses and are an additional cause for concern. More gradual surface deterioration is also present; pigments such as greens are pale in appearance due to the exposure of paintings to natural weathering over time and decohesion and loss of the paint layer. The decoration is considered at medium risk of further deterioration and loss.

Image of the top band of decoration in main chamber (C) showing the fragile nature of the surviving painting. Note general losses in the paint layer and the cracked and unstable edges of the painted plaster around area of loss.

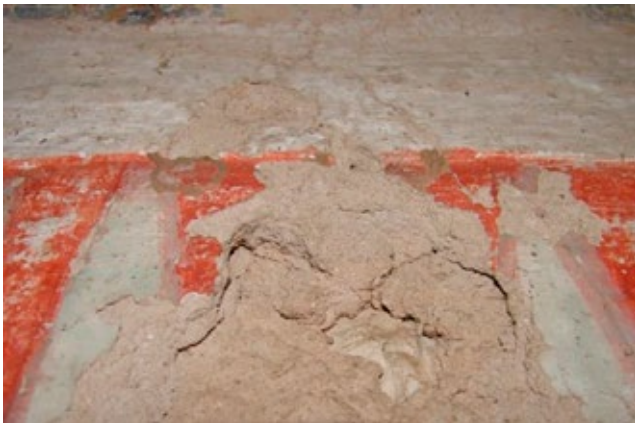
Detail showing fading and loss of the green paint due to weathering and exposure of the paintings over time.

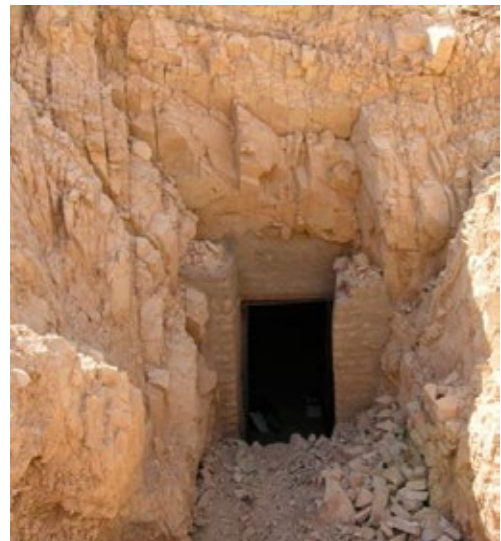
Ramp and entryway in 2007. Severely fractured rock lies above reconstructed entrance. Debris from fallen rock lines the ramp.

The rock into which the tomb is cut is highly fractured and exhibits ongoing loss. Comparison with 1978 CEDAE photographs shows recent loss along the sides of the entrance ramp (A) and above the entryway (B). This area of rock remains at risk of further collapse. Localized areas of recent loss are also present in chamber (C), along the west wall, and especially in the center of the ceiling where post-fire loss is apparent. Substantial rock loss has occurred in doorway (D) and in the ceiling of chamber (E), resulting in a high, vault-shaped ceiling. Some of this loss occurred after blackening of rock surfaces. The rear and front walls of chamber (E) have steeply dipping joints along which rock fragments have broken off, resulting in fragile remains of the front wall.

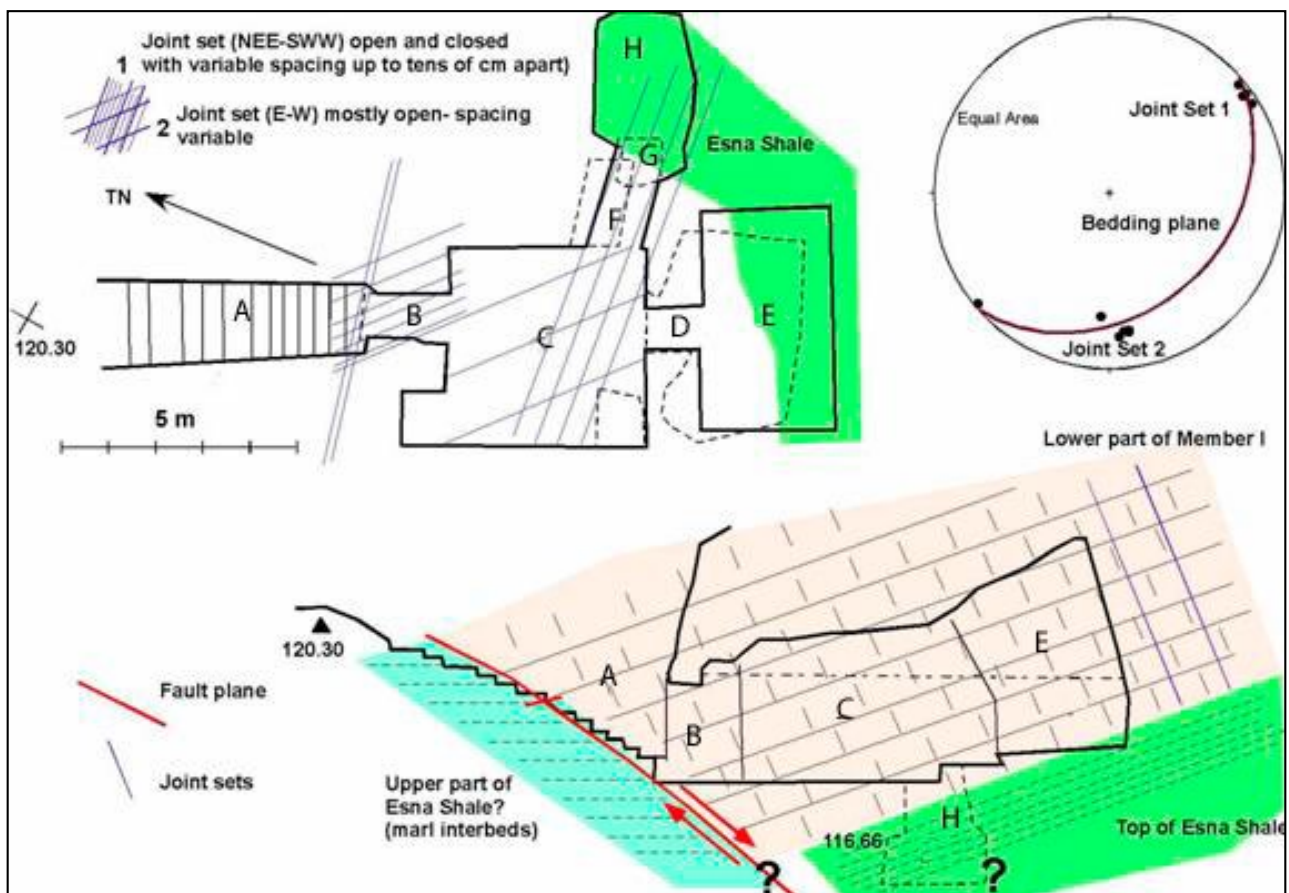
The excavation of the tomb into an area of geological faulting and contact between marl and shale is the principal factor in the inherent poor quality of the rock and its heavy fracturing along bedding and joint planes and subsequent extensive loss both inside the tomb and above the entrance. Rare rain events are likely to be a contributing factor to the fracturing of the rock, especially above the entrance where the rock is most exposed.

Geological and structural analysis of tomb QV33. Note presence of shale and orientation of bedding (Mapping: Wüst 2008).

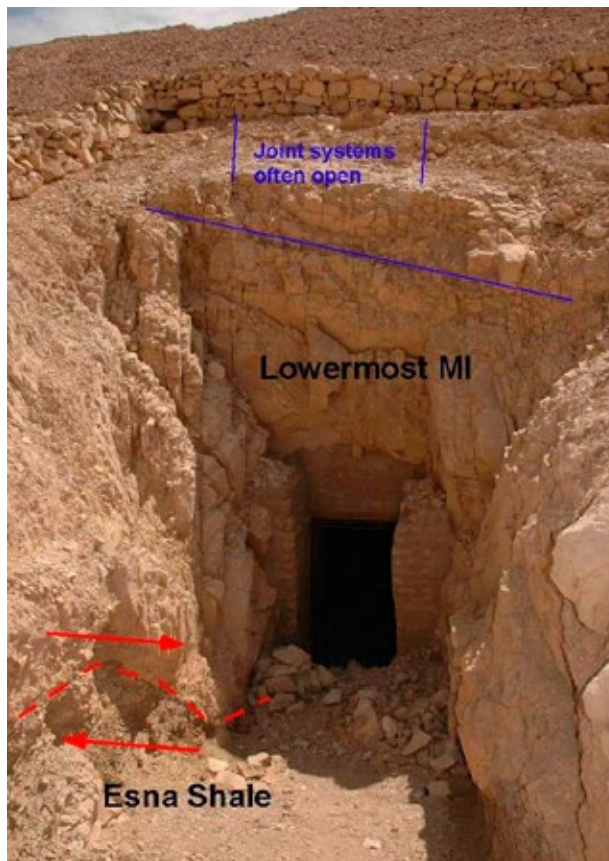
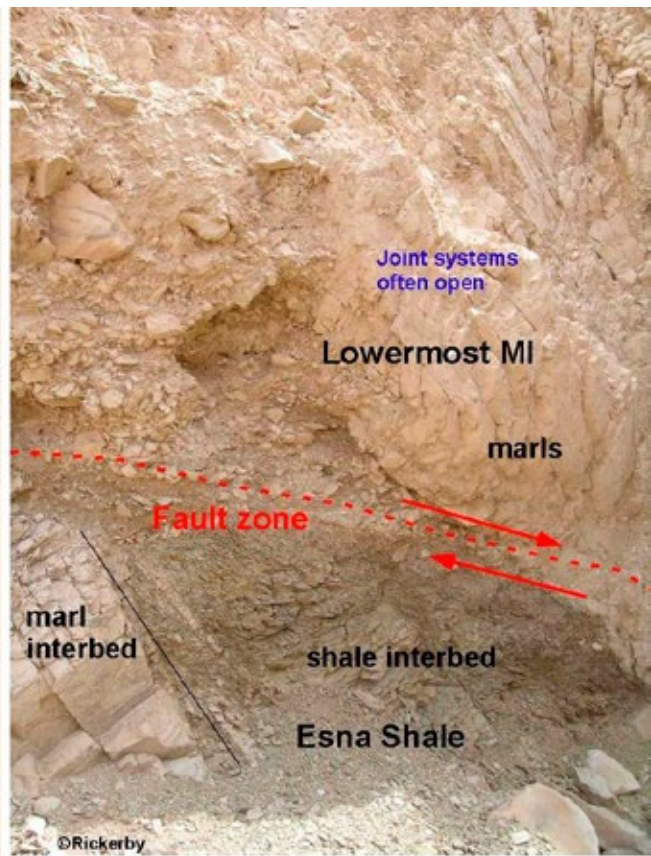
Entrance ramp (A) of QV33 showing the heavily jointed bedrock and the fault plane within the Esna Shale at the base of the upper part of Ramp (A). Marl interbeds lie within the bedrock. The rotation of the block in the Valley of the Queens occurred within the upper and middle parts of the Esna Formation as the shales present an ideal sliding plane. However, during rotational movements, the block experienced multiple small-scale fracturing to accommodate for changes in stress fields.

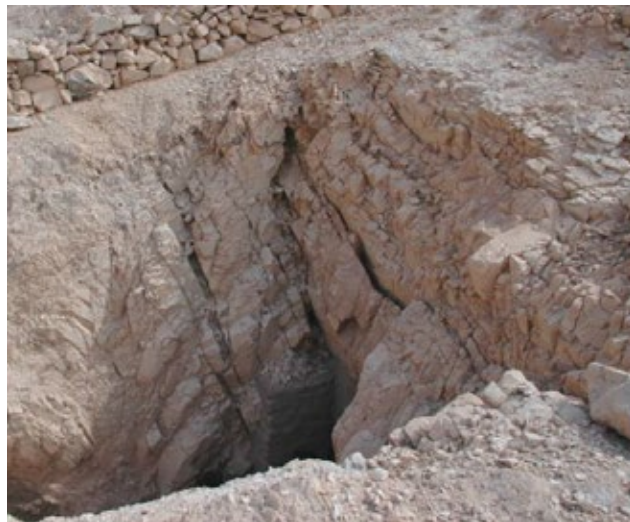
Open joints and related rock detachment above entrance.

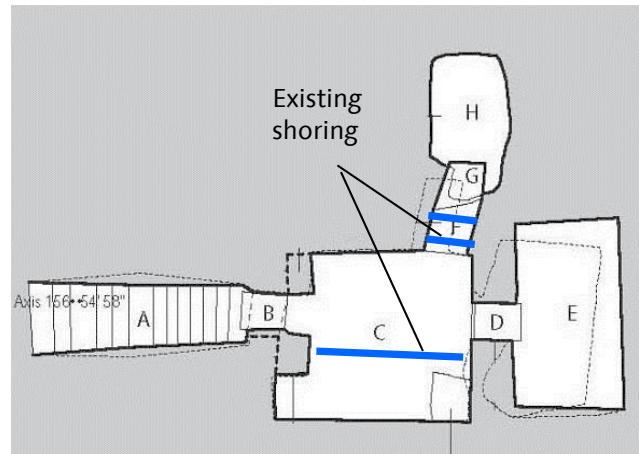
Existing wooden shoring in QV 33.

An assessment of the shoring and the intervention of rock surface plastering inside the tomb is necessary to determine if these methods are adequate to stabilize the tomb and prevent further rock loss.

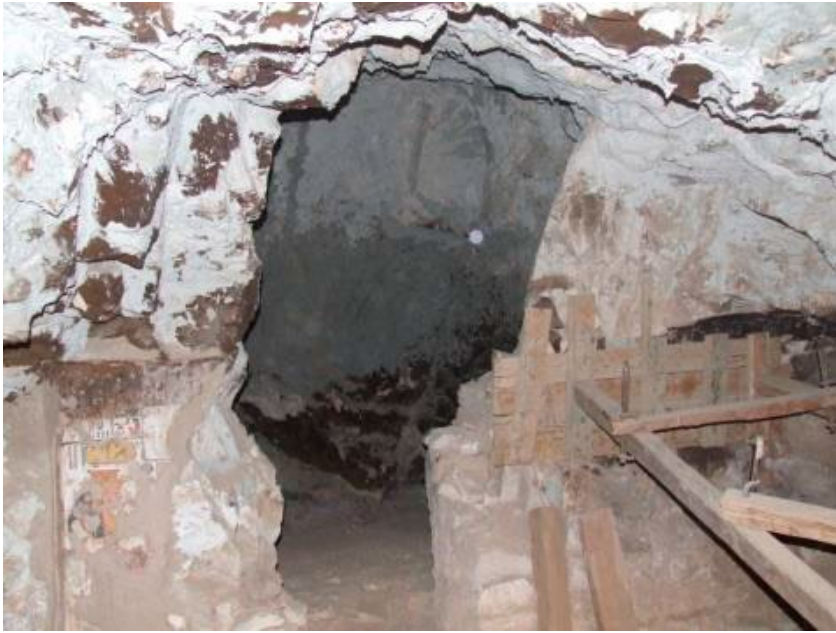
View into burial chamber (E) from main chamber (C). Wooden shoring on the right supports fragile internal wall; white plaster was spread liberally over ceiling rock in an attempt to prevent rock fall.

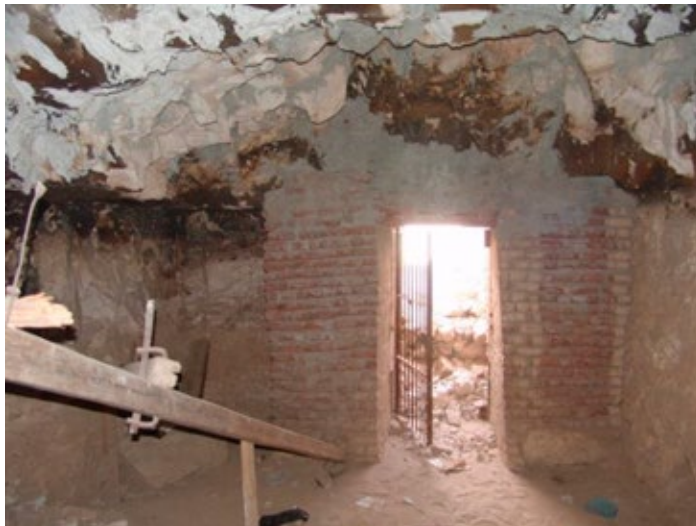
Reconstructed entryway (B) and extensive plastering on ceiling to prevent rock loss in chamber (C)

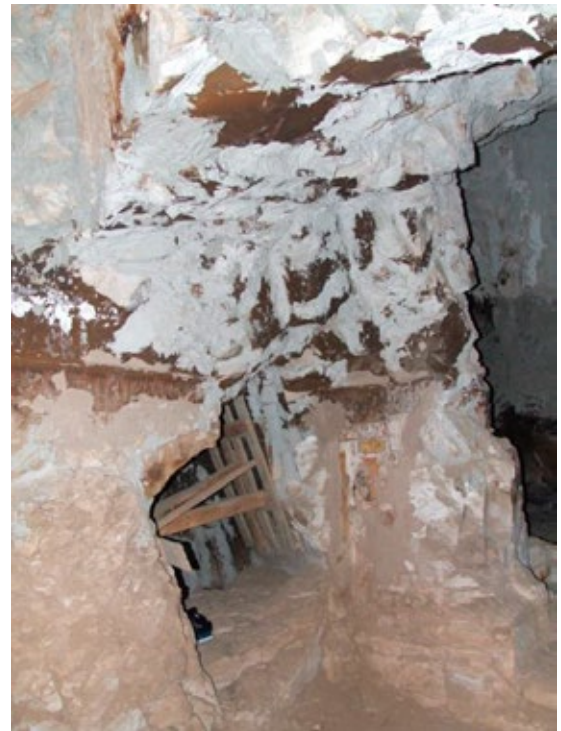
Shoring in niche (F) of east wall of Chamber (C) with plaster repairs of fractured and blackened rock of upper part of wall and ceiling above. In upper left part of wall, post-fire loss of ceiling rock is visible.

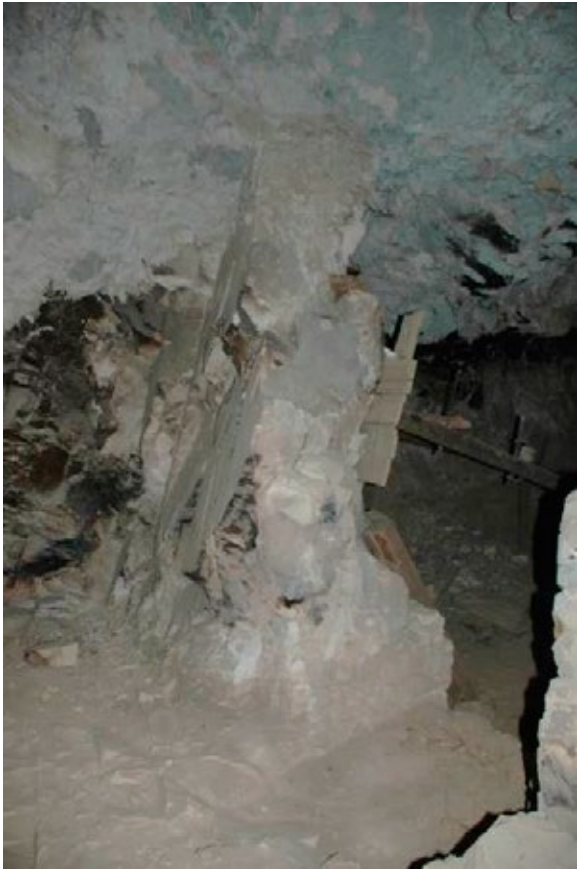
Shoring supporting fragile remains of heavily fractured rock of wall between chambers (C) and (E), west of doorway (D).

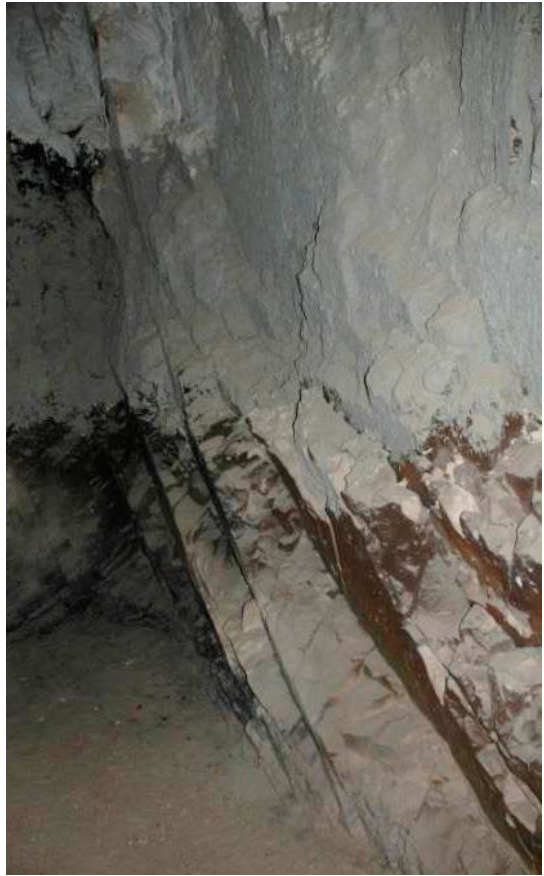
Steep joint planes in rear south wall of chamber (E) with recent rock plastering to prevent loss in upper part of the wall.

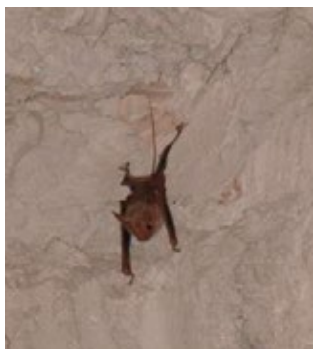
Bat in chamber (E)

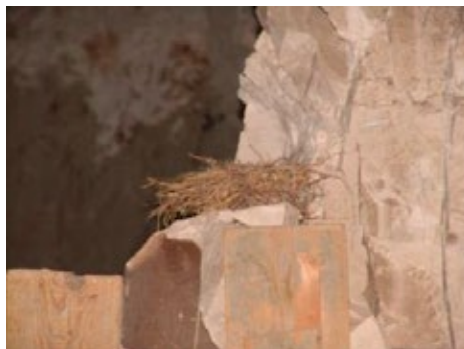
Bird nest on rock in doorway (D)

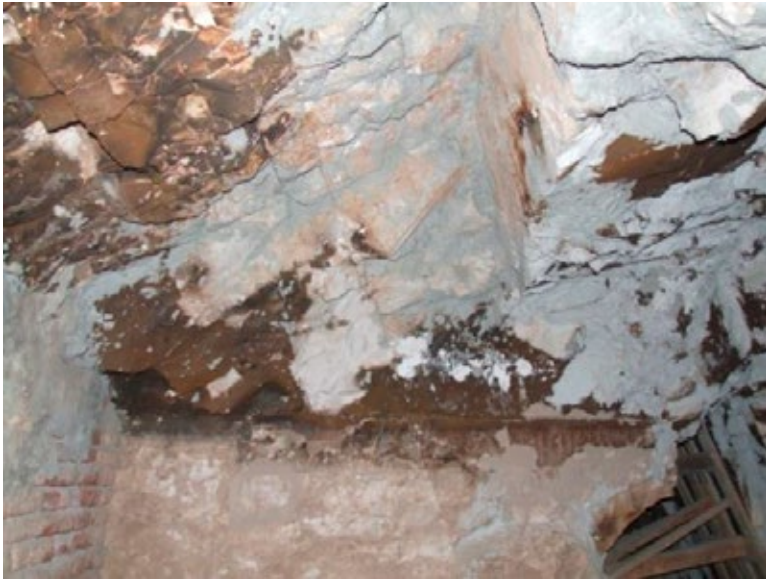
Ceiling of main chamber (C). Note significant amount of post-fire loss. White and gray modern repair plasters are possibly gypsum and cement based.

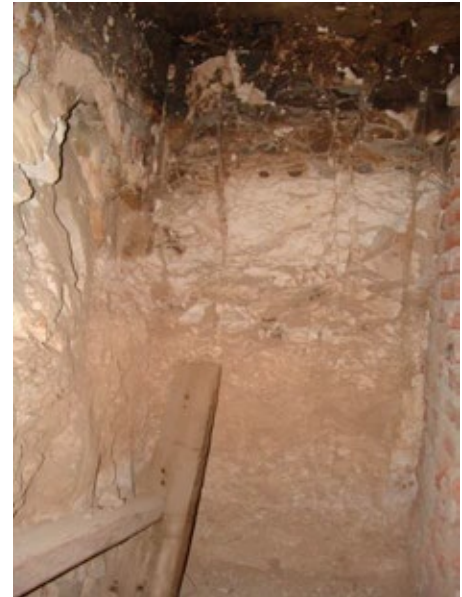
North wall of main chamber (C). Painting survives only at the very top of the wall.

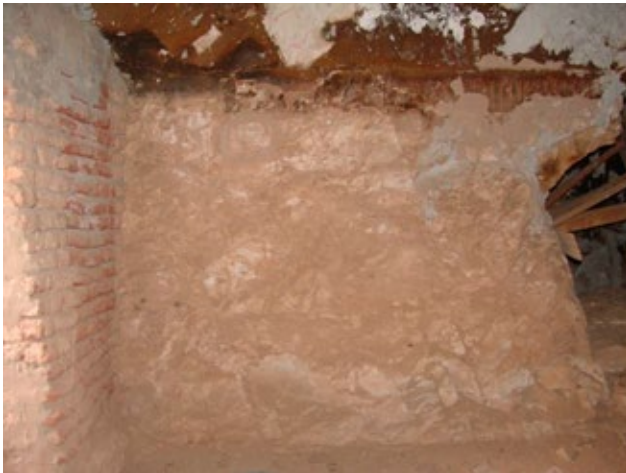
East wall of main chamber (C). Painting survives only at the very top of the wall.

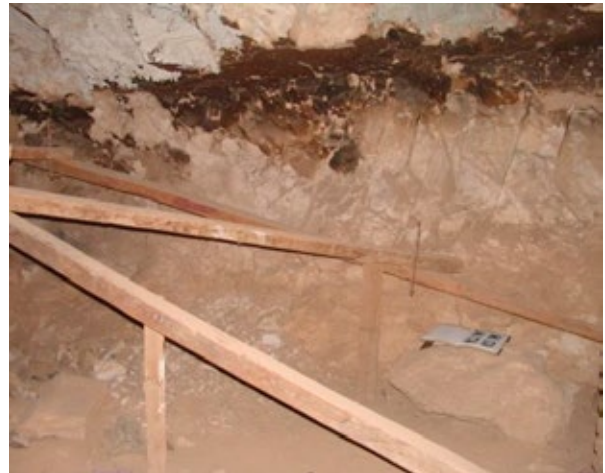
West wall of main chamber (C). Painting survives only at the very top of the wall.
