Valley of the Queens Assessment Report

Volume 2

Assessment of 18th, 19th, and 20th Dynasty Tombs

A collaborative project of the Getty Conservation Institute
and the Supreme Council of Antiquities, Egypt

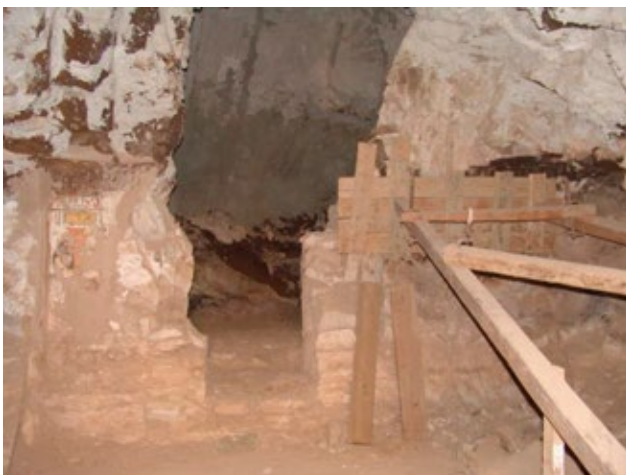
South wall of main chamber (C). Current wooden shoring is covering areas of painted plaster. Substantial amount of original fill plaster also survives on this wall.

Much of the previous treatment of the wall paintings has focused on the surviving area of painting that features the portrait of the queen. Stabilization of fragile areas of painted plaster in other areas of chamber (C) not previously treated is also required to prevent further loss. Currently some decoration is located behind shoring; particular attention should be paid to these fragile areas during structural stabilization work. Treatment required is generally localized and limited in scale.

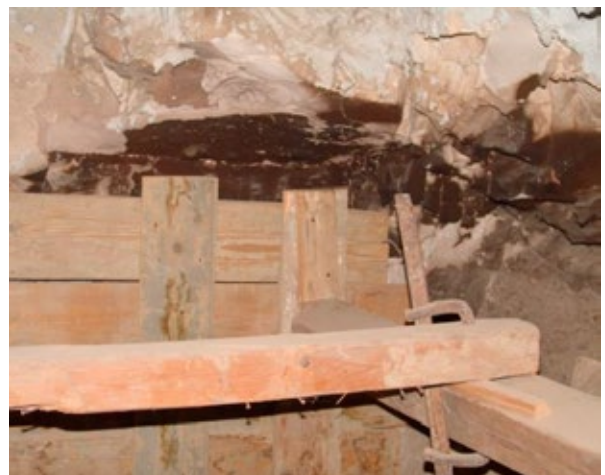
Detail of shoring that is covering areas of painted plaster.

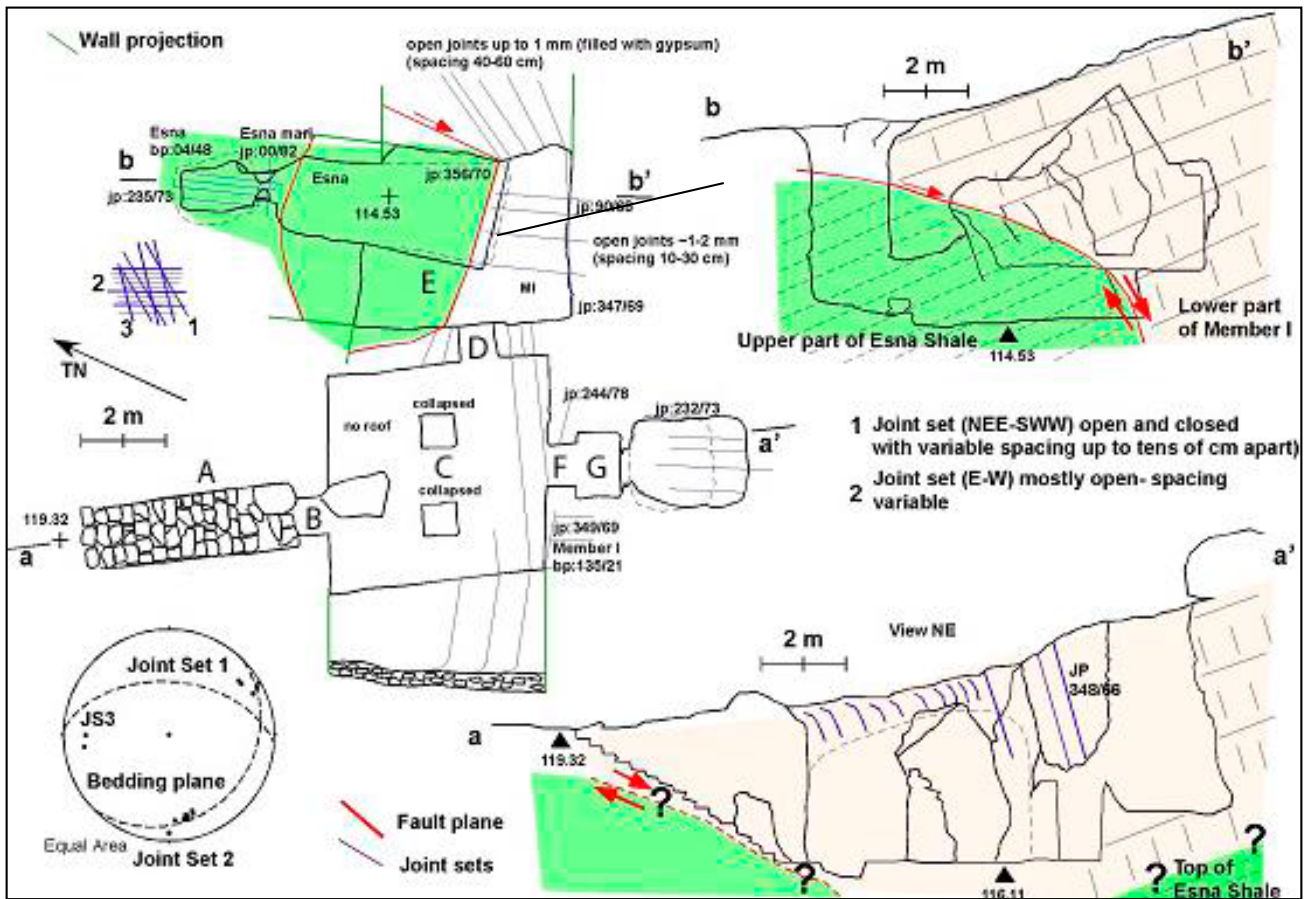
Geologic and structural analysis of tomb QV 34, showing major joint sets, fault plane, and location of shale (Mapping: Wüst 2008).

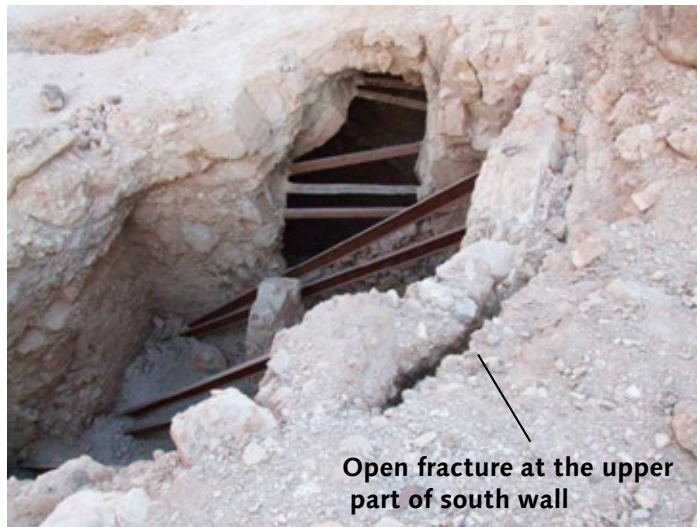
The most striking feature of the tomb is the loss of its roof and overburden, the only example of such collapse in the Valley. This is thought to have occurred in antiquity and was likely due to the highly jointed rock, the thin overburden of the main chamber, and the proximity to the shale below. Severe fracturing is present throughout the rock of the tomb, primarily along the open joints of the tilted rock which curve down towards the north just beneath the surface. The upper part of the south and north walls of the main chamber present significant open fractures running east-west, likely formed when the ceiling collapsed. These walls also contain many perpendicular micro-fractures which make the rock friable and susceptible to small-scale loss. The walls of the entrance ramp are similarly in very poor condition and it is difficult to distinguish between debris fill material and the poor quality bedrock.

Overview of main chamber collapse, with view of shoring in side chamber. Open fractures at ground surface behind the area of collapse is evident.

A roof over the main chamber is required in order to protect the fragile wall plaster remains and wall faces from water erosion and detachment in the event of rain. The existing shoring in both chambers should be modified, and new shoring should be installed in the side chamber to support the thin overburden. The fault zone in the side chamber and rock fractures in both chambers should be monitored for movement and stabilized as needed, and the fragile shale surfaces in the side chamber should be stabilized by plastering over the surface.

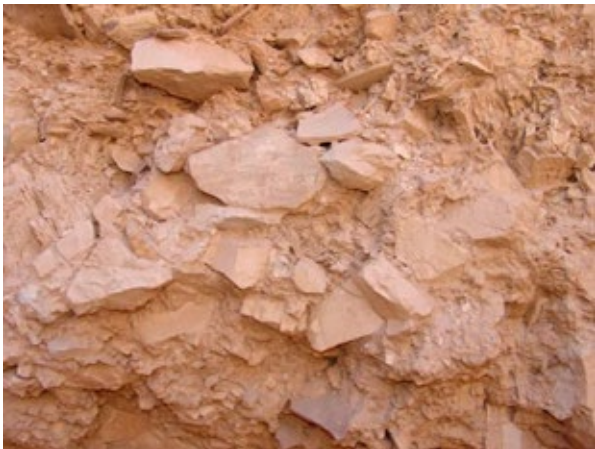
Substantial infill material used to pack out walls. Note large amount of rock and pottery shards mixed with plaster.

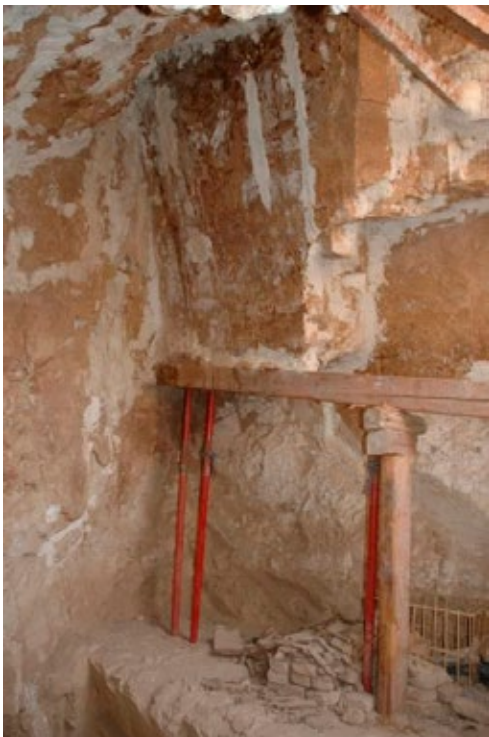
Existing shoring in side chamber (E).

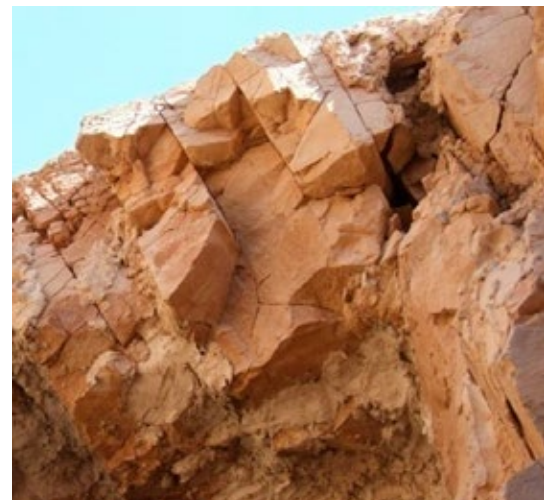
Detail of fractured rock in exposed wall.

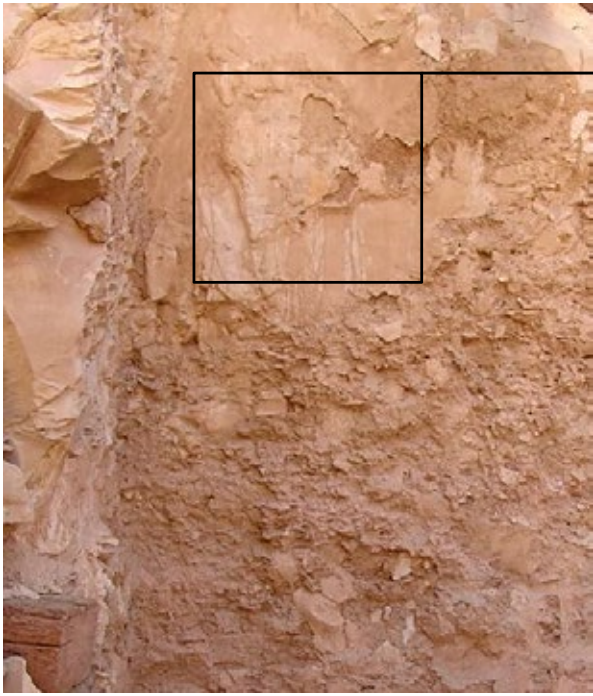
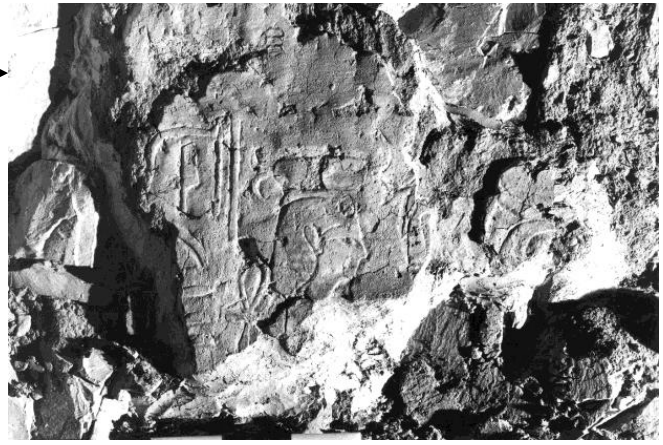
Surviving area of raised relief painting on the south wall of chamber (C). Note substantial losses that have occurred since this 1989 photograph (Image: CEDAE).

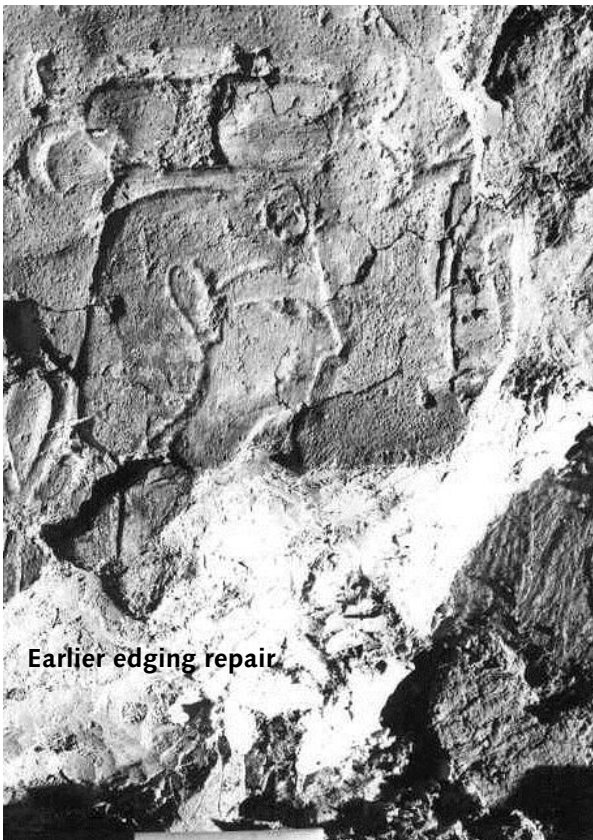
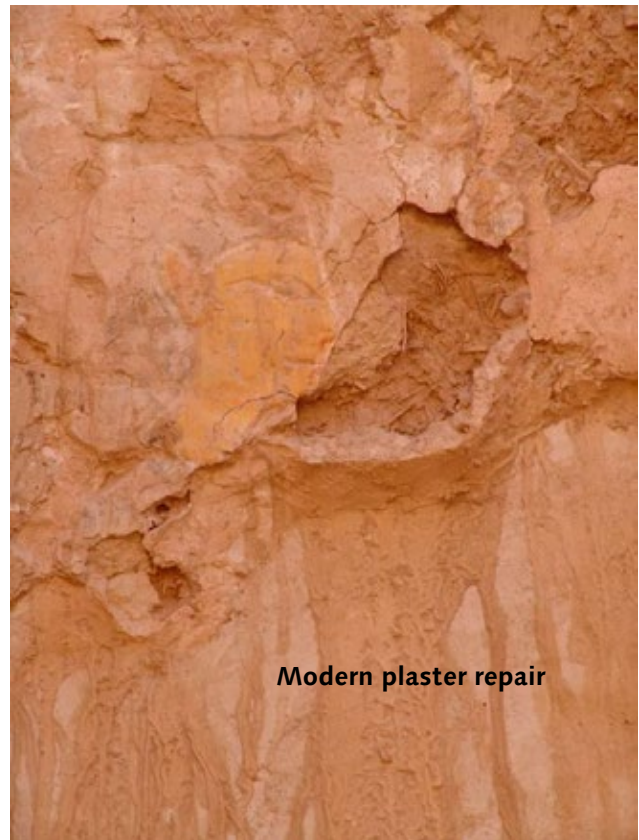
Earlier edging repair

Modern plaster repair

Detail of area of painting on the south wall of chamber (C). Note the large modern plaster repair (above, right) visible since the 1989 CEDAE photograph (above, left) which replaced the earlier edging repair visible in the CEDAE photograph. The loss of painted plaster and the vertical mud streaks are both clearly visible.

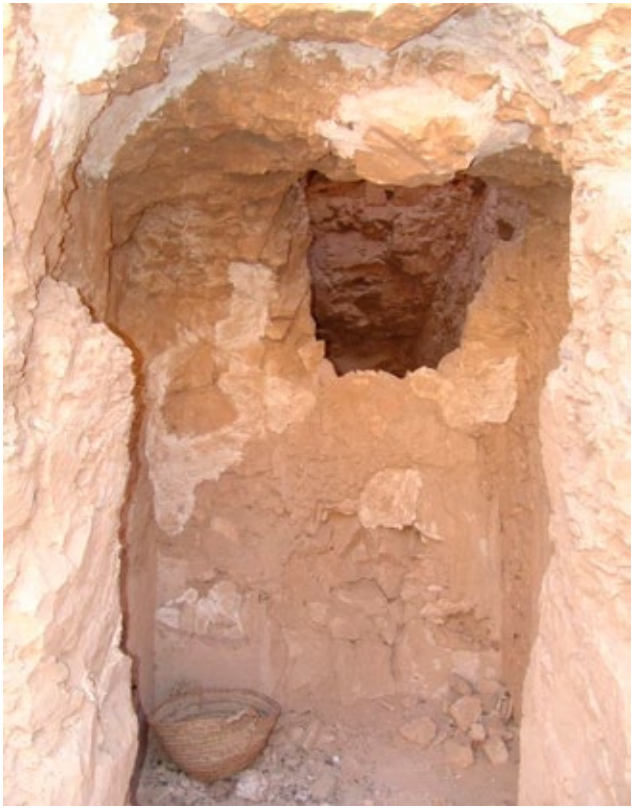
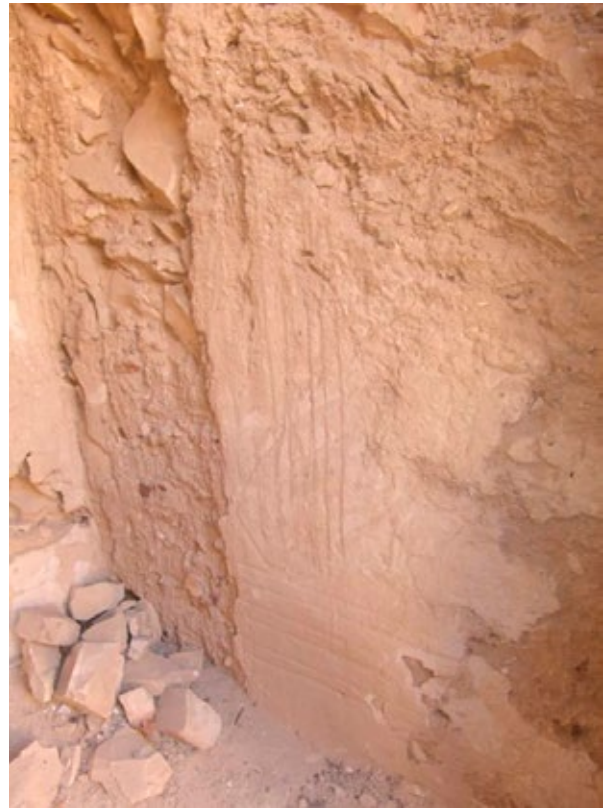
Water poured into small niche (G) from the hole visible in the photograph above left. This eroded away part of the incised plaster decoration on the west wall and left plaster drip marks on the surface of the area that survived. The painting in this area is now in fragile condition.

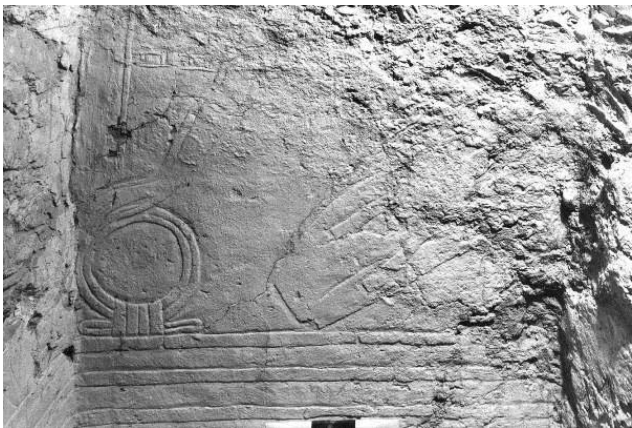
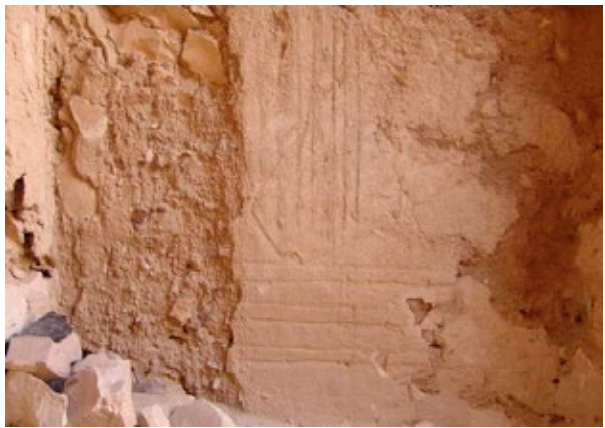
Detail of west wall of niche (G) in 1989 CEDAE photograph (above, left) compared with losses noted during 2007-8 inspection (above, right).

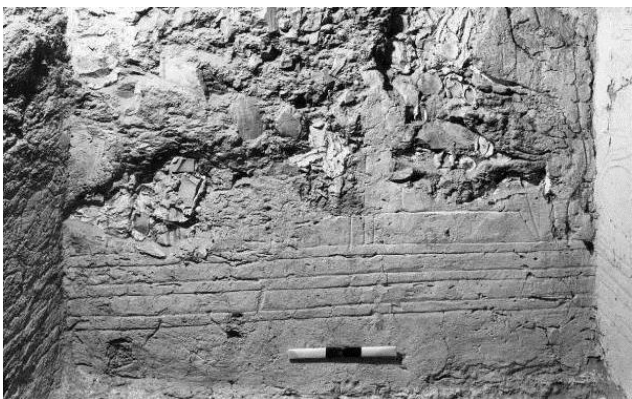
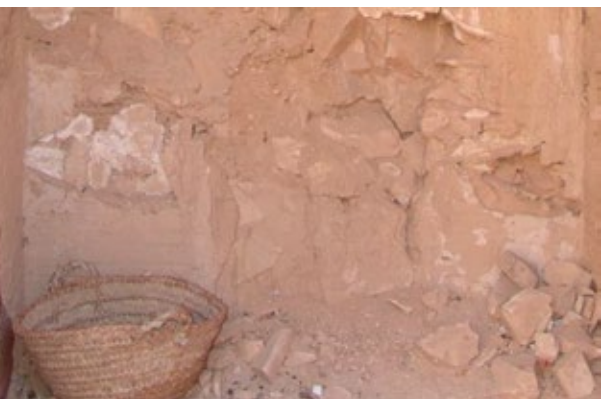
Detail of south wall of niche (G) in 1989 CEDAE photograph (above, left) compared with losses noted during 2007-8 inspection (above, right).

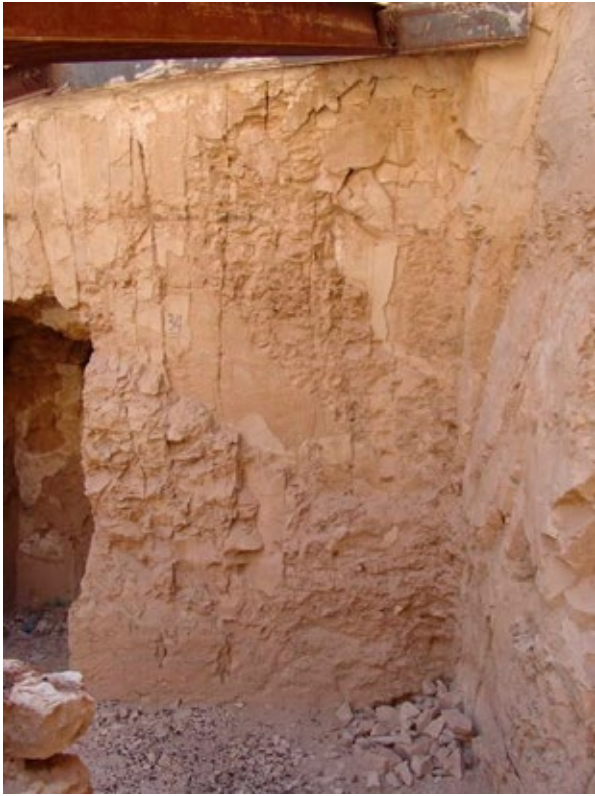
Area of painted plaster survives below steel, raking shoring on south wall of main chamber (C). This area of painting is in fragile condition as the rock support is highly fractured and susceptible to loss.

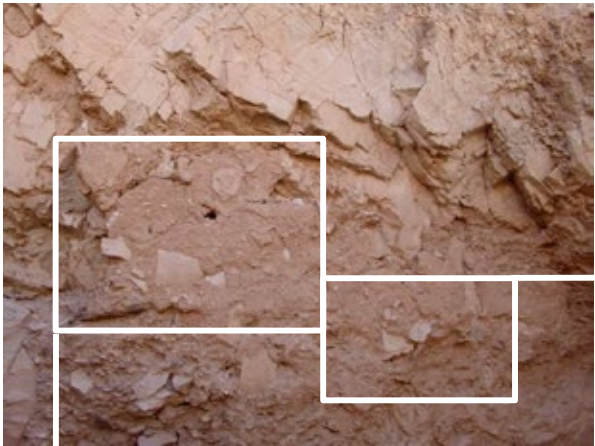
Area on the west wall of chamber (C). Substantial losses have occurred in this area

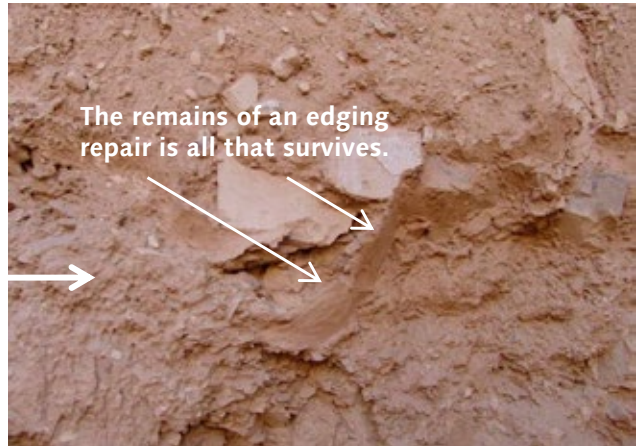
Traces of an edging repair still survive though the painting it once supported has now been lost.

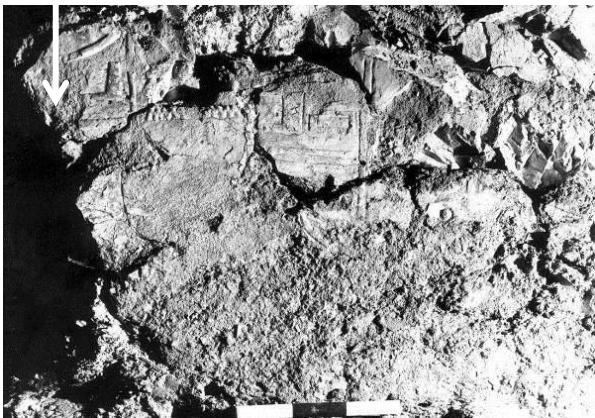
Detail of area on the west wall of chamber (C). Substantial losses have occurred in this area which has lost almost all traces of the raised relief decoration visible in the 1989 photograph, left (Image: CEDAE).

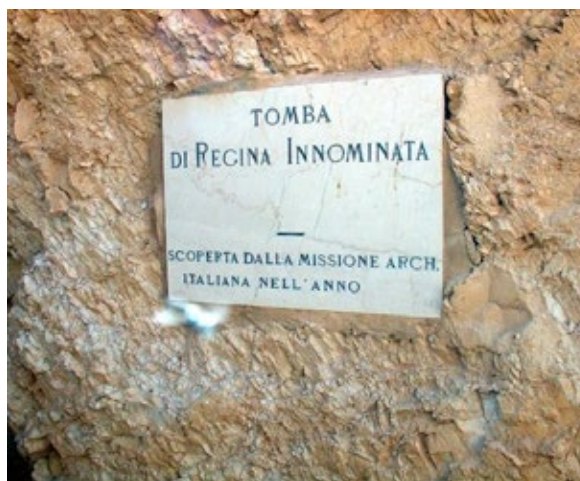
The Schiaparelli plaque, seen in 2005 photo above, is no longer in situ.

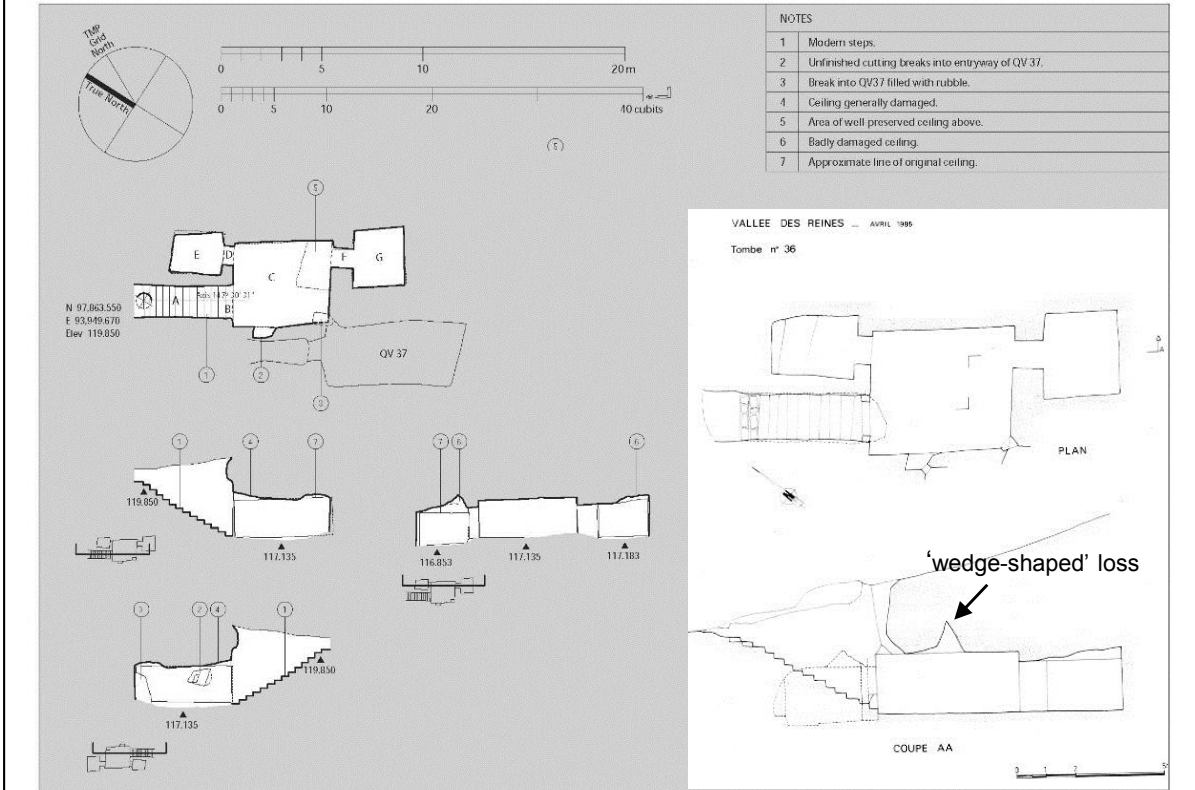
Plan, sections 1:200

Note that large wedge-shaped loss in ceiling of chamber (C) is not shown in the 1981 TMP sections, but it is seen in the CEDAE photographs of 1984 and the 1985 CNRS plan (inset: CNRS).

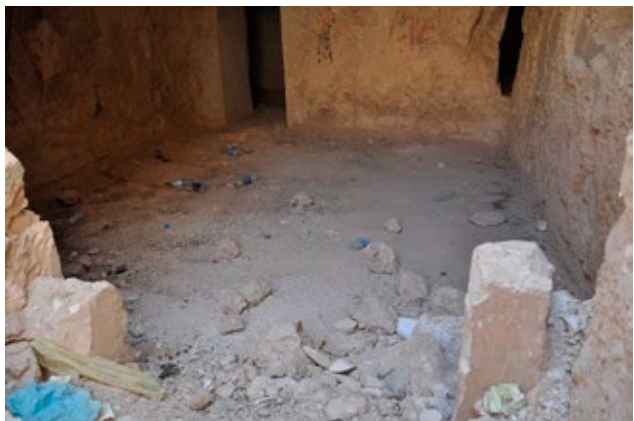
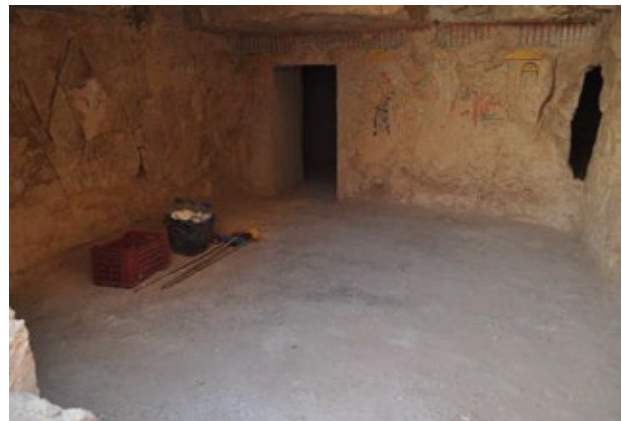
Main chamber (C) with loose rubble and trash in 2007 (left) and after cleaning by GCI-SCA in 2010 (right).

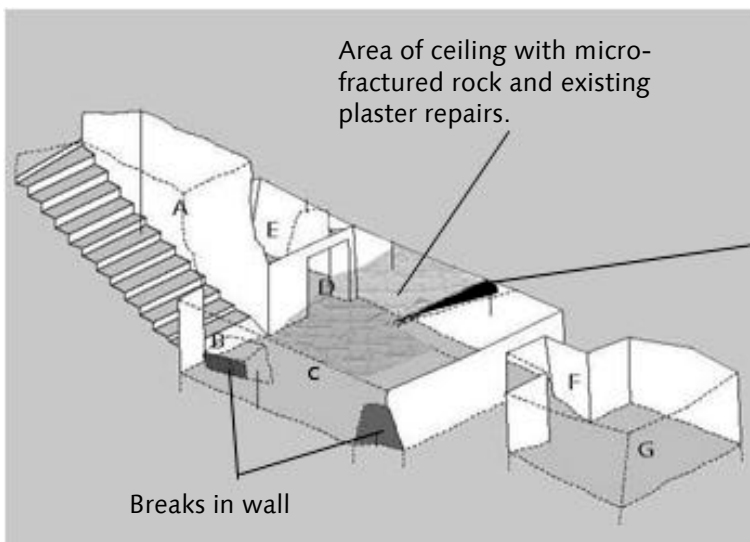
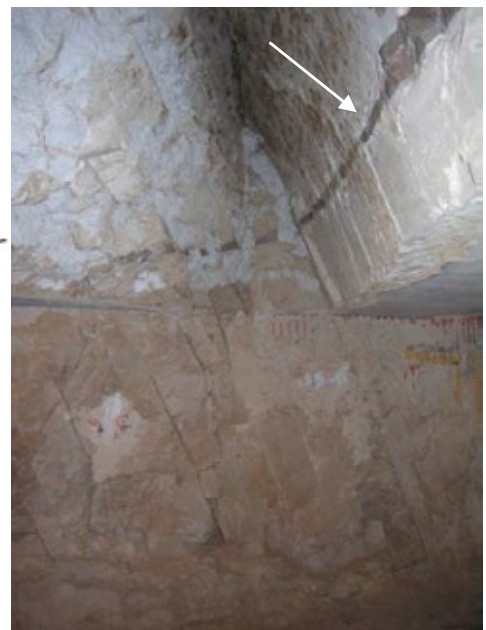
Large fracture at apex of wedge-shaped area of rock loss in ceiling of main chamber (C) shown on isometric plan and in photo, above Note dark diagonal band of chert across area of loss (arrow).

Stabilization of the fractured ceiling and the area of rock above the entrance to the tomb and between QV 36 and 37 is required, and public access to this area prevented. The fracture at the apex of the wedge-shaped ceiling loss should be sealed, and a surface survey above the fracture be carried out to determine if it is present also there, and if so, sealed from above.

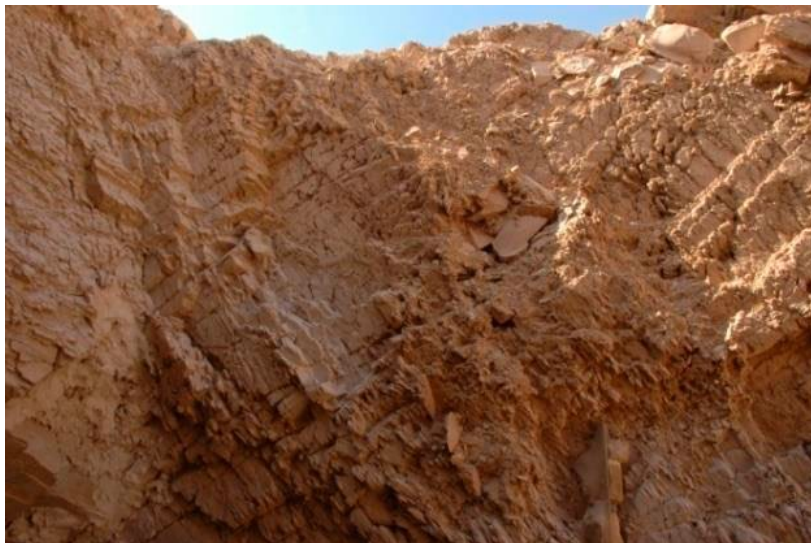
Fractured and friable rock above entrance.

The tomb entrance requires retaining walls and an arched cover for protection from water ingress and that would also serve to stabilize the rock. All interventions in this area must be considered in conjunction with adjacent QV 37, ensuring that closure to both tombs is adequate and prevents entry of animals and floodwater. The openings between the two tombs may be filled, if deemed necessary for structural stabilization.

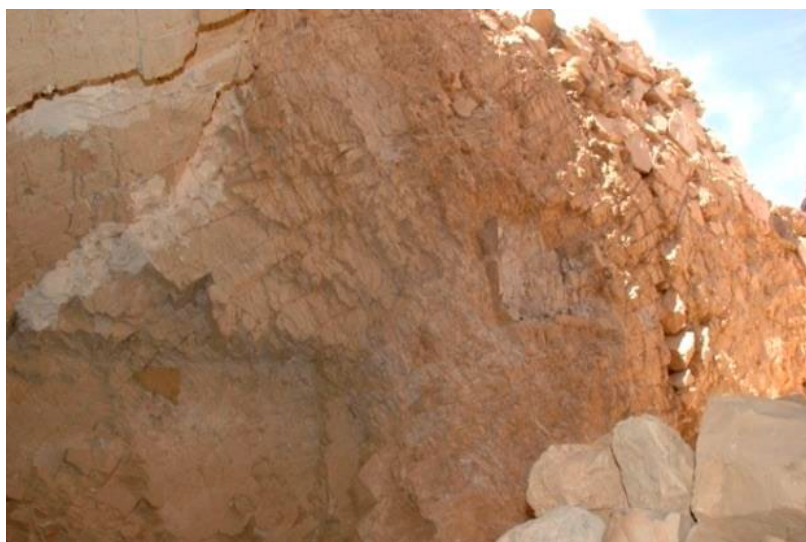
View of rock between QV 36 and 37, as seen within entrance to QV 36.

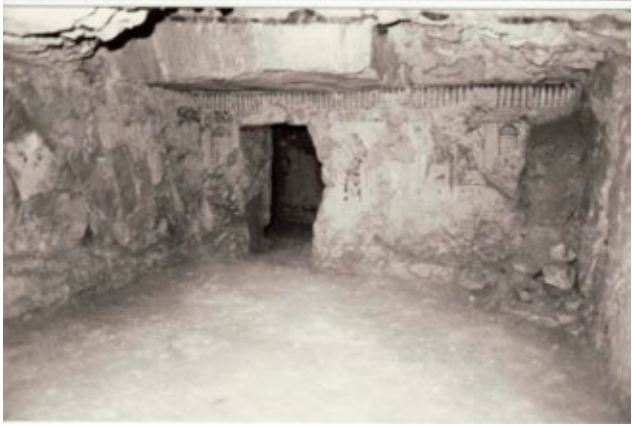
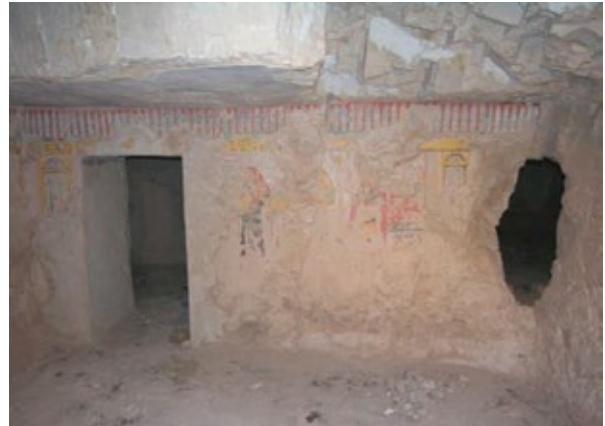
Overviews of main chamber (C) in 1984 (above left, CNRS) and in 2006 (above right). The doorway to the rear chamber (left) has been reconstructed, and the opening to QV 37 (right) has been cleared.

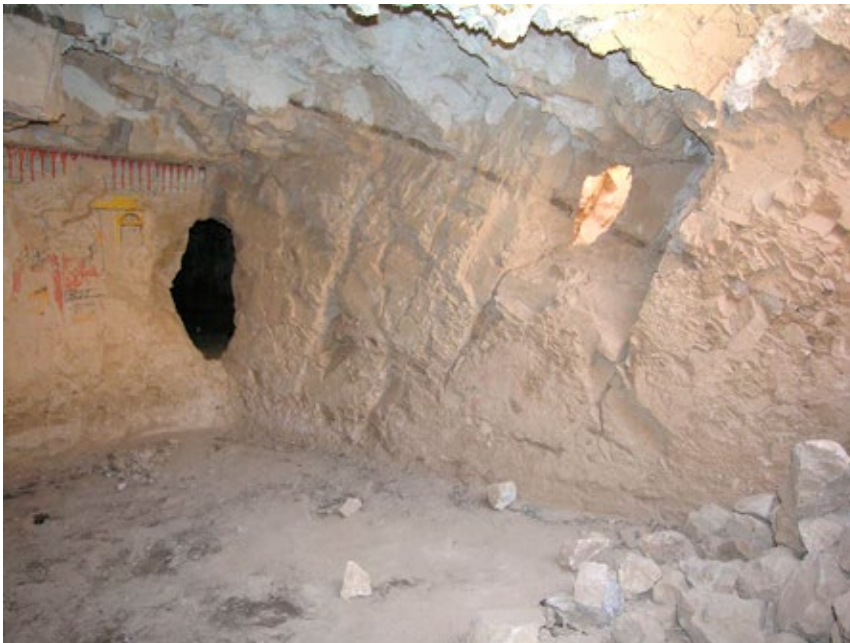
Break in west wall of chamber (C) (right) requiring infill for stability of rock above. Note diagonal band of chert and surface repair plastering of the ceiling rock to prevent further detachment and loss.

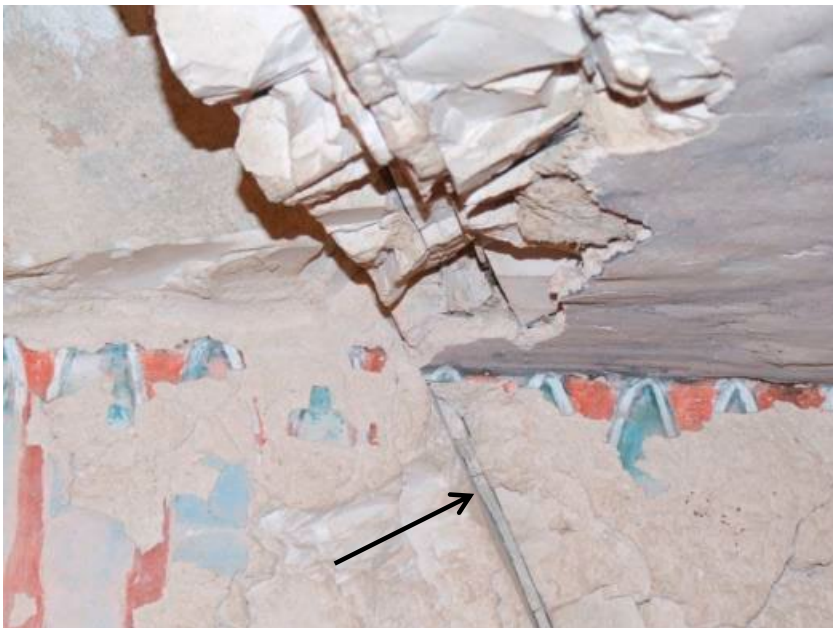
Detail of east wall of chamber (C) with diagonal salt vein which continues into ceiling, along which the large wedge-shaped loss is located. Note the substantial losses of painted plaster in this area.

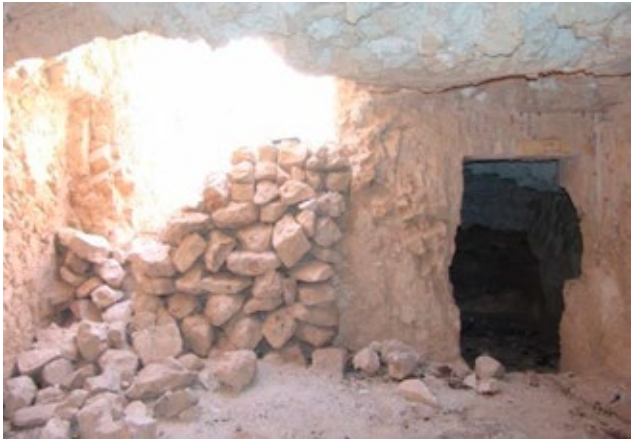
Only small areas of painting survive around doorway (D) on the north wall of chamber (C).

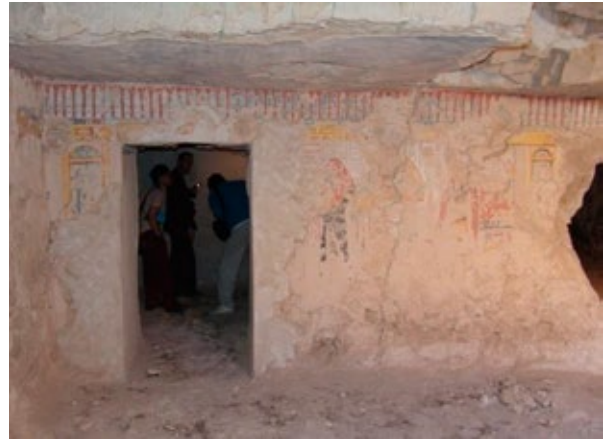
The south wall of main chamber (C) shows the greatest survival of painting in this tomb.

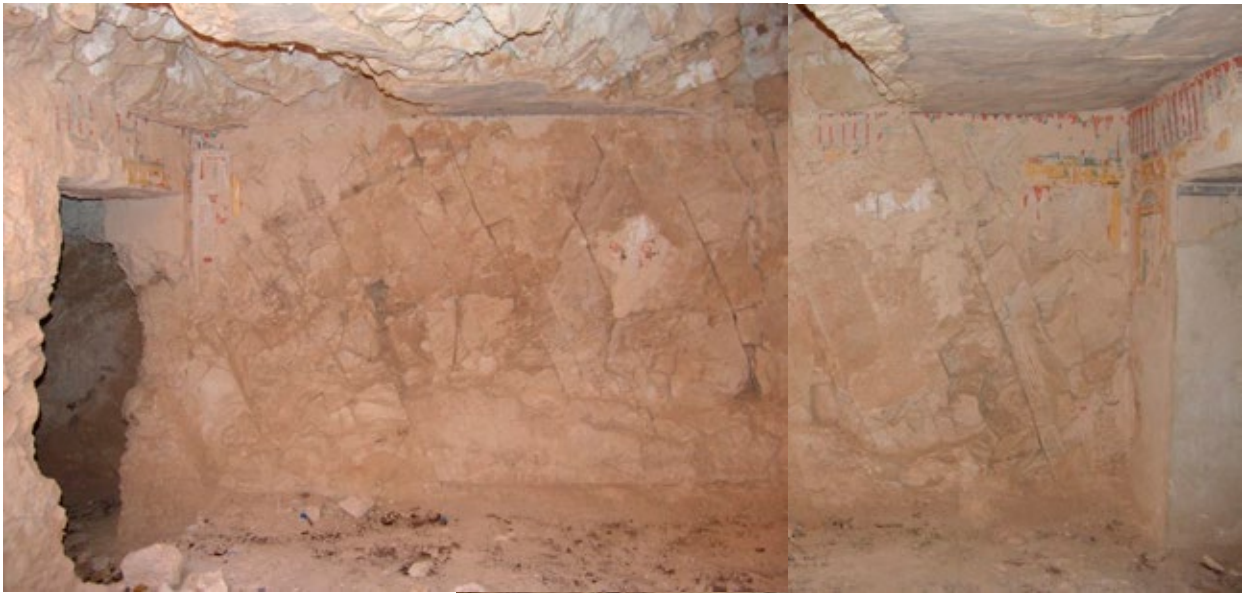
Only traces of surviving painting remain at the top of east wall of main chamber (C).

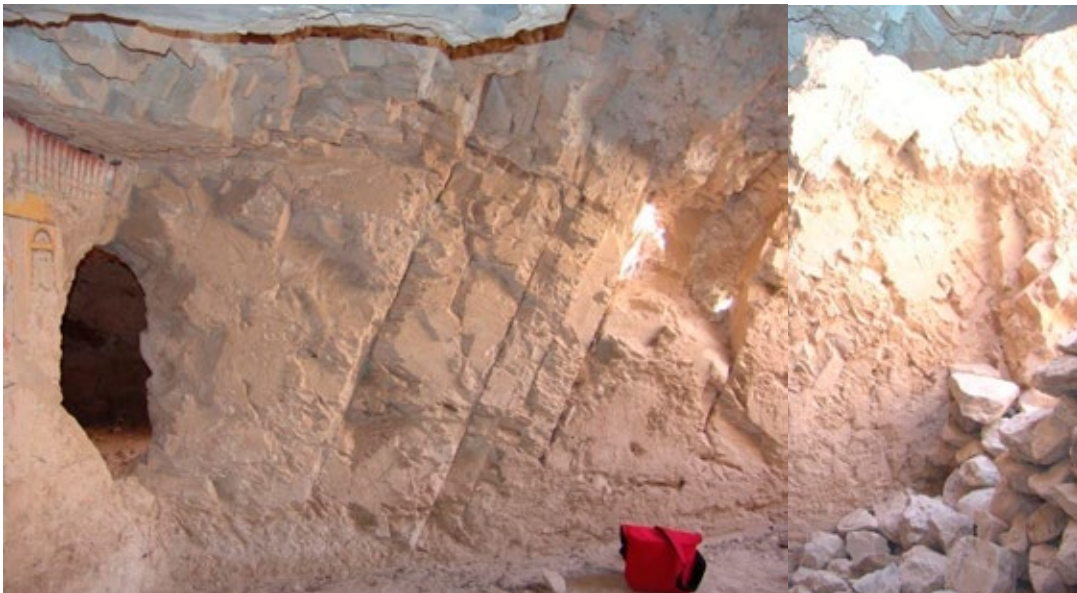
Almost no painting survives on the west wall of main chamber (C).

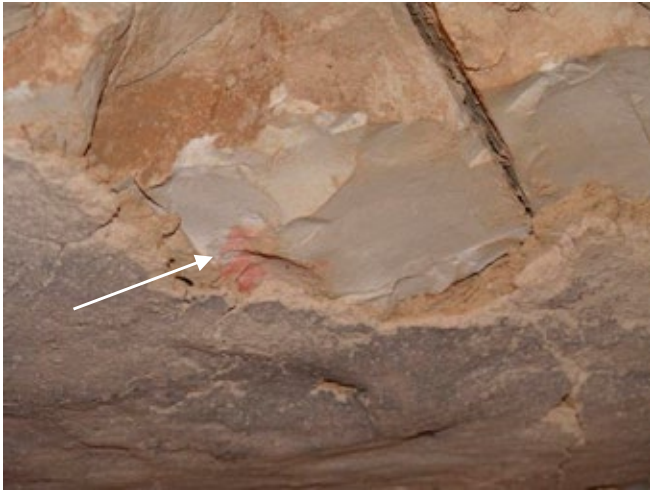
Ceiling of main chamber (C). Two layers of plaster are clearly visible on the ceiling; the final plaster layer having a black wash on it. Also visible is a red mason's mark on the stone (arrow).

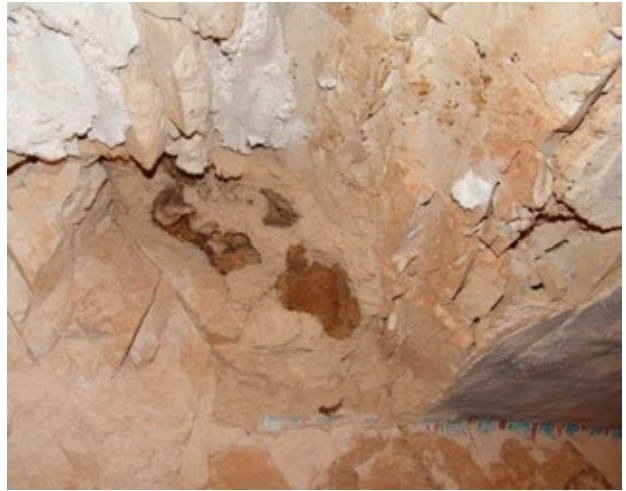
Detail of ceiling of chamber (C) showing traces of infill plaster that might indicate that the ceiling in this area was either never flat or that large amounts of infill material previously filled this space. It also indicates that some of the rock collapse had occurred in antiquity before the tomb was decorated.

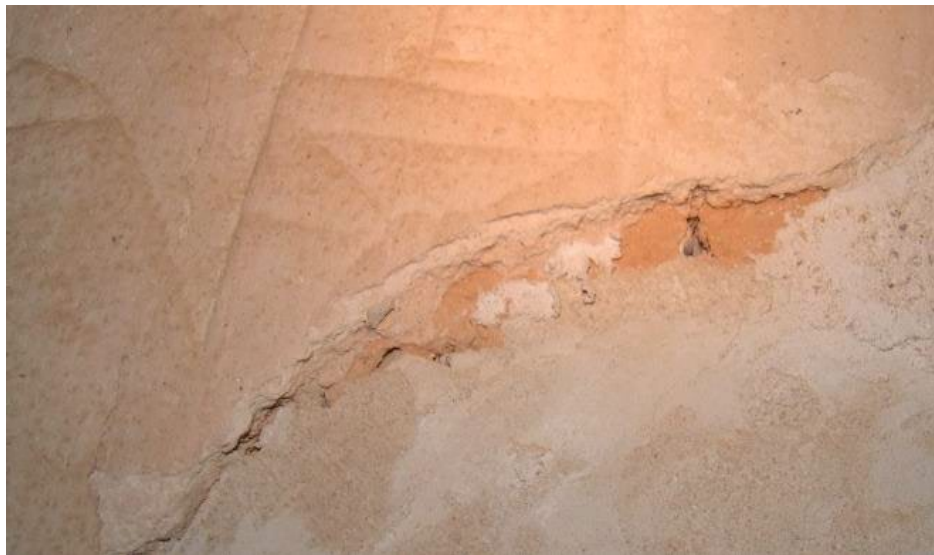
The same plaster layer stratigraphy is seen in rear chamber: lower layer of earthen plaster with an upper *hiba* plaster.

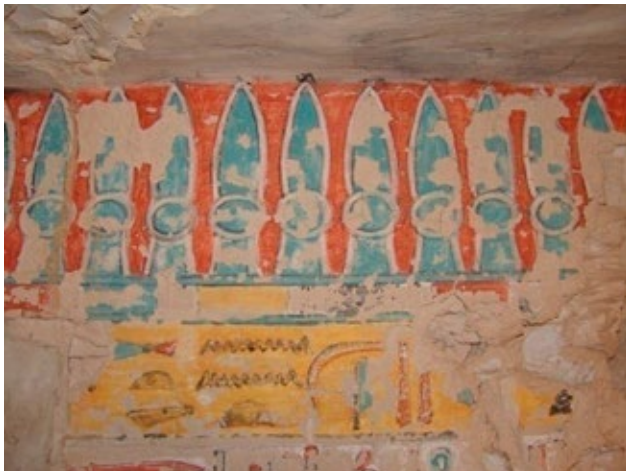
Flaking of the paint layer has led to substantial losses that expose the underlying plaster layer.

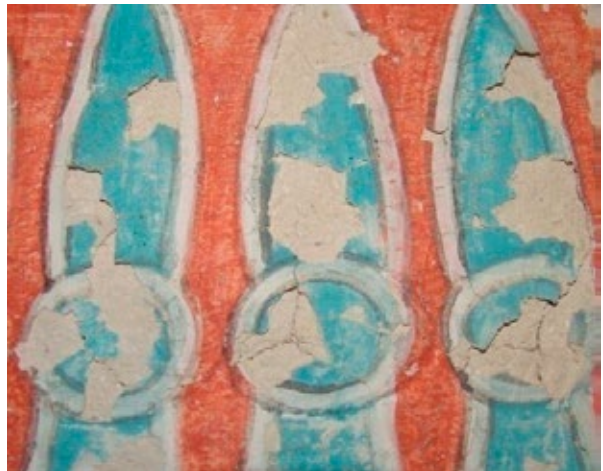
Detail of the flaking paint.

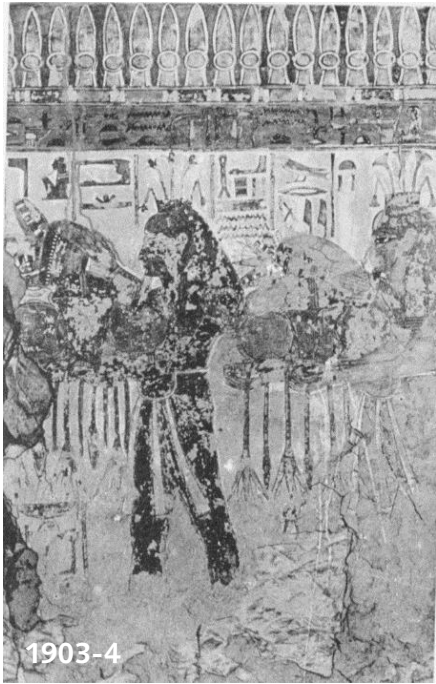
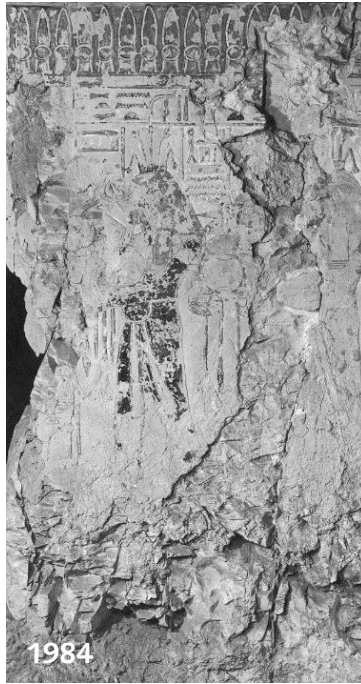
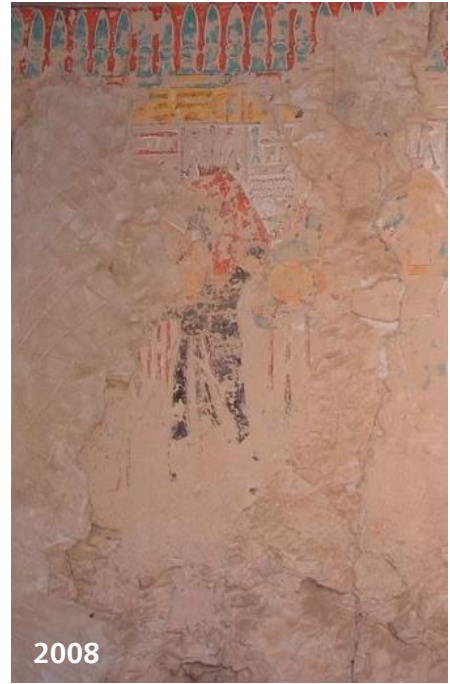
Area on south wall of main chamber (C). Comparison between 1903-4 photo (Image: Schiaparelli 1923) and 1984 photo (Image: CEDAE) shows significant losses.

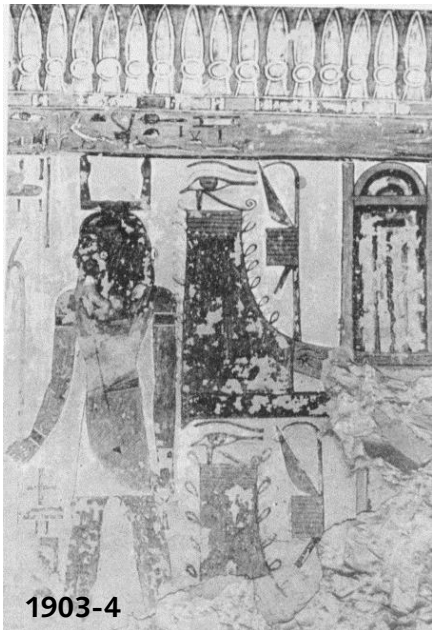
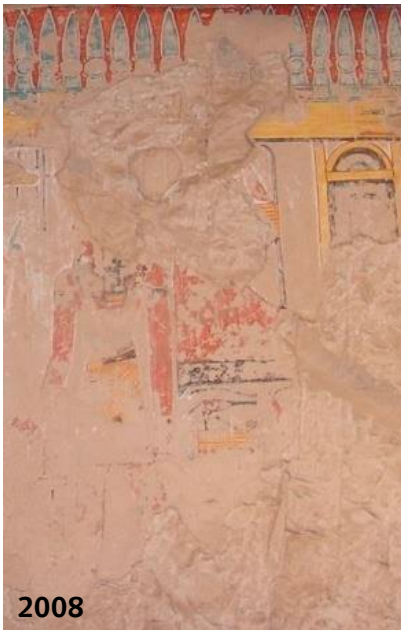
Left: Area of painting on the south wall of chamber C showing the condition in 1903-4 (Image: Schiaparelli 1923) (far left) and in 2008 (near right). There has been extensive loss in this area.

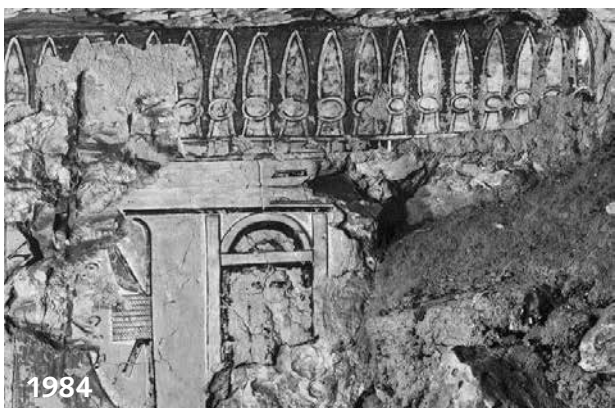
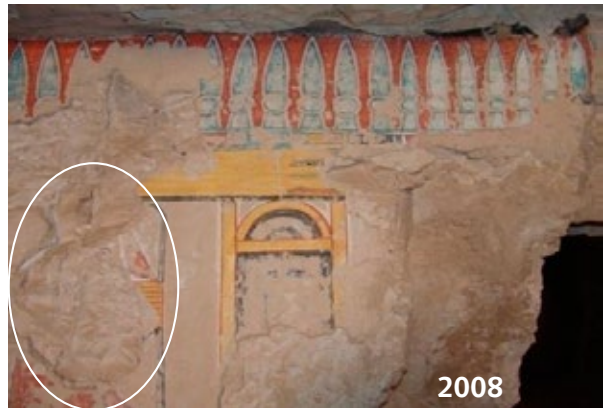
Below: white circle shows recent area of loss (below right) compared with 1984 photograph (below left). (Image: CEDAE).

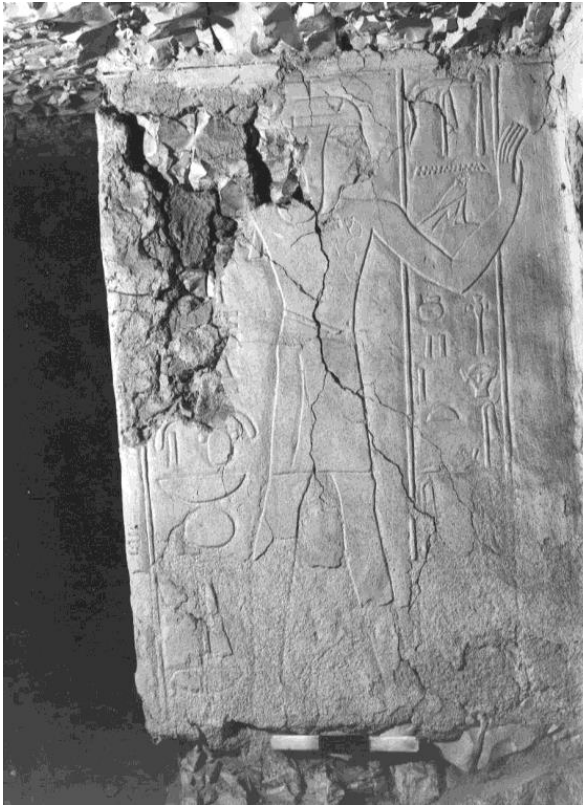
1984 CEDAE image of the north wall of rear chamber (G) shows area before treatment. Cracks and losses of the carved plaster can be seen as well as pitting of the surface on the lower half of the wall, possibly indicating salt and moisture-related deterioration in this area.

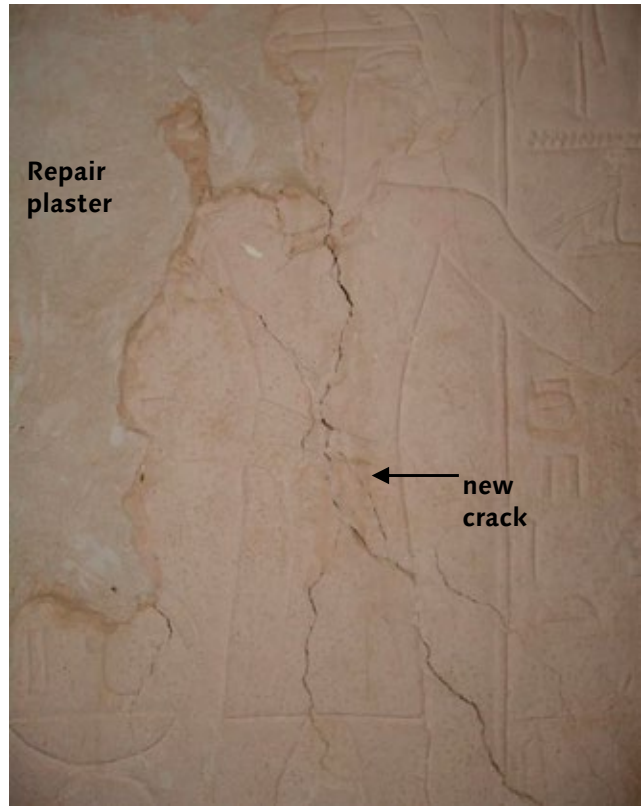
The repairs may conceal structural problems now being manifested as cracking in the painting. Photograph taken in February 2008 shows what looks like a new crack in the original plaster since the repair plaster was put in.

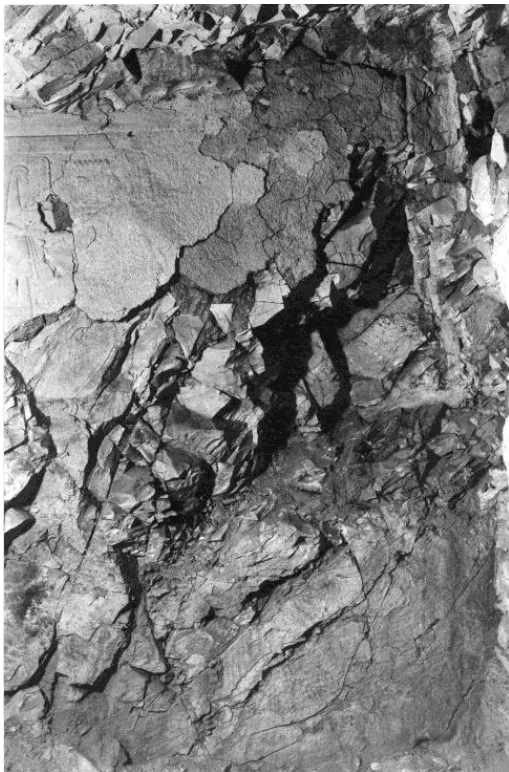
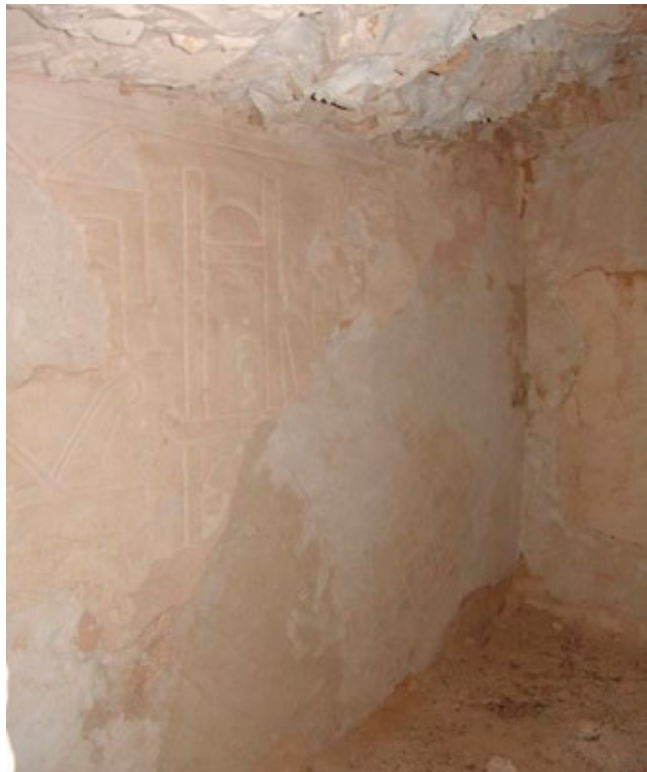
1984 CEDAE photograph (left) shows a large and deep area of loss. The 2008 photograph (right) shows same area with large repair plasters and areas of the ceiling rock secured with plaster.
