Valley of the Queens Assessment Report

Volume 2

Assessment of 18th, 19th, and 20th Dynasty Tombs

A collaborative project of the Getty Conservation Institute
and the Supreme Council of Antiquities, Egypt

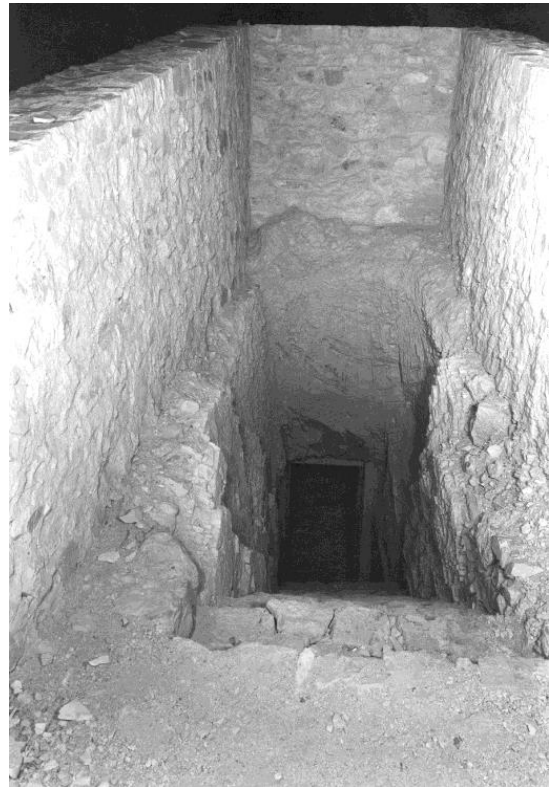
Entrance ramp (A) of tomb in 1989
CEDAE photo showing modern masonry
walls built above historic rock-cut walls.

The entrance ramp requires an arched masonry cover and existing ramp retaining walls may be used as a reconstruction foundation, to prevent future ingress of runoff during rain. Areas of loose rock on the west side of the ramp are recommended to be stabilized.

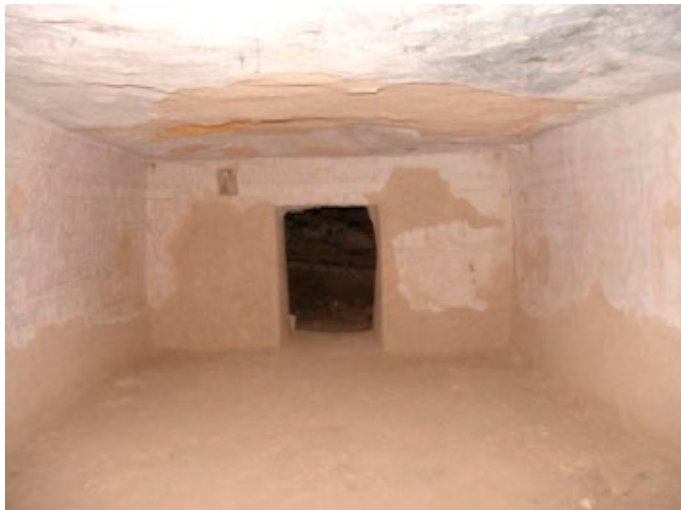
General view of burial chamber (C) and doorway (D), looking south toward rear chamber (E). There are large plaster losses throughout the main chamber that have been repaired with plaster fills.

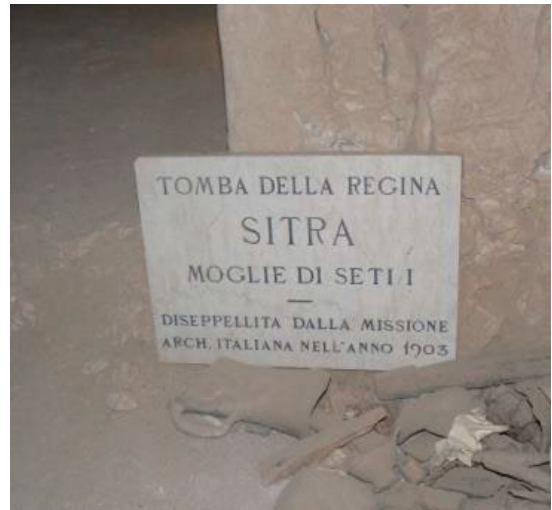
The Italian mission plaque is stored in rear chamber (E).

Replacement of mesh on the door and gap-filling between the door and the reconstructed doorway are recommended. The Italian-mission plaque should be reinstated in its original location in entrance ramp (A).

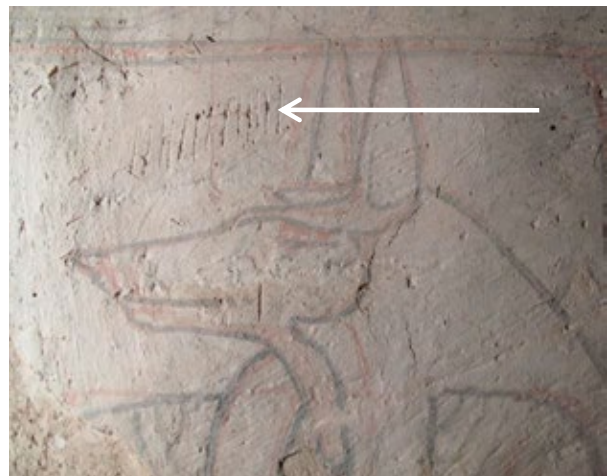
Numerous scratches and graffiti exist throughout the tomb.

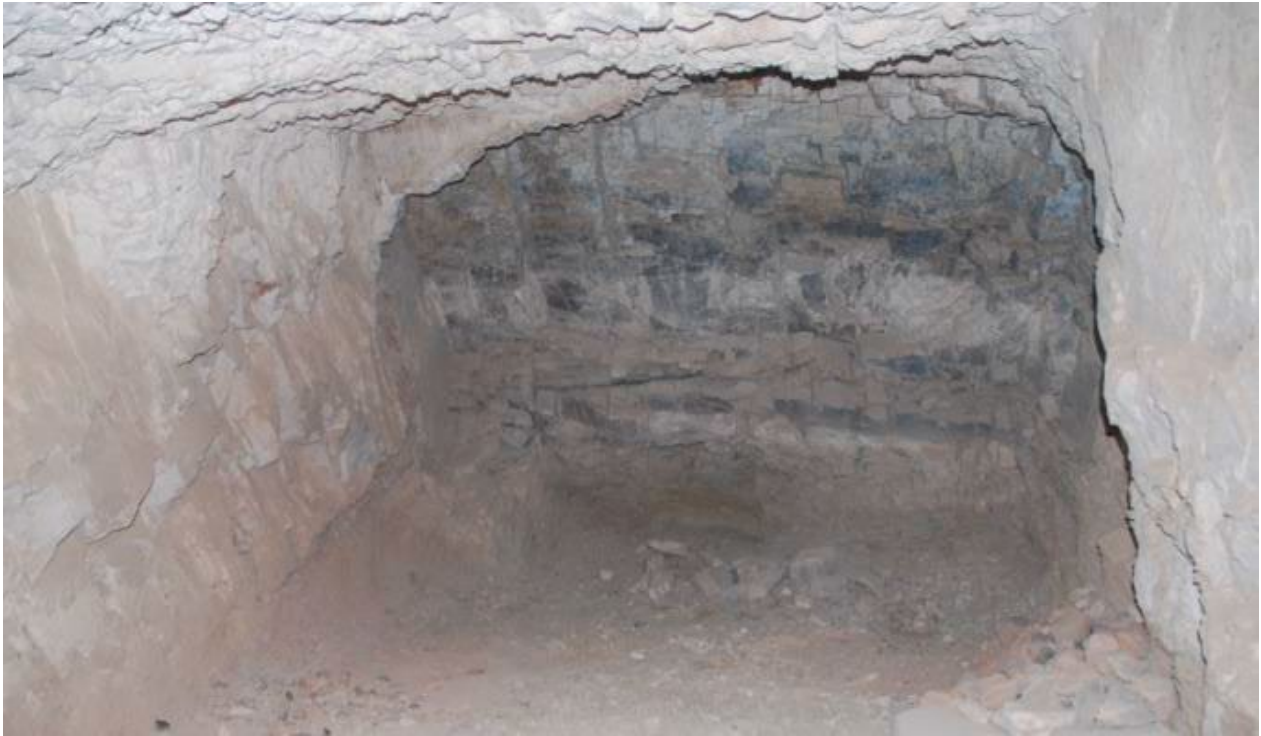
The recent loss and visible detachment of shale rock in the rear of chamber (E) is due to the clay-rich nature of the rock, which has also impacted the less clay-rich marl found adjacent to it, which is also heavily fractured and jointed, and only slightly less fragile and prone to future detachment and loss.

The rear part of chamber (E) is cut out of a shale stratum that is heavily jointed. Fallen fragments on the floor are evidence of recent rock loss from the walls and ceiling.

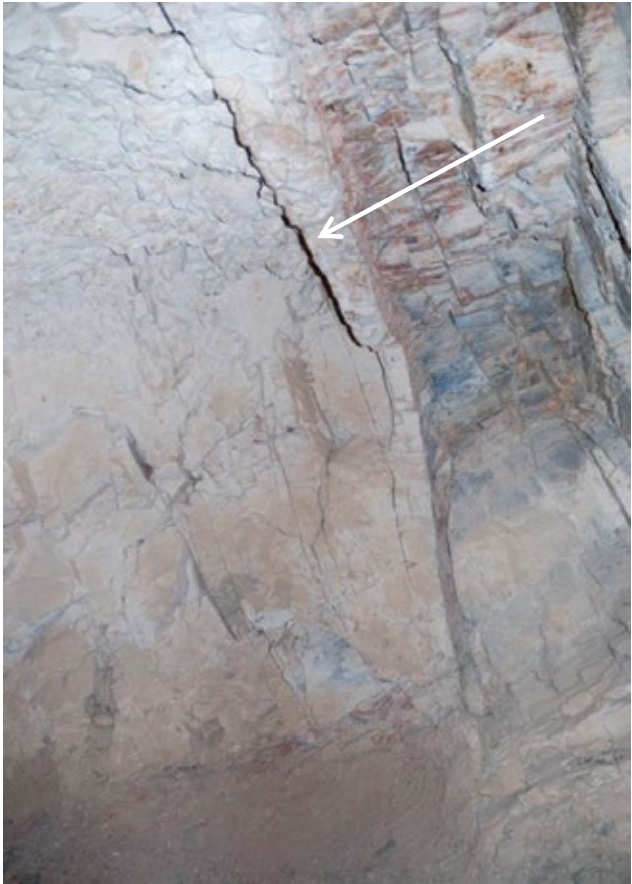
East wall of rear chamber (E) has vertical and diagonal open fractures in the marl which follow the orientation of the shale layer below.

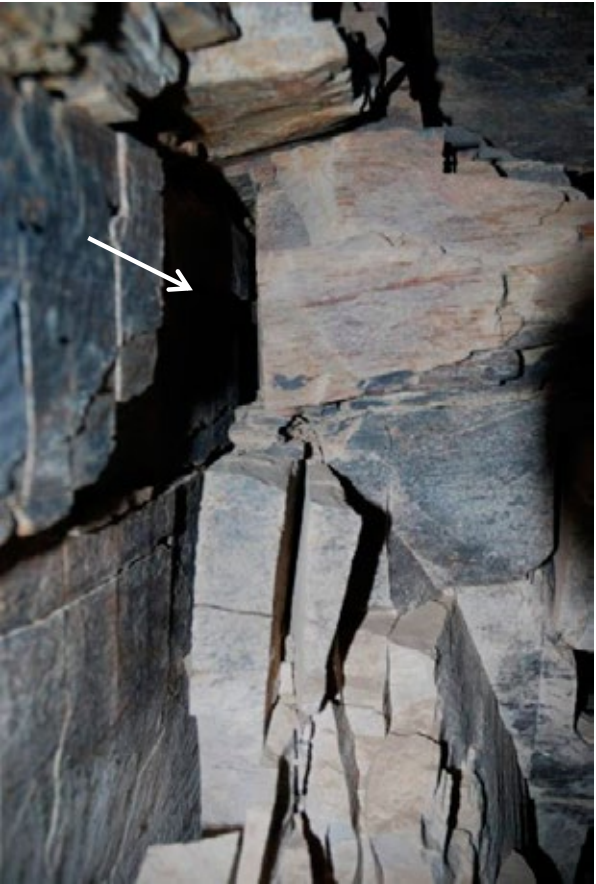
Detail of wide detachment of surface rock layer in rear wall of chamber (E). Areas of surface rock layers threaten to fall.

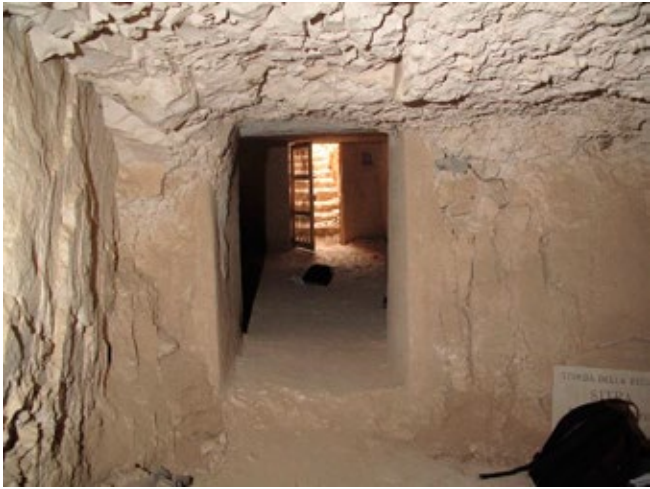
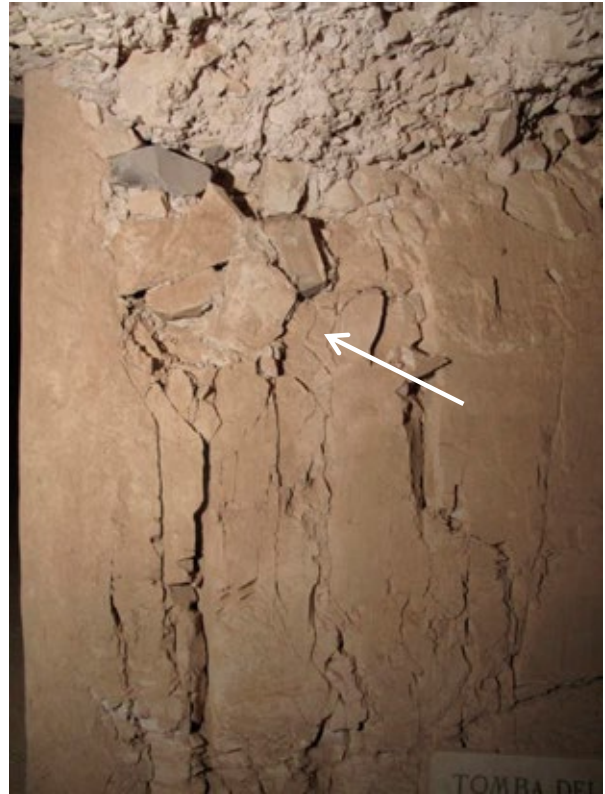
The east side of doorway (D) in this chamber has been partially rebuilt with masonry and the adjacent rock is severely fractured by vertical cracks. Chamber (C) does not exhibit any major structural conditions though the extensive modern plaster repairs obscure much of the condition of the underlying rock. There are no historic photographs, apart from a few Schiaparelli images from 1903-05, that show the condition of the tomb prior to the plaster repairs. 1988 and 1989 CEDAE photographs show the tomb with plaster repairs already made. Part of the east wall of ramp (A) has been stabilized with infilling of small stones and mortar.

Above right: Image showing rock infill needed to rebuild door jamb of doorway (D) taken from chamber (E) looking north toward entrance (above left). Adjacent rock presents severe open vertical fractures.

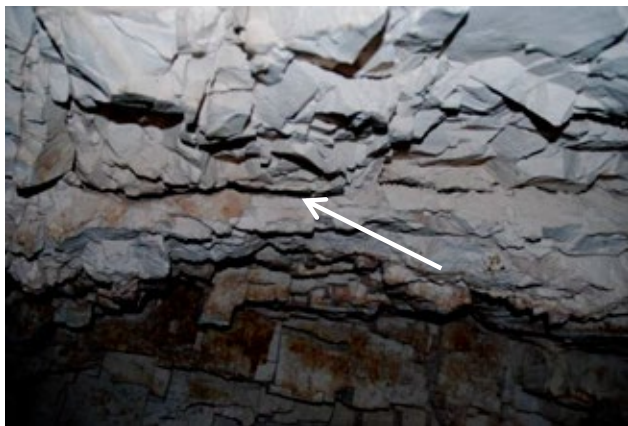
Ceiling of rear chamber (E) is heavily jointed and fractured with areas of detachment.

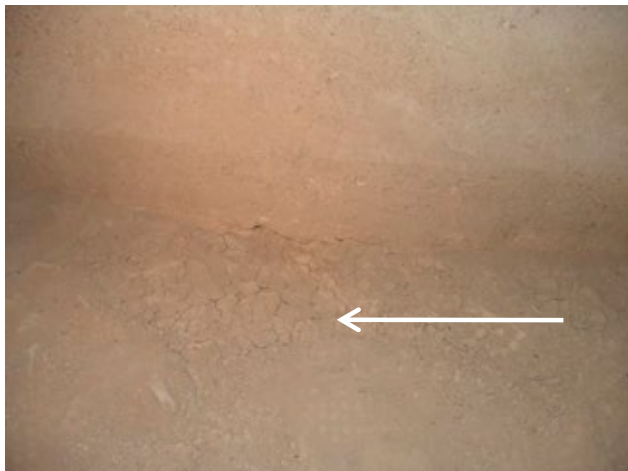
The presence of shale and the collapse of areas of infill material may account for some of the loss of the painted plaster. Loss at the base of walls may be due to past flooding. Dried mud on the floor of chamber (C) to the west of the entrance indicates past water infiltration in the front part of the tomb, which may have caused the loss of repair plaster along the base of the wall to the east of doorway (B). The present plaster repairs do not otherwise indicate moisture problems. Hydrologic analysis shows that the tomb entrance is in a location susceptible to upslope runoff.

Dried mud on floor of chamber (C) to the west of the entrance indicates past flooding.

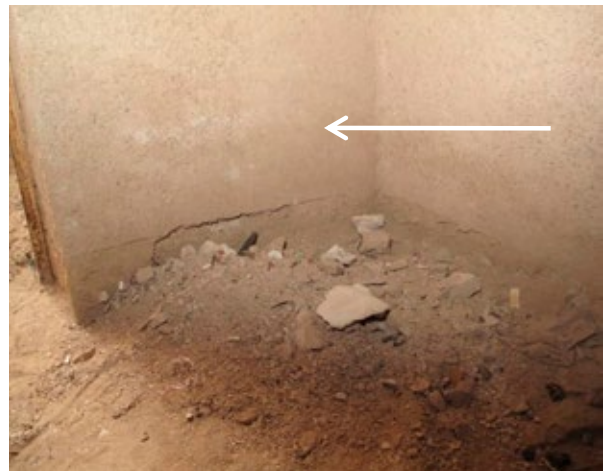
Staining (0.15m high from the ground) at the base of the wall in chamber (C) on repair plaster most likely from the 1994 flood.

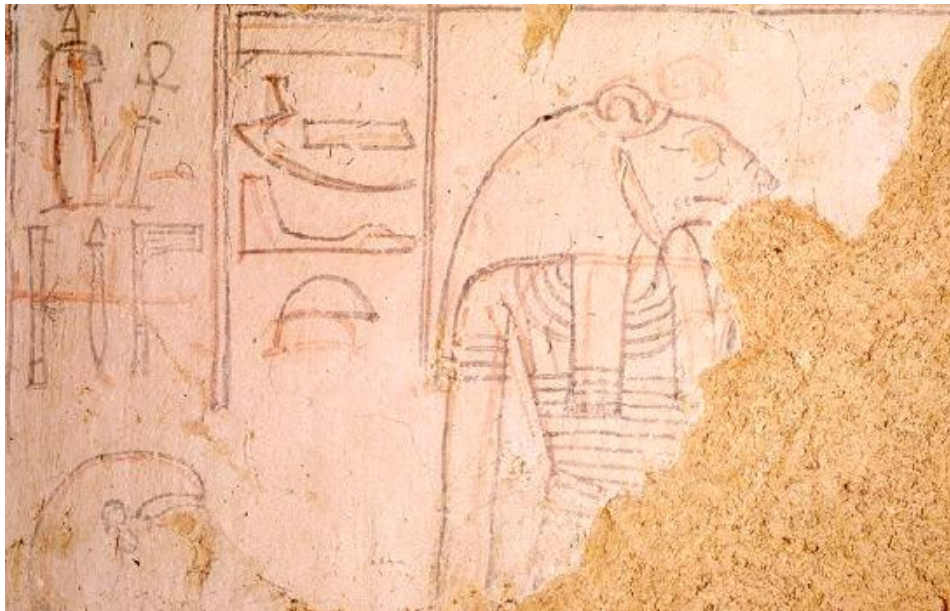
Same area on the north wall, west side of chamber (C) taken by CNRS (unknown date) showing repairs and loss of painting.

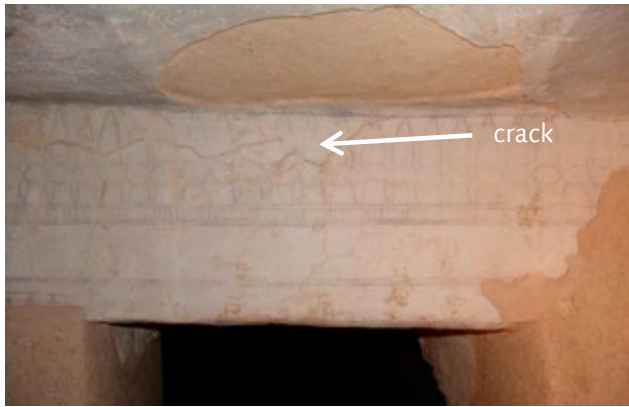
The only area of concern is a large horizontal crack in the painted plaster above doorway (D) on the south wall of chamber (C) which extends eastward into a network of cracks. The cracks adversely affect the figure on the east side of the south wall, likely to be a portrait of Satra, and is therefore of great significance. Although this major crack is already visible in the 1988-89 CEDAE photographs new cracks and losses that have occurred since may indicate rock instability. As the cracks also extend through repair plaster this could be an indication of continued movement in the underlying rock. The majority of these cracks were then smeared over (unknown date) with a very fine and light-colored plaster. In most cases the cracking here has not reopened.

Horizontal crack above doorway (D) on south wall of chamber (C), requires monitoring to assess whether there is fracturing and movement of the underlying rock. Some stabilization work is also necessary here.

The paintings in chamber (C) have already been previously treated and therefore little work is necessary. The large crack above and to the left of doorway (D) is the only area that requires stabilization. The cracks in this area as well as on the ceiling on the figure of Nut should also be monitored as further deterioration may be an indication of an ongoing problem of the underlying rock support.

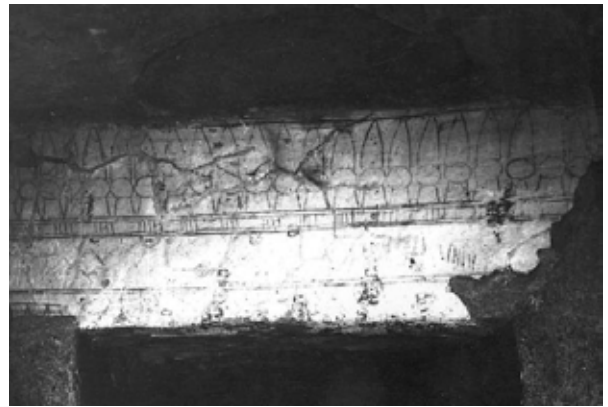
1988-89 CEDAE photograph shows crack already present.

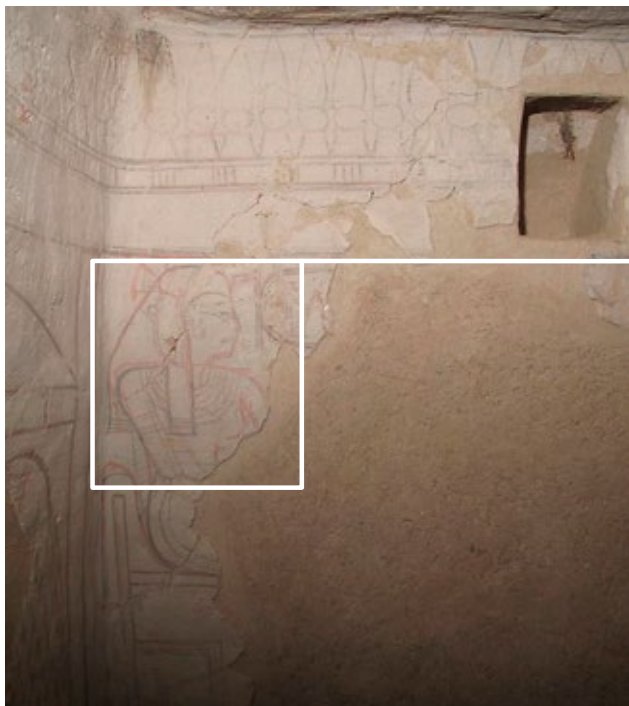
Crack extends eastward through figure of queen.

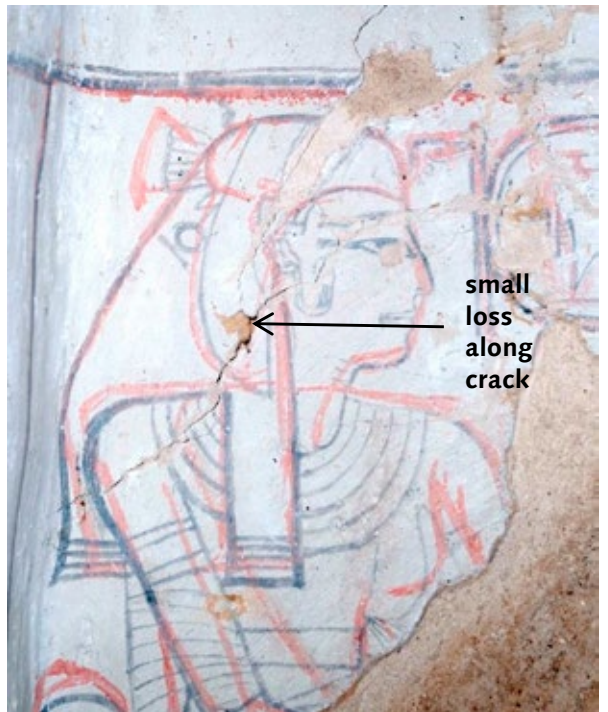
Detail of queen showing cracking and small losses.

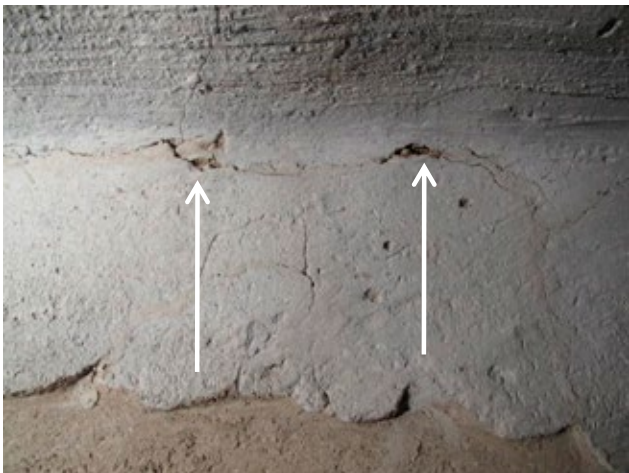
Other small loss along crack.

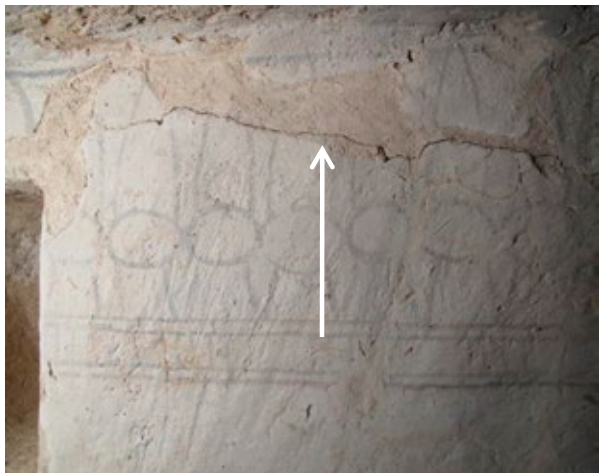
Crack has reopened where a previous plaster repair existed.

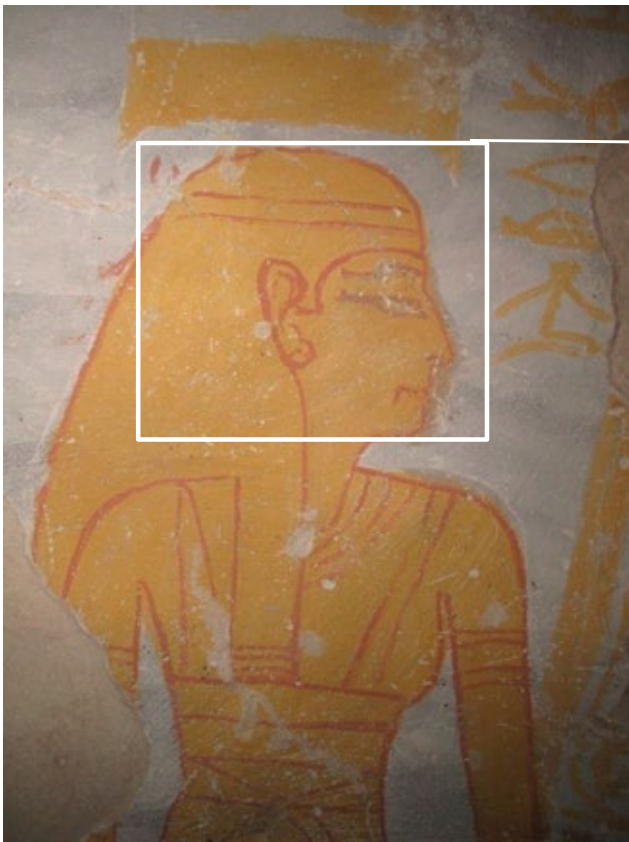
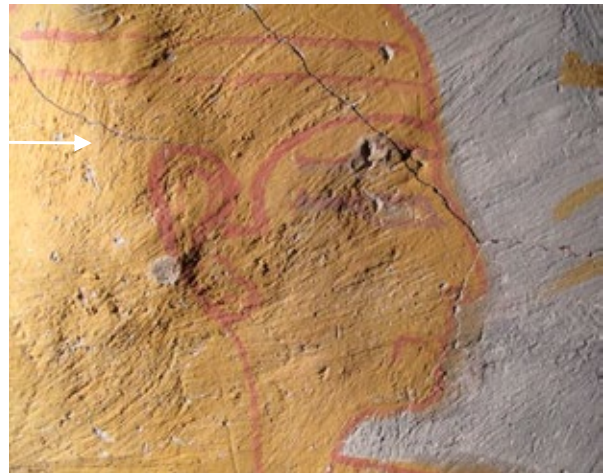
Cracks run across the face of Nut. Though no losses have yet occurred, this area should be monitored to see if cracking is ongoing.

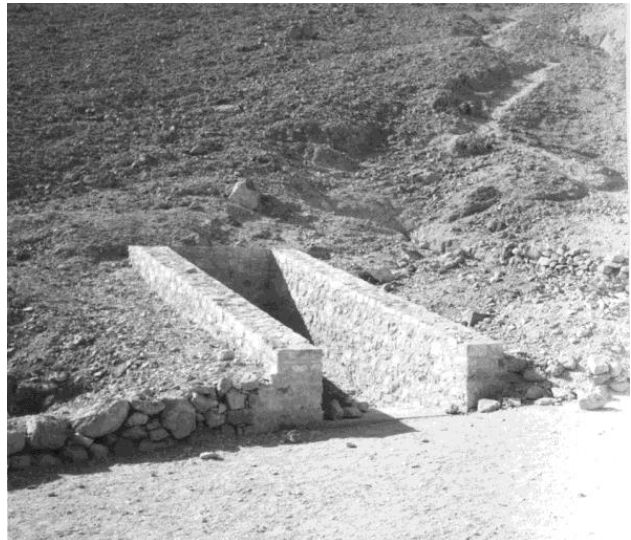
Tomb entrance in 1973 (Image: CEDAE) showing modern ramp walls. The masonry walls were constructed on top of rock-cut wall of the ramp.

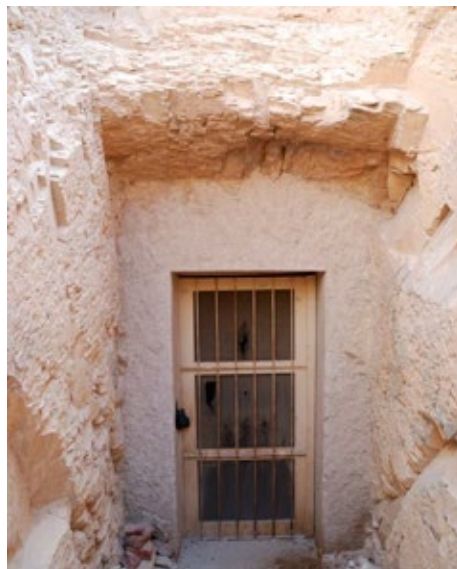
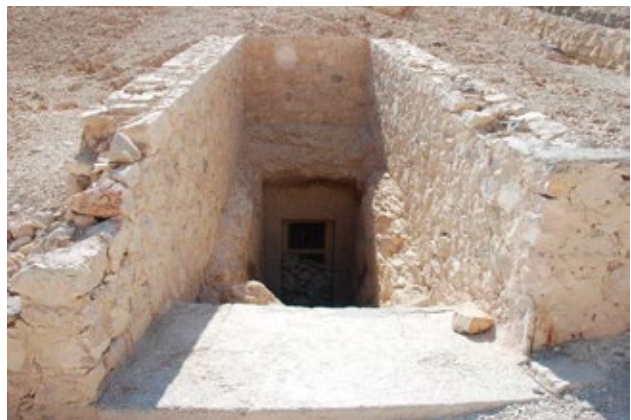
Stepped ramp (A) and entrance (B) in 2008. The irregular overhang of rock over entrance (B) indicates some rock loss has occurred in the past. Stone ramp walls were repaired and plastered in 2010 by SCA.

The irregular overhang of rock over entrance (B) indicates some rock loss has occurred in the past. Some loose surface rock on both sides of the entrance is present.

Construction of an arched cover on existing retaining walls is recommended to mitigate future flooding. Care should be taken to protect remaining areas of original plaster on the entrance ramp. Loose rock on both sides of the tomb entrance should be stabilized.

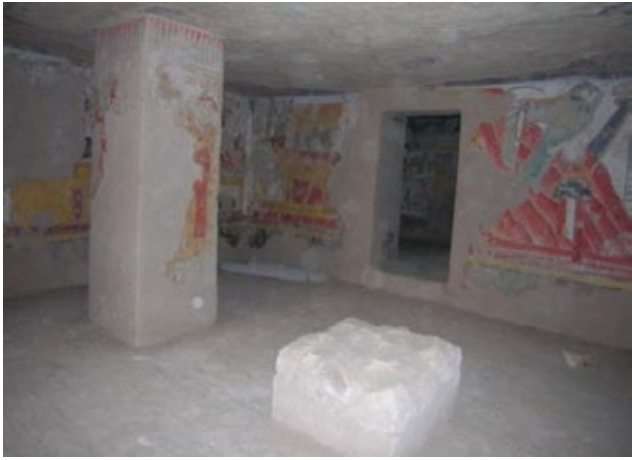
Rock fissuring and loss of substantial infill material have contributed to the fragmentary survival of the decoration we see today. The extent of large areas of loss also may be an indication of past flood damage though there are no recorded reports of flooding in this tomb.

General view of pillared chamber (C), facing the southeast corner. Only the base of the western pillar survives. The large areas of loss on walls and ceilings in this tomb may indicate past flood damage.

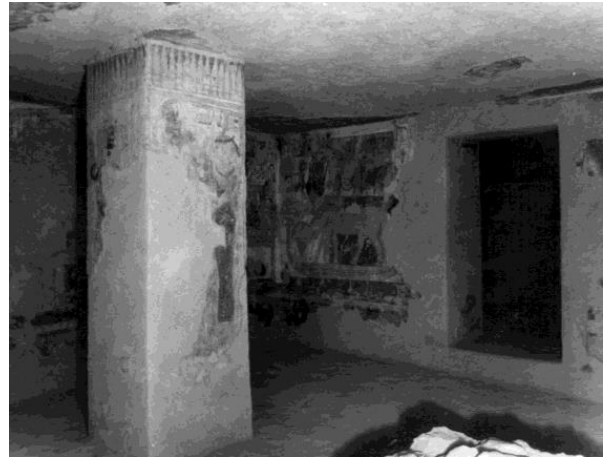
Chamber (C) in 1970 (CEDAE) showing plaster repairs already present. The extensive repairs did not allow for direct observation of the rock condition.

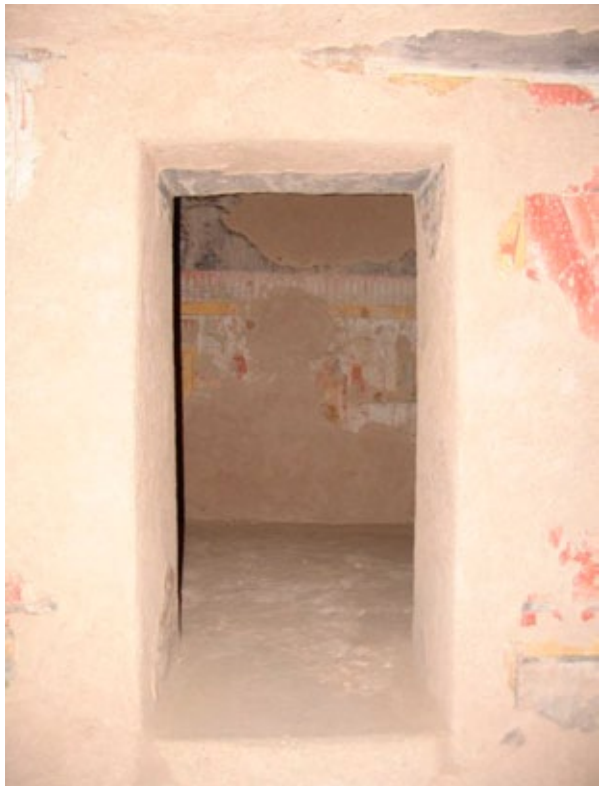
Extensive loss exists especially around doorways. This could be an indication of poor rock condition and/or evidence of past flooding.

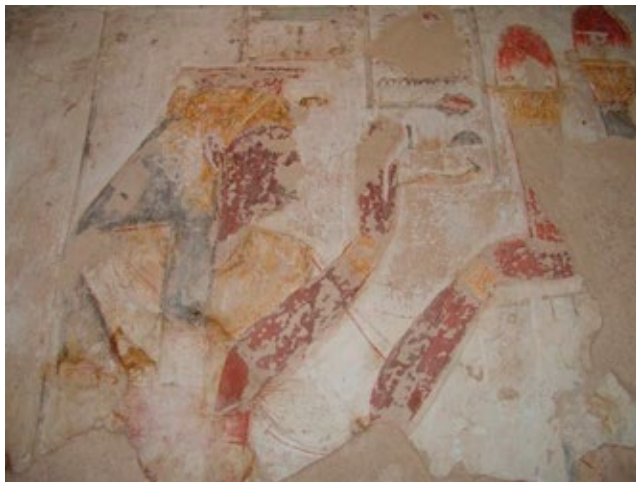
Surface has an abraded appearance with much surface paint loss and red flesh of the figure on the east wall of chamber (C) appears darkened.

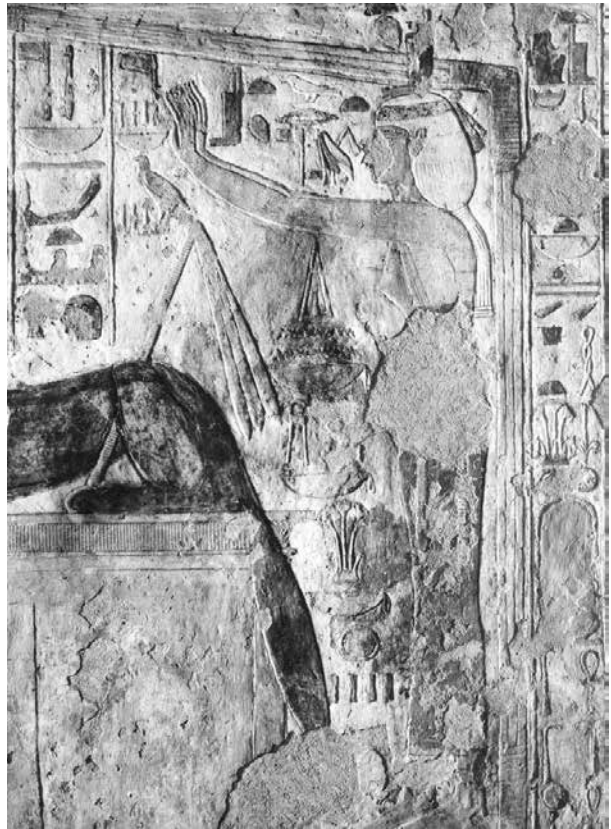
The same area of painting from chamber (C) in 1970 photograph shows what appears to be the result of cleaning to reduce the staining. Plaster fills have also been made (Image: CEDAE).

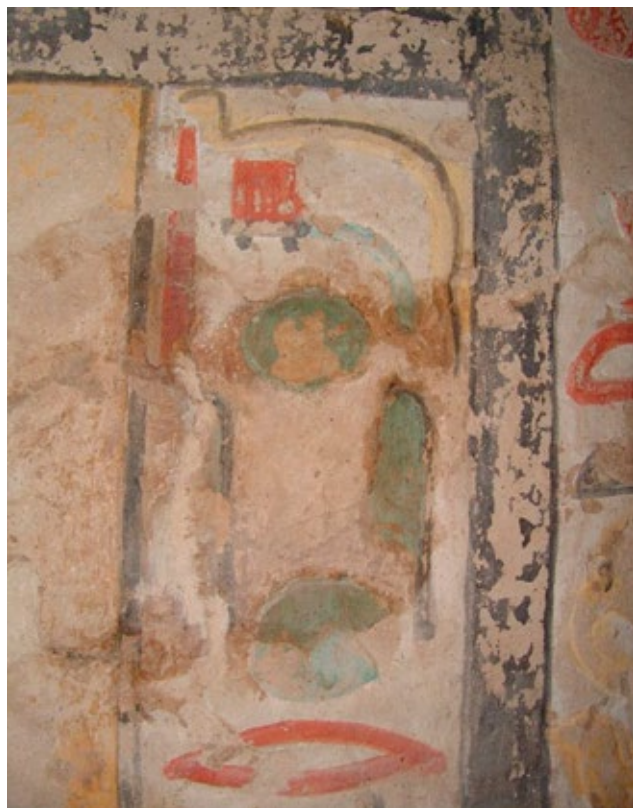
Area of green paint in chamber (G) looks as though it has been consolidated with an adhesive resulting in darkening of the surface.

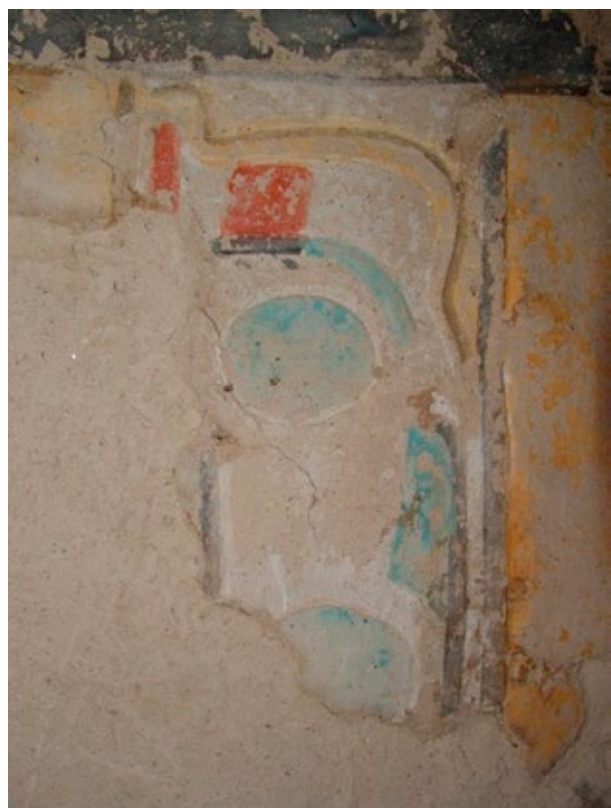
Area of blue paint in chamber (G) appears abraded and faded.

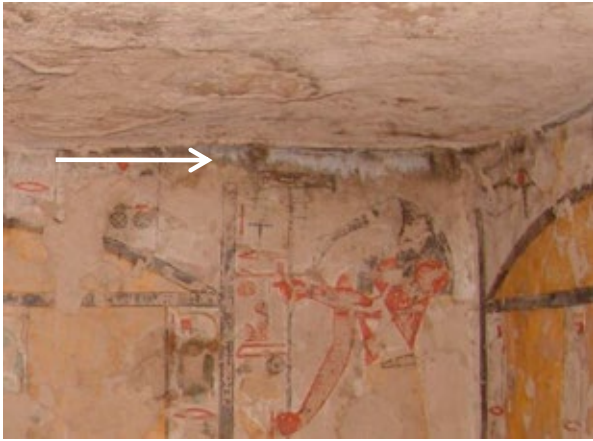
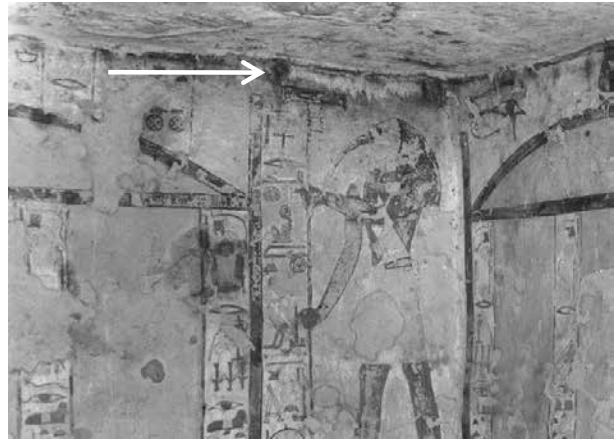
Although no bats were seen during the assessment, there is evidence of considerable past bat activity. Evidence of bats is present in side chamber (G) and in burial chamber (E) at the tops of walls, in the form of white crystalline (salt) residues and dark staining. Many of these dark stains appear to have been overcleaned, with consequent damage.

Evidence of bats on the upper part of walls and ceilings in the side chamber (G), in the form of crystalline deposits (salt residues) and staining. The problem is already evident in the 1973 CEDAE photographs (right).

The wire mesh on the tomb door requires replacement and sealing of doors is needed to ensure that animals and bats cannot access the tomb.

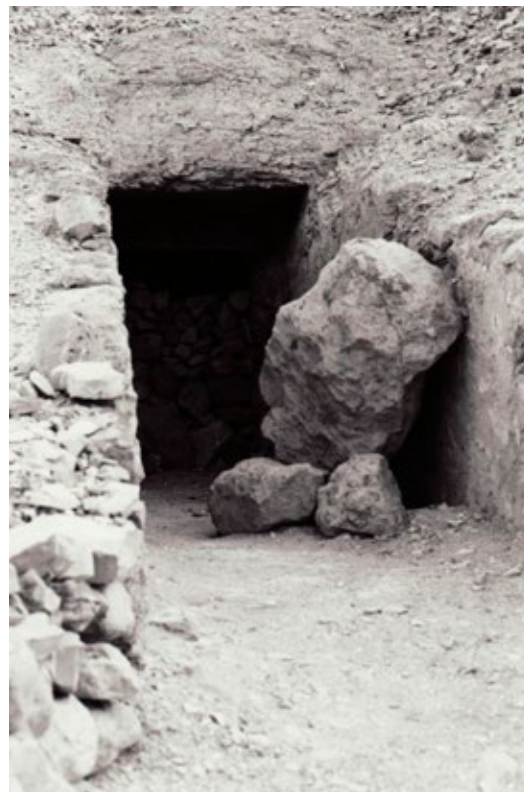
Tomb entrance before ramp wall construction. It is unknown how and why these large boulders may have ended up in the entrance ramp but they have since been removed. (Image: CNRS)

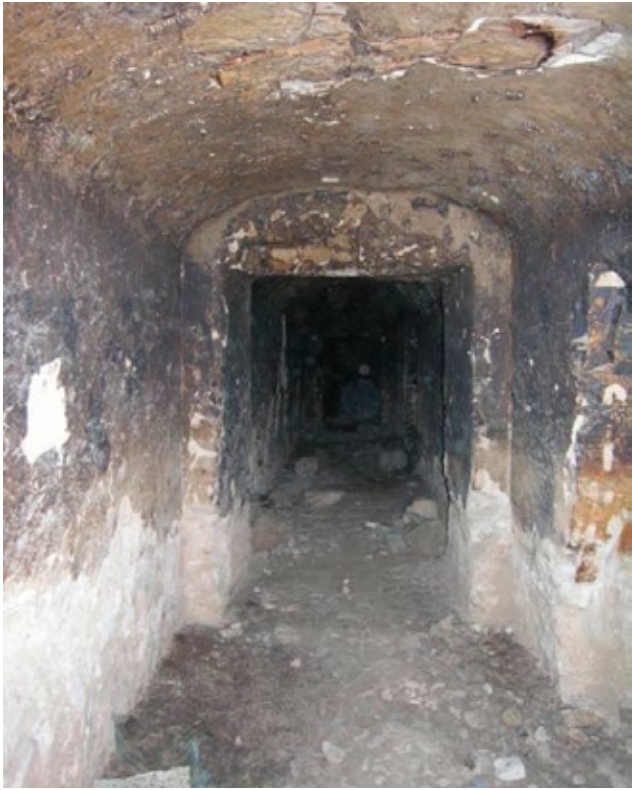
The basal erosion of walls in corridors (C) and (F) and of doorway (E) indicates the likelihood of past damage from flooding. Leblanc has indicated that a large amount of upslope runoff entered into this tomb during the November 1994 flood (pers. comm. 2009).

General view of the corridor (C) and doorway (E) with vaulted ceiling. Localized area of rock loss and basal erosion of walls and doorway are present.

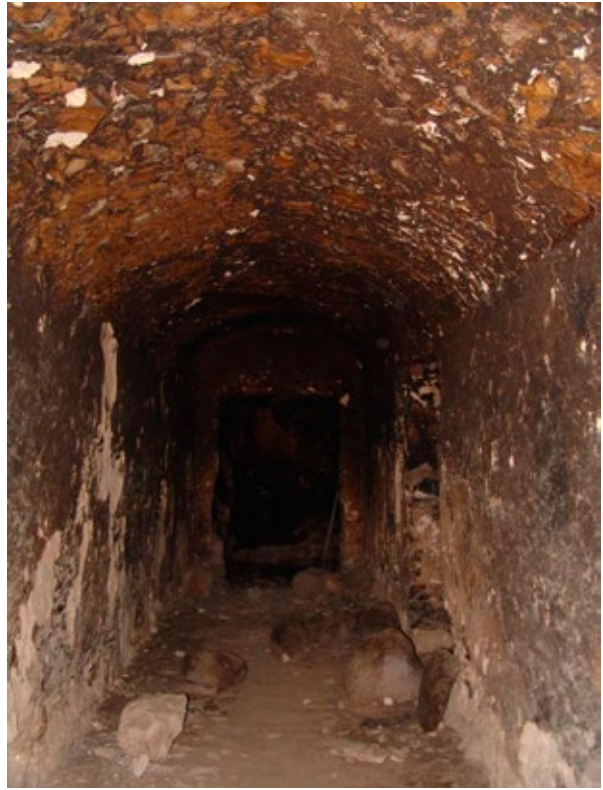
Walls of the tomb are well finished with a base plaster. There is relatively little post-fire loss on walls and ceiling indicating that tomb and surviving plaster is generally stable. Note large rocks on ground in corridor (F).

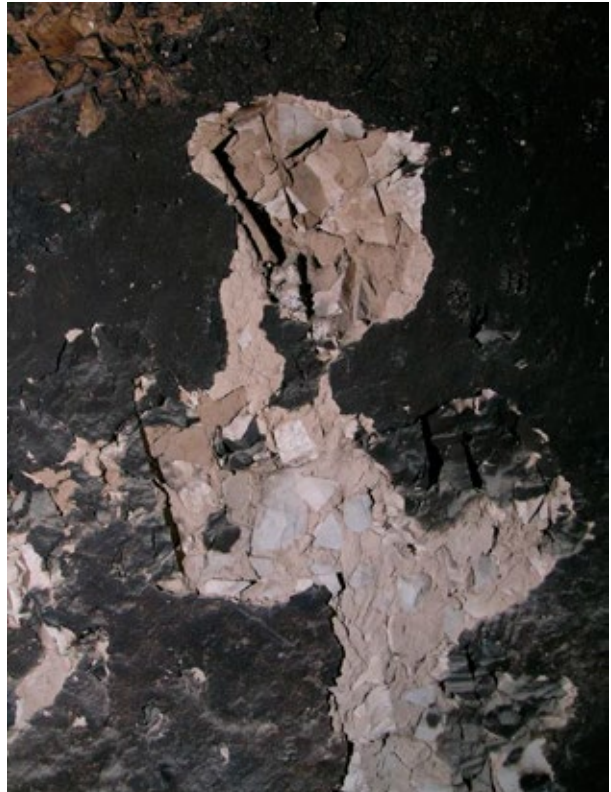
Post-fire loss in corridor (F) exposes areas of packing plaster and rock shards used to create a flat wall surface.

Areas of post-fire loss such as plaster above doorway (D) should be monitored to determine if deterioration is ongoing.

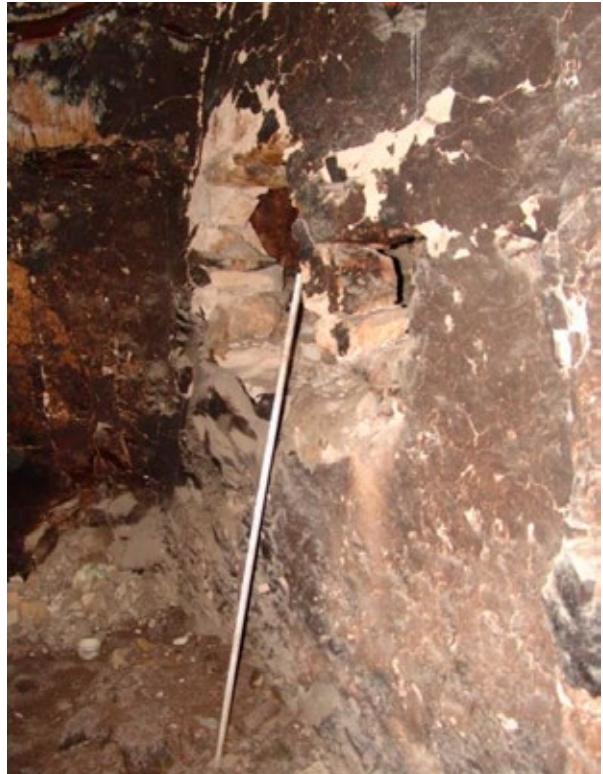
Constructed masonry wall of niche (O) (see also image below).

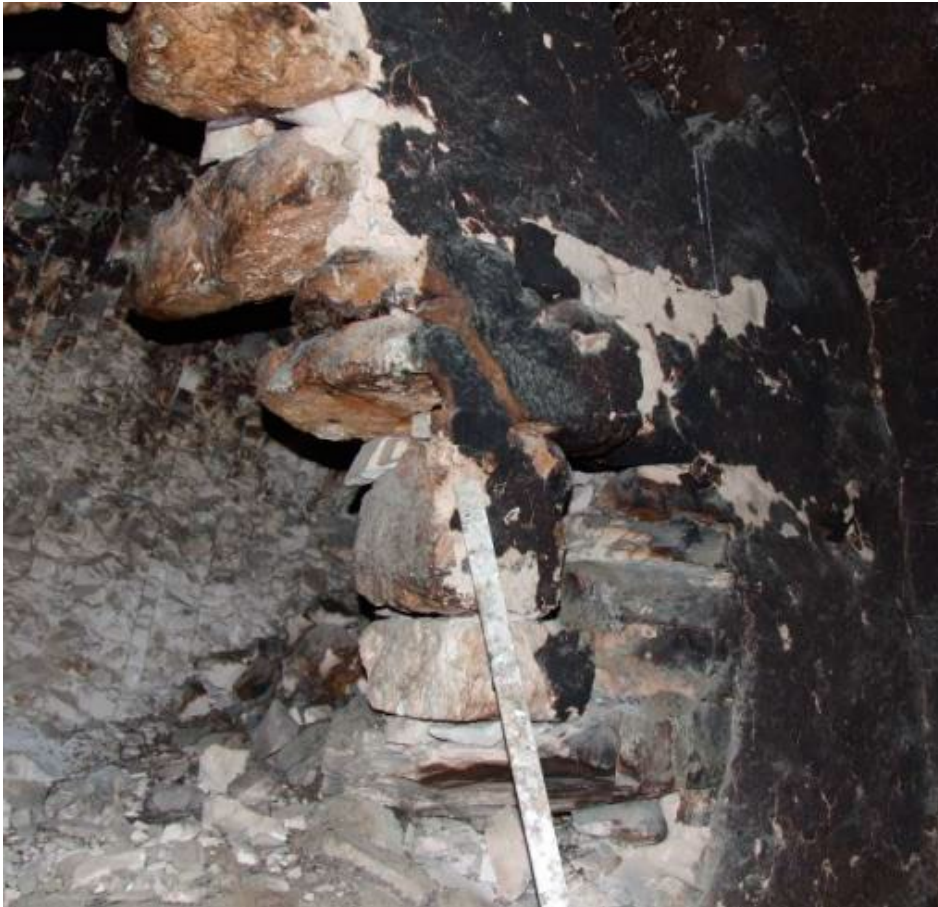
Detail of masonry wall of niche (O). This area requires stabilization to prevent further loss. Localized treatment of plaster may be needed in conjunction with this structural work.

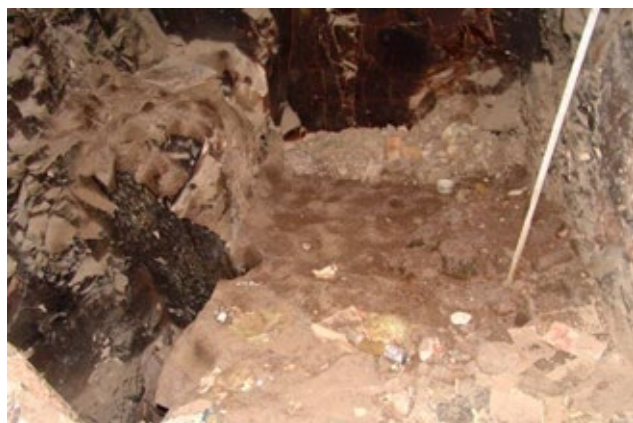
Bat droppings cover the floor of the tomb.

Exclusion of the large bat population in the tomb is necessary to prevent ongoing damage and accumulation of droppings. The tomb requires a door to seal it and prevent entry of bats and other animals, as well as floodwater and related debris. Additionally, removal of the bat droppings is necessary before any work can be undertaken in this tomb.

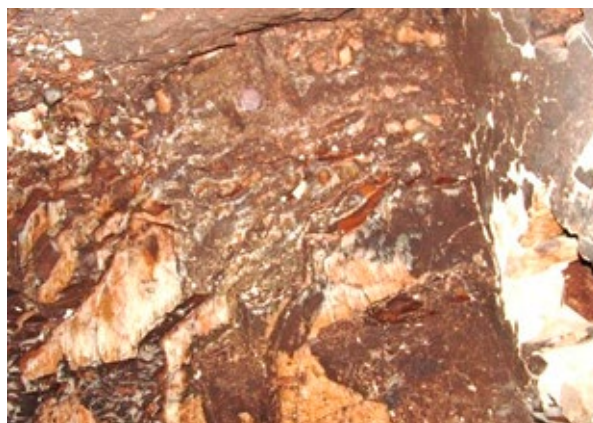
Bat deposits on upper walls and ceilings indicate significant bat activity in this tomb.

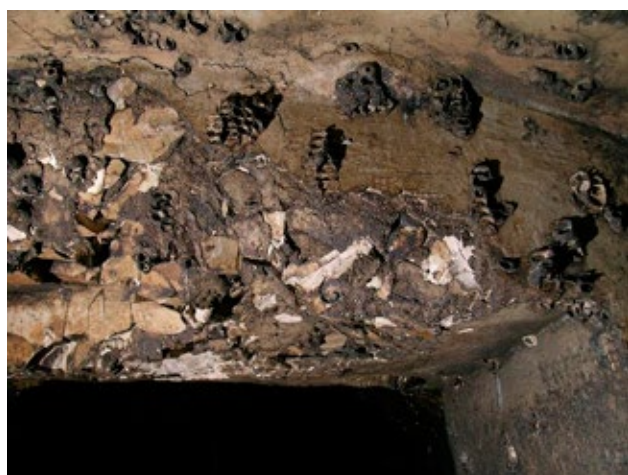
Mud wasp nests on inner doorway.

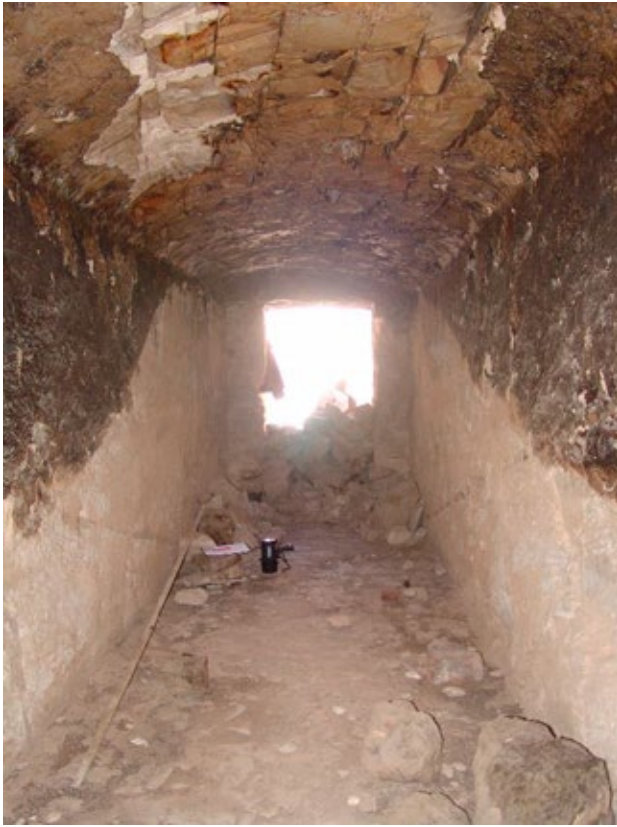
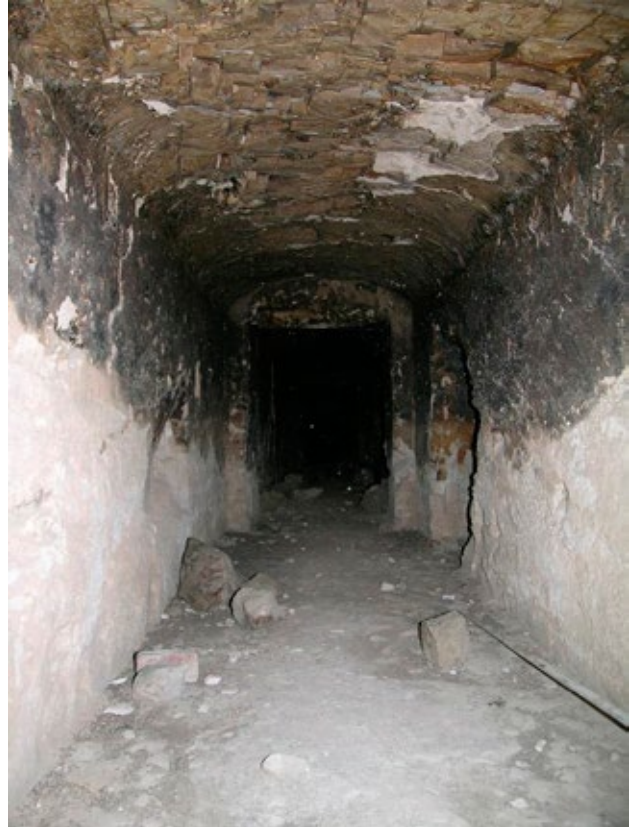
Corridor C: Fire damage rose upwards toward doorway (B), left. Looking from doorway (B) toward doorway (E), right. The lower part of walls of corridor (C) were protected from fire by debris.

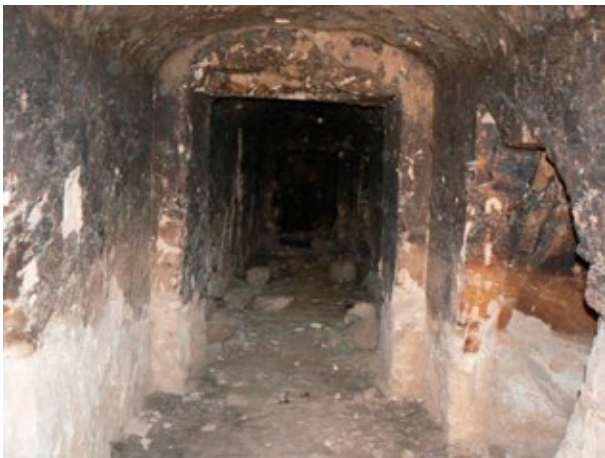
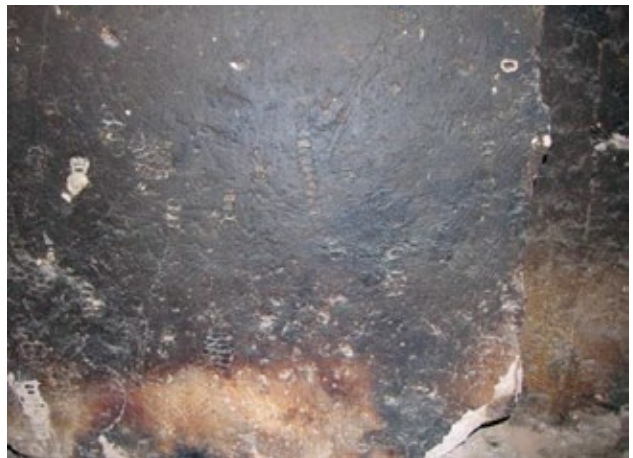
Heavy fire-blackening can be seen on walls and ceilings throughout tomb.

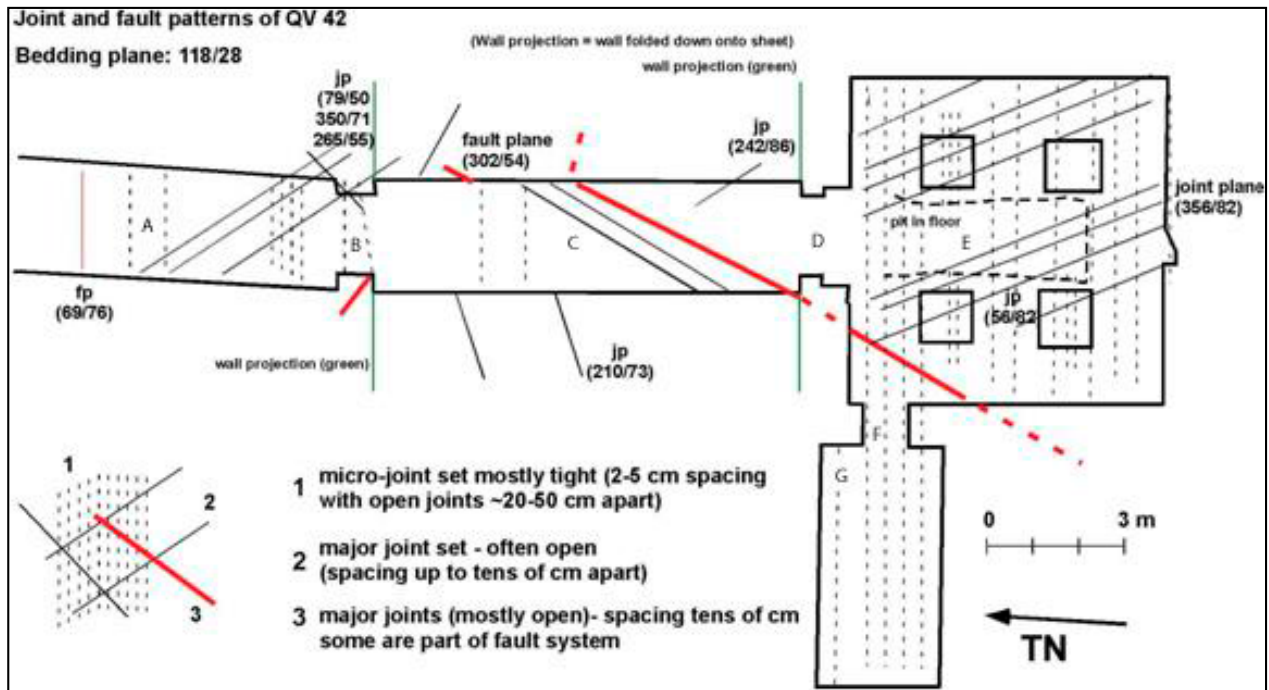
Geotechnical analysis conducted in 1993 by University of Cairo. The principal area of concern is indicated as the ceiling rock between pillars I and III (CNRS).

Stabilization of the heavily fractured remains of pillar III and the ceiling rock above it is needed, as is the stabilization of pillar I. Areas of painting on pillars should be treated in conjunction with any structural stabilization work.

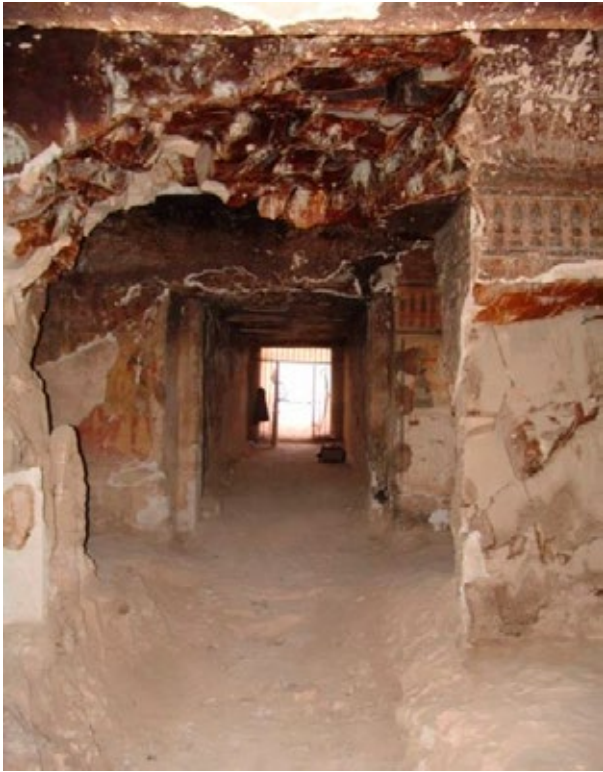
Interior view, looking towards entrance showing pre-fire loss of rock in pillar I (right) and in ceiling between the pillars.
