Valley of the Queens Assessment Report

Volume 2

Assessment of 18th, 19th, and 20th Dynasty Tombs

A collaborative project of the Getty Conservation Institute
and the Supreme Council of Antiquities, Egypt

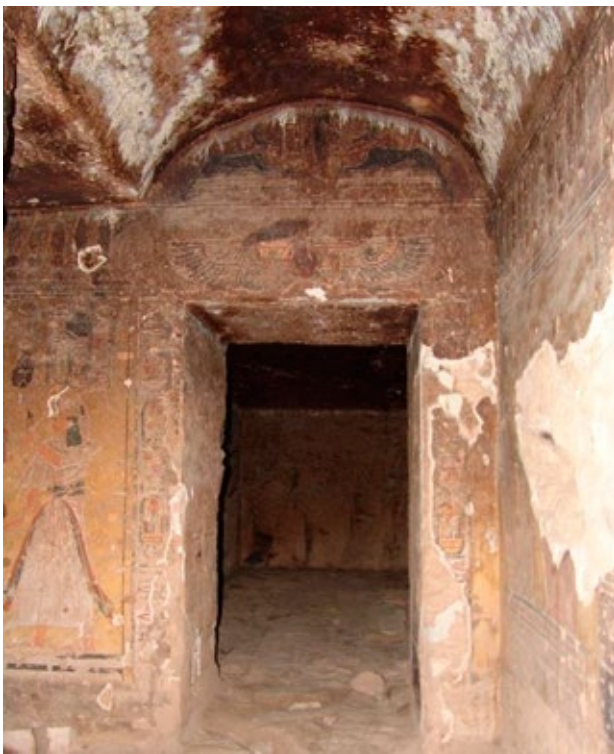
Burial chamber (E) looking toward chamber (G) and showing barrel vaulting of ceiling. Note white deposits of bat urine on wall painting surfaces of the ceiling.

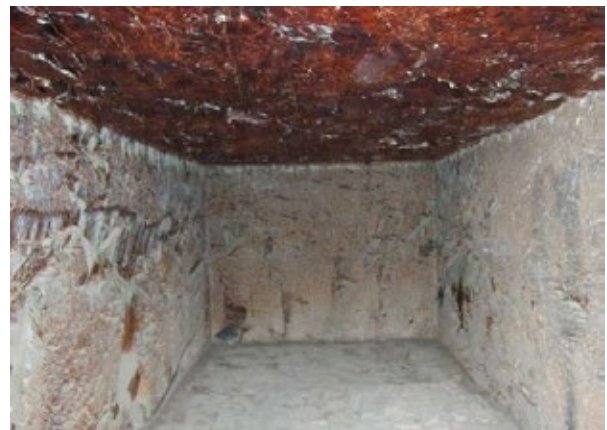
Side chamber (G) with resinous deposit on ceiling; substantial amounts of bat droppings and urine are present on ceiling and walls.

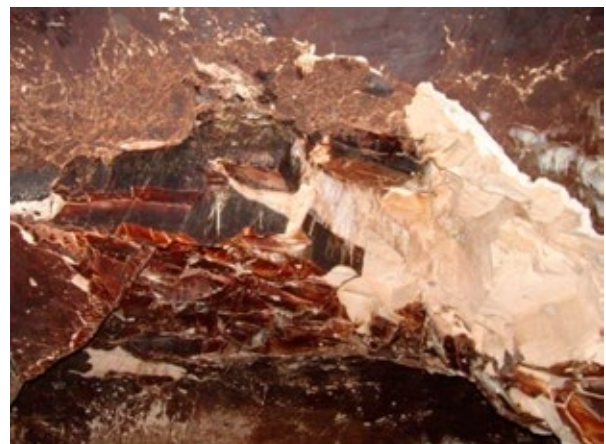
Loss of decoration is due to localized areas of rock loss, such as on pillars and in the burial chamber ceiling, as well as to failure of infill material used to fill large voids in the rock. Fire damage might also have played a role in weakening the plaster in areas, eventually leading to collapse and loss.

Post-fire rock loss in ceiling of chamber (E) above Pillar III.

Stabilization of the heavily fractured remains of pillar III and the ceiling rock above it is needed, as is the stabilization of pillar I. Areas of painting on pillars should be treated in conjunction with any structural stabilization work.

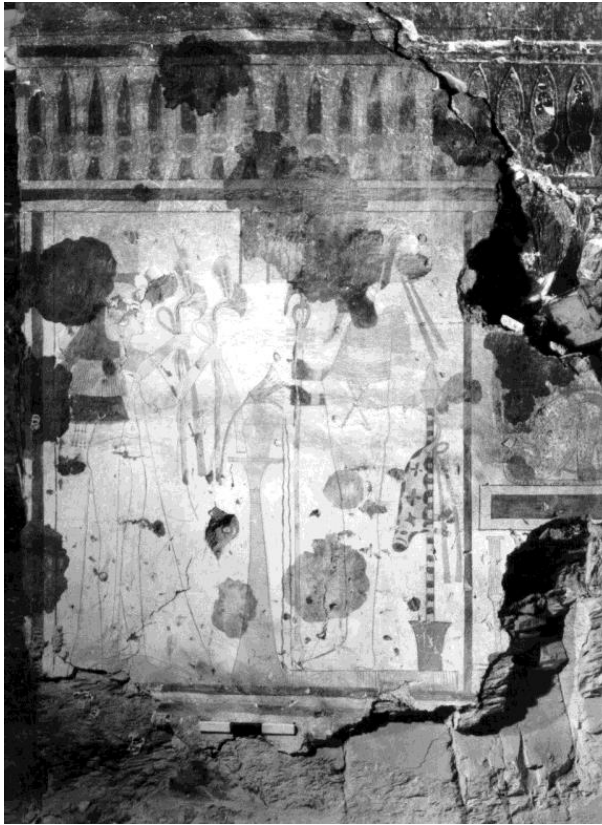
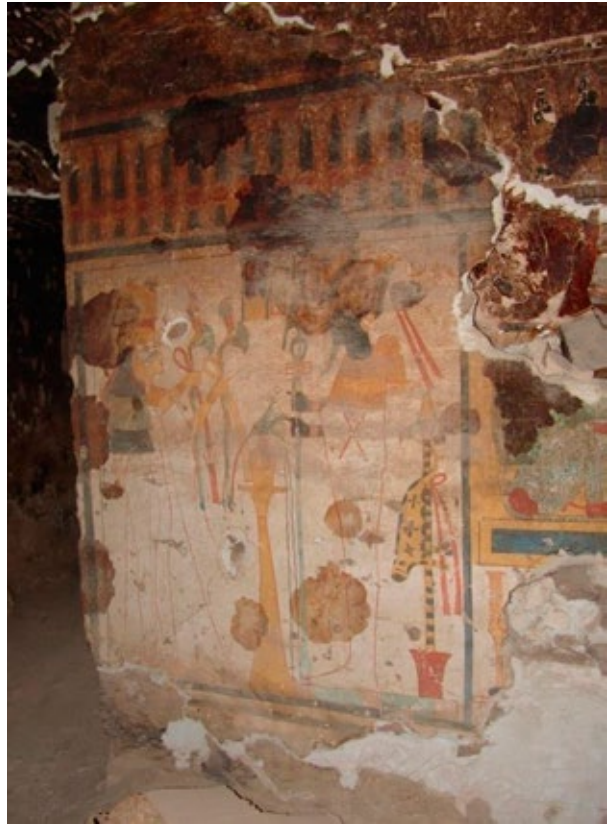
East side of north wall of burial chamber (E) that features depiction of the queen. Unlike most of the decoration in the tomb, this area is painted on a constructed masonry wall support. The painting differs in this area with no relief work and a slightly cruder painting style. Note large diagonal crack and losses of the painted plaster, already evident in the 1977 photo, left (Image: CEDAE).

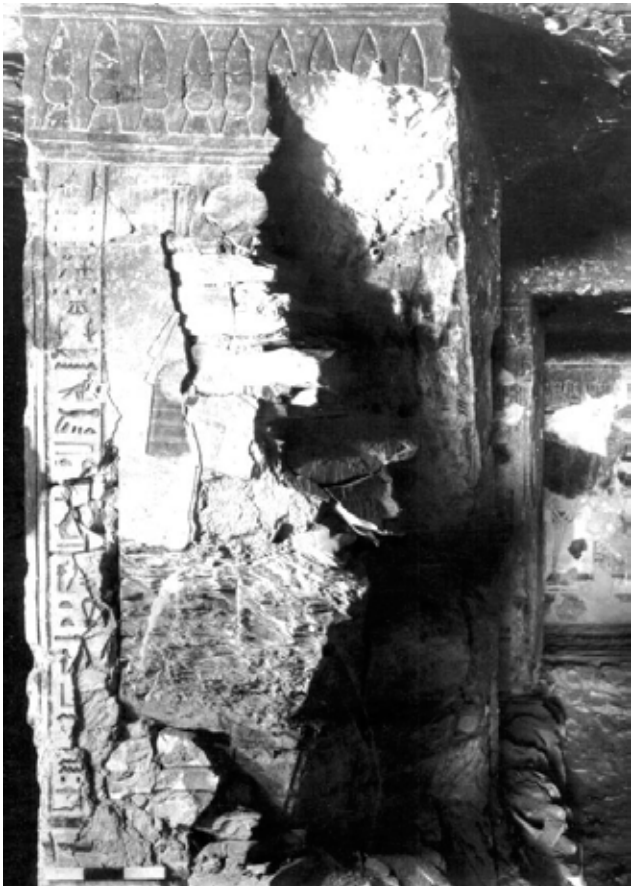
Detail of area of loss on the north wall of burial chamber (E). A gap exists behind the wall plaster.

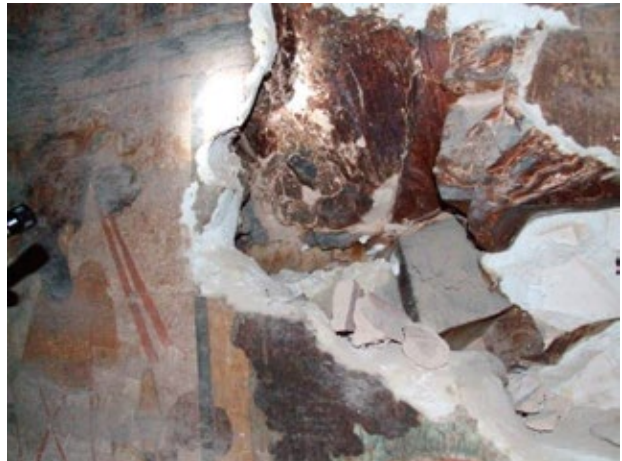
Large voids in the pillars were originally built out with stones to create a flat even surface. Some stone are still visible but most of the infill material has been lost in this 1977 photo (Image: CEDAE).

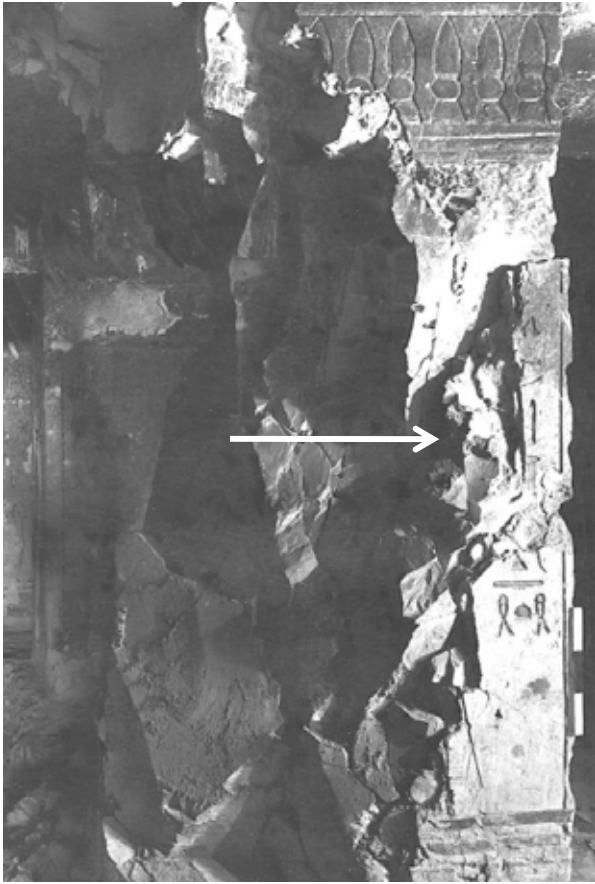
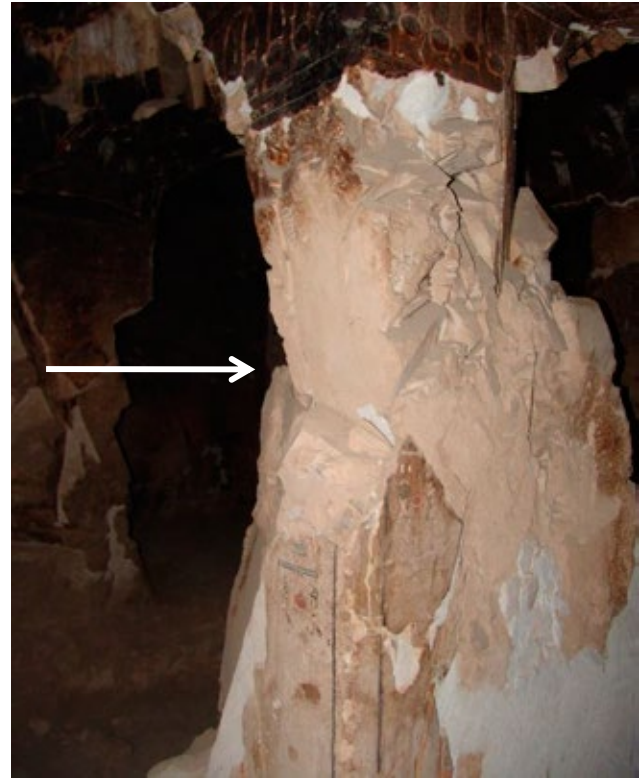
Losses of rock and painted plaster on pillar III in burial chamber (E) can be seen since 1977 photograph (left, Image: CEDAE).

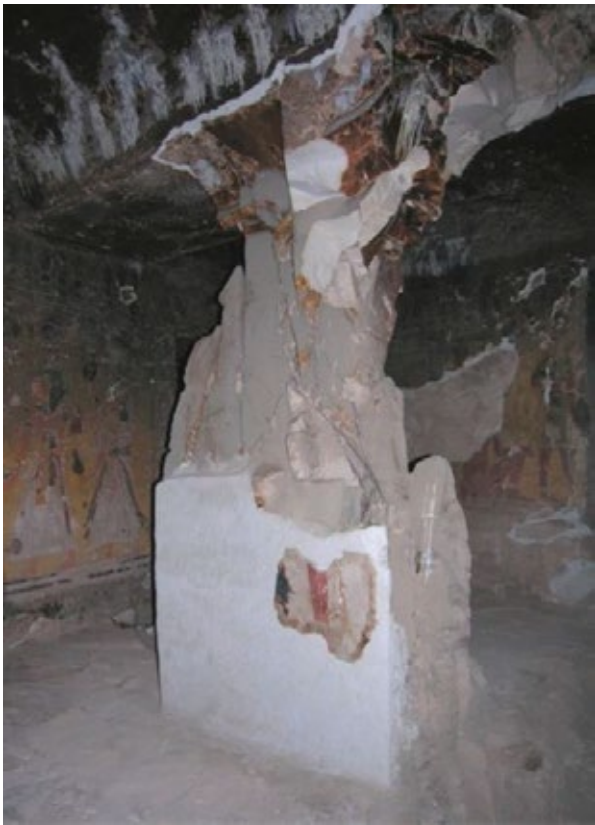
The two northern pillars (I and III) of burial chamber (E) have suffered substantial rock loss and associated decoration loss. Pillar III is in the most serious condition with numerous near vertical fractures in the central rock remains of the pillar. Rock loss continues up to the ceiling where post-fire loss is evident and detached fragments are at risk of falling. Pillar I also has significant loss, but the rock is not as fractured, suggesting less swelling and shrinking pressure in this area. Pillars II and IV are in better condition, though pillar IV has a long diagonal fissure that is causing separation of the northeast corner with a large area of painting.

Fractured remains of pillar III in burial chamber (E) with recently reconstructed base of the south face, and post-fire loss on upper right side.

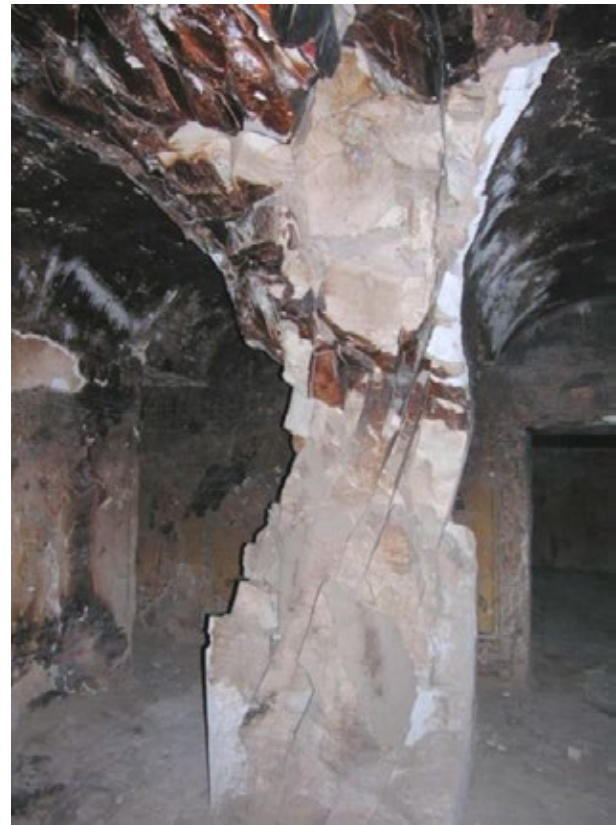
East face of pillar III showing post-fire loss and almost vertical fractures in the remaining rock.

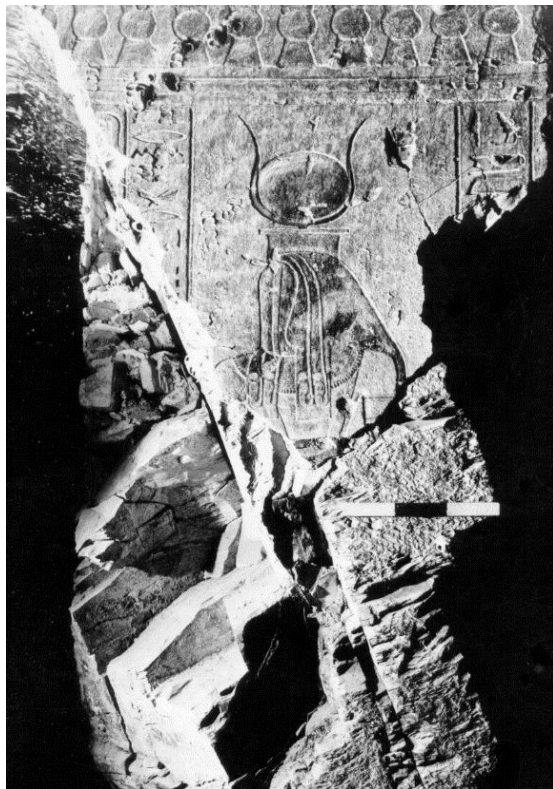
West face of pillar I in burial chamber (E) in 1977 photo (Image: CEDAE).

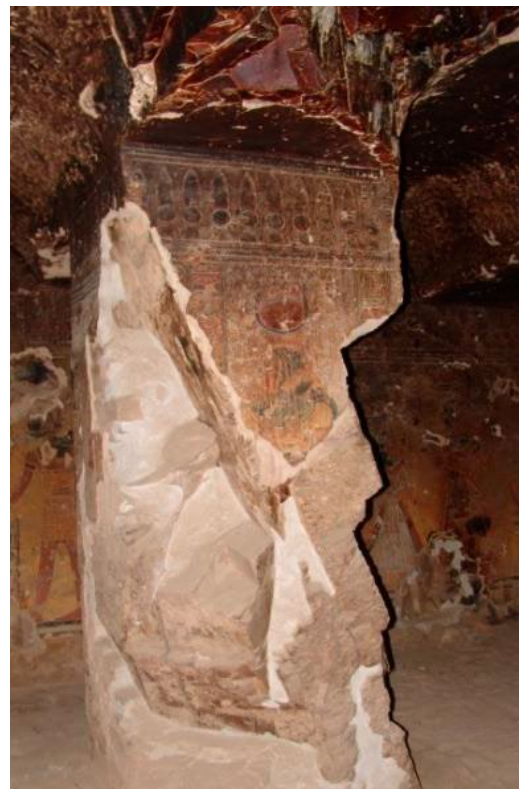
West face of pillar I showing mostly post-fire rock loss and recent (likely 1989-91) edging repairs, but little loss since 1977.

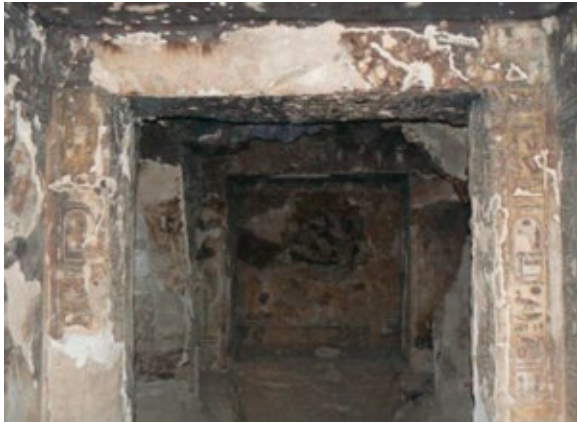
View of doorway (D) into burial chamber (E); jamb loss and repair, and loss of original mortar repair and painted surface since 1977 are visible in foreground; the sunken floor of the burial chamber is in the background.

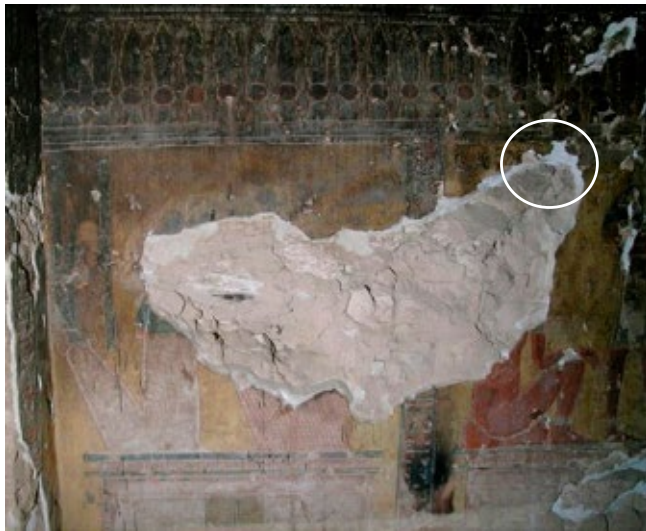
Losses of area of painted plaster since 1977 photograph (right, Image: CEDAE) in burial chamber on north wall, west side.

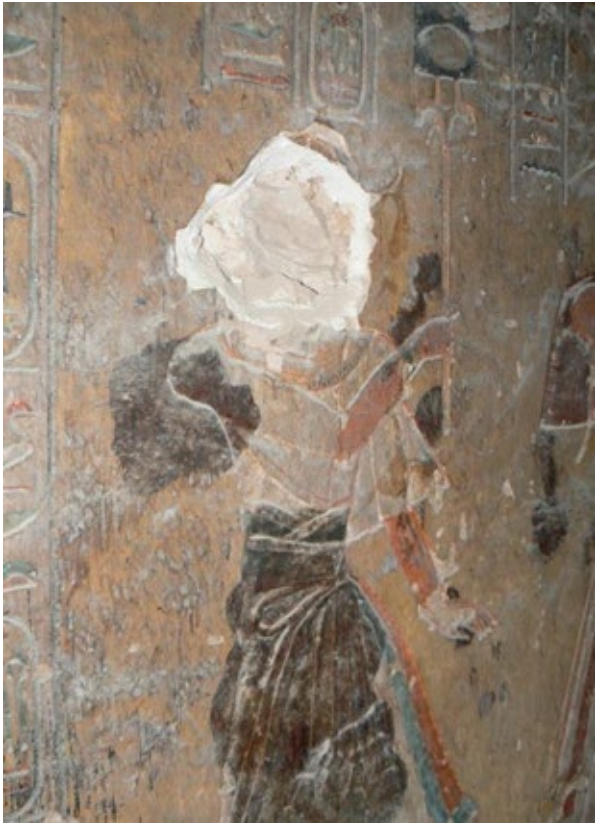
Possible intentional damage of figures can be seen in the burial chamber (E).

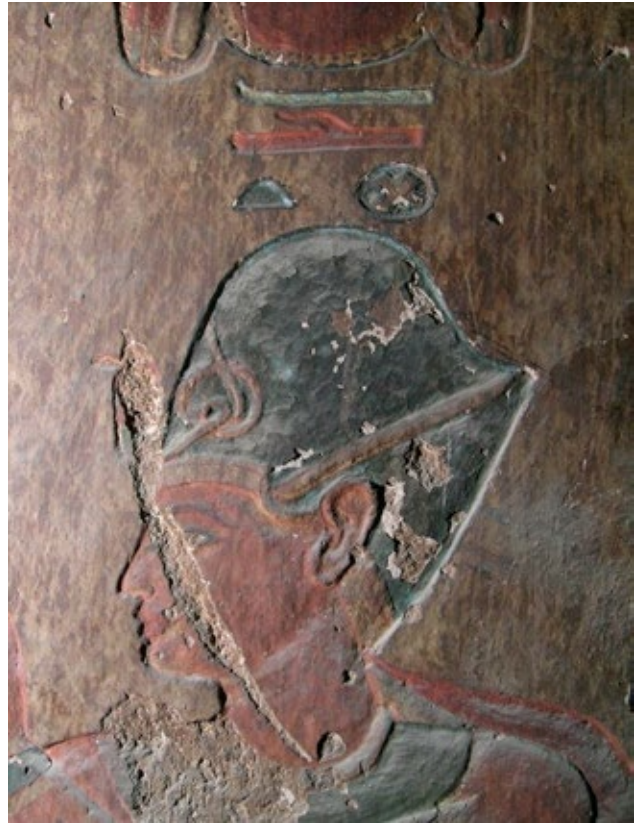
Flaking of the black paint of the headdress.

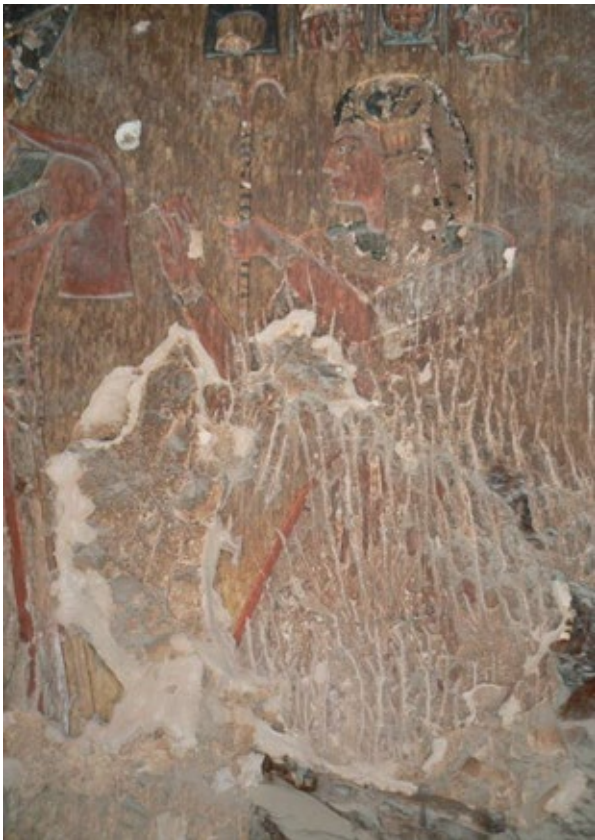
Scratch marks in burial chamber (E) are thought to be caused by bats, birds or other animal activity.

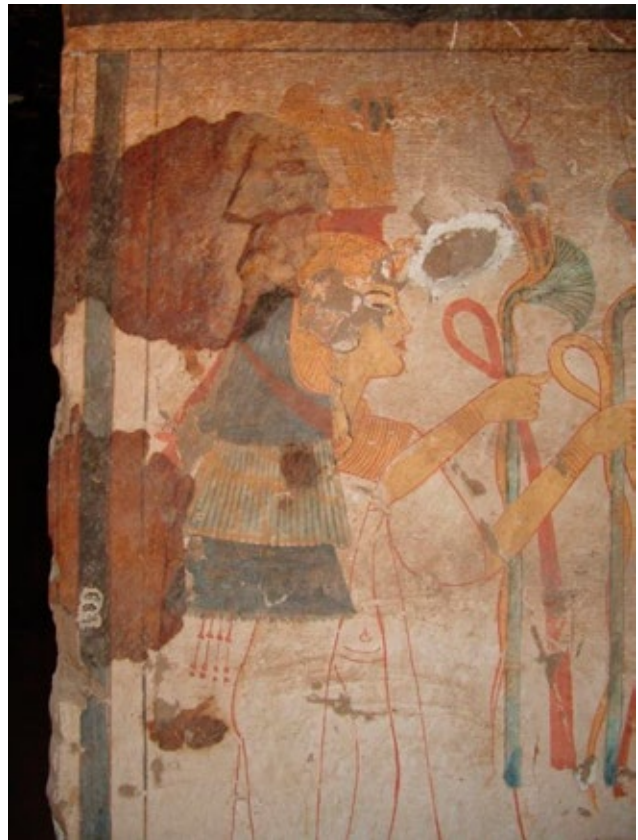
Large dark splotches are attributed to bat activity.

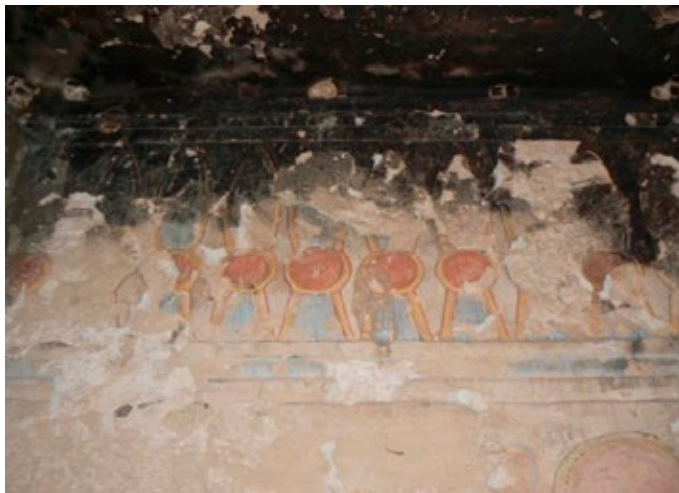
Blackening from fire is worse higher up the walls and on the ceiling of corridor (C). Lower walls have escaped the damage, indicating that the tomb was largely filled with debris at time of fire.

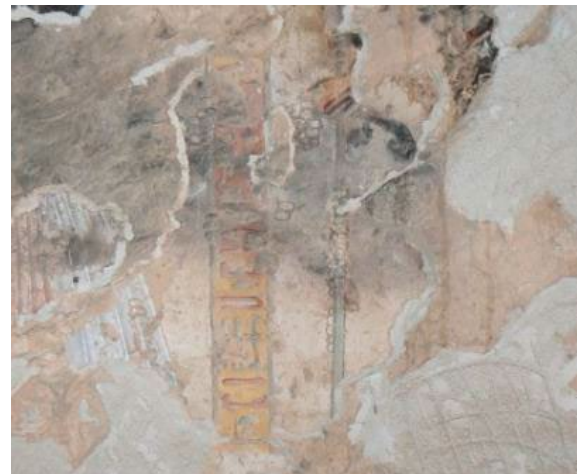
Heat alteration of pigments from yellow to red is also visible.

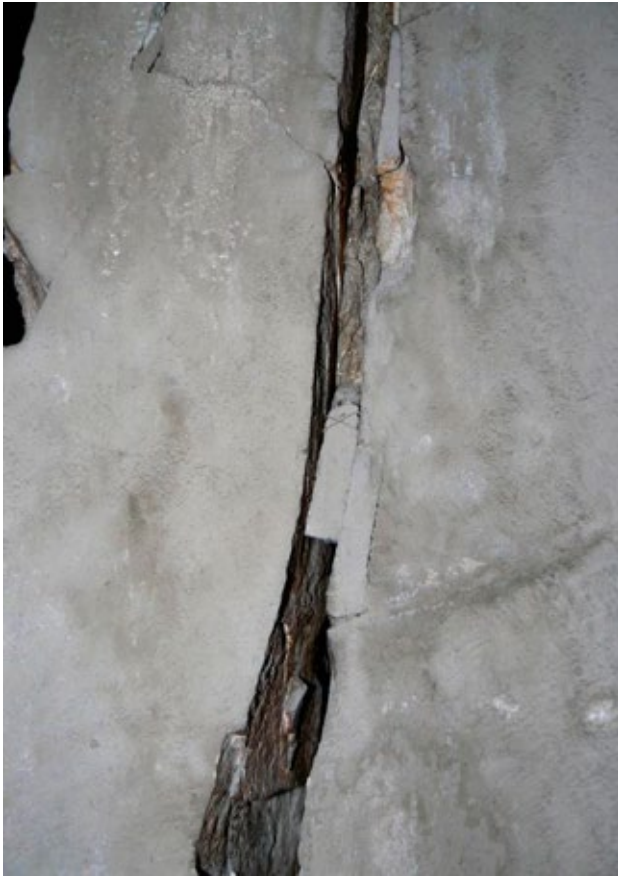
An early attempt in modern times at rock stabilization of pillar using gauze and adhesives.

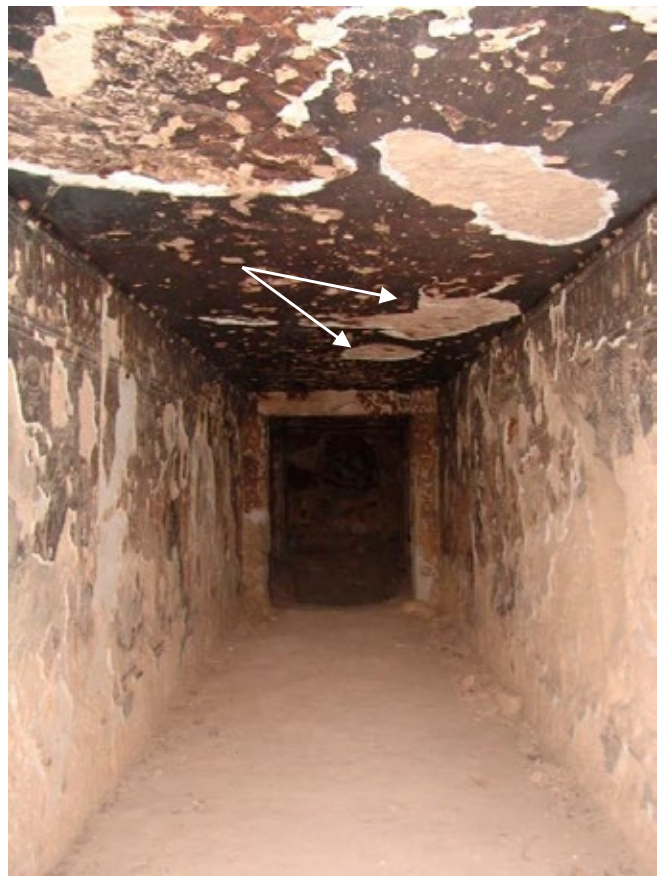
Corridor (C) looking south. Note line of blackening that rises up toward exterior door. Plaster loss on rear part of ceiling (arrows) occurred after Schiaparelli's mission, while loss near front of corridor (in foreground) was already present, based on photographic evidence (see D'Amicone and González 2008, fig 14).

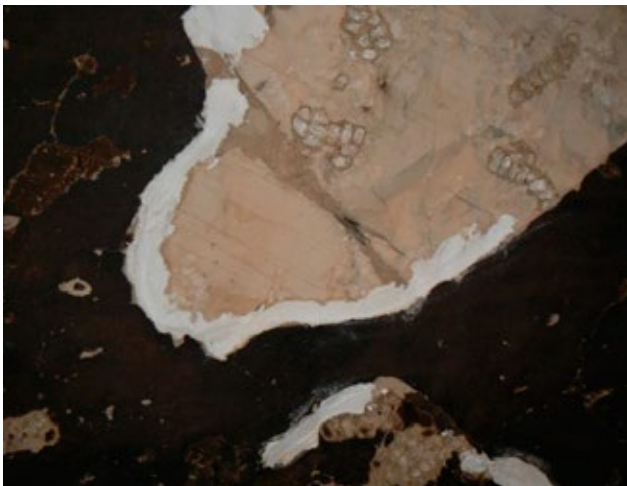
Edging repairs stand out starkly against the heavily blackened ceiling of the corridor. Note that this loss in the plaster is post fire.

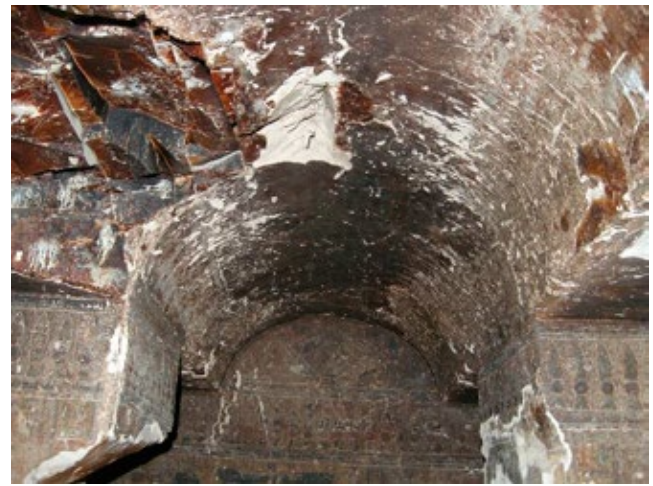
Post-fire loss of ceiling rock in barrel arch that appears more recent.

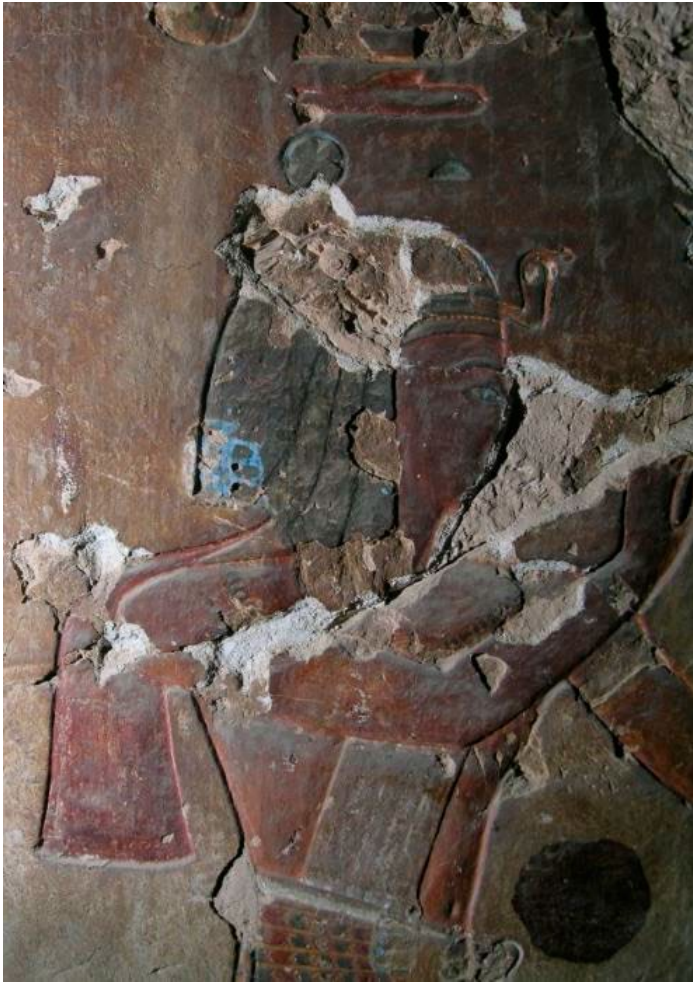
Removal of the insect nest in recent past (likely 1990s) reveals the original blue color of the headdress, now obscured by blackening from fire.

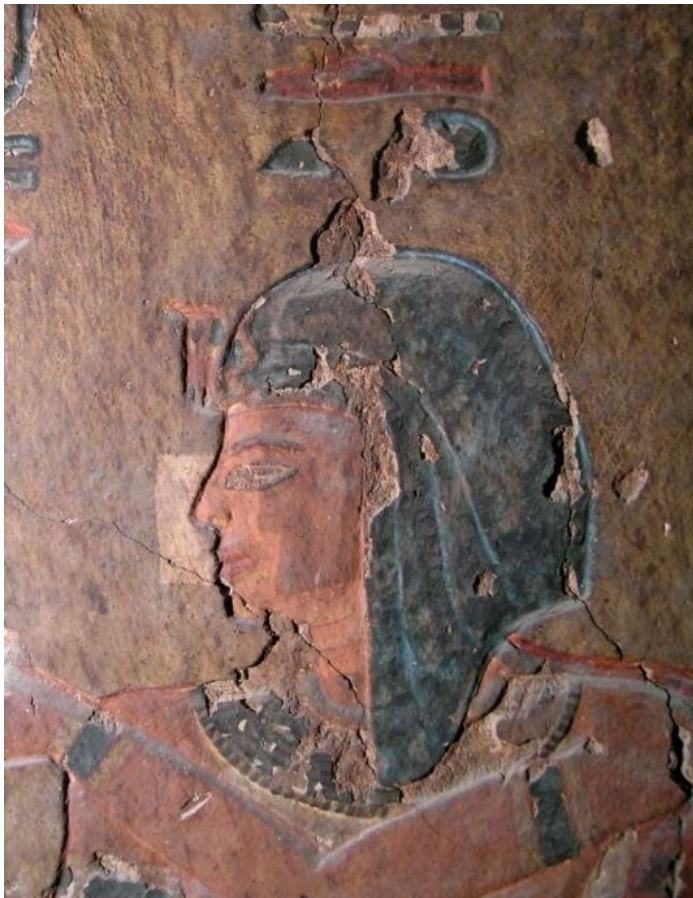
Cleaning test (1990s?) on face of figure on west wall of burial chamber.

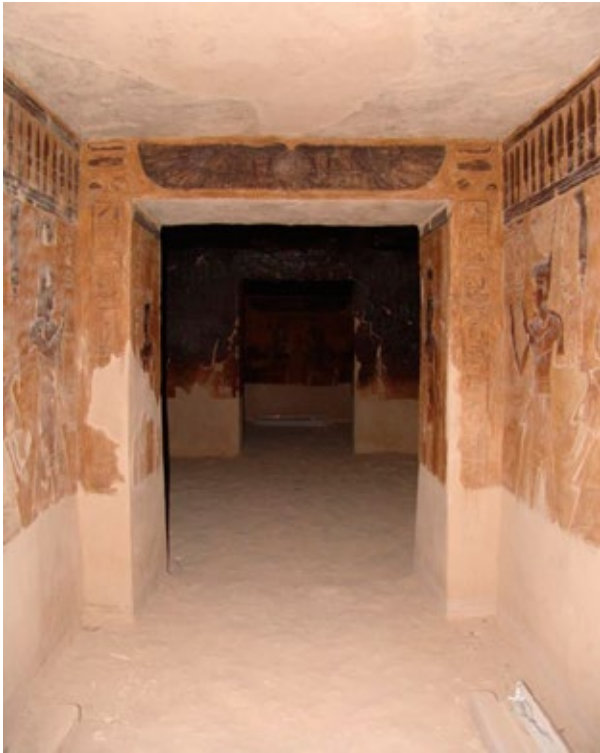
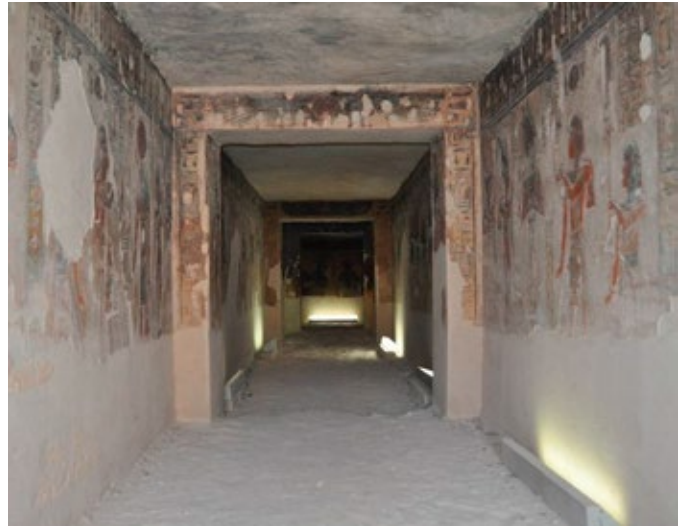
General views of tomb interior, looking southwest. Lighting on ground has not yet been installed in the 2006 photo on left. Extensive interventions have been undertaken in corridors (C), (E) and chamber (I). The loss at the base of the walls is possibly from previous flood damage. These areas are now filled with repair plaster which forms a very regular horizontal line along the bottom edge in the second corridor and main chamber, suggesting that the irregular original plaster may have been cut off during treatment with repair plaster.

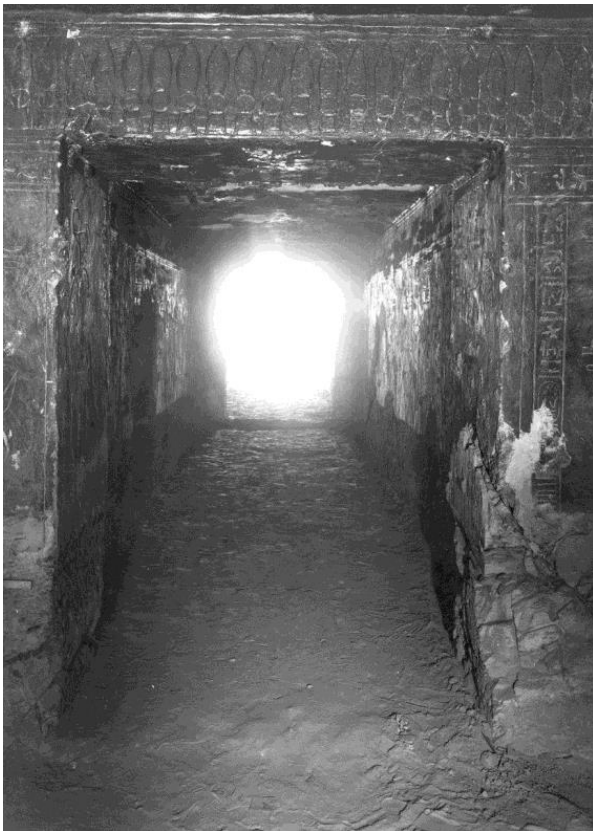
Small area of rock loss in doorway (F) (Image: CEDAE 1977).

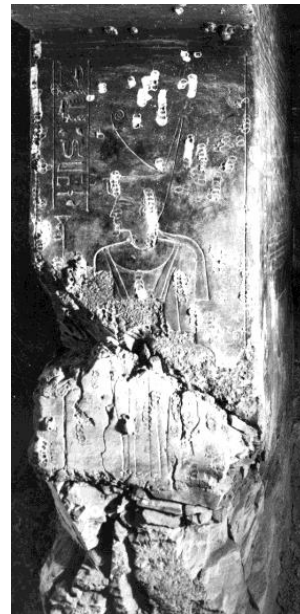
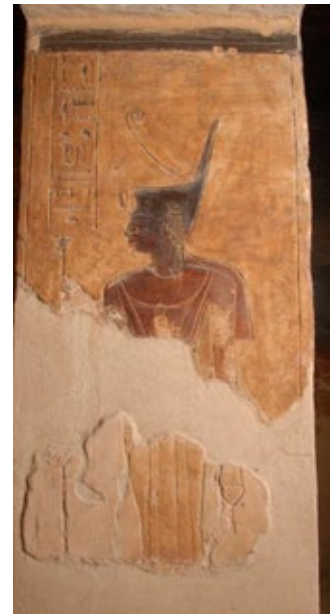
Left: East jamb of doorway (F) before treatment (Image: CEDAE 1977). Right: same area after treatment (Image: CEDAE 2009)

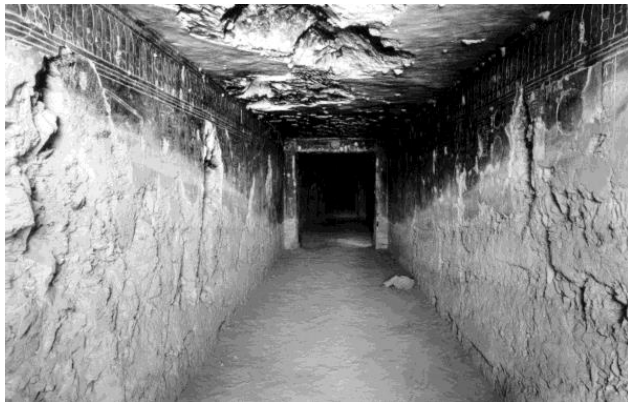
1977 photograph of corridor (C) shows the tomb before any treatment (Image: CEDAE). Note large voids in rock on ceiling and walls. Note also line of blackening that rises up toward the entrance of the tomb.

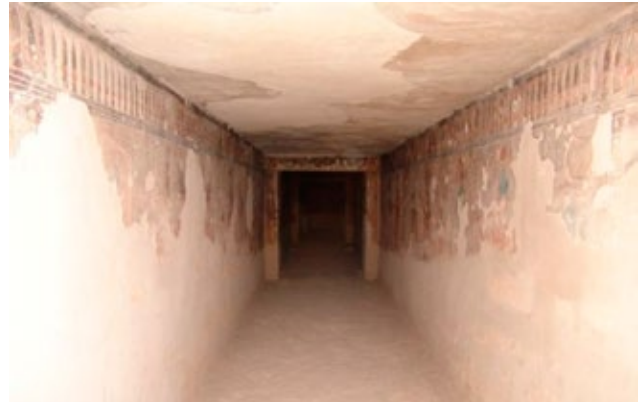
Corridor (C) after treatment (post-1977). All large losses in ceiling and walls have been filled with plaster.

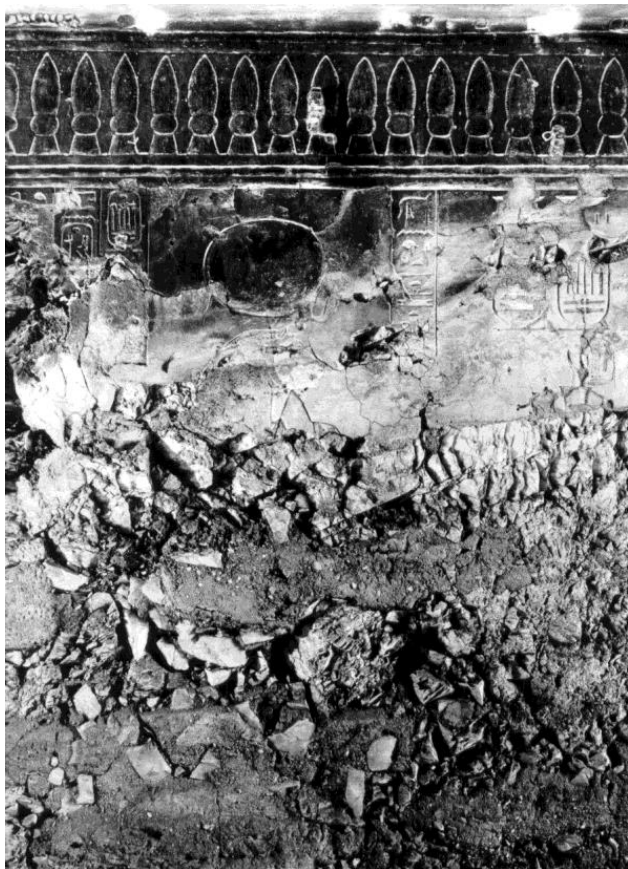
Substantial infill material was needed to pack out walls to provide a flat surface for the decoration as shown in this 1977 photograph from the north wall of corridor (C) (Image: CEDAE).

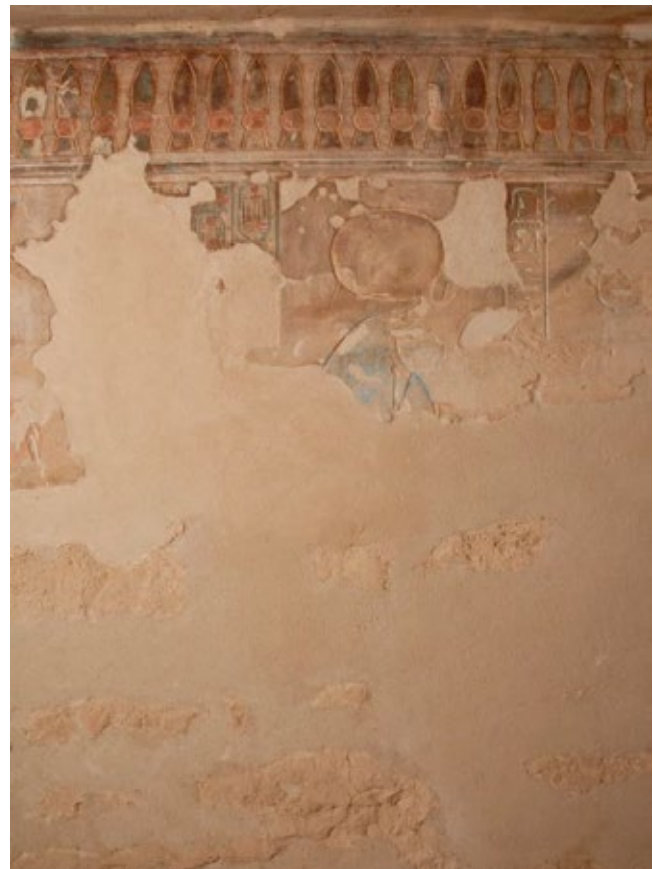
Repair plaster was applied to all areas of rock loss. The exact date of this work is unknown (Image: CEDAE 2009).

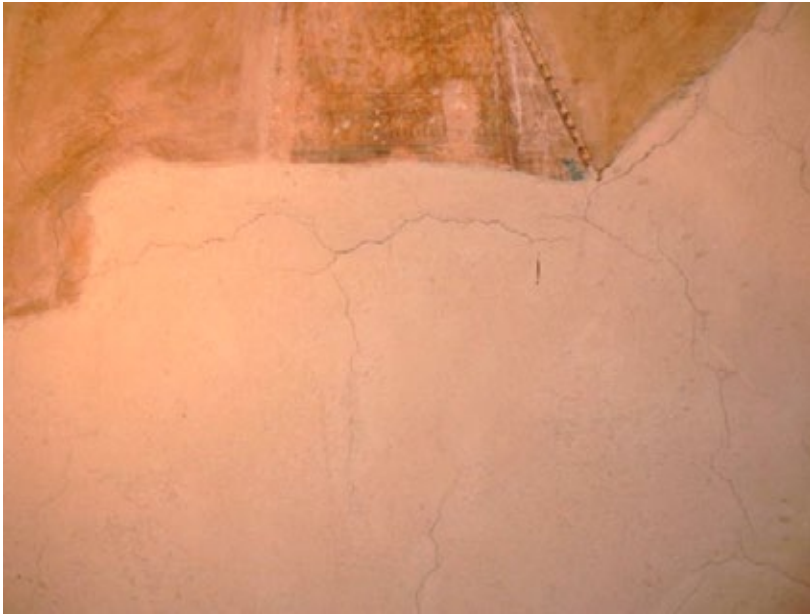
There are cracks visible in the substantial plaster repairs. As they conceal the condition of the underlying rock support these areas should be monitored to assess whether there are ongoing problems.

The entry ramp (A) requires a masonry arched cover constructed over existing retaining walls to protect the tomb from upslope floodwater and debris. Some cracking in original plasterwork where there is likely also plaster detachment requires monitoring, especially around doorways and on ceiling of chambers (I) and (G).

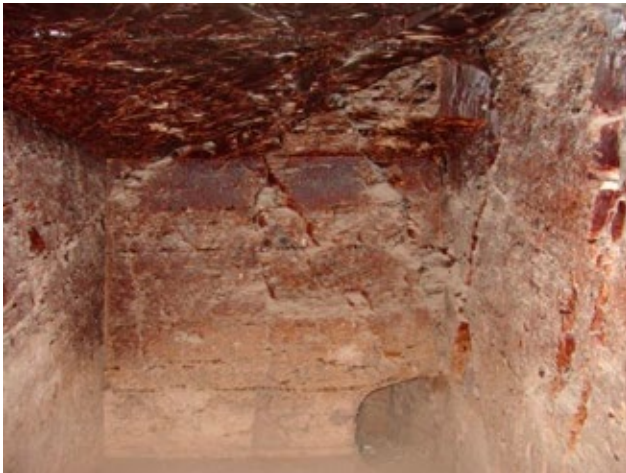
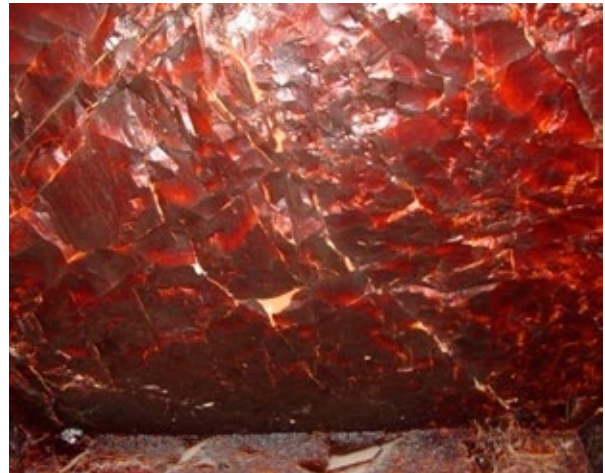
The tomb has been subjected to severe and extensive fire damage, resulting in heavy, glossy blackening of all surfaces. Chamber (K) is the only chamber that is not blackened and instead has an unusual reddish-brown lustrous appearance of the rock surface. The pattern of blackening on the walls in the first corridor (C) indicates that the fire rose toward the tomb entrance. The bases of walls are not blackened and were likely protected by sand banking or debris. A small area of unblackened painting also survives on the exterior face of the entrance doorway (B) which is now obscured by the modern door frame. Other areas of the tomb exhibit heavy blackening, which takes the appearance of a brown deposit with a lustre and gloss.

The rock surface of chamber (K) has an unusual reddish-brown lustrous deposit, similar to that found in QV 42 and 78.

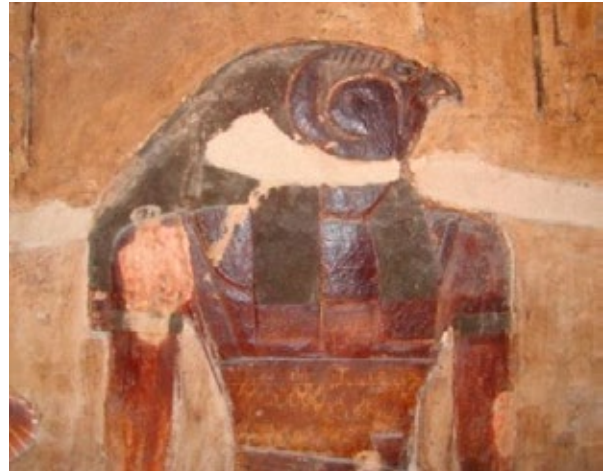
Note shiny surface of blackened decoration in chamber (E).

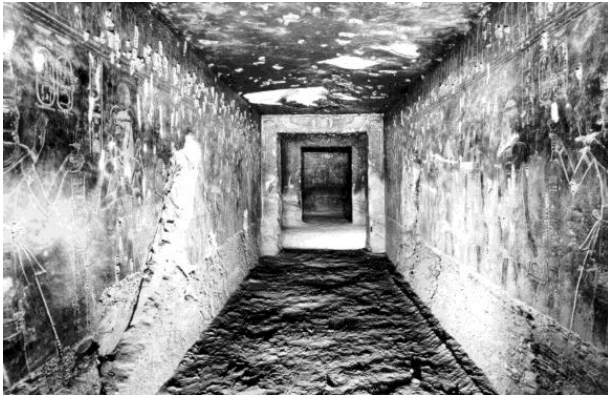
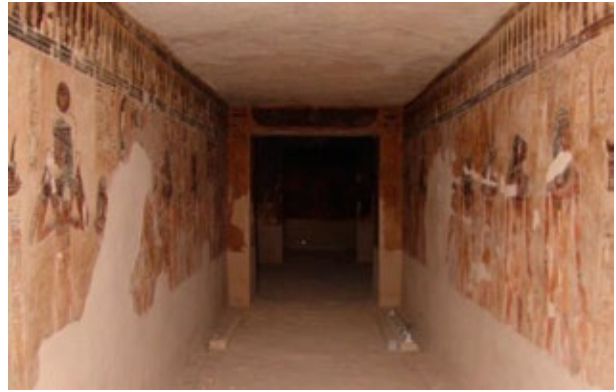
Only the backgrounds were selectively cleaned in the second corridor (E) leaving a silhouette of the figures. 1977 photo above left is before treatment and above right is after treatment (Image: CEDAE). It is unknown when this treatment was undertaken.

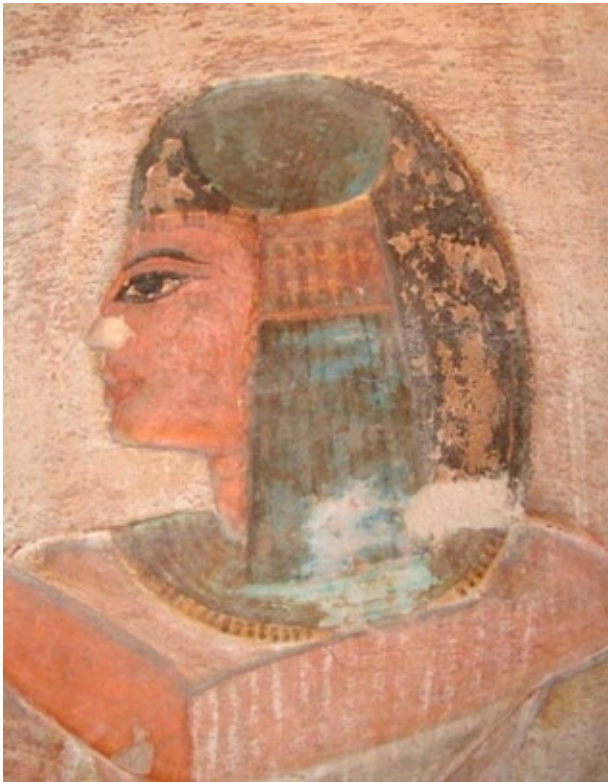
Detail of figure from first corridor (C). The paintings were less blackened in this area of the tomb. Note loss of black areas on wig of figure and abraded look of surface. Painting has been cleaned.

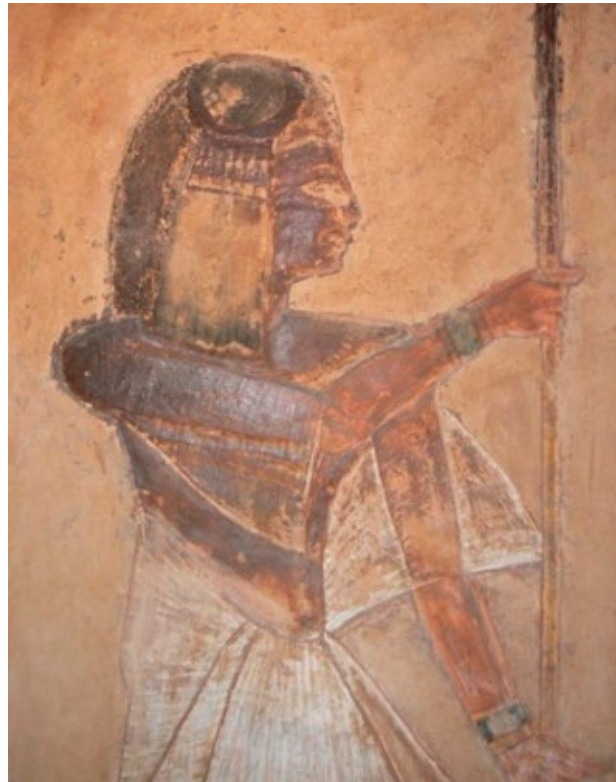
Detail of figure from second corridor (E); note how background was selectively cleaned. All paint was removed from the background.

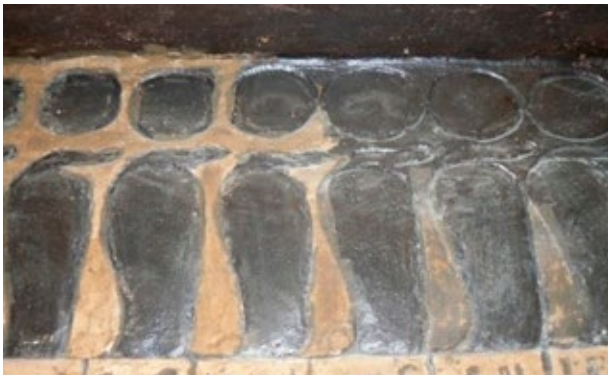
Upper border of second corridor showing partially cleaned surface. Note how the blackened background has been completely removed on the left side but not on the right.

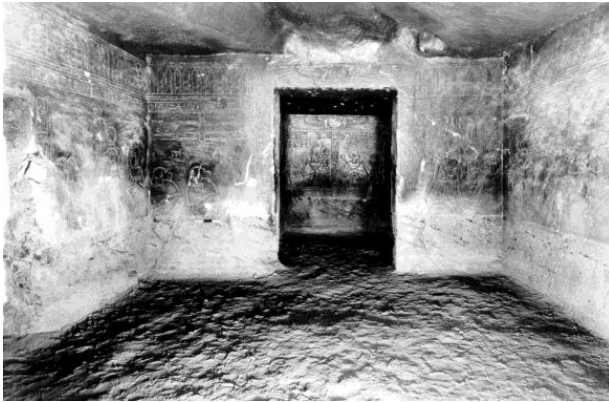
Main chamber (G) before interventions and the insertion of large plaster repairs at the base of walls (Image: CEDAE 1977).

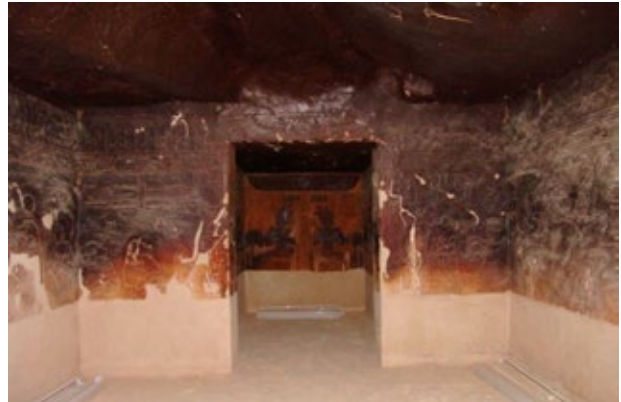
Main chamber (G) as it appeared after interventions (photo 2007).

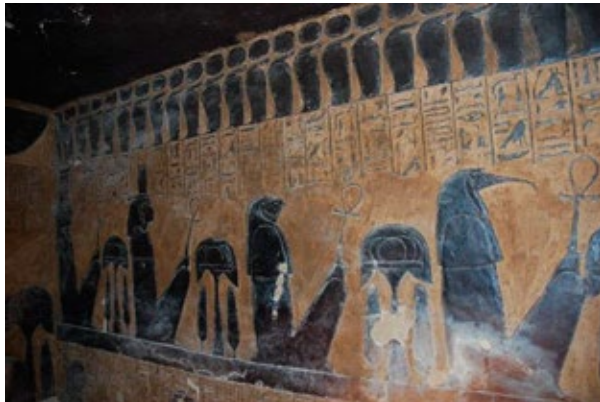
Selective cleaning of background in chamber (I), north wall.

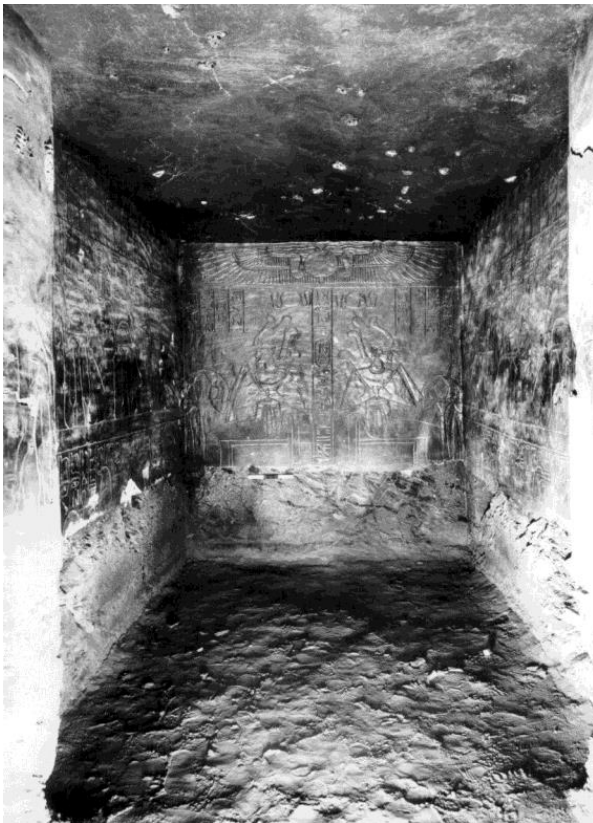
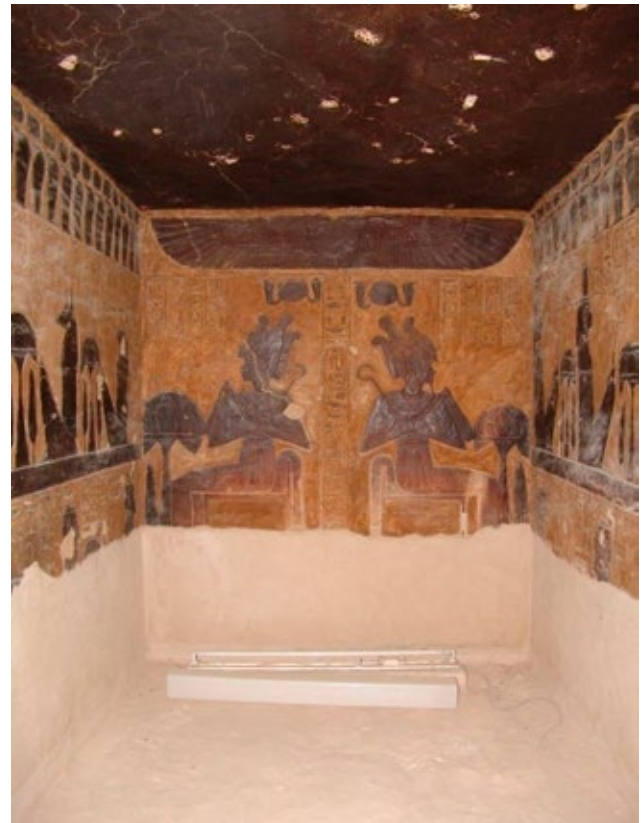
Only the backgrounds were selectively cleaned in rear chamber (I) leaving a silhouette of the figures. The 1977 photograph on the left shows the paintings before cleaning (Image: CEDAE)

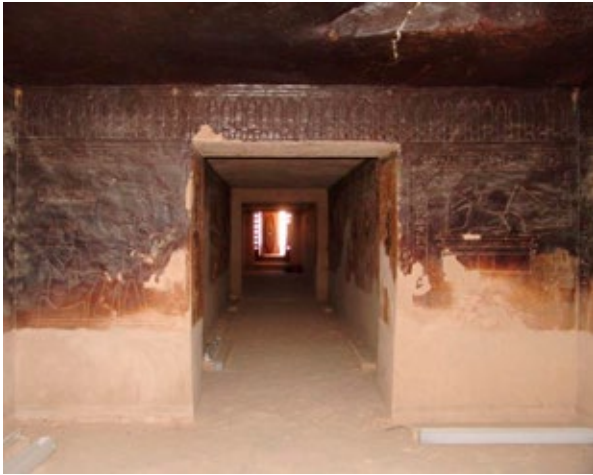
There is cracking around doorway (F) though very little post-fire loss of plaster.
