Valley of the Queens Assessment Report

Volume 2

Assessment of 18th, 19th, and 20th Dynasty Tombs

A collaborative project of the Getty Conservation Institute
and the Supreme Council of Antiquities, Egypt

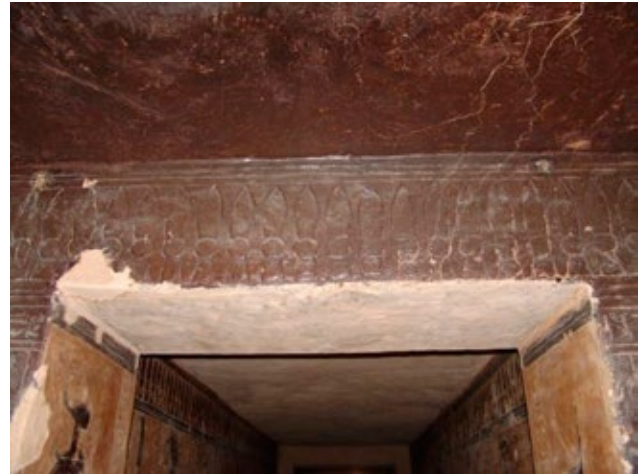
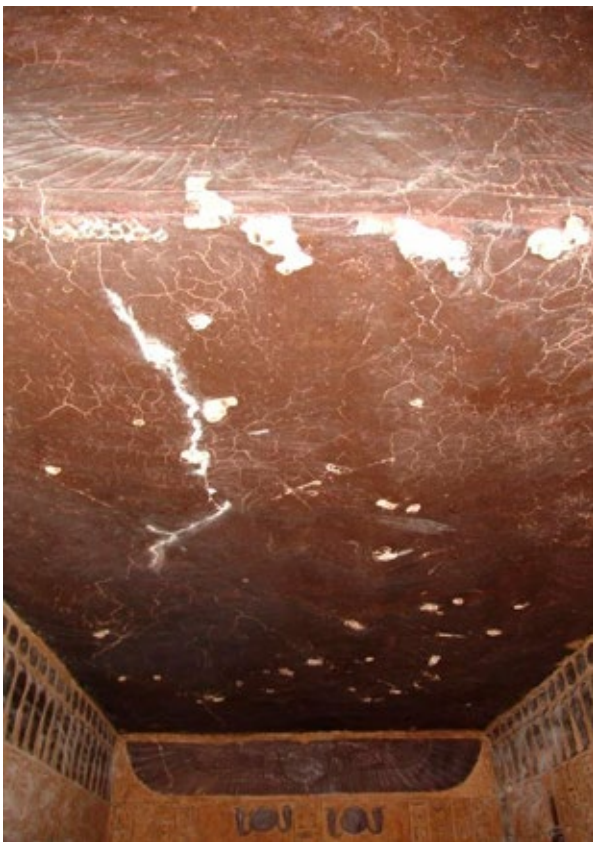
Note extensive cracking on ceiling of rear chamber (I) though very little loss has occurred.

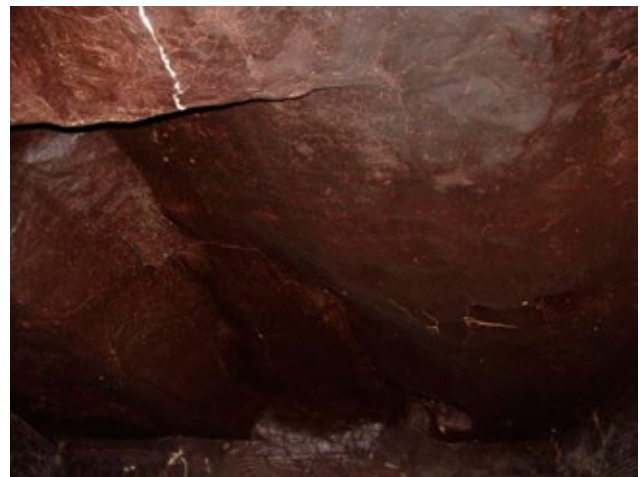
Irregular ceiling of chamber (G) with surviving plaster indicates that ceiling was never flat.

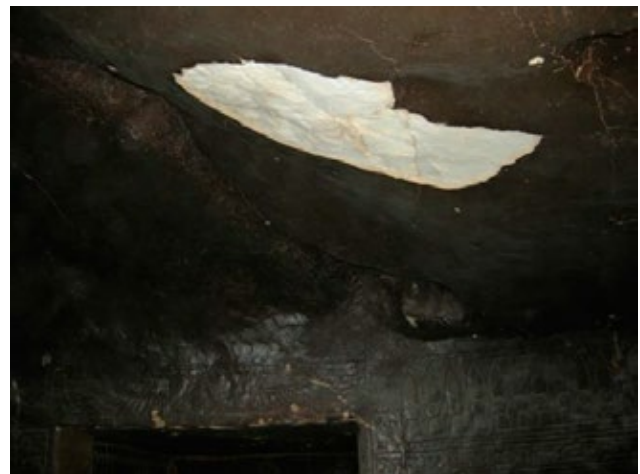
Recent area of plaster collapse in chamber (G) in 2009. This area was then treated by the SCA. Other areas of plaster cracking should be further investigated as it might indicate remaining areas of plaster instability.

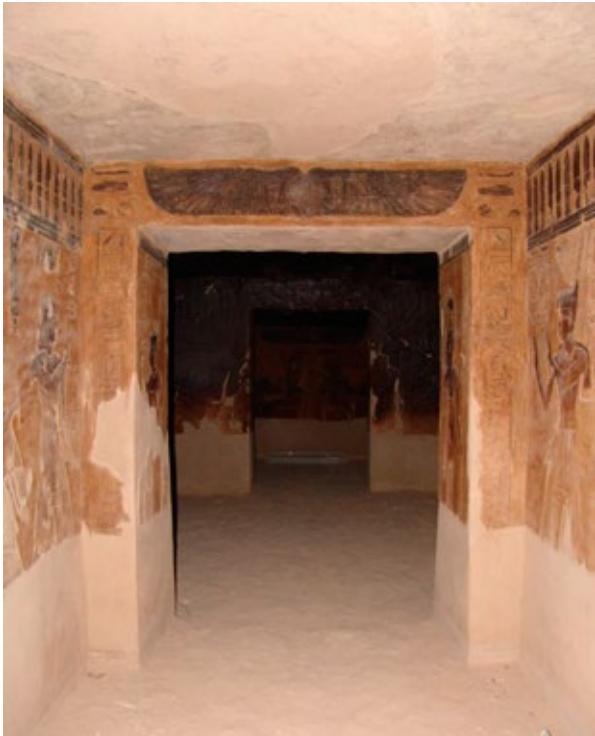
Ceiling of the second corridor (E) has been whitewashed.

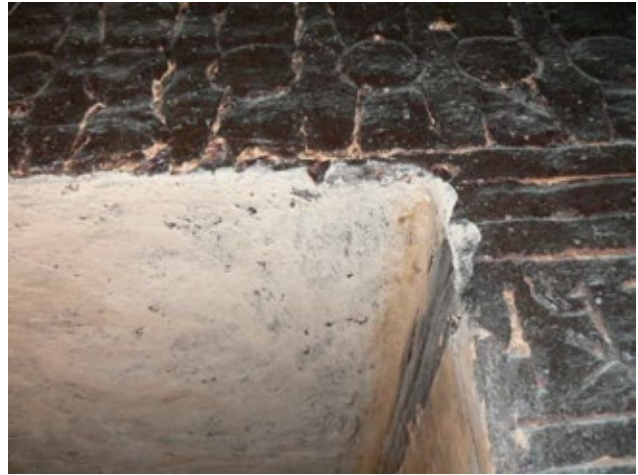
The area around doorway (F) has been whitewashed as part of the previous treatment interventions in the tomb. Note how the whitewash was applied over areas of original blackened plaster.

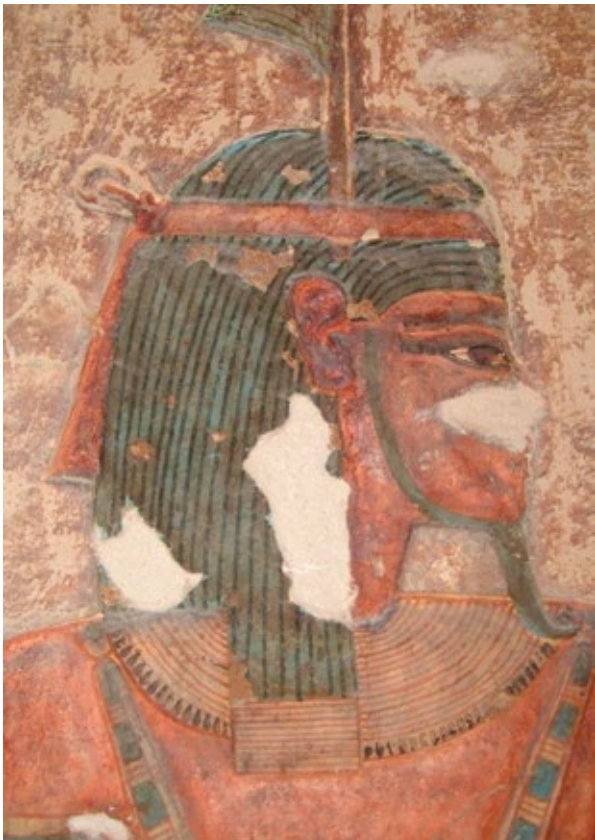
Shiny material is visible on surface of painting in first corridor (C). Most likely a treatment for paint flake relaying.

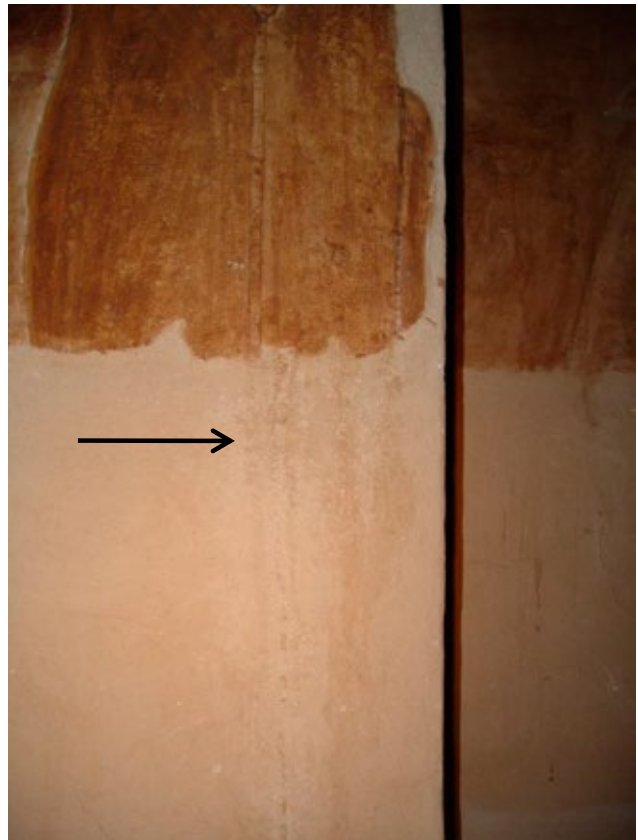
Treatment drips run down the surface of original plaster and modern repairs.

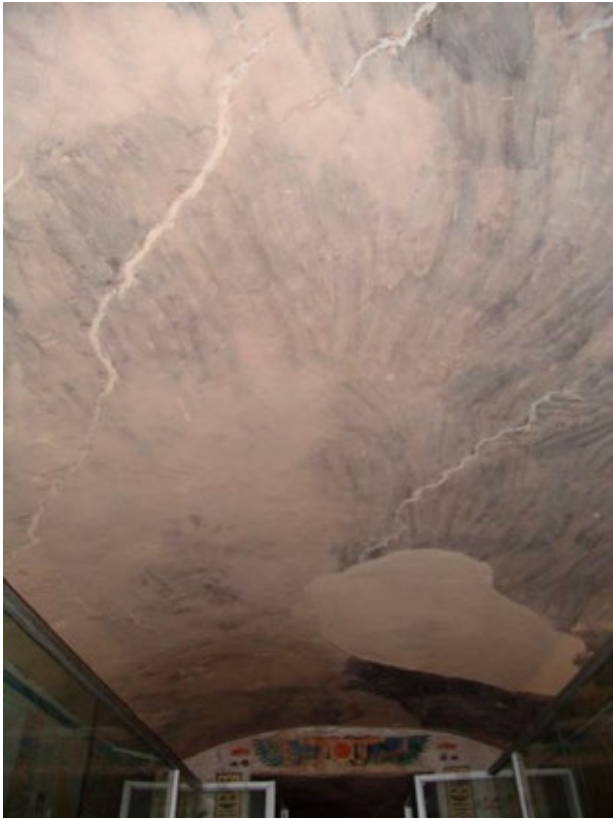
Ceiling of corridor chamber (I) is a shallow vault. It has drying cracks and loss of plaster, but overall appears stable. Some earlier losses have been filled with plaster repairs. Much of the ceiling plaster still survives in this tomb.

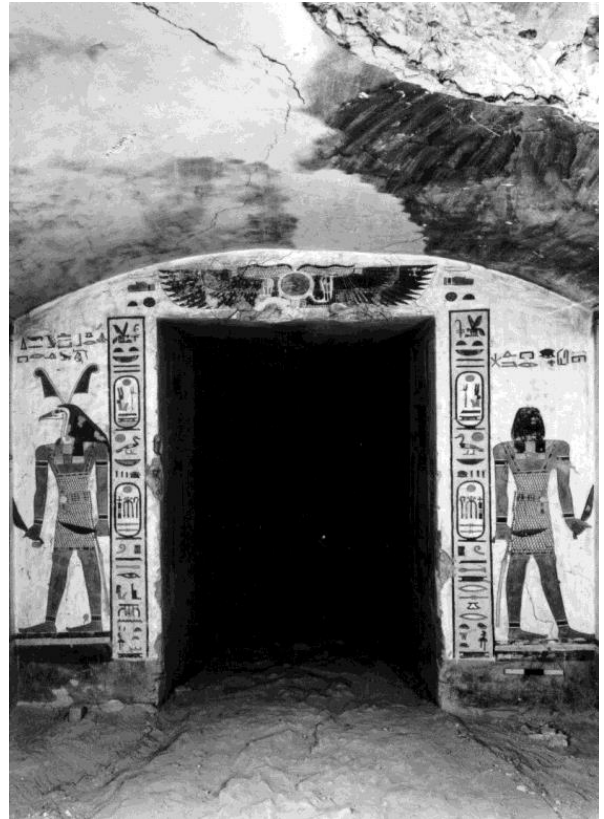
Cracks and loss on ceiling before repair in chamber (I) in 1975 (Image: CEDAE).

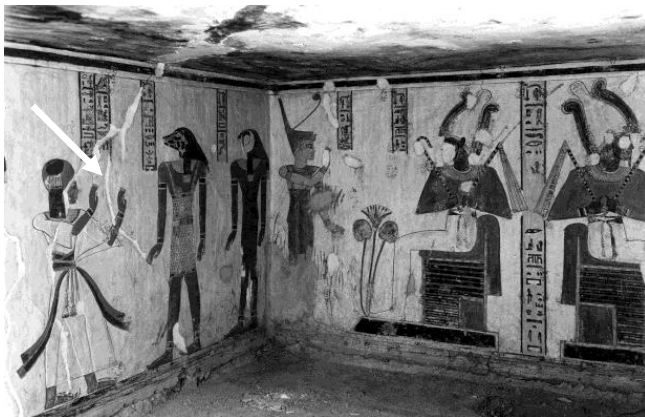
The areas of cracking in the painted plaster, most notably on ceilings, are possibly associated with underlying rock fissuring and/or instability of substantial areas of infill material but this has not been fully investigated and requires further monitoring to correctly assess the potential risk level, if any.

Large cracks can be seen in side chamber (G) that extend across ceiling and walls (Image: CEDAE).

Paintings have already been previously treated. Generally, no further stabilization work is required. Monitoring, particularly of recently repaired areas, such as the ceilings of chambers (E) and (G), which have a history of plaster collapse and cracking and have had repeated treatments, is necessary to identify and record whether or not change is occurring in these areas. Only with regular monitoring will the current risk levels of these areas be accurately determined.

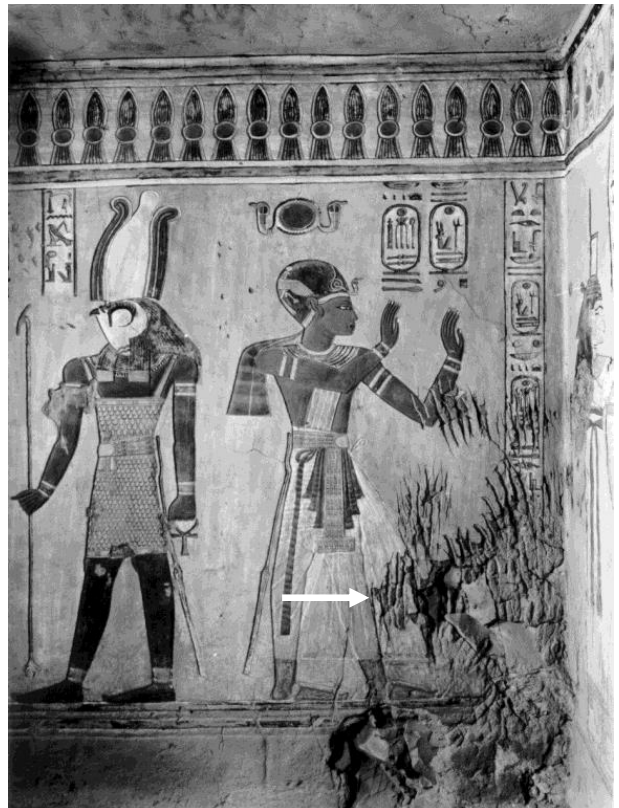
Scratch marks are seen in areas (Image: CEDAE).

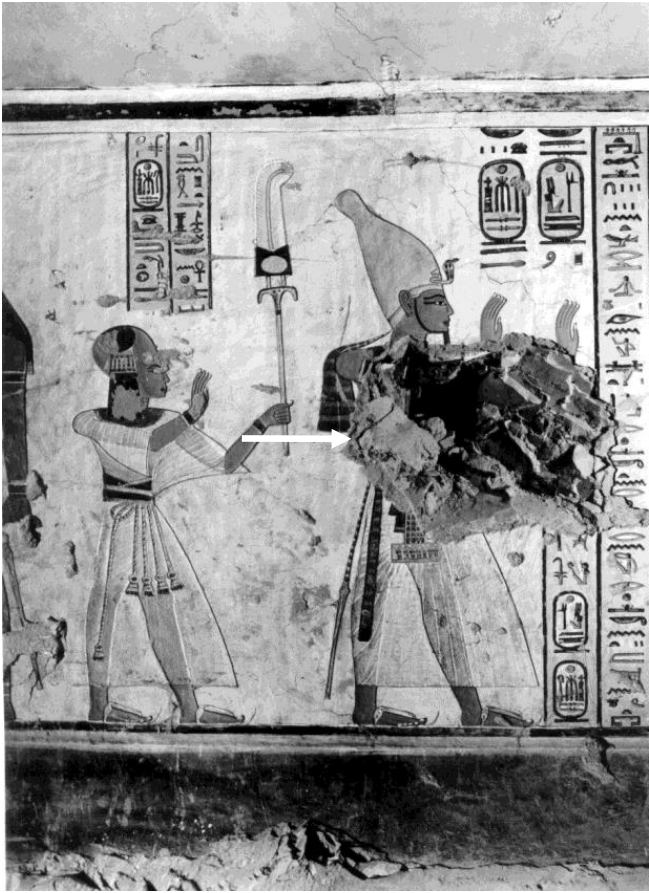
Loss in painting most likely caused by collapse of infill material (Image: CEDAE 1975).

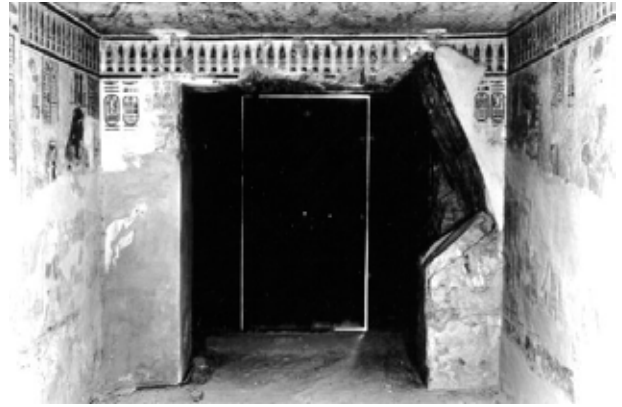
Early plaster repairs are already visible in 1980 photographs. However, not all areas have been treated. Doorway shows large loss that was later filled. (Image: CEDAE)

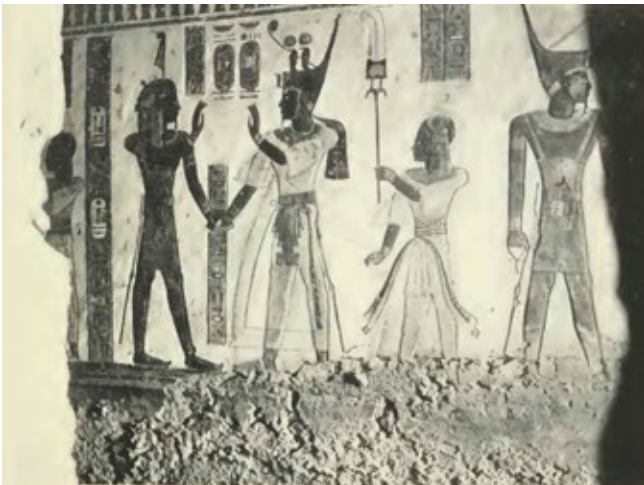
Losses at the base of the walls toward the entrance of the tomb may indicate past flooding episodes as seen in this photograph from ca. 1909-10 (Image: Campbell 1910).

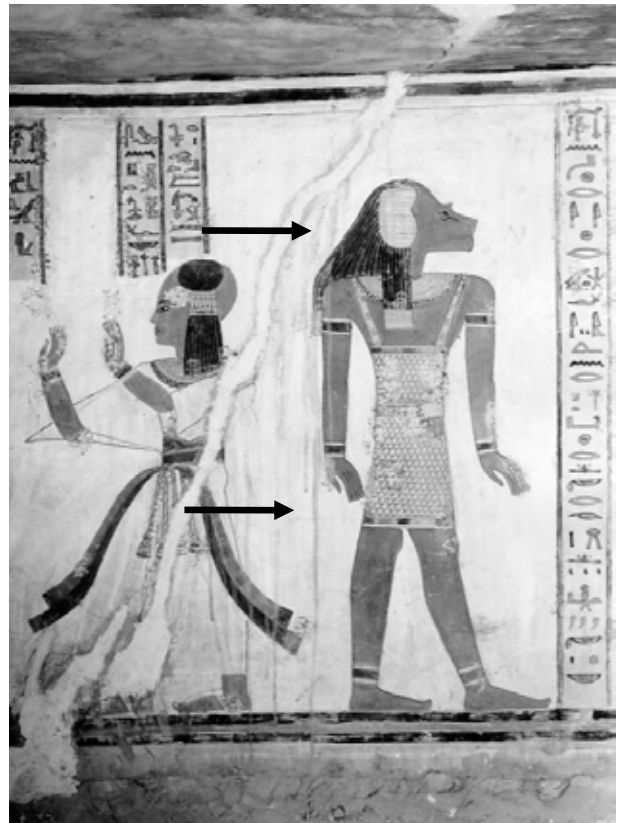
Treatment drip marks can be seen in the 1975 photograph along crack where a plaster fill has also been inserted (Image: CEDAE).

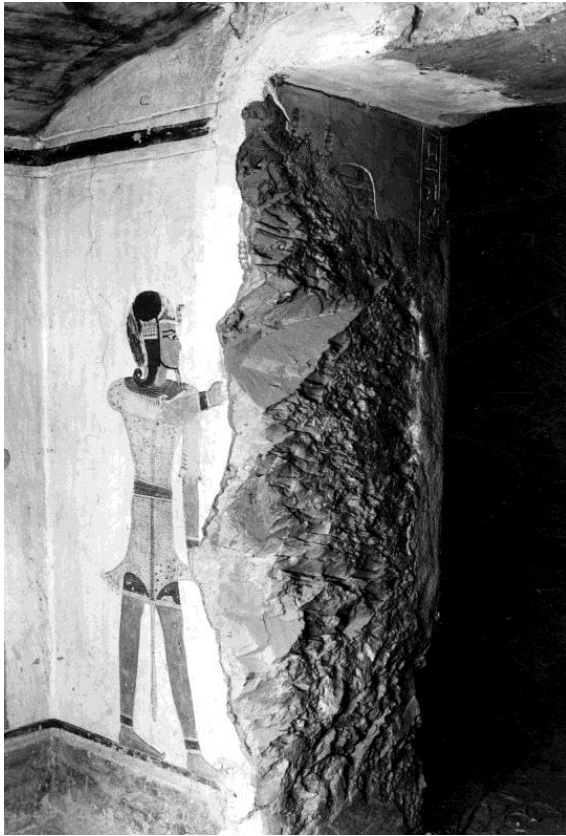
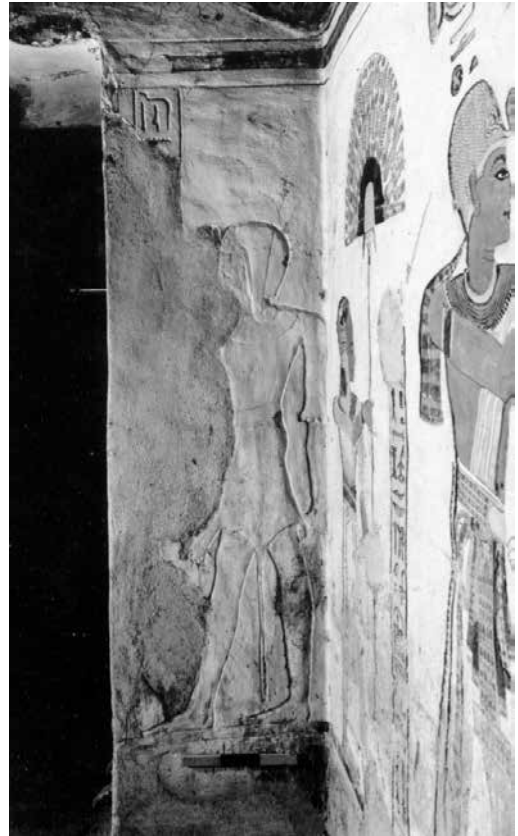
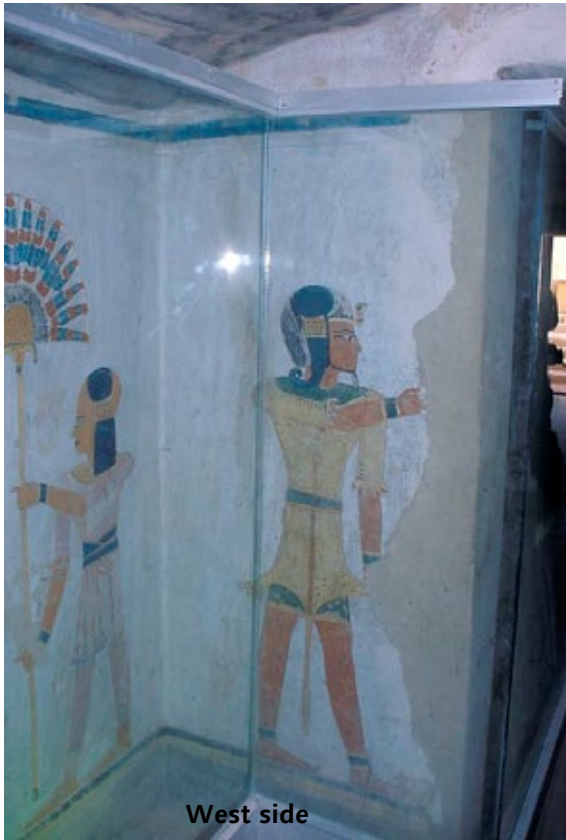
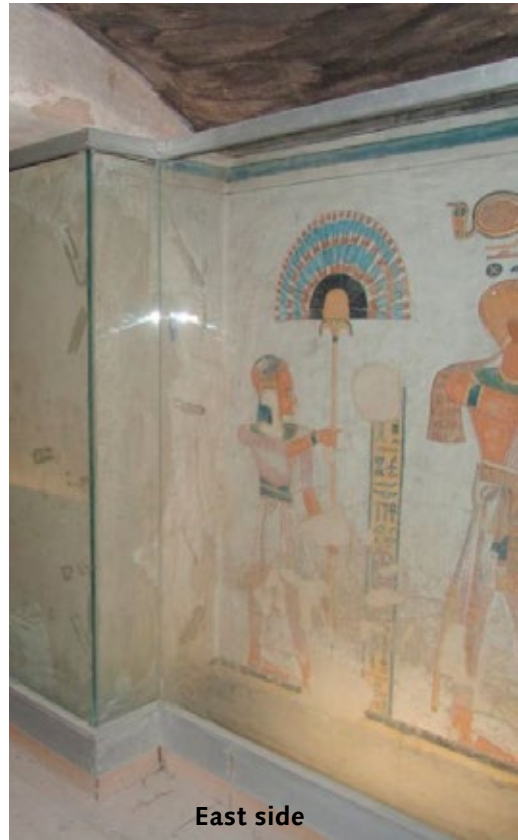
Doorway (H) between the first and second chamber corridors is unfinished. The door was widened in antiquity to accommodate entry of the granite sarcophagus in the burial chamber; the east side of doorway was covered with a thick application of plaster and re-carved, but never painted. There are small areas of surviving paint from an earlier painting scheme visible *below* the later plastering. Red setting out lines are visible on the unpainted but carved plaster. The damaged west side of door was not plastered in antiquity.

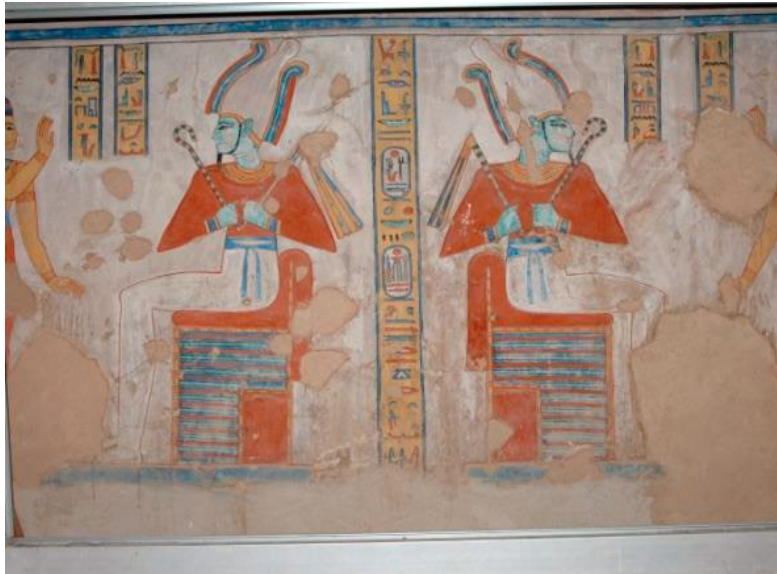
Side chamber (E) is located off corridor chamber (C). This is a small room with low ceiling. Ceiling has a number of different periods of repair plasters indicating ongoing problems in this chamber.

Paintings look to have been cleaned as the blues and the greens are faded and smeared. It is possible that the paint was lost when the insect nests were removed. (Image: CEDAE 2009).

Methods to protect the low ceilings of the side chambers, which have a history of plaster loss and collapse, need to be considered. The protective glass throughout the tomb is dirty and should be cleaned; one large panel of glass is missing in chamber (C) and should be replaced.

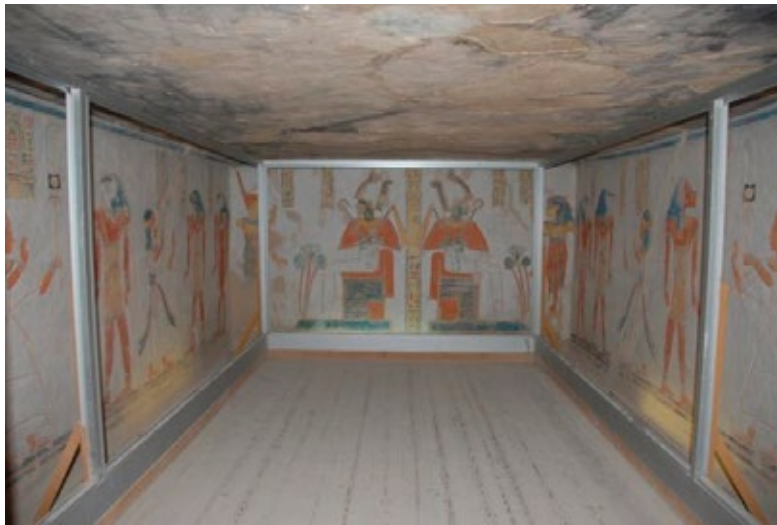
Side chamber (G) is located off corridor (C). This is a small room with low ceiling. Ceiling is irregular and has an area of crystallized bat urine that is positioned above an area of scratch marks on the paintings. The ceiling of this side chamber has had several periods of retreatment. (Image: CEDAE 2009).

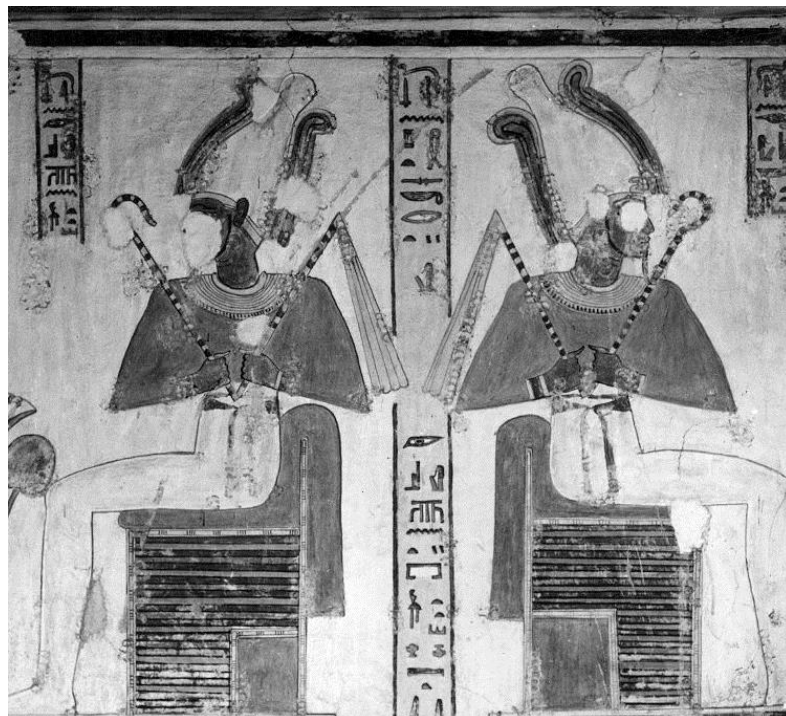
There is evidence of deliberate damage to figures in side chamber (G). (Image: CEDAE 1980).

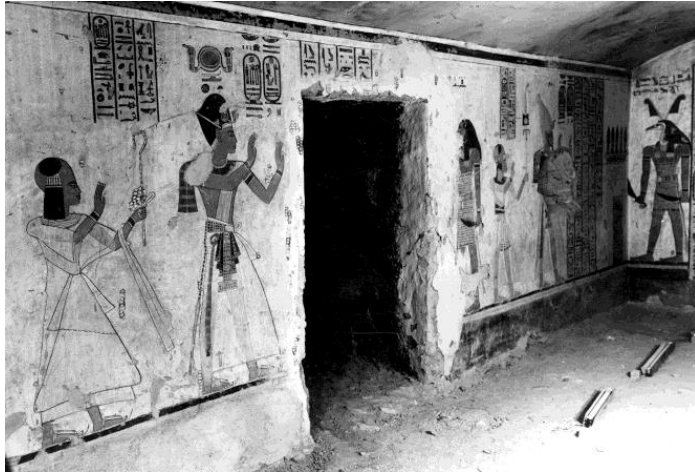
Paintings in second corridor (I) showing doorway to small unfinished side chamber (J) which was cut and plastered with a base plaster (Image: CEDAE 1980).

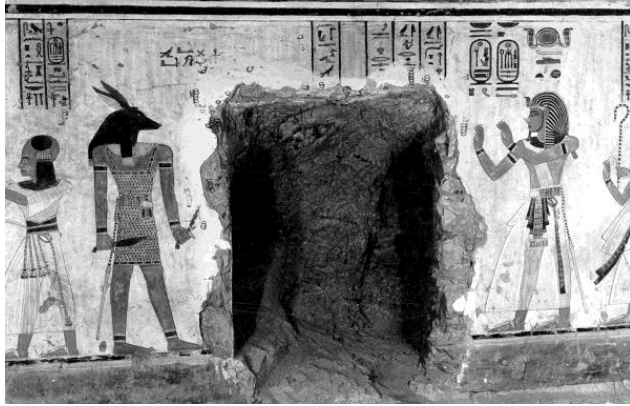
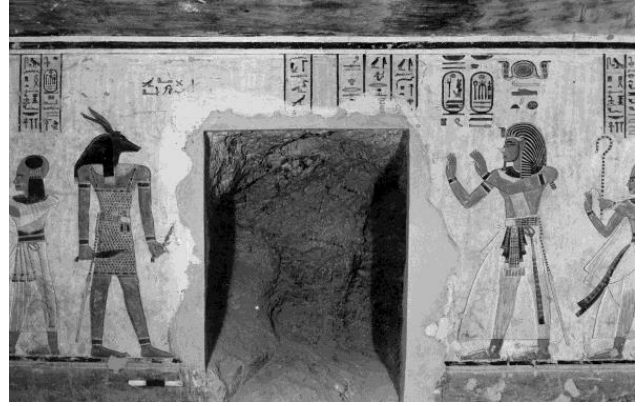
Small unfinished side niche (K) was only partially excavated during the tomb's construction. Photographs show the area before (1980) and after treatment (1993) (Images: CEDAE).

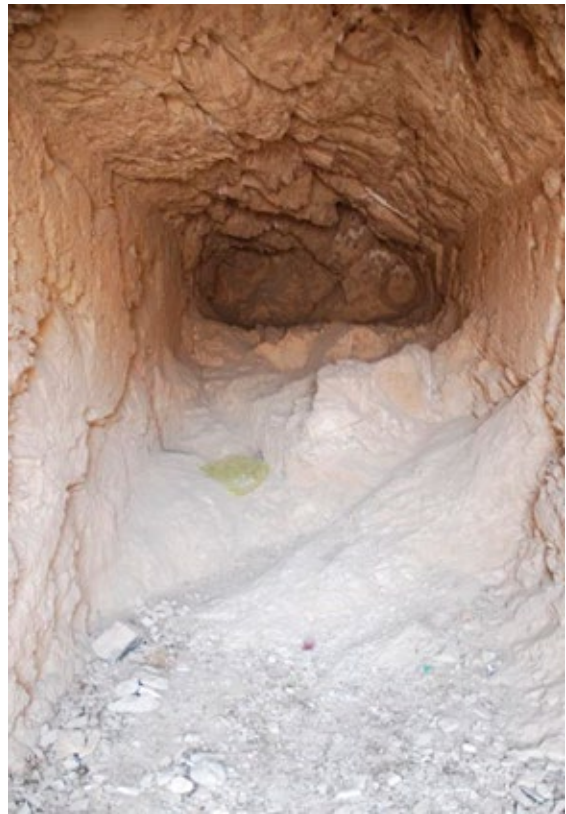
Previous ceiling loss is documented in TMP (1981) and CNRS (1988) mapping.

Rock loss has occurred in the ceiling of corridor (C), perhaps during its excavation in antiquity, as documented by the Theban Mapping Project in 1981 and the CNRS in 1987-8. The ceiling loss is centered at the point where four fractures meet; the major north-south fracture, and three other diagonal fractures. The ceiling fractures and loss may explain why the tomb was not completed.

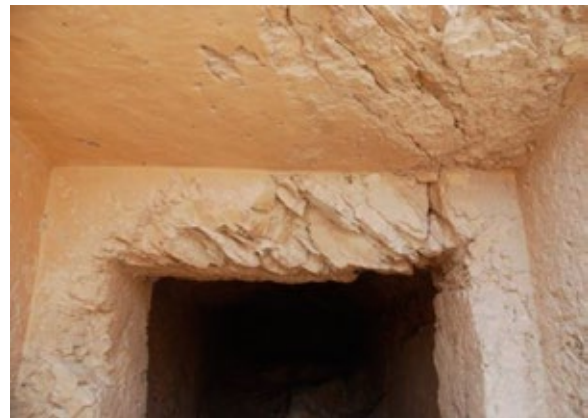
There is a fracture in the ceiling of the ramp which continues west through the doorway lintel on the north side. The doorway lintel is heavily fractured and seems to have suffered from recent loss. The south door jamb has a vertical interior crack and horizontal one which continues in both directions along the ramp wall and inside the chamber. On the north side there are several intersecting cracks.

A fracture continues through the ceiling of the ramp to lintel at doorway.

It is recommended to install a screened door in the entrance to prevent access, use by site personnel, and entry of insects, bats and birds. The door surround should be designed to also function to support the fractured rock to the north of the lintel. Construction of sill walls at entrance and north side of ramp are recommended to prevent water entering the tomb.

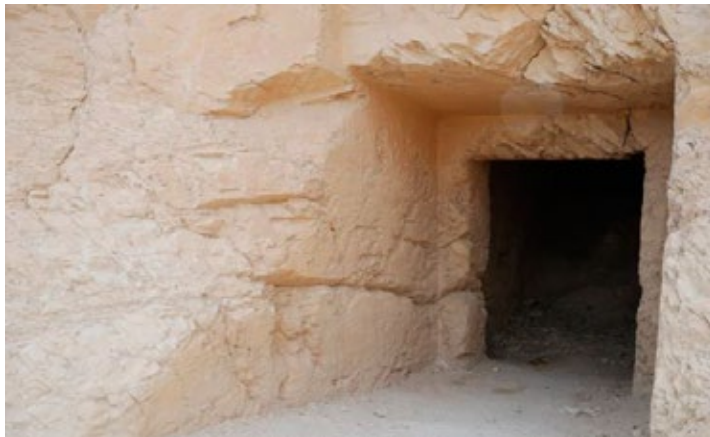
Horizontal crack on south wall in ramp continues to the corridor wall through south door jamb. Areas of loss occur along the crack.

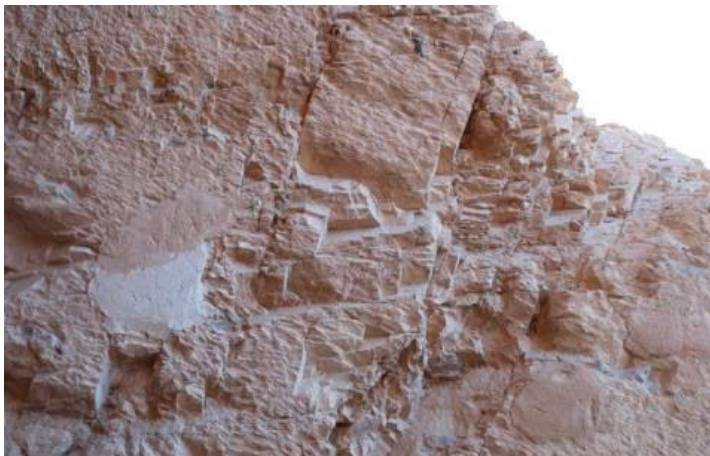
Patches of modern plaster tests.

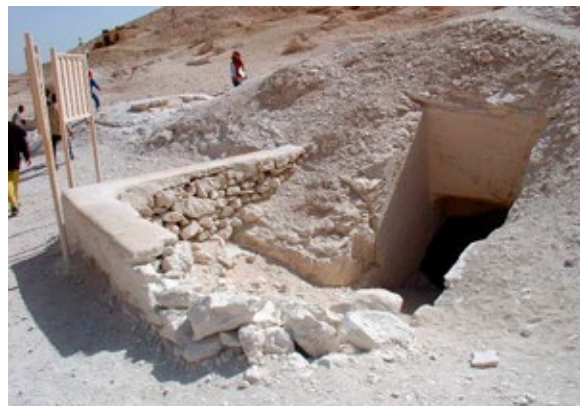
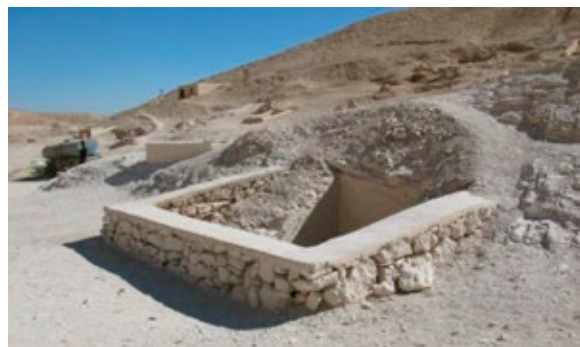
Entrance to QV 50 before (above) and after (below) rebuilding of masonry surround with cement capping.

QV 49 should remain in its current condition. The masonry wall of QV 50 should be rebuilt with a barrier to prevent the entry of visitors.

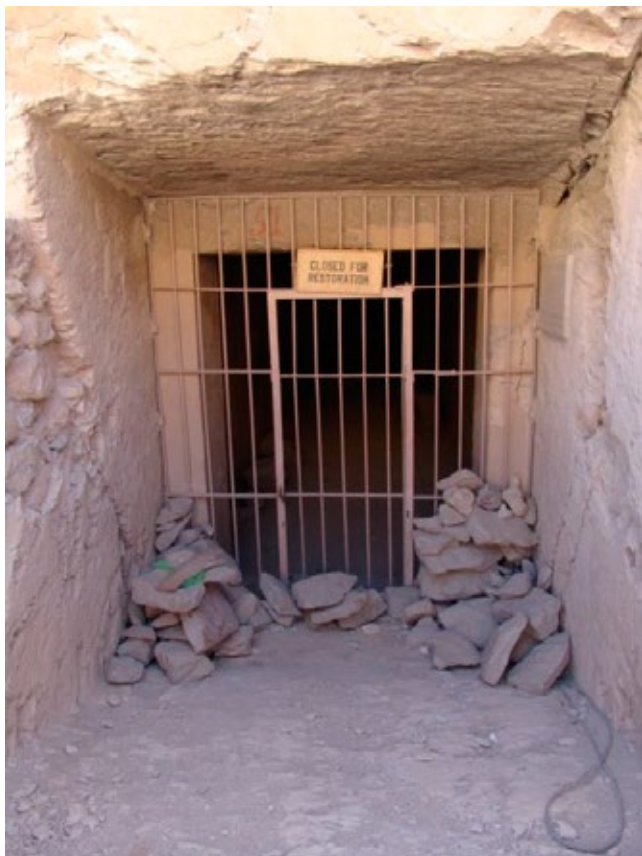
View of entrance (B) in 2006 with Schiaparelli plaque on right and "Closed for Restoration" sign above door.

The entrance door requires replacement and the sill wall surrounding the ramp may need replacement or re-engineering to ensure it can withstand predicted floodwater levels.

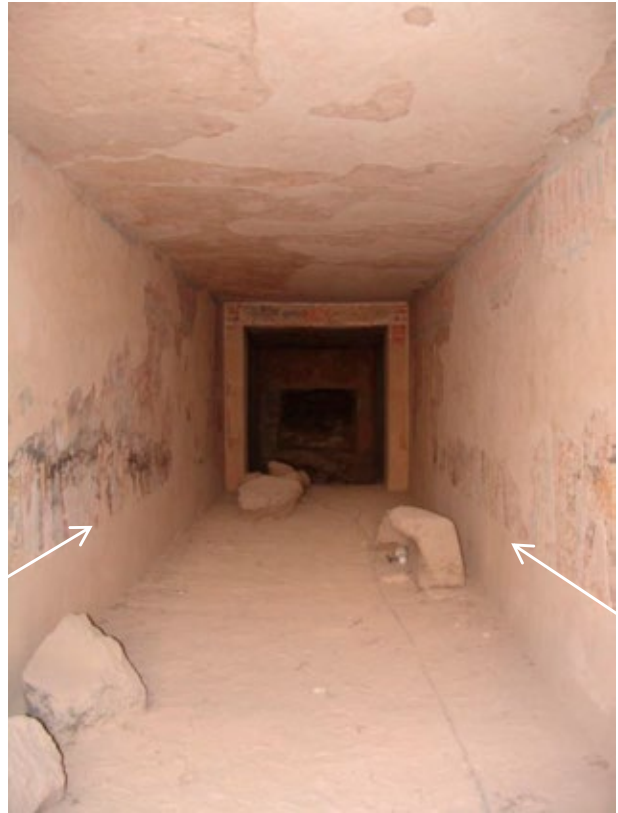
Note regular horizontal line of loss of painting at base of walls of the corridor.

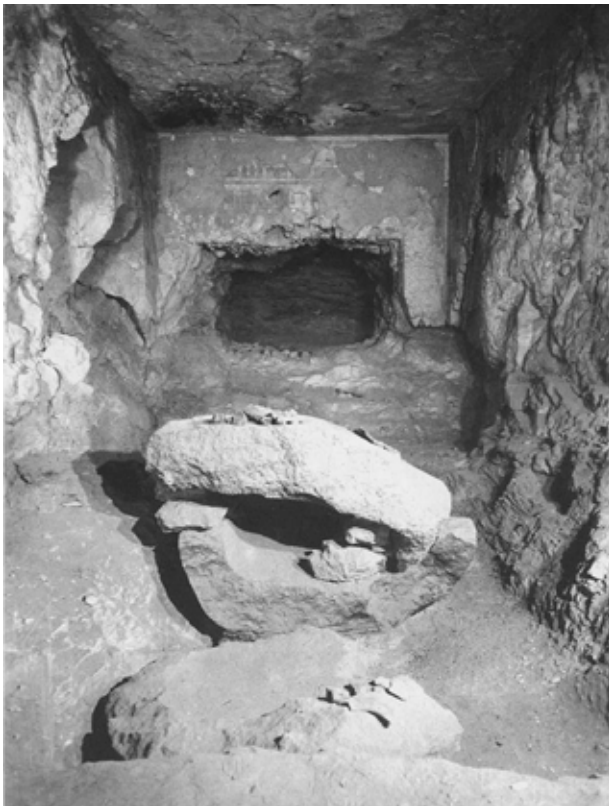
Burial chamber (E) in 1987 before treatment with substantial surface rock loss along walls and broken sarcophagus in shallow pit (F). (Image: CNRS)

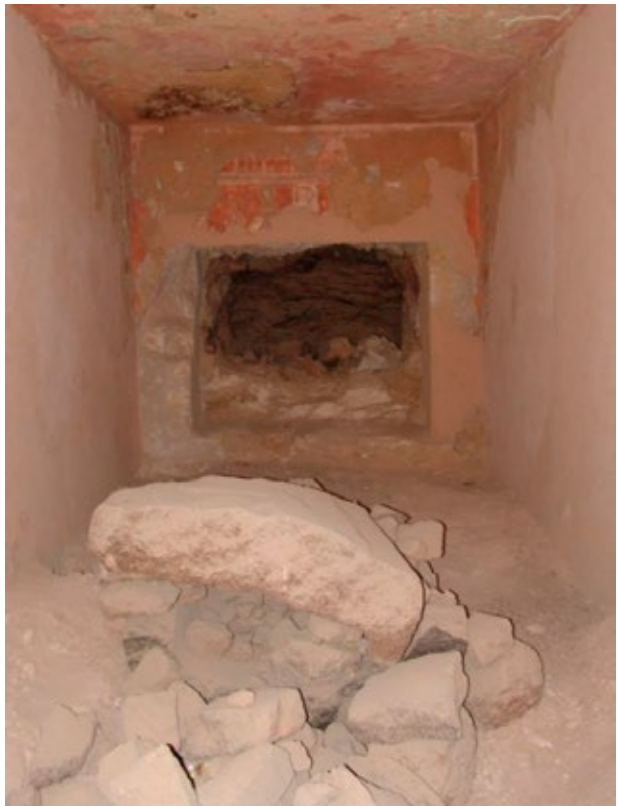
Chamber (E) in 2006 photo, showing post-1987 treatment with plaster infill; the sarcophagus fragments still remain in situ. Little painting survives on the walls of the burial chamber.

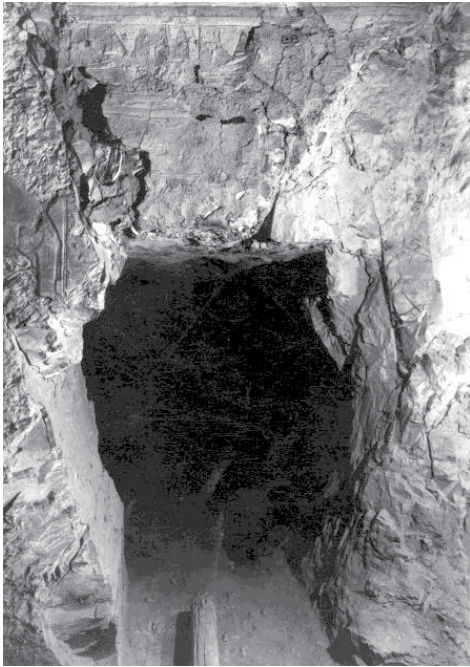
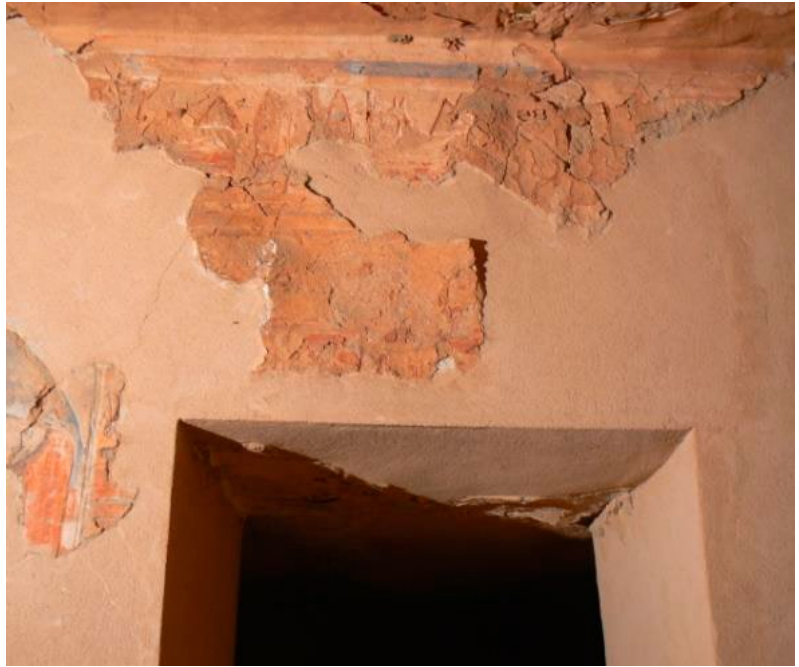
A photograph from 1986 shows rock loss in doorway (H) which may be related to flood damage. The photo at right shows the reconstructed doorway as it appeared in 2006 (Image: CEDAE).

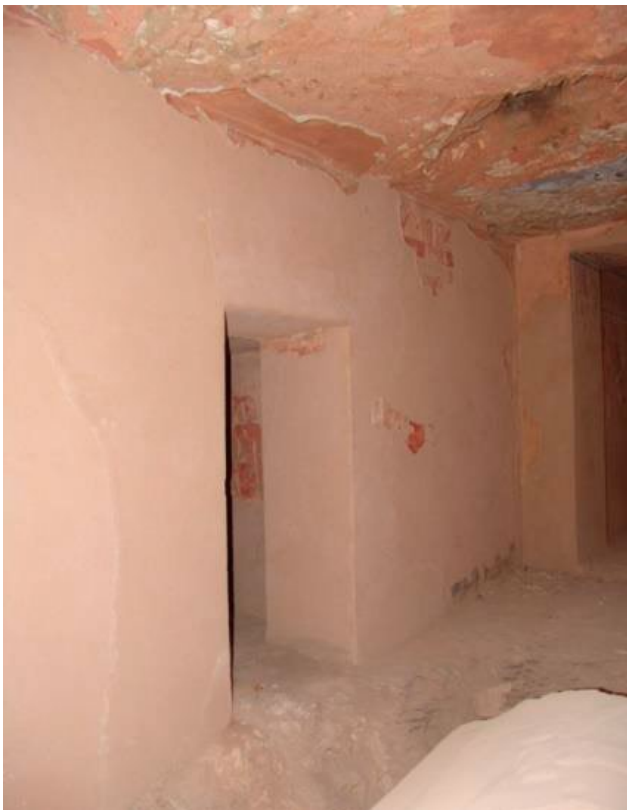
Walls in chamber (E) are largely reconstructed with plaster. Little painted plaster survives.

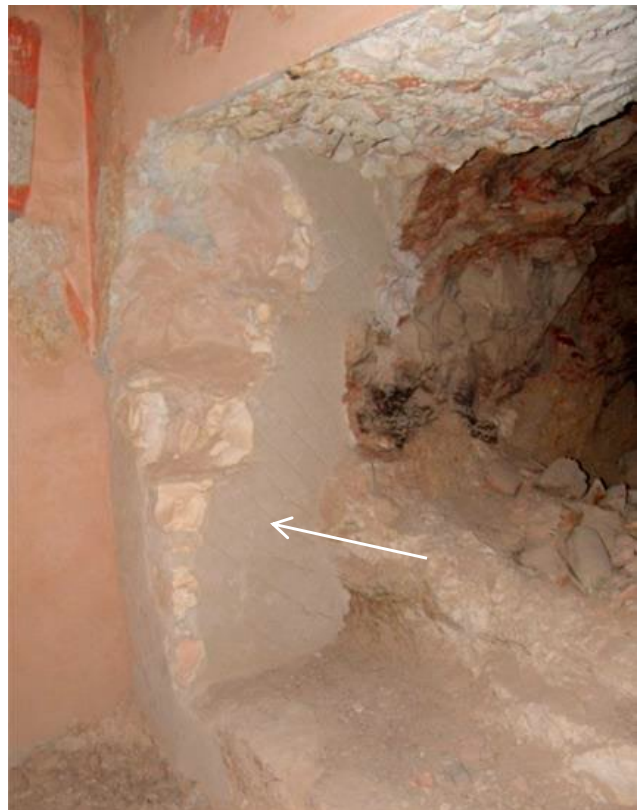
Cement was used in rear niche (G) on the door jambs as a base plaster. Bags of cement and other conservation materials were found in the western side chamber (K). It is possible that this cement plaster was also used elsewhere in the tomb though evidence of this is now obscured by the upper pink-colored final plaster layer. Edging repairs are also present in the burial chamber and in side chambers, though their application is not comprehensive. There is also evidence of injection holes and drips in the corridor but not in the burial chamber.

Niche (G) showing gray cement repair plaster. The repair has been scored in preparation for the final pink-colored finishing plaster that was never completed in this area.

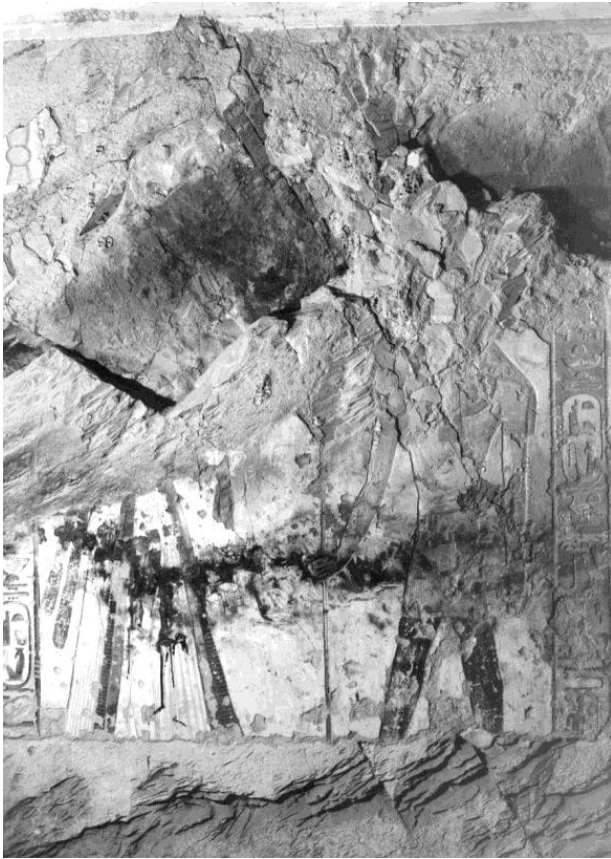
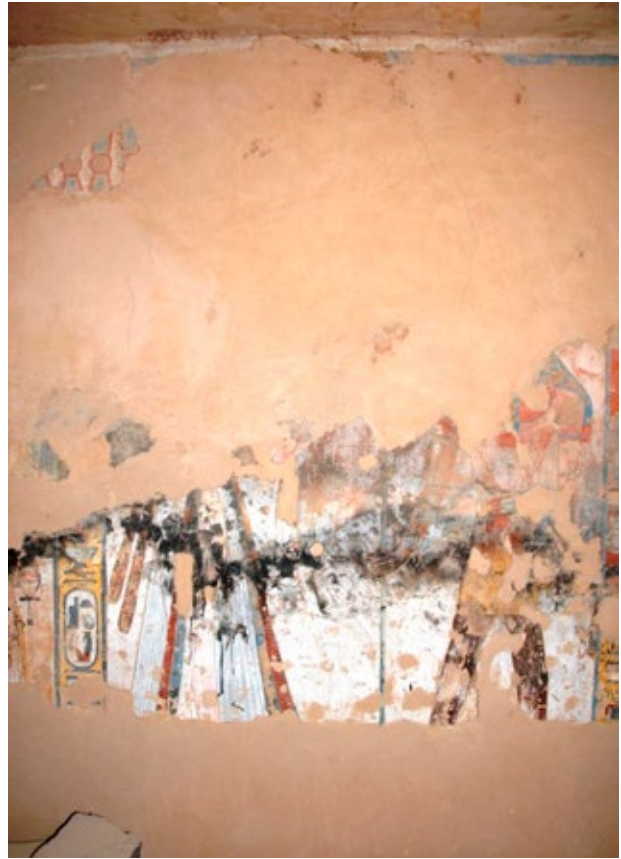
Area of the corridor (C) shown before (1986) and after treatment. Note substantial infill material needed to reconstruct large voids in the wall (Image: CEDAE).

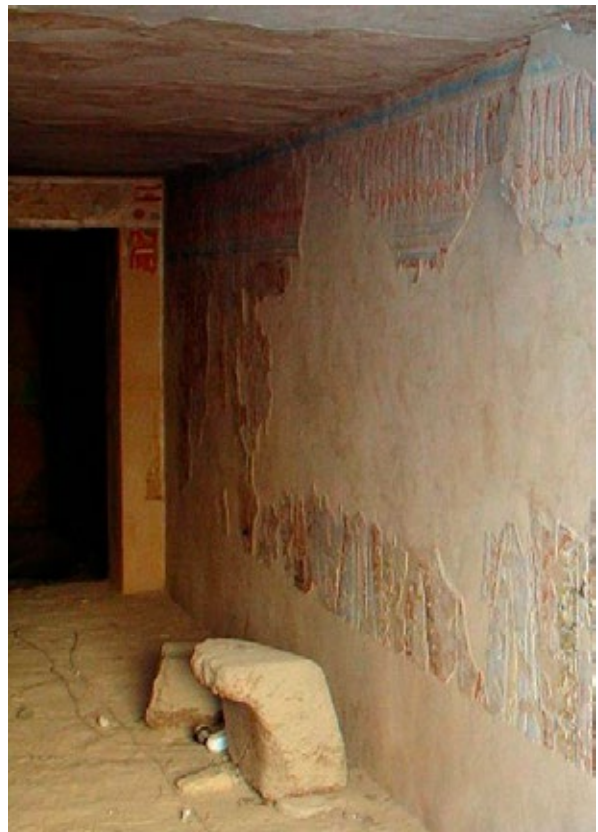
A large repair plaster being undertaken in corridor (C) in 1988 by the EAO (Image: CNRS); right, same area in 2006.

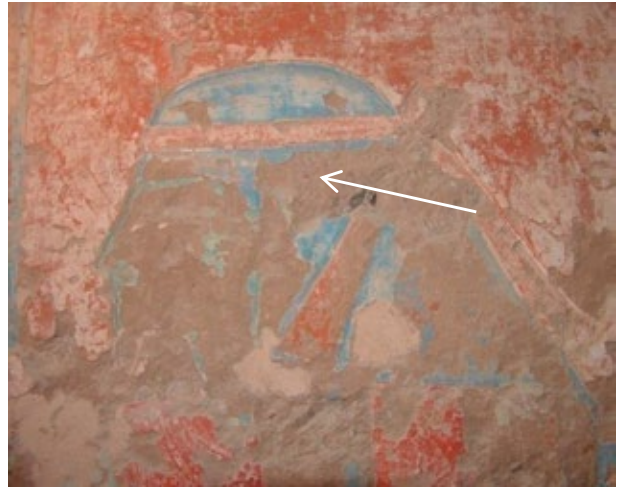
The underlying rock surface is visible in the areas of loss showing how thin the application of plaster was in corridor (C) where the rock quality is good.

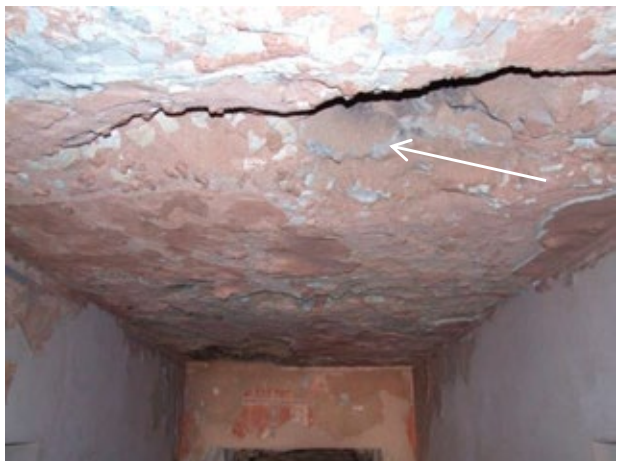
The rock quality worsens toward the rear of the tomb. The large area of rock loss on the ceiling of chamber (E) is historic (from the time of the tomb construction) and shows evidence of rock and plaster infill still remaining.

Fractured ceiling rock of burial chamber (E) should be monitored to determine whether loss is active.

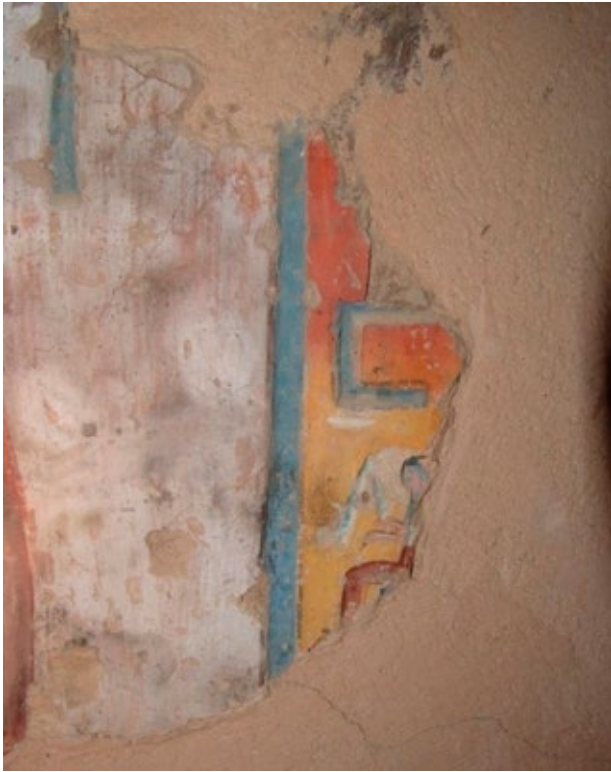
Heat alteration in corridor (C) has changed the cartouche background from yellow to orange to red. Only the upper half of this cartouche has been heat-altered.

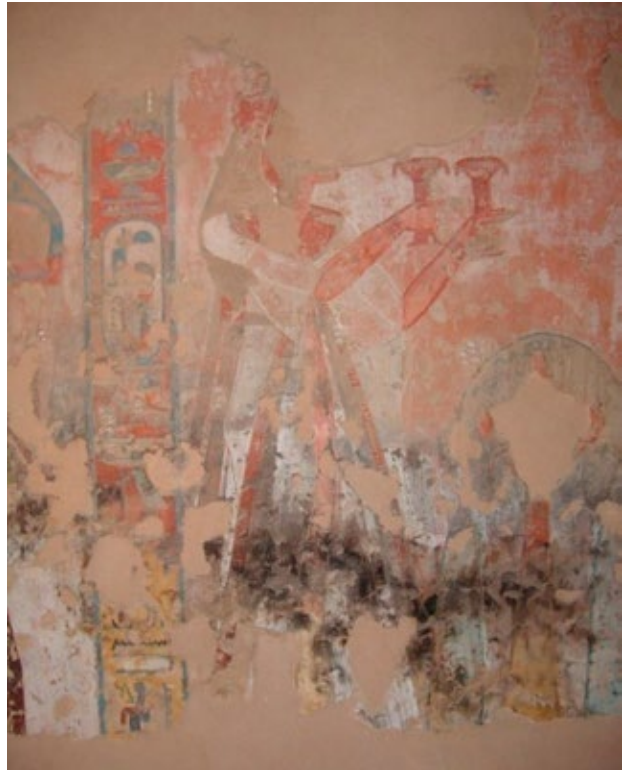
The tomb has suffered intense heat damage but surfaces are not fire blackened except for small areas on the east wall of corridor (C). A horizontal line of heat alteration is also visible in corridor (C), particularly noticeable in the pigment alteration from yellow to red, at the lower parts of the west wall. The base of the wall was perhaps protected by sand or debris so that the fire only affected the upper parts of the tomb. The earth-containing plaster layers have also been heat altered, most notably changing in appearance to a terracotta orange color. The plaster has also become rigid and brittle, cracking and detaching from its substrate, and is lifting up in areas. Post-fire losses show that the underlying plaster, which was protected from the heat, is unfired and is less red in color. The burial chamber has suffered the most heat alteration, though the plasters in the rear side chambers are also heat damaged and fragile with severe cracking and detachment.

The area of heat alteration of the pigments corresponds to the line of blackening. The lower parts of walls may have been protected from fire by sand and debris.

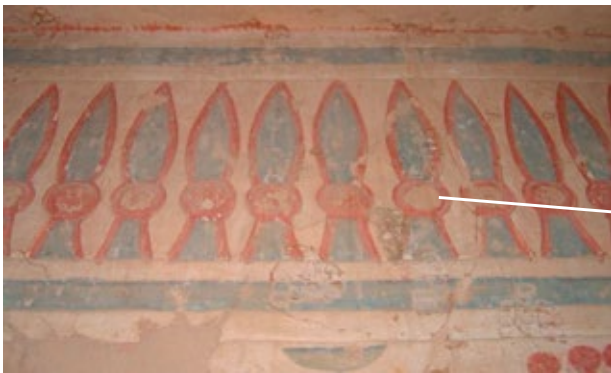
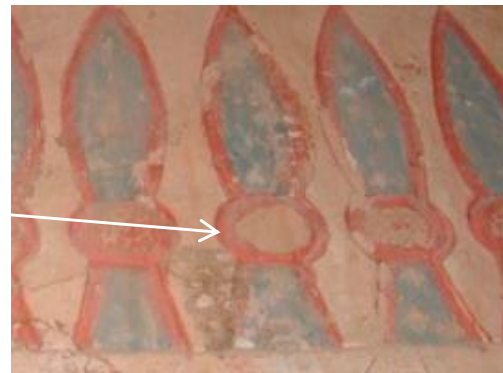
Areas of painting in the corridor also show other forms of deterioration. The upper border *kheker* frieze has an unusual pattern of loss where the red circles are almost entirely lost leaving only a ring of red. This suggests an application of a varnish in specific areas that has led to preferential loss.

Red circles of border decoration look to have been coated with some sort of varnish that has since been preferentially lost.
