Valley of the Queens Assessment Report

Volume 2

Assessment of 18th, 19th, and 20th Dynasty Tombs

A collaborative project of the Getty Conservation Institute
and the Supreme Council of Antiquities, Egypt

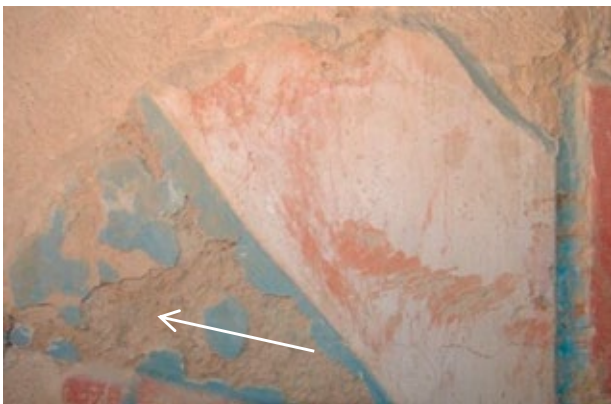
Blue areas have suffered substantial loss, often with both the paint and upper plaster layer missing.

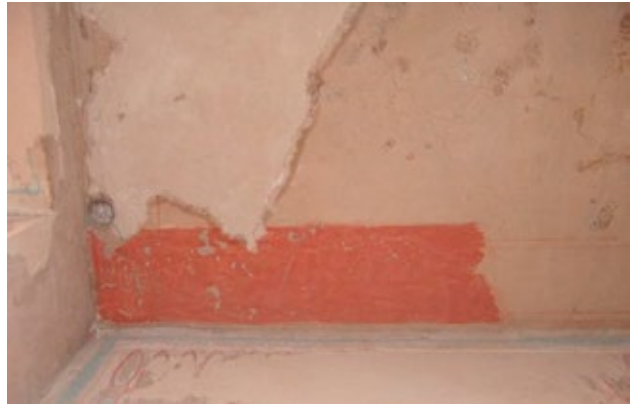
Ceiling in the corridor is unfinished. Setting out lines are visible in one corner but the painting was never finished.

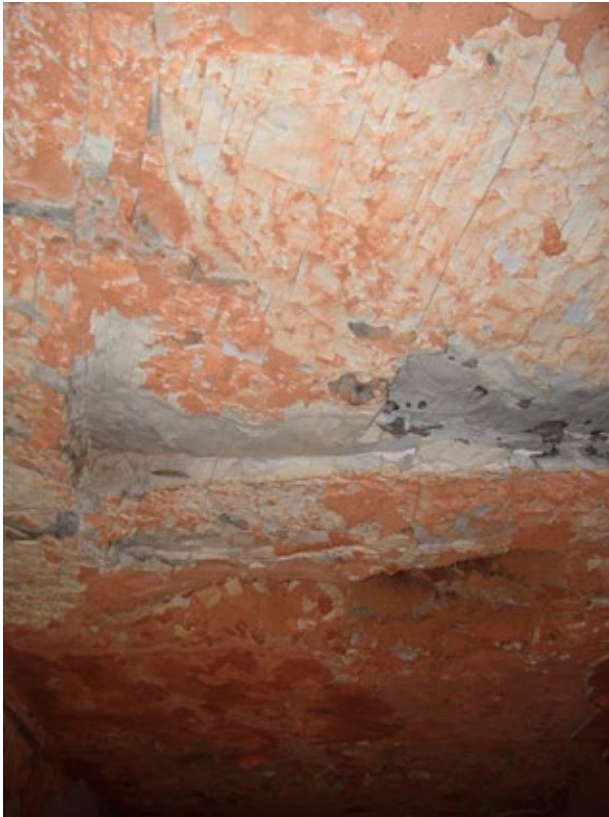
Heat-related damage of ceiling plaster of burial chamber (E) shows a firing of the earth-containing plaster. Rock loss has also occurred here some of which may be recent.

Fractured ceiling rock of burial chamber (E) should be monitored to determine whether loss is active.

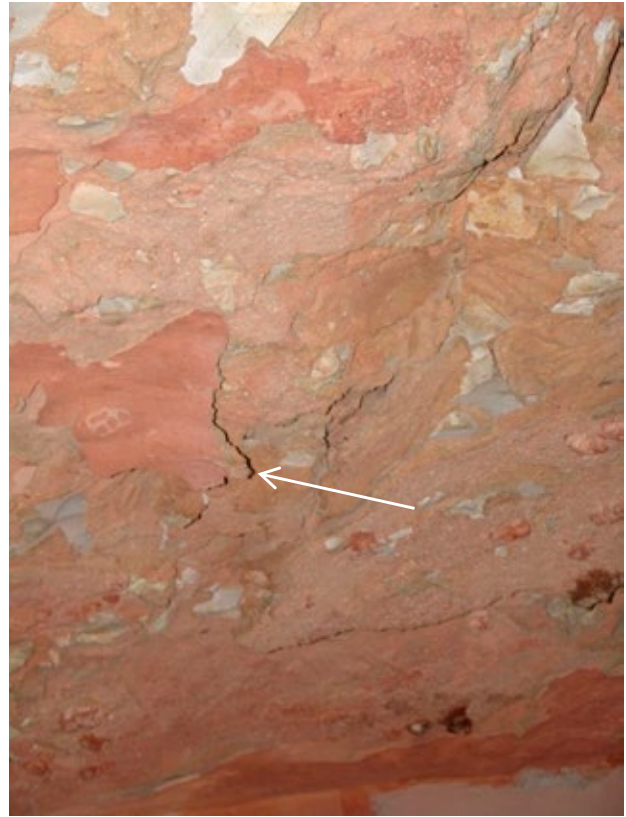
It can be assumed that the fire event(s) reached very high temperatures throughout the tomb. The fire appears to have been contained so that no soot deposited on the surface of the paintings and was instead vented out through the tomb entrance. Heat damage to the paint layer and plaster was severe resulting in permanent altering of the physical properties of these materials. The firing of the plaster layers in particular has made the painting brittle and fragile in areas leading to cracking and detachment and eventual loss.

The firing has made the plaster layer rigid and brittle. The upper layer is detaching from the plaster layer below. This lower plaster layer has rock shards set in it to serve as infill material.

Paintings have already been heavily treated but some stabilization of painted plaster is still required in side chambers (I) and (K) as well as on the ceiling of the burial chamber (E). The heat-altered condition of plaster may require stabilization treatments to be specifically formulated and trialed. Only limited stabilization of areas of plaster is recommended in this tomb.

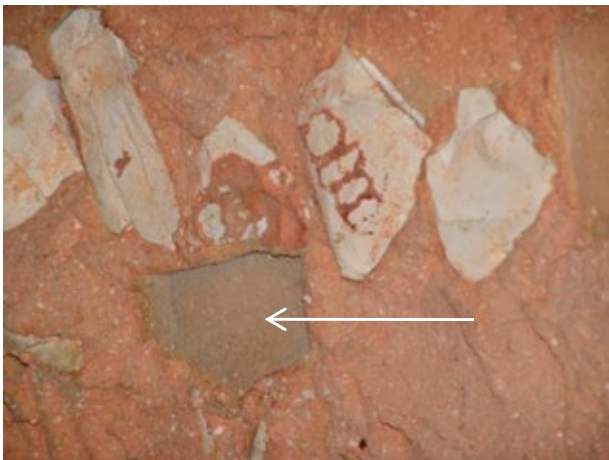
Stone shards are set into the plaster as filling material. Note area where stone shard has been lost. Plaster below this has been protected from the heat and has remained unaltered. It does not have the same pinkish color of surrounding areas where the plaster has been fired.

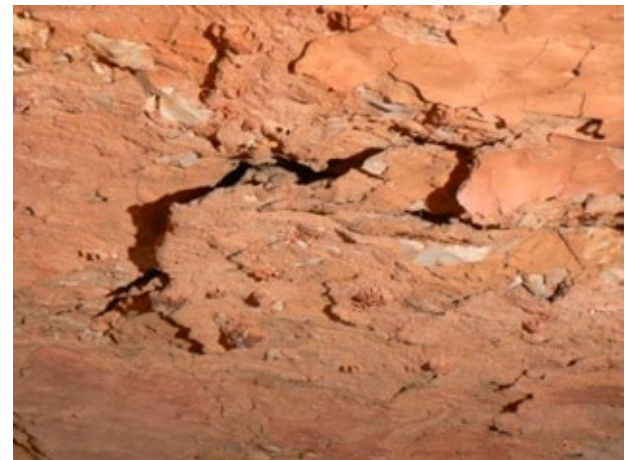
Areas of detached plaster on ceiling of burial chamber (E).

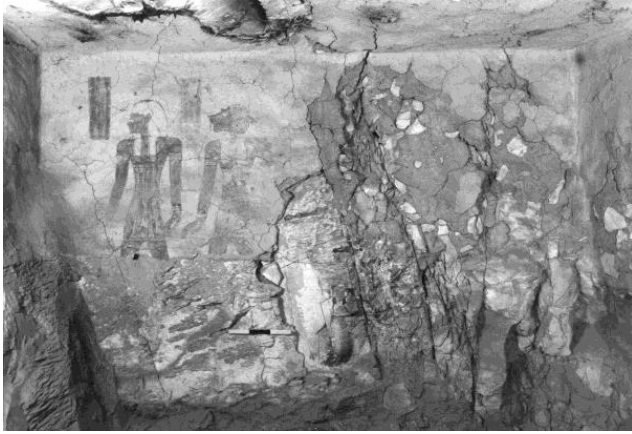
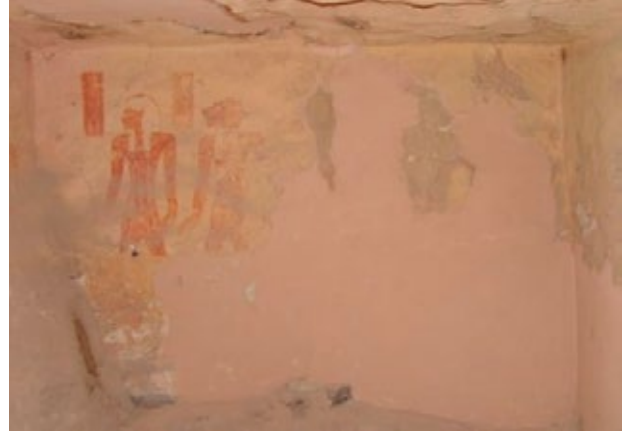
The walls and floor of side chamber (I) were never fully excavated during the tomb construction. The paintings appear unfinished. The image above left shows the area before treatment in 1986 (Image: CEDAE). Image above right shows the area after plaster repairs.

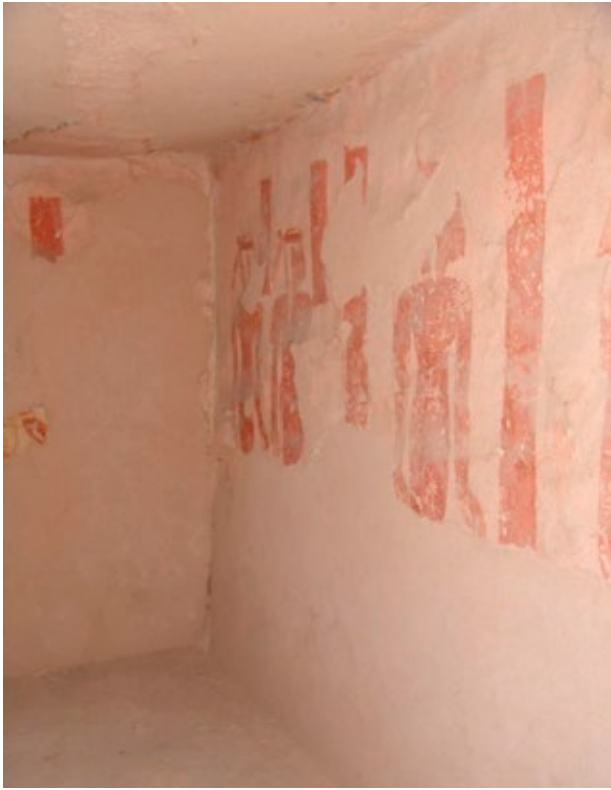
The painted plaster in chamber (K) appears unfinished. There is no relief work in the painting.

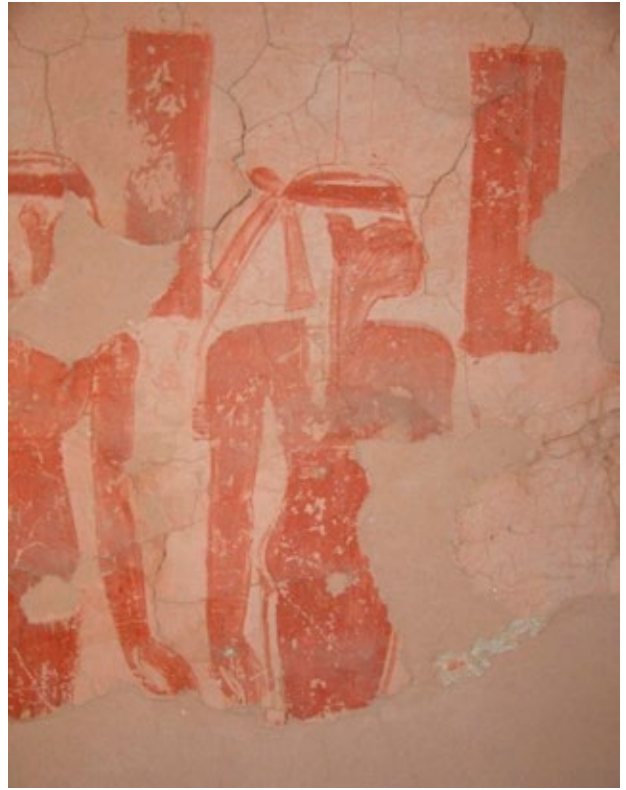
The paintings in chamber (K) are highly fractured and detached in areas.

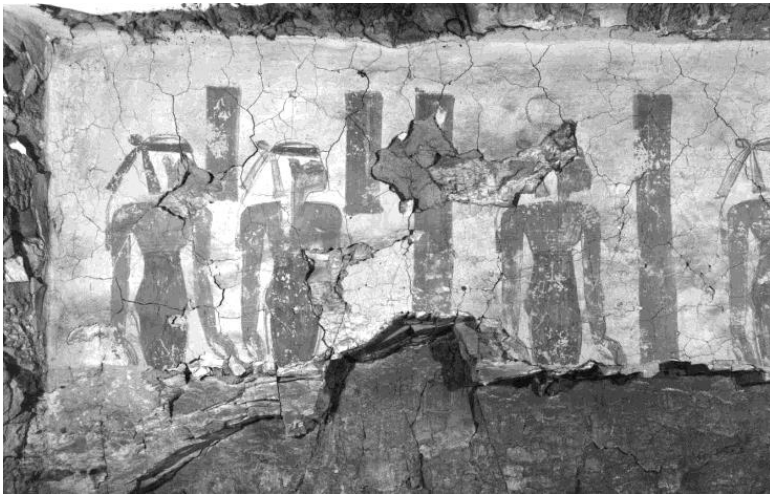
Note significant amount of rock loss in lower half of painting in 1986 photograph (Image: CEDAE).

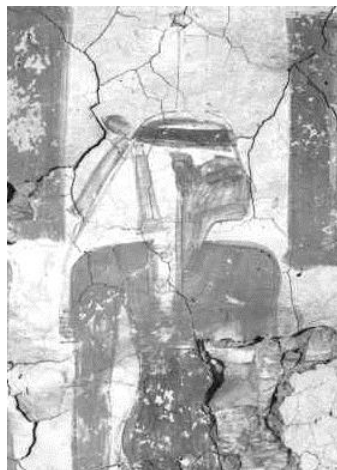
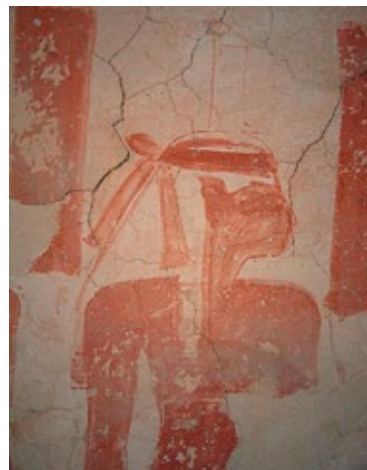
Detail of plaster cracking in 1986, left (Image: CEDAE) and in 2006 showing plaster repair but no additional cracking .

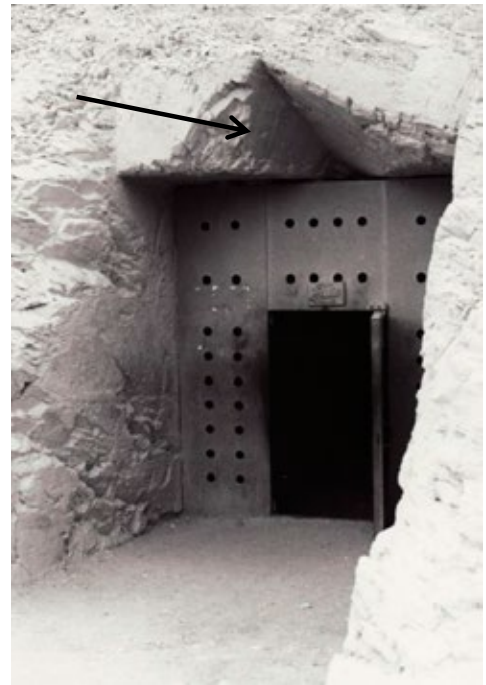
Tomb entrance in 1988 showing large wedge loss of rock. Small open joints are also present in this area, but there is no evidence of ongoing instability (Image: CNRS).

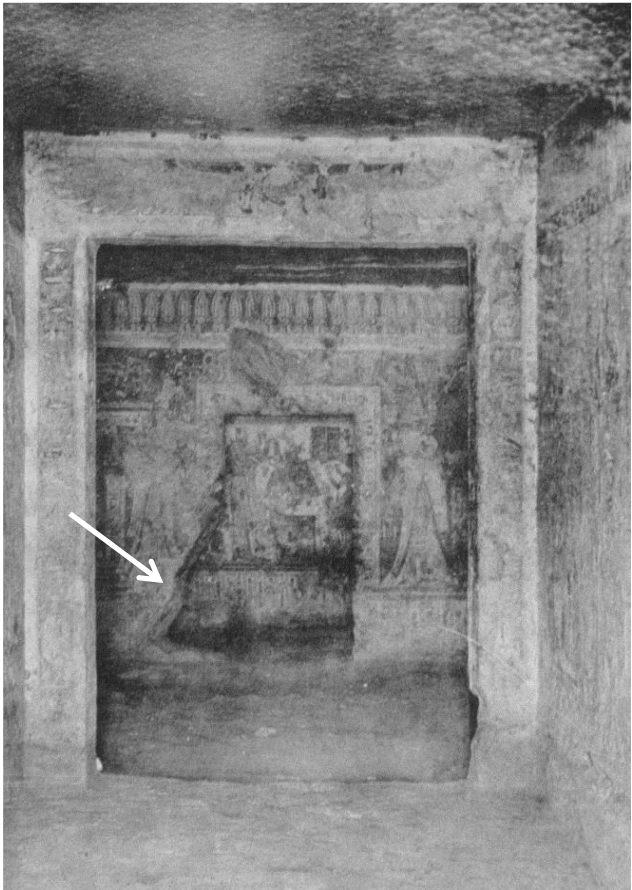
A photograph taken by Schiaparelli showing a large area of rock loss on the south jamb of doorway (F) is one of the few images to show pretreatment condition of the tomb. In addition to this large loss, a few other smaller areas of rock loss can be seen as well as loss of plaster at the base of the walls. This loss can be seen throughout the tomb to a height of approximately 50cm from the base of the wall. Above the entrance doorway there is a large wedge loss of rock and small open joints to the right of the loss, but no evidence of ongoing instability.

Photograph taken in 1903 shows condition of tomb interior. Of note is the substantial area of loss in the jamb of doorway (F) (Image: Schiaparelli 1923).

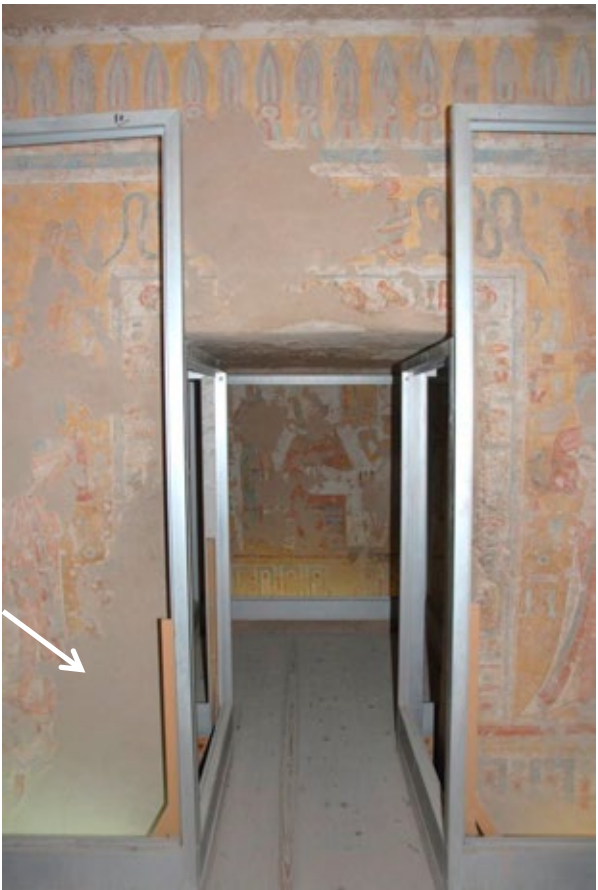
Jamb of doorway (F) in 2008 showing large loss having been reconstructed.

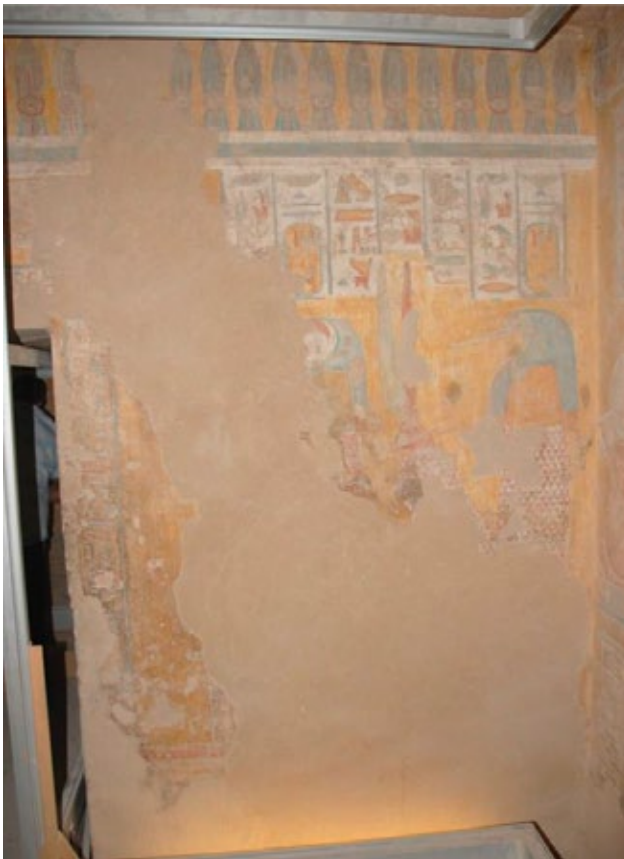
There are some large losses of plaster in the ceilings and in some walls, for example in chamber (E) and side chamber (I) and one area of loss in the lintel of doorway (D), where a small crack in the rock is visible, which continues into the adjacent ceiling plaster. Other cracks in the ceiling plaster of the corridor (C) and burial chamber (E) may also reflect the condition of the underlying rock and possible areas of plaster detachment. The ceiling plaster of chamber (E) exhibits preferential deterioration at its corners, with cracking and staining, worse toward the south side. The surface of the painted plaster is generally abraded and looks almost "keyed" with many small losses as if to have been plastered over in antiquity. The plaster surface is also stained brown in areas, presumably from repeated touching by visitors prior to the glass protective barriers being installed.

Large area of plaster loss on the east wall of chamber (E) where it is presumed that the rock originally required plaster infilling.

Paintings have already been extensively treated and appear generally stable. However, monitoring, particularly of walls and ceilings where substantial modern plaster repairs have been used, such as chambers (E) and (I) and where cracks have been observed such as around doorway (D) and the ceilings of corridor (C) and chamber (E), is recommended to identify and record whether or not change is occurring in these areas. Only with regular monitoring will the current risk levels of these areas be accurately determined.

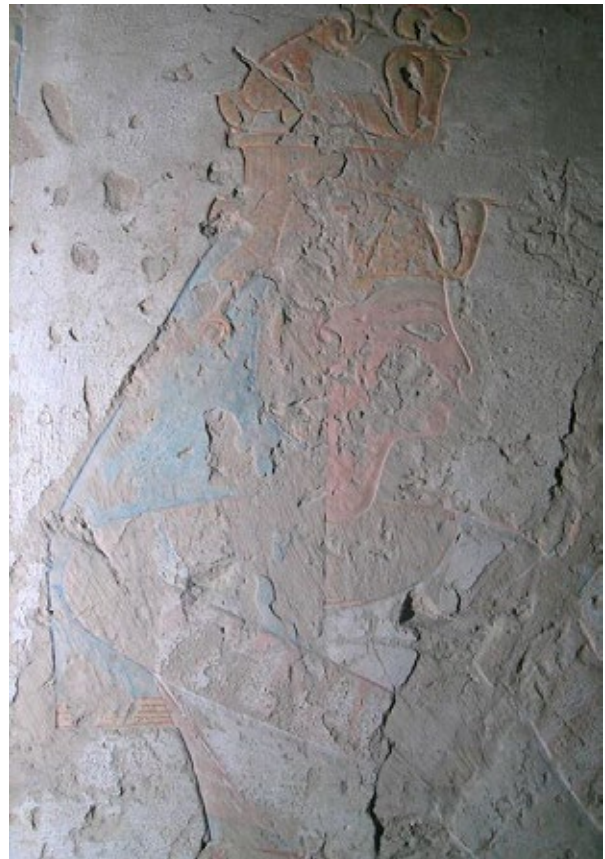
Periods of reuse of the tomb as well as its long history of access and visitation may be responsible for some of the deterioration now visible. Intentional damage to the paintings accounts for the destruction of heads of figures, most notably the depiction of the queen, is apparent in this tomb. E. Thomas also notes that the tomb was partially destroyed by treasure hunters. Furthermore, localized collapse of infill material along fissures may have also contributed to the deterioration.

The sunken relief paintings are executed on an extremely thin layer of plaster. There are many losses in the painting, as shown here, some of which can be attributed to the intentional and systematic defacement of faces, hands, feet, and some hieroglyphs.

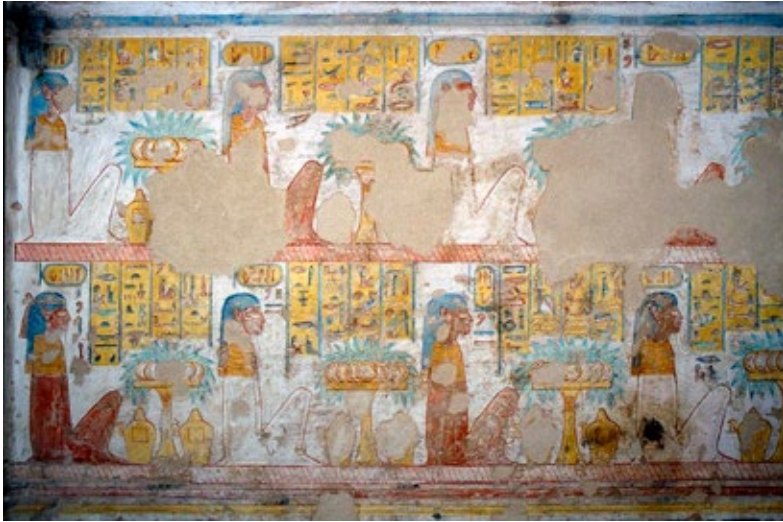
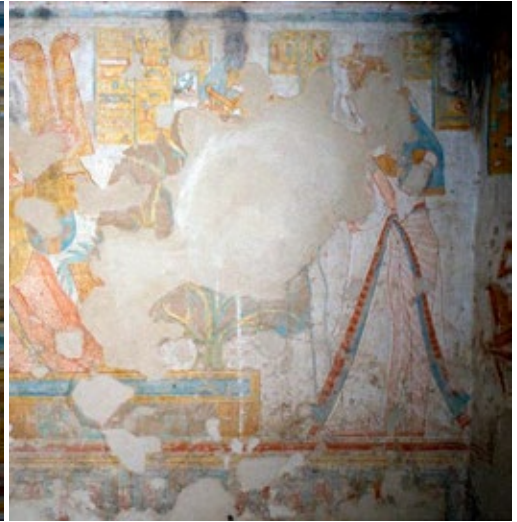
Though much painted plaster survives throughout the tomb, many small losses are found within the painting. The photographs show surviving painting in rear chamber (G), left, and chamber (K), right. (Image: CNRS).

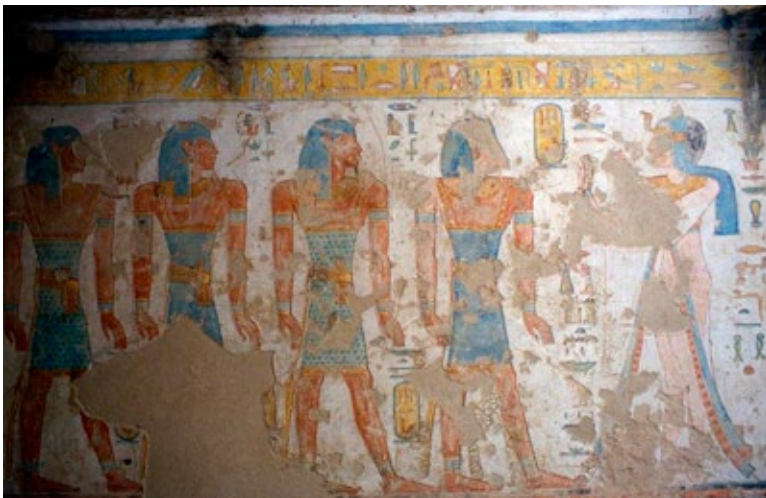
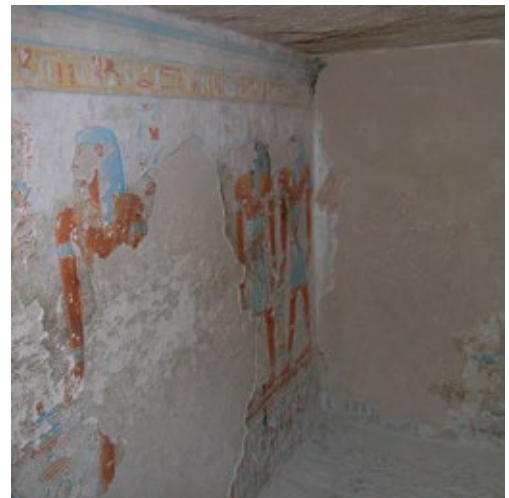
There are large losses in the paintings in side chamber (I). (Left photo: CNRS).

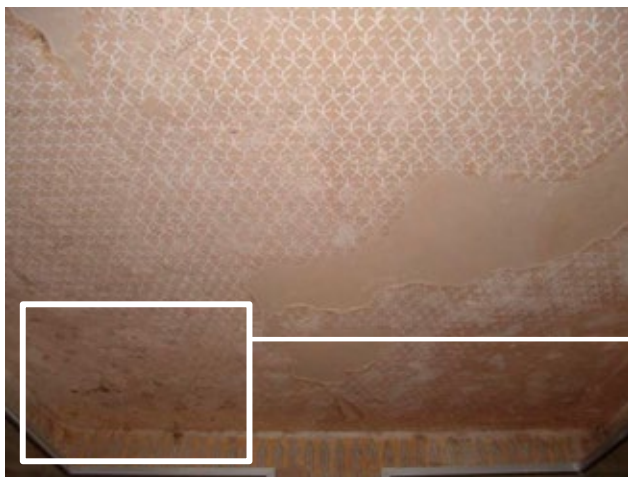
Past bat activity is evident and could be responsible for staining and losses seen in the ceiling corners of chamber (E) and the northwest corner of side chamber (K). More recent losses in the plaster in the low ceilings of rear chambers may be partially attributed to visitors-related damage.

Ceiling of chamber (E) shows losses and deterioration concentrated in the corners.

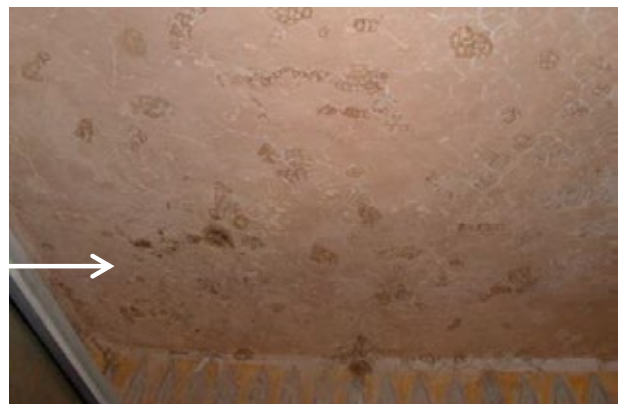
Detail of corner of chamber (E) showing concentration of deterioration and loss of painted plaster, possibly due to bats.

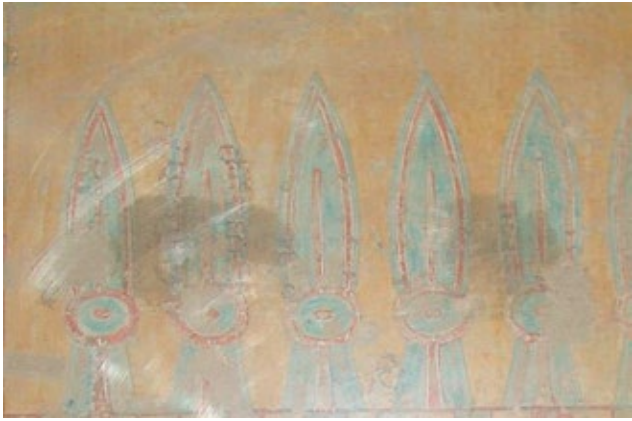
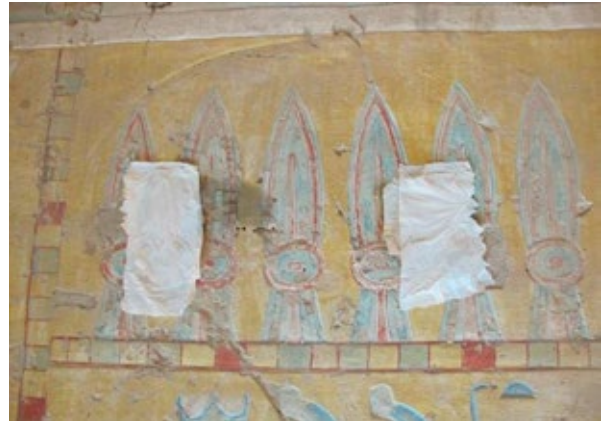
Dark splotches on painting indicate past bat activity. An attempt was made to clean these areas in the past, and again in 2012 (right). The photograph is from an area of painting in Chamber (E).

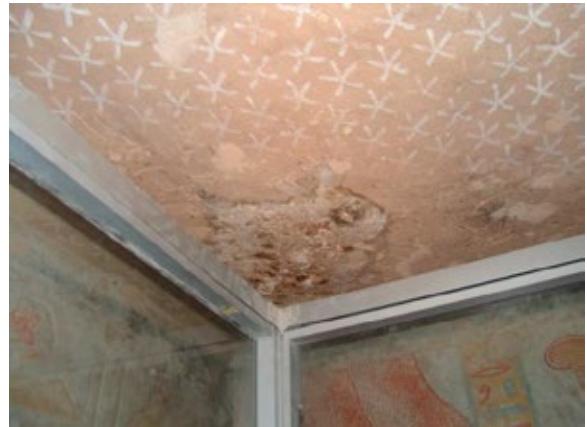
Bat-related damage in the corner of ceiling of chamber (K).

Doorways (F) and (H) need to be protected from visitors touching the paintings. There is currently no protection of these areas. Recommend blocking off rear chamber (G) and side chamber (K) because of low ceilings and possible visitor-related problems with ceiling plaster. These areas should also be monitored.

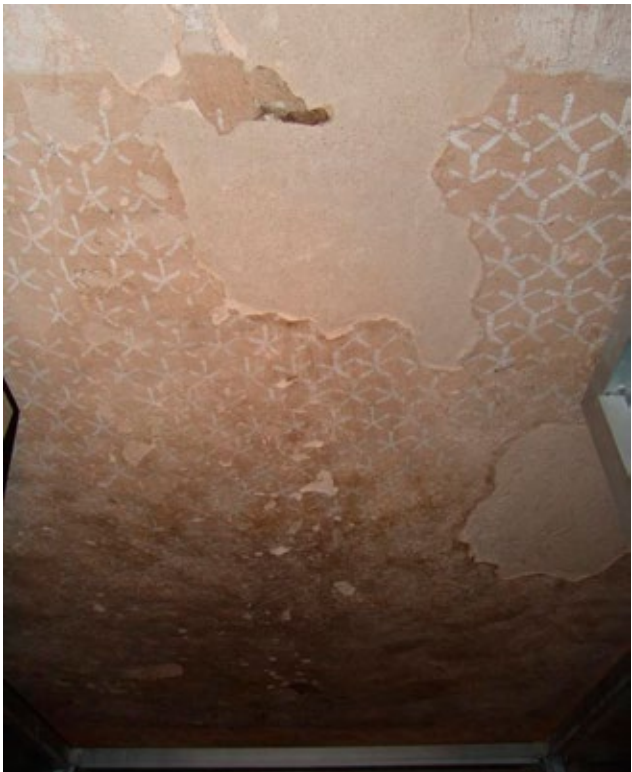
Losses in ceiling of chamber (G) have been filled with plaster repairs.

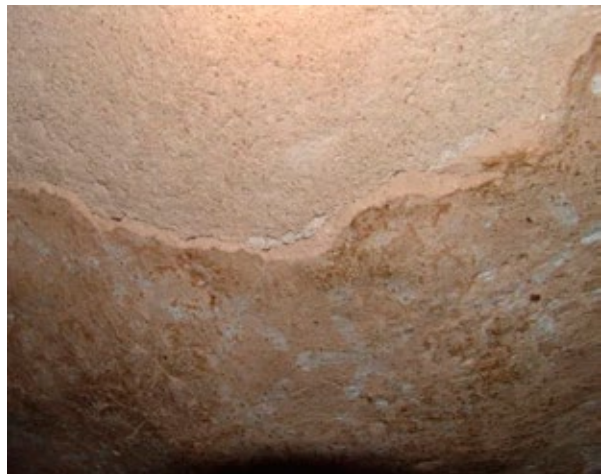
The plaster repairs are slightly recessed from the level of the painting.

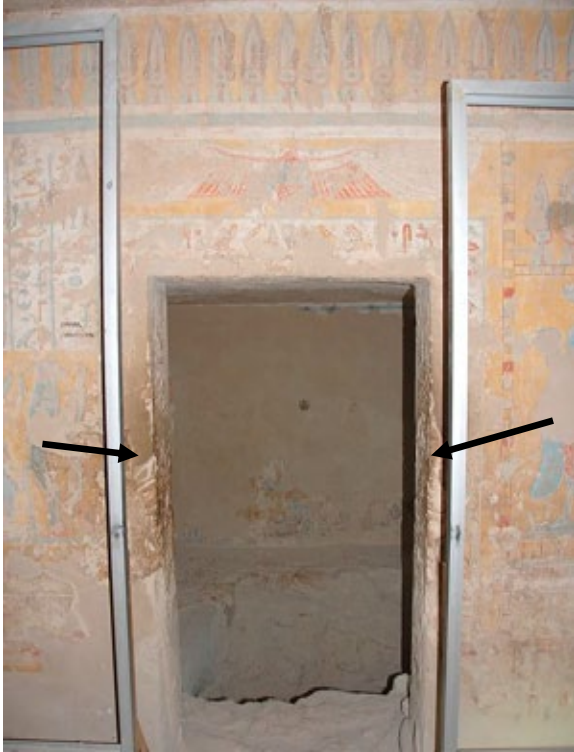
The sides of doorway (H) are unprotected and show staining caused by visitors touching the plaster.

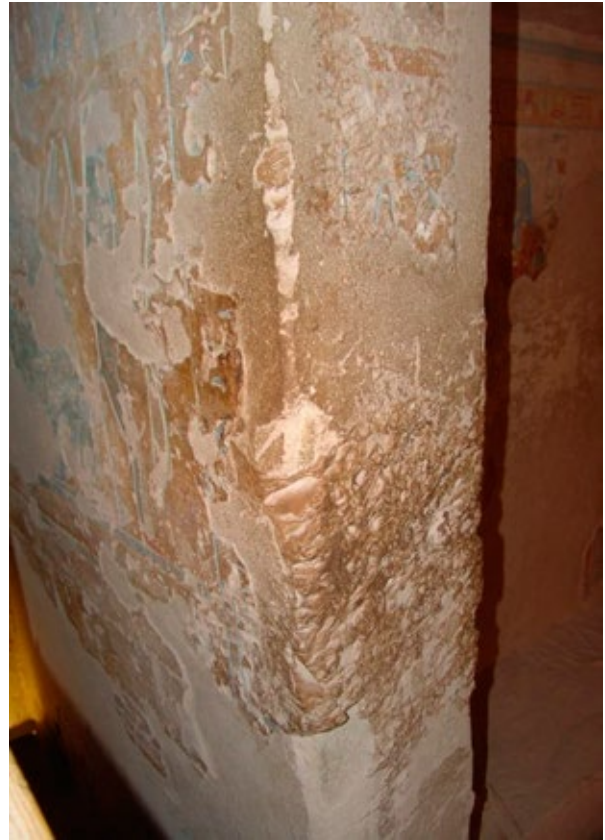
The jambs of doorway (H) show the result of visitors touching the painting. This area should be protected.

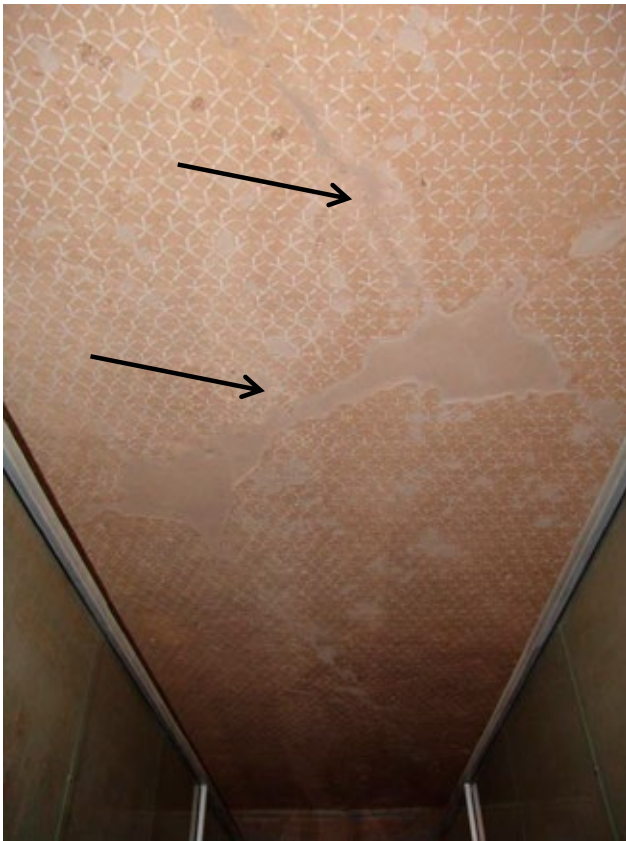
The filled cracks in ceiling of corridor (C) should be monitored.

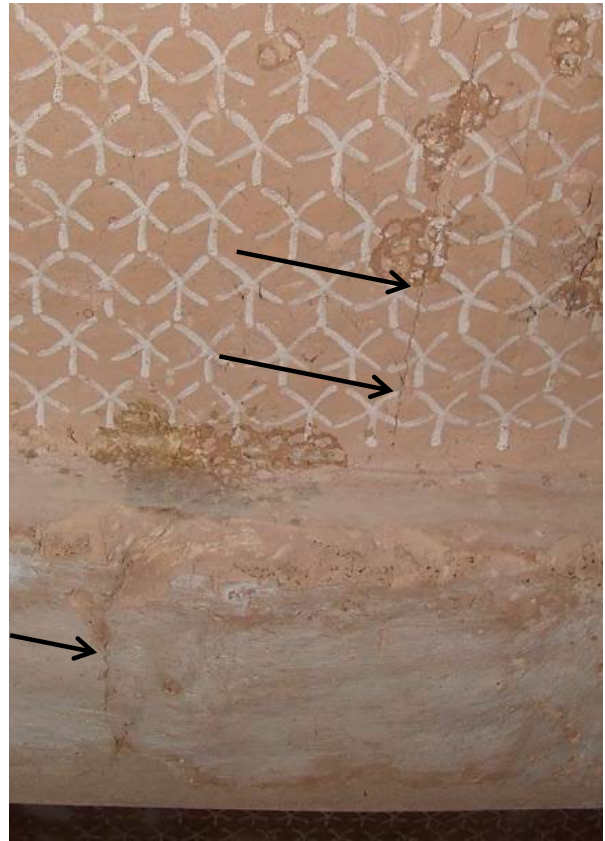
The small crack observed in lintel of doorway (D) should be monitored.

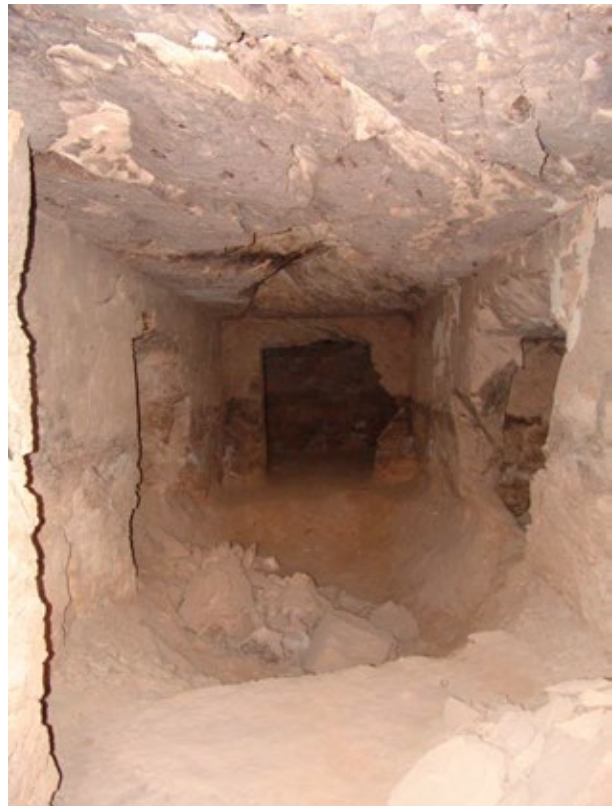
Evidence of recent flooding is visible throughout the tomb in the form of horizontal water marks and basal erosion along walls, and a thick layer of dried, cracked mud on the floor of the chambers, especially those farthest from the entrance. Leblanc records that during the 1994 flood water filled the tomb up to the mid-level of its walls (Leblanc 1995, 212). Elizabeth Thomas noted that the tomb was half full of debris upon her visit in 1959-60, suggesting a long history of periodic flooding.

Overview of the tomb interior in corridor (E) with heavily fractured ceiling and local rock loss; water staining visible along wall.

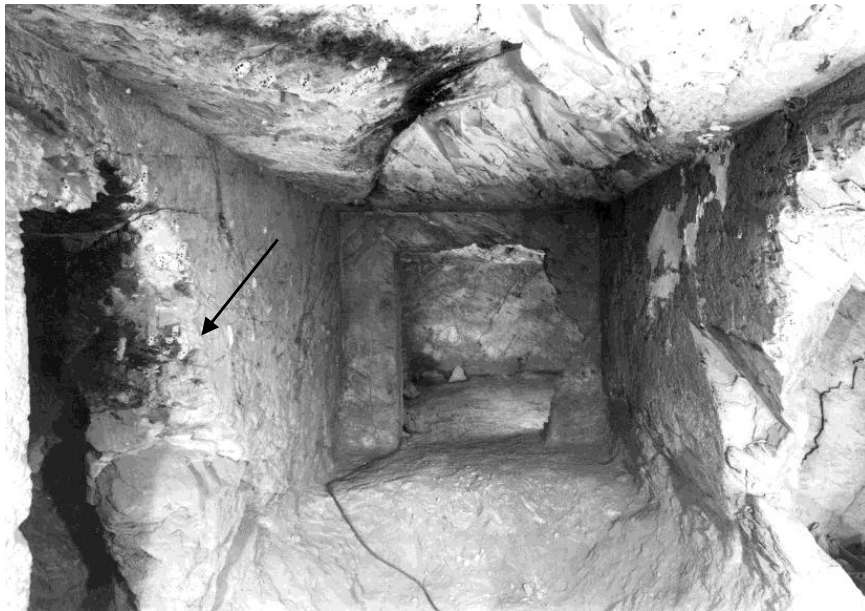
Paintings have been lost since the 1987 CEDAE photographs and correspond to areas of recent rock collapse and loss of plaster repairs. In particular, doorway (D), which was partially reconstructed by the Franco-Egyptian team (date of intervention unknown), has suffered substantial loss. New cracks not seen in the 1987 documentation have also developed in this area. In chamber (C), areas of both painting and repair plaster have also been lost since the 1987 CEDAE photographs, presumably also because of the 1994 flood.

Overview of the tomb interior from central corridor chamber (E), left top: 1987 (Image: CEDAE), below: 2007.

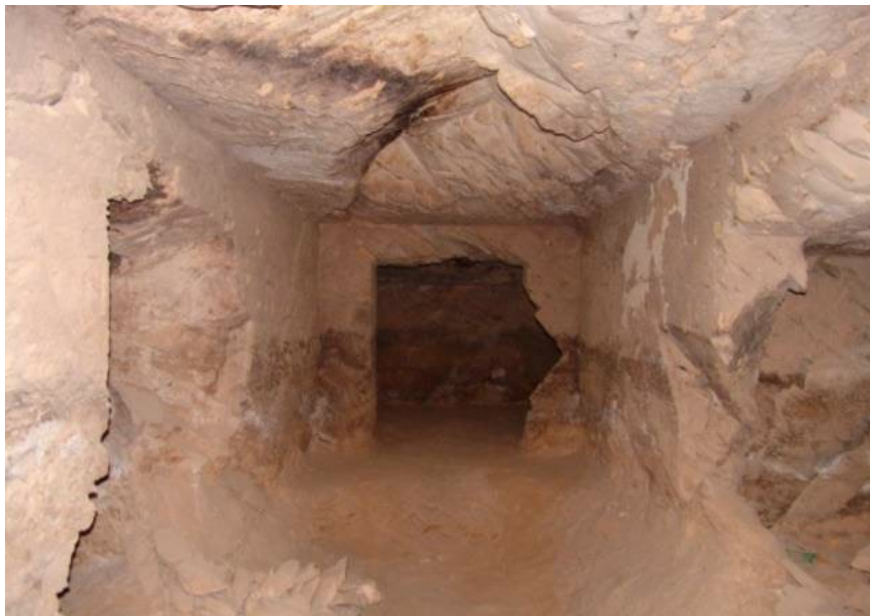
Note loss in left doorway (F) has worsened since the last flood event in 1994.

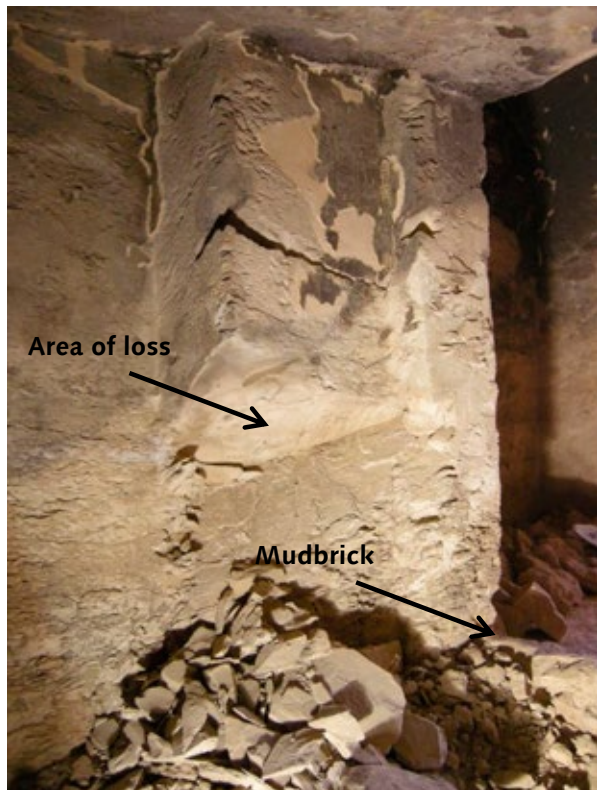
Recent rock and wall plaster loss in doorway (D). Note also remains of mud-brick in the door threshold.

Stabilization of fragile rock is necessary, particularly in areas where recent losses have occurred, such as doorway (D) and the ceilings of chambers (K) and (M). Movement monitoring of selected fractures is also advised. Structural stabilization work should be undertaken with wall painting conservators to treat fragile neighboring areas of painting, if needed.

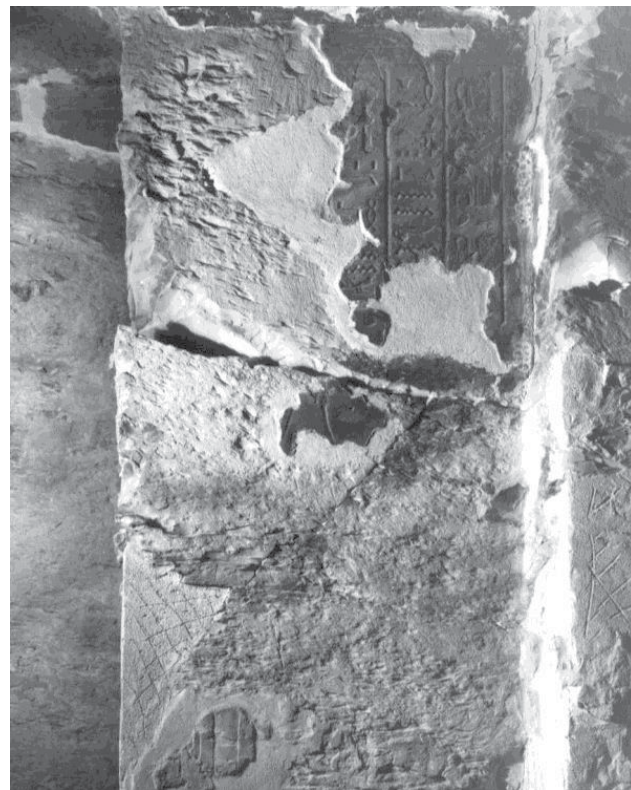
1987 CEDAE photograph of Doorway (D) showing area before loss.

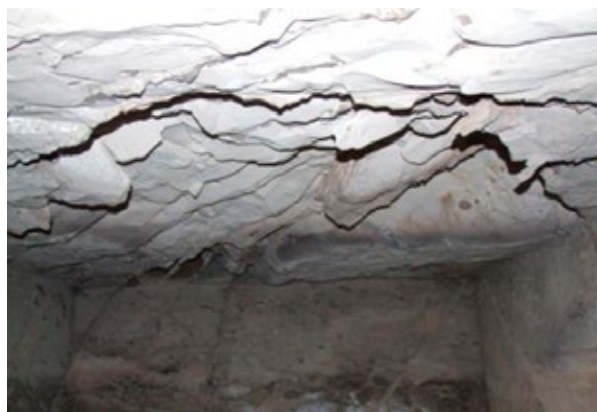
Fractured ceiling rock in side chamber (I).

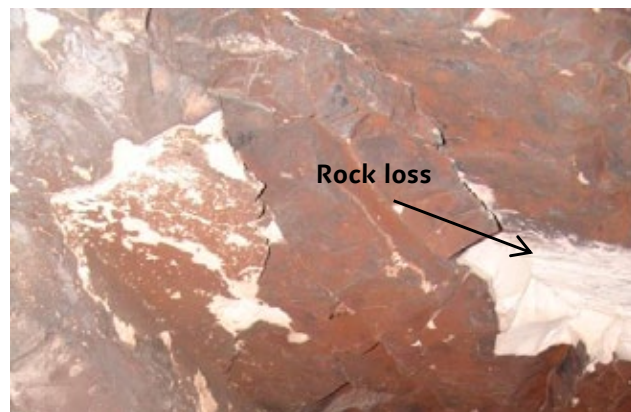
Post-fire rock loss in chamber (G).

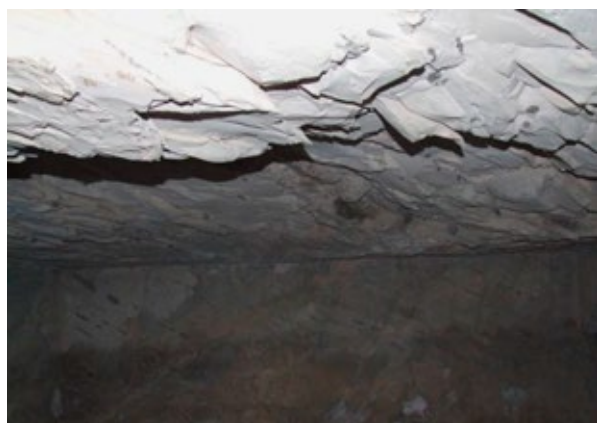
Fractured ceiling rock in chamber (K).

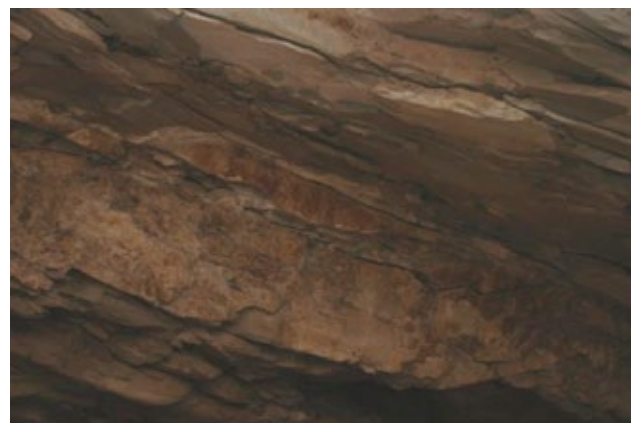
Fractured ceiling rock in rear chamber (M).

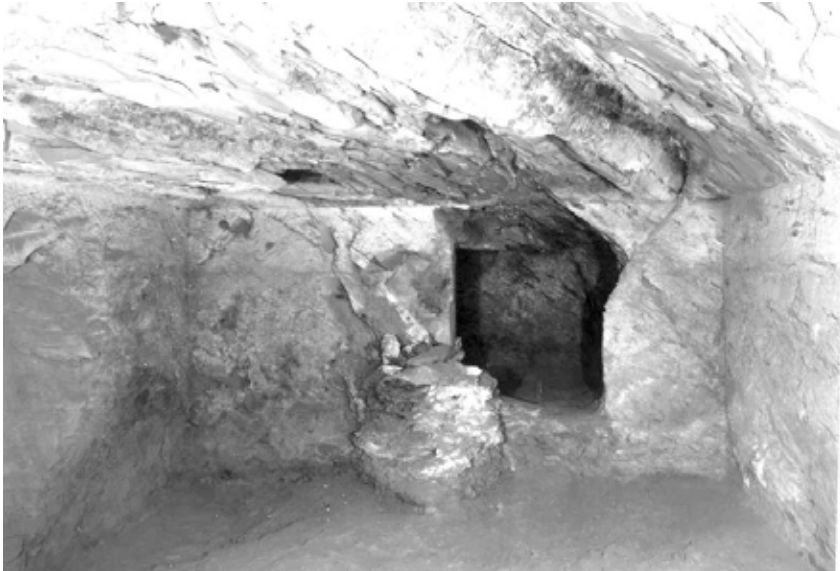
Chamber (M), south wall and niche (O), top in 1986 (Image: CEDAE), bottom in 2008.

Note no significant rock loss, but flood water line and salts efflorescence on the wall and cracked mud on the floor due to 1994 flood event.

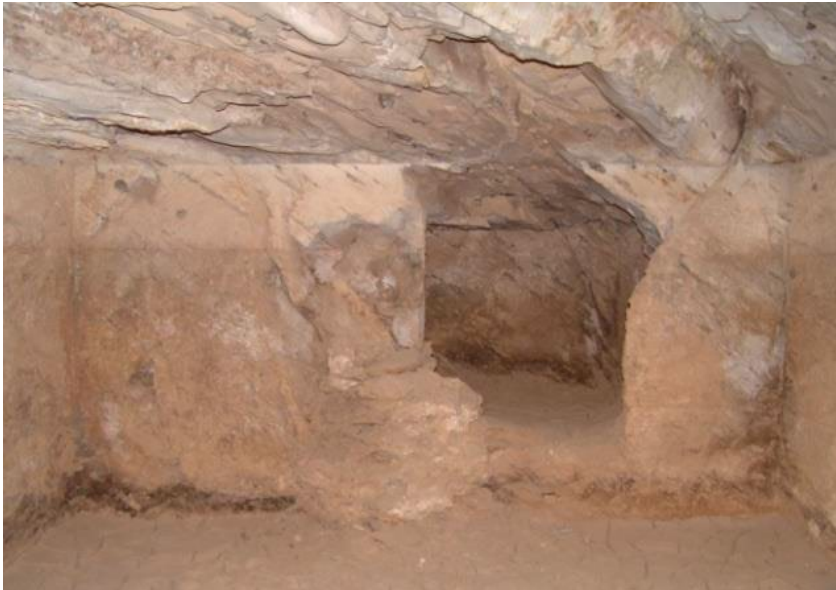
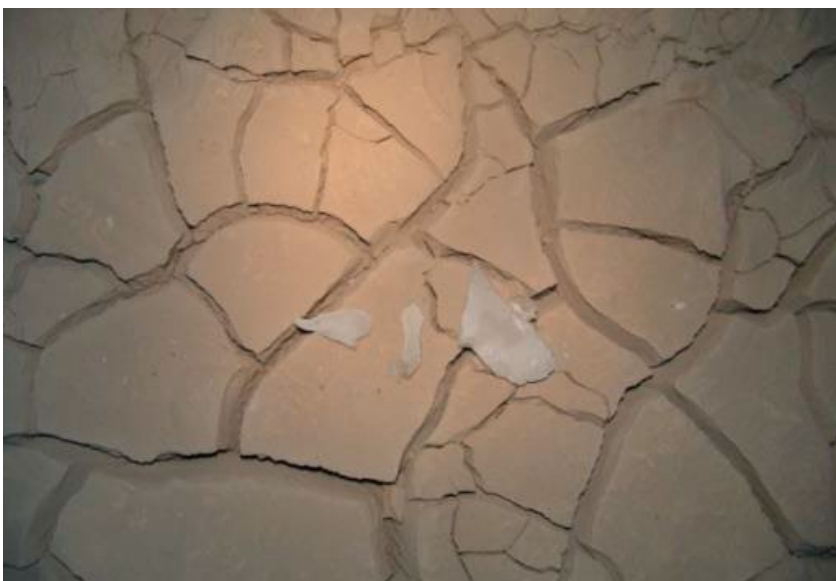
Thick, cracked mud layer on floor in rear chamber (M) deposited in 1994, and fragments of fallen rock from ceiling.

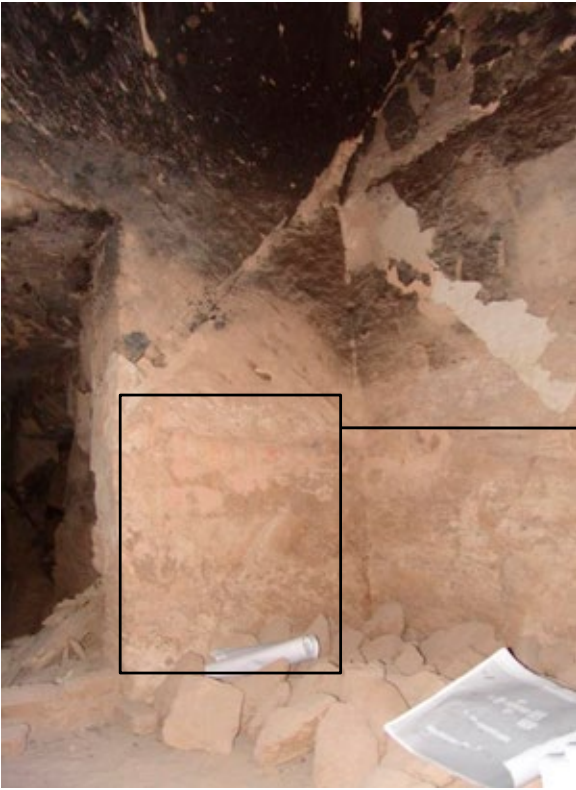
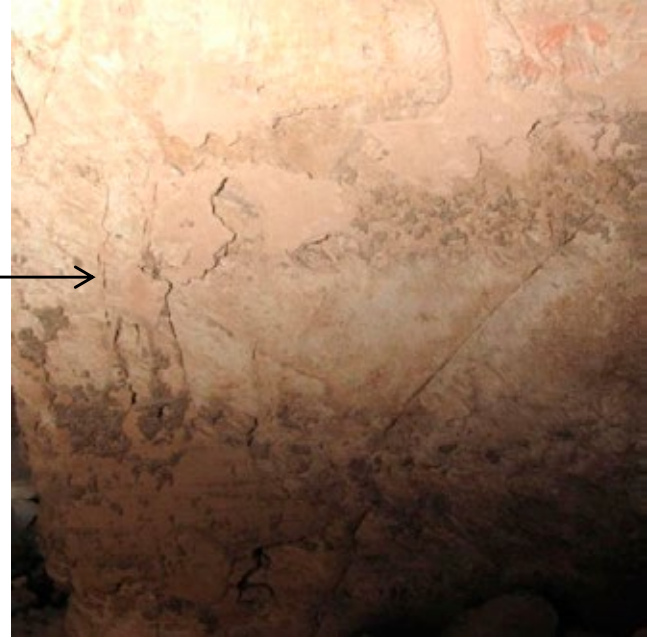
Chamber (C) has heavy soot blackening in the upper parts of the walls. There are small areas of surviving sunken relief paintings at the base of the walls concentrated in the southwest corner. Comparison with 1987 CEDAE photographs below shows substantial losses in this area.

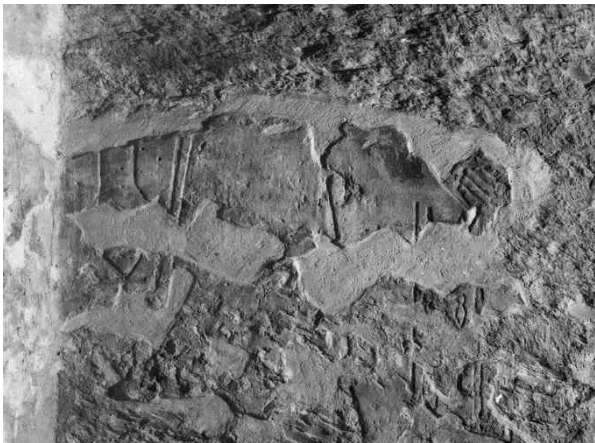
1987 CEDAE photograph of surviving area of painted plaster.

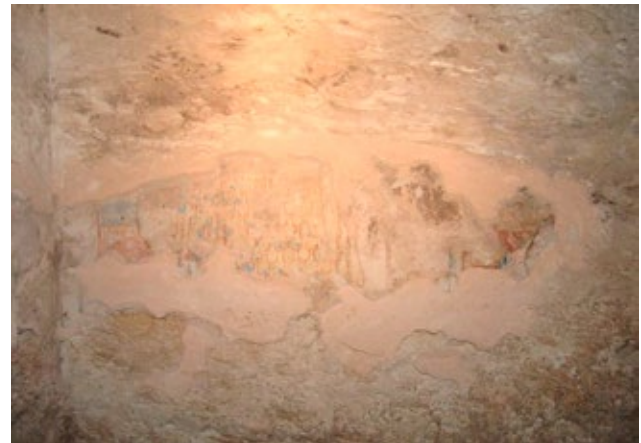
Same area in 2008. Significant areas of painted plaster have been lost.

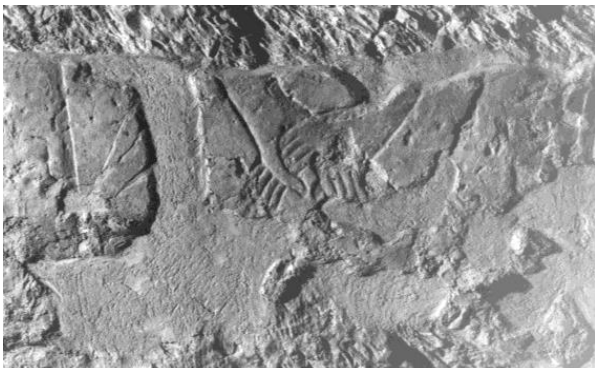
1987 CEDAE photograph of surviving area of painted plaster.

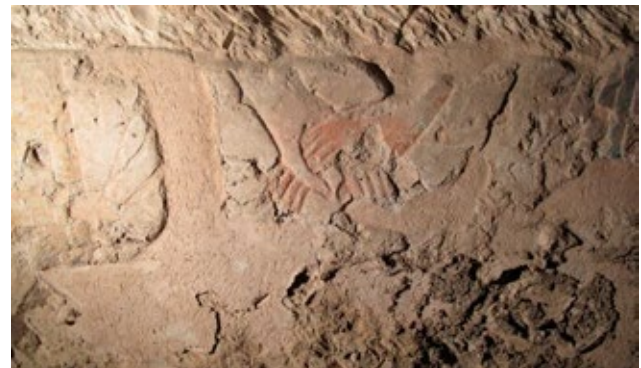
Same area in 2009. Significant areas of painted plaster have been lost.

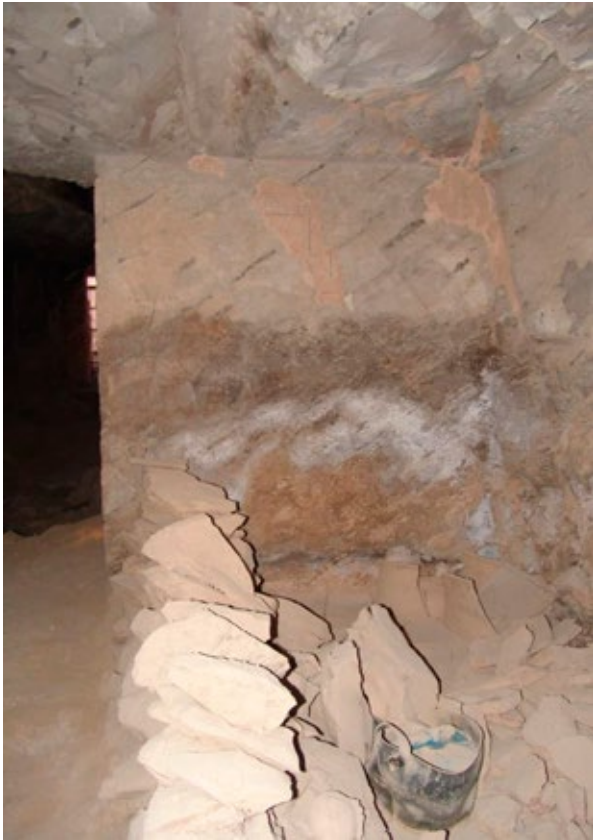
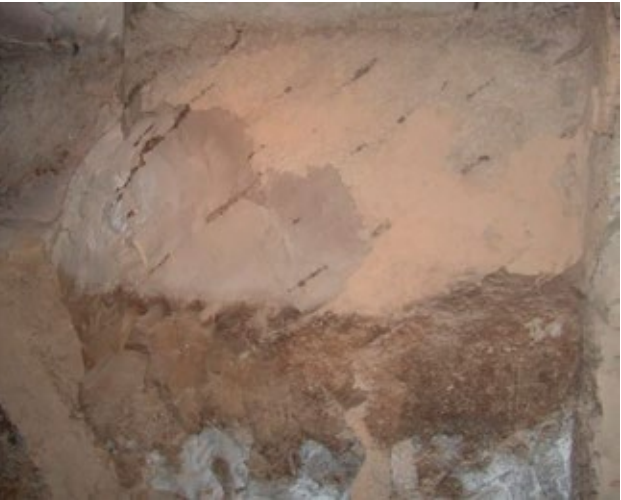
Chamber (K): White efflorescence can be seen on the rock in the flood zone at the base of the walls. Traces of painted original plaster survive above. It is pink in color possibly indicating heat-related damage.
