Valley of the Queens Assessment Report

Volume 2

Assessment of 18th, 19th, and 20th Dynasty Tombs

A collaborative project of the Getty Conservation Institute
and the Supreme Council of Antiquities, Egypt

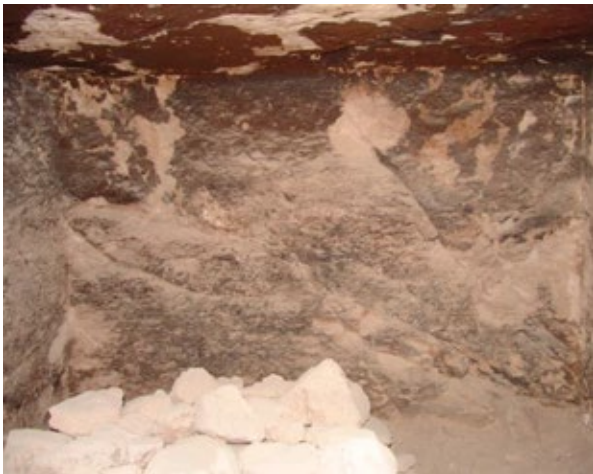
Side chamber (G) has heavy soot blackening and post fire losses.

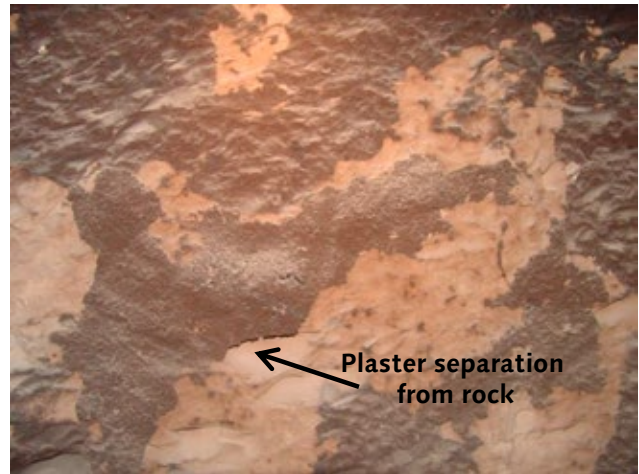
Side chamber (G) has a thin layer of plaster but may not have been painted, though this is difficult to fully assess given the extent of blackening. The plaster layer has suffered heat damage and is now quite fragile; it is separating from the rock in areas.

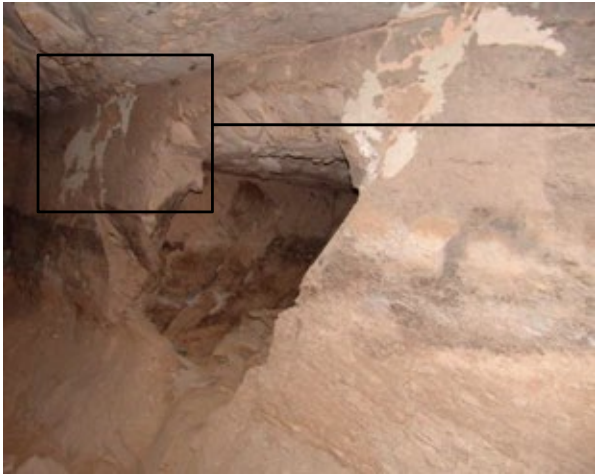
Chamber (E): Only traces of painted plaster still survive in this room.

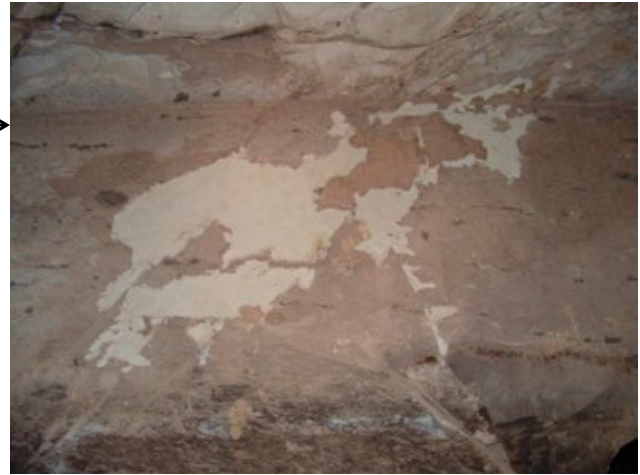
Chamber (E): Detail of surviving area of plaster. The light gray areas are repair plaster.

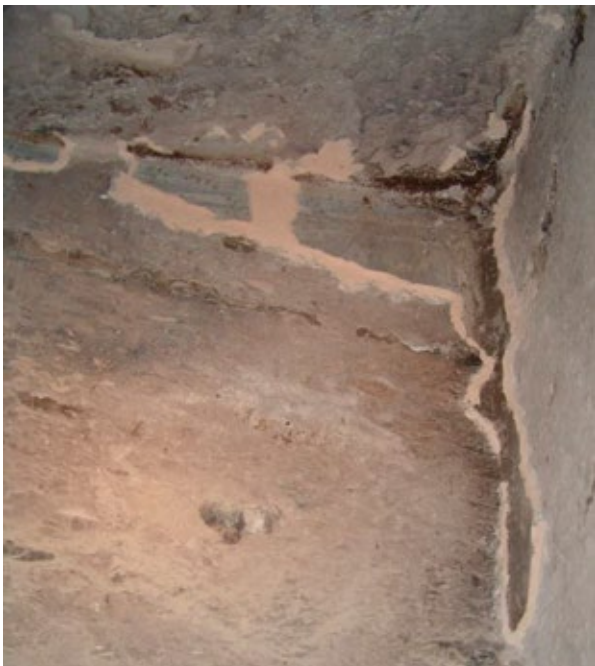
Chamber (E): Pink-colored edging repair are also visible in this tomb.

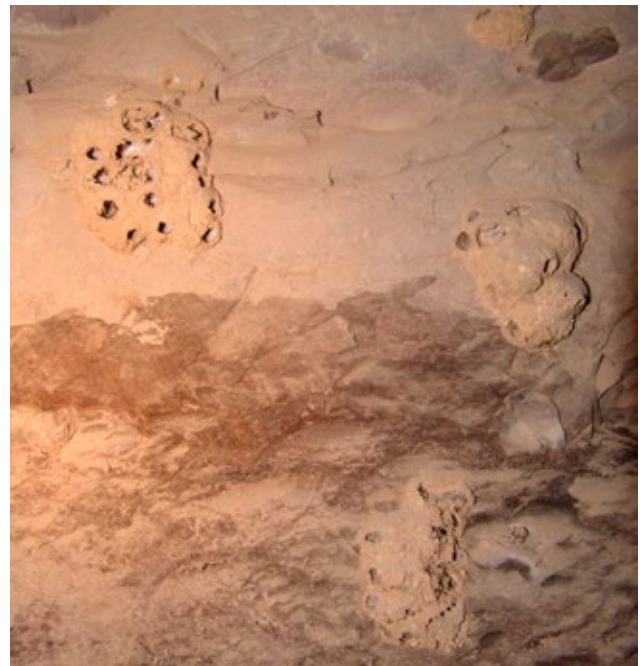
Mud wasp nests still survive in this tomb though they are no longer inhabited.

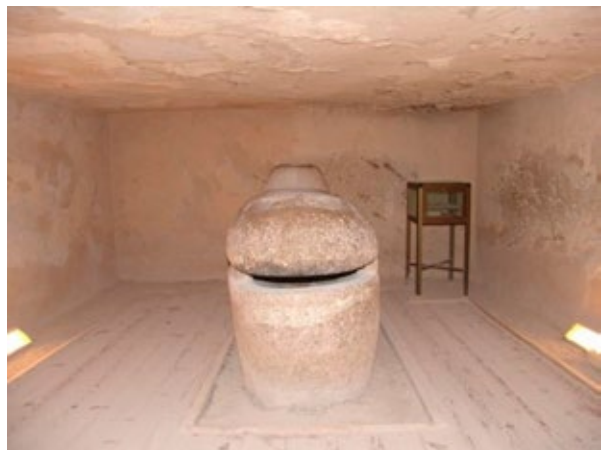
Pink granite sarcophagus and glass case containing a mummified fetus have been displayed in the rear chamber (K). The sarcophagus was originally found in chamber (G). The mummy was found in the Valley of the Prince Ahmose and it was moved to chamber (E) in 2010 to avoid congestion. The ceiling is low in this chamber and there are no protective barriers. Some trash was found inside the sarcophagus.

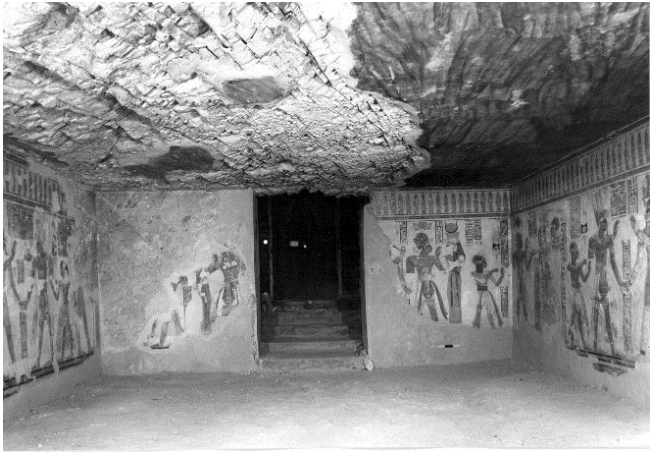
CEDAE photograph from 1974 shows the large losses in the ceiling in chamber (C) before they were plastered.

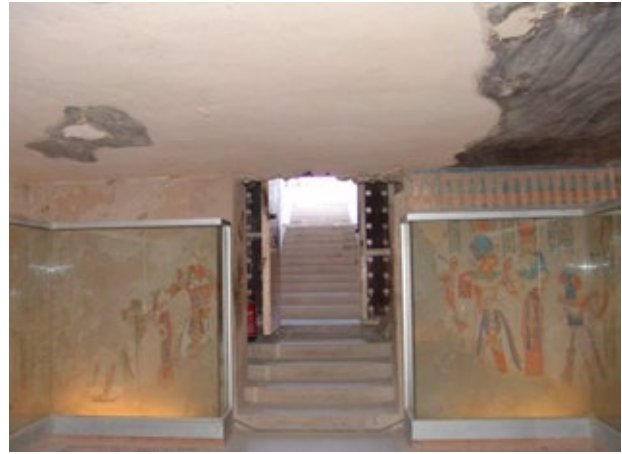
Extensive modern plaster infill now covers two thirds of the ceiling of chamber (C).

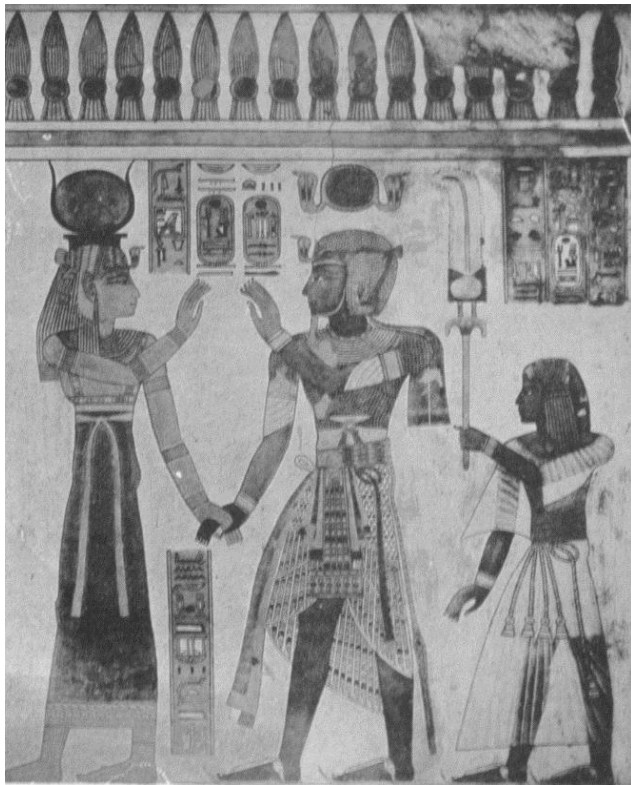
South wall in chamber (C) (1904-5) . Note the area of plaster loss on ceiling (Image: Schiaparelli 1923).

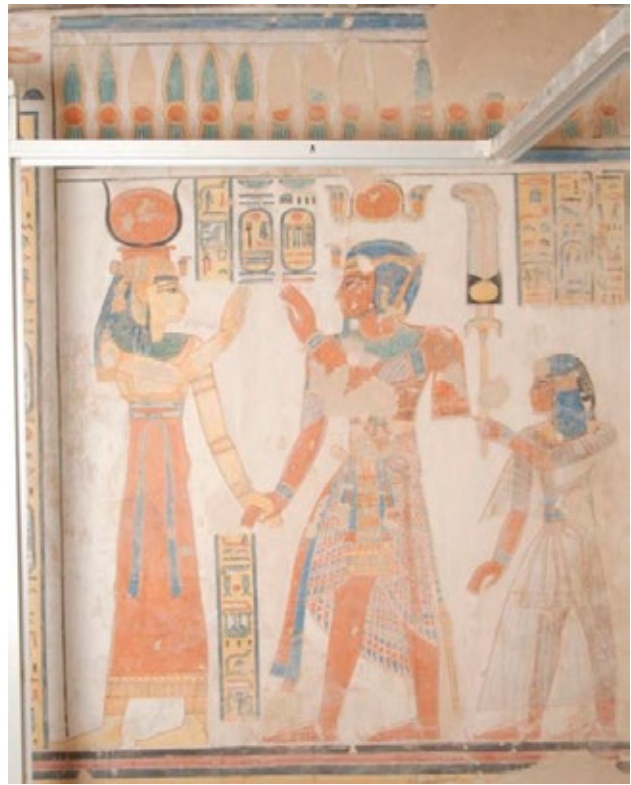
Area of loss on south wall is repaired with mortar. Only fairly small areas of decoration lost since the time of Schiaparelli (Image: CEDAE 2009).

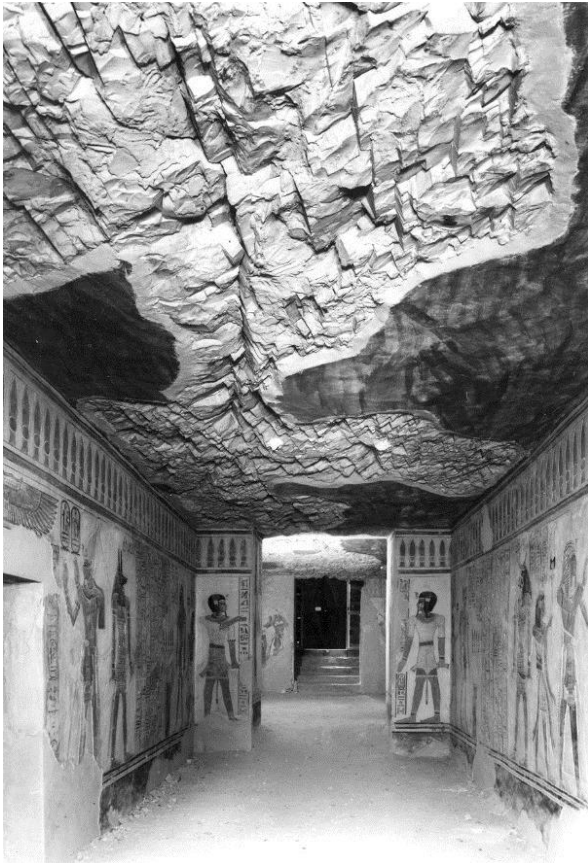
Large losses in the tomb such as on the ceilings of chamber (C) and corridor (G) can be explained by collapse of plaster along fissures of the heavily jointed rock. The current cracking of repair plaster in these areas requires monitoring to better assess their current risk level. It is uncertain whether or not these recent cracks indicate real instability of the rock in these areas, or a failure of the substantial infill material.

Note large loss in ceiling of corridor (G) in 1974 photograph (Image: CEDAE).

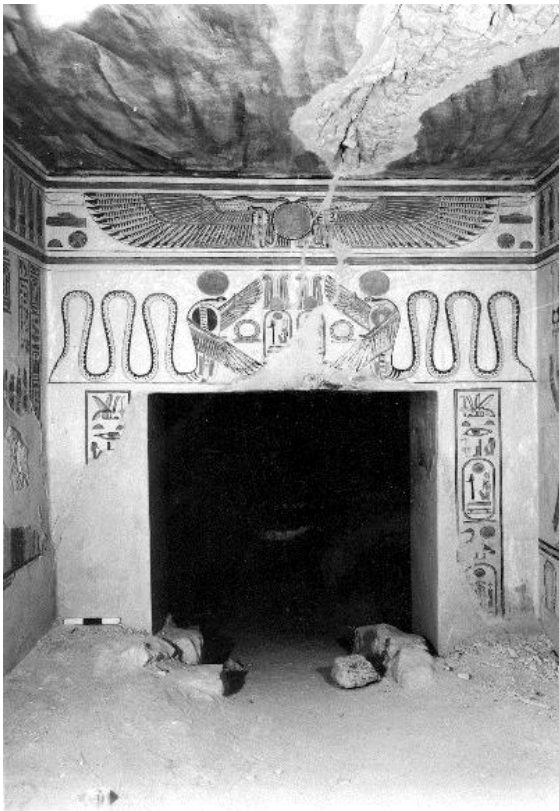
Fracture continues from corridor (G) to doorway (J) in 1974. Plaster on ceiling has been lost along the fracture (Image: CEDAE).

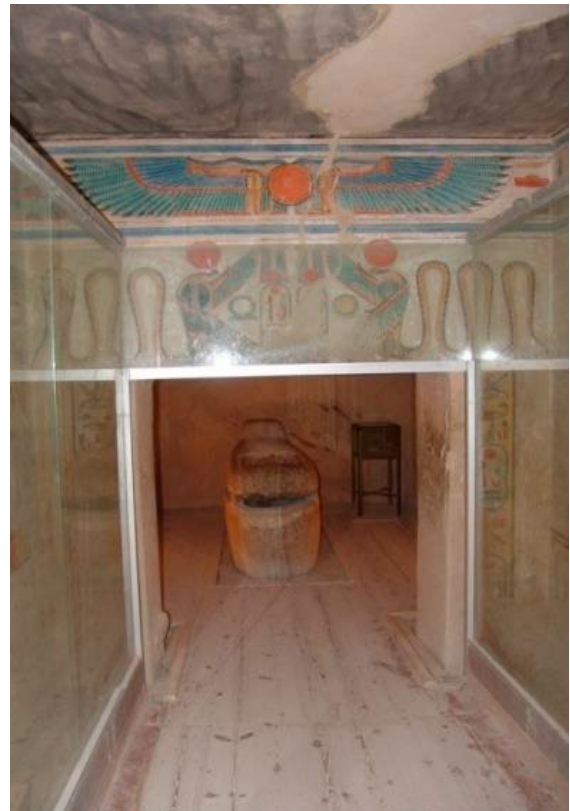
Area of losses were repaired with mortar. Note also the doorway (J) to rear chamber (K) is extremely low.

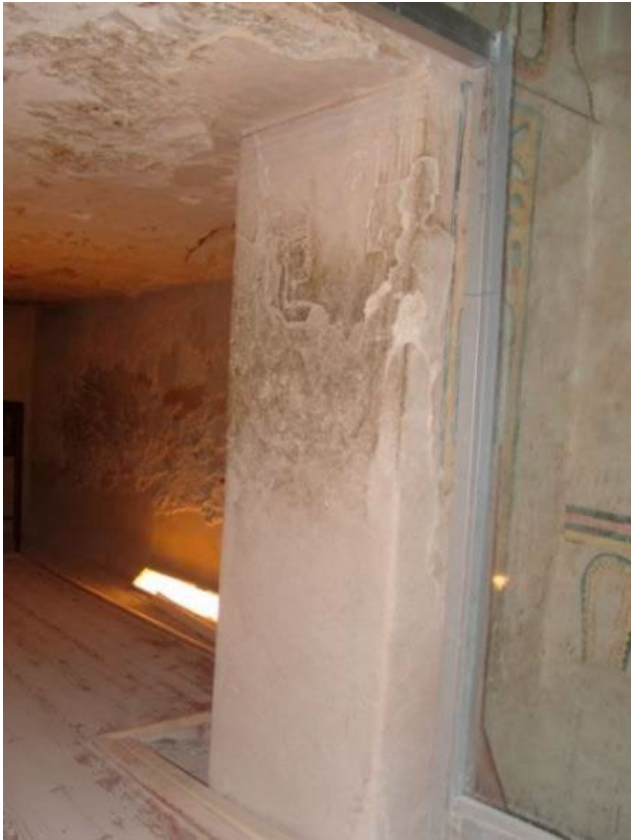
The jambs of doorway (J) leading into the rear chamber (K) are unprotected and show signs of visitors touching the walls. This area should be protected.

The jambs of entrance doorway (B) and doorway (J) leading into the burial chamber show signs of visitors touching the walls (staining from grease of hands) and should be protected.

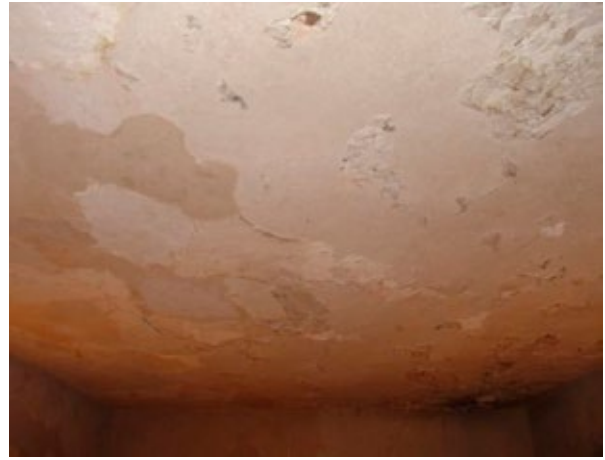
The ceiling of the rear chamber (K) has a number of different types of plaster repairs indicating ongoing losses in this area of the tomb. As the ceiling is extremely low it is recommended that access to the chamber (K) be limited and that the ceiling be monitored.

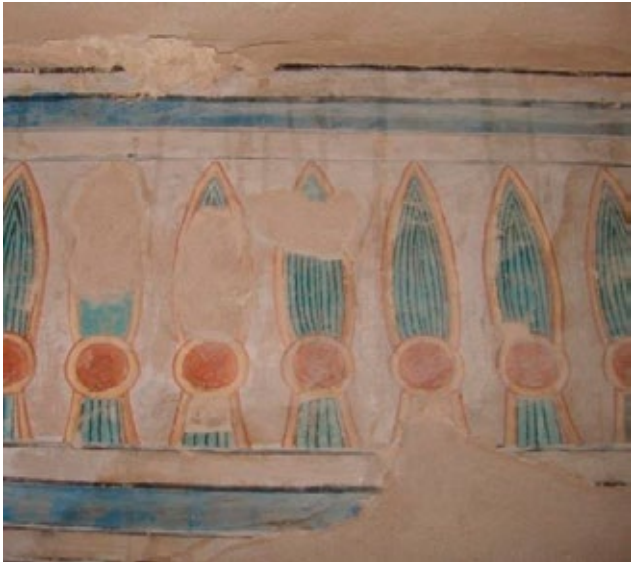
Many treatment drips are visible throughout tomb.

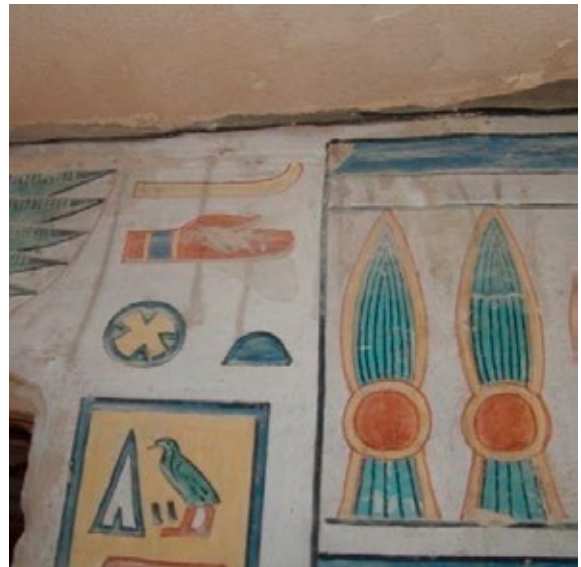
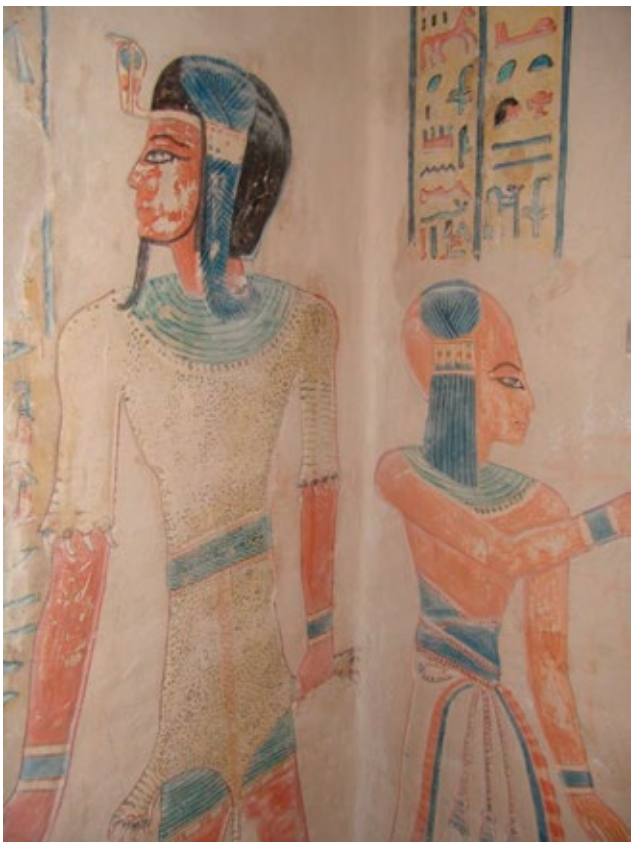
The surface of the paintings is abraded. There are small losses in the painted surface and the white background is nearly gone in areas.

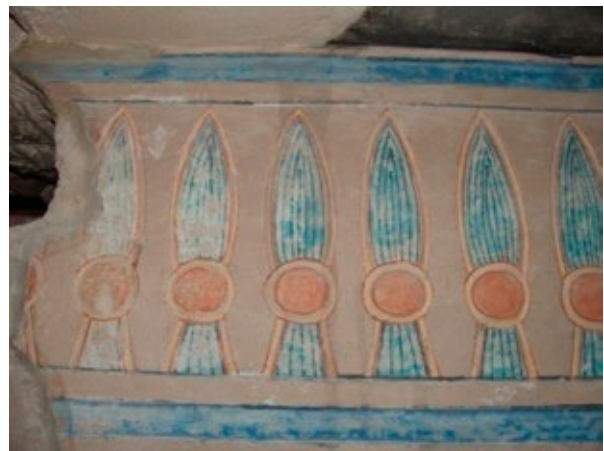
Areas of blue are abraded and appear faded. These areas have been lost over time, possibly from the cleaning of the paintings.

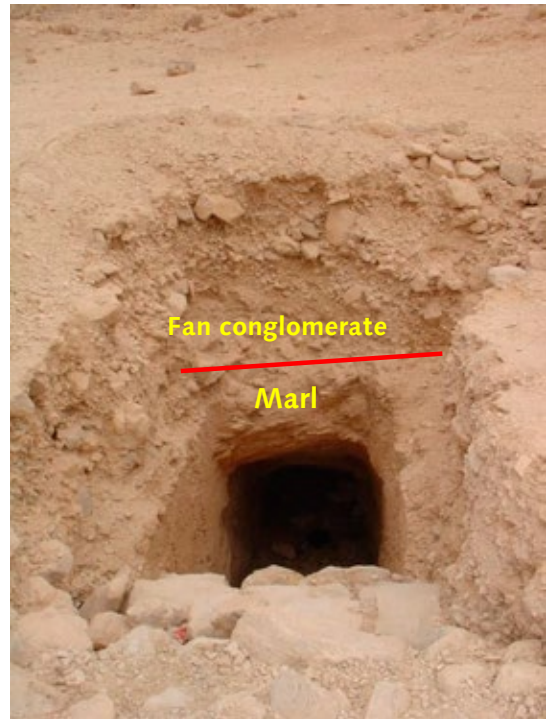
Both tombs were damaged during the flood in 1994. The retaining wall and the steps of QV 56 deteriorated during this time. The conglomerate on the east side of the tomb entrance has collapsed and this slope remains unstable. The marl rock at the bottom of the ramp remains in stable condition, however.

Stepped ramp and entryway of QV 56, with line indicating horizon between rock types.

Both QV 56 and QV 57 should be reburied given their relatively poor condition, their unfinished state, and their proximity to the main drainage channel.

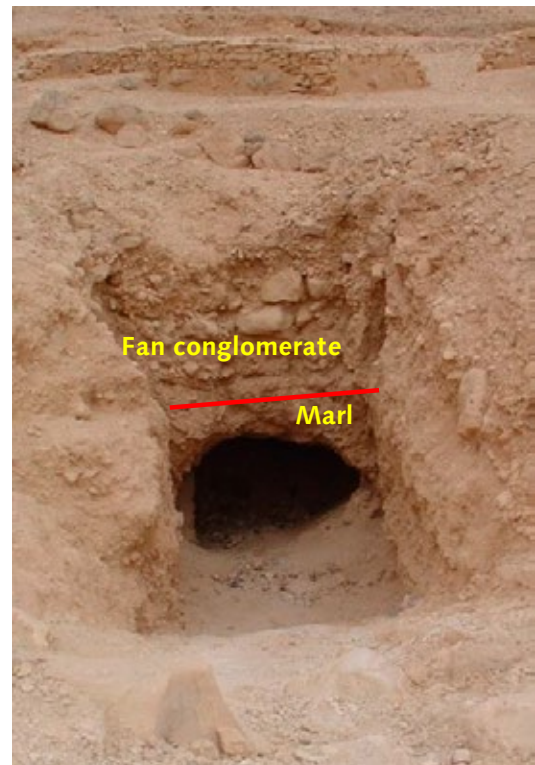
QV 57 is likewise in stable condition, though the fan conglomerate surrounding its entrance continues to erode. Nevertheless, debris caked to the ceiling of chamber (C) suggests that this unfinished tomb is periodically filled with flood waters and runoff.

Ramp and entryway of QV 57, with line indicating horizon between rock types.

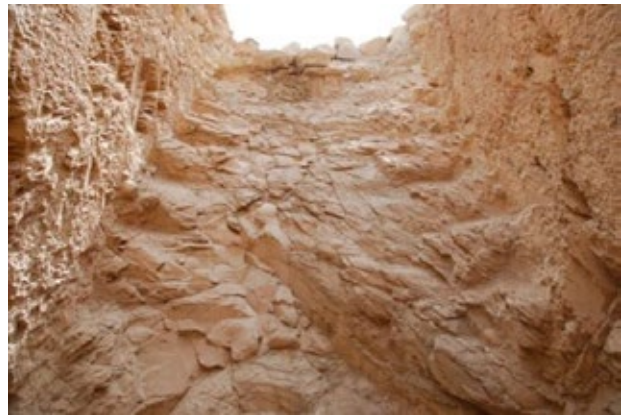
Heavily eroded steps of QV 56.

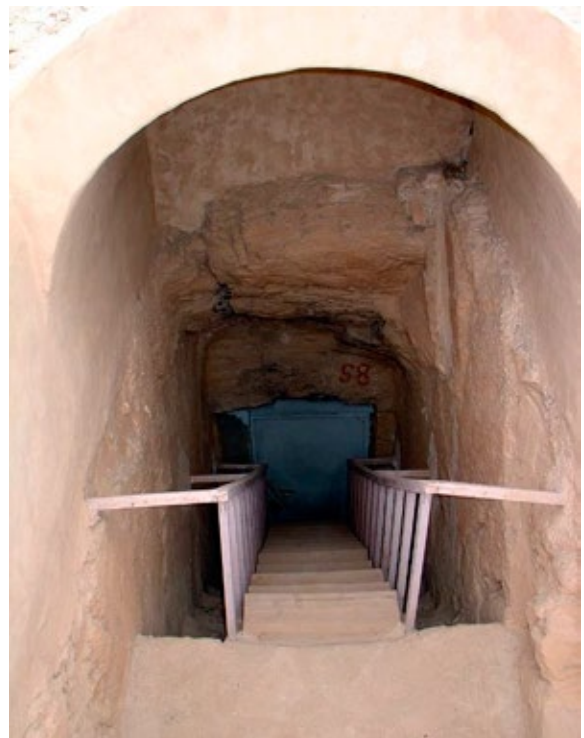
Entry ramp (A) with arched cover and masonry walls, wooden stairs with handrails installed over the original stepped ramp, and exterior metal door without ventilation holes.

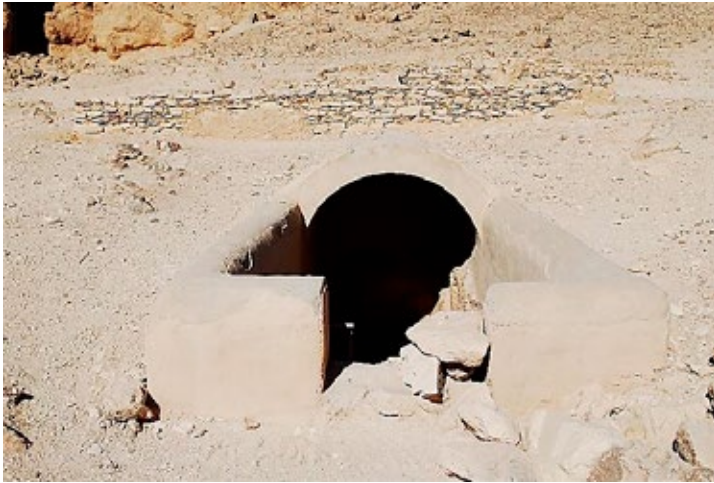
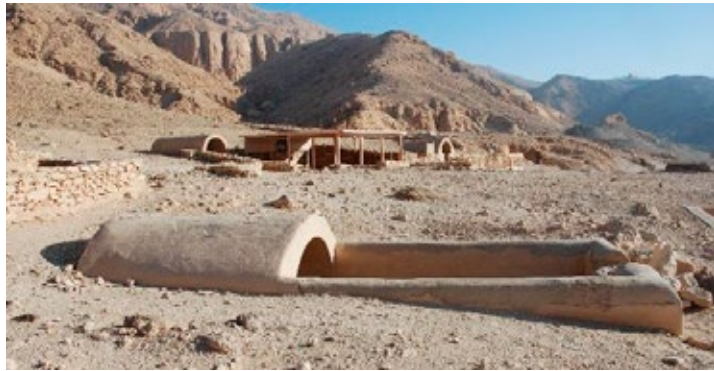
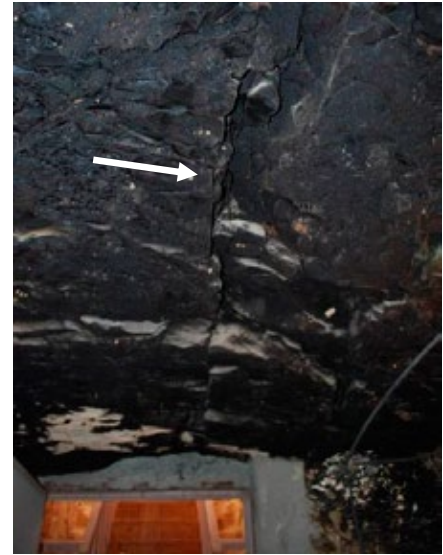
North-south fracture (arrow) in blackened ceiling of entrance chamber (B), with area of recent loss near door.

The tomb ramp has an arched cover and modern a cement coated masonry surround. The surround provides inadequate protection in the event of a major flood.

Given the location of the tomb next to the wadi, and the tomb's current use as a storage facility, protection from flooding by construction of a higher arched cover and surround, as well as a return wall in front of the entrance is strongly advised.

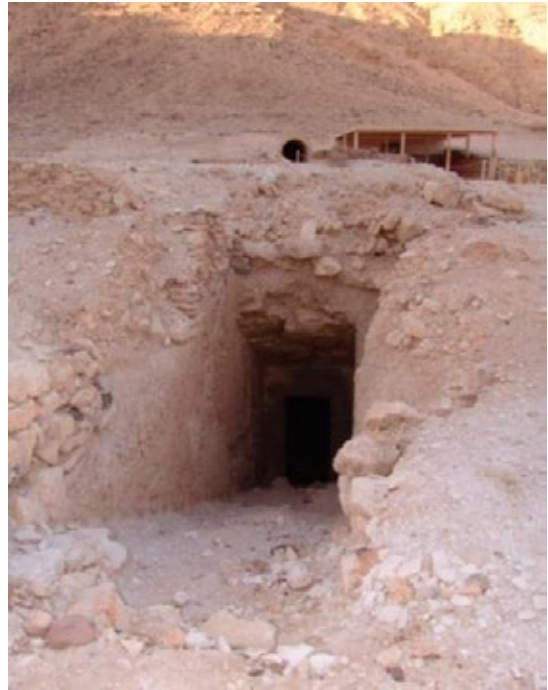
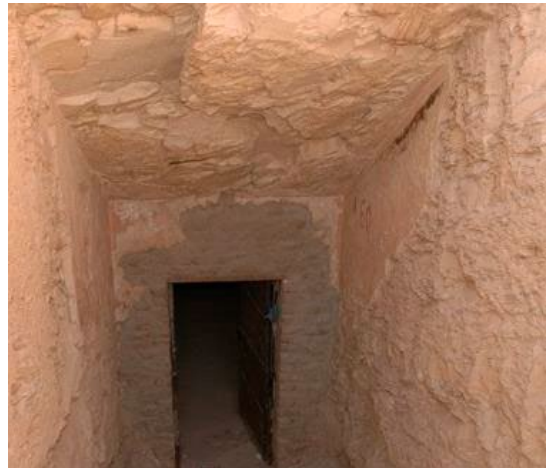
Tomb ramp and entrance with friable rock overhang (above) and well-cut ramp walls with brick entrance jambs (below).

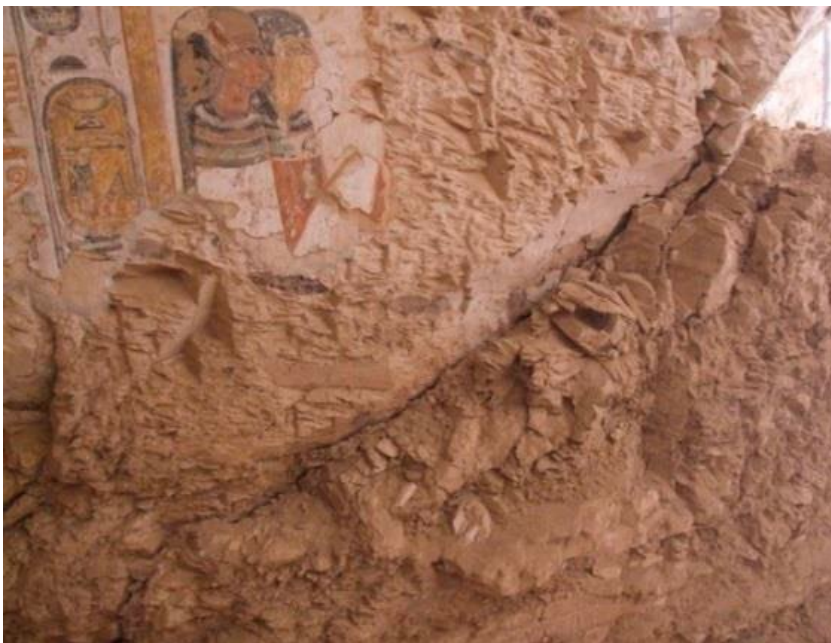
Area of rock fracture and loss adjacent to basal deterioration of wall

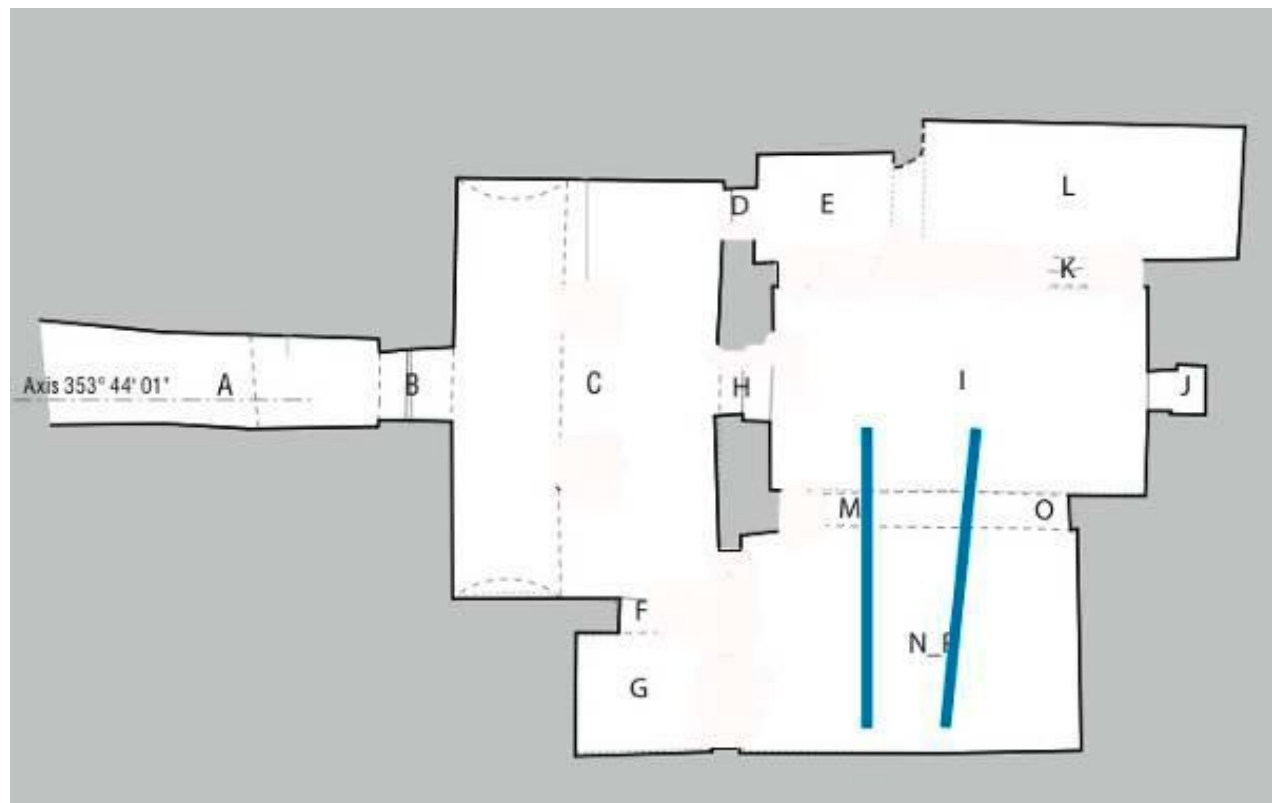
Wooden post and beam shoring has been installed in rear chambers (I) and (N_P) to support the ceiling rock and surviving upper portions of collapsed walls. Some repair fillings of cracks in the ceiling have been carried out with mortar adjacent to the shoring in chamber (N_P). Space between the shoring and the rock has also been filled with the same gypsum/white cement mortar.

Location of existing shoring

The existing wooden shoring in chamber (N_P) should be modified, and additional new shoring installed in other chambers to support ceiling rock at risk of collapse. Selected rock macro-fractures should be monitored and stabilized as needed with localized, spot applications of a structural adhesive. Missing internal walls and their doorways need to be reconstructed with masonry, to stabilize the upper remains of the walls and ceiling rock, and the heavily deteriorated walls between the antechamber and rear chambers should be stabilized by constructing buttress walls or retaining walls around their bases. The micro-fractured ceiling rock in chamber (C) should be stabilized with localized plastering of the surface. Faults and open joints require monitoring for active movement.

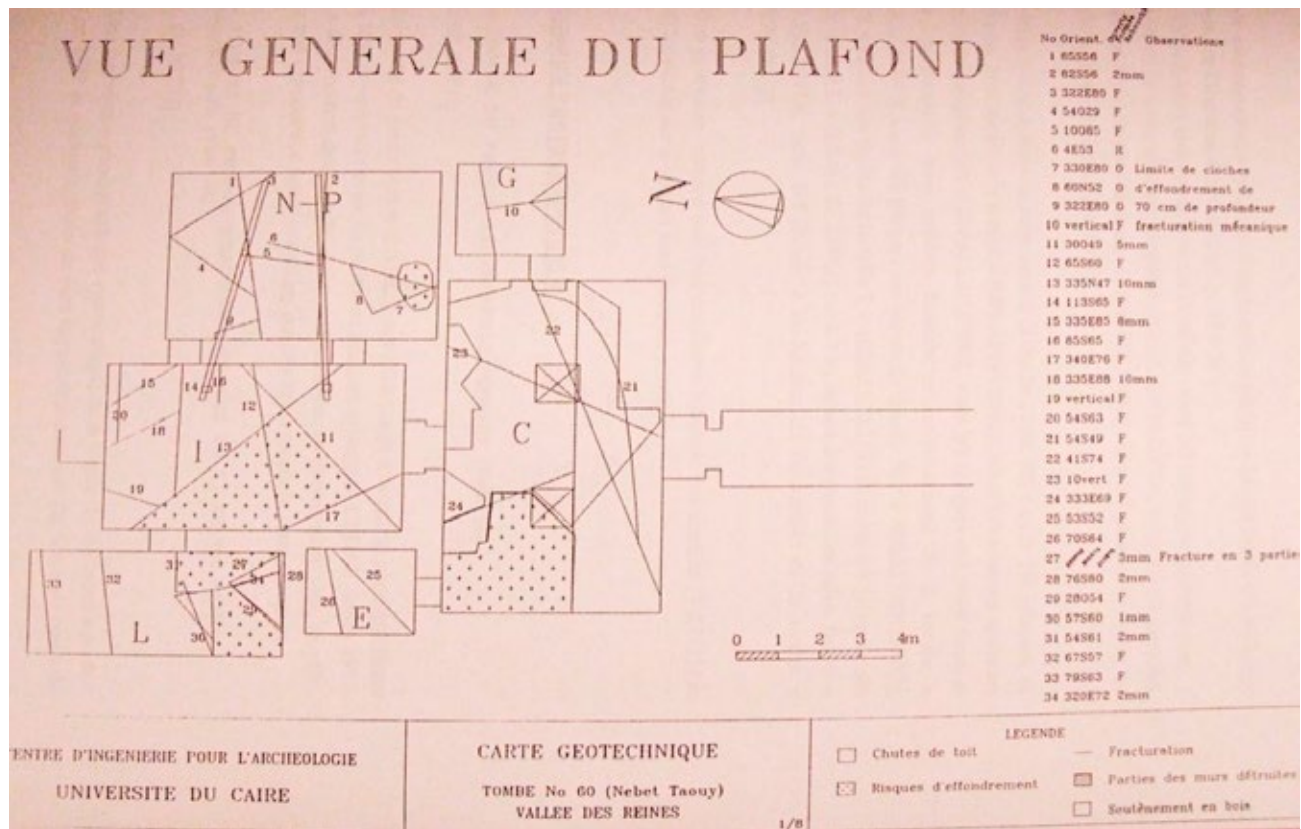
Geotechnical drawing created as part of 1993 study by University of Cairo for CNRS. Stippling represents areas of potential collapse.

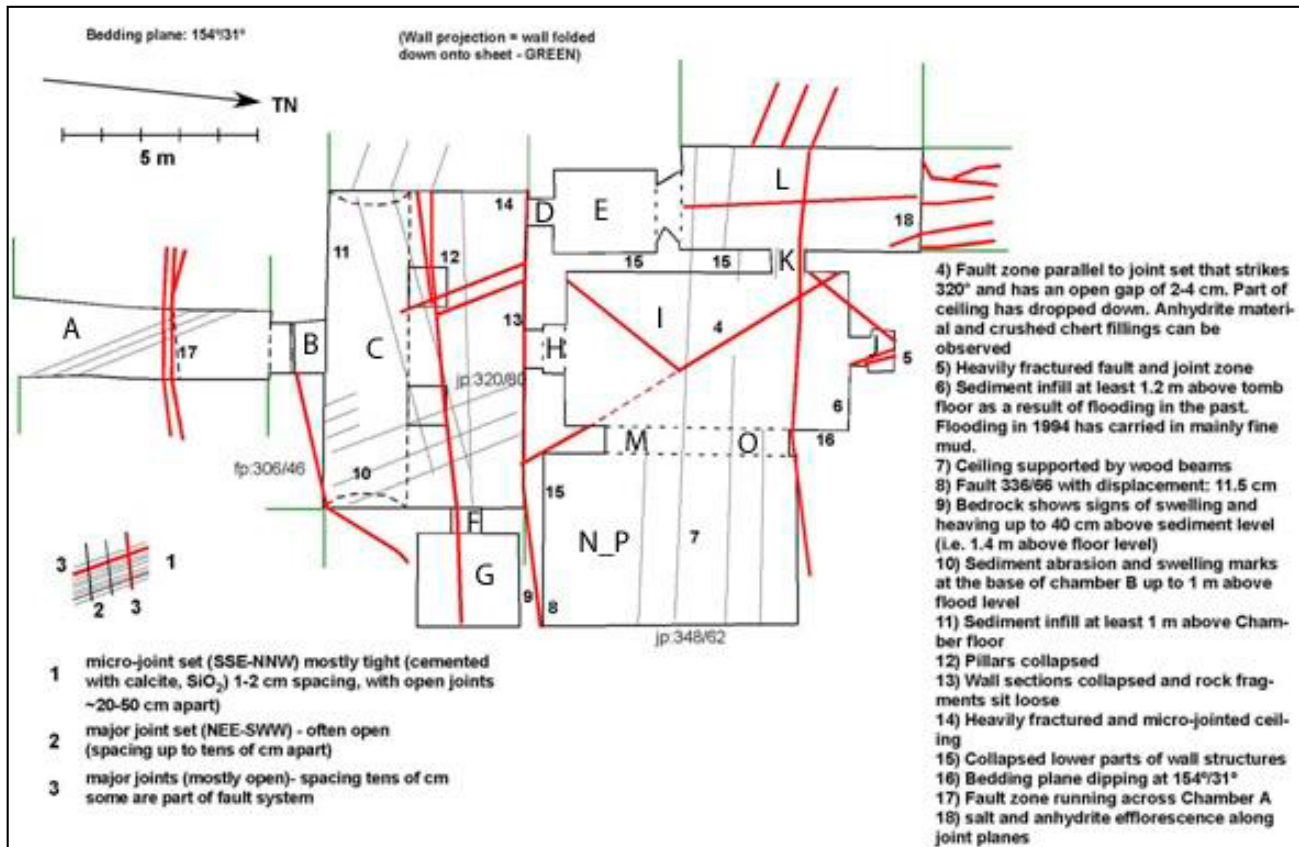
Geotechnical drawing created as part of 2008 geological study by Raphael Wüst, showing jointing and fault systems.

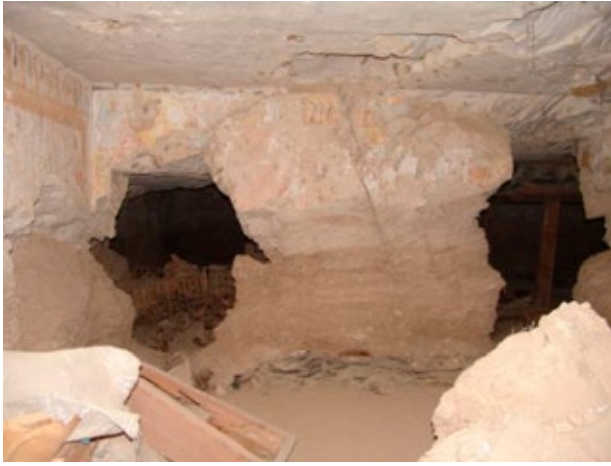
At risk area around doorway (D) between chambers (C) and (E) and doorway (H) between chambers (C) and (I).

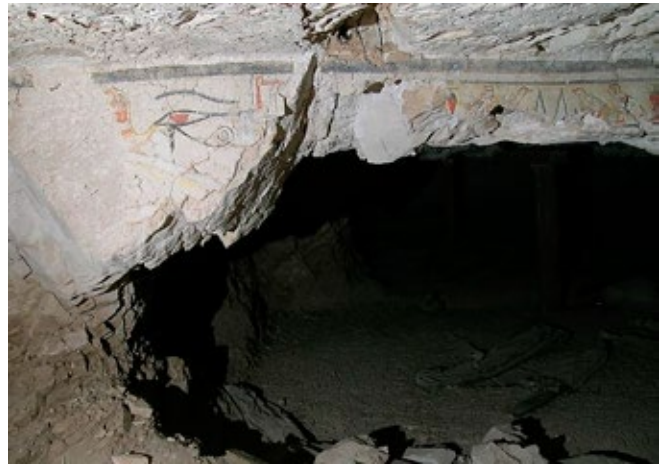
At risk area around doorway (K) between chambers (L) and (I). Loss of walls has resulted in large unsupported spans of rock throughout the tomb and localized loss of hanging rock.

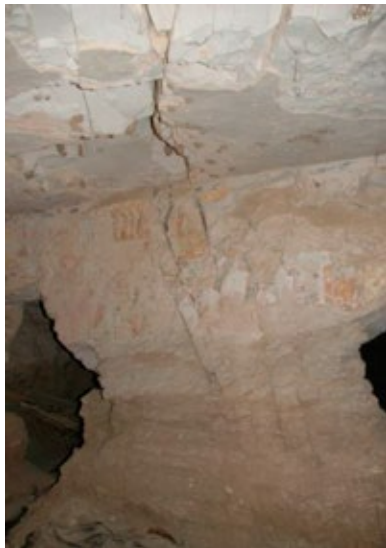
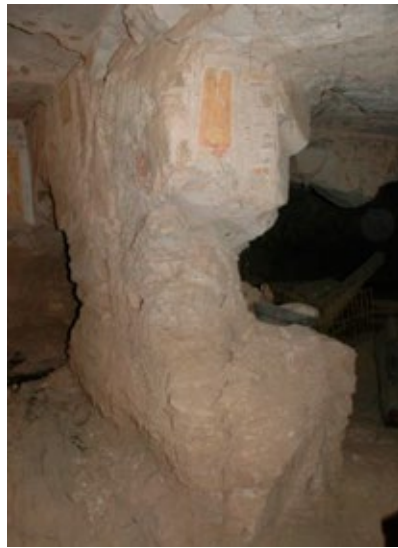
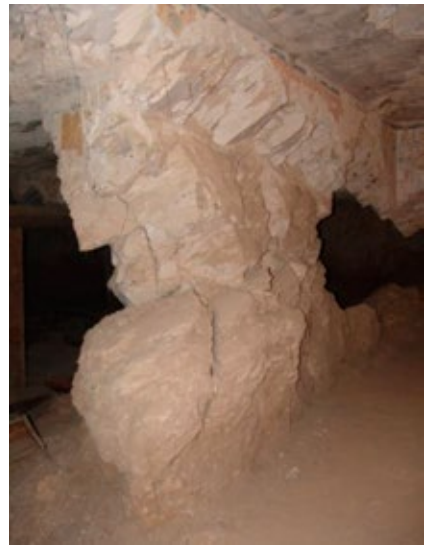
Basal erosion and fracturing of the two remaining piers within tomb. Basal rock is fragile and is incapable of supporting upper portion of rock.

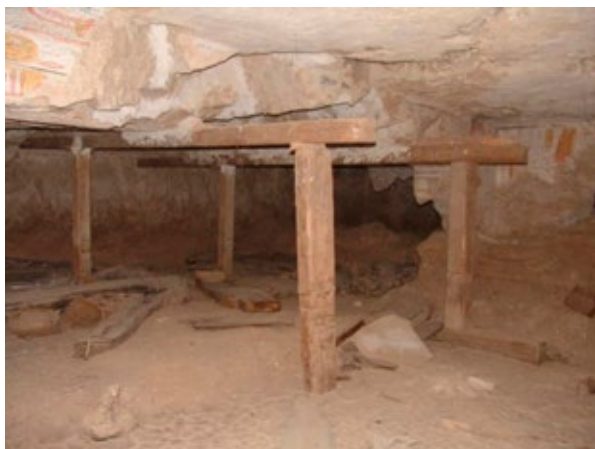
Existing wooden post and beam shoring in rear chamber (N_P).

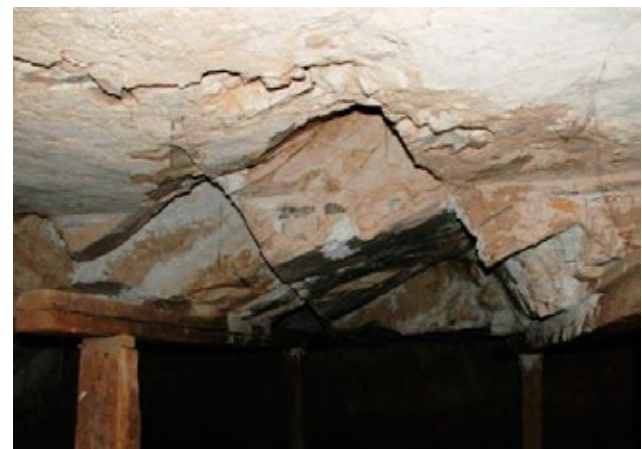
Large block at risk of collapse.

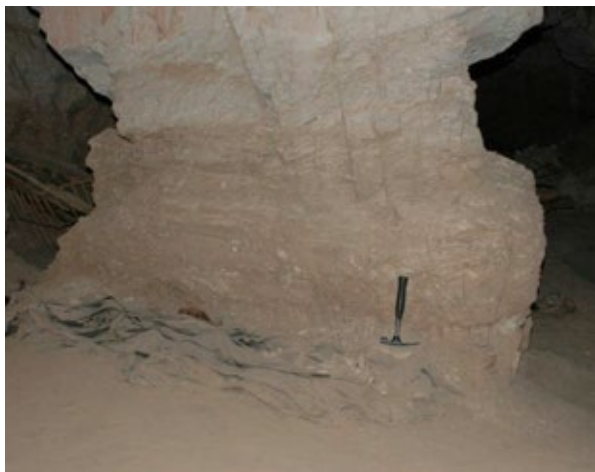
Lower part of wall shows weakening and deterioration by retained moisture in the clay-rich marl.

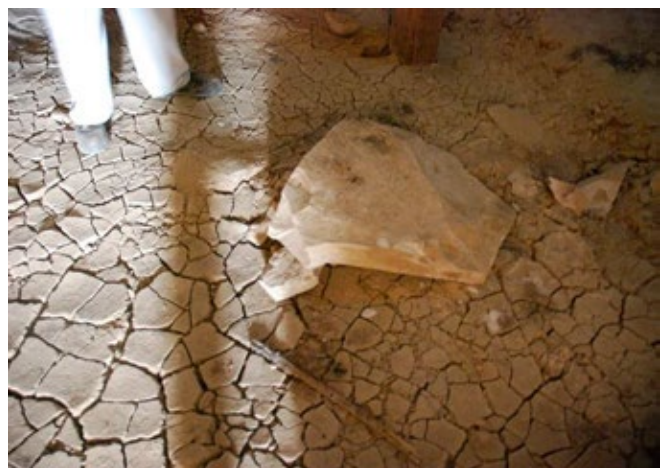
The 1994 flood had significant impact, the floodwaters scattering archaeological finds stored in the tomb and leaving a thick layer of mud on the floor, now dried and cracked. Cyclical wetting of the marl, exacerbated by the presence of sediment that retains moisture, has contributed to its weakening and deterioration.

Thick layer of mud brought in by the 1994 flood in chamber (I).

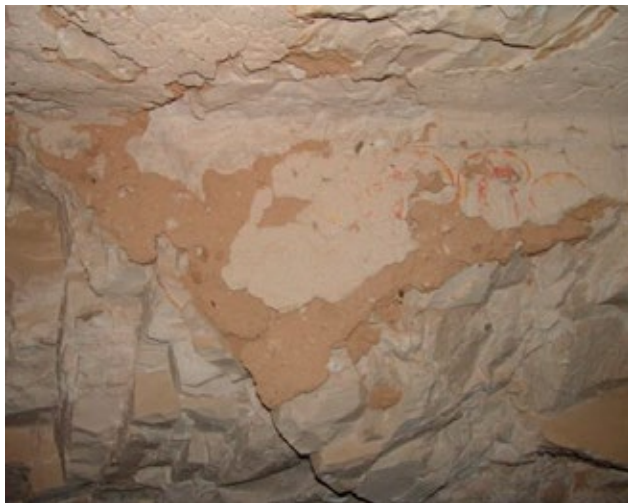
Multiple plaster layers are visible in chamber (L). Walls were filled with plaster and rock shards in preparation for painting.

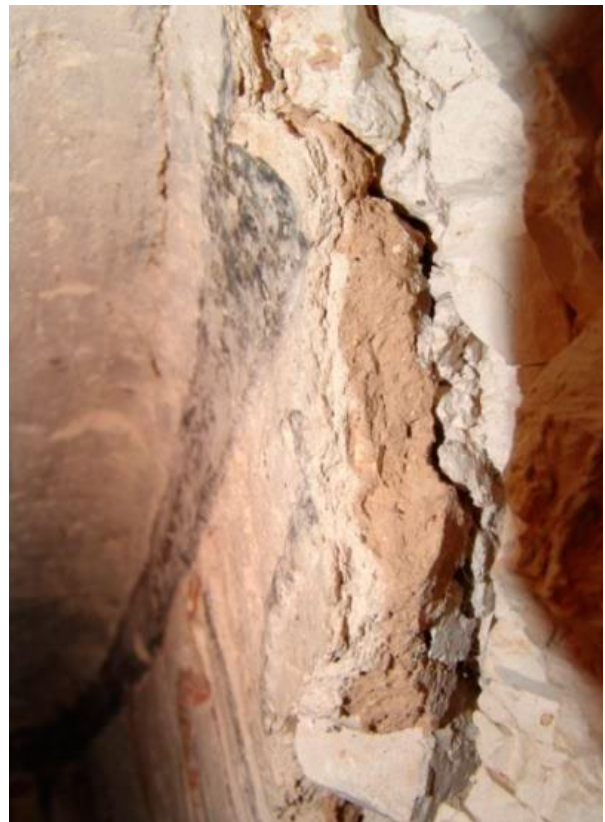
Detail of area of painting in chamber (G). Plaster was thickly applied and the walls packed out with rock shards to create a flat surface for the painting. The plastering technique differs throughout the tomb with multiple layers employed in some areas.

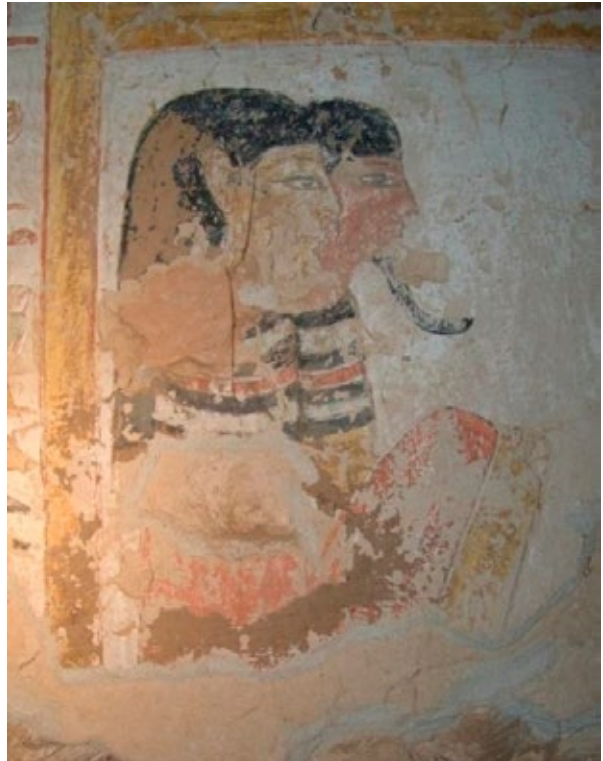
Traces of Coptic overplastering of the pharaonic painting in antechamber (C) is visible in image at right. Note also loss of the paint layer and white background possibly caused during attempts at removal of the mud plaster. Pink repair plaster and gray edging repairs are also visible.

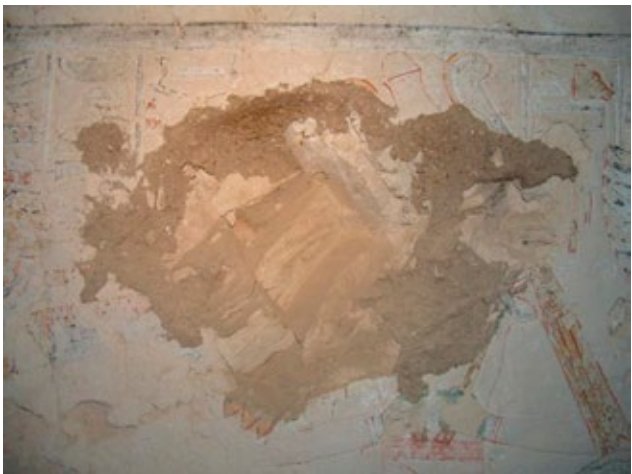
Mud plaster, thought to be Coptic period, was used to fill holes in chamber (G).

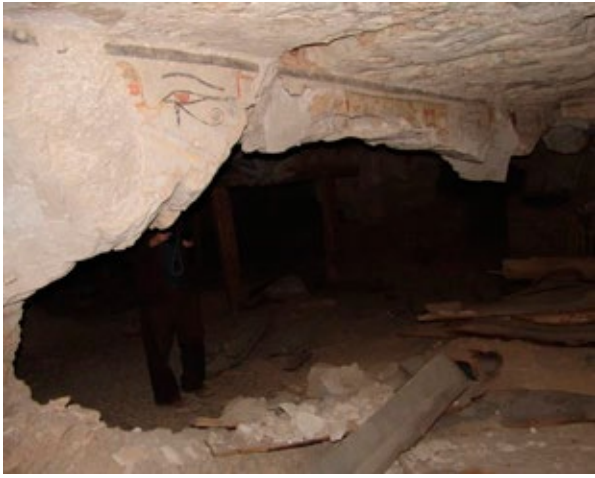
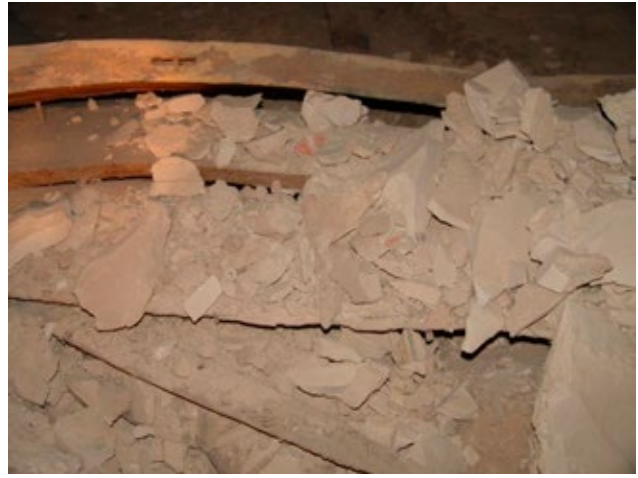
East wall (partially collapsed) of chamber (L) with detail of wall paintings debris from collapse (right).

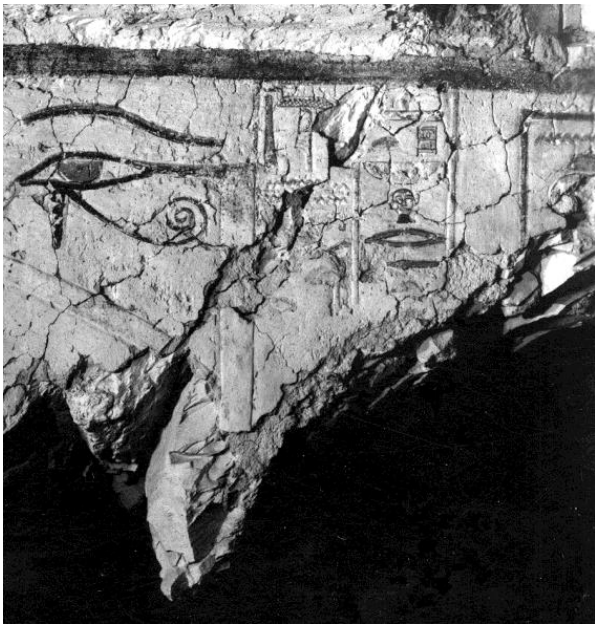
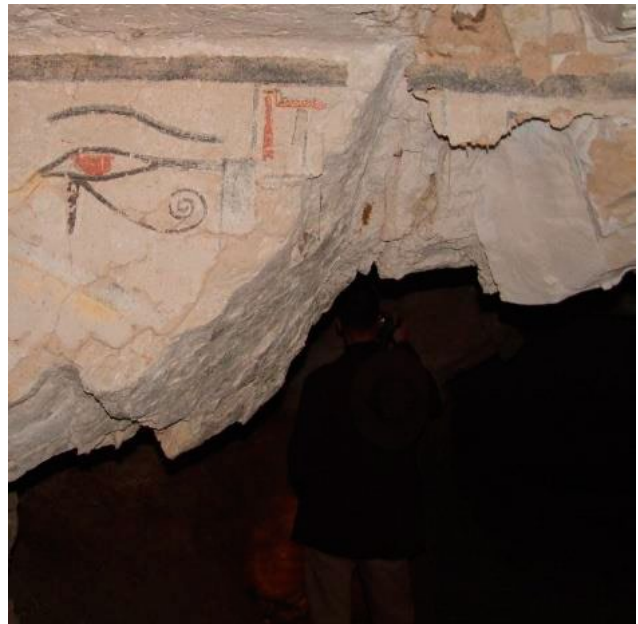
Area of rock collapse and loss of painting on east wall of chamber (L) since 1982 CEDAE photograph.

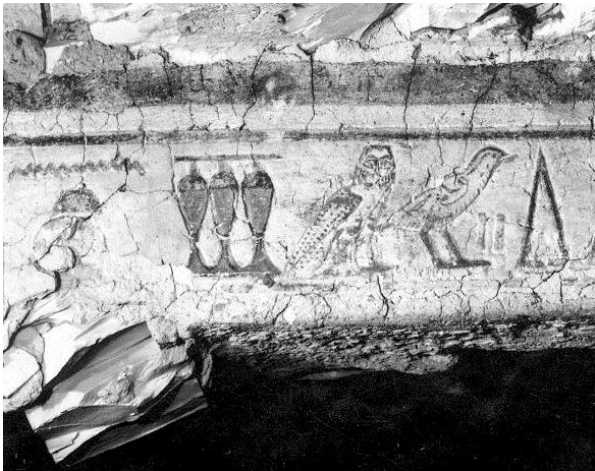
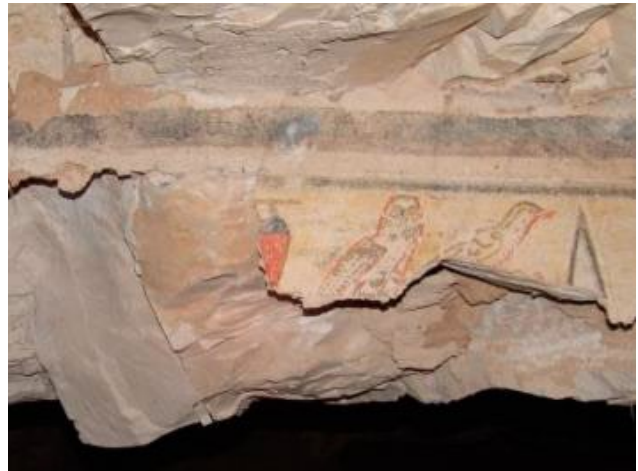
Area of loss of painting on east wall of chamber (L) since 1982 CEDAE photograph.

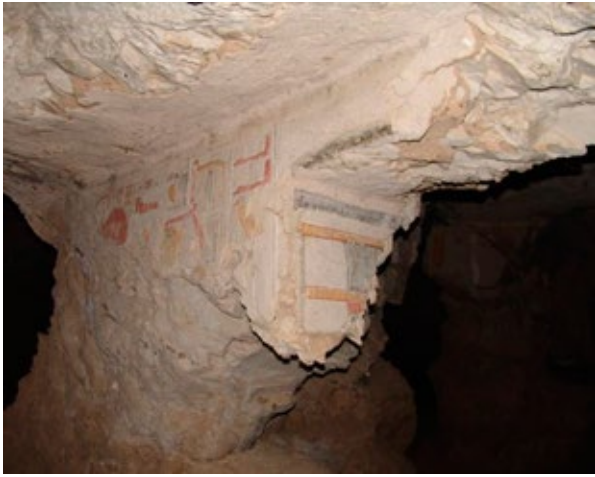
At risk area of painting around what is left of doorway (M) between chambers (N_P) and (I).
