Valley of the Queens Assessment Report

Volume 2

Assessment of 18th, 19th, and 20th Dynasty Tombs

A collaborative project of the Getty Conservation Institute
and the Supreme Council of Antiquities, Egypt

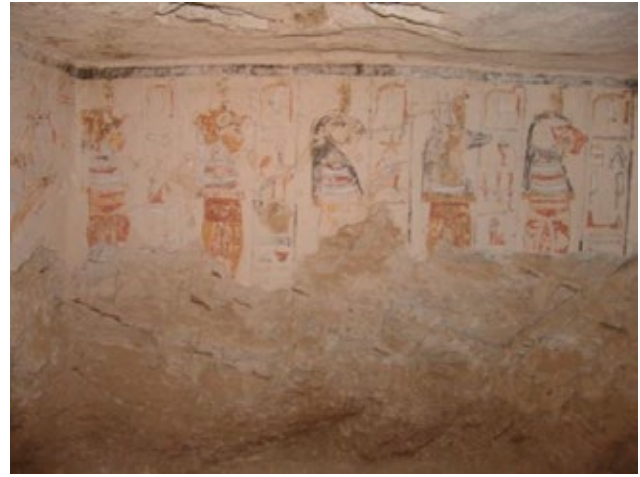
Chamber (G), Large crack through painted plaster runs across entire wall. Plaster is fragile with cracking and detached areas. Also rock at base of wall has been lost.

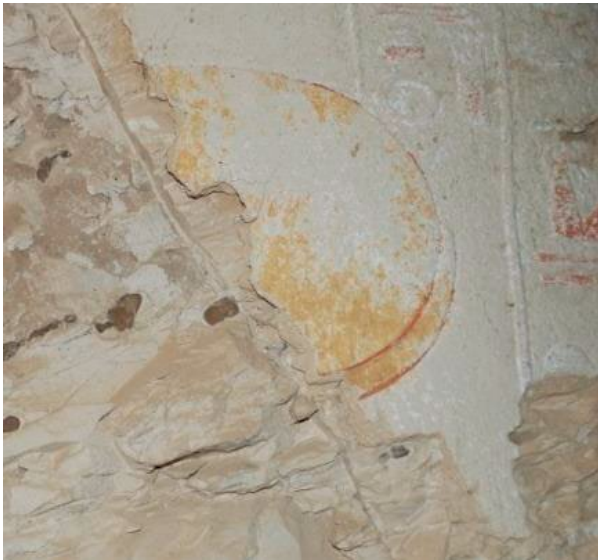
Detail of area of loss on the east wall of chamber (I) showing rock suffering from salt-related deterioration and pitting of the painted surface, also possibly caused by salts.

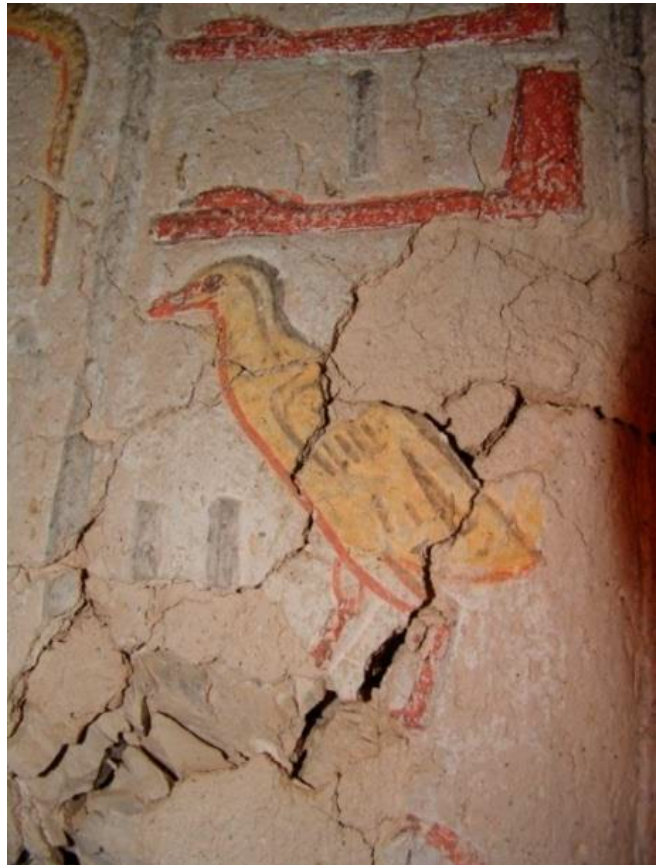
Fractured area of painted plaster on west wall of chamber (N_P) around doorway (M). Note also loss of white background and general pitting of surface, possibly salt related.

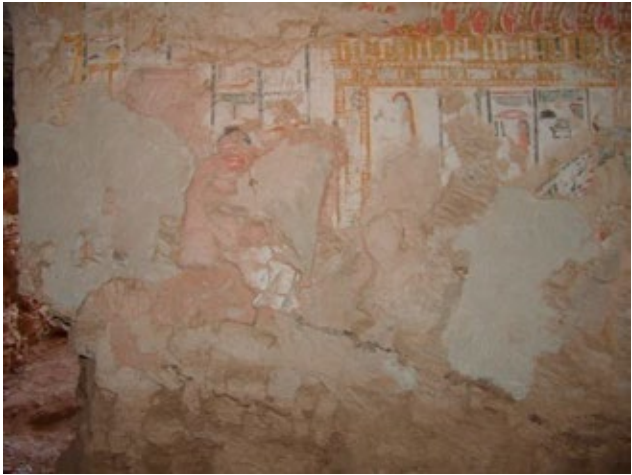
Plaster repairs on south wall of chamber (C).

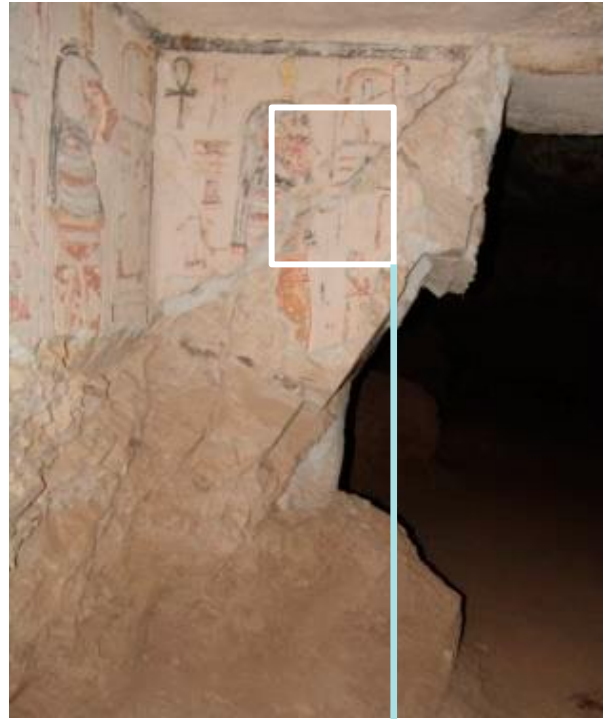
West wall of chamber (G).

Efforts to stabilize the paintings with edging repairs has sometimes caused a transfer of stresses to the original plaster leading to damage in the painting when there is movement along rock fissures. A new crack has formed in the above area of painting since the 1982 CEDAE photograph of the west wall of chamber (G).

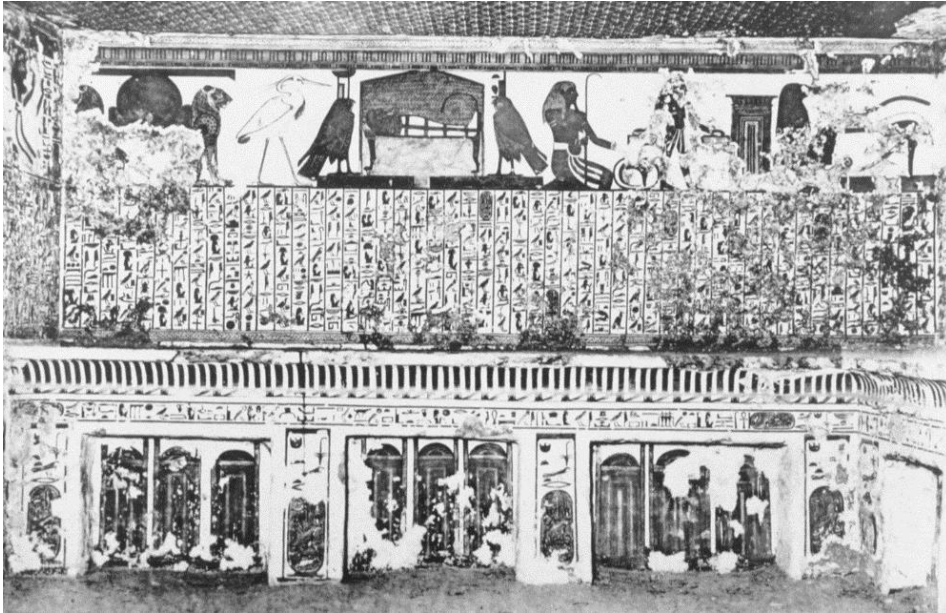
Some loss of painted plaster occurred after the tomb discovery in 1904 as can be seen in these photos. West wall, chamber (C). (Image: Schiaparelli 1923)

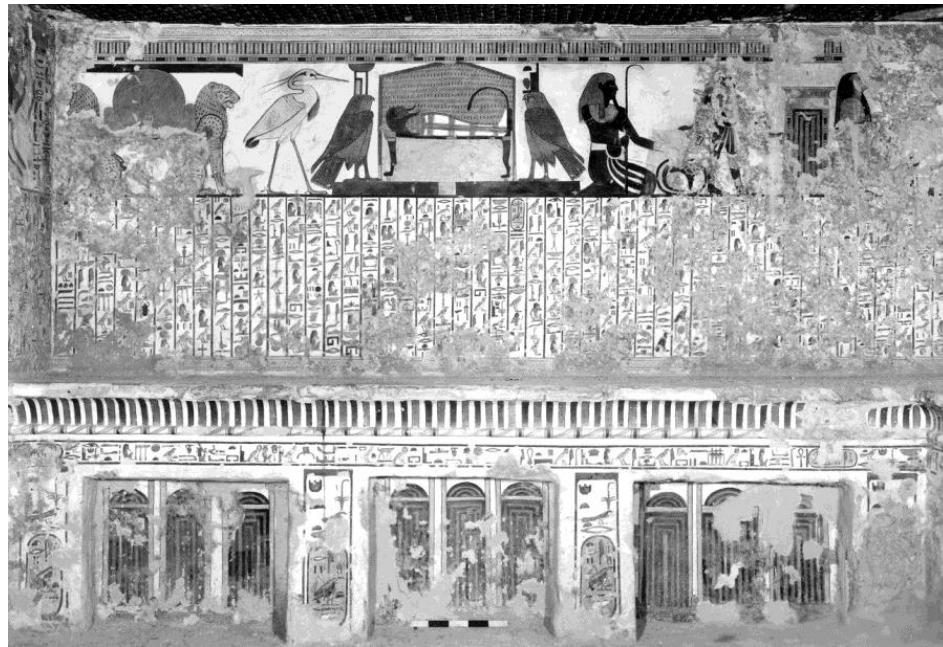
1958 photo shows some additional loss (Image: CEDAE)

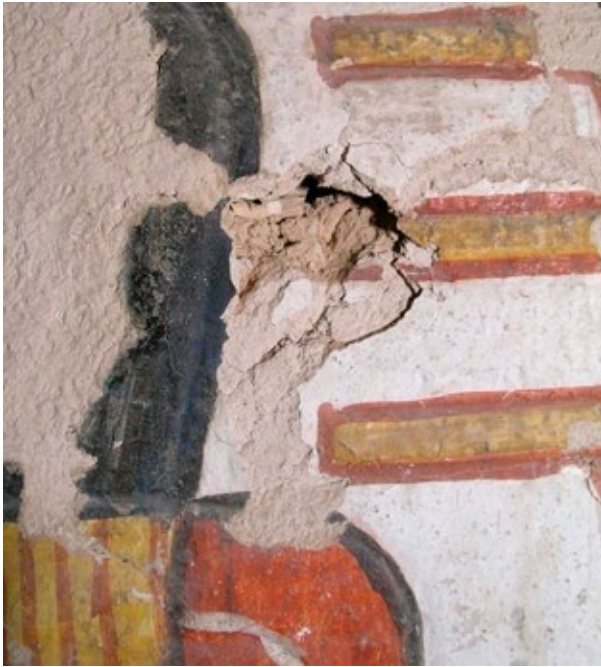
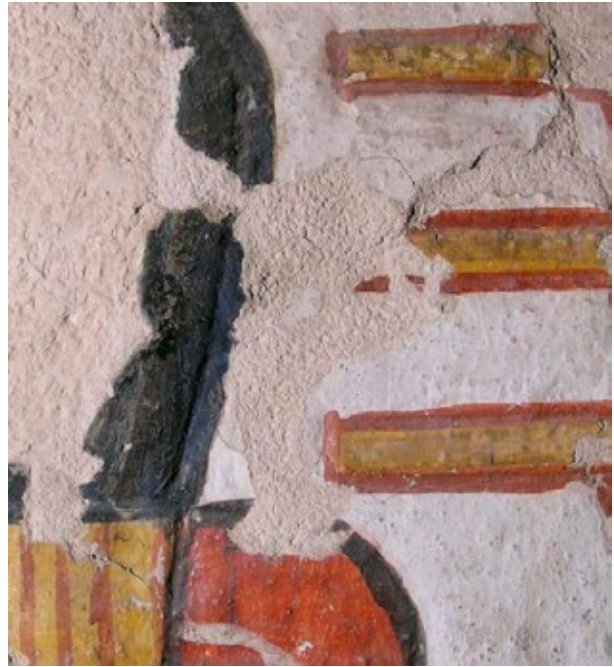
Area of damage on the east wall of chamber (K) before (above left) and after (above right) repair in 2005.

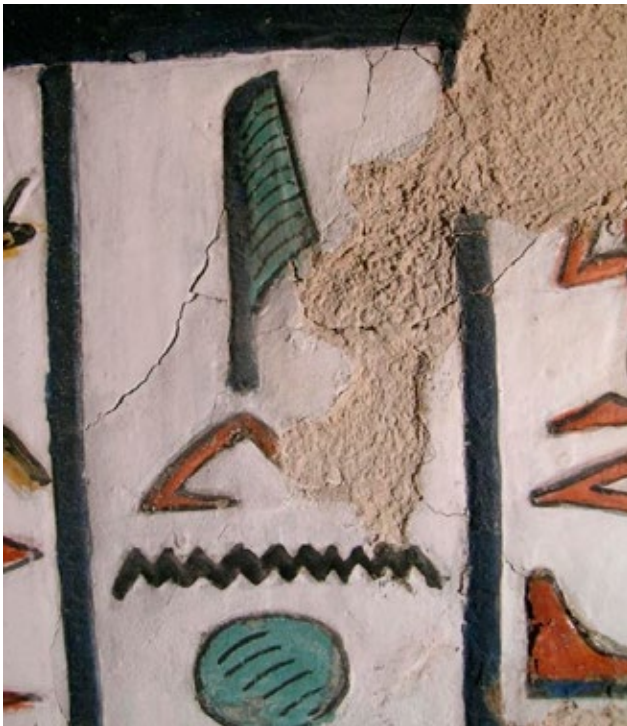
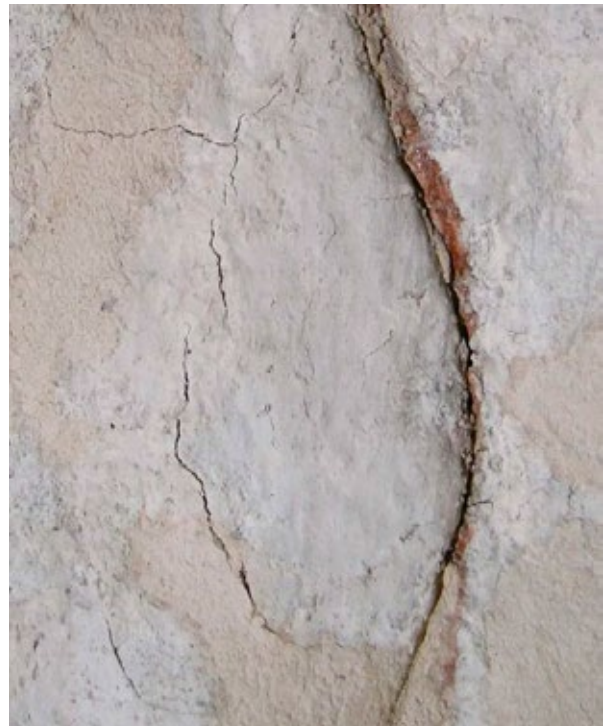
Minor cracks in both original and repair plasters are typically interpreted as evidence of ongoing deterioration. In most cases, cracks in the original plaster already existed, but photographs did not allow this to be properly assessed. These cracks do not represent a serious risk.

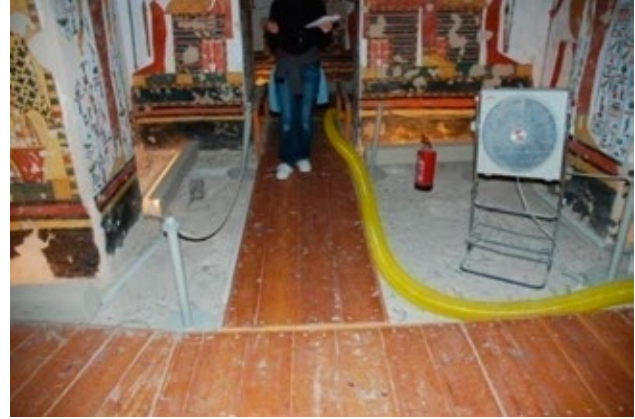
Wooden walkways, fans, fire extinguishers and ventilation ducts are installed in the tomb. Walkways are narrow and too close to walls allowing visitors to touch the walls.

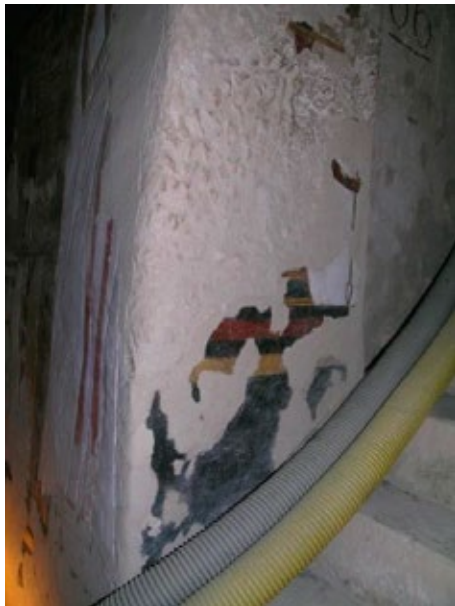
Doorway (B) has no barrier to protect painted surface. The ventilation ducts are in contact with the wall surface at bottom.

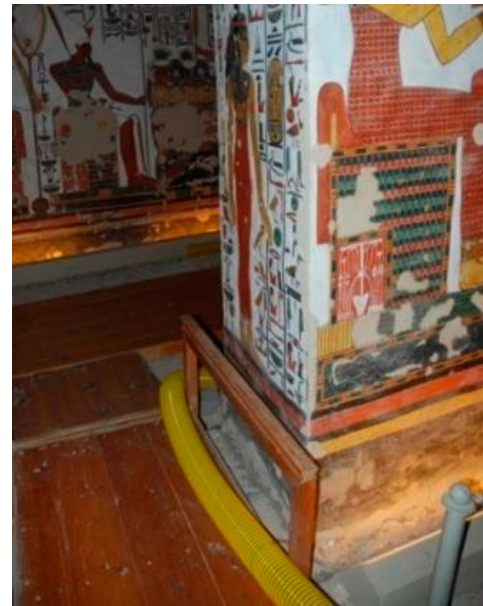
Narrow doorway (F) has no barrier to prevent visitors touching the walls.

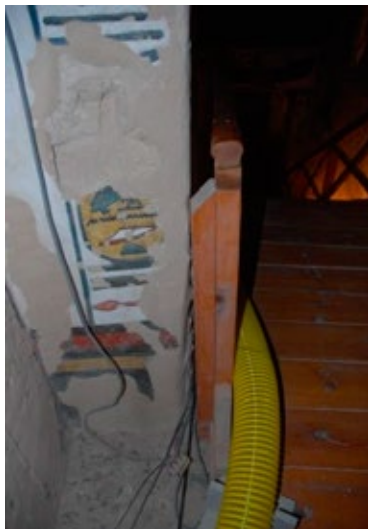
Handrail at doorway (H) is installed too close to the wall.

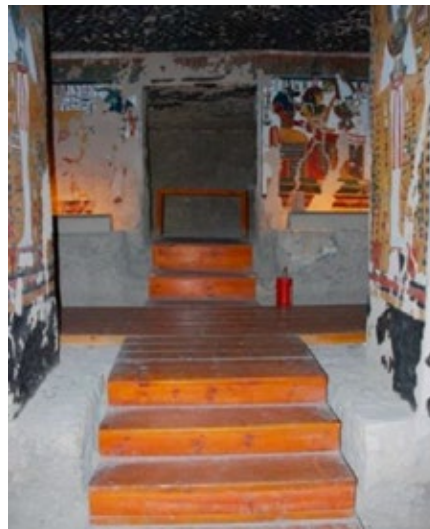
Handrail at doorway (F) is not securely mounted.

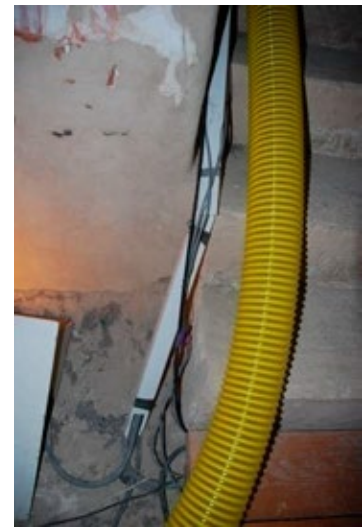
The most urgent and serious threat to the tomb is hazardous electrical wiring that could cause electrical fire, which would be catastrophic given the presence of wooden walkways. The risk of fire is increased by the buildup of lint on the tomb floor coming from the clothing of visitors. The presence of mice that chew on electrical wiring, may also promote the risk of electrical shorting and fire. Given that there is no backup lighting system installed, if visitors were in the tomb during an electrical fire and the interior lighting system were to fail, visitors would likely not be able to see the path to exit the tomb.

Electric cables are not properly covered to prevent a fire hazard.

Since human-induced damage is a serious threat to the safety of the paintings, all deficiencies in interior conditions (weak barriers, poor lighting, etc.) and poor visitor and film crew management practices must be reviewed and improved if the tomb is to remain open for such uses. This should include improved flooring, and a new lighting system with electrical wiring meeting safety standards. Protective barriers at narrow areas are required. Handrails need to be securely mounted. Walkways need to be expanded where possible. In 2009, the GCI covered electrical wiring from the junction box, but this is intended only as a temporary measure and does not obviate the need for rewiring of the whole tomb.

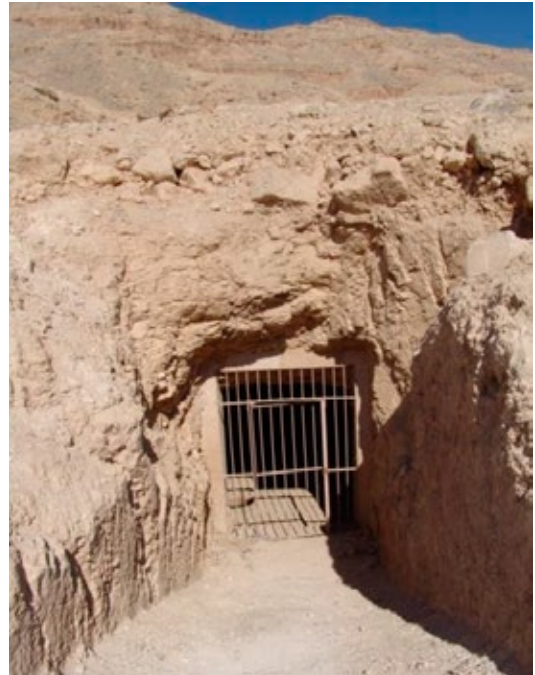
Ramp (A) leading down to entrance doorway (B) with metal grill door.

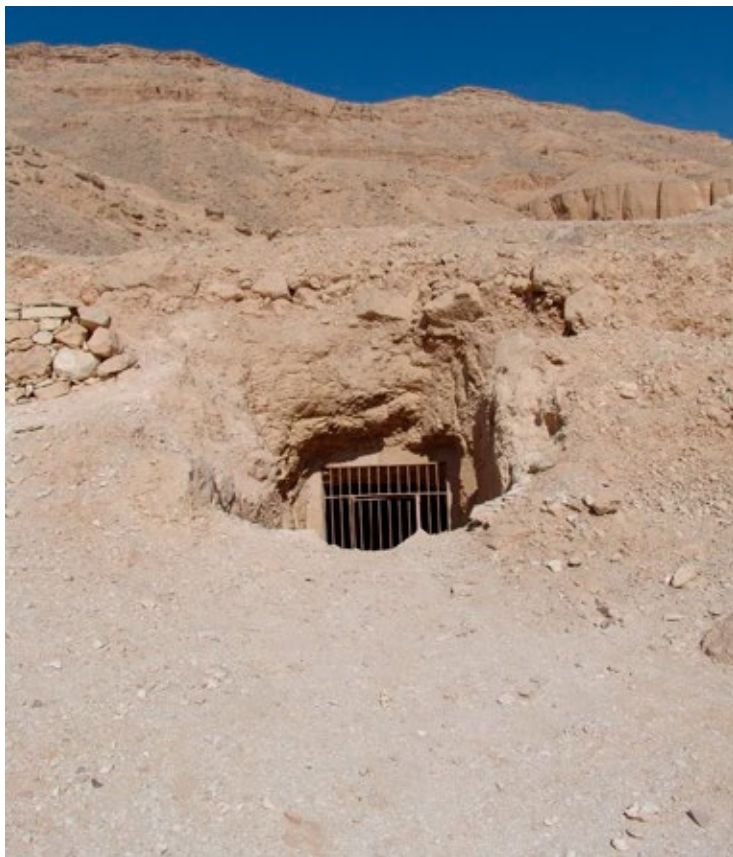
Overburden of marl and fanglomerate on QV 68 entrance and uphill slope from the wadi in front of ramp entry.

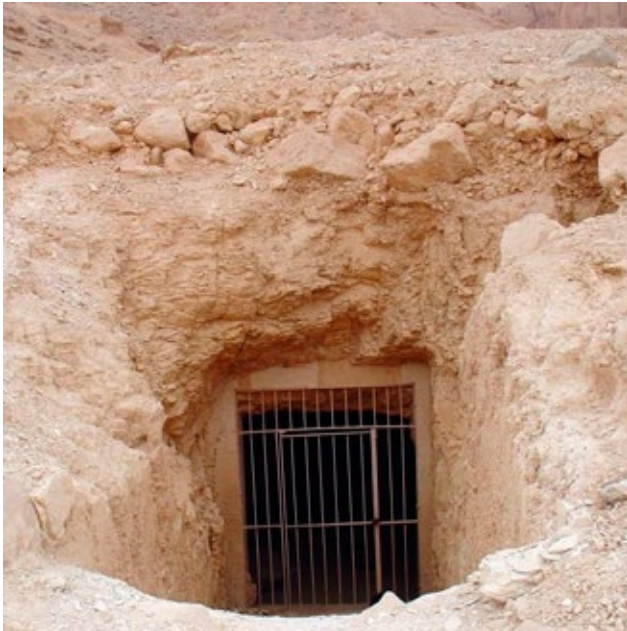
Entrance ramp (A) has heavily weathered marl and a large area of rock loss in the east wall (see also image right). A short overhang of marl rock above entrance doorway (B) exhibits some cracking and disaggregation. Stability of large boulders above entrance and ramp walls is required.

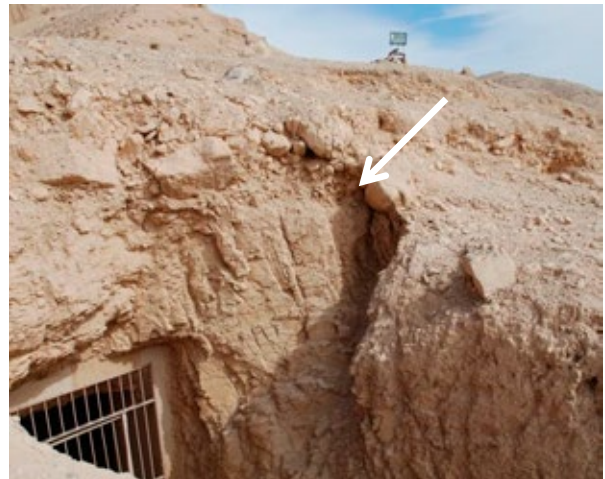
Entrance ramp (A), cut into heavily weathered marl, presents a large area of loss in the east wall, where boulders in the overlaying debris fan have been undercut by water erosion, and risk falling. A short overhang of marl rock above entrance doorway (B) exhibits some cracking and disaggregation. Ramp (A) was originally stepped on the sides with a narrow slope in the middle, but most of the lateral steps have been eroded, leaving only a few that have partial surviving plaster edges along the ramp sides still visible.

Detail of east wall of ramp (A): a large area of rock loss where boulders in the overlaying debris have been undercut by water erosion is now at risk of falling.

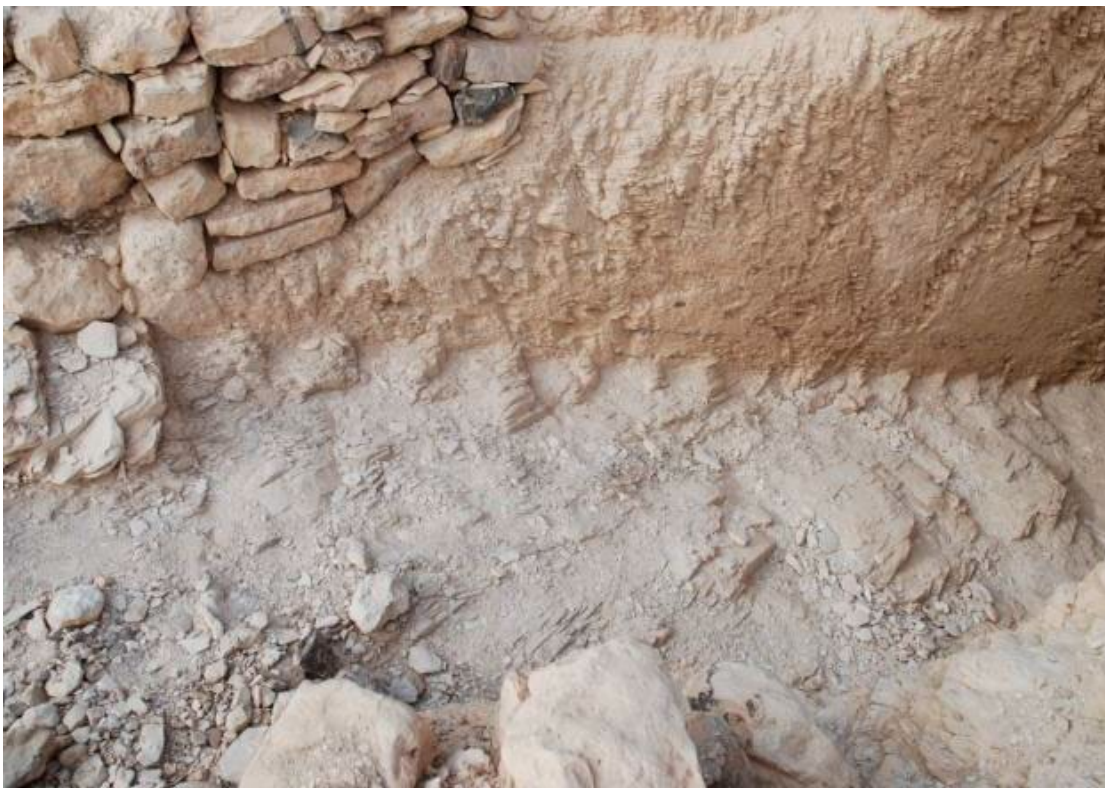
Edges of original rock-cut steps and plaster remain along the walls of entrance ramp (A).

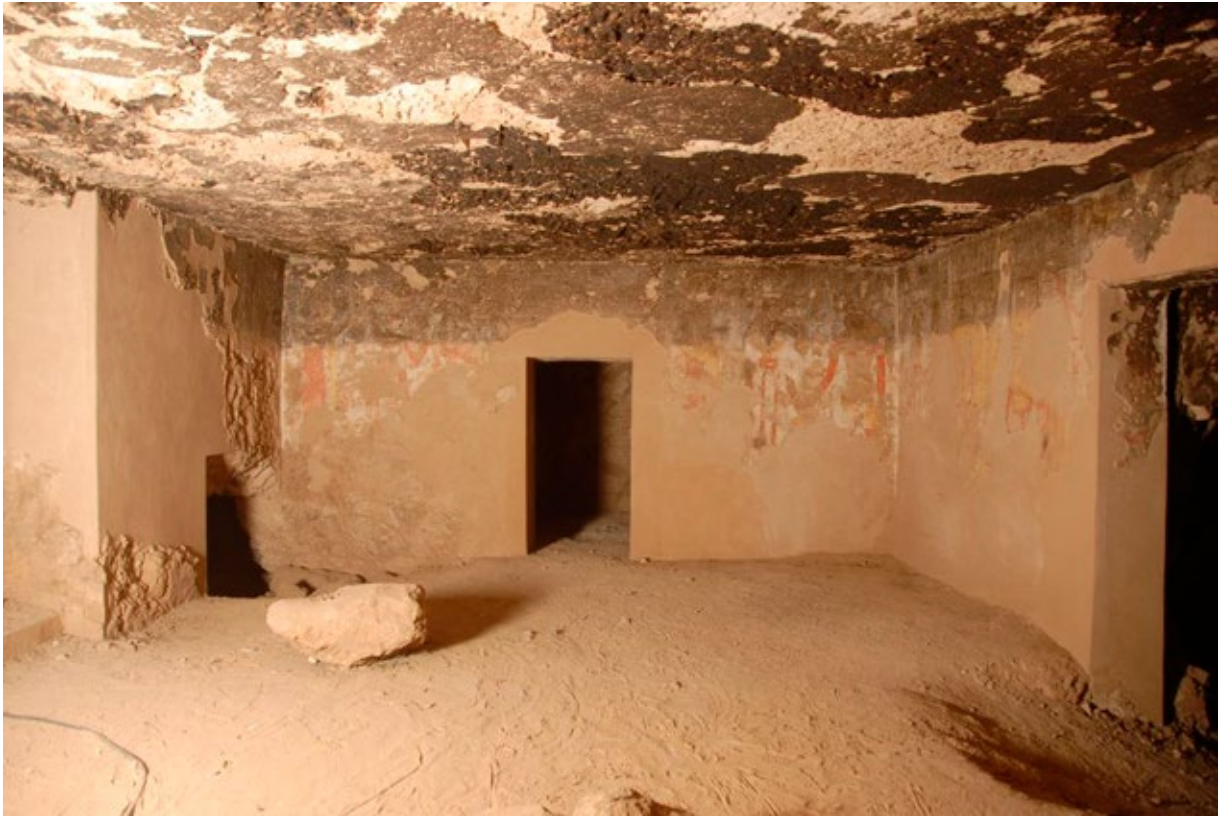
Chamber (C) looking east toward side chamber (G). Only the base of the easternmost pillar and fragments of painted plaster survive. Note blackening on ceiling and upper third of walls. The lower parts of walls were presumably protected from fire by debris. (CEDAE 2009)

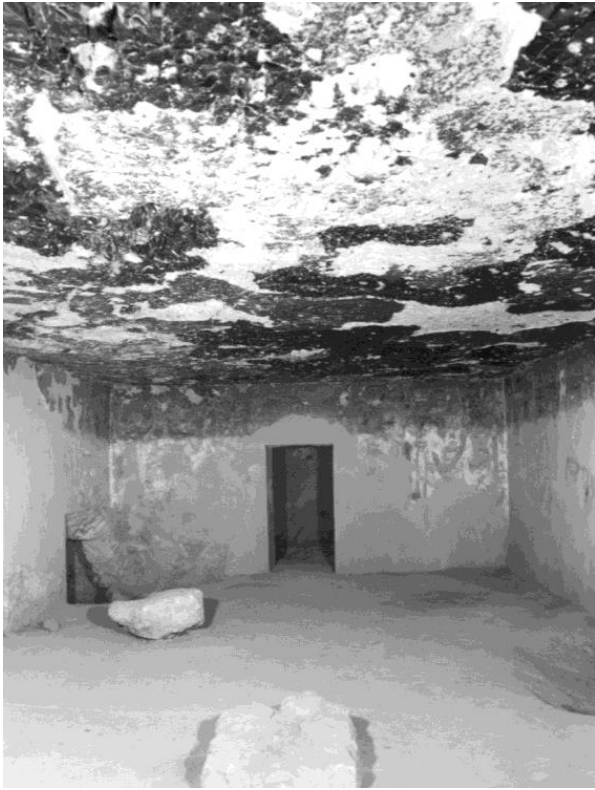
Chamber (C) in 1987 CEDAE photograph already has large plaster repairs and doorways reconstructed. Note also significant post-fire loss of plaster in ceiling. Heat-related damage from fire may have severely weakened the plaster in this area. The ceiling rock, however, is generally in good condition.

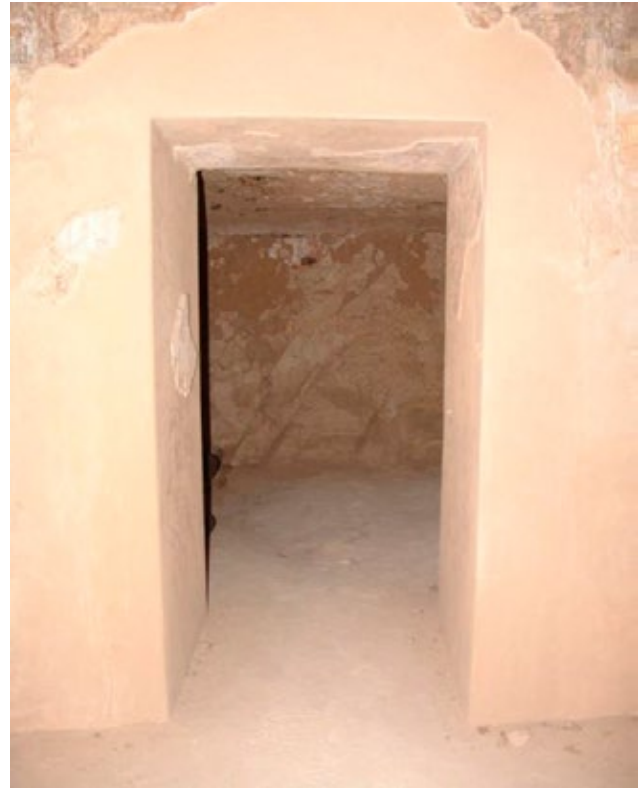
Doorway to side chamber (E) was reconstructed with a substantial amount of repair plaster. The extent of loss in this area suggests that the rock suffered extensive damage possibly caused by flooding.

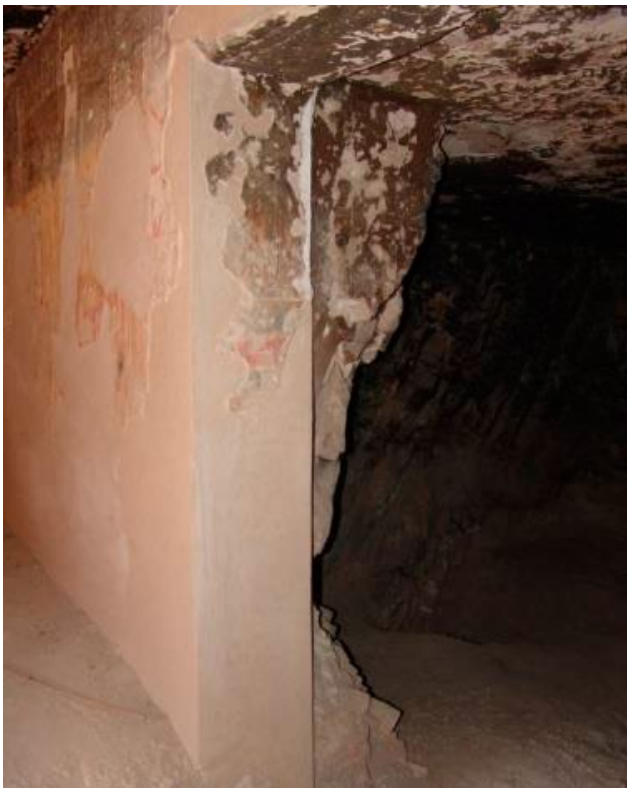
Lower part of the north wall of burial chamber (I) has area of rock loss around doorway (J) leading to niche (K) but otherwise appears stable. This area has not been previously treated.

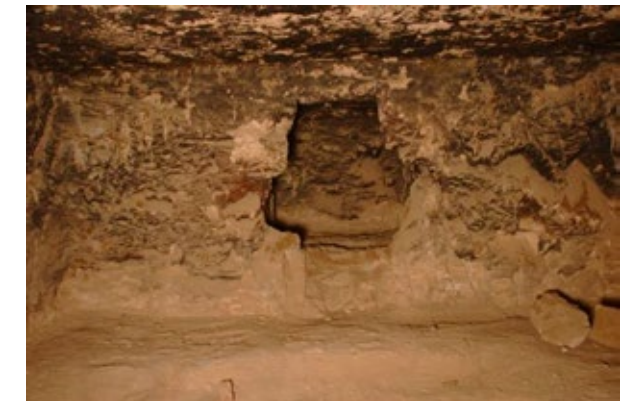
Area of rock loss at lower part of doorway (H) and partial reconstruction.

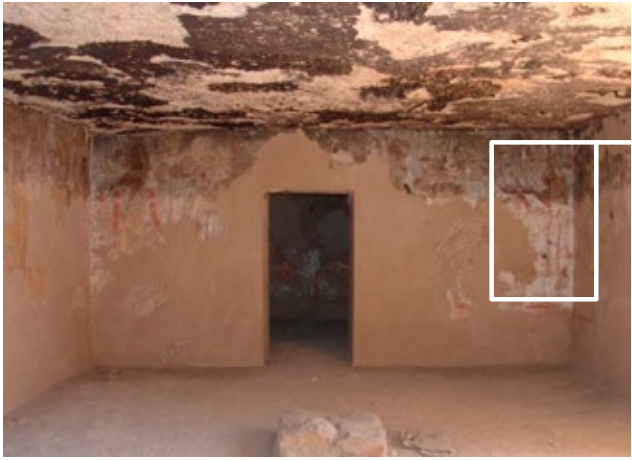
Paintings in chamber (C) are heavily abraded with much loss. The lower two thirds of the walls were protected from fire.

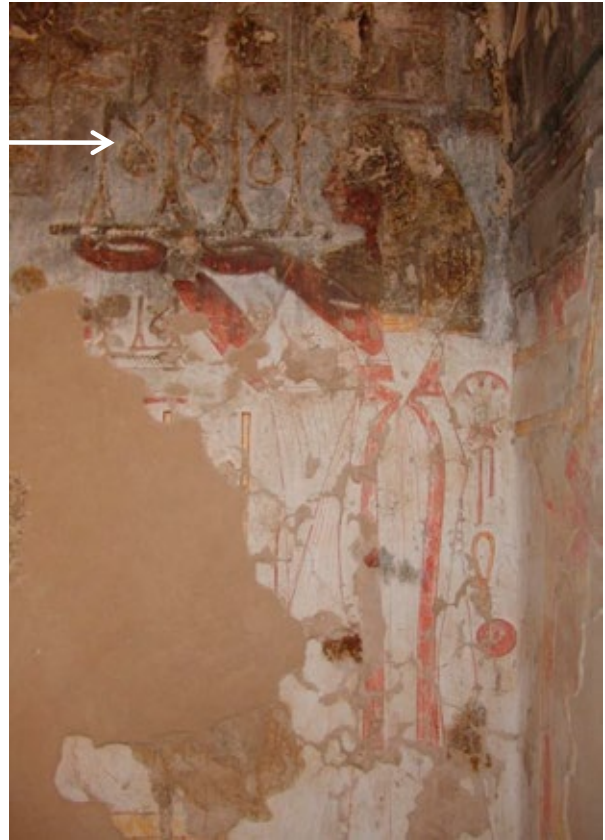
Image above left: Small losses and intentional scratching of painted surface contributes to an overall fragmentary appearance of the painted plaster in antechamber (C).

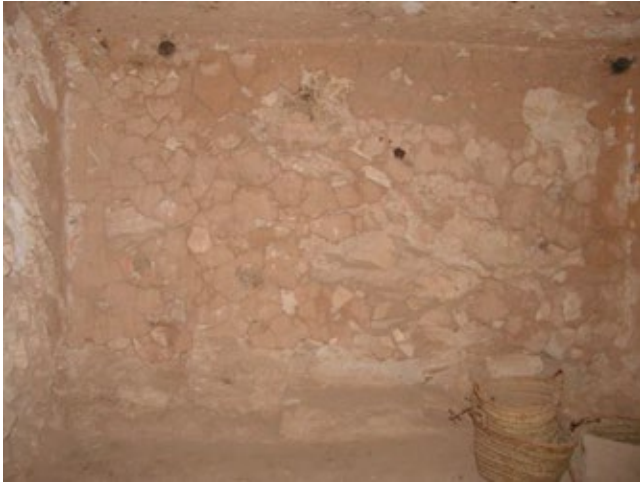
South wall, side chamber (E). Almost all of the upper painted plaster is missing. Note the network of cracking in the plaster. There is no straw in this plaster and it is possible that this could be the reason for the drying cracks.

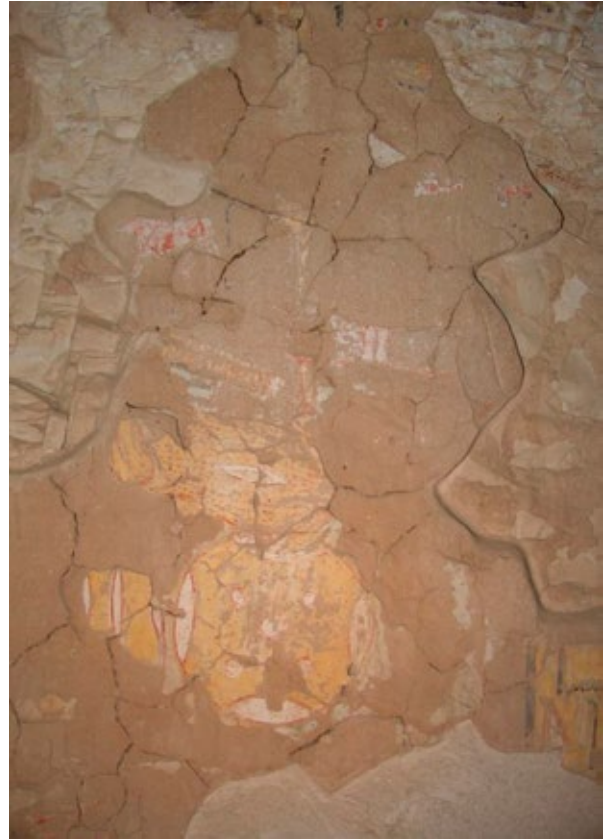
The treatment in side chamber (E) consists of edging repairs used to stabilize surviving areas of plaster. The repairs are quite minimal allowing areas of the rock to be left exposed and leaving the cracks of the plaster untreated.

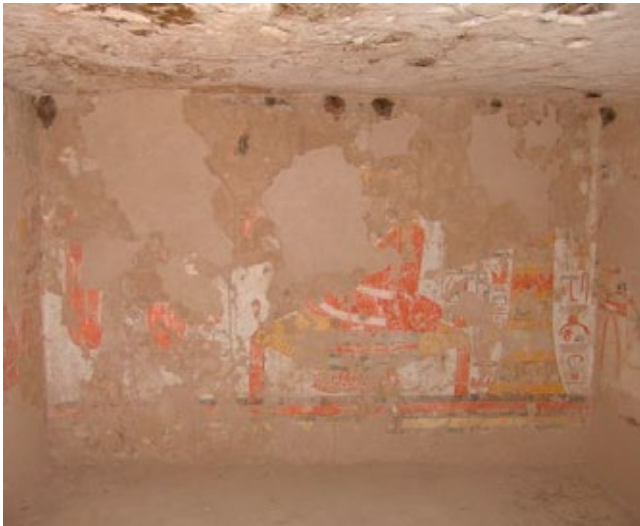
East wall, side chamber (G). The upper painted plaster still survives in this room with better survival than side chamber (E). The large losses in this chamber indicate areas where substantial infill material was needed to pack out the walls to provide a flat surface for the decoration. These areas were often prone to collapse.

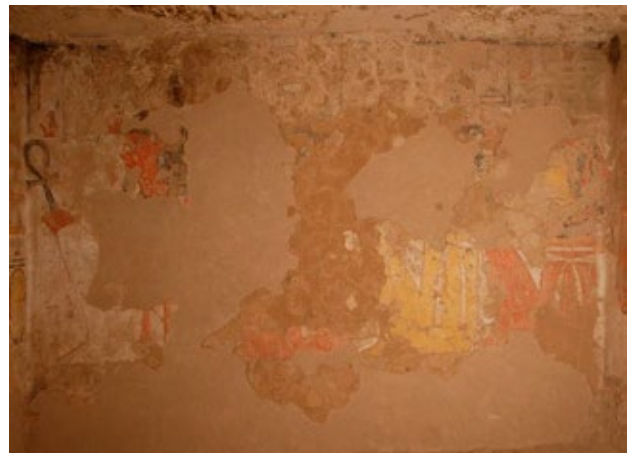
North wall, Chamber (G). This chamber is heavily treated with plaster repairs that fill both large voids and the individual cracks of the plaster. The repair plaster in many cases covers over original plaster.

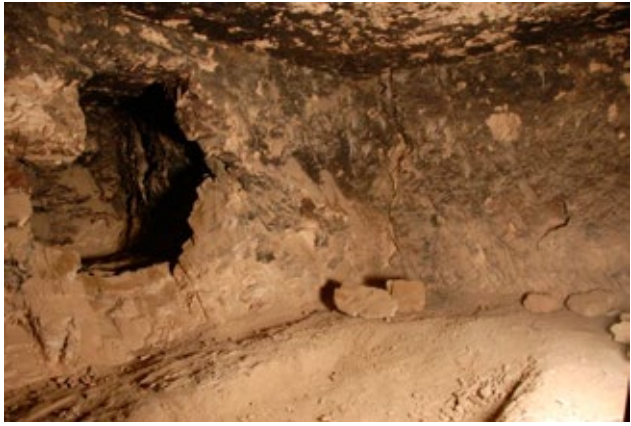
View of northeast corner of burial chamber (I). Only fragments of painted plaster survive in this chamber which has heavy fire blackening from fire.

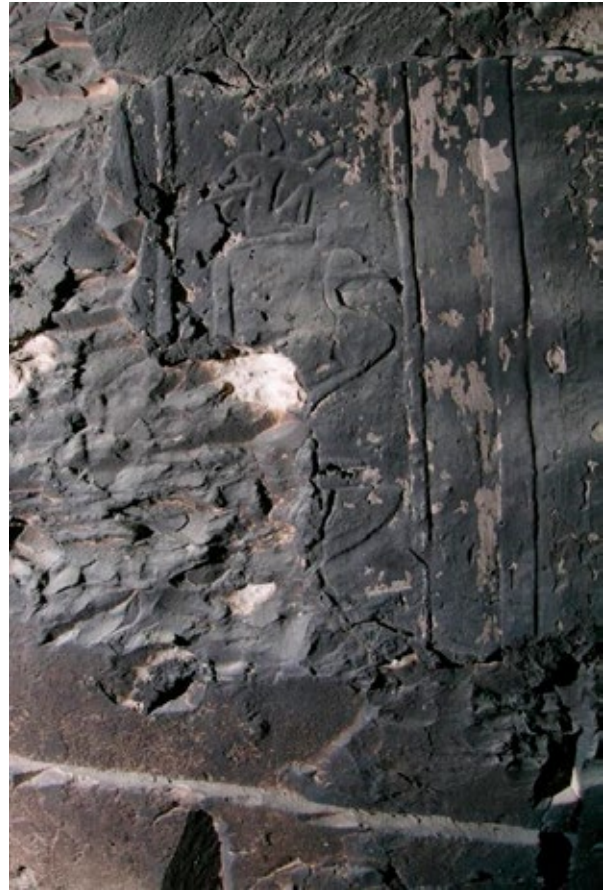
Detail of area of surviving decoration in chamber (I) severely soot blackened.

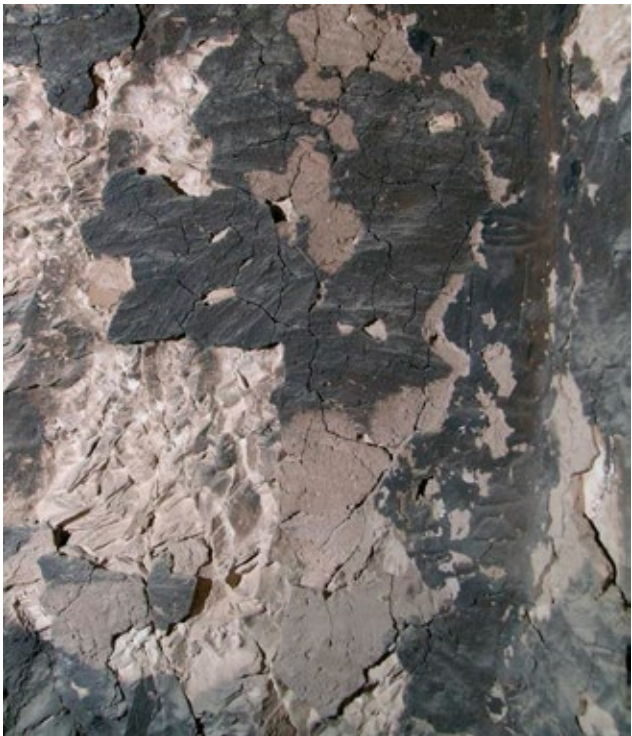
Surviving plaster in chamber (I) is fragile. Post-fire losses have occurred.

Areas of fragile, heat-damaged plaster in burial chamber (I) require stabilization to prevent further loss. The heat-altered condition of the plaster may require stabilization treatments to be specifically formulated, trialed, and applied.

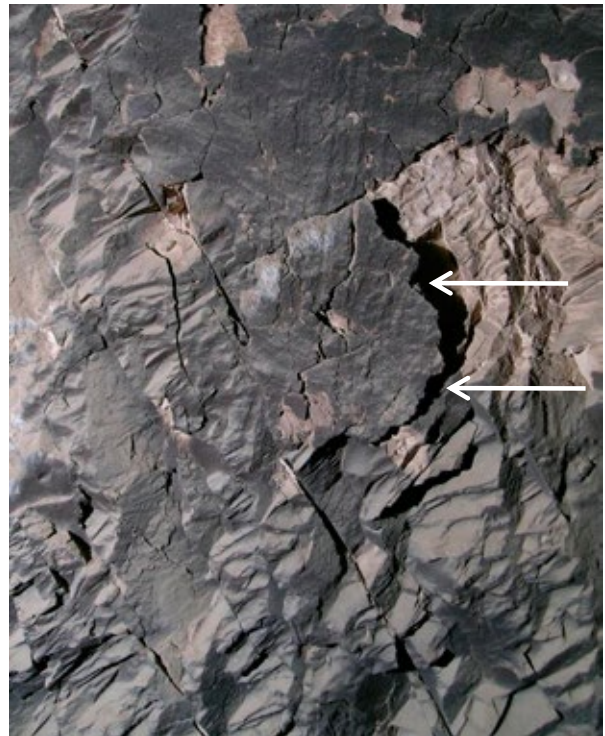
Area of plaster detachment in chamber (I). The burial chamber and rear niche do not appear to have been previously treated.

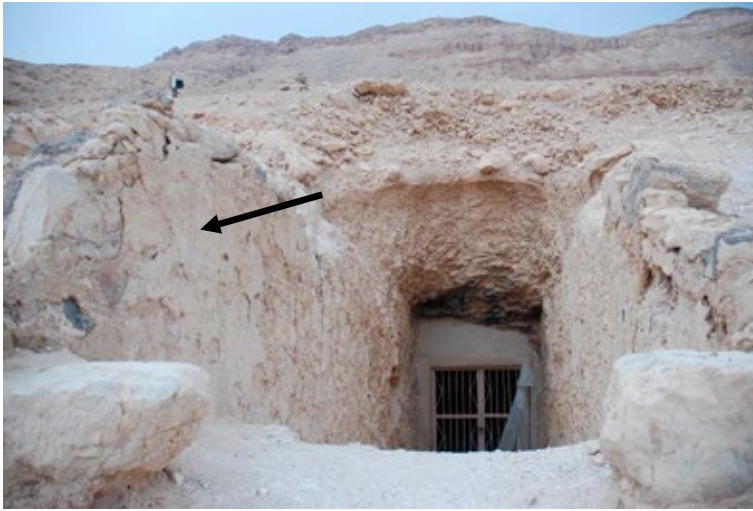
Rock overhang extends approximately 1m in front of entrance with some precarious large boulders in the debris fan located near the edge. Extensive surviving plaster on walls of left side of ramp (arrow).

Stabilization of the overhanging rock and boulders present in the debris fan above and behind the retaining walls and arched cover is also recommended.

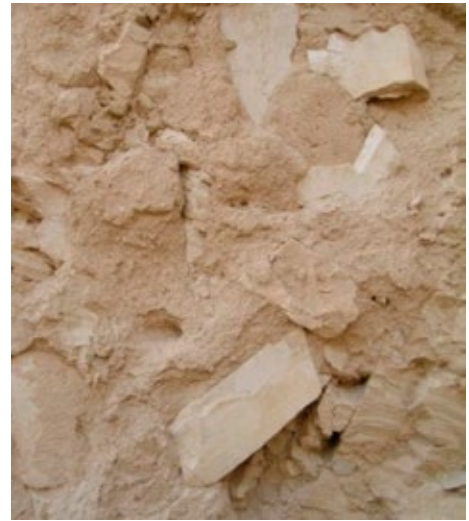
Exposed infill plaster with rock shards on walls of entrance ramp (A).

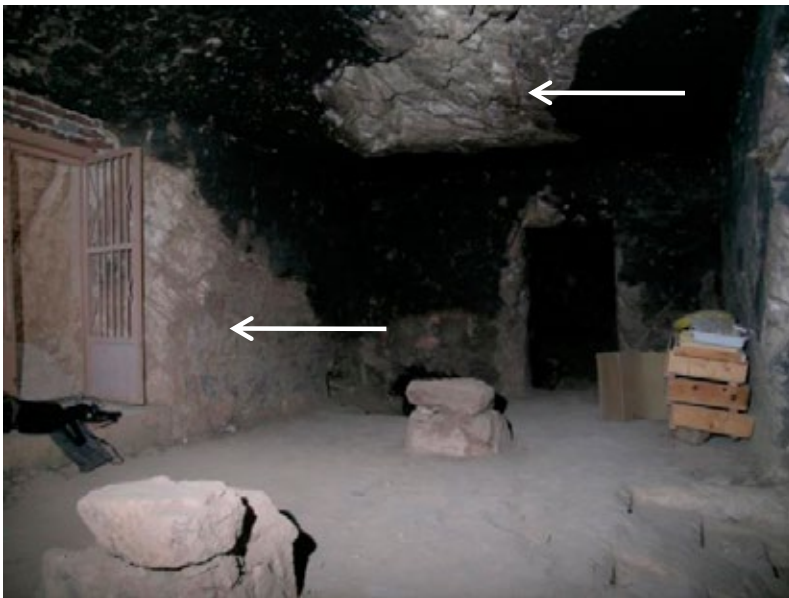
Pillared chamber (C) looking west. Only pillar bases remain. Large post-fire losses have occurred in ceiling and to the left of the entrance doorway (arrows). Note also the crates containing fragments of plaster from QV 66.

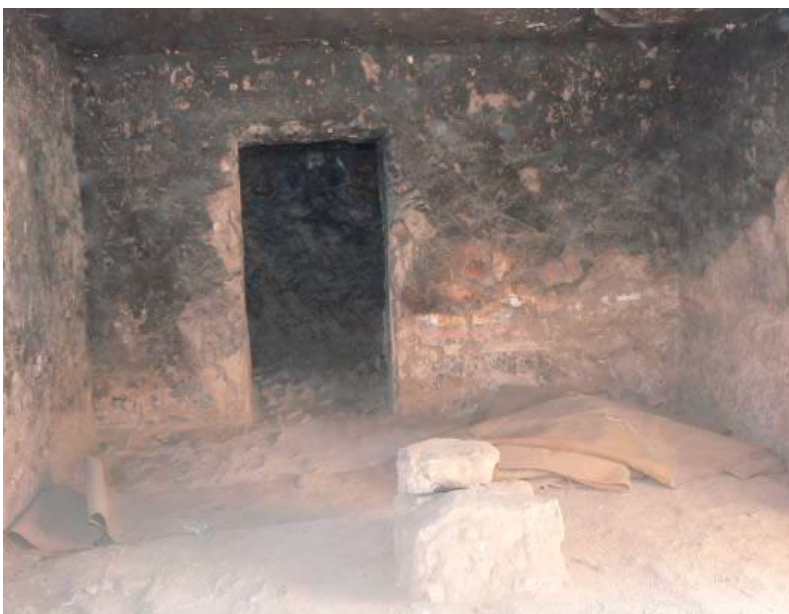
Painted plaster with relief is extensively fire-blackened. Note discarded carpets from QV 66 on floor of chamber (C).

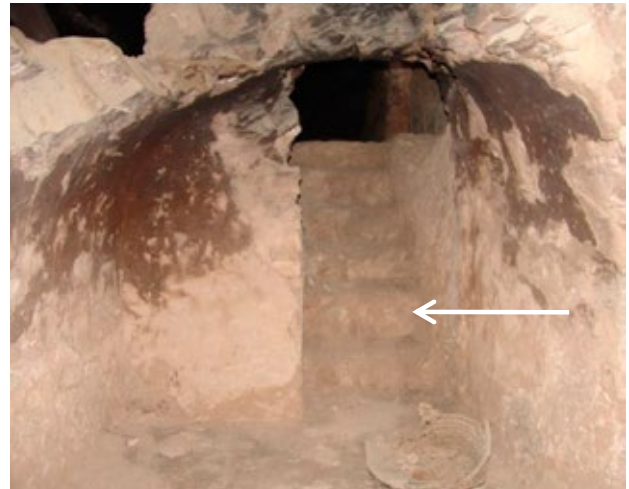
Lower chamber (N) of side chamber (E). The ceiling of the chamber, once vaulted, is now partially collapsed.

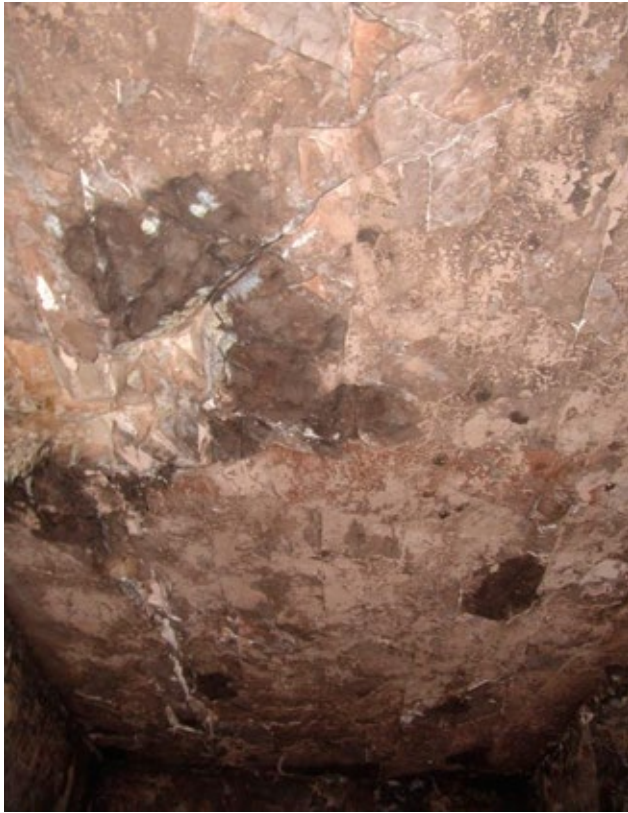
The ceiling of burial chamber (J) shows loss of rock along a fracture.

The fracture in the ceiling of the burial chamber (J) should be monitored for future movement. The open fracture in doorway (K) west jamb should also be monitored as painted plaster is located on the detached corner.

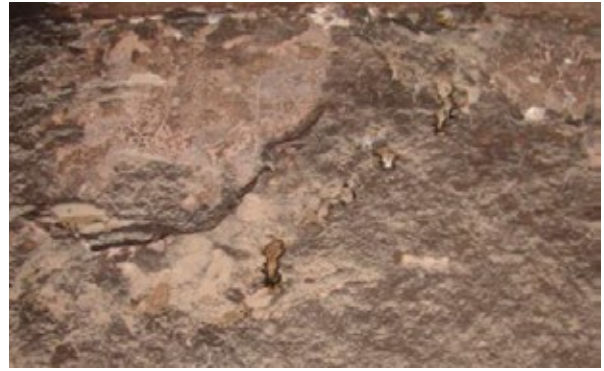
Large salt veins visible in burial chamber (J).

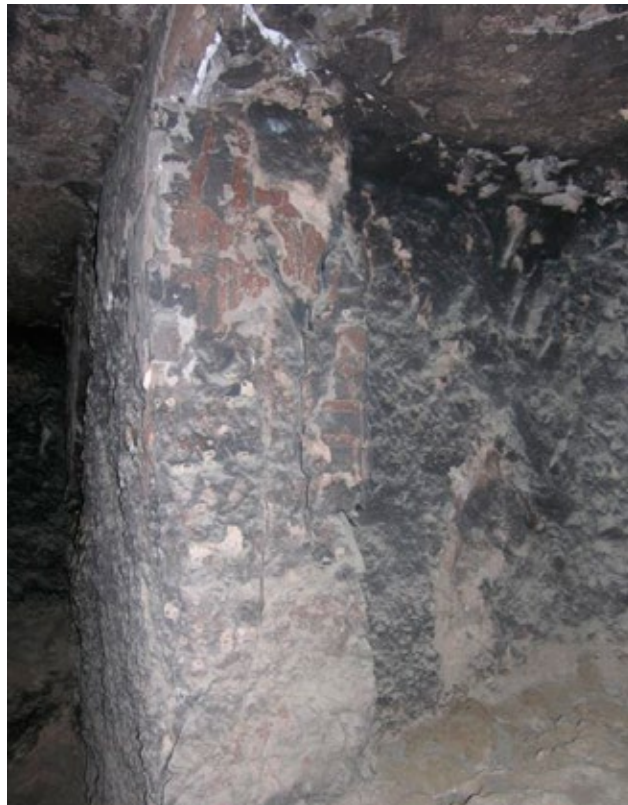
West jamb of doorway (K) to rear niche (L) has a large fracture but this is pre-fire and no adjacent loss has occurred.

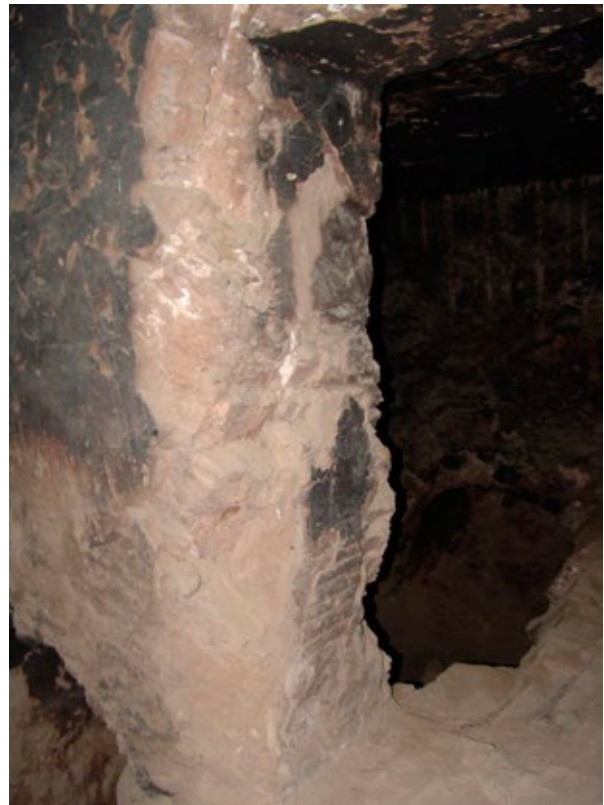
Large post-fire losses have occurred around doorway (D) of both rock and packing material

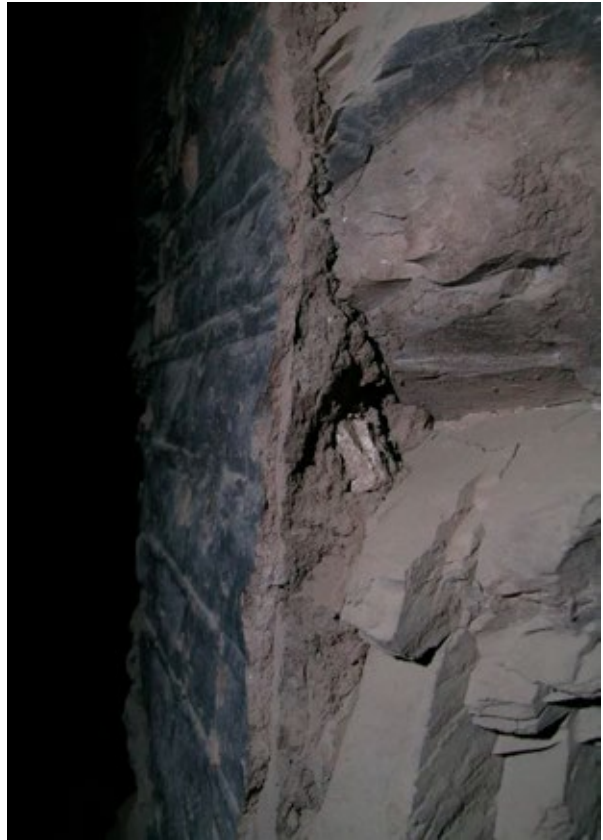
Note irregular surface of rock wall and the rock shards and large amount of infill plaster used to create a flat surface for the decoration.
