Valley of the Queens Assessment Report

Volume 2

Assessment of 18th, 19th, and 20th Dynasty Tombs

A collaborative project of the Getty Conservation Institute
and the Supreme Council of Antiquities, Egypt

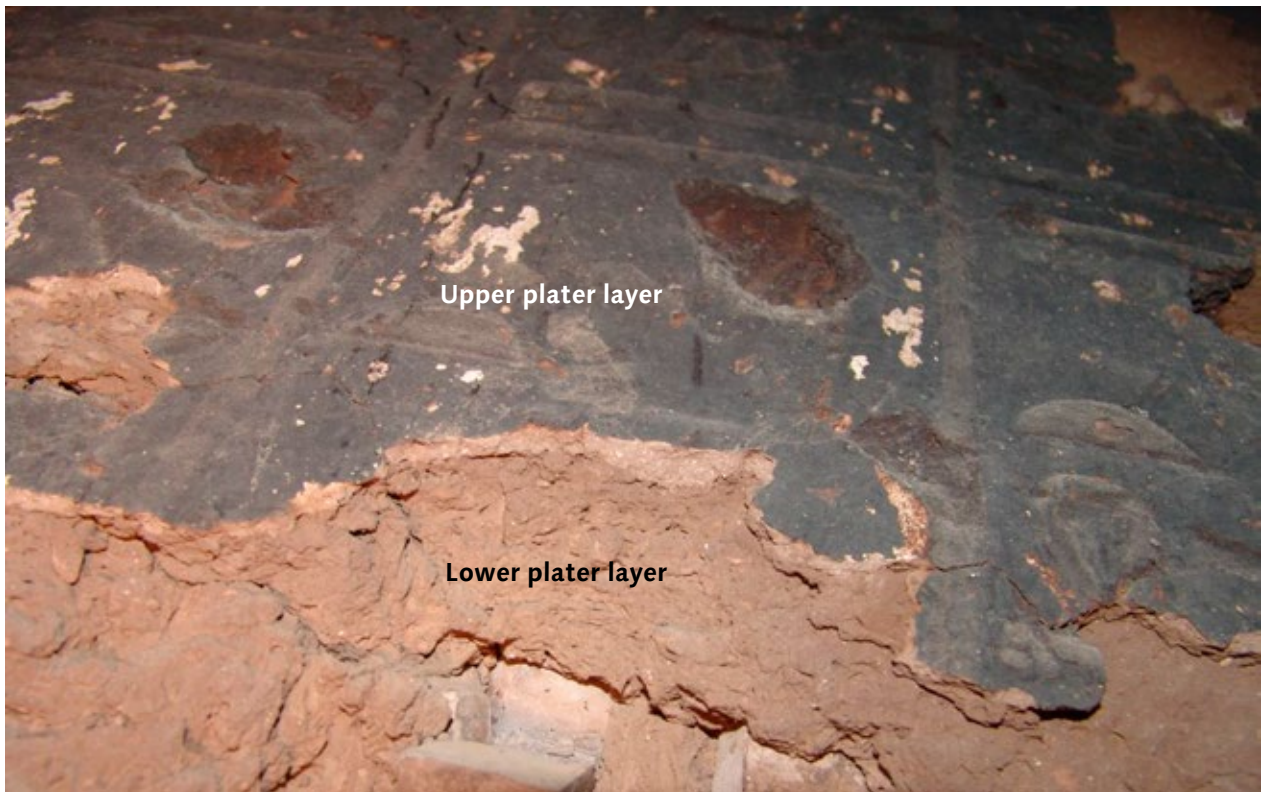
in the lower plaster used in the burial chamber (J) and the thickness of application of this layer might indicate a technique-related failure that has contributed to the extent of loss there.

Lower earth-based plaster layer is extremely thick followed by a thinner upper painted plaster.

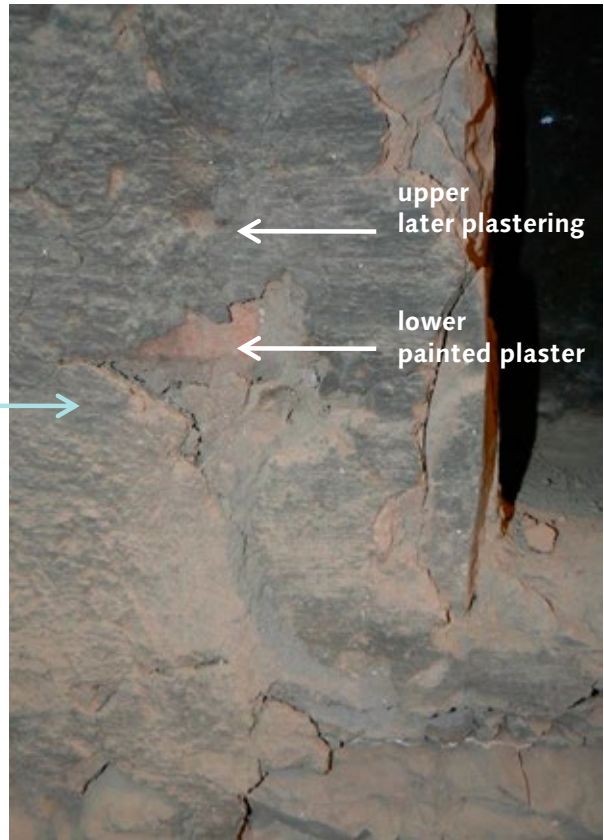
Magical brick niches on the lower parts of the walls in burial chamber (J) shows later plastering. The plaster is rougher in texture and goes over areas of relief painting.

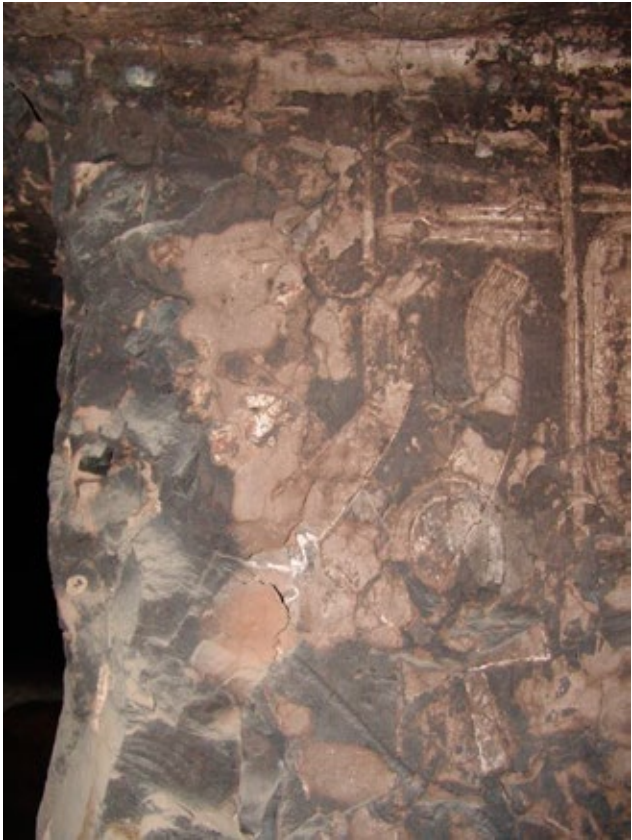
The fire in side chamber (G) caused loss of the upper plaster leaving behind a "negative effect" of the raised decoration. The figure now appears unblackened (as upper plaster layers were lost) while the background is still fire-blackened.

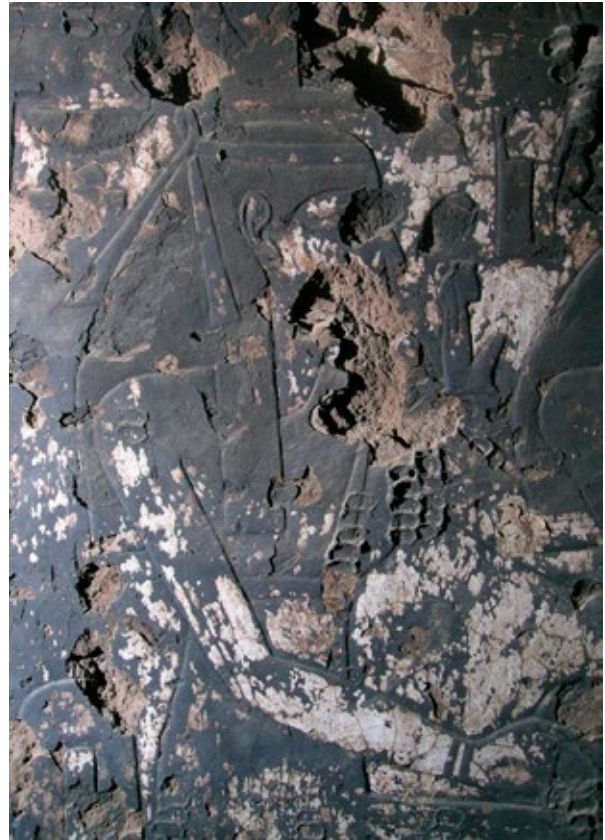
Decoration on north wall of chamber (C) suffered severe fire damage, which has led to both heavy blackening of the surface and complete loss of the paint layer; remains of insect nests also apparent.

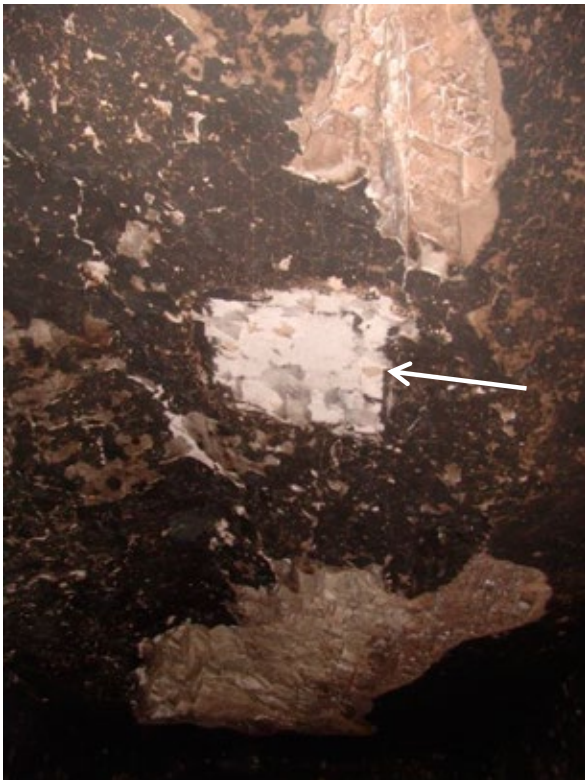
Ceiling of chamber (C) shows that loss of pillar (arrow) was post-fire.

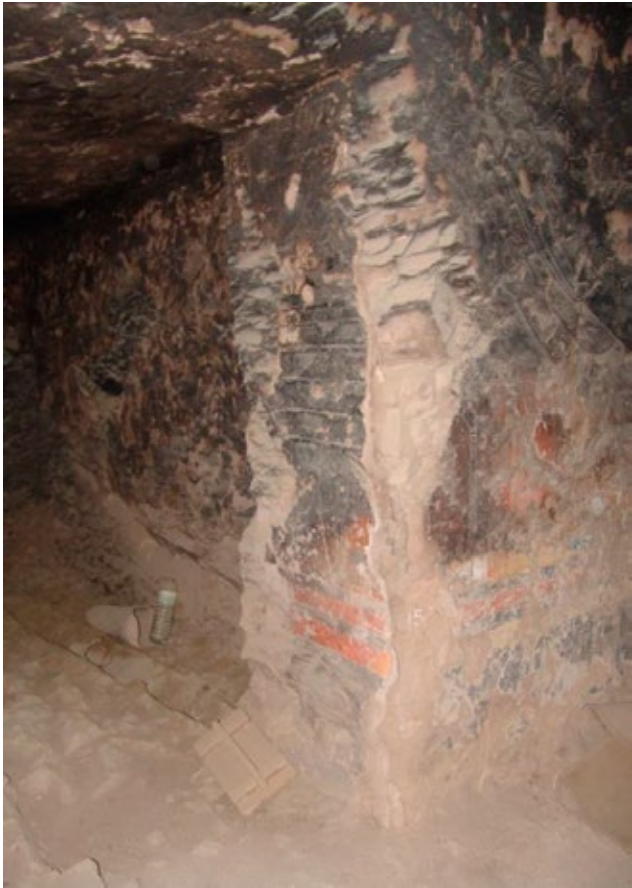
Area at base of wall shows heat alteration of yellow earth pigments to red.

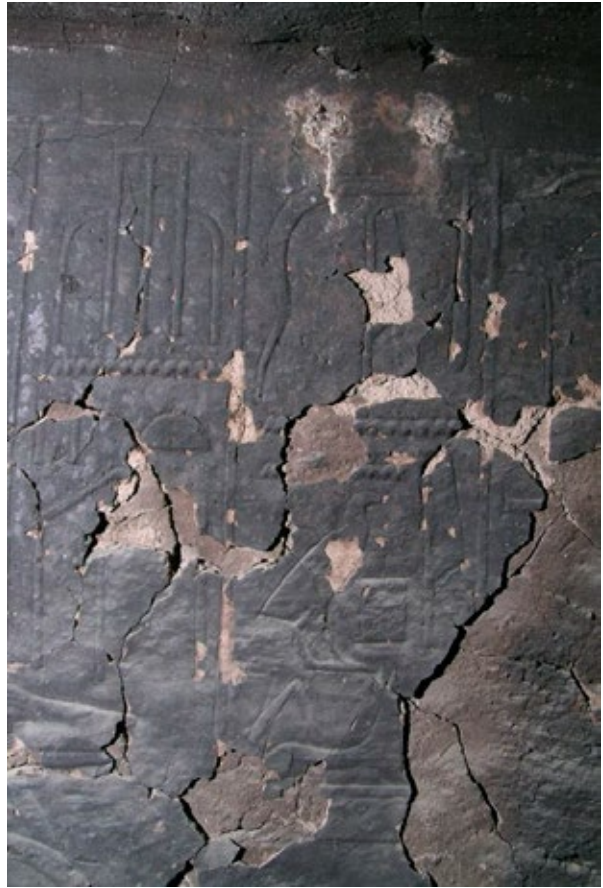
Post-fire losses have occurred throughout the tomb.

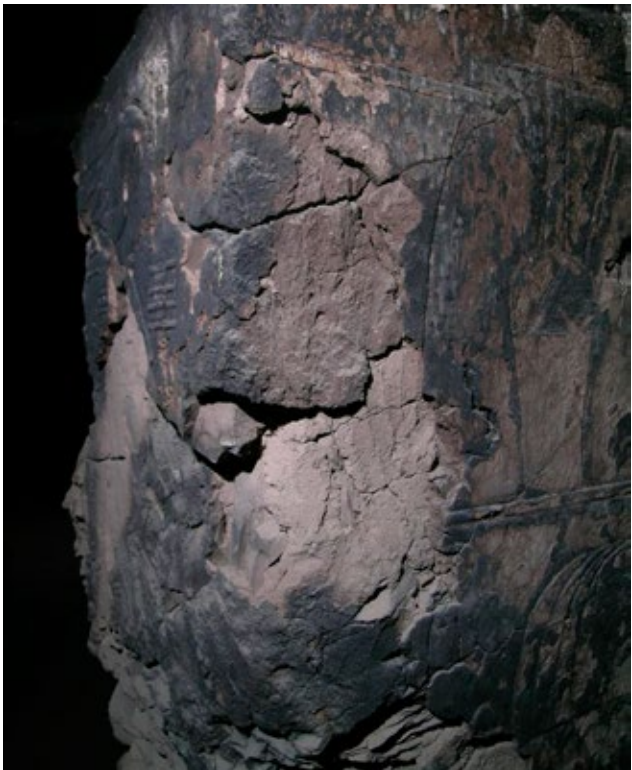
Fragile areas of plaster require stabilization.

Stabilization of fragile areas of painted plaster within the tomb is required to prevent further loss. As little previous treatment has been undertaken in this tomb, the scope of intervention will be more extensive than in other tombs but will also be targeted to only particularly fragile areas of decoration that are at imminent risk of loss. The heat-altered condition of plaster in this tomb may require stabilization treatments to be specifically formulated, trialed, and implemented.

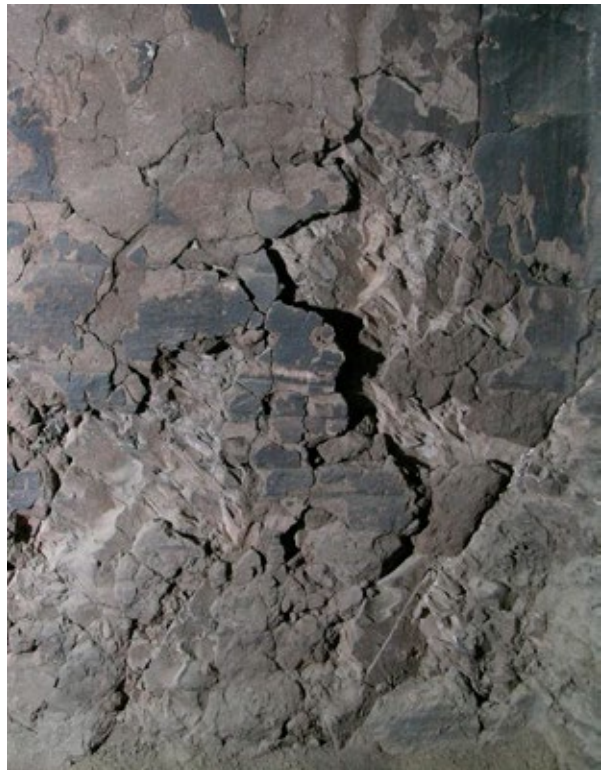
Some areas of decorated plaster are cracked and detached.

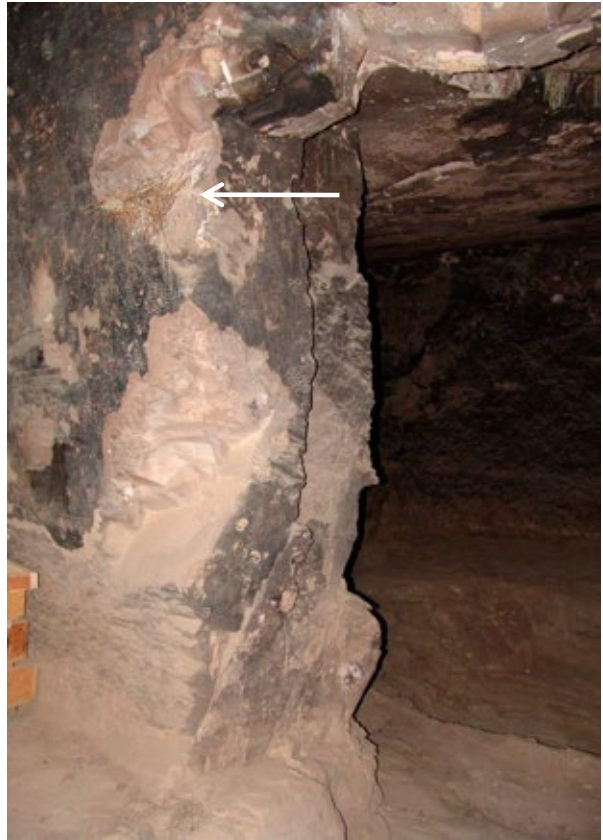
Doorway (D) with bird nest (arrow) in 2007.

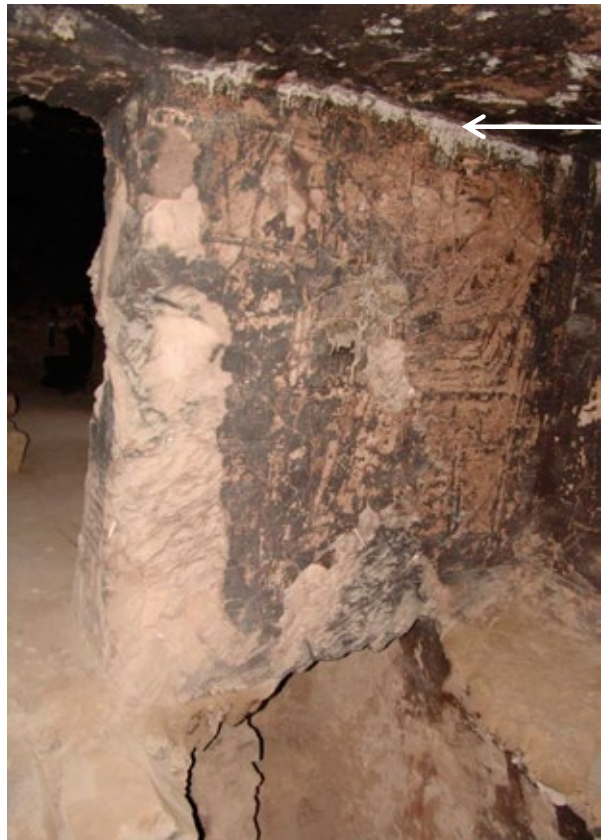
East wall of side chamber (E); note white crystalline material at tops of walls from bat urine.

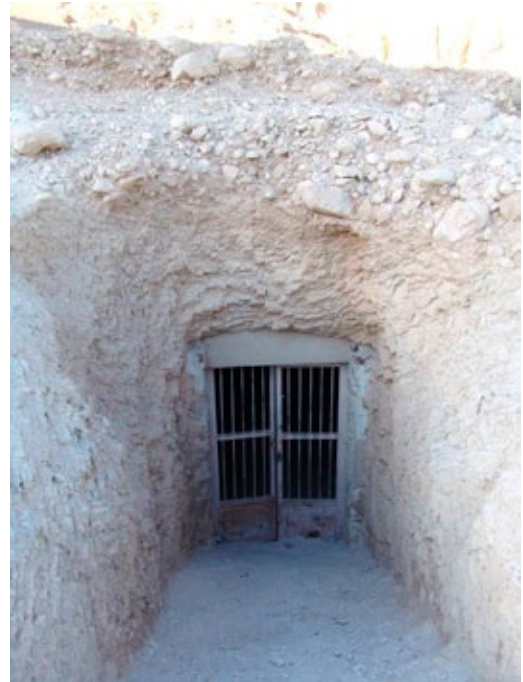
View of ramp and entrance, with shallow overburden composed primarily of partially cemented geological debris, over heavily weathered marl bedrock.

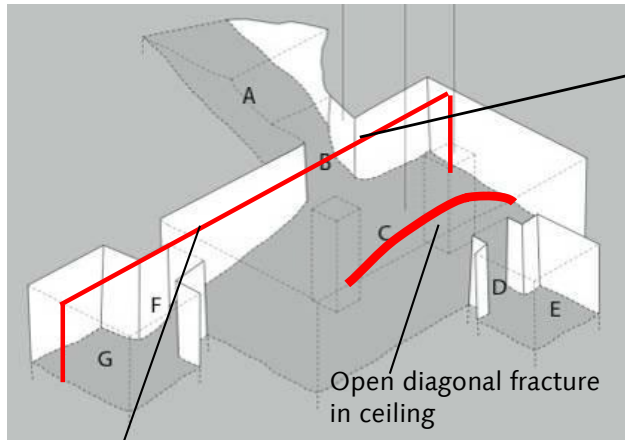
Open vertical ceiling fracture along length of tomb

Stabilization of the rock is required, particularly shoring of the hanging ceiling in chamber (C) and the lintel in doorway (F), and regular monitoring of faults and fractures should be carried out to determine if movement is active. Given the proximity of the vertical ceiling fracture to the external surface, the possibility that the two are connected should be investigated and measures taken to seal the fracture and prevent rainwater infiltration.

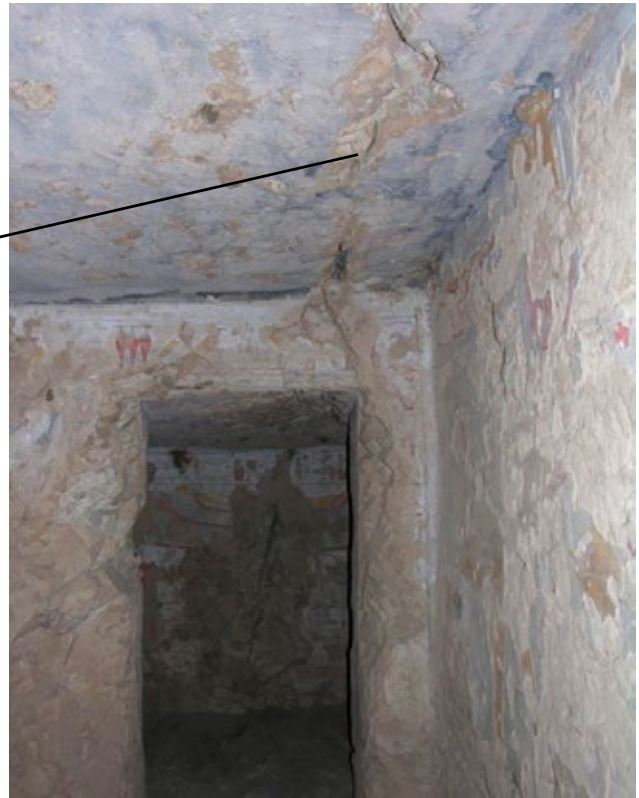
Open vertical ceiling fracture running laterally across the tomb and continuing into the east wall of chamber (G). Presence of original mortar packing in the fracture indicates little movement has occurred since the tomb was excavated in antiquity.

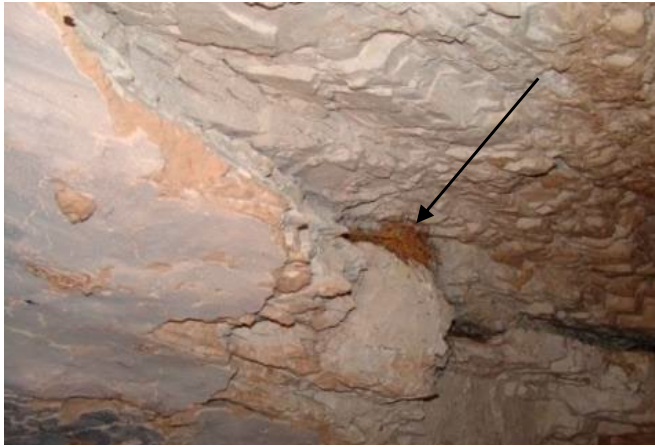
Currently the tomb is not open to visitation. Entry is prevented by a metal grill door with no mesh. Two birds' nests were observed in the large hanging rock ledge in the ceiling of chamber (C) and the presence of a bird has been noted during in situ inspections. The open fracture also has accumulated bird droppings, suggesting that the rock is also used as an active perch.

Bird nest on ledge of ceiling fracture and micro-fractured ceiling rock.

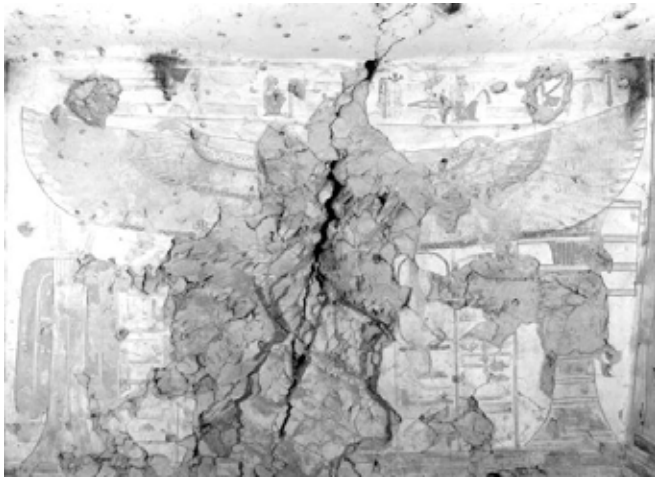
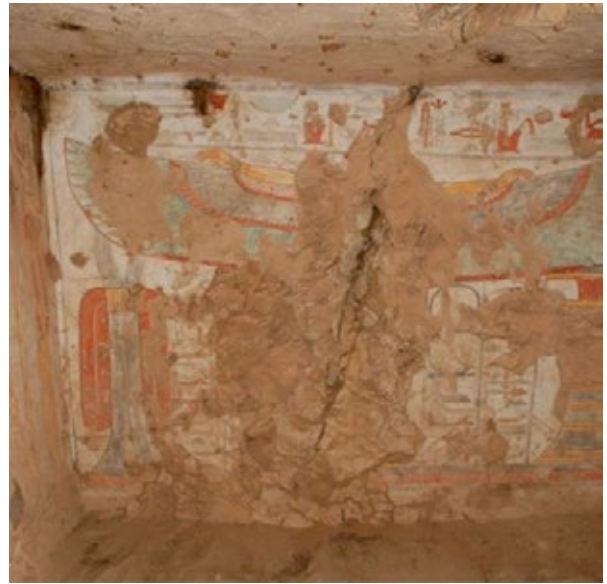
East wall of chamber (G) in 1987 above, and in 2007 on right. Note little change in rock or plaster loss despite the large open rock fracture (Image: CEDAE).

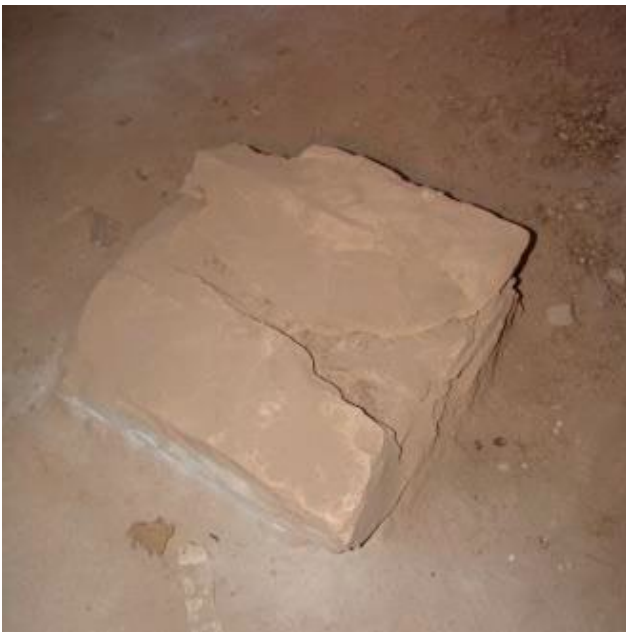
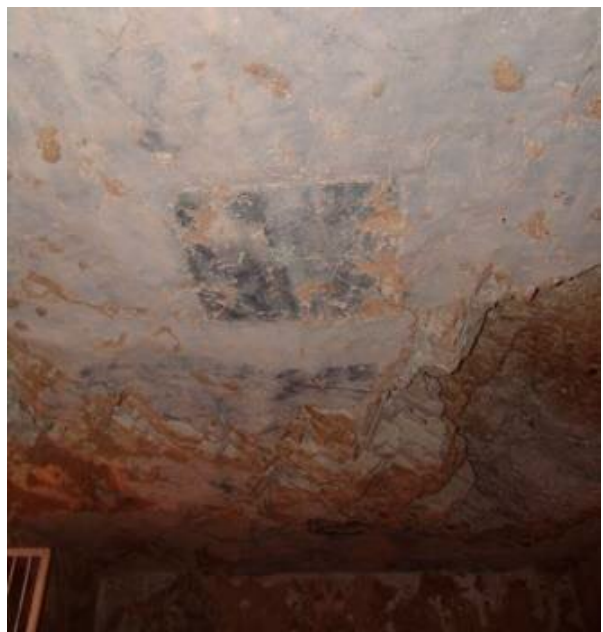
Pillar base (above left) and painted square on ceiling in chamber (C) directly above it (above right), indicating that the pillar was constructed at a later date (after the ceiling was already plastered and painted) and is now largely lost.

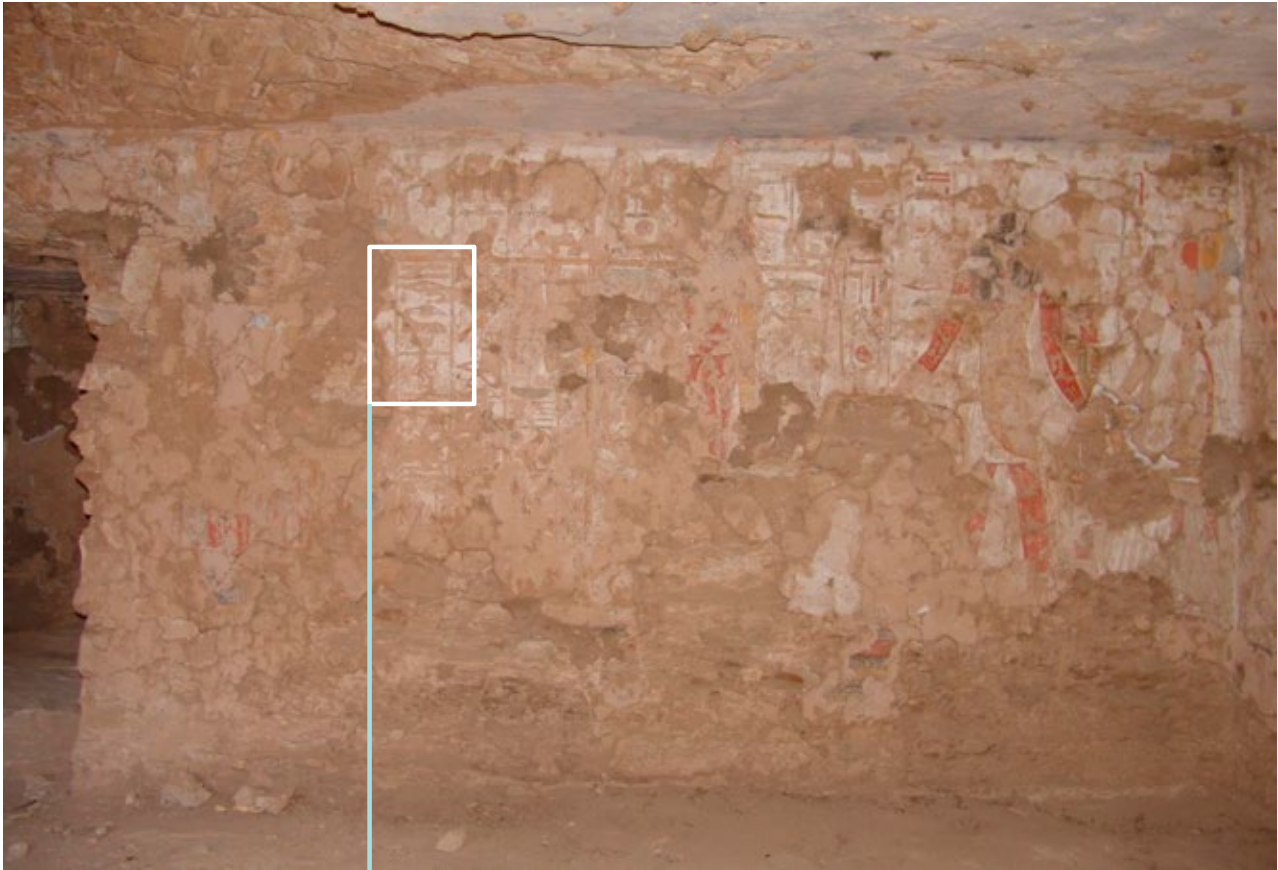
In chamber (C) a significant amount of the infill and coarse plaster survives but it is the upper painted plaster layer that is fragmentary and has suffered substantial losses. The surviving plaster is cracked and generally fragile and vulnerable, with localized areas of detachment.

North wall of pillared chamber (C). Note fragmentary survival of painted plaster in this area.

Ceiling plaster will need to be stabilized in conjunction with rock engineering work. Stabilization of fragile areas of painted plaster, including separation of upper painted layers and cracking of plaster, is required to prevent further loss. This work must take into account geological stresses of existing fractures to ensure that treatments will not lead to further damage.

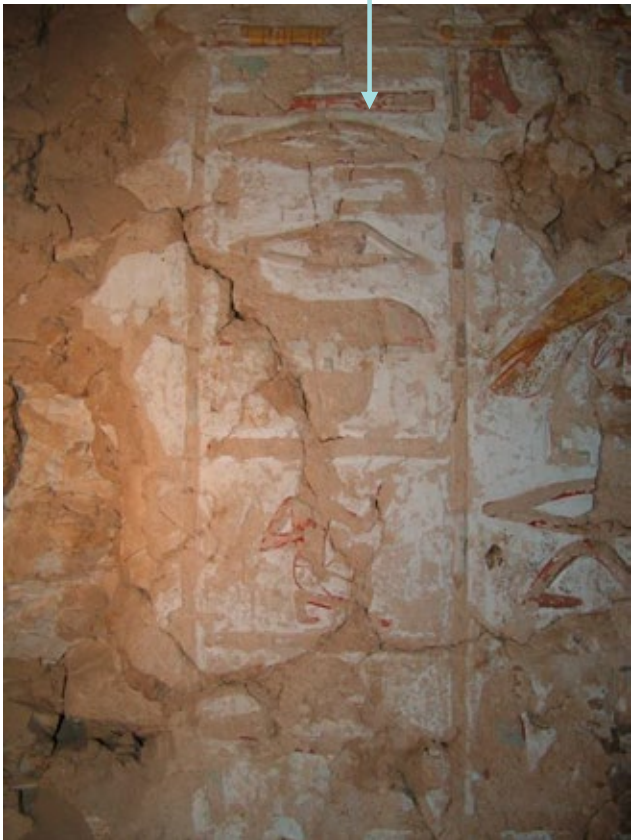
Detail of area of painted plaster on north wall of pillared chamber (C). Note paint loss and cracking in plaster layer.

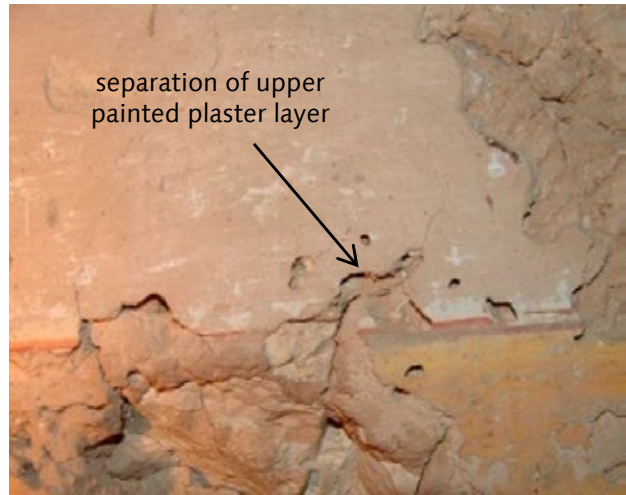
East wall of chamber (C) – condition of the plaster is fragile in areas.

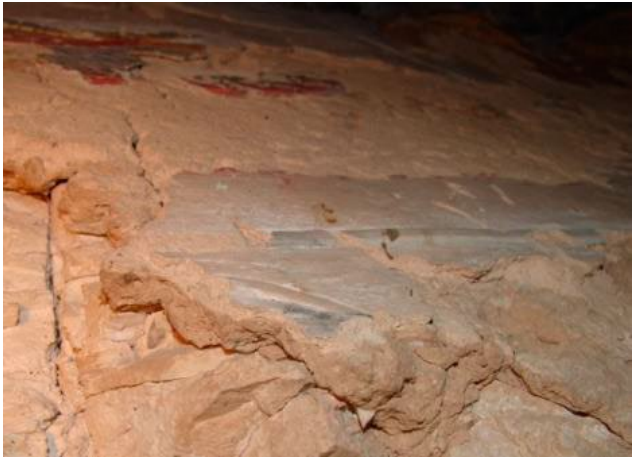
Stratigraphy of painting: deep losses were infilled with plaster and rock shards followed by a coarse plaster and fine plaster layer, then finished with the paint layer.

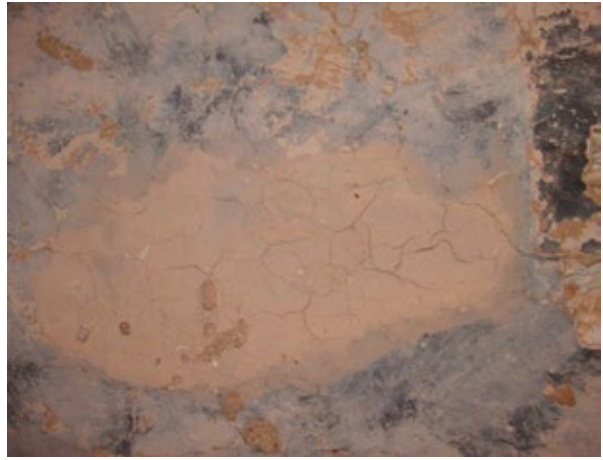
Area of repair on ceiling of chamber (C) is possibly an early repair from antiquity.

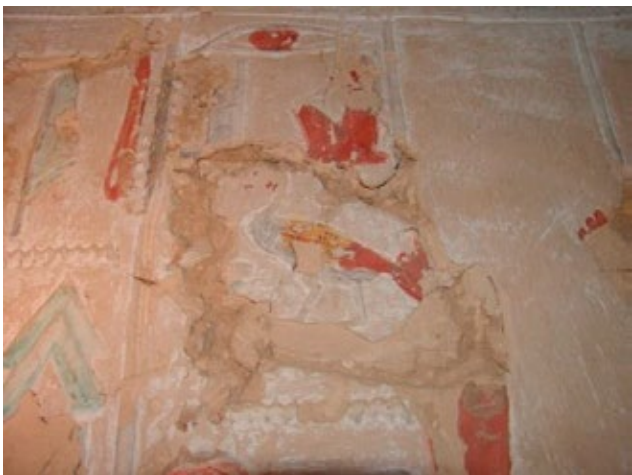
Attempt to remove area of painting in pillared chamber (C)

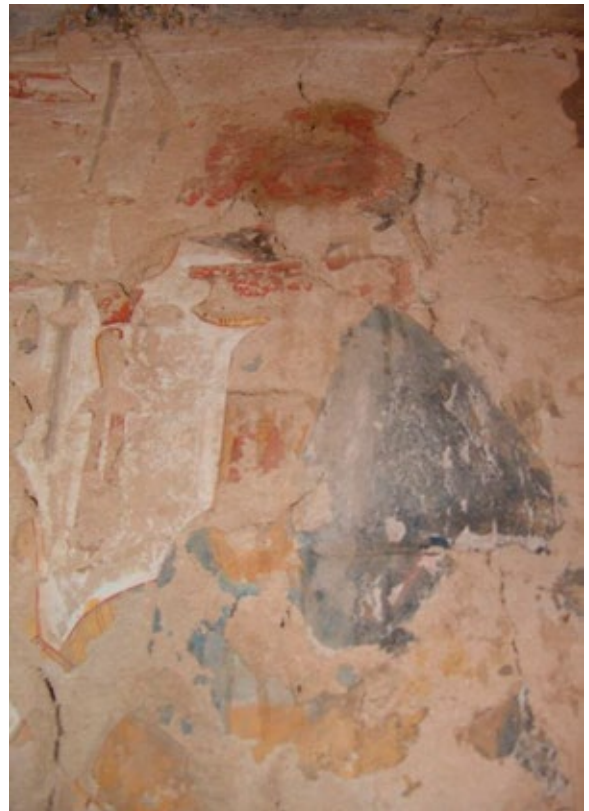
Drips from previous treatment are visible on the painting in chamber (C), north wall, east side.

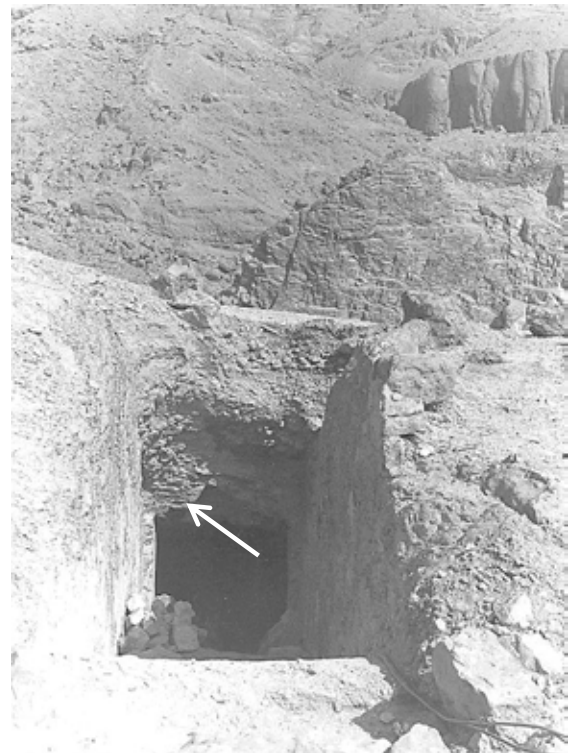
1991 photograph showing entrance before the door was constructed. Rock wedge is visible above doorway (B). (Image: CEDAE)

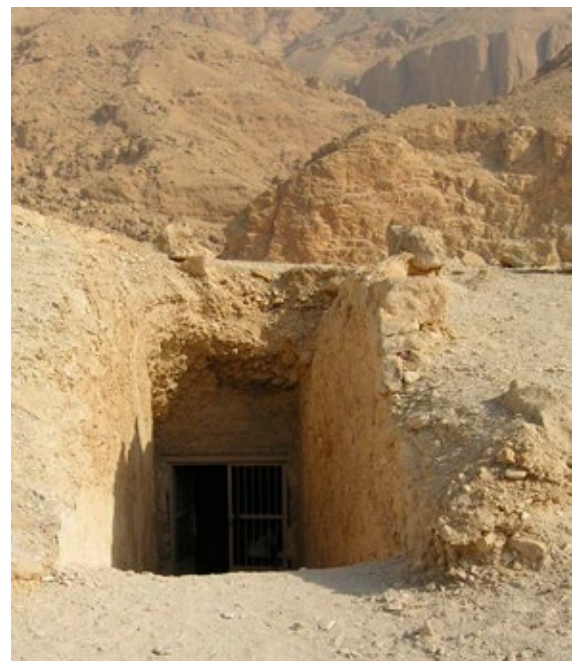
Long, graded ramp (A) leading to entrance doorway (B). Note the paleofan conglomerate layer is largely missing above the tomb entrance.

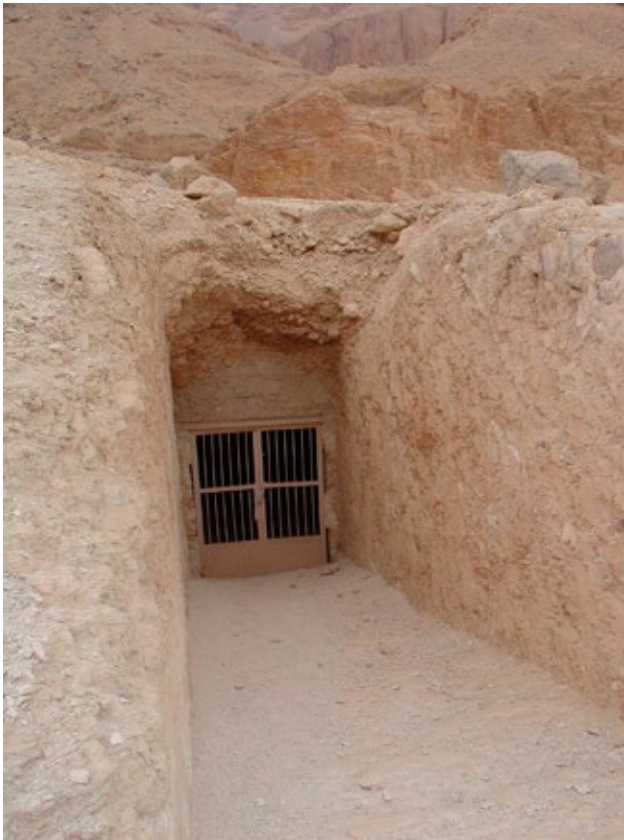
There is a rock overhang of 1m to the right above entrance doorway (B) composed of paleofan conglomerate debris. The loose rubble and boulders are held in a soil matrix, which could be easily eroded and threatens partial collapse as it is not supported by more stable marl rock.

Entrance ramp (A) and doorway (B) have a rock overhang of 1m composed of marl on the west side and paleofan debris to the east. The loose rubble and boulders are held in a soil matrix, which could be easily eroded and threatens partial collapse as it is not supported by more stable marl.

An arched masonry cover is required over the entrance ramp for water infiltration protection. Removal of overhanging boulders and filling behind retaining walls is required. Stabilization of rock above the entrance doorway and in the east wall of pillared chamber (C) is recommended.

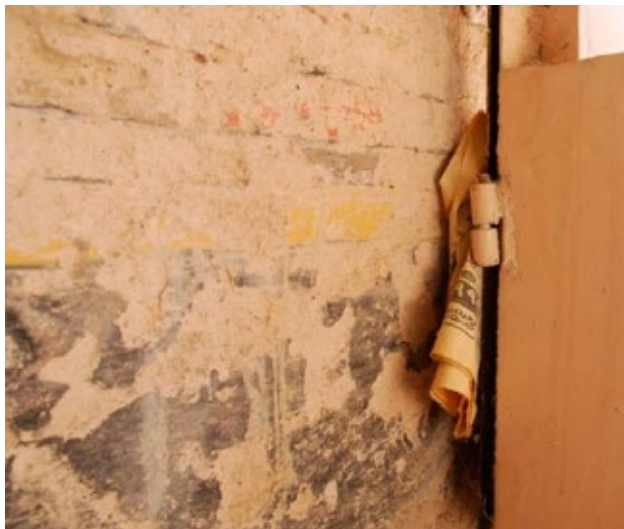
There are surviving areas of painted plaster adjacent to entrance door (B). This area requires protection during any work on the door.

Painted plaster near the entrance door frame requires protection during work on door. Limited stabilization of fragile areas of painted plaster within the tomb is also required to prevent further loss. The heat-altered condition of plaster may require stabilization treatments to be specifically formulated and trialed.

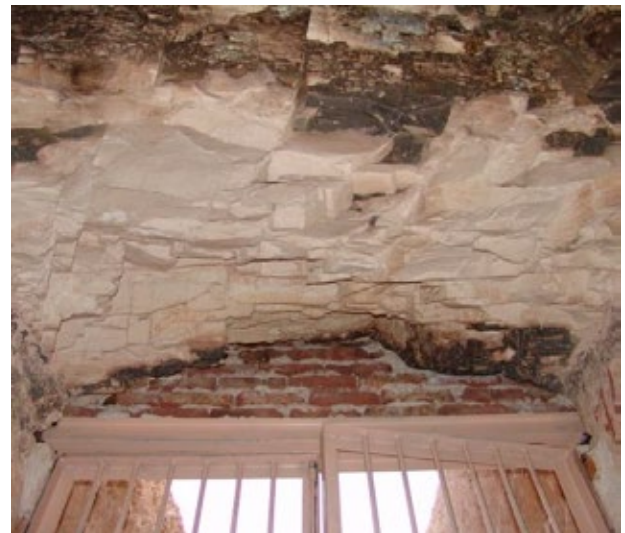
A large post-fire rock loss above doorway (B).

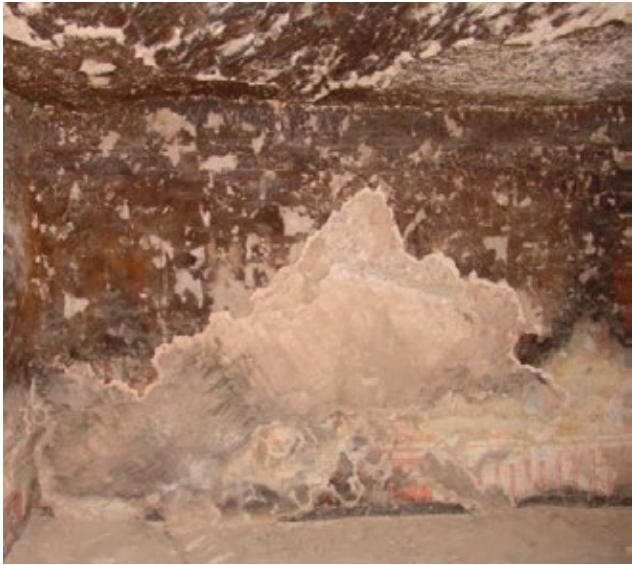
Large post-fire loss on east wall of chamber (C). Some stabilization of rock is necessary in this area.

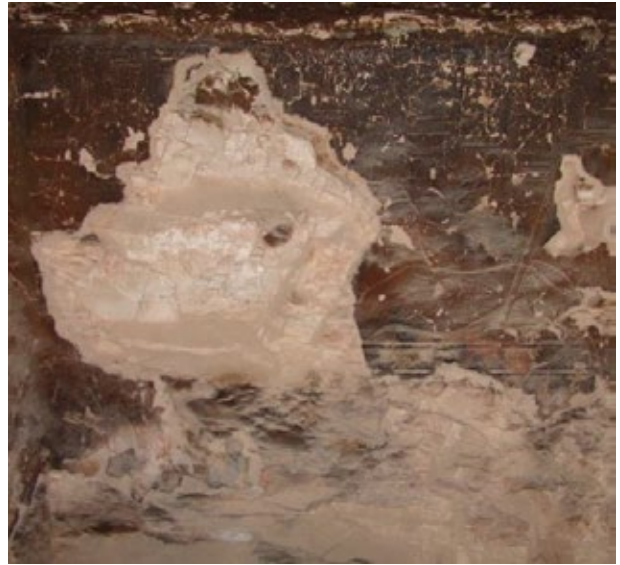
Large post-fire loss on north wall of side chamber (I)

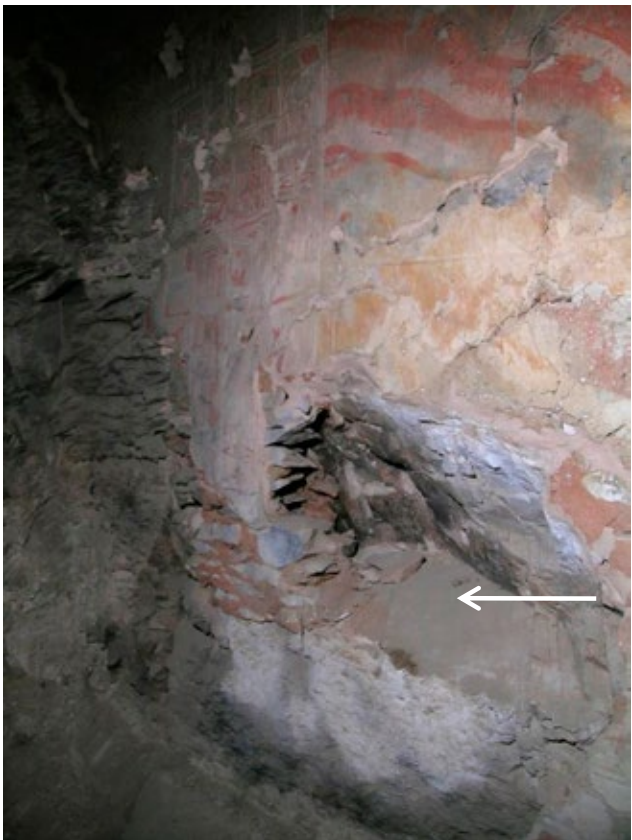
Substantial packing was necessary to fill large voids in the walls. A large amount of this infill material has been lost in chamber (G).

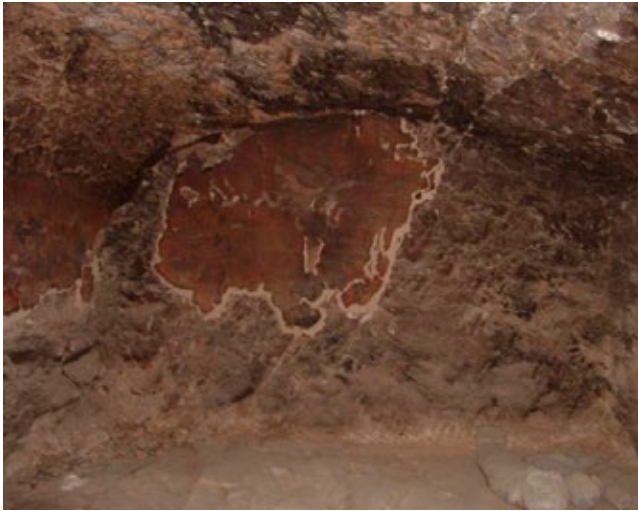
West wall of chamber (G). There are large areas of loss of painting in this room but little post-fire loss. Note reddish color of paint layer and overall blackening in this chamber.

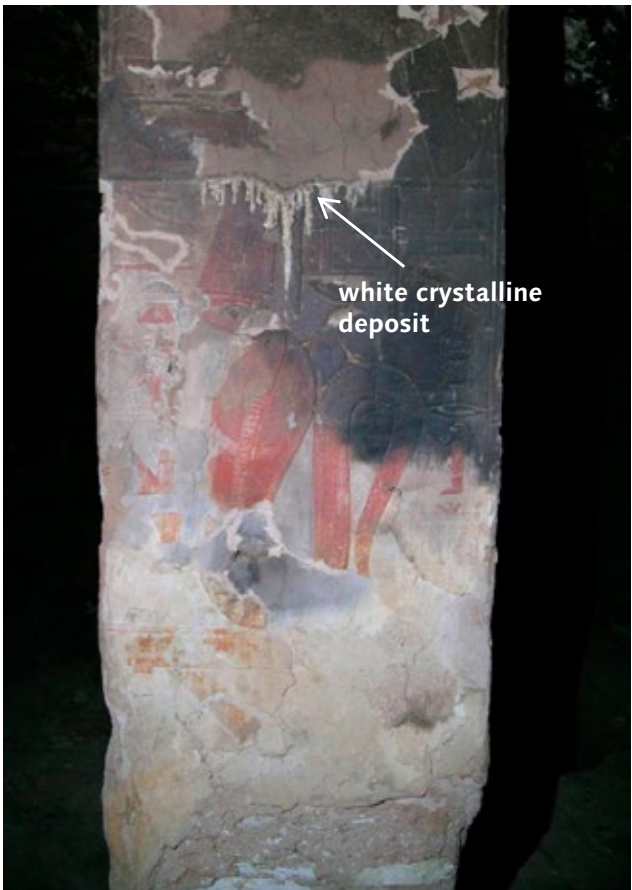
Heat alteration of pigments is most visible in burial chamber (G) where yellow earth pigments have altered to red. The lower parts of pillars and walls escaped fire damage. Note also white crystalline material from bat urine at top edge of painted plaster.

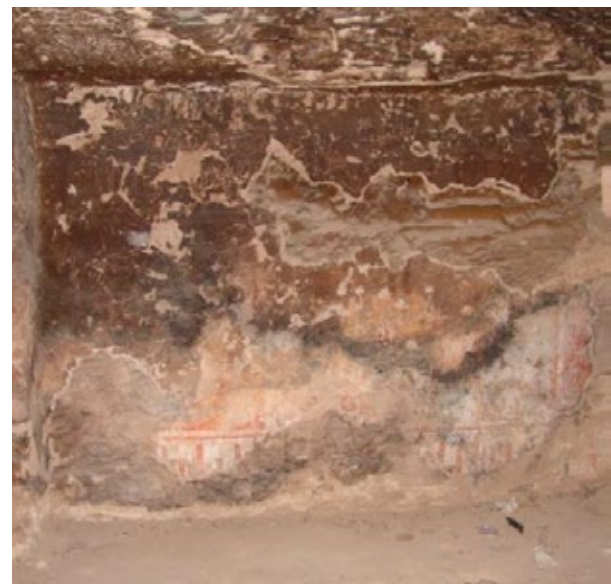
Lower parts of the walls in chamber (C) are not blackened having been most likely protected by sand and debris. Note mustard brown color of fire-related darkening in this chamber.

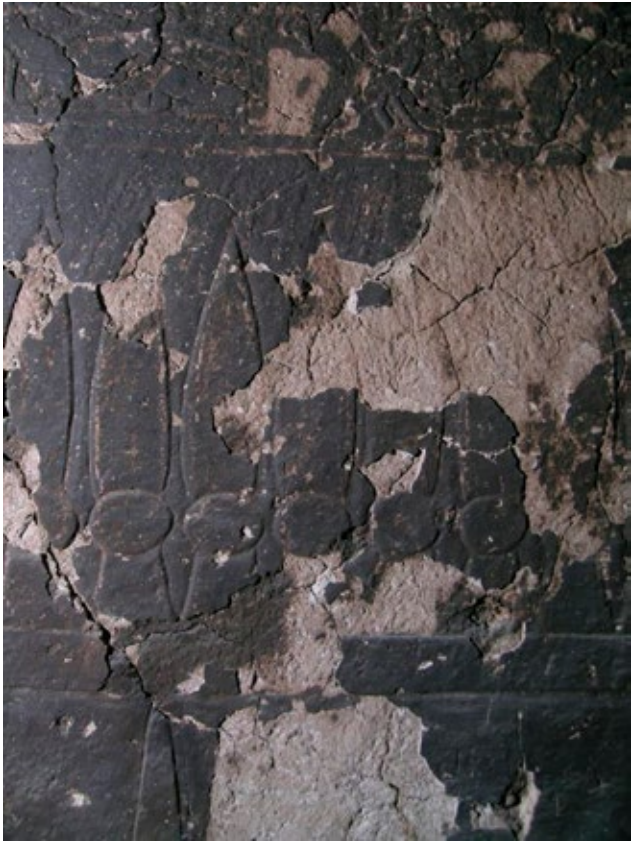
Note cracking and post-blackening losses of the thin upper decorated plaster layer.

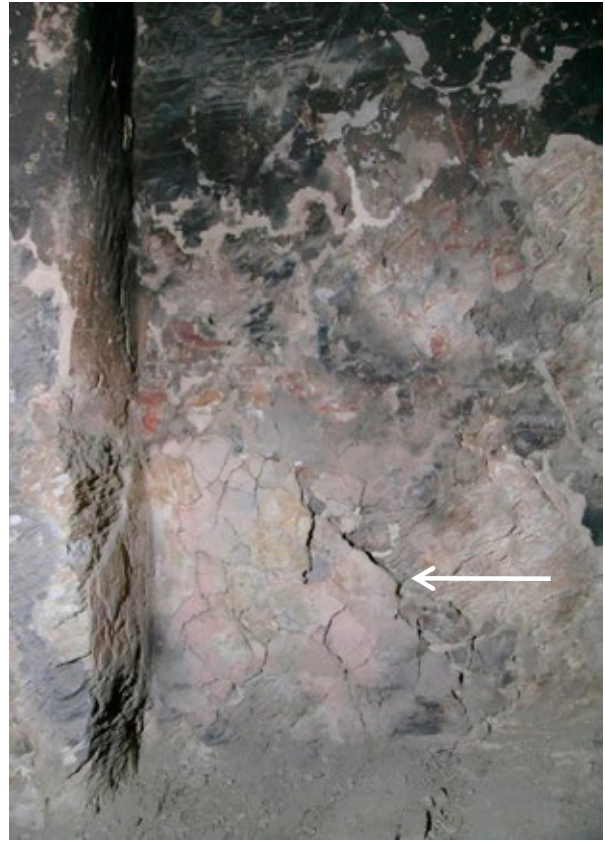
Fragile, cracked and detached areas of plaster on east side of ramp (E).

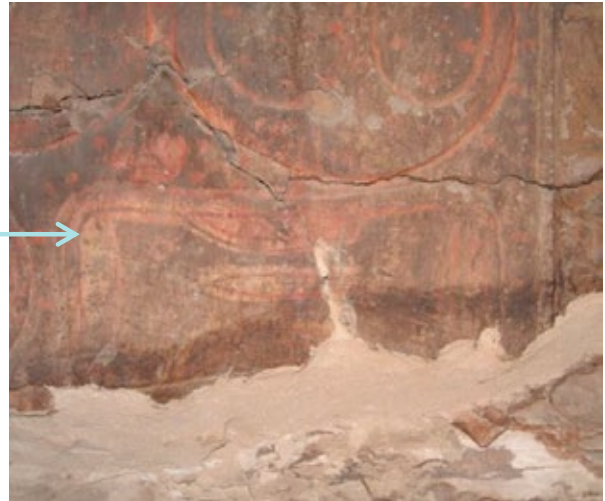
Above the edging repair, a possible cleaning attempt of blackened areas of painting was carried out.

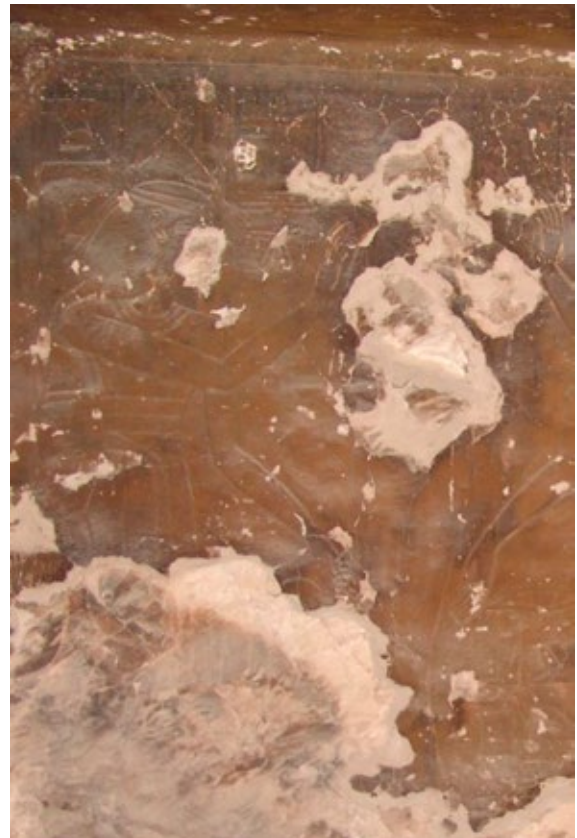
Chamber (I) in 2008 showing same area with 1989/1991 edging repairs.

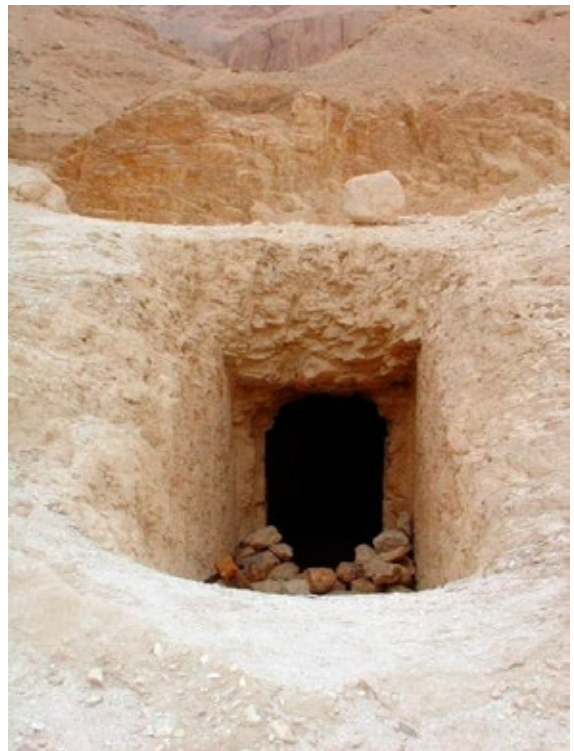
Short ramp (A) and entrance doorway (B). There is no door on this tomb.

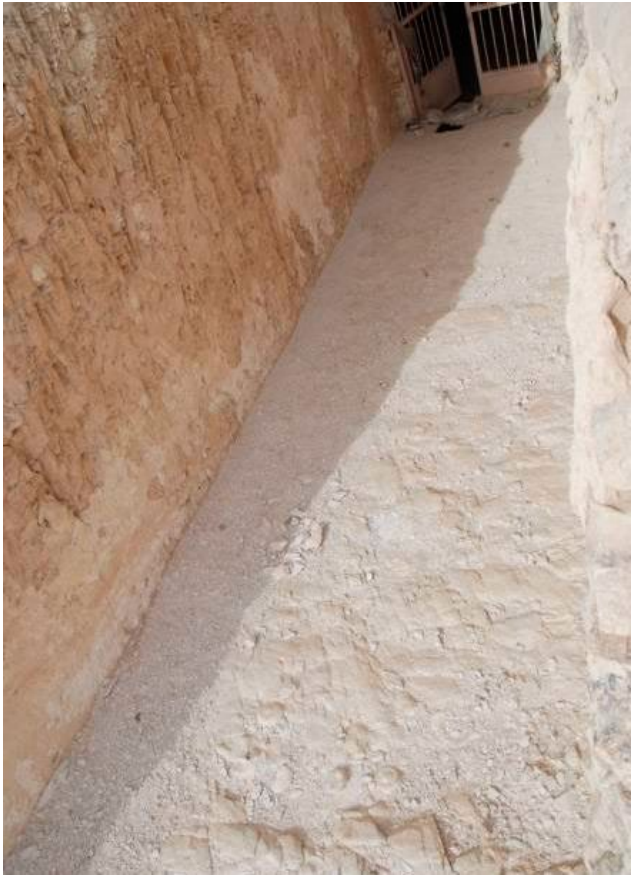
Ramp (A) once had steps, no longer extant. Plaster survives on lower part of ramp walls.

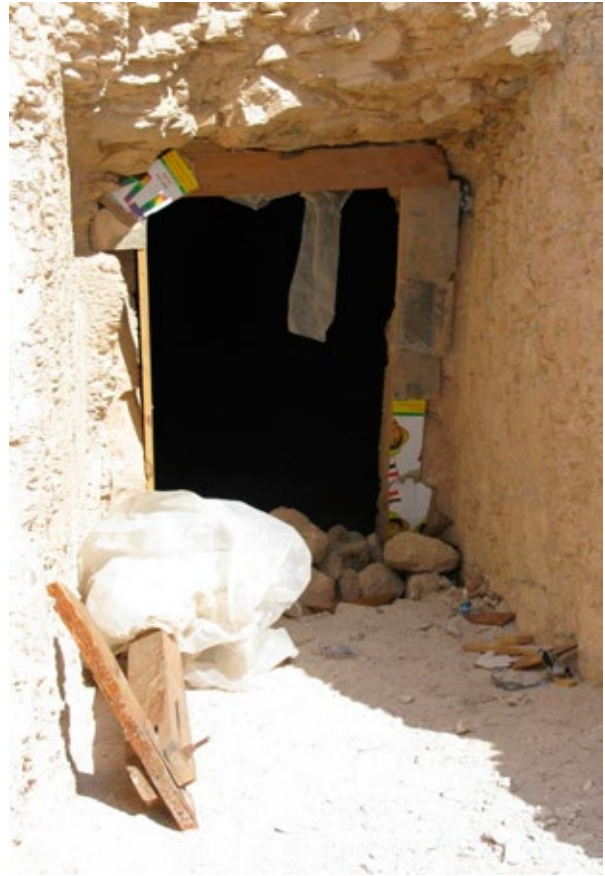
Above the entrance (B) are hanging fragments of rock.

Stabilization of rock fragments above the entrance door and monitoring of ceiling fractures is recommended.

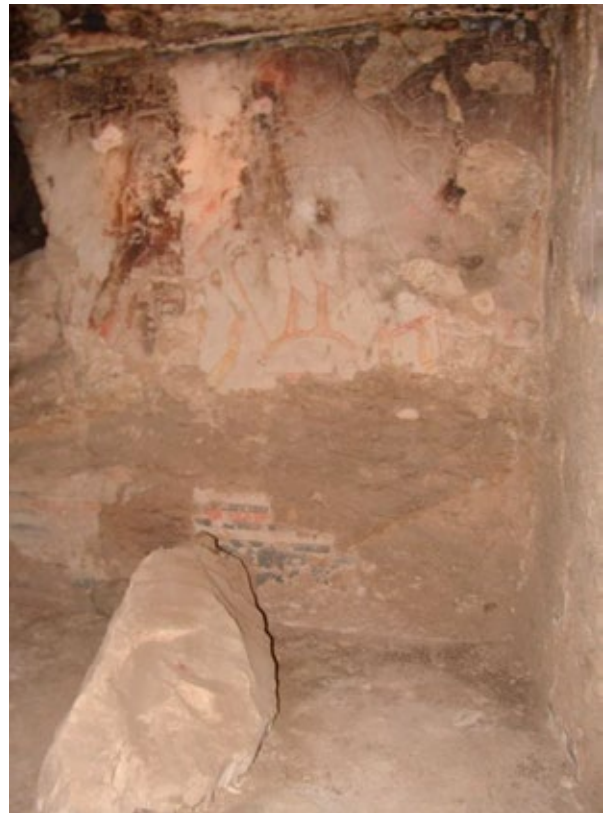
Rock in southwest corner of burial chamber (G) which may have originally been part of a constructed wall.
