Valley of the Queens Assessment Report

Volume 2

Assessment of 18th, 19th, and 20th Dynasty Tombs

A collaborative project of the Getty Conservation Institute
and the Supreme Council of Antiquities, Egypt

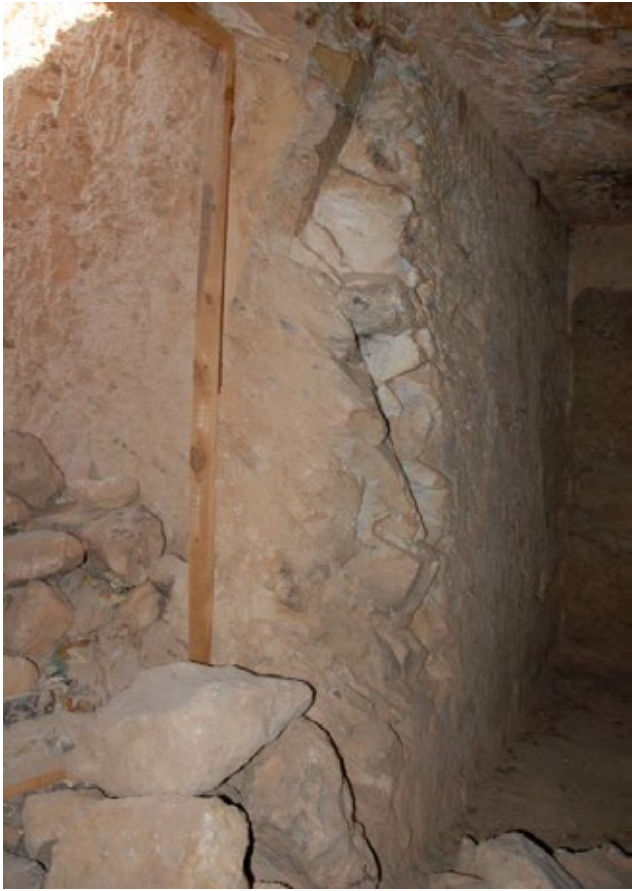
The tomb interior has no apparent structural risks or signs of instability of walls or ceiling. The tomb for the most part retains its rock-cut shape quite intact. The ceiling near entrance doorway (B) shows some collapse though this appears to be historic. The west door jamb of the doorway (B) also presents rock loss and some adjacent loose fragments.

Rock loss and some adjacent loose fragments at doorway (B) west jamb. (Image: CEDAE 2009).

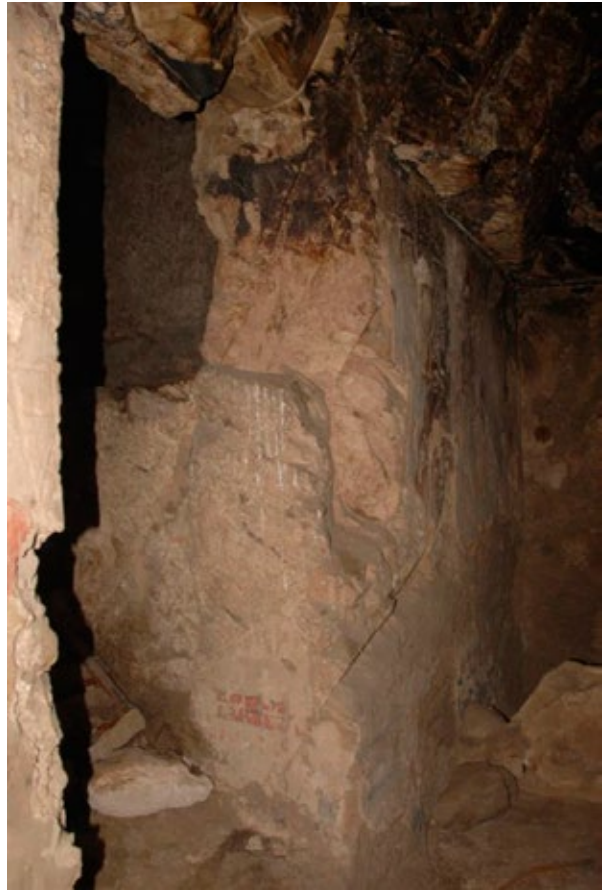
Localized loss and fracturing can be seen on doorway (F) (Image: CEDAE 2009).

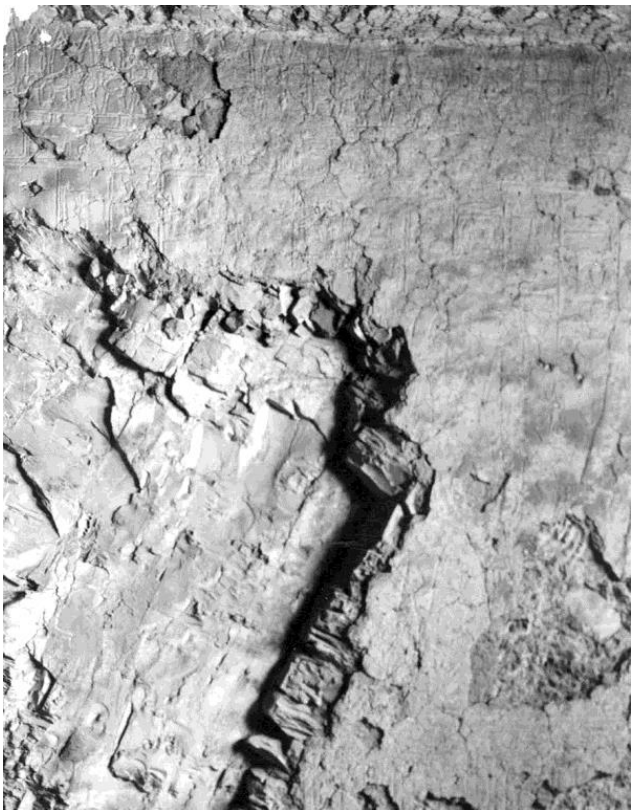
A large area of loss on the west wall in chamber (C) in 1985 (Image: CEDAE).

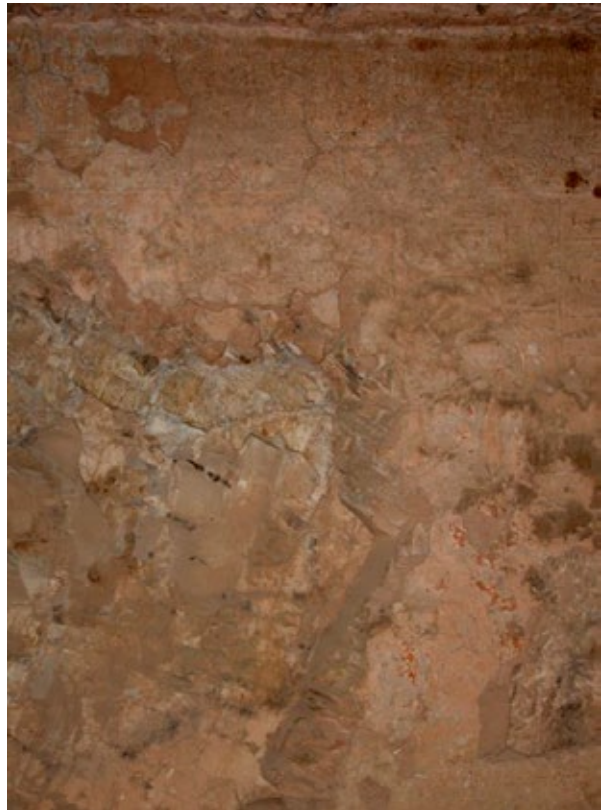
Same area in 2009. Little change in rock condition can be noted.

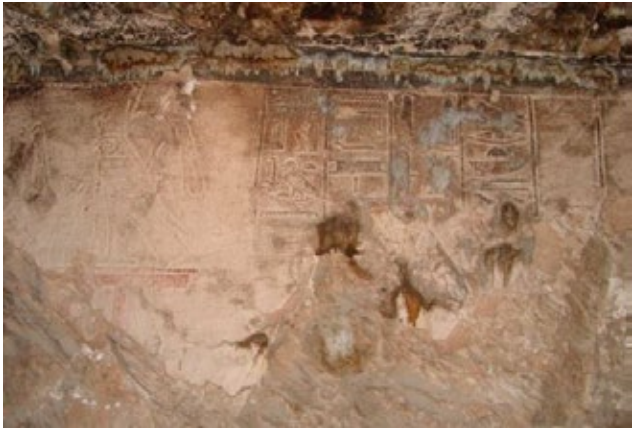
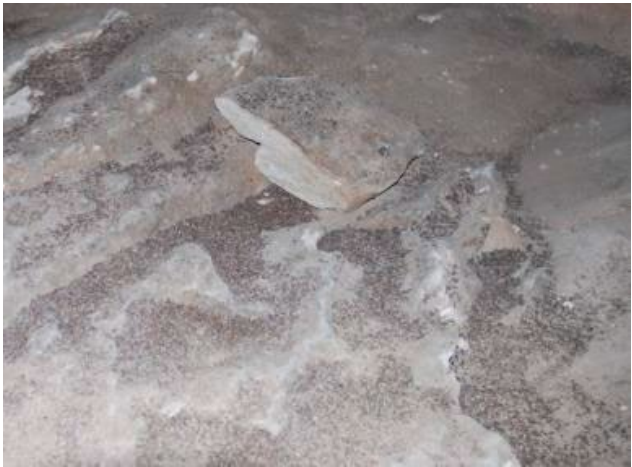
The tomb has had extensive bat activity with crystalline deposits on the surface of the wall paintings and droppings found throughout. Bats were also noted during the February 2008 inspection. The location of the crystalline deposits indicates that the bats tend to roost directly on the upper edges of the paintings. Bird droppings were also noted on a column in the burial chamber as well as insect nests found throughout the tomb.

Extensive bat activity is observed throughout the tomb: Staining on ceiling and wall in intermediate chamber (E) and accumulation of bat droppings on floor of burial chamber (G).

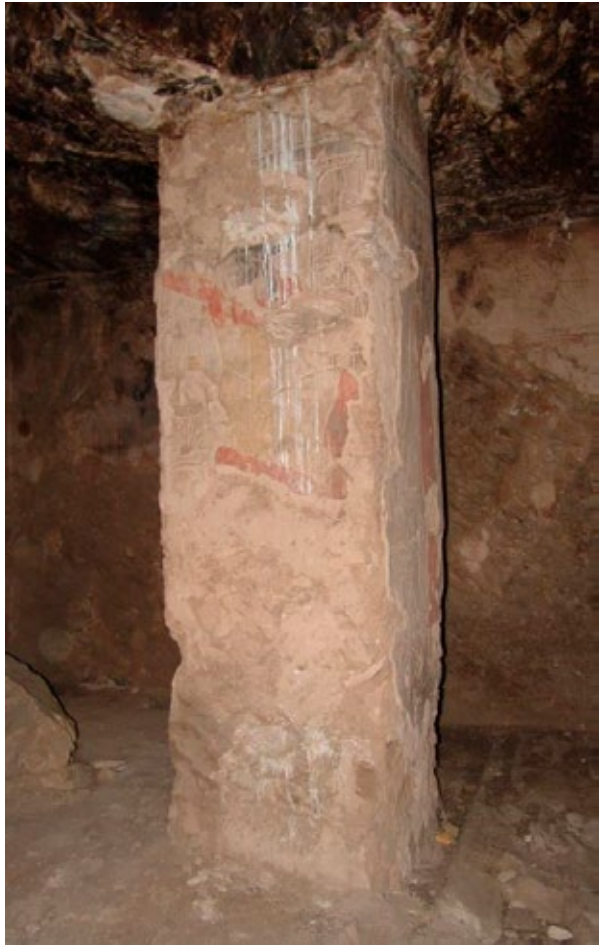
Bird droppings on pillar in burial chamber (G).

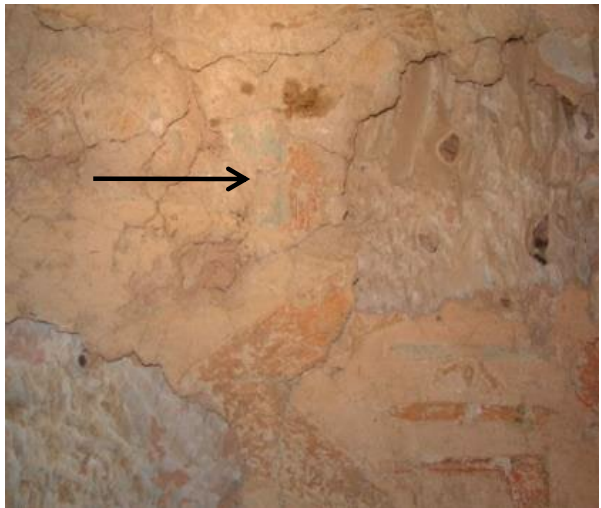
Only small traces of green paint survive.

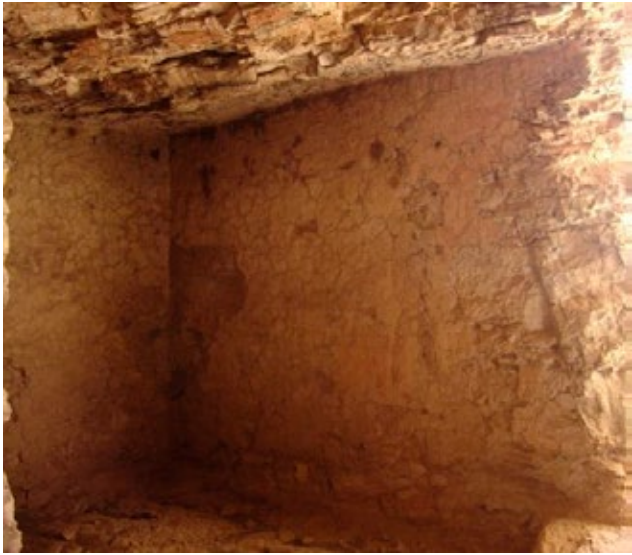
The surviving areas of painting and plaster in the tomb have suffered severe fire damage. The paintings in chamber (C) are not fire-blackened but show signs of heat damage. The plaster layer appears to have been altered, and is now highly fragmented with a network of cracks that has destabilized many areas. Heat has also caused pigment alteration which is most notable in the changes from yellow to red of the iron oxide pigments. These are the most prominent surviving colors; though faint traces of green can be seen in more protected areas. The painted surface is rough in appearance and has suffered loss. In some areas the paint layer is almost entirely gone leaving only the unpainted raised relief plaster behind.

The paintings in chamber (C) have been damaged by fire. Though there is no fire-blackening the paint layer has altered and the plaster layer has been fired. The paintings are now highly fragmented with a network of cracks. In many areas the upper painted layer has been lost with only traces of paint surviving.

Stabilization of fragile areas of surviving painted plaster is required to prevent further loss. The scope and nature of intervention will be wide ranging. The heat-altered condition of plaster may require stabilization treatments to be specifically formulated, trialed, and implemented.

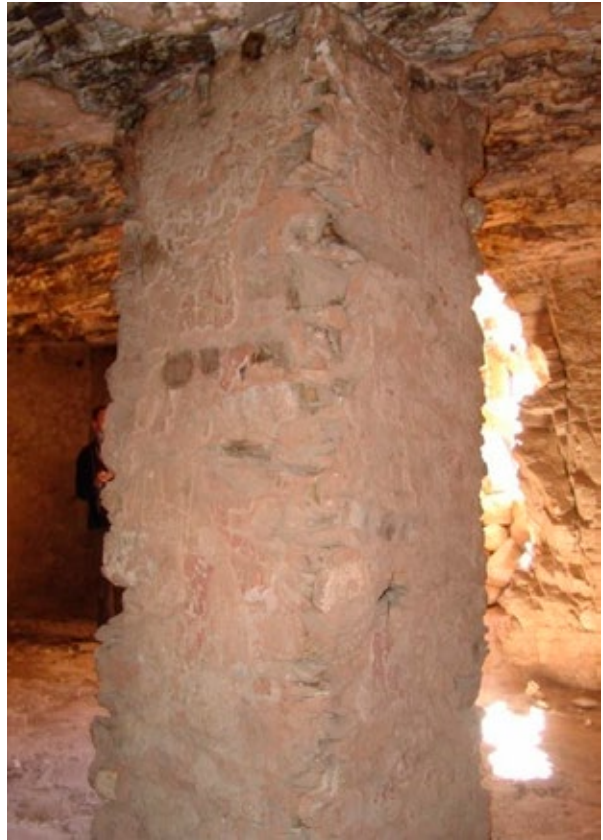
Pillar in chamber (C) are masonry constructed with fragmentary survival of painted plaster.

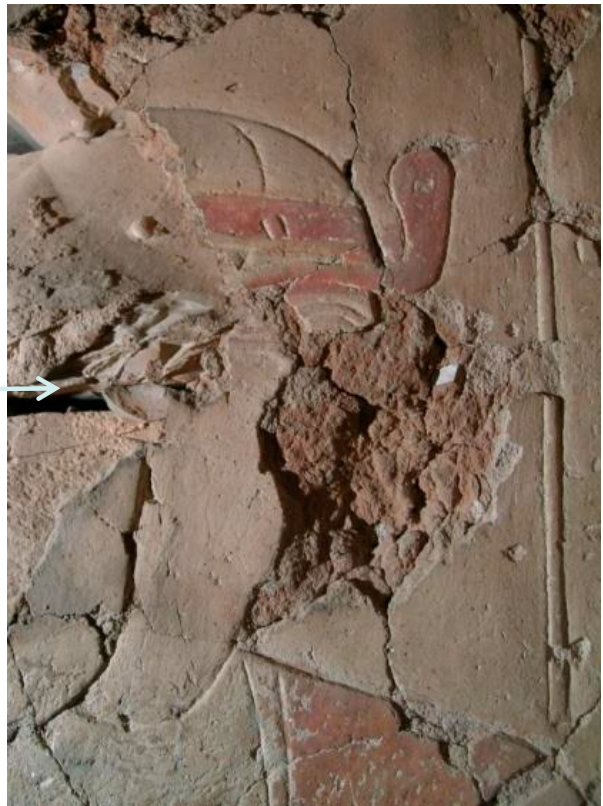
The painted plaster has suffered severe fire damage in areas. Though not fire blackened, the pigments and plaster appear to have been altered by fire.

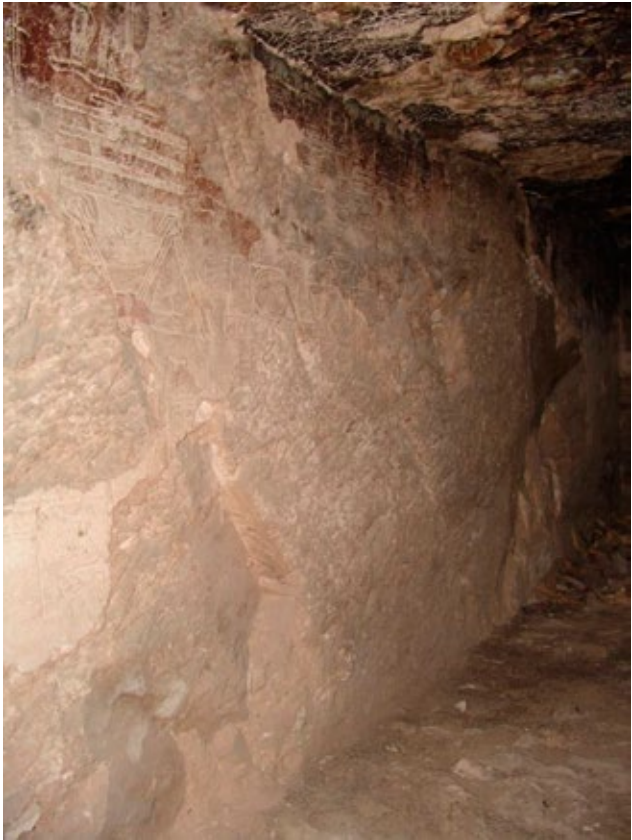
There is fragmentary survival of painting in chamber (G).

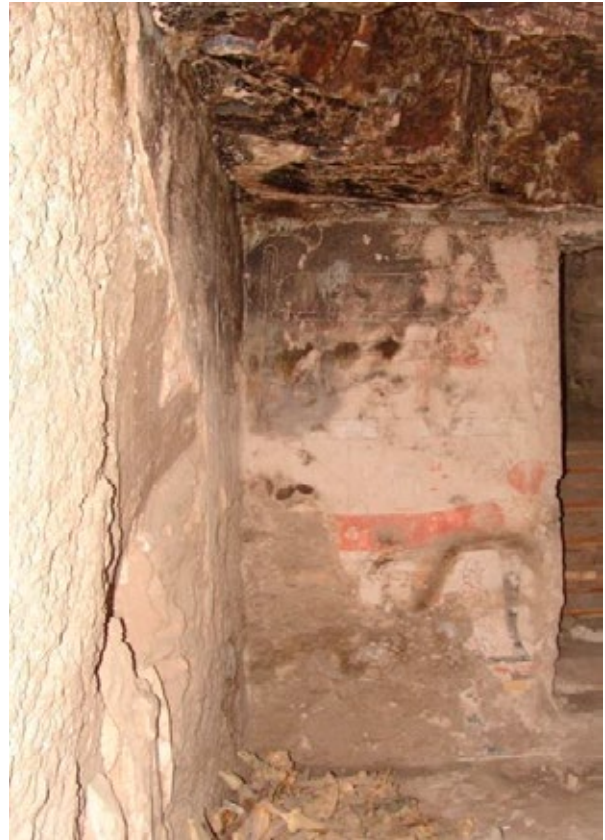
Lower areas of walls in burial chamber (G) are not fire blackened. The void in wall at left would have been filled with plaster and rock shards.

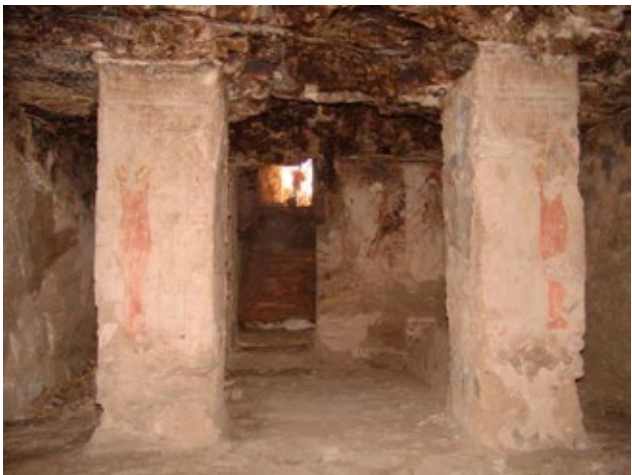
Note extent of surviving painted plaster on pillars of chamber (G) and that fire blackening was only on the upper parts of walls and on the ceiling. The lower parts of the walls and pillars escaped serious fire-related damage.

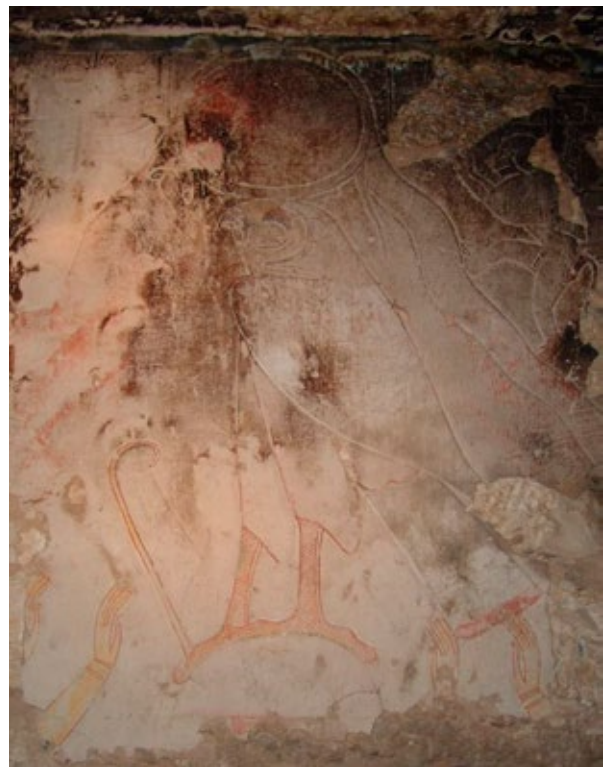
There is less heat alteration in this chamber with unblackened areas and partially unaltered yellow pigment present.

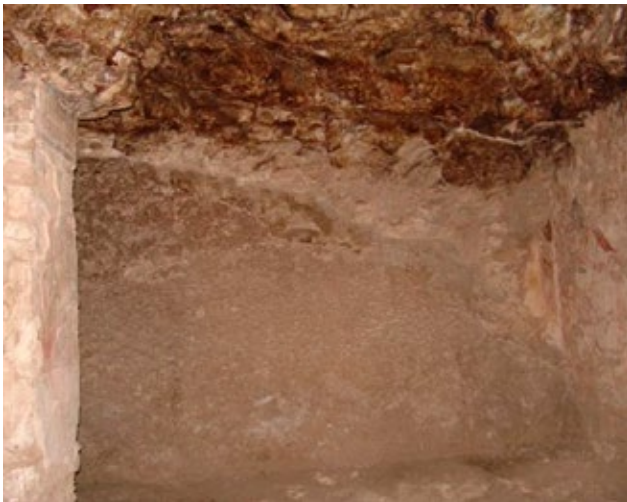
Rear wall of burial chamber (G) has salt accretions and there is almost no surviving decoration on this wall.

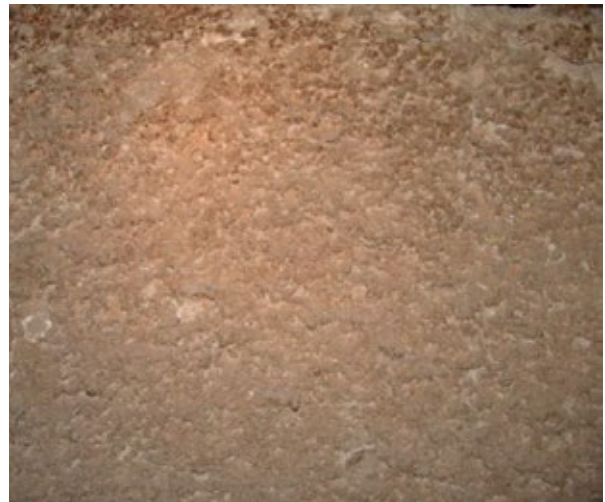
Detail of salt accretions on rear wall of burial chamber (G).

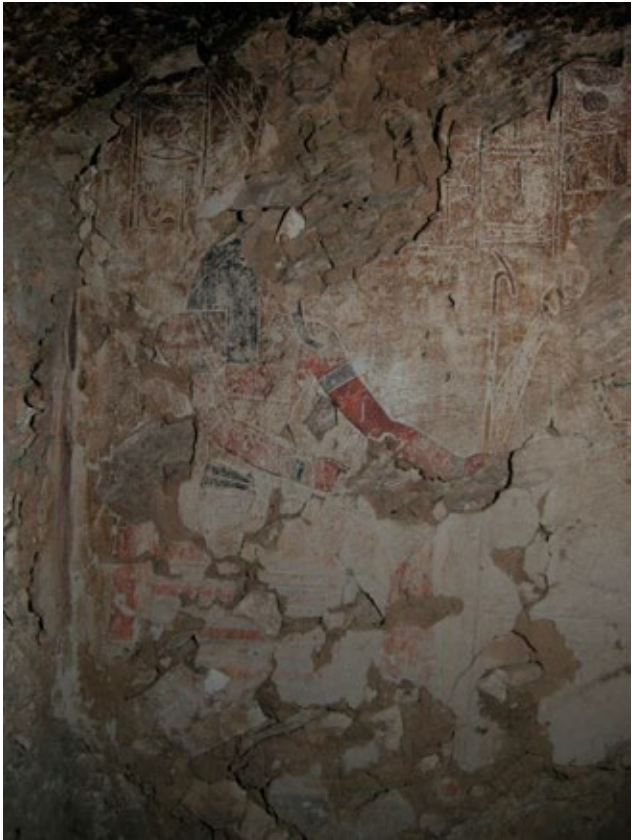
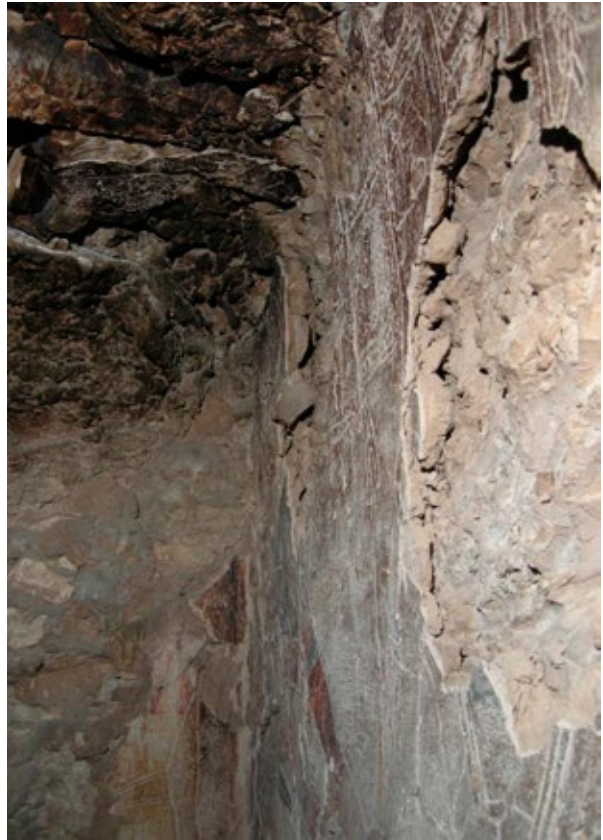
There are vulnerable, at risk areas of decoration in burial chamber (G). Edges of the painted plaster are not secured and the infill material behind the plaster is loose. Fallen fragments were noted during the assessment.

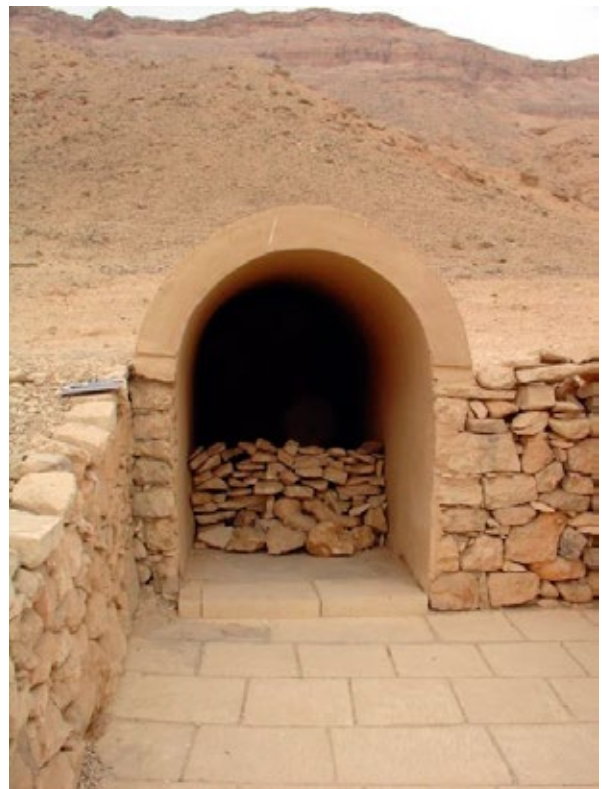
Arched cover and retaining walls on either side of entrance, with dry rubble wall at top of ramp as a barrier (later replaced by SCA with an iron gate).

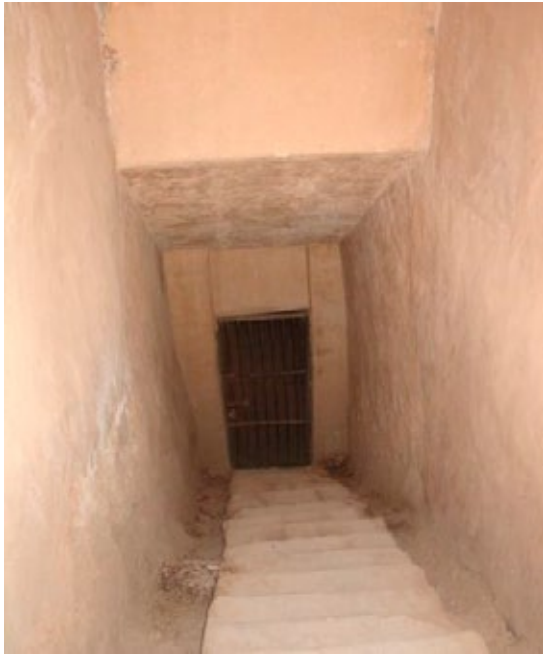
Reconstructed entrance and stepped ramp (A).

Visitor access to the entrance ramp should be prevented by the installation of a gate at the top. The current metal grill door covered with plastic sheeting at the bottom of the ramp should be replaced by a new grill door with intact mesh to permanently exclude bats and insects.

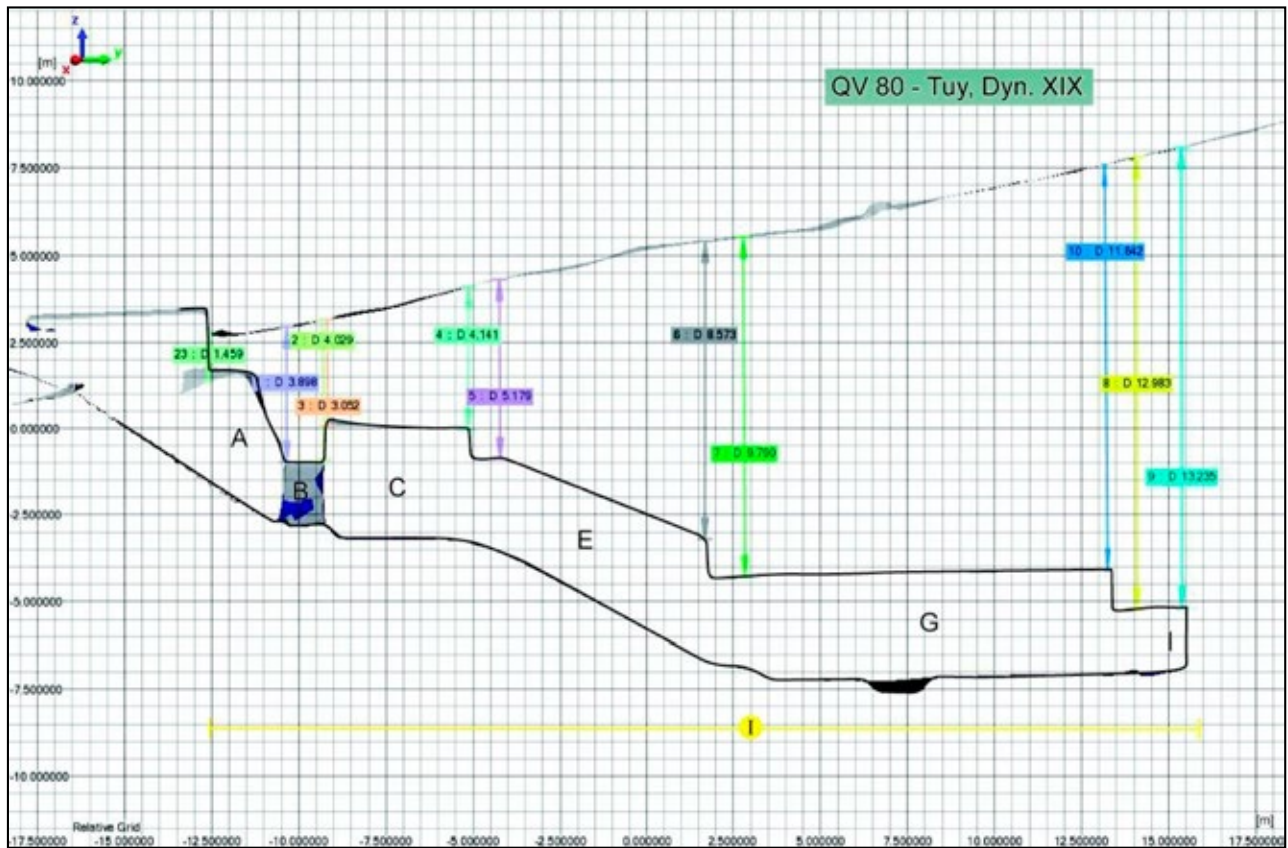
Overburden section showing that its thickness ranges from 3m above antechamber (C) to 13m above the burial chamber (G)

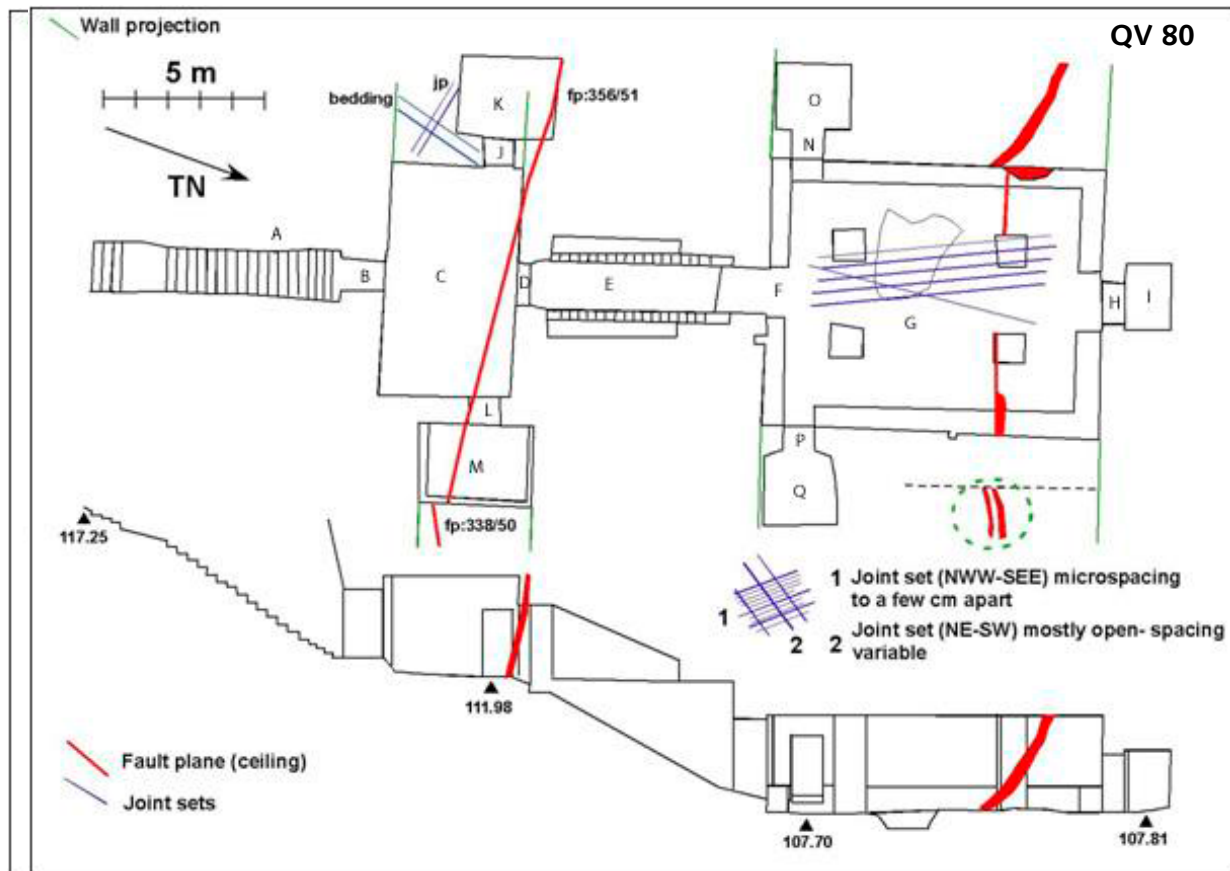
Two principal fault zones are present in the tomb, one running laterally (east-west) in antechamber (C), and side chambers (K) and (M) where there is adjacent rock loss. The other fault zone is visible in the northwestern corner of the burial chamber (G), where the thick chert concretion is located. Extensive salt efflorescence and large crystal growth is present on the east wall of the burial chamber. Salt infill of fractures and faults is present throughout the tomb.

Geologic and structure analysis showing two major fault zones that traverse the tomb laterally, and two joint sets and their relationship to the bedding.

Regular rock monitoring should be carried out to determine if there is continuing movement along the faults in the both chambers, and the ceiling fractures in the upper chamber.

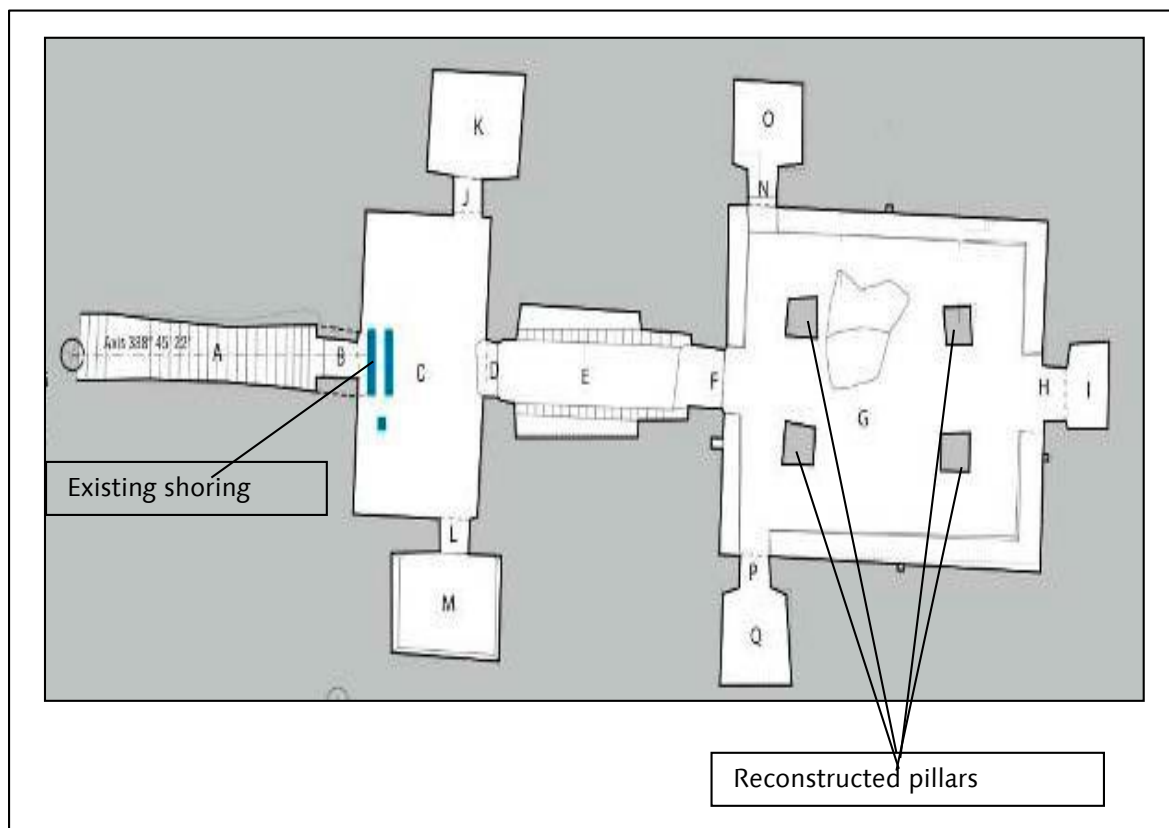
Previous interventions to stabilize the tomb include the erection in antechamber (C) of shoring to support the fractured ceiling rock. The shoring consists of two wooden horizontal beams, each supported by two wooden posts, and an additional fifth post in direct contact with the ceiling. The four pillars in burial chamber (G) were rebuilt using modern fired brick, and the axial door jambs (B), (D), and (F), have been similarly rebuilt, either partially or completely. Areas of wall rock loss adjacent to a door in chamber (C) were also filled. These rock stabilization interventions, both permanent and temporary, are in good condition. The ceiling of the entrance ramp (A) has also been rebuilt and an arched entrance cover, with retaining walls and stairway has been constructed.

Location of shoring and reconstructed pillars in QV 80.

The existing reconstruction of doorways and pillars is also effective and stable, and no further rock repairs are needed, with the possible exception of doorway (L).

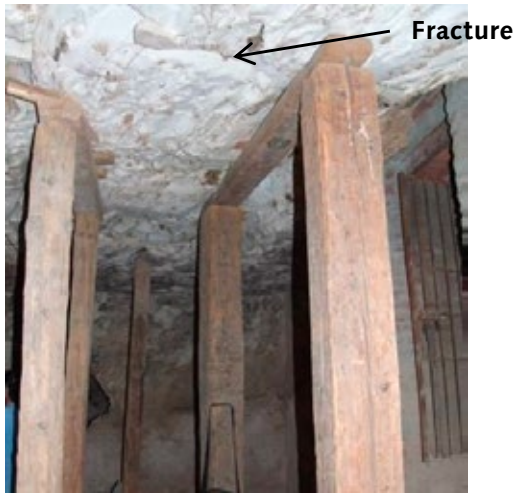
Shoring of ceiling in antechamber (C) with rock fracture.

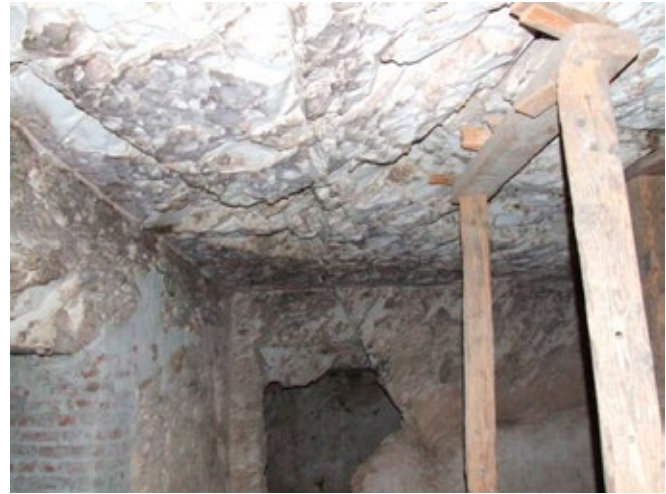
Fault plane in ceiling of antechamber (C) continuing to doorway (L) with adjacent rock loss.

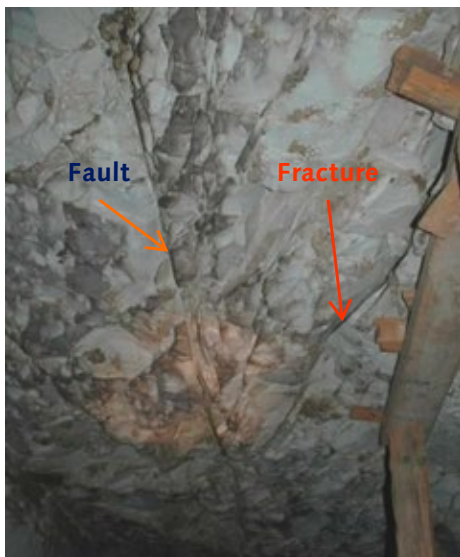
Shored ceiling area in antechamber (C) with fault to the left and fracture to the right.

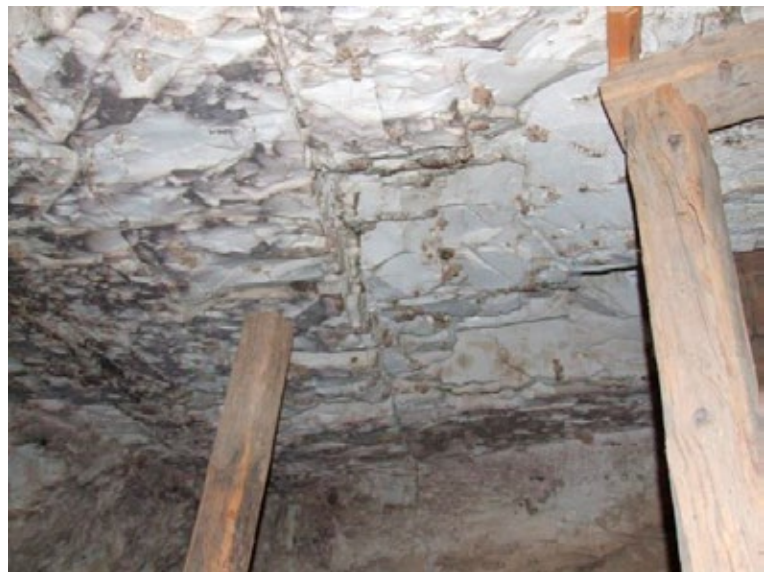
Fracture in ceiling of antechamber (C).

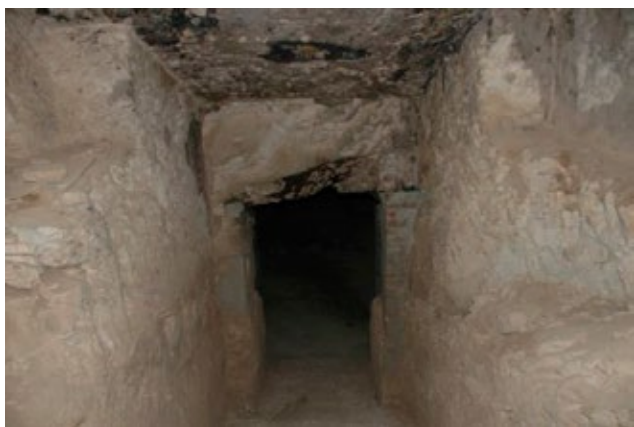
Ramped corridor (E) showing carved ledges of side walls and areas of loss, and rebuilt doorway (F).

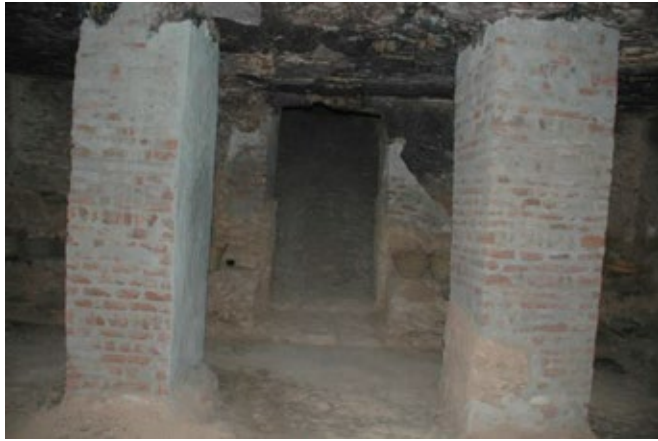
Reconstructed pillars in burial chamber (G) and door jambs of doorway (F) built using modern fired bricks.

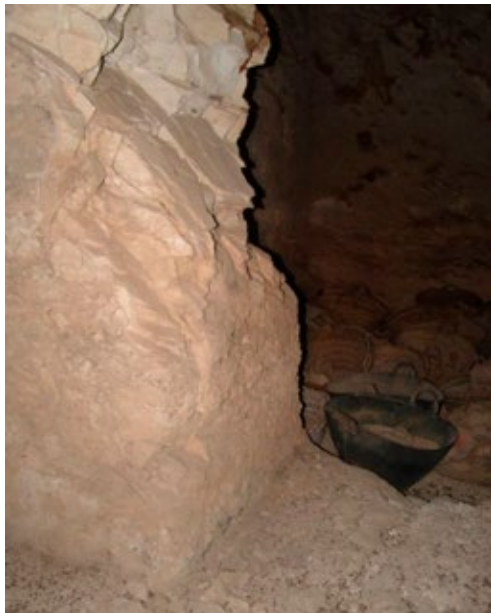
Doorway (J) of side chamber (K). Some rock loss is visible.

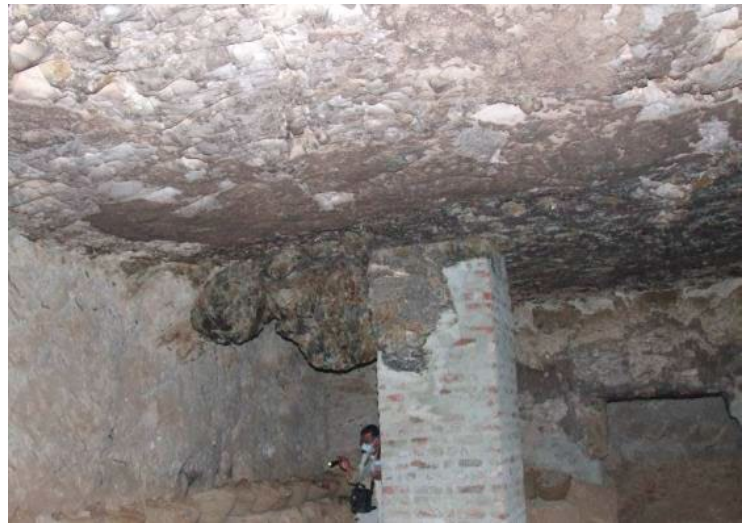
NW pillar in chamber (G), showing surviving top of the rock pillar and reconstructed part below. Thick chert concretion on fire-blackened ceiling indicates major fault zone. Areas of plaster survive at tops of pillars and on ceiling.

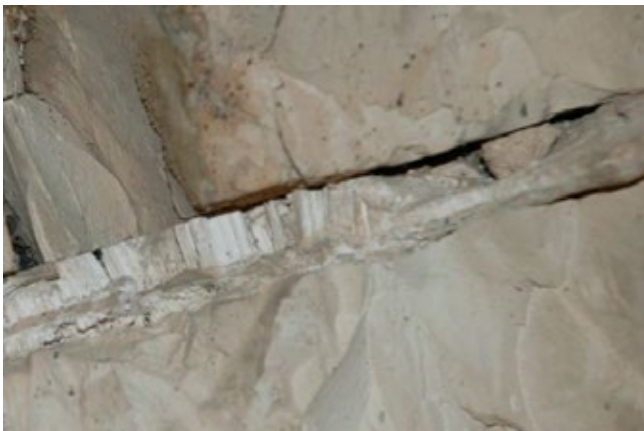
Salt infill of fault zone in antechamber (C).

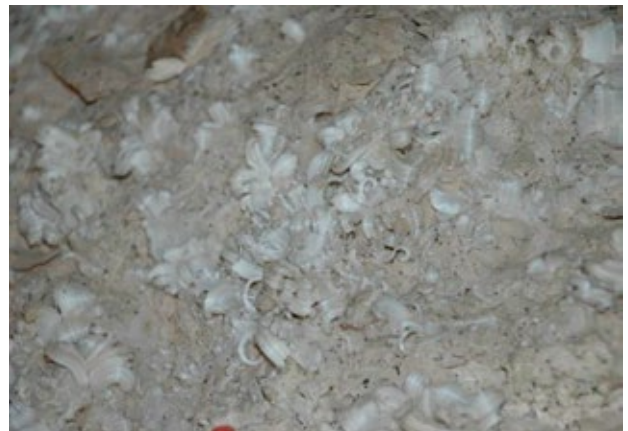
The tomb is cut into an area of rock with open joints and fault planes, often with salt infill. Additionally, widespread salt crystal growth is apparent on the rock surface along most of the east wall of chamber (G), indicating the high content of salts within the rock, mobilized by moisture, which continues to pose a threat to the stability of the rock through the expansion of fractures and faults where salts are present. The loss of rock in the doorways and the four pillars, also indicates that during the many decades that the tomb has been excavated, flooding has likely occurred, as these are the most exposed and fragile parts of the tomb structure.

Substantial salt efflorescence and large crystal growth on east wall in chamber (G).

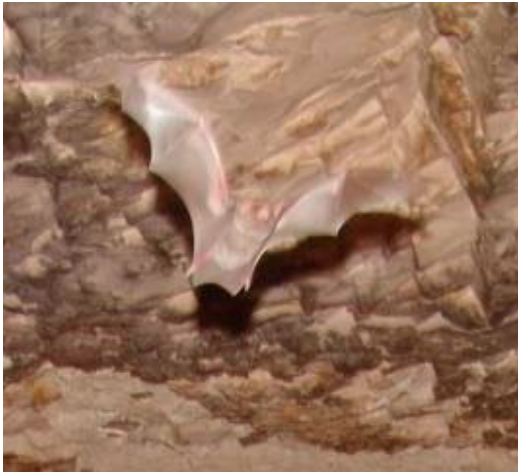
Currently the tomb is not open to visitation. Substantial bat presence was noted and significant quantities of crystalline bat urine and bat feces have been observed and the resulting odor is strong. The tomb entrance is closed by a steel grid door covered with wire mesh that was covered with plastic sheeting by the SCA in November 2008 to prevent bats from entering during testing by the SCA Conservation Center methods of their removal (prior to this there was a small gap between the top of the door and the surround). There are also many insect nests covering the surfaces of the tomb.

Bats were seen during the assessment and their urine and feces is clearly visible throughout the tomb.

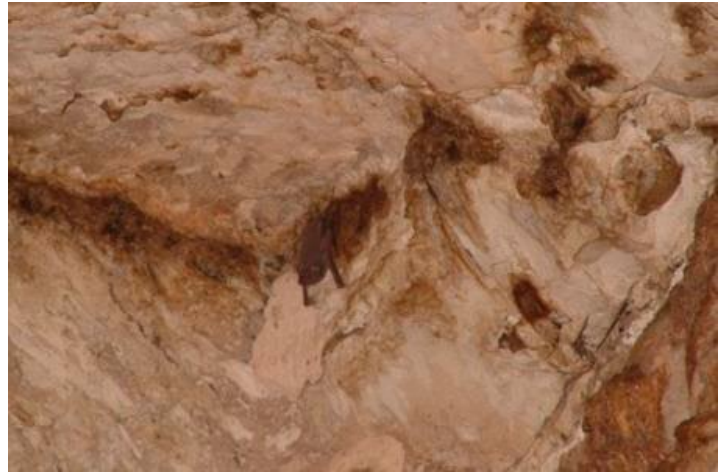
Bats in chamber (K).

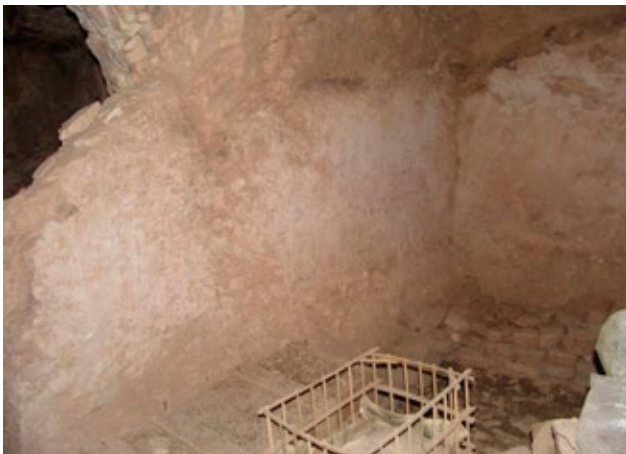
Chamber (C), southeast corner showing large area of surviving decorated plaster.

Stabilization of fragile areas of painted plaster is required to prevent further loss. Scope and nature of interventions will be quite wide ranging. The heat-altered condition of plaster may require stabilization treatments to be specifically formulated, trialed, and implemented.

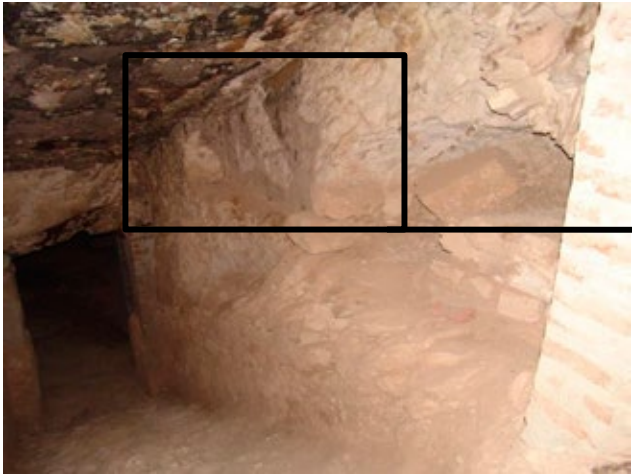
East side of corridor (E). Lower parts of the walls were built up with rocks.

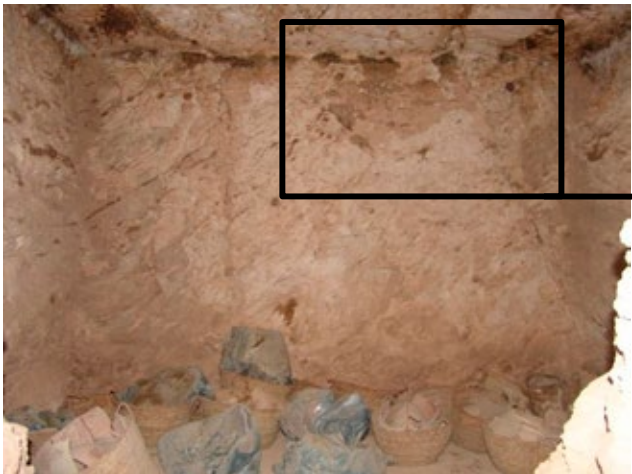
Right upper side chamber (M): small fragments of painted plaster appear heat damaged; paint layer looks to have been carbonized. In some areas the upper plaster layer has been lost which could be due to the fire damage.

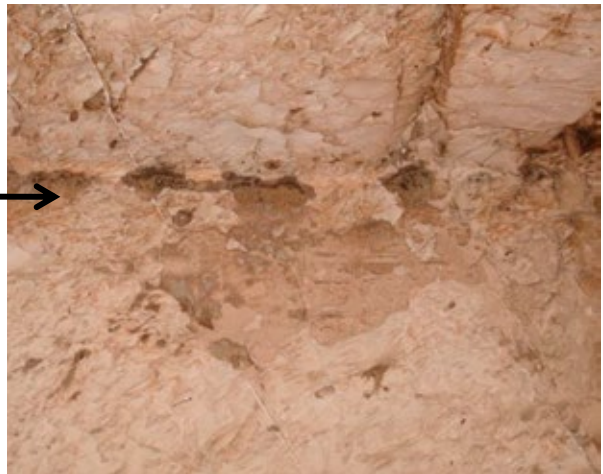
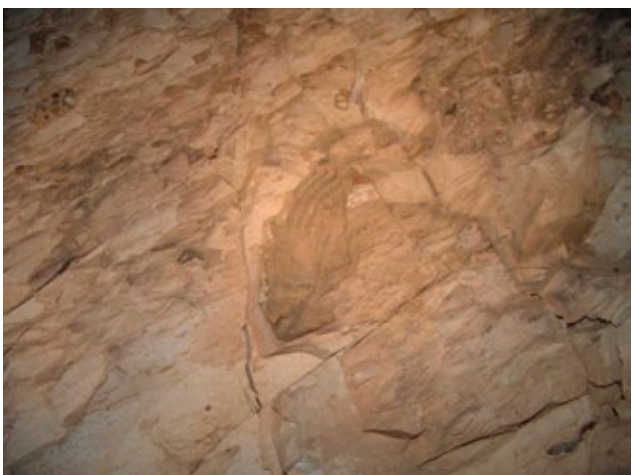
Upper parts of the walls in antechamber (C) have only small patches of surviving plaster that are blackened and heat damaged from fire.

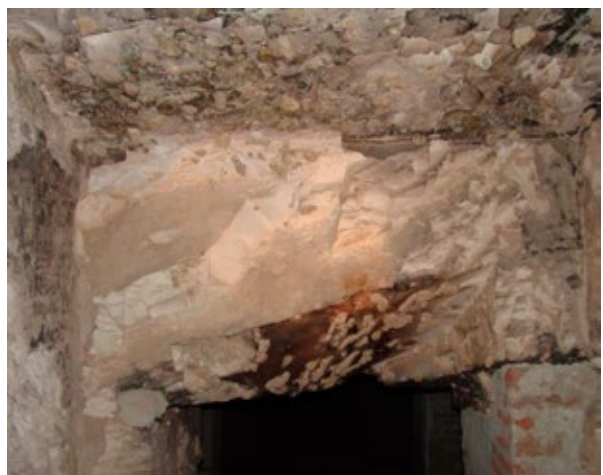
Lots of insect nests cover the surfaces of the tomb.

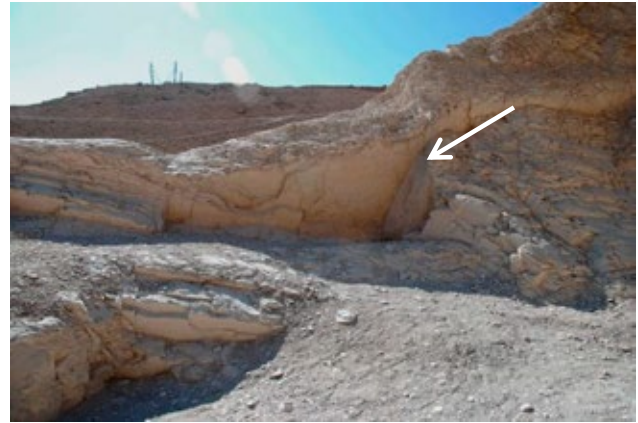
South wall of QV 84 shows deterioration from weathering. Several engravings on the rock surface are observed.

It is recommended to leave them as they are, since they are only shallow trenches.

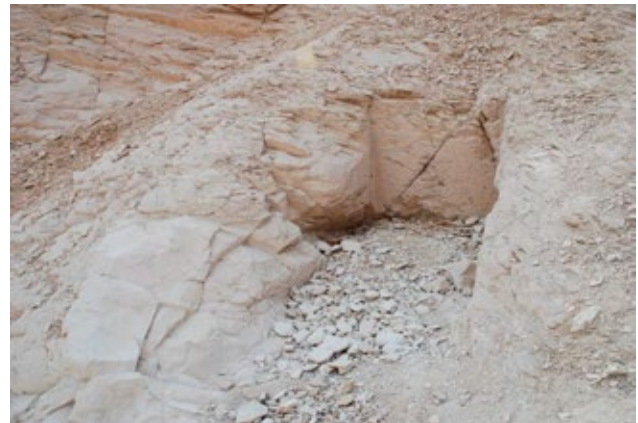
Marl rock of QV 85 is weathered and exposed to rainfall. There are vertical fractures at south and north corners and an area of loss in the east wall of the ramp.

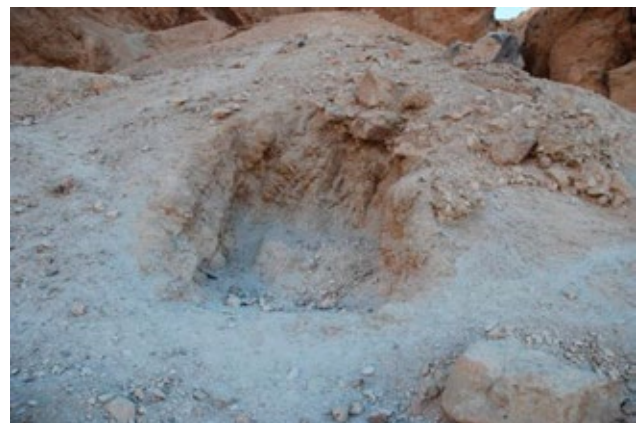
QV 86

Marl rock surface is heavily weathered and fractured along joints at QV 86. Rock surface also presents damage due to exposure to water.

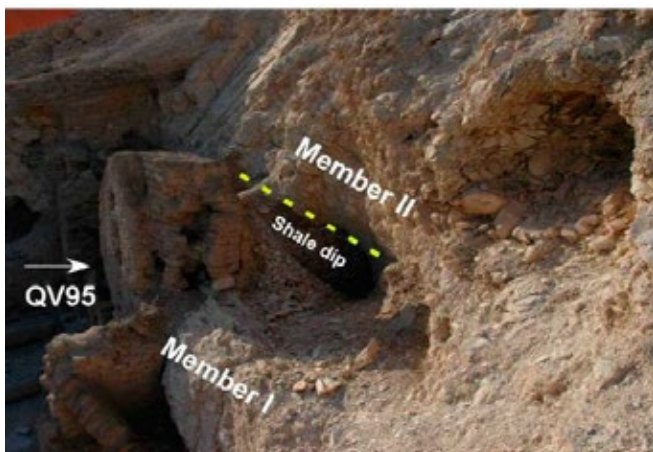
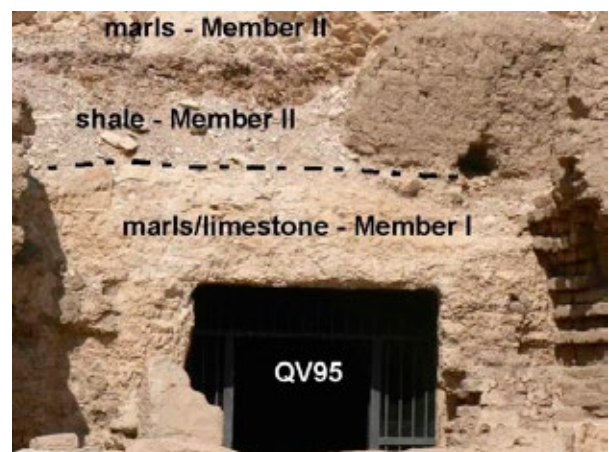
Geological stratigraphy of tomb exterior.

The presence of a layer of marl running through the tomb and on the surface of the rock slope above the tomb door does not currently pose a structural threat to the tomb, but it could in the future due to its weaker, more clay-rich nature, if exposed to water. The rock surrounding the tomb door presents areas of loss in the lower half on the east side, and is highly fractured on the west side.

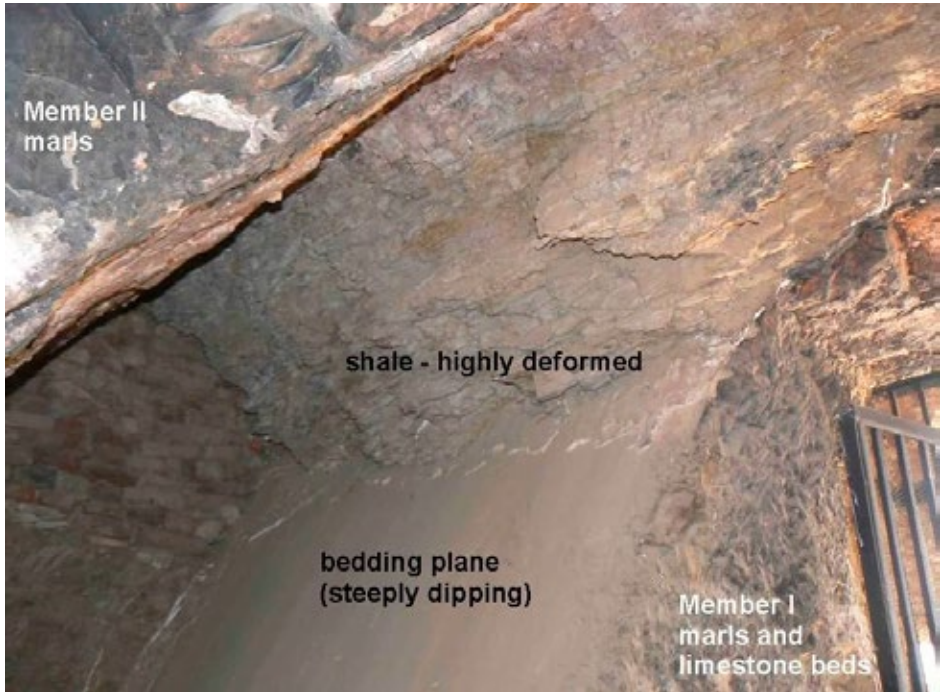
The highly fractured and heavily jointed marl layers present areas of localized loss in the walls and ceiling, particularly on the east side of the chamber at the corner of the niche to the east. There is a wide vertical crack running through the east and west walls of the chamber, but wall plaster remains are located over it on the west wall, so it appears to be stable.

Overview of geology in tomb interior.
