Valley of the Queens Assessment Report

Volume 2

Assessment of 18th, 19th, and 20th Dynasty Tombs

A collaborative project of the Getty Conservation Institute
and the Supreme Council of Antiquities, Egypt

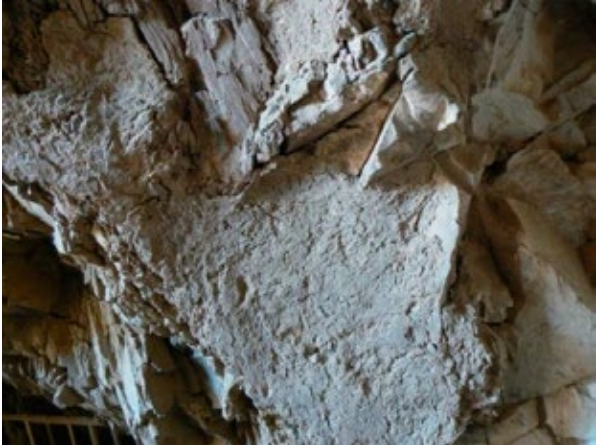
The small fragments of wall plaster in the west niche present areas of detachment, particularly along the edges. There are signs of flood debris on the floor. The walls and ceiling are covered with black deposits presumably due to fires, and urine deposits are found on the rock ceiling and wall surfaces as well, due to the prior habitation by bats. Bird nesting and dropping in the tomb is ongoing.

Extant plaster on west wall.

The remains of the earth plaster should be stabilized with edging repairs and grouting as needed.

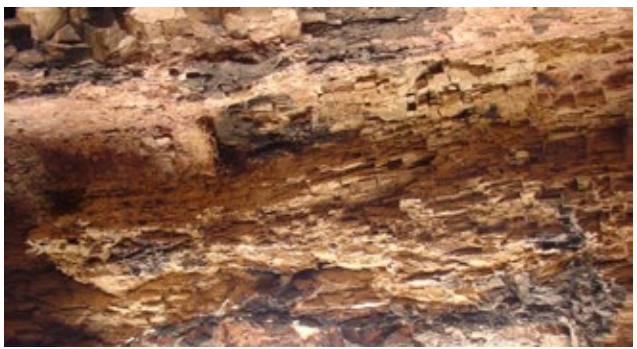
Fractured marl inside tomb, above entrance.

The rock cut doorway should be stabilized with masonry infilling of areas of loss.

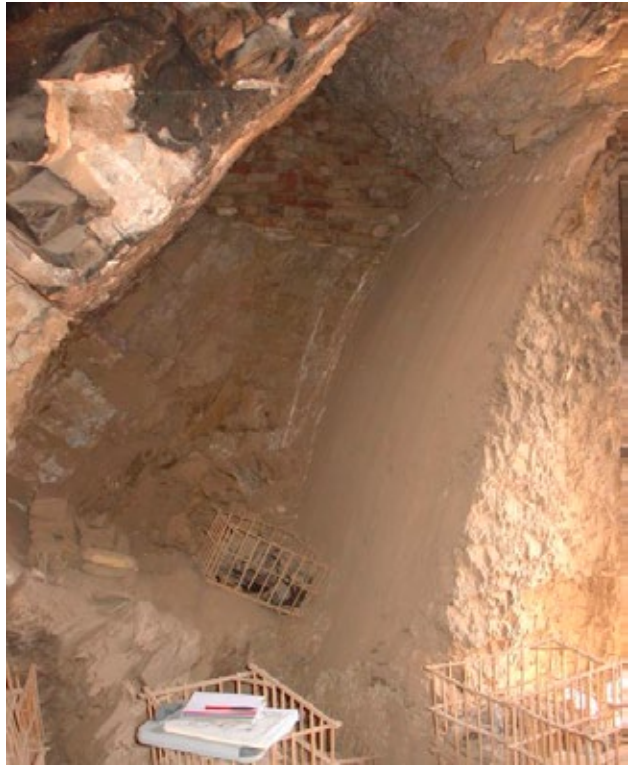
Highly fractured rock and areas of loss in the tomb are due largely to the inherent clay-rich qualities of the rock, and the paucity of the wall plaster remains is due to its fragile nature and possibly the reuse of the tomb, including present use for storage, although it is not known what the plaster's original extent was within the tomb. We also don't know to what extent the space was plastered. The presence of flood debris indicates that water has also been a cause of fracturing of internal rock.

Fractured rock in main chamber
