Conservation Management Plan

GROPIUS HOUSE

68 Baker Bridge Road
Lincoln, Massachusetts

Historic New England
Baseline Report: 2016

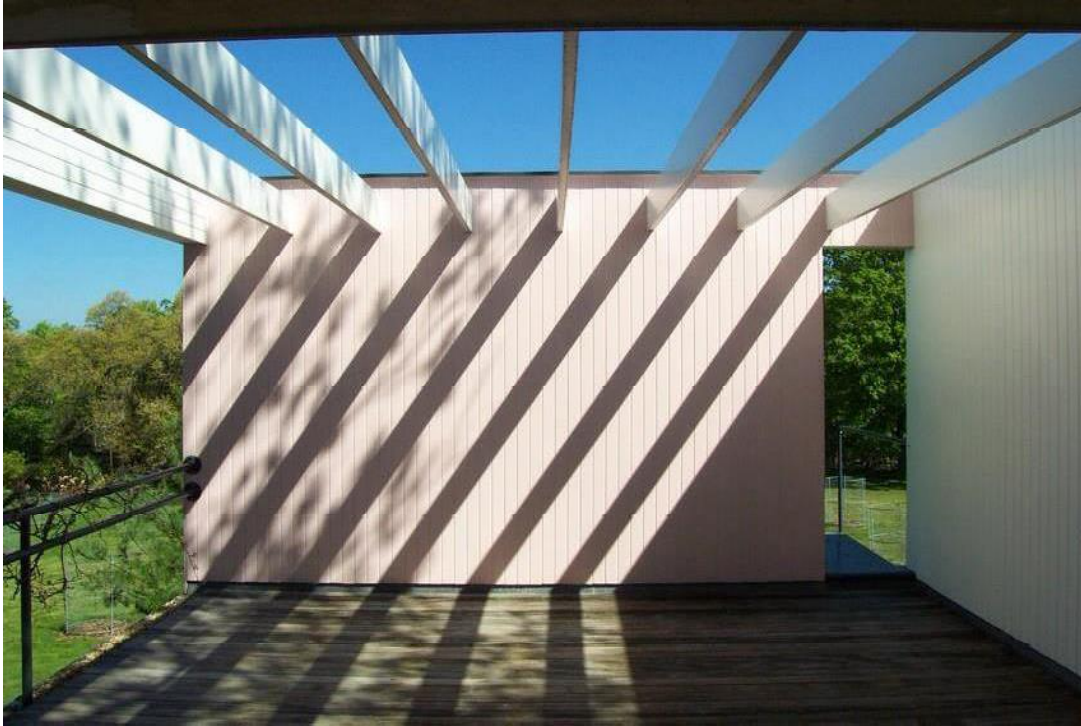
Figure 3: Pink wall of roof deck, 2002
RS ID #57076

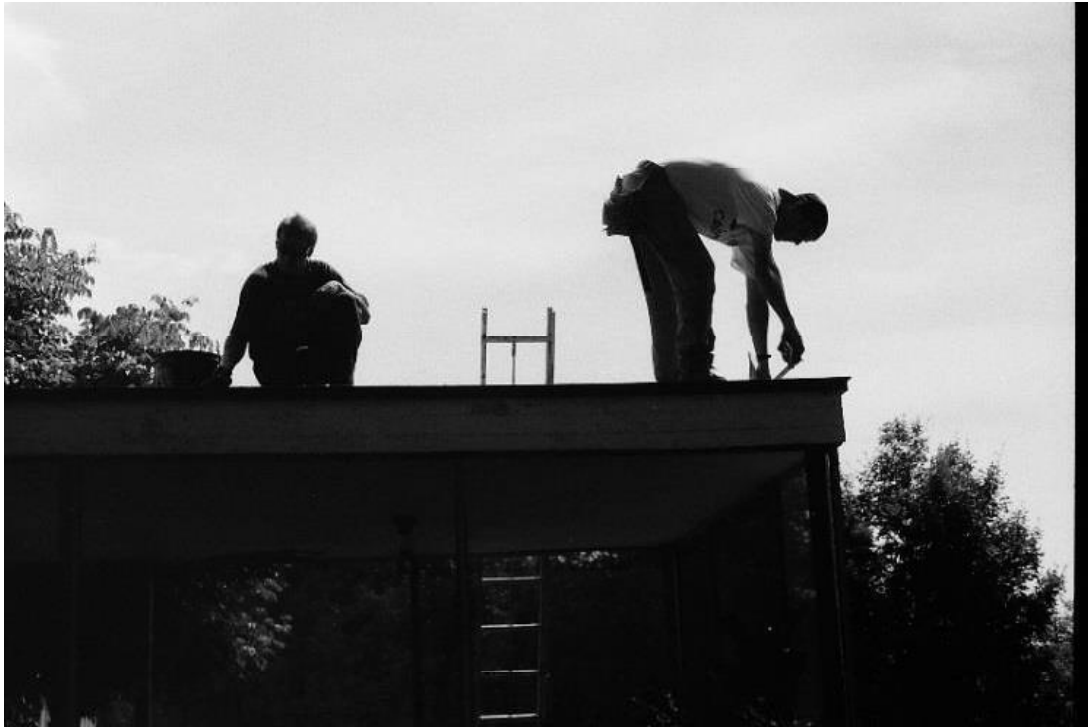
Figure 6: Screen Porch Roof testing, 1996
Historic New England, Property Care Binders

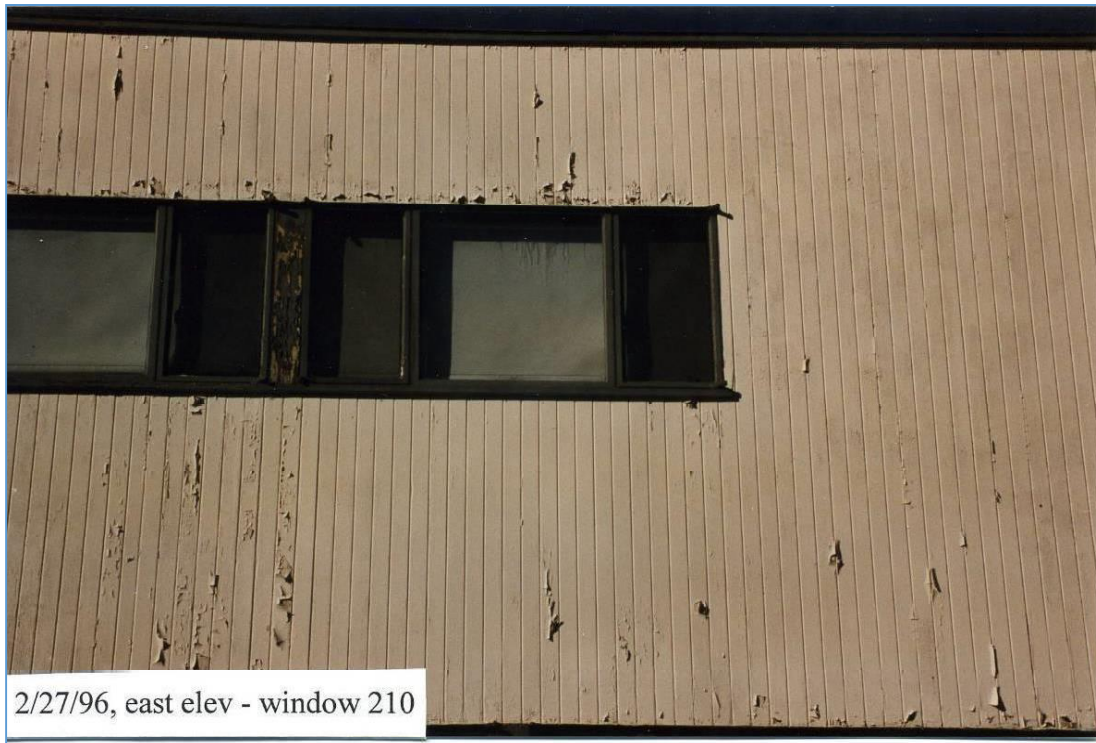
More analytical work in 1993 found that water blisters and discoloring in the lead-based and modern paints that followed the tempera layers caused adhesion issues, and improper cleaning of dirt and biological growth between paint layers exacerbated these problems.³⁶ Several different methods of repainting were carried out on the siding in test patches, and only the finish applied to a space completely scraped of older paint and primer lasted into 1994.³⁷

Figure 4: Siding condition, 1996
Historic New England, Property Care Binders

In 1996 several approaches to removal of paint layers were tested, and the siding on the east elevation and under the sash extending to the front door was removed for chemical stripping.³⁸ Its surfaces were then prepared for paint with a wash and light sanding.³⁹ Finally, it was painted with two coats of primer and two coats of finish paint and reinstalled in 1997.⁴⁰ In 1998 the siding around the north windows, above the porch, the marquee, the main roofs, and beneath second story porch deck had to be removed for window and roof repairs, so they were stripped and repainted as well.⁴¹ The same process was carried out on

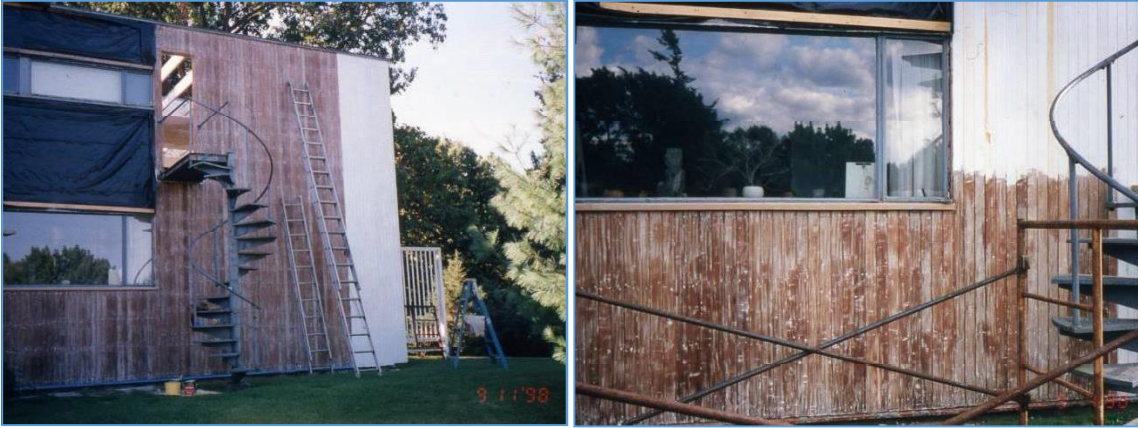
the west elevation siding during window repairs in 2001, but with the addition of a consolidant referred to as "Special Sauce" that includes boiled linseed oil, a known mold medium.⁴²

Figures 5 and 6: Exterior paint is stripped, 1998
Historic New England, Property Care Binders

In 2007 the siding was cleaned with D/2 solution in an attempt to kill accumulating biological growth, but the problem returned only a month later.⁴³ The next year an antifungal treatment was used. In 2014 the exterior was cleaned using Zinsser JOMAX®, but mold growth was evident by the end of the year on all washed surfaces.⁴⁴ The pink wall and white walls of the deck were washed and repainted. The mold growth of the pink wall has been less visible since 2014, but the white walls clearly showed a return of the mold by the end of 2014. In 2016 a conservation plan for the preservation of the siding was completed by Jablonski Building Conservation, Inc. (JBC), and included the results of new test patches for methods of removing biological growth (*Figure 7*).⁴⁵ While the cleaning solutions mostly did work, the siding was moldy again six months later. The only areas that remained clean are likely to have been primed with a product containing zinc.

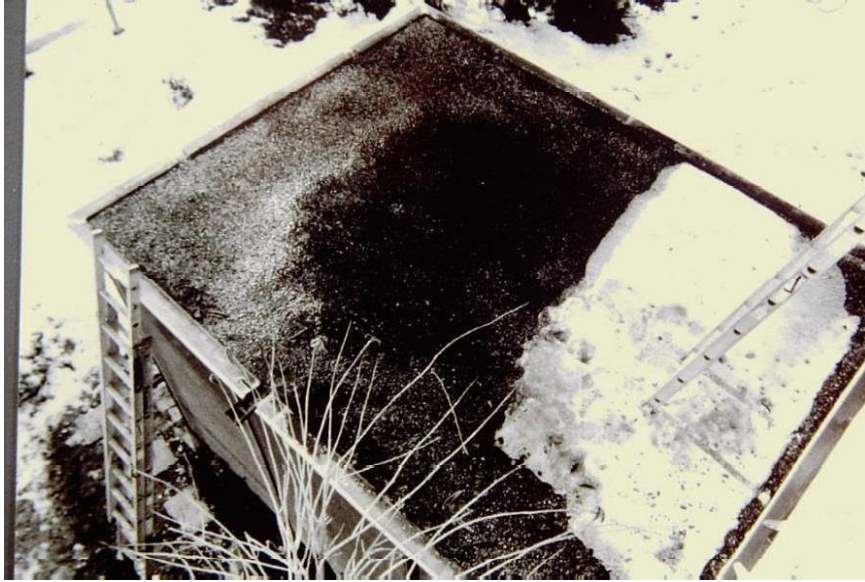
In 1967 a roof leak was repaired and flashing and roofing were installed, but no details about this work are available.³¹ Two years later an engineering firm inspected the porch roof and expressed intentions of installing an interior drain there to prevent water from accumulating.³² They also proposed the addition of insulation in order to raise the interior level of the roof and facilitate draining, in the case that the interior drain was not feasible.³³ A 1970 invoice from the contractor hired by the engineers suggests that either the drain or the extra insulation were installed, but it is unclear what their work actually entailed.³⁴

Figure 5: Porch roof, 1990
Historic New England, Property Care Files

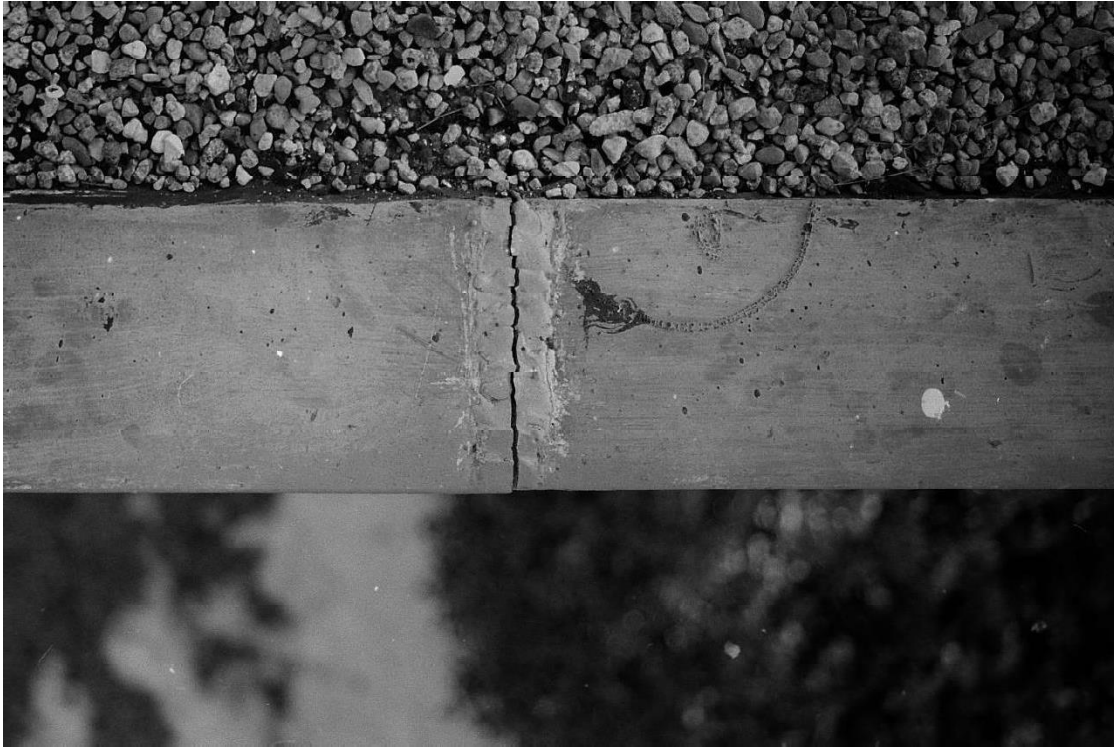
In 1992 an architectural conservator found that the flashing was original to the house, and he asserted that leaks through its joints were contributing to the house's moisture problems (Figure 6).⁴⁹ The following year an expert on coal tar roofing systems visited the house for another analysis. He agreed that the flashing needed to be replaced, but said that the roof itself would last a long time and only needed the application of a re-saturate.⁵⁰ He also recommended that the drains and scuppers on the porch roof be cleaned twice a year, and that strainers be installed on the canopy's drains.⁵¹ Perhaps in response to this advice, the gutters cleaning was included on a budget lists for that year.⁵² The flashing repairs were finally completed in 1994, but by the next year they had already failed.⁵³ The contractors returned to fix their mistakes in 1995, but their work was unsatisfactory again.⁵⁴ It is unclear whether or not they ever finished the job in manner acceptable to SPNEA.

Figure 6: Solder joint of flashing, circa early 1990s
Historic New England, Property Care Files

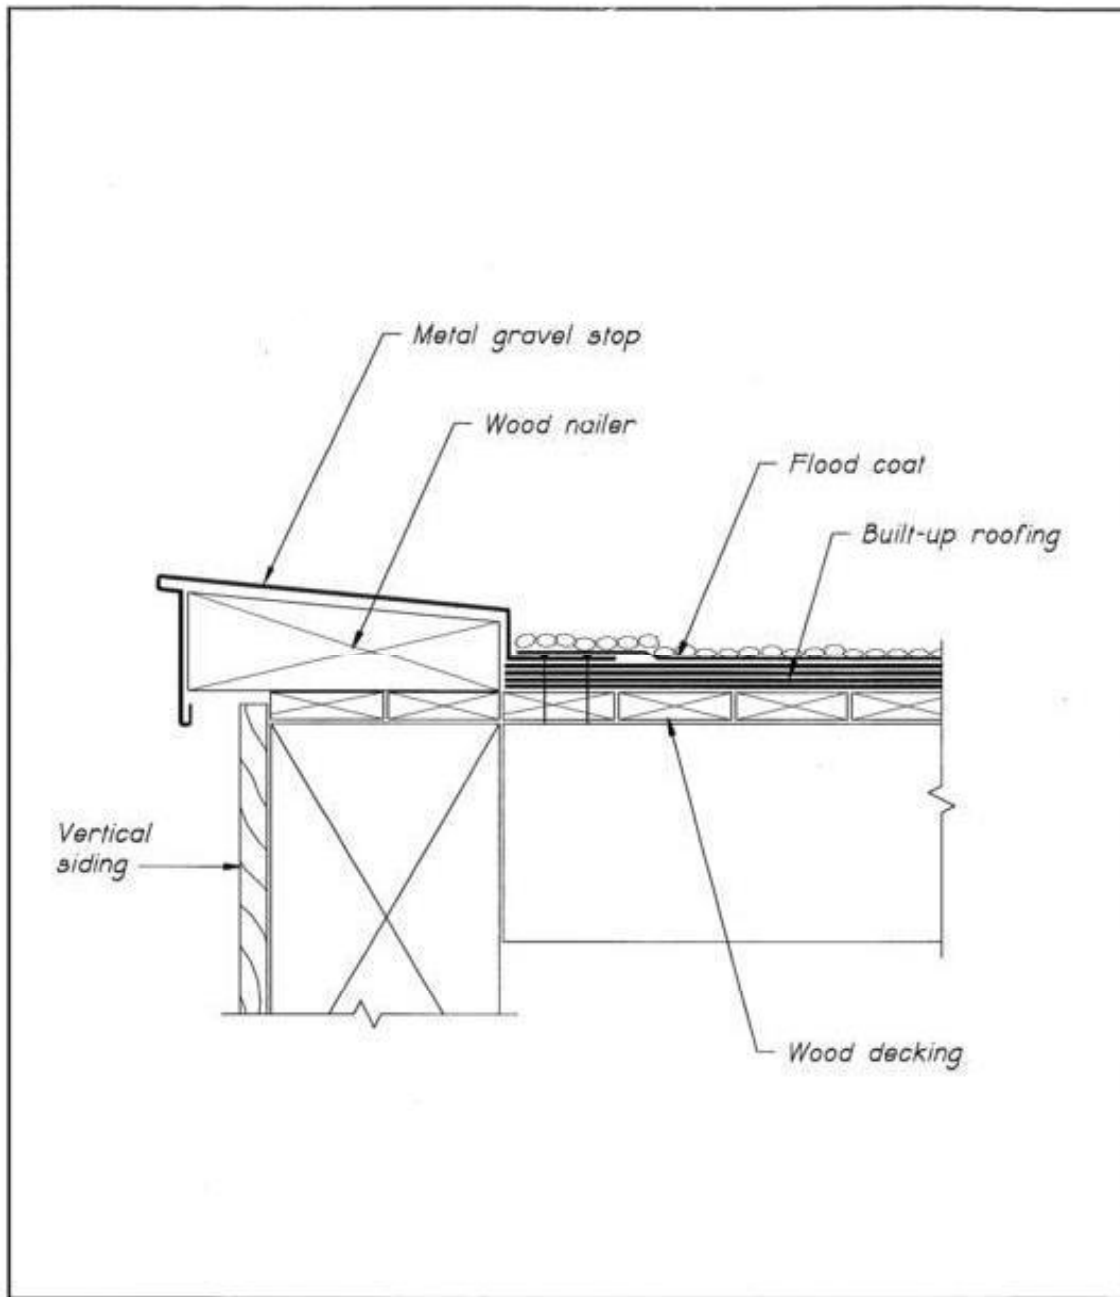
Existing conditions of gravel stop and cornice, Simpson, Gumpertz & Heger, Inc., 1996

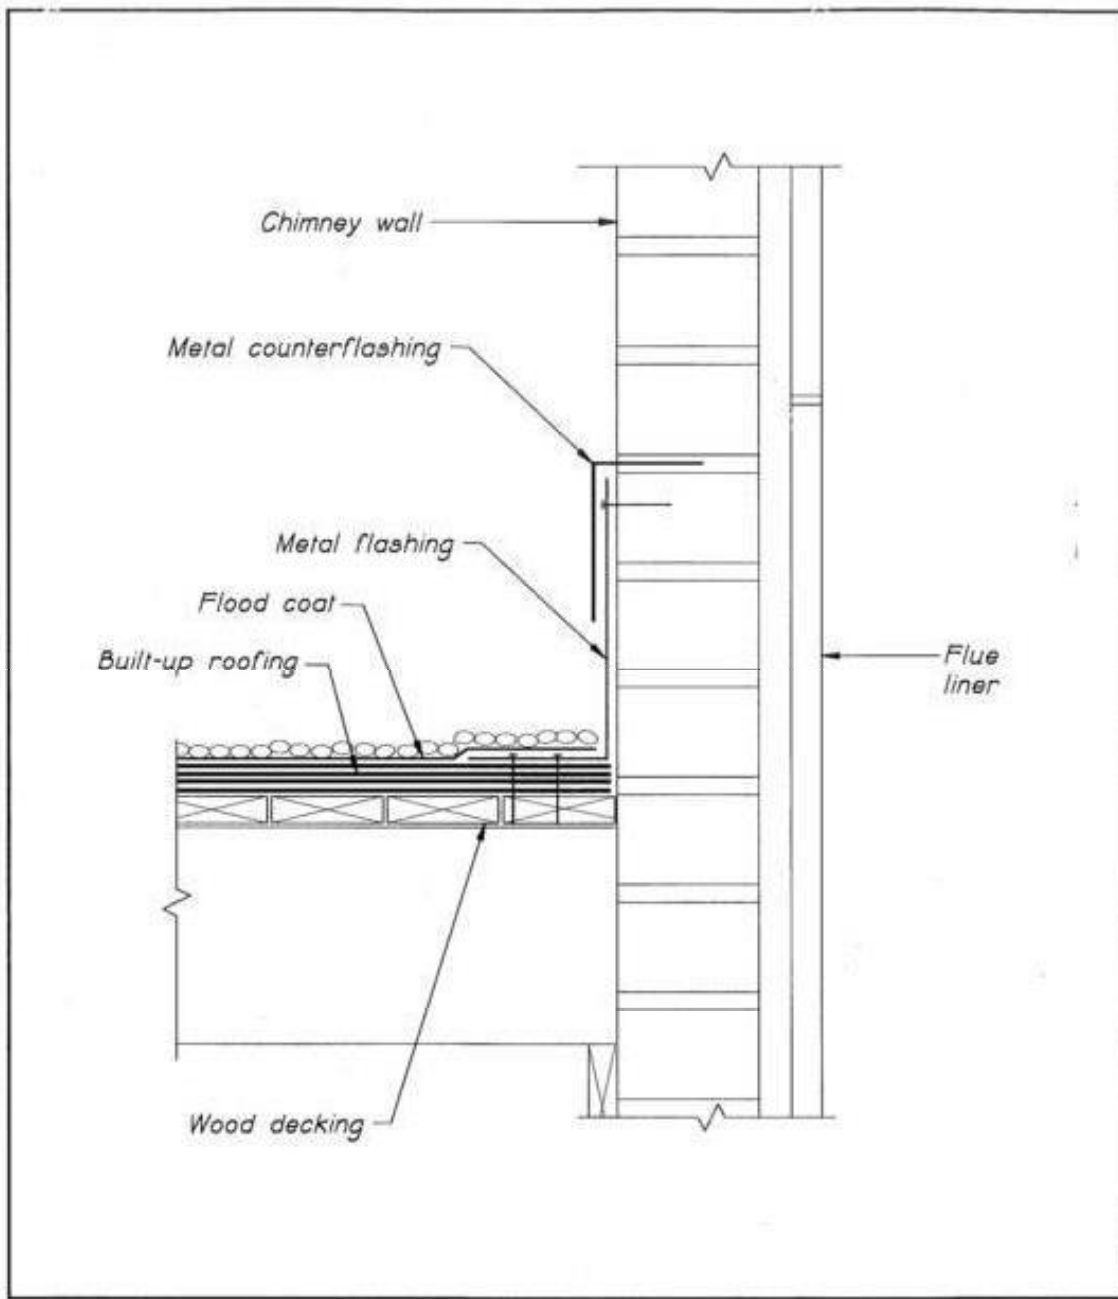
Existing conditions of chimney wall, Simpson, Gumpertz & Heger, Inc., 1996

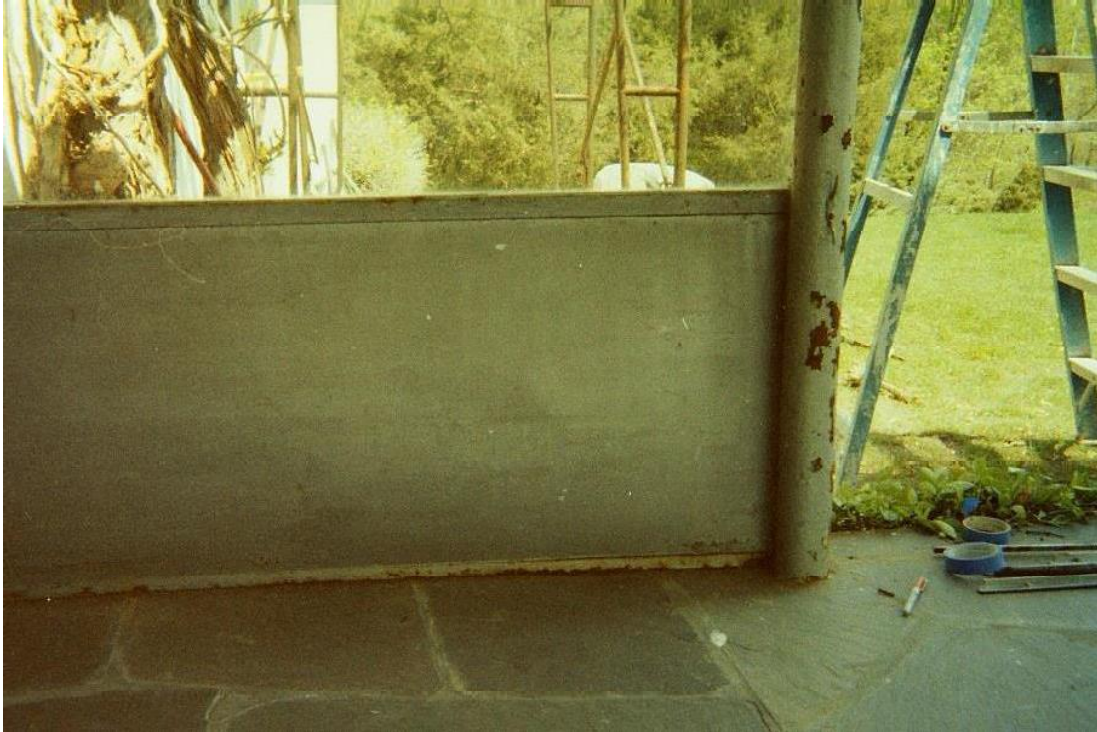
Figure 3: Damaged steel column near porch, 2001
Historic New England Property Care Binders

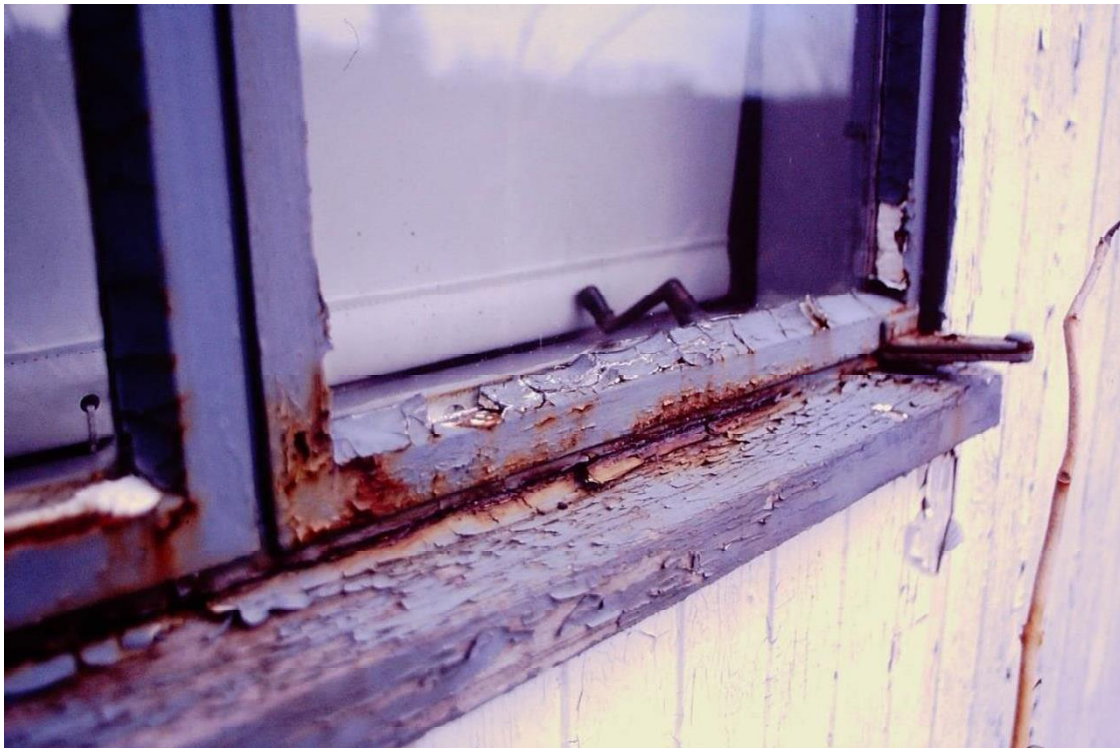
In 1989 a study of climate control carried out by Landmark Facilities Group found the windows to be the source of moisture-related problems in the house.³⁴ This was due to their design, along with the presence of the vertical siding and the excessive shading from trees that allowed rain to penetrate the structure.³⁵ Sills were rotting in the kitchen (W1.9) and in the first floor bathroom (W1.2) due to window condensation that developed when the resident overseer used the sink and shower in the winter.³⁶ The windows' single layer of glass and the steel casements made the building unable to contend well with winter humidity generally.³⁷

Figure 5: Rust on the south elevation master bedroom window, 1990
Historic New England Property Care Binder, Lyman Estate

Likely due to these factors, rust on the window frames' interior continued to present problems through 1991, in addition to questions about how to clean the UV film.³⁸ Repair

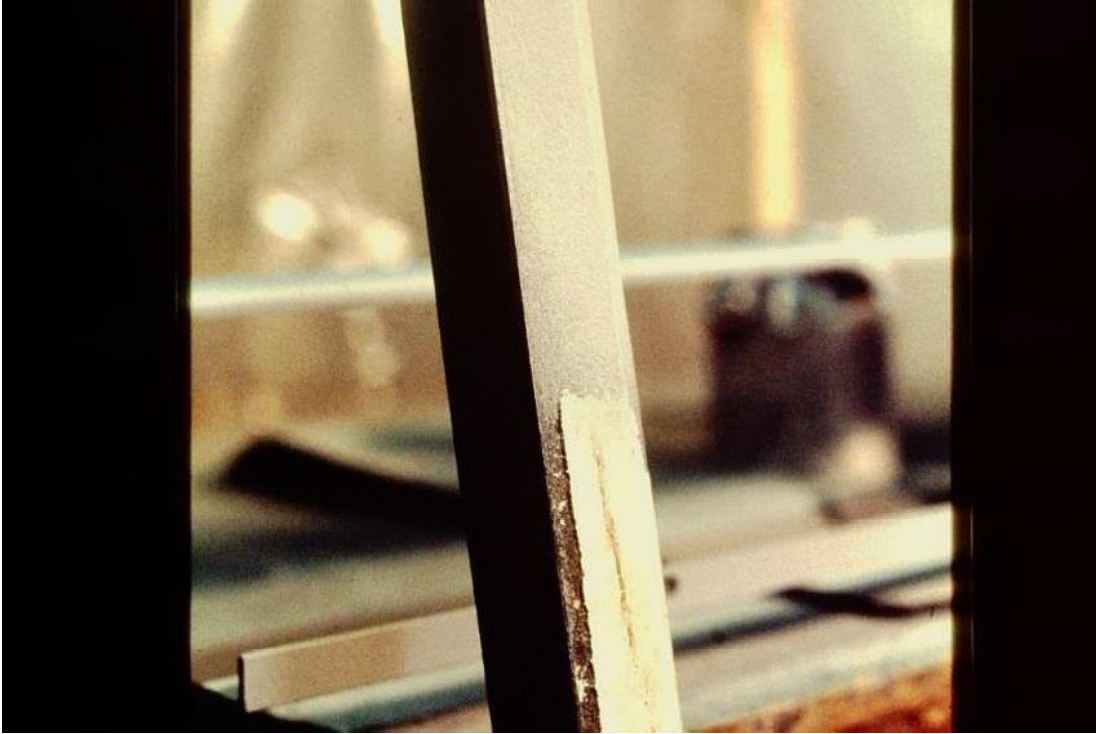
Figure 6: Steel window frame during grit blasting, 1995
Historic New England Property Care Binder, Lyman Estate

In 1995 a paint analysis of the house's exterior revealed the window surrounds' color history and paint adhesion issues. The rusting metal frames were pushing the paint away from the surface, which was exacerbated by the ongoing moisture problems.⁵¹ The same was true of the wooden window surrounds, which were covered with moldy paint layers.⁵² On both the frames and the surrounds, layers of paint containing oil-based and synthetic emulsion binding mediums adhered poorly to one another. There was also evidence of a metallic priming layer on the metal and the wood.⁵³ The colors of the paints on both features were various grays, and the shade chosen for repainting was Benjamin Moore's Westcott Navy (#1624).⁵⁴

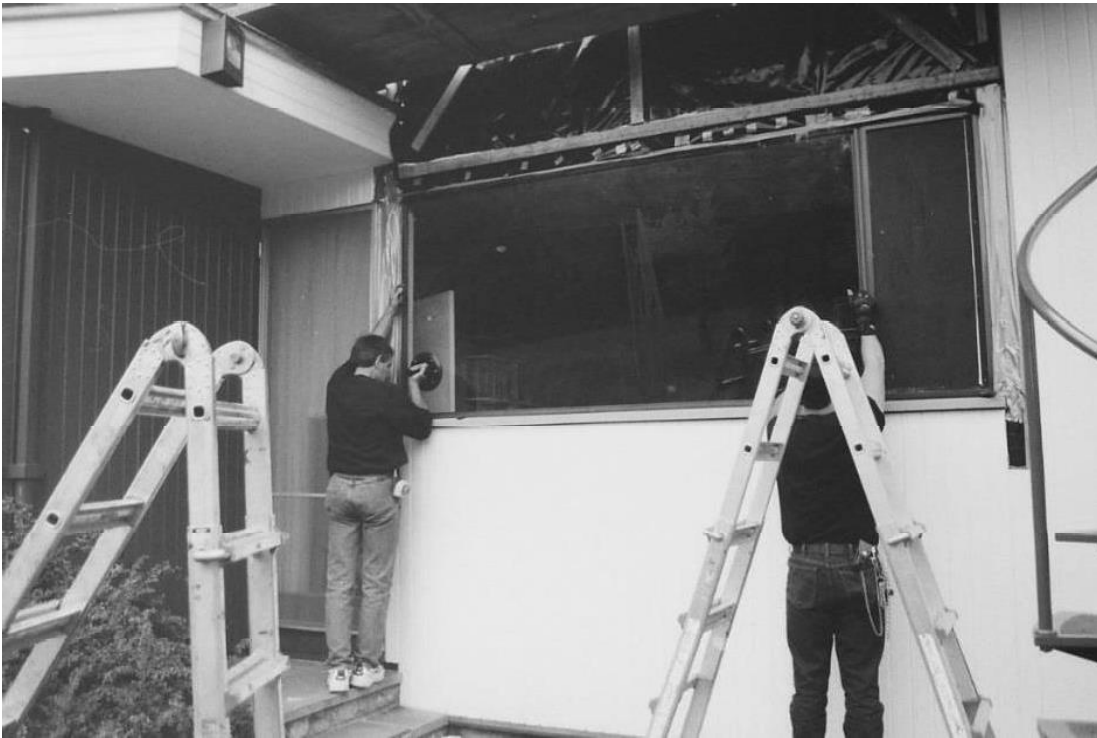
window, the windows on the east elevation underwent a similar repair process in 1997 with the addition of new lead-coated copper flashings (*Figure 7*).⁵⁷ In 1998 the same work was carried out on the windows of the north elevation, including welding and repairs of bottom rails and stiles of the fixed windows.⁵⁸ The damage to vent windows was more limited.⁵⁹ The glass in the study window (W1.4A) had to be replaced after it was cracked during the removal process.⁶⁰ UV film was reinstalled at the same time.⁶¹

Figure 7: Steel window restoration work, 1997
Historic New England Property Care Binder, Lyman Estate

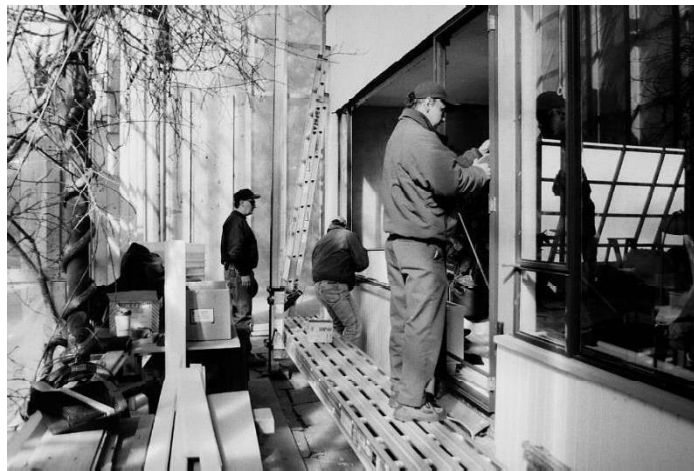
When the glazing was removed during the Save America's Treasures (SAT) grant project in 2001, it was bagged and three types were identified.⁶⁸ However, no information gleaned from these samples appears to have been recorded. Another note indicates that the problem may have come down to adhesion issues with the finish paint rather than the glazing, but this too is unclear.⁶⁹ In any case, the windows on the south and west elevations were eventually removed, repaired, and reinstalled as part of the SAT grant project (*Figure 8*). The process was similar to that which had been carried out on the other elevations, and included cutting the frames in two unspecified places and welding in new material.⁷⁰ During their work staff found that the west living room window (W1.5) was somehow larger than its frame, so it had to be cut out.⁷¹ In addition, the south living room window (W1.6) broke during removal and had to be replaced.⁷² The project solved the major window problems that had been plaguing Gropius House for years.⁷³

Figure 8: Window repair during the SAT grant project, 2001
Historic New England Property Care Binder, Lyman Estate

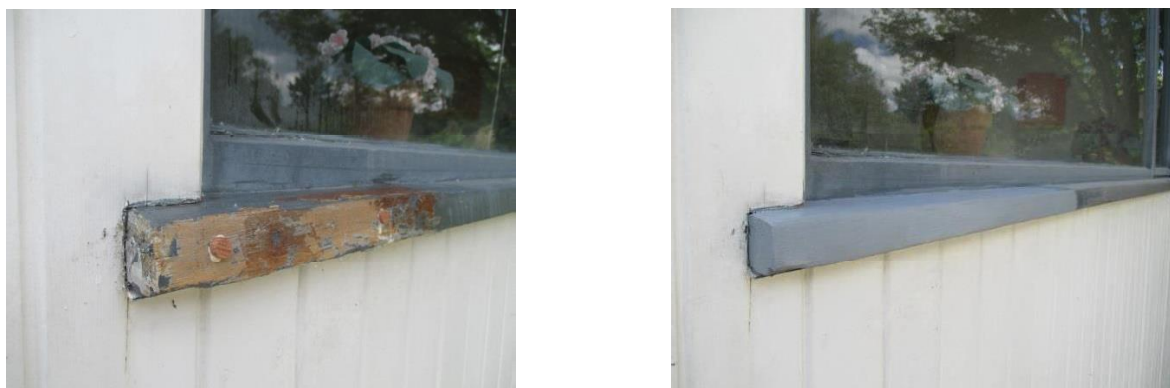
Two tempered glass windows were re-glazed in 2003, and spot glazing also took place in 2013 and 2014.⁷⁴ In 2015 the wooden sill of the kitchen window (W1.9) pulled away from the building, allowing water into its interior and causing deterioration of the wall cavity.⁷⁵ A Dutchman repair was carried out on the sill (*Figures 9 and 10*).⁷⁶

Figures 9 and 10: Sill repair, 2015
RS ID #249326 and RS ID #249330

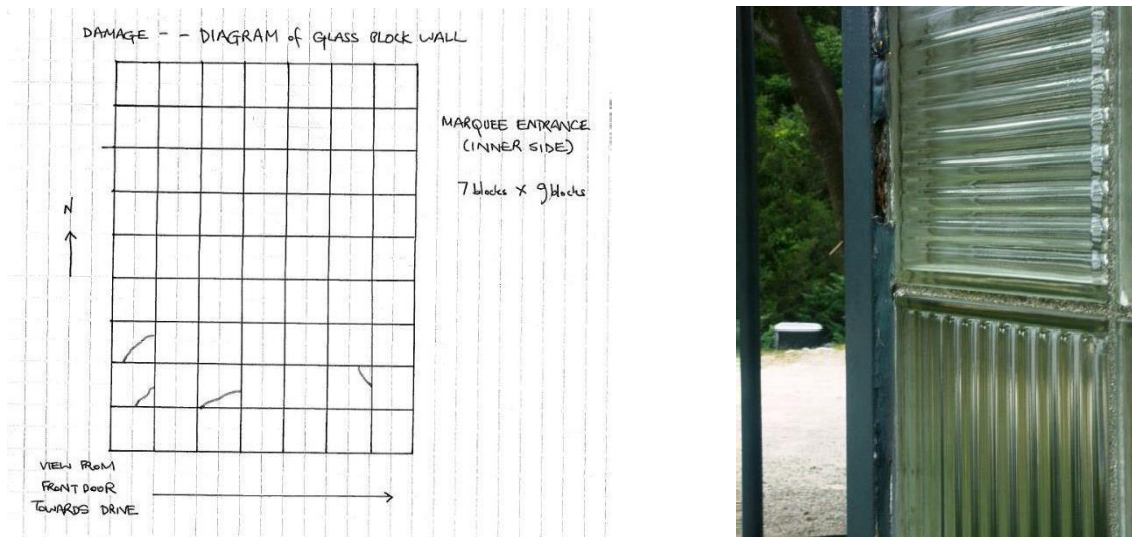
Figures 4 and 5: Sketch of glass block wall condition, Annabel Hanson, 1996 and failure of glass block caulking, 2009

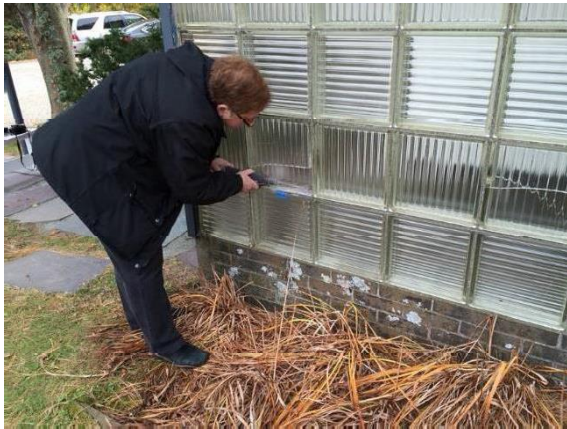
Figure 6: Mary Jablonski surveys broken glass block, 2015.
RS ID #265467

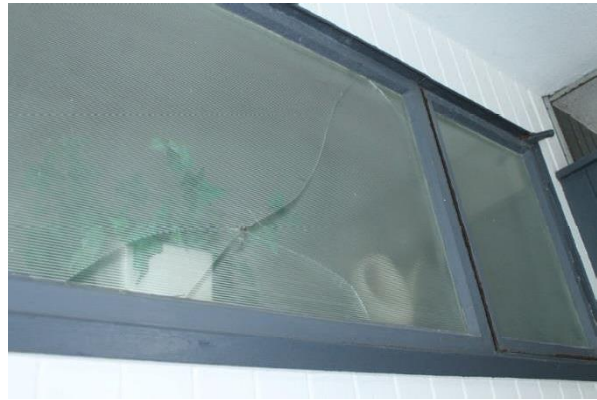
Figure 7: Crack in ribbed glass on south elevation, 2015
RS ID #277155

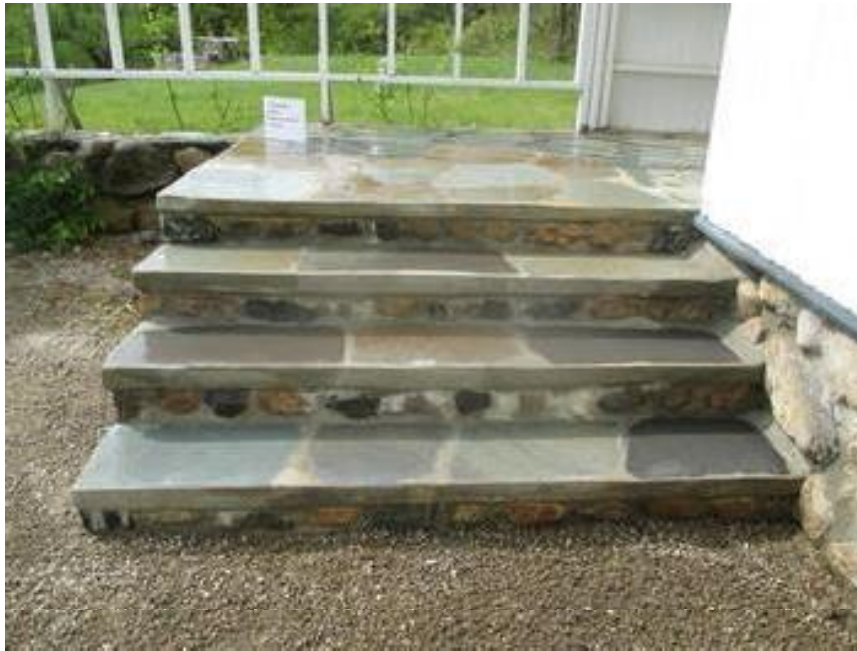
The first recorded intervention on the kitchen steps took place in 1986 during a Massachusetts Historical Commission (MHC) grant project undertaken by the Society for the Preservation of New England Antiquities (SPNEA). The steps needed to be rebuilt entirely after frost heaving caused the flagstones to loosen from the concrete, but due to budget constraints the flagstones and cement trim were simply patched.⁸ In 1997, unspecified repairs were carried out on the feature.⁹ It was finally reconstructed in 2001, but the flagstones were coming loose from the concrete stairs again by 2012.¹⁰ They were collected and stored by Historic New England staff to allow for the replacement of the mortar.¹¹ Further repairs were required two years later after the mortar failed completely.¹² By 2016 the nosing on the stairs presented a trip hazard, so it was repaired by Historic New England (*Figure 4*).¹³

Figure 4: Kitchen steps after nosing repair, 2016
RS ID #278687

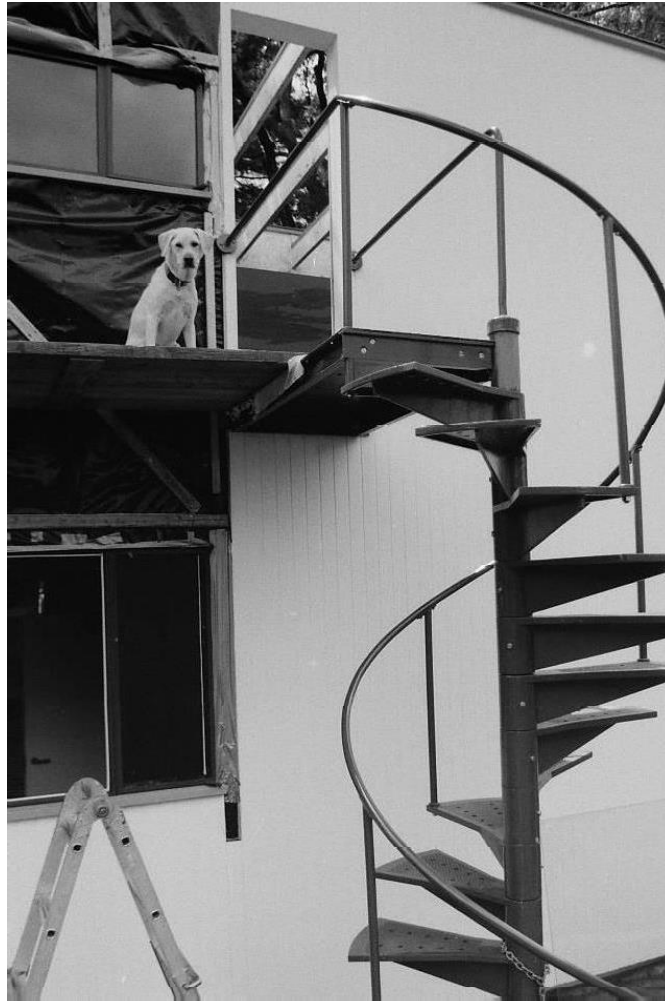
The limited budget of 1986 MHC project prevented the blast-cleaning and refinishing of the spiral staircase that was necessary at the time, but the feature's rusty areas were brushed or ground smooth, spot-primed, and painted instead.¹⁴ The staircase was exhibiting severe corrosion by 1997.¹⁵ It was finally grit-blasted the following year, and subsequent treatments included hot-dip galvanizing, new coats of paint, and the brazing of three rings attaching treads to the center post.¹⁶ The stair was reinstalled about ¼ off the building in order to allow for water drainage. The top threshold was loose in 2009, and it was repaired within the next few years.¹⁷

Figure 5: Spiral staircase, 1997
Historic New England Property Care Binders

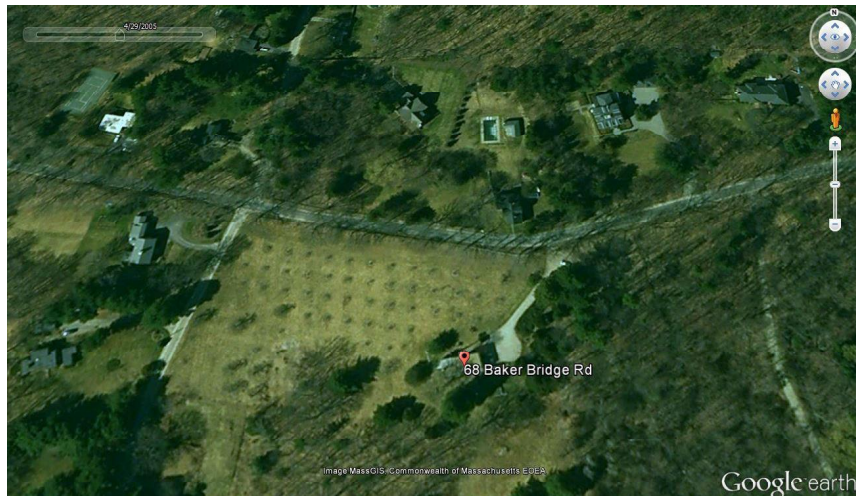
Figure 10: Orchard's grid pattern restored, 2005
Google Earth

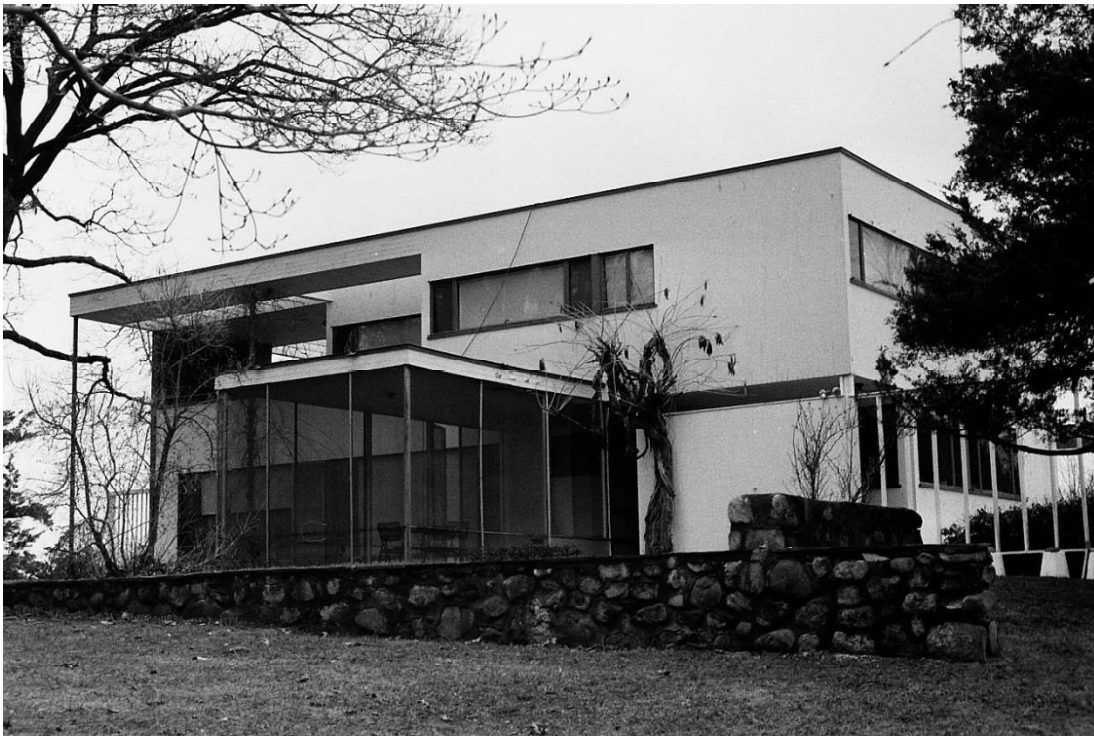
Figure 3: Retaining walls reflecting edges of house, 1994
Historic New England Property Care Files

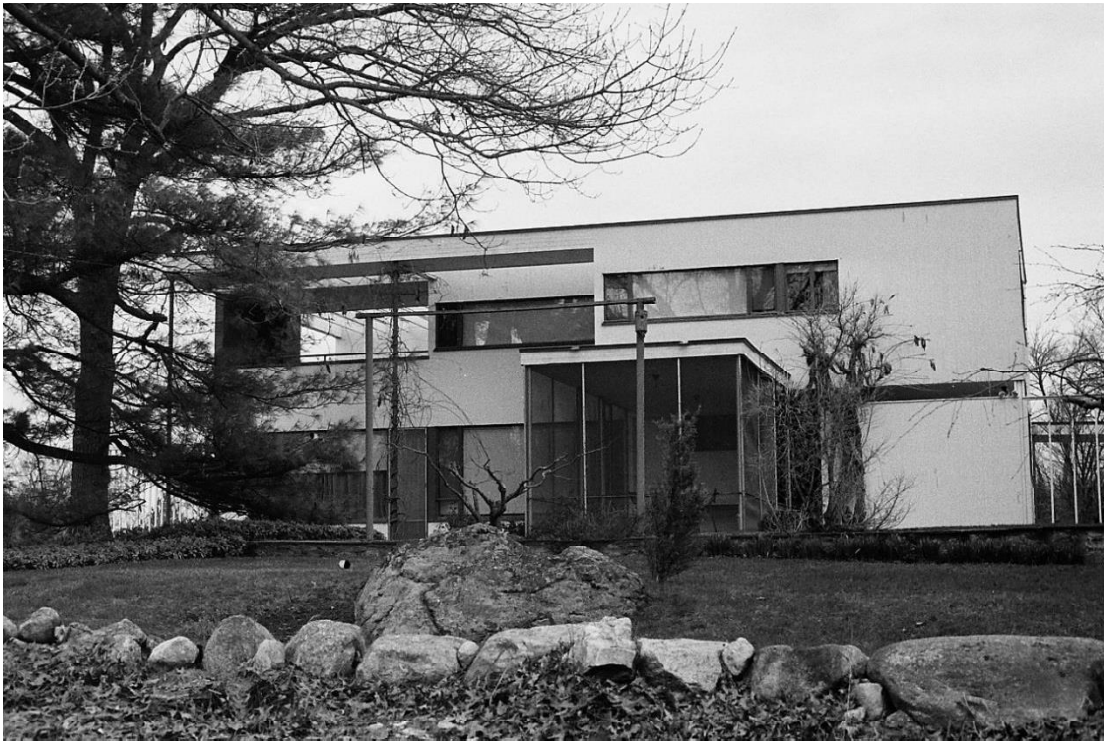
section of the wall along Baker Bridge were included on a to-do list.¹⁹ By 1994 an unspecified wall needed repairs to the southeast and the stone walls were included in the major improvements and wishes sections of a 1995 budget list.²⁰

Figure 5: Old drystone wall and newer retaining wall parallel to south façade, 1994
Historic New England Property Care Binders

The stone walls were reset in 1996 after the site's grounds were disturbed for an excavation related to utilities maintenance.²¹ One year later the flagstone capping on the west wall was reset, and an unidentified fieldstone wall was rebuilt at the same time.²² In 2009 a comprehensive stone wall project was carried out. Fallen stones from the crumbling wall bordering Baker Bridge Road were replaced, and a section of the wall near the east trellis was rebuilt after it had been damaged by a snow plow.²³ Stones in a fifteen-foot section of the wall behind the porch had moved outward due to freeze/thaw action in the ground over time, so the mortared wall was rebuilt (*Figure 6*).²⁴ Finally, some of the unstable flagstone caps behind the house were reset in new mortar.²⁵ Similar flagstone capping repairs were carried out in the next year.²⁶

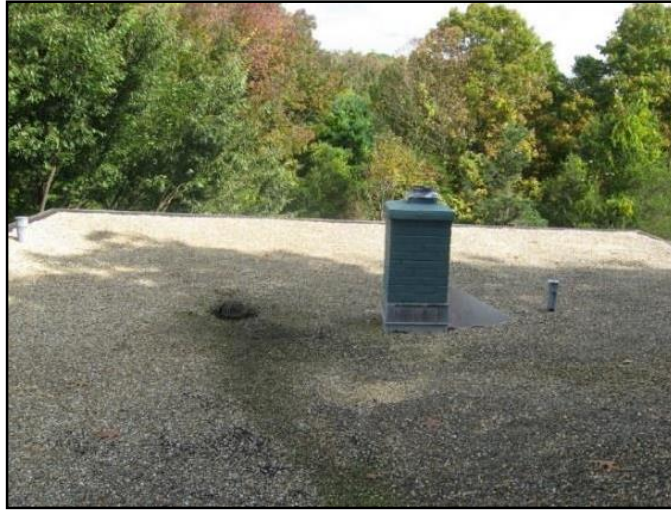
Main body of roof with center chimney, vent stack (right) and roof drain (left)

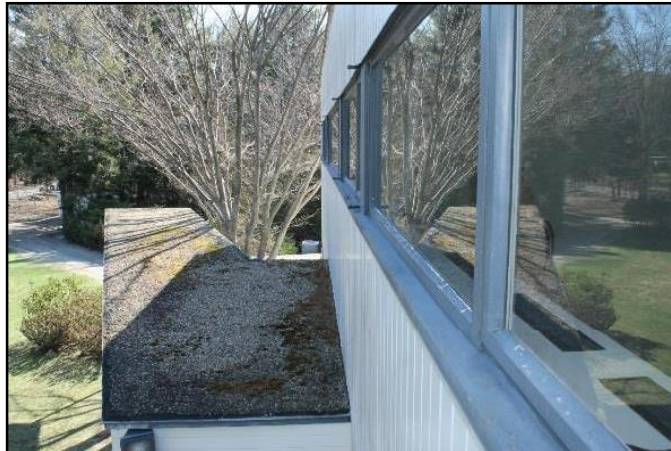
Roof over front entry walk way

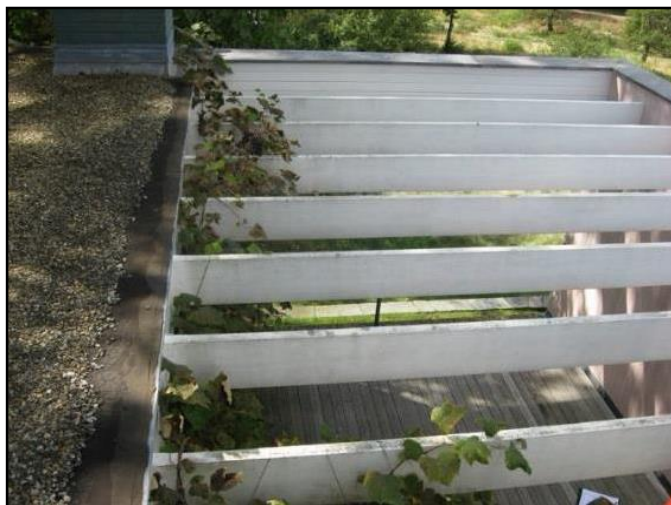
Brise soleil / trellis over 2nd floor roof deck

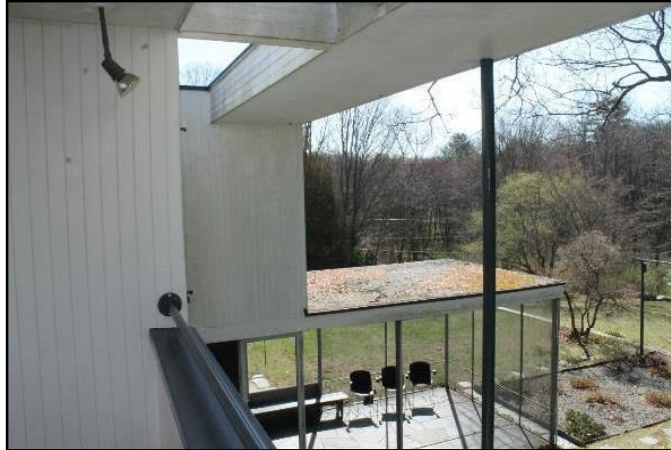
Roof over south elevation screen porch

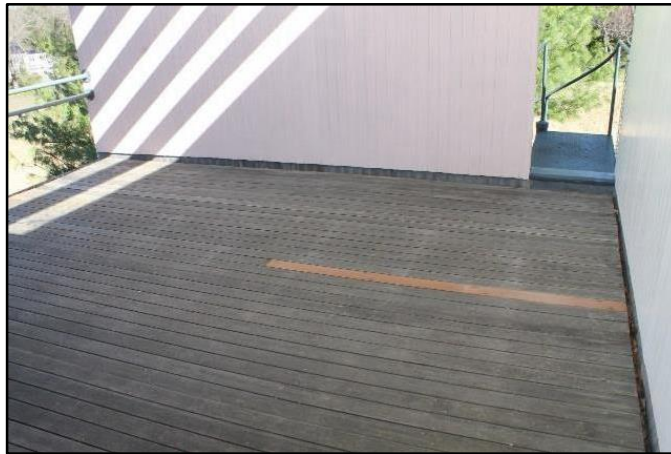
*Decking of roof porch;
Built-up asphalt and gravel roof underneath*

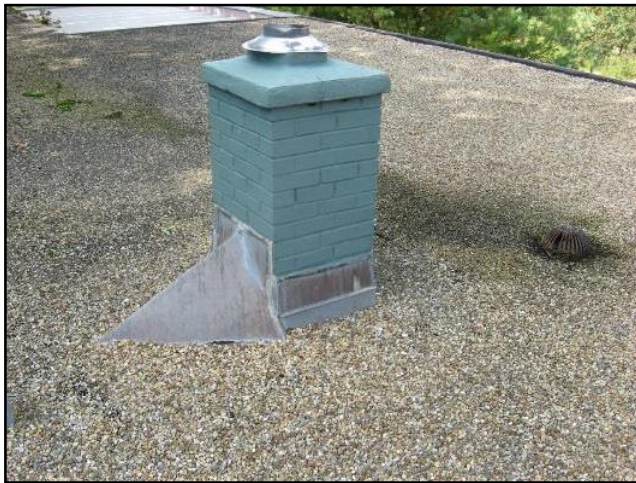
The chimneys (masonry and coatings) appear to be in good condition and no leaks were reported at this time.

Both chimneys include a metal cap (presumably copper), their flues are open to daylight so falling water does freely enter the chimney, but no adverse effects have been noted in the living room fireplace.

Active chimney in center of building

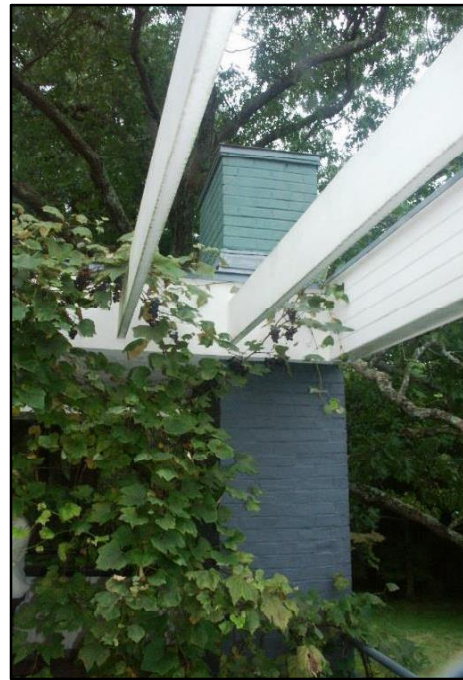
Inactive chimney on west elevation

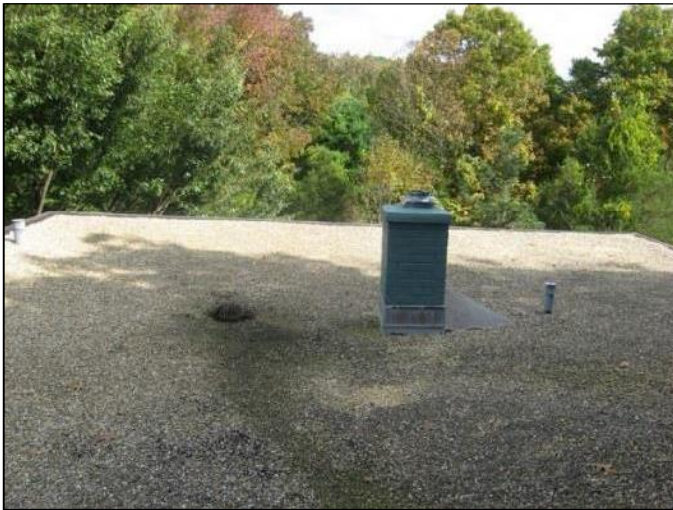
Main body of roof drain and biogrowth suggesting route of water

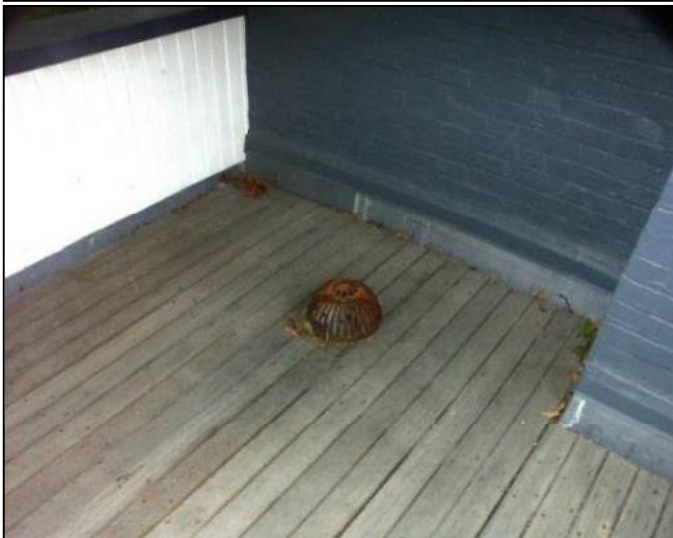
Drain on second floor porch deck

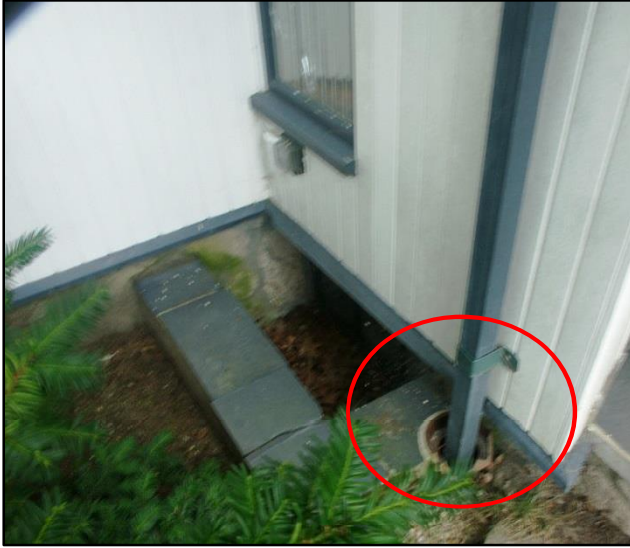
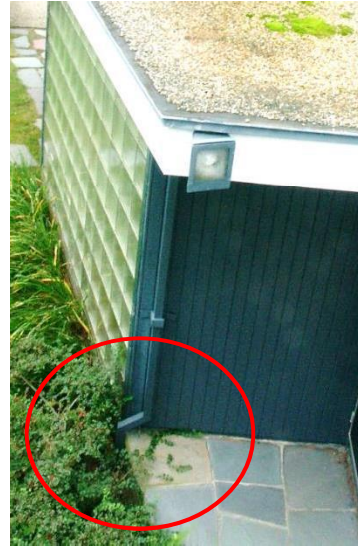
The entrance or portico roof drains into two metal downspouts on either side of the western edge. One of these downspouts is tucked into a clay pipe while the other daylights to the base of the foundation. Assessment of these systems during a heavy rain may shed light on efficacy and indicate if there are maintenance issues to address. There are no visible water issues on the face of the building and no known water leaks or basement flooding issues that suggest there are current problems.

Downspouts of front entry porch draining to underground clay tile pipes
