Conservation Management Plan

GROPIUS HOUSE

68 Baker Bridge Road
Lincoln, Massachusetts

Historic New England
Baseline Report: 2016

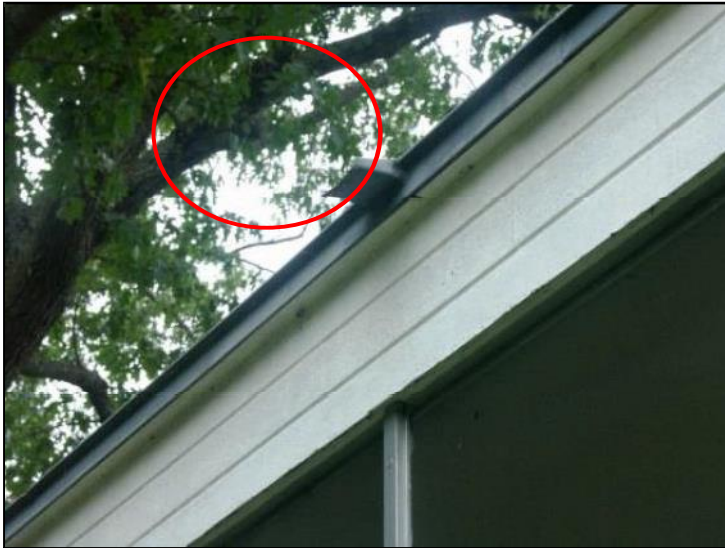
The south porch roof drains from two scuppers located on the southern-most edge. There seems to be a missing scupper on the east side of the south porch roof. A metal water deflector is located at the base of the porch potentially to catch the water from a scupper above. However, there is no evidence of a scupper presently, though historic photos show one located there. A significant amount of water seems to pool at this location.

Scupper on south elevation of screen porch

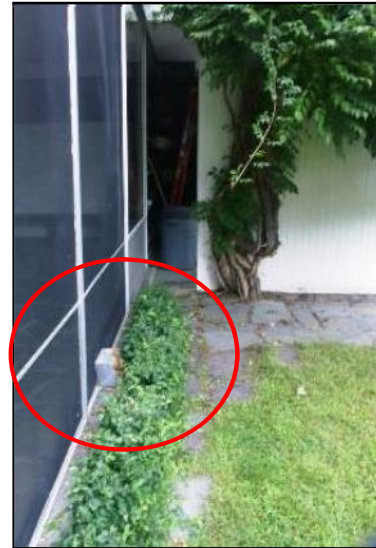
Water deflector on east elevation of screen porch

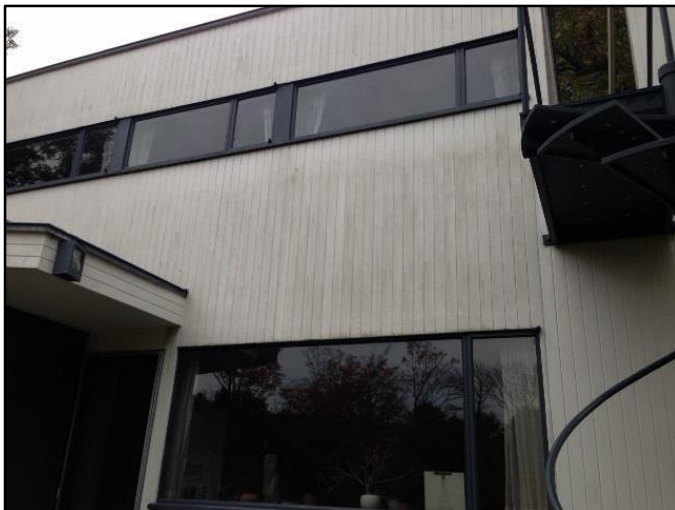
The “solution” to the paint adhesion problem was the removal of all paint layers prior to a new paint campaign. Currently, the paint adhesion is good, however the siding suffers from a very visible black mildew layer on all elevations. It is likely that at this point the mildew spores or so embedded in the wood that this surface mildew – once removed through topical washing treatments – will continue to resurface.

Excessive mildew build up on north elevation

- The exterior cladding was washed in the spring of 2014 with a dilute solution of Jomax House Cleaner. Areas of failed paint were repainted with Benjamin Moore Aura, Exterior Acrylic Latex Paint, matching the previously documented colors. These activities resulted in a clean crisp appearance rather than a muddy gray.

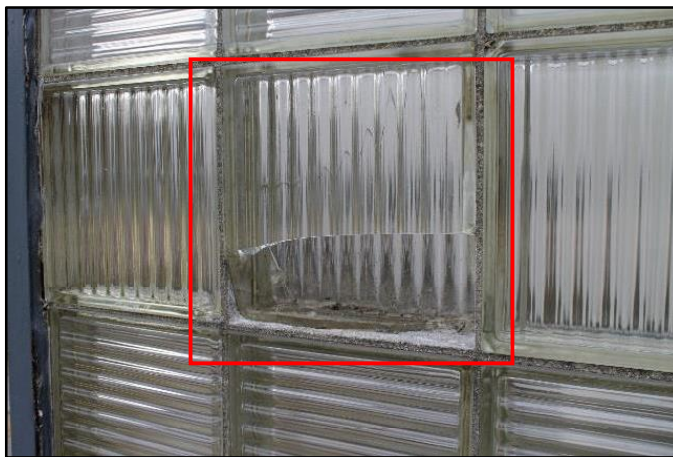
One wall of the north (front) entry is nominal 12" x 12" glass block. This wall is largely in good condition although one block has broken apart and several are cracked. The glass block is not intended to be structural, but it is possible that other support elements have not held up over time, shifting some structural load to the glass block. It is possible that this has led to some of the cracking. It is equally possible that debris from mowers or trimmers in the landscape could have also cracked the blocks. Once cracked, water can enter the hollow glass blocks. Freeze / thaw cycles may then contribute to additional fracturing of the piece. Internal documents make note of the cracked block going back at least 10 years. No repair action is currently scheduled as conditions have not worsened over the past 5 years. The mortar is in good condition.

Fracture with loss of glass

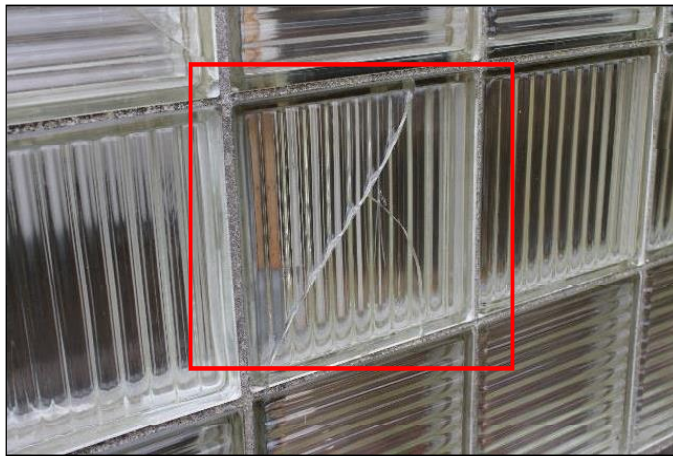
Typical intact fracture of glass block

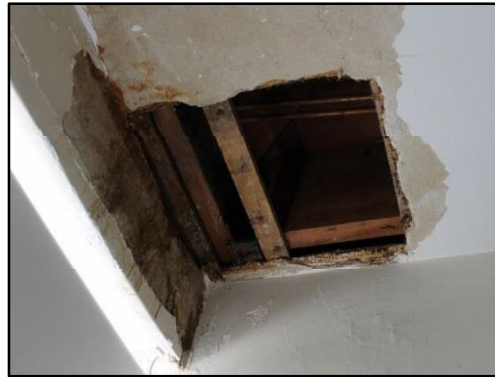
Nominal 2" framing stock as in the first floor ceiling due to a radiator leak

- A radiator located in the dressing room developed a leak which damaged the ceiling of the servant's quarters (now staff office). It is understood that at some point, antifreeze had been introduced to the system; this antifreeze is thought to have caused some corrosion leading to leaks. The radiator was taken off line and no longer provides heat to the dressing room space. Other radiators have been taken off line previously, but the central air core is sufficient to keep the building adequately heated through the winter.

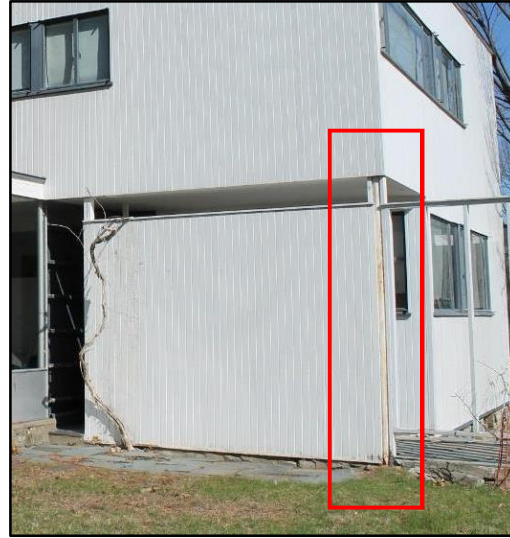
The various elements outside of the main block of the building are supported by relatively narrow (approximately 4" diameter) steel columns. One column on the southeast elevation exhibits significant surface rusting. It is unclear why this one column exhibits the condition. It is also unknown if this rusting has compromised the overall structural capacity of the column.

Rusted column on southeast corner

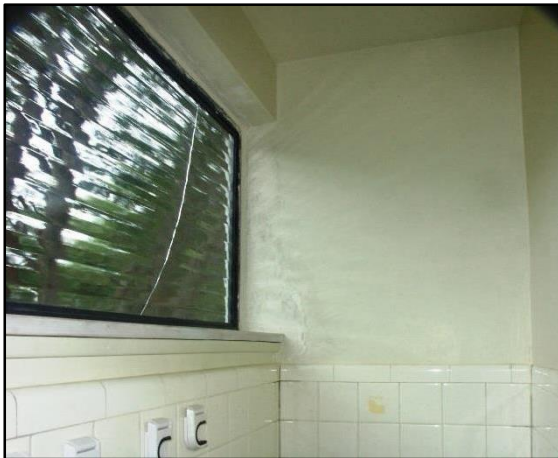
The window frames at the house are comprised of steel with brass hardware and wood sills and are painted a dark grey. Most windows are large expanses of single, pane, plate glass—generally fixed with smaller casements adjacent. In the 1990s, ultra-violet film was applied to the interior of the windows for collection preservation. There are a few instances of specialty prism glass for windows requiring a little more privacy. There are several cracks in the specialty glass throughout the building. An extensive window survey should be performed.

Example of broken specialty glass

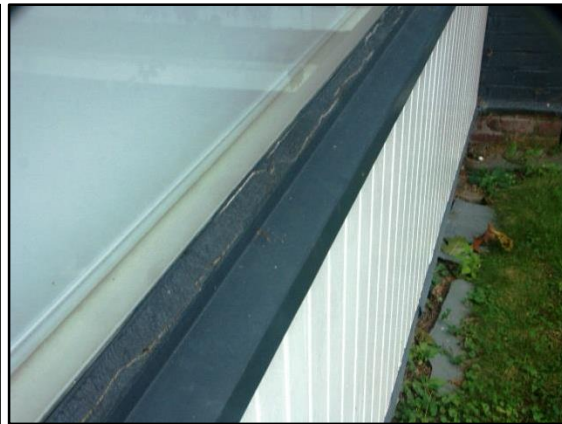
In the late 1990s an extensive restoration took place on the windows. Documents indicate that the cladding was rotted at the window lintels and the sash were severely rusted. Many of the sash were removed and repaired or replaced. Presently, it appears that the glazing putty and paint used were either applied incorrectly or were incompatible resulting in a wrinkling affect. The two products did not dry at the same rate. Although the result is unsightly, the glazing and paint appear to be fair condition.

Typical glazing conditions

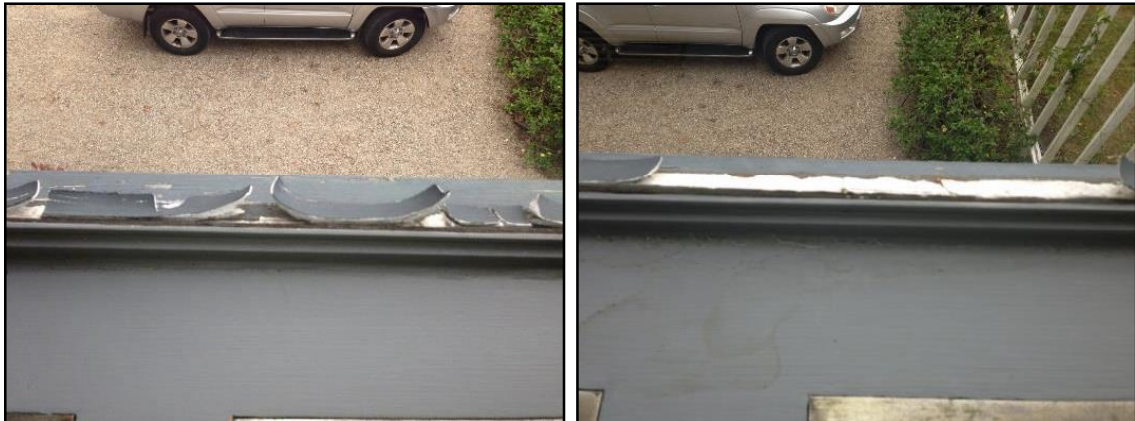
- Several areas of glazing are seen to be failing, especially along the bottom edge of the windows.

Typical glazing failure issues on east elevation - 2013

- Areas of glazing failure were treated by removing loose and failing glazing, priming the any metal sash frame exposed and applying new glazing putty (Sarco DualGlaze). Once firm to the touch, the new putty was painted with Wescott Navy to blend in with the existing paint scheme.

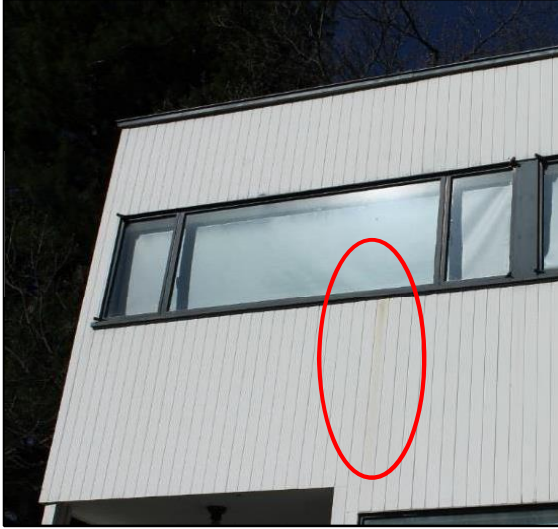
*Rust staining evident on east elevation due to glazing failure and underlying rust development
- 2013*

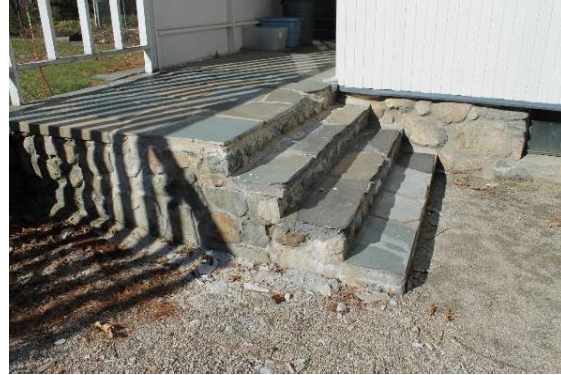
Rear entry steps – general conditions

The staff office is accessed through the rear door that opens into the main kitchen. This door is located off of the driveway and up four bluestone steps set on a fieldstone foundation. Some of the mortar has spalled off the risers, which could be a potential hazard. The steps do not include hand railings.

- The condition of the steps accessing the rear kitchen entrance is very poor. The mortar was repaired in a conservative fashion using lime based mortar and monitored for durability.

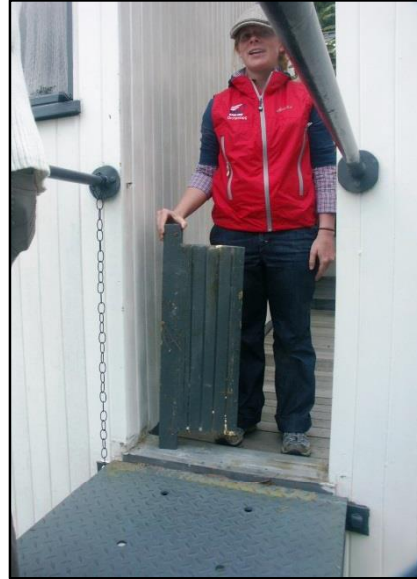
The threshold at the top of the spiral staircase is very loose and can be picked up with little effort. The railings have large openings, which, even though the stairs are chained off, can be easily accessed due to the noncompliant railings. Although these stairs are not accessed by the public, the threshold should be at secured.

Loose threshold

- Threshold for spiral staircase repaired and reinstalled securely.

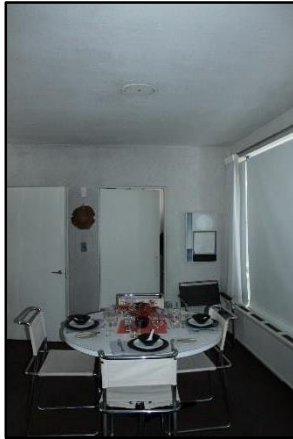
*Dining Room view
showing ceiling
discoloration and
lighting fixture*

Most of the lighting appears to be in good condition with the exception of the dining room ceiling light. The fixture is a stage light that focuses a beam directly onto the dining room table. It is situated within the ceiling/floor interstitial space and creates tremendous heat and the potential for fire. It may be possible to find a replacement bulb that will generate the same effect at a lower wattage.

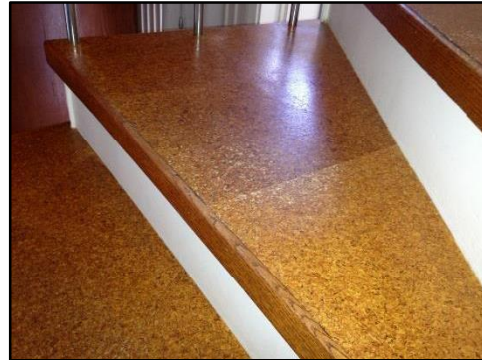
*Wear patterns on cork
flooring*

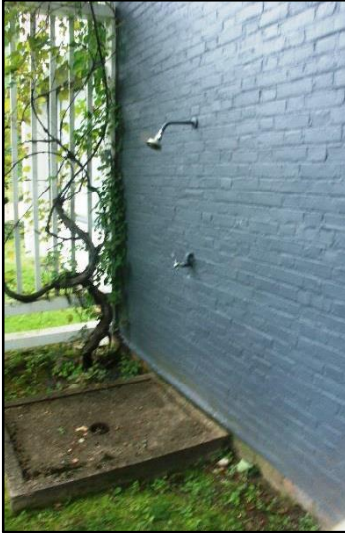
The building includes two exterior spigots (on south elevation and east elevation). Both spigots are operational, do not have any leaks and are drained seasonally. There is an exterior shower on the west elevation that is no longer operable.

Exterior shower – no longer functional

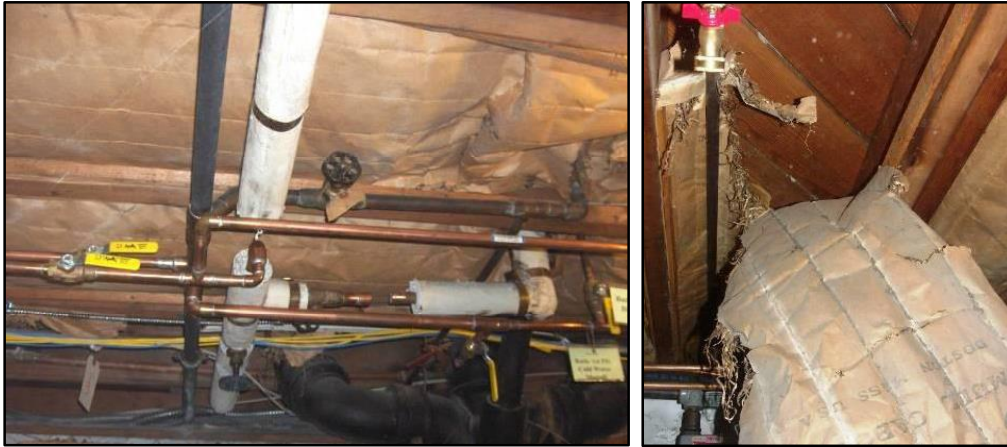
The basement is lined with eelgrass insulation at the ceiling. There are several areas where the insulation has come unsecured and is loose or has fallen from the ceiling altogether. Several of the pipes located in the basement near the electrical panels have been insulated.

Views of basement insulation

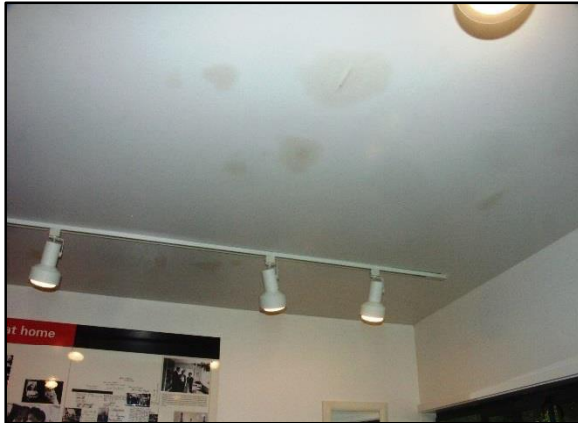
Unfortunately, due to the cold climate of New England, ice dams frequently form on flat roof systems, which allow water to pool. The interior of the building has a number of water stains on the ceiling indicating water penetration at the roof probably due to ice dams and vegetation build-up.

Water stains in ceiling of visitor center

- Roof inspection revealed that the seam between the asphalt rough and the copper border was not sealed, allowing for water penetration. The copper border was replaced, soldered, and well sealed to the roof system.

- Observing no further staining a year after the repair, the ceiling stains in the gift shop were treated with Zinsser B*I*N to make them less visible, pending full repainting of the ceiling.

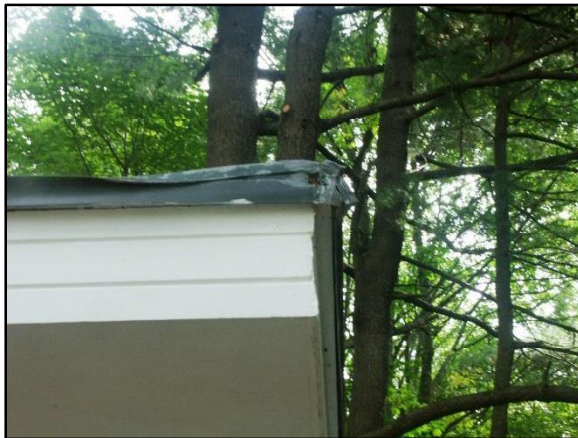
Exterior roof line damage – northeast corner

At the northwest corner of the building there is damage to the roof flashing, which may have been done by a large vehicle.

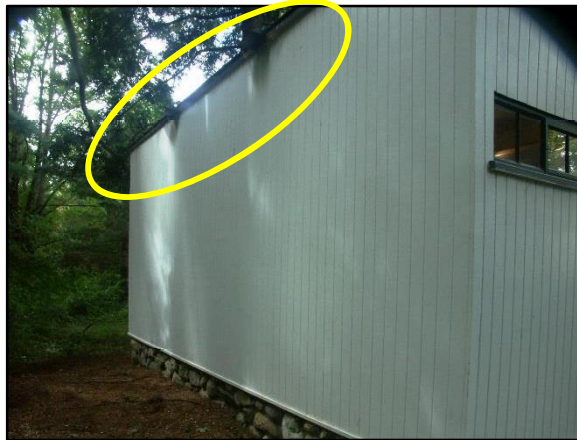
The building does not have a gutter and downspout system but includes two scuppers at the rear of the building. They appear in good condition, but the ceiling in the building is showing water staining indicating that water is not draining properly from the roof.

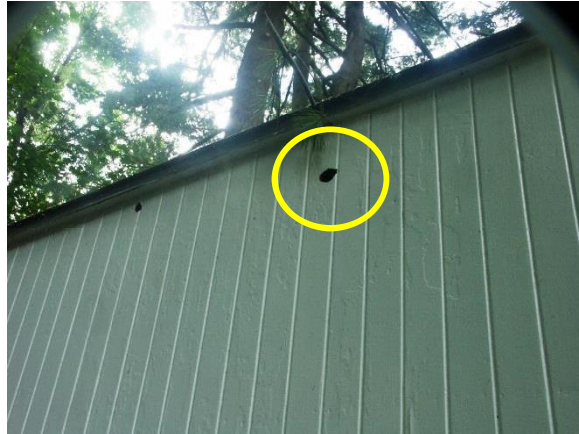
The building is sided with redwood cladding laid vertically—except at the garage door overhang—and painted white. Generally, the cladding is in good condition, with the exception of the east elevation that shows damage probably done by a wood pecker. This could mean that the cladding is infested with insects.

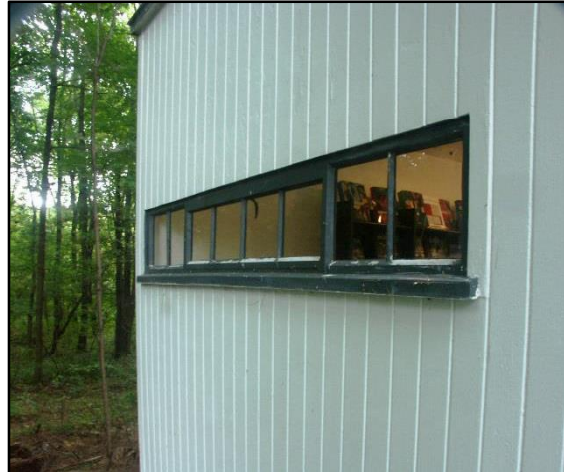
Window arrangement on north elevation

In general, the window openings are in good condition. The side elevation openings could use some surface glazing and repainting. One of the panes on the north elevation appears to have been hit with a rock and needs replacement.

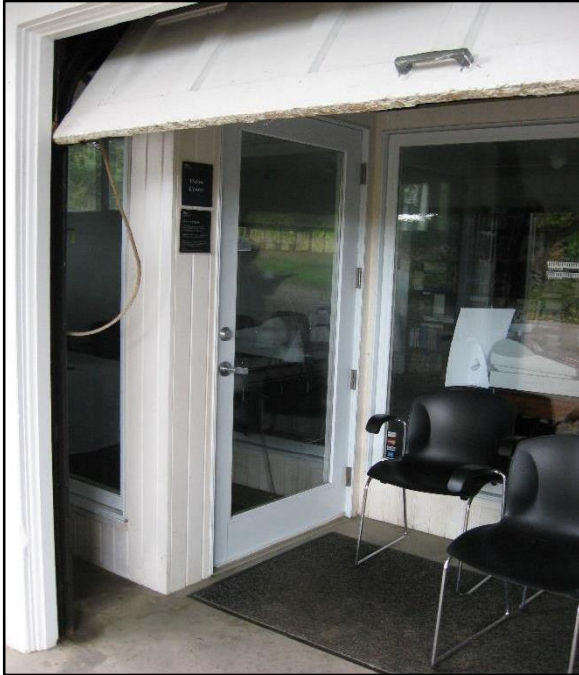
Visitor center entry located behind garage door.

- Handle and lockset replaced due to failure. Handle is same style, but heavier grade quality.

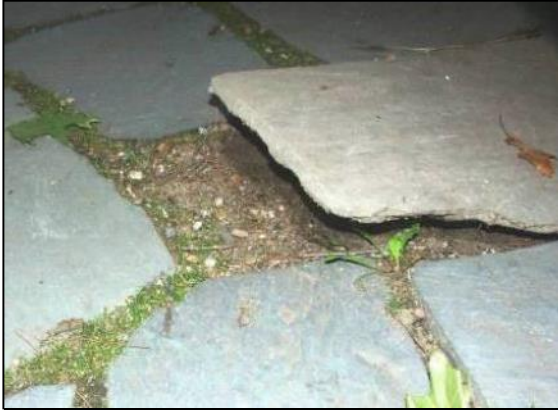
The paths and walkways around the house are a combination of gravel and bluestone. In some cases the bluestone has heaved and shifted and has the potential to be a trip hazard.

Shifting paving stones

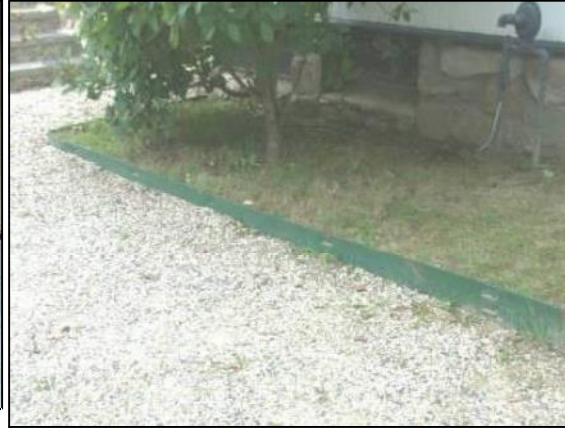
The building garden beds and lawn spaces are protected with a small metal perimeter, which could also be a tripping hazard.

Metal landscape border

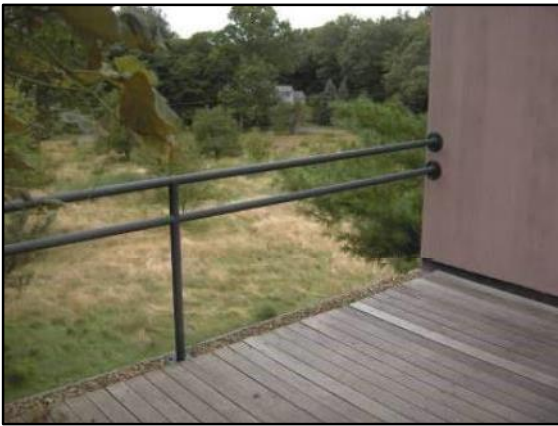
The site includes a metal spiral staircase leading to the second floor porch, which is blocked off from the public. The second floor porch includes a noncompliant metal railing and could potentially be a hazard.

2nd story porch deck

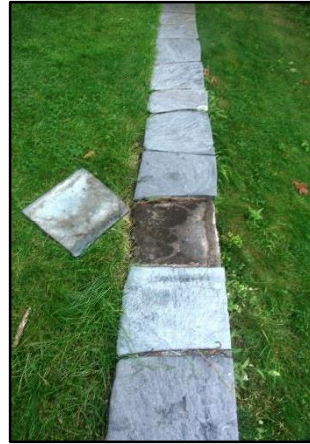
There is a low retaining wall along the south and west elevations of the house. This wall is comprised of mortared rubblestone with a slate or bluestone cap. In many instances the cap pieces are loose. As the caps are in line with the grade as one walks around the house, there is a natural tendency to walk on these walls. The loose caps present a potential hazard for visitors and a long term loss for the integrity of the walls. In their current state there is growing structural deterioration of the wall with mortar cracks throughout likely due to frost heaving.

Stone capped walls (above)

- Olde Mohawk Masonry repaired the stone wall damaged by the snowplow in the winter of '08-'09, resecured the bluestone caps, and rebuilt one retaining wall on the south east side of the property.

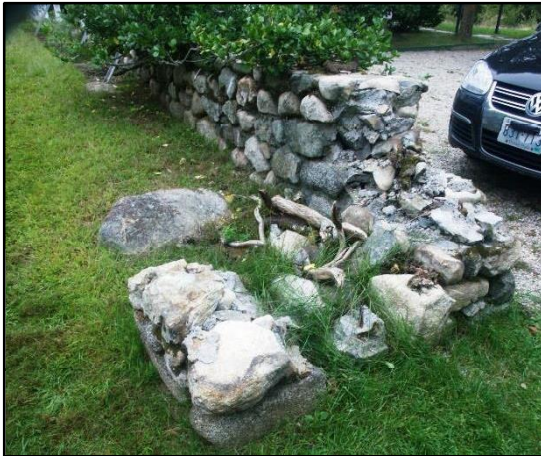
Wall damage at top of driveway

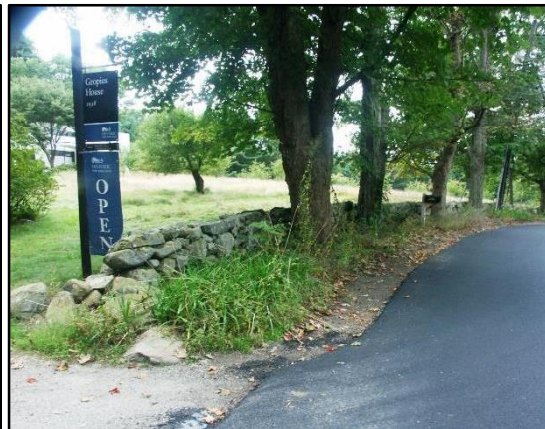
The site includes two trellis walls on the west and east elevations of the house. The one on the east side appears to be slightly out of plumb, but seems stable. Retaining walls include bluestone caps that are loose and could be a potential trip hazard. The site also includes stone walls, one of which was damaged by a snow plow (at the staff parking area) during the winter 2008 and should be repaired. Stone walls along the perimeter of the site also appear to be deteriorating.

Stone wall at property entrance

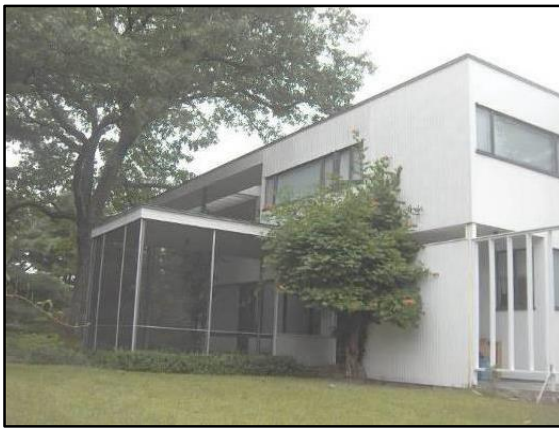
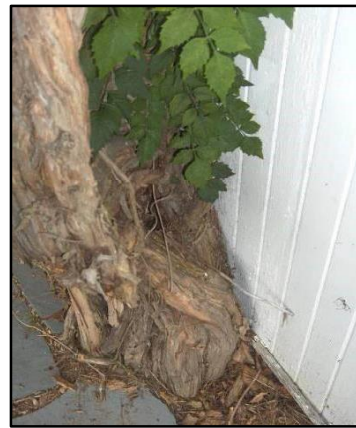
The shading from the overhanging trees is allowing plant material to thrive on the flat roof. The trumpet vine trunk is growing very close to the base of the cladding. The shade and moisture from this vine has started to deteriorate the paint.

Trumpet vine on south elevation

Trumpet vine base

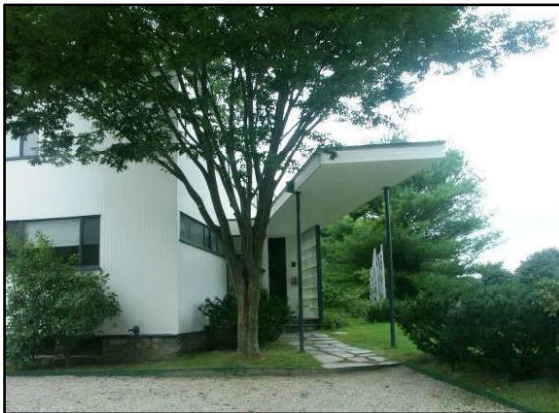
There are two significant trees overhanging the house. There is a large oak tree at the southwest corner and a Zelkova that overhangs the front entry portico on the northeast corner. The proximity of these pieces to the house warrant close attention to ongoing maintenance.

Zelkova at house entrance

There are several trees in close proximity to the house that need to be pruned back for increased air and light flow to the structure. The **Zelkova** (#1) by the covered entryway should be pruned back, or, consider removal if it is not historically appropriate. The large **Red oak** (#3 at the rear corner) is obviously right on top of the building. The tree looks to be in good shape structurally, but the proximity of the canopy to the roof and siding will trap moisture, and may be problematic over time. A lightning protection system in this tree would protect the tree, as well as the house and the adjacent **mature pine** (#3). The pine should be periodically crown reduced to decrease snow loading, and to reduce shading on adjacent understory plantings. The **smaller pine** (#2) by the front lawn should be periodically crown reduced, or removed. It would not be advisable to allow another large pine to develop so close to the structure.

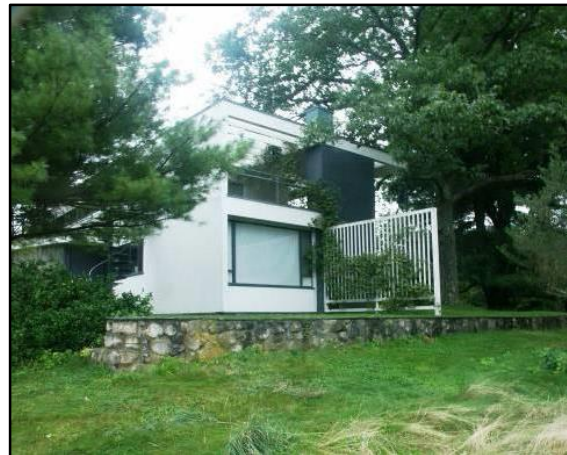
Shading trees on west elevation

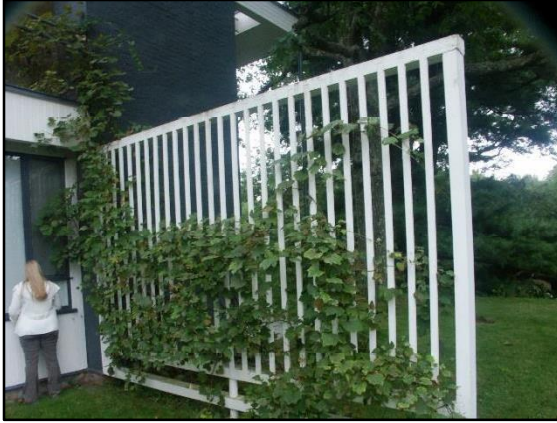
There is a trellis on the west elevation that supports a grape vine. This vine is trained up onto the trellis that is integral to the 2nd floor porch deck. This trellis appears to be in good condition although its constant contact

with the grape vine warrants constant vigilance to routine maintenance. The posts and bottom rail of the trellis were replaced in 2005.

Trellis at western elevation

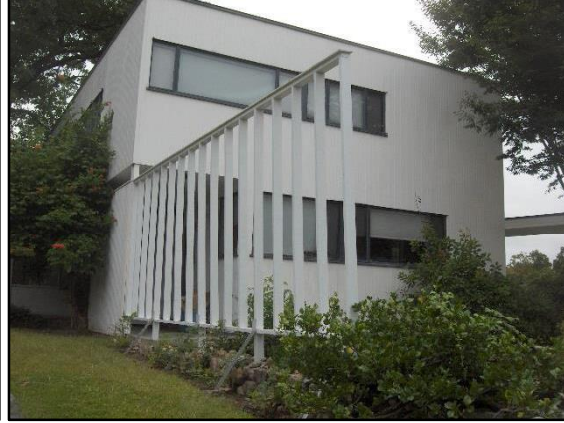
There is a trellis on the east elevation that has been pushed out of plumb. It is thought that this condition relates to the knocked over stone wall (winter 2008-2009) adjacent to the trellis although these may be two unrelated events as the distance from the damaged wall to the start of the trellis is a few feet – and the wall between the two is relatively unharmed. It is more likely that the footings for the trellis may be shifting, thus pulling the trellis out of plumb.

Trellis at eastern elevation

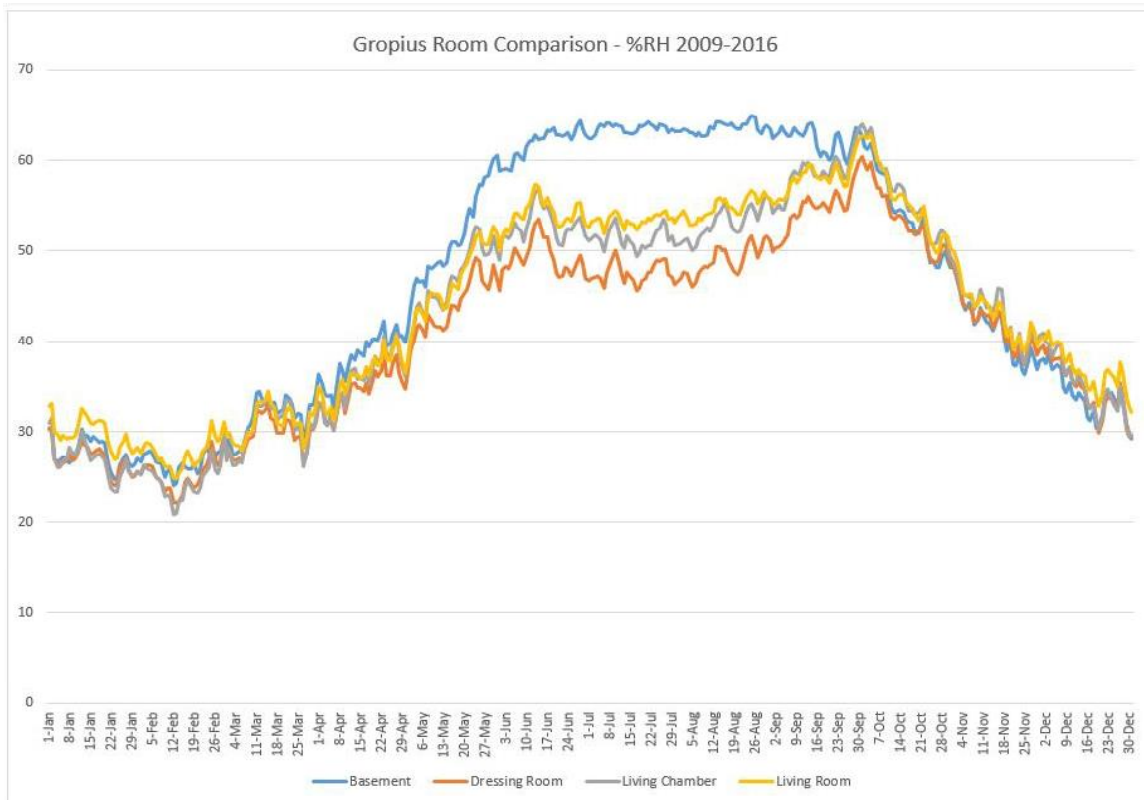
Figure 2: Relative Humidity Trends by Room

Since Gropius House is open for visitation year round and provides office space for one site manager year round, the winter heating plan results in the relative humidity profile dipping below 30%. Rather than add artificial humidity to the space, Historic New England will be looking at moderating temperature in the house. As is typical with most below grade basements, the relative humidity in the summer in the basement is elevated. This is somewhat exacerbated by the large crawlspace with unfinished floor. (Figure 2)

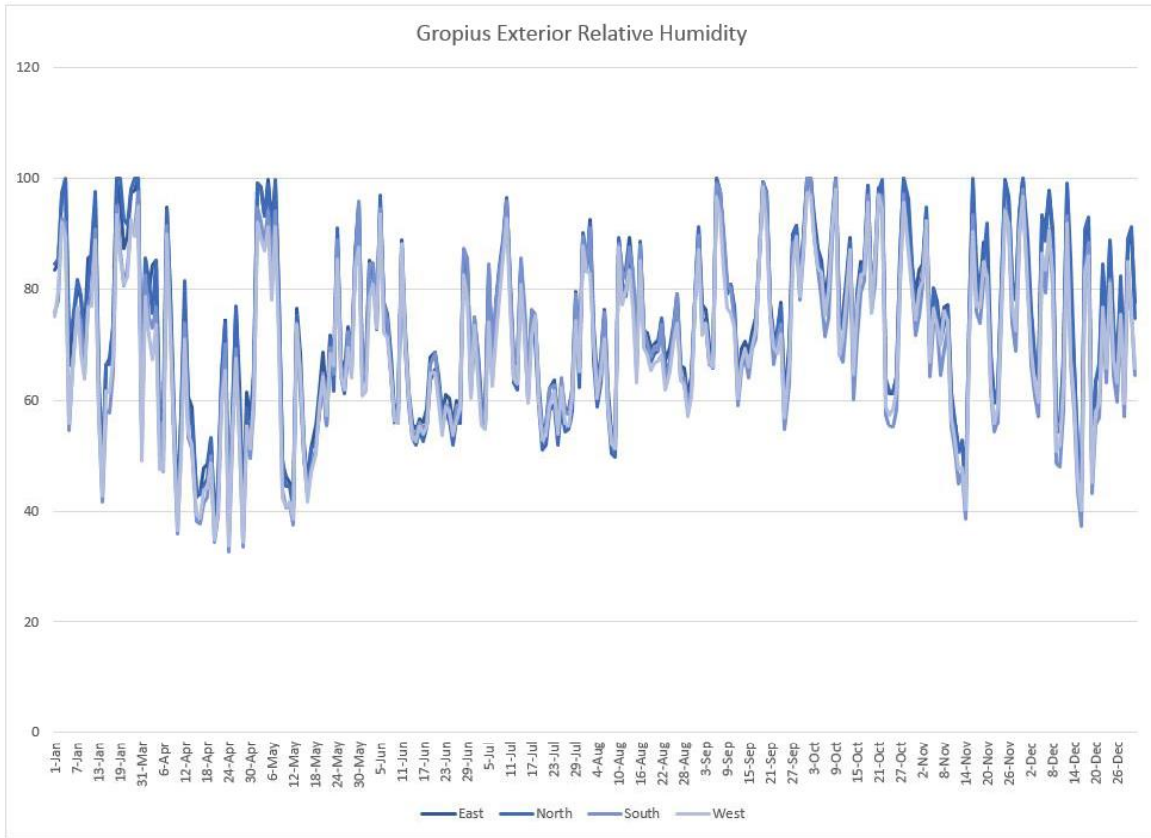
Figure 6: Exterior Humidity Trends by Elevation

With respect to the data collection on the exterior elevations, Onset's U23-001 weatherproof temperature and relative humidity data logger. The relative humidity data was remarkably similar across all four elevations. The overall trend of relative humidity on the exterior ranged from approximately 65 to 80%. This would be a suitably hospitable environment for mold growth on the exterior cladding. (Figure 6)

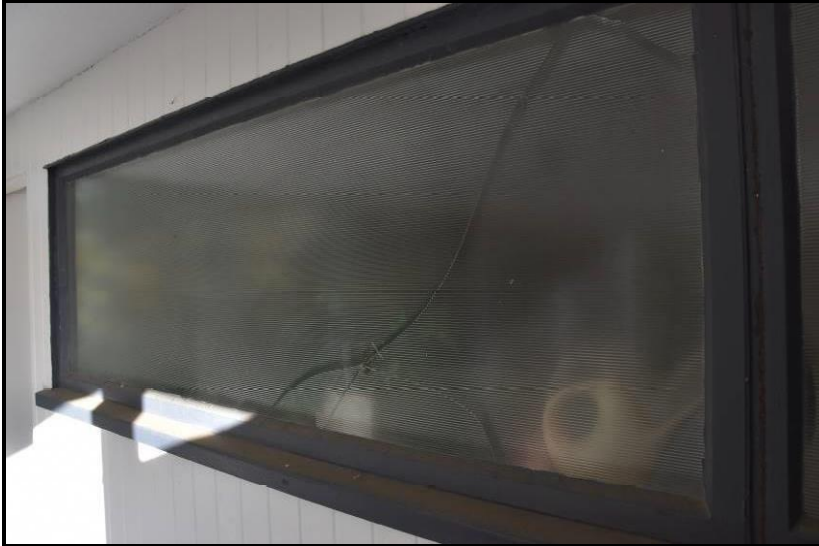
Window 102 (South Elevation)

Glazing in the fixed (westernmost) sash of this window exhibits severe cracking. Multiple cracks traverse the ribbed glass. A hole in the lower portion of the glass that was likely caused by an impact has been covered over by a clear film (probably packing tape). In addition to impact-related damage, the extent of the cracking suggests that stress on the glazing may have caused or contributed to further cracking. Glazing in the adjacent, operable sash is intact and in good condition.

Figure 6. Stress/impact related damage in fixed-pane of Window 102.

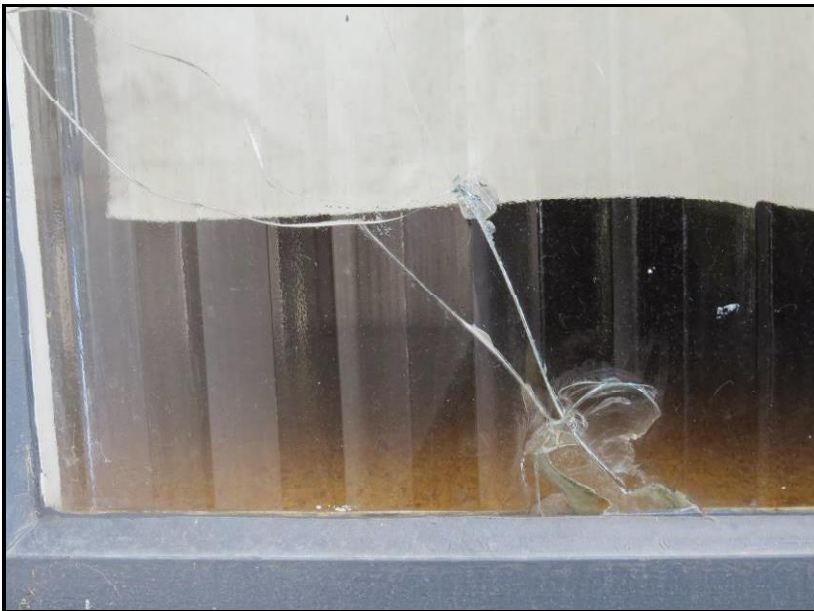
Window 109 (East Elevation)

Glazing in the lower sash of this window exhibits extensive stress cracking. Several cracks culminate in an area of “oyster” shaped, conchoidal surface loss occurring along the bottom edge of the pane. Glazing in the small upper sash is intact and in good condition.

Figure 7. Stress cracks and "oyster" shaped loss in lower sash of Window 109.

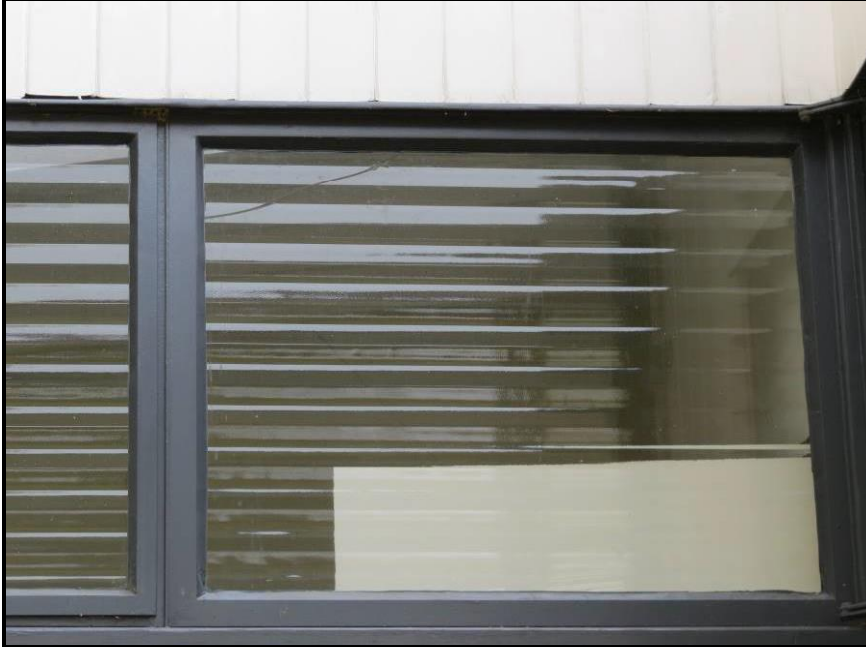
Window 110 (North Elevation)

Glazing in the fixed (westernmost) sash of this window exhibits a single stress crack in the upper east corner. Glazing in the smaller adjacent operable sash is intact and in good condition.

Figure 8. A single stress crack seen in Window 110.

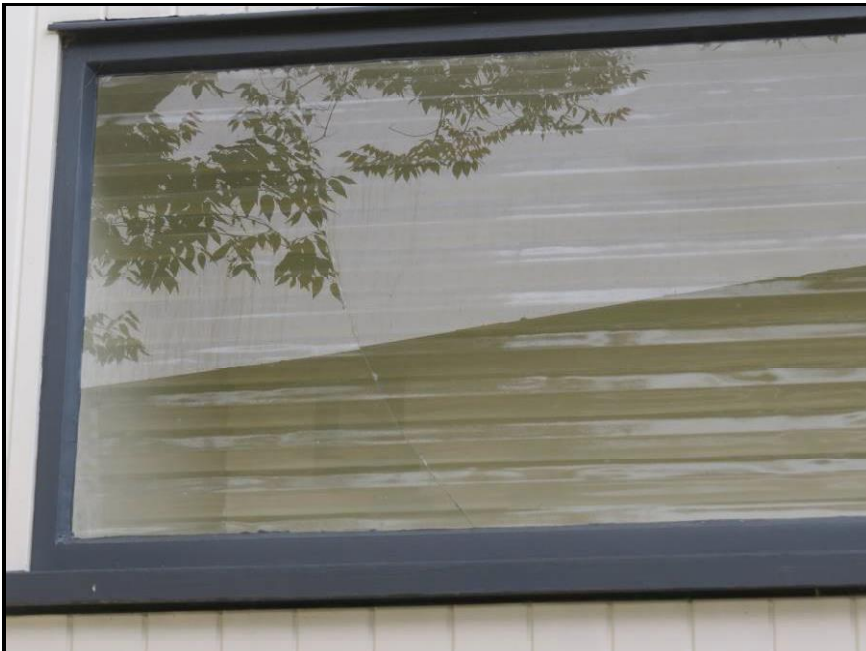
Window 111 (North Elevation)

Glazing in the fixed (easternmost) sash of this window exhibits a single, vertical stress crack. Glazing in the adjacent, operable sash is intact and in good condition.

Figure 9. A single stress crack seen in Window 111.

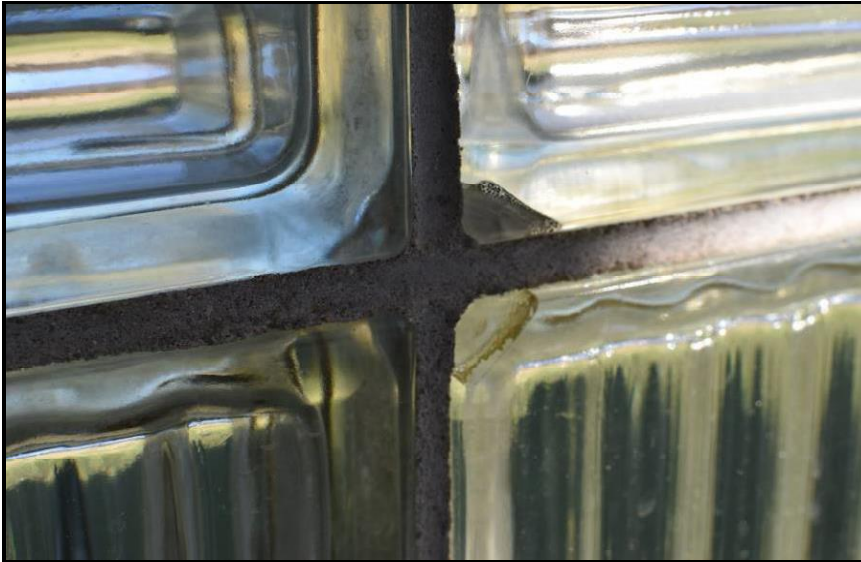
Blocks D2, G11, H3, H11, and J11 all exhibit a minor spall in one corner edge on their north (exterior) -facing side (Figure 10). Similar damage was observed on the south (interior) -facing side of Blocks E2, E3, and F2. In some blocks, these spalls are slightly displaced. Cracking is present on the north side of Block G1 and on both sides of Blocks G7, H2, H5, H7, and H8 (Figure 11). The most severe damage was observed in Block H2, which exhibits extensive cracking and is missing a large section on its north side (Figure 12).

Figure 10. Typical corner spalls in glass block units.

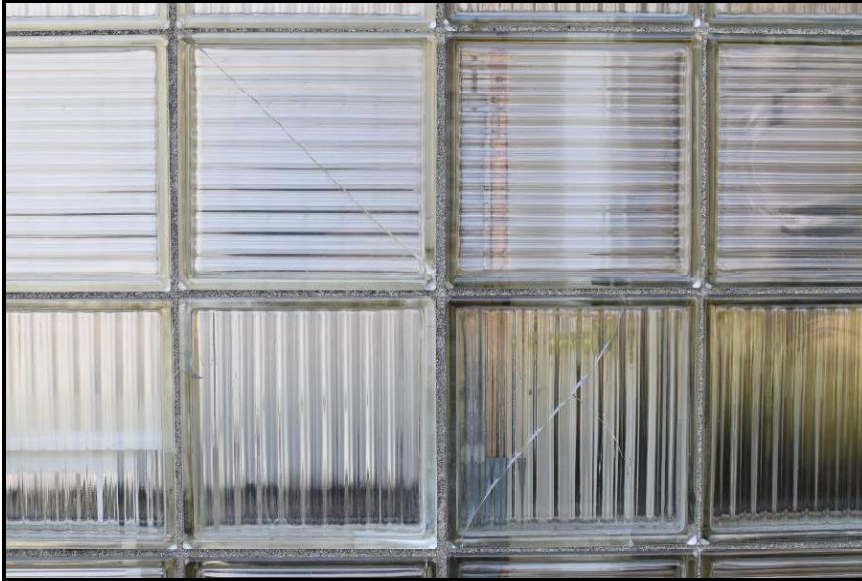
Figure 11. Typical cracks in glass block units.

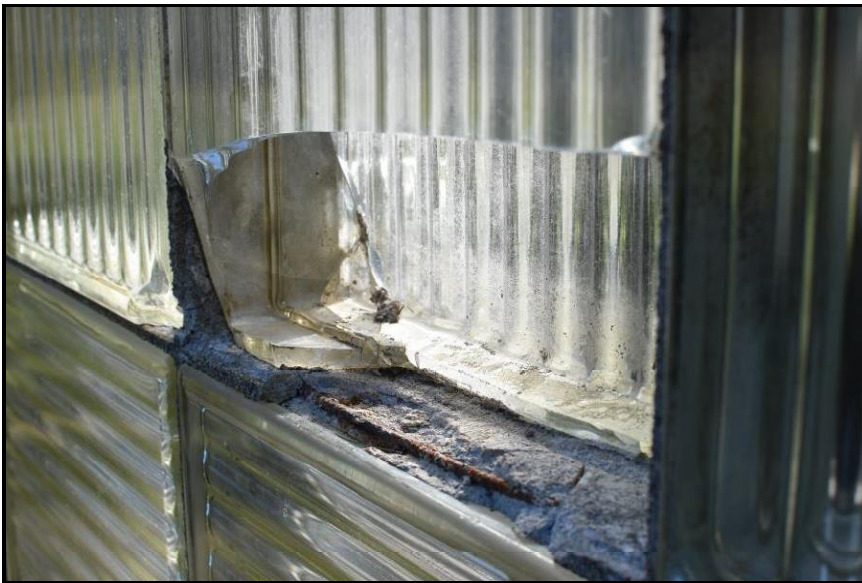
Figure 12. Block H2 exhibiting extensive cracks, losses, and exposed corroding metal joint reinforcement.

Steel reinforcement bar in the block wall mortar joints exhibits corrosion where deterioration of the block has exposed the steel to air and moisture. Corrosion of embedded steel in cementitious materials is, in most cases, prevented by the inherent alkalinity of the cement. The high pH of the cement permits the formation of only a thin

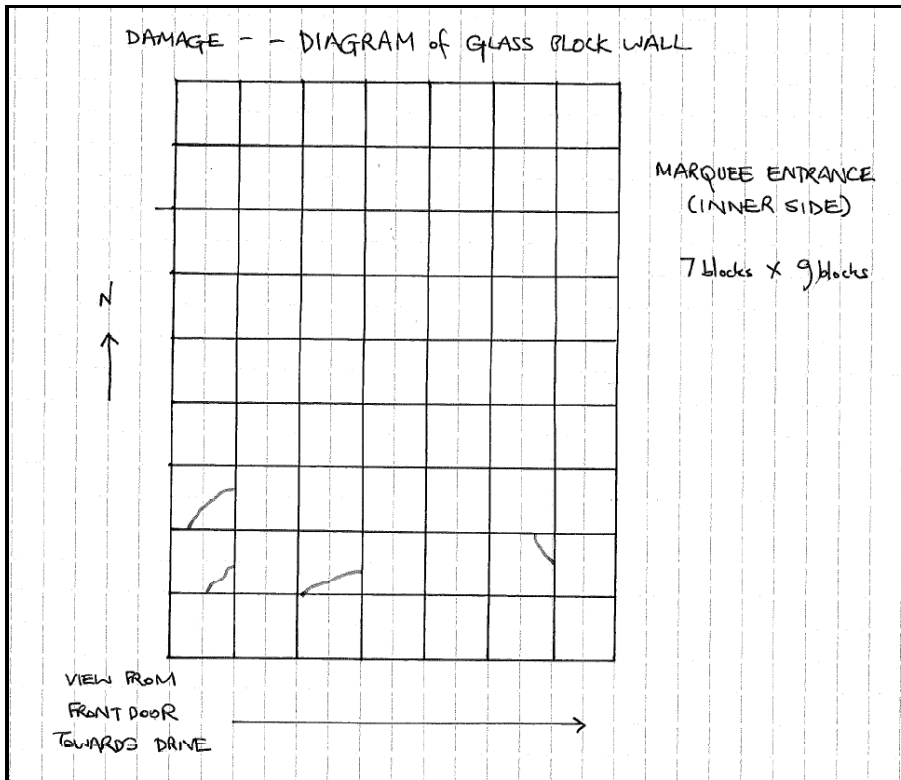
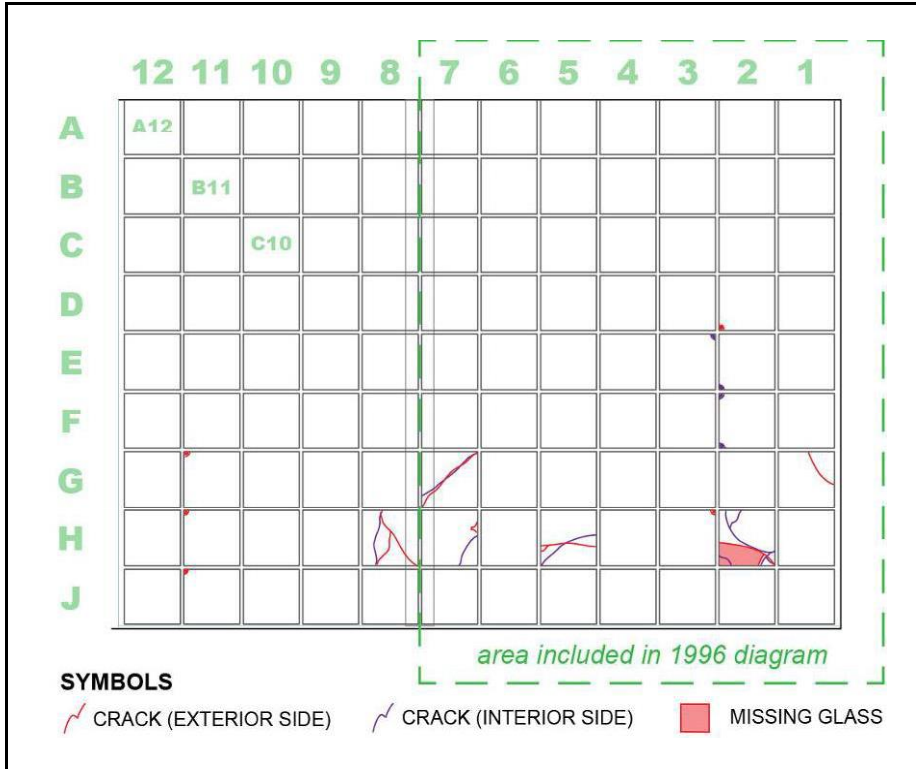
A review of documentation of cracks in the block wall prepared in 1996 indicates that the condition of the blocks has progressively deteriorated over time, with cracks increasing in size and propagating in number (see Figure 13 and Figure 14). This indicates that the deterioration is active and will continue to worsen if not corrected.

Figure 13. Diagram of cracks in the glass block wall (looking north) from 1996 memo (HNE Collection).

Figure 14. Current condition of glass block wall (interior elevation looking north), with location of 1996 condition diagram noted.

Cracks in the glass block units are likely caused by shear stress created by corrosion of the steel channel which frames the vertical ends of the wall (see Engineer's Report in Appendix B). The generally horizontal direction of the cracks forms a pattern consistent with a local horizontal shear stress. Stress-related cracks are exacerbated as moisture intrudes into the crack and expands in freezing conditions. As a crack grows in size, it will allow moisture to further infiltrate and fill the inner cavity of a block where freezing temperatures place further stress on the already compromised material (see Figure 23).

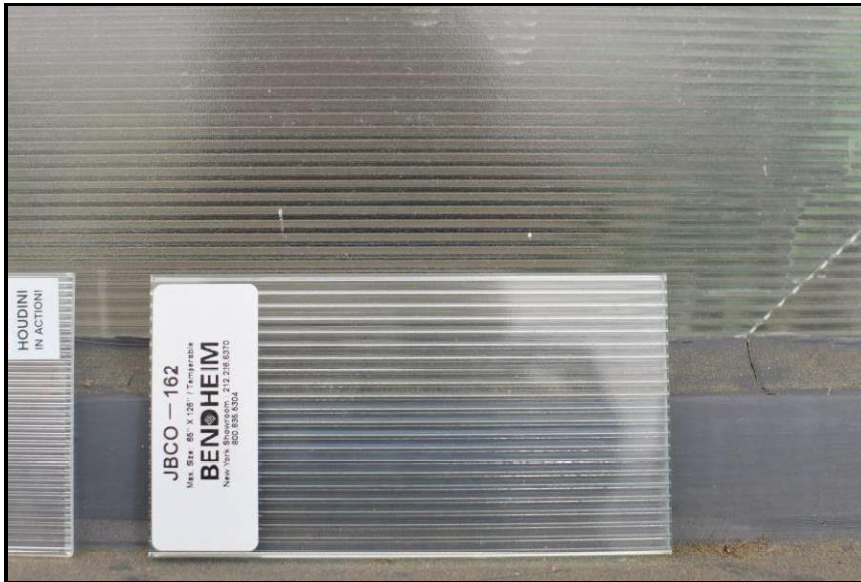
Figure 16. Sample of Bendheim's JBCO-162, "ribbed" glass compared to original glass in Window 102 (south elevation).

Replace original glass with identical modern or salvaged material. Identical modern materials are not available. However, a very close match for the ribbed glass is available in Bendheim's JBCO-162, "ribbed" product (Figure 16).³⁵ The pattern and thickness dimensions of this product are nearly identical to the original. However, it is not available with an etched finish (as found on the original) from the manufacturer. This can be reproduced with acid etching or sandblasting, services available at some glass shops. The color of the glass may vary slightly from the original, but the effect can be mitigated if the glass in the adjacent, operable sash is also replaced.

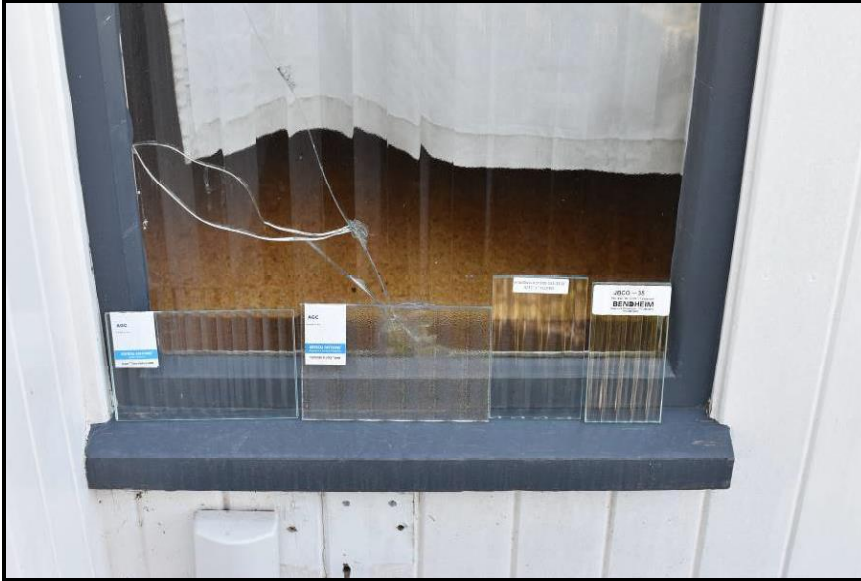
Figure 17. Samples of replacement glass compared to original Louvrex glass in Window 109 (east elevation). Samples (left to right): AGC “Flutes” Clear Pattern, AGC “Textured Flutex”, Gray Glass “1-inch Fluted”, Bendheim’s JBCO-35.

Replace deteriorated glass with a material that approximates the character defining features of the original. This option applies especially to the Louvrex glass. If no salvage material can be procured, replacement may proceed using a fluted glass that has a different profile but maintains the effect of the original. One such material is the 1-inch "fluted" glass manufactured by Gray Glass.³⁶ While this glass lacks the same pattern width, profile shape, and textured surface, it conveys a linear character that is similar to the original Louvrex. Note that, in order to maintain continuity of appearance, undamaged glass in adjacent sashes would have to be replaced.
