Conservation Management Plan

GROPIUS HOUSE

68 Baker Bridge Road
Lincoln, Massachusetts

Historic New England
Baseline Report: 2016

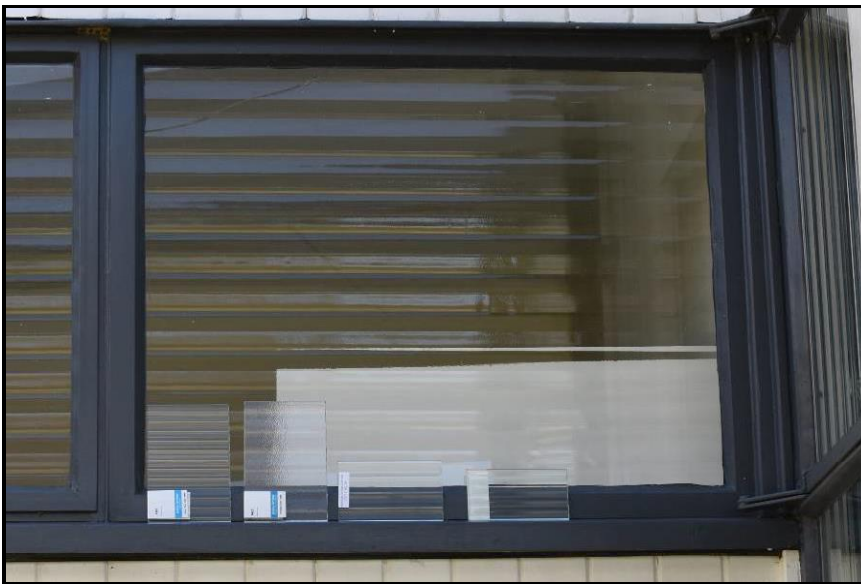
Figure 18. Samples of replacement glass compared to original Louvrex glass in Window 110 (north elevation). Samples (left to right): AGC “Flutes” Clear Pattern, AGC “Textured Flutex”, Gray Glass “1-inch Fluted”, Bendheim’s JBCO-35.

Replace deteriorated glass with a material that approximates the character defining features of the original. This option applies especially to the Louvrex glass. If no salvage material can be procured, replacement may proceed using a fluted glass that has a different profile but maintains the effect of the original. One such material is the 1-inch "fluted" glass manufactured by Gray Glass.³⁶ While this glass lacks the same pattern width, profile shape, and textured surface, it conveys a linear character that is similar to the original Louvrex. Note that, in order to maintain continuity of appearance, undamaged glass in adjacent sashes would have to be replaced.

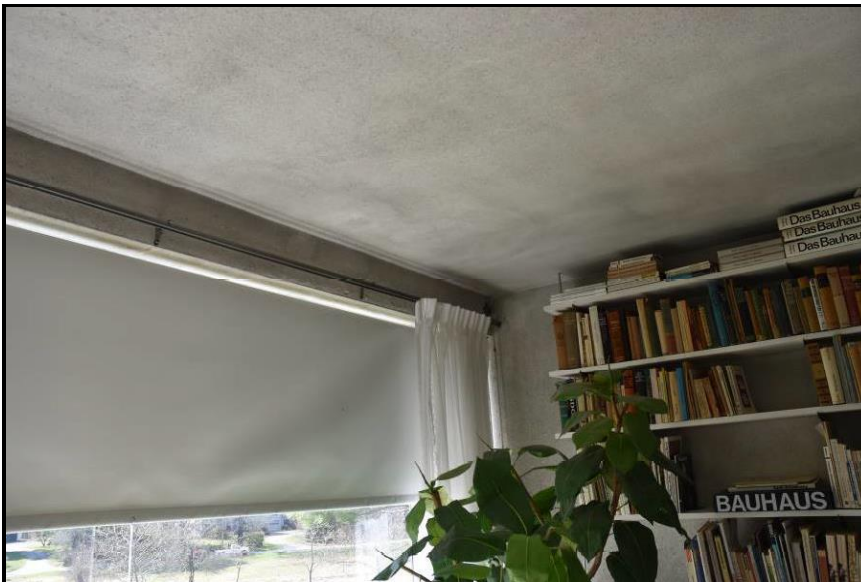
Figure 22. Typical soiling and staining observed on the plaster ceiling of the living room.

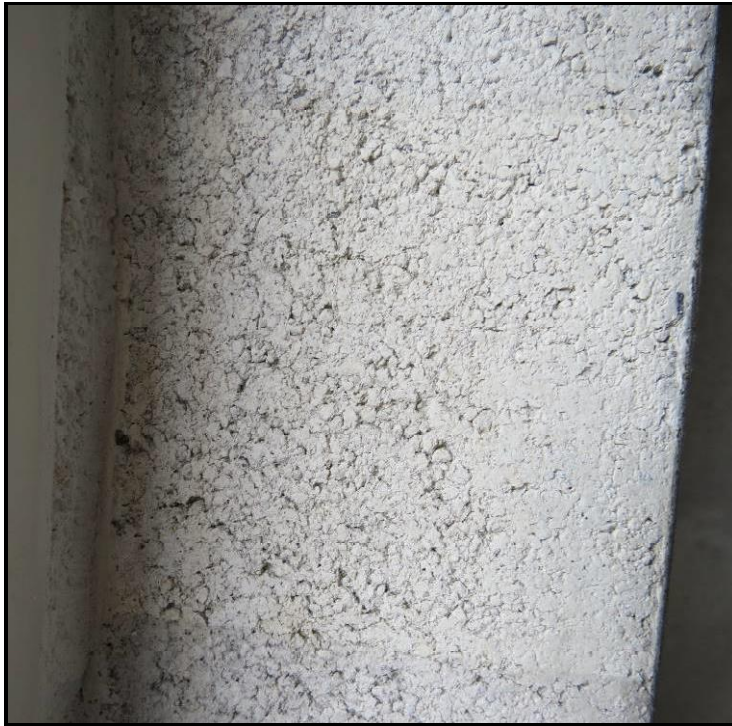
Type A: Substrate appeared slightly yellow after treatment.

Figure 27. ABR Type A test patch, post-treatment.

⁴⁷ The yellowing observed on treated plaster surfaces is unusual. In JBC's experience, the same treatments applied to similar plaster materials did not have this effect. The manufacturers of these products report the same experience. Regardless of past experience, it is apparent that, barring any change in the formulation of the products, some constituent specific to the acoustical plaster used at the Gropius House must have reacted to a component in the poultrice.

An exact cause of the yellowing could not be determined. One plausible theory is that the yellowing is due to oxidation of ferrous metallic particles present in the plaster matrix. Chelating agents, present in some of the products tested, are intended to bond to metal ions so that they can be extracted from the substrate. It may be that the chelators and metallic particles were drawn to the surface of the plaster, where they readily oxidized due to moisture in the poultrice materials, but were not completely removed when the poultrice was lifted away. If this were the case, re-treating the area might successfully decrease or eliminate any discoloring. However, additional treatments could serve to exacerbate the yellowing. Attempts to recreate the yellowing on plaster samples prepared with iron filings in JBC's laboratory were unsuccessful. The yellowing may alternatively be related to wood fiber present in the plaster matrix.

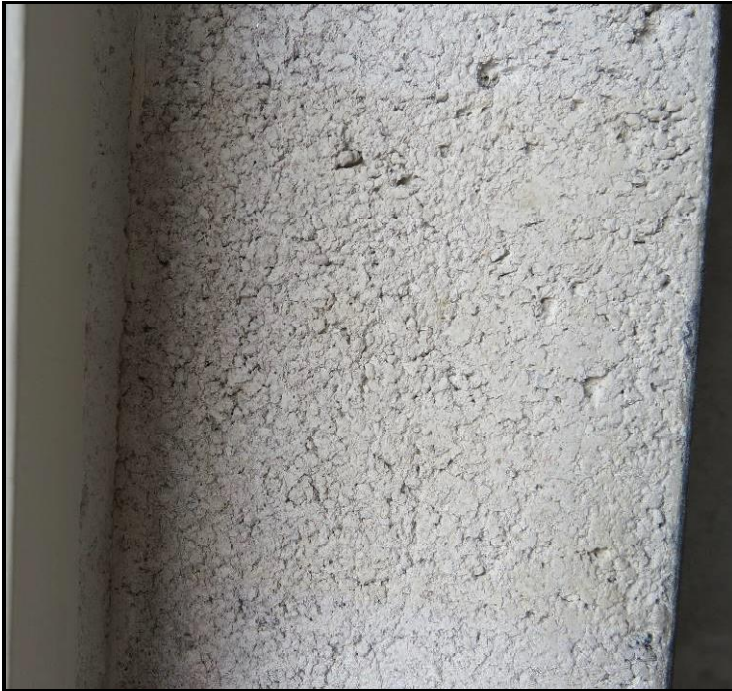
Type AM: Substrate appeared slightly yellow after treatment. The poultice material felt “stiffer” than others tested. However, this did not appear to have an effect on the substrate (i.e. no excess material removed).

Figure 28. ABR Type AM test patch, post-treatment.

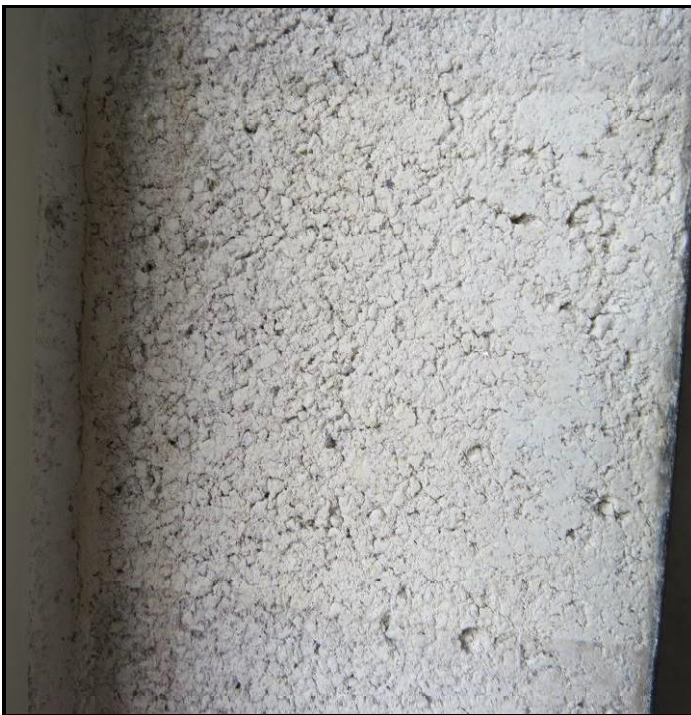
Type B: Substrate appeared slightly yellow after treatment.

Figure 29. ABR Type B test patch, post-treatment.

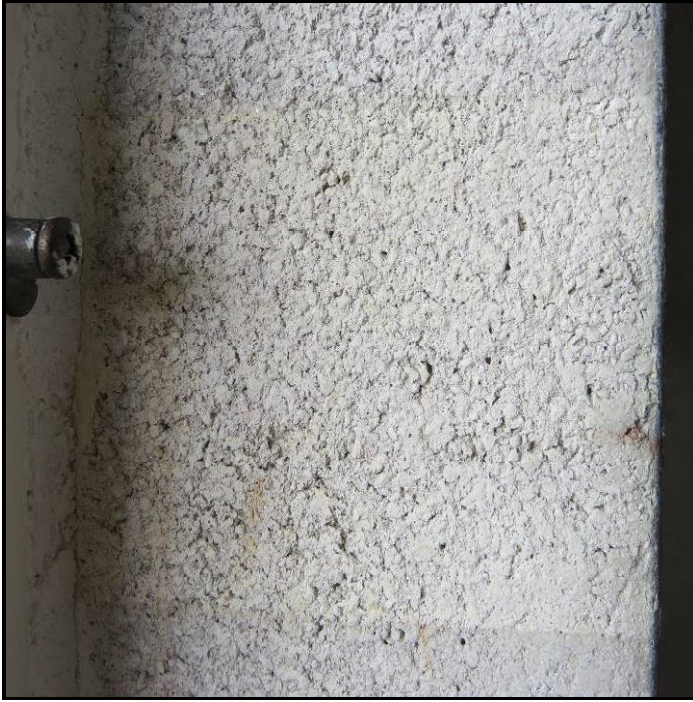
Type C: Substrate appeared very yellow after treatment (this appears to have yellowed the worst of the products tested).

Figure 30. ABR Type C test patch, post-treatment.

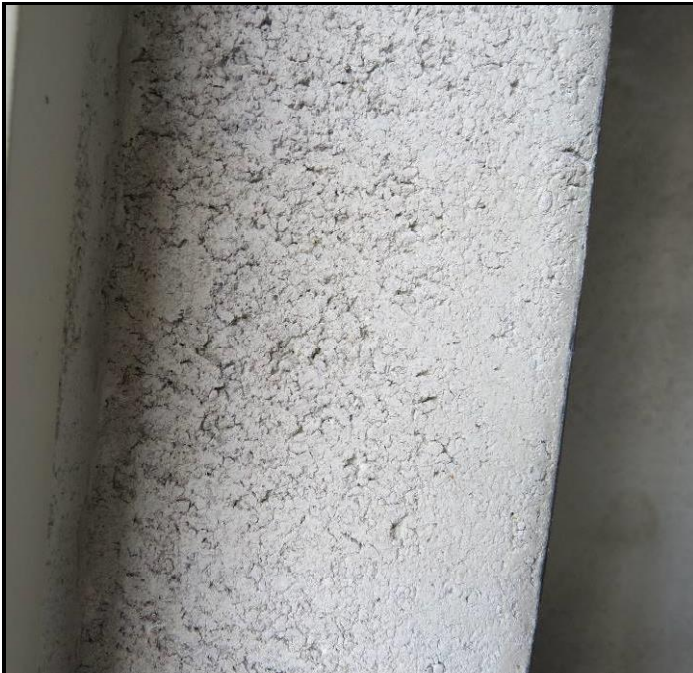
Type I: Substrate appeared slightly yellow after treatment.

Figure 31. AM Type I test patch, post-treatment.

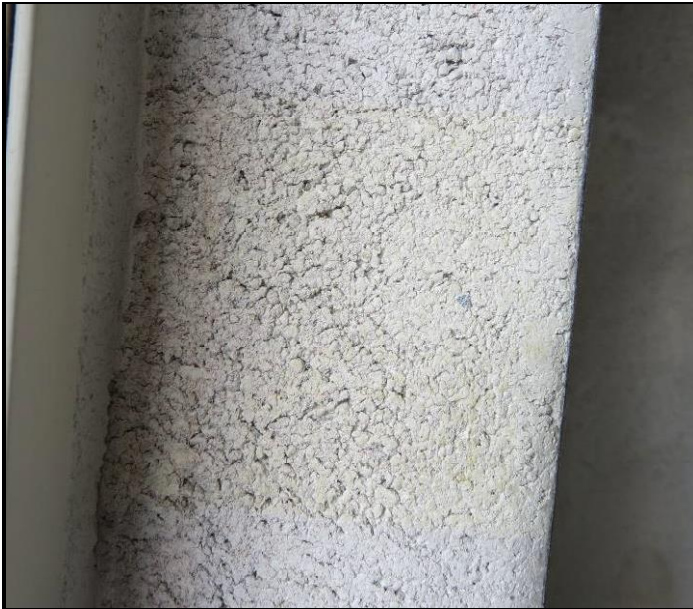
Type II: Substrate appeared slightly yellow after treatment.

Figure 32. AM Type II test patch, post-treatment.

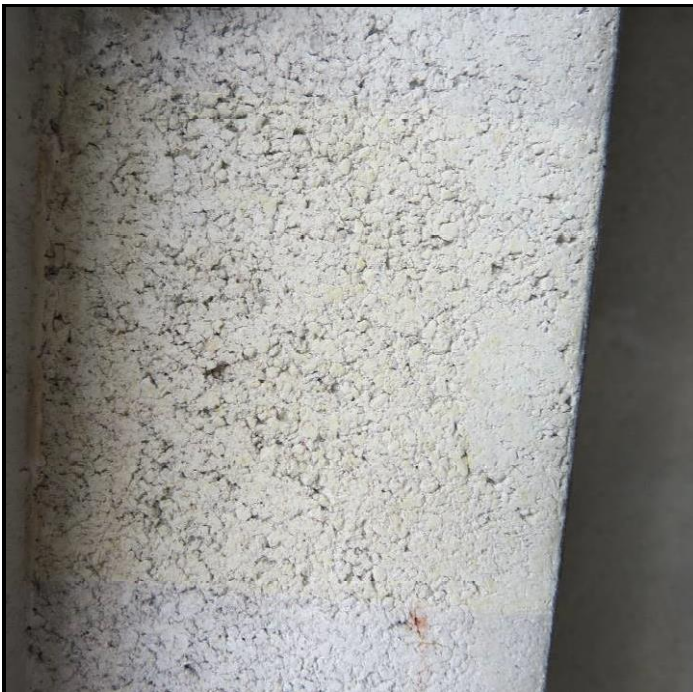
Type III: Substrate appeared very yellow after treatment.

Figure 33. AM Type III test patch, post-treatment.

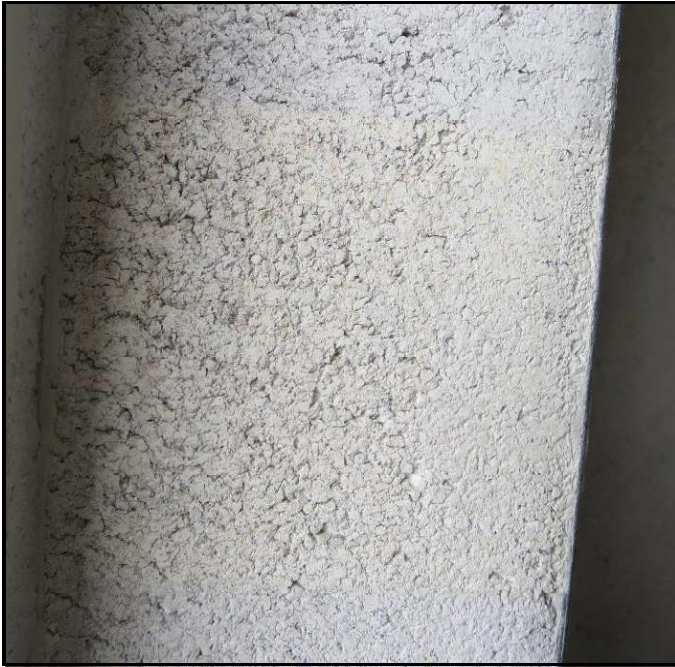
Eco: Substrate appeared slightly yellow after treatment.

Figure 34. AM Eco test patch, post-treatment.

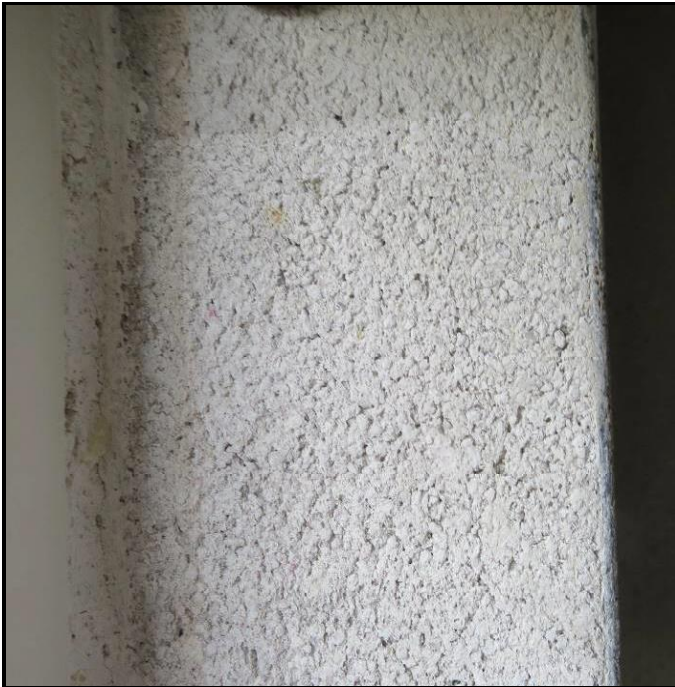
MasonRE Latex 20: This poultice was difficult to remove (the most difficult of any of the products tested). Strong adhesion to the plaster substrate provided both favorable and unfavorable results. While the poultice was very effective in trapping and lifting soiling from the surface, a small portion of the substrate was also removed. Yellowing of the substrate, as seen with other products tested, was not observed.

Figure 35. MasonRE test patch, post-treatment.

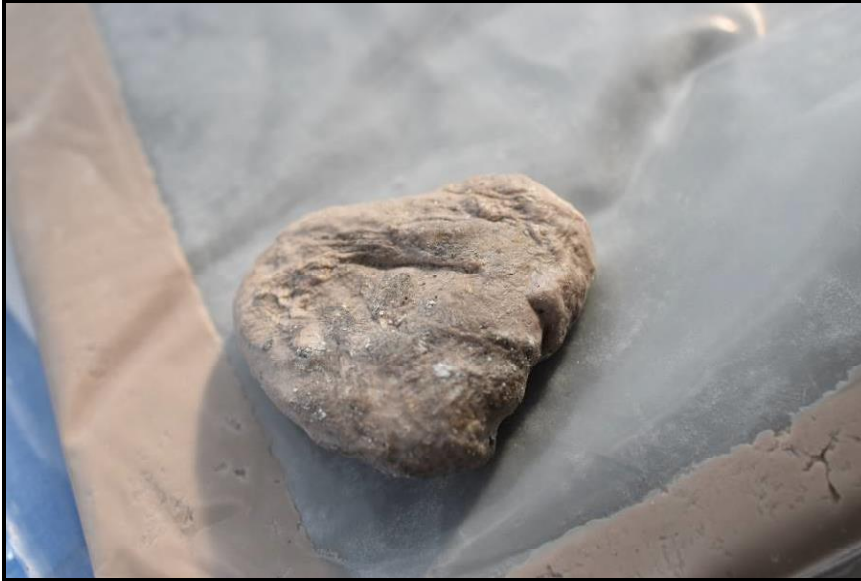
Both of the abrasive products tested were very easy to use. The surface of Groom/Stick grew noticeably darker with use, indicating that the product successfully lifted soiling from the surface (Figure 37). This product also picked up small friable pieces of the plaster. Following treatment, the test patch cleaned with Groom/Stick appeared no cleaner than before (Figure 38). A similar result was observed with the Dry Cleaning Sponge. While the surface of the sponge appeared soiled after use, the cleaning effect on the plaster was indistinguishable (Figure 37). The Dry Cleaning Sponge did not appear to remove any friable plaster fragments.

Figure 37. Groom/Stick after use. Note darker color of used product (center) compared to unused product in packaging (left). Also note white plaster fragments embedded in used product.

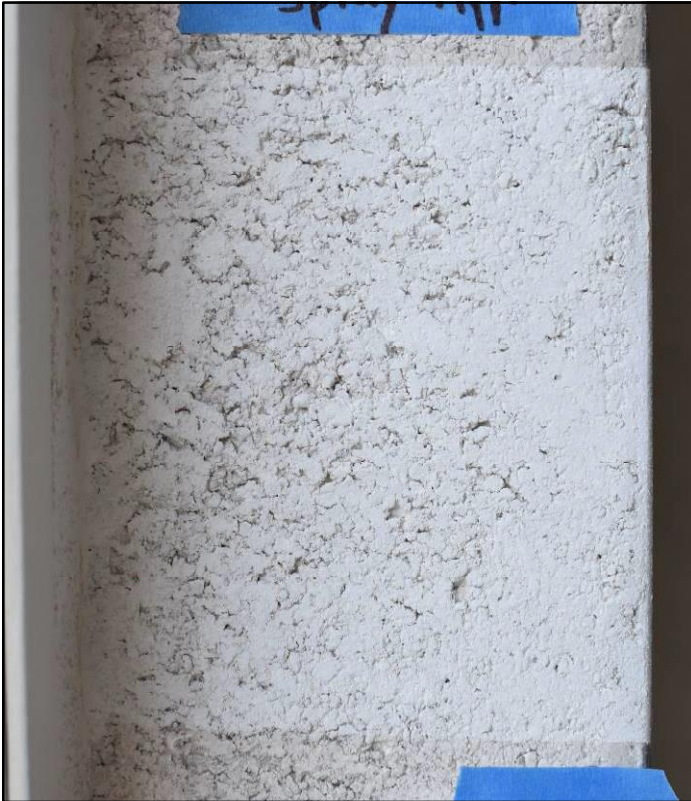
Spray application provided excellent results (Figure 43). While the spray inevitably coated the air voids, it didn't fill them as seen with brushing. With only two light passes with the sprayer, the opacity of the finish was excellent and would easily conceal most of the soiling found on the plaster. As before, the acrylic additive performed well and only minimal chalking of the dried finish was observed. Overall, the spray application provided the best results of all the variations tested, creating a very thin coating that effectively masked the soiling while maintaining the appearance of the character defining surface texture of the plaster.

Figure 43. Spray-applied Acrylic-modified Type S limewash test patch.

As a result of testing, JBC recommends that the soiled and stained acoustical plaster located in the living and dining rooms and study be coated with spray-applied limewash. While a less invasive treatment would be to clean the plaster using MasonRE Latex 20, this product is unlikely to produce the desired result. MasonRE Latex 20 was effective in removing some surface soiling but also removed small amounts of plaster. Further, its effectiveness on subsurface staining is unknown.

The plaster should be moistened with water and patted dry before the application of limewash. The limewash should be applied using HVLP spray equipment or similar equipment capable of producing a fine, nebulized mist. The limewash should be regularly stirred or agitated in the sprayer’s canister as lime particles can quickly fall out of suspension. Care should be taken to minimize the number of passes, overlap, or coats applied in order to produce thinnest possible coating with the desired opacity. Two coats produced the desired effect in testing, however, additional testing using the same equipment that will be used to execute the full-scale work should be conducted to determine the best approach.

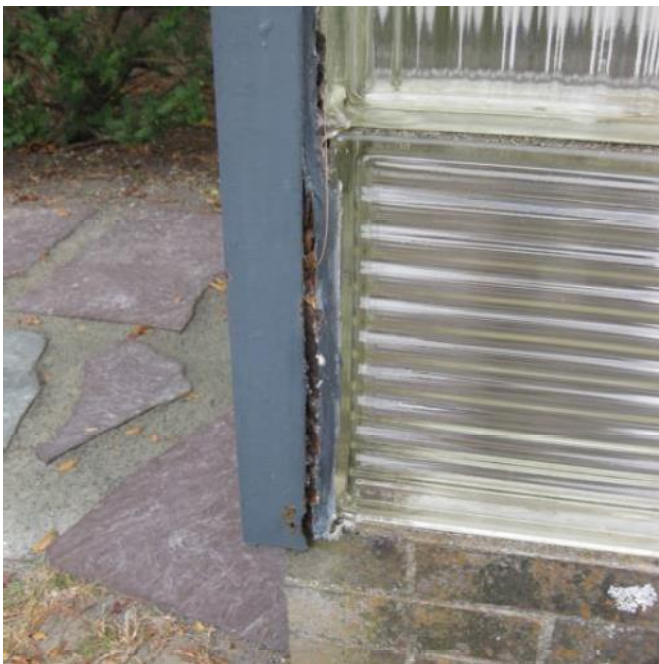
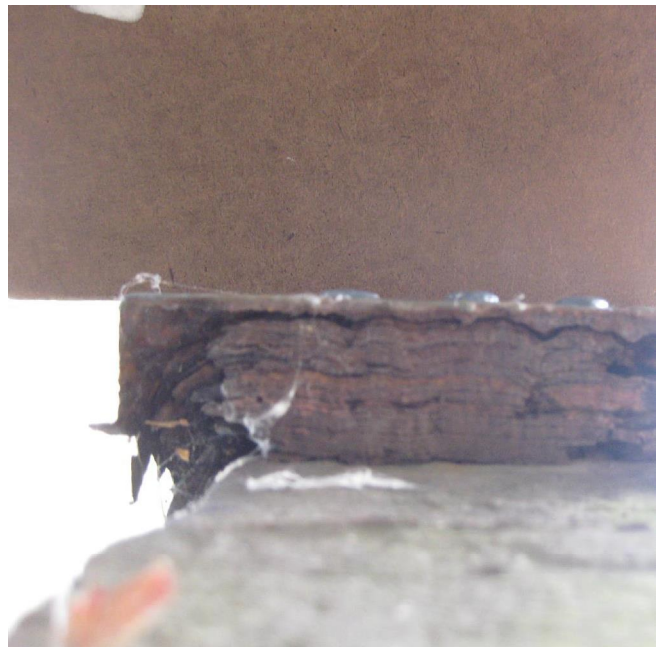
2. Corroded Steel Channel Framing East End of Wall

We determined the cracking in the glass block wall to be caused by shear stress from the corrosion of the base of the steel channel to the east pushing against the glass. We recommend that the channel and the broken glass block be replaced. Re-caulking the perimeter of wall will prevent additional water infiltration.

Significant corrosion is visible on the web of the channel at the base of the east end of the wall. The likely cause of the corrosion is moisture from snow that is often piled against the channel in the winter. Corrosion from steel expands approximately 10 times its volume, and has done so in this case in a lamellar pattern. It appears that as the corrosion grew on the west side of the web it pushed against the glass block wall introducing a shear stress into the wall. Once contact was established between the corroded web and glass wall, further corrosive expansion pushed the base of the steel channel to the east causing a visible deflection.

Ultimately we recommend that the channel be replaced with a corrosion resistant material; however, in order to do this mindfully the connection at the top of the steel channel above the ceiling must be understood and addressed. Obtaining and studying the structural drawings for the house might give some insight to the detail above the ceiling. Removing a few of the fascia boards along the side of the overhang would allow a direct look at the top of the channel and would likely be required for installation of a new steel channel.

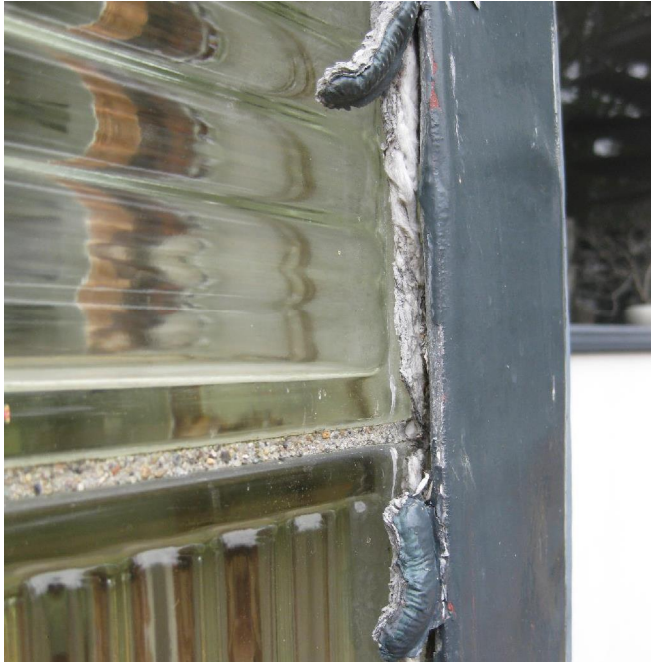
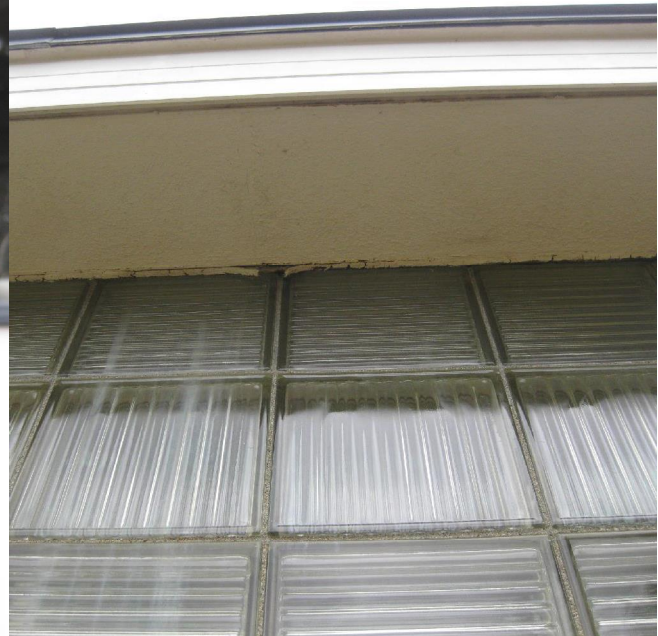
Caulking Failure at West End of Wall and Ceiling, continued

The caulking has failed leaving the rope backer exposed on all edges of the wall.

The caulking and backer should be replaced with materials compatible with the adjacent surfaces and the environment.

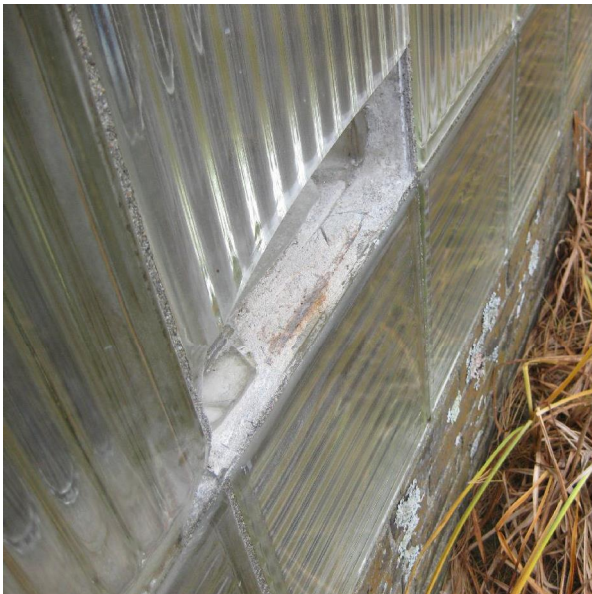
4. Wire Reinforcement Surface Corrosion

Minor surface corrosion visible in 1/8" diameter steel wire due to exposure to the elements following glass loss at the failed block.

We recommend that the wire be coated with r and embedded in mortar prior to replacement

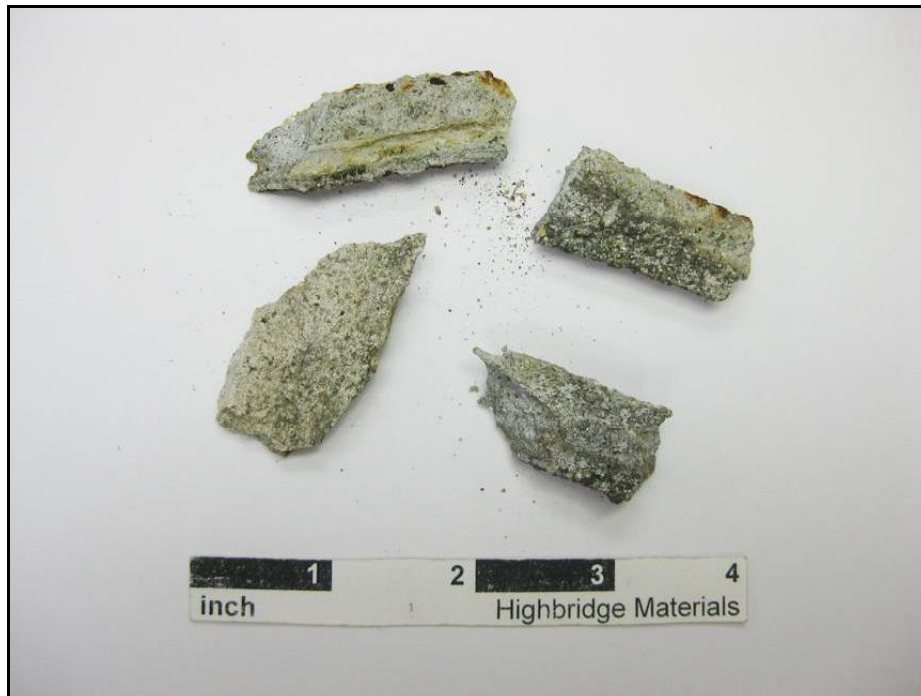
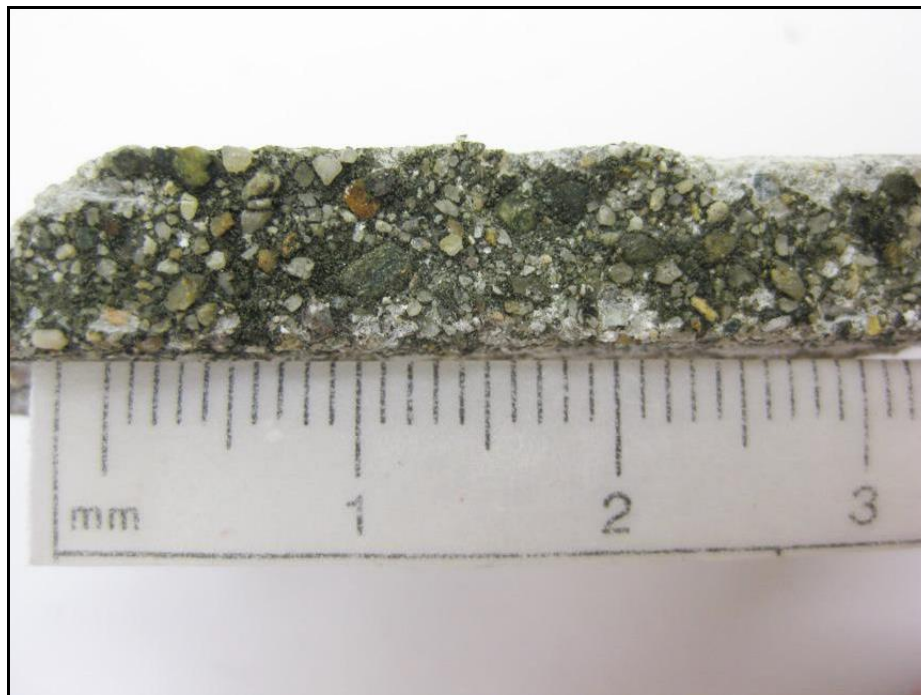
Figure 1: Photographs of the mortar sample provided to Highbridge for examination. The mortar is uniform in appearance with a gray color. The cured product is hard, nonfriable, and not noticeably water absorptive. The lower image shows a closer view of the tooled surface. The exposed aggregate contributes some color and textural variegation to the weathered joint face. However, the overall color is much darker than the fresh paste due to soiling at the surface.

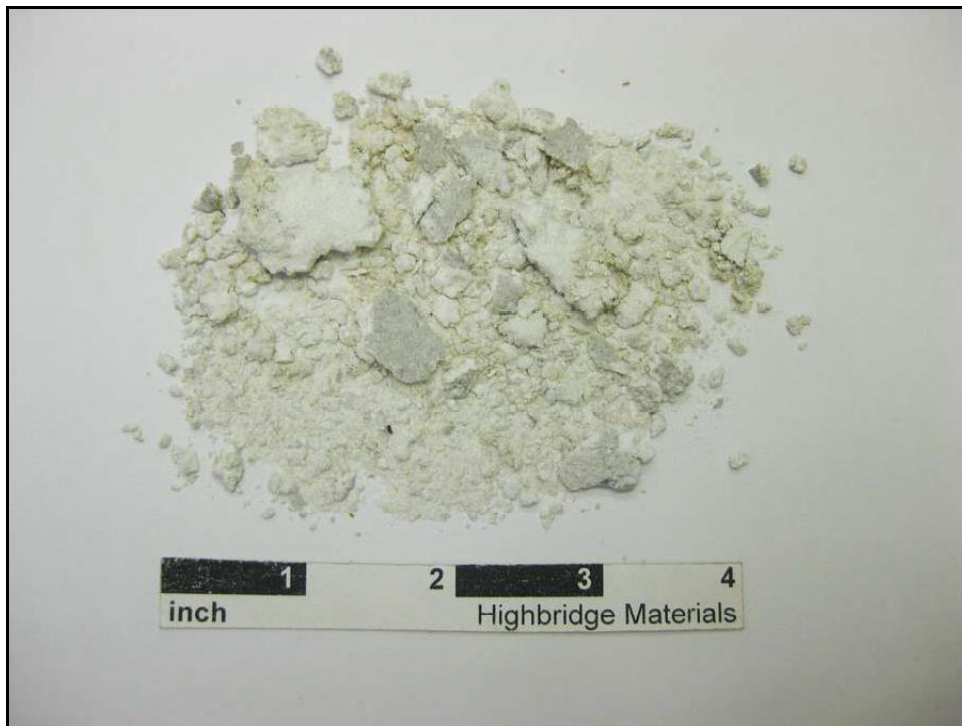
Figure 1: Photograph of the sample provided to Highbridge for examination. The acoustical plaster is nearly white except where soiled to a light gray color.

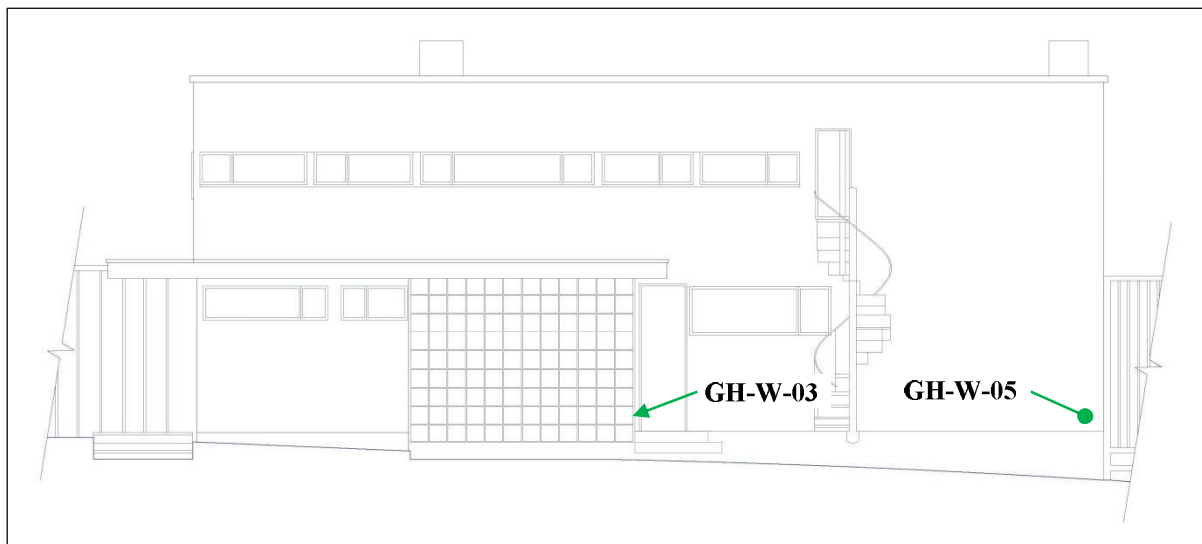
Figure 1. North elevation showing siding sampling locations.

Samples of the wooden siding were removed using a scalpel from a total of three locations on the north and east elevations. Samples were labeled as GH-W-03, 04, and 05. Sampling locations are identified in Figures 1 and 2 below.

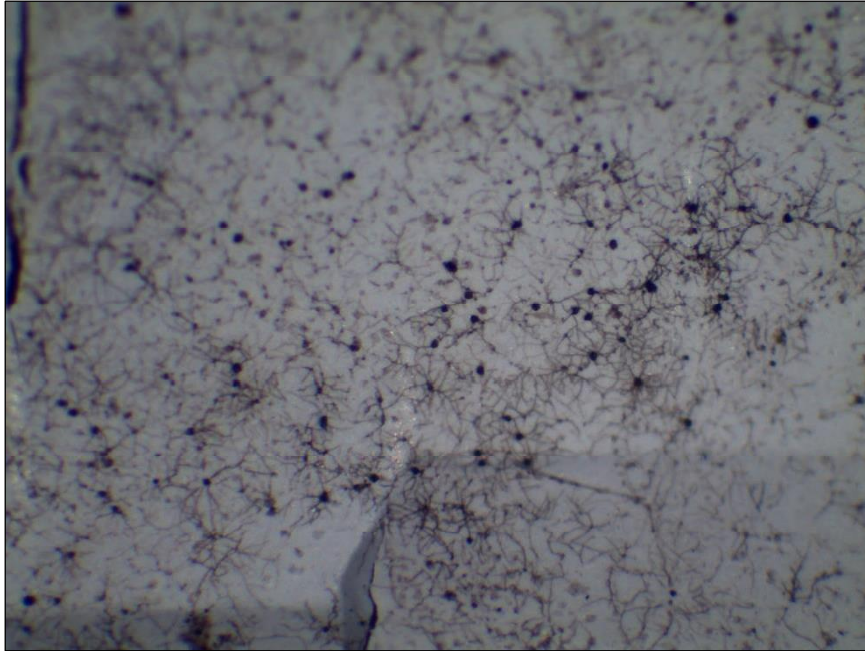
³Mold spores were observed on the wood surface in sample GH-W-05, taken from the end of a siding board nearest the ground.

Figure 9. Coated surface of siding showing mold spores and hyphae (40X).

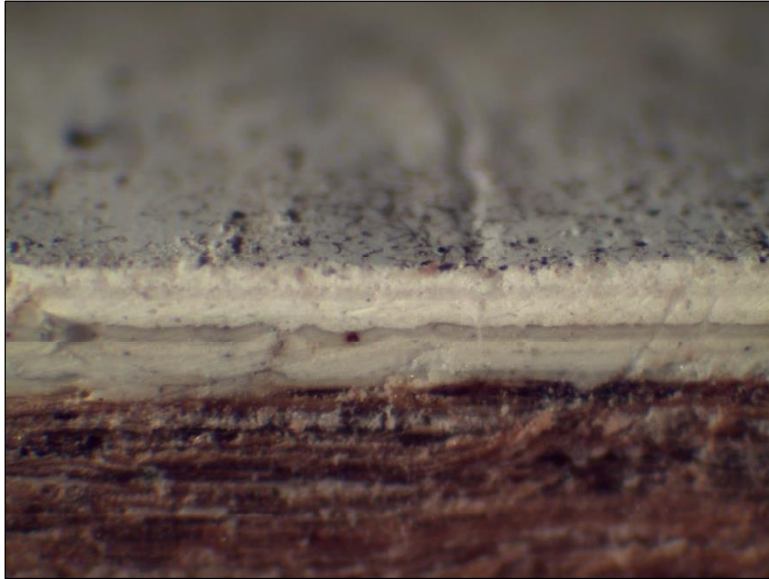
Figure 11. Cross-section through coatings and wood showing mold colony on upper surface and lack of hyphae penetrating coating layers (40X).

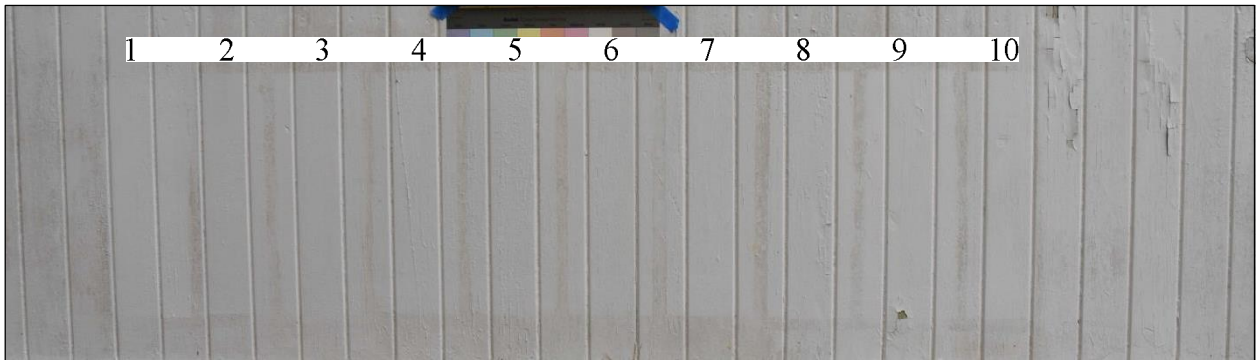
Figure 15. Cleaning test area on east elevation of garage after application. Products: (1) Vulpex, (2) Water, (3) D/2, (4) Wet & Forget, (5) TSP, (6) 3% Hydrogen Peroxide, (7) 30% Hydrogen Peroxide, (8) 1.25% Sodium Hypochlorite, (9) 5% Sodium Hypochlorite, (10) Orvus.

Of the eight products tested, D/2 Biological Solution and both concentrations of sodium hypochlorite were most effective in removing biological soiling and preventing its recurrence. All products, including water, were effective in initially cleaning biological soiling from the test surfaces (see Figure 15 and Figure 18). However, none could completely prevent recolonization of the siding. Areas treated with 3% hydrogen peroxide, trisodium phosphate, water, Wet & Forget, and Vulpex exhibited the least long-term preventative effect. Areas treated with 30% hydrogen peroxide and Orvus had some long-term effect. The difference between areas treated with 30% hydrogen peroxide and Orvus and the best-performing areas treated with D/2 and sodium hypochlorite is slight.

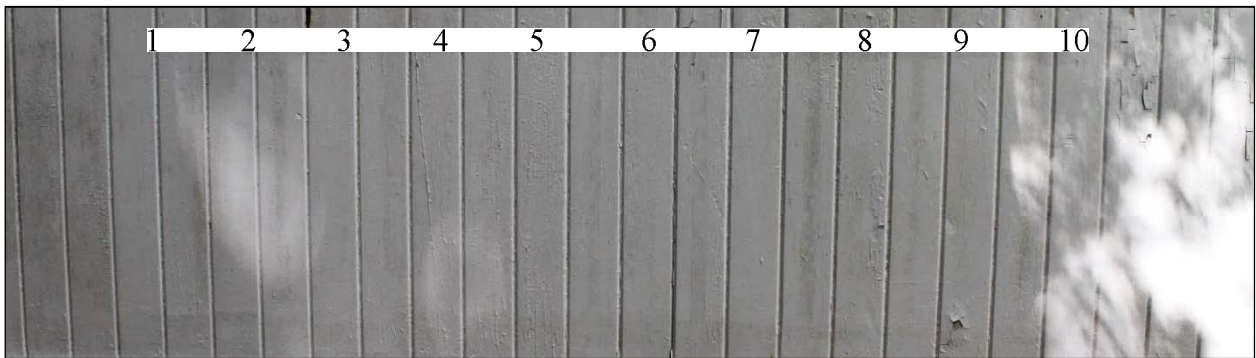
Figure 16. Cleaning test area on east elevation of garage after ten months of exposure (Credit: Colleen Chapin|HNE). Products: (1) Vulpex, (2) Water, (3) D/2, (4) Wet & Forget, (5) TSP, (6) 3% Hydrogen Peroxide, (7) 30% Hydrogen Peroxide, (8) 1.25% Sodium Hypochlorite, (9) 5% Sodium Hypochlorite, (10) Orvus.

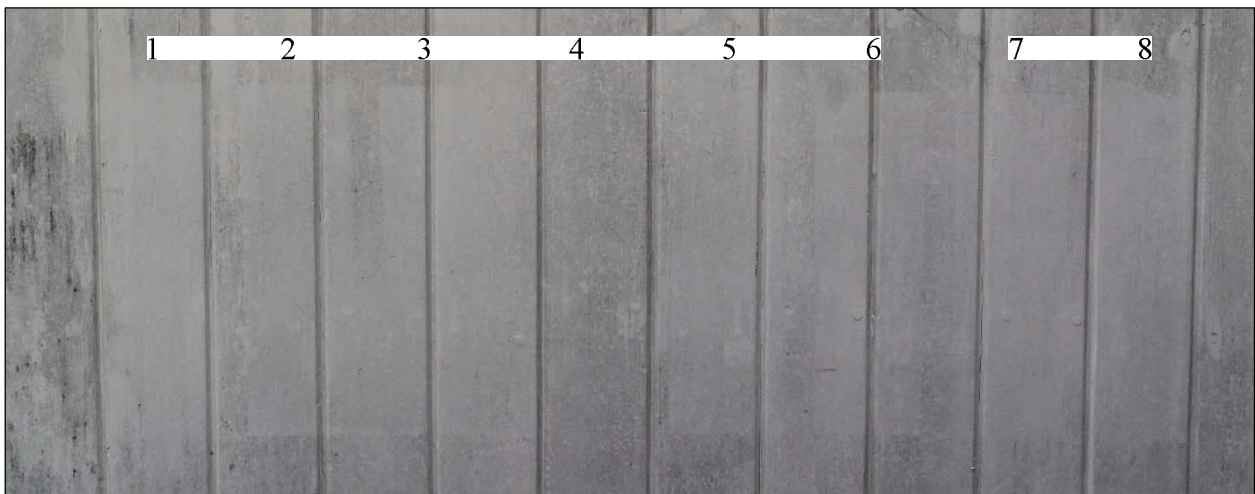
Figure 19. Cleaning test area on west elevation of roof deck after ten months of exposure (Credit: Colleen Chapin[HNE]). Products: (1) 1.25% Sodium Hypochlorite, (2) Water, (3) Wet & Forget, (4) [untreated], (5) Vulpex, (6) Orvus, (7) D/2, (8) 5% Sodium Hypochlorite.

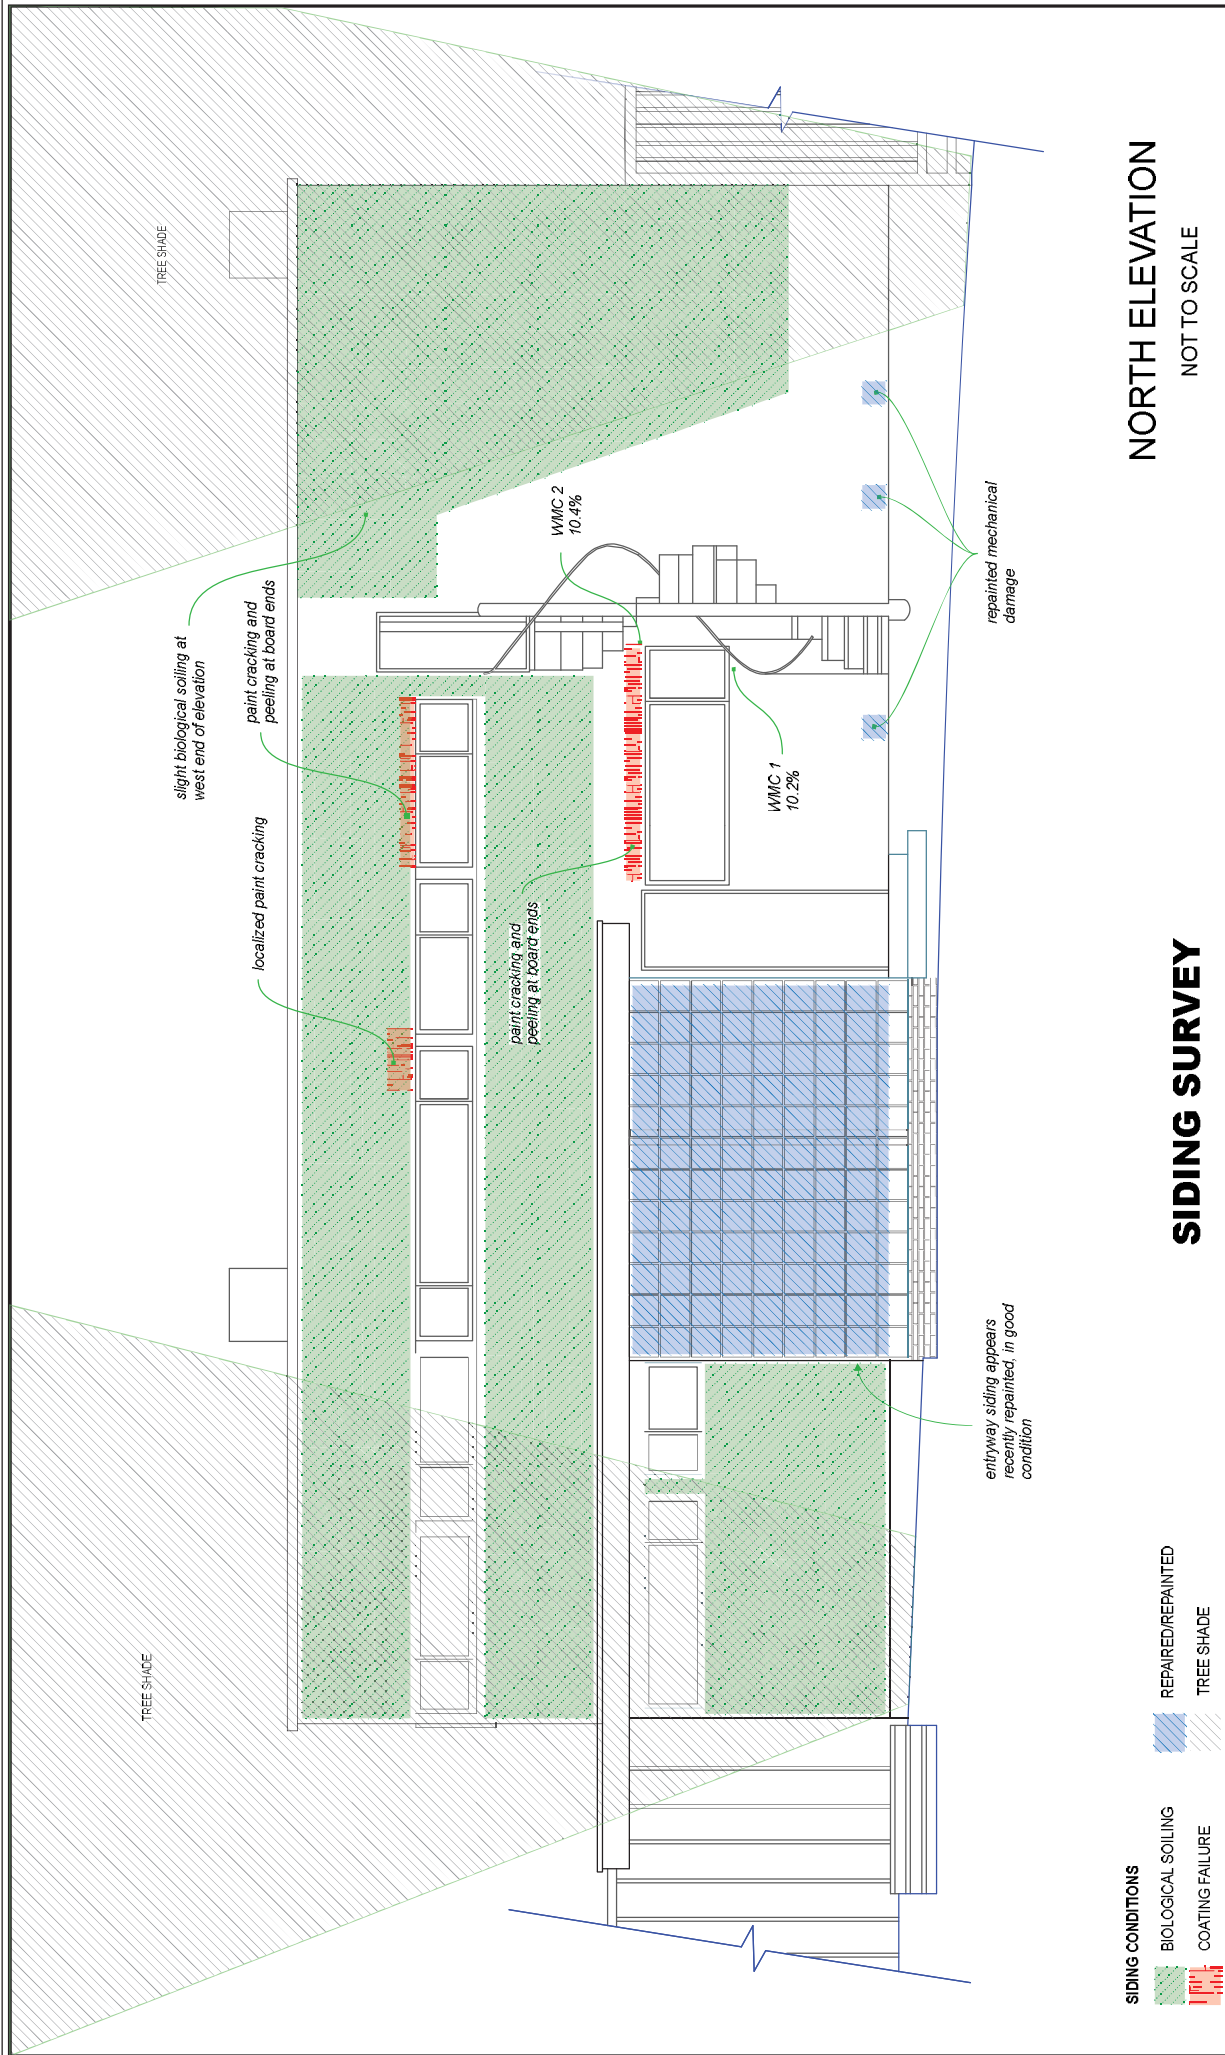
NORTH ELEVATION
NOT TO SCALE

Results of the field survey documenting conditions affecting the siding indicates that biological soiling, while present to some degree on all elevations, is concentrated in areas protected by tree shade (see Appendix B). The soiling is most prevalent on the east end of the north elevation and across the south and west elevations. All of these areas receive tree shade.

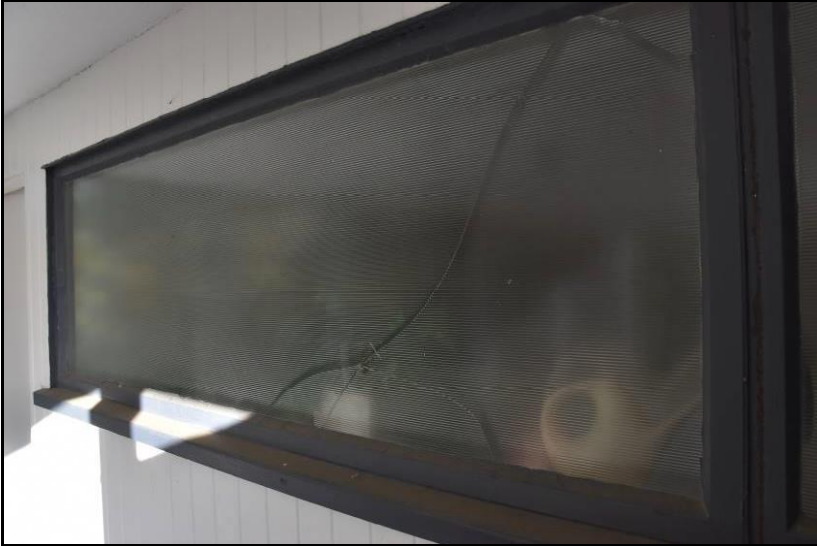
Window 102 (South Elevation)

Glazing in the fixed (westernmost) sash of this window exhibits severe cracking. Multiple cracks traverse the ribbed glass. A hole in the lower portion of the glass that was likely caused by an impact has been covered over by a clear film (probably packing tape). In addition to impact-related damage, the extent of the cracking suggests that stress on the glazing may have caused or contributed to further cracking. Glazing in the adjacent, operable sash is intact and in good condition.

Figure 6. Stress/impact related damage in fixed-pane of Window 102.

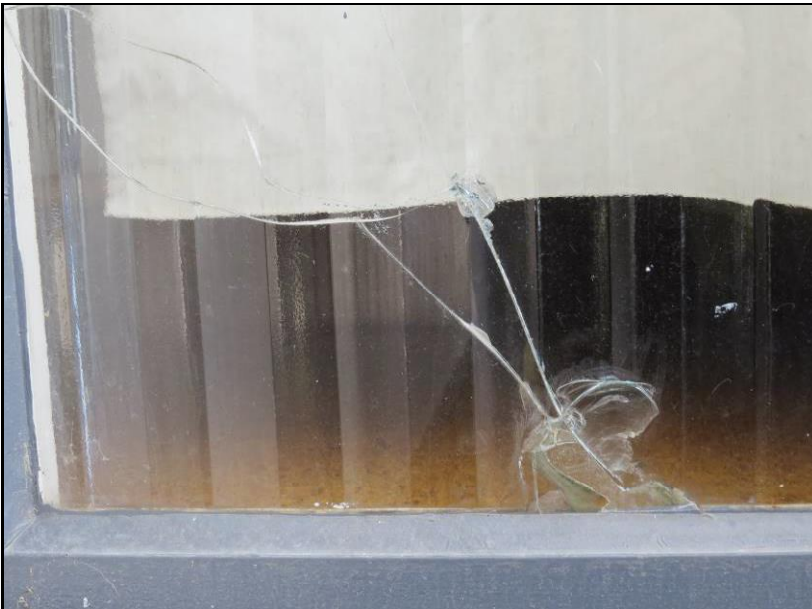
Window 109 (East Elevation)

Glazing in the lower sash of this window exhibits extensive stress cracking. Several cracks culminate in an area of “oyster” shaped, conchoidal surface loss occurring along the bottom edge of the pane. Glazing in the small upper sash is intact and in good condition.

Figure 7. Stress cracks and "oyster" shaped loss in lower sash of Window 109.

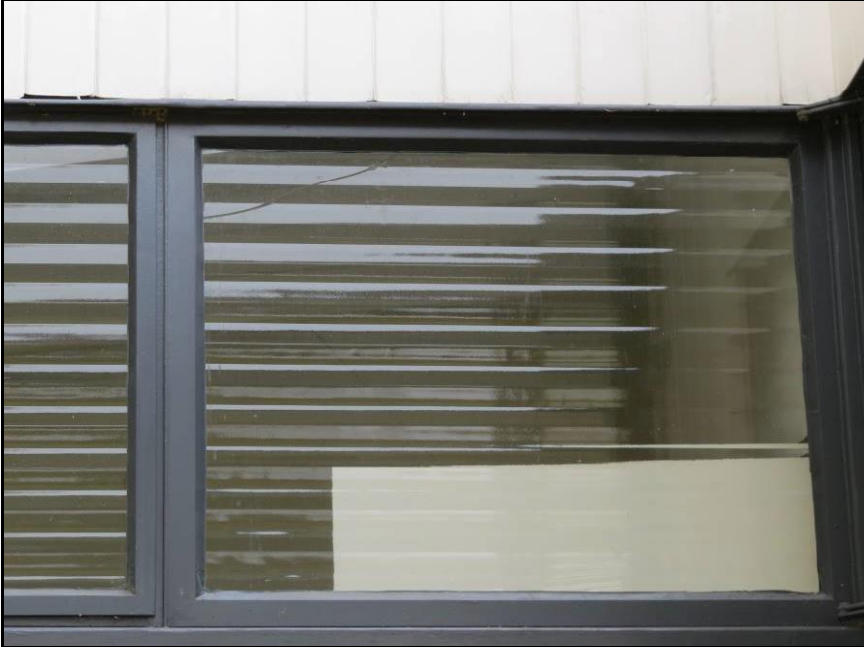
Window 110 (North Elevation)

Glazing in the fixed (westernmost) sash of this window exhibits a single stress crack in the upper east corner. Glazing in the smaller adjacent operable sash is intact and in good condition.

Figure 8. A single stress crack seen in Window 110.

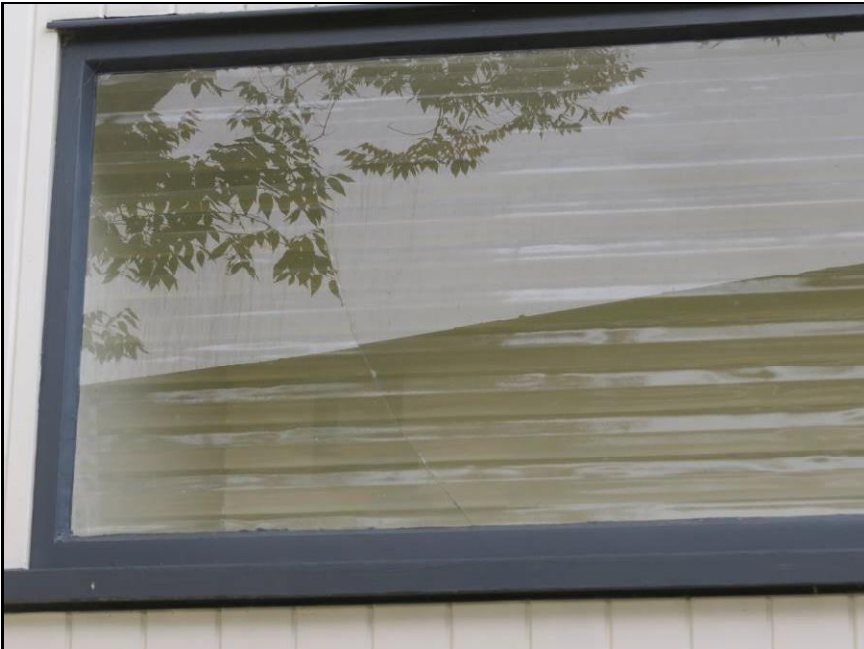
Window 111 (North Elevation)

Glazing in the fixed (easternmost) sash of this window exhibits a single, vertical stress crack. Glazing in the adjacent, operable sash is intact and in good condition.

Figure 9. A single stress crack seen in Window 111.

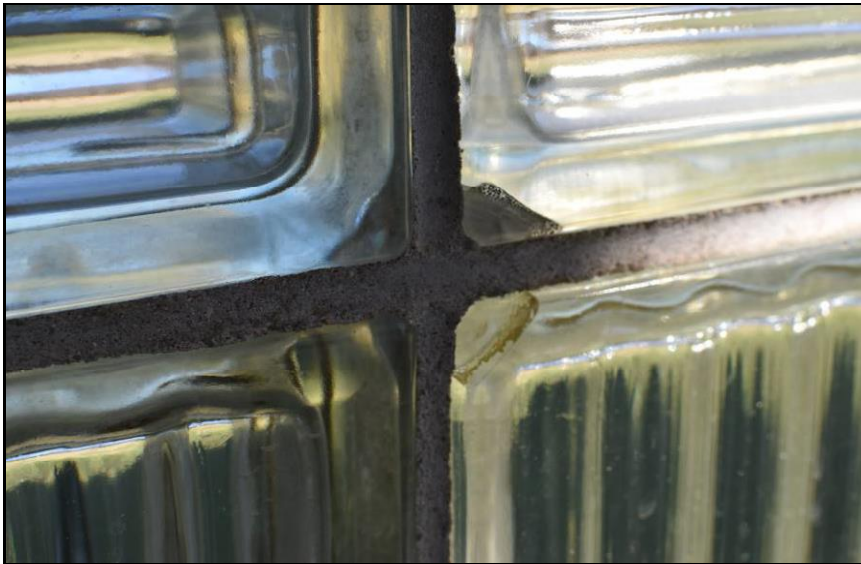
Blocks D2, G11, H3, H11, and J11 all exhibit a minor spall in one corner edge on their north (exterior) -facing side (Figure 10). Similar damage was observed on the south (interior) -facing side of Blocks E2, E3, and F2. In some blocks, these spalls are slightly displaced. Cracking is present on the north side of Block G1 and on both sides of Blocks G7, H2, H5, H7, and H8 (Figure 11). The most severe damage was observed in Block H2, which exhibits extensive cracking and is missing a large section on its north side (Figure 12).

Figure 10. Typical corner spalls in glass block units.
