Conservation Management Plan

GROPIUS HOUSE

68 Baker Bridge Road
Lincoln, Massachusetts

Historic New England
Baseline Report: 2016

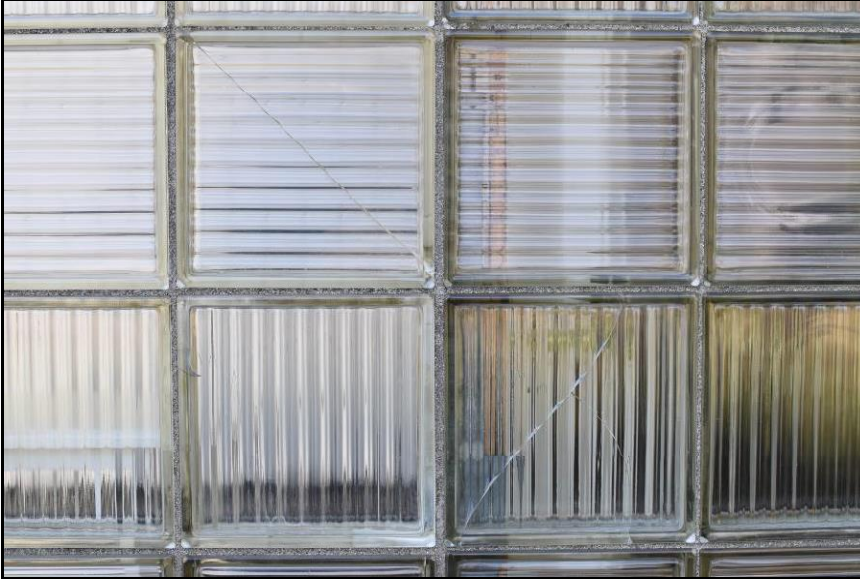
Blocks D2, G11, H3, H11, and J11 all exhibit a minor spall in one corner edge on their north (exterior) -facing side (Figure 10). Similar damage was observed on the south (interior) -facing side of Blocks E2, E3, and F2. In some blocks, these spalls are slightly displaced. Cracking is present on the north side of Block G1 and on both sides of Blocks G7, H2, H5, H7, and H8 (Figure 11). The most severe damage was observed in Block H2, which exhibits extensive cracking and is missing a large section on its north side (Figure 12).

Figure 11. Typical cracks in glass block units.

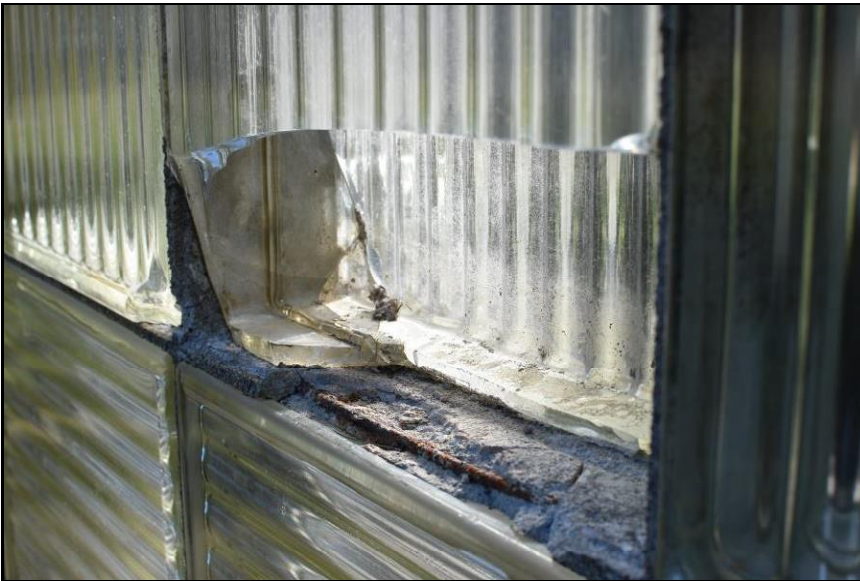
Figure 12. Block H2 exhibiting extensive cracks, losses, and exposed corroding metal joint reinforcement.

Cracks in the glass block units are likely caused by shear stress created by corrosion of the steel channel which frames the vertical ends of the wall (see Engineer's Report in Appendix B). The generally horizontal direction of the cracks forms a pattern consistent with a local horizontal shear stress. Stress-related cracks are exacerbated as moisture intrudes into the crack and expands in freezing conditions. As a crack grows in size, it will allow moisture to further infiltrate and fill the inner cavity of a block where freezing temperatures place further stress on the already compromised material (see Figure 23).

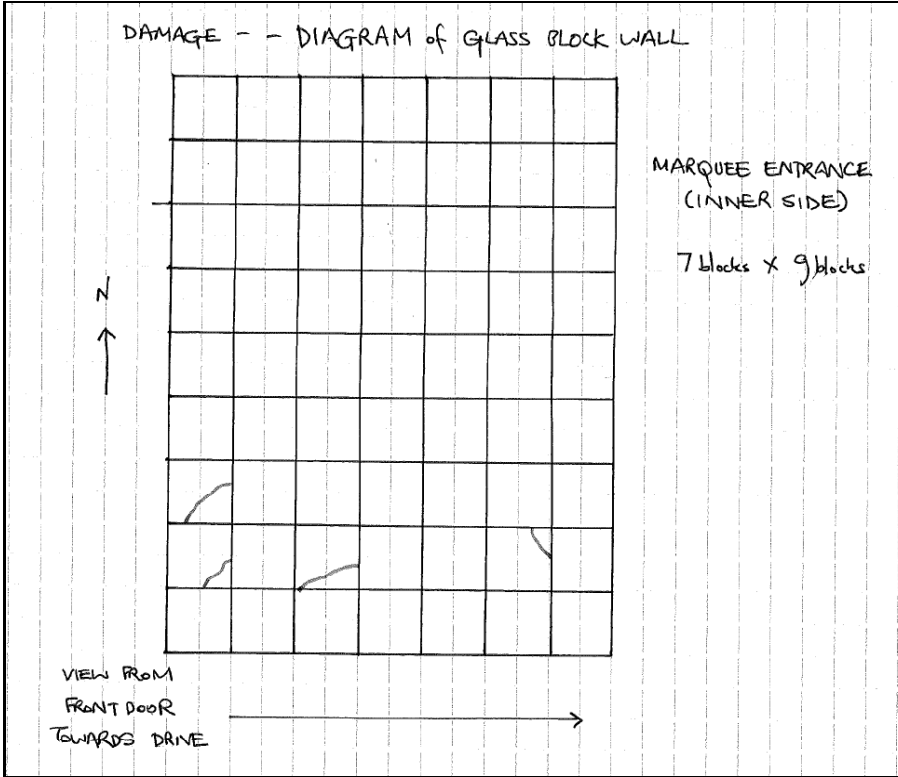
A review of documentation of cracks in the block wall prepared in 1996 indicates that the condition of the blocks has progressively deteriorated over time, with cracks increasing in size and propagating in number (see Figure 13 and Figure 14). This indicates that the deterioration is active and will continue to worsen if not corrected.

Figure 13. Diagram of cracks in the glass block wall (looking north) from 1996 memo (HNE Collection).

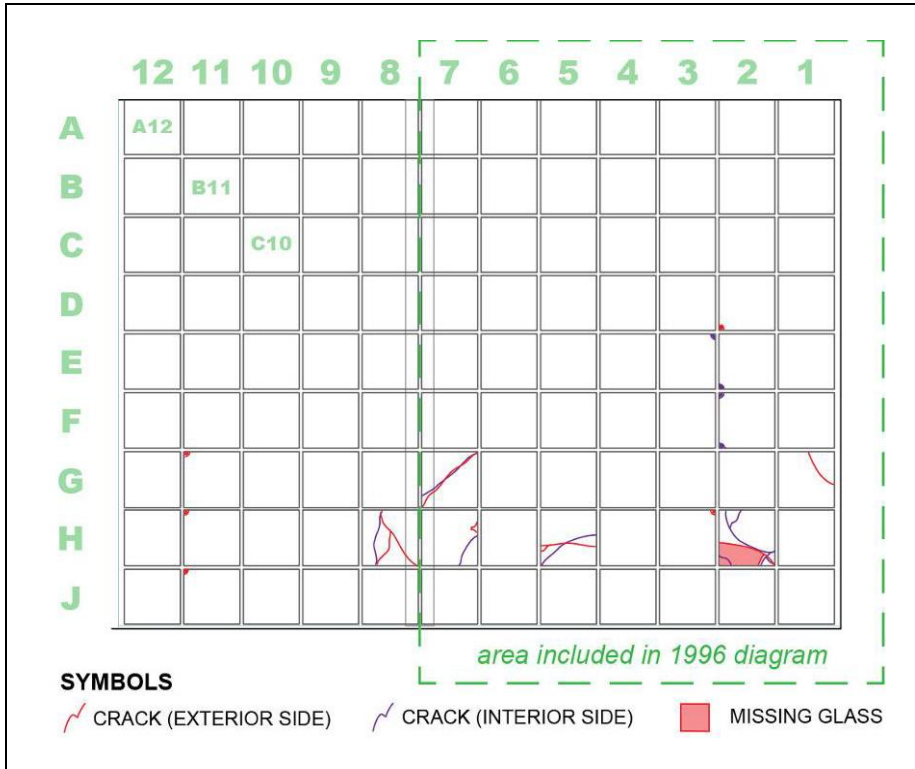
Figure 14. Current condition of glass block wall (interior elevation looking north), with location of 1996 condition diagram noted.

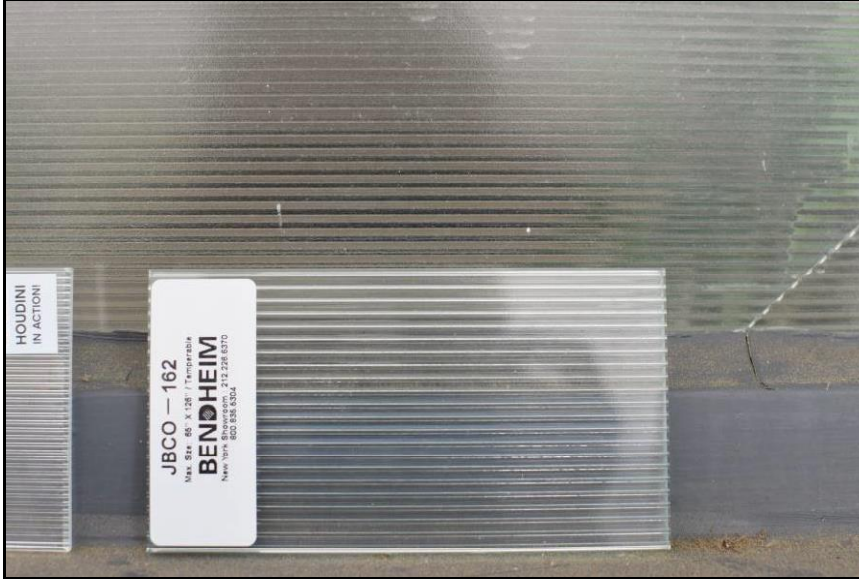
Figure 16. Sample of Bendheim's JBCO-162, "ribbed" glass compared to original glass in Window 102 (south elevation).

Replace original glass with identical modern or salvaged material. Identical modern materials are not available. However, a very close match for the ribbed glass is available in Bendheim's JBCO-162, "ribbed" product (Figure 16).³⁵ The pattern and thickness dimensions of this product are nearly identical to the original. However, it is not available with an etched finish (as found on the original) from the manufacturer. This can be reproduced with acid etching or sandblasting, services available at some glass shops. The color of the glass may vary slightly from the original, but the effect can be mitigated if the glass in the adjacent, operable sash is also replaced.

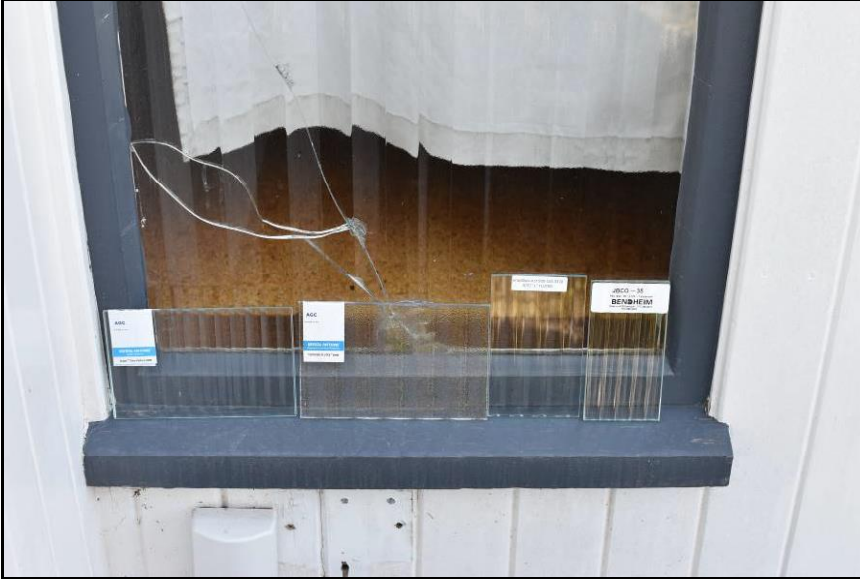
Figure 17. Samples of replacement glass compared to original Louvrex glass in Window 109 (east elevation). Samples (left to right): AGC “Flutes” Clear Pattern, AGC “Textured Flutex”, Gray Glass “1-inch Fluted”, Bendheim’s JBCO-35.

Replace deteriorated glass with a material that approximates the character defining features of the original. This option applies especially to the Louvrex glass. If no salvage material can be procured, replacement may proceed using a fluted glass that has a different profile but maintains the effect of the original. One such material is the 1-inch "fluted" glass manufactured by Gray Glass.³⁶ While this glass lacks the same pattern width, profile shape, and textured surface, it conveys a linear character that is similar to the original Louvrex. Note that, in order to maintain continuity of appearance, undamaged glass in adjacent sashes would have to be replaced.

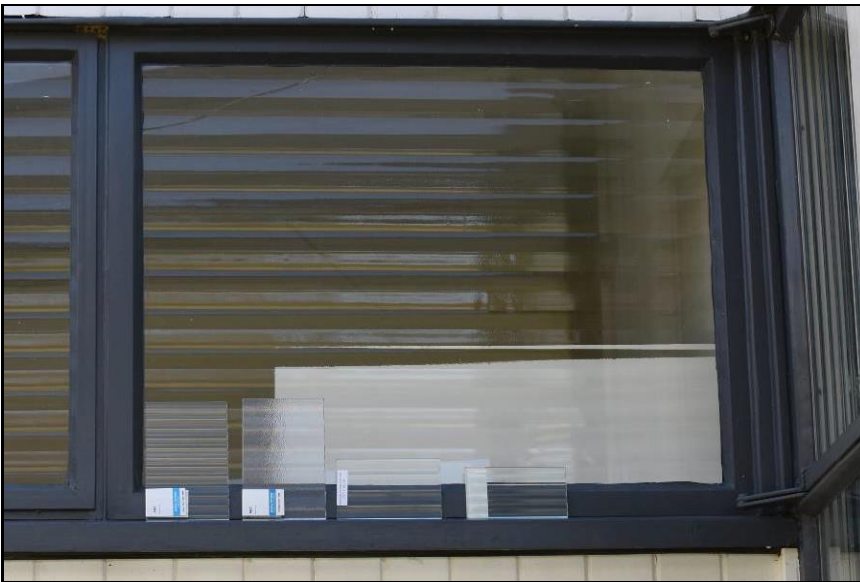
Figure 18. Samples of replacement glass compared to original Louvrex glass in Window 110 (north elevation). Samples (left to right): AGC “Flutes” Clear Pattern, AGC “Textured Flutex”, Gray Glass “1-inch Fluted”, Bendheim’s JBCO-35.

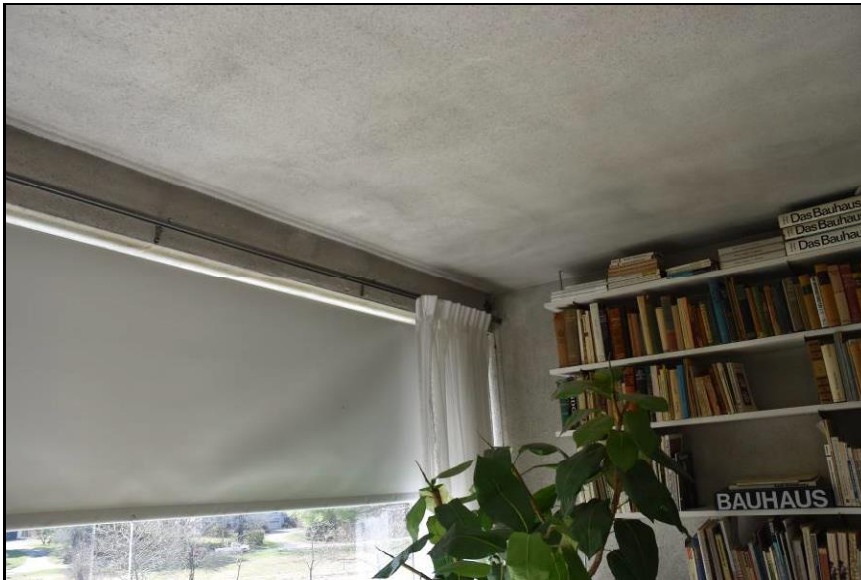
Several different treatments were devised and tested for improving the appearance of the stained and soiled acoustical plaster (Figure 22). Due to the hygroscopic nature of the acoustical plaster, it was determined that “wet” cleaning methods and materials should be avoided if possible. JBC’s prior experience in cleaning similar acoustical plaster materials suggested that latex poultices would likely be effective and so nine commercially available latex poultices were tested. Dry cleaning tests were also performed using a gentle abrasive rubber sponge and a tacky rubber putty. Following limited success in the cleaning tests, additional tests were conducted using limewash to mask soiling on the plaster. Materials and methods were tested in situ. Methodology, results, and recommendations are reported below.

Figure 22. Typical soiling and staining observed on the plaster ceiling of the living room.

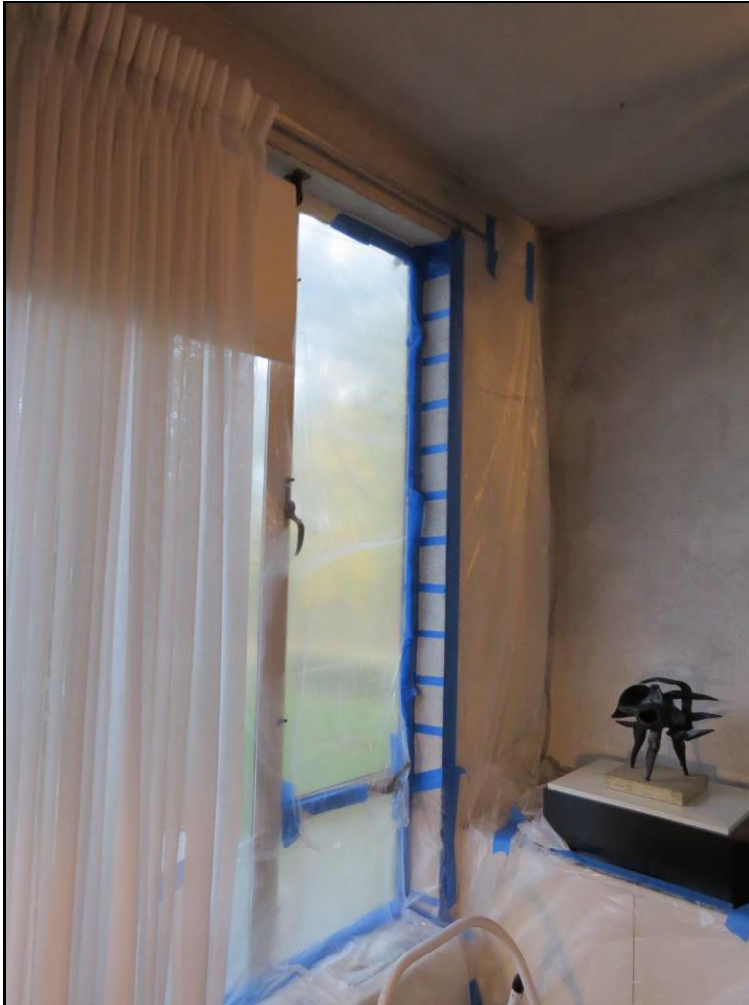
Figure 23. Location of cleaning test patches (marked in blue tape) on window return in living room.

Nine latex-based poultice-type products were selected for testing (see Table 1). These products are supplied by their manufacturers in the form of a one or two-part paste that, following application, dries to form a firm, elastic material. Product data sheets are contained in Appendix E. A location for the application of test patches was selected by JBC in consultation with HNE staff (see Figure 23). The western-most window return on the bay of windows fenestrating the living room along the south elevation was selected because the area is normally concealed behind a curtain. The test area was photo-documented and masked before the products were applied.

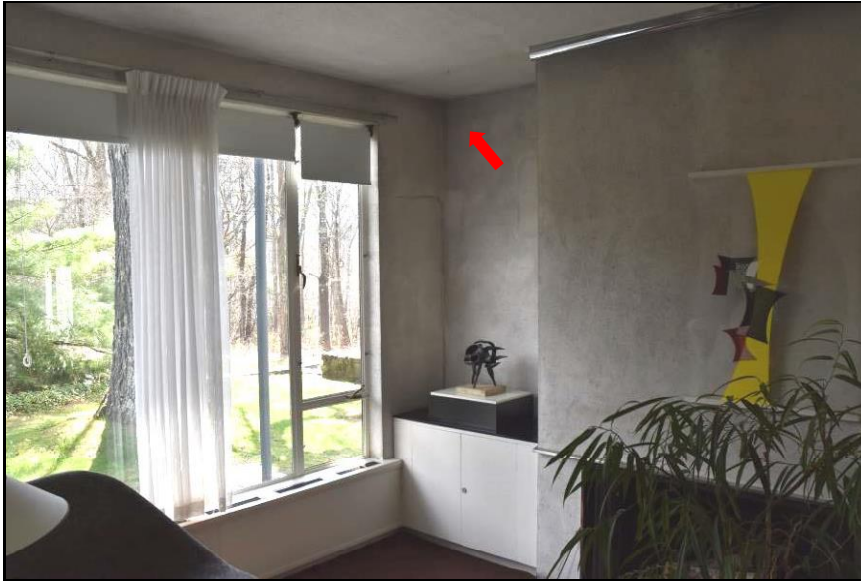
Figure 24. Location of abrasive cleaning tests (red arrow) on west living room wall.

Two gentle abrasive cleaning tests were conducted on soiled plaster on the west alcove wall in the upper southwest corner of the living room (Figure 24). The two products tested included Groom/Stick, manufactured by Picreator Enterprises Ltd. (located in the UK), and Absorene's Dry Cleaning Sponge (also known as "soot sponge"). Groom/Stick is a kneadable, pH-neutral natural rubber product used to trap soiling and lift it from the surface. The product was kneaded into a ball and pressed repeatedly into the surface of the acoustic plaster. The cleaning sponge is made of a non-toxic vulcanized rubber. This product was gently rubbed across the soiled plaster. Both products and treated plaster were then examined to determine whether any soiling had been removed.

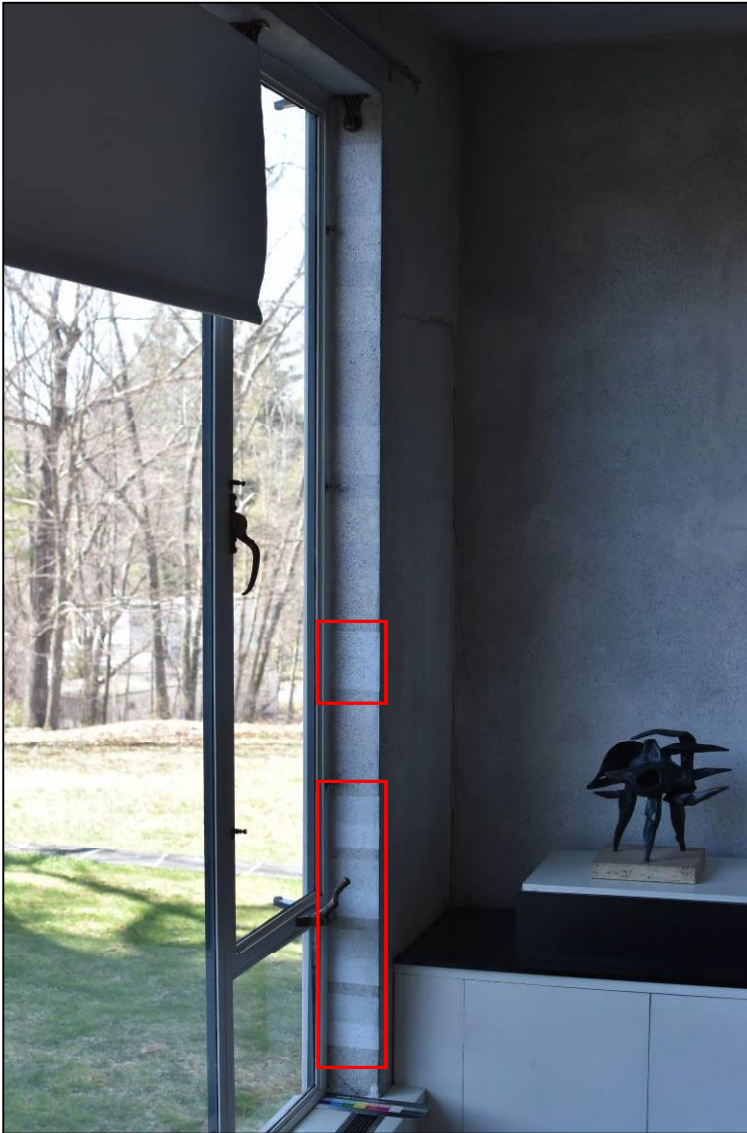
Figure 25. Location of limewash test patches (outlined in red) on window return in living room.

Following limited success experienced in the cleaning tests, JBC sought to develop a coating that would mask soiling on the plaster, be compatible with the substrate, and be reversible should future re-treatment be necessary. In a 1936 advertisement for Stucoustic, the manufacturer recommends spray application of “water-mixed” (water-based) paints should a coating or color change be desired (Figure 21). While a diluted water-based latex paint would be compatible with the material, it would be difficult and damaging to reverse and would most likely “read” as a coating rather than the surface of an uncoated plaster. Instead, limewash was selected for the coating tests because it is both compatible with the lime plaster substrate and reversible should future re-treatment be desired. Five test patches of limewash were applied below the latex poultice tests adjacent to the south window in the living room (Figure 25).

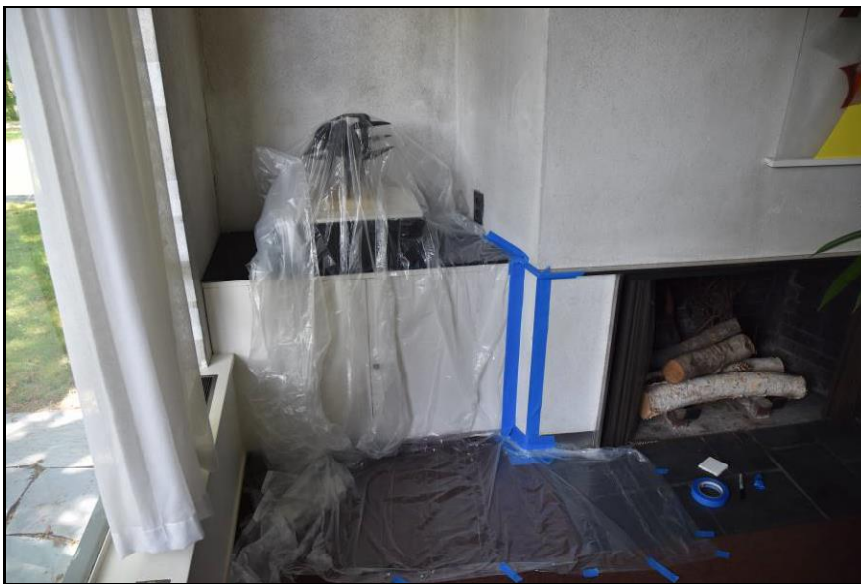
Figure 26. Location of pigmented limewash test patch (outlined in blue tape) adjacent to living room fireplace.

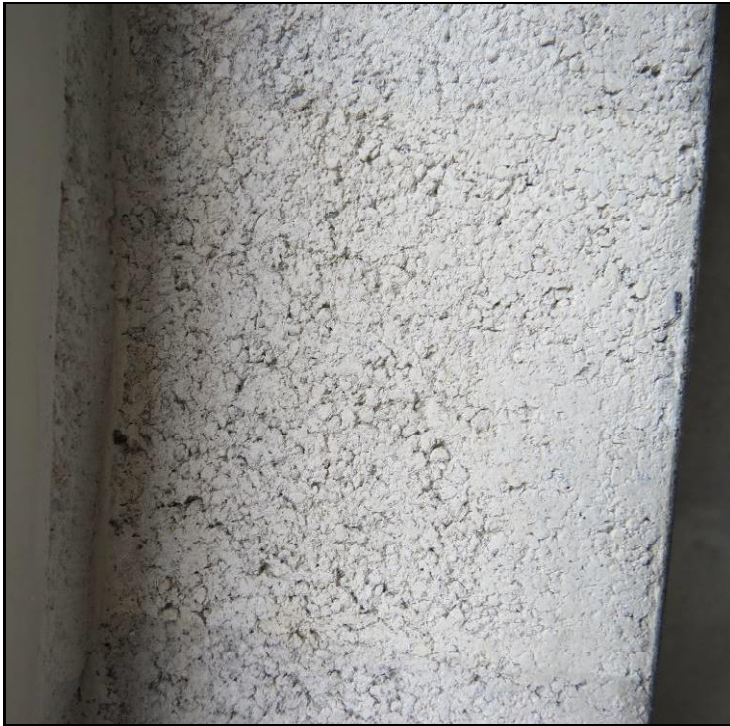
Type A: Substrate appeared slightly yellow after treatment.

Figure 27. ABR Type A test patch, post-treatment.

An exact cause of the yellowing could not be determined. One plausible theory is that the yellowing is due to oxidation of ferrous metallic particles present in the plaster matrix. Chelating agents, present in some of the products tested, are intended to bond to metal ions so that they can be extracted from the substrate. It may be that the chelators and metallic particles were drawn to the surface of the plaster, where they readily oxidized due to moisture in the poultrice materials, but were not completely removed when the poultrice was lifted away. If this were the case, re-treating the area might successfully decrease or eliminate any discoloring. However, additional treatments could serve to exacerbate the yellowing. Attempts to recreate the yellowing on plaster samples prepared with iron filings in JBC's laboratory were unsuccessful. The yellowing may alternatively be related to wood fiber present in the plaster matrix.

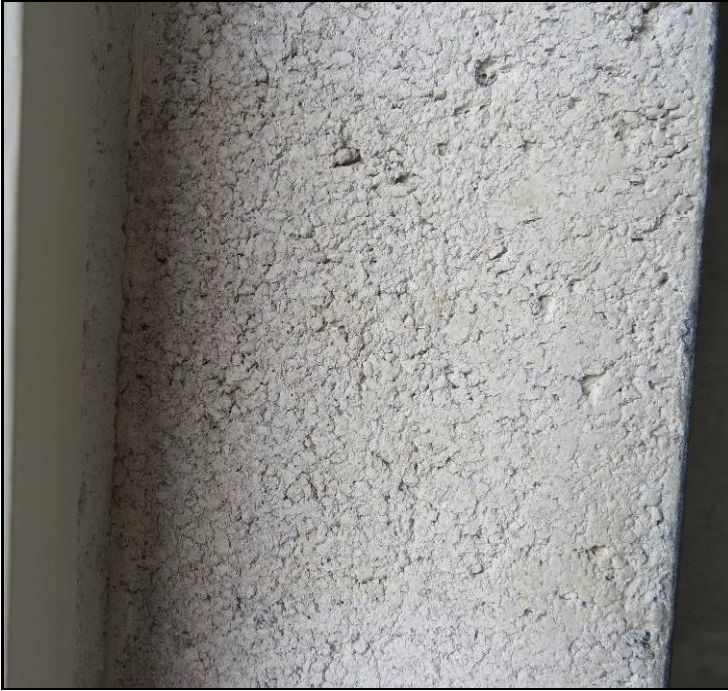
Type AM: Substrate appeared slightly yellow after treatment. The poultice material felt “stiffer” than others tested. However, this did not appear to have an effect on the substrate (i.e. no excess material removed).

Figure 28. ABR Type AM test patch, post-treatment.

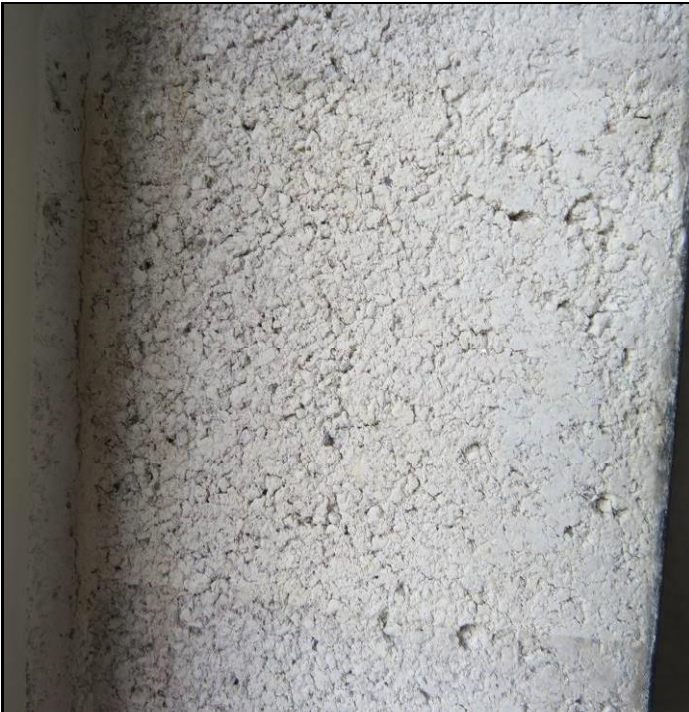
Type B: Substrate appeared slightly yellow after treatment.

Figure 29. ABR Type B test patch, post-treatment.

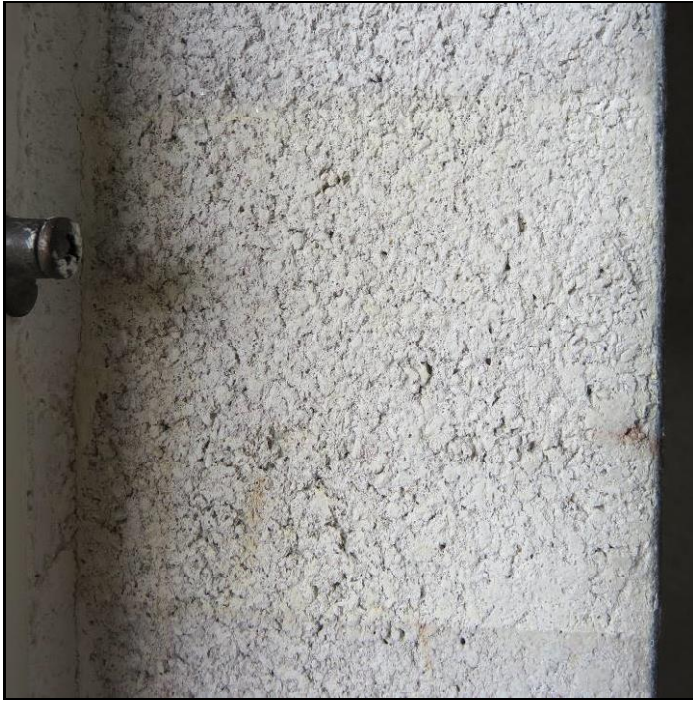
Type C: Substrate appeared very yellow after treatment (this appears to have yellowed the worst of the products tested).

Figure 30. ABR Type C test patch, post-treatment.

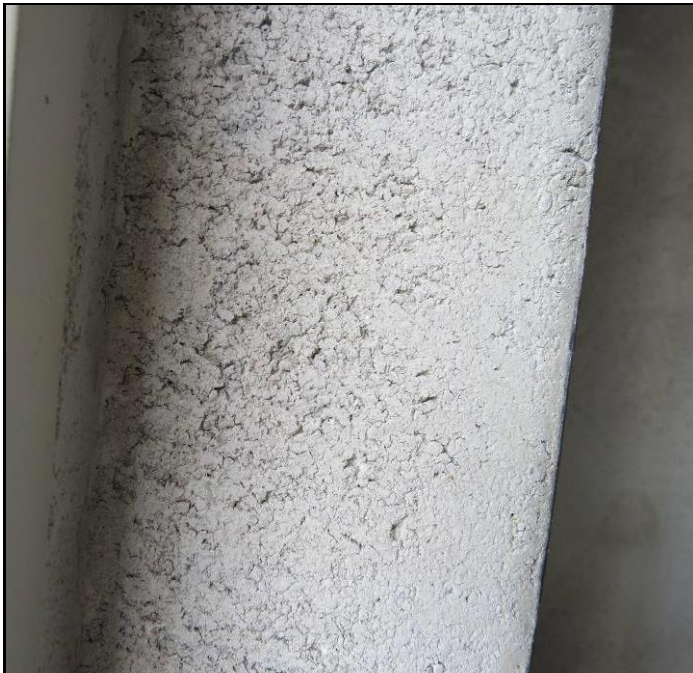
Type I: Substrate appeared slightly yellow after treatment.

Figure 31. AM Type I test patch, post-treatment.

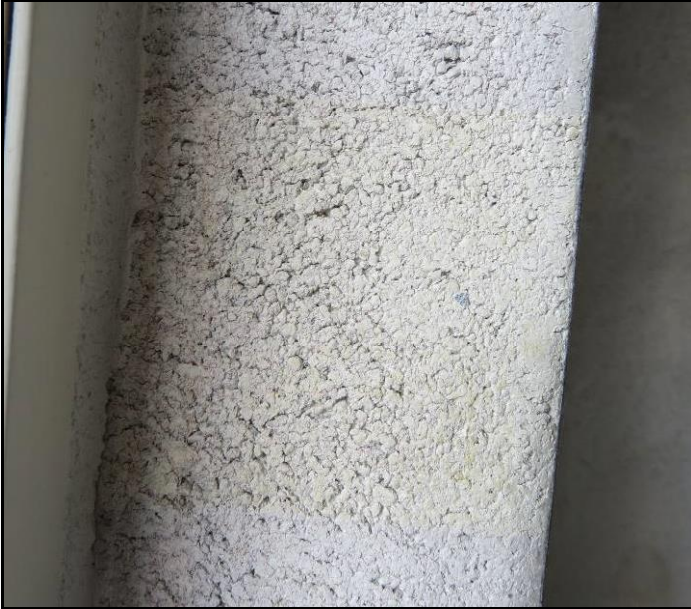
Type II: Substrate appeared slightly yellow after treatment.

Figure 32. AM Type II test patch, post-treatment.

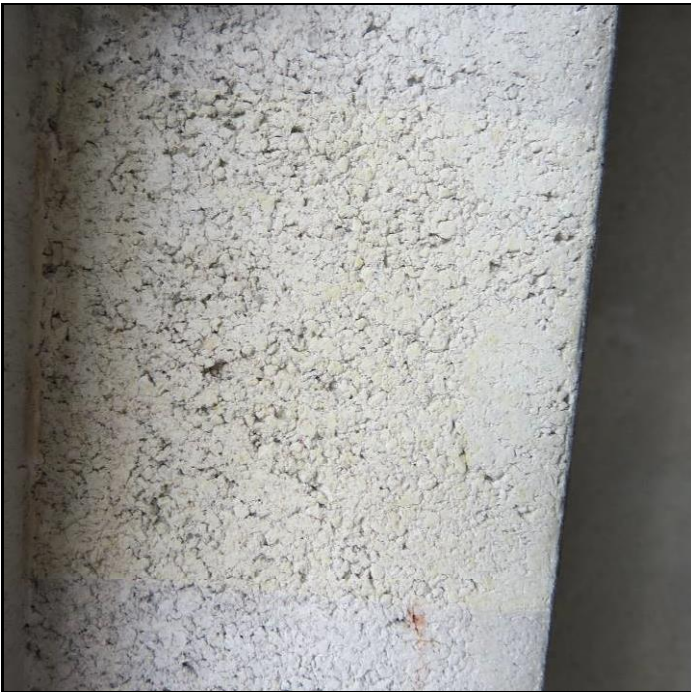
Type III: Substrate appeared very yellow after treatment.

Figure 33. AM Type III test patch, post-treatment.

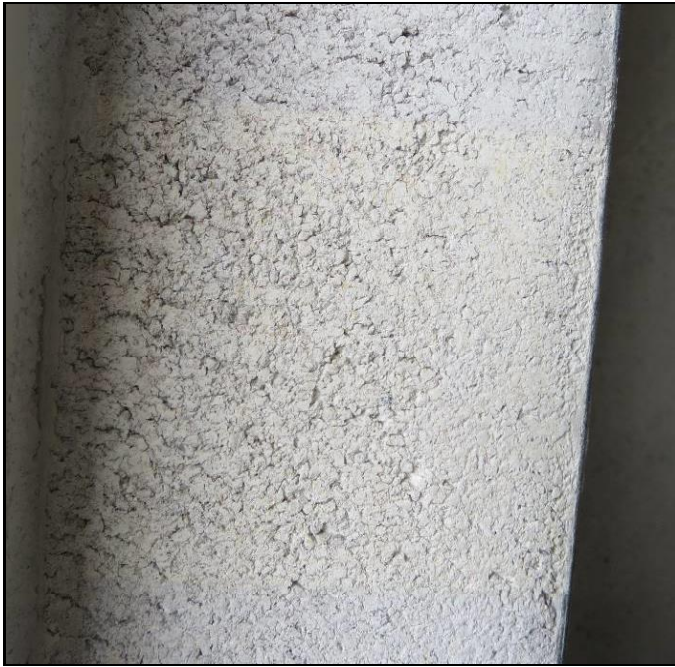
Eco: Substrate appeared slightly yellow after treatment.

Figure 34. AM Eco test patch, post-treatment.

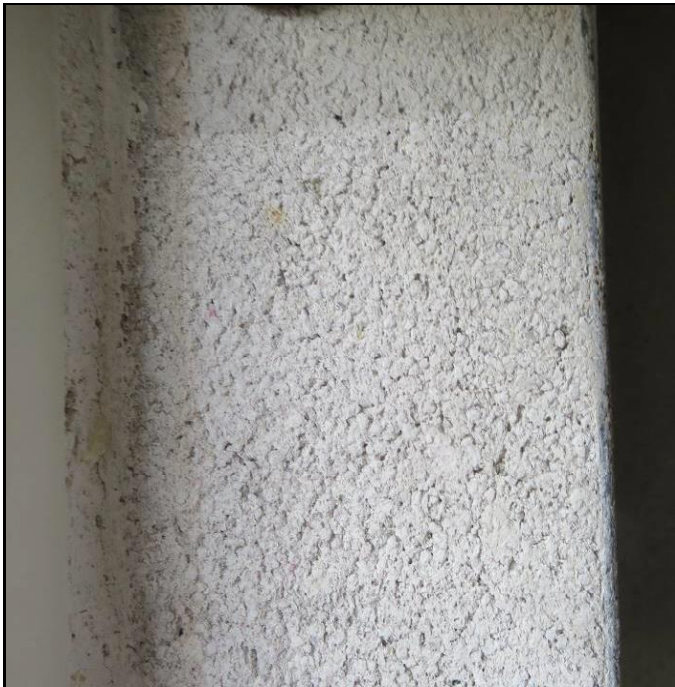
MasonRE Latex 20: This poultice was difficult to remove (the most difficult of any of the products tested). Strong adhesion to the plaster substrate provided both favorable and unfavorable results. While the poultice was very effective in trapping and lifting soiling from the surface, a small portion of the substrate was also removed. Yellowing of the substrate, as seen with other products tested, was not observed.

Figure 35. MasonRE test patch, post-treatment.

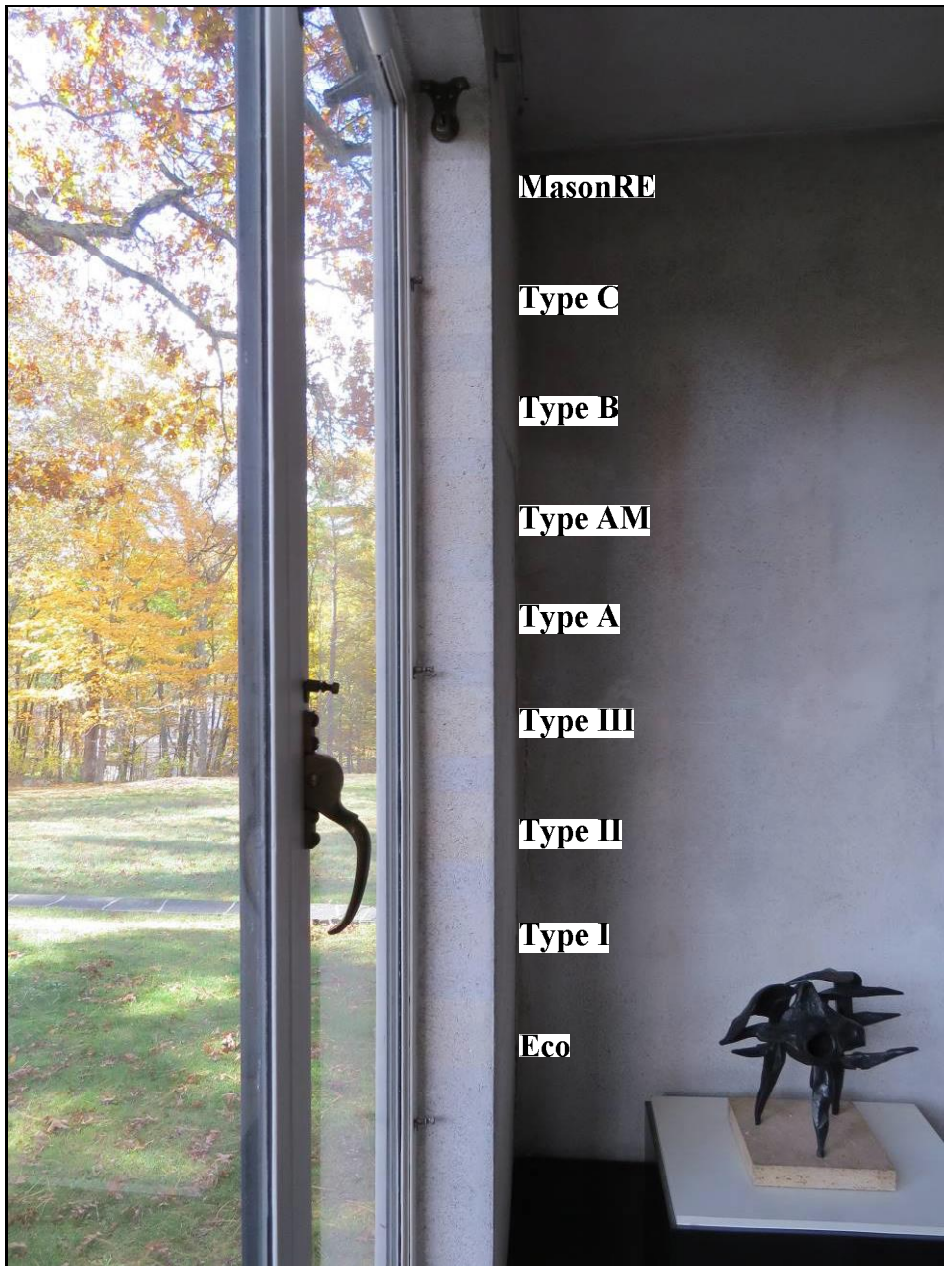
Nearly all of the latex poultrice products caused a yellow discoloration of the plaster.⁴⁷ The most yellowing occurred in the test patch treated with ABR Type C. No yellowing was observed in only one test patch: that treated with MasonRE Latex 20. This product successfully lightened the substrate but was difficult to remove and caused very minor detachment of some friable plaster. The cleaning effect of the other products was difficult to ascertain because of the discoloration. Observations from each test patch are included below.

Figure 36. Poultice test area, post treatment (product names positioned next to test patch location).

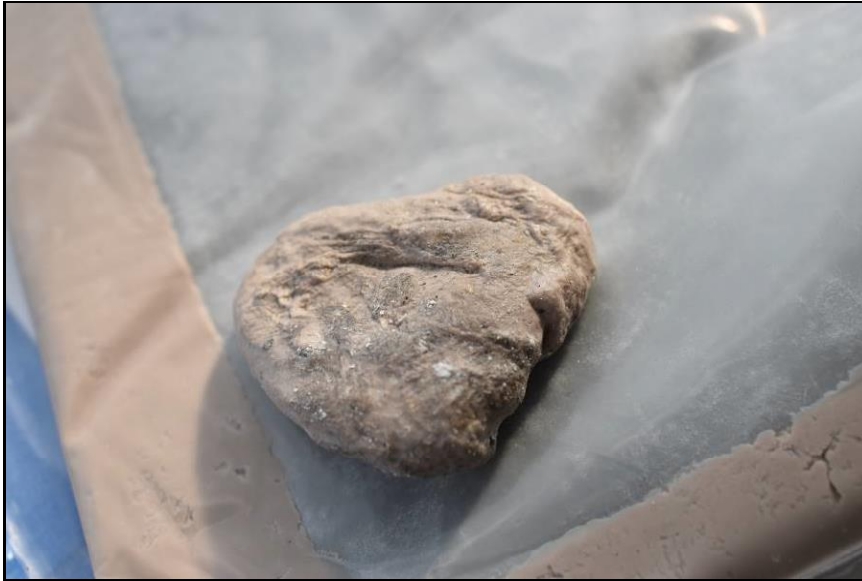
Both of the abrasive products tested were very easy to use. The surface of Groom/Stick grew noticeably darker with use, indicating that the product successfully lifted soiling from the surface (Figure 37). This product also picked up small friable pieces of the plaster. Following treatment, the test patch cleaned with Groom/Stick appeared no cleaner than before (Figure 38). A similar result was observed with the Dry Cleaning Sponge. While the surface of the sponge appeared soiled after use, the cleaning effect on the plaster was indistinguishable (Figure 37). The Dry Cleaning Sponge did not appear to remove any friable plaster fragments.

Figure 37. Groom/Stick after use. Note darker color of used product (center) compared to unused product in packaging (left). Also note white plaster fragments embedded in used product.

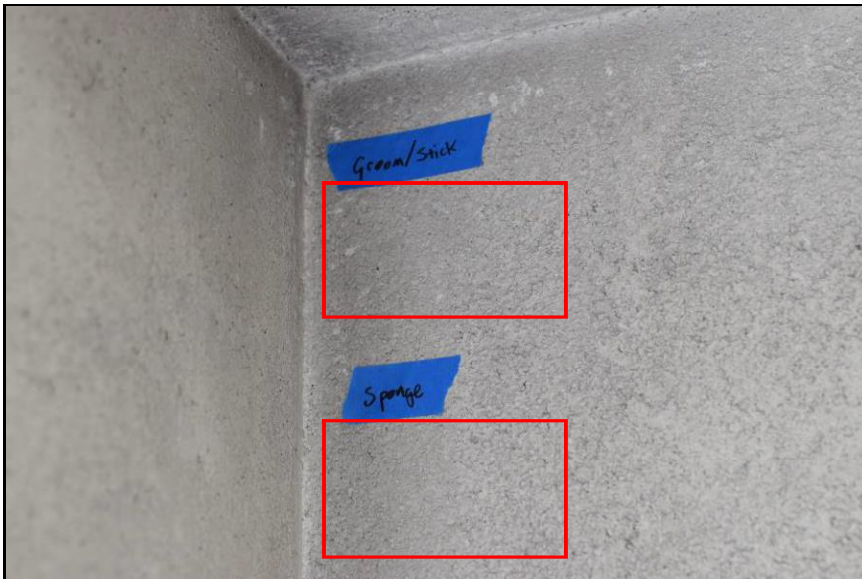
Figure 38. Abrasive cleaning test area with Groom/Stick patch (above) and Dry Cleaning Sponge patch (below) outlined in red.

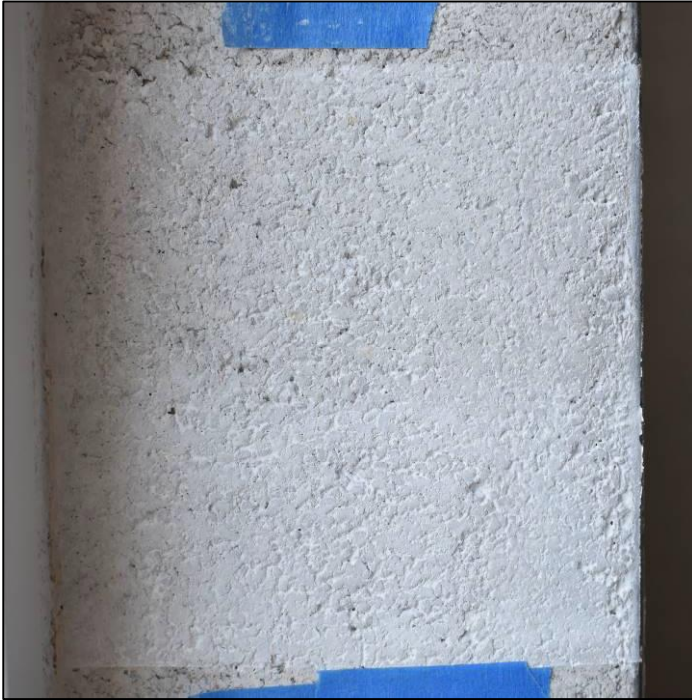
tended to fill the characteristic air voids in the plaster substrate, creating a more homogenous appearance. The second coat provided a more desirable level of opacity but also deposited more lime in the voids. Images of each test patch are included below.

Figure 39. Brushed-on lime putty limewash test patch with one (above) and two (below) coats.

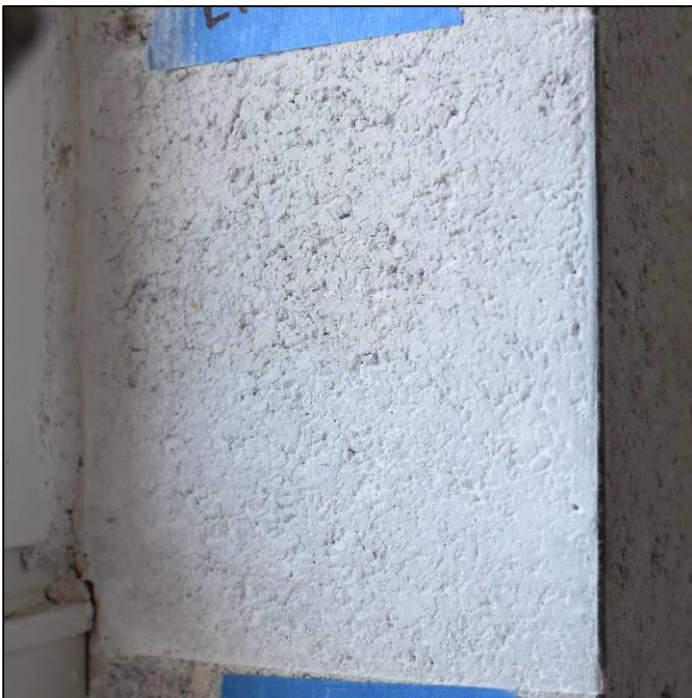
Figure 40. Brushed-on acrylic-modified lime putty limewash test patch with one (above) and two (below) coats.

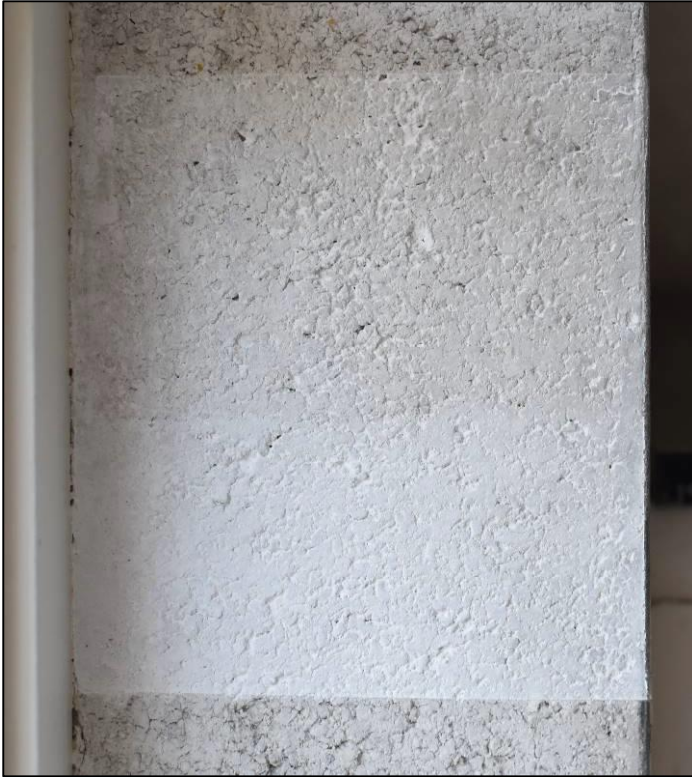
Figure 41. Brushed-on Type S limewash test patch with one (above) and two (below) coats.

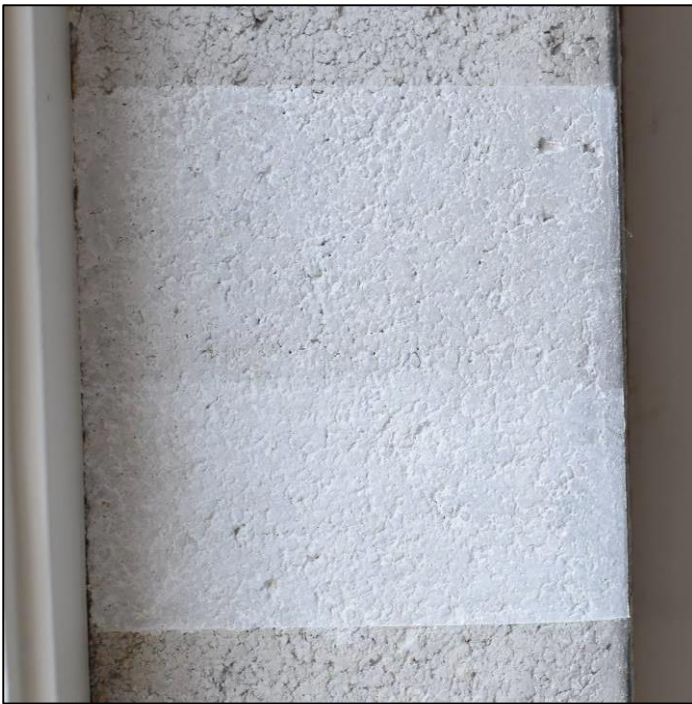
Figure 42. Brushed-on Acrylic-modified Type S limewash test patch with one (above) and two (below) coats.

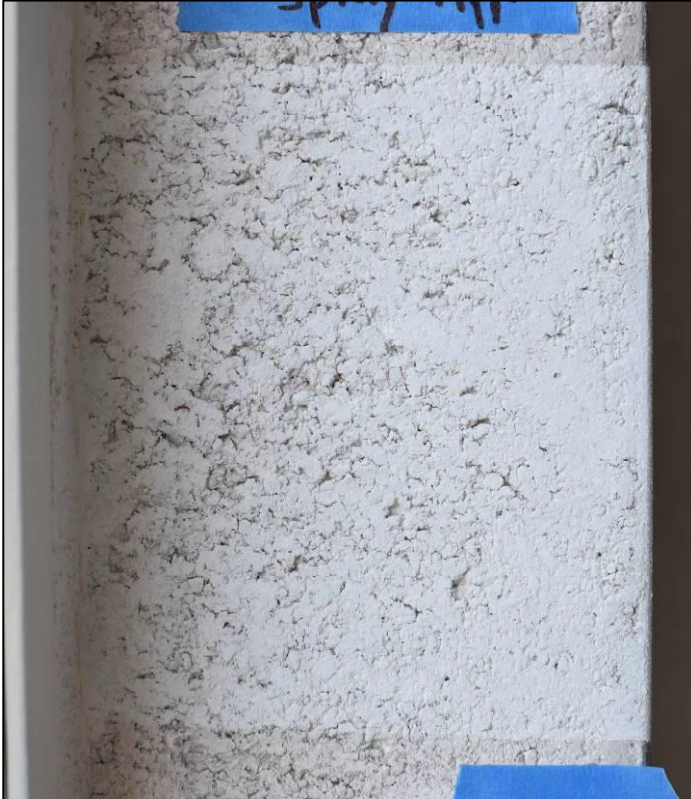
Spray application provided excellent results (Figure 43). While the spray inevitably coated the air voids, it didn't fill them as seen with brushing. With only two light passes with the sprayer, the opacity of the finish was excellent and would easily conceal most of the soiling found on the plaster. As before, the acrylic additive performed well and only minimal chalking of the dried finish was observed. Overall, the spray application provided the best results of all the variations tested, creating a very thin coating that effectively masked the soiling while maintaining the appearance of the character defining surface texture of the plaster.

Figure 43. Spray-applied Acrylic-modified Type S limewash test patch.

As a result of testing, JBC recommends that the soiled and stained acoustical plaster located in the living and dining rooms and study be coated with spray-applied limewash. While a less invasive treatment would be to clean the plaster using MasonRE Latex 20, this product is unlikely to produce the desired result. MasonRE Latex 20 was effective in removing some surface soiling but also removed small amounts of plaster. Further, its effectiveness on subsurface staining is unknown.

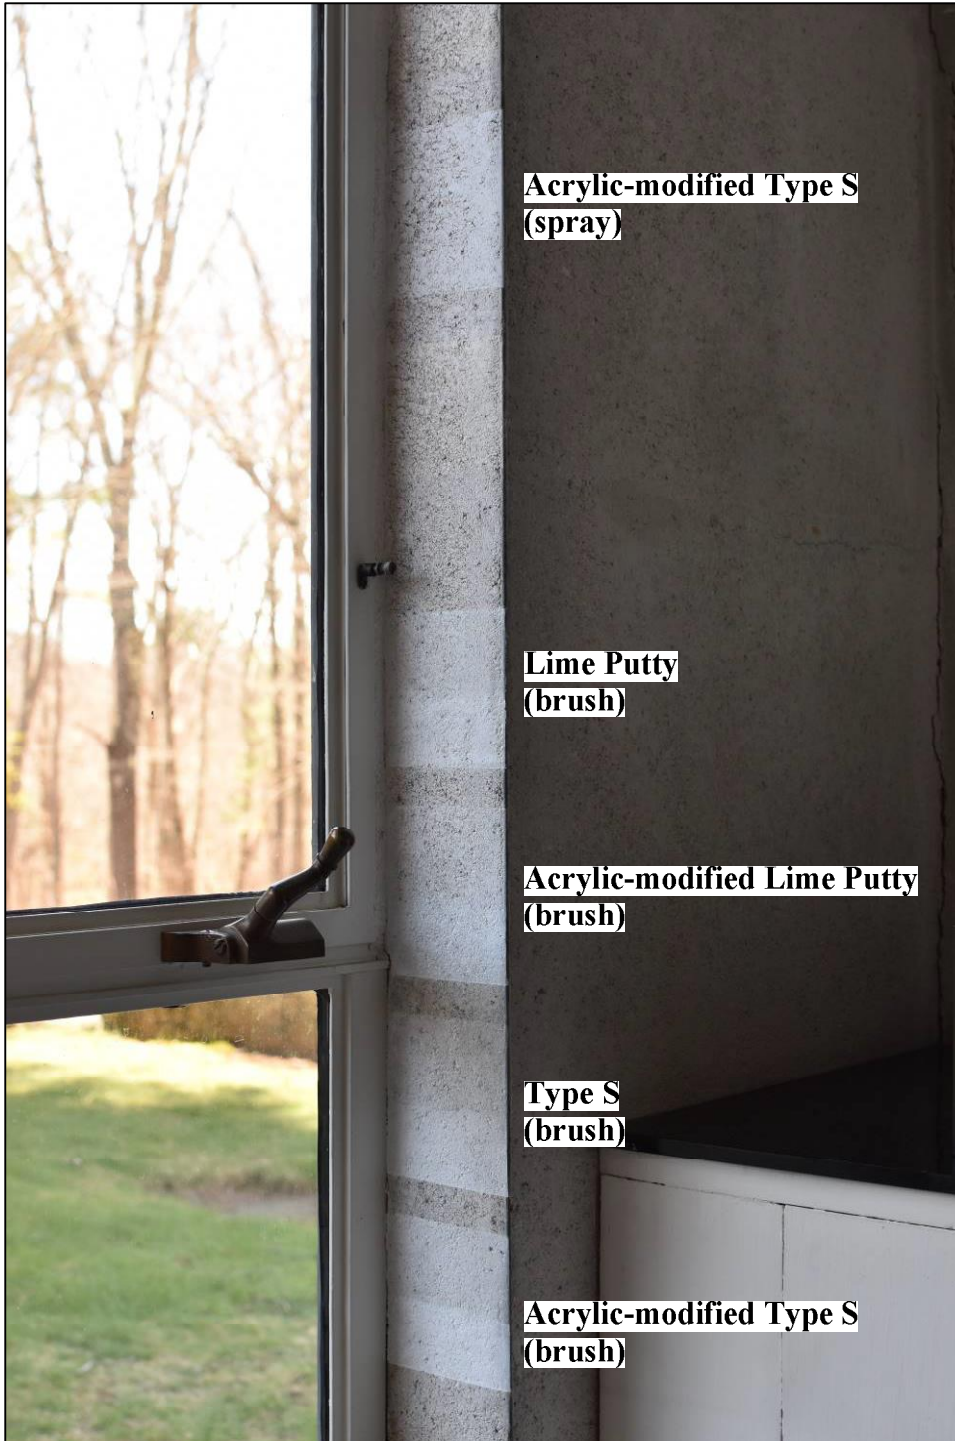
Figure 44. Limewash test area, post treatment, with variations and application methods labeled.

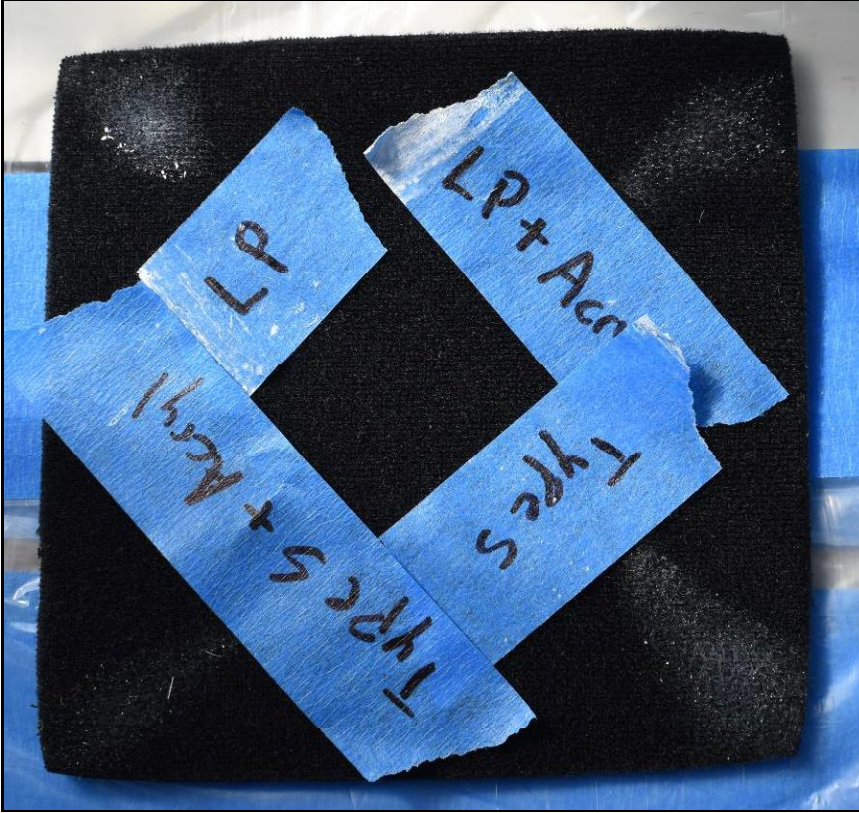
Figure 45. Chalking test cloth with residue from brush applications of (clockwise from top left corner) lime putty, acrylic-modified lime putty, Type S, and acrylic-modified Type S limewash variations.

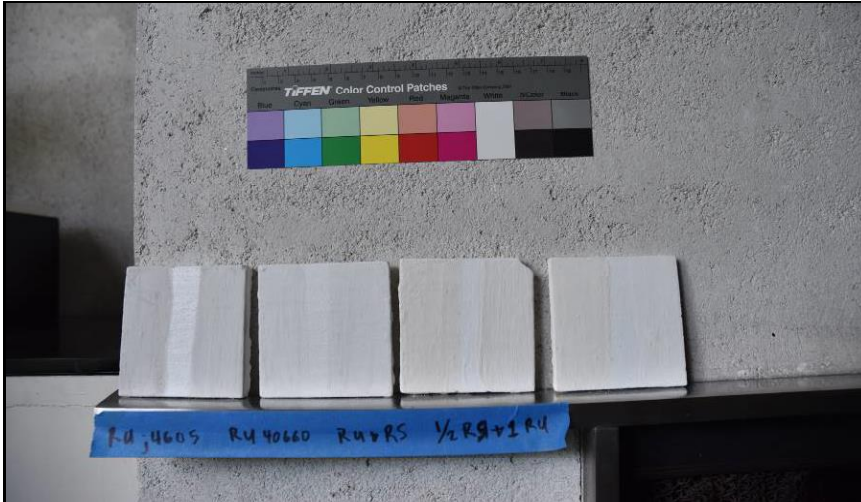
With the application method and composition of the limewash determined, JBC sought to create a custom tinted wash that would approximate the appearance of unsoiled acoustic plaster. Several pigment combinations were developed in JBC's laboratory to match the reference color of the plaster recorded in the field (PPG 1006-1 "Gypsum"). However, after comparison of samples of each finish with the plaster *in situ*, it was determined that only one of these might provide an appropriate color match (Figure 46). The selected pigmented wash contained 6 parts Type S hydrated lime, 16 parts diluted (1:10) Acryl 60, and 1/128 part light raw umber pigment (manufactured by Rockwood, available from Edison Coatings, stock no. j4605). This was spray-applied (two light coats) to test area adjacent to the fire place in two concentrations: one at full strength and one with twice the amount of limewash to pigment (i.e. 50% less pigment). Both concentrations seemed too white to match the existing plaster. Otherwise, the application verified the validity of the treatment.

Figure 46. Tinted limewash samples (prepared off-site) compared to plaster above living room fireplace mantle (sample at far left selected for test).
