Conservation Management Plan

GROPIUS HOUSE

68 Baker Bridge Road
Lincoln, Massachusetts

Historic New England
Baseline Report: 2016

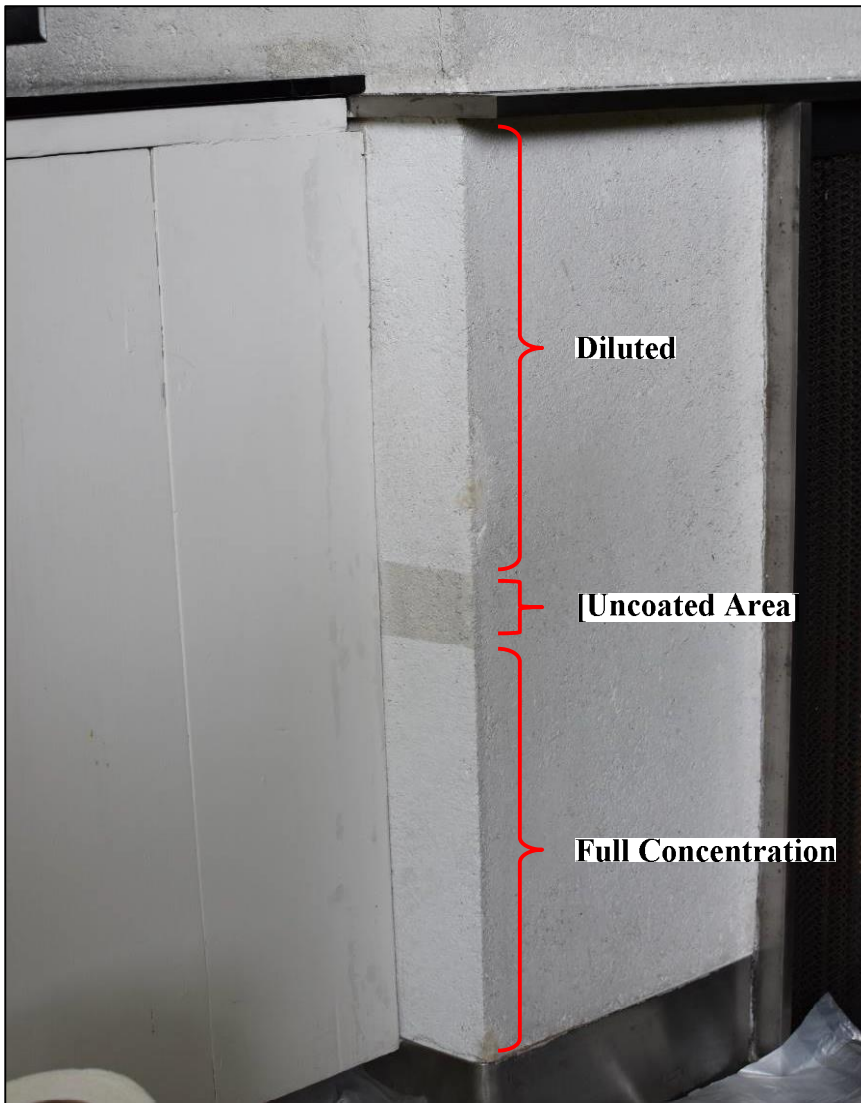
Figure 47. Tinted limewash test area with concentrations labeled.

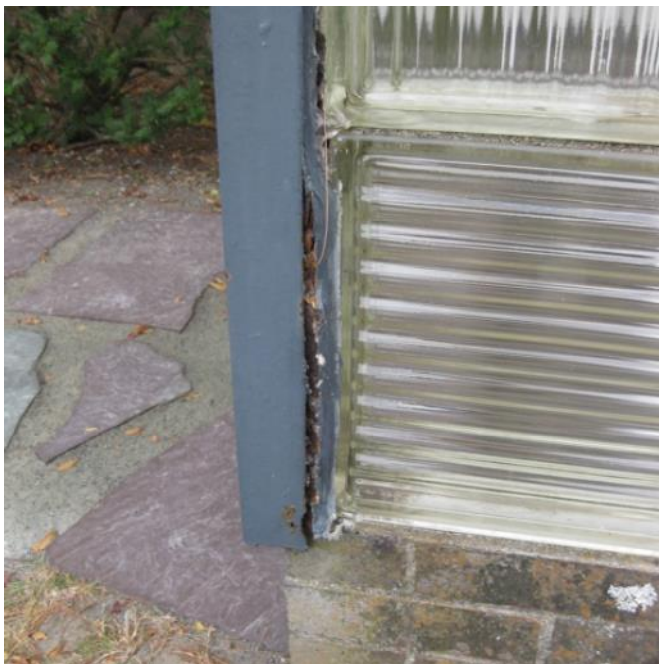
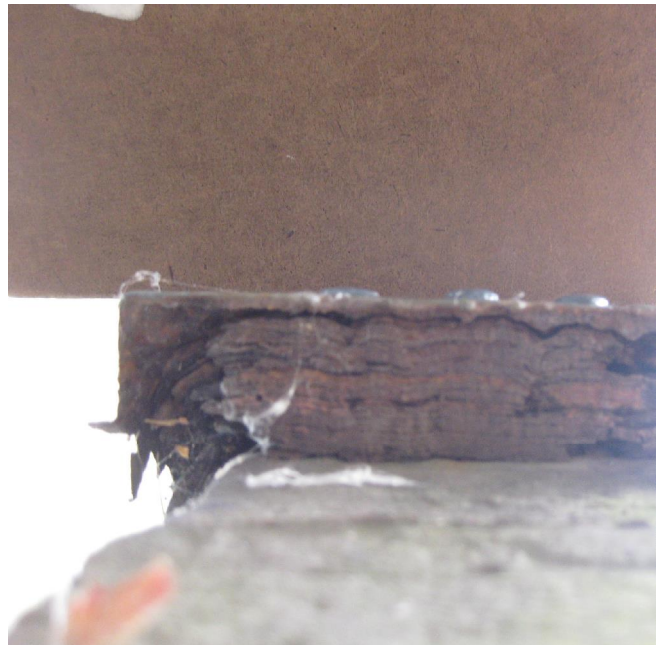
2. Corroded Steel Channel Framing East End of Wall

Significant corrosion is visible on the web of the channel at the base of the east end of the wall. The likely cause of the corrosion is moisture from snow that is often piled against the channel in the winter. Corrosion from steel expands approximately 10 times its volume, and has done so in this case in a lamellar pattern. It appears that as the corrosion grew on the west side of the web it pushed against the glass block wall introducing a shear stress into the wall. Once contact was established between the corroded web and glass wall, further corrosive expansion pushed the base of the steel channel to the east causing a visible deflection.

Ultimately we recommend that the channel be replaced with a corrosion resistant material; however, in order to do this mindfully the connection at the top of the steel channel above the ceiling must be understood and addressed. Obtaining and studying the structural drawings for the house might give some insight to the detail above the ceiling. Removing a few of the fascia boards along the side of the overhang would allow a direct look at the top of the channel and would likely be required for installation of a new steel channel.

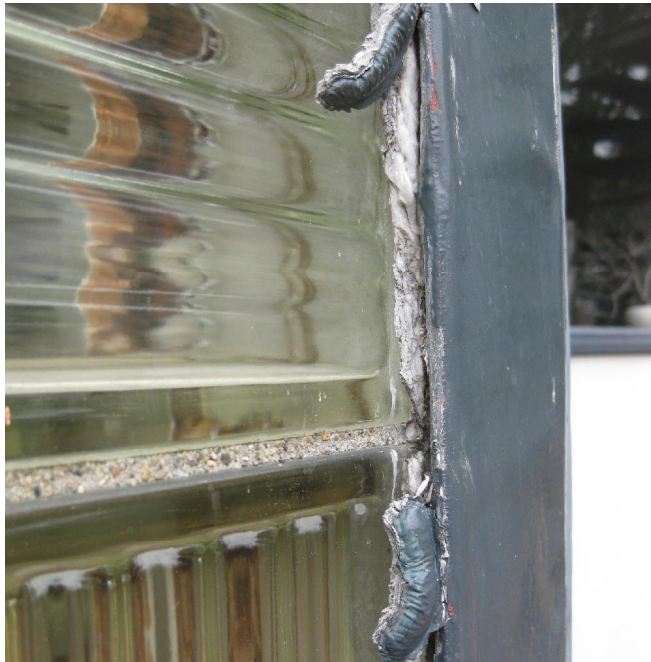
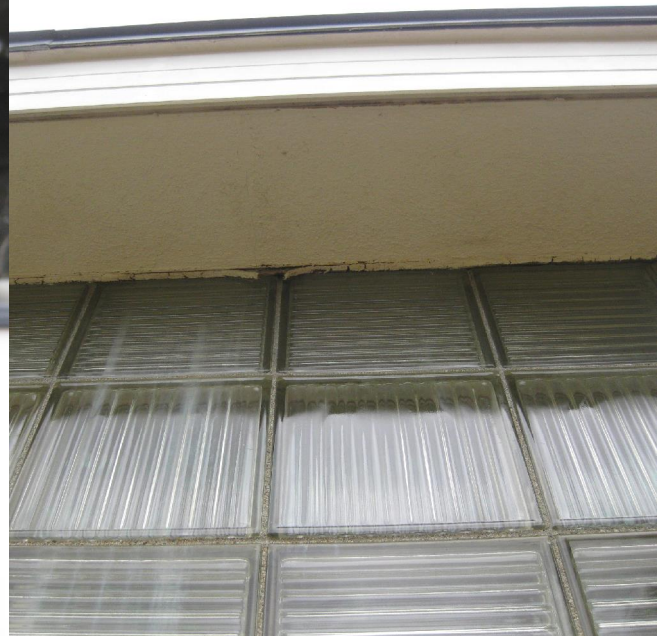
Caulking Failure at West End of Wall and Ceiling, continued

The caulking has failed leaving the rope backer exposed on all edges of the wall.

The caulking and backer should be replaced with materials compatible with the adjacent surfaces and the environment.

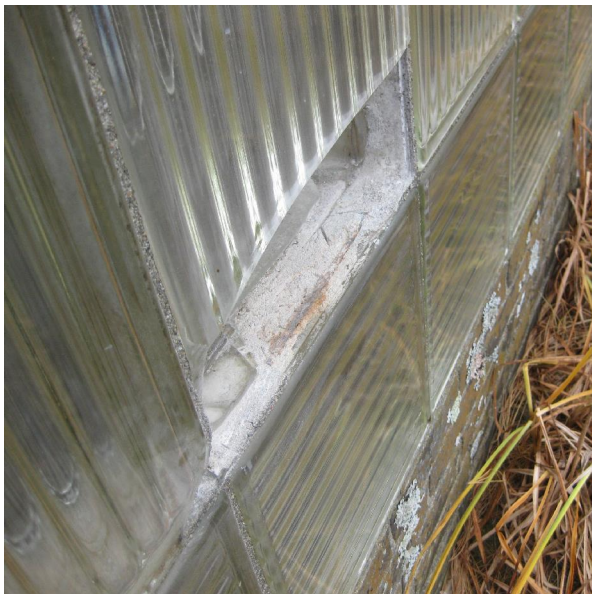
4. Wire Reinforcement Surface Corrosion

Minor surface corrosion visible in 1/8" diameter steel wire due to exposure to the elements following glass loss at the failed block.

We recommend that the wire be coated with r and embedded in mortar prior to replacement

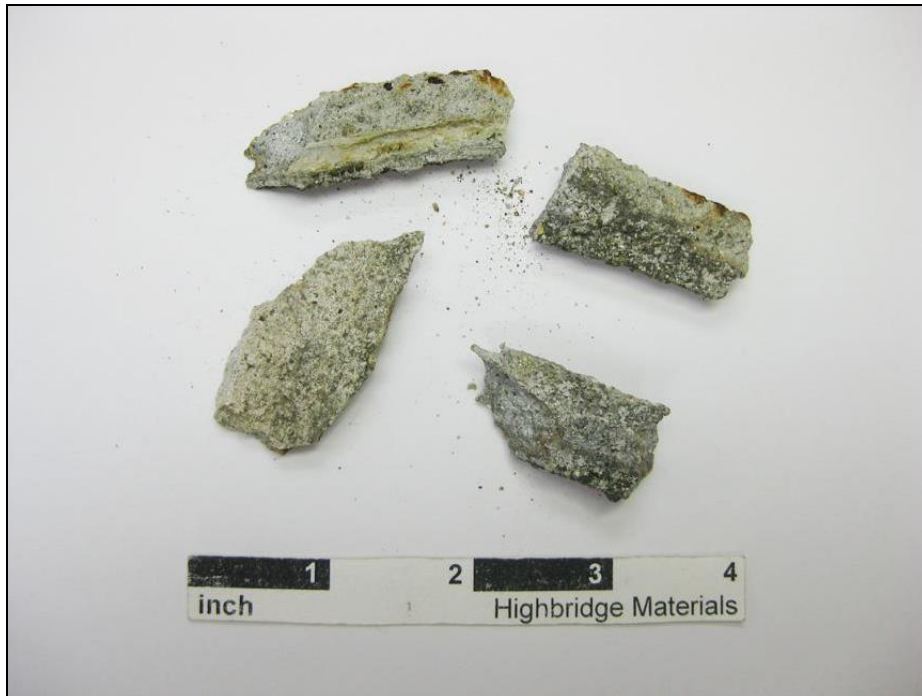
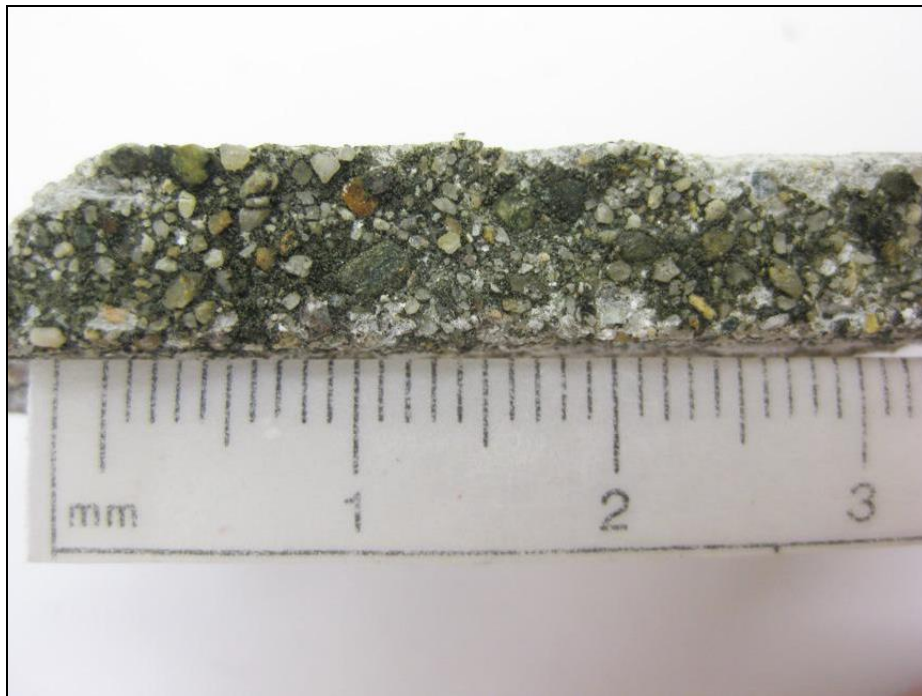
Figure 1: Photographs of the mortar sample provided to Highbridge for examination. The mortar is uniform in appearance with a gray color. The cured product is hard, nonfriable, and not noticeably water absorptive. The lower image shows a closer view of the tooled surface. The exposed aggregate contributes some color and textural variegation to the weathered joint face. However, the overall color is much darker than the fresh paste due to soiling at the surface.

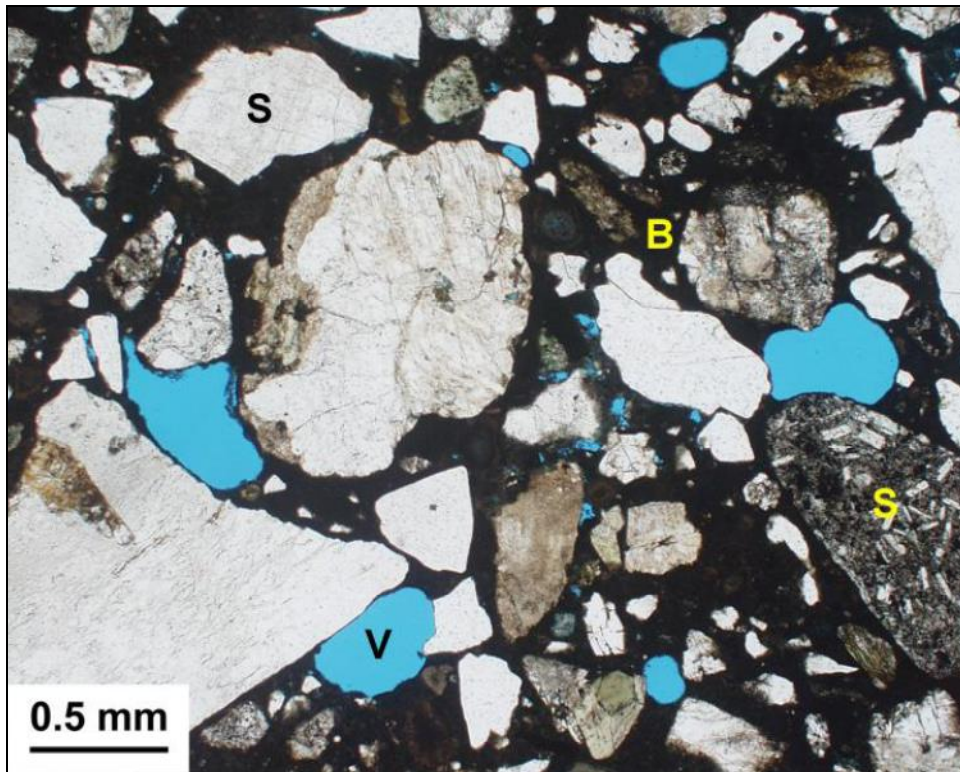
Figure 2: PPL photomicrograph illustrating the overall microtexture of the mortar. The sample is impregnated with a low-viscosity, blue-dyed epoxy in order to highlight cracks, pores, and voids. The homogeneously developed binder matrix (B) has a moderate to moderately low capillary porosity as indicated by lack of absorption of the dyed epoxy. Sand grains (S) are somewhat sharp-textured and well distributed throughout the paste. The content of air-voids (V) is somewhat high but not overly excessive. Overall, the mortar is compacted and rather well consolidated.

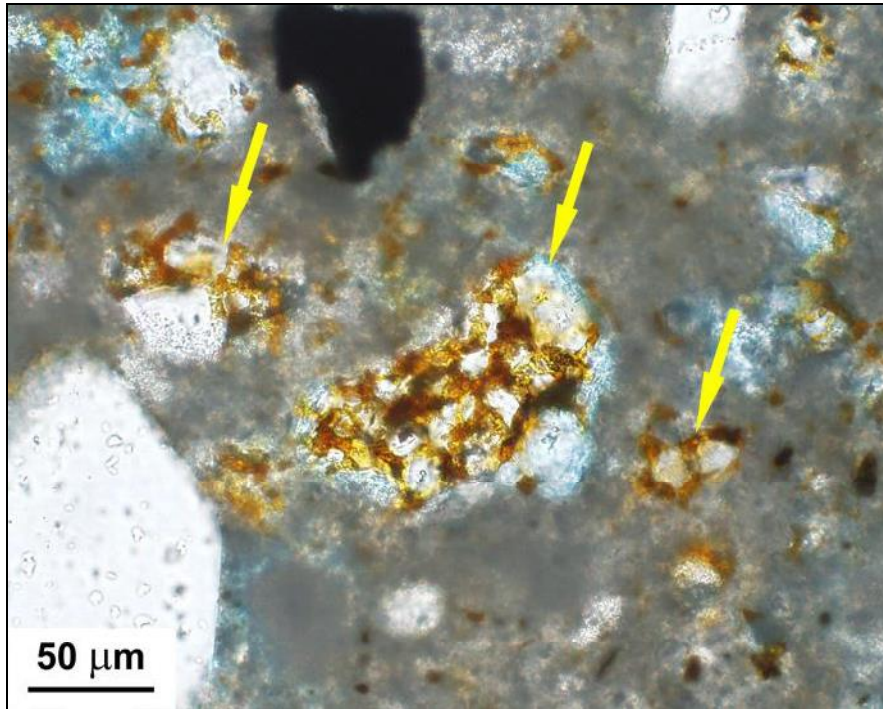
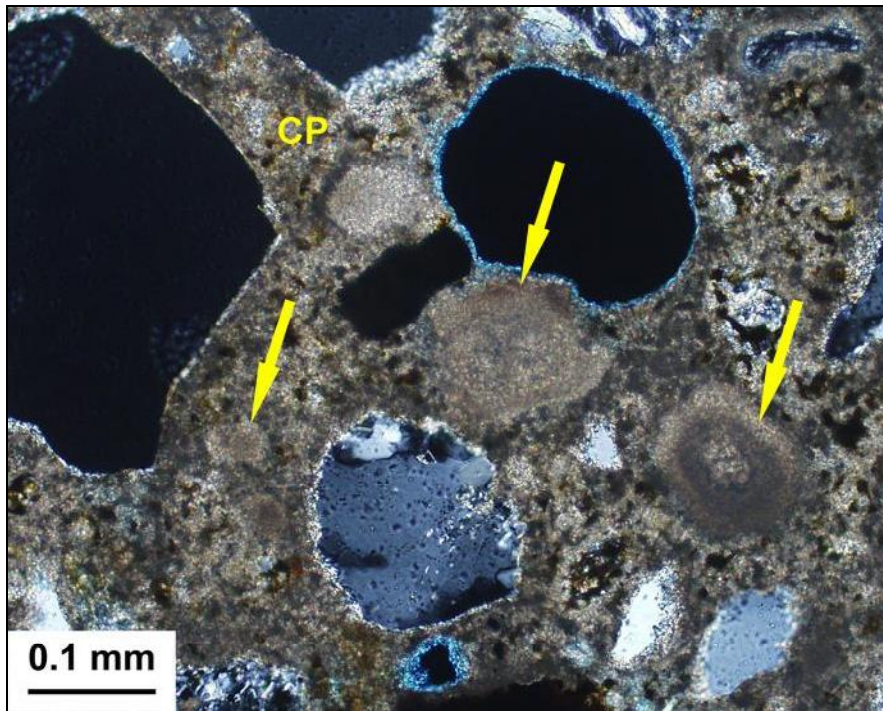
Figure 4: PPL photomicrographs illustrating the binder characteristics identified in the mortar sample. (Upper image) Residual portland cement grains (arrows) are present in moderate abundance as mostly hydrated agglomerates of former calcium silicate with interstitial iron-bearing ferrite. The ferrite identifies the cement as a gray rather than white variety. The ferrite has a distinctly orange color in the area shown in this photograph. This discoloration corresponds to a visual discoloration from gray to salmon. This is not unusual in older carbonated cement mortars. The cement has a fine to medium grind, which is consistent with the 1937-38 construction date provided by the client. (Lower image) There is a moderately high abundance of nondescript lime inclusions (arrows) that are mostly less than 150 μm in size. All of these lime grains are carbonated and well distributed throughout the carbonated paste (CP). The particulate texture of the lime suggests a product that was added as a prepackaged dry hydrate.

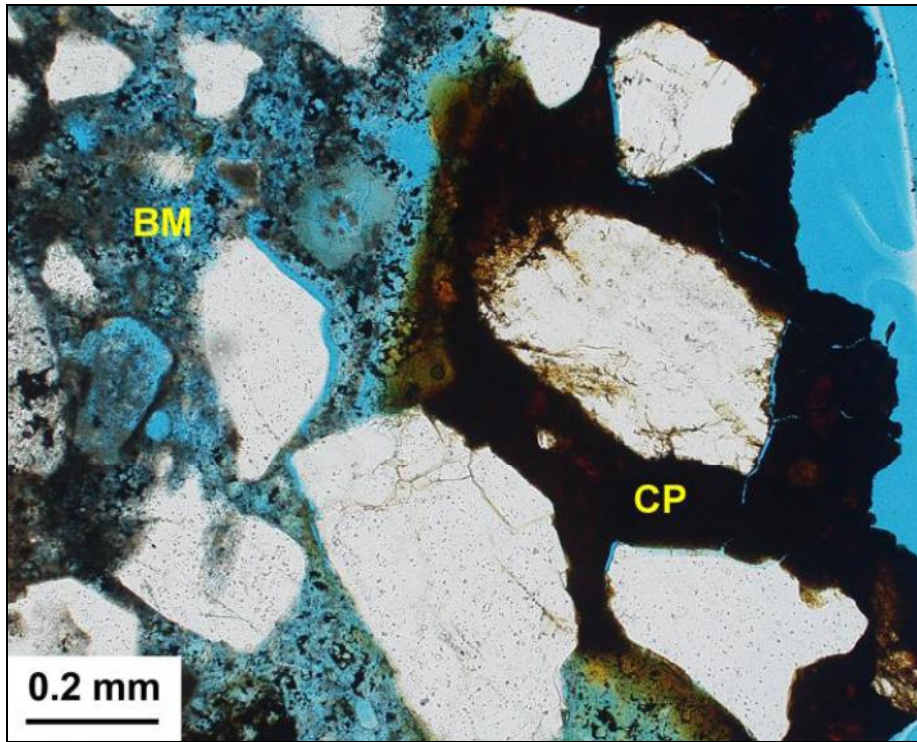
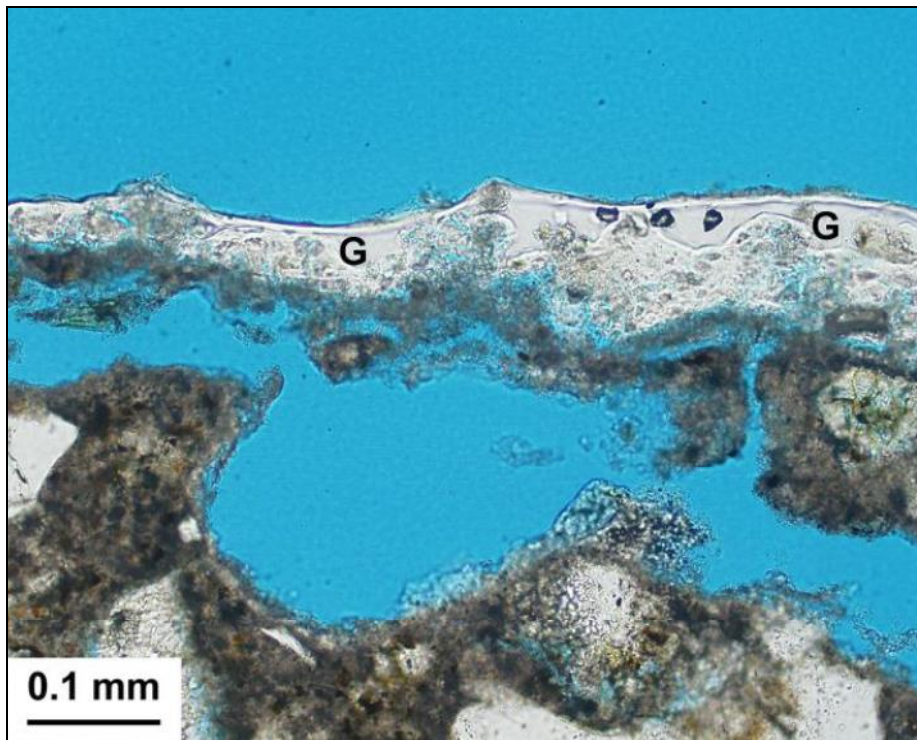
Figure 6: PPL photomicrographs illustrating secondary effects observed in the mortar sample that are potentially related to other materials in the masonry assembly. (Upper image) There is a thin layer of corrosion product (CP) opposite from the tooled joint surface. It is shown here directly adjacent to the binder matrix (BM) and enveloping sand grains. The laboratory is not aware of the construction details but it is possible that this is due to corrosion of some encased steel in the carbonated mortar. (Lower image) There is also one surface with a thin deposit of what could be a silica or alkali-silica reaction gel (G). This identification of the material is not confirmed but is likely due to the association of the bed surface with the glass block masonry units.

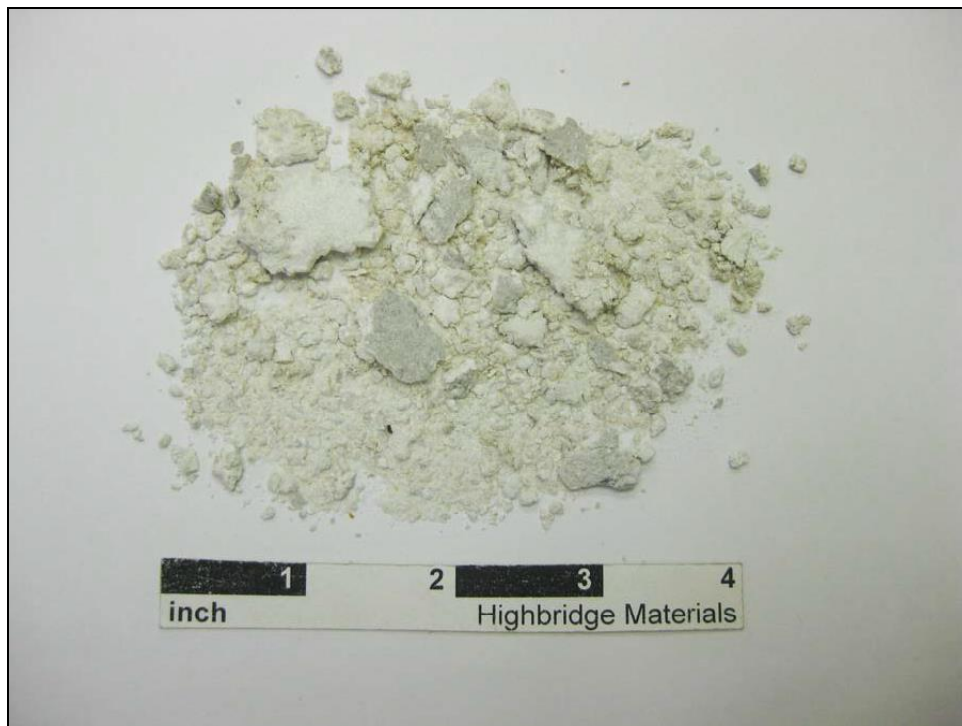
GH-007: Acoustical plaster removed from water-damaged interior wall. Likely "Stucoustic" brand manufactured by California Stucco Products Co.

Figure 1: Photograph of the sample provided to Highbridge for examination. The acoustical plaster is nearly white except where soiled to a light gray color.

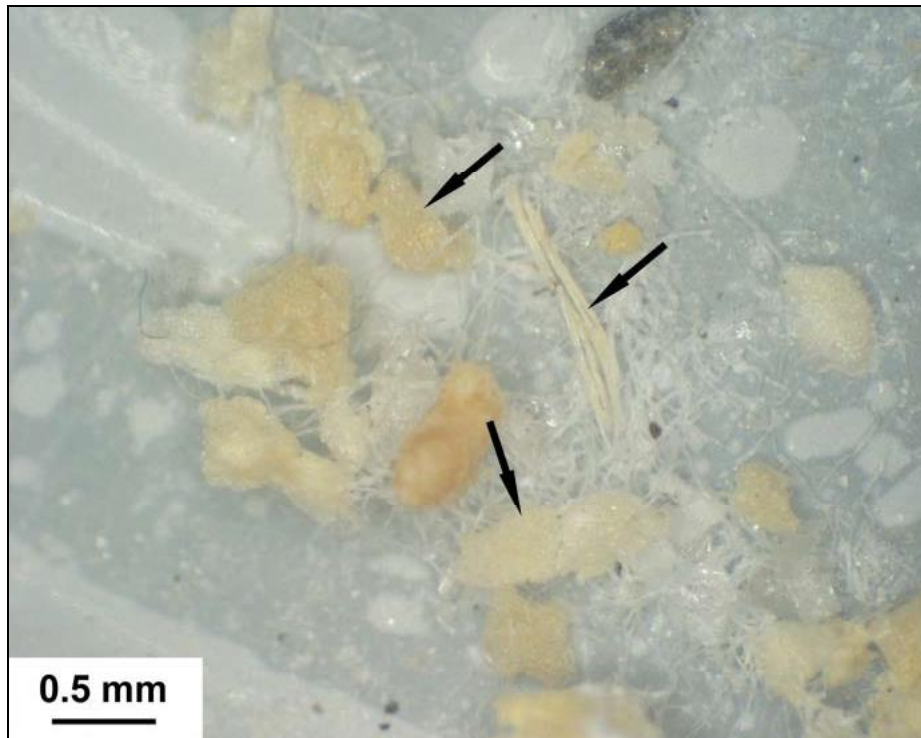
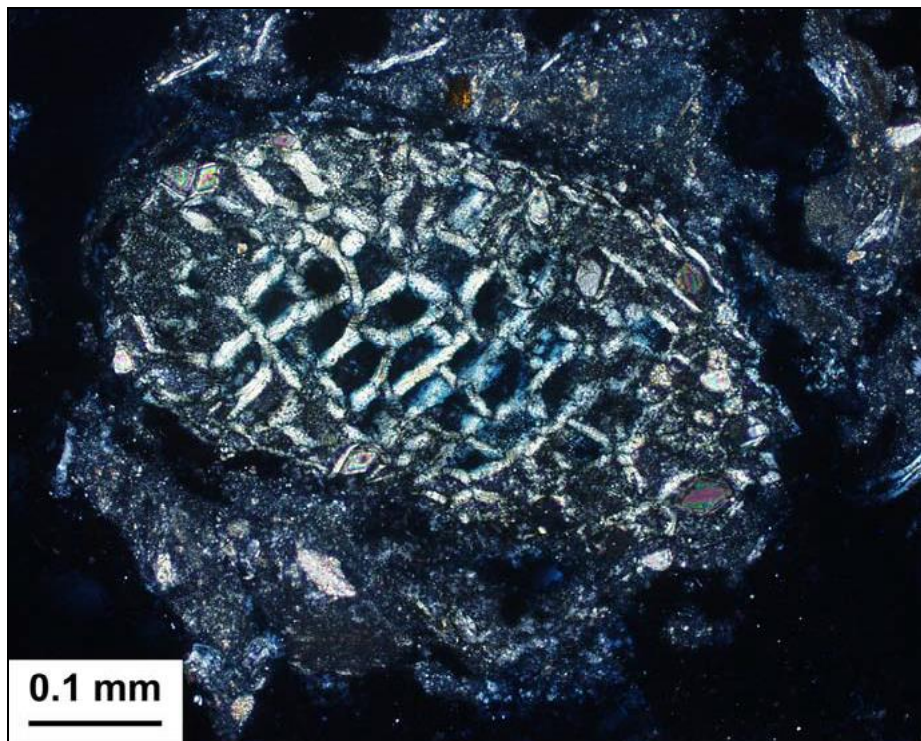
Figure 3: (Upper reflected light image) The arrows indicate cellular material extracted from the plaster by dissolving the binder in acid. The granules are consistent with some type of woody material. (Lower XPL image) The cellular nature of these fragments is more apparent in petrographic thin section.

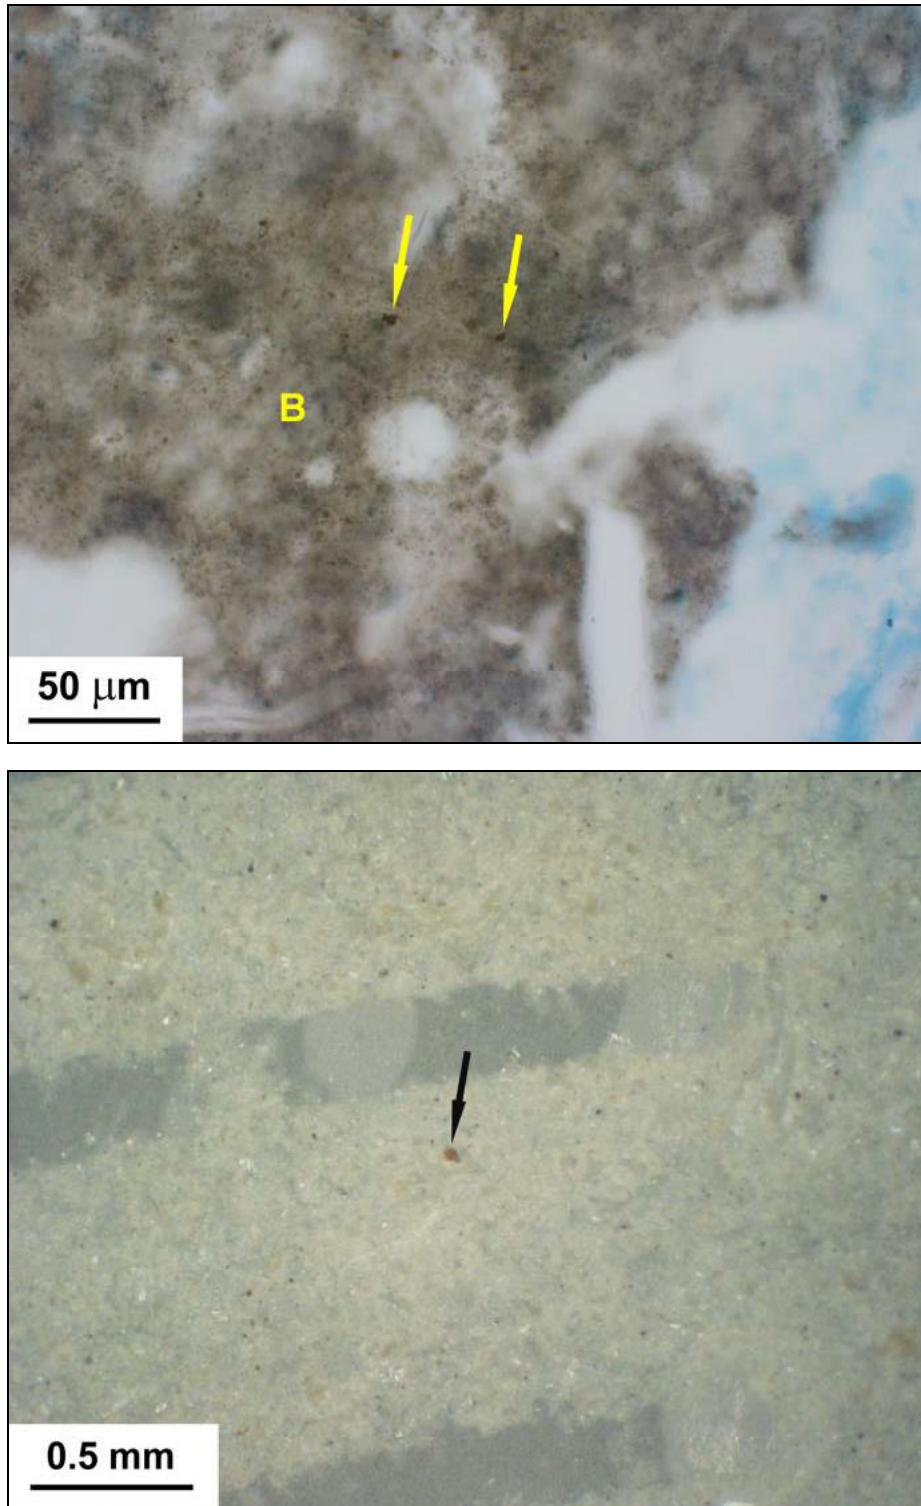
Figure 7: (Upper PPL image) The image is taken with a condenser lens inserted into the light path. The condenser blurs the image but allows for increased contrast of ultrafine-grained particles. The arrows indicate brownish particulates detected within the binder (B). (Lower reflected light image) A similar type of particle is shown on a filter paper after acid-dissolution of the binder. While any of these particles might represent an intentional pigment, the binder is a bright white color when freshly exposed.

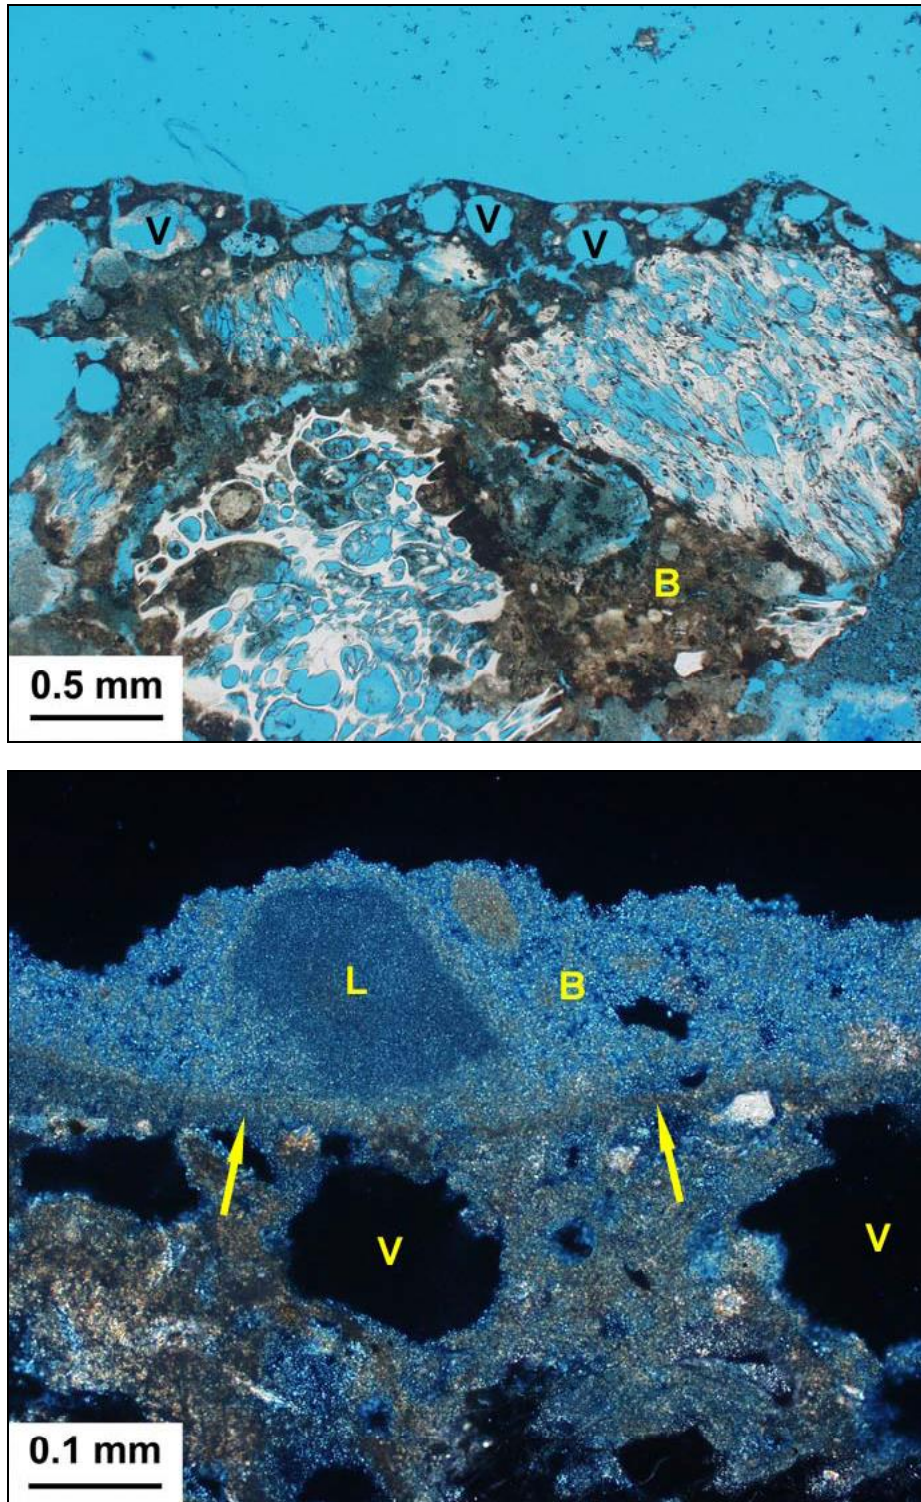
Figure 8: (Upper PPL image) In a few places, what appears to be the outermost skin of the plaster contains a concentration of fine, spherical air-voids (V). There is no discrete boundary with the substrate plaster. However, note that the binder within (B) is uniform with relatively few micropores. Note also that this microstructure is not consistent with the addition of a foaming agent. (Lower XPL image) A higher magnification view is shown for one of these outer layers. The voids (V) appear dark under crossed polars. The arrows indicate the boundary between the plaster and an adhered remnant of lime paste. The paste consists solely of carbonated lime binder (B) with fine-grained undispersed lime inclusions (L).

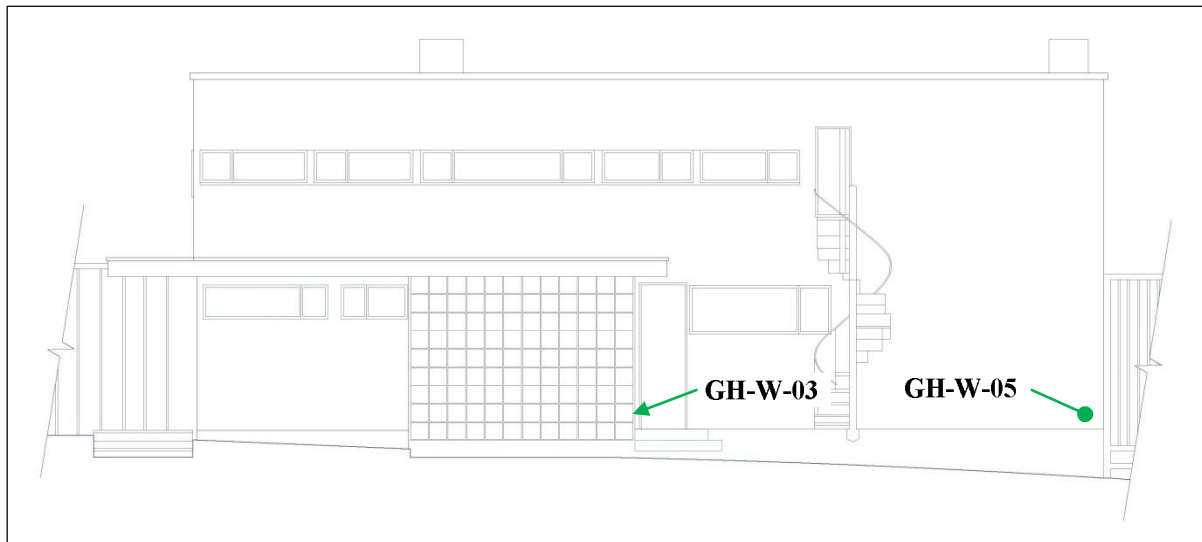
Figure 1. North elevation showing siding sampling locations.

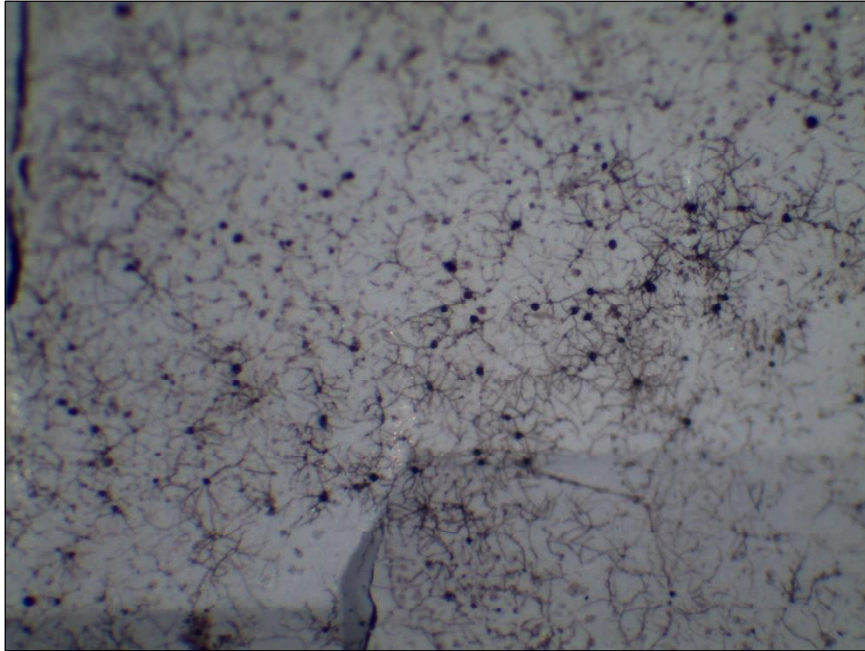
In conversations with HNE staff, concerns were raised regarding the use of a linseed oil-based wood preservative treatment that was applied to the stripped siding prior to repainting. Specifically, the staff questioned whether this could be the cause of the biological growth. While linseed oil would indeed provide nutrients to support mold and other forms of biological growth, the *aspergillus* present on the siding does not appear to penetrate the coating film. A cross-section of the colonized coating sample shown in Figure 9 shows no sign of hyphae penetrating through the layers of paint and into the linseed oil-treated wood substrate (Figure 11). In this case, the mold appears to be growing on nutrients supplied by the paint and from organic wind-borne debris (such as pollen) deposited on the coated surface.

Figure 9. Coated surface of siding showing mold spores and hyphae (40X).

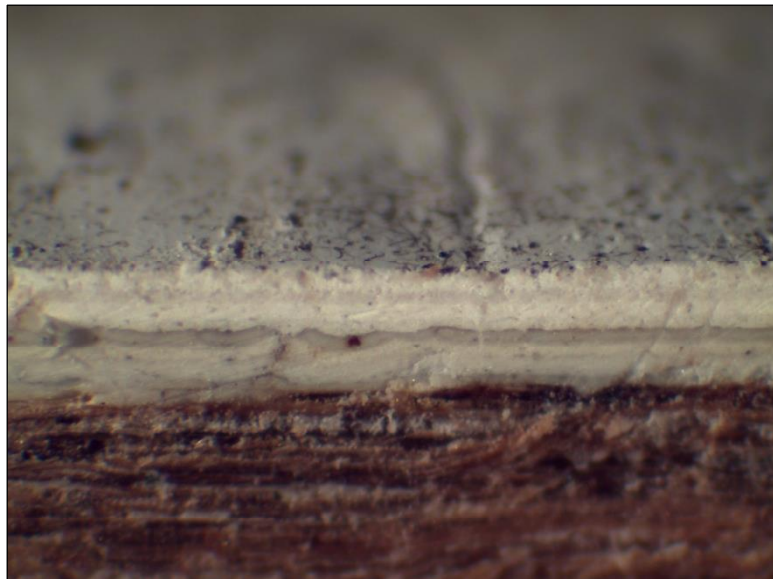
Figure 11. Cross-section through coatings and wood showing mold colony on upper surface and lack of hyphae penetrating coating layers (40X).

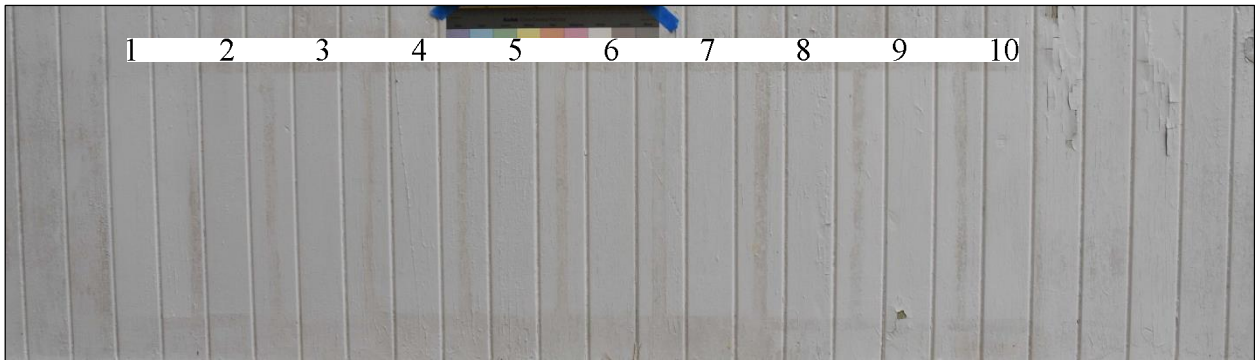
Figure 15. Cleaning test area on east elevation of garage after application. Products: (1) Vulpex, (2) Water, (3) D/2, (4) Wet & Forget, (5) TSP, (6) 3% Hydrogen Peroxide, (7) 30% Hydrogen Peroxide, (8) 1.25% Sodium Hypochlorite, (9) 5% Sodium Hypochlorite, (10) Orvus.

Of the eight products tested, D/2 Biological Solution and both concentrations of sodium hypochlorite were most effective in removing biological soiling and preventing its recurrence. All products, including water, were effective in initially cleaning biological soiling from the test surfaces (see Figure 15 and Figure 18). However, none could completely prevent recolonization of the siding. Areas treated with 3% hydrogen peroxide, trisodium phosphate, water, Wet & Forget, and Vulpex exhibited the least long-term preventative effect. Areas treated with 30% hydrogen peroxide and Orvus had some long-term effect. The difference between areas treated with 30% hydrogen peroxide and Orvus and the best-performing areas treated with D/2 and sodium hypochlorite is slight.

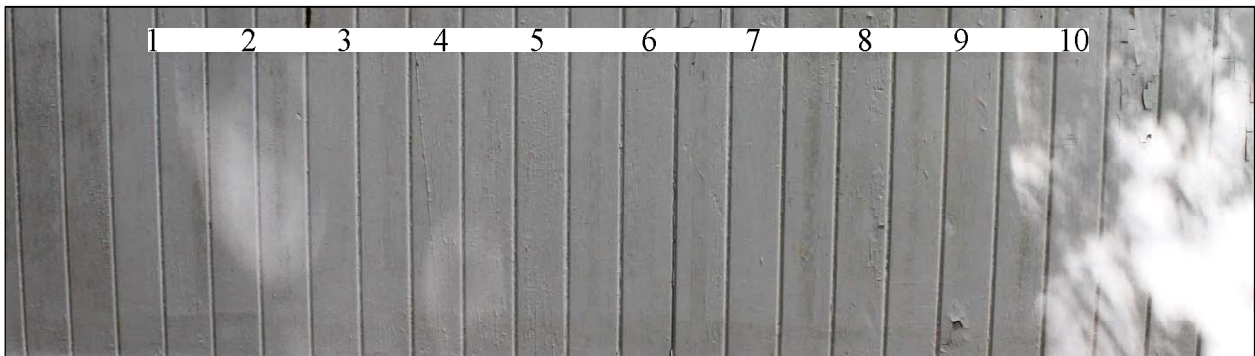
Figure 16. Cleaning test area on east elevation of garage after ten months of exposure (Credit: Colleen Chapin|HNE). Products: (1) Vulpex, (2) Water, (3) D/2, (4) Wet & Forget, (5) TSP, (6) 3% Hydrogen Peroxide, (7) 30% Hydrogen Peroxide, (8) 1.25% Sodium Hypochlorite, (9) 5% Sodium Hypochlorite, (10) Orvus.

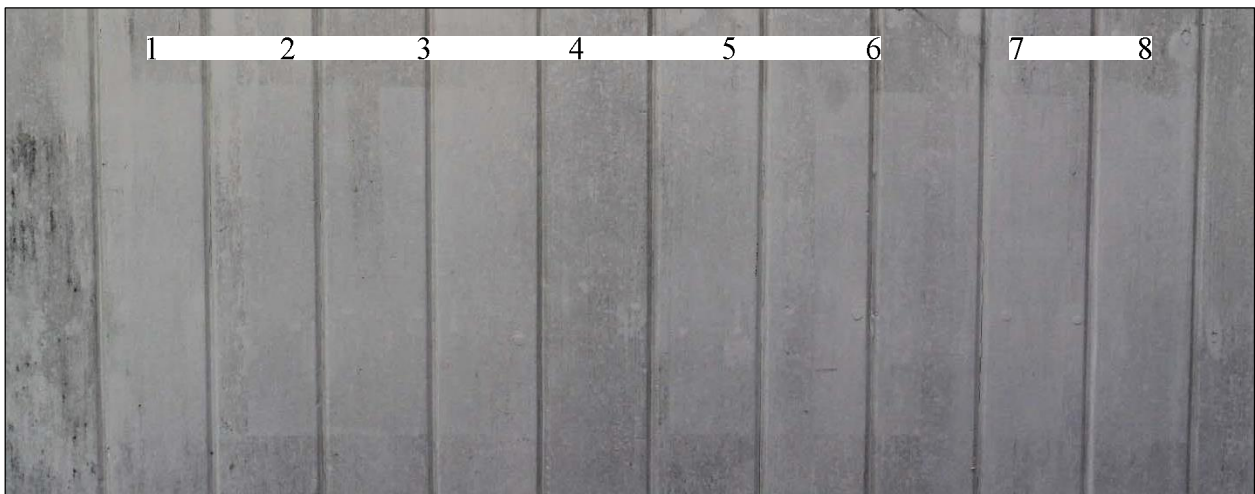
Figure 19. Cleaning test area on west elevation of roof deck after ten months of exposure (Credit: Colleen Chapin[HNE]). Products: (1) 1.25% Sodium Hypochlorite, (2) Water, (3) Wet & Forget, (4) [untreated], (5) Vulpex, (6) Orvus, (7) D/2, (8) 5% Sodium Hypochlorite.

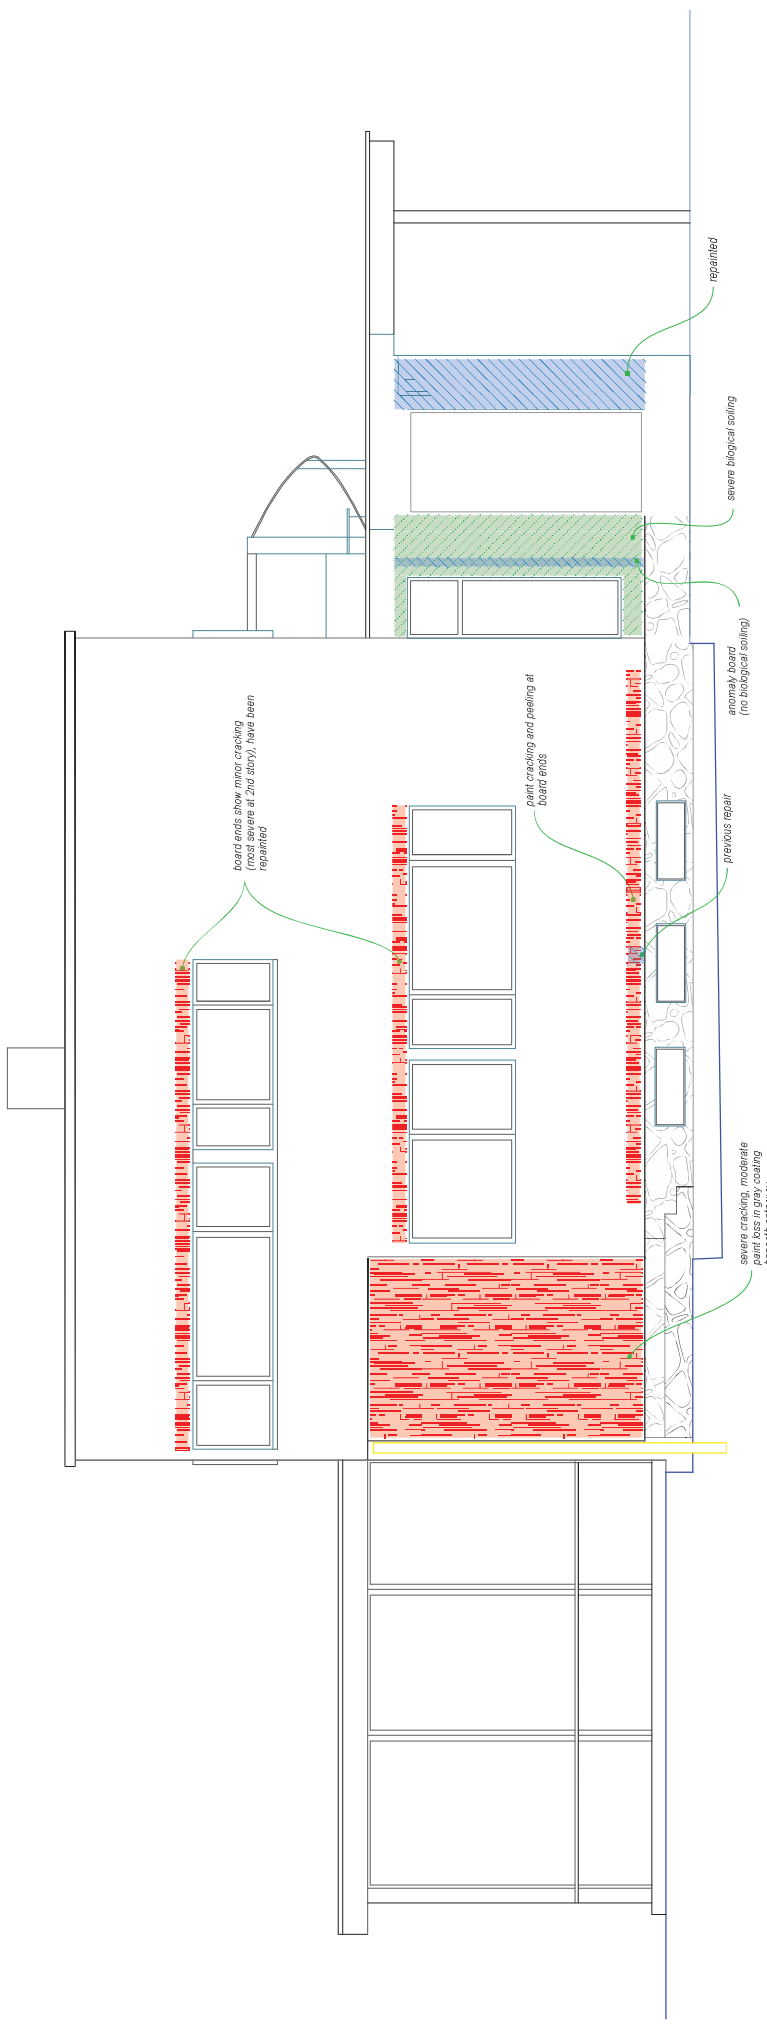
NORTH ELEVATION
 NOT TO SCALE

Results of the field survey documenting conditions affecting the siding indicates that biological soiling, while present to some degree on all elevations, is concentrated in areas protected by tree shade (see Appendix B). The soiling is most prevalent on the east end of the north elevation and across the south and west elevations. All of these areas receive tree shade.
