HERITAGE & ARCHITECTURE

5 November 2018

Keeping it Modern Grant,
The Getty Foundation

Conclusions and recommendations from the research Colour, Form and Space: Rietveld Schröder House challenging the Future.

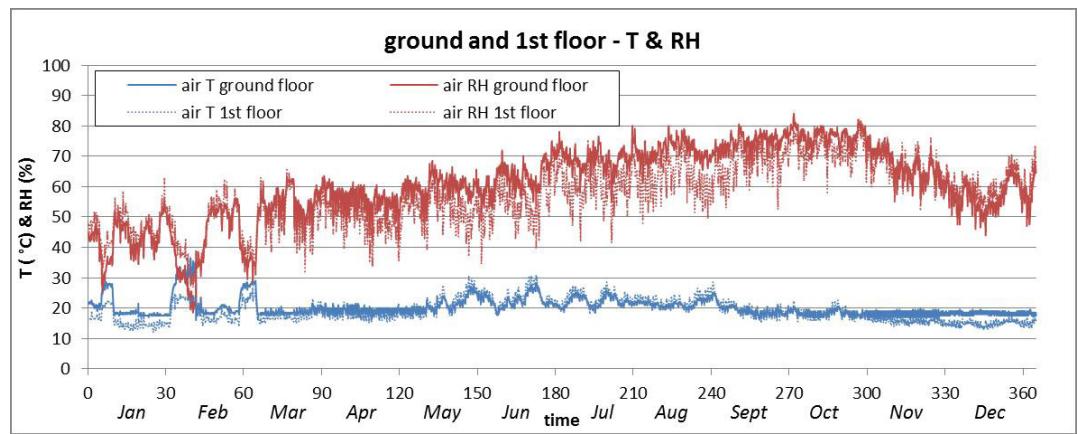
Figure 7: *T* and *RH* at the ground and first floor

The T and RH during the complete year period (365 days, from January 1st to December 31st) for the ground floor and 1st floor are reported in figure 7. Remarkable are several periods with very high T (a maximum T of 36.5 °C was recorded on the ground floor) and corresponding very low RH (a minimum RH of 18,5% was measured on the ground floor in the same period) during the winter period. These extreme values have shown to be due to problems with the heating system, which have been resolved.

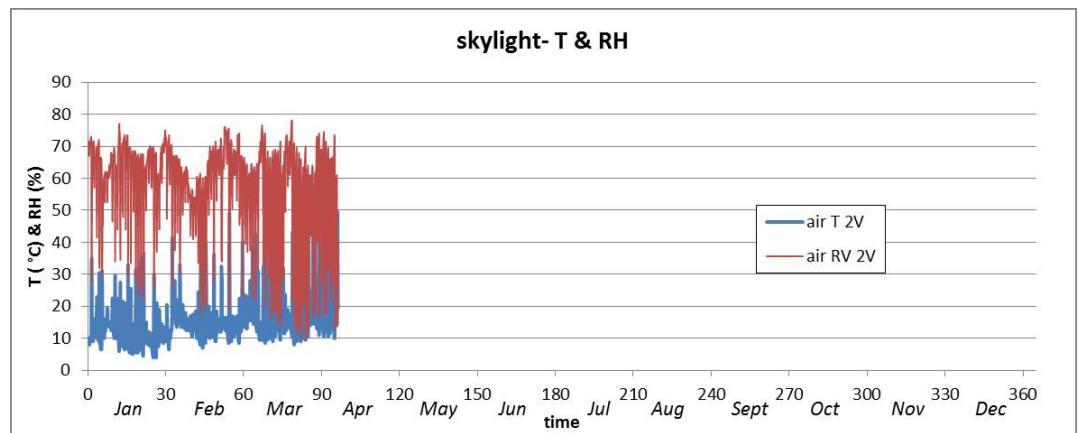
Figure 8: *T* and *RH* in the skylight

In figure 8 the T and RH in the skylight is reported. As expected, very large T and RH variations were measured, due to sun radiation and rainwater leakages.

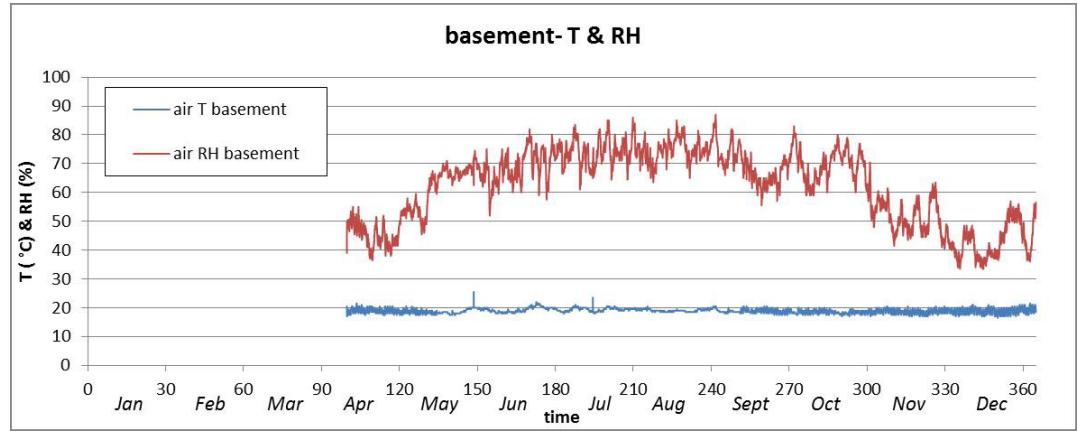
Figure 9: *T* and *RH* in the basement

In April '17 the sensor was moved from the skylight to the basement. The T and RH values recorded in the basement are reported in figure 9. The temperature in the basement is very stable while the RH varies considerably, and reaches very high humidity values at the end of the summer period, following the outdoor absolute humidity.

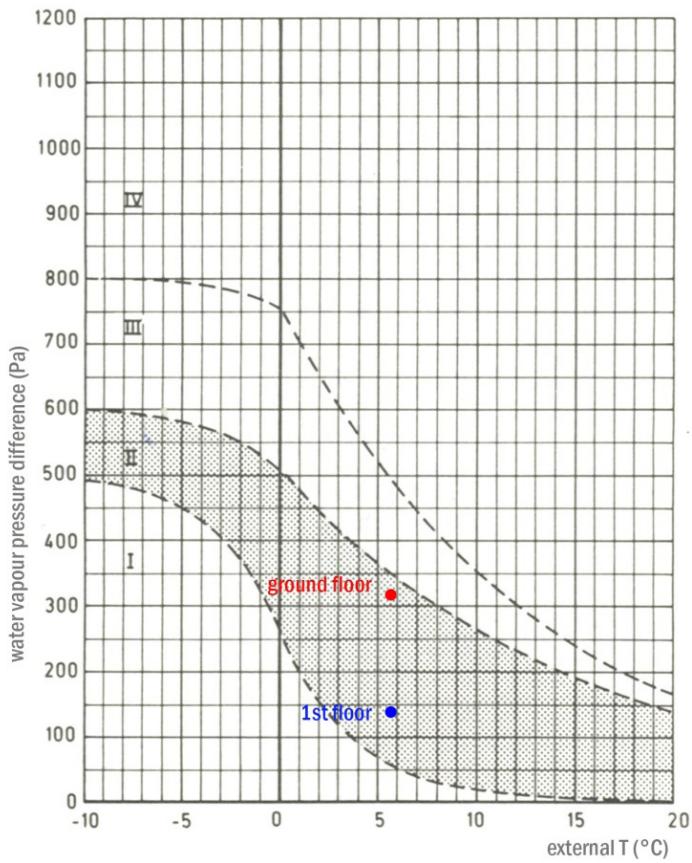
In figure 18 the indoor climate is compared to the classes of indoor climate as defined in [1]. It can be concluded that the building indoor climate falls within class II; as already observed, the indoor climate at the ground floor is more humid than on the first floor, but still falls within climate class II. Therefore in principle (under the current regime) no moisture problems in the sense of surface condensation or mould growth on the building construction are to be expected (see also paragraphs 3.6 and 3.7).

However, high RH_{surf} (maximum values of 88% RH on the ground floor) have been recorded. Further, the RH_{surf} variations recorded are larger than the variations recorded for RH of the air.

In spite of the fact that no surface condensation occurs, high values of air RH near the surface (> 80-85% RH) might still lead to biological growth on plaster and wooden surfaces if these periods are long enough. This risk is further discussed in section 3.6.

Figure 18: The indoor climate class at the ground and 1st floor of the building (the period between 20/01/17 and 20/03/2017 has been considered).

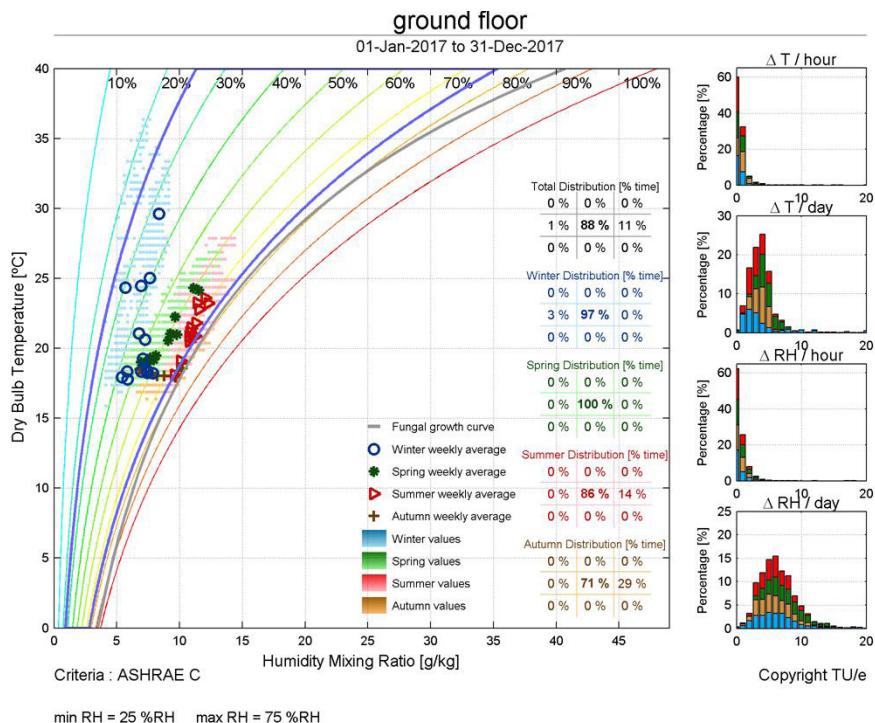
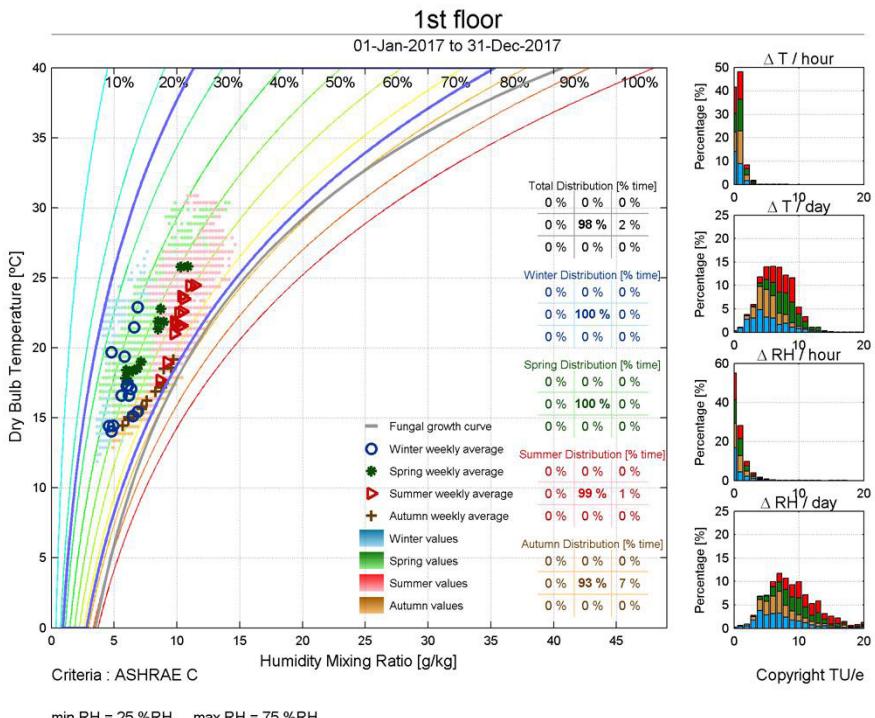
Figure 21: *T and RH data recorded at the ground floor of the building in 2017 compared to the specifications for class C; graphical elaboration performed by means of the web-tool available at <http://www.monumenten.bwk.tue.nl/>*

Figure 22: *T and RH data recorded at the 1st floor of the building in 2017 compared to the guidelines for class C; graphical elaboration performed by means of the web-tool available at <http://www.monumenten.bwk.tue.nl/>*

In the case the indoor climate is compared to class C, 88% and 98% (for the ground floor and 1st floor) of the T and RH values are within the given criteria. In summer and, even more in the autumn period, there is still a significant % of values, which exceed the RH requirements; this % is higher for the ground floor than for the 1st floor.

It can therefore be concluded that the indoor climate mostly (but not fully) falls within the criteria given for the class of control C; this seems to be the climate class of control appropriate for this type of building. Imposing another climate class would imply the use of air condition systems, to reduce the indoor climate conditions during the summer months.

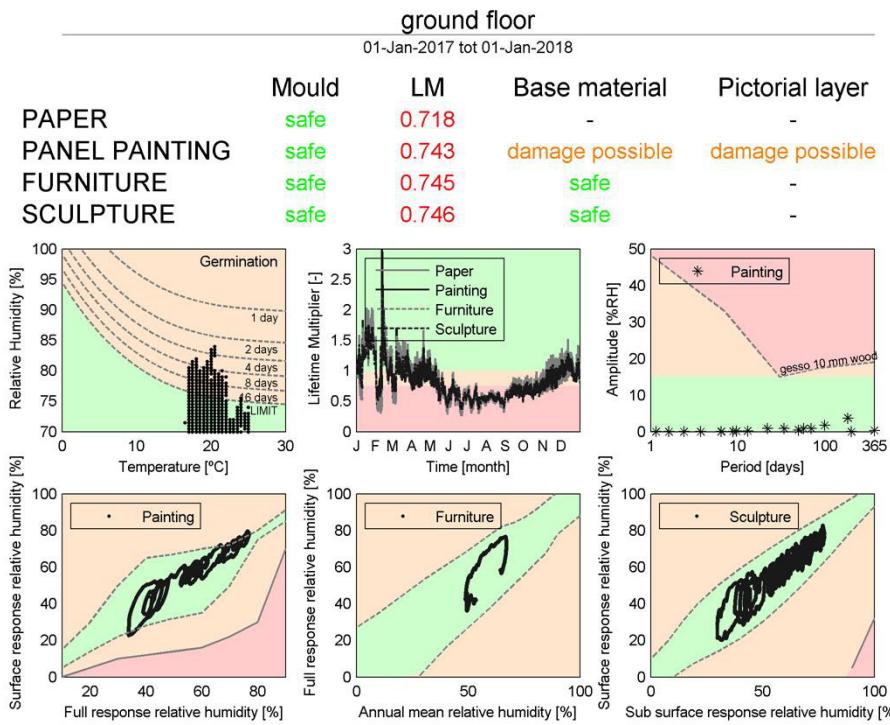
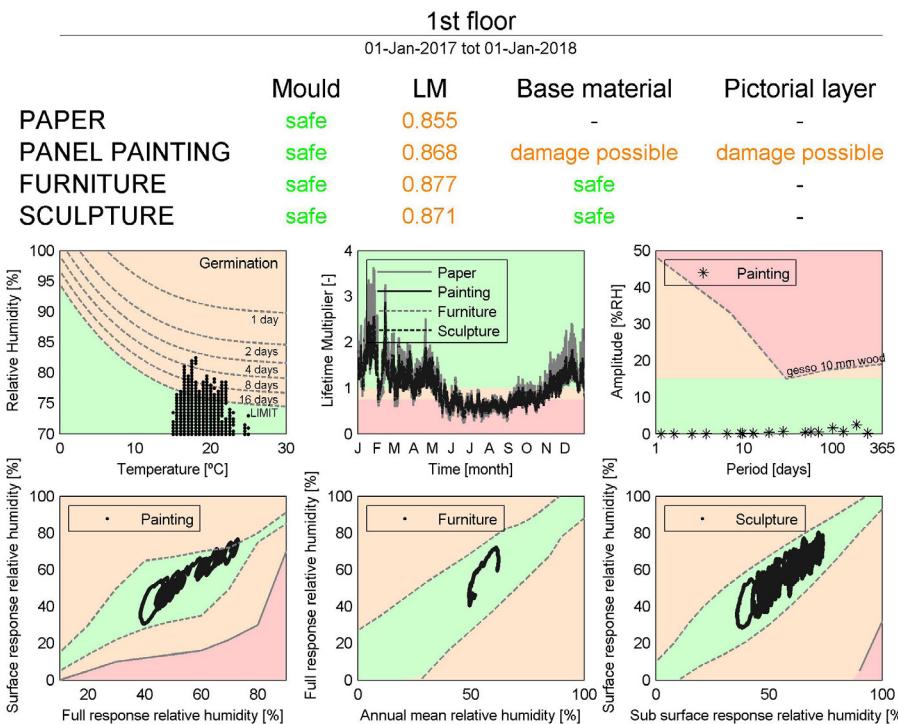
Figure 23: Evaluation of risks posed by the indoor climate of the ground floor to the conservation of different types of objects, among which "furniture". Graphical elaboration performed by means of web-tool available at <http://www.monumenten.bwk.tue.nl/>

Figure 24: Evaluation of risks posed by the indoor climate of the 1st floor to the conservation of different types of objects, among which "furniture". Graphical elaboration performed by means of the web-tool available at <http://www.monumenten.bwk.tue.nl/>

Figures 23 and 24 report the results of elaboration of the climate data collected at the ground and 1st floor; the elaboration was performed by the use of the web-tool available at <http://www.monumenten.bwk.tue.nl/>,

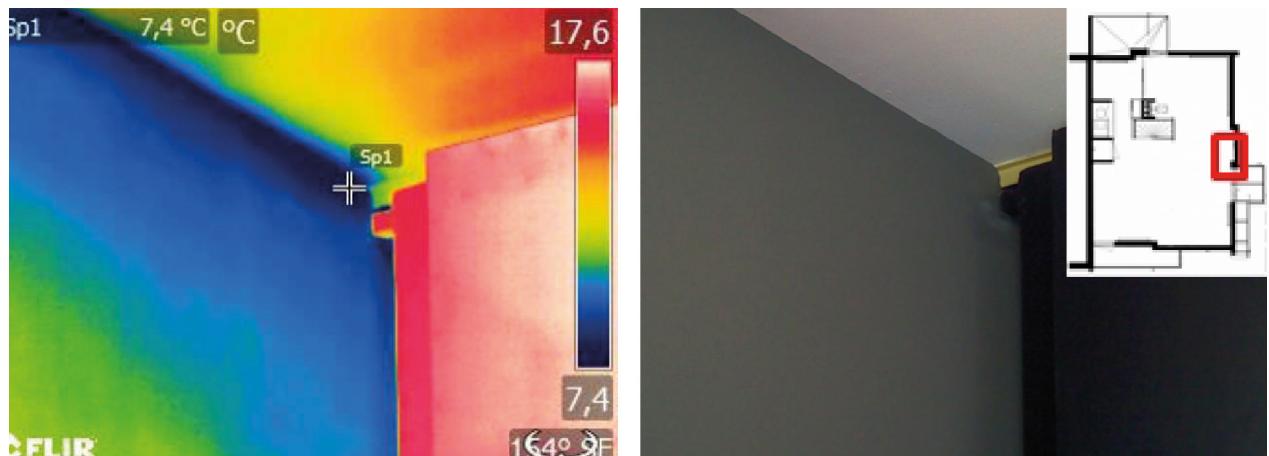
During the survey it became clear that the façade construction has several weak parts in thermo-hygic sense. For example steel profiles and concrete beams are present that have no thermal interruption, which may lead to locally very low temperatures.

The infra-red images collected in the building show that thermal bridges also occur, related to the geometry of the construction (figures 25-26).

Figure 25: Surface temperature in a corner of the construction, (left: IR image, right: normal image; the insert reports the plan of the 1st floor with the location (in red) of the inspected area

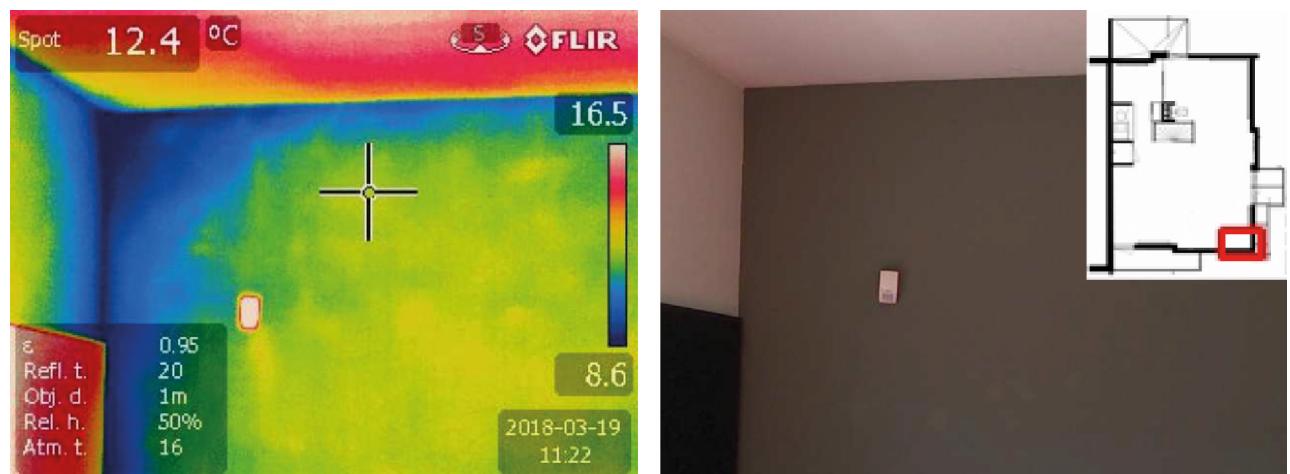
Figure 26: Surface temperature in a corner of the construction, 1st floor (left: IR image, right: normal image); the insert reports the plan of the 1st floor with the location (in red) of the inspected area

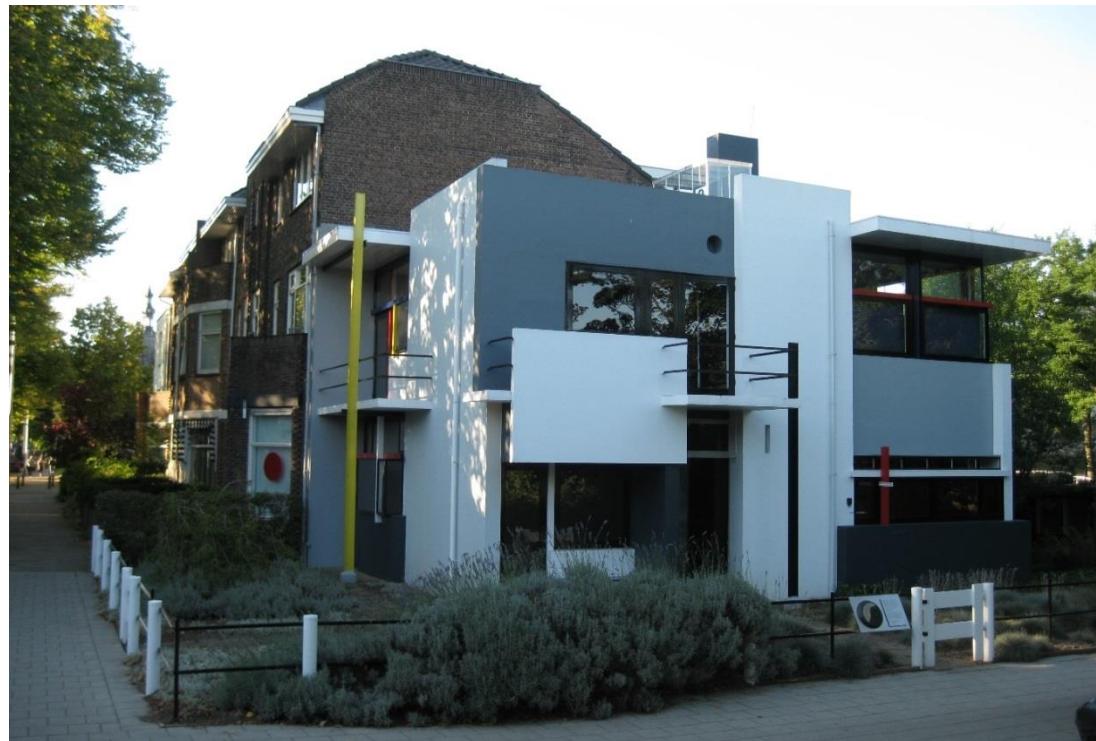
Foto 1 Oostgevel

Het gebouw lijkt in een goede staat van onderhoud. Er zijn geen zichtbare scheefstanden of scheurvorming in constructieve onderdelen waargenomen. Hierbij moet wel worden opgemerkt dat het gebouw in het verleden meermalen grondig is gerenoveerd en dat scheuren in dragend metselwerk onder nieuwe pleisterlagen verborgen zijn geraakt. Sinds de laatste renovatie zijn geen nieuwe scheuren ontstaan. De constructie bevindt zich op dit moment kennelijk in een stabiele toestand.

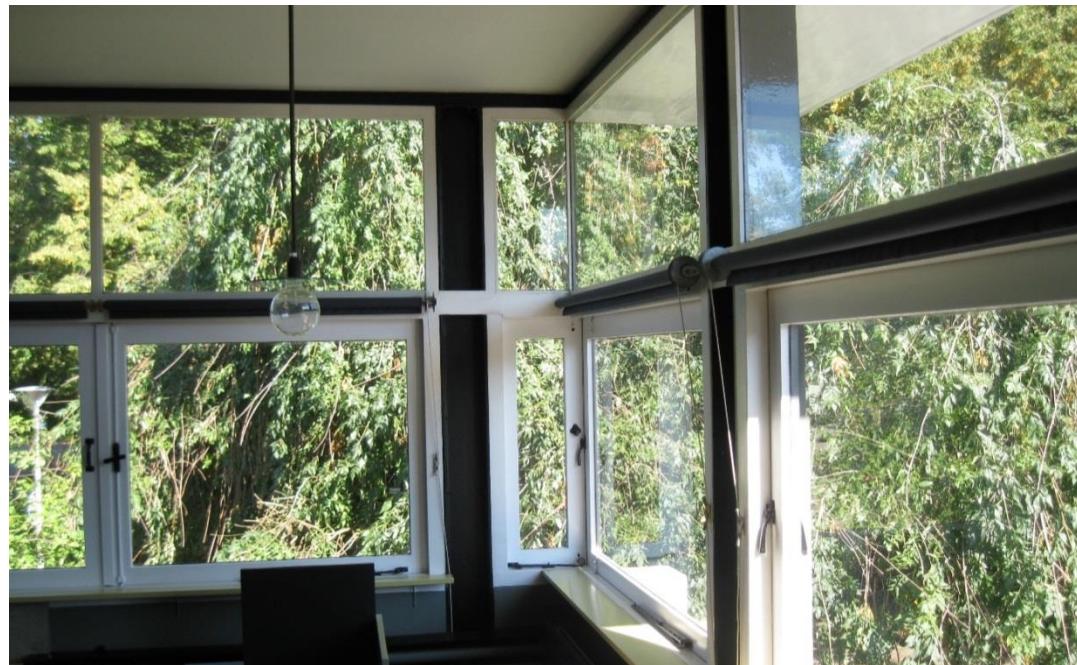
Het gebouw bevat veel koudebruggen en is niet geïsoleerd. Dit levert een groot risico op condensvorming op. Bij de inspectie zijn echter geen vochtplekken waargenomen.

Foto 5 ongeïsoleerde pui met enkelglas en ongeïsoleerde staalprofielen. Dragende dakbalken zijn door het plafond niet zichtbaar

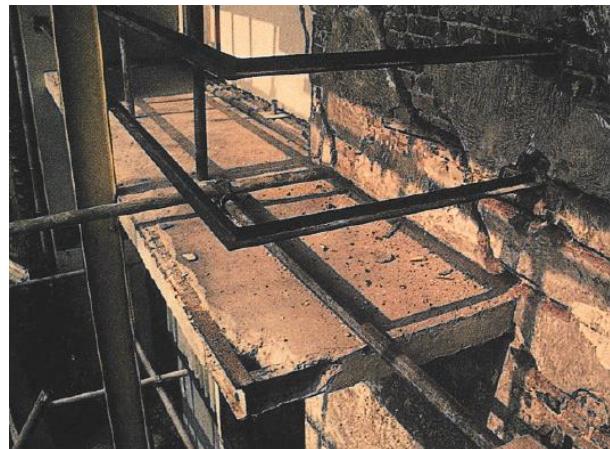
Foto 16 Balkon zuidgevel tijdens restauratie. Staalconstructie zichtbaar. (Zijl and Mulder 2009)

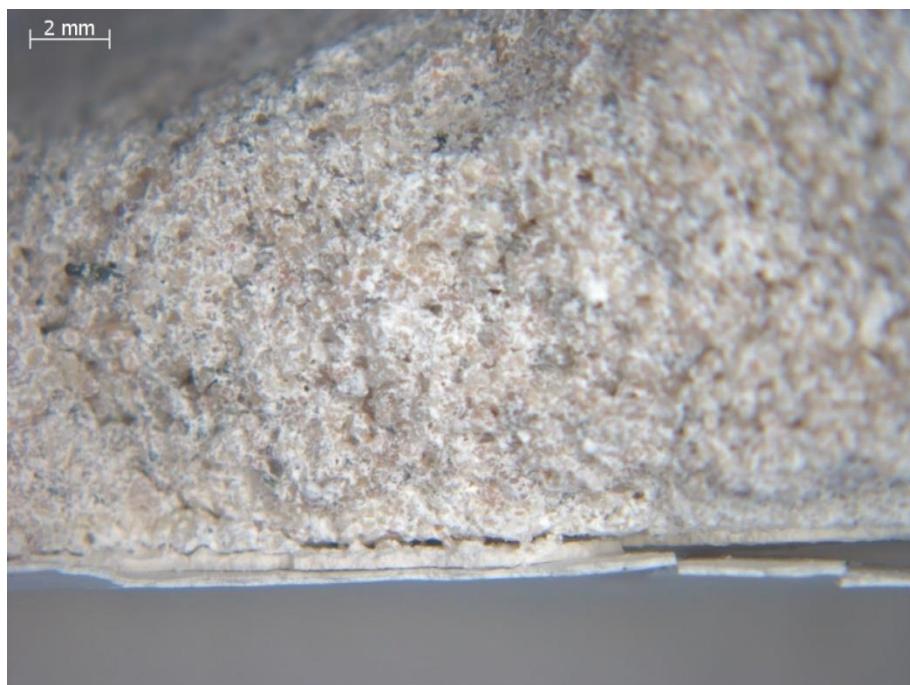
Fig. 1. Stereomicroscopische opname van de dwarsdoorsnede van de aangeleverde pleister.

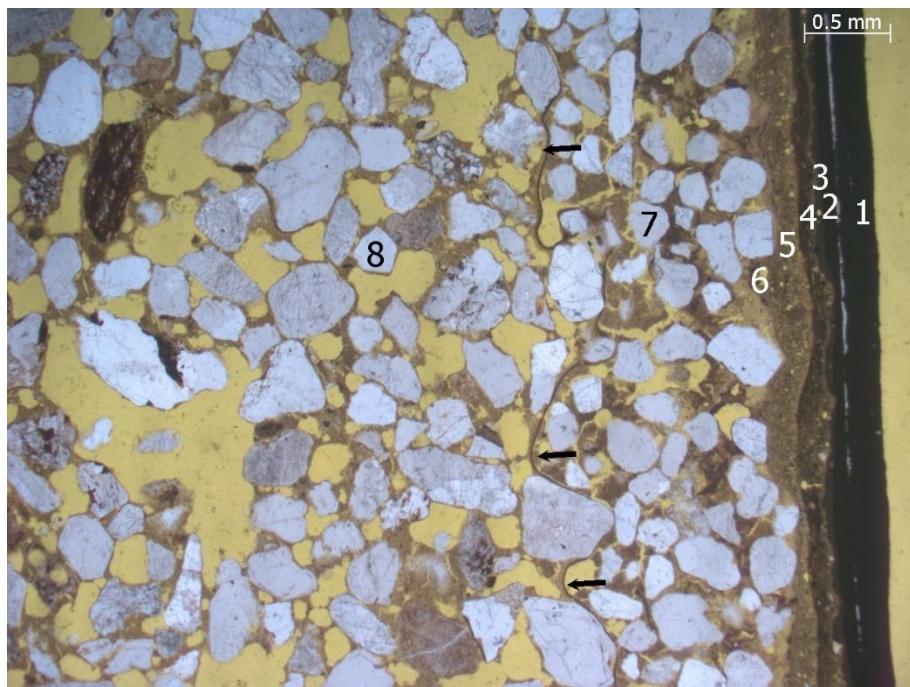
Mortels nummer 7 en 8 zijn, gelet de huid die ontstaan is op het oppervlak van mortel 8 (Fig. 2), met een geringe tussentijd aangebracht, niet nat-in-nat. Dat geldt ook voor afwerklaag 6 op mortel 7 (Fig. 6).

Fig. 2. Microfoto met overzicht van de laagopbouw (zichtvlak naar rechts; parallel gepolariseerd licht).

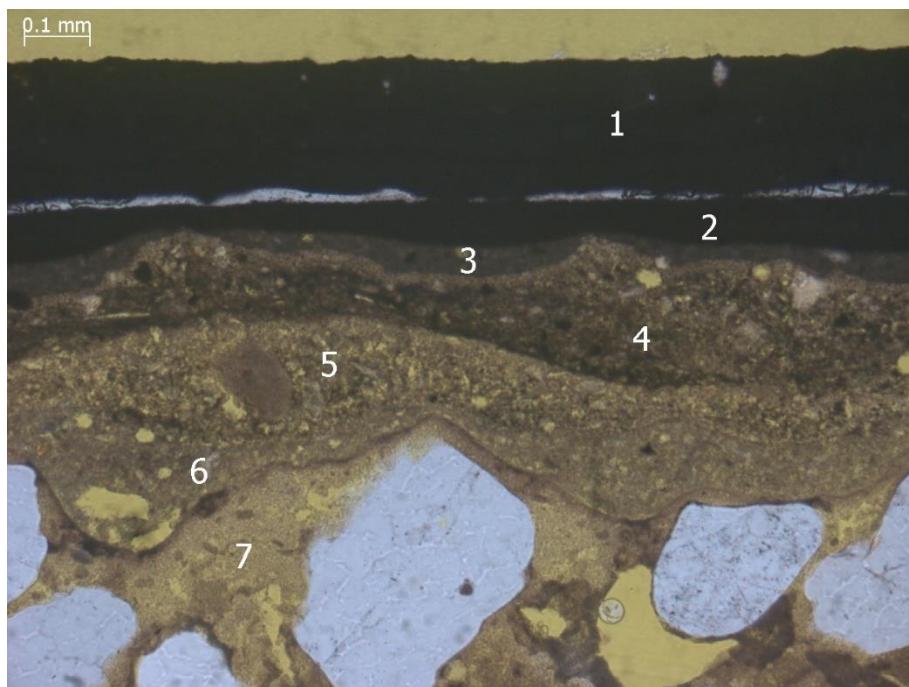
Fig. 3. Microfoto met overzicht van de laagopbouw (zichtvlak naar boven; parallel gepolariseerd licht).

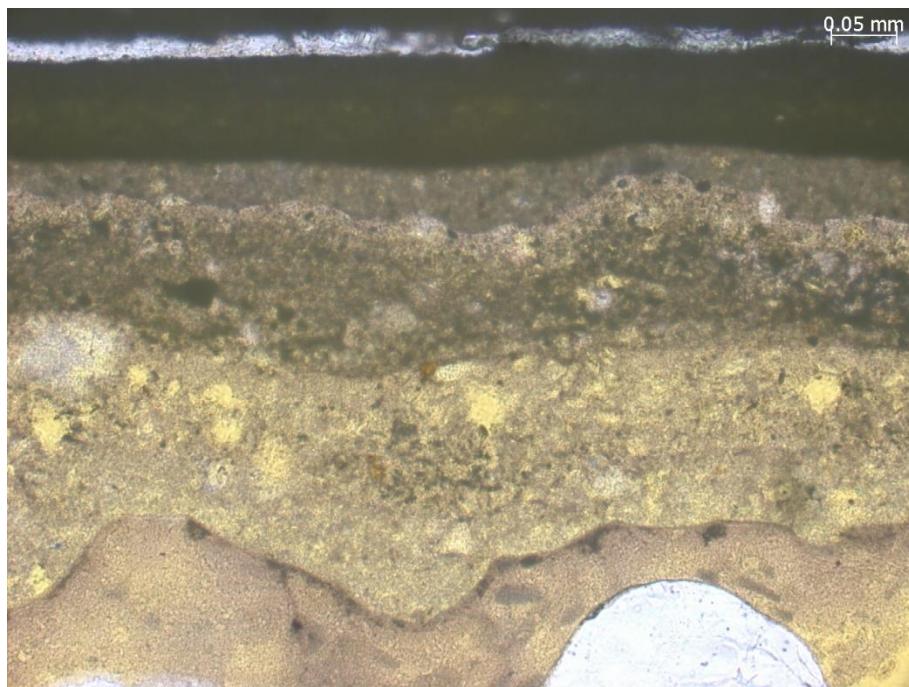
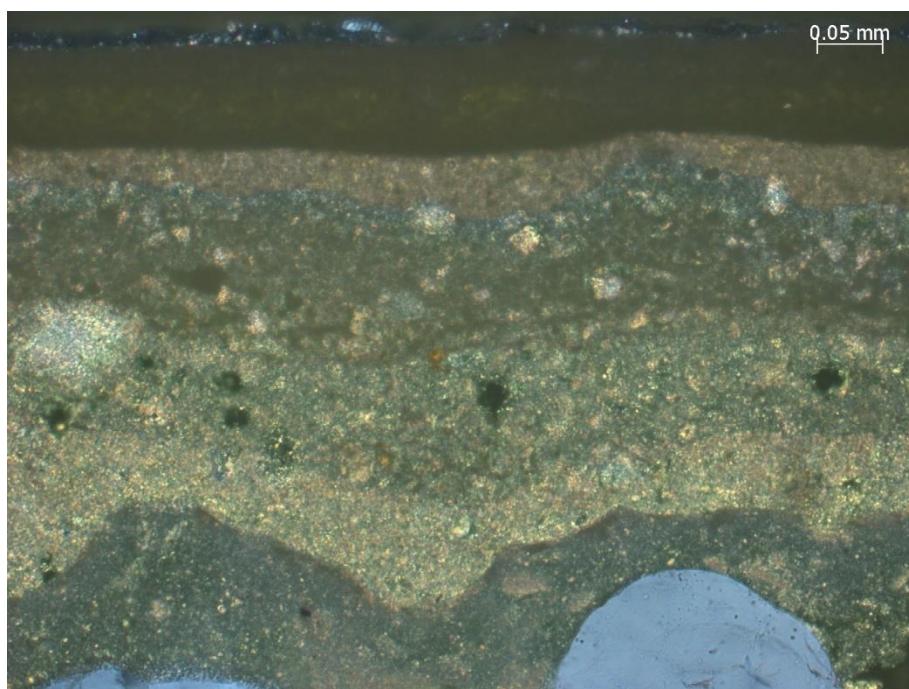
Fig. 4. Overzicht opbouw afwerklagen en coating (zichtvlak naar boven; boven parallel, onder kruislings gepolariseerd licht).

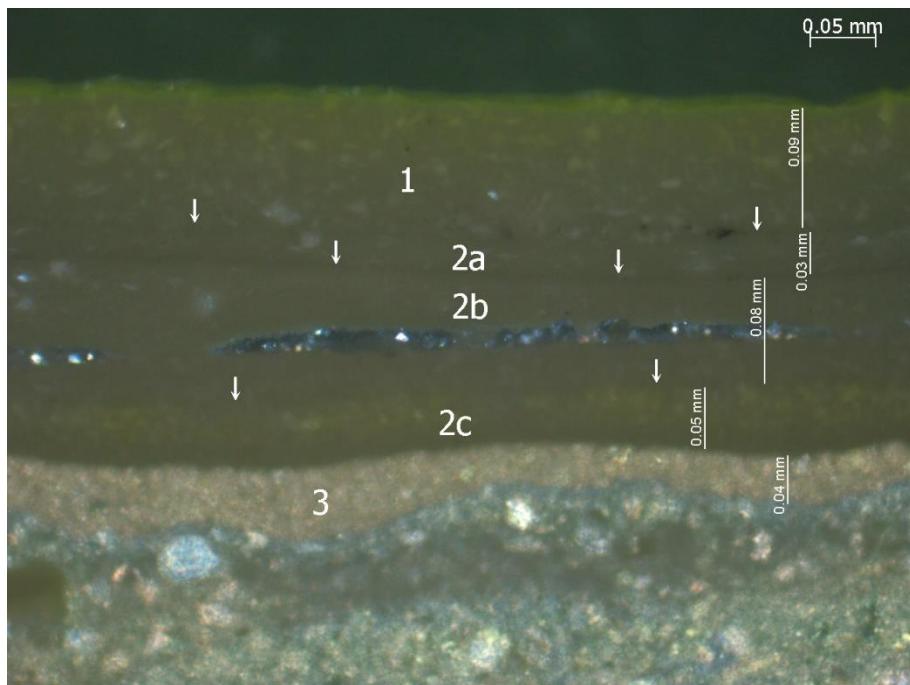
1. Coating (Fig. 5)
2. Coating, optisch iets verschillend van coating onder nummer 1. Hierin zijn drie lagen / zones delen te onderscheiden: twee lagen (2a en 2b), die identiek zijn maar van elkaar gescheiden worden door hetzij een grensvlak (wat zou betekenen dat deze coating in twee lagen is aangebracht) hetzij een blaas in de coating, en daaronder een zone waarin de coating (2c) in de bovenste afwerklaag (3) gedrongen is (Fig. 5).

Fig. 5. Microfoto met overzicht van de laagopbouw van de coating met diktes en interne grensvlakken aangegeven (zichtvlak naar boven; kruislings gepolariseerd licht).

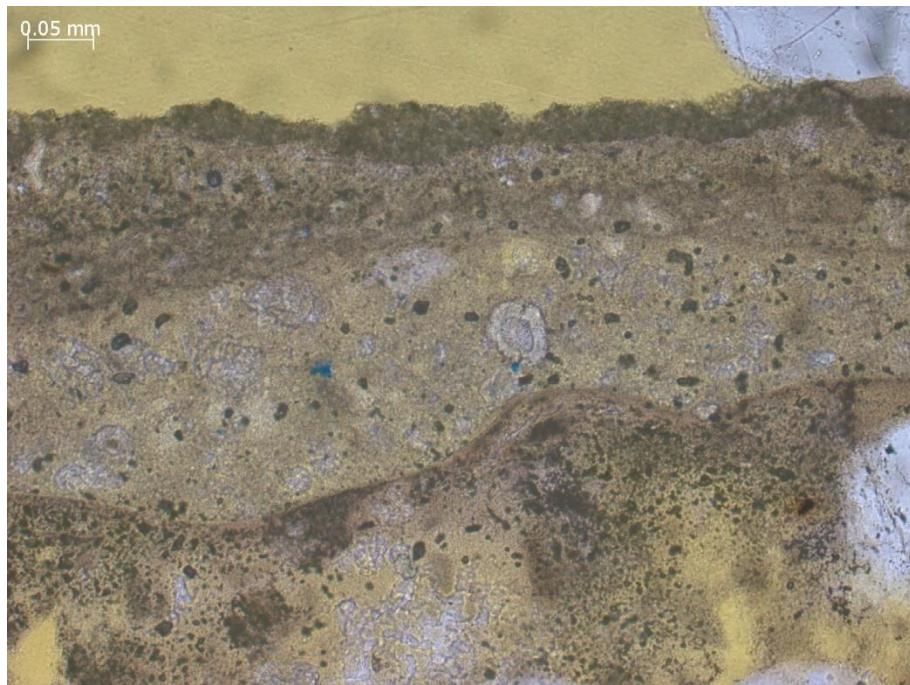
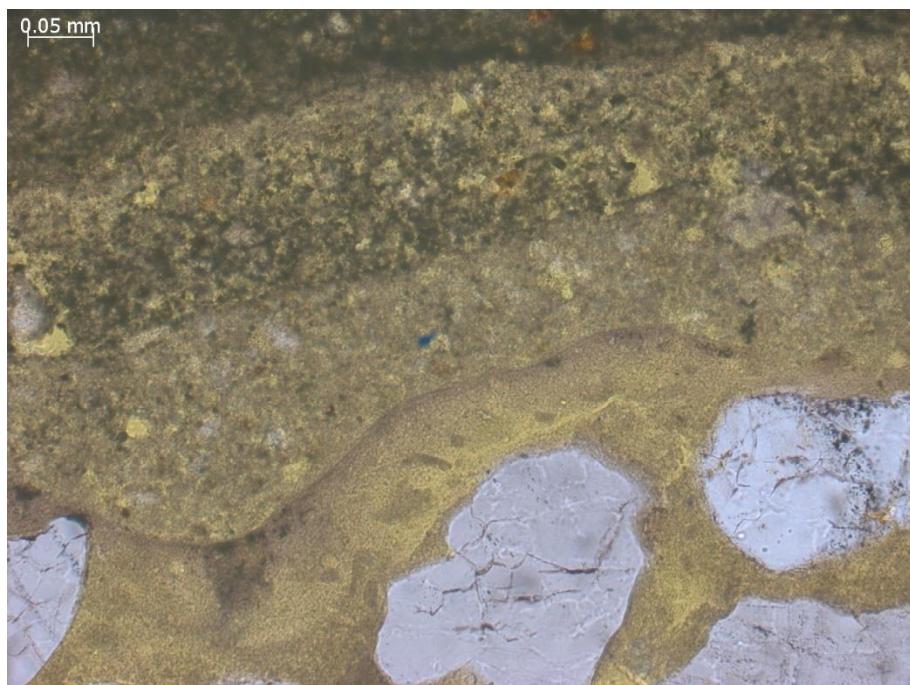
6. Afwerklaag met kalk als bindmiddel. In de afwerklaag is zeer sporadisch een blauw pigment aanwezig (Fig. 6).
7. Mortel met kalk als bindmiddel, enkele kalkklompjes en zand met een typische korrelgrootte van 0,15-0,3 mm.

Fig. 6. Microfoto's van blauw pigment in de onderste afwerklaag (6) en de huid (zichtbaar aan de scherpe begrenzing) op de bovenste mortel (7, onder op de foto) (zichtvlak naar boven; parallel gepolariseerd licht).

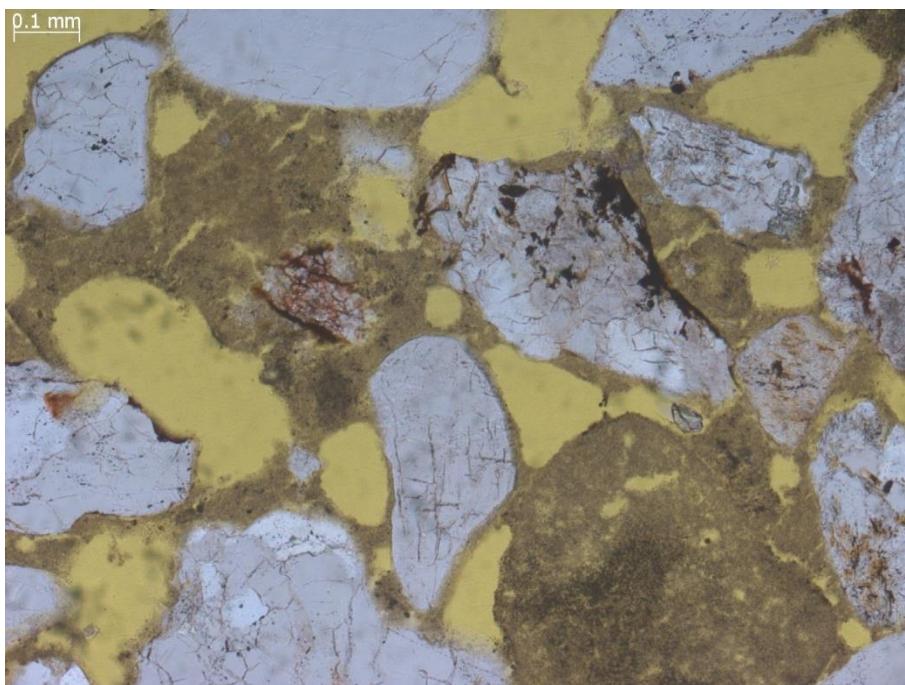
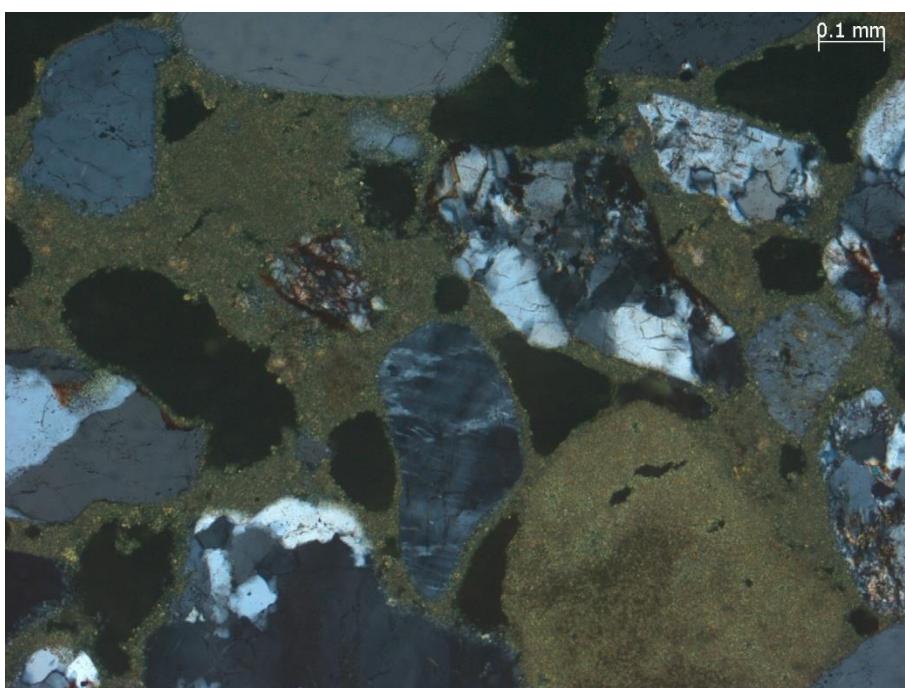
Fig. 8. Microfoto's met overzicht van de onderste mortel (8) (boven parallel, onder kruislings gepolariseerd licht).

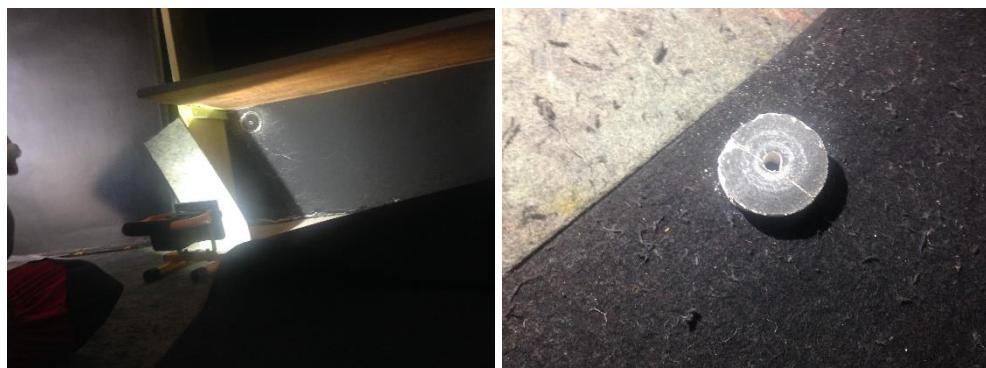
Fig. 1. Location sample RSH 18/1 (pictures M.T.A. van Thoor, TU Delft).

RSH 18/1 - Southern interior wall of the study of the ground floor (Fig. 1). This is the same wall from which a sample of plaster has been investigated previously (Nijland 2017). The current sample has been collected from the black painted lower part of the wall, below the book shelves. The plaster is supposed to be original.

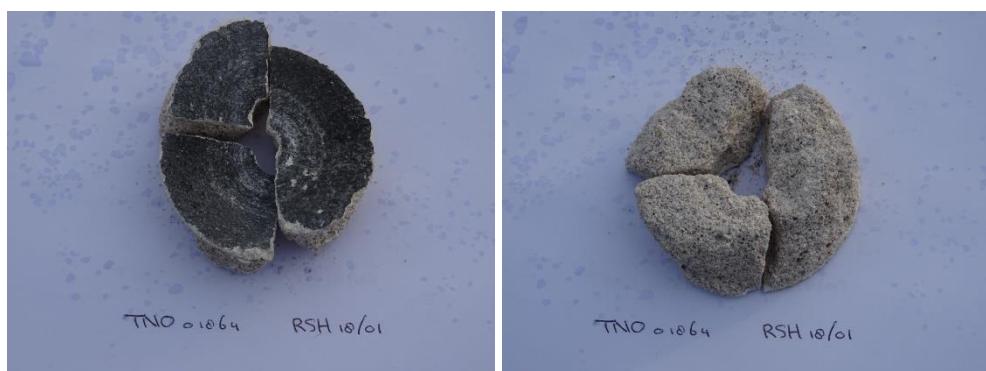
A thin core of mortar broken into three pieces (Fig. 2). The plaster is composed by two layers of mortar and finished with a greyish black coating (Fig. 3). The outer mortar layer of ca. 2 mm thickness is white, the inner mortar layer less bright white. Both mortars contain quartz sand.

Fig. 2. Sample RSH 18/1, surface (left) and wall side (right).

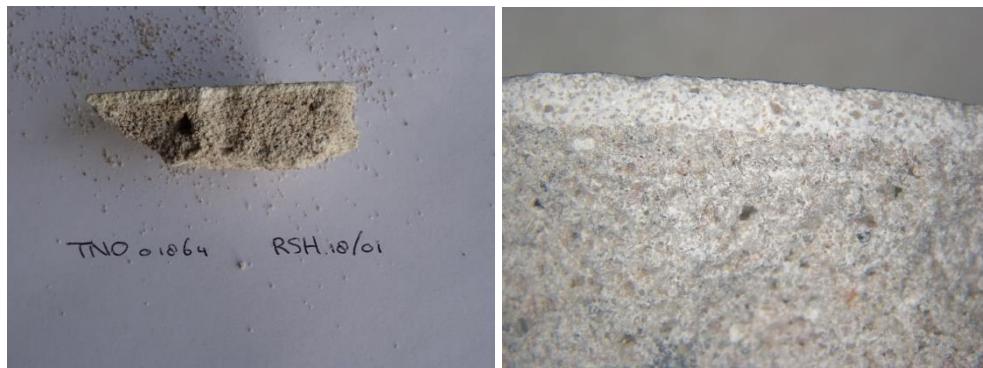
Fig. 3. Sample RSH 18/1, cross section (surface to the top); right detail by stereomicroscope.

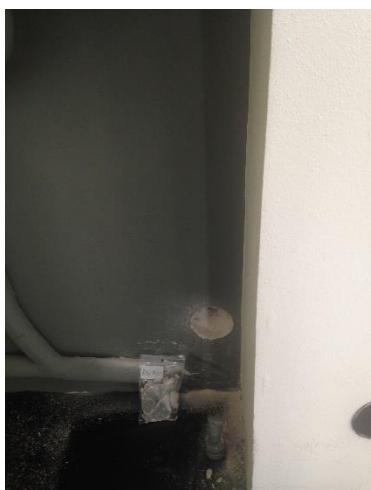
Fig. 4. Location sample RSH 18/3 (picture M.T.A. van Thoor, TU Delft).

RSH 18/3 - Southern interior wall of the girls chamber facing the Prins Hendriklaan on the first floor, below the washing basin (Fig. 4). The sample is supposed to be a renovation plaster.

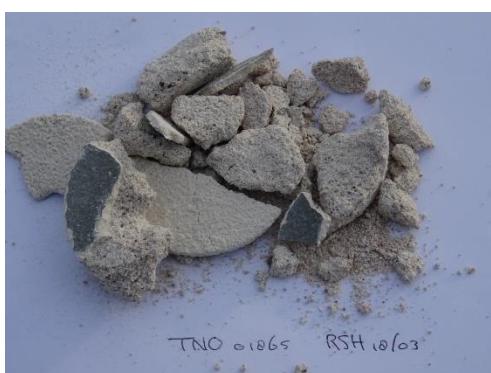
Fig. 5. Sample RSH 18/3, overview.

The sample consists of fragments of mortar and some powder (Fig. 5) and is to some extent comparable to sample RSH 18/1, i.e. it is also made up by two layers of mortar and finished by a coating (Fig. 6). However, the outer mortar in this sample appears to contain less aggregate than the outer mortar in sample RSH 18/1.

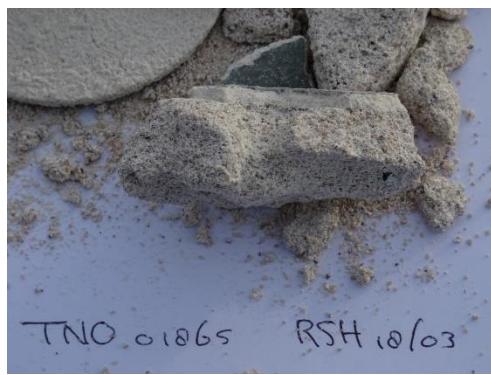
Fig. 6. Sample RSH 18/3, cross section of one of the fragments

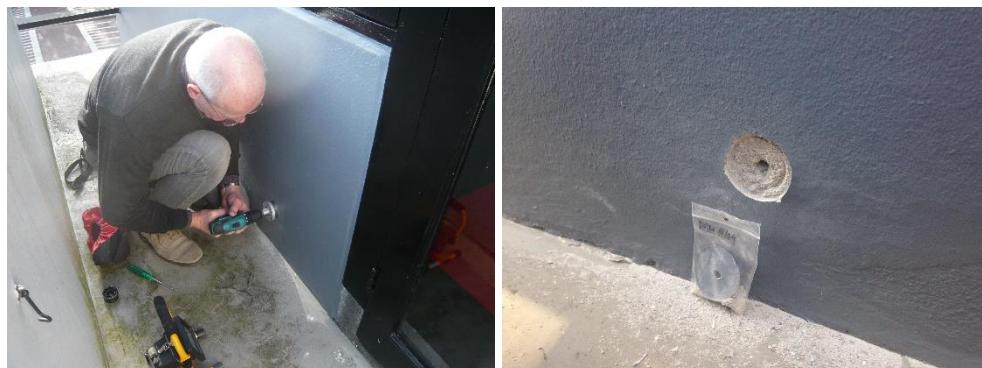
Fig. 7. Location sample RSH 18/4 (pictures M.T.A. van Thoor, TU Delft).

RSH 18/4 - Outside on the balcony at the eastern wall of the son's room situated above the entrance; the sample has been taken at the bottom of the white (very light grey) wall (Fig. 7). The sample is supposed to be a renovation render.

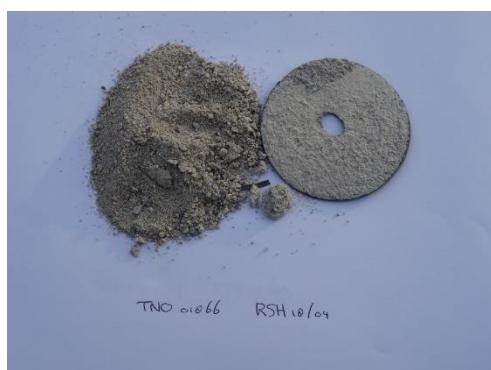
Fig. 8. Sample RSH 18/4, overview.

The sample consists of powdered mortar with a single separate slice of coating (Fig. 8). The sample is darker and more greyish than samples RSH 18/1 and 18/3; the powder seems to represent one mortar only. In order to make a thin section, the powder has been embedded in epoxy first. The thin section has been coded TNO 01866.

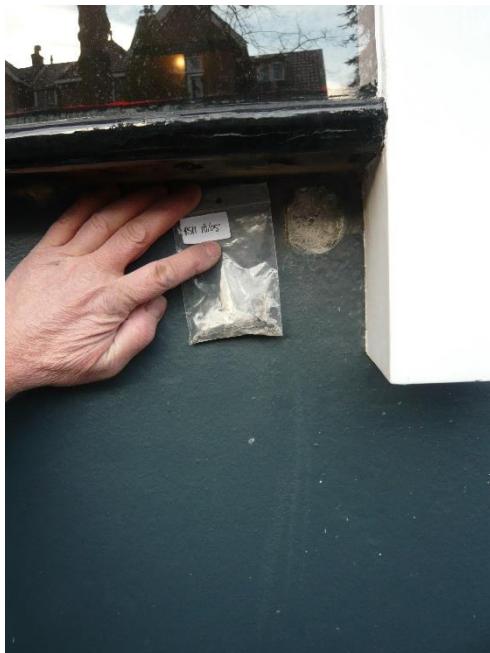
Fig. 9. Location sample RSH 18/5 (picture M.T.A. van Thoor, TU Delft).

RSH 18/5 - Outside, from the wall below the window of the atelier on the ground floor facing the Prins Hendriklaan. The sample has been taken from the right corner direct beneath the window (Fig. 9). The render is considered to possibly be original.

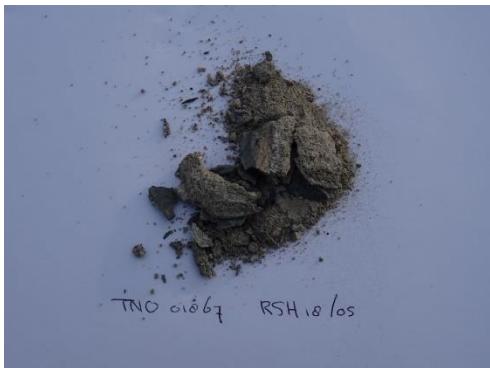
Fig. 10. Sample RSH 18/5, overview.

The sample consists of tiny fragments and powder of mortar (Fig. 10), partly covered by various coating(s). The fragments represent a grey, sandy mortar.

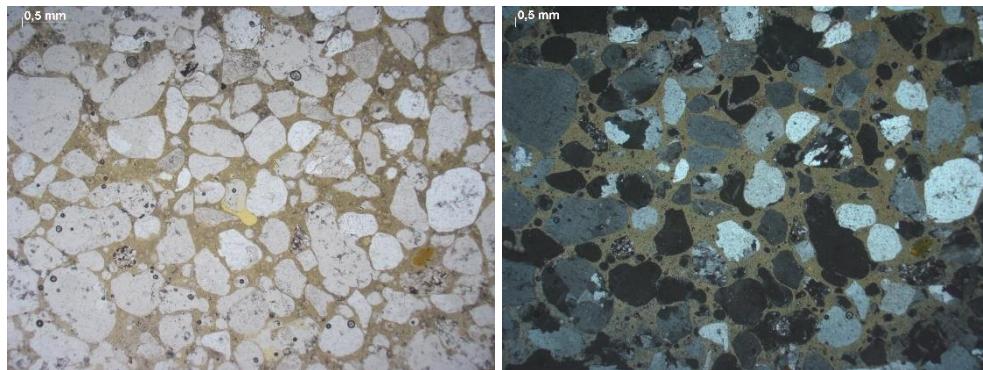
The thin section contains one single mortar (Fig. 11), corresponding to the inner mortar seen on Figure 2. The outer mortar and coating are not continuous, and not present in the thin section.

Fig. 11. Microphotographs showing an overview of the microstructure of the inner mortar in sample RSH 18/1 (TNO 01864, left plane, right cross polarized light).

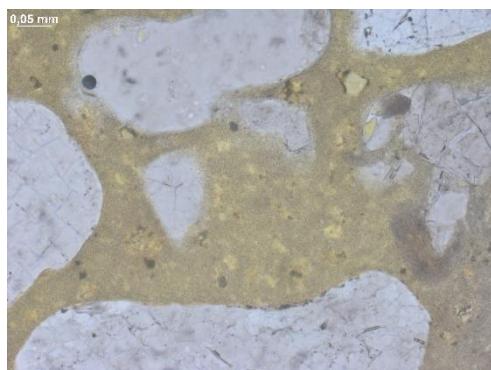
The mortar has hydraulic lime as a binder (Fig. 12), containing relatively abundant belite (C_2S) (Fig. 13) and has completely been carbonated. No evidence for additional binder components, such as trass, gypsum or Portland clinker has been found. The aggregate is quartz sand, with D_{max} ca. 1 mm, and a typical grain size of about 0.5 mm.

Fig. 12. Microphotograph showing detail of the binder matrix of the inner mortar in sample RSH 18/1 (TNO 01864, plane polarized light).

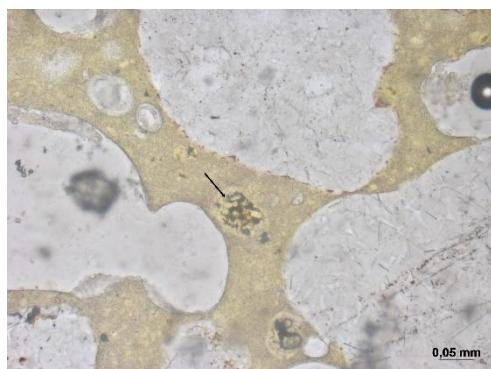
Fig. 13. Microphotograph illustrating the presence of some belite (C2S) in the binder of the inner mortar in sample RSH 18/1 (TNO 01864, plane polarized light).

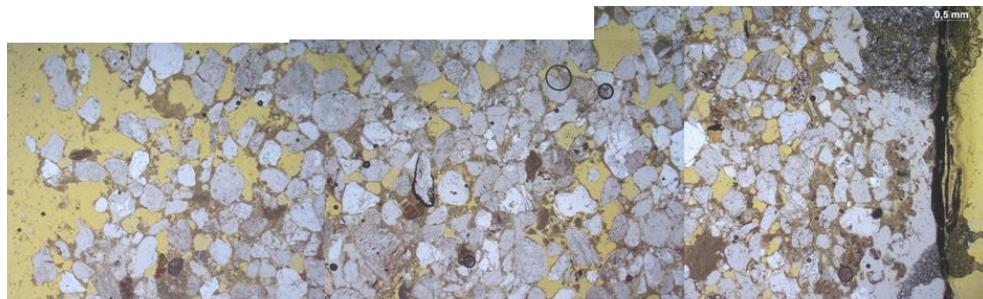
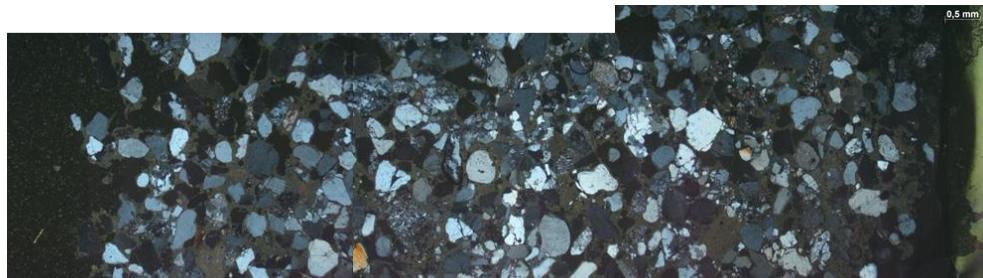
The thin section contains a stratigraphical sequence of two mortars with a coating on top (Fig. 14). The inner mortar is made up by two layers (Fig. 15); this inner mortar has apparently been applied in two layers. On top of the outer part of the inner mortar, a very thin skin is present, indicating some gap in time between the application of the inner and outer mortars.

Fig. 14. Microphotographs of a cross section through the stratigraphy in sample RSH 18/3 with right the outer face, covered by a coating (TNO 01865, above plane, below cross polarized light).

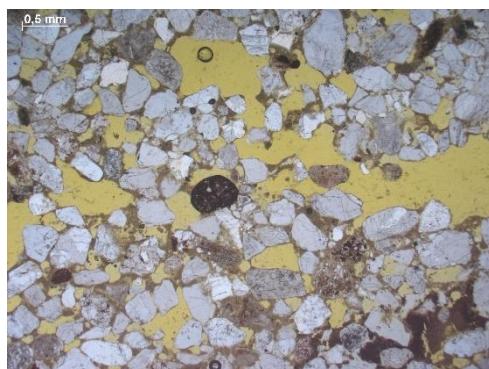
Fig. 15. Microphotograph showing the internal boundary in the inner mortar of sample RSH 18/3, manifest by the series of elongate voids (TNO 01865, plane polarized light).

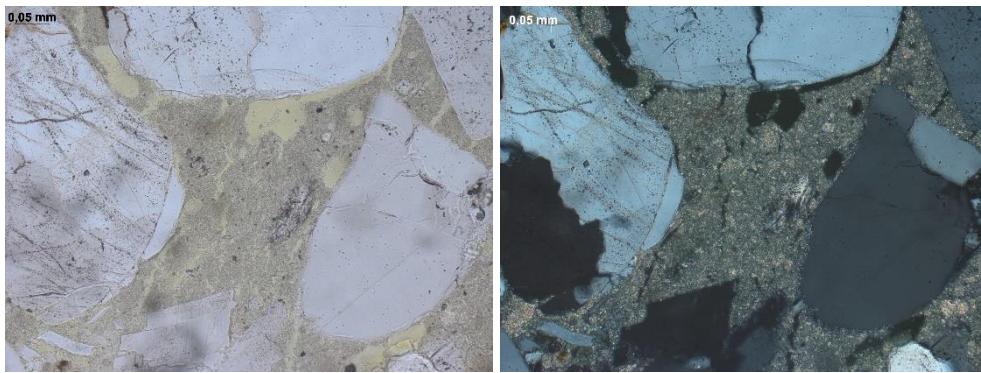
The inner mortar has been made with a hydraulic lime as a binder (Fig. 16). However, belite (C_2S), typical for hydraulic limes, is scarce. Its content appears to be less than in sample RSH 18/1 (Fig. 17). Rare shell fragments occur. No indications for other binder components has been found. The aggregate is rounded quartz sand with D_{max} of ca. 1 mm and a typical grain size of 0.2 – 0.4 mm.

Fig. 16. Microphotographs showing a detail of the binder matrix of the inner mortar in sample RSH 18/3 (TNO 01865, left plane, right cross polarized light).

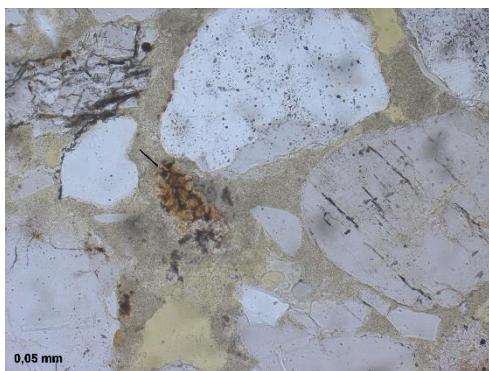
Fig. 17. Microphotograph showing one of the scarce, iron-bearing, belites (indicated by a small arrow) in the binder matrix of the inner mortar in sample RSH 18/3 (TNO 01865, plane polarized light).

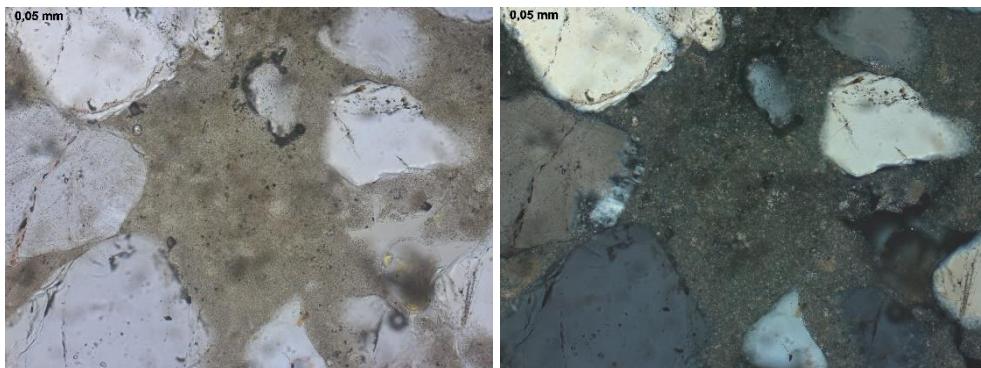
The outer mortar has a binder based on lime and gypsum (Fig. 18, 19); no belite or trass have been found. The aggregate is also rounded quartz sand, but the typical grain size is slightly finer than in the inner mortar, i.e. 0.2 – 0.3 mm.

Fig. 18. Microphotographs showing a detail of the binder matrix of the outer mortar in sample RSH 18/3 (TNO 01865, left plane, right cross polarized light).

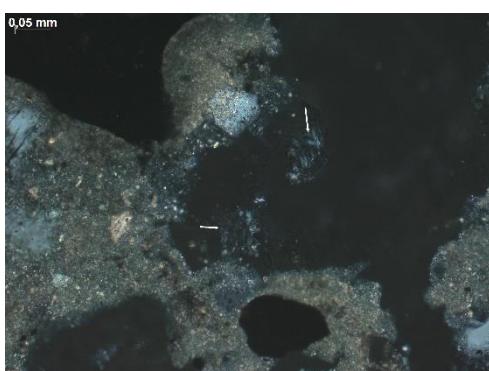
Fig. 19. Microphotographs illustrating the presence of gypsum (indicated by small arrows) in the binder of the outer mortar in sample RSH 18/3 (TNO 01865, cross polarized light).
