HERITAGE & ARCHITECTURE

5 November 2018

Keeping it Modern Grant,
The Getty Foundation

Conclusions and recommendations from the research Colour, Form and Space: Rietveld Schröder House challenging the Future.

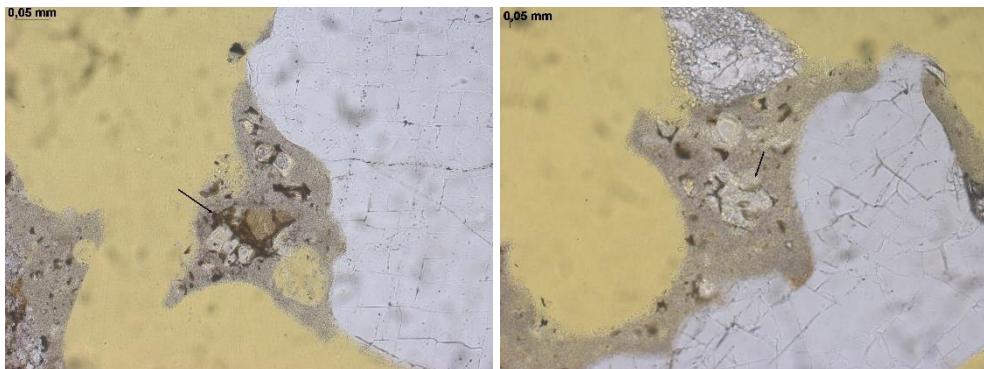
The binder of the mortar has completely been carbonated. Besides lime, clinker components such as alite (C_3S), belite (C_2S) and ferrite (C_4AF) are present (Fig. 20). Clinker components are relatively abundant. The binder has probably been made by a mixture of Portland cement and lime. The aggregate is quartz sand. Some of the larger fragments contain abundant air voids in the mortar (Fig. 21), suggesting the use of an air entraining agent.

Fig. 20. Microphotographs illustrating the presence of alite, C_3S (left) and belite, C_2S (right; both indicated by small arrows) in the binder of sample RSH 18/4 (TNO 01866, plane polarized light).

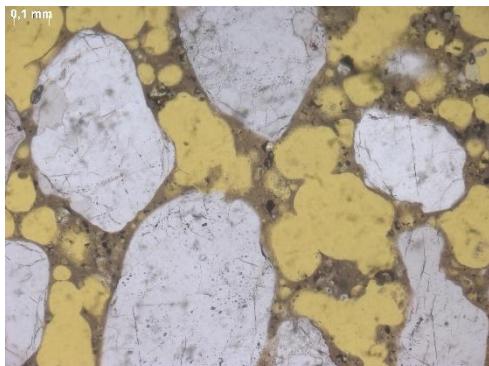
Fig. 21. Microphotograph showing the abundant air voids in the mortar in sample RSH 18/4 (TNO 01866, plane polarized light).

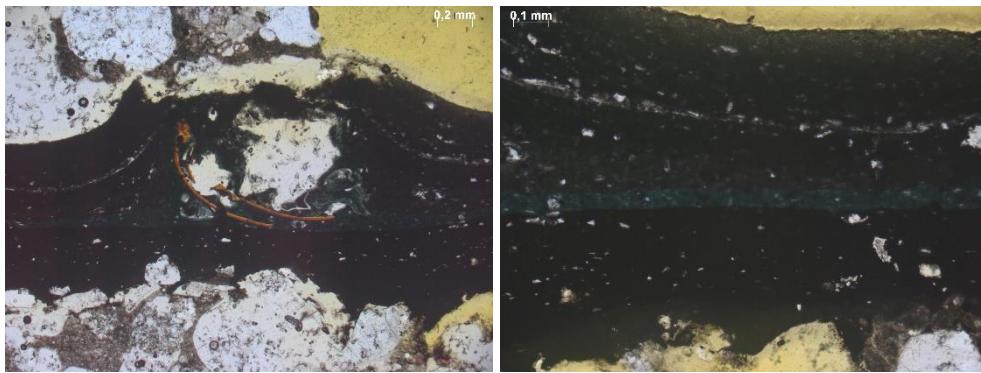
The thin section contains several fragments of one and the same mortar, some of them covered by a series of coatings (Fig. 22).

Fig. 22. Microphotographs showing details of the coating series on top of one of the mortar fragments in sample RSH 18/5 (TNO 01867, plane polarized light).

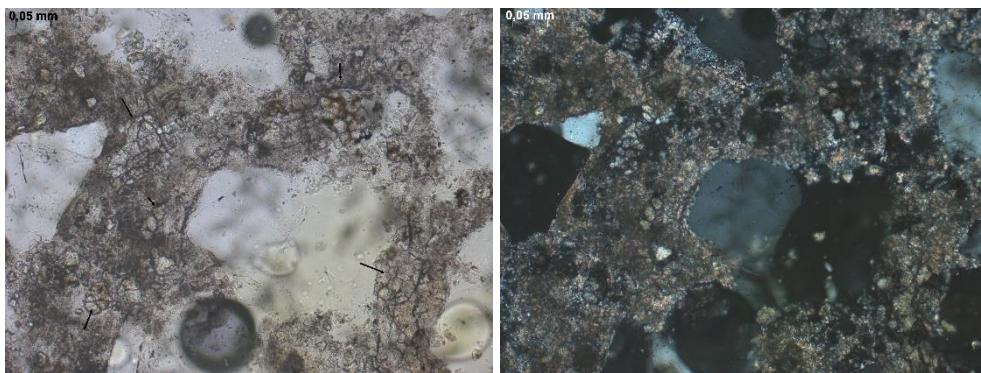
The mortar itself has rounded quartz sand as an aggregate. The binder contains very abundant coarse belite, C_2S , but no other clinker components (Fig. 23). It is most probably a strongly hydraulic lime (or perhaps an early Portland cement).

Fig. 23. Microphotographs showing a detail of the belite-rich binder (indicated by small arrows on the left picture) in sample RSH 18/5 (TNO 01867, left plane, right parallel polarized light).

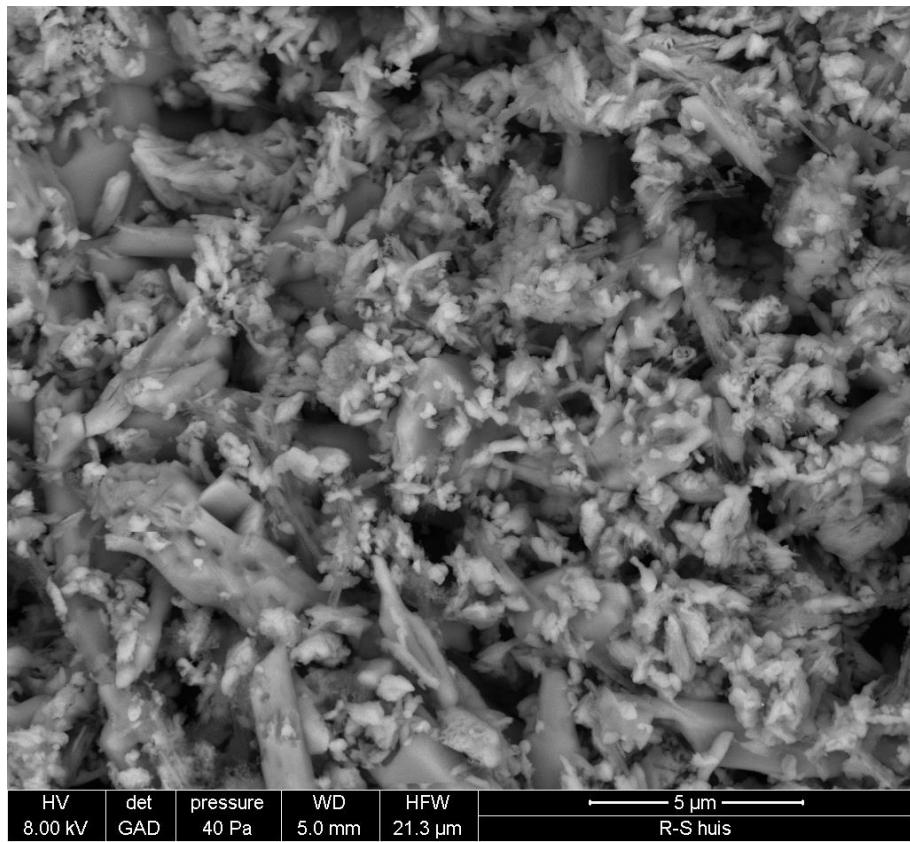
SEM clearly shows that the binder in the outer mortars is made up by gypsum and calcium carbonate (Fig. 24). This is confirmed by EDS analysis (Fig. 25).

Fig. 24. Scanning electron microphotograph showing detail of the binder in sample RSH 18/1, made up by gypsum and calcium carbonate.

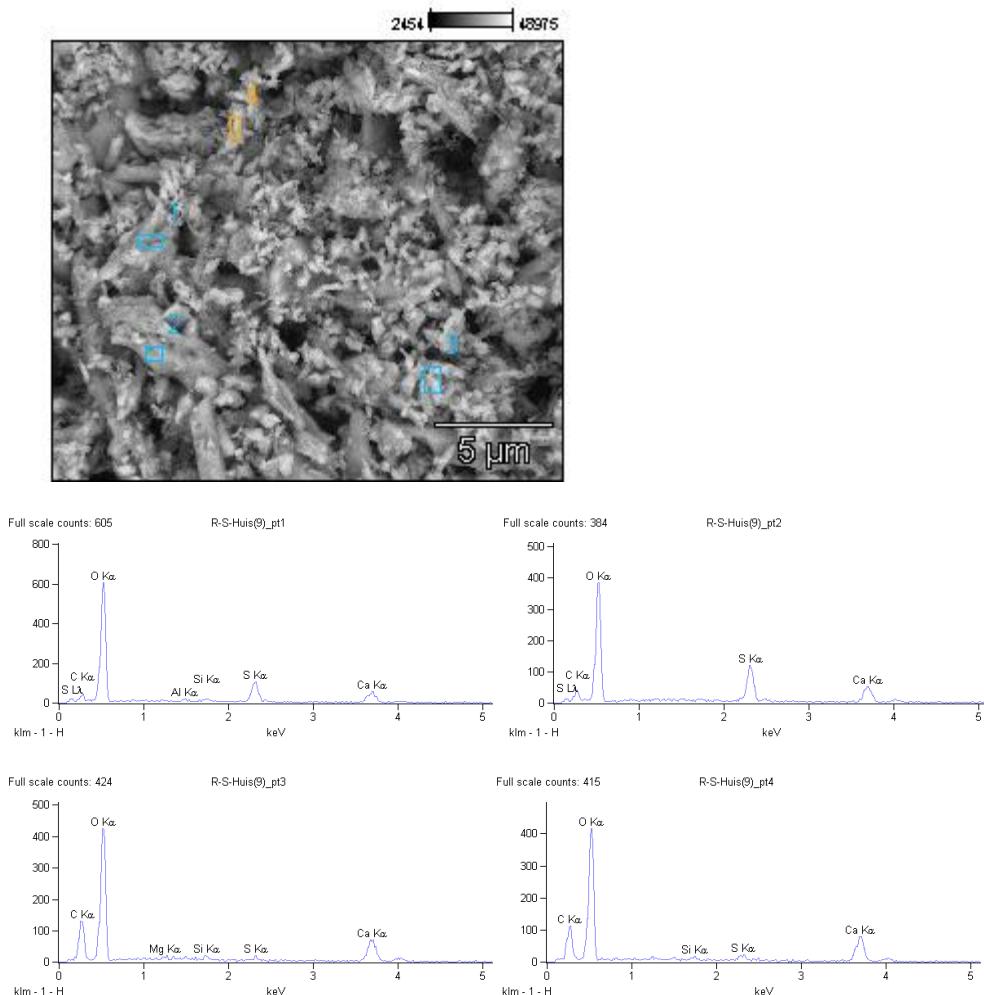
Fig. 25. EDS spectra of selected spots on the binder shown in figure 21.

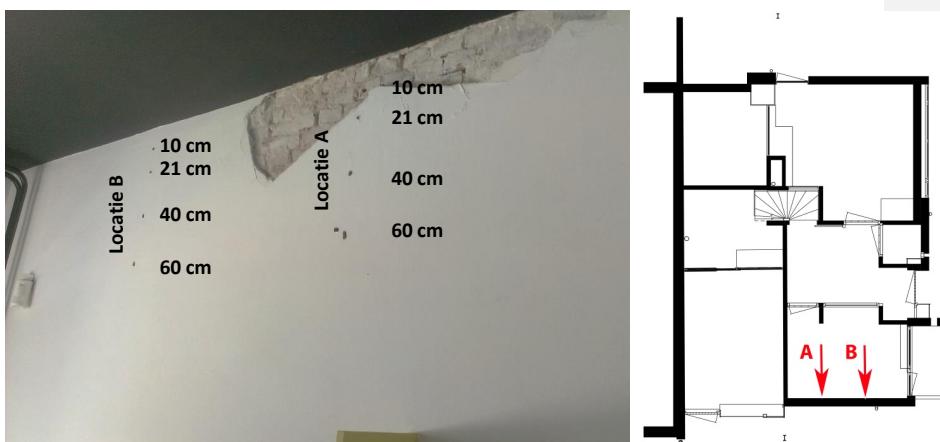
Figuur 2. Locaties van de bemonstering van gruismonsters

Om de aanwezigheid van vocht en/of hygroscopische zouten vast te stellen zijn gruismonsters uit de pleisterlaag en het achterliggende baksteen metselwerk genomen; deze zijn geboord op verschillende hoogten (10, 21, 40 en 60 cm vanaf het plafond) en diepten (0-2, 2-5, 5-12 cm) in het metselwerk, langs twee verticale profielen: een op de beschadigde (locatie A) en een daarnaastgelegen niet beschadigde locatie (locatie B) (figuur 2). In totaal zijn 23 gruismonsters genomen. Volledige informatie over de monsters is in bijlage A te vinden.

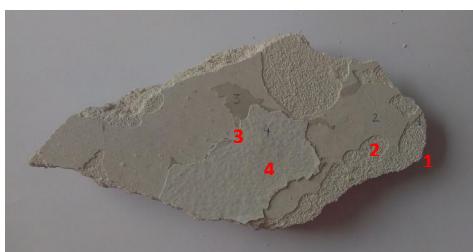
Uit de archiefdocumenten is helaas niet vast te stellen of het pleisterwerkwerk van de studeerkamer (volledig) vervangen is. Daarnaast is het type van de verschillende verflagen die op het pleisterwerk zichtbaar zijn (figuur 3) ook onbekend..

Figuur 3. Stuk van het pleisterwerk dat losgekomen is van de wand: er zijn 4 lagen verf visueel te onderscheiden

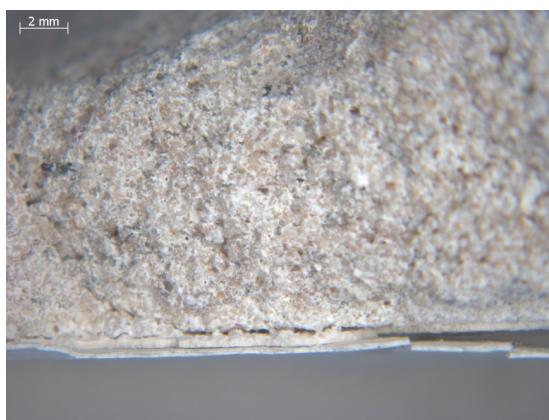
Ten behoeve van het onderzoek is aan TNO een monster pleisterwerk aangeleverd, met daarop een coating (figuur 4).

Figuur 4. Stereomicroscopische opname van de dwarsdoorsnede van het aan TNO aangeleverde monster van het pleisterwerk

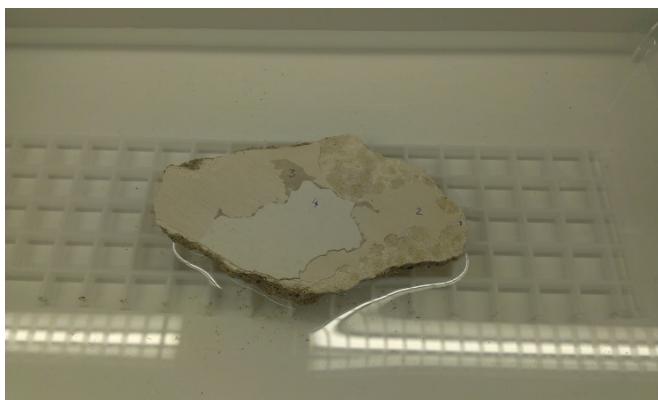
Figuur 5. Capillaire waterabsorptie metingen aan de pleisterlaag

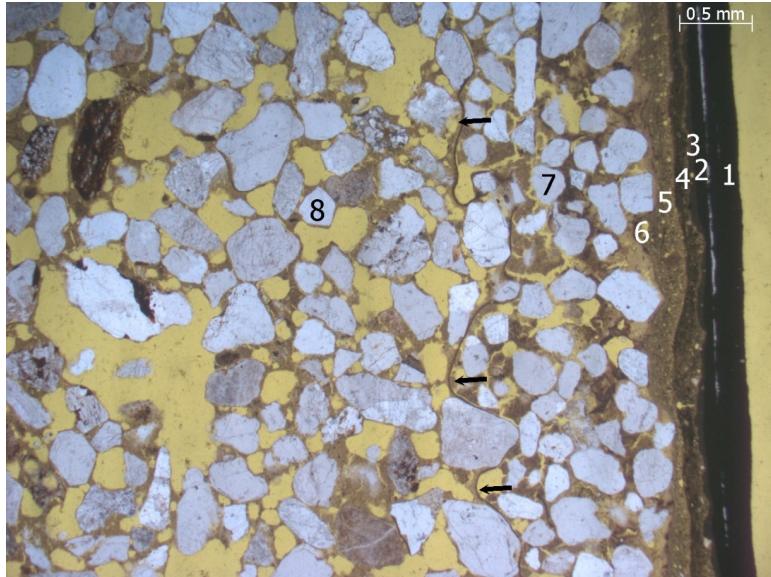
Figuur 7. Microfoto met overzicht van de laagopbouw (zichtvlak naar rechts; parallel gepolariseerd licht).

Mortels nummer 7 en 8 zijn, gelet de huid die ontstaan is op het oppervlak van mortel 8 (figuur 7), met een geringe tussentijd aangebracht, niet nat-in-nat. Dat geldt ook voor afwerklaag 6 op mortel 7 (figuur 11).

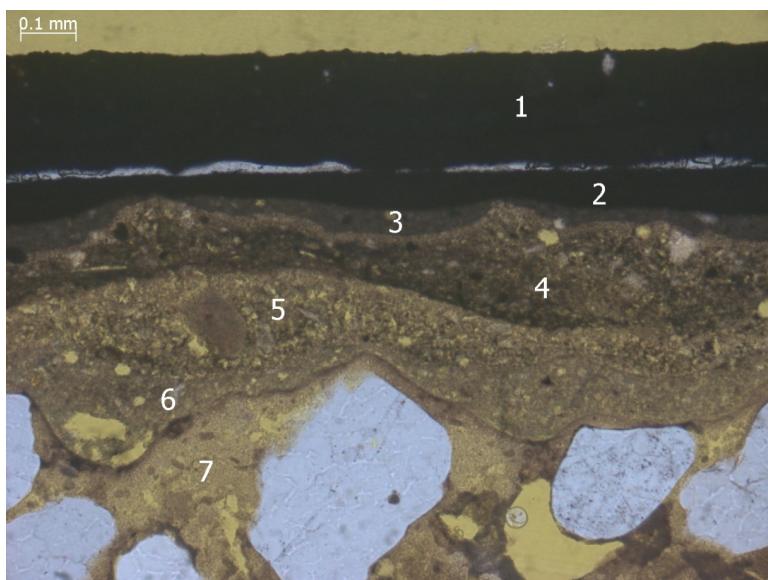
Figuur 8. Microfoto met overzicht van de laagopbouw (zichtvlak naar boven; parallel gepolariseerd licht).

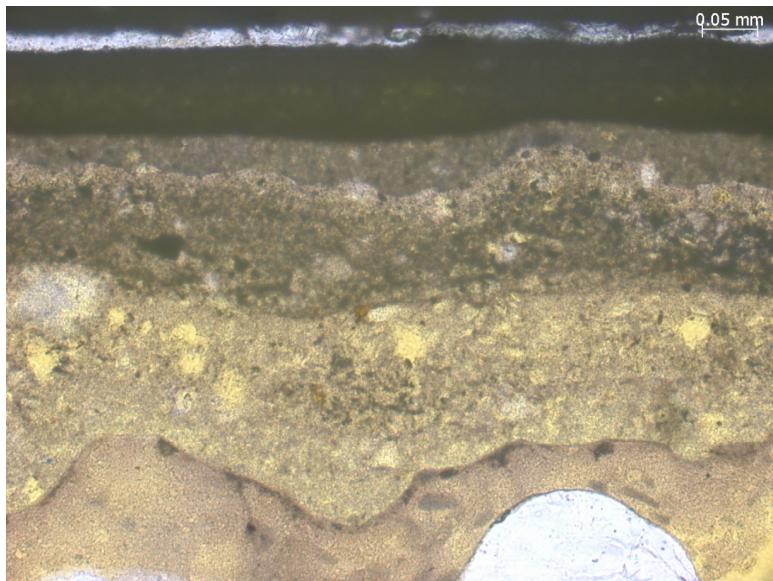
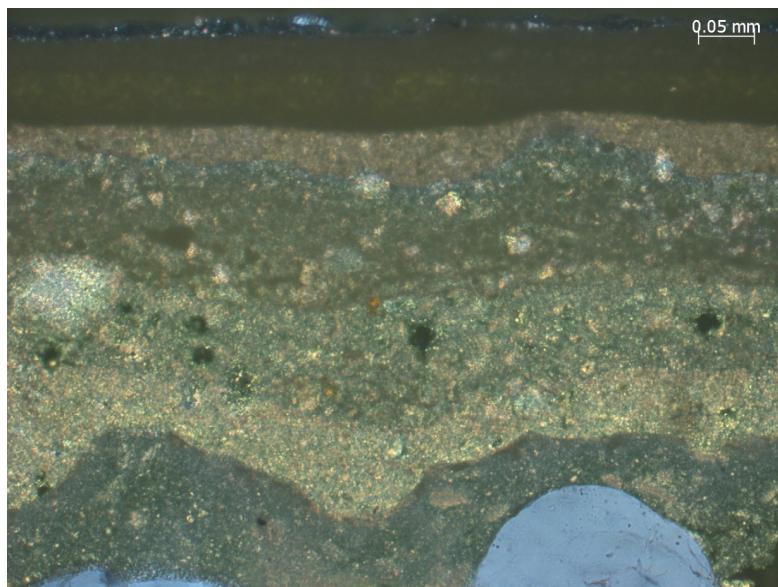
Figuur 9. Overzicht opbouw afwerklagen en coating (zichtvlak naar boven; boven parallel, onder kruislings gepolariseerd licht).

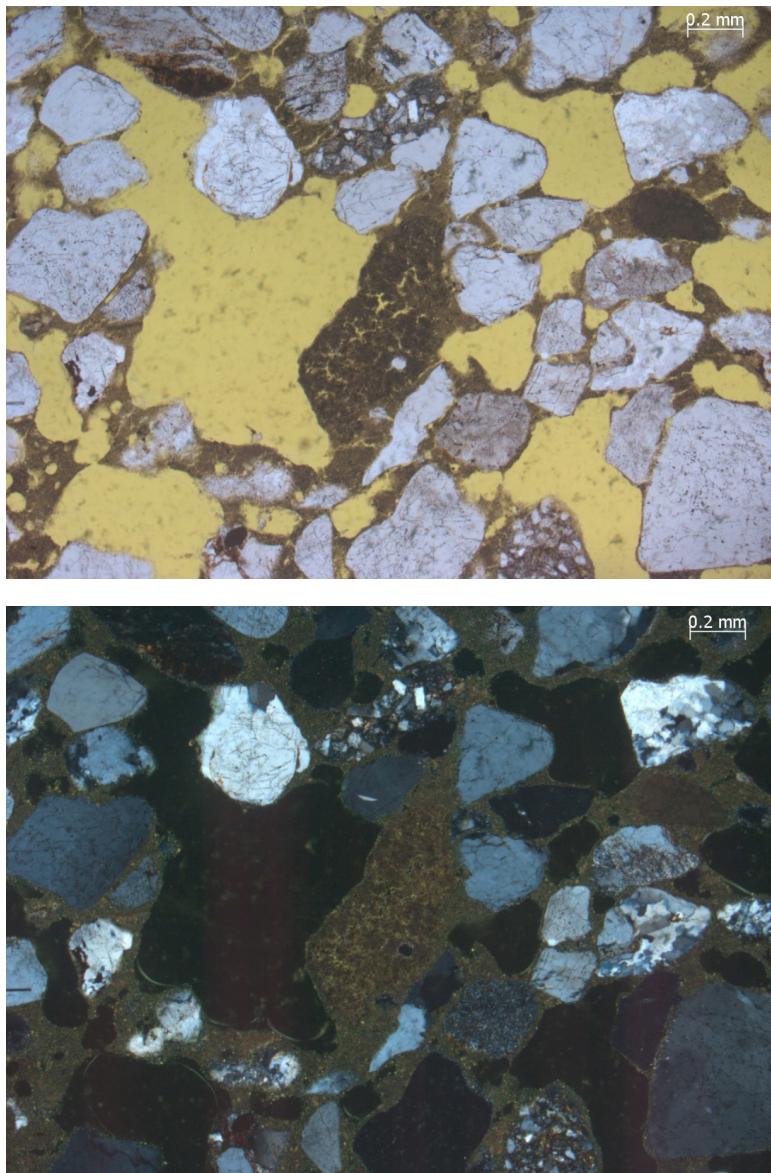
Figuur 12. Microfoto's met overzicht van de onderste mortel (7) (boven parallel, onder kruislings gepolariseerd licht).

Noch in het bindmiddel van de afwerklagen (3 t/m 6), noch in het bindmiddel van de onderliggende lagen (7 en 8) zijn hydraulische componenten zoals C2S (karakteristiek voor hydraulische kalk) of de combinatie van C2S en C3S (karakteristiek voor Portland klinker) aangetroffen; tras is evenmin aangetroffen (figuren 12, 13). In de mortel zijn geen aanwijzingen aangetroffen voor aantasting.

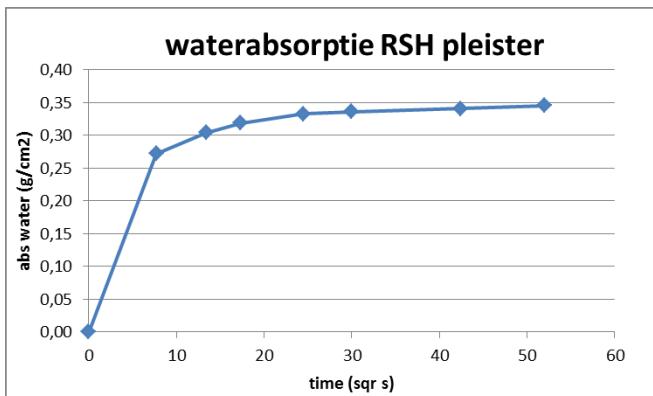
Figuur 14. Capillaire waterabsorptie van het pleisterwerk

Figuur 14 geeft de capillaire absorptie curve van het pleisterwerk. In het begin is de hoeveelheid geabsorbeerd water hoog en de indringing van het vochtfront erg snel: dit geeft aan dat de binnenste laag van het pleisterwerk een hoge en grove porositeit heeft en dus snel veel water absorbeert. De afwerklaag heeft een iets tragere absorptie. Na 30 minuten is de bovenkant van het pleisterwerk nat en na 45 minuten is het pleisterwerk volledig verzadigd.

De dichtheid van het pleisterwerk in zijn geheel, gemeten door immersie bij atmosferische druk, is 1666 kg/m^3 ; de porositeit 37 vol%.

In het geval dat het pleisterwerk in de studeerkamer gedeeltelijk vervangen moet worden, het is van belang dat het nieuwe pleisterwerk ook qua vochttransport compatibel is met het bestaande pleisterwerk. Het is dus nodig om enkele relevante eigenschappen van het pleisterwerk te bepalen. Als eerste is de capillaire waterabsorptie van het pleisterwerk gemeten. Een stukje pleisterwerk is in een oven bij 40 °C gedroogd en vervolgens met zijn binnenoppervlak (d.w.z. het oppervlak dat oorspronkelijk in contact met het metselwerk was) in contact met water gebracht (figuur 5). Het gewicht van de monster is op verschillende tijdstippen gemeten tot een constant gewicht is bereikt. Door het geabsorbeerde water per eenheid van oppervlak tegen de wortel uit de tijd af te zetten, kan de absorptiecurve worden getekend.

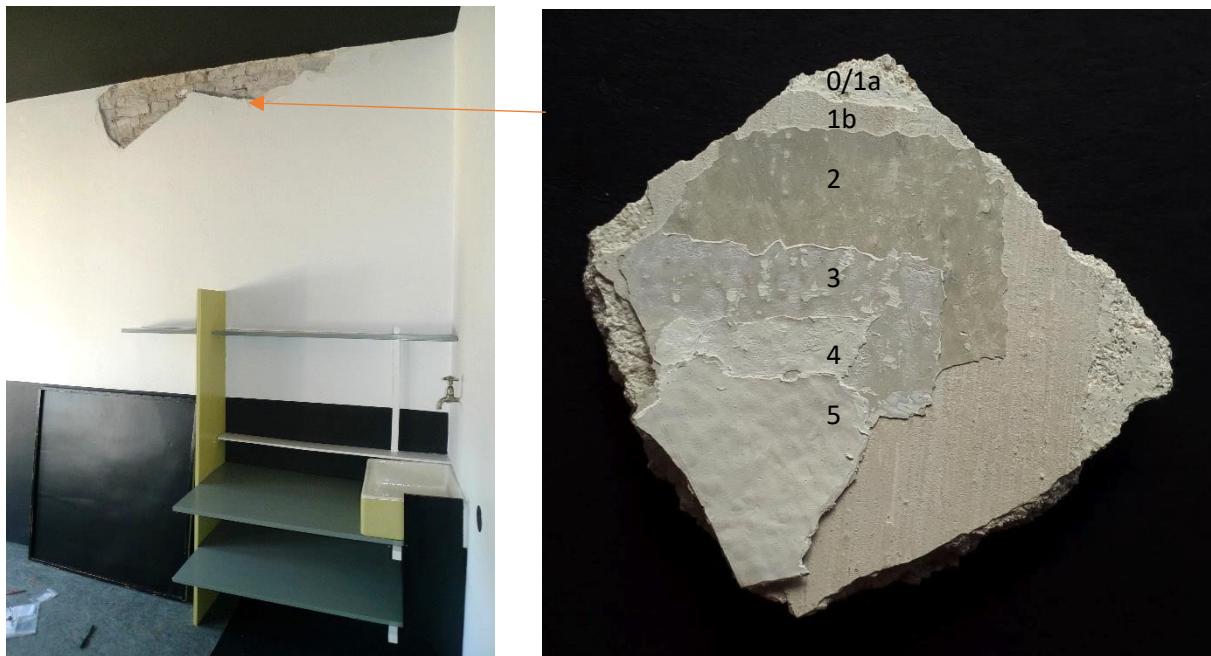
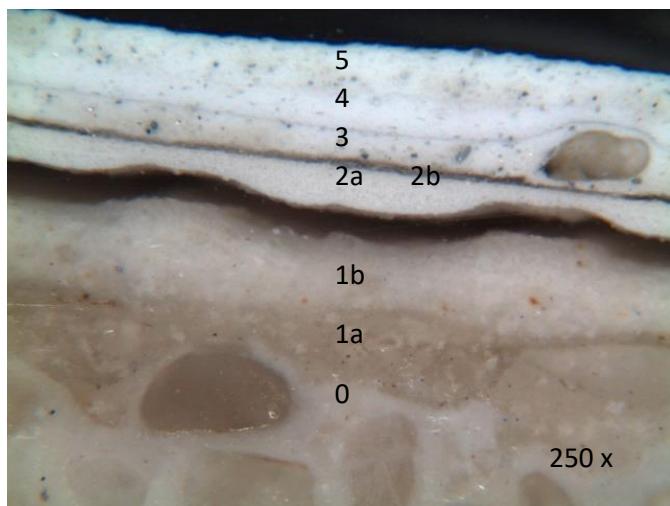
Studeerkamer begane grond; stratigrafie 1.1 en monster RSH10-K01 (SEM/EDX)

Boven aan de **zuidwand** van de **studeerkamer** (begane grond) zijn enige tijd geleden door waterschade stukken pleister met verflagen van de bakstenen muur losgekomen. Op een al geborgen fragment werd onder de stereomicroscoop een stratigrafie van de verflagen gemaakt en een verfmonster genomen voor een verfdwarsdoorsnede en SEM-EDX onderzoek. In totaal zijn hier 5 afwerkfasen aangetroffen (monster **RSH-18 K01**). Als eerste op een kalkpleister en plamuurlaag bevindt zich een **matte lichtbeige kalkverf** waarin de kwaststreep duidelijk zichtbaar is. In de verfdwarsdoorsnede zijn fijne zwarte en okerkleurige pigmenten aanwezig. De tweede afwerking bestaat uit een witte grondering en een dunne grijze afwerking gevuld door drie grijze modernere verflagen. De huidige tint is duidelijk koeler dan de oorspronkelijke.

Op een pleisterfragment zijn met een microscoop de opeenvolgende lagen vrijgelegd. De nummers van de lagen corresponderen met de nummers van de lagen in de verfdwarsdoorsnede hieronder. De eerste afwerking is mat en streperig door de kwast; de huidige en daaraan voorafgaande lagen laten een gebobbelde verfroller textuur zien.

- 0 kalkpleister
- 1a gips en kalk houdende plamuur?laag (Ca, Na, Cl, Mg, Si, S)
- 1b lichtbeige kalkverf met kwaststreep, zwarte en okerkleurige partikels herkenbaar, niet te detecteren met SEM/EDX
- 2a wit met krijt (Ca) en titaanwit (Ti) (grondering)
- 2b dun, lichtgrijs toplaag met lampen/roetzwart
- 3 heel licht grijs, met titaanwit (Ti) en kaolien (Al en Si), sporadisch blauw en zwarte pigmenten
- 4/5 wit, titaanwit en kaolien, moderne muurverf, vermoedelijk Sikkens Alfatex

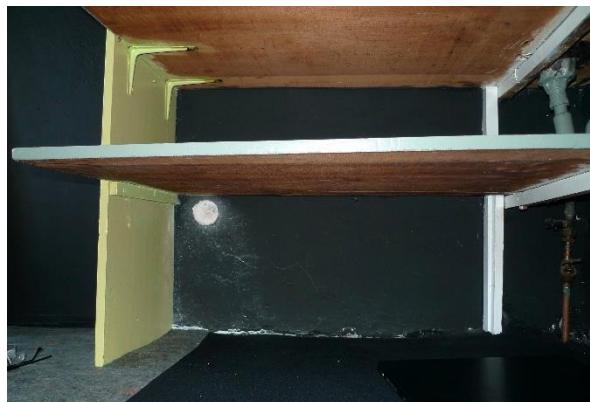
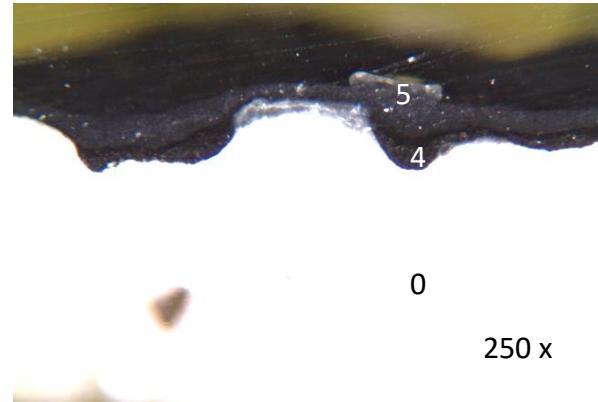
Studeerkamer begane grond; stratigrafie 1.2 en monsters RSH 18-K03 en RSH 18-K10

Locatie monstername onder de kast, zuidwand

RSH18-K03 (de pleisterlaag is overbelicht om de verflagen zichtbaar te maken; er zijn hier enkel moderne verflagen aanwezig: nr. 5 en 6)

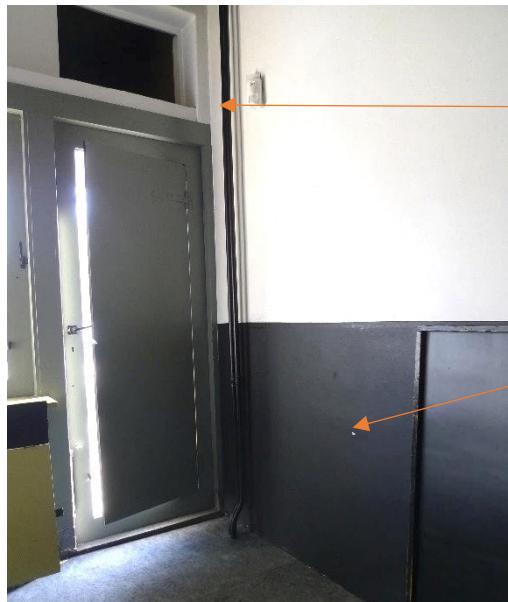
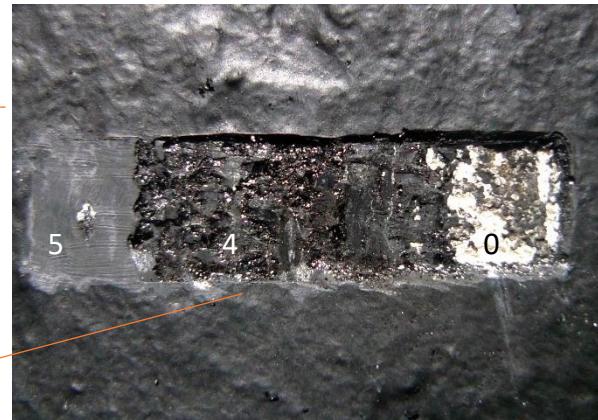
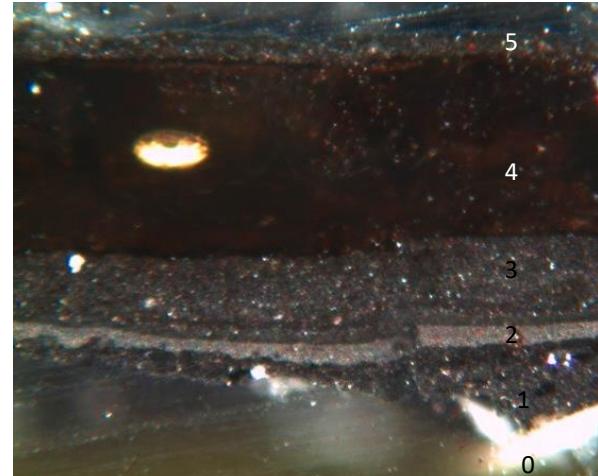
Linker zijde zuidwand studeerkamer

- 0 pleisterlaag (o.m. Ca, Mg, Na, Si)
- 1 donkergrijs/zwart met beenderzwart, krijt, aardpigment (oker)
- 2 grijs, zwart (organisch pigment)
- 3 donkergrijs/zwart
- 4 bruin-zwart glinsterend, bitumen (C, S)
- 5 donkergrijs/zwart, moderne muurverf, vermoedelijk Sikkens Alfatex SF

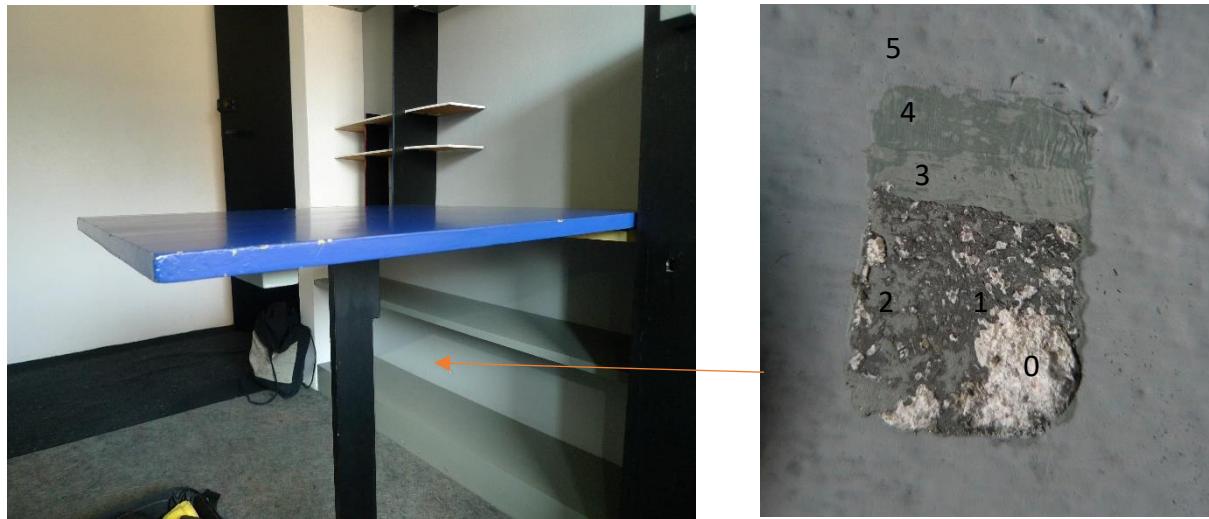
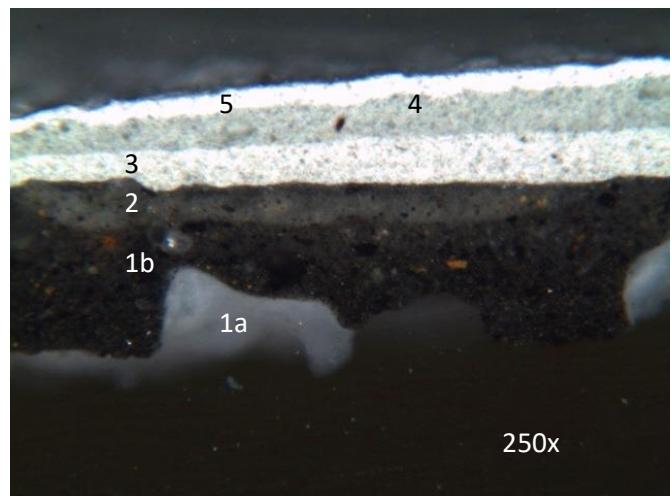
Studeerkamer begane grond; stratigrafie 1.3 en monster RSH18-K11

Locatie noordwand onder het bureau

- 1a witte grondlaag?
- 1b donker grijs met zwarte en okerkleurige partikels (mogelijk kalkhoudende verf)
- 2 grijs met blauwe, zwarte en okerkleurige partikels (mogelijk kalkhoudende verf)
- 3 groenig lichtgrijs; moderne muurverf
- 4 groenig grijs; moderne muurverf
- 5 lichtgrijs; moderne muurverf

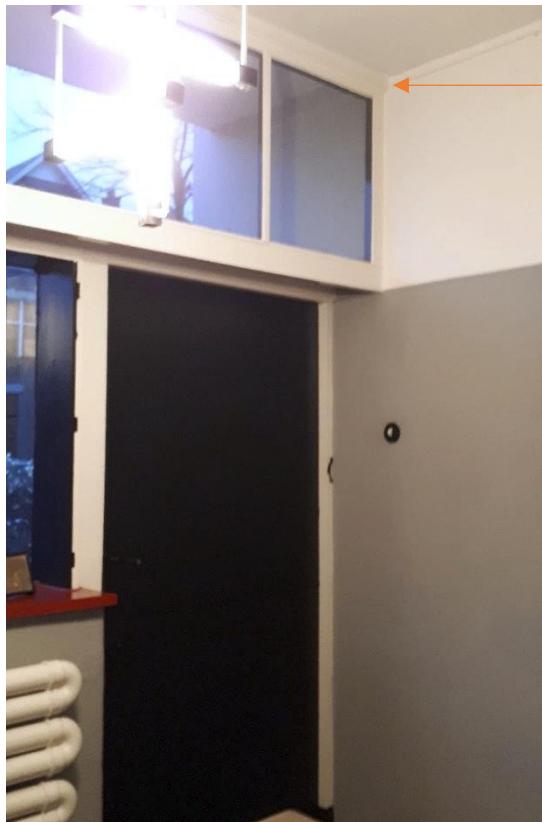
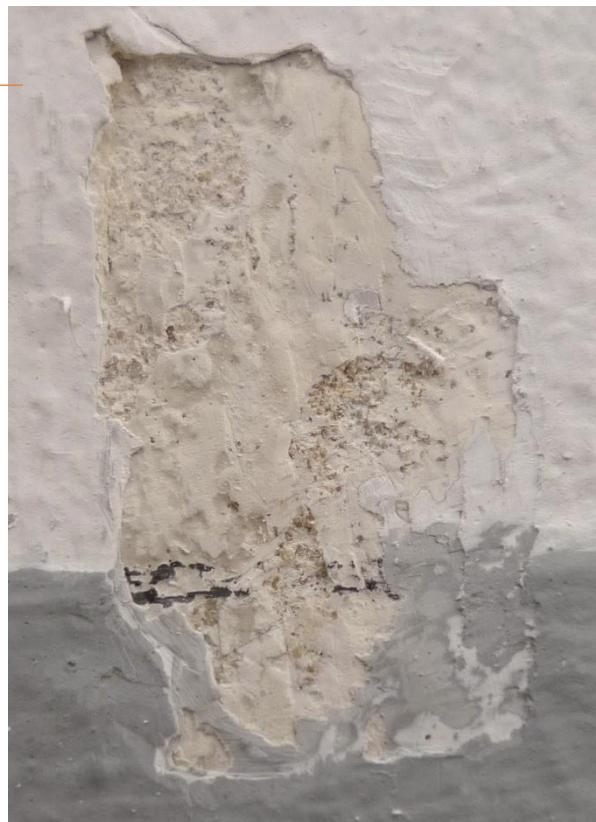
Atelier begane grond; stratigrafie 2.3

Er zijn hier alleen moderne verflagen aangetroffen

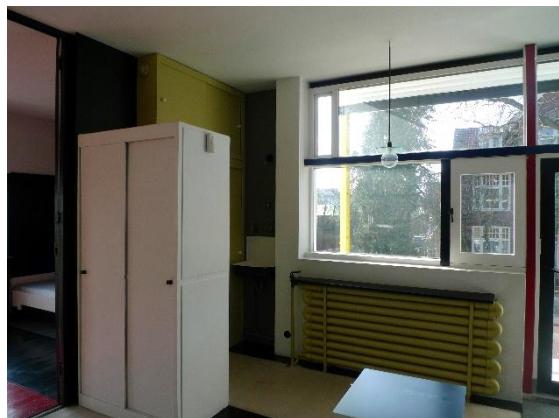
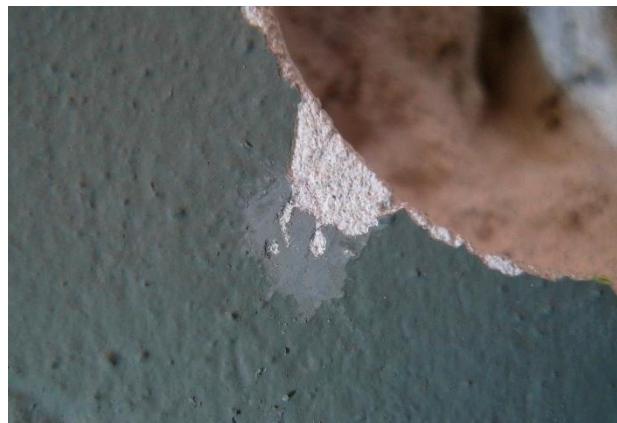
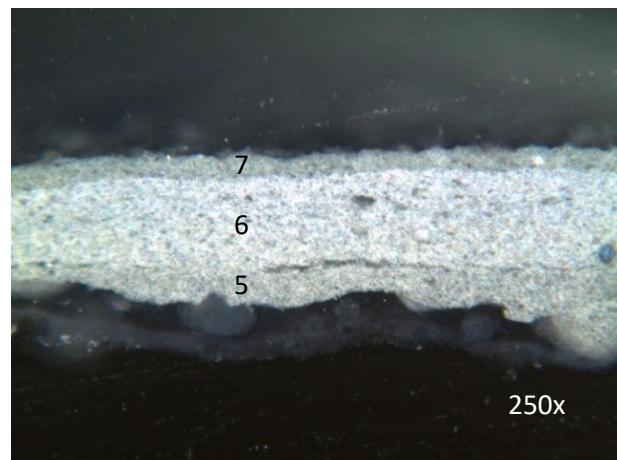
Meidenkamer bovenverdieping; stratigrafie 3.1 en monster RSH18-K08

Er zijn hier enkel drie moderne grijze verflagen aanwezig die vanaf 1987 zijn aangebracht; het pleisterwerk is vervangen.

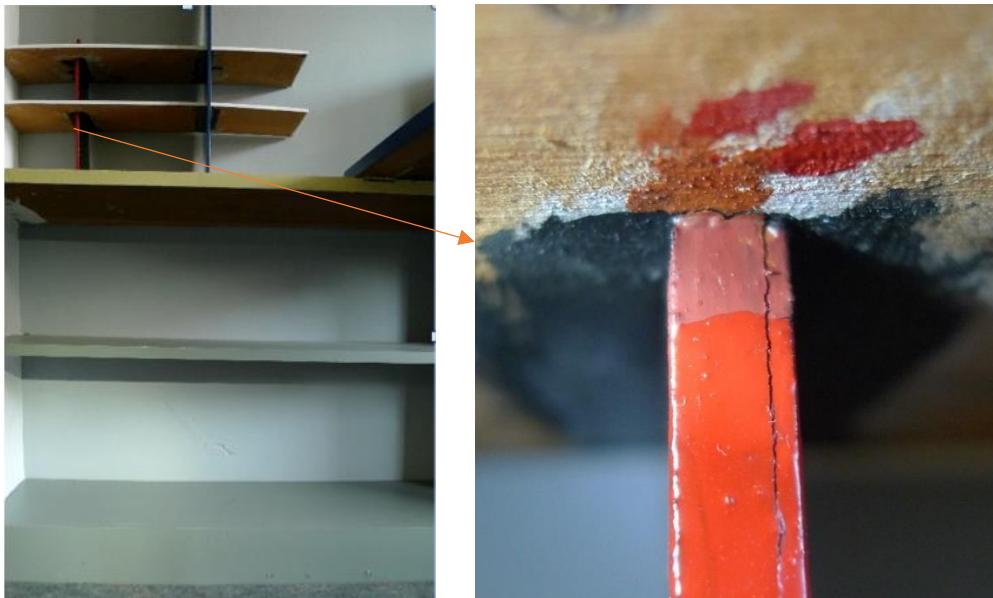
In de nis van de bureau en de wandplankjes (studeerkamer) is onder de huidige rode verf een klein stuk van oudere rode verf te zien, die iets bleker is. Aan de onderkant van het plankje zitten gemorste plekjes van nog weer andere roodtinten.

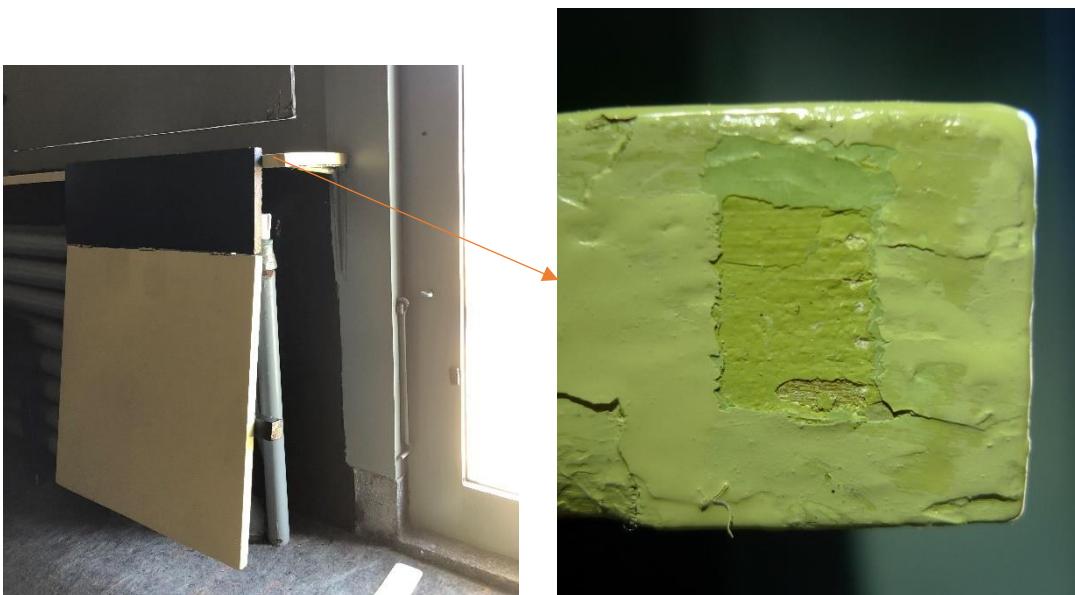
Aan de geel geschilderde vensterbank (studeerkamer) is bij een bestaande beschadiging een sondering gemaakt. Er zijn nog oudere verflagen aanwezig. Mogelijk zijn de oudste twee groengele lagen uit de bouwtijd. Ze zijn intenser van kleur; mogelijk is het olieverf waarvan een lichte kwaststreek nog zichtbaar is.

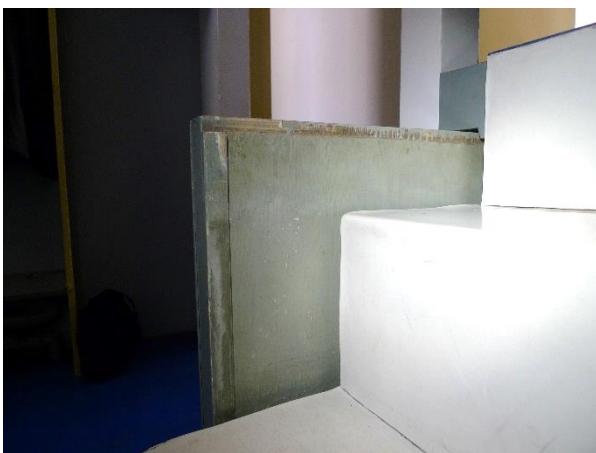
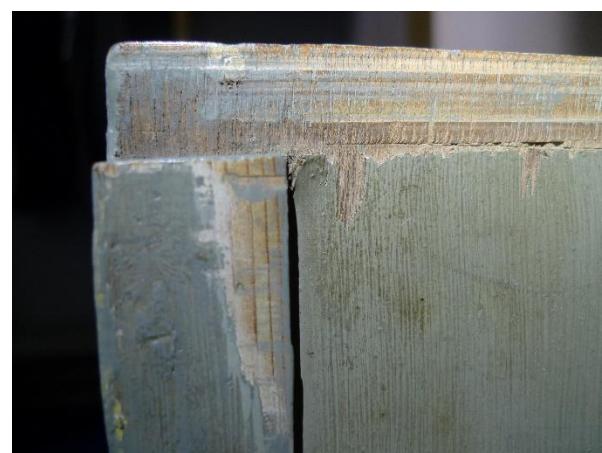
Aan de rand van het blauwe tafelblad van het bureau (studeerkamer) zit een beschadiging waar een aantal grijze, zwarte en blauwe verflagen te onderscheiden zijn.

Aan de binnenkant van het zwarte kastje ernaast zijn oudere blauwe verflagen te zien. Deze zijn deels zeer fragiel en mat, (mogelijk lijm of tempera verf, waarschijnlijk geen olieverf.)

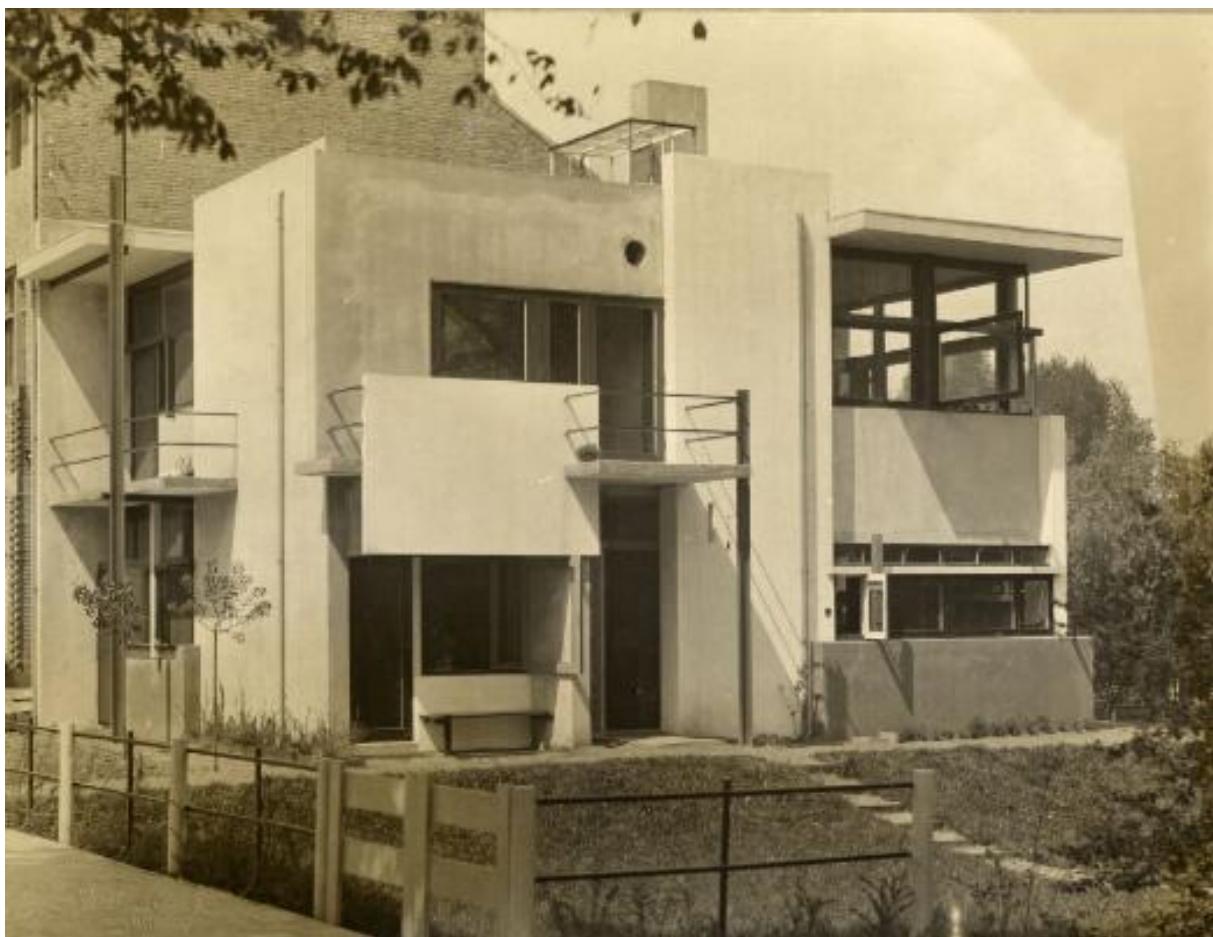
1925

De donkere kleurvlakken zijn vlekkerig. Het lijkt erop dat Mulder er in zijn geschreven stuk vanuit gaat dat hier de eerste overschildering in kalkverf aanwezig is en niet meer de gekleurde pleisterlagen. Het is echter ook mogelijk dat hier de pleisterlagen nog aanwezig zijn. De voorkanten van de balkonvloeren zijn hier grijs; op alle overige foto's zijn ze wit.

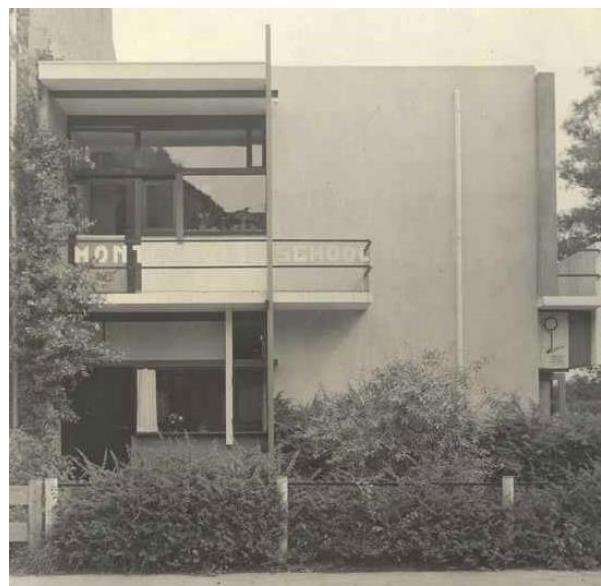
1935/36

De bovenverdieping diende tijdelijk als Montessori school. De vlakken van de gevel zijn gelijkmatiger van kleur. Er zijn zeker 4 gradaties van wit naar grijs te onderscheiden. Zijkant balkonvloer is nu wit.

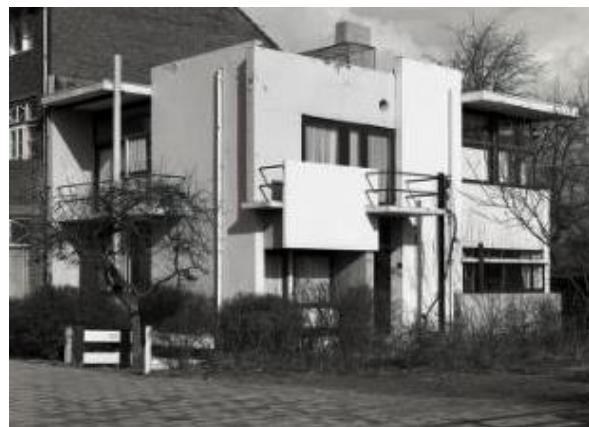
voor de 1^e restauratie exterieur. De verschillen van grijstinten zijn klein, de grijstinten koel.

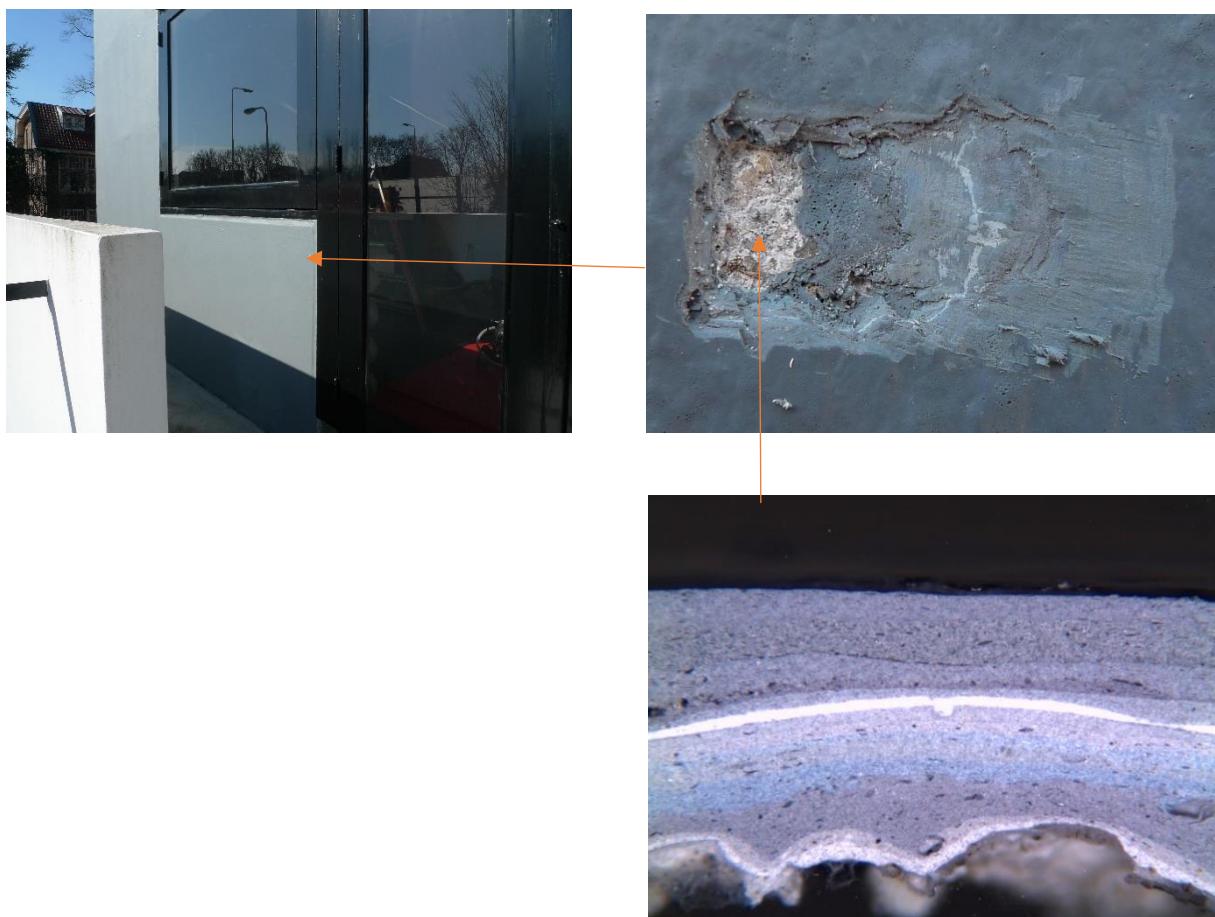
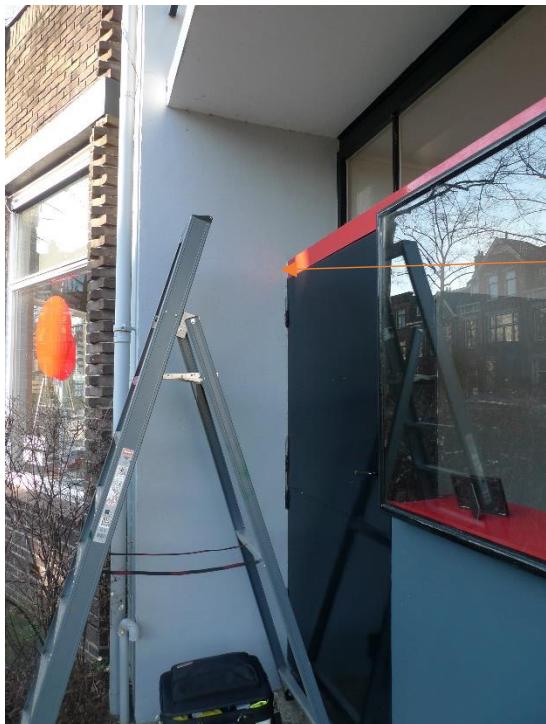
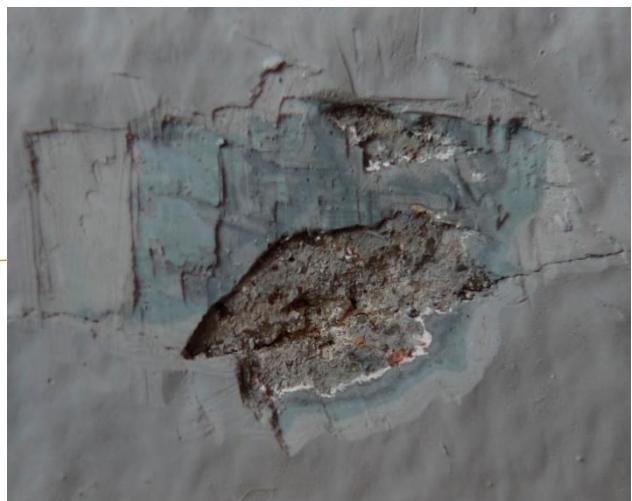
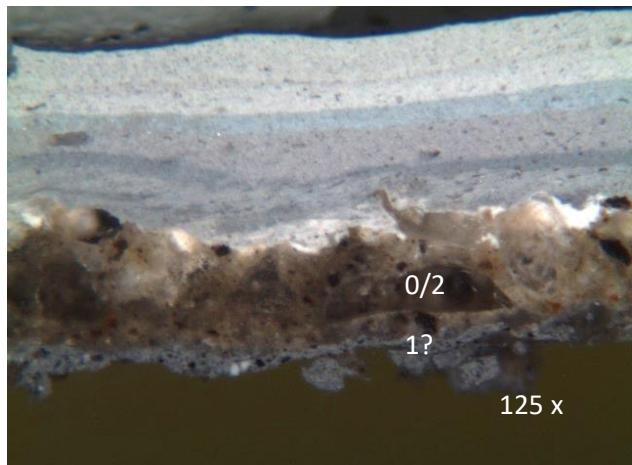
Middengrijs verticaal vlak zuidgevel; monster RSH18-K13 (SEM/EDX)

Van dit vlak is bekend dat het volledig is ontpleisterd tijdens de restauratie 1979. Volgends het onderhoudsplan wordt de buitengevel elke 5 jaar opnieuw geverfd naast de noodzakelijke kleine onderhoudsbeurten. Dit betekent dat er zeker 8 verflagen op het nieuwe pleister aanwezig zullen zijn. Middels een stratigrafie is dit lastig te achterhalen, de lagen hebben meer of minder dezelfde kleur en verfsamenstelling waardoor ze lastig van elkaar te scheiden zijn. In de verfdwarsdoorsnede zijn er 13 verflagen te onderscheiden, de 3 eersten vormen waarschijnlijk samen de 1^e afwerking. De 4^e en 6^e laag zijn relatief koel groenig, die zijn mogelijk afgekeurd en overgedaan. De 9^e laag is wit en zal een vul- of plamuur laag zijn.

Laagopbouw met samenstelling m.b.v. SEM/EDX: zwart

- 1 grijsgroen met wit (lithopoon; Ba, S, en Zn) en zwart (veel koolstof-houdend pigment); verder aanwezig Ca, Si, Al, Fe)
- 0/2 pleisterlaag (o.m. Ca, Si, Fe) vermoedelijk aangebracht tijdens restauratie 1974 of 1987

Dat er onder de pleisterlaag nog een rest oudere grover gepigmenteerde verf is gevonden komt waarschijnlijk omdat er een scheur gerepareerd is. Alle lagen op de pleisterlaag zijn vanaf de restauratie in 1979 aangebracht.

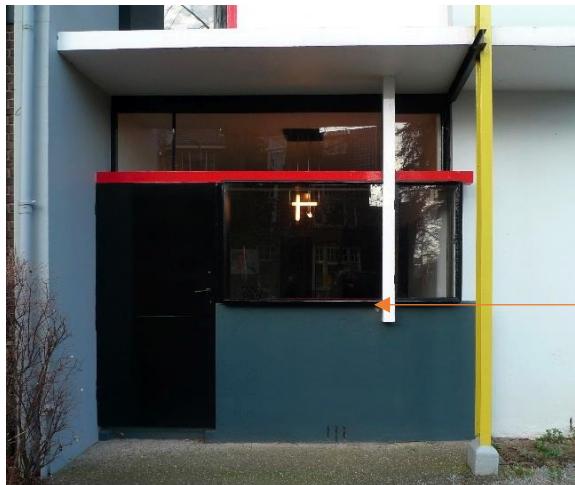
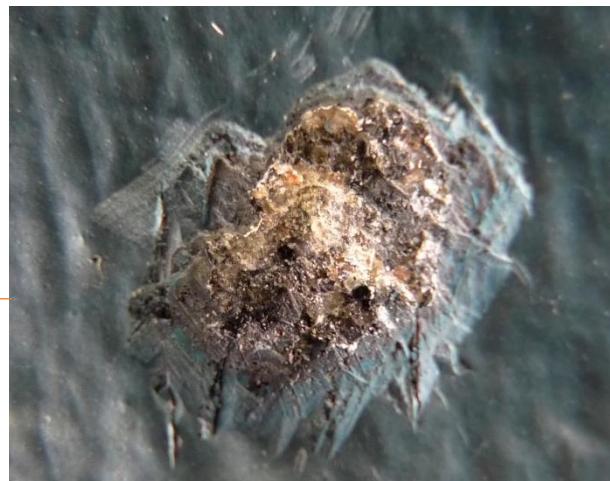
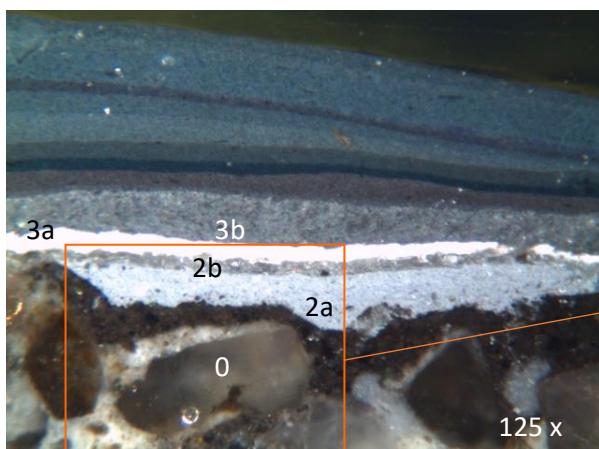
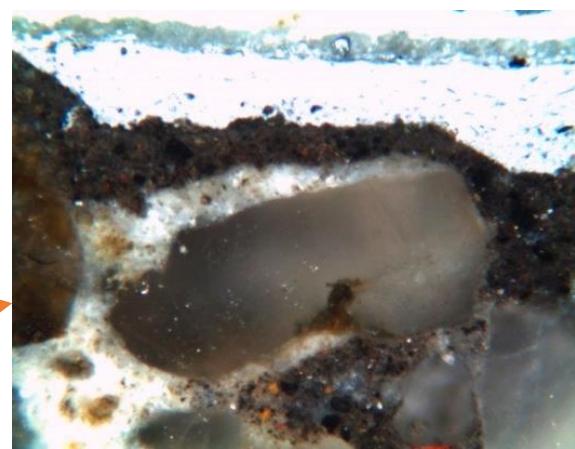
Donker grijs vlak van borstwering atelier zuidgevel; monster RSH-18 K04 (SEM/EDX)

Laagopbouw:

- 0 pleister
- 1 Donker grijs met zwarte en okerkleurige partikels; duidelijke overeenkomsten met laag 1 in RSH-18 K 13; waarschijnlijk resten van de gekleurde pleister aangebracht direct na de bouw; de laag is vermengd met de pleisterlaag eronder (Ca, Si, S, Zn, Ti, Al, Fe)
- 2a lichtgrijs, titaanoxide, talk (Mg) als vulmiddel; technische laag
- 2b middengrijs
- 3a wit
- 3b middengrijs
vanaf 4 donker grijs in blauwgroene variaties
