HERITAGE & ARCHITECTURE

5 November 2018

Keeping it Modern Grant,
The Getty Foundation

Conclusions and recommendations from the research Colour, Form and Space: Rietveld Schröder House challenging the Future.

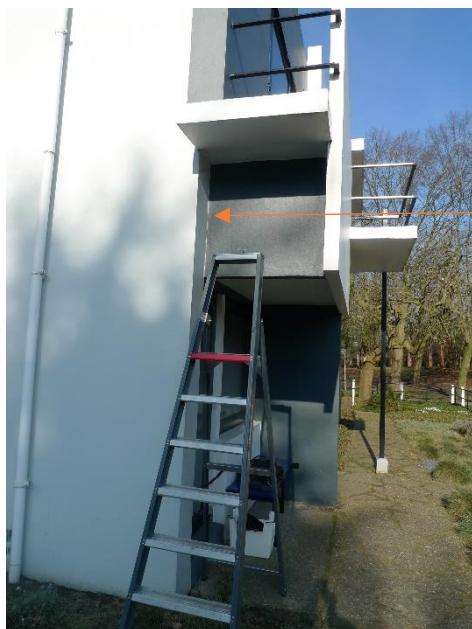
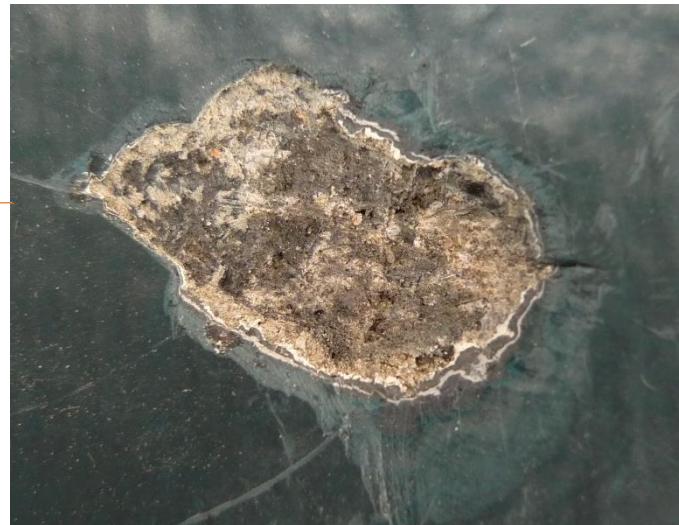
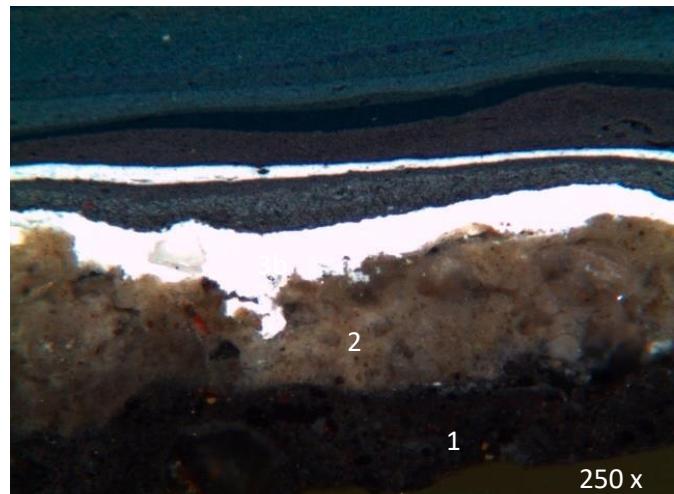
Donkergrijs klein vlak aan onderkant balkon, zuidgevel; monster RSH18-K12

De Laagopbouw van monster RSH18-K12 komt grotendeels overeen RSH18-K05. Alleen zit de grof gepigmenteerde donkergrize laag 1 hier onder een reparatiepleisterlaag (nr. 2). De 11 lagen op de reparatiepleisterlaag zijn aangebracht sinds de restauratie van 1979.

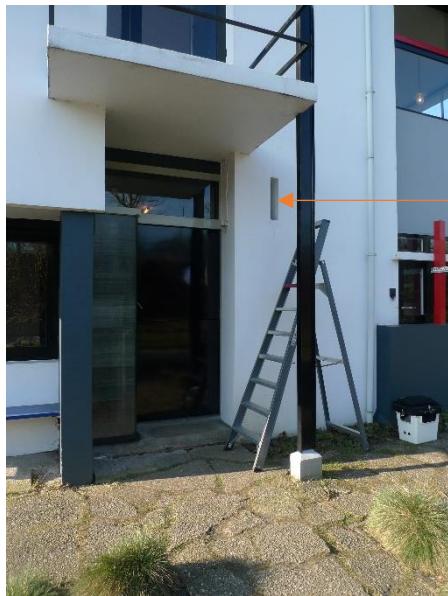
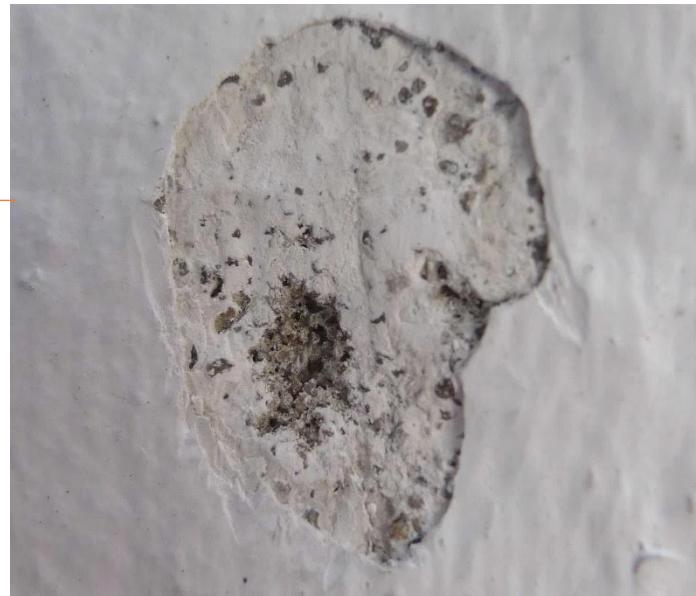
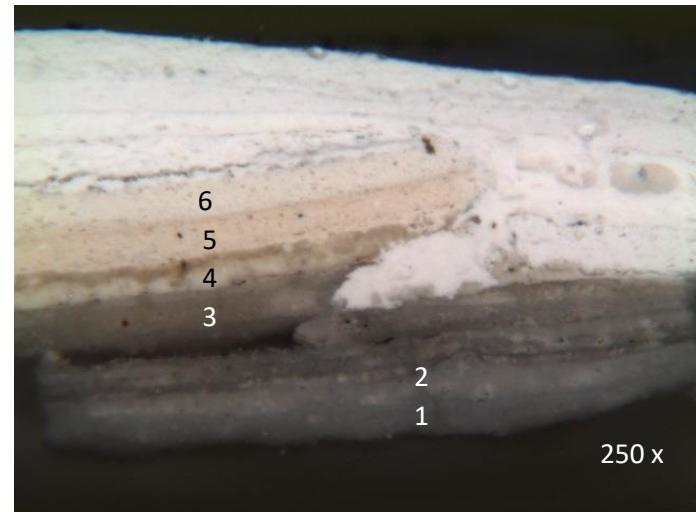
Groot wit verticale vlak, oostgevel (dagkant smal raam); RSH-18 K-14

Er is gekeken in de dagkant van het smalle raam omdat de kans groot werd geacht dat daar meer oude afwerkingen bewaard zijn gebleven. En inderdaad zijn er kalklagen teruggevonden die ook in het bestek staan omschreven.

Laagopbouw:

- 0 pleister, zeer hard en grofkorrelig (net als in RSH18-K04); niet op foto
- 1-3 meerdere kalkverflagen zoals ook omschreven in het bestek (er is ook zwavel aanwezig die nog niet nader te verklaard is)
- 4-6 een nadere duiding van deze lagen is vooralsnog niet mogelijk. Het is onduidelijk of nr. 4 een gronderingslaag is en of laag 5 door Mulder aan werd gebracht of van voor 1987 dateert.
