Conservation and Restoration

CHURCHES, SYMBOLS OF COMMUNITY: THE PRESERVATION OF NEW MEXICO'S ADOBE CHURCHES

Nancy Arnon and Sam Baca
New Mexico Community Foundation
110 North Guadalupe Street, Suite 6
Santa Fe, New Mexico 87504
U.S.A.

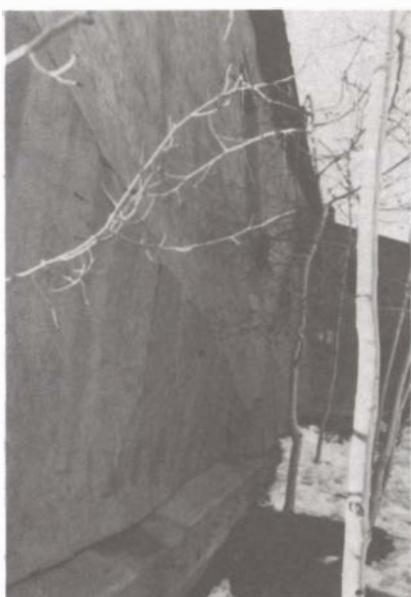
Figure 8
Distressed Cement Stucco
Holy Trinity Church
Arroyo Seco, New Mexico

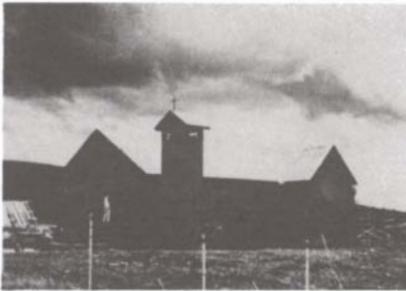
Figure 9
Cement Stucco Removal
La Capilla de San Antonio
Chacon, New Mexico

Following this explanation, the community decided to remove the cement stucco and concrete plynth (see fig. 9). The harmful effect of cement on adobe structures became clearly evident upon removal of the concrete and stucco on the work day held during the summer of 1989. The walls were extremely wet. Coursing patterns of adobe bricks were indistinguishable at the base of the walls. In other places, the adobes were severely eroded. A pattern of white spots, or efflorescence, indicated that moisture had moved through the wall.

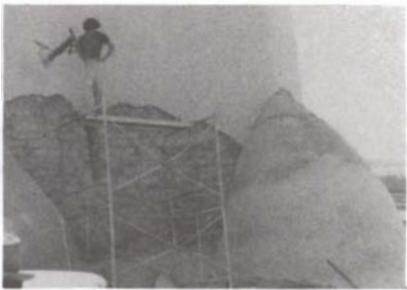
Figure 14
Removing Cement Stucco
Before Mud Plaster
San Francisco de Assisi
Ranchos de Taos, New Mexico

In a time of economic decline, rural communities often need additional support in carrying out the preservation of their adobe churches. New Mexico Community Foundation initiated the "Churches: Symbols of Community" project to provide necessary assistance. Yet, the traditional bonds between community and church must not be weakened by outside intervention since it is the local resources which will continue to preserve the church. Through community-selected services and resources, the churches are restored, using traditional techniques and materials, to a condition maintainable by the communities (see fig. 14). Following this, a support network assists the communities to continue the work.

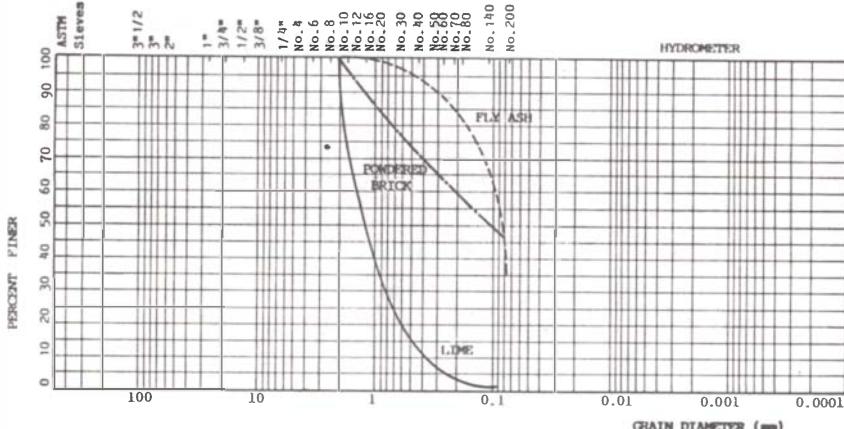
Fig. 1: Grain size distribution of Powdered Brick, Lime and Fly ash

One of the most widely used building materials in Turkey is fired brick. About 10% of the 800 million bricks produced in 1988 were deformed, irregular or damaged. These by-products are not utilized in any way. For the purpose of the present study these wastes were crushed and reduced to fine powder (see fig. 1). Hydrated lime, available in commercial paper sacks, was also used.

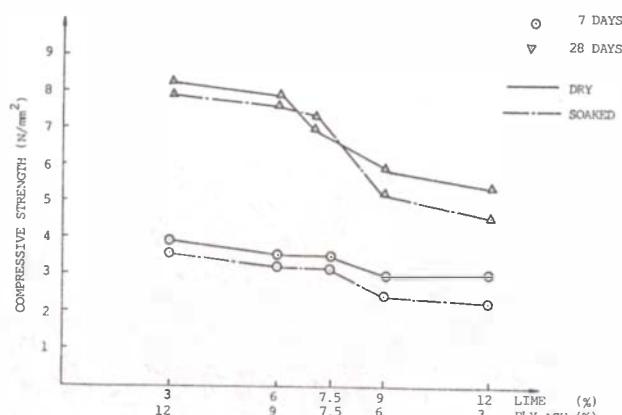
Fig. 5: Compressive strength vs. Lime/Fly ash ratio for lime-fly ash stabilized powdered brick.

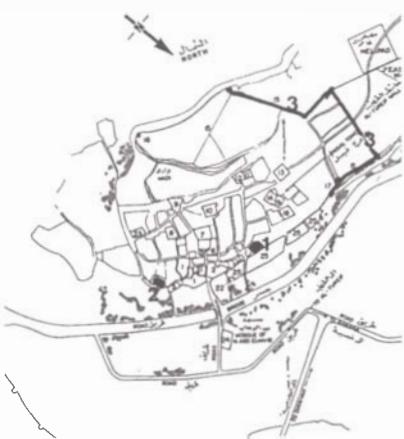
2. Plan of the al-Turaif Quarter showing the locations of the Palace of Omar (1), the Subaalat and Mosque of Moudhi (2), and the al-Turaif fortifications (3).

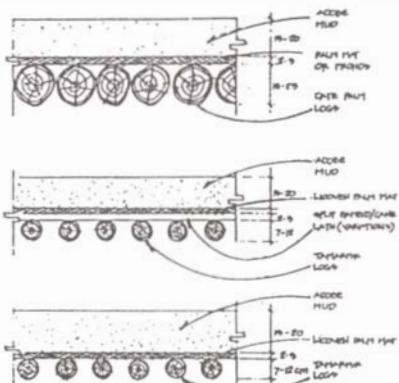
5. Sections illustrating typical types of floor/roof construction.

There were also specialists who made adobe bricks using rectangular wood frames (*al milben*, see fig. 4) which were set on level ground and filled with wet mud. The clays and sands of the region are particularly well-suited for making adobe bricks and plasters. Adobe was also used as a roofing material. Supported by wood logs (tamarisk and date palm) set close together, the logs were covered by a thick palm frond mat layer which was, in turn, covered by a thick layer of adobe mud to form the roof (see fig. 5). Other specialized craftsmen did the plastering and decorated doors, windows, lintels, and beams.

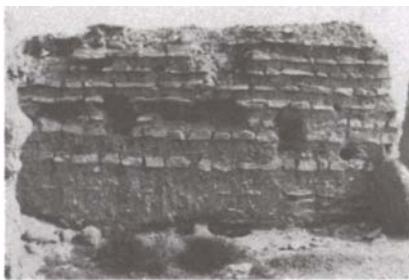
6. Example of horizontal coursed stone used in wall construction.

At al-Turaif extensive coursed stone foundations were used in combination with adobe brick walls. Walls were also constructed with various layering techniques utilizing stone fragments laid horizontally or in herring-bone fashion in adobe mud beds (see fig. 6). Except for the exposed stone foundations, walls were coated with thick layers of adobe and gypsum plasters. Long thin stones were used to frame many of the nonrectangular wall niches and openings, in particular the traditional triangular keel arch found in mosques (see fig. 7). Logs were generally inserted into the walls as lintels for rectangular doors, windows, and niche openings.

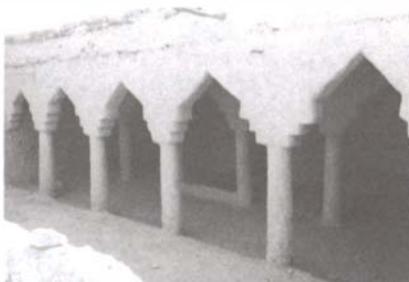
7. Example of stone keel arch construction typically used in mosque and public building construction.

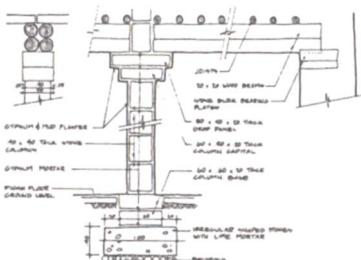
8. Detail of typical column construction showing both footing and beam.

Saudi architecture relies on post-and-beam construction. Roof joists were set directly into the adobe walls, while larger beams sat on stone plates set into the walls to distribute the load and to prevent the adobe bricks from crushing. Columns were used to develop large interior spaces (see fig. 8). These consisted of rough-hewn cylindrical stone drums set in adobe mud mortar and finished with a coat of gypsum plaster. Each column had a rectangular flat stone corbel capital that supported the large multiple log wood beams.

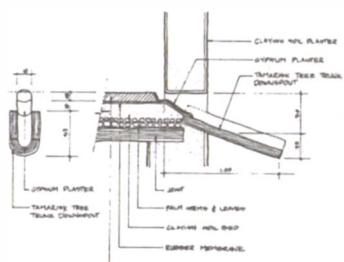
9. Detail of downspout (mirzam) construction.

Water removal was handled by downspouts placed about the perimeter of exposed roof areas (*mirzam*, see fig. 9). These consisted of half-hollowed tamarisk logs built into the roof construction. Roofs were sloped towards these downspouts, which were notched at the outer end to provide a drip to throw water away from the walls.

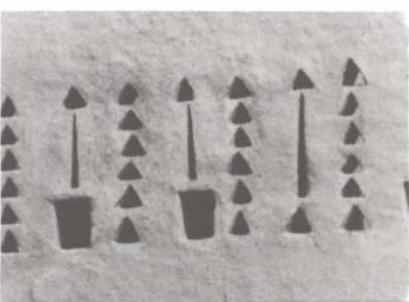
10. Detail of the wall ventilation pattern on the Sa'ad Palace.

Ventilation openings were of major importance in controlling the climate of the interior spaces. Dir'iyah's buildings exhibit a wide variety of patterns of small triangular and rectangular openings in the upper levels of exterior walls (see figs. 10 - 11). These openings provided ventilation and privacy as well as being decorative. During the winter months the openings were plugged with mud plaster to prevent the entry of winter cold and to help retain heat.

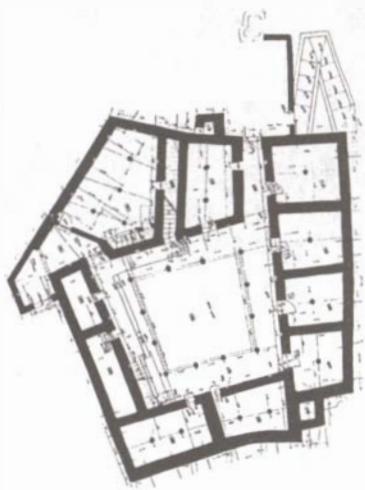
17. Reconstruction ground plan of the Palace of Omar.

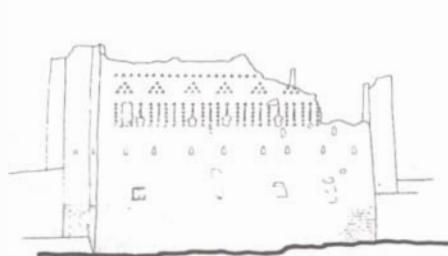
18. Wadi elevation of the palace as it exists today.

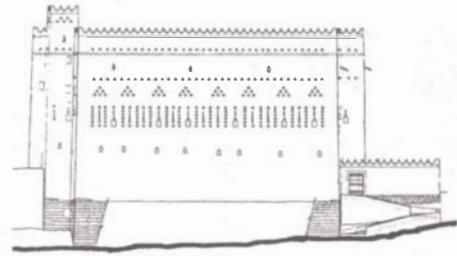
19. Wadi elevation of the reconstructed palace.

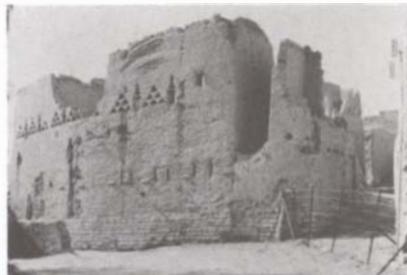
20. The Subaalat and Mosque of Moudhi as seen from the wadi.

The Subaalat and Mosque of Moudhi bint Ibn Wahtan (see figs. 20 - 25)

Located at the edge of the eastern residential section of al-Turaif, the subaalat and mosque structure was badly damaged during the 1818 siege. The subaalat, according to tradition, provided lodging for travelling merchants. It was a modest two-story structure built around a long, narrow courtyard. Several doors located along an adjacent lane provided temporary shop space for the merchants. The mosque connected to the subaalat was small and intimate, serving the immediate community around it.

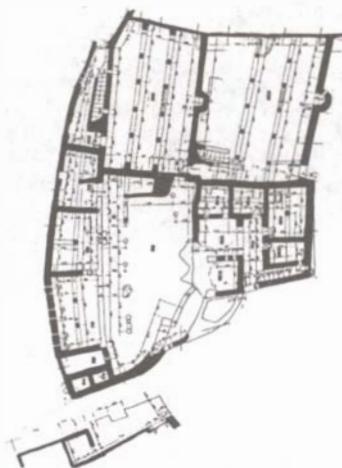
22. Existing condition ground plan of the Subaalat and Mosque.

The structure that we see today has been considerably altered over time. Formed from the components of earlier structures, probably one or more residences, the final configuration of this structure made it an unusual hybrid. The mosque itself was altered and rehabilitated during the mid-twentieth century when al Turaif was again inhabited.

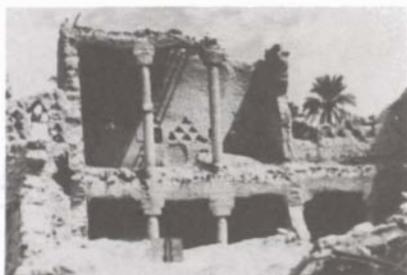
21. Interior detail of the Subaalat of Moudhi.

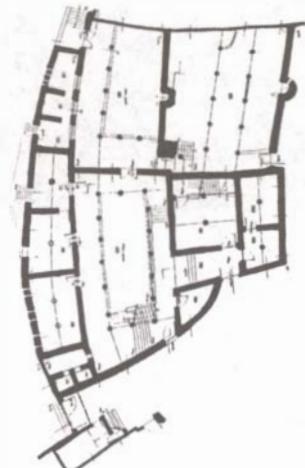
23. Reconstruction ground plan of the Subaalat and Mosque.

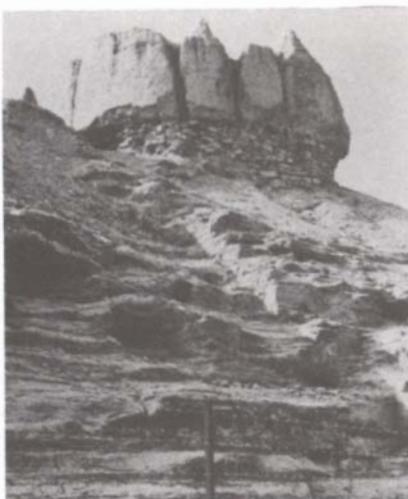
26. Faisal Tower prior to reconstruction as seen from the wadi below.

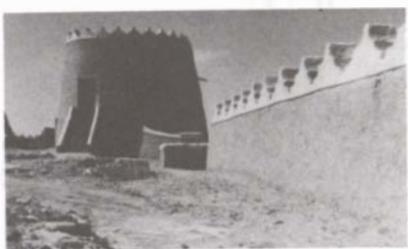
27. The reconstructed Faisal Tower and part of the defense wall.

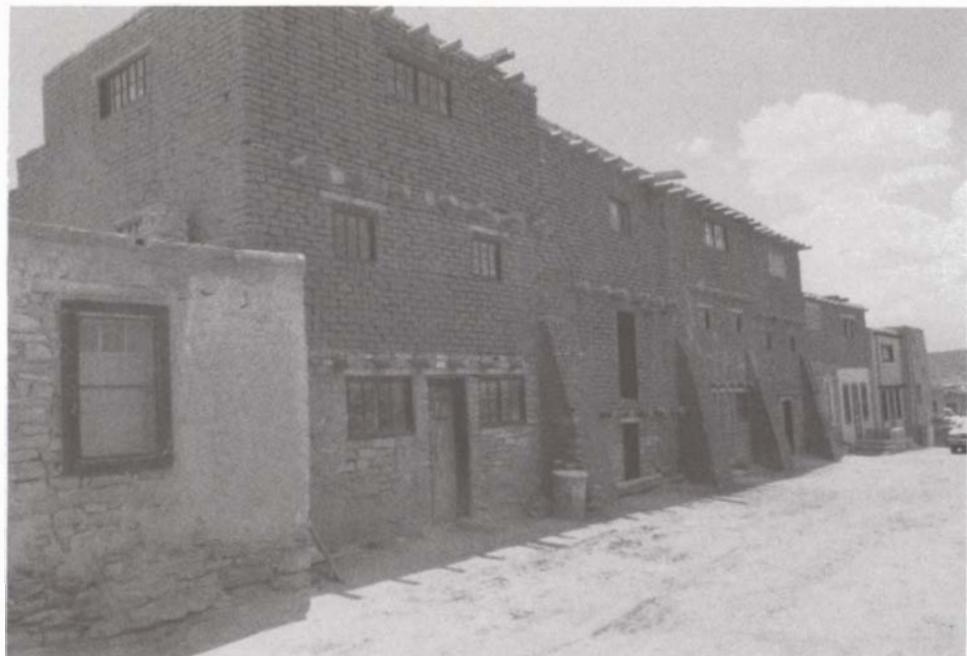
Architectural elements without historical background; buttresses and side by side windows.

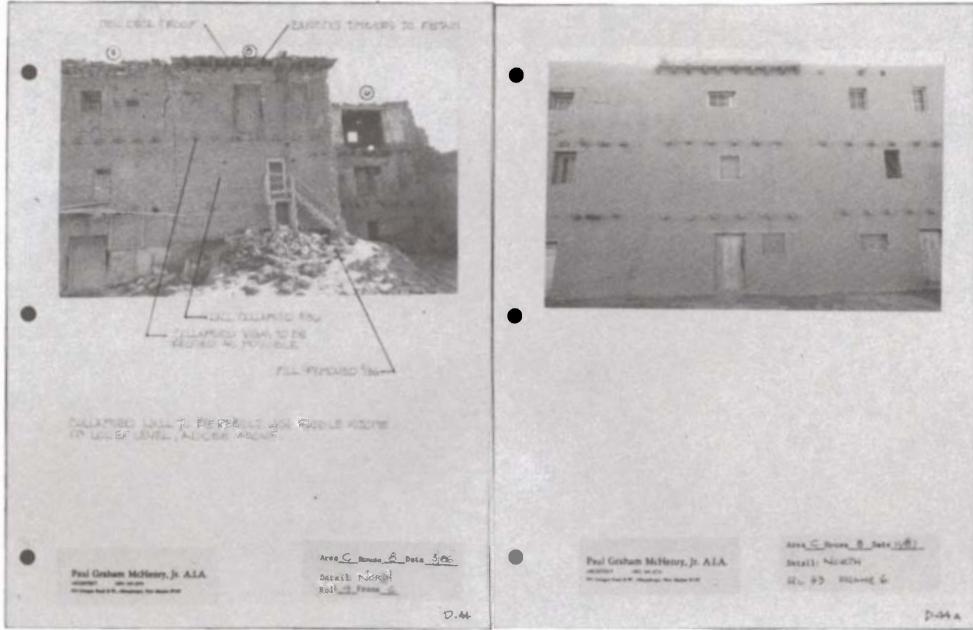
Sample pages from workbook.

In order to minimize the costs required for architectural planning and documentation and to meet the Standards, an innovative approach was required. A simple photo and drawing scheme was proposed by the architect to create a project "workbook" with pages for each individual house. The photography was done at minimum expense using 35mm black-and-white film. Each photo used for the workbook was enlarged to a 5" x 7" print and mounted on an 8-1/2" x 11" sheet of paper which was incorporated in the work book. Additional photos were taken of significant interior details and elevations after completion to provide full photo documentation. A floor plan and front/rear elevations were drawn approximately to scale for each level of each house, prepared from aerial photos and limited field measurements. These were grouped in sections of the workbook appropriate to each house unit. An overall elevation drawing and floor plan was prepared for the entire house block.

Additional sections of the workbook included standard details of expected repairs common to several buildings, drawn in an isometric style for easier understanding by the construction crews. A section for historic photos was created with suggested approximate photo points. Before and after photos also proved beneficial. This system accomplished two necessary steps: documentation of condition of the monument, and simple directions for repairs and improvements at minimal cost and complication.

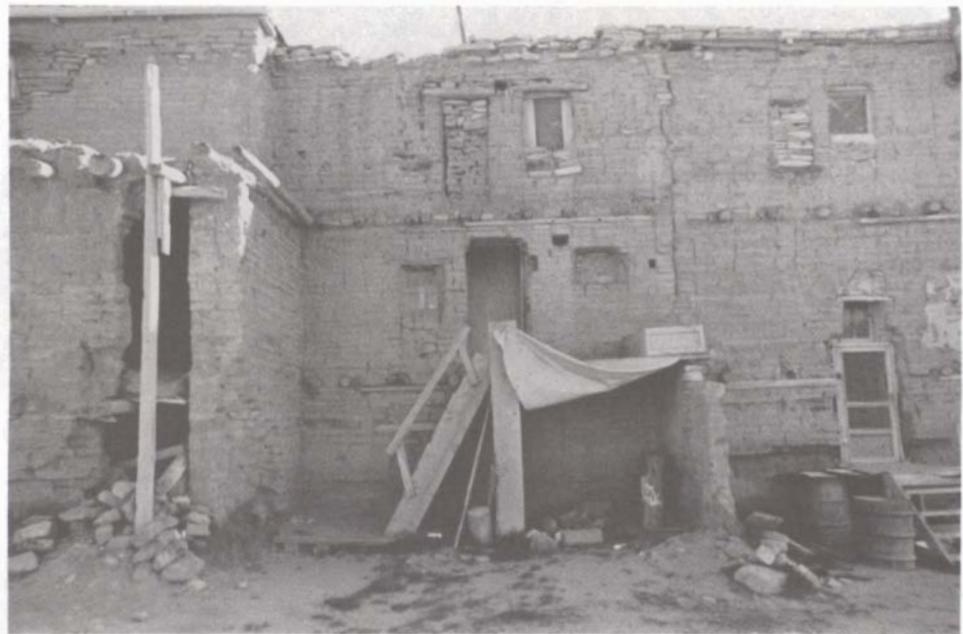
Area "C" north side, before rehabilitation.

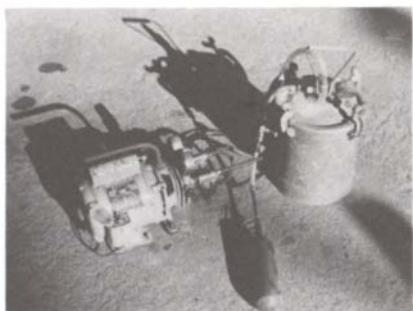
Fig. 2 - First prototype of our accelerated carbonation chamber

water. In order to accelerate the process of lime carbonation, an hermetically closed carbonation chamber was created (Fig. 2, 3). Our first prototype was a pressure container used for painting, which had a metal frame inside to support the samples. In order to maintain an atmosphere saturated with water vapor, it was necessary to provide a layer of water below the frame. A vacuum pump was used for twelve hours in order to remove the air from inside the pores of the samples. Then the pressure was stabilized allowing the introduction of CO₂. We used gas from fire-extinguishers, so the costs of the equipment and the operation were very low.

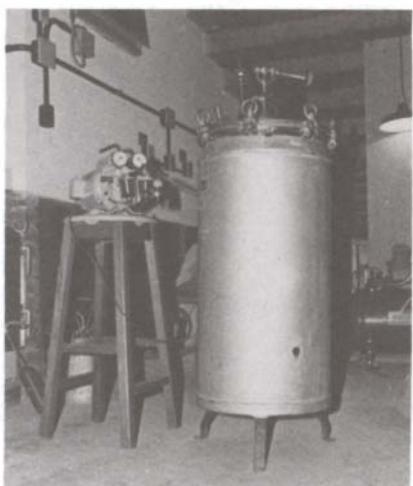
Fig. 3 - Second prototype of the chamber

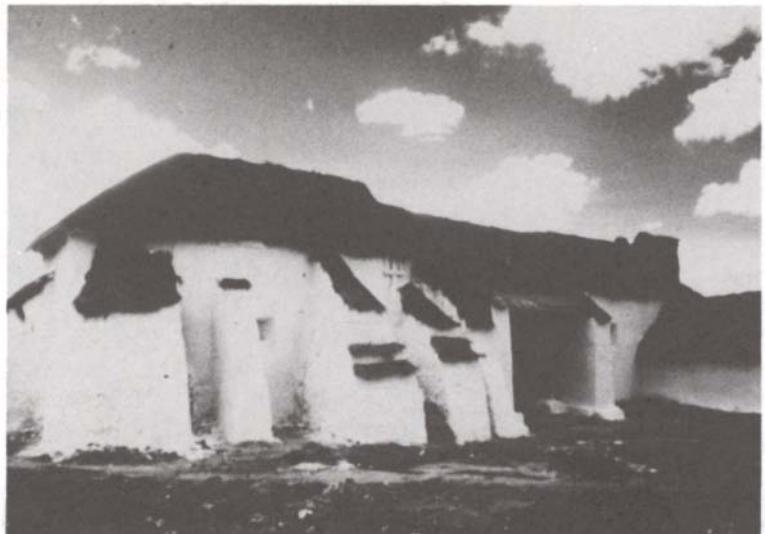
FIGURE 3. Exterior view of the church at Curahuara de Carangas.

Mud brick has been used in this area for centuries, as attested by nearby pre-Incan tombs constructed of the material. The site of the church at Curahuara is slightly sloping, with a 2 percent grade from east to west. Built at the end of the sixteenth century, this is a typical Renaissance church of the early Spanish colonial altiplano period. The interior consists of a single long nave, a sacristy, a baptistry, and a presbytery. A separate bell tower stands within the churchyard (see figures 2, 3).

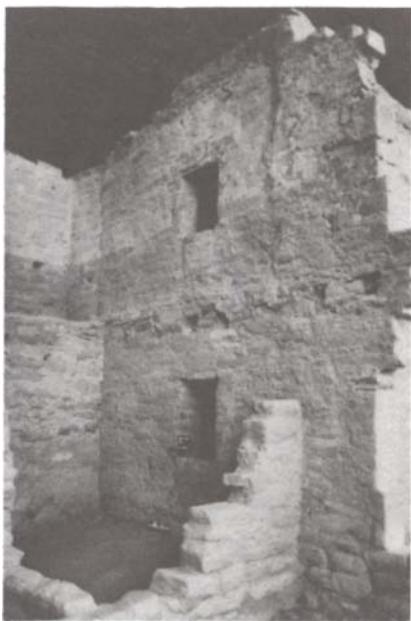
5. Mesa Verde National Park. Spruce Tree House, rendering painted with a bichrome design.

X-ray diffraction was used. The Pueblo renderings and samples from the possible "adobe soil quarry," Mesa Verde National Park, tested negatively for the presence of mineralogical clay. These results were so surprising that the samples were tested independently with SEM X-ray analyses (SEM and EDS). Again, the results were negative for the presence of clay. There are two possible explanations. First, the samples may, indeed, contain no clay. Second, and more likely, there is a clay component but it is present in amounts too small to be detected by the X-ray diffraction analyses. That is, in general a mineral phase will not be detected if it comprises less than 10 percent of the total sample. To detect clay, the clay-size category of the particle size distribution should be analyzed separately for the Pueblo renderings.⁽⁷⁾

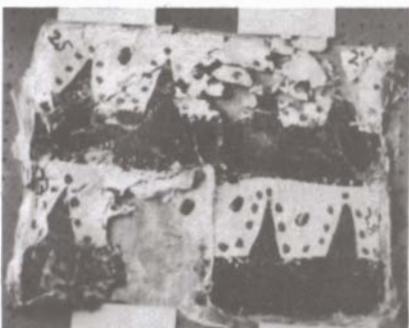
7. Simulated Pueblo mural paintings, after detachment.

Murals 1-6 were left untreated, as controls. Murals 7-18 were consolidated with Conservare OH. Murals 19-32 were consolidated with Conservare H, which contains a hydrophobe. Various combinations of isolating coatings on the painted surfaces, facing fabrics, and adhesives for facing fabrics were tested. Adhesives and isolating materials included: polyvinyl alcohol; rabbit skin glue; Acryloid B 72; BEVA^(R); Soluvar Matte^(R); and Blair Spray Fix^(R). Facing fabrics included: Japanese tissue paper; surgical gauze; crepeline; and monofilament. Each individual mural was treated with a different combination of these materials.

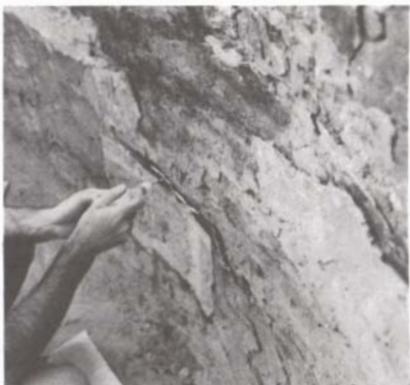
8. On-site pilot conservation treatment. Injection of adhesive after facing with Japanese tissue.

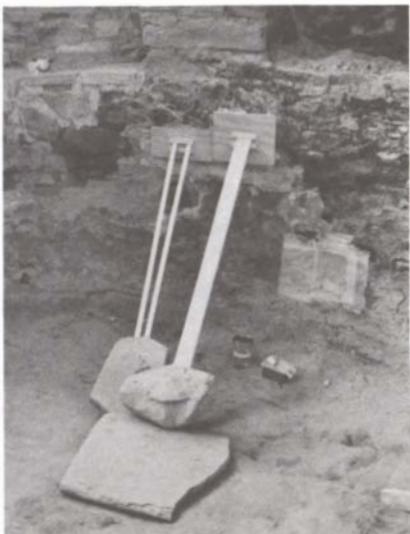
9. The treated area drying under pressure.

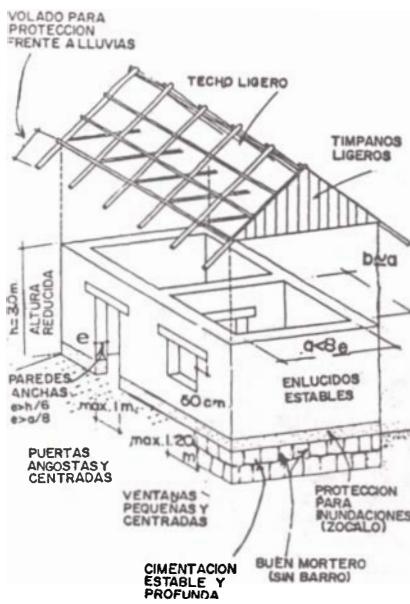
Gráfico 1

- CONSTRUCCIONES DE UN PISO
- HABITACIONES CASI CUADRADAS ($a \approx b$)
- DISTRIBUCION SIMETRICA DE MUROS
- VANOS PEQUEÑOS
- DISTANCIA MAXIMA ENTRE CONTRAFUERTES 8

CONFIGURACION ADECUADA

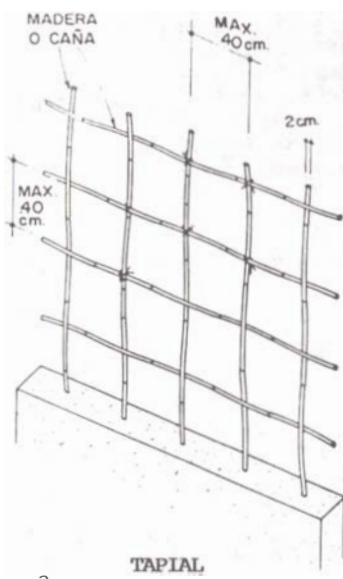
Gráfico 2

REFUERZO NECESARIO EN LOS MUROS DE CONSTRUCCION DE TIERRA

**ADOBÉ****REFUERZO NECESARIO EN LOS MUROS DE CONSTRUCCIÓN DE TIERRA**

d) Refuerzos: El refuerzo más efectivo para los muros es el de caña o madera, constituyendo mallas amarradas en los nudos y colocadas al interior de los muros en una o dos capas verticales según el espesor de los mismos (Ver graf. 2a, 2b, 2c).

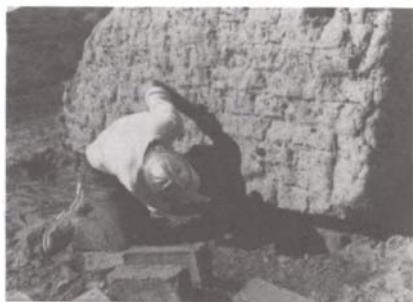
Workman preparing eroded wall base for insertion of new adobe bricks, 1974. New Mexico State Monuments.

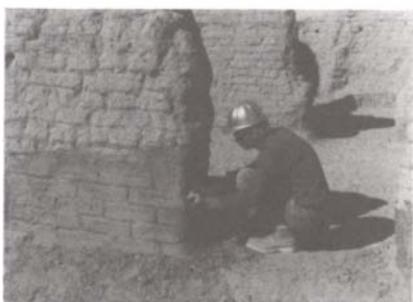
Workman contouring new adobe bricks to fit profile of historic wall, 1974. New Mexico State Monuments.

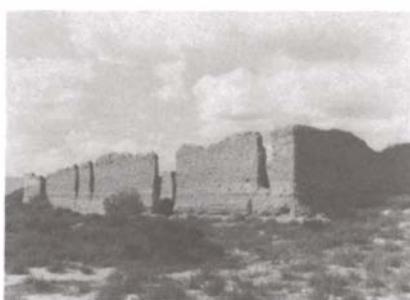
Adobe wall before stabilization, 1974. New Mexico State Monuments.

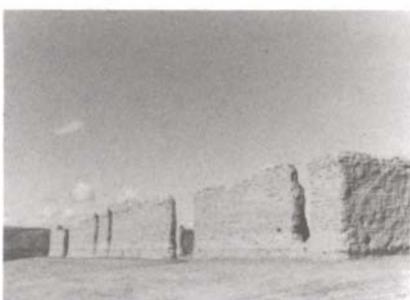
Adobe wall after stabilization, 1974. The ground surface has been raised to provide wall support and graded to facilitate water runoff. New Mexico State Monuments.

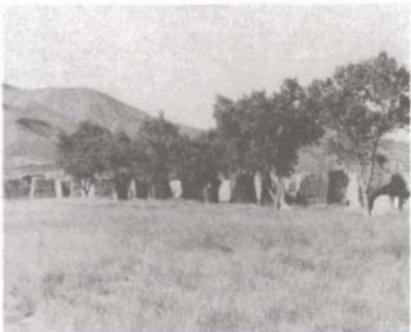
Preservation landscaping. Grass was planted on the parade ground to reduce the amount of wind carried abrasives. The trees replicate the historic landscape, 1985. New Mexico State Monuments.

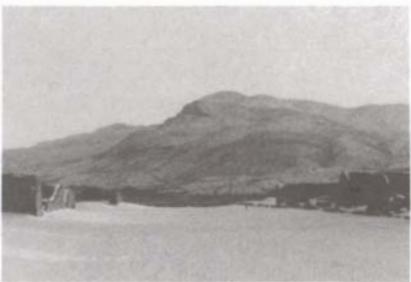
Drainage contours to prevent accumulation of water next to walls. The grade is established to the center of this roadway. After snow, 1974. New Mexico State Monuments.

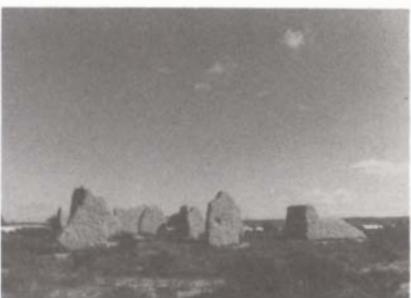
Officer's Quarters before stabilization, 1974. New Mexico State Monuments.

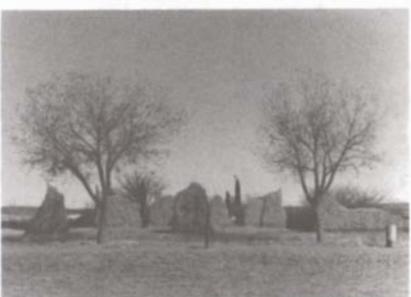
Officer's Quarters after stabilization, 1980. New Mexico State Monuments.

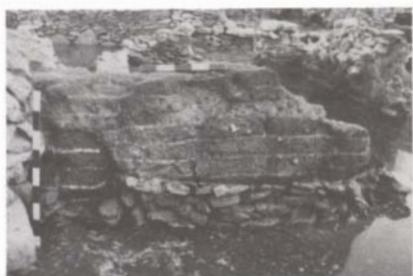
FIG. 4 Mur de fond d'une maison du premier village (IVème s. av. J.C.) Elévation d'adobes sur soubassement de pierres. Photo J.C-L.

La fonction de la partie basse en pierres n'est pas identique selon qu'il s'agit de constructions initiales ou de reconstructions. Dans le premier cas la nature meuble du sous-sol rendait nécessaire une fondation enterrée destinée à protéger la base de la maçonnerie de l'affouillement. Quand le mur est rebâti sur une ancienne construction ruinée, la fondation devient un simple soubassement, à peine enterré, qui assoie la partie en terre et l'isole des remontées capillaires d'humidité. La hauteur de ce socle, généralement peu importante (0,30 m à 0,50 m) peut atteindre 1 m sur certains murs de façade plus exposés aux chocs et à l'érosion (voir fig. 5).

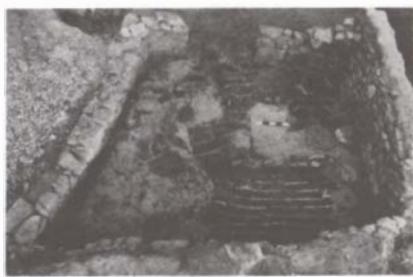
FIG. 6 Murs d'adobes effondrés dans une maison du premier village (IVème s. av. J.C.). Photo J.C-L.

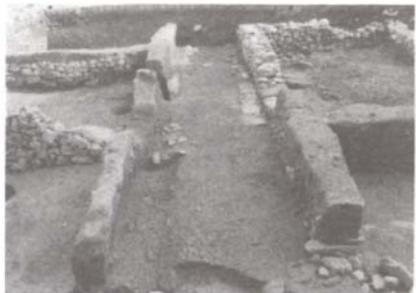
FIG. 9 Murs de façade en pisé du deuxième village (IIe s. av. J.C.)
Photo J.C.-L.

Les murs massifs deviennent majoritaires dans le second village où ils apparaissent représentatifs d'une technique véritablement novatrice. Reposant sur un soubassement de pierres plus large (0,50 - 0,60 m) le matériau terre présente une coloration et une composition à peu près uniformes. C'est un mélange de sables, limons et argiles plus hétérogène que les briques. Dans certains cas, des pierres dessinent des lignes horizontales interprétées comme des niveaux intermédiaires entre deux banchées de terre. Faute de vestiges attestant l'emploi de coffrage, ce sont les rares indices matériels d'utilisation du pisé. De plus la période d'apparition à Martigues de ce mode d'architecture correspond à son introduction sur d'autres sites méridionaux proches (Entremont, Marignane). Le pisé apparaît ici comme un transfert de technologie italique de même que la brique avait été empruntée au monde grec quelques siècles plus tôt (5) (voir fig. 9 et 10).

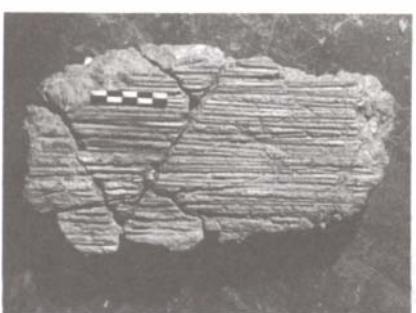
FIG. 11 Fragment de la couverture d'un toit-terrasse. Empreintes de roseaux sur la face inférieure.
Photo G. Xuereb (Martigues Communication)

La couverture est faite d'un lit de roseaux arrangés à plat sur lequel est déposée une couche de terre crue. Elle nous est connue par les nombreux fragments cuits accidentellement, offrant une face inférieure striée d'empreintes de végétaux, l'autre plane et lissée (voir fig. 11). Cette couche est un mélange de sables, argiles, graviers et fibres végétales, présentant les traces de multiples recharges, témoins d'un entretien permanent, qui finissent par former une épaisseur de terre allant jusqu'à 0,20 m, ce qui induit une charge importante de l'ordre de 300 à 500 kg/m² (6).

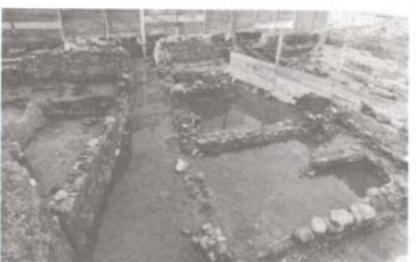
FIG. 12 Partie nord-ouest du premier village recouverte par la nappe phréatique. Photo J.C.-L.

Enfin, pour éviter, dans l'architecture, tout désordre lié à la présence de la nappe phréatique sous-jacente (voir fig. 12), nous avons enterré avec du sable les structures les plus profondes et protégé les vestiges par un système d'é-tanchéité et de drainage adéquat (chape de béton et feuille de plastique) (7).

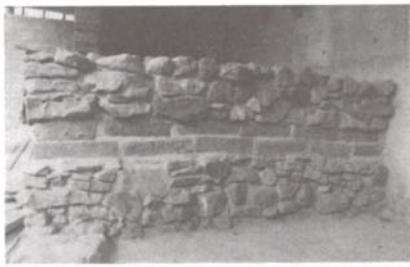
FIG. 14 La même maçonnerie après restauration. Photo J.C-L.

A cause des contraintes techniques les murs restaurés ne représentent que les dernières périodes d'occupation du village primitif. Ils montrent le remontage de la maçonnerie de pierres la plus récente (fin 3ème siècle avant J.C.) sur la portion conservée de l'élévation en adobes du mur antérieur (milieu 4ème - milieu 3ème siècle). Par souci pédagogique ils sont dénués d'enduit protecteur. Une attention particulière a été portée sur les joints qui révèlent l'appareil. Toutes les fissures de retrait intervenues après la pose du mortier ont été bouchées et la surface des joints lissée.

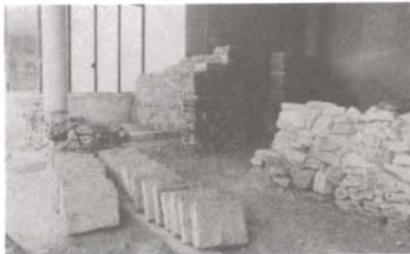
FIG. 15 Stockage des adobes en vue de la reconstitution de l'îlot nord. Photo J.C-L.

La présence d'un pilier d'angle du bâtiment actuel a interdit de respecter exactement le plan-masse des maisons. L'exiguité des espaces intérieurs exposés nécessitait de modifier légèrement l'implantation primitive des maisons pour masquer cette intrusion contemporaine en l'englobant dans un mur de refend (voir fig. 15 et 16).

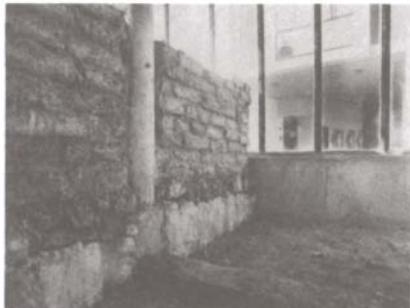
FIG. 16 Masquage par le mur de briques crues d'un pilier d'angle en béton de la "Vitrine Archéologique". Photo J.C-L.

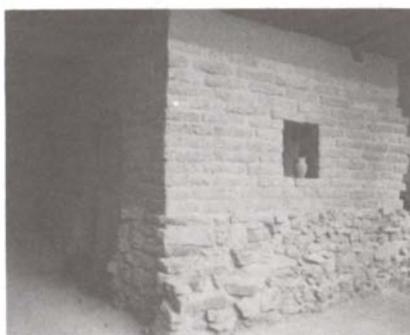
FIG. 18 Elévations de briques crues sur soubassement de pierres. Parements dénus de revêtement. Photo J.C-L.

Dans la continuité des vestiges de la partie sud du local, la maison d'angle est dépourvue d'enduit extérieur. Au-dessus du soubassement original en pierres restauré, l'élévation restituée montre un appareil soigné d'adobes maçonnes avec un mortier argileux selon la règle de recouvrement des joints verticaux. La façade donnant sur la place a été percée d'une petite fenêtre dont la présence répond à une triple motivation : donner une prise de lumière à l'ouest, permettre une meilleure intégration de la maison au dispositif urbain de la place et démontrer, notamment par l'absence de linteau, la résistance mécanique de la terre crue quand elle est correctement mise en oeuvre (voir fig.18).

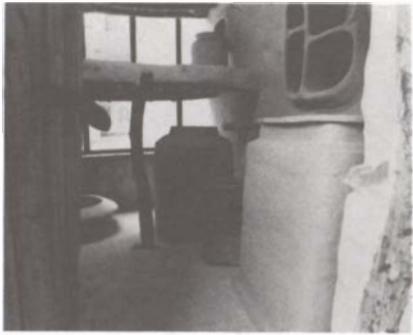
FIG. 19 Espace intérieur d'une maison reconstituée. Badigeon d'argile blanche et aménagements domestiques. Photo G. Xuereb (Martigues Communication).

A l'inverse, les élévations des maisons qui forment la façade nord de la ruelle sont enduites intérieurement et extérieurement, conformément aux observations de terrain. A l'intérieur, ces revêtements ont un rôle autant fonctionnel qu'esthétique. Fréquemment restaurés, ils présentent, pour un même niveau d'occupation, jusqu'à trois ou quatre recharges correspondant aux réfactions du sol avec lequel ils viennent se confondre. Cette accumulation masque les différentes épaisseurs du mur. Très fins et appliqués en surface sous forme de badigeon, ils concourent à éclaircir les pièces. Incontestablement ces revêtements participent à l'embellissement de l'espace intérieur de la maison dont ils suppriment les angles vifs (8) (voir fig. 19).

Ne disposant d'aucun espace intérieur complet nous avons opéré ici de façon didactique, sélectionnant pour chacun d'eux un type d'aménagement. Ainsi pour l'habitation vue en coupe à l'angle nord-ouest de la vitrine, on a privilégié l'hypothèse d'un demi-plan restreint servant de support à deux grands silos en torchis. Ancré dans le mur et soutenu au sol par un poteau d'angle, il est constitué d'un plancher en pin recouvert de quelques centimètres de terre (voir fig. 26). La deuxième maison est dotée d'une mezzanine couvrant toute la largeur de la pièce. Zone de stockage pour des vases à provision et lieu de repos, ce niveau intermédiaire, soumis à de plus lourdes charges, a nécessité le recours à des bois plus importants. Il s'accompagne d'un système d'accès composé de pièces de bois plantées en escalier dans le mur (voir fig. 19 et 27).

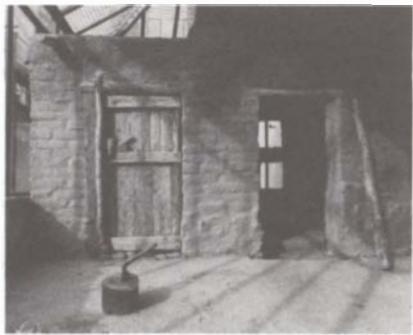
FIG. 20 Façade de l'îlot nord reconstitué. Parement revêtu d'un enduit de terre argileuse. Photo G. Xuereb (Martigues Communication).

A l'extérieur, les enduits étaient plus dégradés du fait de leur exposition aux intempéries et aux chocs. Le projet de reconstitution insiste sur cet aspect par une composition différente et une apparence moins homogène qui atteste leur usure (voir fig. 20).

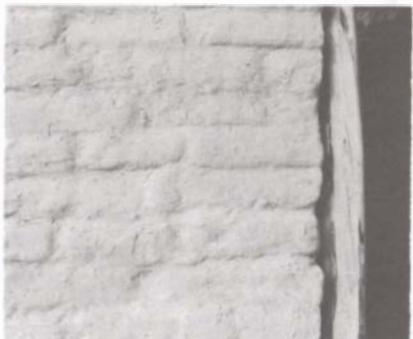
FIG. 21 Détail d'un enduit extérieur renforcé de végétaux. Photo J.C-L.

Nous fondant sur des témoignages anciens et actuels nous avons renforcé cet enduit de fibres végétales qui améliorent sa résistance à l'érosion. Un badigeon fin de terre argileuse lissée l'imperméabilise (9) (voir fig. 21).

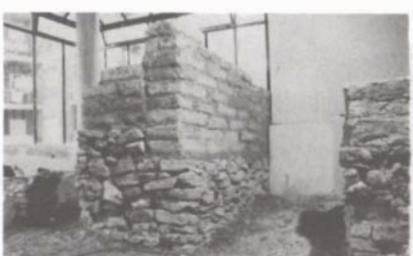
FIG. 22 Construction d'un mur de refend sans chaînage avec la façade. Photo G. Xuereb (Martigues Communication).

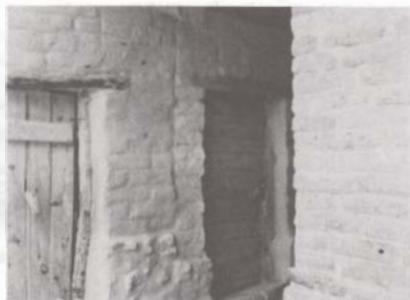
FIG. 23 Le même ensemble une fois édifié et recouvert d'enduit. Photo J.C-L.

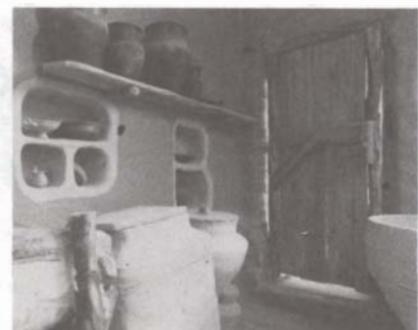
FIG. 24 Niches et étagères murales dans une maison reconstituée. Photo G. Xuereb (Martigues Communication).

Certains dispositifs ont été introduits pour pallier les problèmes de rangement du petit mobilier qui abonde dans chaque maison. Il s'agit d'étagères constituées d'une planche appuyée sur des piquets de bois fichés dans la maçonnerie, de niches réservées dans l'épaisseur du mur, dont les formes et les dispositions ont été empruntées à des exemples actuels du pourtour méditerranéen (10). Ces aménagements permettent de disposer les objets qui ne trouvent pas au sol de place appropriée (voir fig. 24).

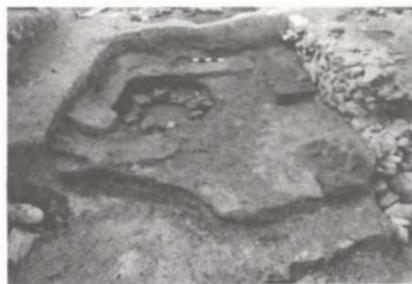
FIG. 25 Banquette basse en terre dans une maison du second village (IIe s. av. J.C.) Photo J.C-L.

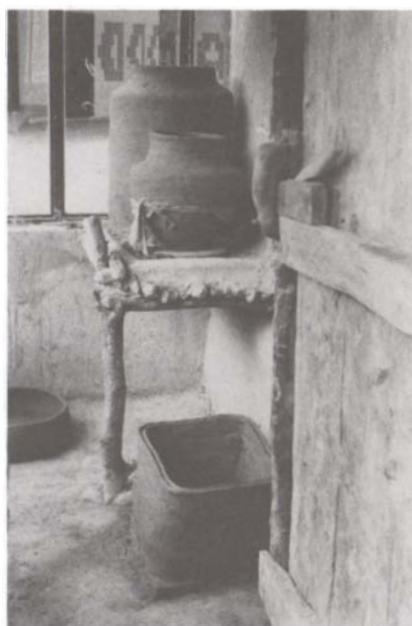
FIG. 26 Demi-plan restreint servant de support à des silos en torchis. Photo J.C-L.

On trouve d'abord des silos ou vases de réserve pour les céréales, fruits séchés etc... Grandes jarres cylindriques, carrées ou rectangulaires, récipients bas en forme de jatte droite ou carénée, ils sont montés à l'intérieur de la maison, à leur emplacement définitif et reposent sur un socle isolant de pierres ou d'adobes ou sur une étagère qui les protège des prédateurs et de l'humidité (voir fig. 26).

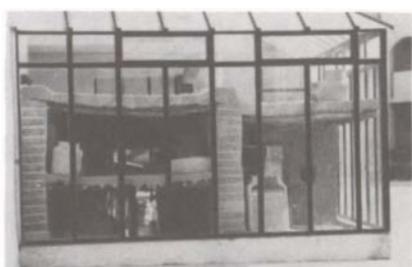
FIG. 27 Vue extérieure en coupe de deux maisons reconstituées. Toits terrasses et mezzanines. Photo J.C-L.

Ils jouent aussi un rôle esthétique rendu ici par les différences de niveaux entre les toitures et les acrotères d'angle. Bâtis en terre façonnée, ils devaient être régulièrement restaurés par suite de l'érosion et du ruissellement. Le badigeon de couleur claire appliqué en surface, en augmentant la réflexion solaire, contribue à une meilleure isolation thermique des toitures (voir fig. 27).

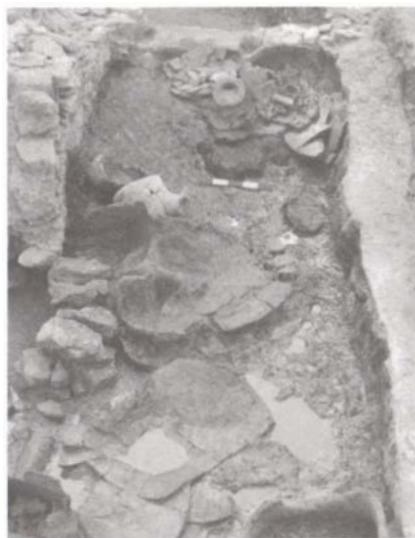
FIG. 28 Mobilier en torchis (silos rectangulaires, couvercles, jattes etc...) dans une maison incendiée du 1er village (IVe s.av. J.C.) Photo J.C-L.

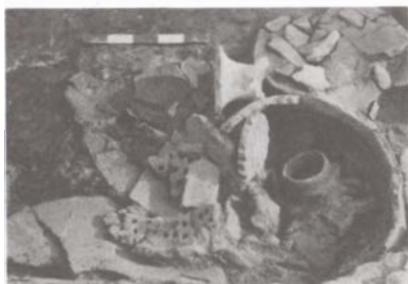
FIG. 29 Four complexe en torchis effondré à l'angle d'une maison incendiée du premier village gaulois (IVème s. av. J.C.) Photo J.C-L.

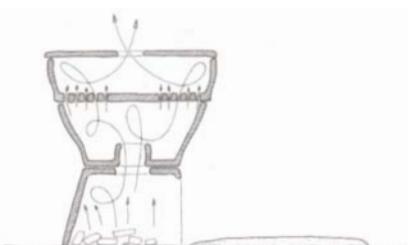
FIG. 30 Dessin schématique du four complexe. Dessin L. Domallain.

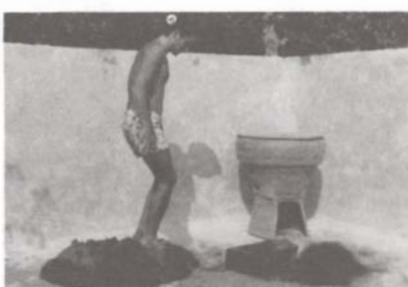
FIG. 31 Reconstitution du four en torchis. Photo J.C-L.

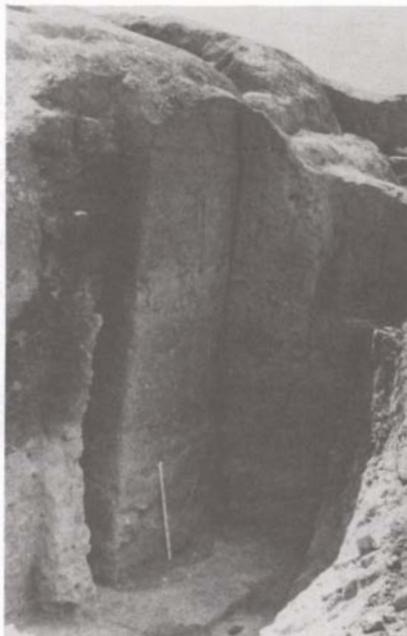
Fig.1. Façade of the 7th house dismantled from additional mud-brick masonry (early 8th century).

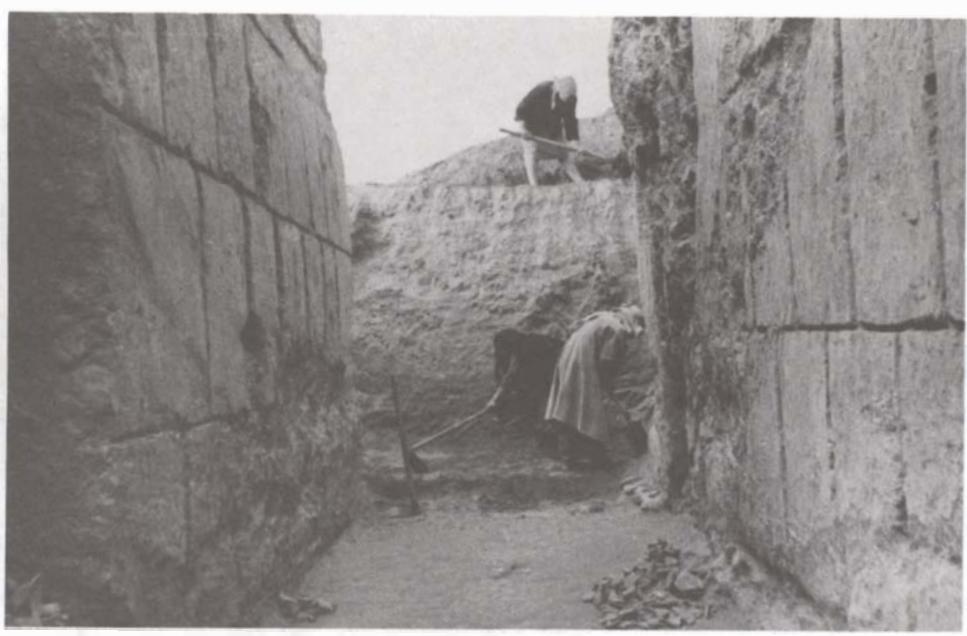
Fig.2. Vaulted alley with the walls from pise divided into large blocks.

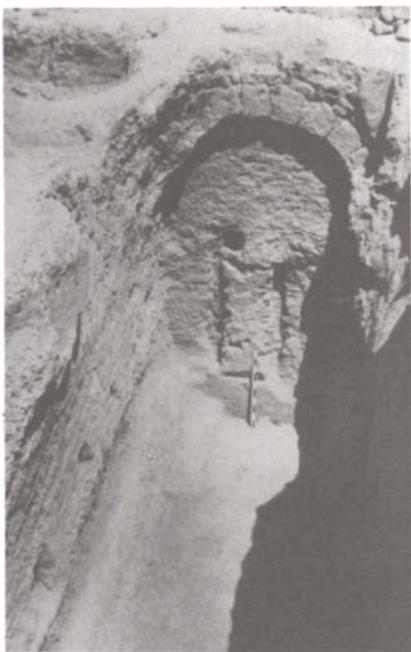
Fig.3. Ground floor room with its vault. Early 8th century.

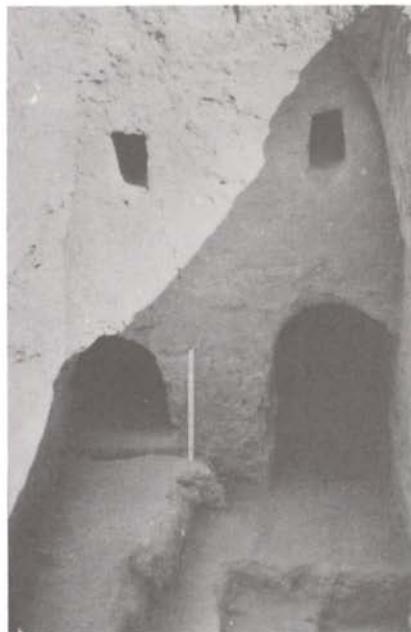
Fig.4. Lobby with two doors and two windows for the stair-case. Early 8th century.

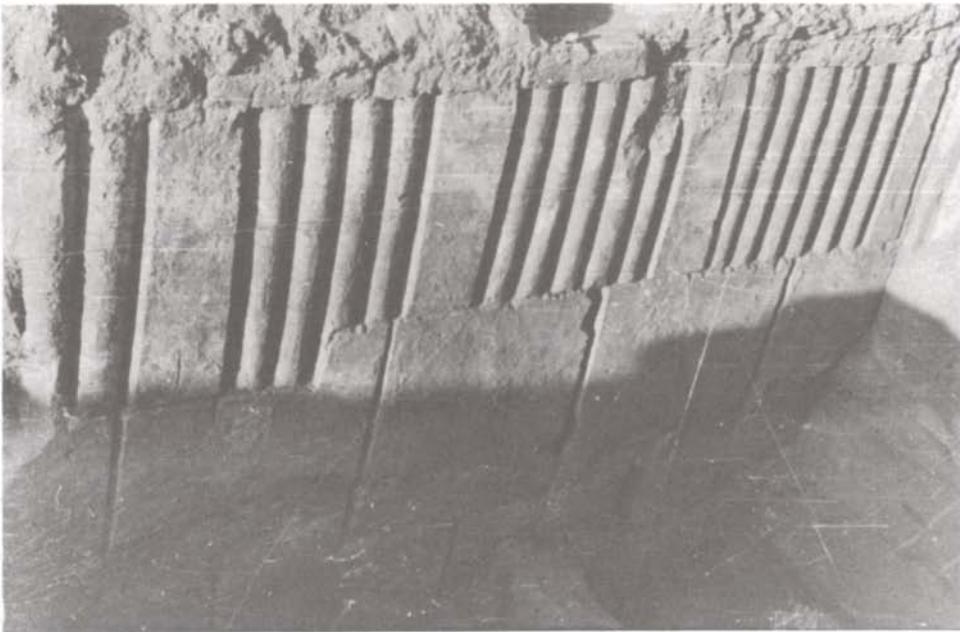
Fig.5. Room with pisé walls. Half-columns were carved in pisé blocks. Early 8th century.

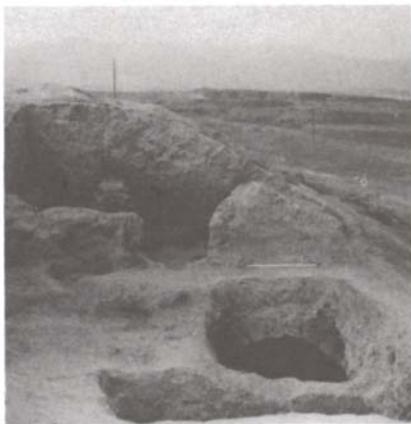
Fig. 6. Two-storied house.
Below a vaulted ground
floor room. Early 8th
century.

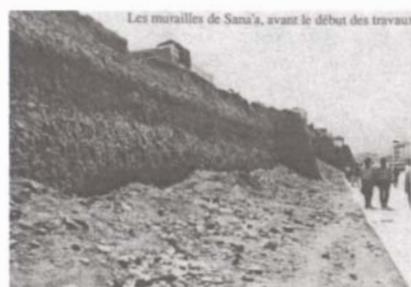
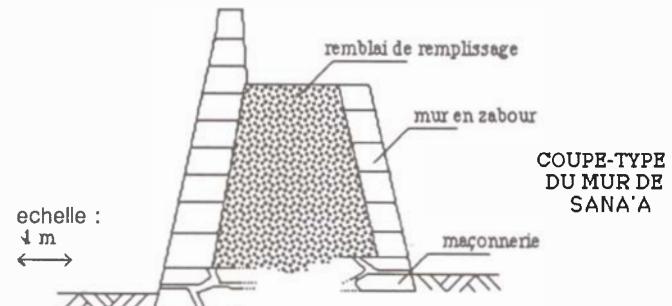
figure 1 : coupe type originelle du mur de Sana'a

Le corps de la muraille est constitué de deux murs de zabour, montés sur une maçonnerie très résistante, et enserrant un remblai argilo-sabloneux. Un "garde corps" extérieur est réalisé en zabour sur une hauteur qui devait être d'environ 1,5 à 2 m. La largeur utile du dessus du mur varie de 3 à 5 m.

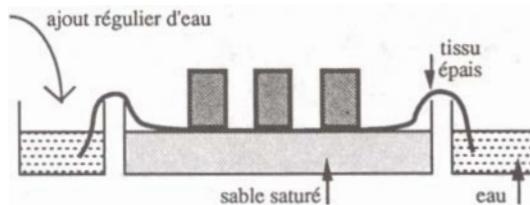
figure 4 : essai de remontées capillaires

3.4 Essai de remontées capillaires : Les éprouvettes ont été posées sur un lit de sable, puis soumises à une pression capillaire très faible entretenu par la circulation d'eau dans un tissu épais, déposé sur le sable et dont les bords baignaient dans deux récipients contenant de l'eau.

Les récipients étaient disposés de manière à ce que le niveau de l'eau et la surface supérieure du lit de sable soient dans un même plan horizontal. Un contrôle suivi tout au cours du déroulement de l'expérience a permis de maintenir constant le niveau de l'eau dans les récipients. Le poids des éprouvettes a été relevé régulièrement pour calculer la quantité d'eau absorbée par le matériau.

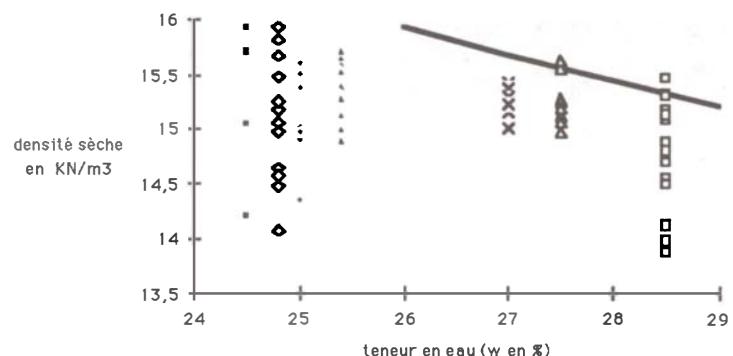
figure 6 : (densité sèche / teneur en eau) pour le matériau stabilisé à 6% de ciment

On observe également une grande variation des valeurs de densité sèche à teneur en eau constante (par exemple, pour le matériau stabilisé à 6 % de ciment, γ_d varie de 1,40 à 1,59 pour $w=24,8\%$). Ces résultats peuvent s'expliquer par le fait que la quantité de terre introduite dans le moule lors de la fabrication d'une éprouvette varie d'une éprouvette à une autre, surtout à teneur en eau faible, et comme aucune force n'a été utilisée pour compresser la terre, la répartition des vides, le tassement et la cohésion finale de l'éprouvette s'en trouvent modifiés.

En comparant les valeurs de densité sèche pour le matériau brut et le matériau stabilisé, on constate qu'on obtient de plus fortes valeurs de densité sèche pour le matériau brut que lorsqu'il est stabilisé. L'ajout de ciment entraîne une baisse de densité, car la chaux libre présente dans le ciment entraîne une flocculation quasi instantanée des argiles, qui s'oppose à la mise en place du matériau. On se trouve alors avec un pourcentage de vides plus élevé avec les matériaux stabilisés.

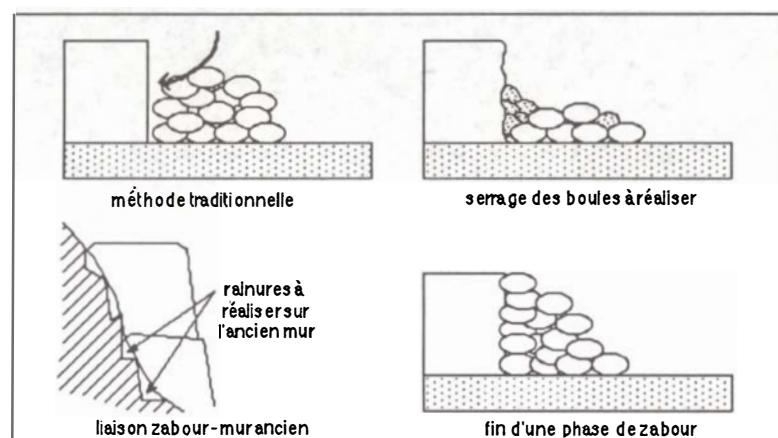
figure 11 : Mise en place du Zabour

2.3 Mise en place du Zabour : afin de limiter la fissuration dans le mur, due au séchage de la terre et au retrait lors de la prise du ciment, il est nécessaire de s'assurer que le minimum de vides subsiste après mise en place des boules. Pour cela, les points suivants sont à surveiller :

- les boules doivent être placées directement à la jonction de la tranche de Zabour en cours de fabrication et la tranche précédente, il est, en effet, insuffisant de simplement repousser ce Zabour pour le mettre en place ainsi qu'on procède traditionnellement,
- des rainures devront être réalisées dans l'ancien mur afin de faciliter l'adhérence du nouveau Zabour sur celui-ci. De même que précédemment, les boules de Zabour devront être lancées directement dans le creux entre l'ancien et le nouveau mur,
- à la fin d'une phase de travail, il faudra également terminer le Zabour par une forme en escalier afin de favoriser ensuite l'adhérence avec le nouveau Zabour.
- une cure de 15 jours du zabour sera réalisée en disposant une bâche sur le mur.
