# A Climate Control System for Hollybourne Cottage, Jekyll Island Historic District, Georgia

Shin Maekawa, P.E.,  
Member ASHRAE

Franciza Toledo, Ph. D.

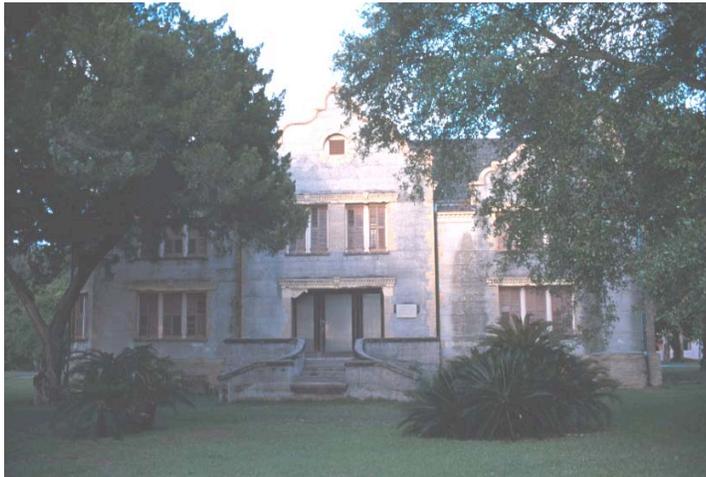
*Figure 1 Main (west) façade of Hollybourne Cottage.*

Hollybourne Cottage dates from 1890 and is part of the Jekyll Island Historic District. It has a distinctive architecture style described as “Jacobethan Revival” (Figure 1), with a building structure that reflects the professional interest of its owner, Charles Maurice, a successful bridge builder from Athens, PA (Watson&Henry 1998). The cottage is situated on the west side of the island, and the surrounding area is flat and filled with overgrown trees taller than the cottage. It was sold by the Maurice family in 1947 to the State of Georgia, and has been vacant ever since.

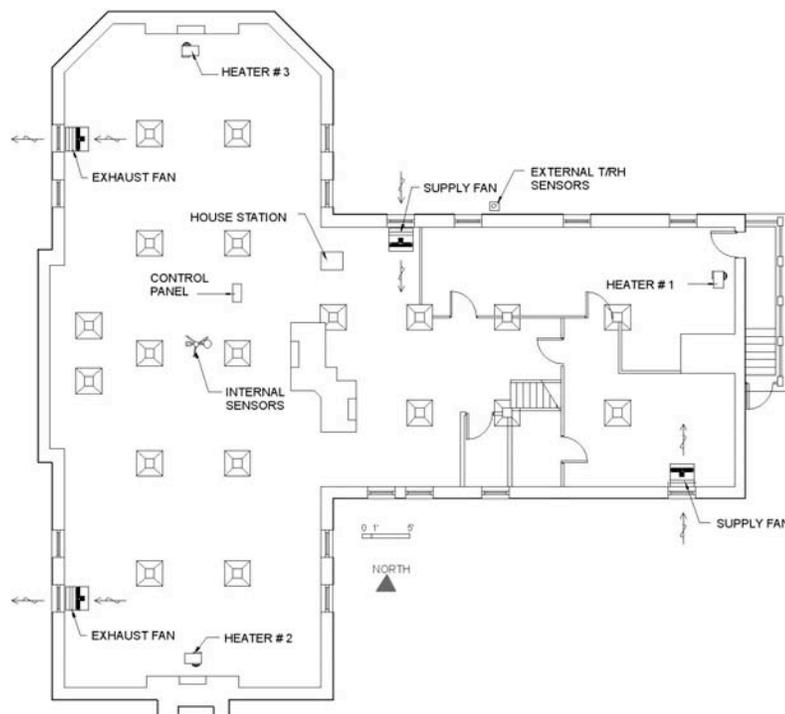
Figure 2 Basement plan of the cottage, showing the position of the climate control system and its mechanical units (ventilators and heaters).

**Basement.** Figure 2 shows the basement floor plan. Double brick foundation walls with an air gap of about 0.13 m (5 in) create the basement boundary, about 2.44 m (8 ft) high. It has a concrete slab floor that has been broken or lost in several areas. The floor area is approximately 279 m<sup>2</sup> (3000 ft<sup>2</sup>) and the air volume is 651 m<sup>3</sup> (23,000 ft<sup>3</sup>). The walls have a total of 17 identical hinged (operable) windows, measuring 0.6 x 0.9 m (2 x 3 ft), and are symmetrically distributed just above the grade (1.2 m or 4 ft from the basement floor). These windows do not have a louver. During heavy summer rains (in August), water leaks were confirmed at some windows.

In the basement, two supply fans, two exhaust fans, and three convection heaters (see Table 1 for their specifications) were installed as shown in Figure 2. The supply fans were placed in existing windows on the north and south facades of the east wing, and the exhaust fans were placed far apart on the windows of the west (front) façade of the north-south wing. With this arrangement, fresh air entered from the east (rear) wing and the central area, and then exited from the north and south ends of the basement. The excess amount of supply air was designed to produce slightly positive pressure in the basement in spite of large air leakage paths in the space. The heaters were mounted on floor joists at the three (north, south and east) ends of the basement, to avoid localized heating and to uniformly distribute the heat.

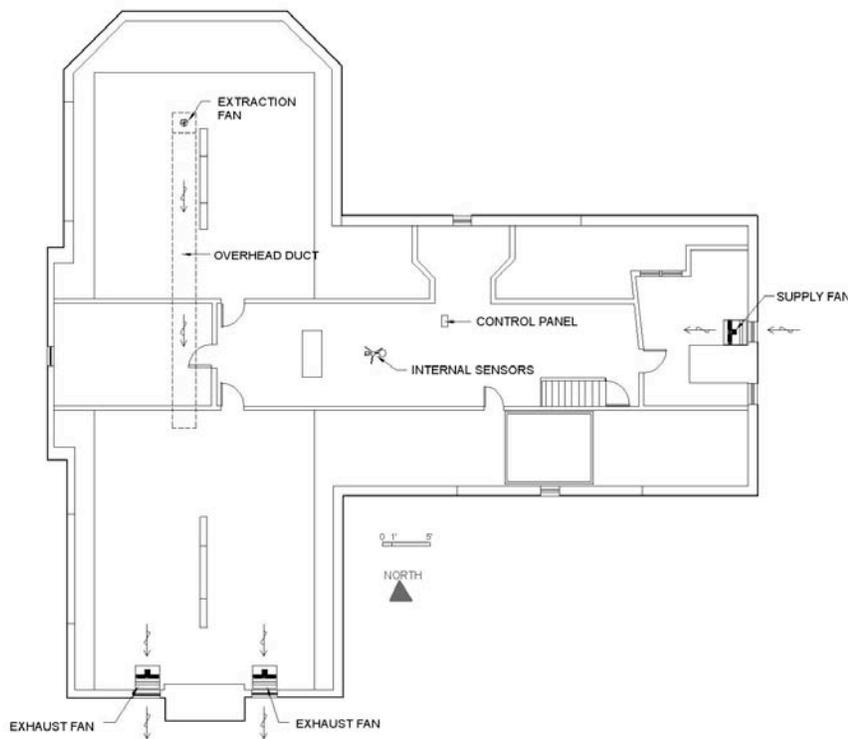
*Figure 3 Attic plan of the cottage, showing the position of the climate control system and its mechanical units (ventilators).*

**Attic.** Figure 3 shows the attic space floor plan, consisting of a long narrow finished area extending east-west, with two small rooms at both the west (front) and east (rear) ends, and an unfinished north-south wing. The attic has an area of approximately 214 m<sup>2</sup> (2300 ft<sup>2</sup>) and an estimated air volume of 396 m<sup>3</sup> (14,000 ft<sup>3</sup>). The ceiling height in the midpoint is 2.3 m (7 ft 6 in). It has seven windows of various sizes: two large, rectangular -- 0.9 x 0.6 m (3 x 2 ft), on the east façade; two large, quarter circle with 0.9 m (3 ft) of radius, on the south façade; one small square -- 0.6 x 0.6 m (2 x 2 ft) on the west façade; one small square -- 0.6 x 0.6 m (2 x 2 ft) on the north façade, in the middle; and the last square one -- 0.6 x 0.6 m (2 x 2 ft), facing south, also in the middle of the space. The windows had no louvers. Central and rear chimney shafts penetrated the space.

In the attic, one supply fan, two exhaust fans, and one residential-type extraction fan (see Table 1 for their specifications) were installed as shown in Figure 3. The supply fan was placed in one of the two windows located on the east (rear) end of the building, and the exhaust fans were placed in two windows at the south façade of the south wing. Fresh air entered from the east end of the building and flowed through the east wing, exiting through the south wing. Since the attic's north wing did not have an outside opening, a ducted extracting fan was placed in the middle of the space at approximately 2 m (6 ft 6 in) from the floor to draw hot stagnant air to the south wing, where the two exhaust fans evacuated the hot air along with air directly flowing from the east wing.

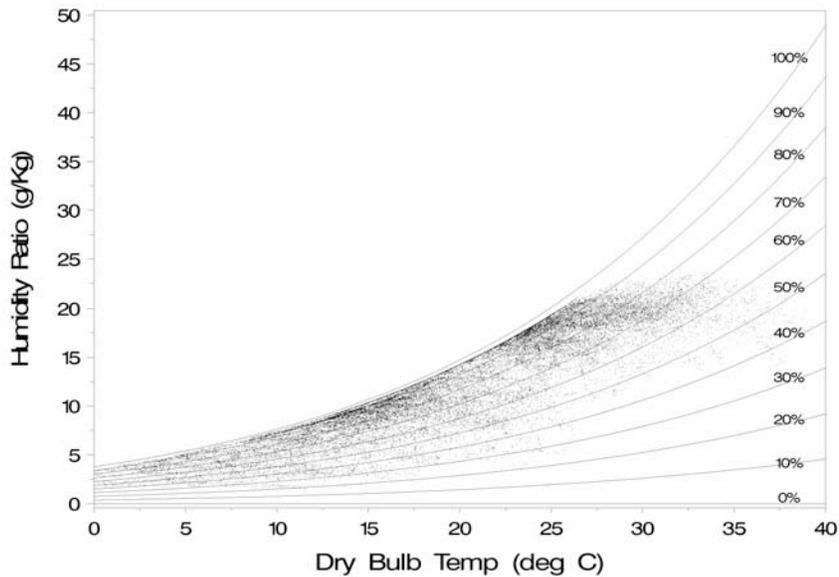
*Figure 4 Psychrometric chart showing the measured outdoor air conditions at Hollybourne Cottage, 1999-2000 (15-minute data).*

In 1999, the average outdoor temperature was 20.4°C (68.7°F) with a standard deviation of 6.7°C (12.1°F). 25% of the collected data were higher than 25.3°C (77.5°F), and 25% were lower than 15.5°C (60°F). The maximum value recorded was 39.2°C (102.6°F) on August 1st at 4:00 PM, and the minimum was - 2°C (28.4°F) on December 26th at 7:30 AM. The average relative humidity was 82.5% with a standard deviation of 16%. 25% of the measurements taken onsite were higher than 96% RH, and 25% were lower than 73% RH. The minimum relative humidity value measured was 21% on March 2nd at 12:45 PM. Figure 4 shows temperature and relative humidity values recorded at the site, plotted on a psychrometric chart.

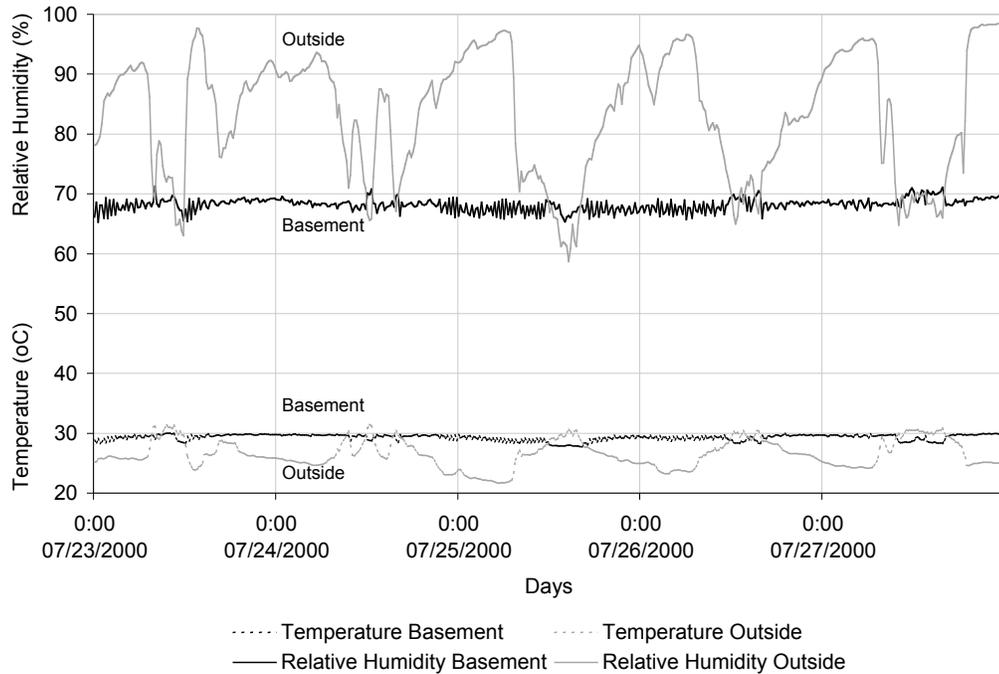
Figure 5 Measured environmental conditions in the basement, while the climate control system was in operation.

**Operation of the Climate Control System.** During the summer, both ventilators and heaters in the basement were activated frequently. The ventilators operated during daytime (from about 10:00 AM to about 4:00 PM), and heaters warmed the basement throughout the night (from about 6:00 PM to about 8:00 AM). With these operations, relative humidity values in the basement were kept below 70% most of the time, while air temperature was kept below 30°C (86°F). Climate in the basement during July 23-27, 2000 while the system was operating is shown in Figure 5. The ventilators were activated during midday when the outside relative humidity decreased to less than 70%. The heaters, to a greater or lesser extent, were activated the rest of the days.

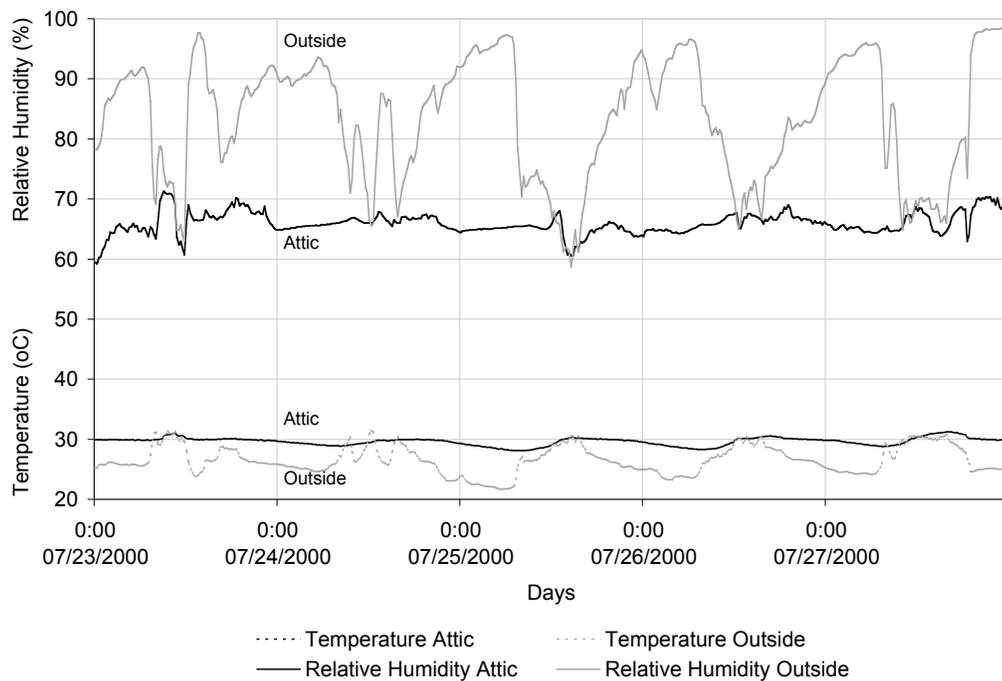
Figure 6 Measured environmental conditions in the attic, while the climate control system was in operation.

In the attic, the ventilators were activated normally in the afternoon until late in the evening (from about 12:00 PM to about 10:00 PM). Their operation was extended on hot days, when the roof's inner surface temperature rose above 35°C (95°F), as occurred on days 23rd and 27th of July 2000 (Figure 6). The attic temperature was kept at a few degrees above 30°C (86°F), while the relative humidity was maintained between 60% and 70%.

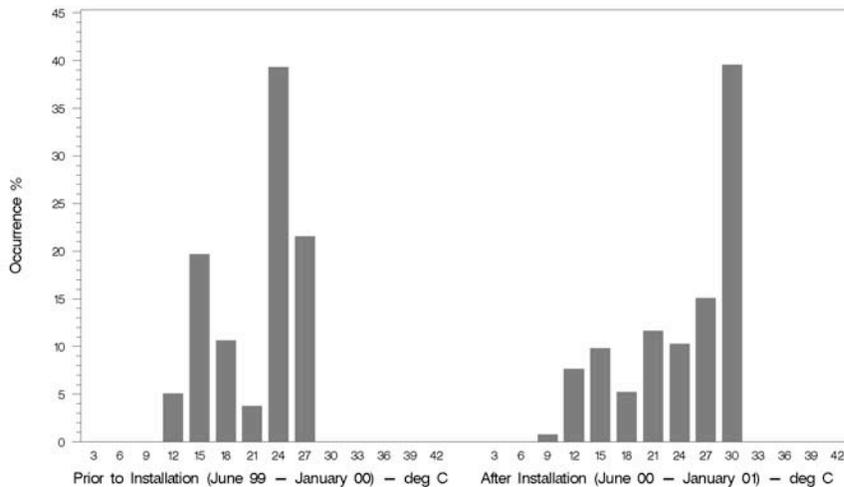
Figure 7 Histogram of air temperature values, before and after installation of the climate control system in the basement.

Histograms of air temperature and relative humidity before and after the installation of the climate control system for the basement are shown in Figures 7 and 8. In the basement, the major change in the temperature distribution was the addition of events for 27.5°C (81.5°F) - 32.5°C (90.5°F), which was the largest occurrence (Figure 7). Prior to the installation of the system, 50% of the data points for relative humidity measurements (Figure 8) were found between 84% and 100% (34% of the data were above 95% RH). Relative humidity values above 75% were eliminated after the installation, and the largest occurrences are now found between 65% and 75%.

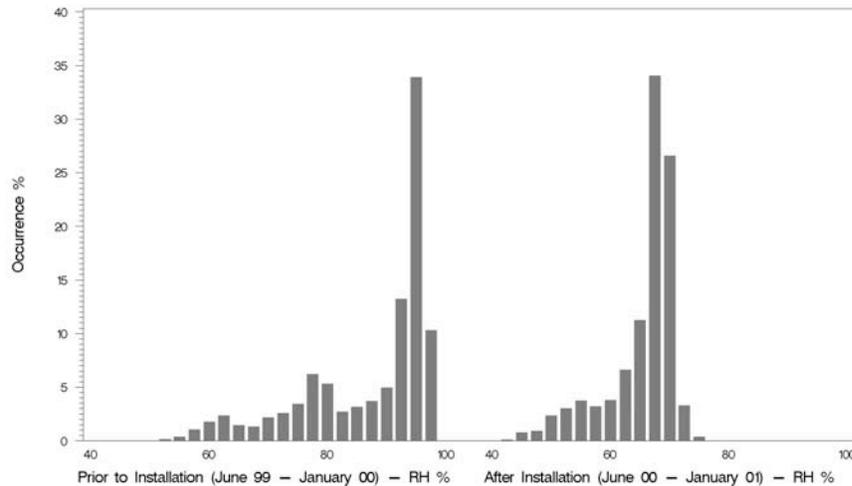
Figure 8 Histogram of relative humidity values, before and after installation of the climate control system in the basement.

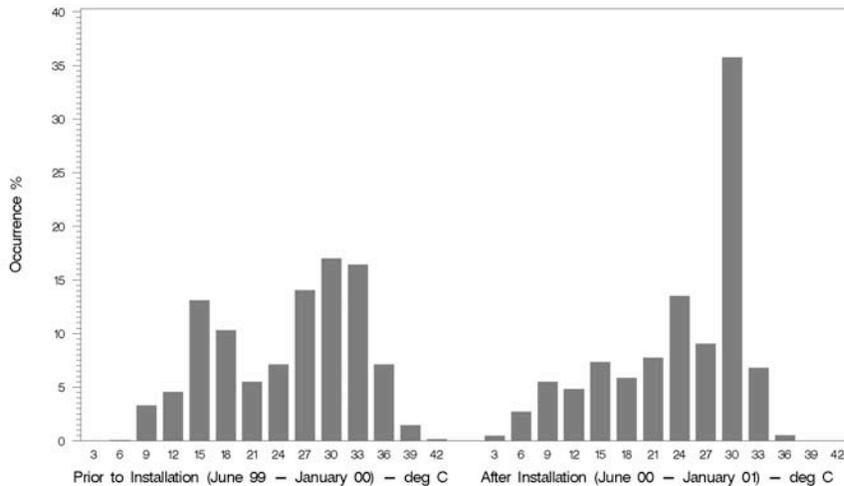
Figure 9 Histogram of air temperature values, before and after installation of the climate control system in the attic.

In the attic, the occurrence of high temperature events recorded prior to the installation of the climate system were eliminated or significantly reduced, and the largest occurrence is now found in a range from 27.5°C (81.5°F) to 32.5°C (90.5°F) as shown in Figure 9. This indicates that the effort to reduce high temperature events has been successful. Although the relative humidity distribution at the higher end did not change, more events of lower relative humidity were found (Figure 10). This may be due to ingestion of warm dry air for venting the attic or influenced by the lower outdoor humidity conditions experienced during the post-retrofit period.

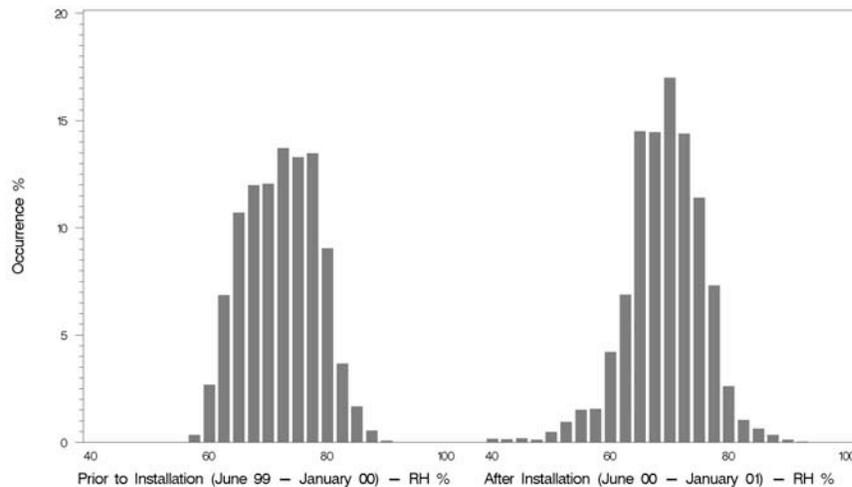
Figure 10 Histogram of relative humidity values, before and after installation of the climate control system in the attic.

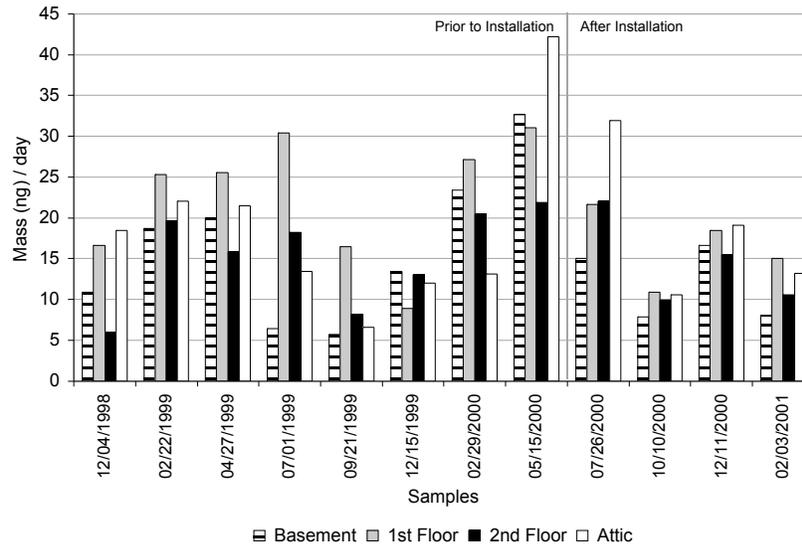
Figure 11 Dust monitoring results for Hollybourne Cottage.

**Dust Deposition.** Dust deposition has been monitored in the cottage since it was swept clean in early December 1998. So far, there have been 12 samples taken on each floor as shown in Figure 11. As a general rule, the amount of particles in the building followed a seasonal pattern. The amounts were less in the wet season (see samples of 9/21/99 and 10/10/00) than in the dry period. Smaller amounts of particulate matters were present in the environment during rain and highly humid days, resulting in lower deposition

rates. In the period prior to the installation of the system, the first floor produced the highest average value (22.7 ng/day), followed by the attic (18.6 ng/day). The basement and the second floor presented similar values (16.4 and 15.4 ng/day). After the installation of the system, the trend was maintained, with lower figures, except for the attic. The dust level in the basement was reduced to an average of 11.9 ng/day, 16.5 ng/day on the first floor, 14.5 ng/day on the second floor, and increased slightly to 18.7 ng/day in the attic.

Prior to the installation of the climate control system, preparation work was performed in the cottage. The highest deposited values occurring in May 2000 coincide with the work, and the high deposition rate continued for the following two months. However, in the months after that, the rates reduced and stabilized to those levels recorded prior to the installation. Variations that existed prior to the installation among floor levels were significantly reduced, indicating that mixing of the climate in the building by the climate system was effective.

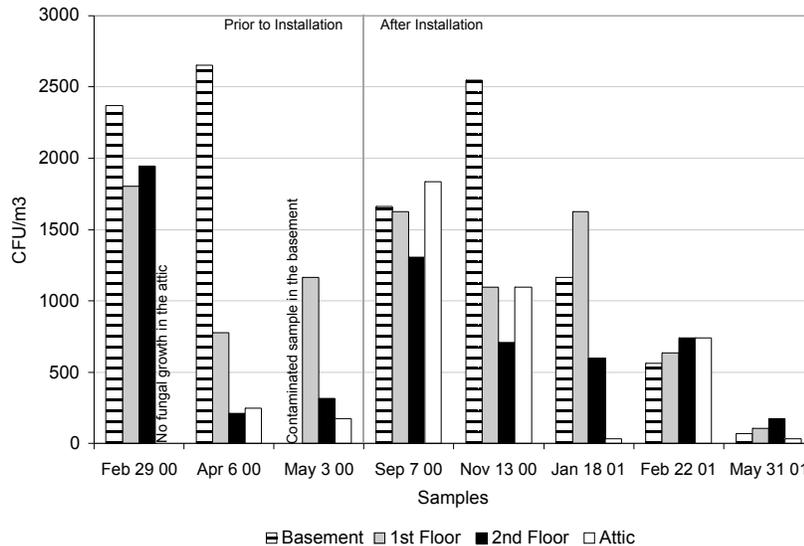
Figure 12 Microbial monitoring results for Hollybourne Cottage (fungi).

Figure 12 shows a bar graph of the fungal activity in the cottage before and after the installation of the climate system. Contrary to bacterial activity, no seasonal trend was detected for fungal activity, although a general decrease in activity was noted for the last sampling performed (5/31/01). The most ubiquitous

fungi in the cottage were *Cladosporium cladosporioides*, *Penicillium frequentans*, *Chaetomium species*, followed by *Geotrichum candidum*, *Aspergillus fumigatus*, *Trichoderma viride*, and *Alternaria alternata* (PureAir 2001). After the installation of the climate control system, the average fungal activity decreased in all floors, except in the attic (from 141 to 749 CFU/m<sup>3</sup>).
