总体状况概述 Overall Condition Summary

会乘殿，室内 - 塑像：

Huicheng Hall, Interior - Sculpture:

Avalokitesvara (*Guanyin*) on a *chaotianhou*

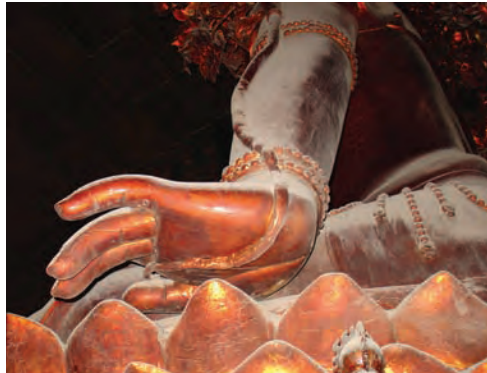
塑像上堆积厚重的灰尘。

Note heavy dust deposition on the sculpture

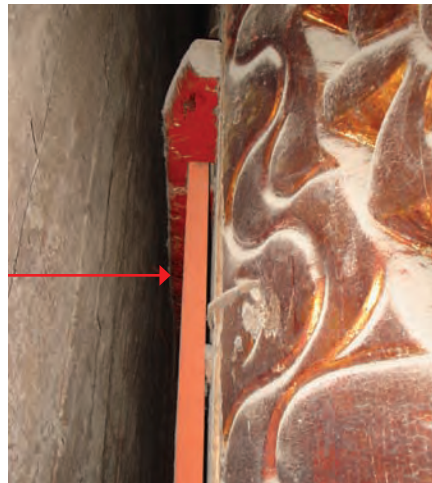
朝天吼和珊瑚树的部分装饰构件储藏于塑像底座后面。

Decorative elements from the *chaotianhou* and pieces of the coral trees were found stored behind the sculpture base.

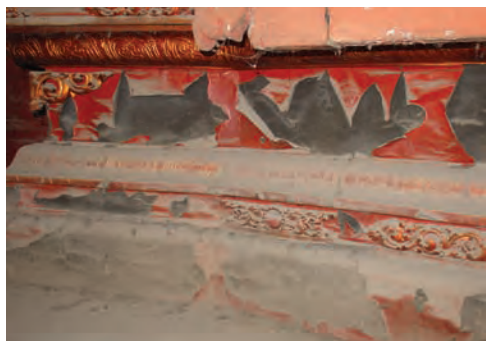
塑像底座漆面剥落和大面积脱落。

Peeling paint and large areas of loss on the sculpture base.

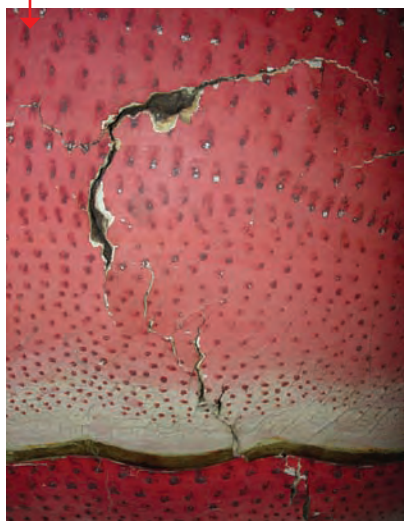
裂缝细部。
Detail of a crack.

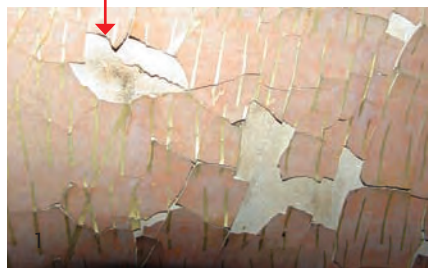
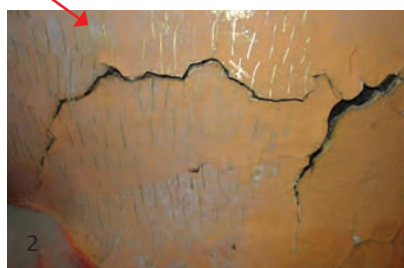
1. 起甲及脱落区域
Flaking and areas of loss
2. 裂缝细部
Detail of a crack

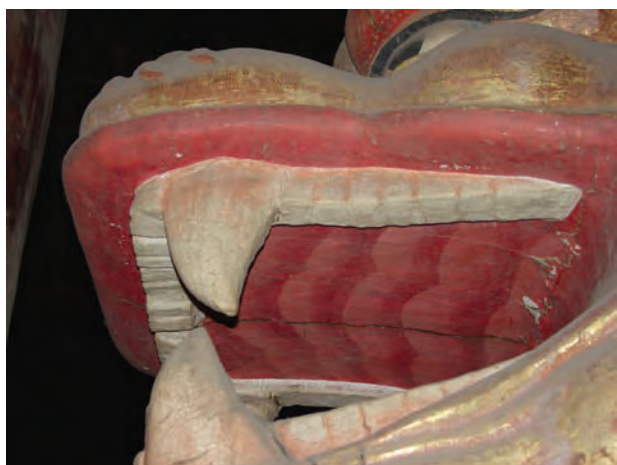
朝天吼上悬挂的装饰物细部，可见灰尘堆积以及涂层脱落。

Detail of ornament hanging from the *chaotianhou* showing dust accumulation and losses in the paint layer.

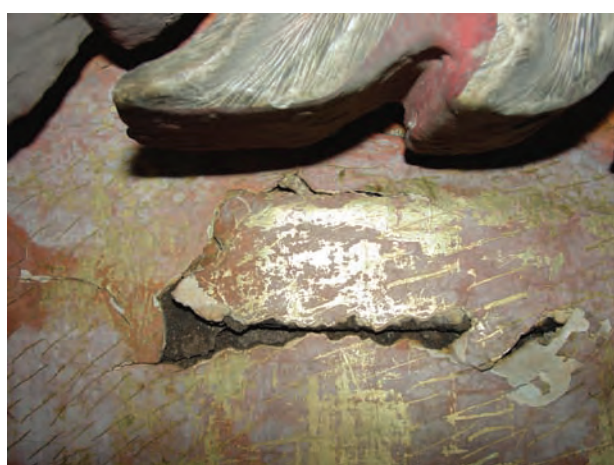
表面涂层脱落的详图，露出了其下的金箔层。

Detail showing losses in the upper paint layer revealing the gold leaf layer below.

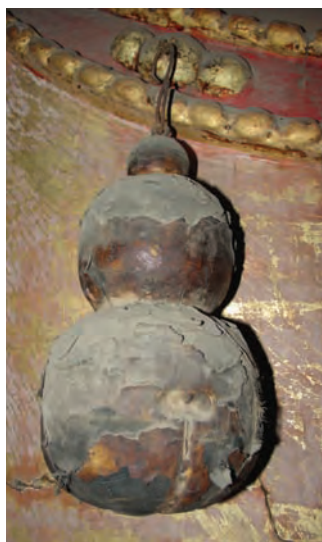
开裂及缺失部位细部。

Detail of an area of cracking and loss.

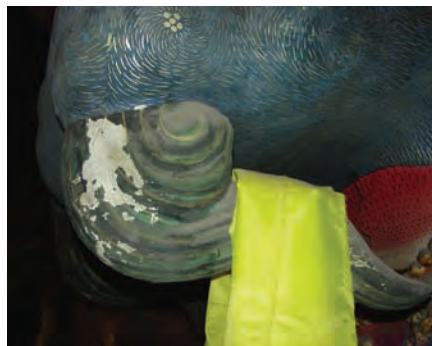
狮子下颚油漆层脱落的详图。

Detail of area of paint loss on lion's chin.

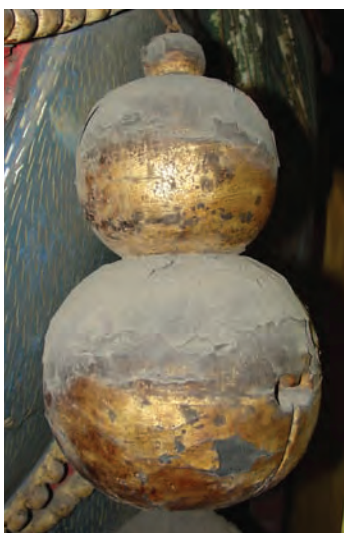
狮身悬挂的一个装饰物，其上可见大量灰尘堆积。

Large amount of dust accumulation on one of the ornaments hanging from the lion.

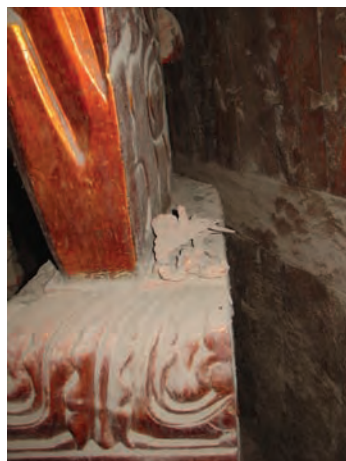
脱落的小装饰构件暂时储藏于塑像后面。

Small fallen decorative pieces are temporarily stored behind the sculpture.

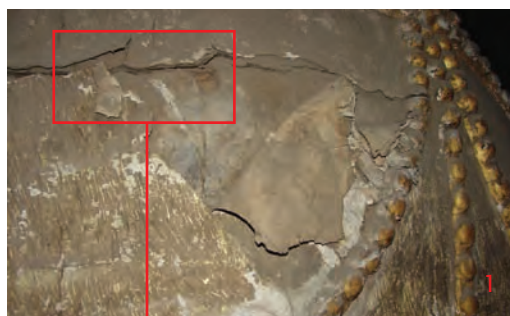
象左后部的大面积脱落。
Large area of loss on the left backside of the elephant.

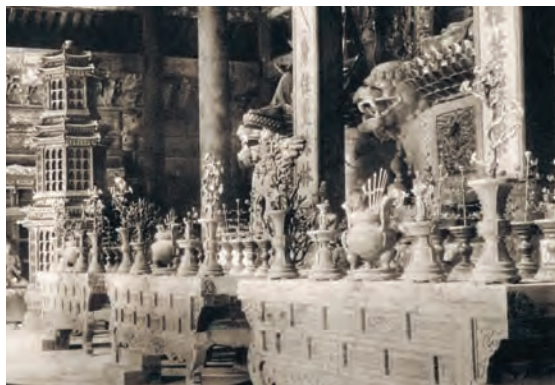
1933年关野贞的照片中显示的供桌（看不见后排的供柜）。前面的供桌可见到明显的表面漆层缺失。

1933 Sekino photograph showing the offering table (the back row of offering chests is not visible). Some losses to the painted surfaces are visible on the front of the offering tables.

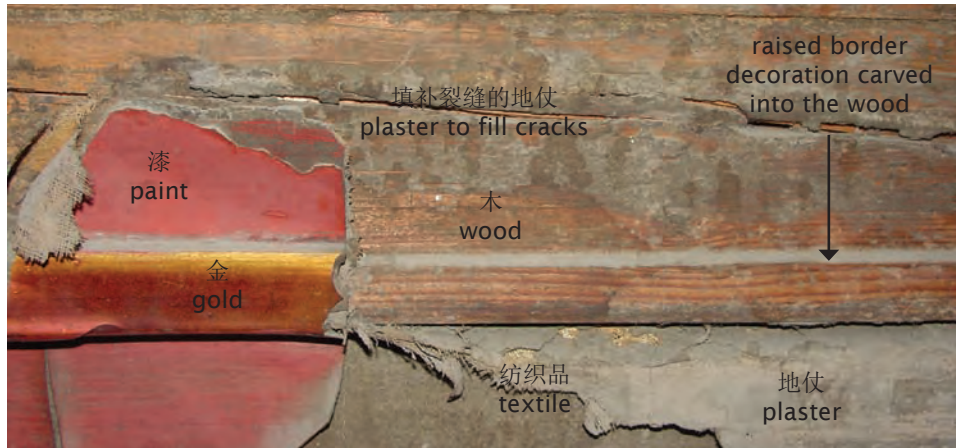
供桌上颜料地仗层的脱落显示制造的工艺和层数。

Loss in the painted plaster of the offering table shows the stratigraphy and the techniques of execution used in their construction.

注意有些凸起边缘是直接雕在木材上，再上地仗与颜料层。

Note the raised border decoration carved into the wood of the offering table before application of the painted plaster.

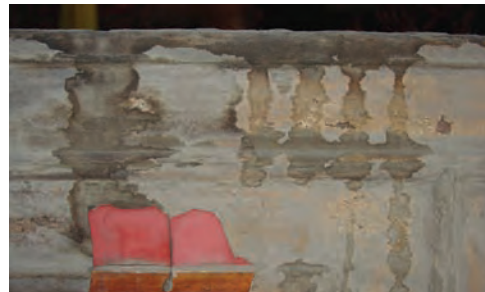
西供桌上的深色水斑。

Westernmost offering table shows darkened moisture stains.

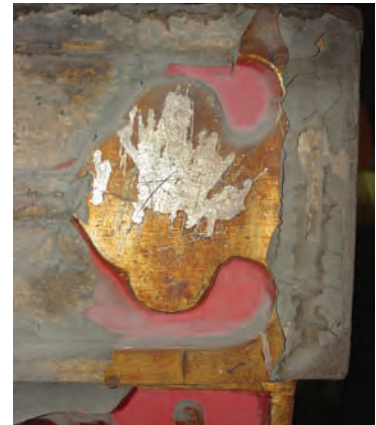
金色装饰上的擦痕明显可见。

Abrasions are visible in the gold decoration.

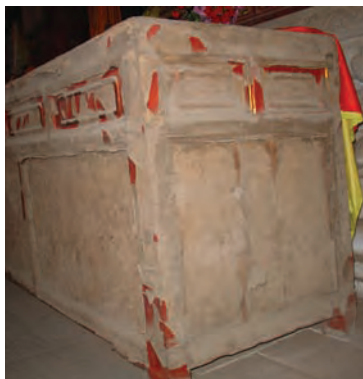
供桌侧面大量的颜料层起甲，并在这些部位有大量的脱落。

Macro flaking of paint on the sides of the offering tables. There are large areas of loss in these areas.

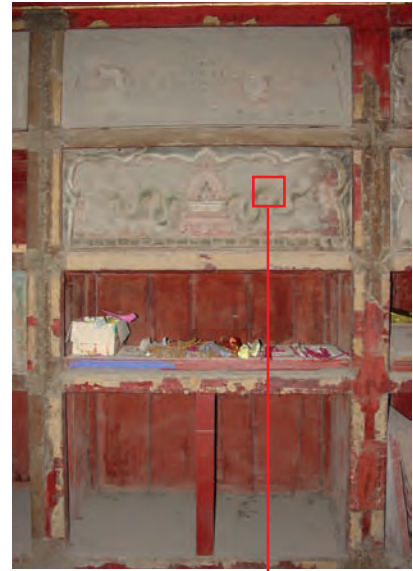
东侧经格南边算过来第三间格的经格门上有原来的装饰。注意立体装饰纹上存留精致。

East side sutra shelf door, third section from the south side, shows an area of original decoration. Note the delicate gold painting that survives on the raised decoration.

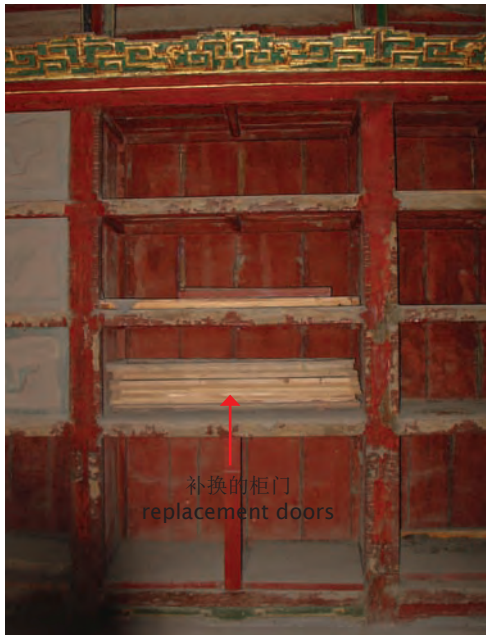
很多的经格门都已缺失。虽然有一些后来补换的门，但并没有被装上。

Many of the sutra shelf doors are now missing. However, later replacement doors exist but have not yet been attached.

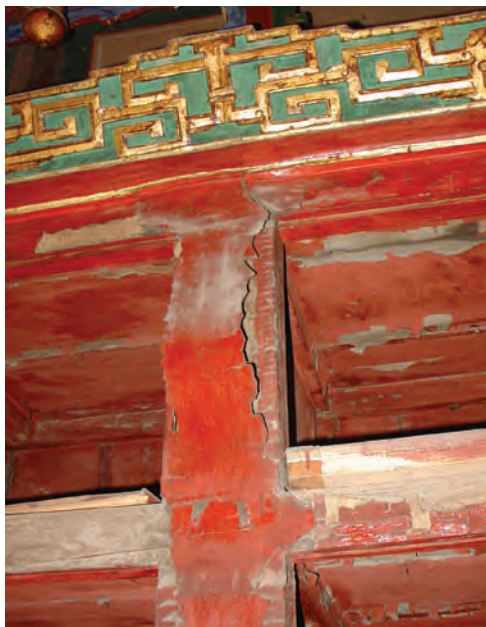
大面积空鼓的彩绘地仗。

Large detached area of painted plaster.

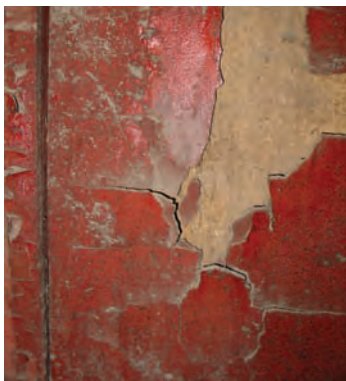
彩绘地仗上的裂缝、空鼓和完全脱落的部分。

Cracking, detaching areas and complete loss of the painted plaster.

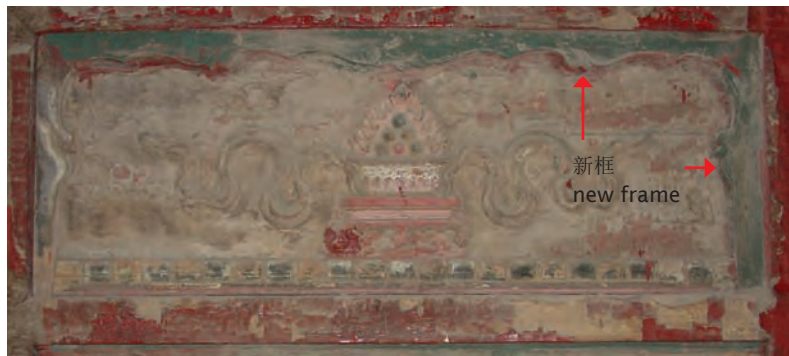
原经格门，但有补换的部分，如上沿和左沿的绿框。

Original sutra shelf door with replaced elements such as the green frame on the top and left edges.

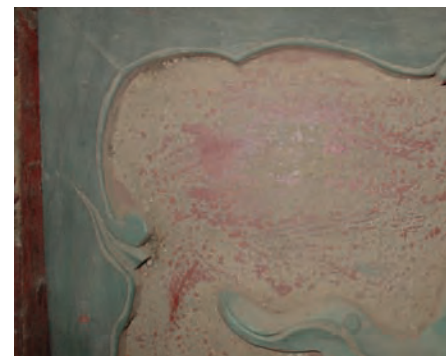
完全修复过的经格门细部。红色表面盖满灰尘，看起来很老旧。

Detail of fully restored sutra shelf door. Red surface appears to be covered with sand to give it an aged appearance.

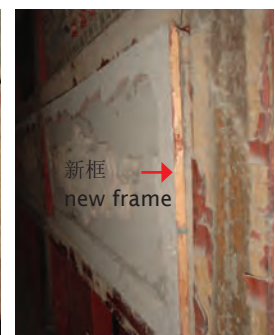
在已更换的经格门边缘可看到加在原经格门上的新框。

Edge of replaced sutra shelf door showing new frame added to original door.

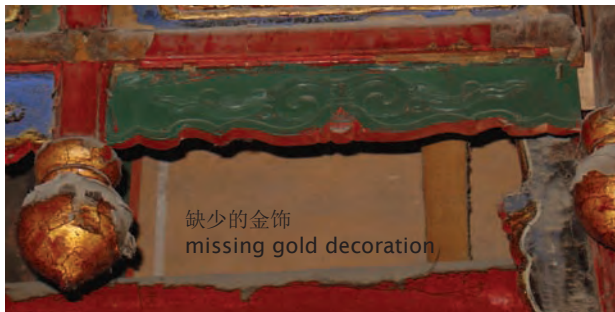
完全用绿漆重绘的部分，没有加上金色装饰。

Detail of area completely repainted with green paint. Note that the gold decoration was never added.

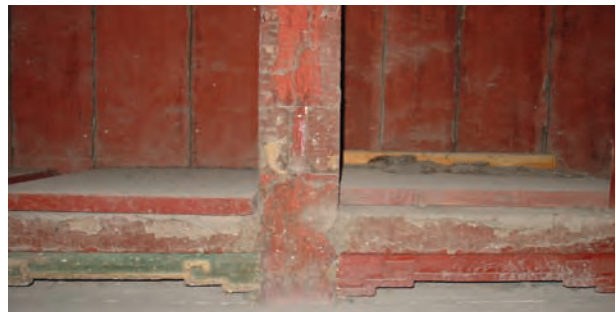
底部储物柜显示只有一边重漆过。

Detail of the lower cabinets showing that only one side has been repainted.

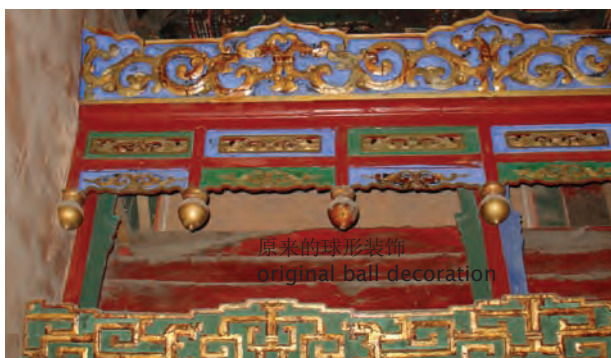
东侧经格的顶部装饰。北端四间隔完全重漆。只保存了一个原来的球形装饰。

Upper tier decoration from the east side sutra shelves. The northern four sections have been completely repainted. In this image only one of the original ball decoration remains.

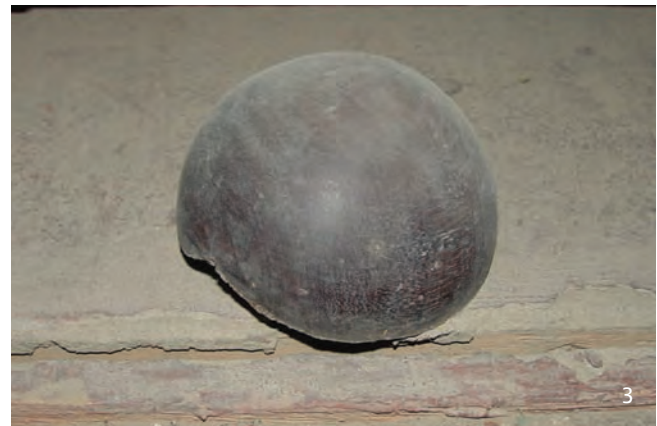
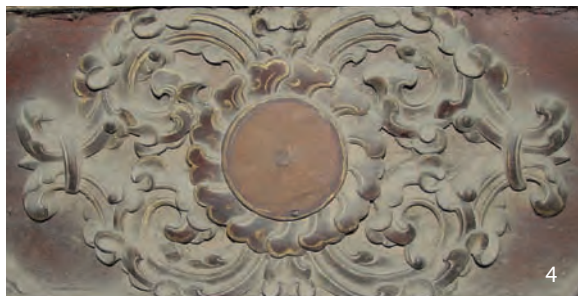
The western pagoda is in good condition with only minor missing decorative elements such as some of the ball decorations along the base, animal pieces from the roofs, hanging bells from the roof eaves and balustrades. A small hole exists in the lowest level of the pagoda.

1. 西侧木塔。
View of the west pagoda.
2. 木塔上的现代标签。
Modern label on the pagoda.
3. 木塔底部缺失的木构件。
Missing wooden pieces from pagoda base.
4. 球形装饰缺失的部分。
Detail of area of missing ball decoration.
5. 木塔底层标示缺失球形装饰的部位。
Lower level of pagoda showing locations of missing ball decoration.

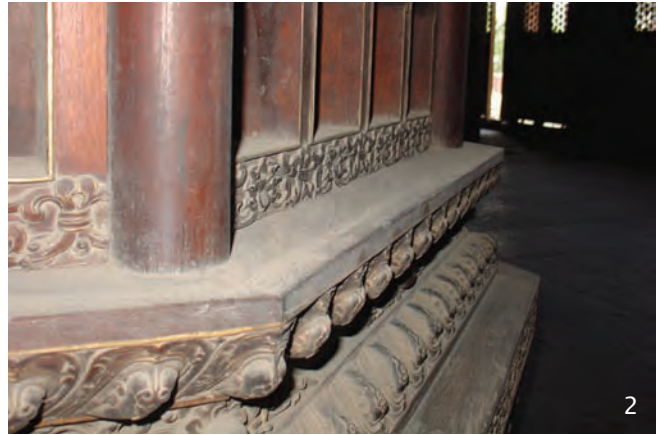
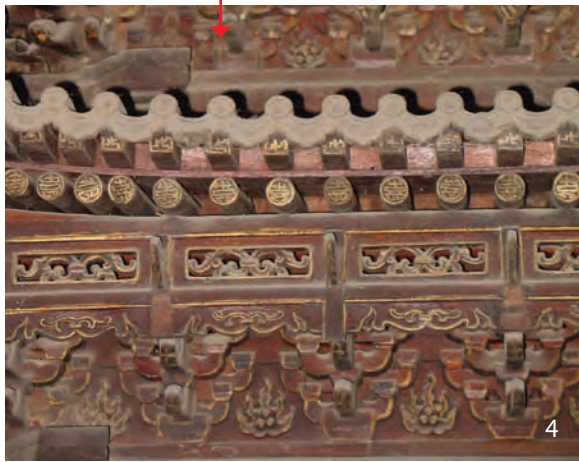
1. 木塔上的装饰性木作。
Decorative woodwork of pagoda.
2. 缺失栏杆装饰物。
Area missing balustrade decoration.
3. 插入木栏杆凹槽的详图。
Detail showing groove where wooden balustrade would be inserted.
4. 木塔上的装饰性木作详图。
Detail of the decorative wood work on pagoda.

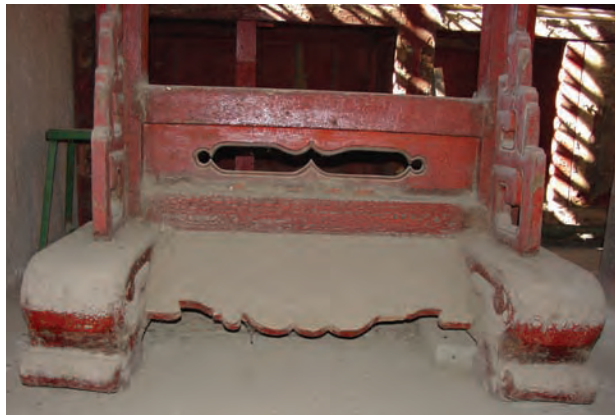
底座上的厚重尘土。

Heavy dirt deposition on stand base.

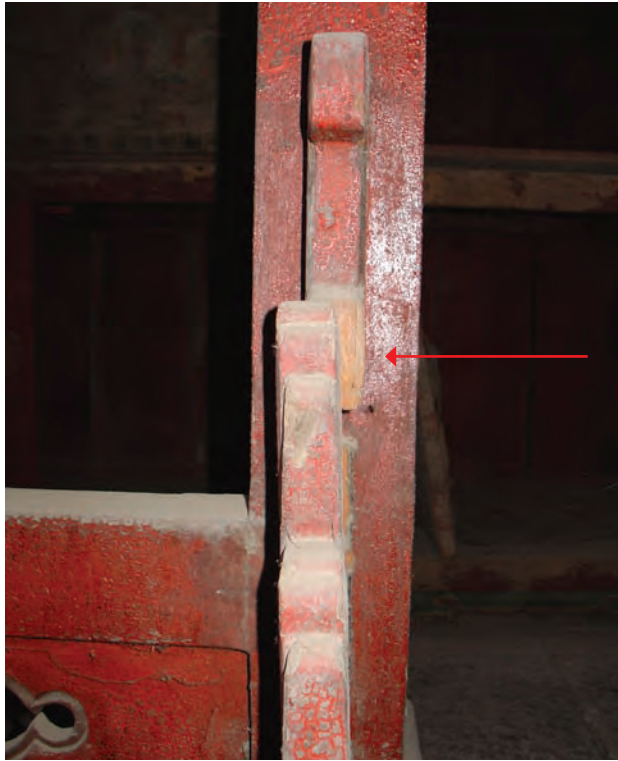
底座的装饰构件已脱离。

Decoration at base is detached.

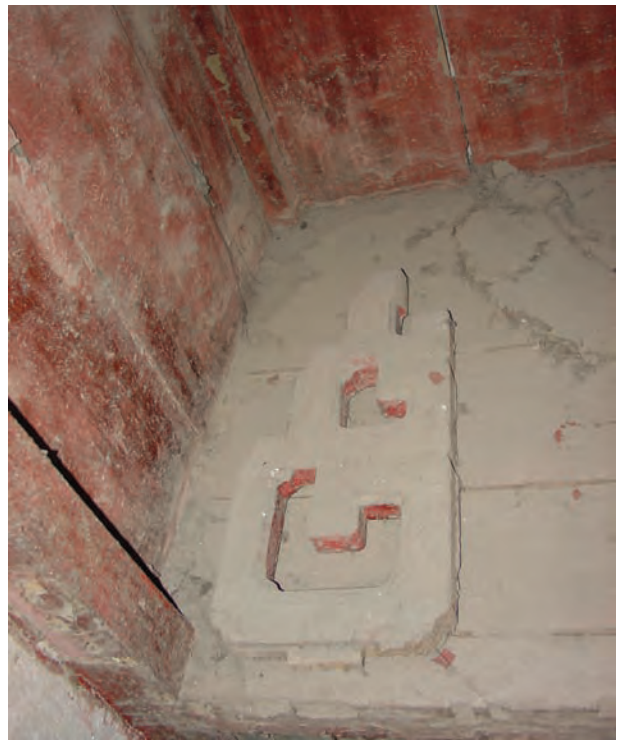
在附近的经格内发现缺失的装饰构件。

The missing decorative piece was found in a nearby sutra shelf.

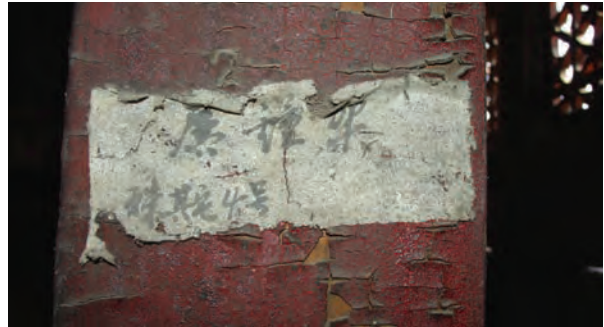
钟架底座木构件细部的详图。可看到油漆的状况。

Detail of the wooden detailing at the base of the bell stand. Note the condition of the paint.

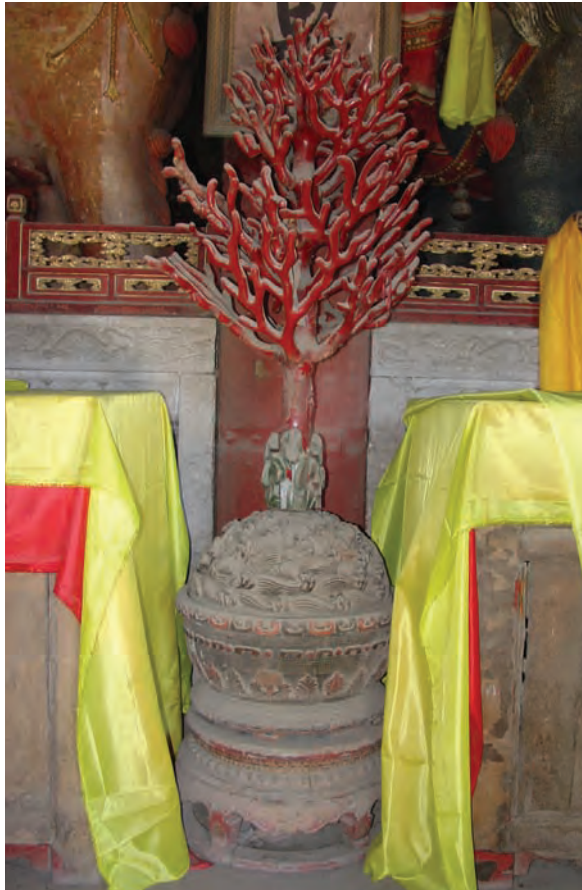
原来的四株珊瑚树只有两株保存下来。

Only two of the original four coral trees survive.

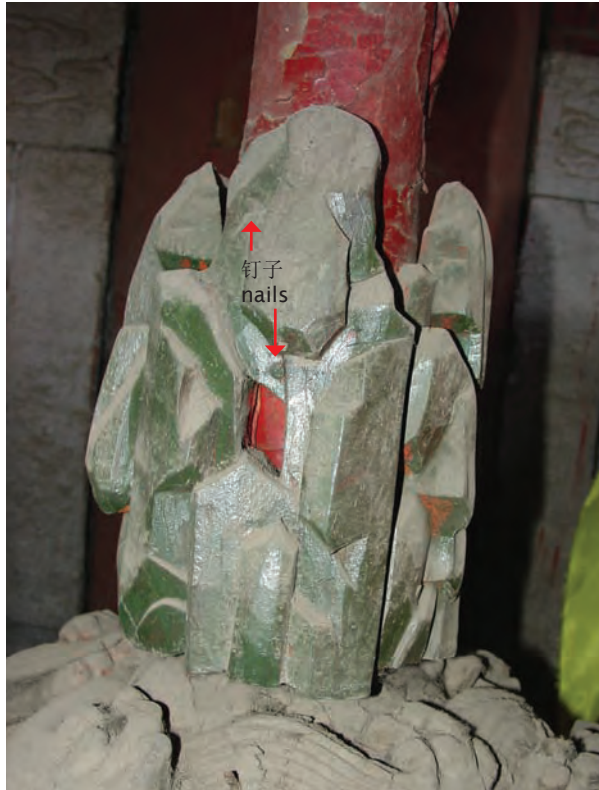
珊瑚树底部。可看见将装饰性构件钉到珊瑚树底座上的钉子。
Base of coral tree. Nails used to attach the decoration to the coral tree base are visible in this image.

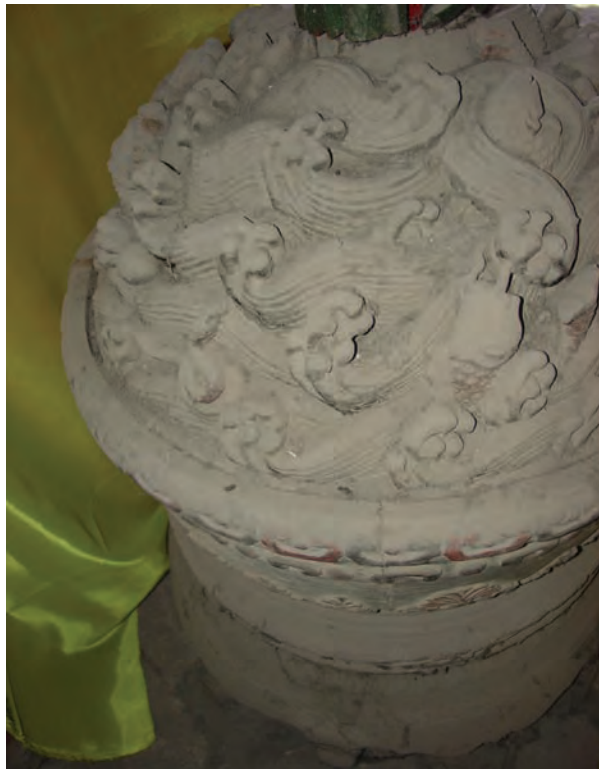
珊瑚树底座侧面图显示浮雕装饰上的裂缝和小面积脱落。
Side view of coral tree base showing showing cracks and small losses in the painted relief decoration.

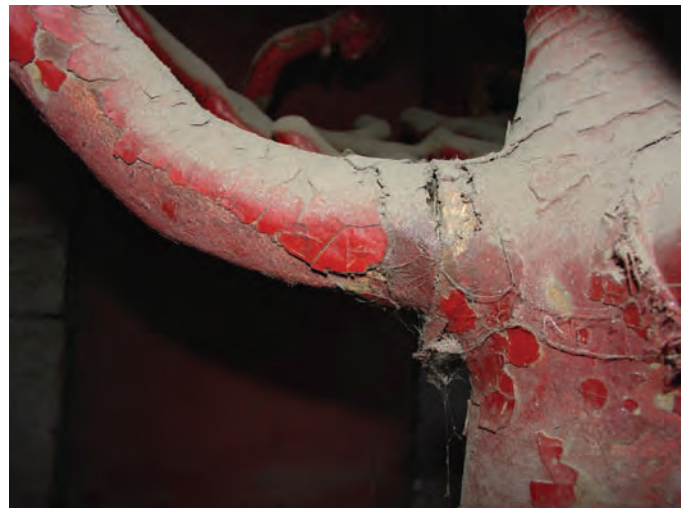
从这张图片上可以看到很多珊瑚树典型的残损状况。油饰地仗上的表面尘土、开裂、起甲和脱落。

Many of the typical conditions of the coral trees are visible here. Surface dust, cracking, flaking, and loss of the painted plaster.

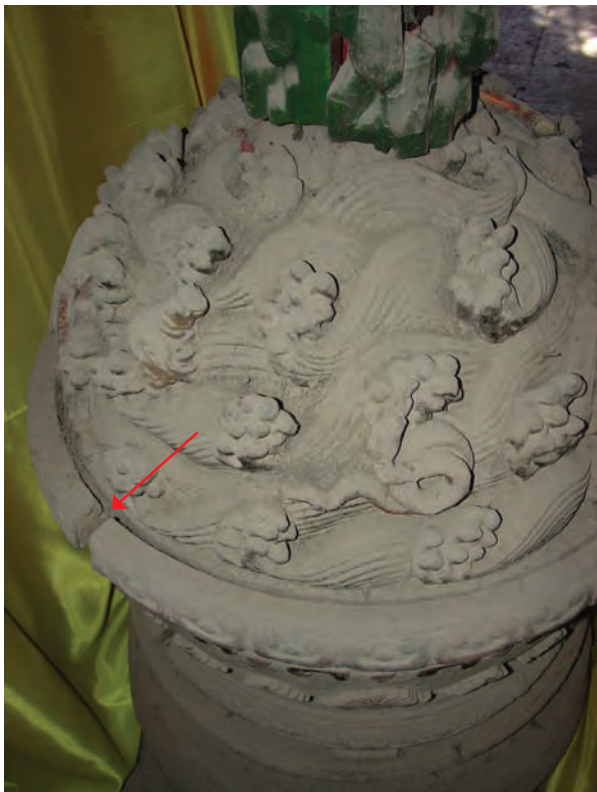
底座上一只螃蟹的详图，显示地仗装饰上轻微的脱落。
Detail of a crab on the stand showing minor losses in the plaster decoration.

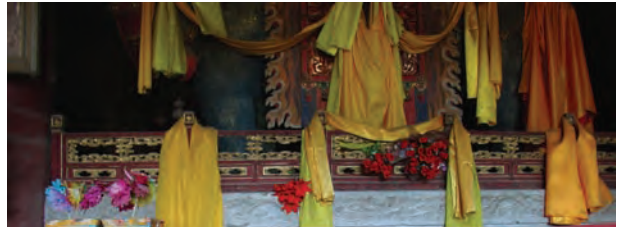
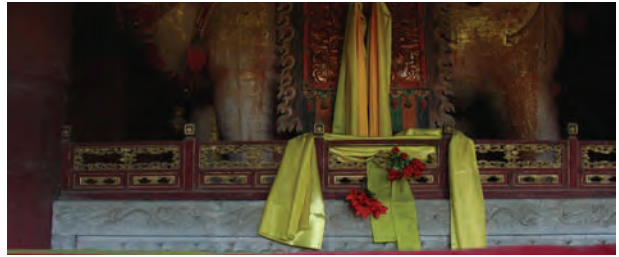
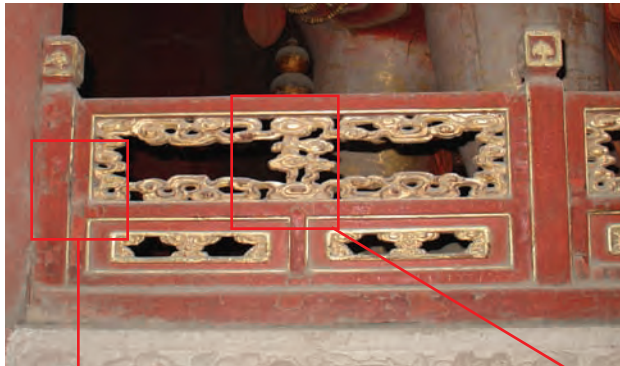
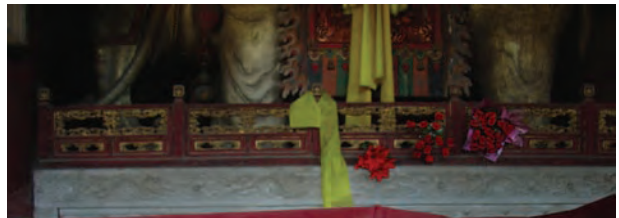
佛台上动物塑像前的装饰栏杆。
Balustrades on altar platform in front of animal statues.

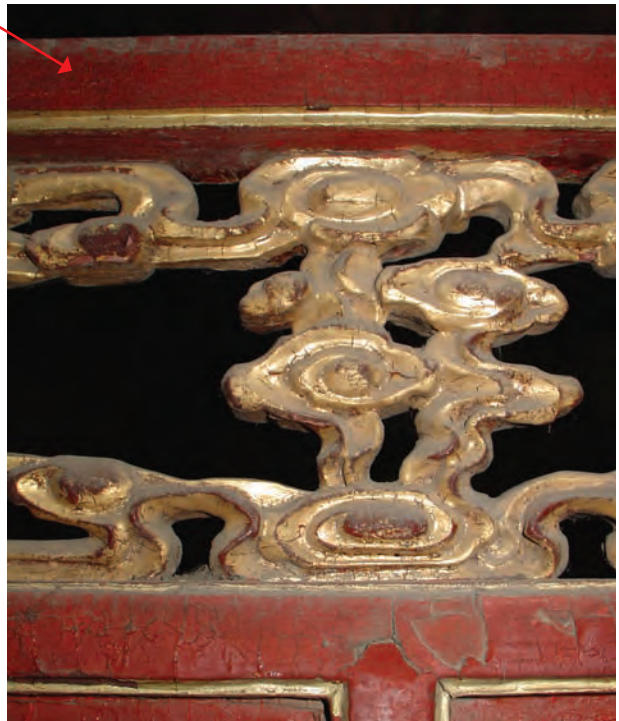
栏杆上的金色装饰详图。
Detail of gold decoration on balustrades.
